**Optimal Design of Stormwater Basins with Bio-sorption Activated Media (BAM) in Karst Environments – Phase I: Site Screening and Selection**

FDOT Phase I Final Report

Submitted December 2015

**Agency Number: BDV24-977-12**

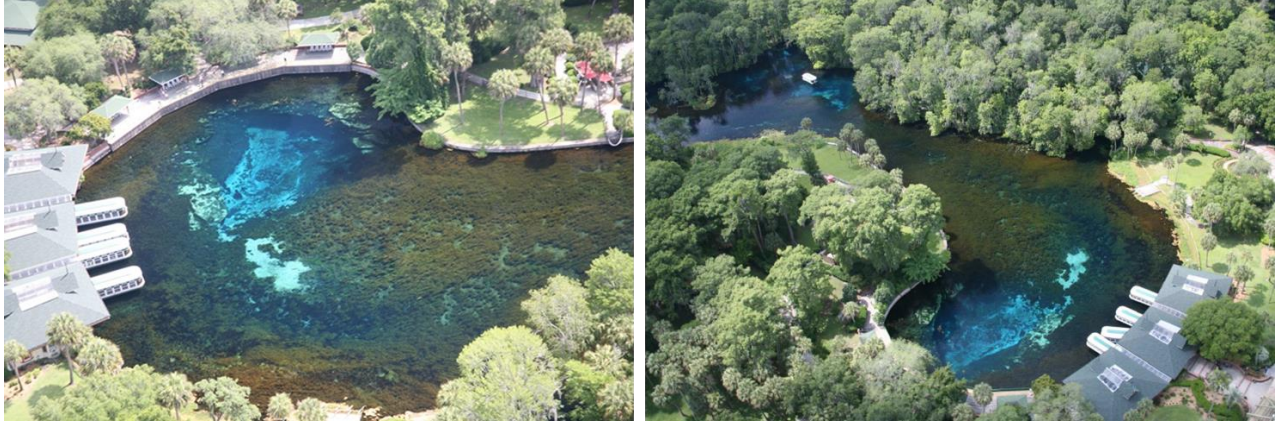
**Figure 1: Eutrophication of Silver Springs State Park**

Nutrients, particularly nitrate, are a growing concern in groundwater aquifers and springs throughout many areas in Florida. The nitrate-nitrogen concentration in many of Florida's aquifer springs has risen above  $1 \text{ mg}\cdot\text{L}^{-1}$  in recent years. This trend of increasing nutrient concentrations can be attributed to agricultural and urban land-use practices near groundwater recharge zones. A prime example of this is the Silver Springs area, located in Central Florida. Silver Springs is one of Florida's largest springs and is the source for the majority of flow in the Ocklawaha River and is the largest tributary of the St. Johns River (St. Johns Riverkeeper, 2014). Silver Springs was one of Florida's earliest major tourist attractions, famous for its glass bottom boat tours; however, these tours have since been abandoned due to eutrophication resulting from elevated nitrate concentrations, a decrease in flow rates resulting from excessive groundwater pumping, and a decline in the economy. Environmental degradation within the springshed over recent decades has resulted in nitrate-nitrogen concentrations more than 25 times higher than historic values. In addition, more than a 30% reduction in the spring flow from the long-term average (Silver Springs Restoration Plan, 2014) has been observed. These changes reveal that anthropogenic activities near the spring are having adverse effects on groundwater quality and in turn harming the quality and quantity of surface-water bodies. An aerial image of the eutrophication of Silver Springs is presented in Figure 1.

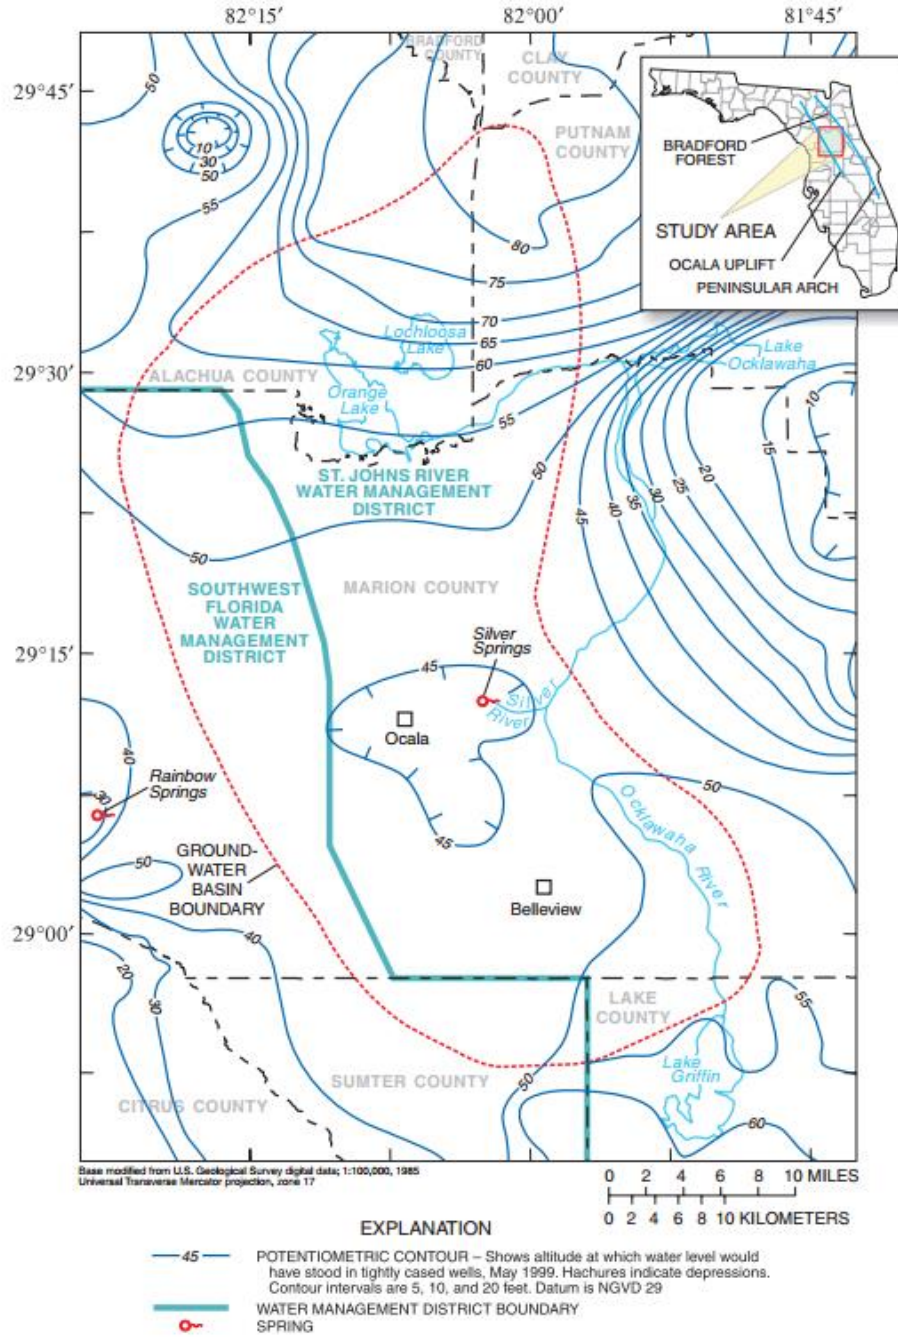
**Figure 2: Silver Springs Springshed as delineated by Phelps (2004)**

Stormwater is a relatively untapped resource when it comes to meeting today's freshwater demand. Stormwater, if properly treated and managed, could provide an alternative source of freshwater for multiple uses. Proper management to reduce nitrogen concentrations within groundwater aquifers, lakes, and springs is essential to meet freshwater demands and can be accomplished in many ways, such as stormwater retention basins and/or injection wells with underground natural or constructed treatment systems. The addition of BAM to existing treatment strategies can provide effective treatment and storage of stormwater from a variety of roadway systems. This strategy can help reduce stormwater impacts, decrease transportation costs and water loss due to evaporation. If a stormwater basin is sized based on nutrient removal standards, incorporation of a BAM treatment system can decrease the required size of the stormwater basin, resulting in decreased construction and maintenance costs and a smaller environmental footprint. The goal of this research is to provide another flexible treatment option for nutrient reduction in impaired springsheds areas, through applications of BAM. Developing nutrient control or removal plans via a BAM treatment system will contribute to restoring the Silver Springs watershed by reducing nitrogen concentrations, with the hope it may again one day be enjoyed by tourists and the people of Florida. An image of the approximate extent of the Silver Springs springshed is presented in Figure 2.

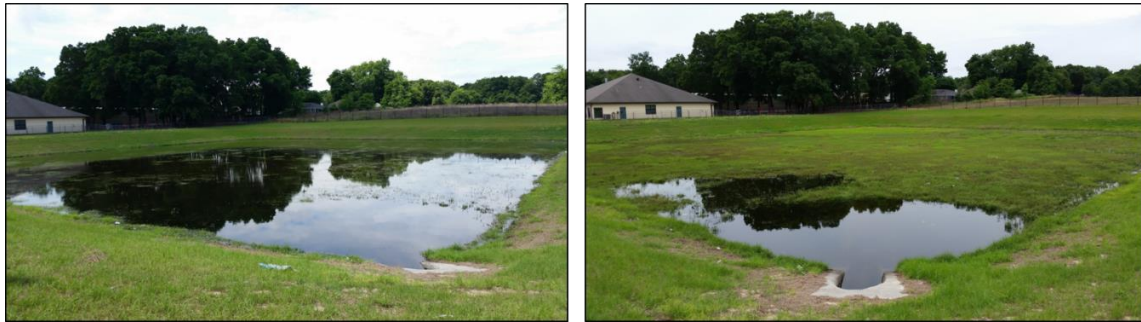
**Figure 3: SR 35 Basin 3 on April 15 (left) and April 20 (right)**

Initial sampling showed promising results and revealed the average concentration of TN in basin water at SR 35 Basin 2, SR 35 Basin 3, and SR 35 Basin 5 was above 1 mg·L<sup>-1</sup>. This result was also considered in the multi-criteria decision support system. A comparison of SR 35 Basin 3 from the April 15 to April 20, 2015, site visits is presented in Figure 3. Figure 3 shows the infiltration capacity of SR 35 Basin 3 over a time period of five days.

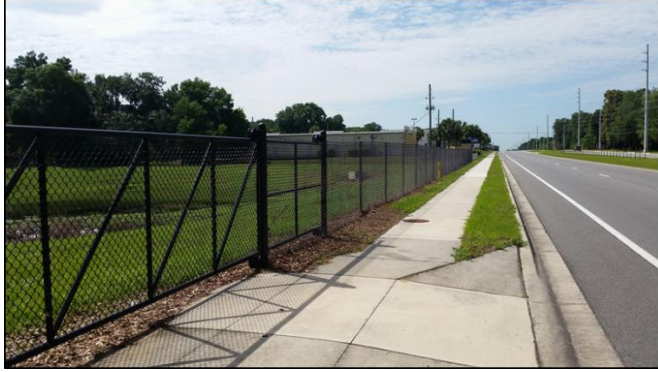
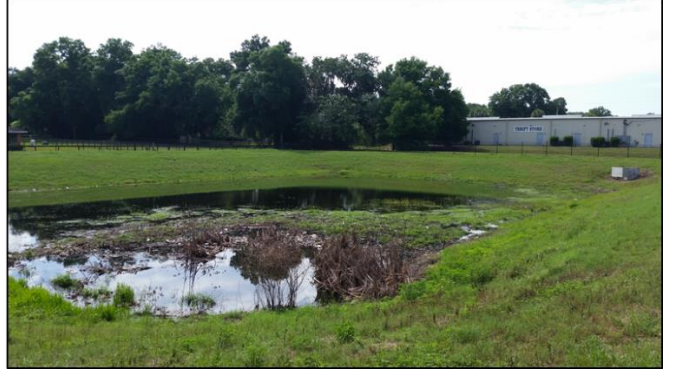
**Figure 4: SR 35 Basin 5 watershed April 15 (left) and April 20 (right)**

Images of SR 35 Basin 5 are presented in Figure 4. The watershed as well as the basin conditions during the April 15, 2015, site visit can be seen in Figure 4. SR 35 Basin 2 is presented in Figure 5. On the April 15 site visit there was a small quantity of water present in the inlet pipes of SR 35 Basin 2, however, on the April 20 site visit there was no water present in the stormwater basin. Lastly, SR 35 Basin 9a/9b can be seen in Figure 6. There was no water present in SR 35 Basin 9a/9b during either the April 15 or April 20, 2015, site visits. It is interesting to note that SR 35 Basin 9a/9b is located directly across the street from the Silver Springs State Park and recreational water park slides could be seen from the roadway during the site visits.

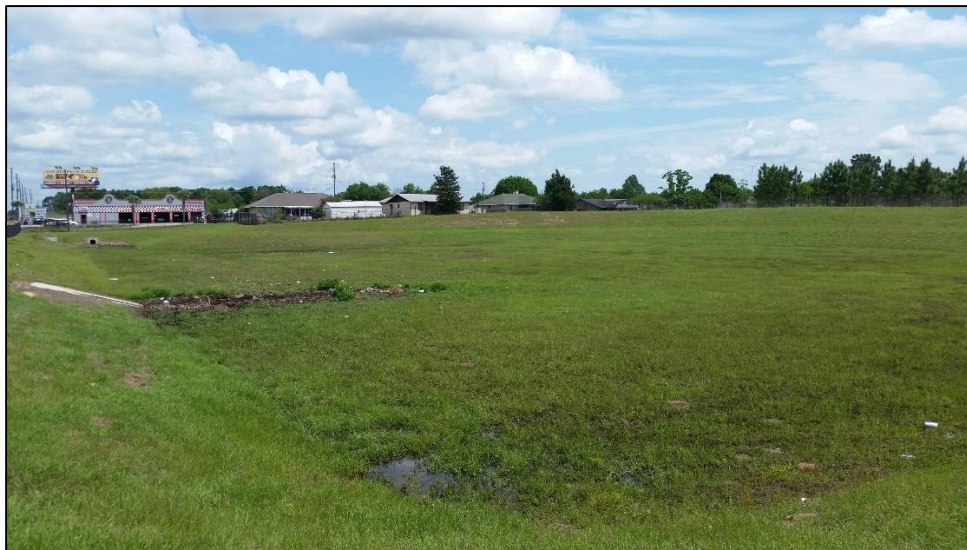
**Figure 5: SR 35 Basin 2 (same dry condition all visits)**

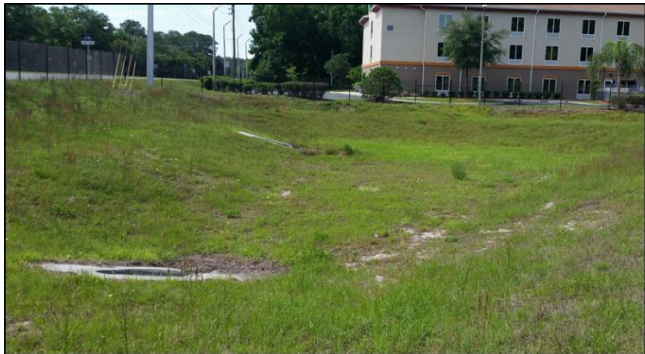
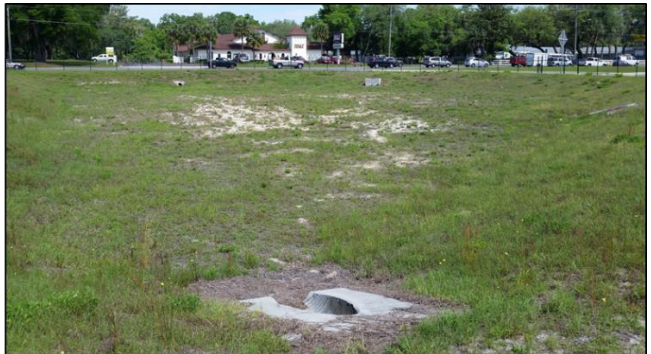
**Figure 6: SR 35 Basin 9a (left) and SR 35 Basin 9b (right) (same dry condition all visits)**

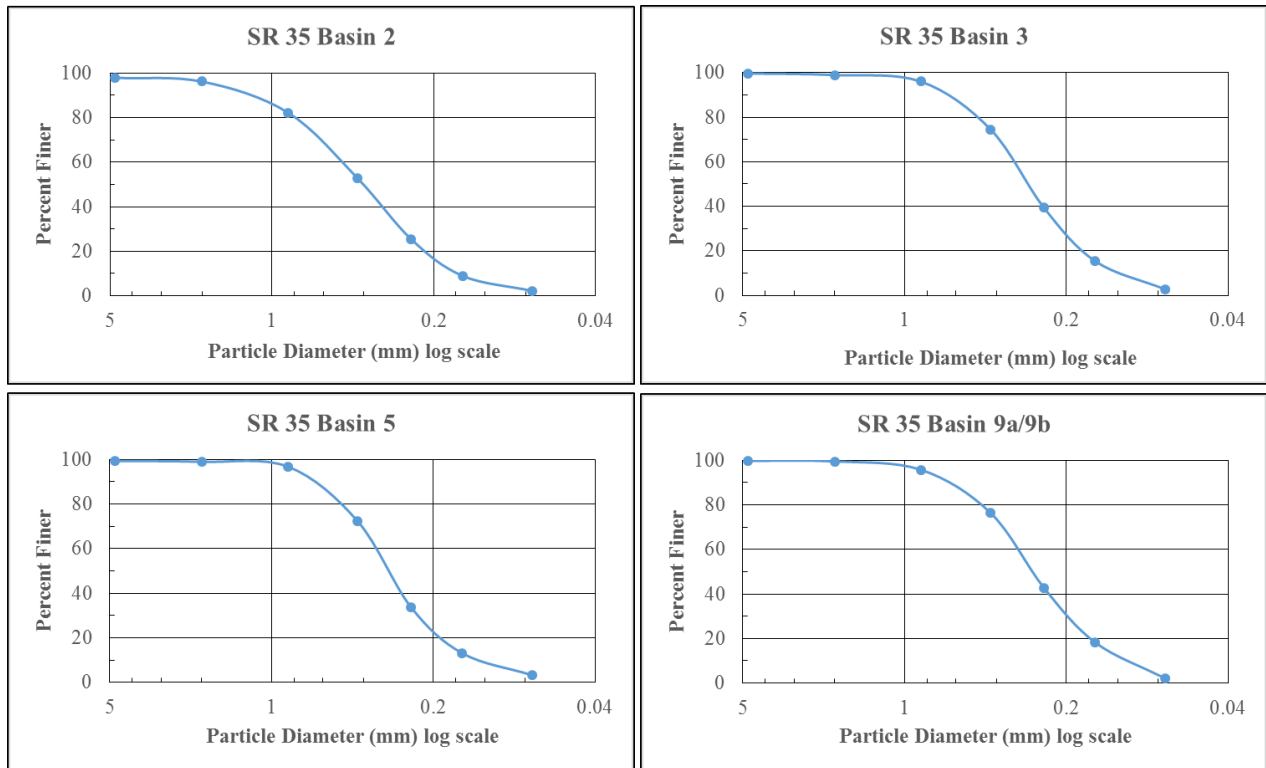
**Figure 7: Sieve analysis results**

Soil samples were collected from the four stormwater basins on April 15, 2015, using a hand auger. These samples were tested using a sieve analysis to document the soil characteristics near the ground surface. The soil samples collected contained a distribution of soil from the ground surface to a depth of roughly four feet. The soil characteristics near the ground surface are important because they disclose essential soil characteristic for determining water retention and infiltration rates through the top soil layer. Understanding these characteristics is vital to the process of selecting the two stormwater basins for BAM application during Phase II and reveal why some stormwater basins held water (ponded environments) and others were dry during the site visits. The results of the sieve analysis on soil collected from each of the four stormwater basins is presented in Figure 7. Soil characteristics obtained from the sieve analysis are presented in Table 7.

Based on interpretation of sieve analyses, the soil found between the ground surface and a depth of four feet can be classified as poorly graded sand with little or no fines (SP) for each of the four stormwater basins. The similarity of the soil types to a depth of four feet suggests the soil causing water to be retained or infiltrated is likely found at depths greater than four feet, or other soil properties exist to reduce infiltration rates. These other properties were investigated using GPR and mechanical soil borings. The uniformity coefficient ( $C_u$ ) for these soil samples ranges from 2.92 to 3.25. The coefficient of gradation ( $C_c$ ) of the soil samples ranges from 1.04 to 1.17. In order for a sand to be classified as well graded, the following criteria must be met,  $C_u \geq 6$  and 1

$< C_c < 3$ ; thus, these samples are classified as poorly graded. Poorly graded soils will typically have better drainage rates than a well graded soil because there are more available void spaces for water to infiltrate in a poorly graded soil. Images of the soil samples collected from each of the stormwater basins are presented in Figure 8. It should be noted that because samples were only collected from one location within the stormwater basins and to a depth of four feet, these results may not accurately depict the soil characteristics of the whole stormwater basin and are only a preliminary source of data.

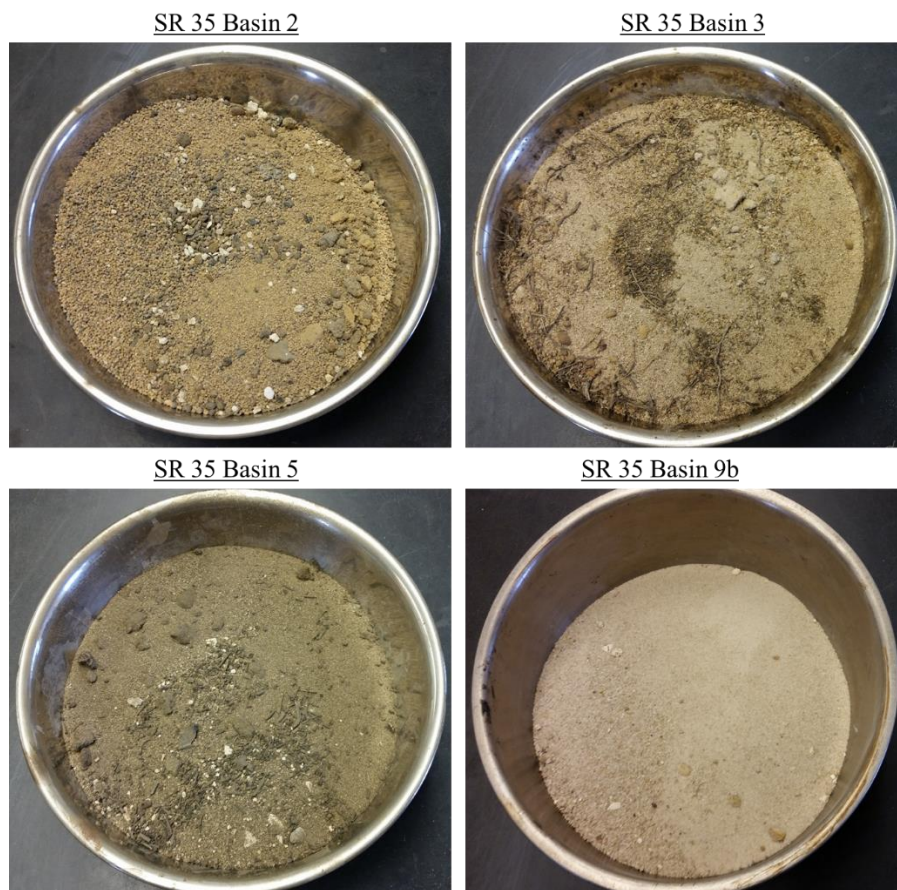
**Figure 8: Collected soil samples**

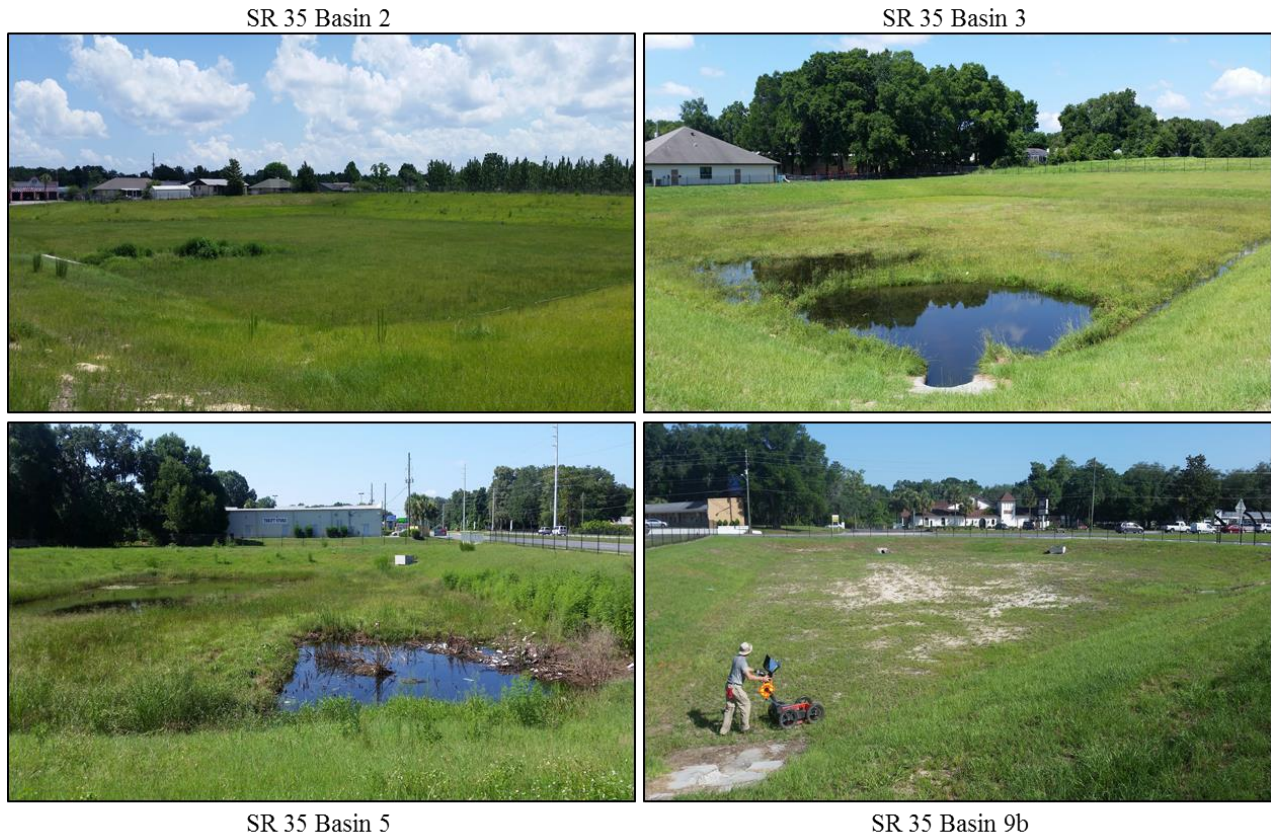
**Figure 9: Basin conditions during GPR investigation**

SR 35 Basin 9b and SR 35 Basin 2 were both dry during the GPR investigation and the GPR survey was conducted along a series of perpendicularly oriented transects spaced 25 ft. apart (see figures in Appendix B). SR 35 Basin 3 and SR 35 Basin 5 were both holding water during the time of the investigation so the GPR survey was conducted along the four sides of the basin berm. The GPR data were collected from all four stormwater basins using a GSSI radar system with a 270-Megahertz antenna. The time range setting used for the GPR data collection was 100 nanoseconds, which provided a maximum depth of investigation of between 16 and 17 feet below the ground surface. Images of the stormwater basin conditions during the GPR investigation are presented in Figure 9.

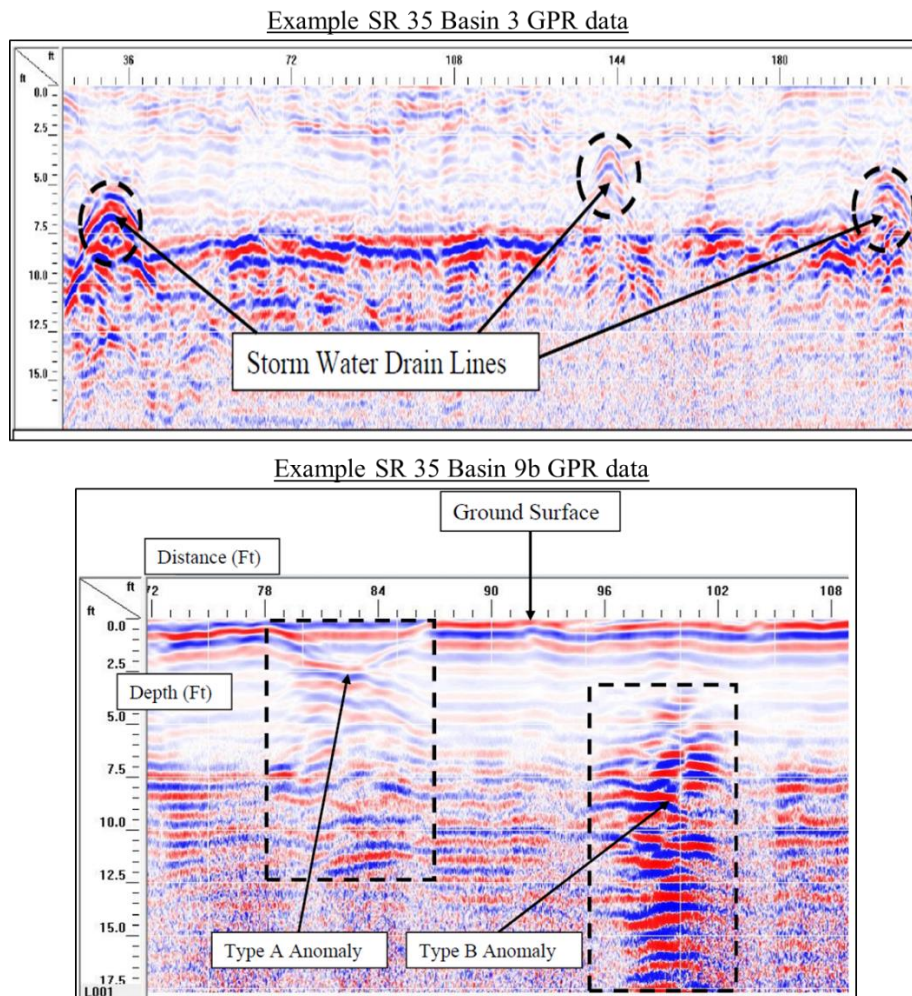
**Figure 10: GPR data comparison of SR 35 Basin 3 (top) and SR 35 Basin 9b (bottom)**

Examples of the GPR data obtained from the analysis of all four stormwater basins are presented in Figures 10 and 11. These data validated that the uniform and consistent sandy clay to clayey sand layer found within SR 35 Basin 3 and SR 35 Basin 5 is inhibiting water infiltration and causing the stormwater basins to retain water. As seen in Figures 10 and 11, the presence of karst features (denoted as Type A and Type B anomalies) is providing areas of enhanced permeability within SR 35 Basin 9b and SR 35 Basin 2, allowing the stormwater runoff to concentrate in these areas and easily infiltrate to deeper soil layers. This phenomenon explains why SR 35 Basins 9b and SR 35 Basin 2 have been predominantly dry during all site visits. Due to SR 35 Basin 3 and SR 35 Basin 5 having a uniform layer of soil consisting of sandy clay to clayey sand that is causing the stormwater basins to retain water, it is likely that these stormwater basins will not be suitable candidates for additional BAM-related studies.

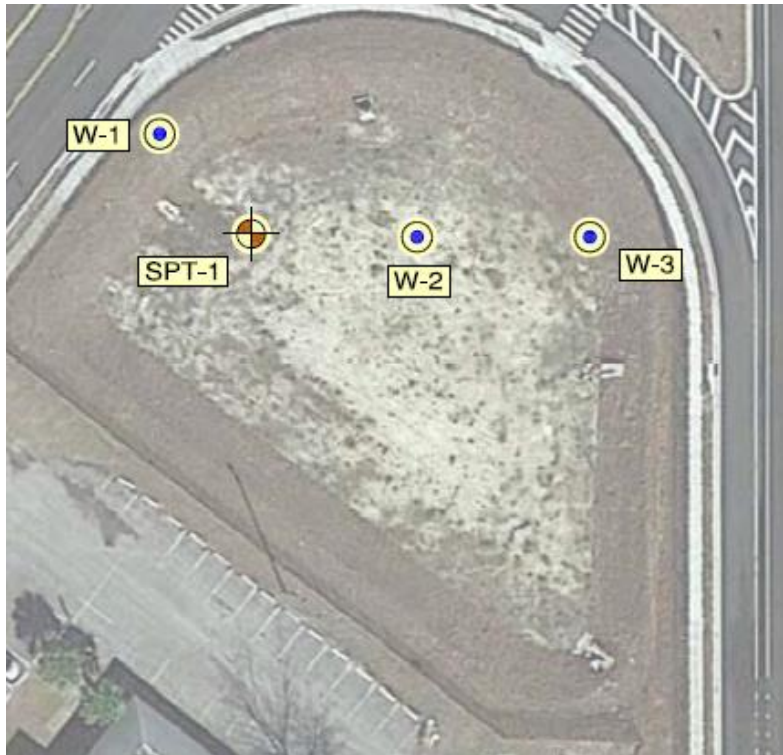
**Figure 12: Well locations at SR 35 Basin 9b**

One SPT boring (SPT-1) was performed to a depth of ten feet and four PVC observation wells were installed at SR 35 Basin 9b. An image of the boring locations for SR 35 Basin 9b is presented in Figure 12. Details of the observation well construction and depth to groundwater table for each well is detailed in Table 10.

Soil samples obtained from SPT-1 and SPT-2 were reviewed by a geotechnical engineer to identify soil descriptions. The well logs of the SPT at each stormwater basin are presented in Appendix C. The results of SPT-1 at SR 35 Basin 9b show sand (SP) in the first 3.5 feet of soil. The soil then transitions to clayey sand (SC) from a depth of 3.5 to 5.5 feet. After a depth of 5.5 feet the soil transitions to limerock to a depth of 10 feet, where the boring was terminated. The groundwater table was observed at a depth of 5.8 feet. The soil classification matched the results of the sieve analysis discussed earlier in the report for roughly the first four feet of soil. The comparison of the GPR anomalies found and the results of the SPT performed at SR 35 Basin 9b were consistent and directly over a large Type B anomaly. Type B anomalies represent a localized increase in sand content or a decrease in soil density, which could be explained by the limerock soil layer found between 5.5 and 10 feet.

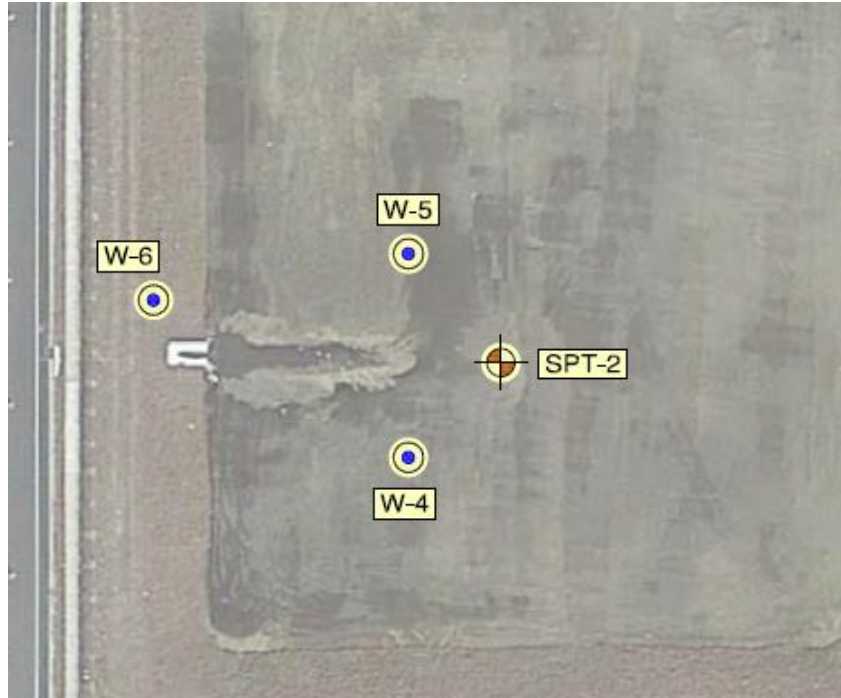
**Figure 13: Well locations at SR 35 Basin 2**

One SPT boring (SPT-2) was performed to a depth of 26 feet and four PVC observation wells were installed at SR 35 Basin 2. An image of the boring locations for SR 35 Basin 2 is presented in Figure 13. Details of the observation well construction and depth to groundwater table for each well is detailed in Table 11.

The results of SPT-2 at SR 35 Basin 2 show sand (SP) from the ground surface to a depth of 26 feet. The groundwater table was observed at a depth of 24.2 feet. The SPT was the only boring to discover the groundwater table at SR 35 Basin 2, the other three auger borings were drilled to a depth of 20 feet (not deep enough to reach the groundwater table). The location selected for SPT-2 revealed the soil is much more uniform and the groundwater table is located far deeper when compared to SR 35 Basin 9b. The location selected for SPT-2 was located near two Type A anomalies discovered during the GPR, however, there were no variations in soil characteristics observed in the SPT.

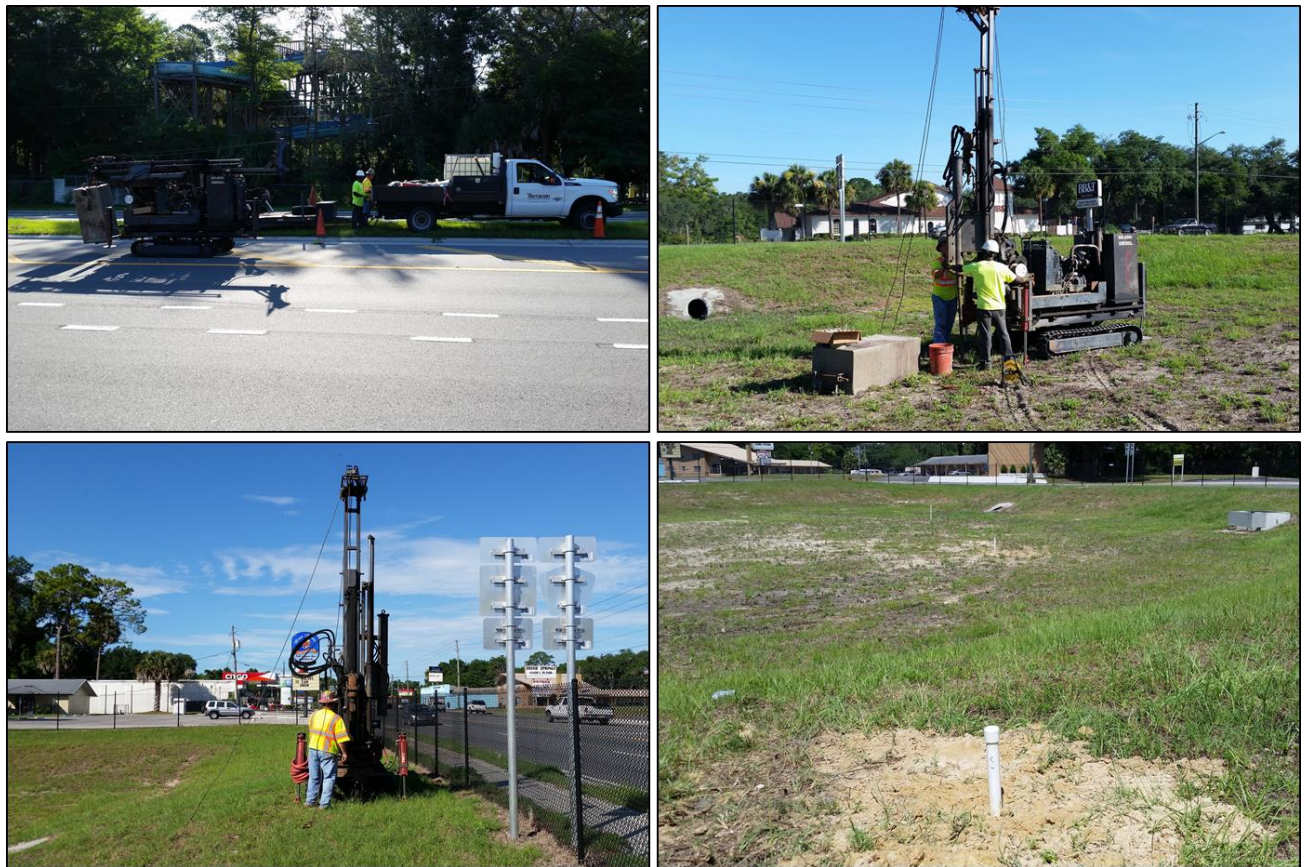
**Figure 14: SPT and well installation at SR 35 Basin 9b**

Photographs taken during the field work conducted on June 24, 2015, are presented in Figures 14 and 15 for SR 35 Basin 9b and SR 35 Basin 2 respectively.

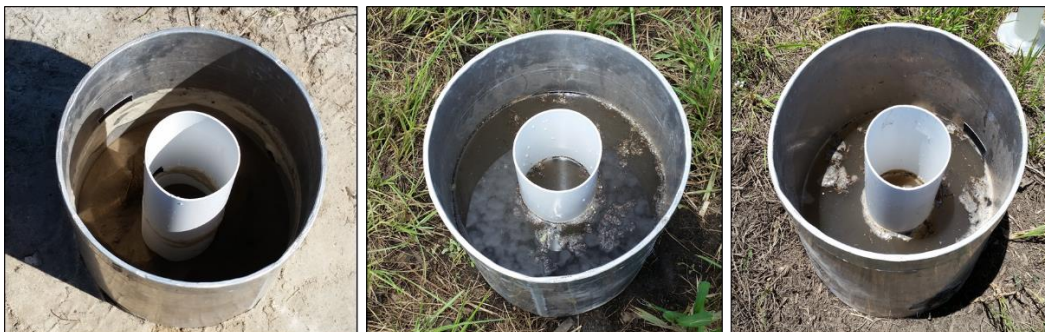
**Figure 16: Double ring infiltrometer test at SR 35 Basin 9b (left), SR 35 Basin 2 near inlet (middle), SR 35 Basin 2 center of stormwater basin (right)**

On June 24, 2015, a double ring infiltrometer test was conducted at SR 35 Basin 9b and SR 35 Basin 2. Infiltrometers are devices used to measure the rate of water infiltration into soil or other porous media. The most commonly used infiltrometers are a single ring or double ring infiltrometer. The double ring infiltrometer test was conducted in the center of SR 35 Basin 9b and at two locations within SR 35 Basin 2 (near the inlet along SR 35 and in the center of the stormwater basin). Two locations were selected for SR 35 Basin 2 because water was observed to be pooling around the inlet (see Figure 15), while the rest of the stormwater basin was dry. The interest was in characterizing changes in soil permeability from the inlet to the center of the stormwater basin. The test was performed by first driving a four-inch diameter PVC pipe eight inches into the ground. Next, a twelve-inch diameter aluminum pipe was driven eight inches into the ground, so that it surrounded the smaller four-inch pipe. Next, water was poured into the pipes until the water level in each pipe reached a height of five inches. As water within the pipes

infiltrates into the soil, the water level within the pipes begins to drop. The objective of the test is to keep the water level constant within the pipes by adding additional water when the height drops below the five-inch mark. Every 15 minutes, the volume of water added to both the inner and outer pipes to keep the water level constant at five inches was recorded. Each test was conducted for a time period of one-hour. Images of the double ring infiltrometer tests are presented in Figure 16.

The results of the double ring infiltrometer tests are presented in Table 12. SR 35 Basin 2 – Test 1 was performed near the inlet and SR 35 Basin 2 – Test 2 was performed in the center of the stormwater basin. As would be expected from the observation of pooling water near the inlet of SR 35 Basin 2, the infiltration rate of the soil near the inlet was much lower when compared to the soil in the center of the stormwater basin. The infiltration rate of the soil in the center of SR 35 Basin 9b was higher when compared to SR 35 Basin 2. This finding explains why SR 35 Basin 9b has been dry during all site visits, while SR 35 Basin 2 has had some minor pooling near the inlet and sporadically throughout the basin. The presence of very permeable soil, the anomalies found during GPR, and the higher water table leads to the conclusion that stormwater in the basin infiltrates faster through the vadose zone at SR 35 Basin 9b and may not be receiving sufficient residence time for nutrient removal before entering the groundwater table. Conversely, the soil type at SR 35 Basin 2 and large vadose zone is most likely not providing nitrate removal before the water enters the groundwater.

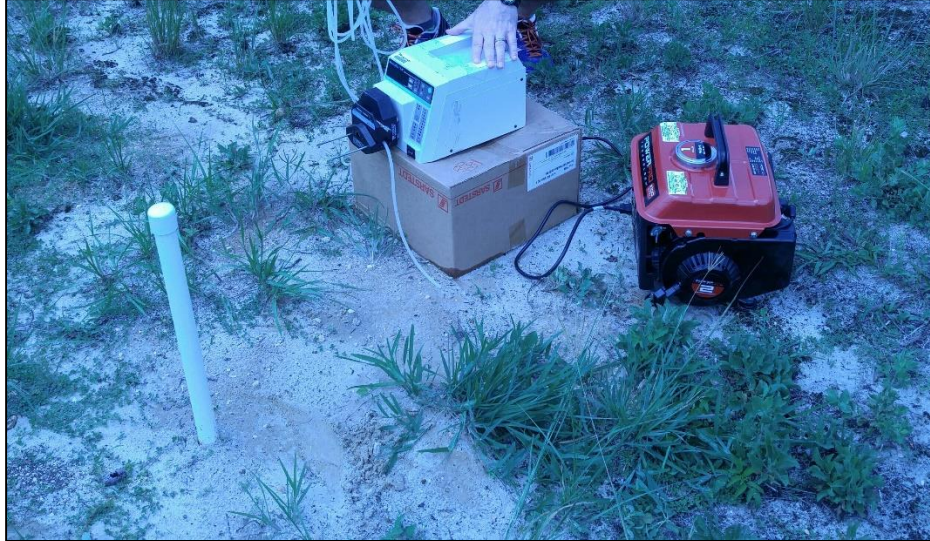
**Figure 17: Groundwater sampling at SR 35 Basin 9b**

On July 26, 2015, groundwater samples were collected from the groundwater monitoring wells constructed during Task 2 at SR 35 Basin 9b. A portable generator and peristaltic pump were utilized to pump groundwater out of the monitoring wells (shown in Figure 17). One sample was collected from each monitoring well at SR 35 Basin 9b. The resulting TN concentration of each groundwater sample is presented in Table 15. The location of each groundwater monitoring well can be found in Figure 12. These results show the TN concentration in groundwater at SR 35 Basin 9b is consistently equal to or greater than  $1.0 \text{ mg}\cdot\text{L}^{-1}$ .

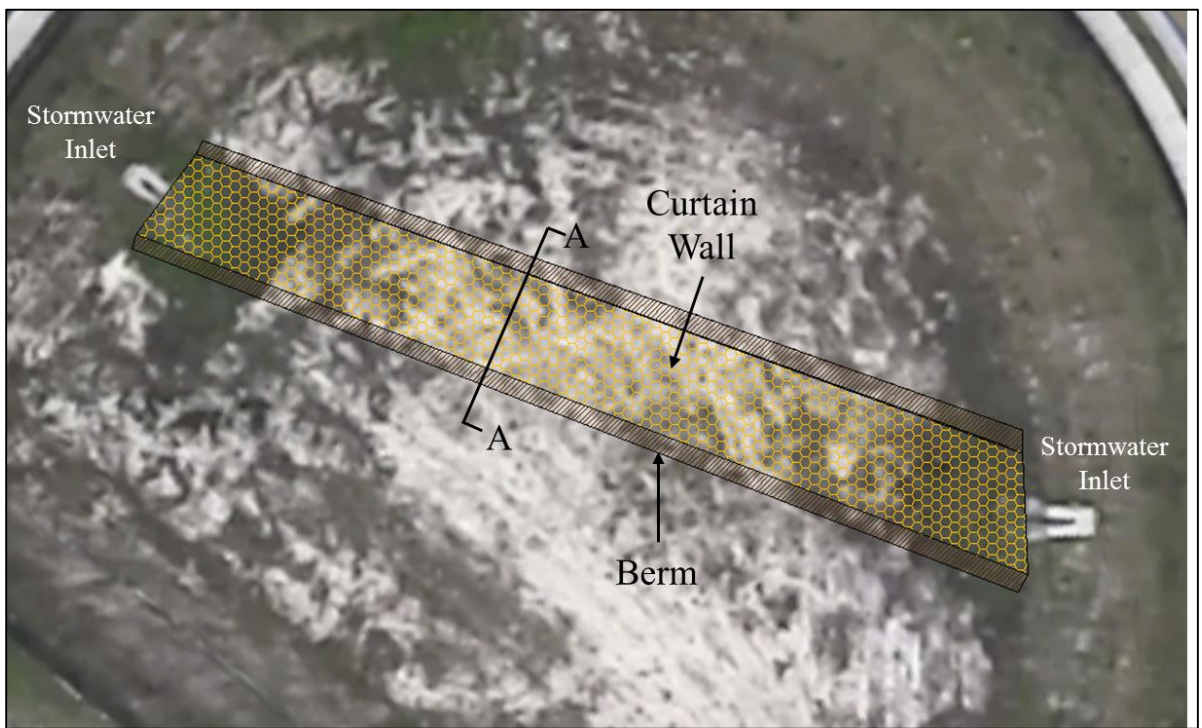
**Figure 18: Plan view of a horizontal curtain wall in Basin 9b (dimensions in feet)**

For application to Basin 9b, the goal is to remove nitrates from stormwater and groundwater by amending the stormwater basin with Bold & Gold (B&G), a type of BAM, which is a proven technology for removing nutrients and other pollutants through a combination of physical, chemical, and biological processes. Installation of a horizontally oriented curtain wall (i.e., parallel to the ground surface) may be best suited for SR 35 Basin 9b, due to the high infiltration rate and relatively shallow groundwater table in the stormwater basin. Example diagrams of a horizontal curtain wall is presented in Figure 18 and Figure 19. In this example, the 2-foot thick, 15-foot wide horizontal curtain wall would be located four feet beneath the ground surface and would intercept and treat stormwater as it percolates through the soil profile. Also, groundwater that rises above the bottom of the curtain wall will also be directed into the BAM. At Basin 9b, the water table was identified as about six feet below the ground on one occasion. The depth of the bottom of the BAM must be identified before construction.

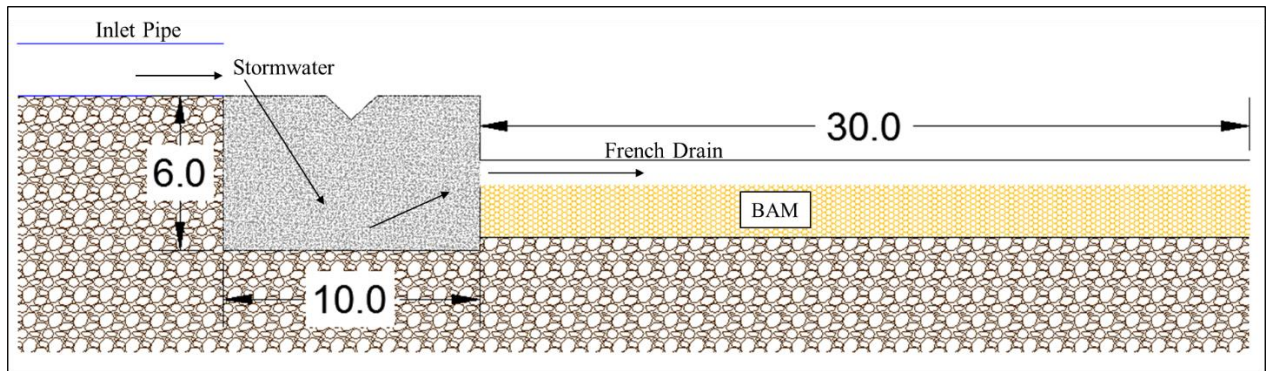
**Figure 20: Section view of a potential French drain system (dimensions in feet)**

French drains are a type of horizontal trench filled with gravel, rock, or other media that contain a perforated pipe that redirects surface water and groundwater away from an area. In stormwater management, the traditional French drain can be retrofitted with BAM to not only control stormwater quantity, but also provide stormwater treatment. By directing collected stormwater through a pipe filled with BAM, nutrients and other pollutants can be removed.

Installation of a French drain would be best suited for SR 35 Basin 2, due to the large size of the stormwater basin, deeper groundwater table, and slower infiltration rates. An example diagram of a French drain is presented in Figure 20. In this example, stormwater flowing into the stormwater basin is first collected in a concrete holding tank. As the tank begins to fill, the stormwater eventually reaches a height where the inlet to the French drain is located. As the water level continues to rise within the holding tank, stormwater begins to flow out of the concrete holding tank and is transported through a French drain filled with B&G. A 30 foot section is shown in Figure 19, but that is only for illustrative purposes. Three different lengths of French drain are recommended to test the idea of longer residence times with effectiveness. Nutrients and other pollutants are removed within the French drain through a combination of physical, chemical, and biological processes that occur within the B&G.

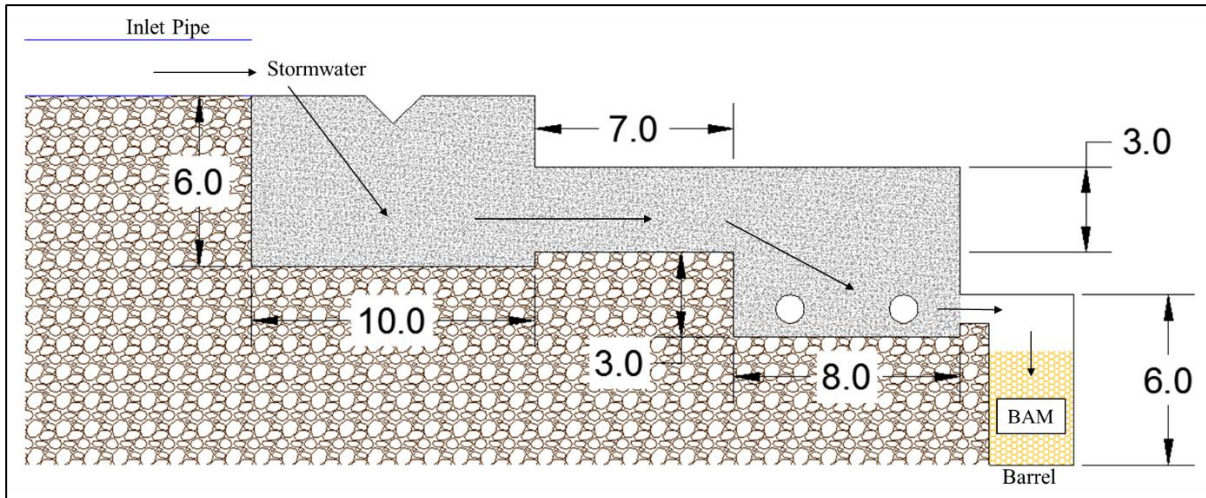
**Figure 21: Section view of a potential barrel treatment network (dimensions in feet)**

A barrel treatment network is an innovative, simple, and cost-efficient strategy for removing excess nutrients from stormwater runoff. A barrel treatment network functions by directing the stormwater runoff into a set of infiltration barrels, which would be filled with B&G. As the stormwater percolates downward through the barrels, nitrates and other pollutants are removed by the B&G before the stormwater is discharged from the bottom of the barrel. A barrel treatment network is also a flexible technology in that different lengths of barrels can be tested for comparative removal purposes and barrels can easily be accessed for maintenance. An example diagram of a barrel treatment network is presented in Figure 20. In this example, stormwater flowing into the stormwater basin is initially collected in a concrete holding tank. As the holding tank begins to fill, stormwater is transported to a second, smaller holding tank where the inlets to the treatment barrels are located. When stormwater within the second holding tank reaches a certain height, it begins flowing into the inlet pipes attached to the treatment barrels. In this example, there would be six total treatment barrels, two on each side of the second holding tank (excluding the inlet side of the tank). The treatment barrels in Figure 20 are 6-foot long, 3-foot diameter pipes that would be placed within the stormwater basin and filled with the B&G mixture.

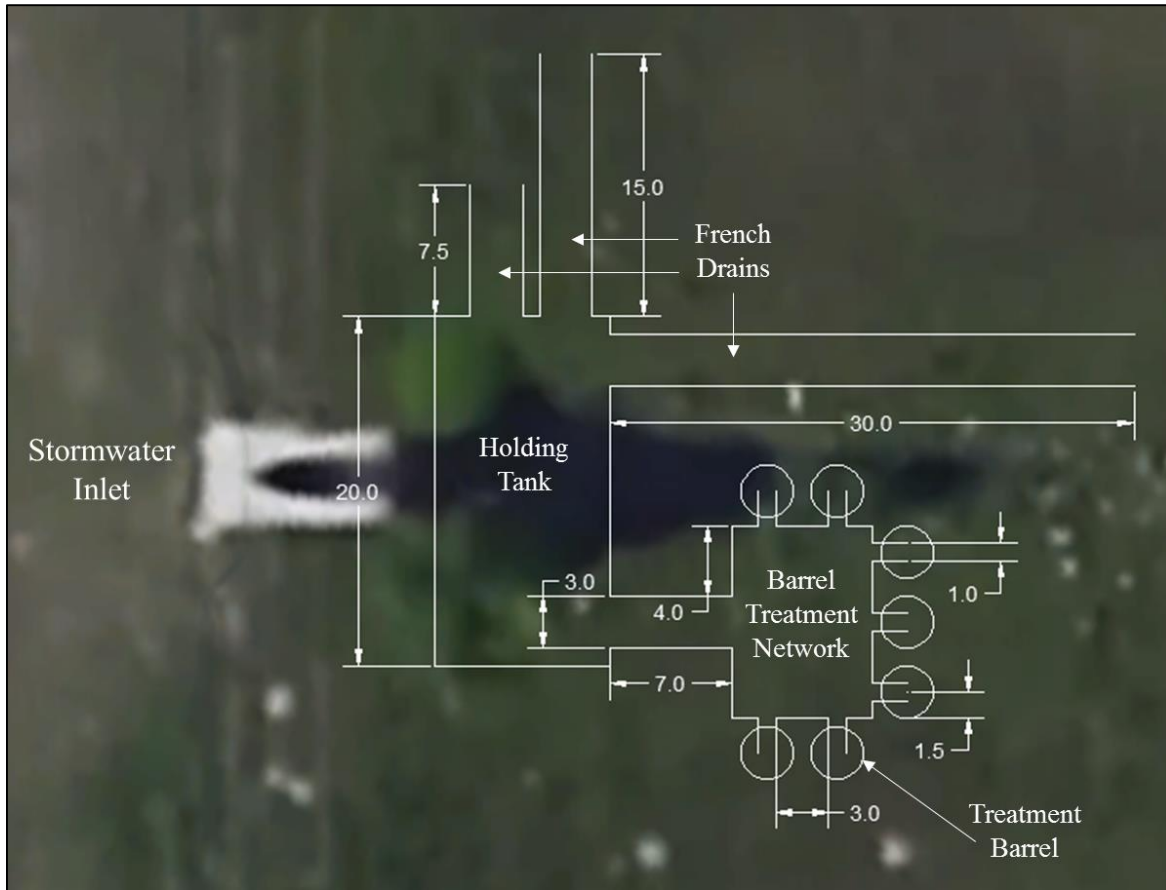
**Figure 22: Plan view of potential French drains and barrel treatment network in parallel at SR 35 Basin 2. All dimensions are in feet and only for preliminary sizing.**

BAM based treatment technologies may be combined in series or parallel to provide enhanced nutrient removal and co-treatment of stormwater runoff. For example, the French drain and barrel treatment network may both be installed at the same initial holding tank and the flow could be split into two equivalent treatment trains. For comparative purposes, the total volume of B&G within the French drains should be equivalent to the total volume of B&G within the treatment barrels. This would allow for comparisons to be made between the two treatment technologies with regards to removal efficiency, mass of pollutants removed per mass of BAM, and operability. An example of the dual stream treatment train, combining French drains and a barrel treatment network, is presented in Figure 20. This combination of treatment technologies would be best suited for SR 35 Basin 2, due to the large stormwater basin area and high volume of stormwater runoff required to be treated. The diagram in Figure 21 shows a potential location of the B&G treatment system at the southern inlet at SR 35 Basin 2. All dimensions are approximated and will be determined in Phase II and before construction to retrieve data on removal effectiveness as a function of size and residence time.
