**FINAL REPORT**

**MSE Wall Void Repair Effect on Corrosion of  
Reinforcement – Phase 2: Specialty Fill Materials**

**Contract No. BDV25-977-07  
Final Report to Florida Department of Transportation**

**A. A. Sagüés  
Principal Investigator  
Department of Civil and Environmental Engineering**

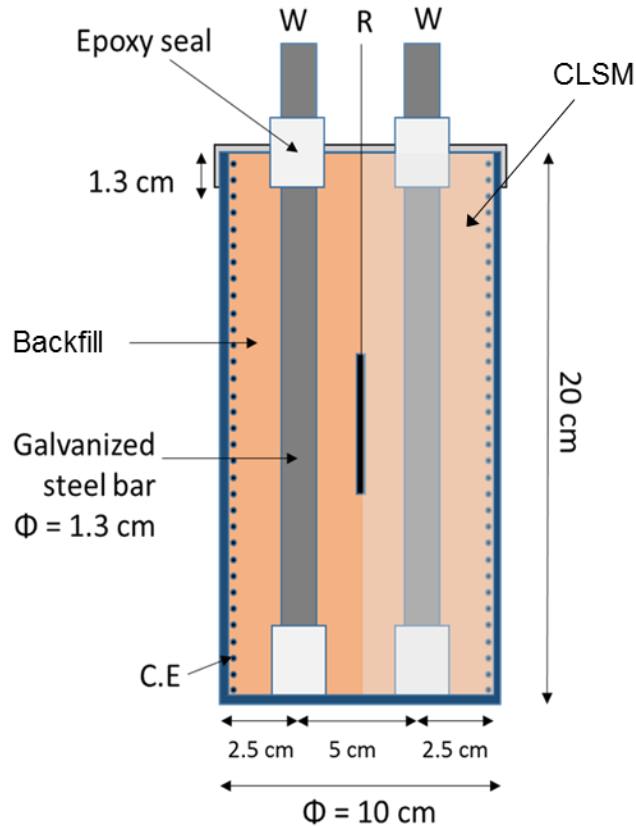
**Figure 1. Diagram of small-scale specimens for testing cement-CLSM and slag-CLSM fill materials.**

In some of the cells the wires embedded in the backfill and in the CLSM sides were left disconnected from each other, to evaluate the corresponding self-corrosion in that uncoupled condition. In other cells containing both backfill and filler, the wires were permanently interconnected to evaluate the macrocell corrosion flowing between them in that coupled condition. All cells had a sealing lid to minimize water evaporation.

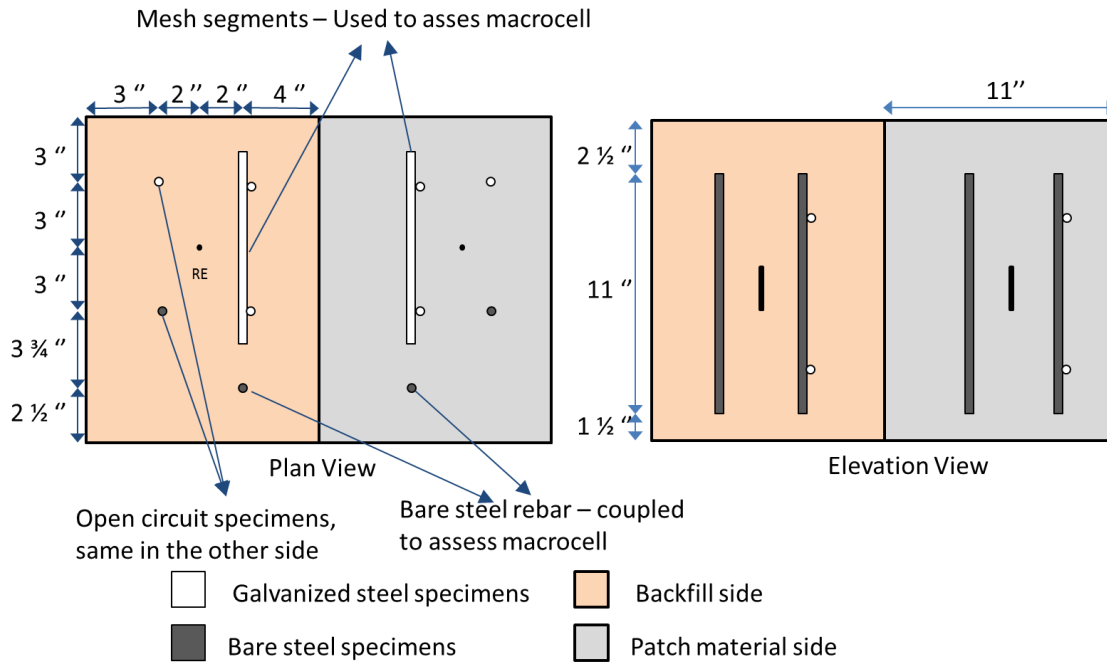
**Figure 2. Diagram of soil tanks for testing of MgO-CLSM and polyurethane grout fill materials.**

polyurethane-embedded reinforcement and the rest of the soil in the system, with associated possible corrosion development. This situation was similarly considered for the modeling calculations presented in Section 2.2.3. For the laboratory tests the preconditioning was important, as otherwise embedment of pristine reinforcement in essentially insulating polymeric foam would have had little chance to reveal potential corrosion risk in an actual field application.

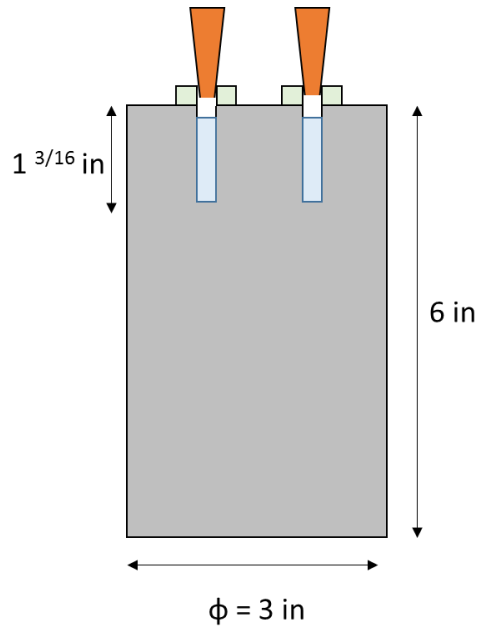
**Figure 3. Specimen for in situ leaching measurements of pH.**

CLSM specimens were also cast in 3 x 6 in (7.5 x 15 cm) plastic mold cylinders (Figure 3) in order to conduct pH measurements of the pore water by the in-situ leaching technique [18,19,20]. Two cylinders were cast for each CLSM mix. Three holes 1/8 in (0.3 cm) in diameter were drilled to a depth of 1-3/16 in (3 cm) into each specimen, after which ~0.25 mL of deionized and decarbonated water was added to each hole. Some of the water was absorbed so the water was replenished almost daily for the first week and then weekly from then on. After equilibrium was reached about 3 weeks in, in-situ measurements as described elsewhere [18,20] were performed using an activated titanium wire as a pH sensing electrode and a silver – silver chloride microelectrode as a reference electrode. Measurements were performed periodically to allow for stabilization of the cementation reactions. The values reported here are for the end of a 90-day stabilization period. The pH of the backfill was measured separately using the Florida method of test for pH of soil and water [21]; given the non-reacting nature of the soil a stabilization period of only 1 day was used.

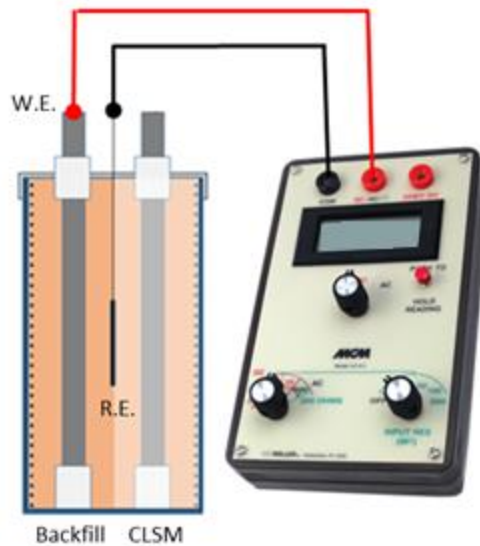
Figure 4. Potential measurement of small-scale specimens.

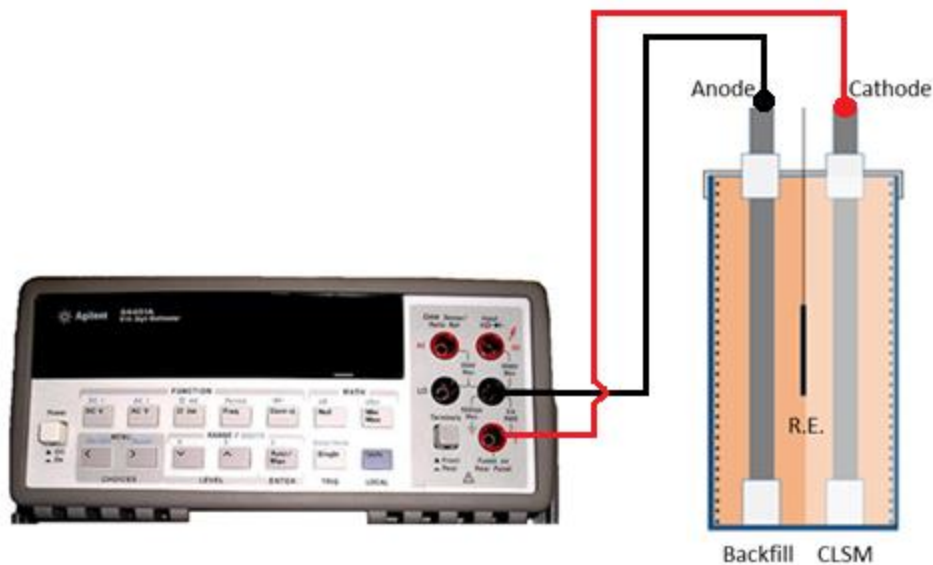
Figure 5. Macrocell current measurement of small-scale specimens.

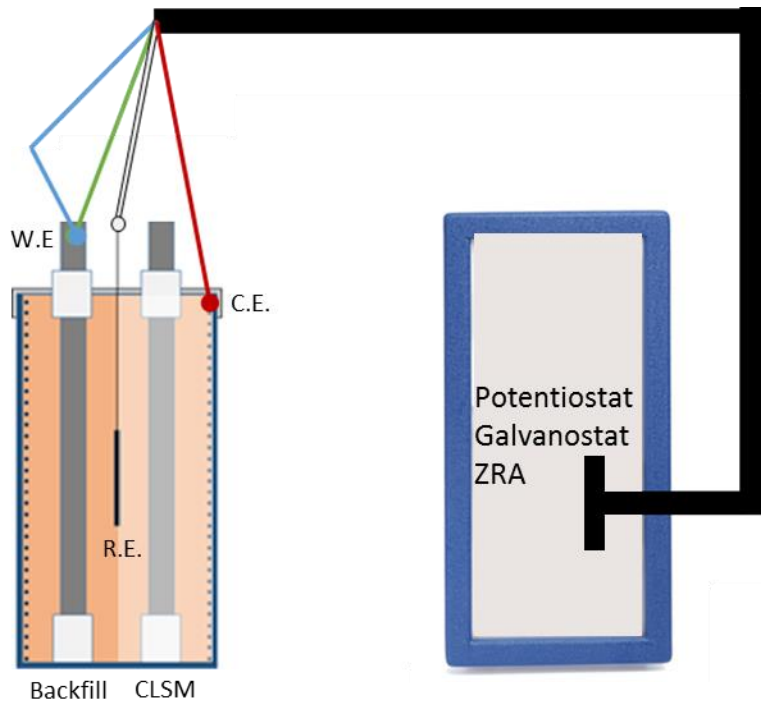
**Figure 6. Setup of EIS measurements for small-scale specimens.**

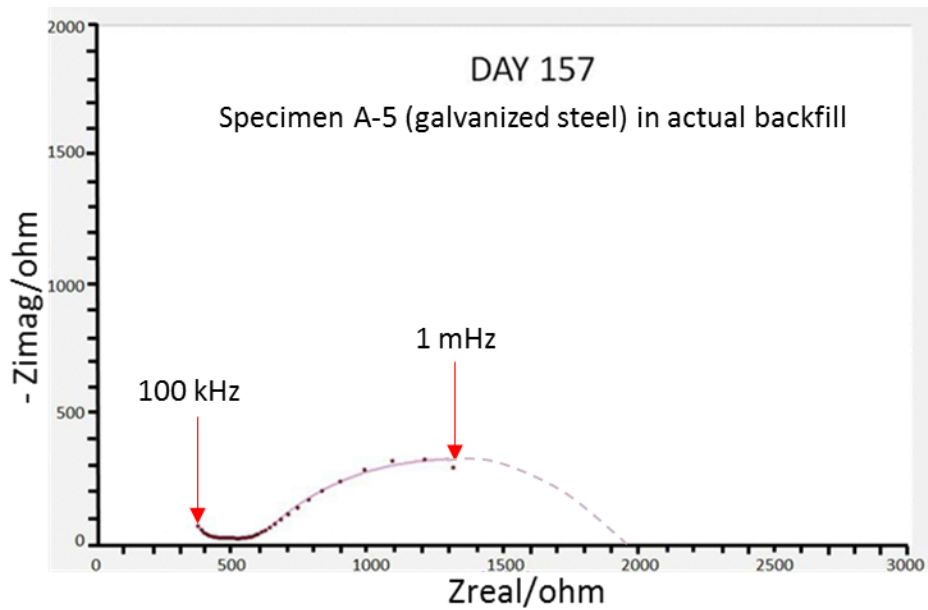
**Figure 7. Typical EIS diagram (before surface-area normalization) obtained for galvanized steel in backfill. Specimen area was  $\sim 80 \text{ cm}^2$ .**

Typical EIS spectra (Figure 7) presented significant high frequency dispersion in the form of an apparent constant imaginary component. Hence only the lowest frequency decade (5 data points ranging from 1 mHz to <10 mHz) were used for analysis (Figure 8) to obtain an estimate of the surface-area normalized Polarization Resistance ( $R_p$ ), by fitting to a modified Randles equivalent circuit (Figure 9) that included a Constant Phase angle Element (CPE) and a nominal solution resistance ( $R_s$ ) [22]. This is a provisional evaluation method that is a subject of a continuing investigation [23].

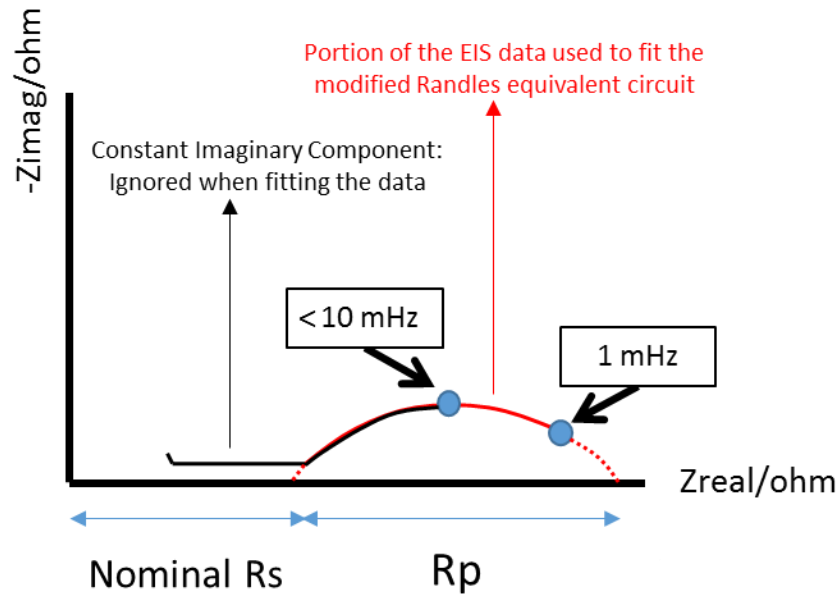
**Figure 8. Schematic Typical Nyquist plot showing the range and portion used to fit the surface area-normalized data.**

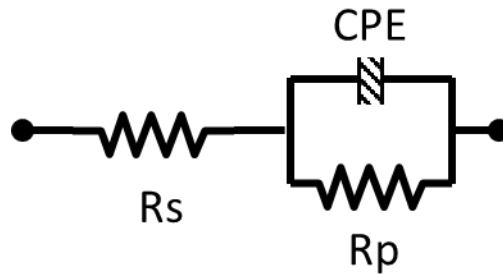
**Figure 9. Modified Randles equivalent circuit used to fit the data.**

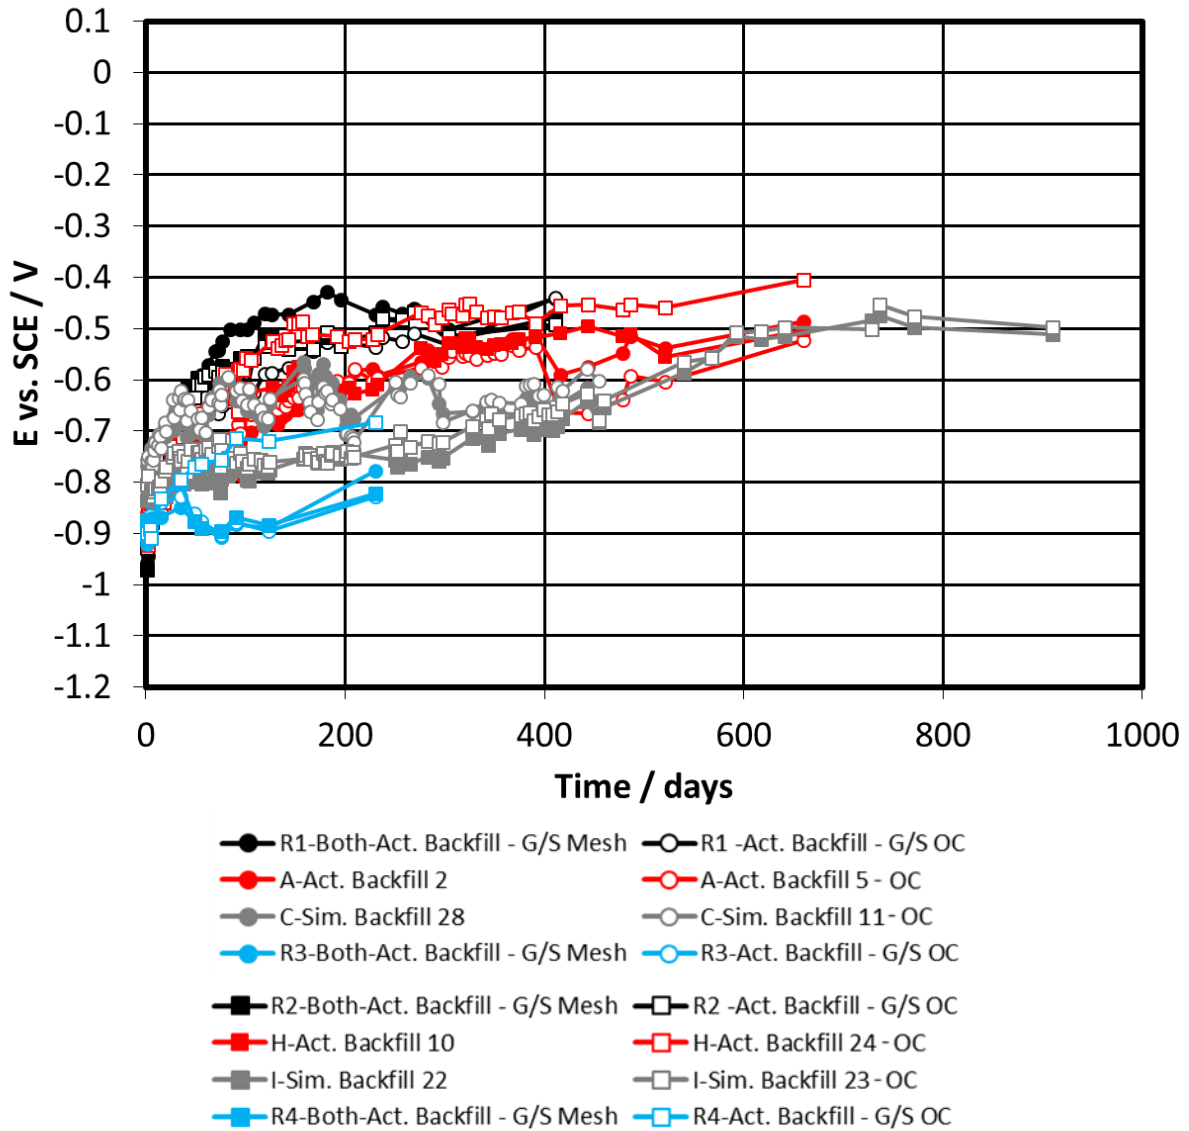
**Figure 10. Potential evolution of galvanized steel electrodes (instant-off whenever applicable) buried in backfill (actual or simulated) in the different systems.**

<sup>(1)</sup> Based on the results shown in Figures 10 and 11, the behavior of the reinforcement in actual or simulated backfill was deemed to be equivalent, so for interpretation of results, both types of backfill were considered as interchangeable.

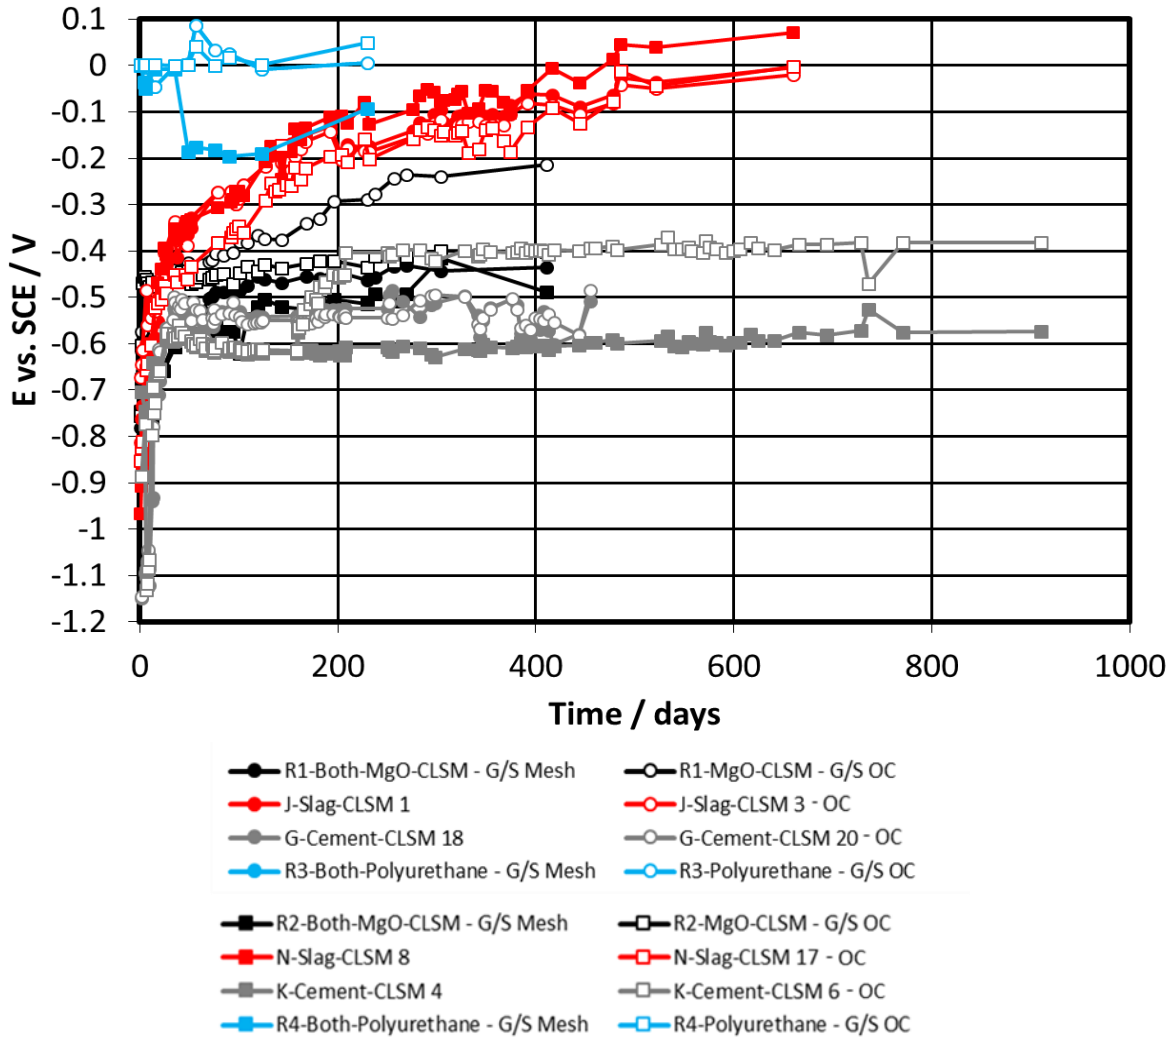
**Figure 11. Potential evolution of galvanized steel electrodes (instant-off whenever applicable) buried in patching material in the different systems.**

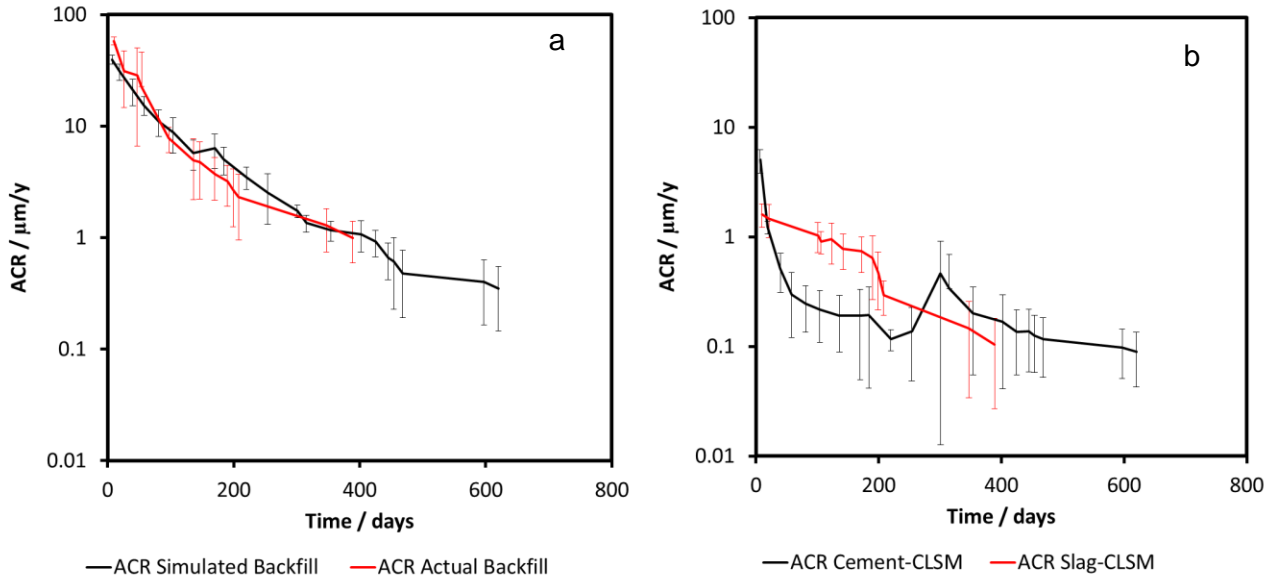
**Figure 12. Apparent corrosion rate evolution of galvanized steel buried in a) backfill systems and b) CLSM systems.**

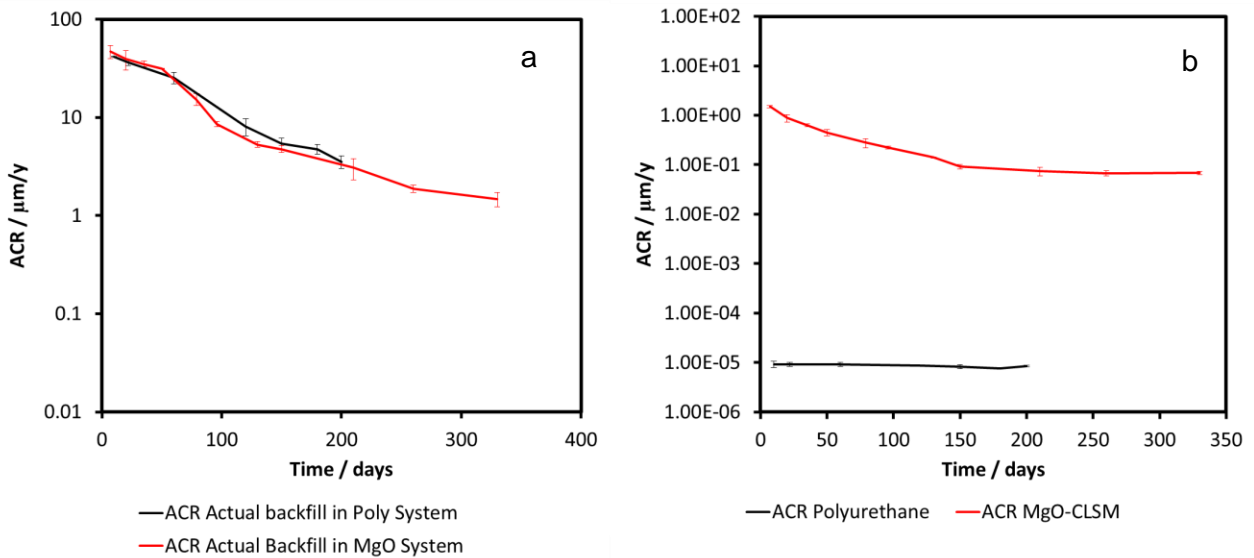
**Figure 13. Apparent corrosion rate evolution of galvanized steel buried in a) backfill systems and b) alternative filler systems. The results for polyurethane are nominal near-nil values as explained in the text.**

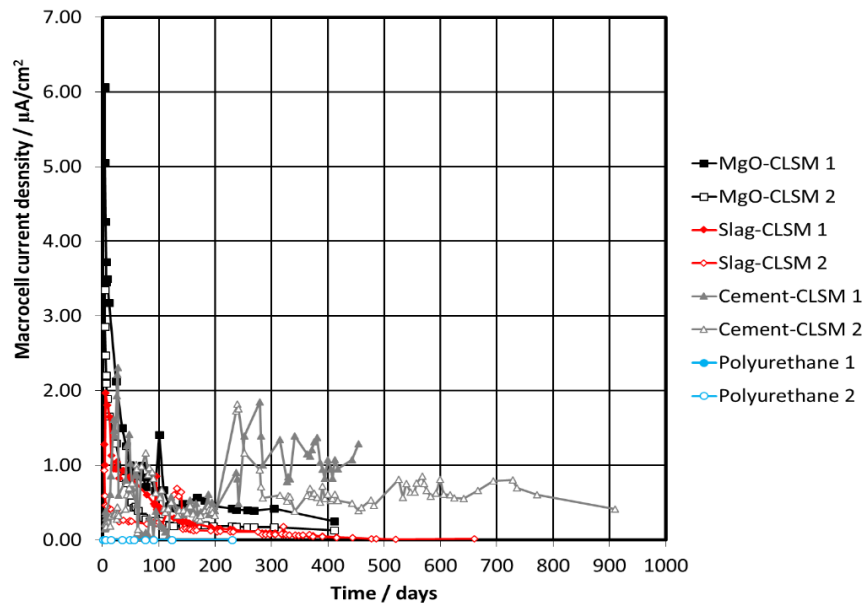
**Figure 15. Macrocell current measured for the different systems.**

The macrocell current results for all the systems evaluated are shown in Figure 15, after converting into current densities by dividing the macrocell current measured by the area of the anodic wire. For the CLSM systems the macrocell anode was always found to be, as expected, on the backfill side of the cell.

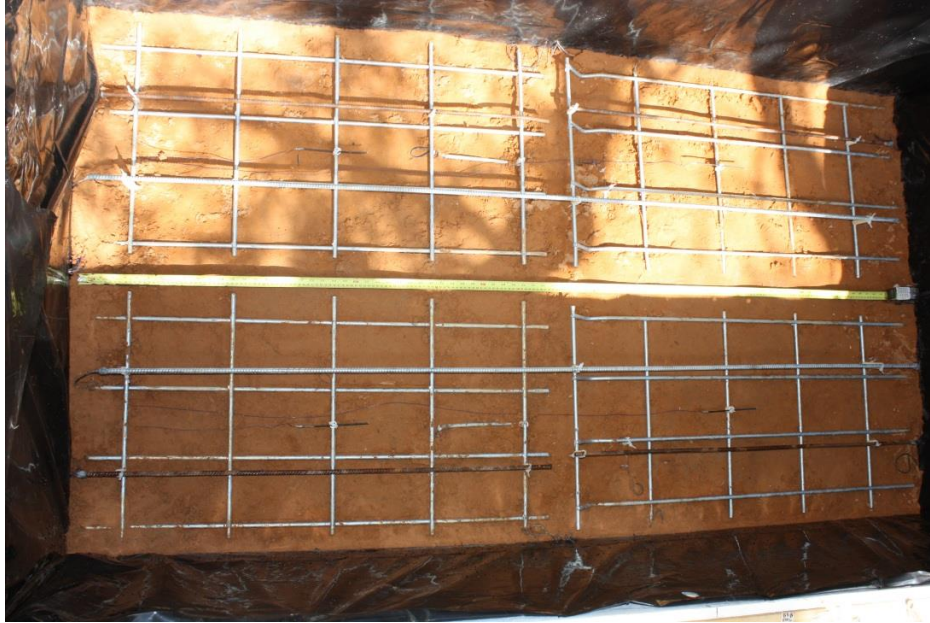
**Figure 22. Distribution of specimens in the first layer of the soil box. Front is the right side of the picture.**

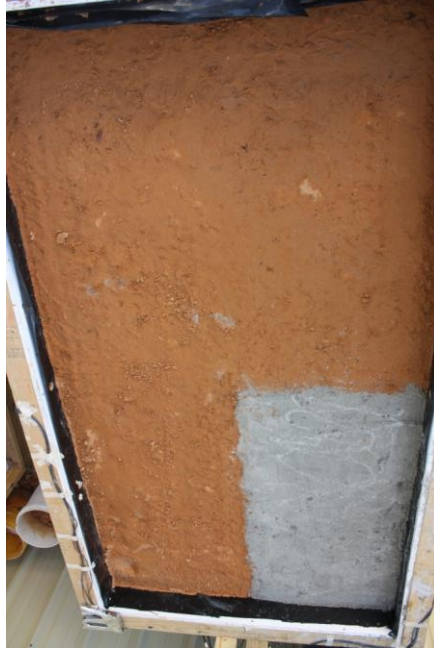
**Figure 28. Box completely filled (7/8 of the volume is backfill and 1/8 a simulated void repair with CLSM).**

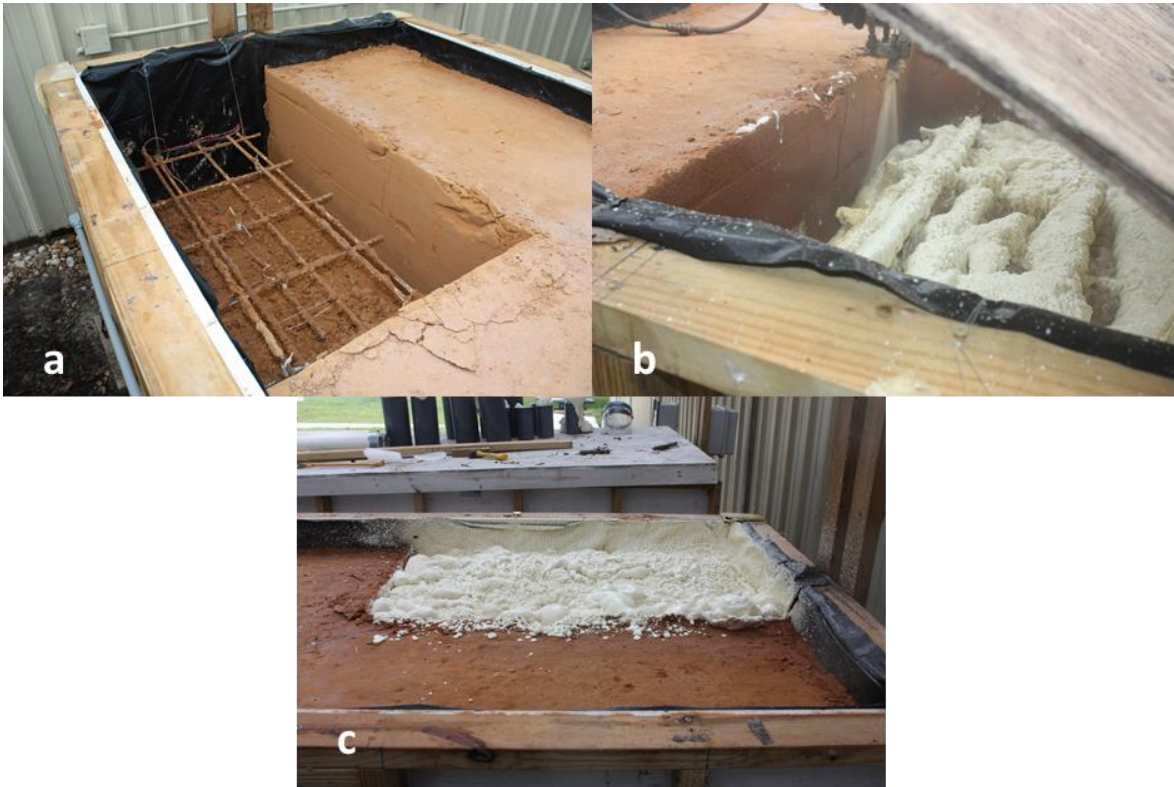
**Figure 29. Filling of empty octant in box #2: a) Simulated void, b) repair using polyurethane grout, c) repaired void.**

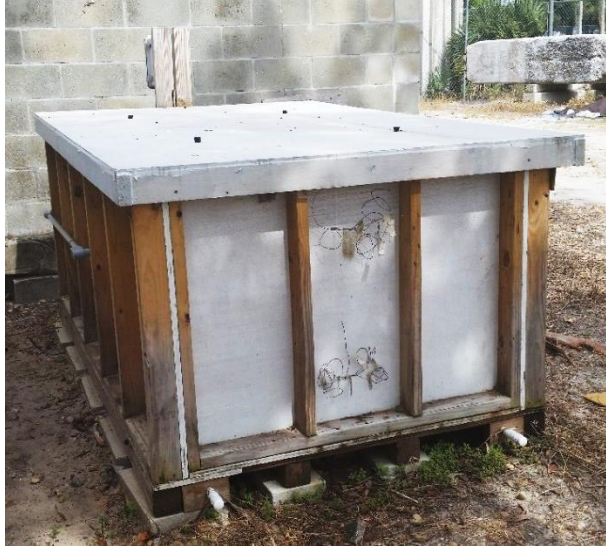
**Figure 30. Completed box.**

After the fill was put in place and allowed to set, a more permanent cover made of wood was placed on top of all boxes (Figure 30) to protect them from the environment. An initial battery of measurements was performed, and 2 days afterwards, the macrocell was established, and monitoring of the newly patched boxes continued.

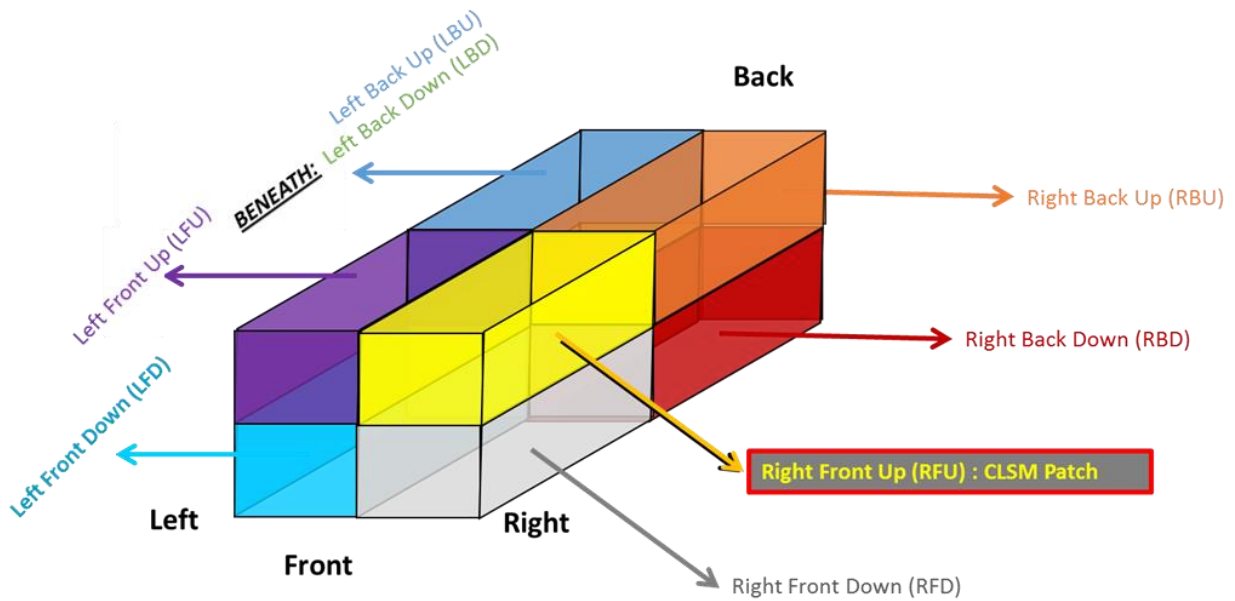
**Figure 31. Box seen in perspective showing the 8 octant sections.**

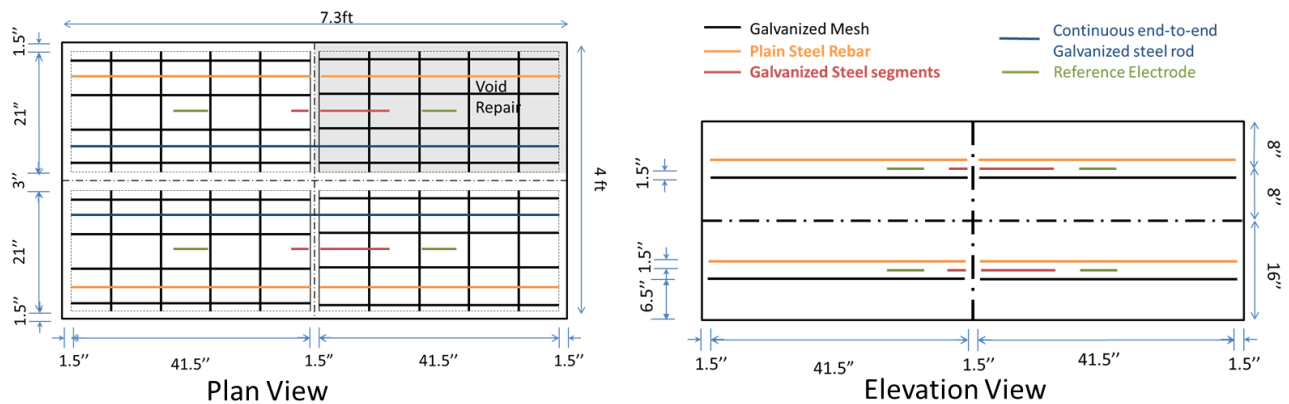
**Figure 32. Distribution of reinforcement inside the boxes.**

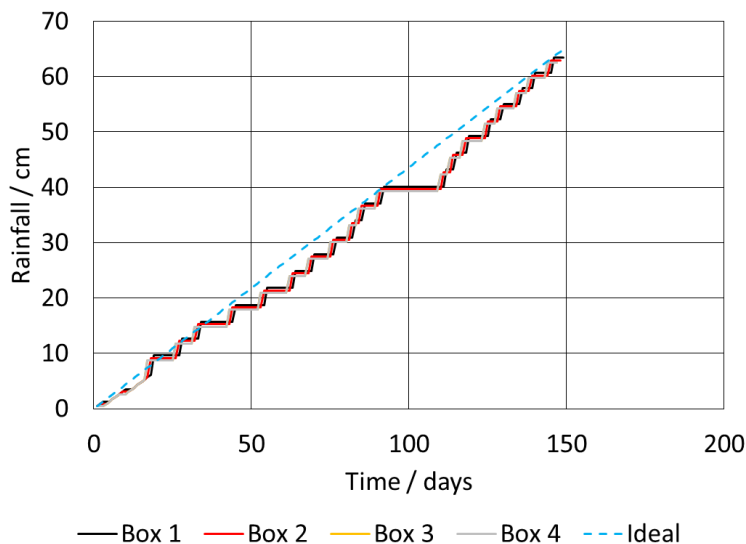
**Figure 33. Cumulative simulated rainfall in each box.**

Simulated rainfall accumulation in cm is shown in Figure 33, where the blue dashed line represents an ideal cumulative rainfall. Up to approximately day 150, approximately 63 cm of rain have been sprayed to each box. Initially simulated rain was applied daily and about weekly afterwards.

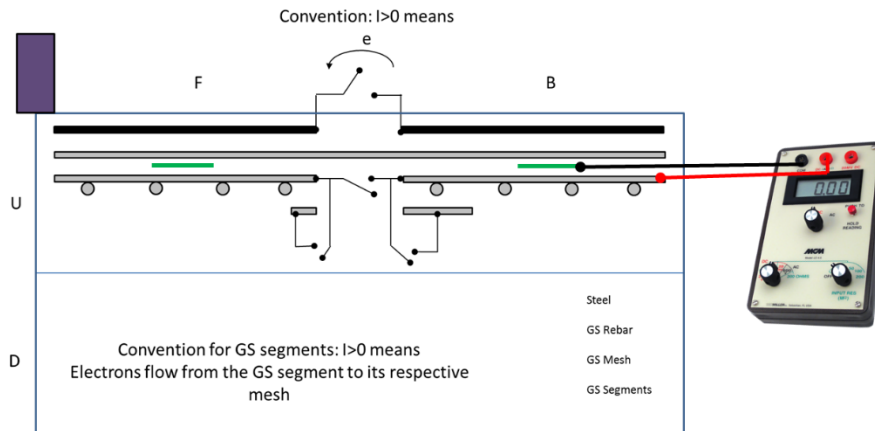
**Figure 34. Schematic of potential measurements.**

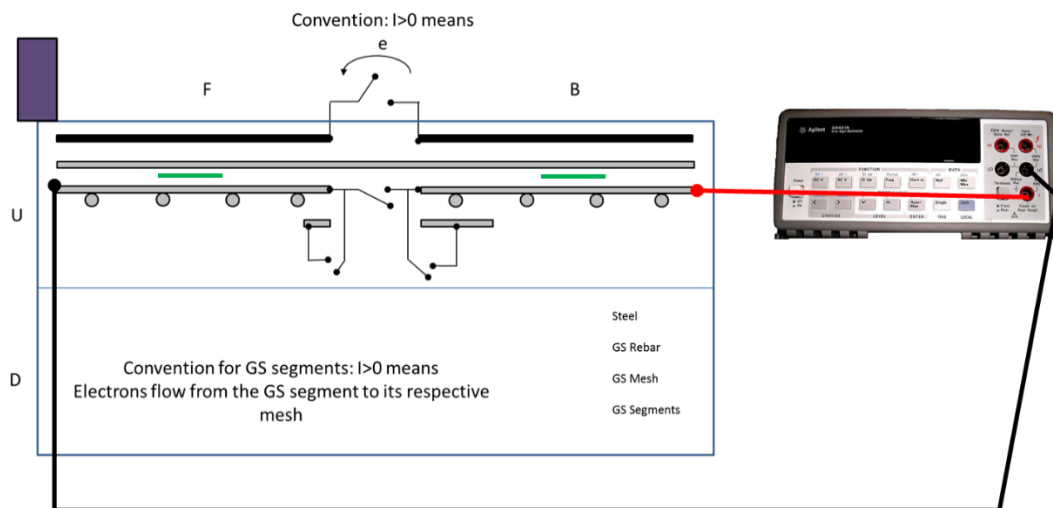
**Figure 35. Schematic of macrocell current measurements.**

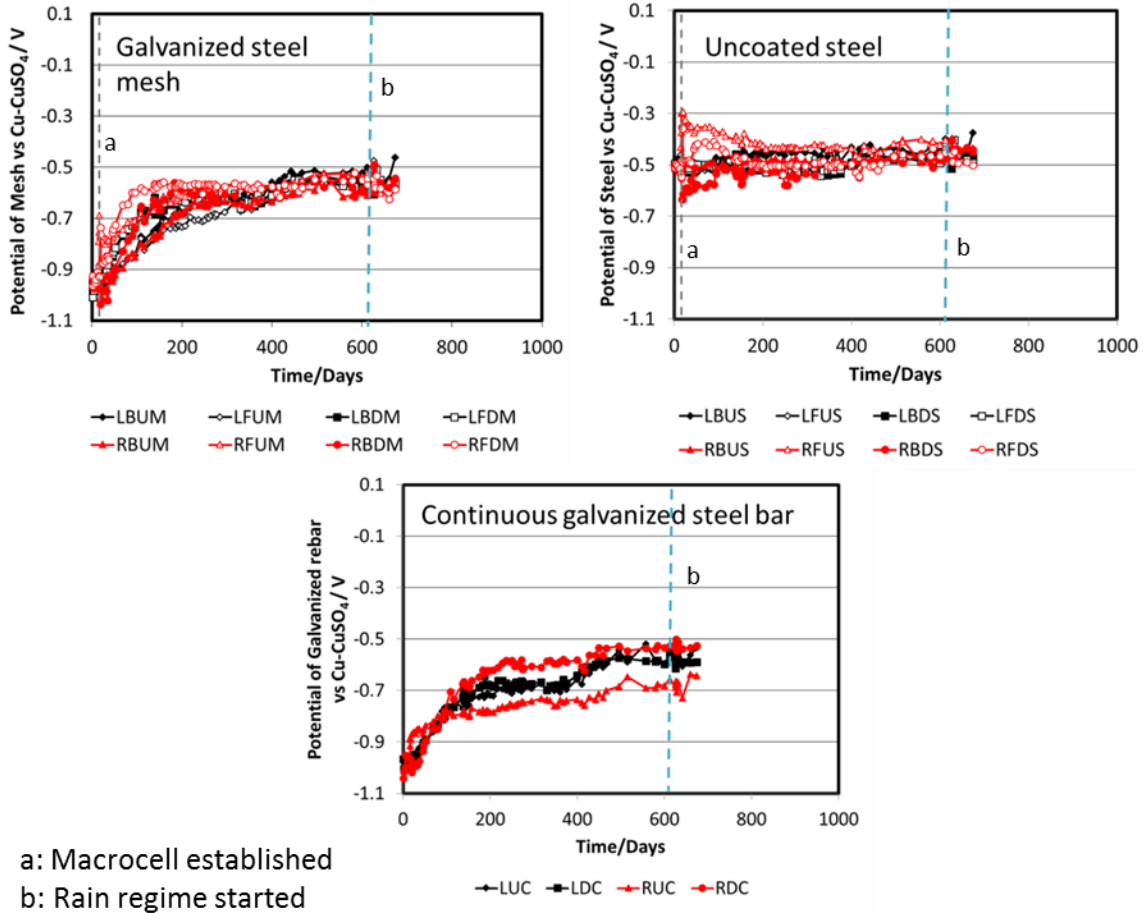
**Figure 37. Potential (instant-off whenever applicable) evolution of electrodes in box 1 (with cement-CLSM repair fill). Red lines/markers correspond to right side (side with patch); black to left. Gray dashed line corresponds to the moment of establishing the macrocell by closing the connecting switch, and blue dashed line corresponds to the start of rain simulations.**

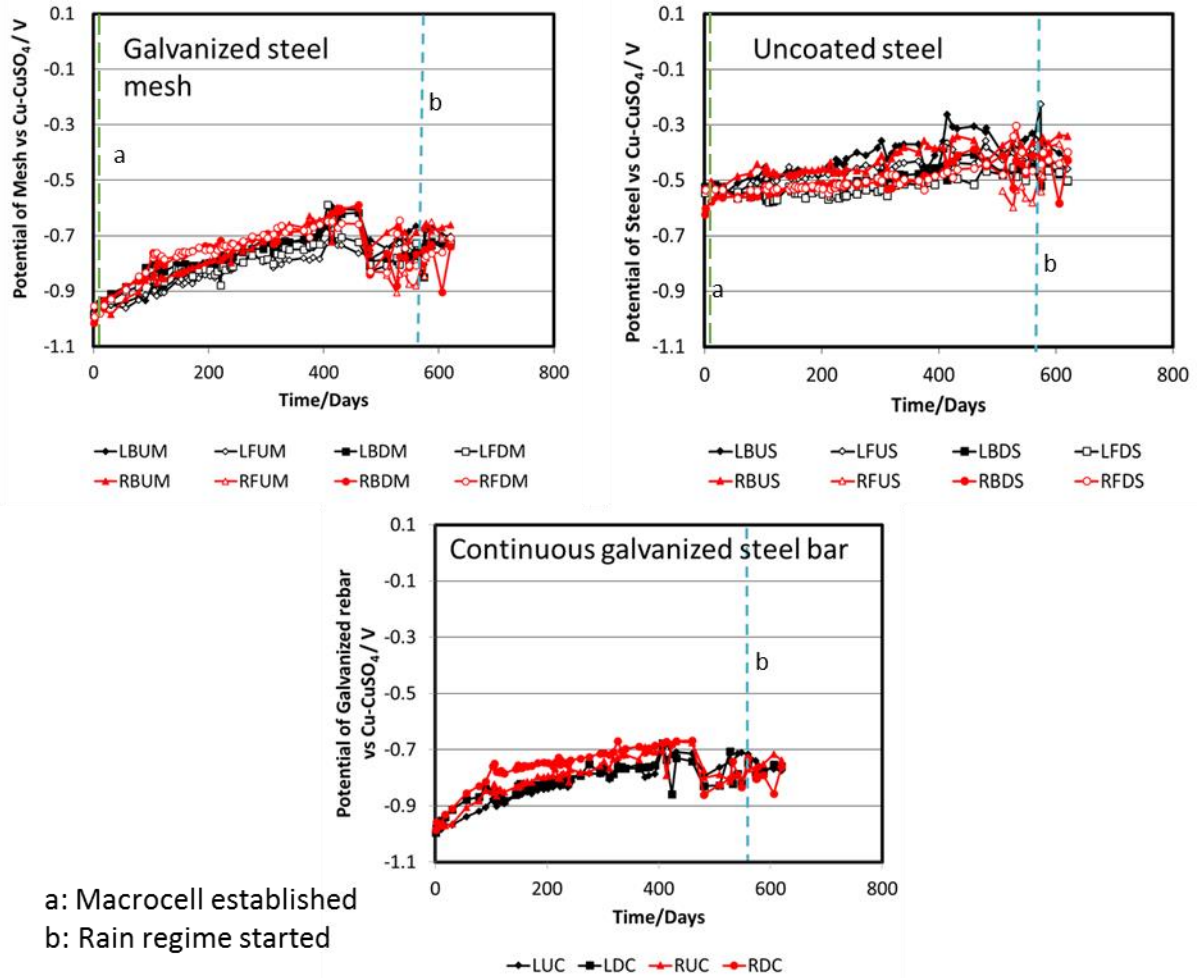
**Figure 38. Potential (instant-off whenever applicable) evolution of electrodes in box 2 (with polyurethane repair fill). Red lines/markers correspond to right side (side with patch); black to left. Green dashed line corresponds to the moment of establishing the macrocell by closing the connecting switch when the repair material was delivered, and blue dashed line corresponds to the start of rain simulations.**

Potential evolution of box 2, (polyurethane repair fill) (Figure 38) showed little change after rainfall simulations started, remaining relatively steady for all types of reinforcement.

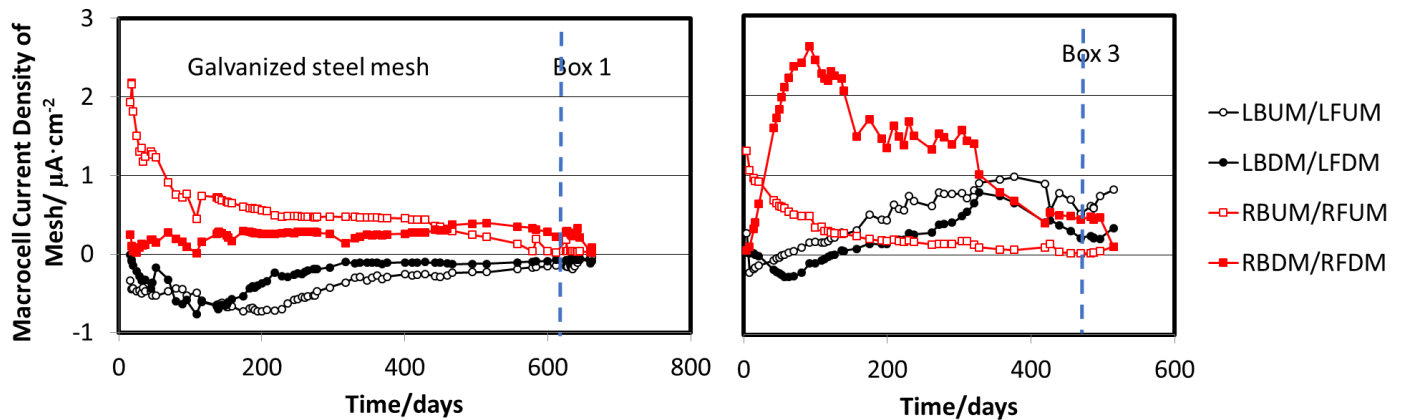
**Figure 39. Macrocell current evolution for the galvanized steel meshes in duplicate boxes 1 and 3 with cement-CLSM repair fill. Positive values indicate the mesh in the back side is anodic. Blue dashed line corresponds to the start of rain simulations.**

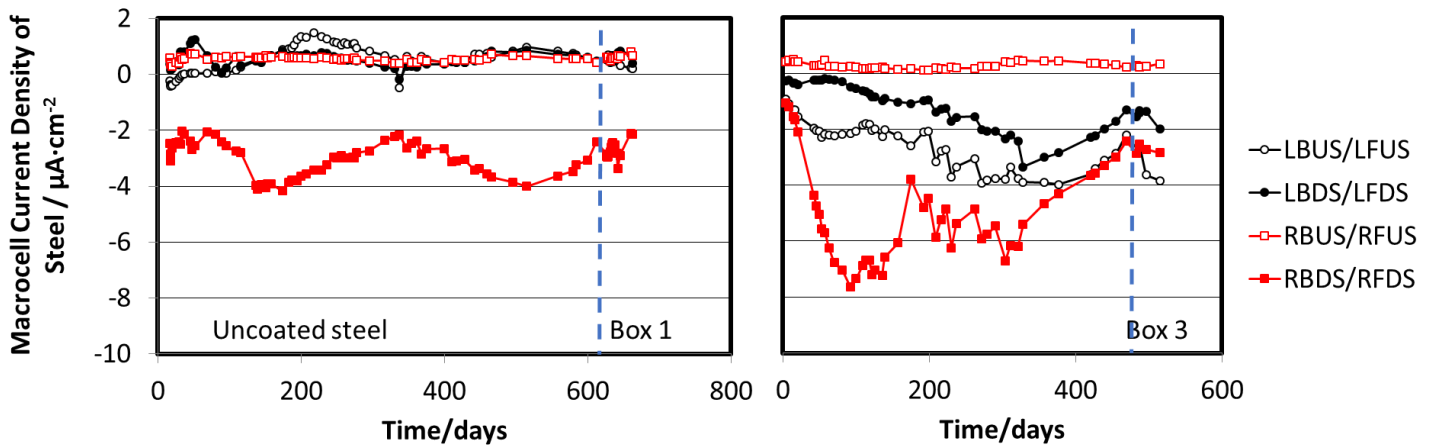
**Figure 41. Macrocell current evolution for the uncoated steel bars in duplicate boxes 1 and 3 with cement-CLSM repair fill. Positive values indicate the mesh in the back side is anodic. Blue dashed line corresponds to the start of rain simulations.**

quadrant beneath it showed reverse macrocell polarity and much greater current density values. This behavior appears to be due to stray currents originating from the galvanized mesh array in the CLSM-backfill system immediately above.

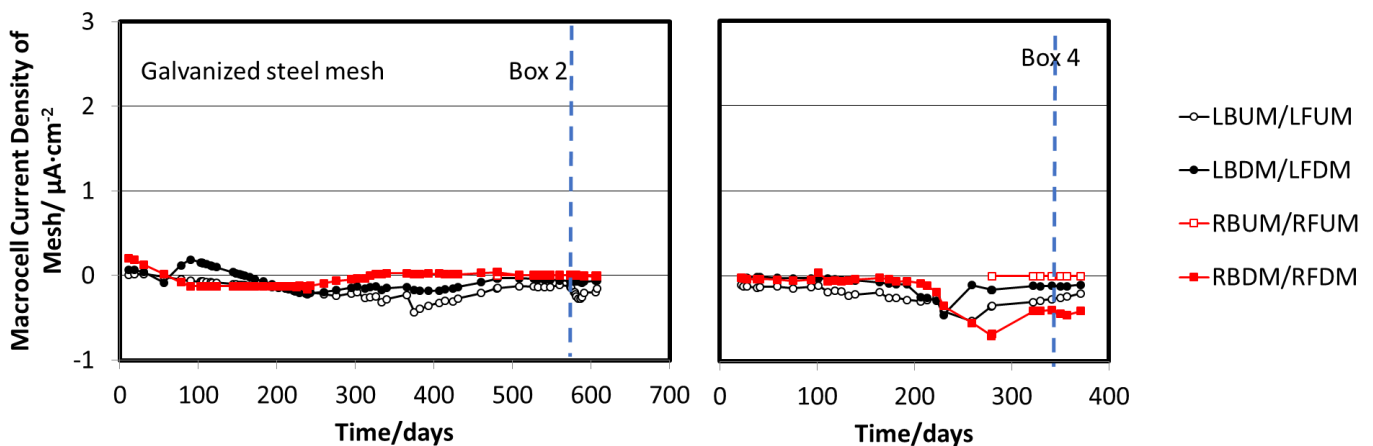
**Figure 42. Macrocell current evolution for the galvanized steel meshes in duplicate boxes 2 and 4 with polyurethane repair fill. Positive values indicate the mesh in the back side is anodic. Blue dashed line corresponds to the start of rain simulations.**

Galvanized steel meshes in boxes 2 and 4 (Figure 42) (repair-filled with polyurethane grout) show very little sign of macrocell activity when compared with boxes 1 and 3 (cement-CLSM), consistent with small-scale experiments. Furthermore, the meshes in the other quadrants show very little macrocell action. This may be explained by noting that boxes 2 and 4 have no cementitious compound that could potentially affect the soil chemistry. Thus, from a corrosion control standpoint these results favor the use of polyurethane grout for fill repair applications.

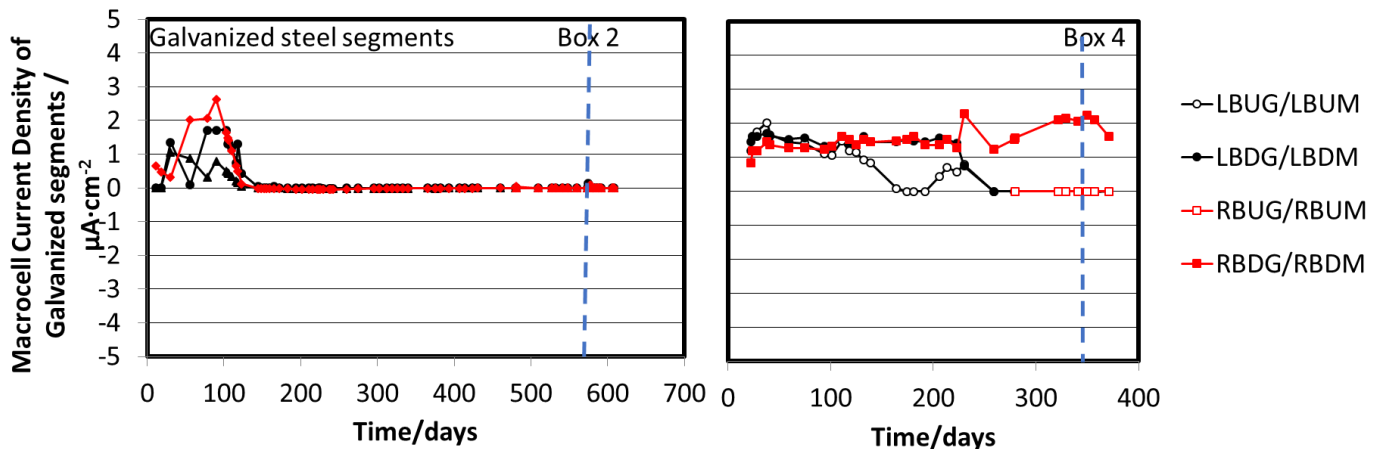
**Figure 43. Macrocell current evolution for the galvanized steel wire segments on back side in duplicate boxes 2 and 4 with polyurethane repair fill. Positive values indicate segment is anodic. Blue dashed line corresponds to the start of rain simulations.**

The short galvanized steel segments showed a slight macrocell action for the first 150 days in polyurethane repair fill box 2 and 250 days in duplicate box 4 (Figure 43), which then remained at near 0  $\mu\text{A}/\text{cm}^2$  afterwards. This is in contrast with the case for CLSM repair fill boxes 1 and 3, which showed a significantly higher macrocell activity that remains up to the latest measurement.

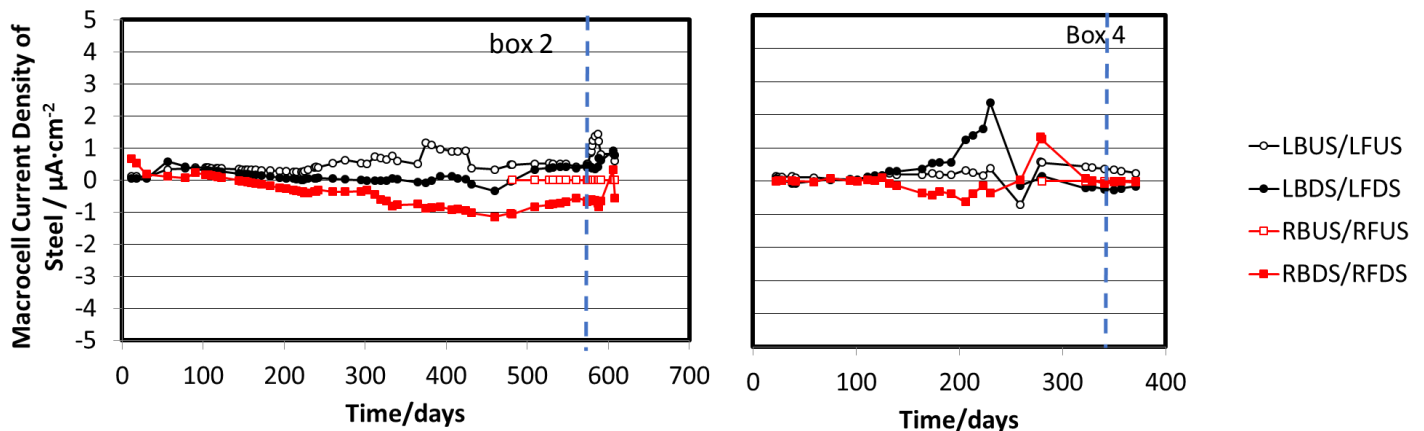
**Figure 44. Macrocell current evolution for the uncoated steel bars in duplicate boxes 2 and 4 with polyurethane repair fill. Positive values indicate the mesh in the back side is anodic. Blue dashed line corresponds to the start of rain simulations.**

Bare steel in polyurethane repair fill boxes (Figure 44) showed signs of macrocell activity but only in the order of  $\sim 1 \mu\text{A}/\text{cm}^2$ , value that pales in comparison to those of CLSM repair fill boxes 1 and 3. These results further indicate that the use of polyurethane foam for void filling application minimize the macrocell activity of the system.

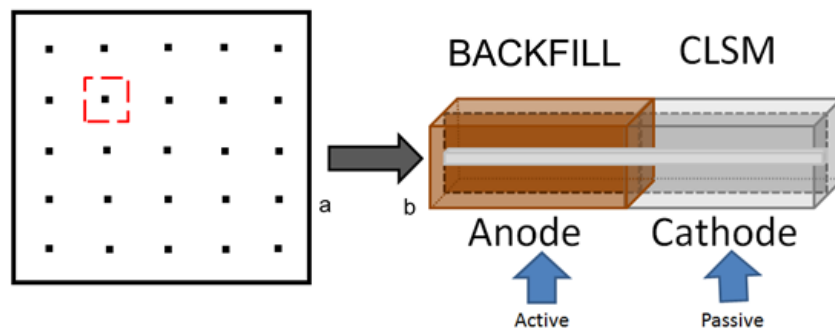
Figure 45. Rationale for the geometry used for model simulations.

An exploratory corrosion distribution model was proposed and implemented by an idealization of an MSE Wall where reinforcing elements (in this case rod-like strips) are regularly distributed on a view from the outside of the wall (Figure 45 a). A square cross section unit portion of the MSE Wall, such that the wall could be reconstructed by combination of multiple identical unit portions, was then extracted as illustrated In Figure 45 b. Half of the unit was assumed to consist of a void filled with CLSM and the other half with normal backfill. The square cross section (Figure 46) was then approximated by a cylindrical symmetry section of equivalent cross sectional area. The reinforcing element was represented by a central rebar. A Finite Element Modeling (FEM) COMSOL Multiphysics ® platform was used to implement the calculations. The base case used parameters generally based on the laboratory experiment data presented earlier. A variation was performed to assess a different scenario, where the CLSM and backfill resistivity is 10 times greater than that found with the nearly saturated laboratory media, thus bracketing other possible realistic conditions. Figure 47 summarizes the ruling equations assumed for the system. Meaning of the symbols is indicated in the List of Symbols at the beginning of this report and in Table 4. The underlying assumptions are similar to those used in related modeling efforts for the corrosion of steel in concrete, and for brevity the description is deferred to material cited in the References section [28 ,29]. The anodic reaction in the CLSM media was assumed to proceed at a potential-independent rate with the indicated value, as a nominal representation of predominantly passive behavior there and with the understanding that more sophisticated expressions may be used in future implementations of the model. Table 4 lists the tentatively assumed model parameter values and sources additional to those just indicated. The medium-specific values were chosen to yield corrosion rates and potentials representative of those observed in the laboratory specimens generally toward the end of the first year of testing. It is emphasized that those choices are not intended as definitive descriptors for each case, but rather as a sampling of the variety of conditions and ways of quantifying behavior that may be used in this type of idealization. More representative values of those parameters of direct relevance to specific field conditions are expected to emerge as longer test times and additional information from large scale testing and field data become available.

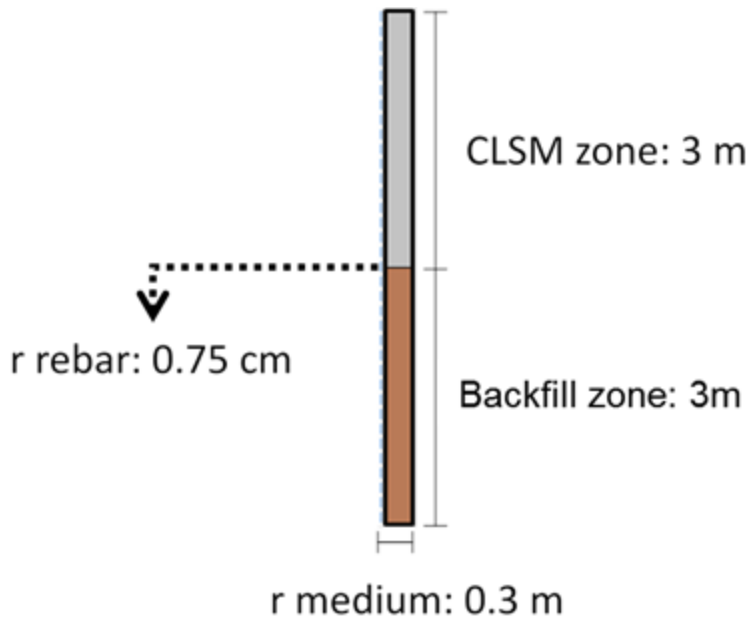
Figure 46. FEM domain geometry for model simulations. Rotational symmetry axis is located at the left.
