**FINAL REPORT**

**MSE Wall Void Repair Effect on Corrosion of  
Reinforcement – Phase 2: Specialty Fill Materials**

**Contract No. BDV25-977-07  
Final Report to Florida Department of Transportation**

**A. A. Sagüés  
Principal Investigator  
Department of Civil and Environmental Engineering**

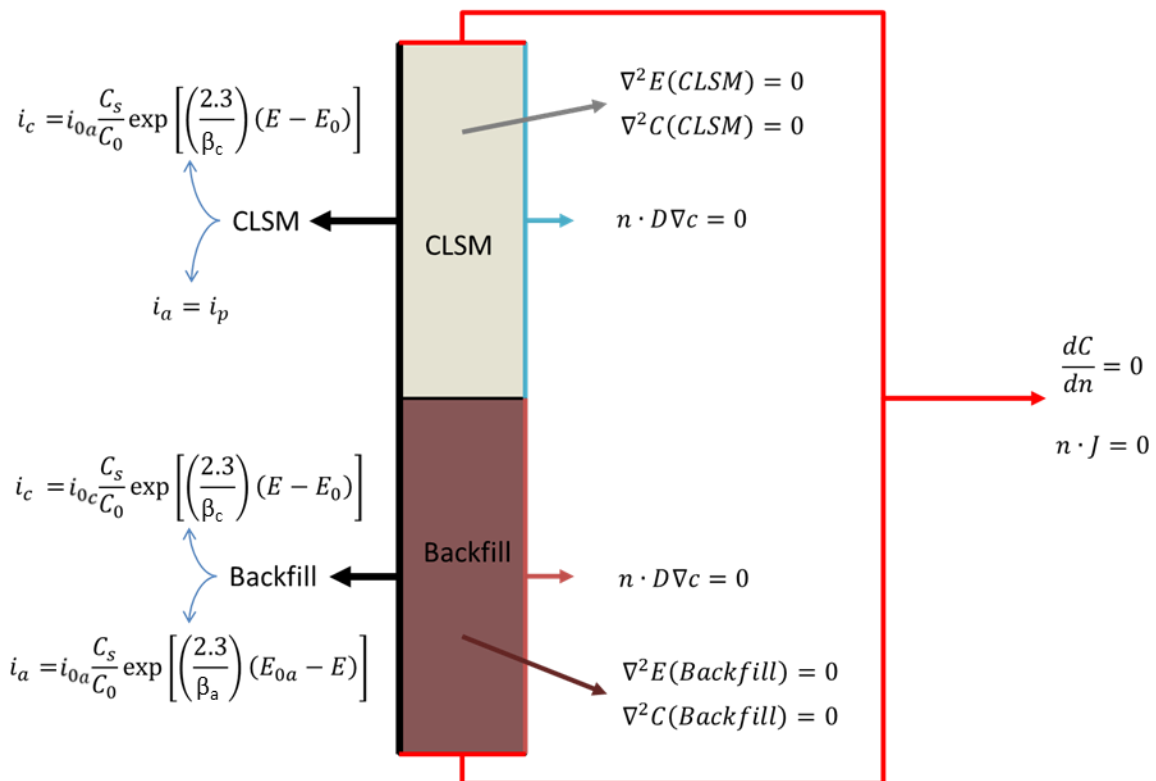
Figure 47. Ruling equations for model simulations.

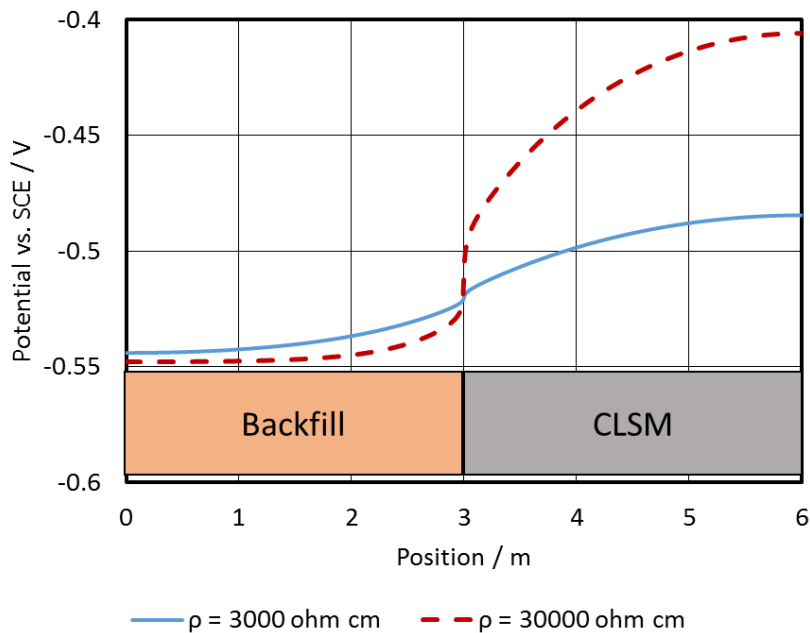
**Figure 48. Corrosion potential vs. position in the reinforcement.**

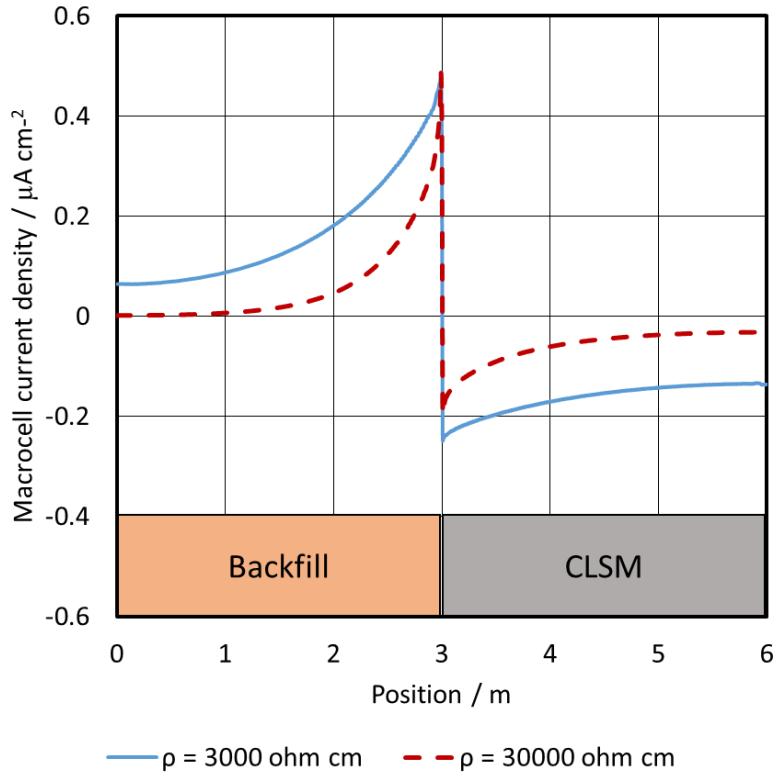
**Figure 49. Macrocell current density vs. position in the reinforcement.**

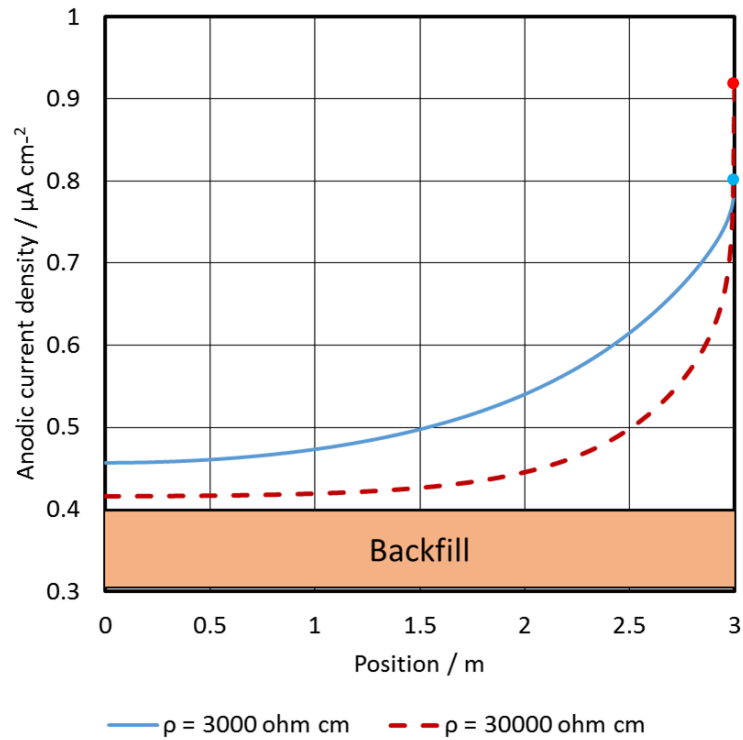
**Figure 50. Corrosion current density vs. position (anodic portion).**

Figure 50 shows corrosion current density as a function of position in the anodic region (backfill-embedded steel). A marked increase in corrosion current density when nearing the backfill – CLSM interface was projected by the model. This implied as expected that this portion of the reinforcement near the interface is the one more susceptible to rapid loss of the galvanized film. The resistivity variation results indicate as expected that the zone of enhanced corrosion becomes narrower as the assumed resistivity increases [25].

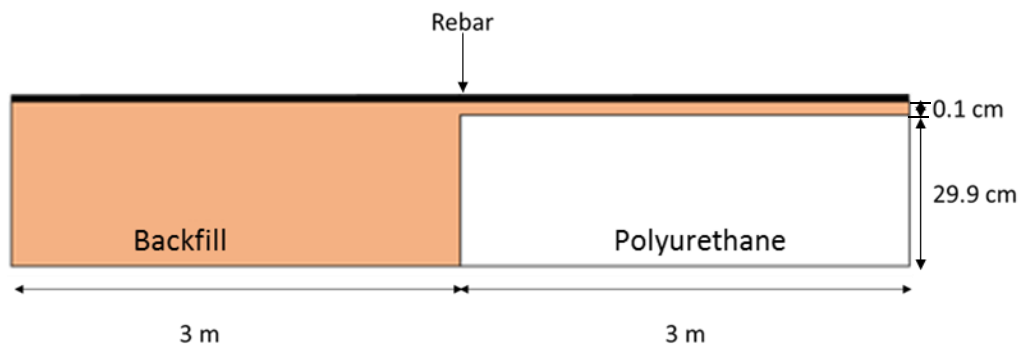
**Figure 51. Model geometry for simulation with a void filled with polyurethane grout.**

In additional calculations the model was modified (Figure 51) to explore the behavior when using the polyurethane void fill. Following the conditions discussed in the previous sections, it was assumed that a small layer of backfill (possibly mixed with corrosion products) would be left on the surface of the reinforcement after formation of the void. The layer thickness was assumed to be in the order of 1 mm, and for simplicity to have the same electrochemical properties as that of the bulk backfill. The steel in both sides of the interface is assumed to be in the active condition, as expected since the polyurethane is not assumed to have passivating properties in any residual interstitial water.

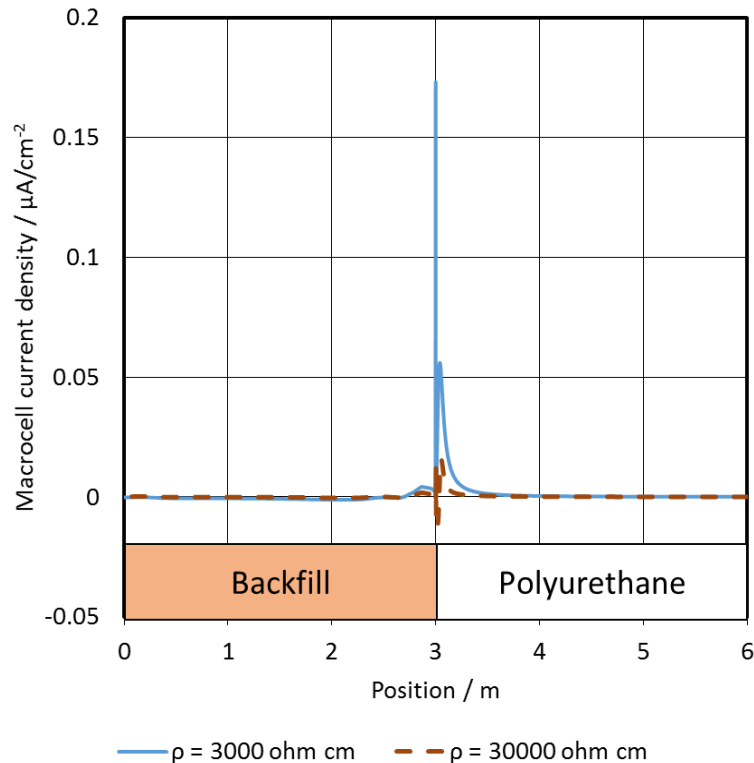
**Figure 52. Macrocell current distribution for the polyurethane case. Compare with Figure 49 (thin vertical feature at 3 m is interpreted as a digitization artifact).**

reinforcement just inside the polyurethane boundary. That effect reflects the formation of a limited differential oxygen concentration cell, which is not expected to strongly enhance corrosion on the anode side as long as the reinforcement on the backfill side remains in the active condition (as assumed in the model). However, if a condition approaching passivity were to develop on the backfill side, a situation not unlike that of classic crevice corrosion could take place [25]. The possibility of events of that type, as well as the long term effects of moisture inside the interstice surrounding reinforcement inside polyurethane foam should be carefully investigated in follow up work. Direct examination of the polyurethane-embedded specimens in the laboratory and the large soil boxes after longer exposure times have been accrued may provide important additional information on this issue.

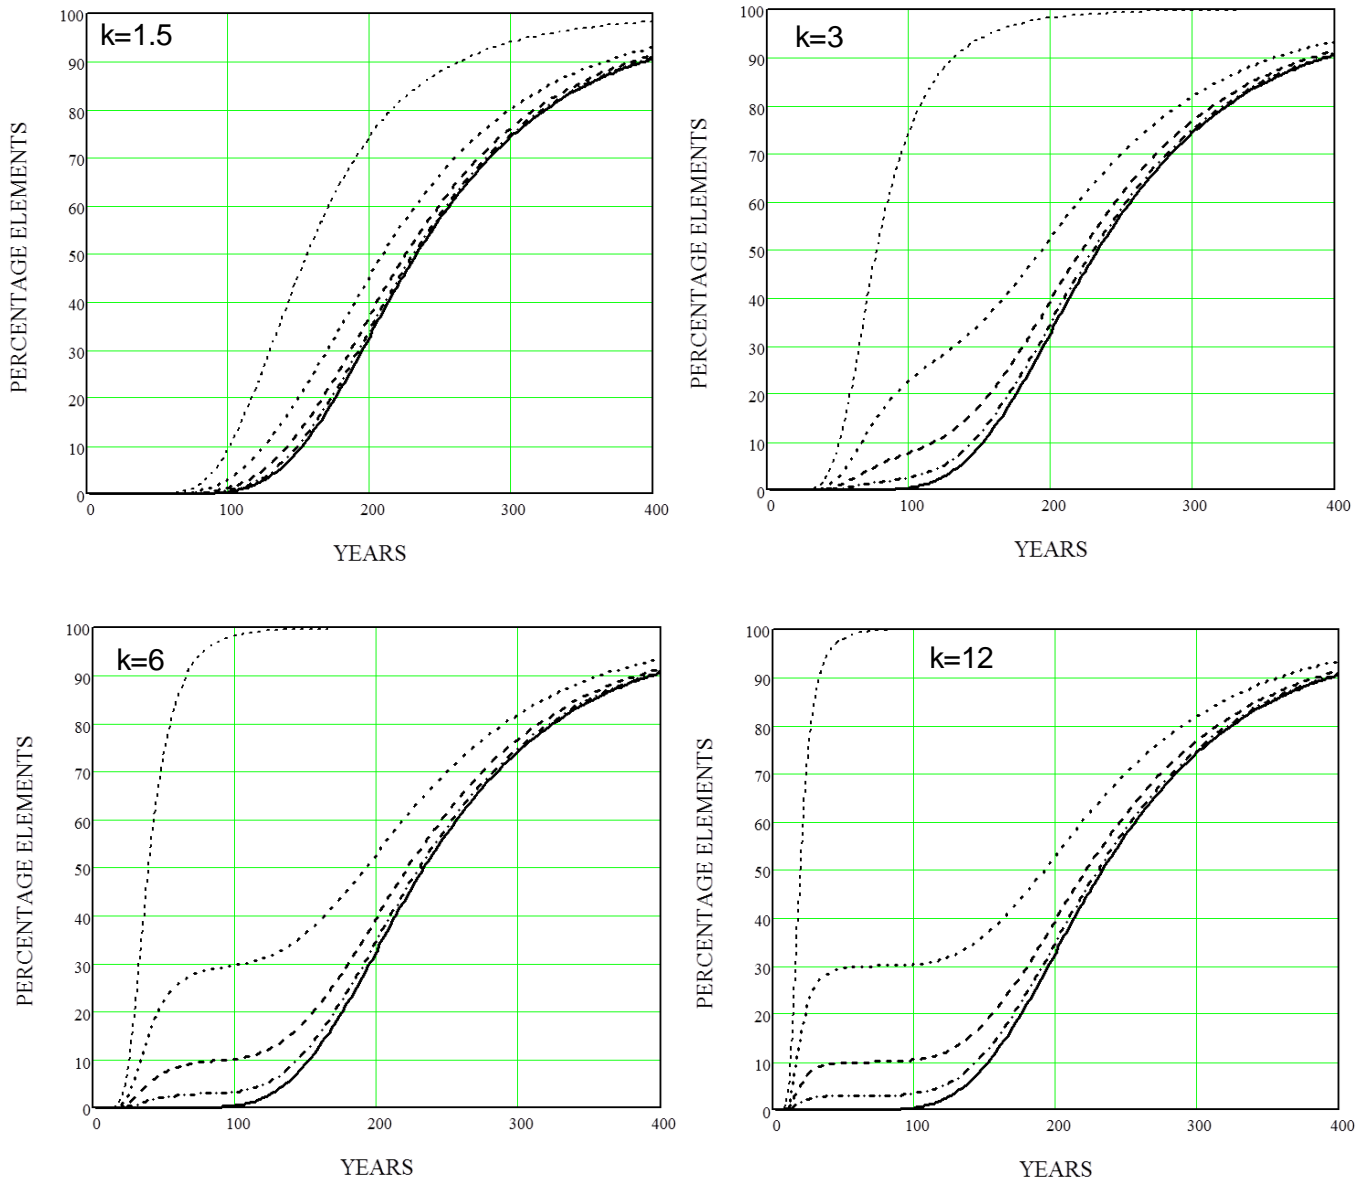
**Figure 54. Modeling projections showing damage function as percentage of reinforcing elements having reached their limit state at the structure age indicated. Solid line corresponds to the base case (no voids). Each family of cases corresponds to the indicated corrosion aggravation parameter  $k$ . Broken lines to the left of the base case indicate progressively greater void incidence parameters corresponding to 3%, 10%, 30%, and 100% of all elements affected by repaired voids.**

As in the initial modeling approach [2,3], a baseline localized corrosion concentration factor = 2 (effectively multiplying the median values by 2 and increasing  $\mu$  accordingly over the values in Table 5) was assumed as well, to capture the effects of non-uniform soil conditions and to compensate for possible non-conservativeness in the other modeling assumptions. The value of  $k$  acts as a compounding factor on that base multiplier. The resulting modeling projections are shown in Figure 54.
