BDV25-977-11

Final Report

A Pilot Study for Preventing Incorrect Turns at Highway-Rail Grade Crossings

December 2017

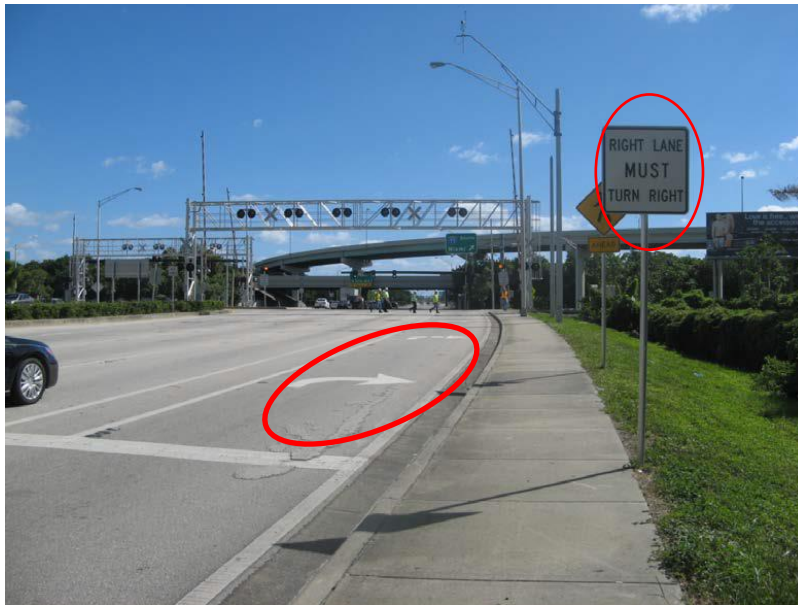
Figure 1-2 Example of potentially misleading right-turn sign and pavement markings.

According to the previous NCTR study, the most recognized regulatory signs and pavement markings in front of a railroad grade crossing that may confuse drivers are “Right Lane Must Turn Right,” “Left Lane Must Turn Left,” right turn only, and/or left turn only pavement markings [1]. Figure 1-2 shows an example of these signs and markings before a railroad crossing on W Commercial Blvd near I-95 in Oakland Park, Florida. To eliminate this potential confusion, the national NCUTCD Technical Committee suggests placing them a minimum of 100 ft in advance of the stop line for a highway-rail grade crossing. The specific recommendation was proposed in NCUTCD Technical Committee Railroad/Light Rail Transit Technical Committee (RRLRT) Item No. 1 [3]. The proposed changes were supported by the Association of American Railroads (AAR) in a letter to the Federal Highway Administration (FHWA) recommending adoption of the changes into MUTCD.

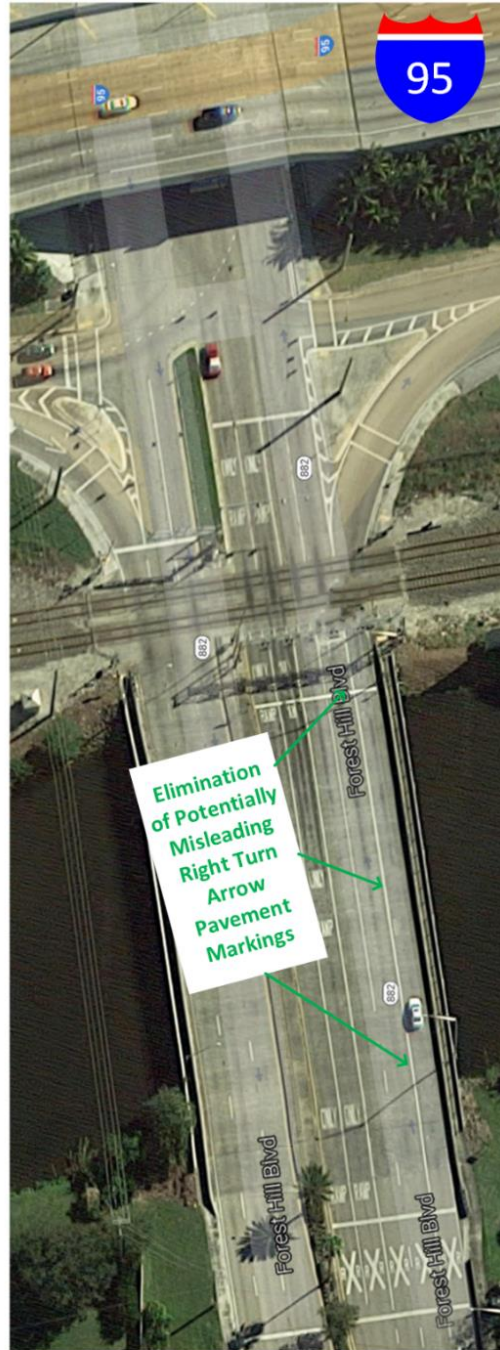
Before

Potentially Misleading Pavement Markings

After I

Elimination of Potentially Misleading Pavement Markings

Figure 1-3 shows an example of the before-after comparison of proposed Countermeasure I in front of a grade crossing on Forest Hills Blvd near I-95 in Lake Clarke Shores, Florida. In this case, an arrow pavement marking denoting an exclusive lane was located on the roadway between the stop line for the grade crossing and the track area. According to the proposal by NCUTCD [3], the arrow pavement marking between the stop line and rail crossing and those within 100 ft before the stop line is suggested to be eliminated. CUTR also suggests eliminating arrow pavement markings before a grade crossing, as shown in Figure 1-3. In this case, the “Right Lane Must Turn Right” sign before the grade crossing will also be eliminated to avoid confusion.

For illustration purposes, recommended countermeasures I, II, III, and a combination of the three, as described in Chapter 1 (Figure 1-3, Figure 1-5, and Figure 1-6), were proposed for panel review.

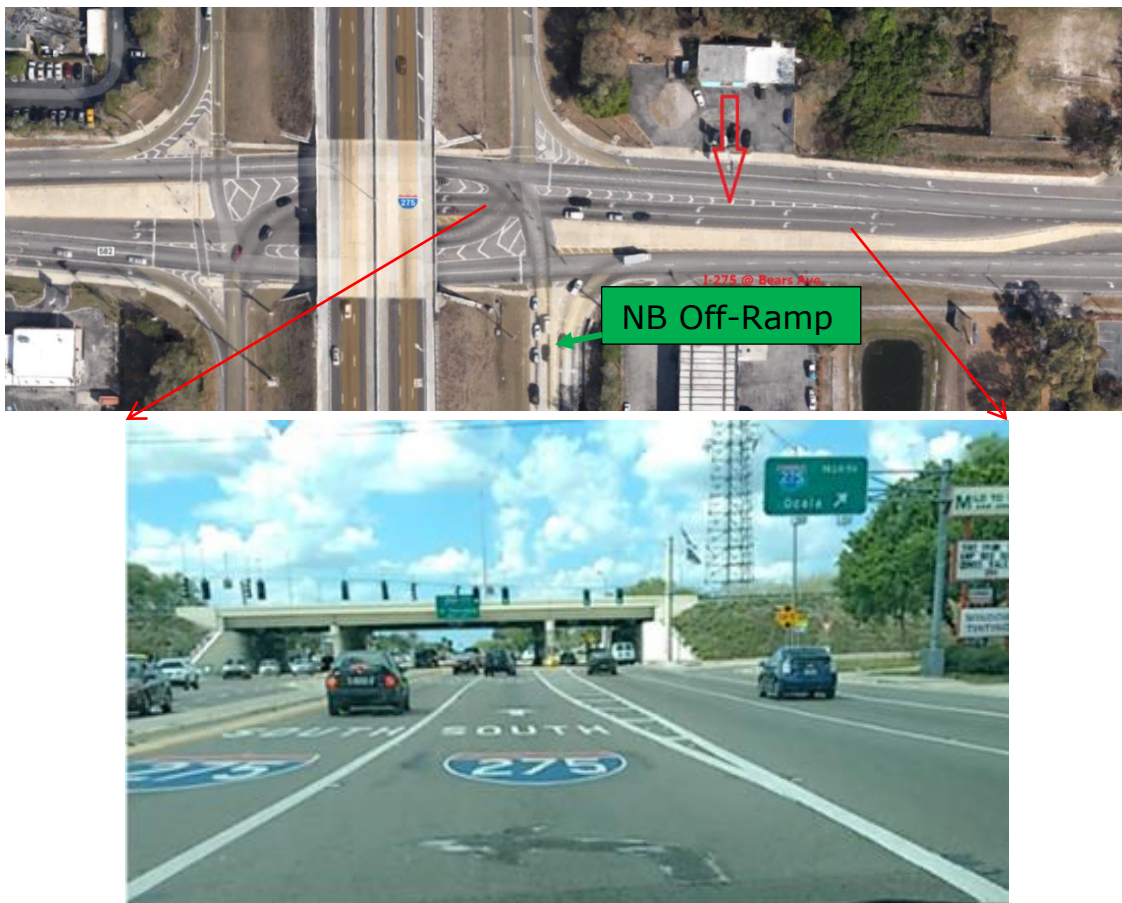
Figure 1-4 Pavement markings with guidance information at I-275 NB off-ramp at Bearss Ave, Tampa, Florida.

Pavement words, symbols, and arrow markings are used for the purpose of guiding, warning, or regulating traffic. According to MUTCD, symbol messages are preferable to word messages (MUTCD, 2009) [4]. In particular, route shield pavement markings are available for use in accordance with the MUTCD Section 3B and FDOT's *Traffic Engineering Manual (TEM)*, Section 4.2. One example is the route shield lane pavement markings used on Bearss Avenue at I-75, shown in Figure 1-4. These pavement markings are used to reduce a spate of wrong-way driving incidents in which drivers were incorrectly attempting to enter I-275 using its exit ramps. Incorrect turning by drivers at highway-rail grade crossings is also a type of wrong-way driving. This pilot study recommends the use of similar pavement markings with guidance information to deter and prevent future incidents of incorrect turns at highway rail grade crossings near interchange ramps or at-grade signalized intersections with exclusive turn lanes.

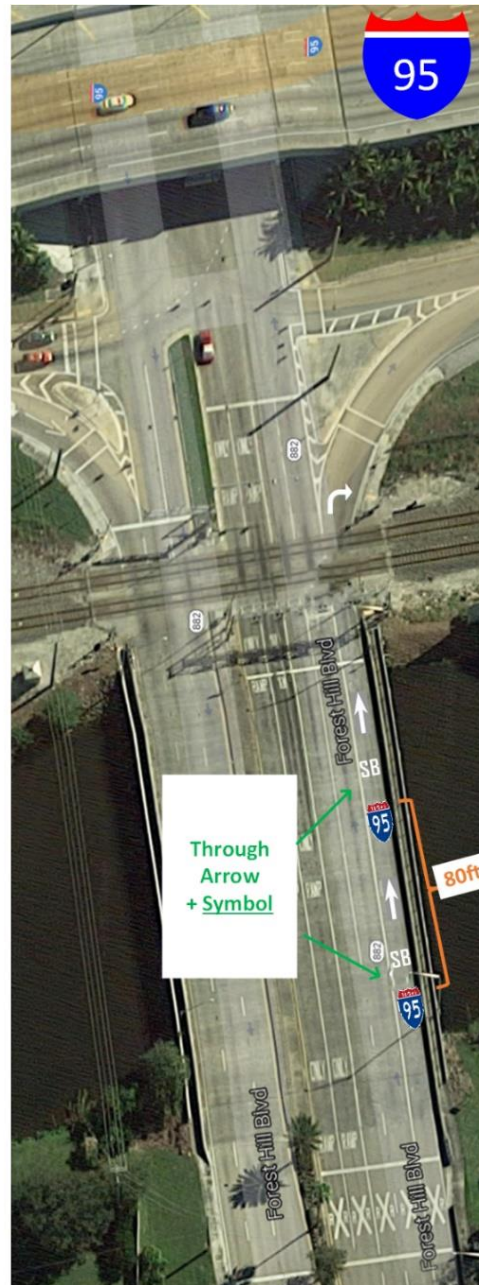
After II-Design A

Pavement Markings with Guidance Information

After II-Design B

To adopt the suggestion from MUTCD and apply successful FDOT experience on preventing wrong-way driving, CUTR explored two types of designs, including through arrow pavement markings with target roadway information (name and direction) to replace the turning arrow pavement markings on the upstream of the railroad crossing, as illustrated in Figure 1-5.

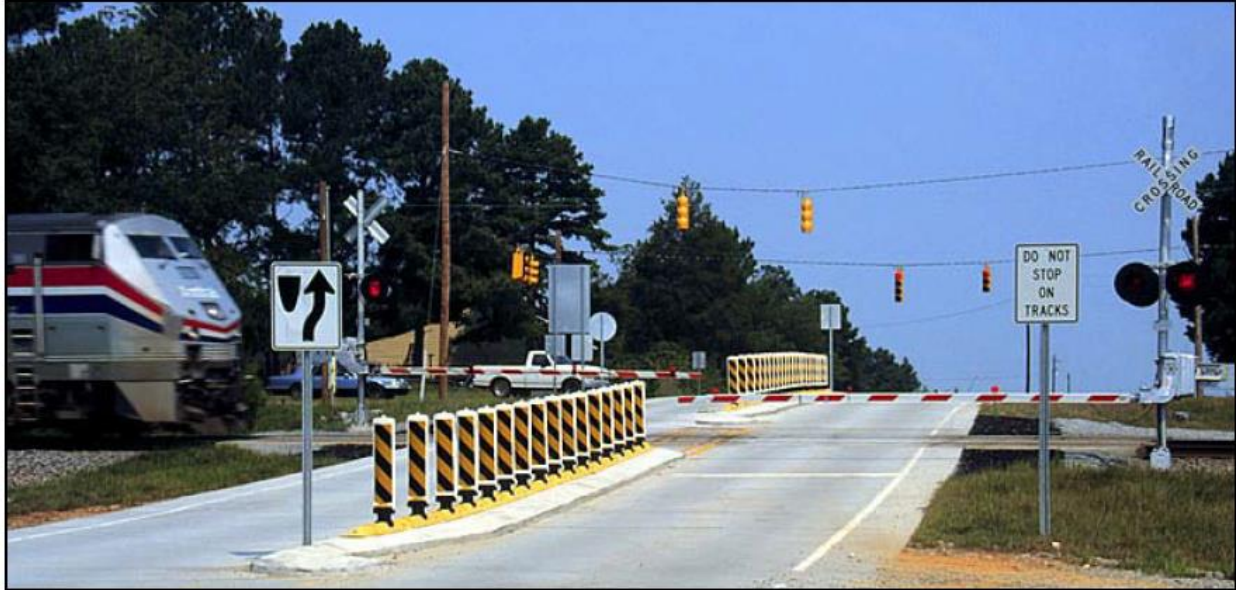
Figure 1-9 Example of Qwick Kurb at railroad crossing (*photo courtesy of NCDOT*).

Qwick Kurb can deter motorists from turning around before or at railroad crossings, consequently preventing incorrect U-turns. The U.S. Department of Transportation (DOT) Federal Railroad Administration (FRA) promotes the use of traffic channelization devices (e.g., Qwick Kurb) at highway-rail grade crossings with active warning devices, where applicable. These traffic channelization devices provide a proven safety benefit. A previous study [7] was conducted at locations where driver violations occurred at highway-rail grade crossings and after installation of channelization devices at these locations, resulting in a significant reduction in driver violations. Figure 1-9 shows an example of Qwick Kurb at a railroad crossing.

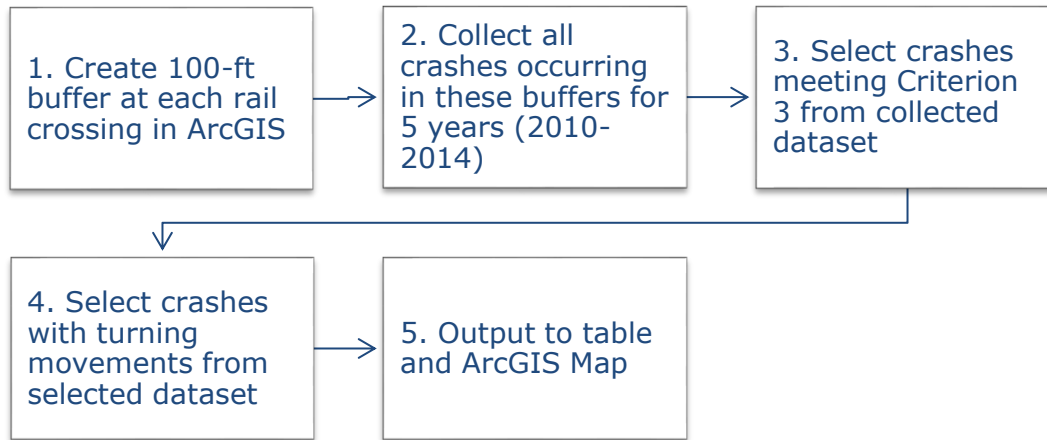
Figure 2-1 Procedure to filter crashes due to incorrect turns at highway-rail grade crossings from FDOT CARS.

To filter incorrect turn-caused crashes from the millions of historical crash data, a GIS-based procedure was developed, as shown in Figure 2-1. In total, 14 crashes were identified from the FDOT CARS, as shown in Table 2-1.

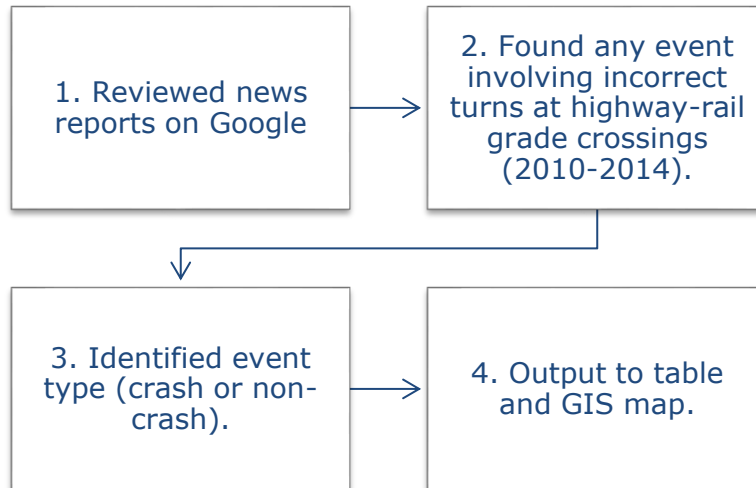
Figure 2-3 Procedure to filter events caused by incorrect turns at highway-rail grade crossings from news reports.

CUTR searched news reports that recorded events caused by incorrect turns at highway-rail grade crossing that occurred in Florida from 2010–2014. Based on descriptions in the reports, the research team identified any event involving incorrect turns at railroad crossings and matched the event to the FDOT CARS to determine if the events were crashes. The procedure is shown in Figure 2-3. In total, eight events were identified from the news reports, as shown in Table 2-1.

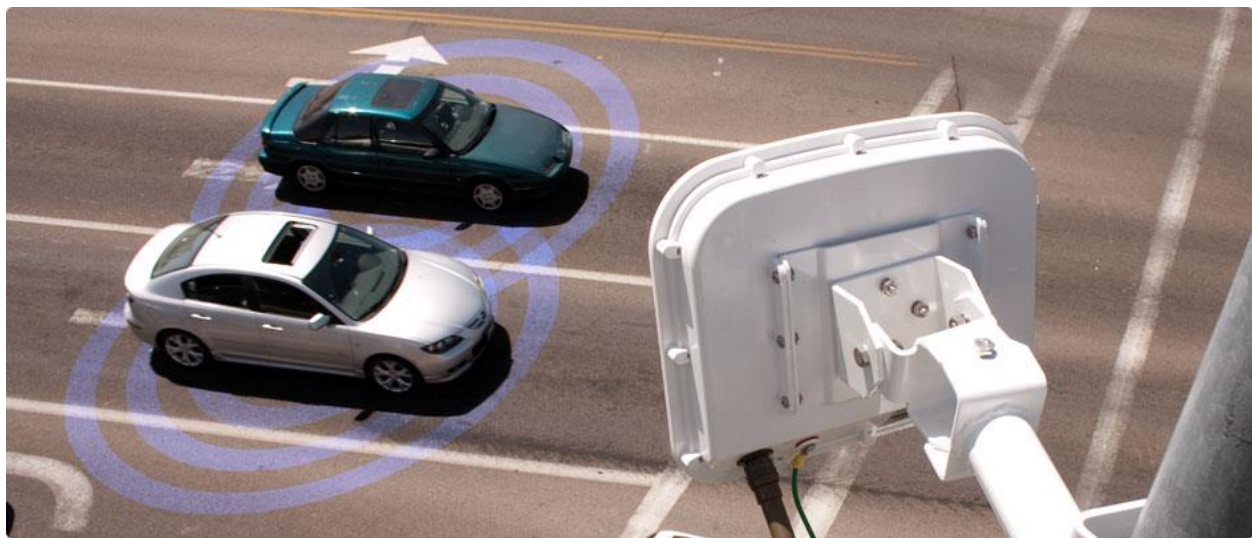
Figure 4-21 Wavetronix SmartSensor.

A Wavetronix SmartSensor (Figure 4-21) and a camera (such as GoPro 5) on a Pneumatic Locking Telescoping Mast will be mounted at each candidate site. The installation positions and detection zones for the ten candidate sites are shown in Figure 4-1 Combee Rd @ US 92, Figure 4-3 US 41 @ US 301, Figure 4-5 Hollywood Blvd @ I-95, Figure 4-7 Forest Hill Blvd @ I-95, Figure 4-9 W Hallandale Beach Blvd @ I-95, Figure 4-11 W Commercial Blvd @ I-95, Figure 4-13 W Pembroke Rd @ I-95, Figure 4-15 Busch Blvd @ N Boulevard St, Figure 4-17 E Adamo Dr @ N 39th St, and Figure 4-19 Tampa Rd @ State St W. The Wavetronix SmartSensor uses the latest radar technology to collect and deliver traffic statistics, including traffic volume and classification, average speed, individual vehicle speed, lane occupancy, and presence on multiple lanes. Data for individual speeds of cars approaching the railroad crossings will be processed to identify hesitation behaviors using the methodology introduced below. Traffic monitoring videos from the camera will be used to verify the hesitating vehicles.

The Wavetronix SmartSensor and cameras will be powered by a gasoline-powered inverter generator. An RS-485 cable will be used to connect the Wavetronix SmartSensor with a laptop. Researchers can configure and monitor the SmartSensor on the laptop through the SmartSensor Manager software. The data collection procedure will be as follows:

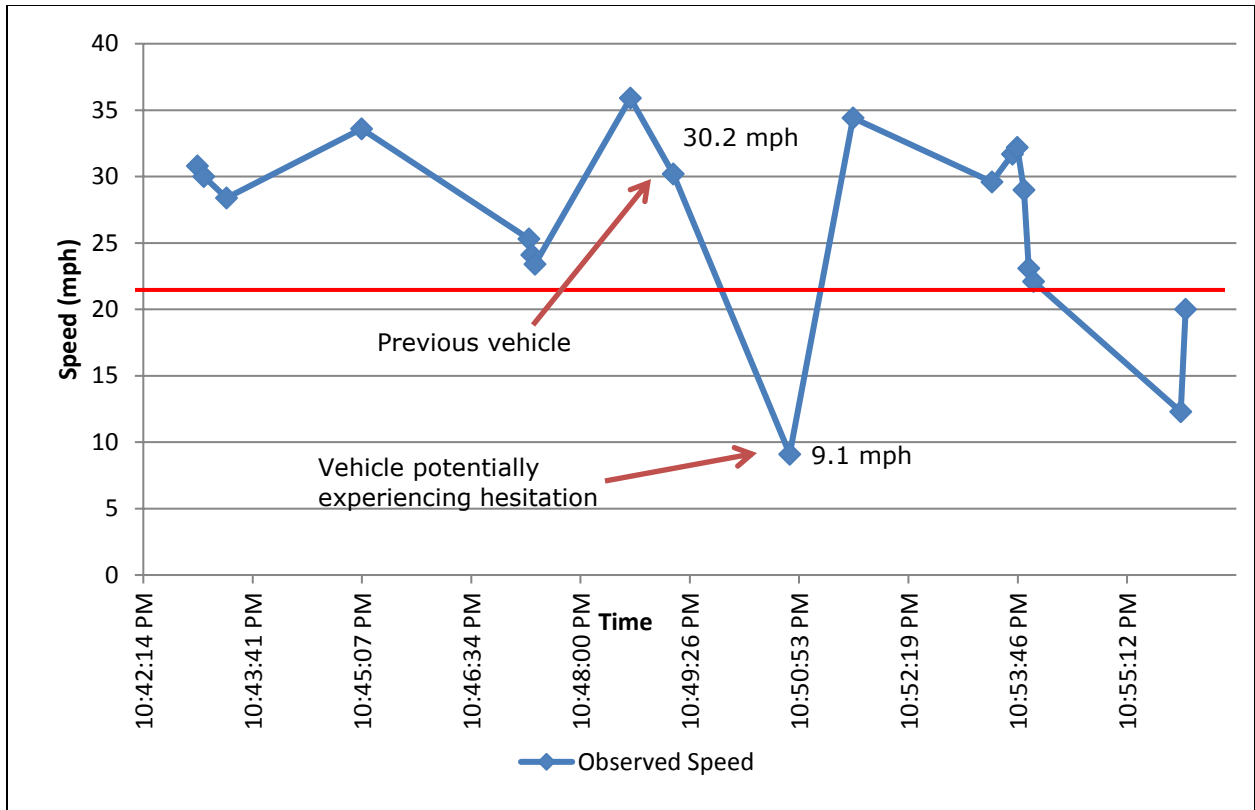
Figure 4-22 Example of hesitation vehicle.

$$\text{Hesitation rate} = \# \text{ of hesitation vehicles} \div \# \text{ of turning vehicles}$$

A statistical comparison will be conducted on hesitation rates between the “before” and “after” stages. If the hesitation rates are significantly reduced after implementing the countermeasures, it could state the proposed countermeasures can reduce the risk of incorrect turns at highway-rail grade crossings.
