**BDV25-977-11**

## **A Pilot Study for Preventing Incorrect Turns at Highway-Rail Grade Crossings**

**PREPARED FOR  
Florida Department of Transportation**

**December 2017**

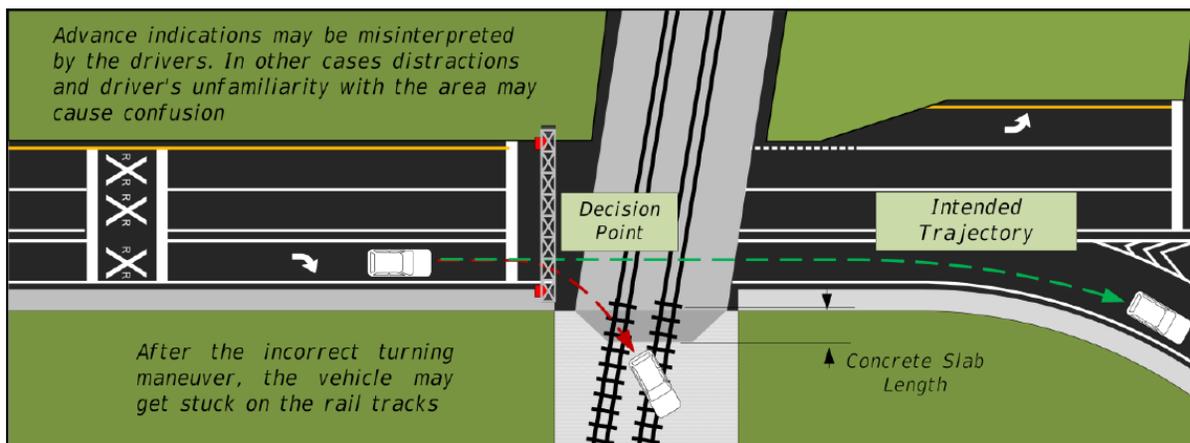
**Figure 1-1 Sketch of incorrect turning maneuver near an interstate ramp [1].**

Preventing incorrect turns at highway-rail grade crossings has received considerable attention in an effort to decrease fatalities and injuries for both road users and rail users/operators. To mitigate serious injuries and fatal collisions due to incorrect turns at highway-rail grade crossings, a previous National Center for Transit Research (NCTR) research project titled, “Improved Traffic Control Measures to Prevent Incorrect Turns at Highway-Rail Grade Crossings,” successfully identified five major contributing causes of incorrect turns onto railroad tracks: (1) potentially misleading signs and pavement markings near highway-rail crossings, (2) darkness and low visibility near or at highway-rail crossings, (3) following inaccurate turn instructions from a GPS device onto railroad tracks, (4) skewed highway-rail grade crossings, and (5) driver distraction. Right-turn arrow pavement markings in front of a railroad grade crossing could cause the most confusion for drivers who turn onto the railroad tracks, as illustrated in Figure 1-1 [1].

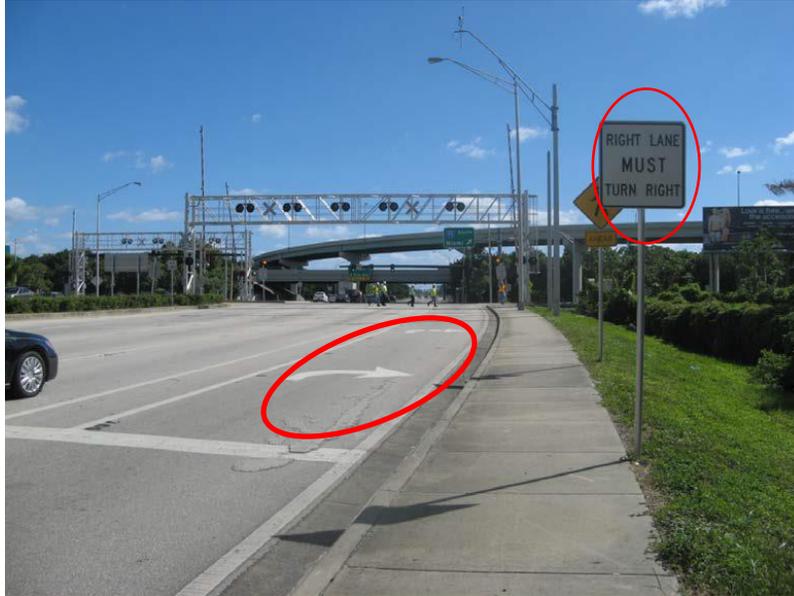
**Figure 1-2 Example of potentially misleading right-turn sign and pavement markings.**

According to the previous NCTR study, the most recognized regulatory signs and pavement markings in front of a railroad grade crossing that may confuse drivers are “Right Lane Must Turn Right,” “Left Lane Must Turn Left,” right turn only, and/or left turn only pavement markings [1]. Figure 1-2 shows an example of these signs and markings before a railroad crossing on W Commercial Blvd near I-95 in Oakland Park, Florida. To eliminate this potential confusion, the national NCUTCD Technical Committee suggests placing them a minimum of 100 ft in advance of the stop line for a highway-rail grade crossing. The specific recommendation was proposed in NCUTCD Technical Committee Railroad/Light Rail Transit Technical Committee (RRLRT) Item No. 1 [3]. The proposed changes were supported by the Association of American Railroads (AAR) in a letter to the Federal Highway Administration (FHWA) recommending adoption of the changes into MUTCD.

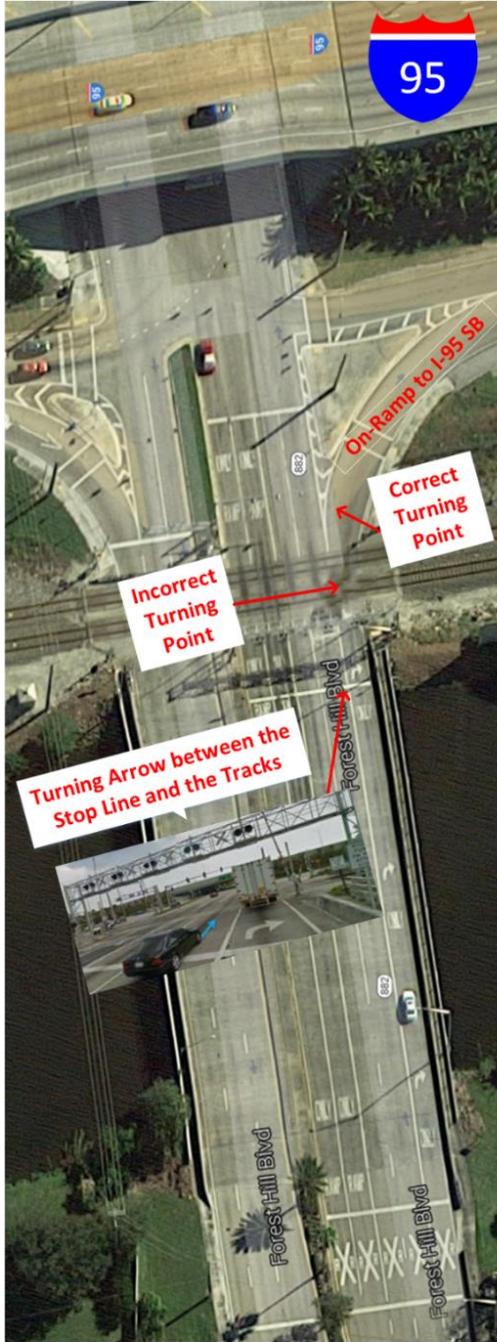
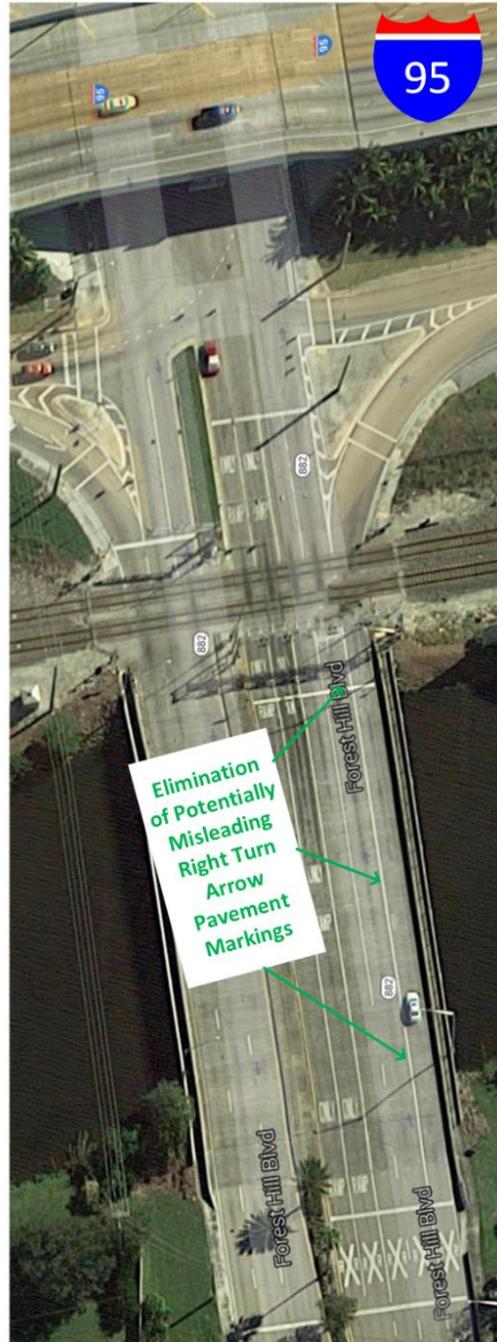
Before

Potentially Misleading Pavement Markings

After I

Elimination of Potentially Misleading Pavement Markings

Figure 1-3 shows an example of the before-after comparison of proposed Countermeasure I in front of a grade crossing on Forest Hills Blvd near I-95 in Lake Clarke Shores, Florida. In this case, an arrow pavement marking denoting an exclusive lane was located on the roadway between the stop line for the grade crossing and the track area. According to the proposal by NCUTCD [3], the arrow pavement marking between the stop line and rail crossing and those within 100 ft before the stop line is suggested to be eliminated. CUTR also suggests eliminating arrow pavement markings before a grade crossing, as shown in Figure 1-3. In this case, the “Right Lane Must Turn Right” sign before the grade crossing will also be eliminated to avoid confusion.

For illustration purposes, recommended countermeasures I, II, III, and a combination of the three, as described in Chapter 1 (Figure 1-3, Figure 1-5, and Figure 1-6), were proposed for panel review.

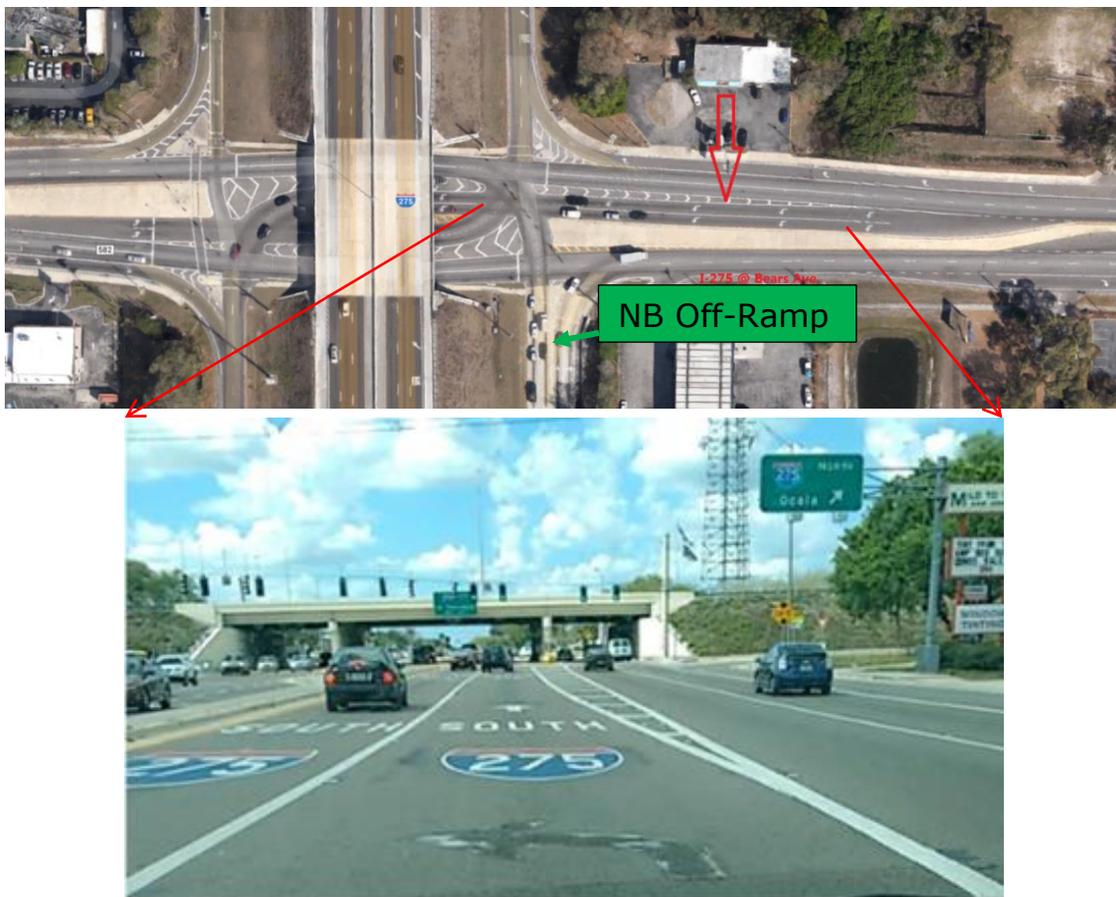
**Figure 1-4 Pavement markings with guidance information at I-275 NB off-ramp at Bearss Ave, Tampa, Florida.**

Pavement words, symbols, and arrow markings are used for the purpose of guiding, warning, or regulating traffic. According to MUTCD, symbol messages are preferable to word messages (MUTCD, 2009) [4]. In particular, route shield pavement markings are available for use in accordance with the MUTCD Section 3B and FDOT's *Traffic Engineering Manual (TEM)*, Section 4.2. One example is the route shield lane pavement markings used on Bearss Avenue at I-75, shown in Figure 1-4. These pavement markings are used to reduce a spate of wrong-way driving incidents in which drivers were incorrectly attempting to enter I-275 using its exit ramps. Incorrect turning by drivers at highway-rail grade crossings is also a type of wrong-way driving. This pilot study recommends the use of similar pavement markings with guidance information to deter and prevent future incidents of incorrect turns at highway rail grade crossings near interchange ramps or at-grade signalized intersections with exclusive turn lanes.

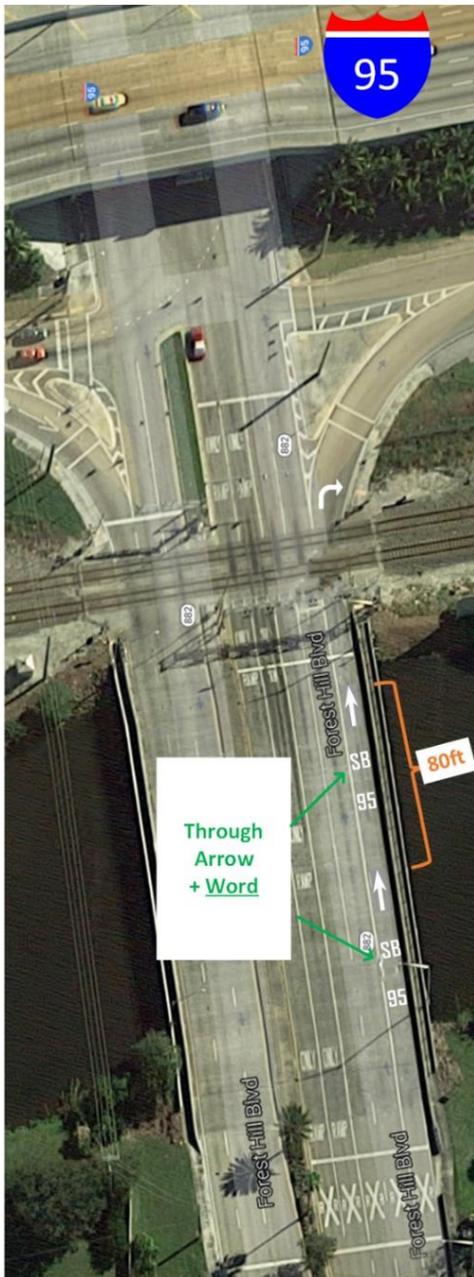
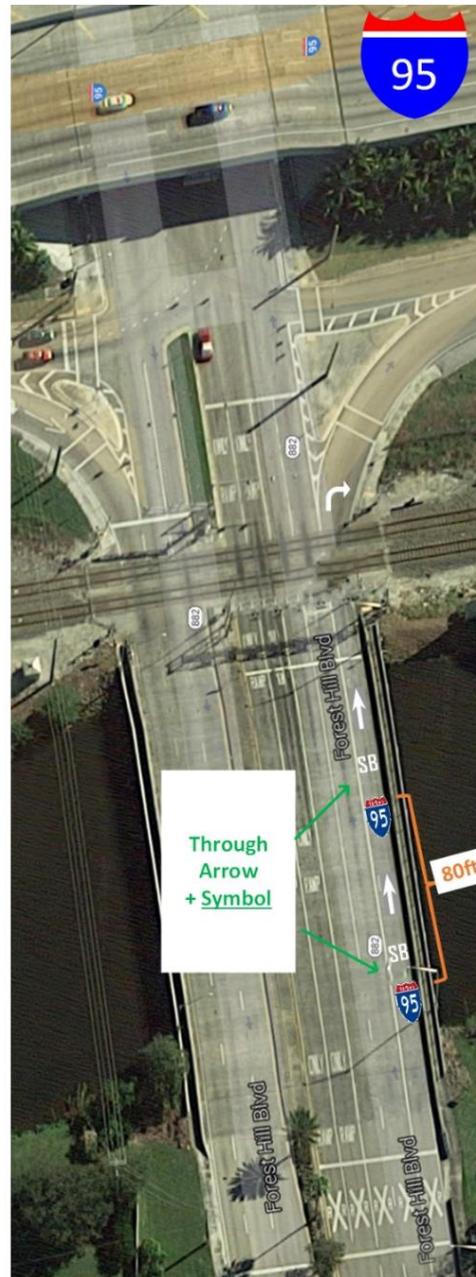
**After II-Design A**

Pavement Markings with Guidance Information

**After II-Design B**

To adopt the suggestion from MUTCD and apply successful FDOT experience on preventing wrong-way driving, CUTR explored two types of designs, including through arrow pavement markings with target roadway information (name and direction) to replace the turning arrow pavement markings on the upstream of the railroad crossing, as illustrated in Figure 1-5.

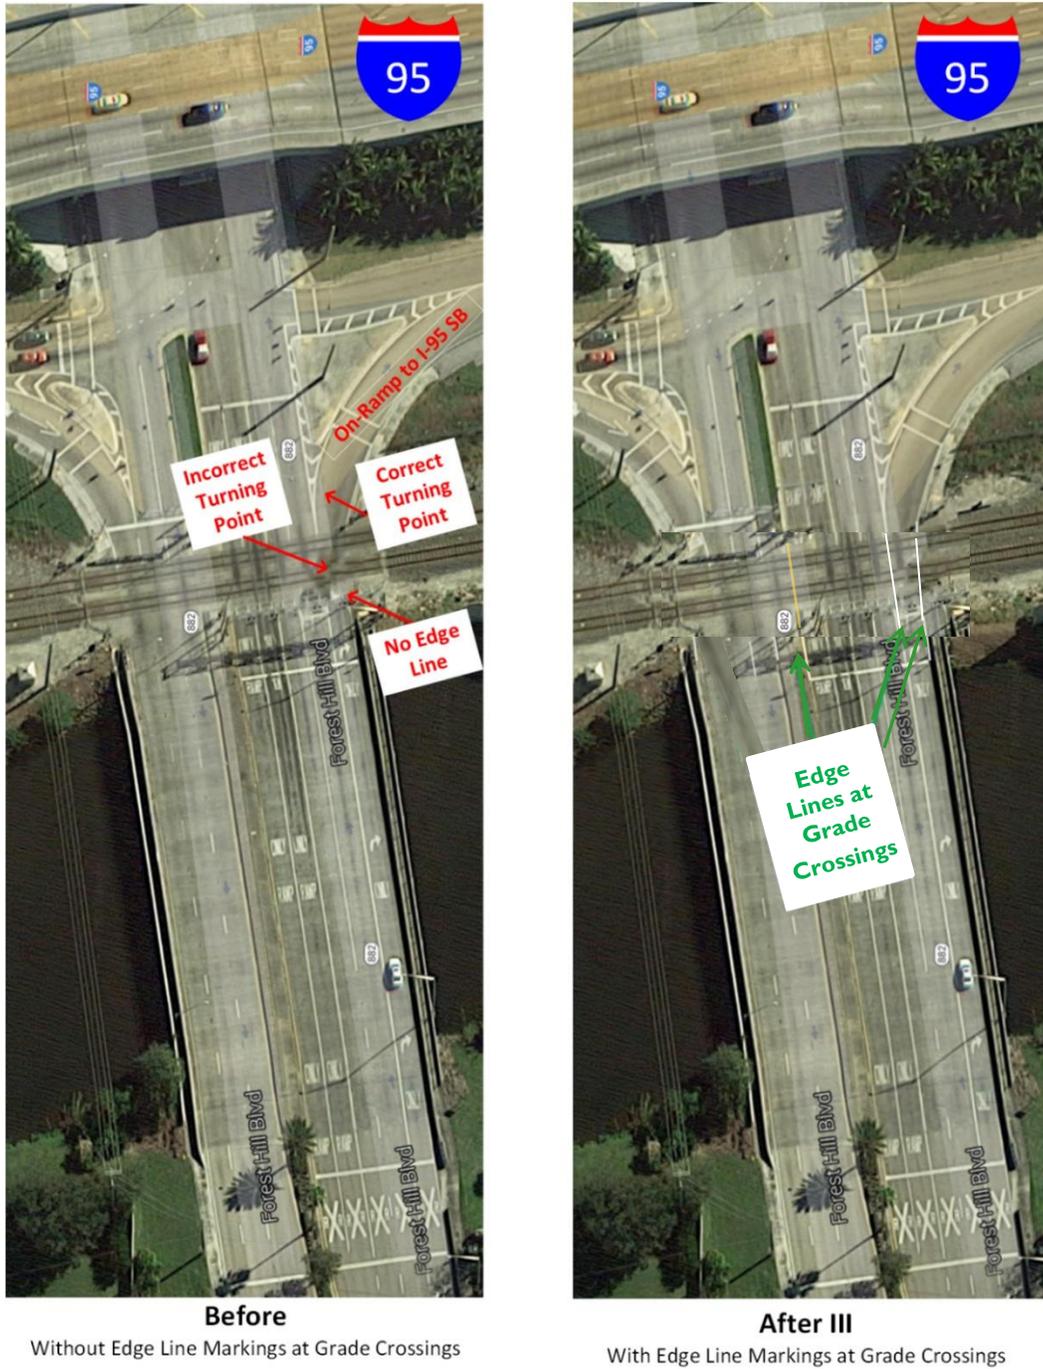
**Figure 1-6 Countermeasure III: Extension of edge lines.**

Figure 1-6 shows an example of a before-after comparison of Countermeasure III in front of a railroad crossing on Forest Hills Blvd near I-95 in Lake Clarke Shores, Florida. Extending edge

lines markings to and across grade crossings will increase the visibility of the edge of the travel lane for road users and emphasize the message the crossing curb cut is not a place to turn.

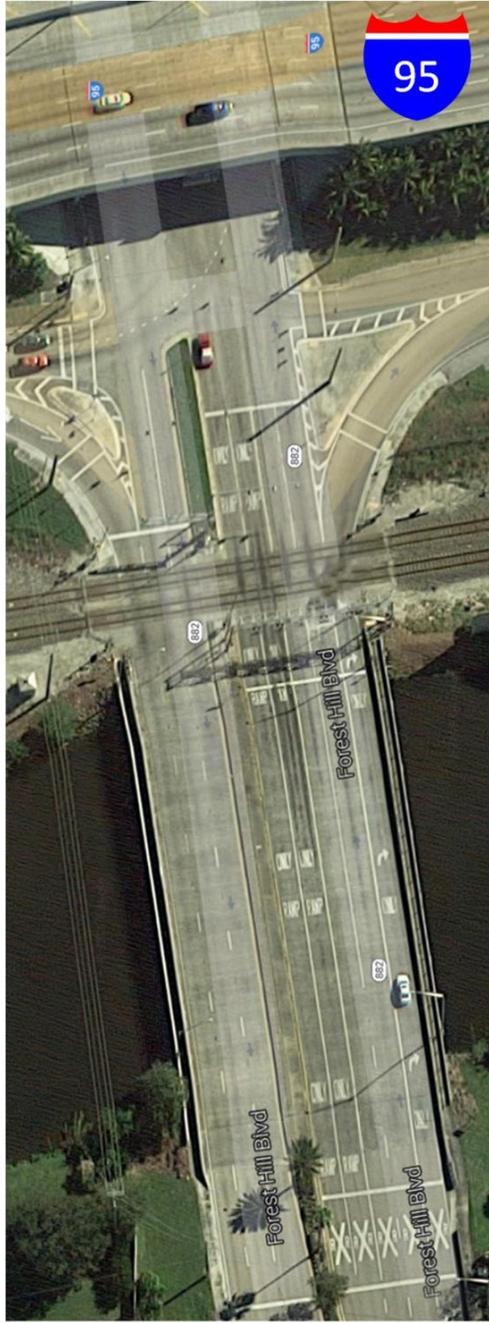
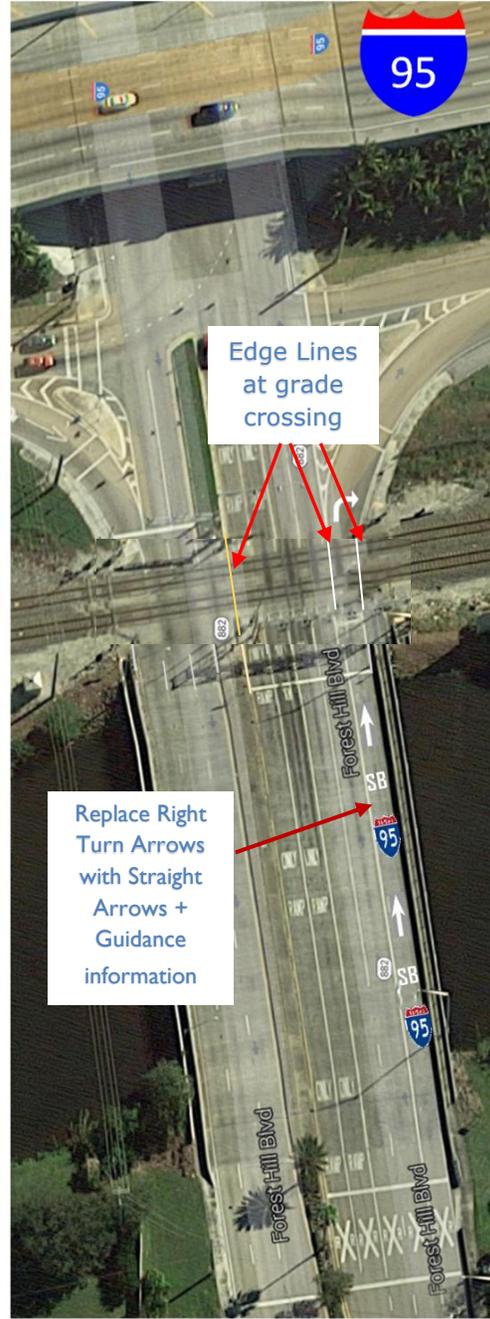
Figure 1-7 Combination of Countermeasures I, II and III.

The combination of the above three recommended countermeasures, as illustrated in Figure 1-7, could be a holistic treatment to prevent incorrect turns onto railroad tracks.

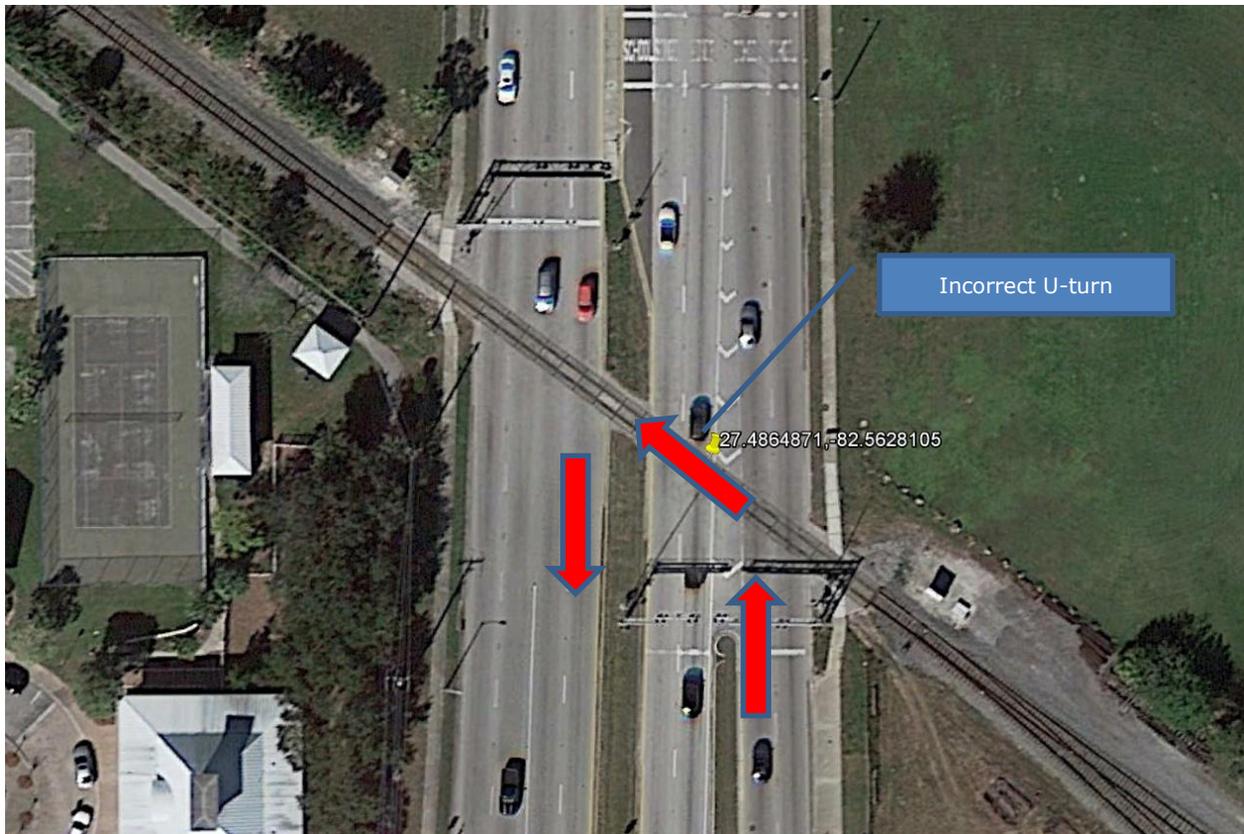
**Figure 1-8 Example of incorrect U-turn at railroad crossing.**

At some rail crossings, there is a potential risk of drivers turning around (making a U-turn) using railroad tracks. An example of an incorrect U-turn is shown in Figure 1-8.

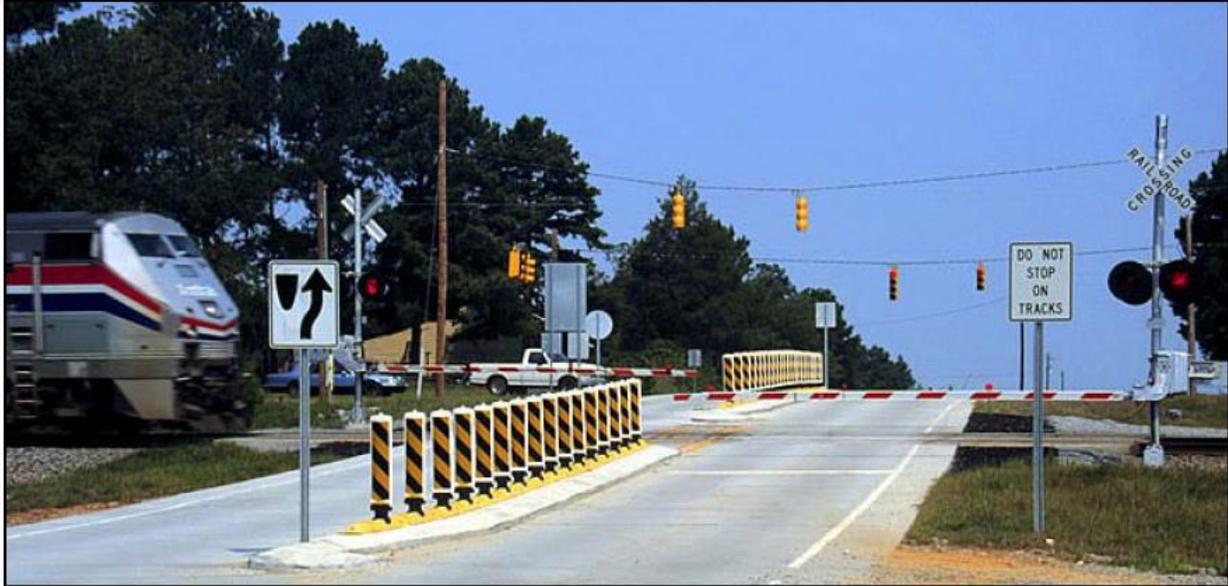
**Figure 1-9 Example of Qwick Kurb at railroad crossing** (*photo courtesy of NCDOT*).

Qwick Kurb can deter motorists from turning around before or at railroad crossings, consequently preventing incorrect U-turns. The U.S. Department of Transportation (DOT) Federal Railroad Administration (FRA) promotes the use of traffic channelization devices (e.g., Qwick Kurb) at highway-rail grade crossings with active warning devices, where applicable. These traffic channelization devices provide a proven safety benefit. A previous study [7] was conducted at locations where driver violations occurred at highway-rail grade crossings and after installation of channelization devices at these locations, resulting in a significant reduction in driver violations. Figure 1-9 shows an example of Qwick Kurb at a railroad crossing.

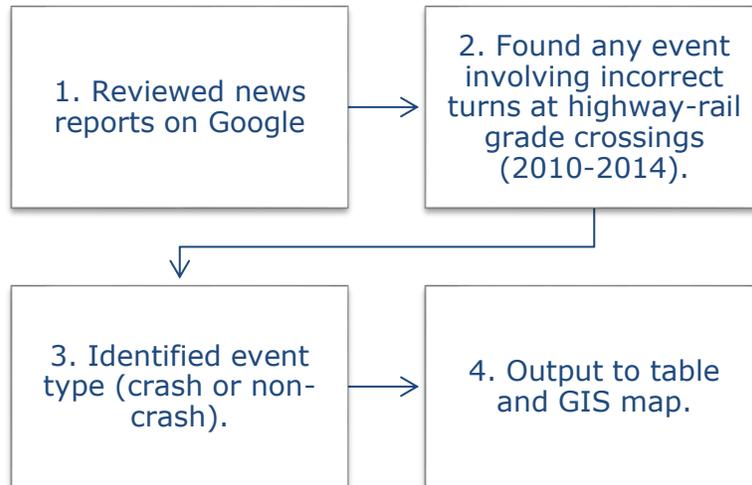
**Figure 2-3 Procedure to filter events caused by incorrect turns at highway-rail grade crossings from news reports.**

CUTR searched news reports that recorded events caused by incorrect turns at highway-rail grade crossing that occurred in Florida from 2010–2014. Based on descriptions in the reports, the research team identified any event involving incorrect turns at railroad crossings and matched the event to the FDOT CARS to determine if the events were crashes. The procedure is shown in Figure 2-3. In total, eight events were identified from the news reports, as shown in Table 2-1.

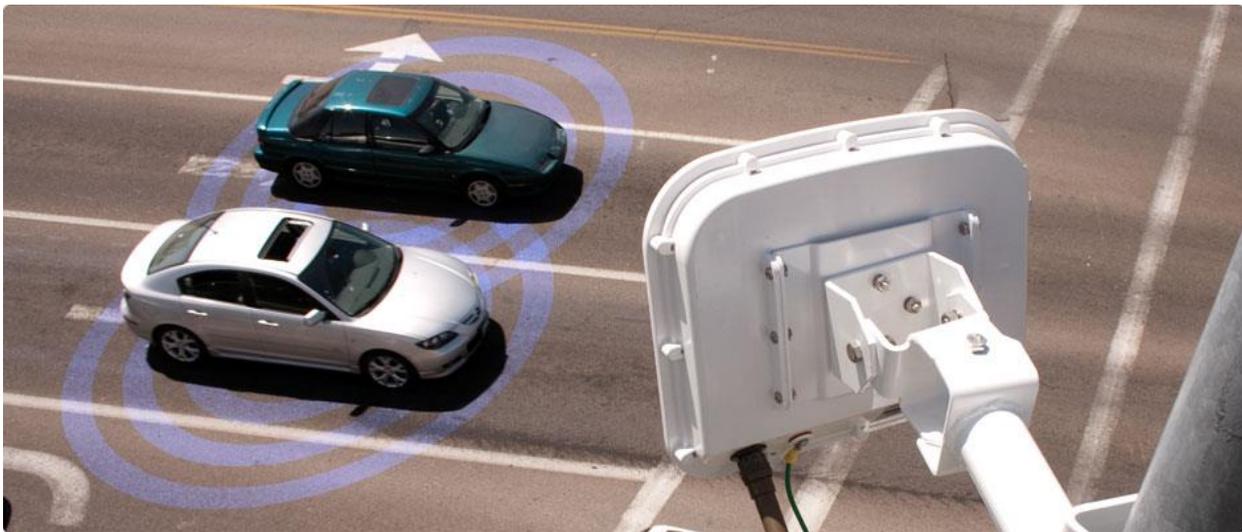
**Figure 4-21 Wavetronix SmartSensor.**

A Wavetronix SmartSensor (Figure 4-21) and a camera (such as GoPro 5) on a Pneumatic Locking Telescoping Mast will be mounted at each candidate site. The installation positions and detection zones for the ten candidate sites are shown in Figure 4-1 Combee Rd @ US 92, Figure 4-3 US 41 @ US 301, Figure 4-5 Hollywood Blvd @ I-95, Figure 4-7 Forest Hill Blvd @ I-95, Figure 4-9 W Hallandale Beach Blvd @ I-95, Figure 4-11 W Commercial Blvd @ I-95, Figure 4-13 W Pembroke Rd @ I-95, Figure 4-15 Busch Blvd @ N Boulevard St, Figure 4-17 E Adamo Dr @ N 39th St, and Figure 4-19 Tampa Rd @ State St W. The Wavetronix SmartSensor uses the latest radar technology to collect and deliver traffic statistics, including traffic volume and classification, average speed, individual vehicle speed, lane occupancy, and presence on multiple lanes. Data for individual speeds of cars approaching the railroad crossings will be processed to identify hesitation behaviors using the methodology introduced below. Traffic monitoring videos from the camera will be used to verify the hesitating vehicles.

The Wavetronix SmartSensor and cameras will be powered by a gasoline-powered inverter generator. An RS-485 cable will be used to connect the Wavetronix SmartSensor with a laptop. Researchers can configure and monitor the SmartSensor on the laptop through the SmartSensor Manager software. The data collection procedure will be as follows:

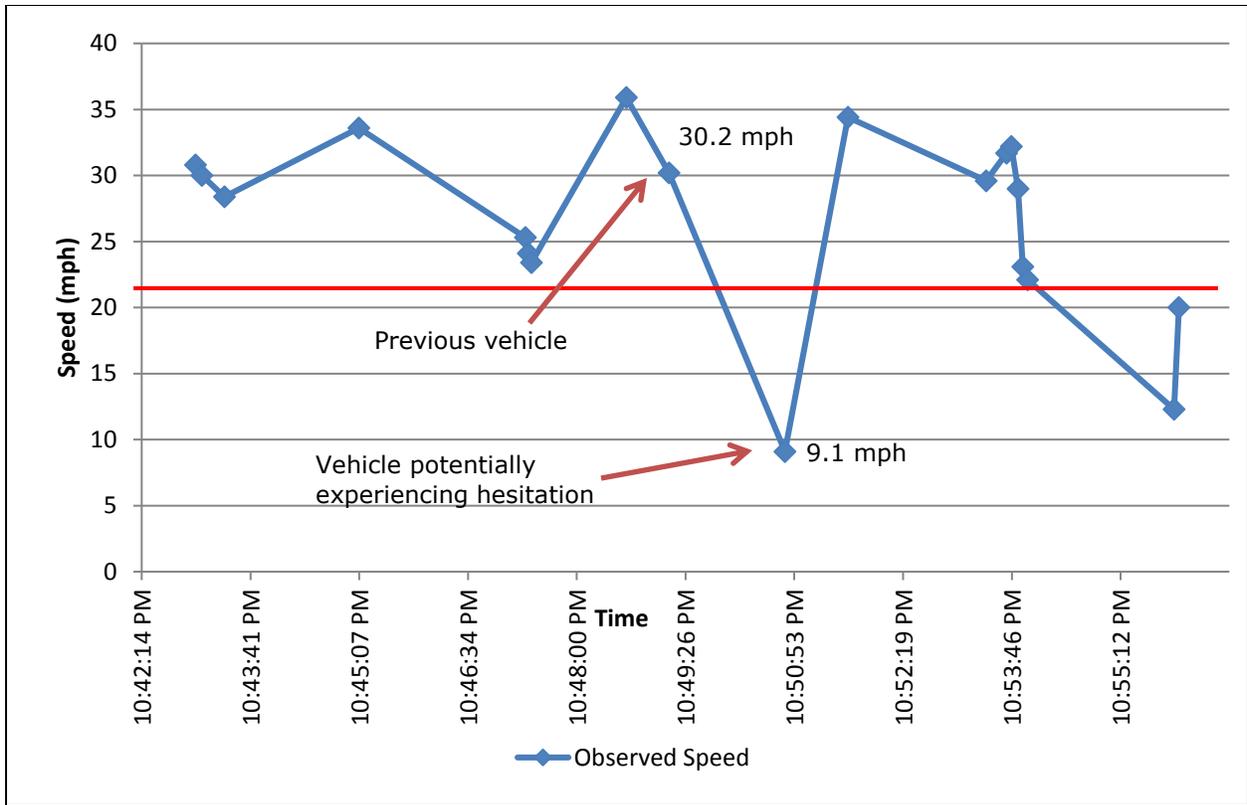
**Figure 4-22 Example of hesitation vehicle.**

$$\text{Hesitation rate} = \# \text{ of hesitation vehicles} \div \# \text{ of turning vehicles}$$

A statistical comparison will be conducted on hesitation rates between the “before” and “after” stages. If the hesitation rates are significantly reduced after implementing the countermeasures, it could state the proposed countermeasures can reduce the risk of incorrect turns at highway-rail grade crossings.
