FINAL REPORT

DEVELOPMENT OF TENDON IMAGING SENSOR

FDOT Contract Number: BDV25-977-24

Department of Civil and Environmental Engineering

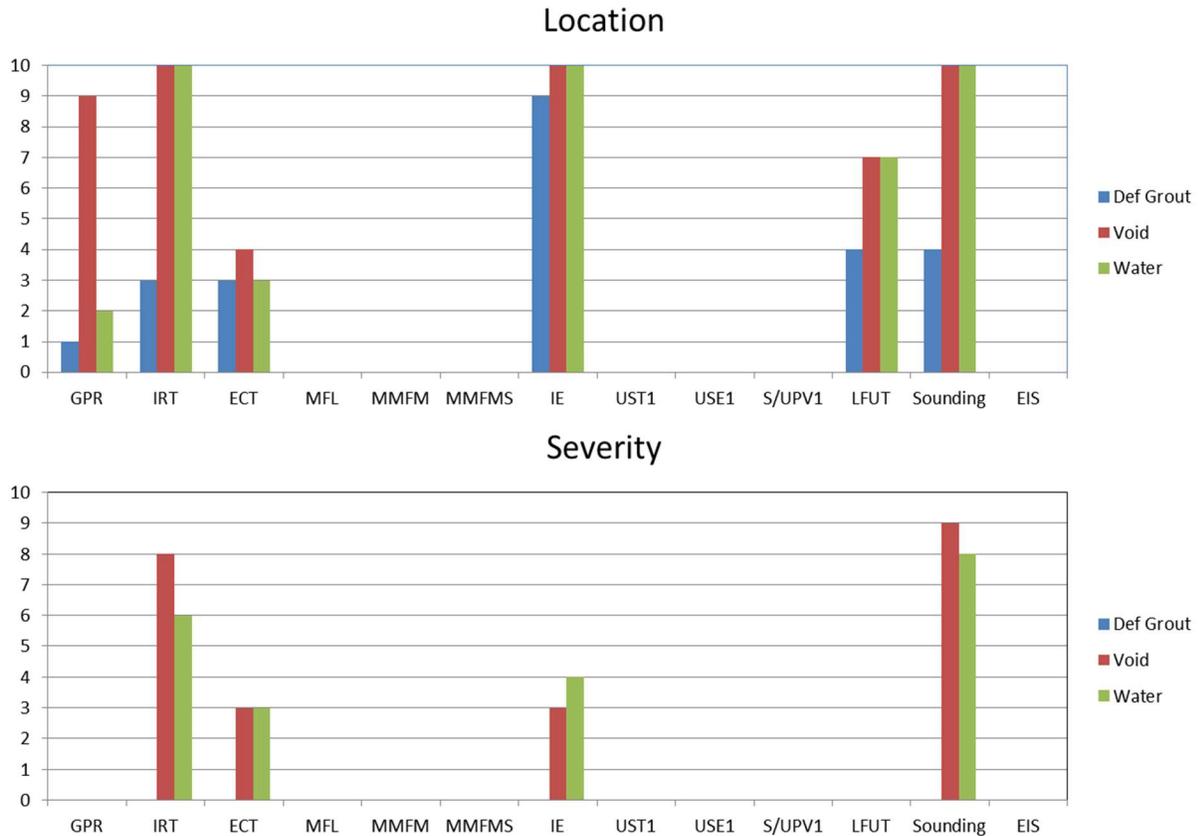
Figure 3.1 Summary of rankings (10 is best) from the NCHRP investigation [33] for ability of methods to identify location and severity of grout deficiencies, air voids, and excessive water conditions. This summary applies only to evaluation of external, polymer-duct tendons.

Some of those methods were oriented to evaluation of the strand corrosion condition and less so, or not at all, for grout condition evaluation. Figure 3.1 has been prepared based on data developed in that investigation, which evaluated the suitability of each method for detecting grout deficiencies, air voids, and excessive water conditions in polymer-ducted external tendons. The method appropriateness for each case was ranked in a 0-10 scale (10 best) based on how accurately the location and the severity of each condition was detected. It is important to note that those rankings do not include the ability of a given method to differentiate between the various deficiencies. For example, sounding provides an alert that either a void or water is present, but not an indication of which of the two it is. Those rankings indicate nevertheless that for the present analysis only a comparison set of methods GPR, IRT, ECT, IE, LFUT and Sounding merits consideration as the other methods received zero ranking.

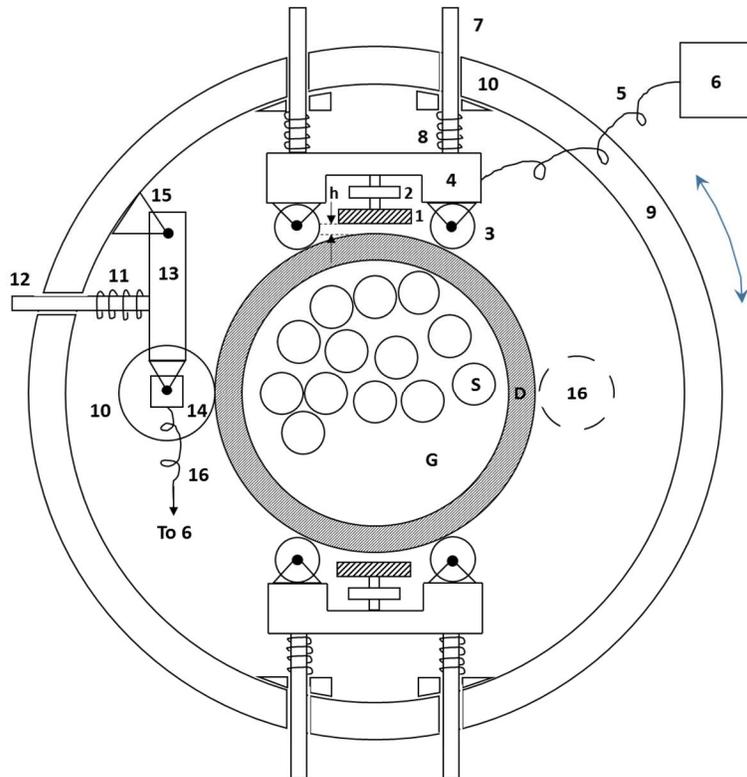
Figure 4.2 Approximate prototype configuration. The bottom carriage shares the same part designations (omitted for simplicity) as the upper carriage. [42].

The prototype sensor was built approximately following the configuration schematically illustrated in cross-section in Figure 4.2. There the sensor is placed around the tendon to be imaged, consisting of duct D which contains multiple strands S and grout G (which may be sound or contain deficiencies) filling the remaining space. The key elements of the sensor are subassemblies each containing a magnet 1 held at a distance h from the external duct surface by means of a magnet carriage 4 that rides on wheels 3 and is held in place against the duct by an arrangement of studs 7 and springs 8. Those permit the magnet carriage to move radially following any irregularities in the roundness of the duct D, while maintaining a fixed azimuth position with respect to the main sensor ring 9 which rotates around the tendon and causes the wheeled magnet carriages to rotate with the ring 9. Ring 9 for this prototype was built as a solid ring as it is simply inserted at one end of the laboratory test tendon pieces. For implementation in the field, the ring will be a multi-part piece for placement around the tendon, with the parts reunited via a combination of hinges and/or assembly braces. For the present realization which contained two subassemblies located at opposite sides of the tendon, the ring is rotated around the tendon by hand in a back and forth, 180-degrees clockwise and counterclockwise manner so that the footprint of the magnets each cover one half of tendon perimeter, thus covering the

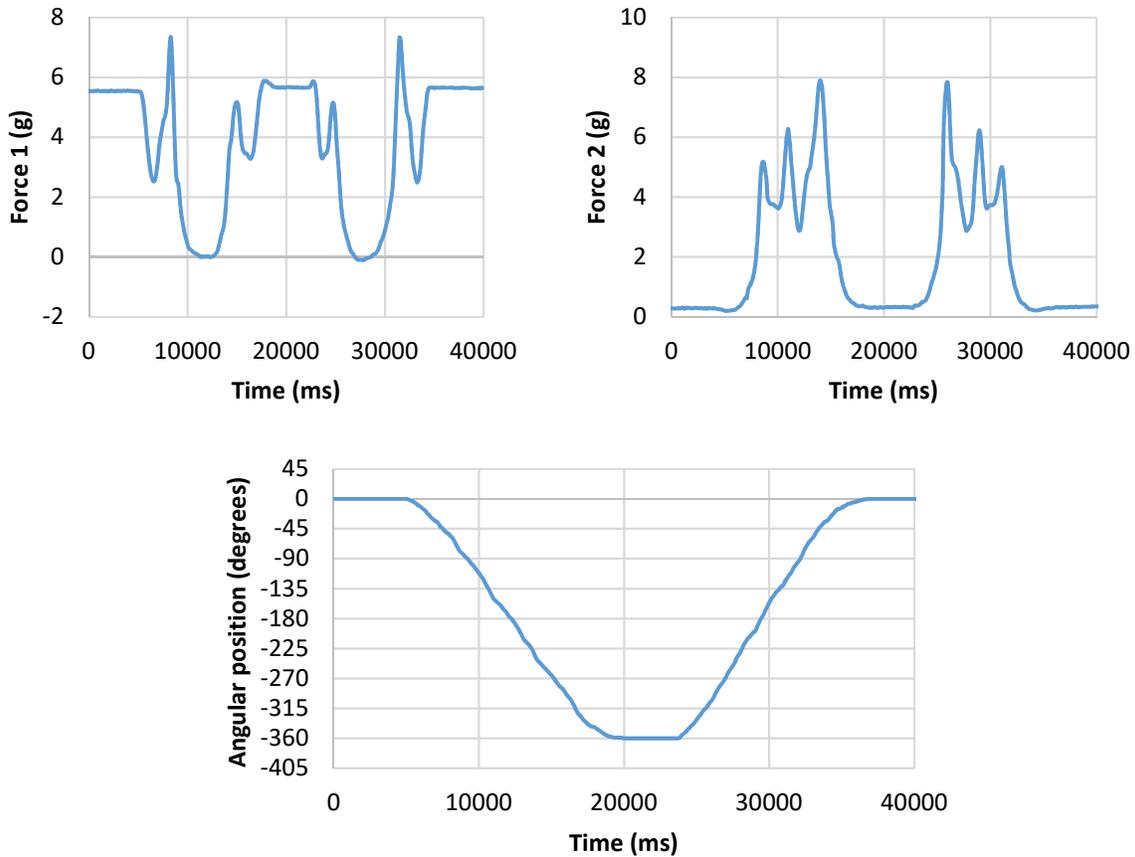
Figure 4.4 The upper two graphs show the two sensor outputs for each carriage, where Force 1 and Force 2 (in gram-force) are plotted versus time. The variation of forces as a function of position on the tendon duct perimeter reflects variations on how far the steel strand envelope is beneath each position. The lower graph shows the angular position versus time as the run is being conducted.

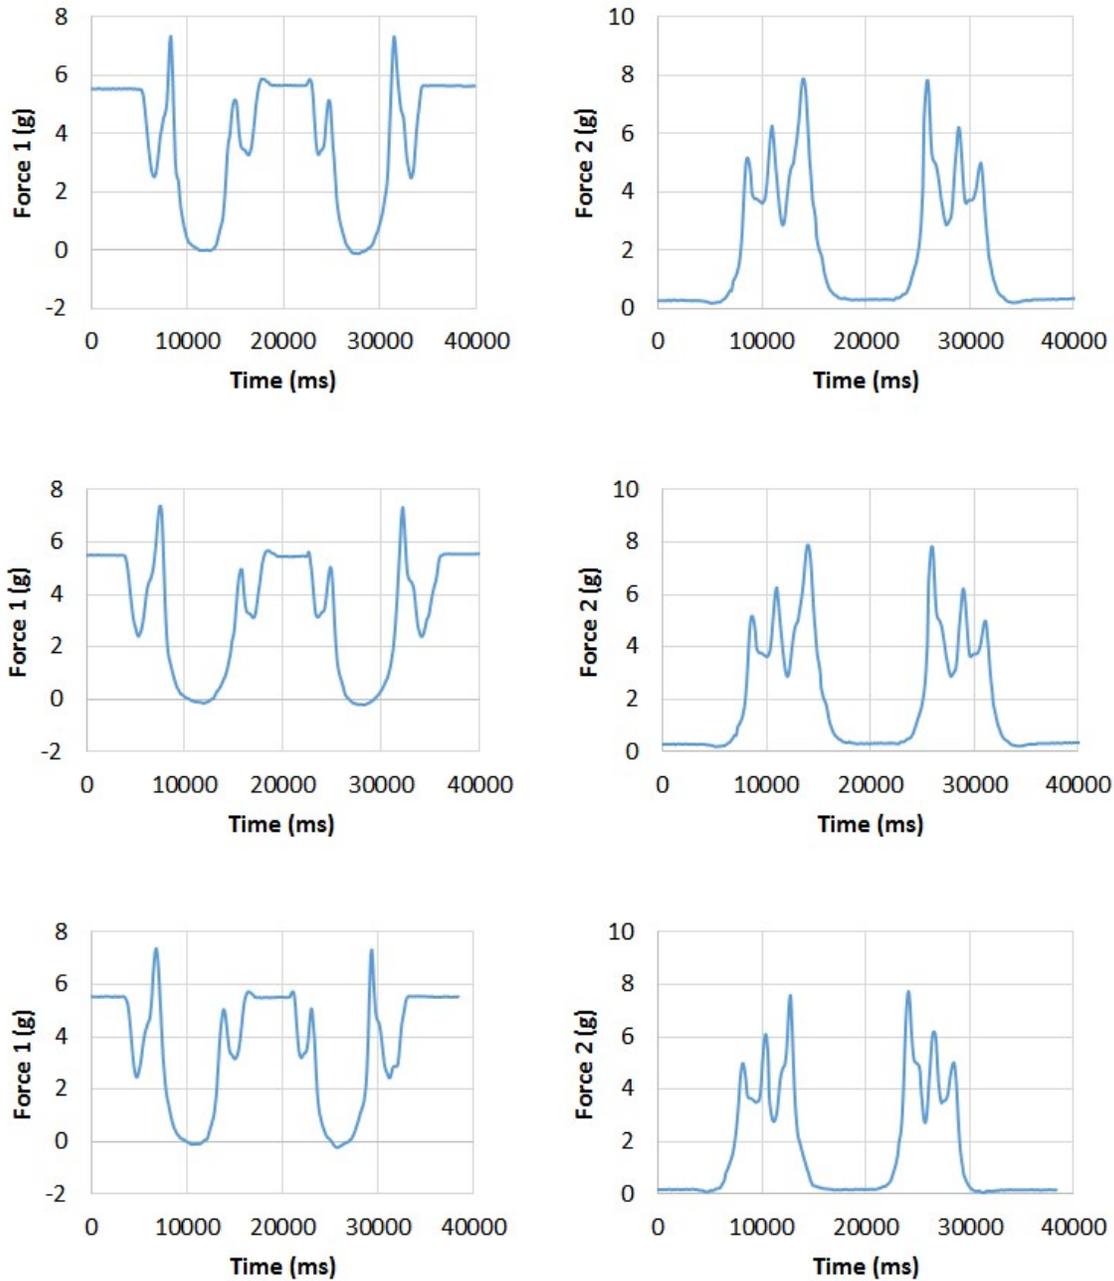
Figure 4.5 Example of three replicate runs performed on the same tendon duct.

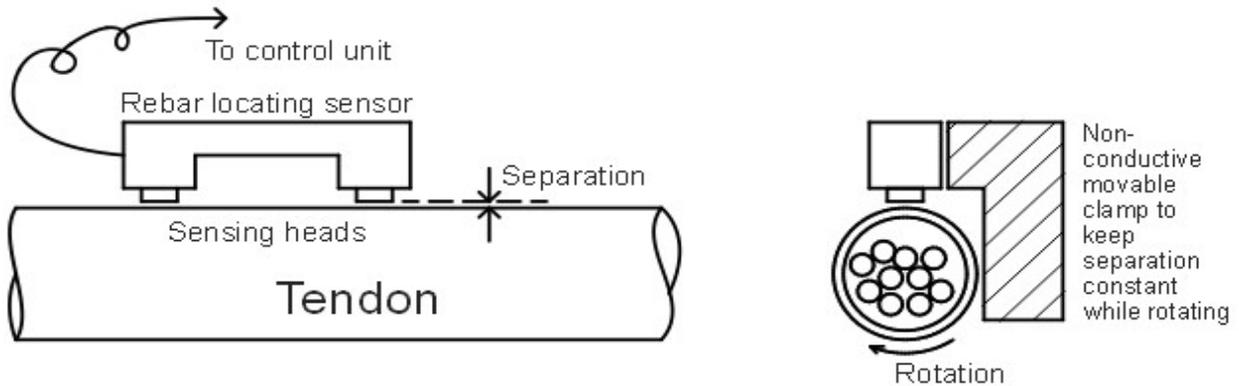
Figure 4.7 Schematic of the Model C-4956 R-Meter® placement.

As noted elsewhere [42], strand positioning information can be obtained by alternative procedures using, for example, inductance changes (related to changes in overall magnetic flux in a system) akin to commonly used rebar location instrumentation. For examination of this concept exploratory measurements were conducted by adapting a James Instruments, Inc. Model C-4956 R-Meter® with a custom non-conductive clamp so that, as it rotated, the meter sensor was kept parallel to the longitudinal axis of the tendon with the two magnetic sensing heads, which are typically in contact with the external reinforced concrete surface but were instead kept separated from the external tendon duct surface by a distance of 3/16 in as shown in Figure 4.7.

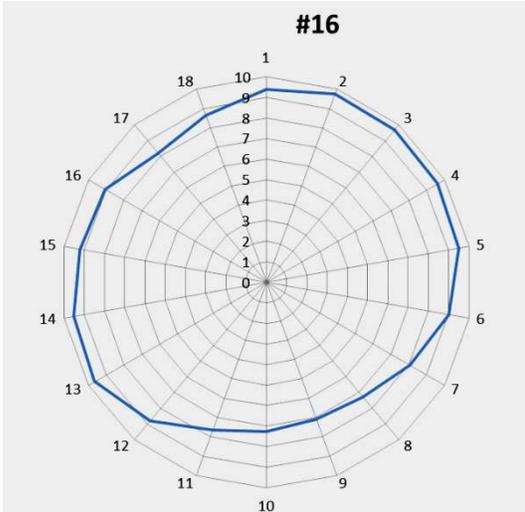
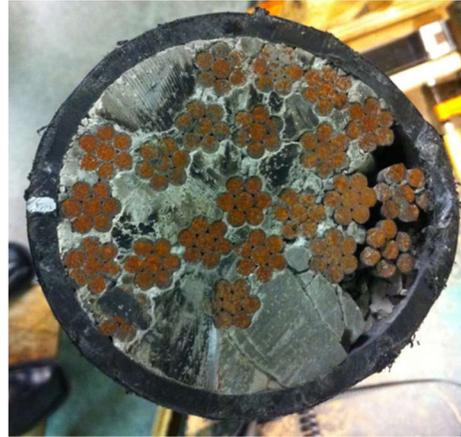
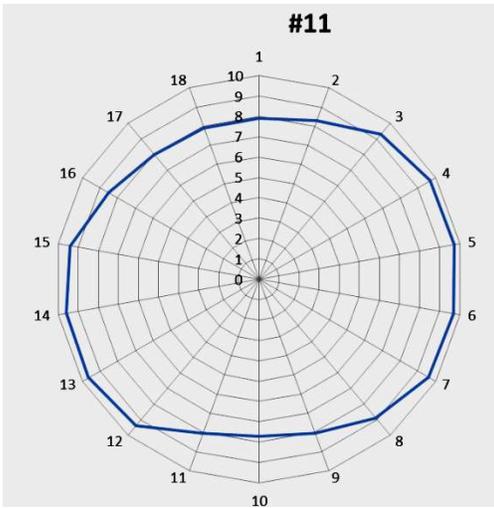
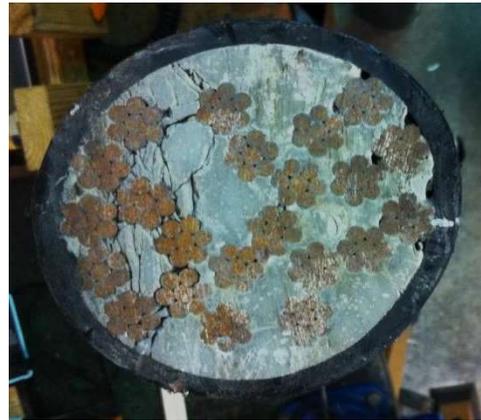
Figure 4.8 Results of semiquantitative strand configuration evaluation using an inductance device applied to two tendon samples from the John Ringling Causeway Bridge.

Given the large dimensions of the sensor, tests of the concept were not made in the small tendons used for the rotating magnet unit, but were instead made on 4 thicker tendon samples obtained from the FDOT John Ringling Causeway Bridge. The samples have 22 strands grouted within a polymeric duct of $\frac{1}{4}$ in wall thickness and an outer diameter of 4.5 in. Results are illustrated in Figure 4.8, which shows general semi-quantitative agreement with the cross-section location of the strand envelope.

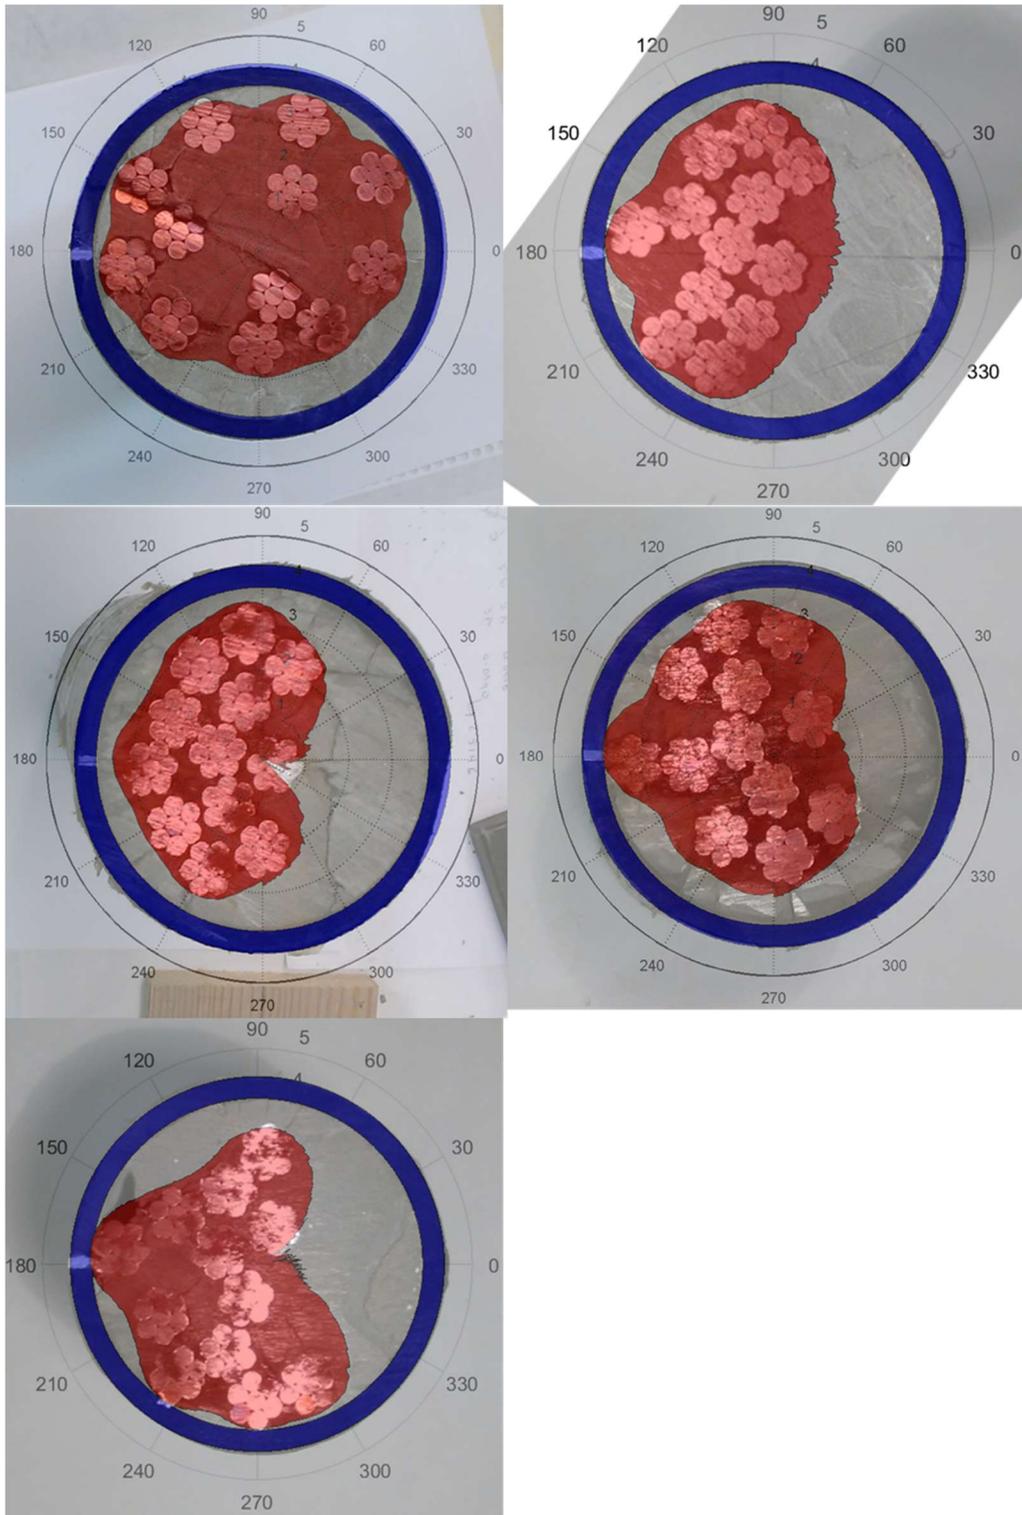
Figure 4.12 Examples of strand envelope recovery on cross-section of various tendon segments examined. Duct outer diameter is ~3.5 in; duct wall section represented by the blue ring. The recovered envelope (red) has been superimposed on an actual picture of the tendon segment cross-section at the end of the segment.

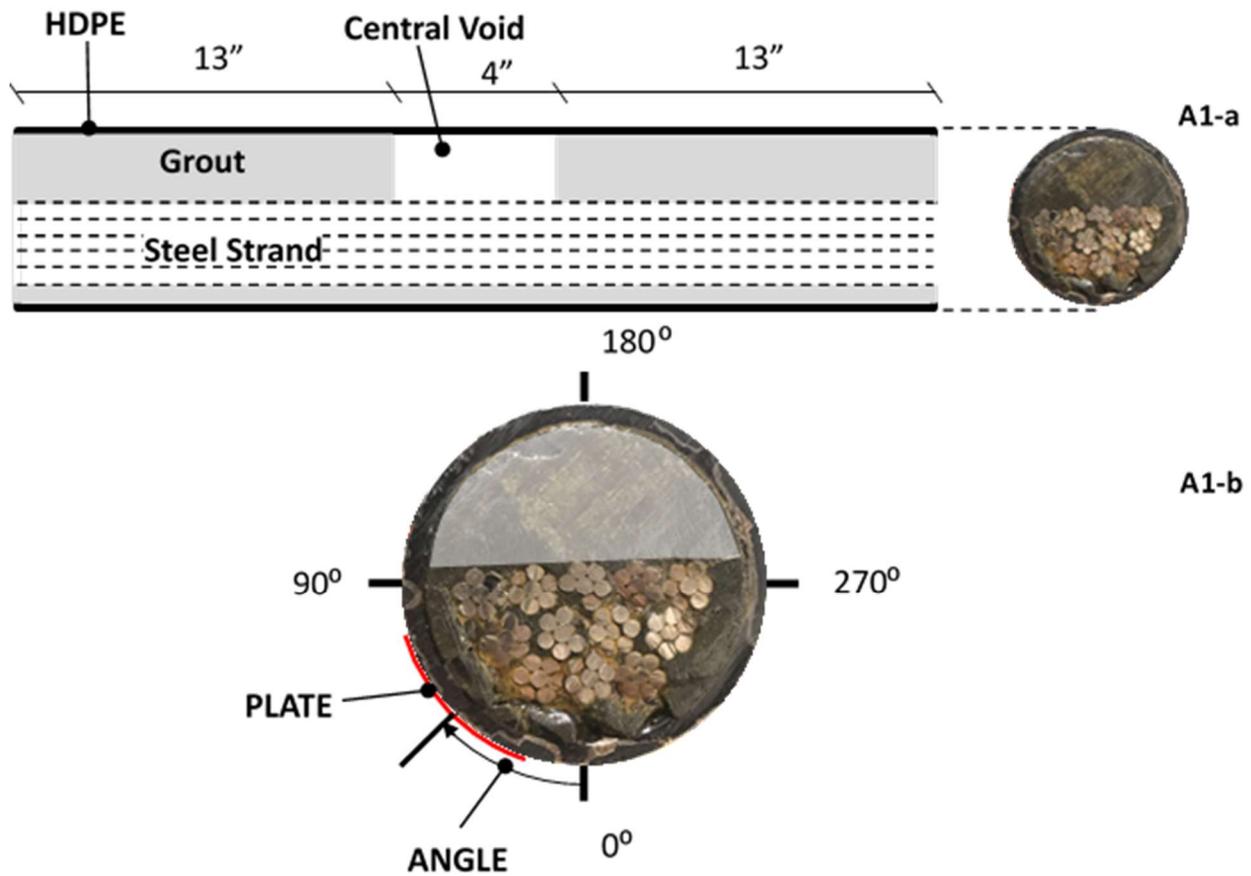
Figure 5.2 - Plan view of a custom cast tendon's geometrical features (A1-a); cross-section of the cast tendon (A1-b). Strands are lumped. Central void is highlighted.

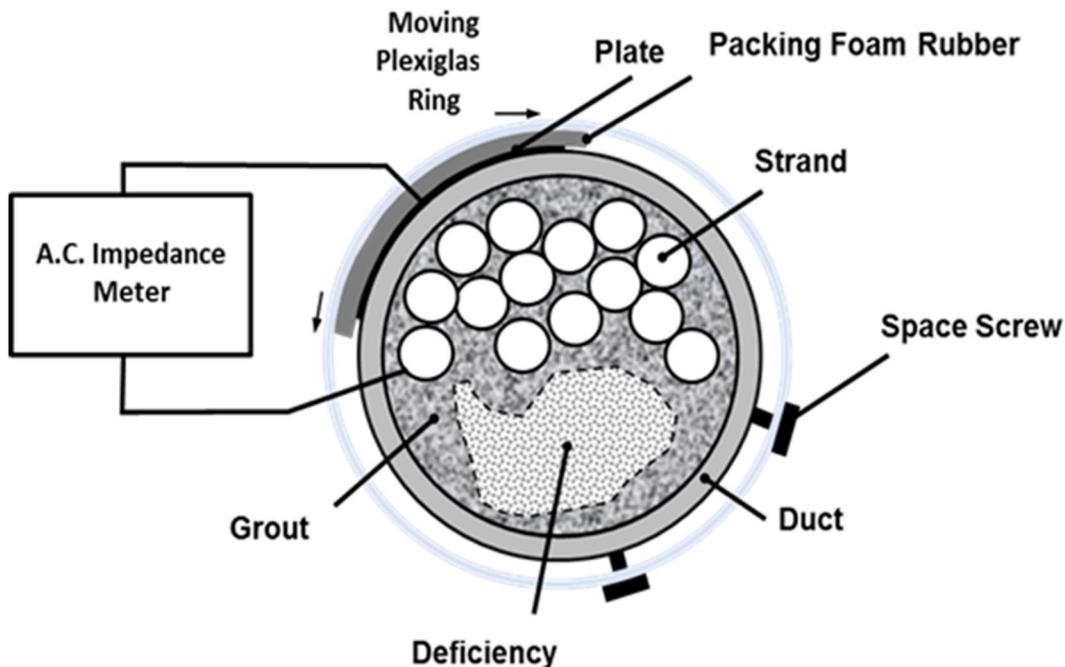
Figure 5.3 Electromagnetic coupling test method arrangement. Use of a plastic frame, pressure foam pad, and spacers for stable movement of the sensing plate on the outer duct perimeter.

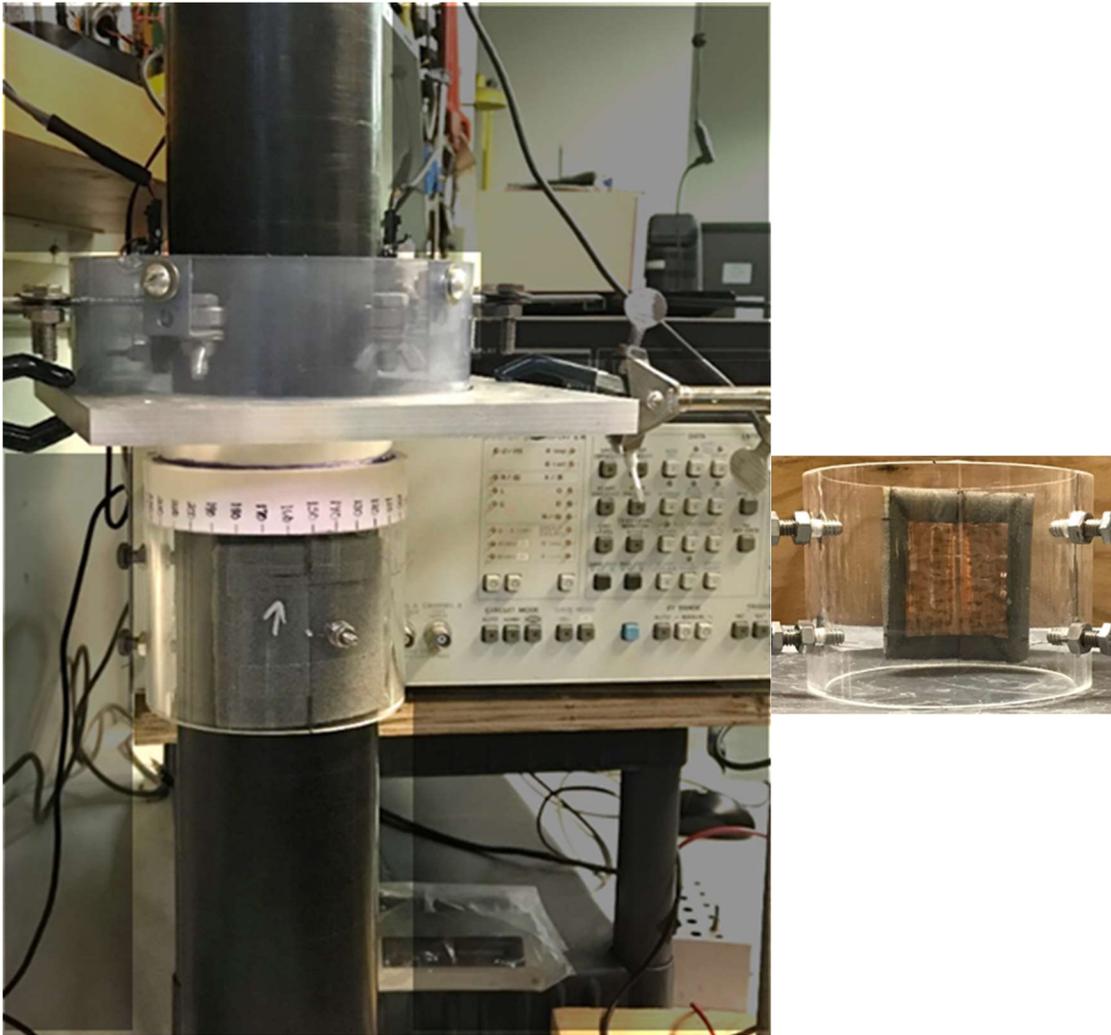
Figure 5.4 Left: Experimental prototype arrangement for steel strand location detector prototype and impedance module for tendon measurements. Right: inner part of the impedance module with a 5 cm x 5 cm copper plate.

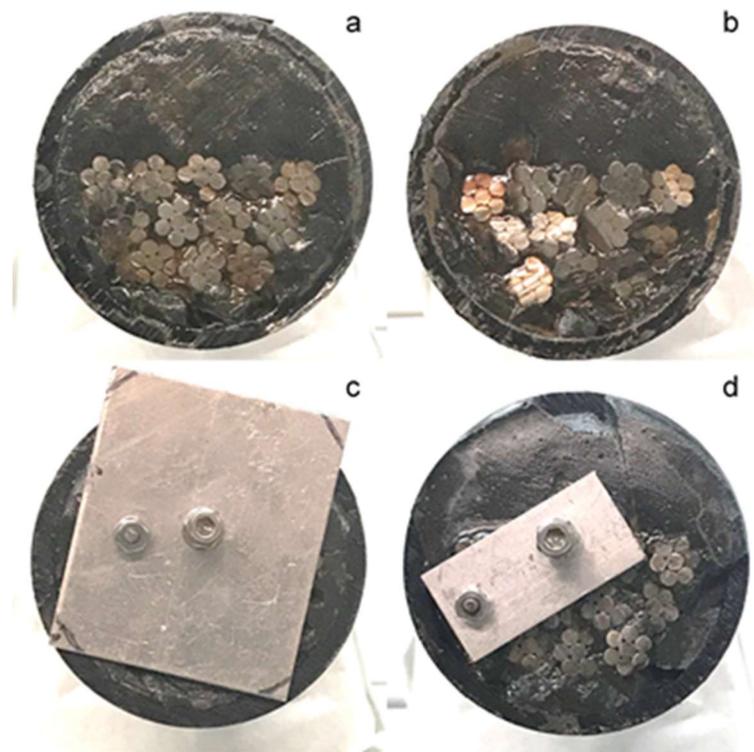
Figure 5.5 (a-b) Cross-section profile of the custom-built Tendons #1 and #2. (c-d) Cross-section of the back end of tendons #1 and #2.

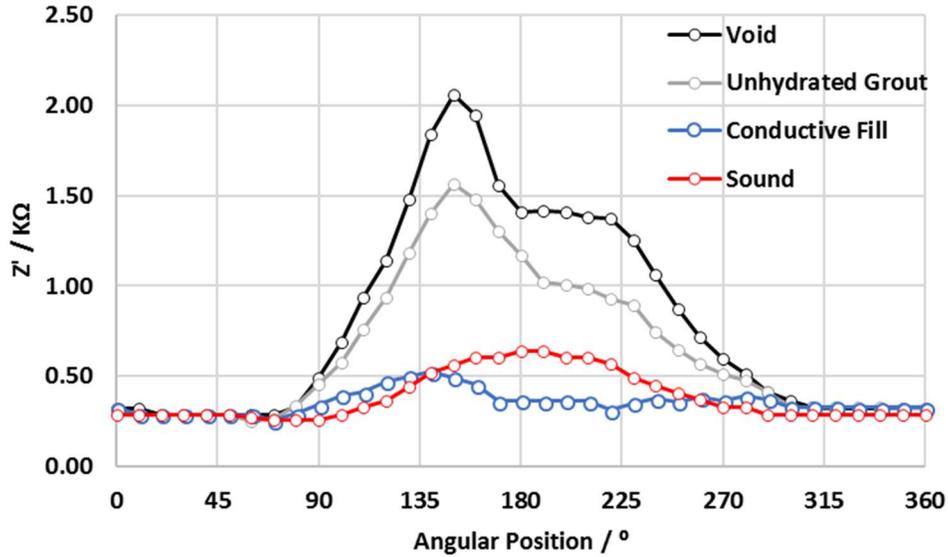
Figure 5.6 Real part of the complex impedance vs. angular position for Tendon #2 (age 166 days for void and sound, 163 days for unhydrated grout, and 169 days for conductive fill) at center with section filled with air, unhydrated grout, and conductive fill. Impedance results for a sound cross-section also included. All experimental results in this and subsequent figures are for a frequency of 1 MHz.

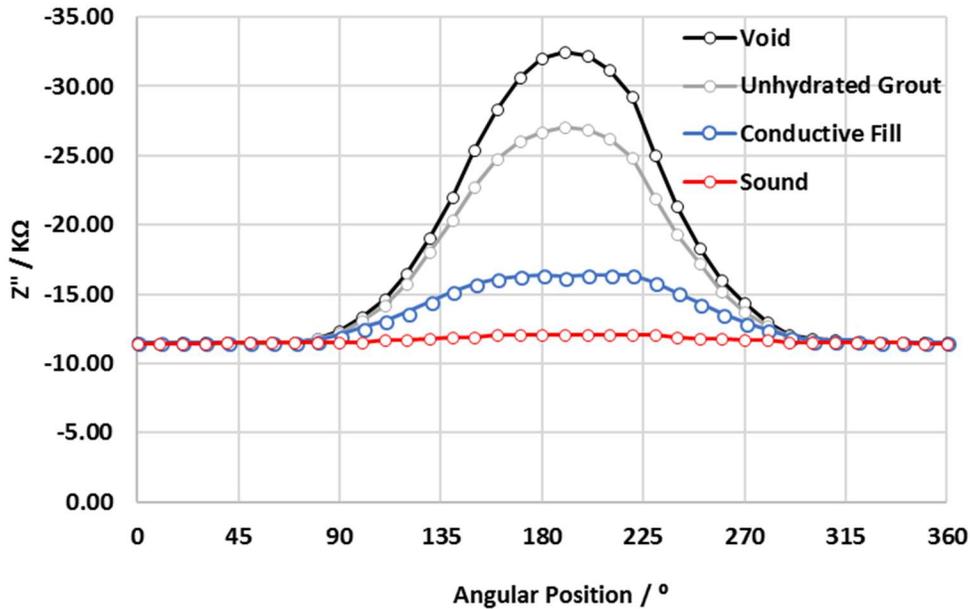
Figure 5.7 Imaginary part of the complex impedance vs. angular position for tendon segment #2 (same ages as in Figure 5.6) at center with section filled with air, unhydrated grout, and conductive fill. Impedance results for a sound cross-section also included.

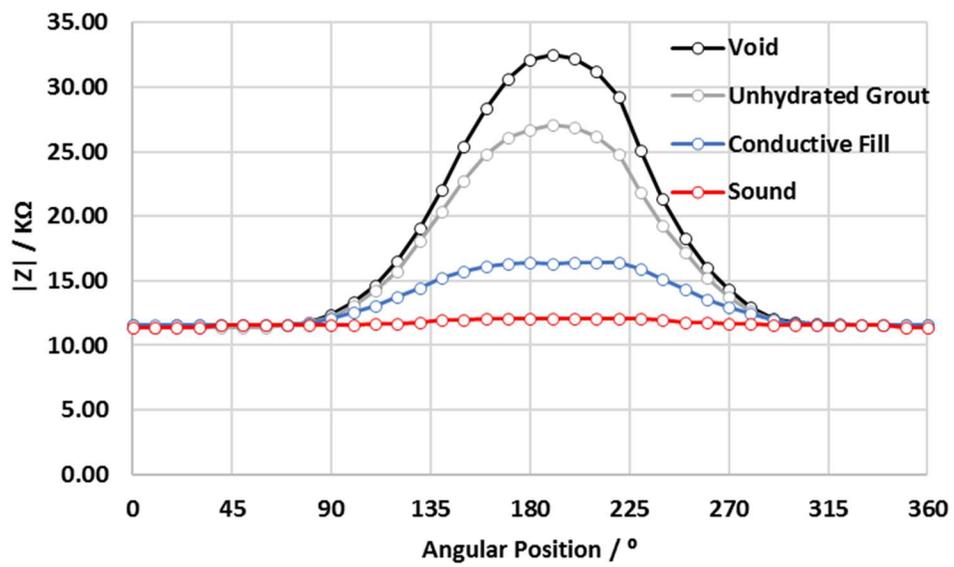
Figure 5.8 Modulus of impedance vs. angular position for tendon segment #2 (same ages as in Figure 5.6) at center with section filled with air, unhydrated grout, and conductive fill. Impedance results for a sound cross-section also included.

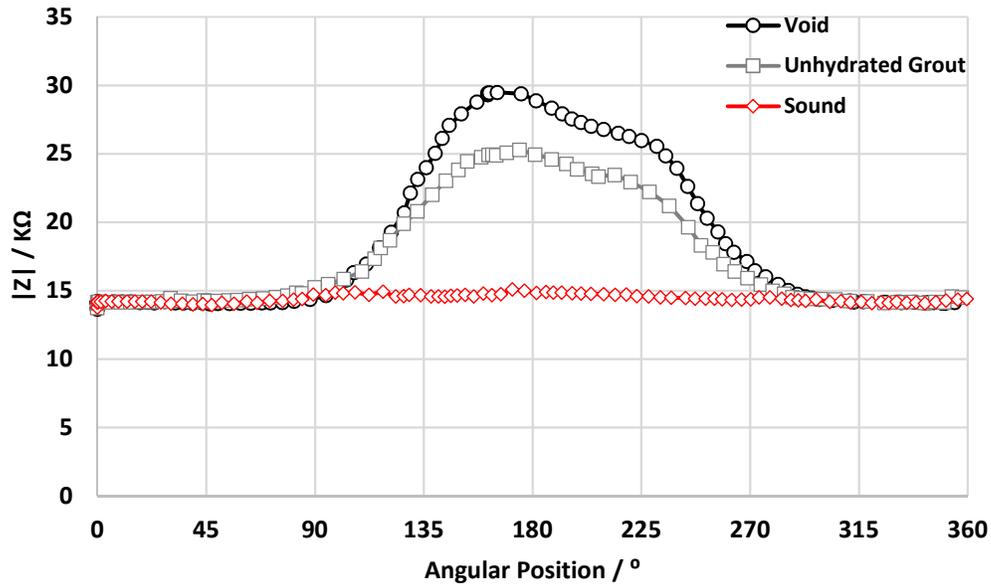
Figure 5.9 Modulus of impedance vs angular position for tendon A, at the same void (Position P1) that had air (age 36 days) and then was filled with unhydrated grout (age 55 days). Impedance results for a sound cross-section (P2) (age 55 days) also included. All experimental results in this and subsequent figures are for a frequency of 1 MHz.

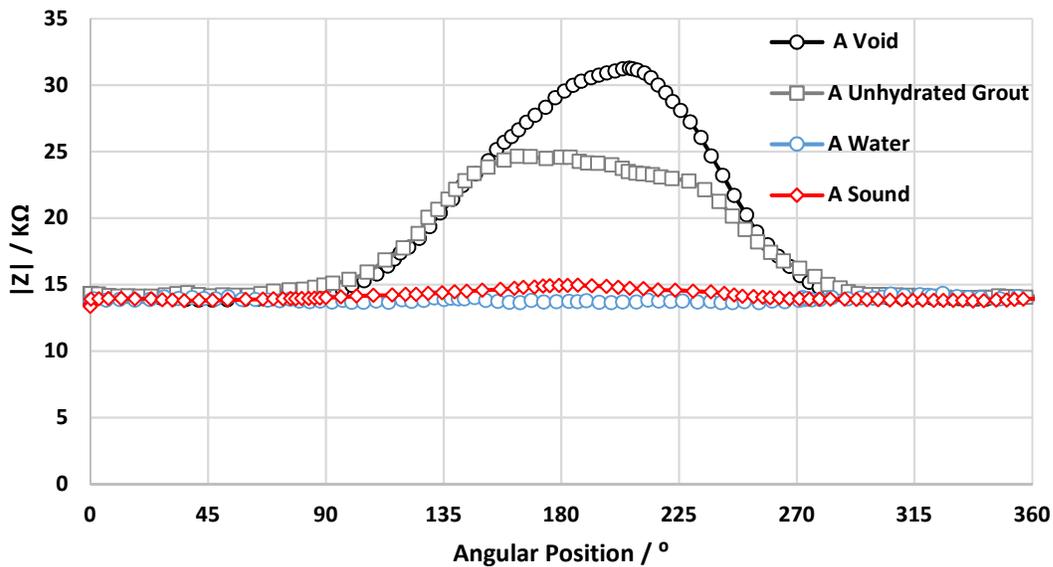
Figure 5.10 Modulus of impedance vs angular position for tendon A (age 105 days) for void (Position P3), unhydrated grout (P1), water (P5), and sound cross-section (P2).

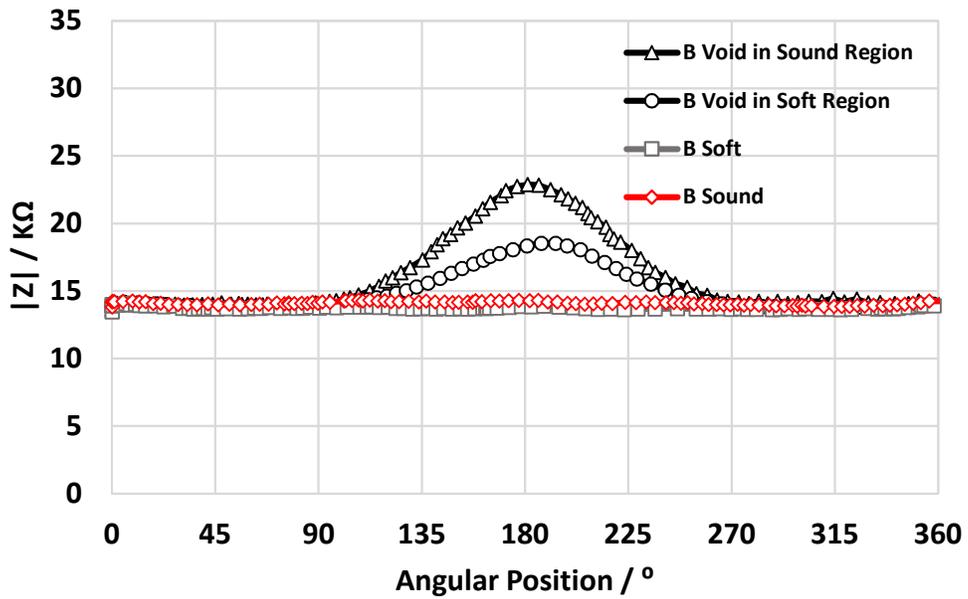
Figure 5.11 Modulus of impedance vs angular position for tendon B (age 105 days) for the different cross-sections; void in soft (P1) and void in sound grout (P4), soft (P2), and sound grout (P3).

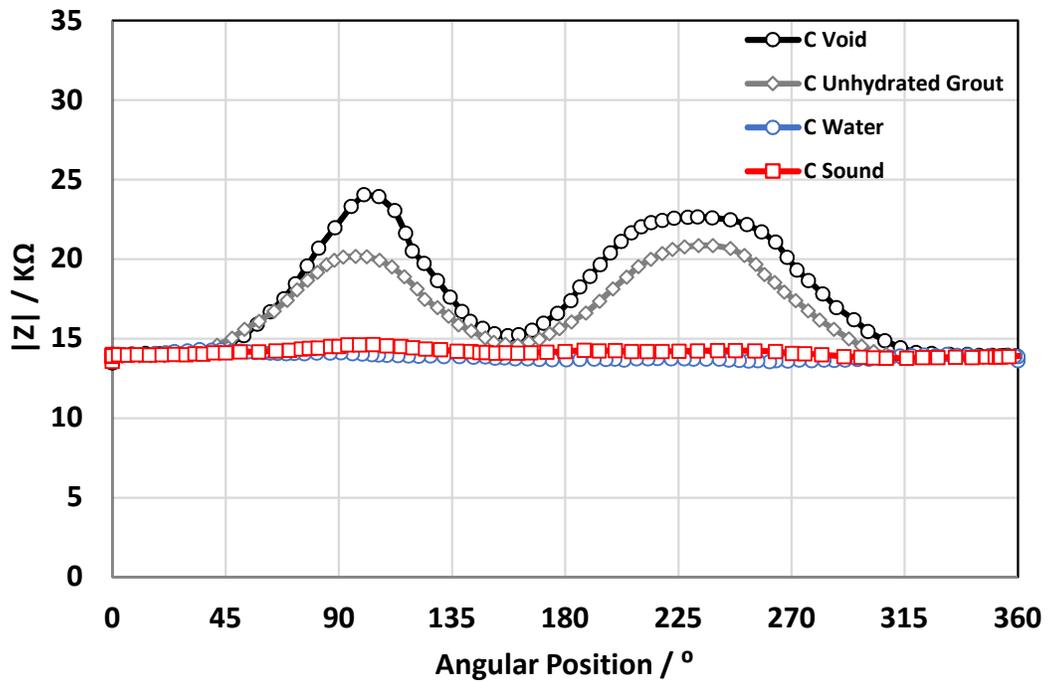
Figure 5.12 Modulus of impedance vs angular position for tendon C (age 105 days) for the different cross-section; void (P3), unhydrated grout (P1), water (P5), and sound grout (P2).

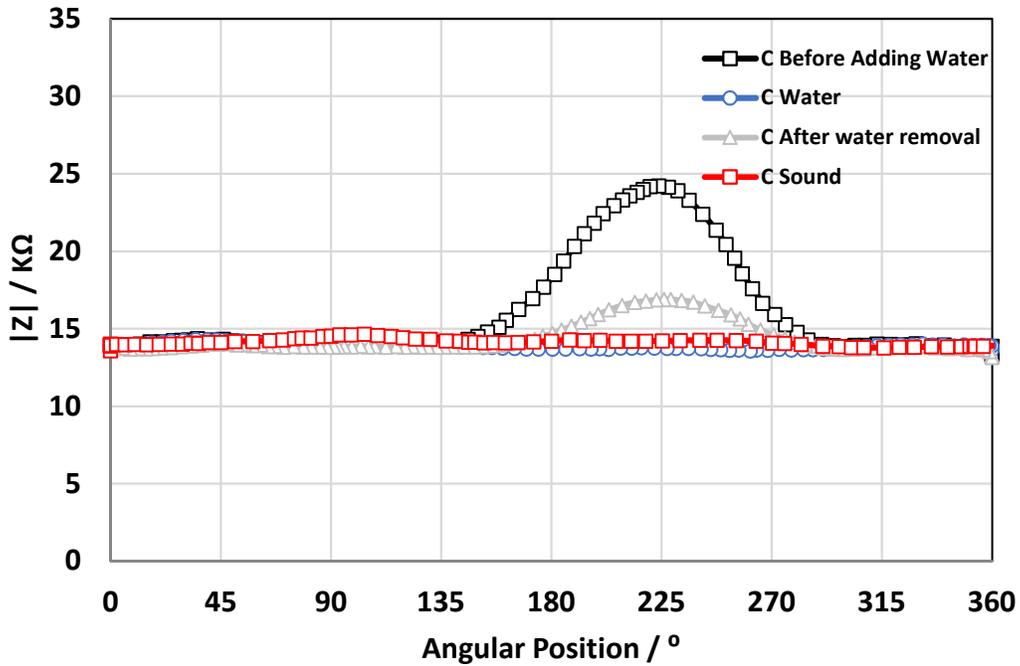
Figure 5.13 Modulus of impedance vs angular position for tendon C (age 105 days) for the same void (P5) before adding water, when water was added, and ~30 min after the water was removed. Impedance results for a sound cross-section also

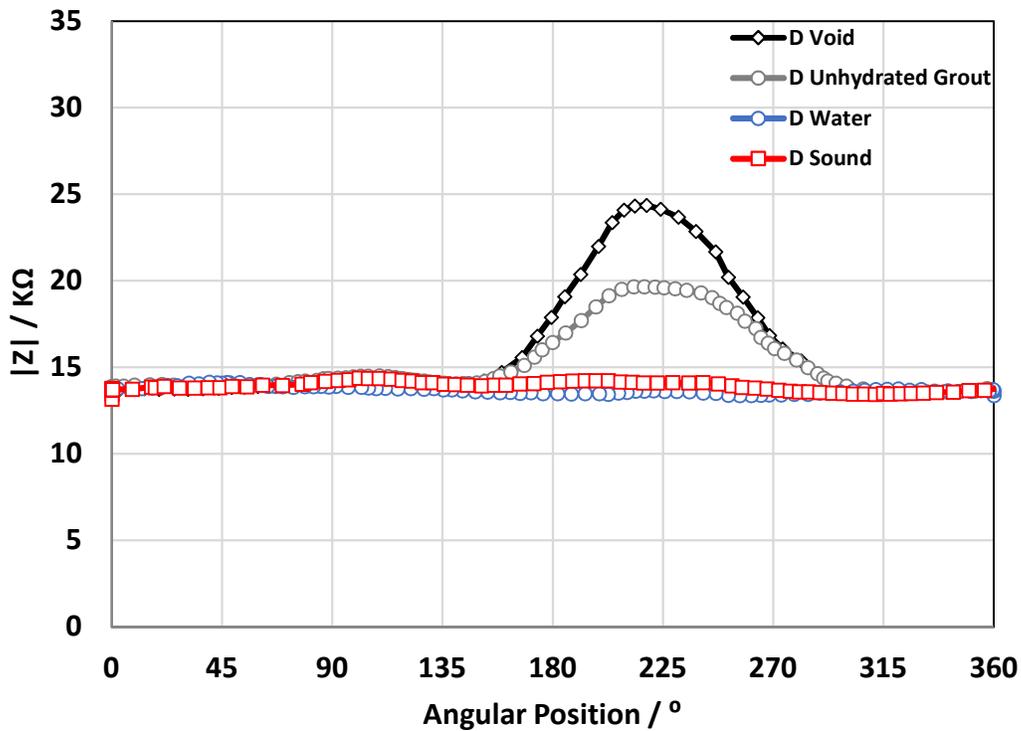
Figure 5.14 Modulus of impedance vs angular position for tendon D (age 105 days) for the different cross-section; void (P3), unhydrated grout (P1), water (P5), and sound grout (P2).

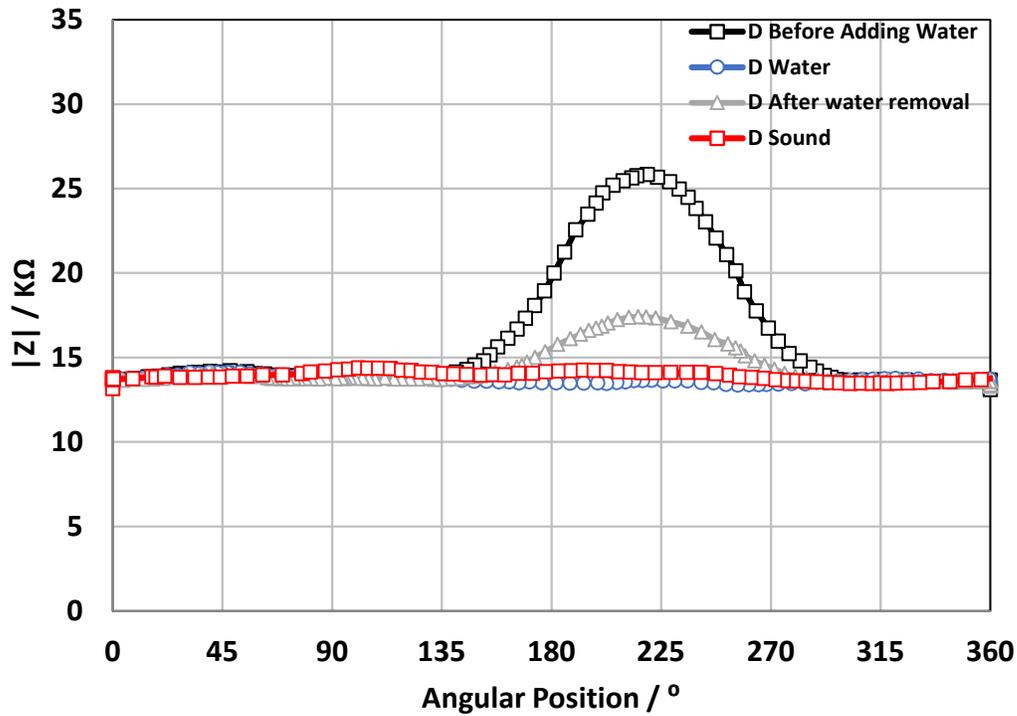
Figure 5.15 Modulus of impedance vs angular position for tendon D (age 105 days) for the same void (P5) before adding water, when water was added, and ~10 min after the water was removed. Impedance results for a sound cross-section (P2) also included.

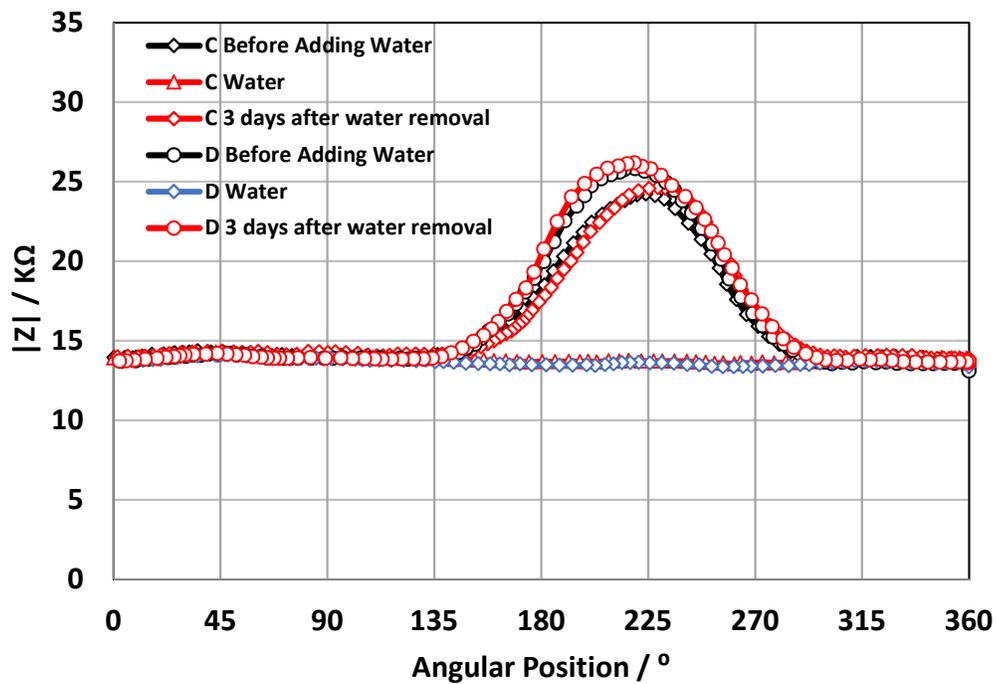
Figure 5.16 Modulus of impedance vs angular position for tendons C and D (age 105 days) for the same void (P5) before adding water, when water was added, and 3 days after the water was removed.

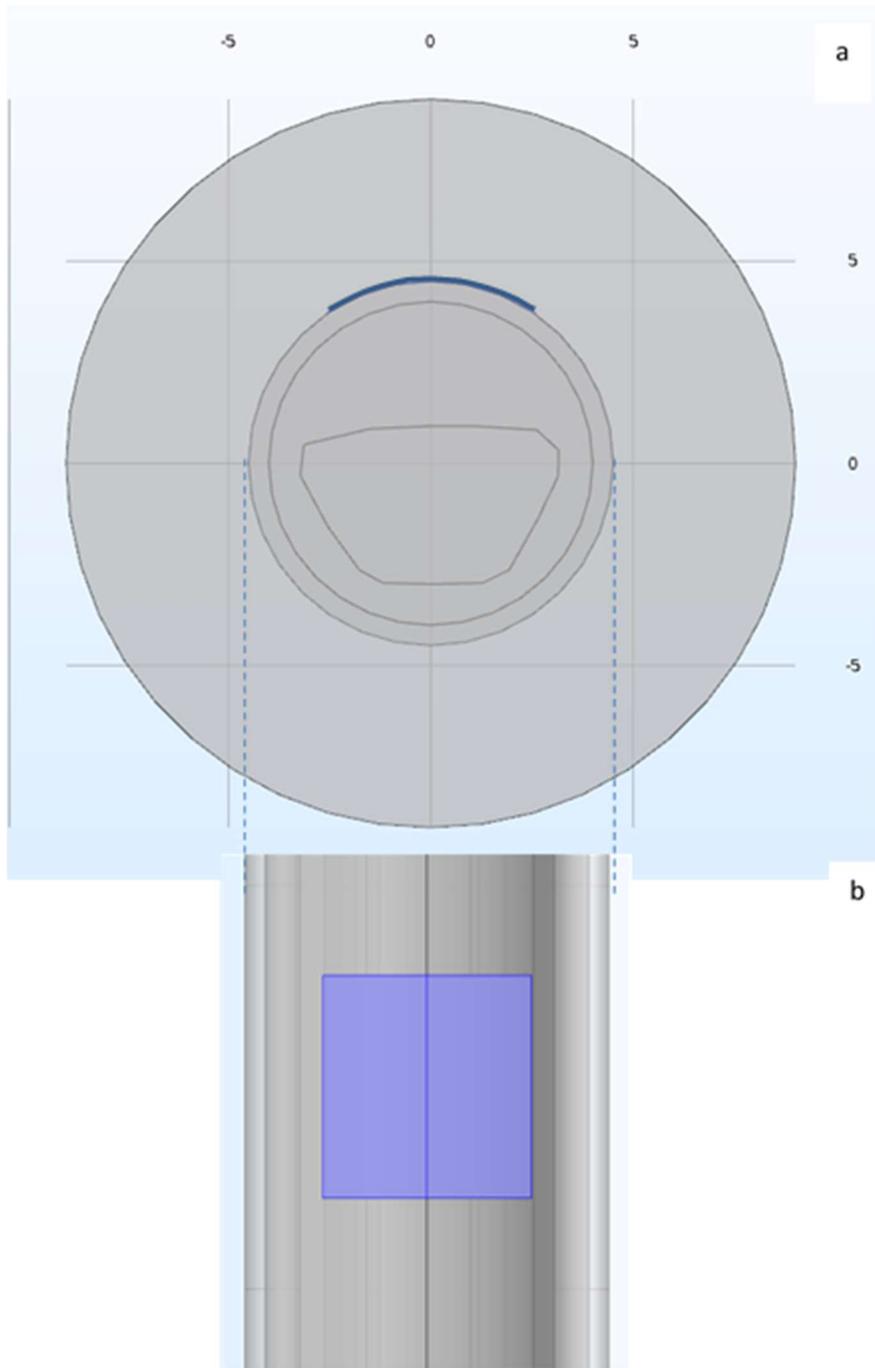
Figure 5.17 (a) – Cross-sectional view of 3.5-inch (8.9-cm) nominal outer diameter tendon with steel strand envelope imported from steel strand location detector prototype. The tendon is surrounded by a 9-cm radius air cylinder to represent field and laboratory conditions. (b)– Top view of 5 cm x 5 cm plate used for model (edge view on (a)). Grid scale is in cm.

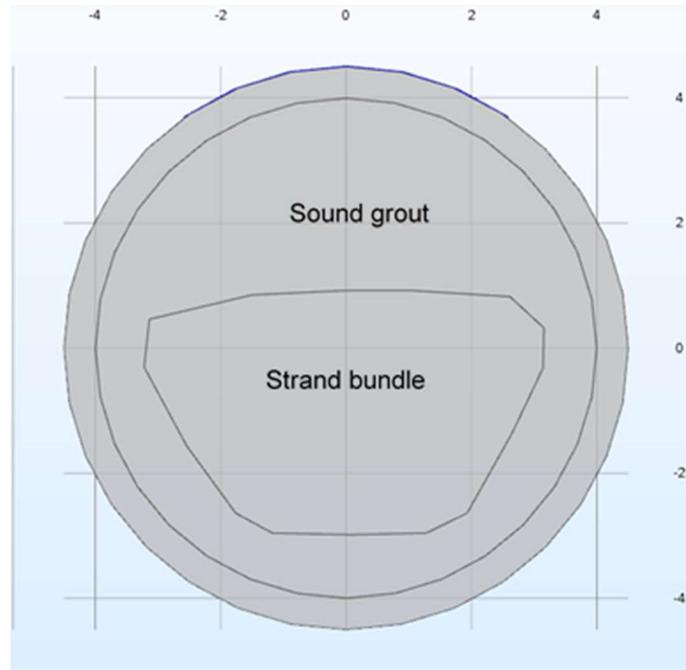
Figure 5.18 Cross-sectional view of 3.5-inch diameter with sound grout.

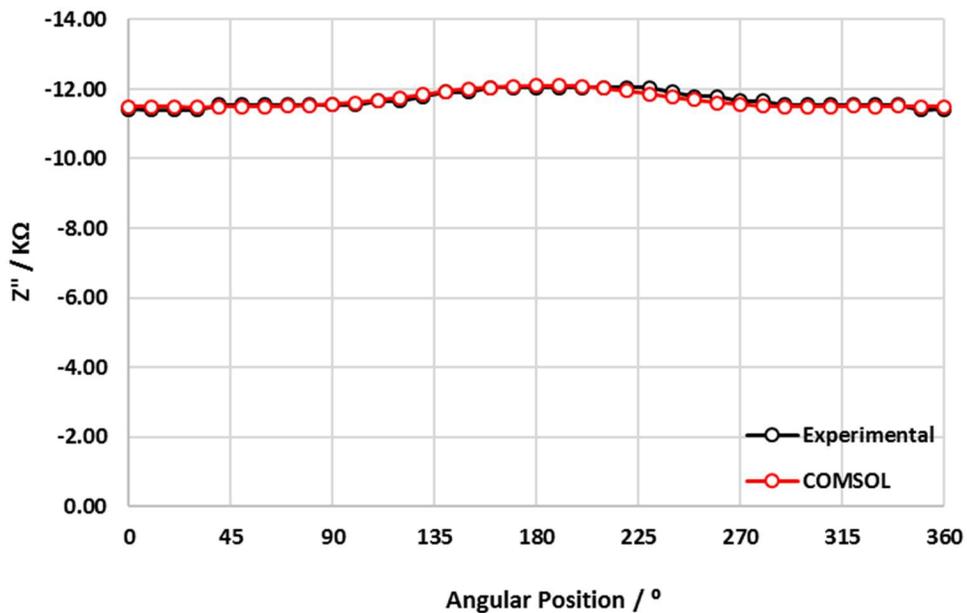
Figure 5.21 Imaginary impedance value vs. angular position of the tendon (sound grout) showing the experimental values (Figure 5.7) and the model values at 1 MHz for the profile in Figure 5.18. The model results follow the experimental trends.

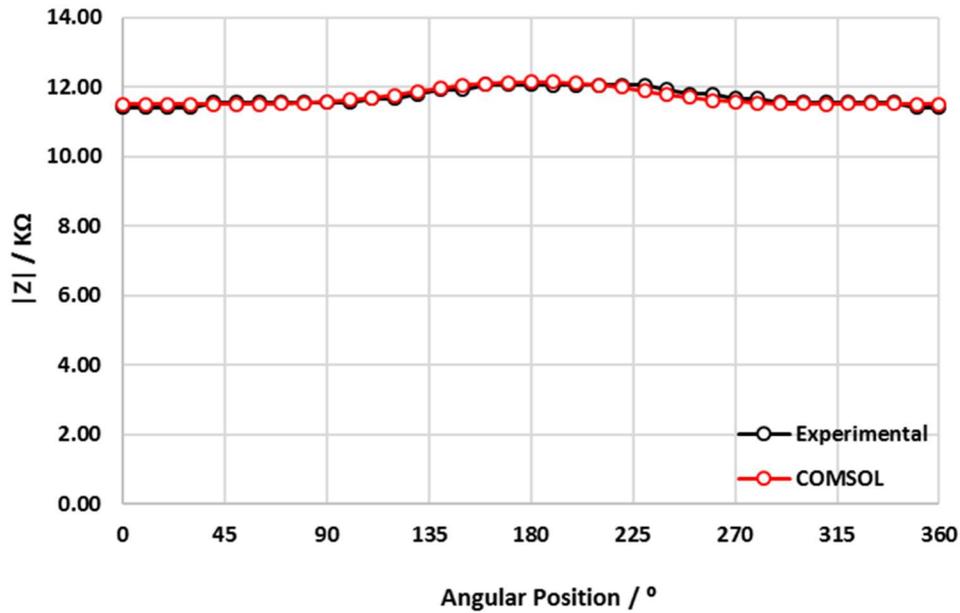
Figure 5.22 Modulus of impedance vs. angular position of the tendon (sound grout) showing the experimental values (from Figure 5.8) and the model values at 1 MHz for the profile in Figure 5.18. The model results follow the experimental trends.
