FINAL REPORT

DEVELOPMENT OF TENDON IMAGING SENSOR

FDOT Contract Number: BDV25-977-24

Department of Civil and Environmental Engineering

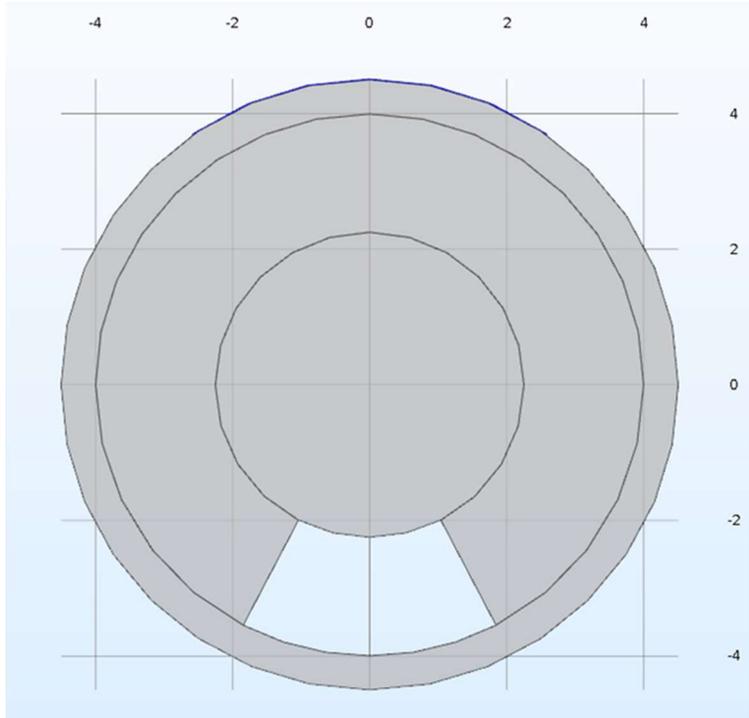
Figure 5.24 Cross-sectional view of 3.5-inch nominal diameter tendon, with a Full 58-degree void. The plate (blue line on perimeter) is 5 cm x 5 cm.

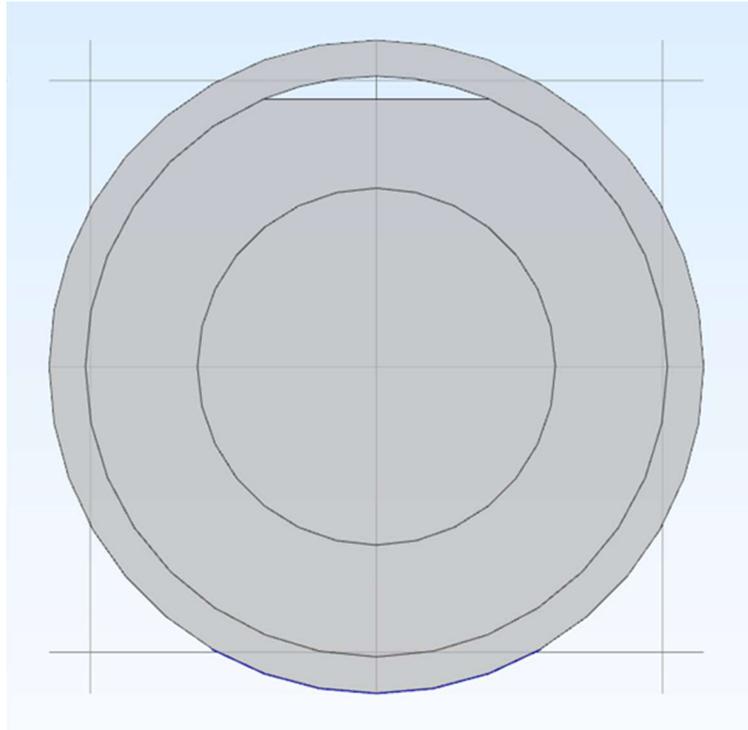
Figure 5.32 Cross-sectional view of 4-inch nominal diameter tendon, with Void #3. The plate is 5 cm x 5 cm.

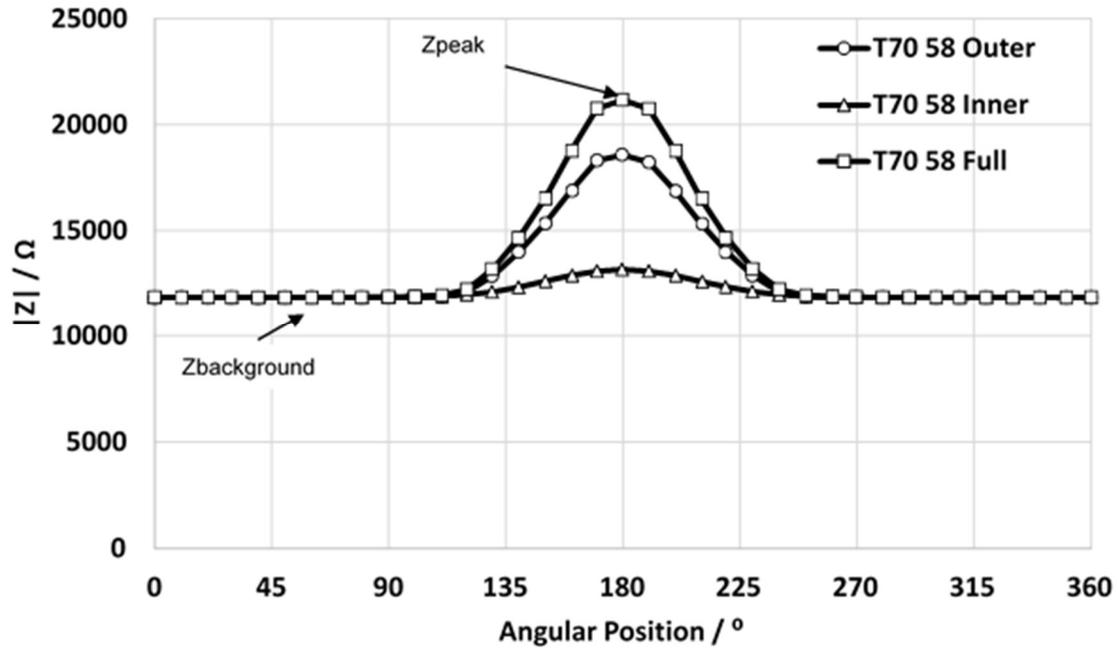
Figure 5.33 Modulus of impedance vs. angular position of the tendon showing the model values for a full, outer and inner void at 1 MHz for the profiles in Figure 5.24-5.26. The plates used for these models are 5 cm x 5 cm.

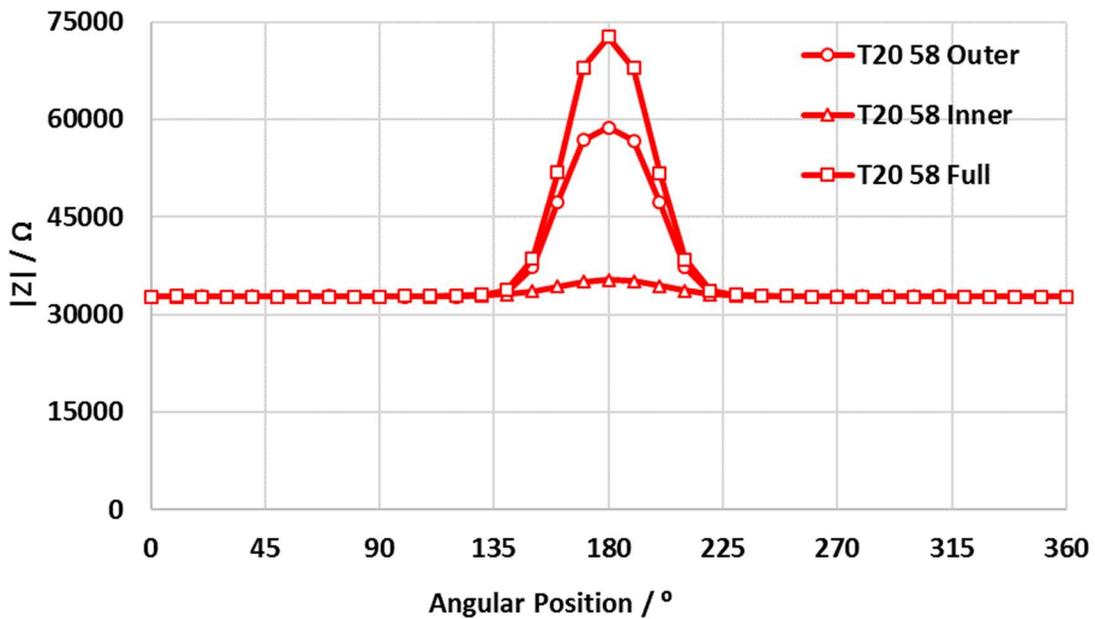
Figure 5.34 Modulus of impedance vs. angular position of the tendon showing the model values for a full, outer, and inner void at 1 MHz for the profiles in Figure 5.27-5.29. The plates used are 2.54 cm x 5 cm.

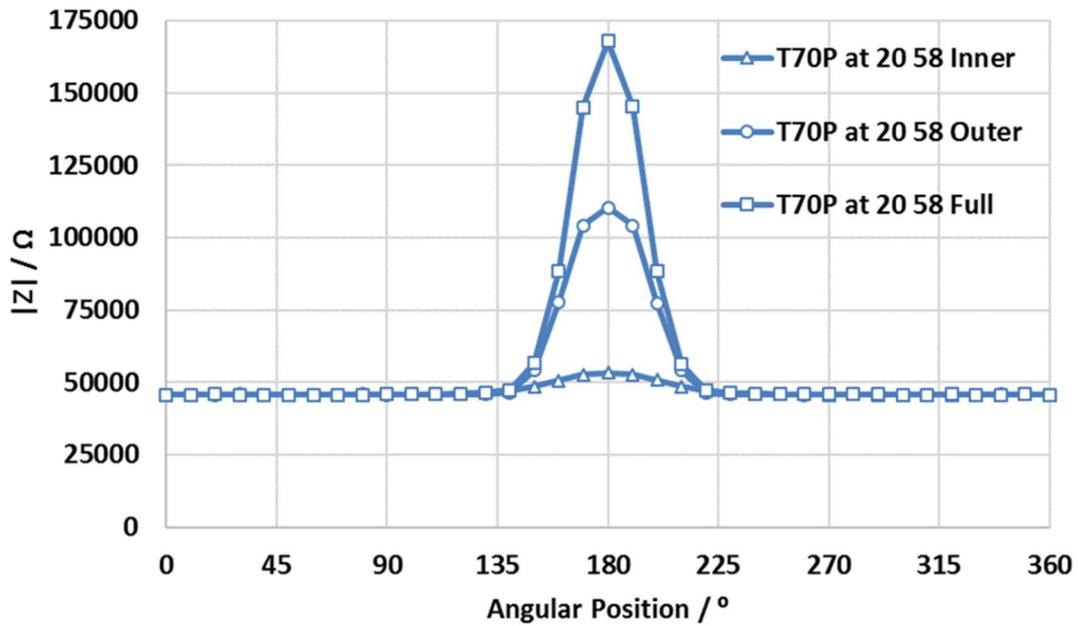
Figure 5.35 Modulus of impedance vs. angular position of the tendon showing the model values for a full, outer, and inner void at 1 MHz for the profiles in Figure 5.24-5.26. The plates used are guarded.

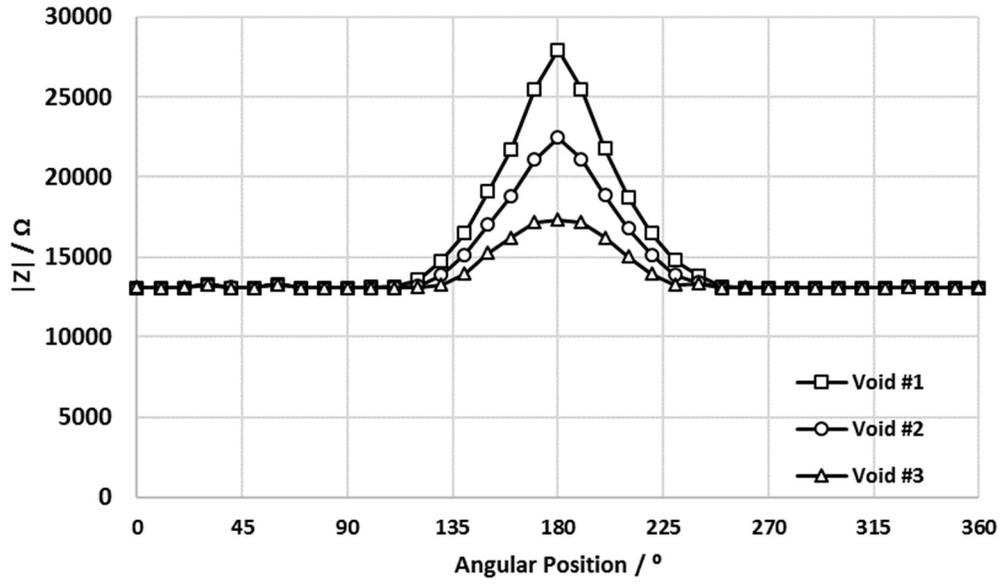
Figure 5.36 Modulus of impedance vs. angular position of the tendon showing the model values for three different-size voids at 1 MHz for the profiles in Figure 5.30-5.32. The bigger the void, the higher the modulus of impedance value. The plates used for these models are 5 cm x 5 cm.

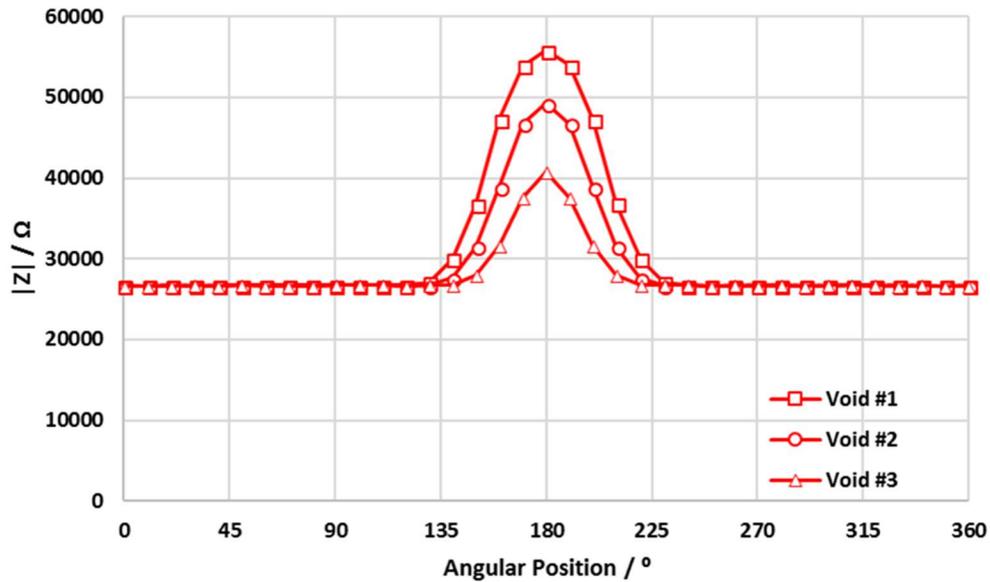
Figure 5.37 Modulus of impedance vs. angular position of the tendon showing the model values for three different-size voids at 1 MHz for the profiles in Figure 5.30-5.32. The bigger the void, the higher the modulus of impedance value. The plates used for these models are 2.54 cm x 5 cm.

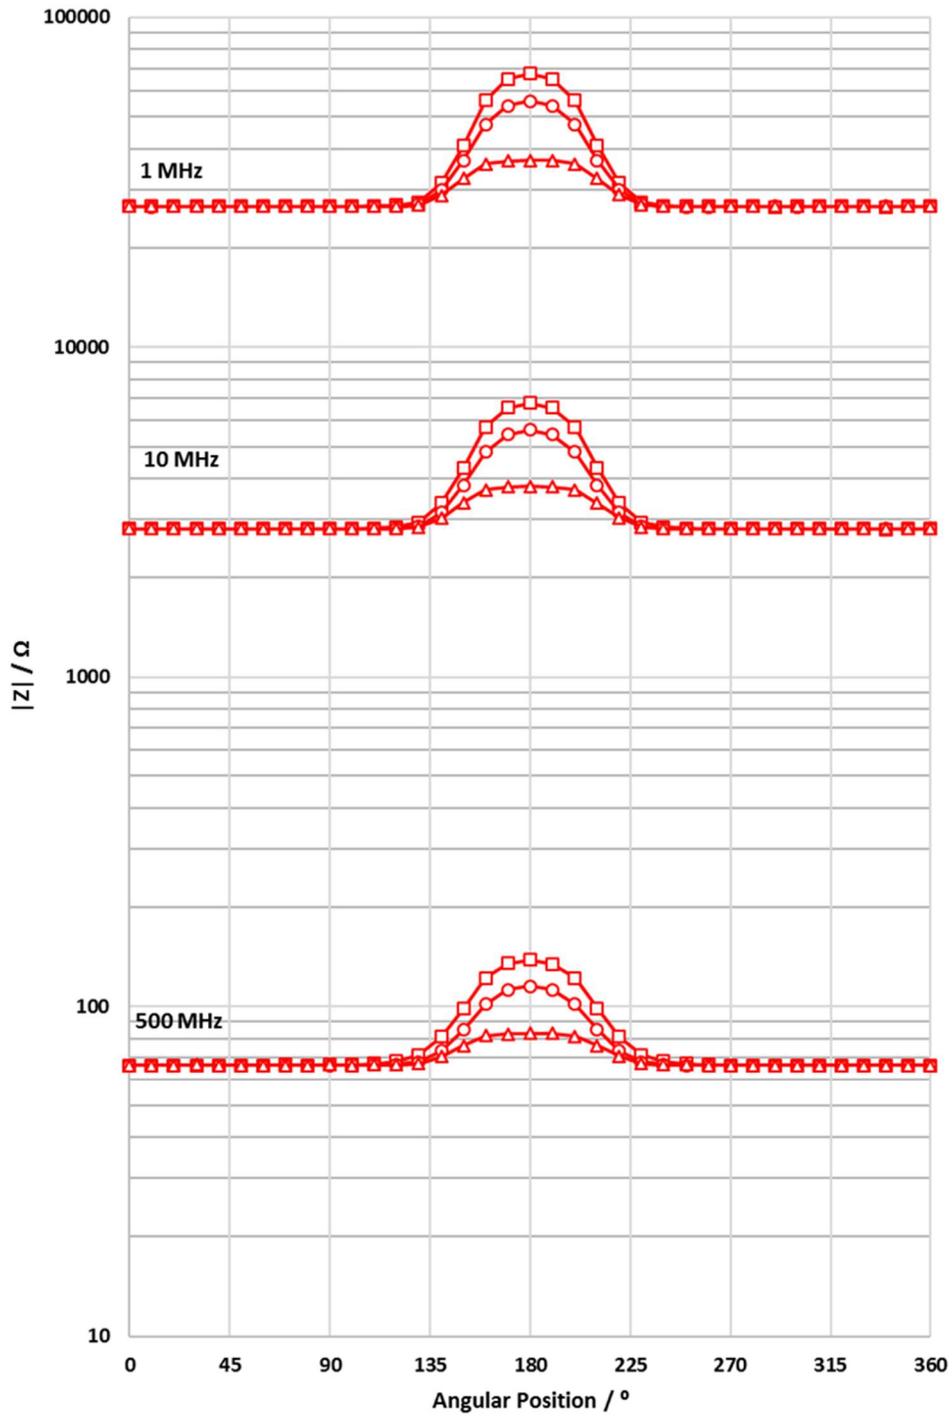
Figure 5.41 Modulus of impedance vs. angular position for Table 5.6; Tendons 1(squares), 2 (circles), and 3 (triangles) at 1 MHz, 10 MHz, and 500 MHz. Log scale is used for the y-axis to show comparison of the output of the frequencies on the same graph. The plates used for these calculations are 2.54 cm (Narrow) x 5 cm.

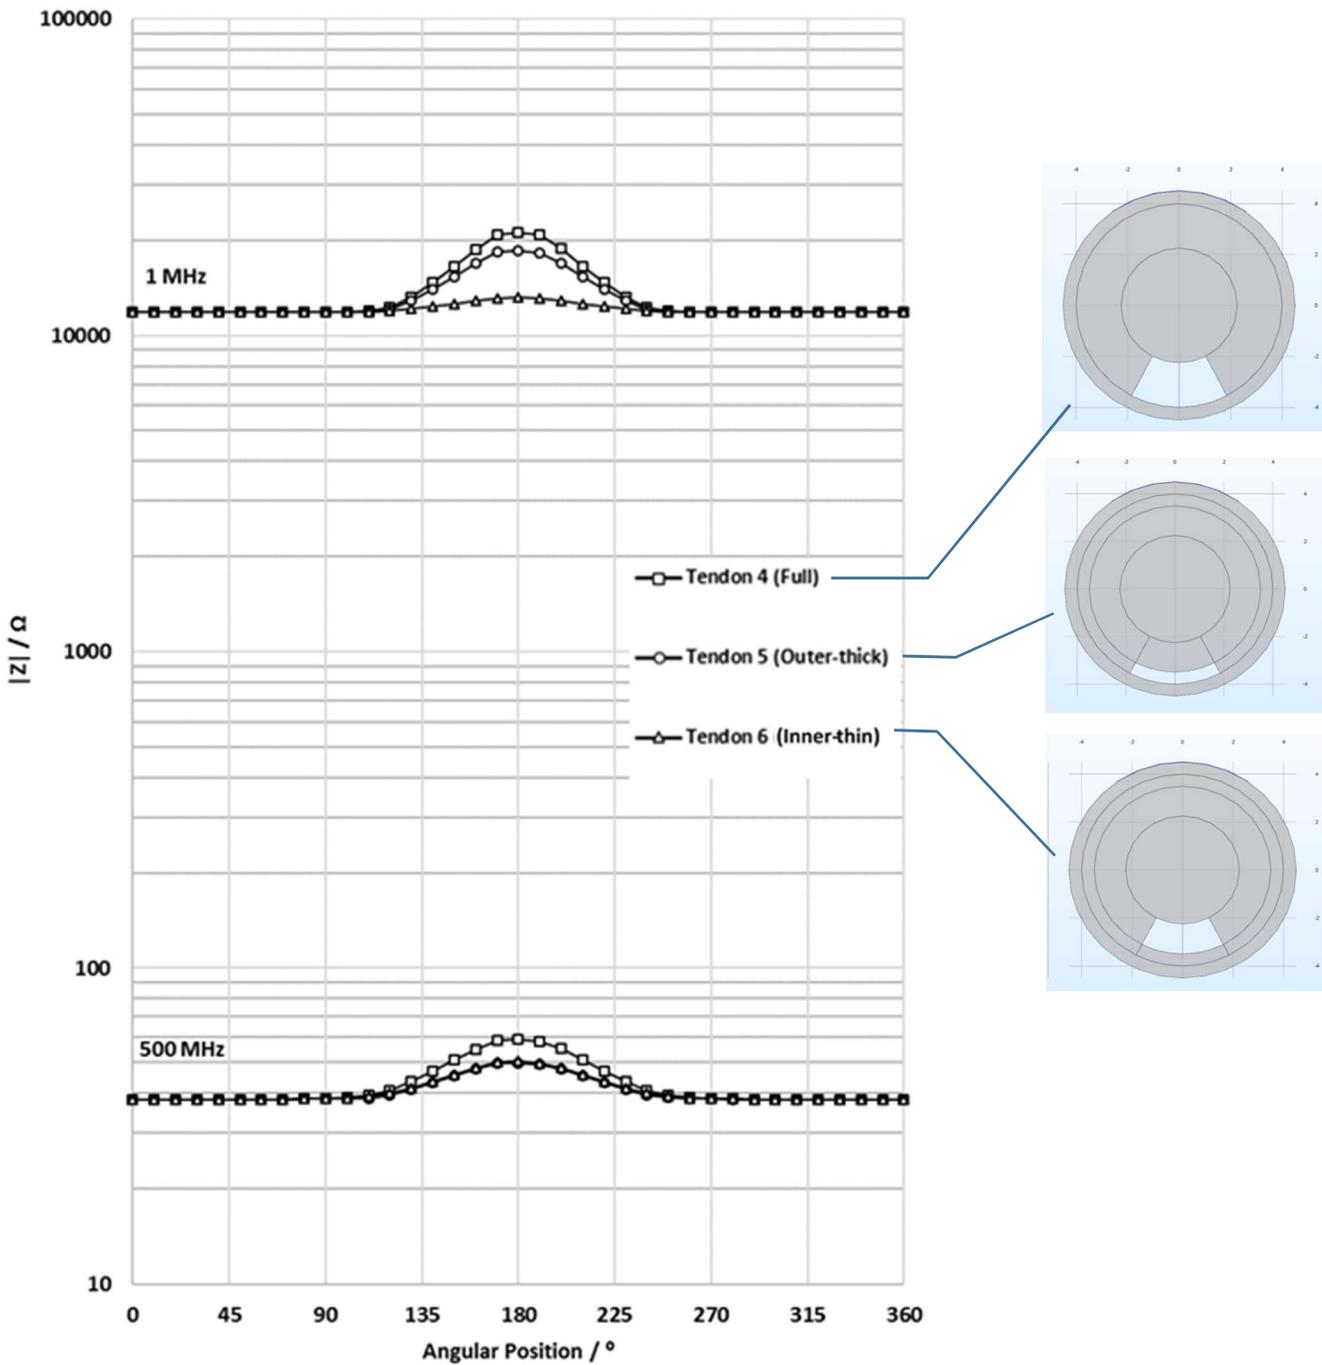
Figure 5.42 Modulus of impedance vs. angular position for Table 5.6; Tendons 4, 5, and 6 at 1 MHz and 500 MHz. Log scale y-axis permits direct comparison of relative descriptors. Note that at 1 MHz, the outer void is strongly apparent, but the inner void is barely detectable. Using 500 MHz instead, the results can identify the void regardless of whether it is on the outer part of the cross-section or buried deeper.

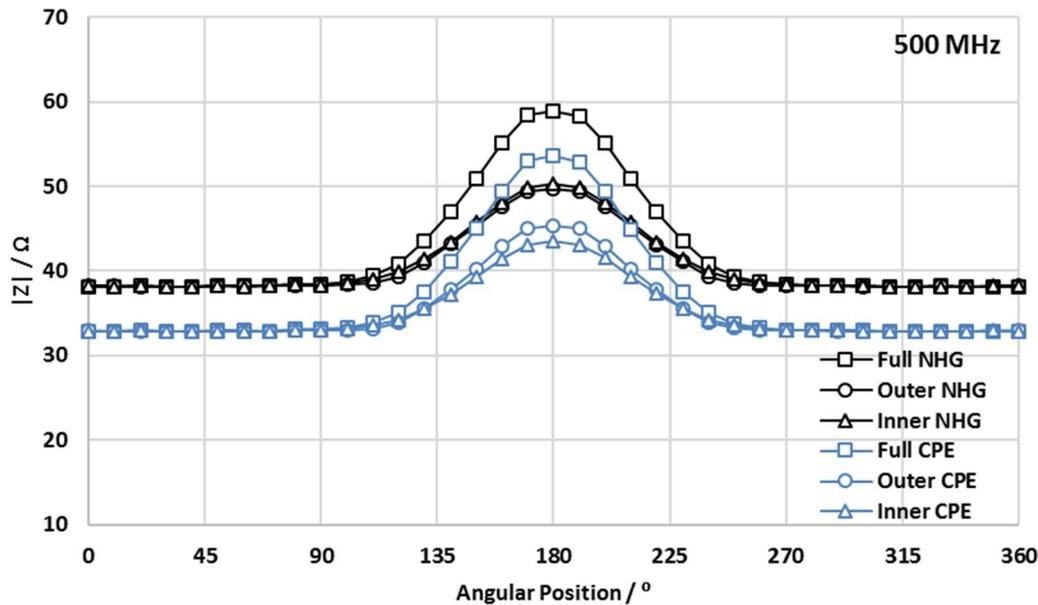
Figure 5.43 Modulus of impedance vs. angular position of the tendons addressed in Figure 5.34, using two alternative means of estimating high frequency grout dielectric behavior. The series in black are calculated using NHG input parameter, and the blue series are from the CPE input parameters.

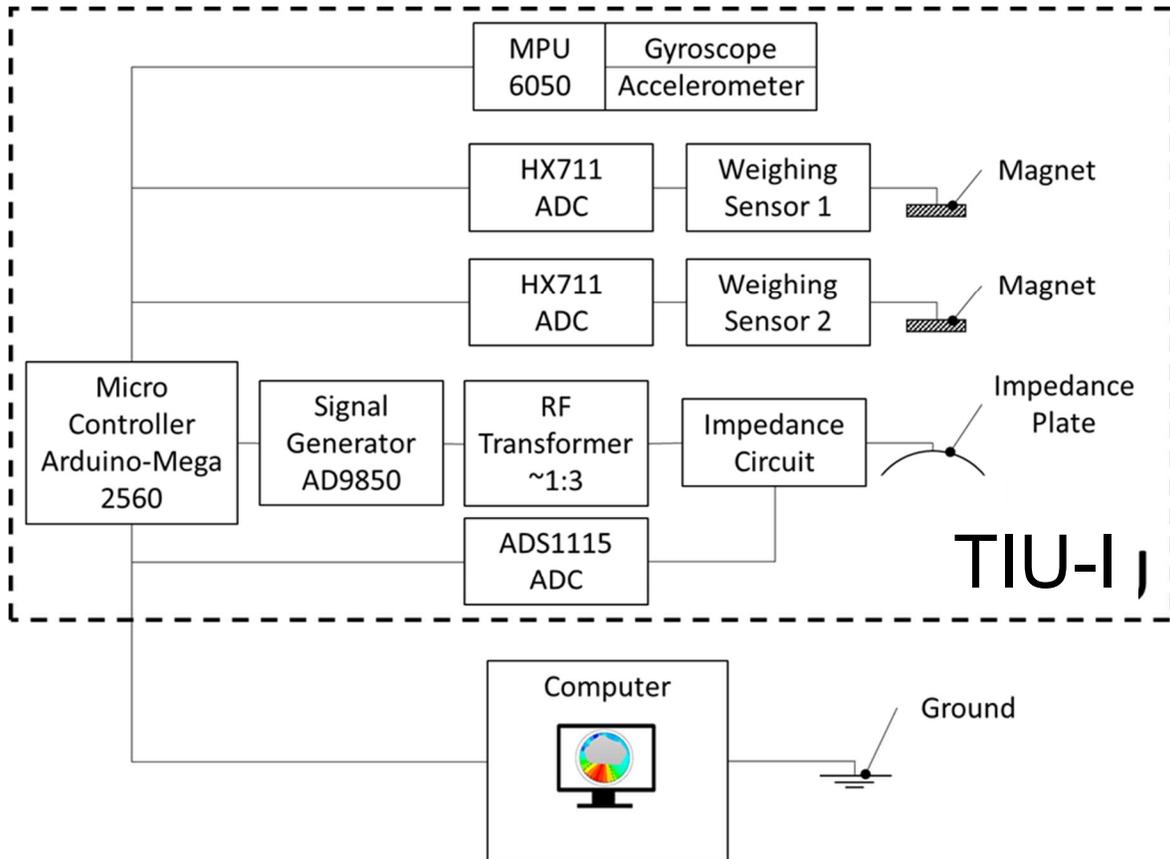
Figure 6.1 Block diagram schematic for the TIU-I laboratory prototype. Patent pending.

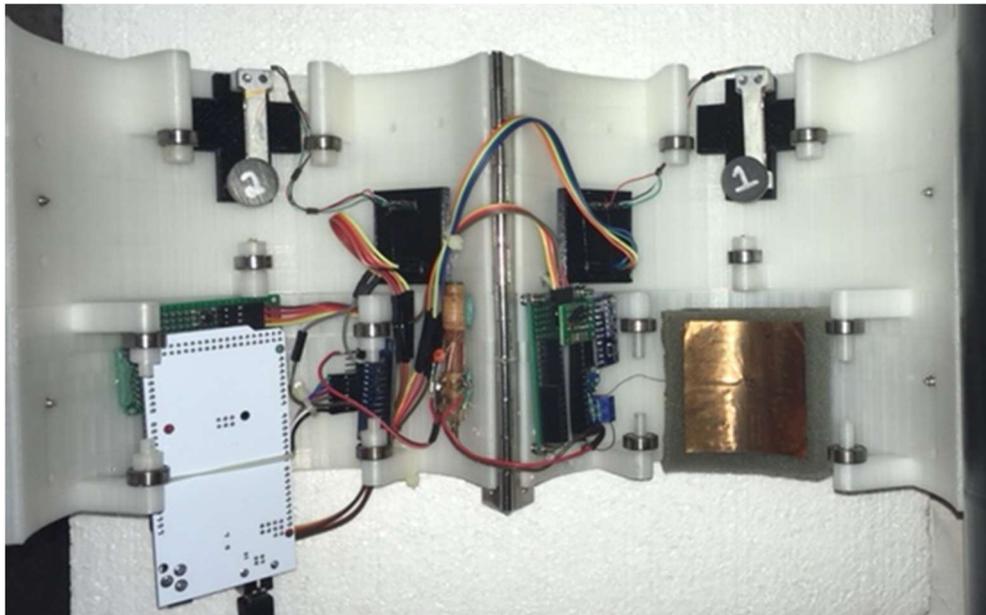
Figure 6.2 TIU-I with the clamshell opened to show internal components. Magnetic sensing load cells (numbered 1 and 2) are at the top. The capacitive sensor plate is at lower right. Roller bearings maintain precise positioning of the sensing elements on the external tendon duct surface. Electronic processing boards fit amply in the remaining gaps. Patent pending.

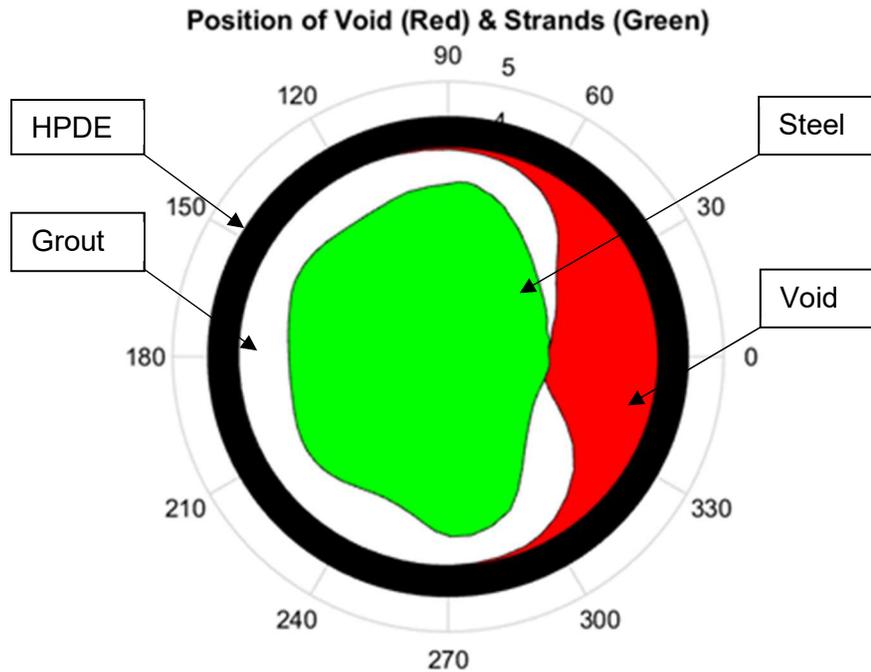
Figure 6.3 Image generated from the TIU-I after scanning an in-house cast tendon with the device centered on an existing void. Patent pending.

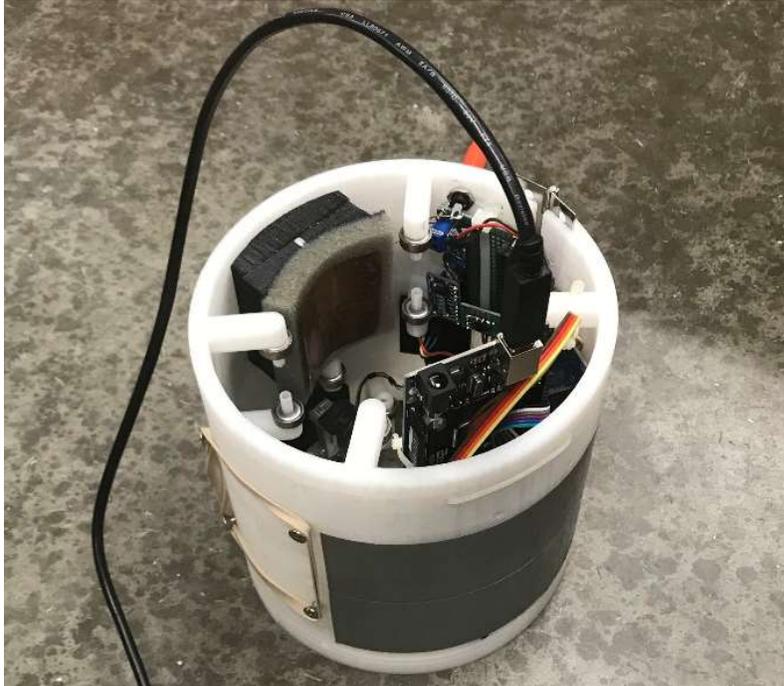
Figure 6.4 TIU-I placed in the vertical calibration position away from steel mass. Patent Pending.

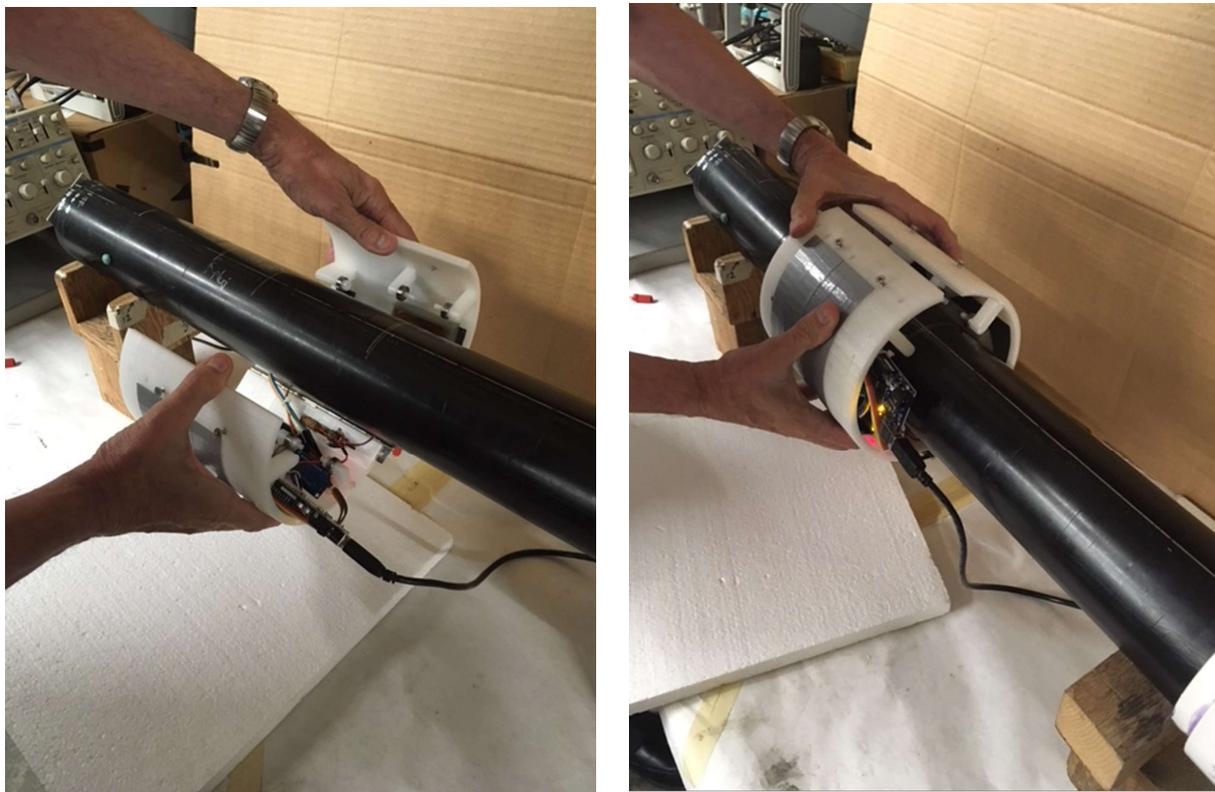
Figure 6.6 Placing the TIU-I around the tendon. Patent pending.

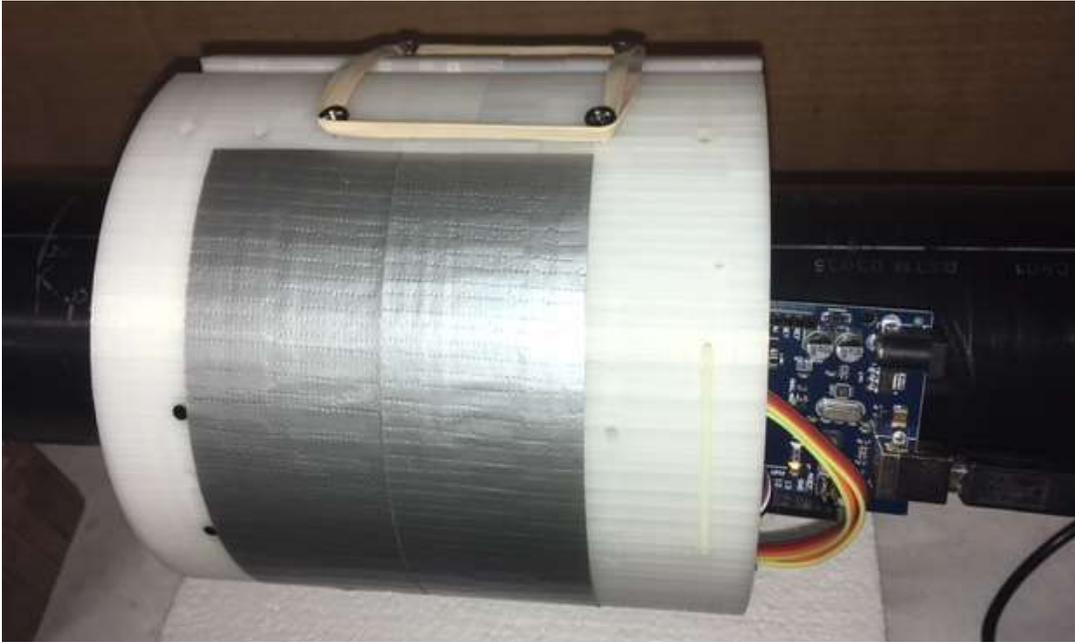
Figure 6.7 TIU-I secured to the tendon with elastic bands.

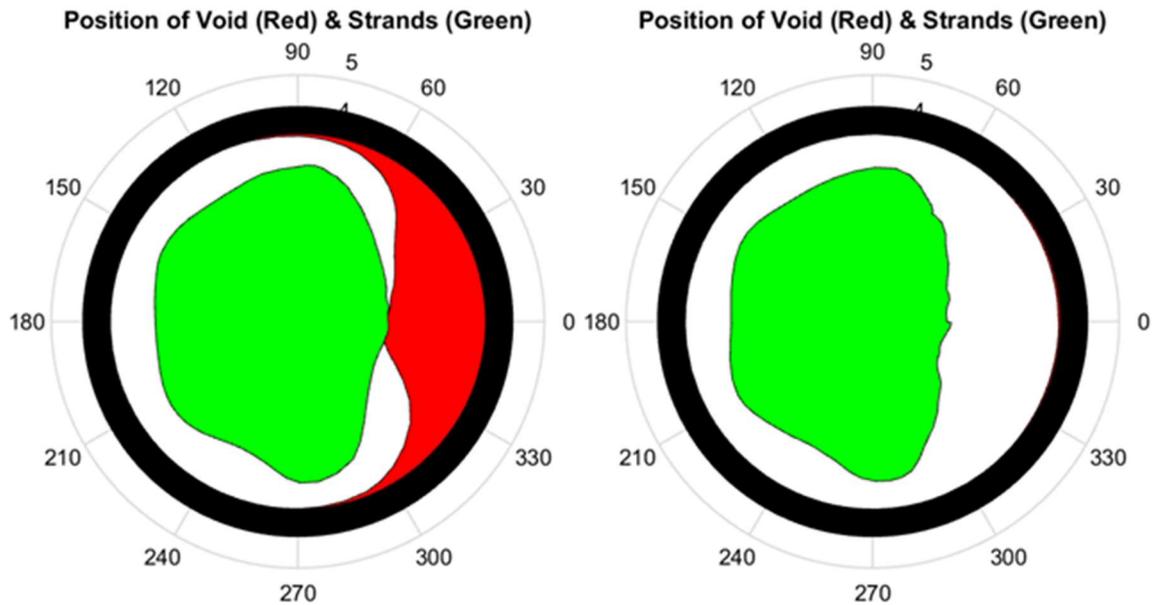
Figure 6.8 IAs generated from two different positions of the same piece of tendon. The left image was taken where a purpose-build void was cast into the tendon. The right image was taken where no void was cast. Patent pending.

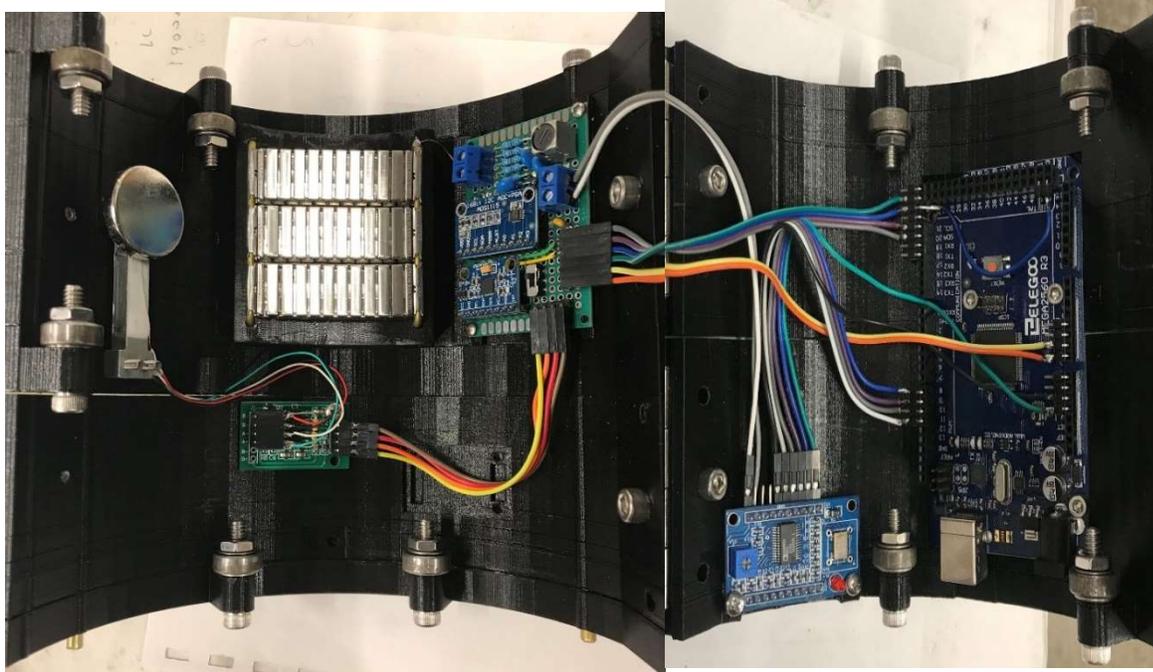
Figure 6.9 TIU-II with clamshell open to show internal components. Patent pending.

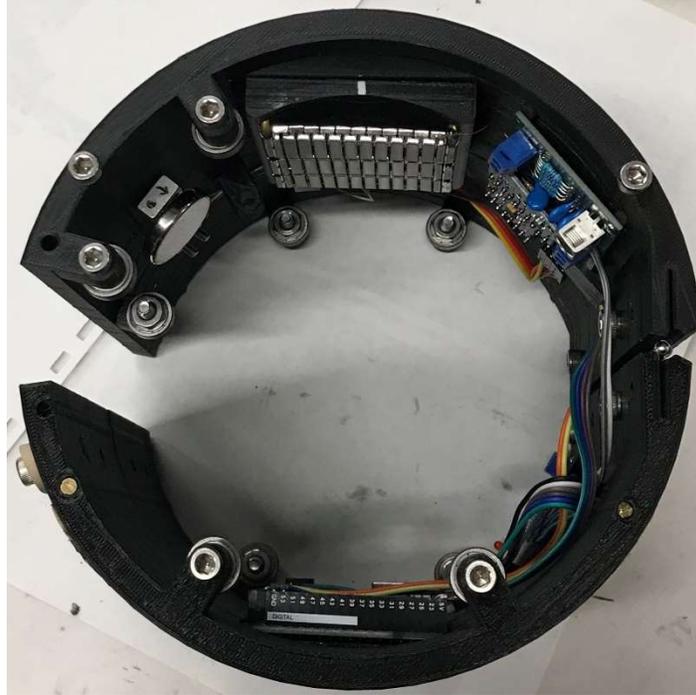
Figure 6.10 Top view of the TIU-II. Patent pending.

- Redone 3D printed clamshell that allows testing of 4.5 nominal inch diameter tendons.
- New stronger Neodymium magnet for improved force/magnet weight ratio for more accurate compensation for magnet weight in tendons that are not in vertical alignment.
- A capacitive plate made of a more robust reliable material that is more tolerant to the irregular surface of the outer perimeter of the HDPE polymer
- Software includes compensation for magnetic properties of some grouts, which corrects for more accurate measurement of the steel strand envelope.
- The overburden around the duct diameter is < 1 inch as per design goals for minimum interference by nearby tendons or structural walls.

Based on its improved performance, the TIU-II was chosen to generate the images of the 4.5 nominal inch diameter tendon segments that were used for the gamma ray tomography validation tests described in chapter 7. The TIU-II was further improved as a Mark III, TIU-III version, called the Field Tendon Imaging Unit (FTIU). The FTIU is described in detail in the Final Report for FDOT Project Number: BDV25-977-52, Field Demonstration of Tendon Imaging Methods [39].

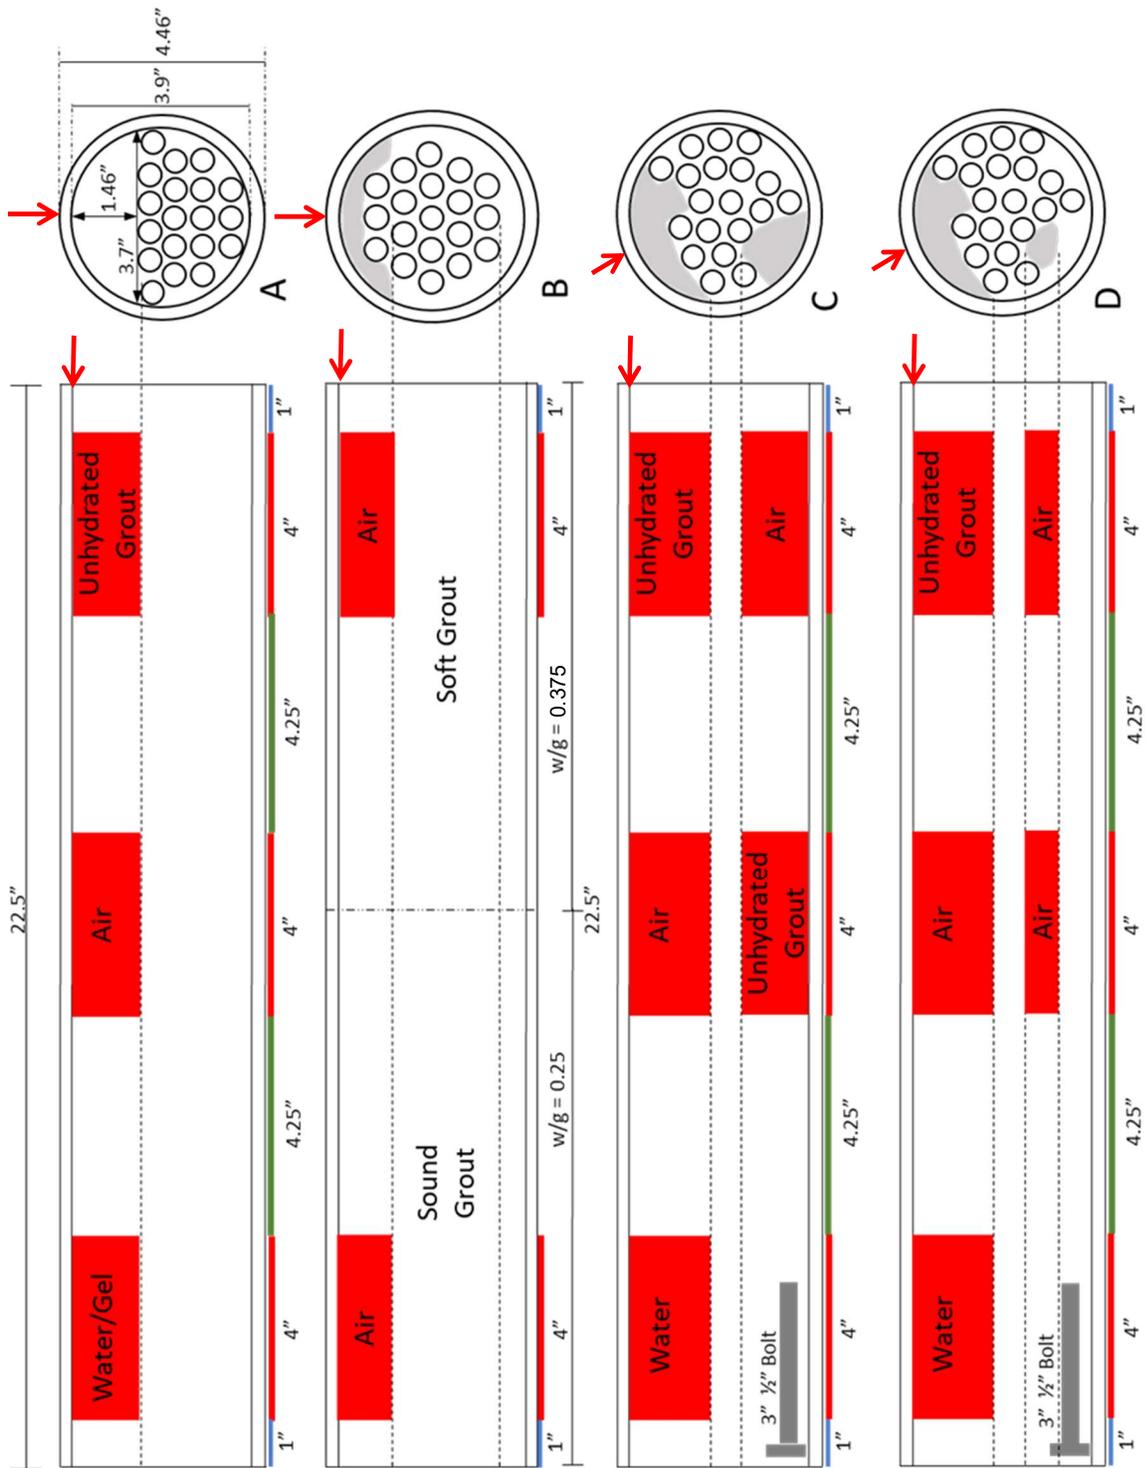
Figure 7.1 Approximate configuration for Ducts A-D.

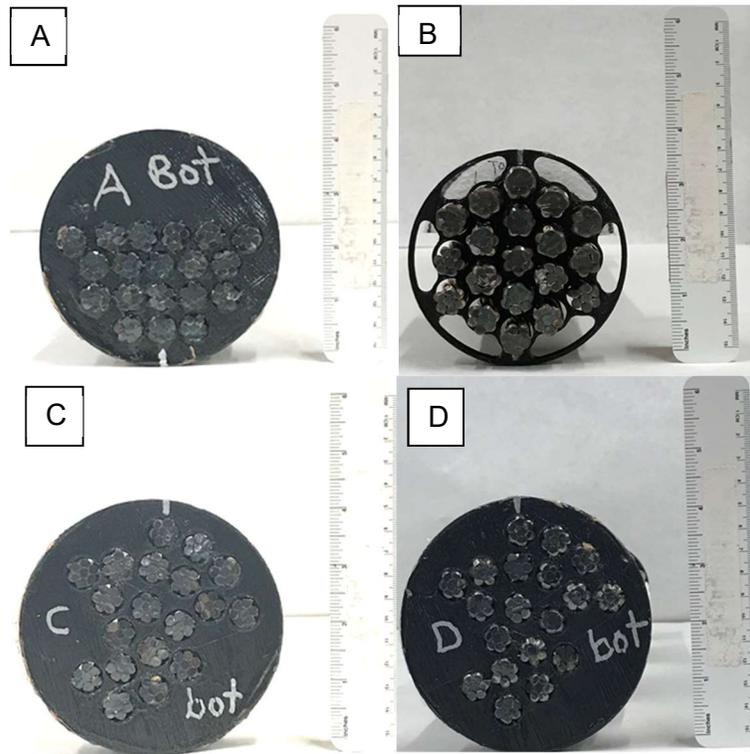
Figure 7.2 End cross-section of steel strand assembly for each Duct A-D cast.

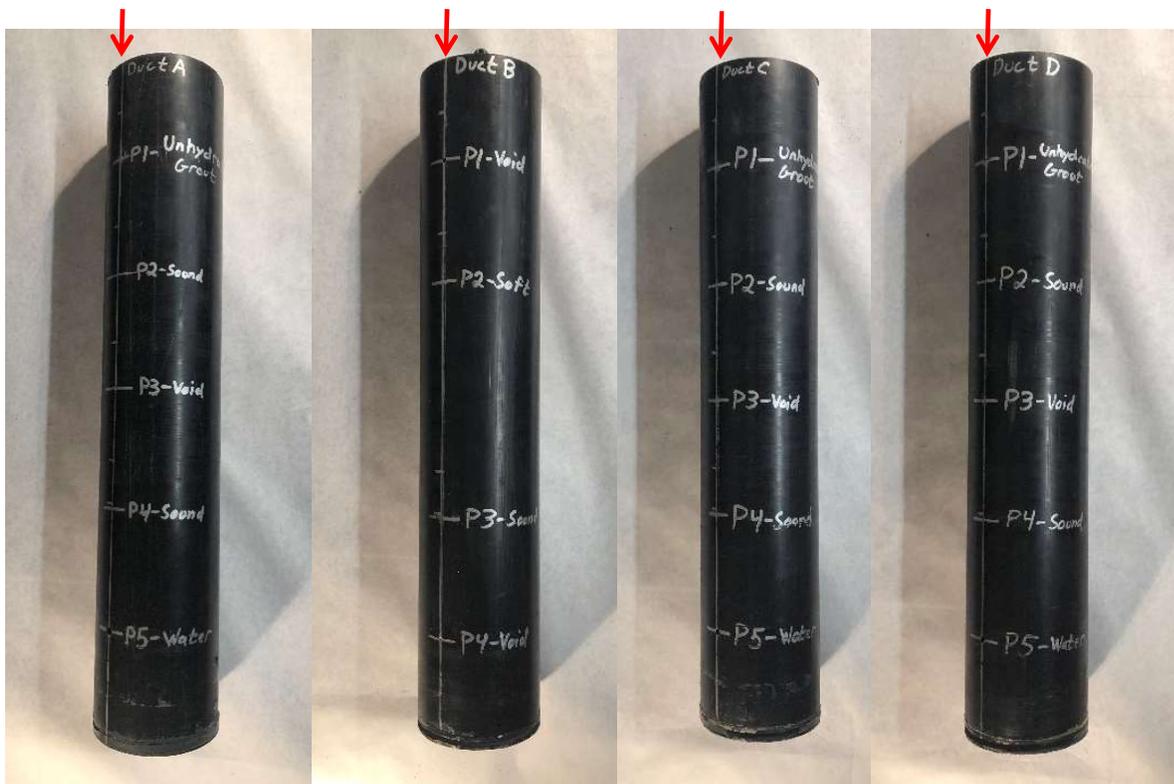
Figure 7.3 Side view of ducts A-D showing the locations of P1-P5 (different grout configurations). Arrows are keyed to positions shown in Figure 7.1

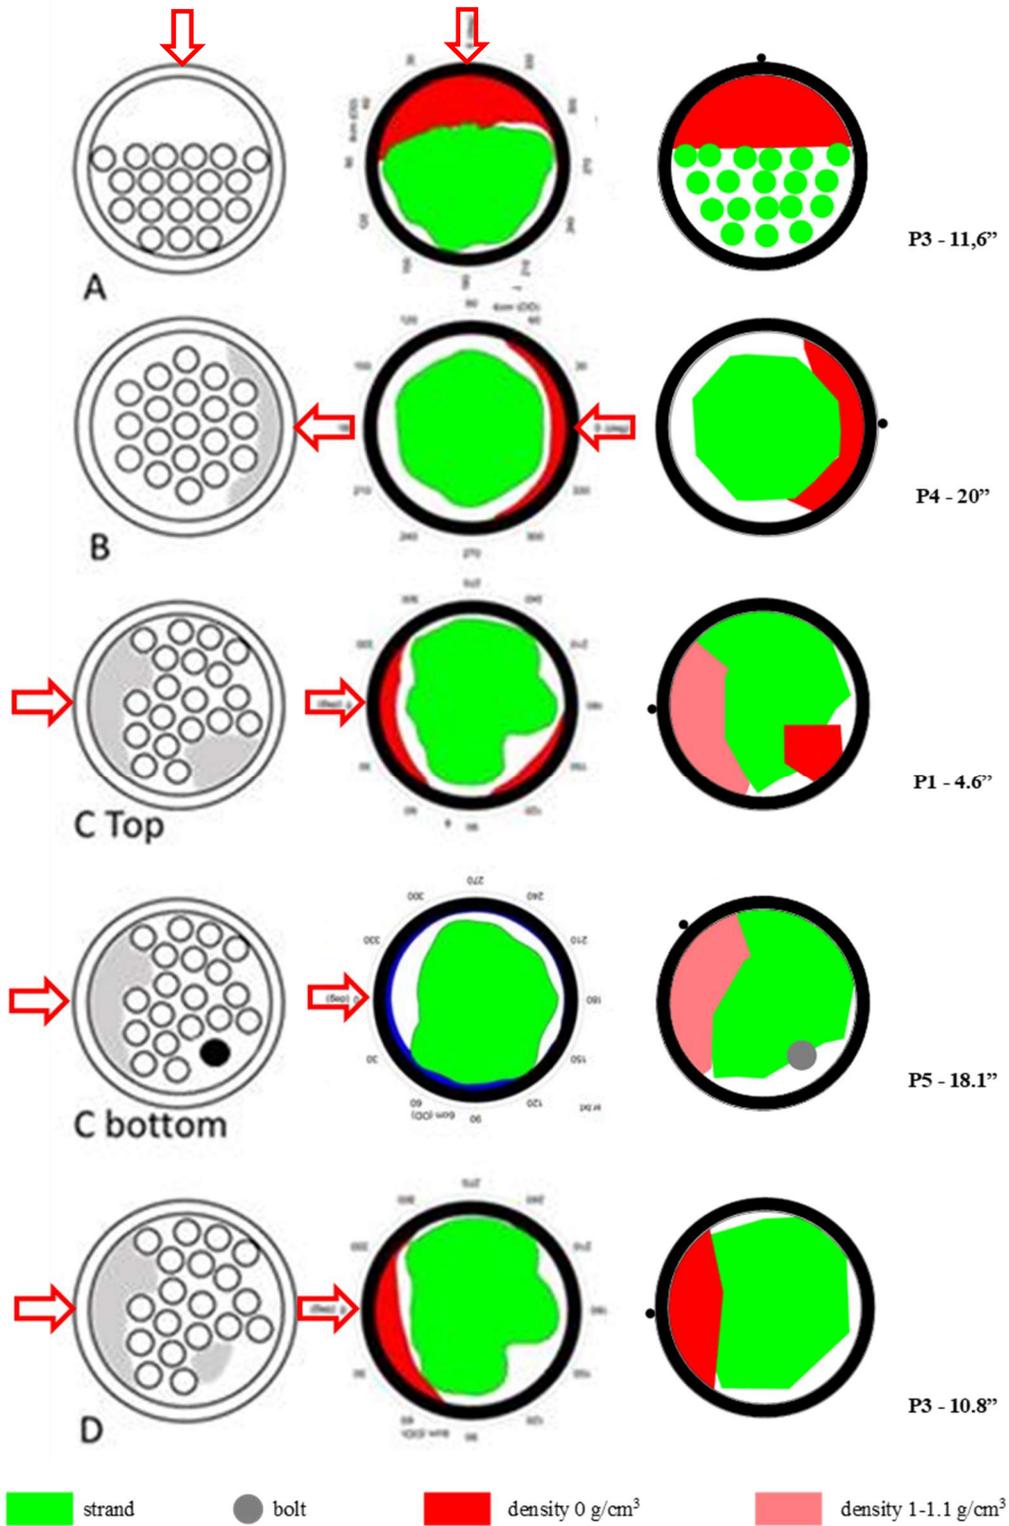
Figure 7.26 Comparison of selected cross-sections per design (left) obtained with the Laboratory Prototype (center) and GRT (right). Arrows indicate orientation per Figures 7.4-7.25. Adapted from information in Appendix C.

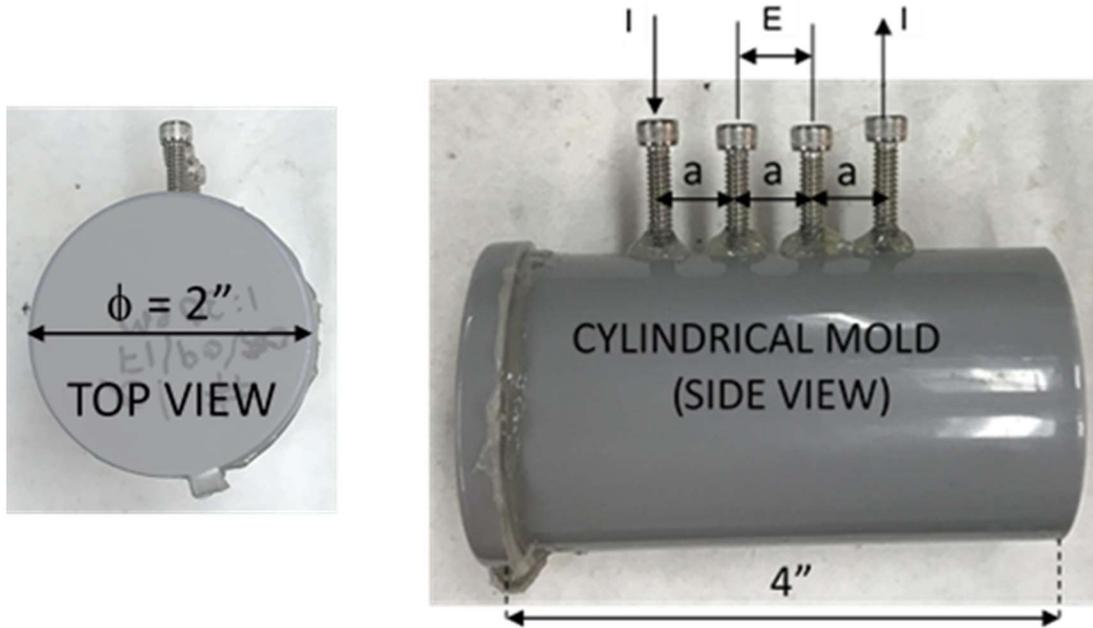
Figure A.1 Top and side view of cylindrical mold used for EIS, resistivity Wenner array test. Mold dimensions are internal.

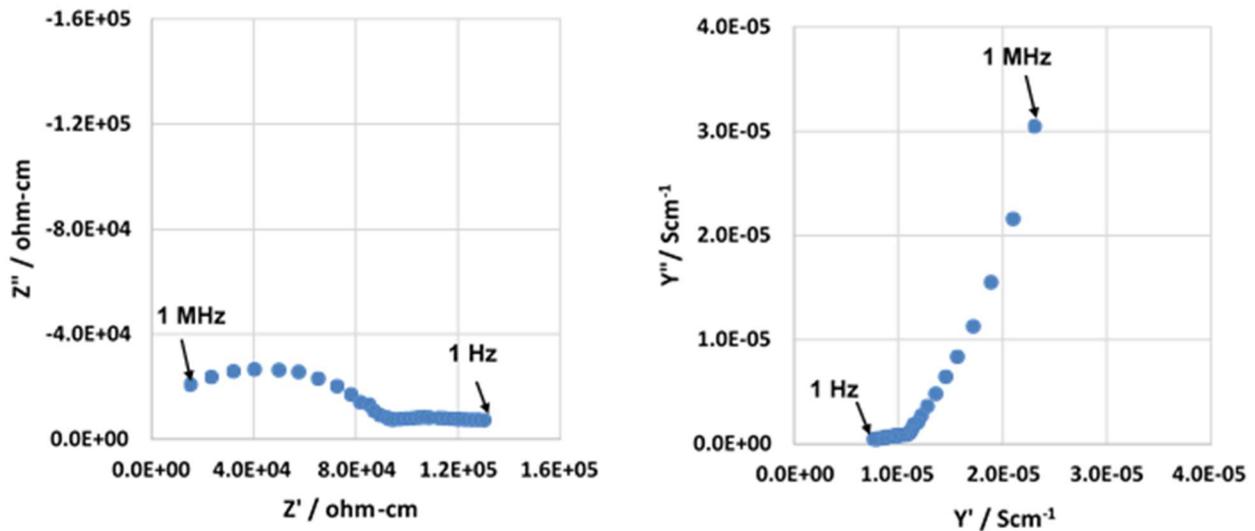
Figure A.2 Nyquist diagrams (Left: Impedivity; Right: Admittivity) for grout in test cylinder 1a using the Wenner array test to determine impedance behavior of grout. Frequency range shown, 5 points/decade. Specimen age after casting: 193 days.

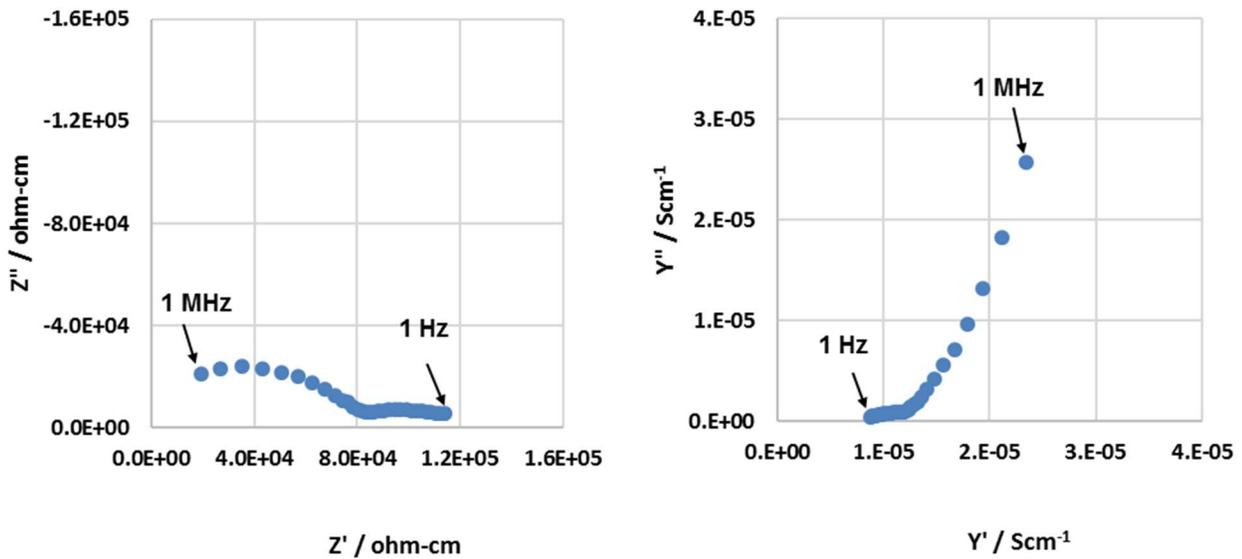
Figure A.3 Nyquist diagrams (Left: Impedivity; Right: Admittivity) for grout in test cylinder 2b using the Wenner array test to determine impedance behavior of grout. Frequency range shown, 5 points/decade. Specimen age after casting: ~193 days.
