FINAL REPORT

DEVELOPMENT OF TENDON IMAGING SENSOR

FDOT Contract Number: BDV25-977-24

Department of Civil and Environmental Engineering

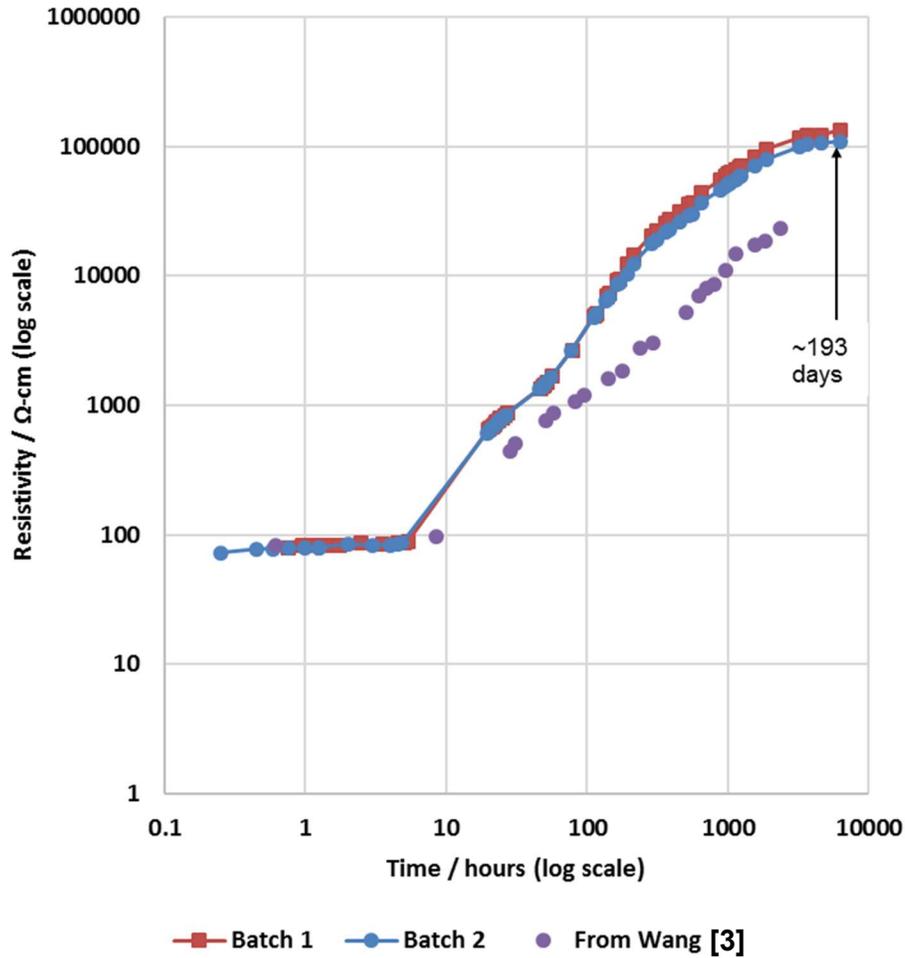
Figure A.4 – Average resistivity of grout cylinders vs. time corrected for geometry and temperature. Shown for comparison are data for a representative grout from an earlier investigation of modern grouts [3]

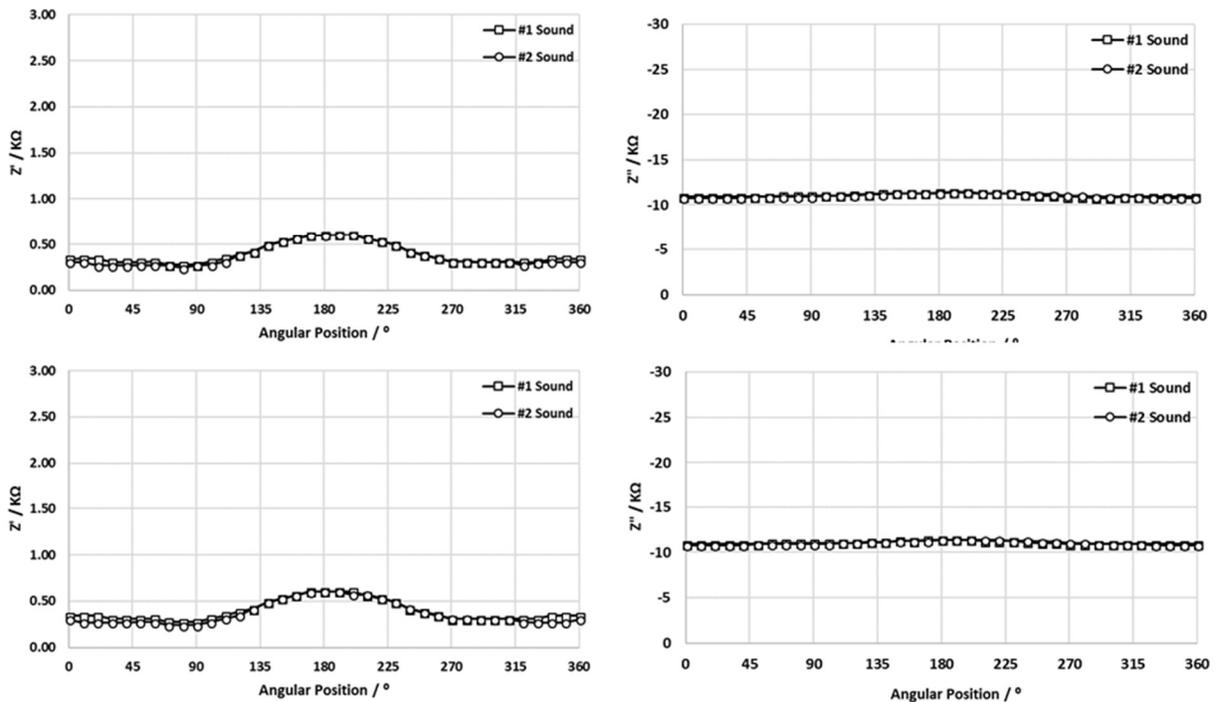
Figure B.4 Complex components of impedance, real (left) imaginary (right), for tendons #1 and #2 plotted as function of angular position for a cross-section containing Sound grout. Top and bottom: repeat measurements at ages 64 and 65 days respectively.

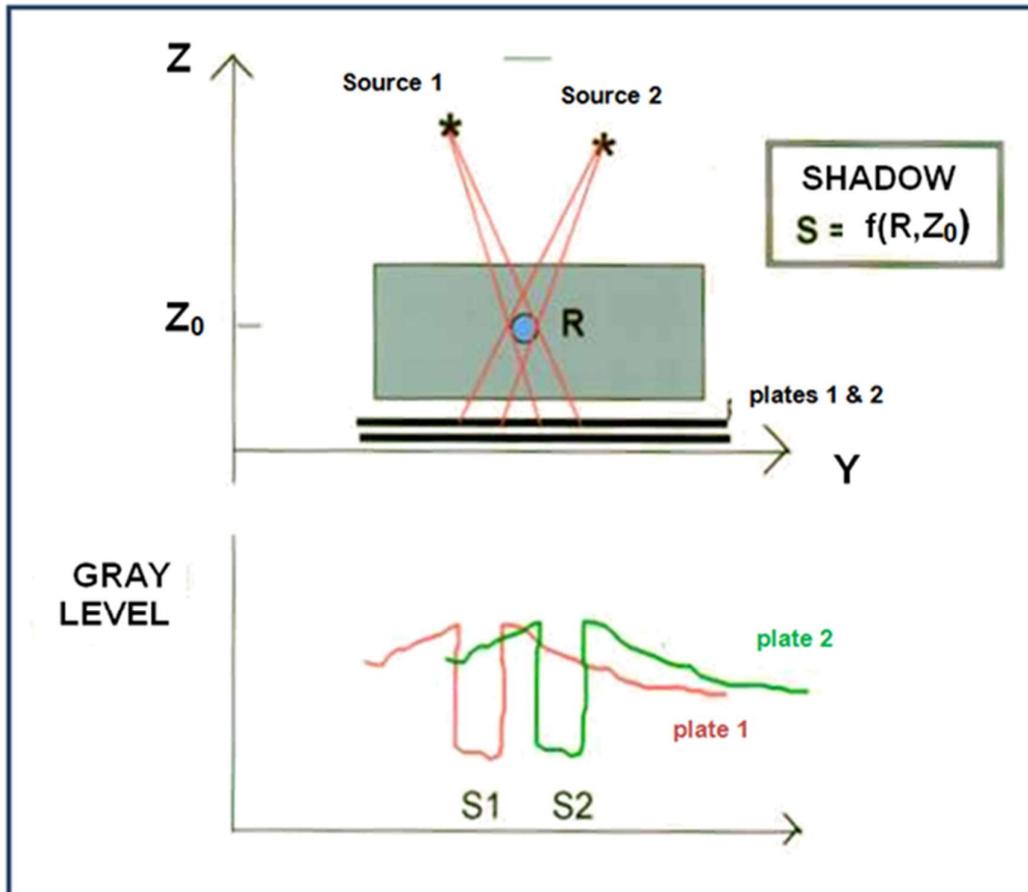
Fig. 1. Illustration of how position and diameters of steel bars are determined by RCT performing 2 irradiations at different angles.

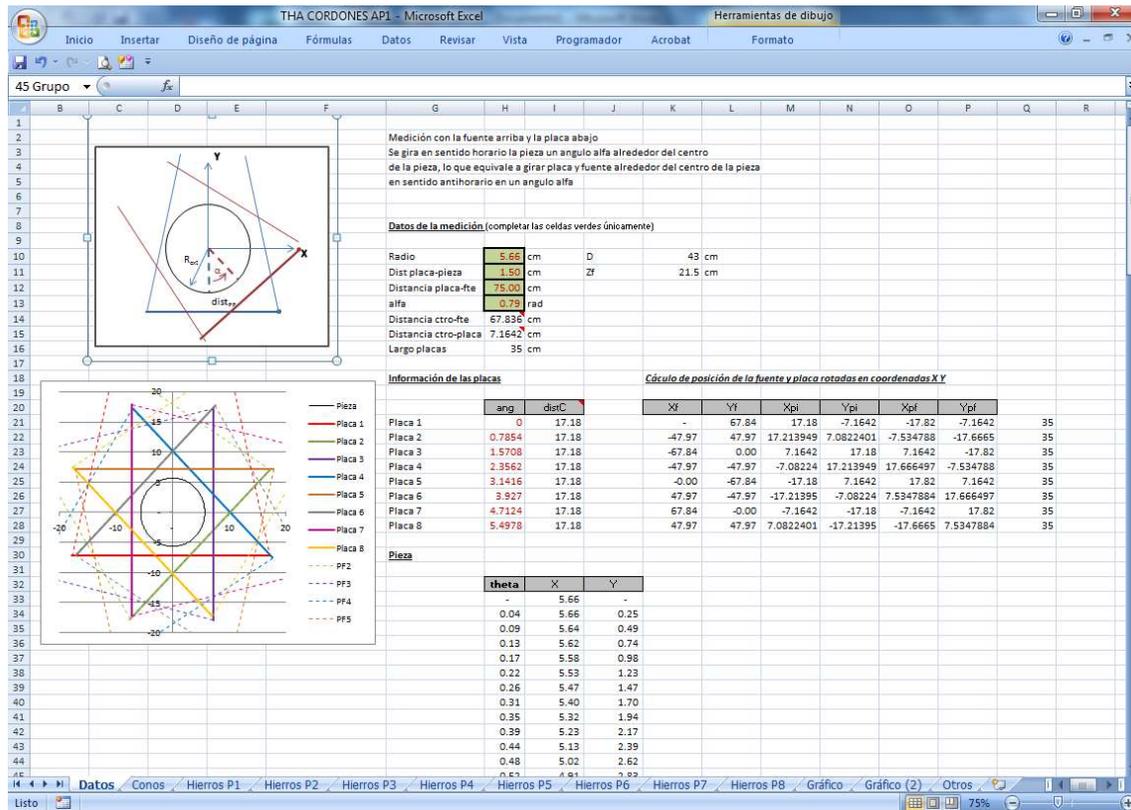
Fig. 2. Program screen with the data and drawings of sample and plate orientations. The upper graph is used to define coordinates and parameters.

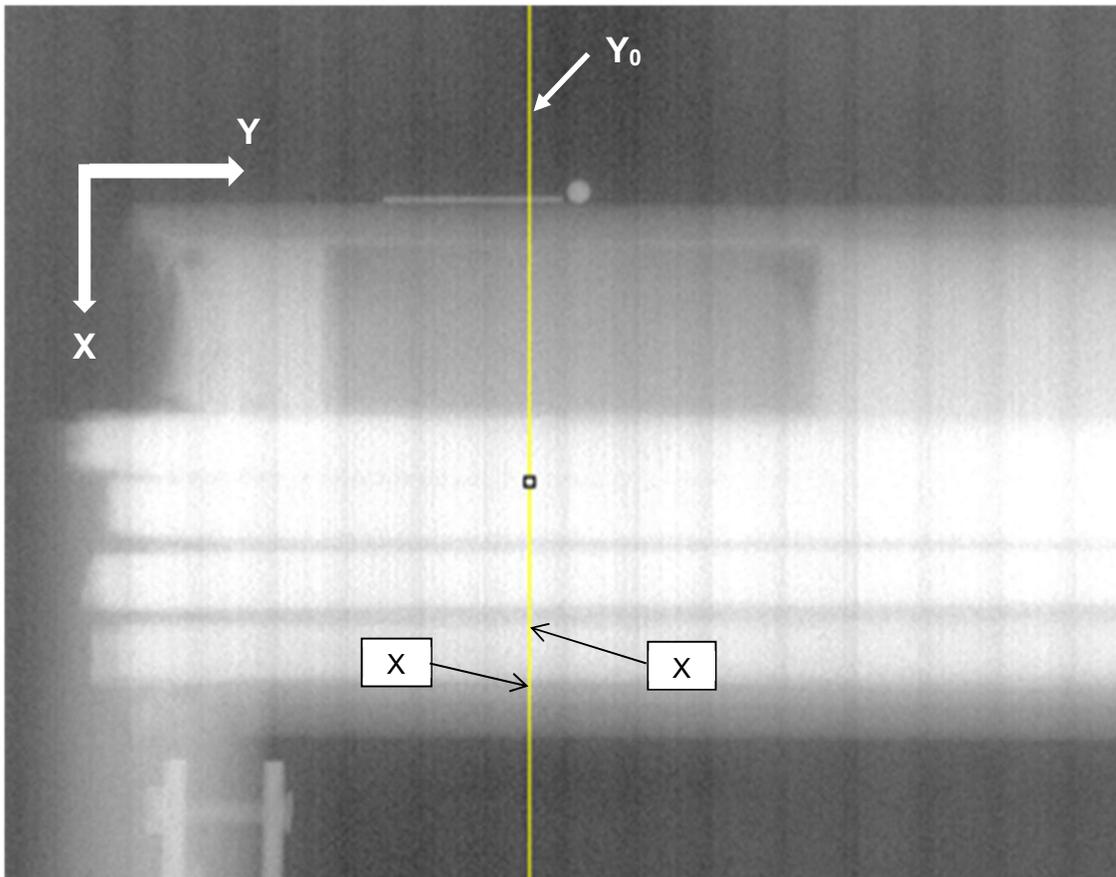
Fig. 3. Gammagraphy of a duct. The whiter horizontal bands are the strands. The X_1 and X_2 values indicate the pixel position along the X axis (yellow vertical line) of the edges of the strand shadow projected onto the plate. (The vertical dark lines are an instrumental defect).

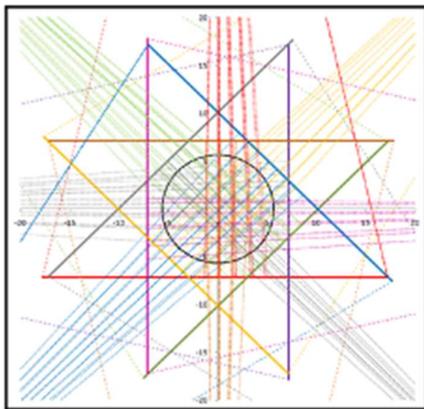
Fig. 4. Program drawing of all cones resulting from the set of X -values for every strand observed in the gammagraphies taken at different angles (shown in different colors).

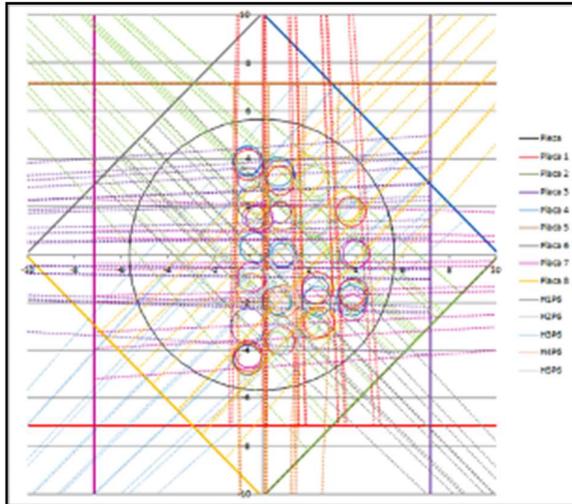
Fig. 5. Program drawing of all cones and intersections defining strands (case of Duct A).

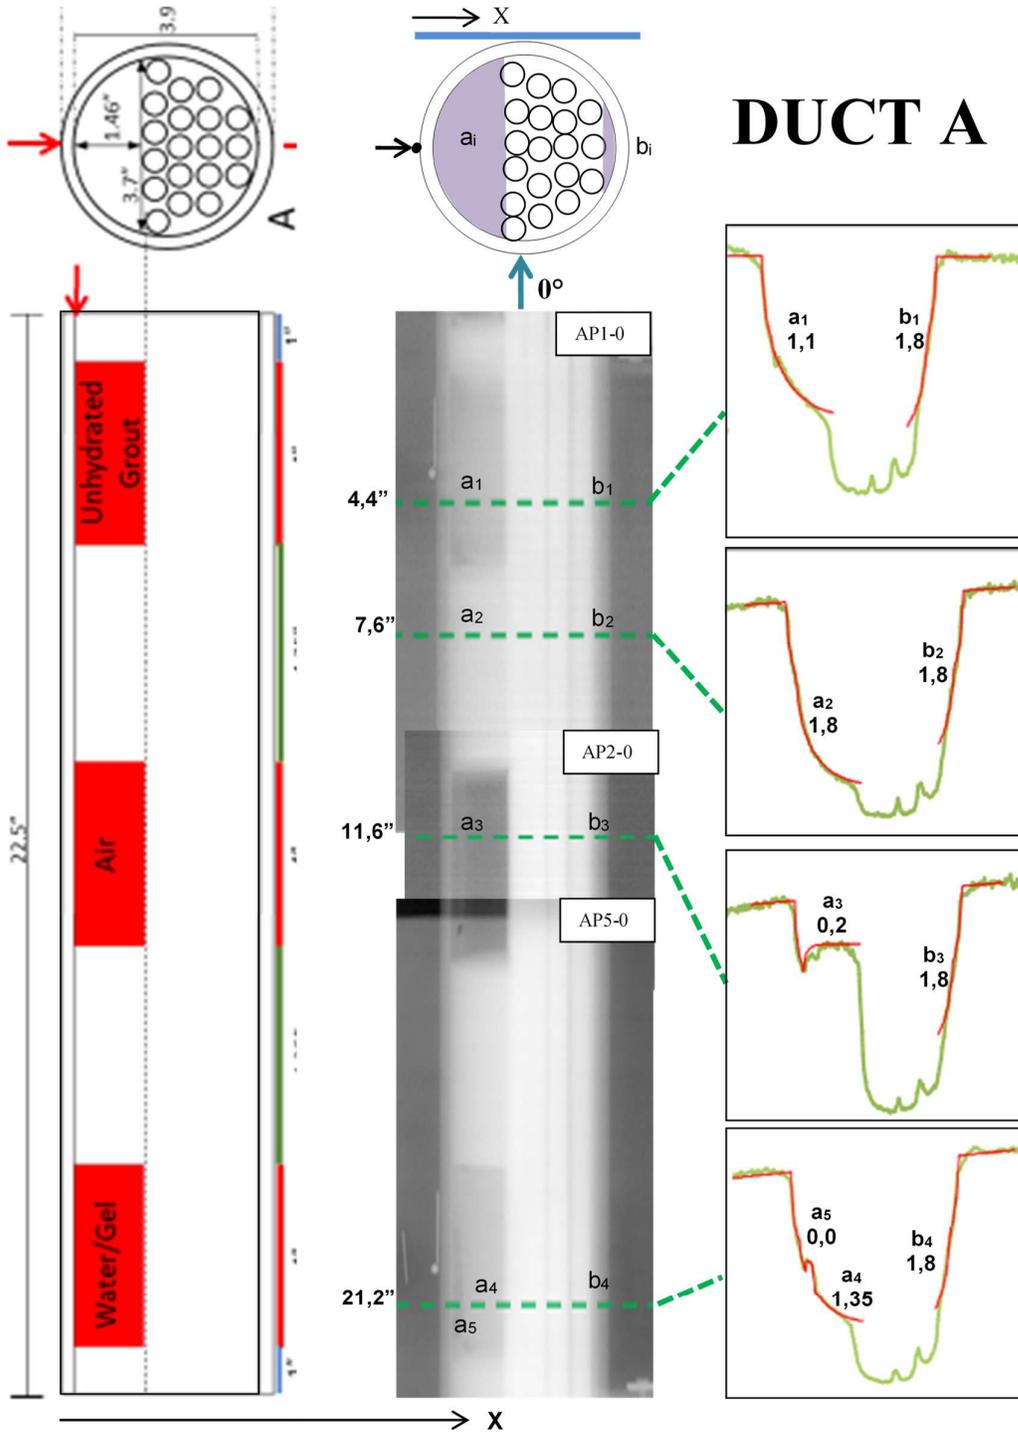
Fig. 8. Results for Duct A. Left: USF construction drawings; Center and right: Results of measurements performed by THASA, (circles indicate strands location; purple, areas of measured grouting defects, see text)

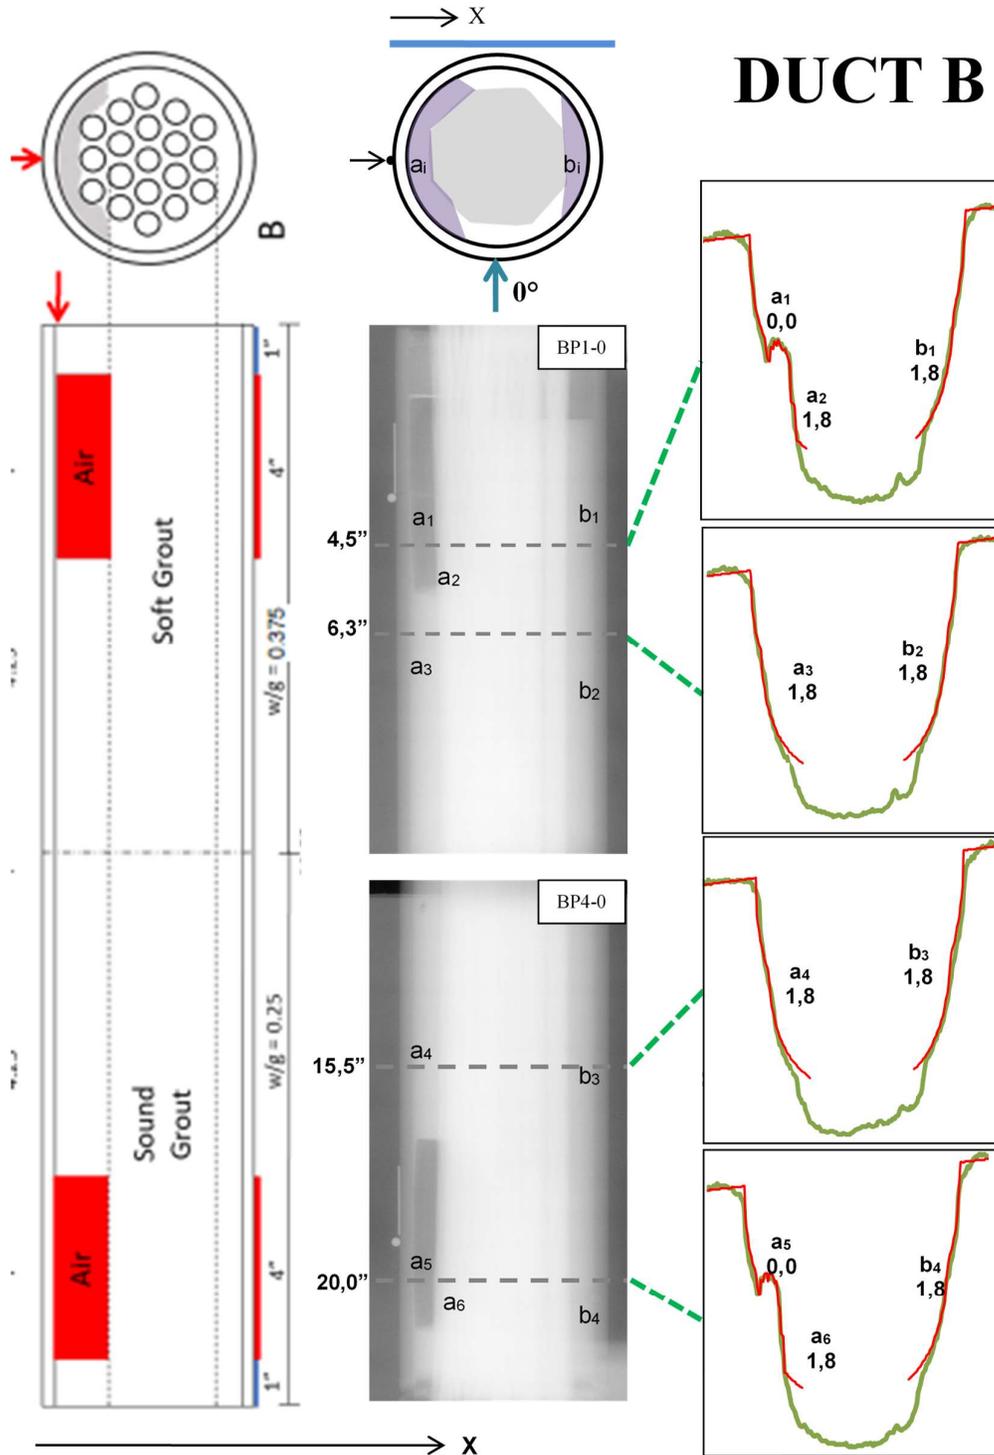
Fig. 9. Results for Duct B. Left: USF construction drawings; Center and right: Results of measurements performed by THASA, (gray indicate tendon location; purple, areas of measured grouting defects, see text).
