**THERMAL INTEGRITY PROFILING FOR  
AUGERED CAST-IN-PLACE PILES -  
(IMPLEMENTATION PLAN)**

**BDV25-977-34**

**FINAL REPORT**

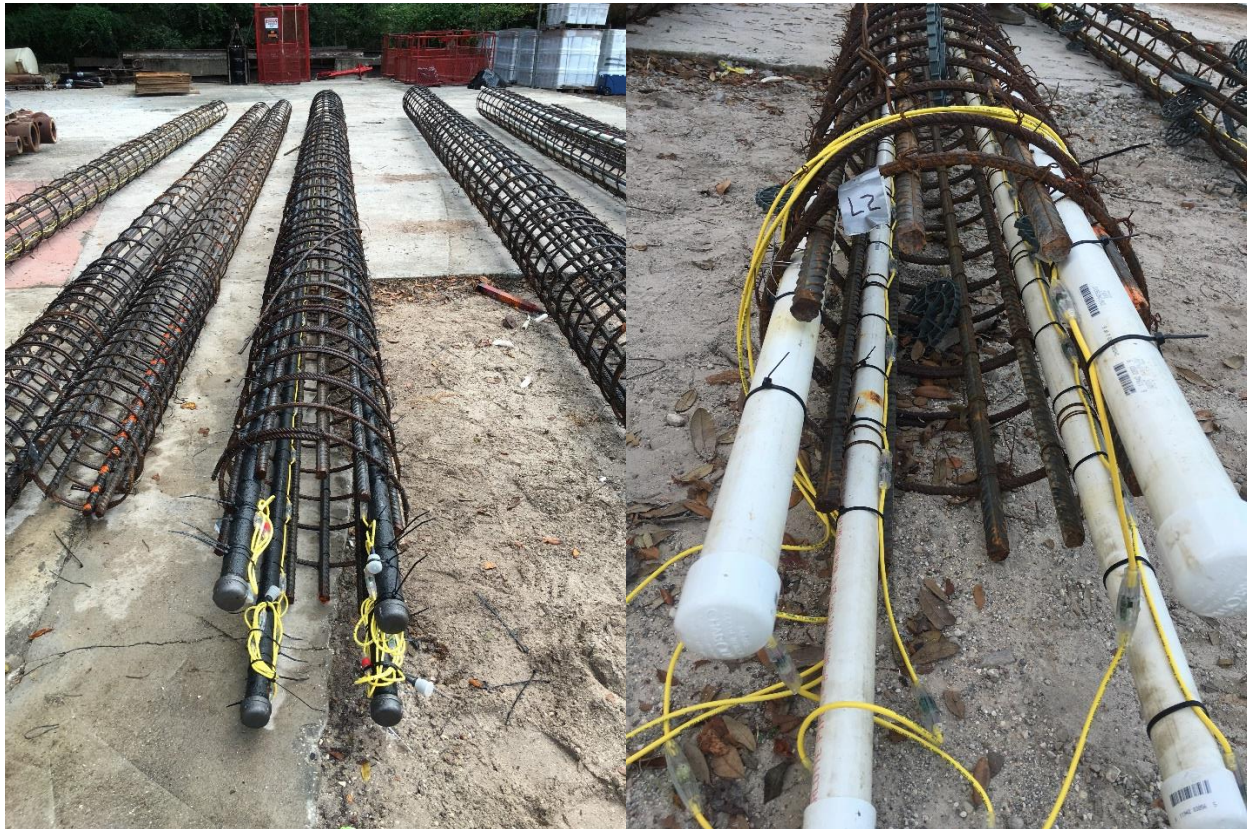
**Figure 2.5** Bottom end view of reinforcement cages for 24-in piles C2 (left) and L2 (right) instrumented with thermal wires and access tubes for thermal probe testing.

Piles C2 and L2 were equipped with both access tubes and thermal wires. While the cages were not intended to extend full depth, the access tubes were slightly extended 1 ft below the bottom of cage for some additional information as there would be no interference with the bottom of the excavation. Access tubes were first installed to prevent damage to wires if installed before access tubes. Tubes were tied with steel tie wire at 2-ft intervals to provide a secure attachment. Wires were tied to the access tubes such that the sensors were all positioned 90 degrees counterclockwise from the inward direction of each tube. This aligned the radial distance from the center of pile to each wire sensor with the centerline distance of each access tube.

which made the installation of four wires conveniently spaced on multiples three bars for the 24-in piles and two bars for the 18-in piles. Excess wire length was bundled and attached to either the top of the access tubes or reinforcing bars (Figure 2.5). Figures 2.5 - 2.8 show each of the five reinforcing cages and the center bars that were instrumented with a single wire similarly secured with two ties per sensor.

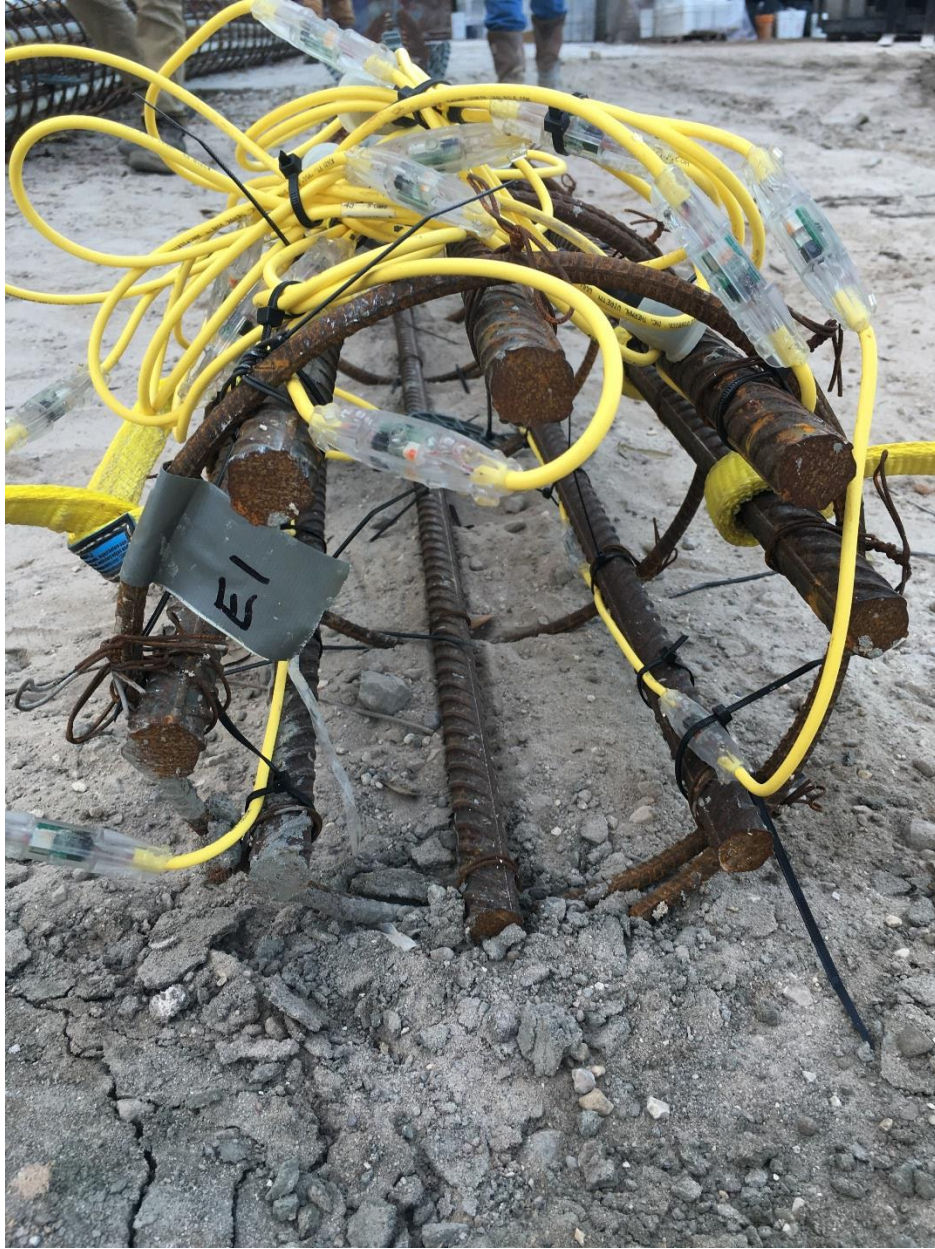
**Figure 2.7** Pile E1 reinforcing cage with thermal wires attached.

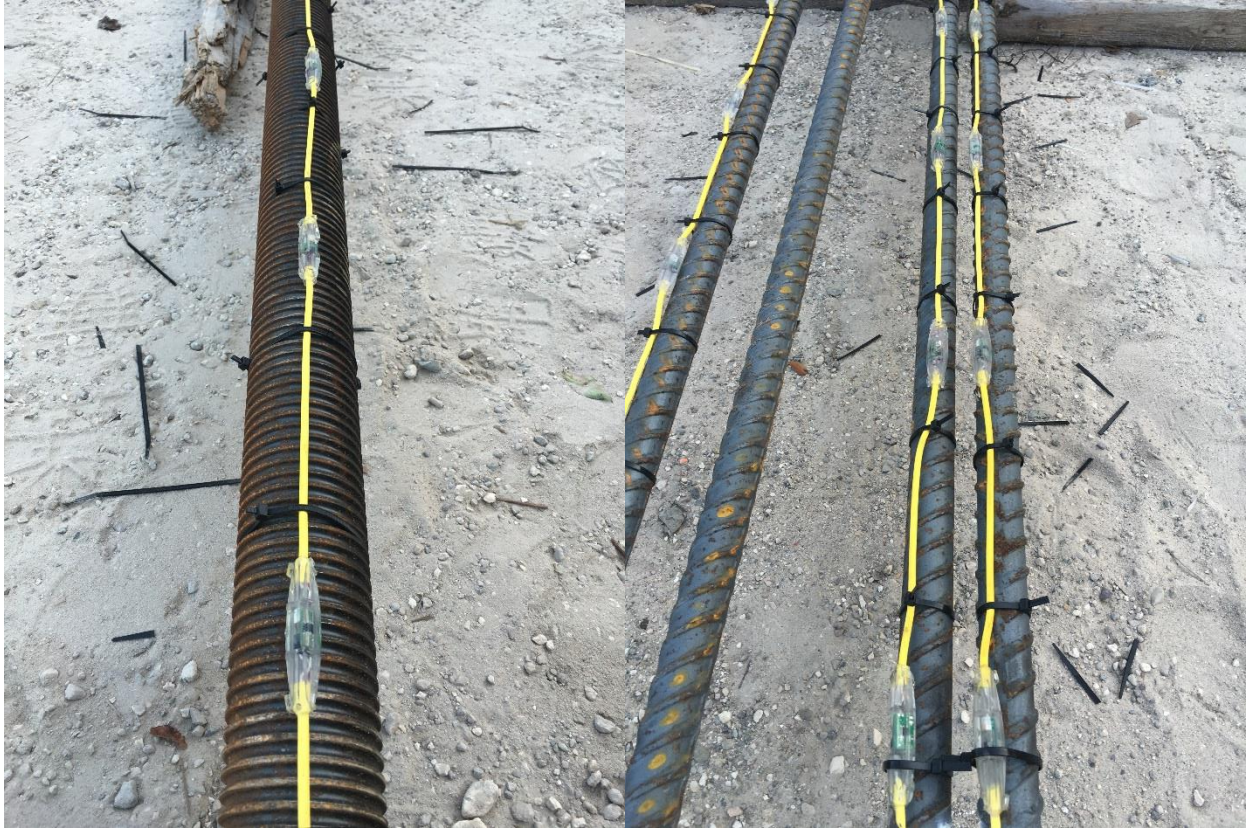
**Figure 2.8** 3-in center bars (left) and #11 center bars (right) instrumented with thermal wires.

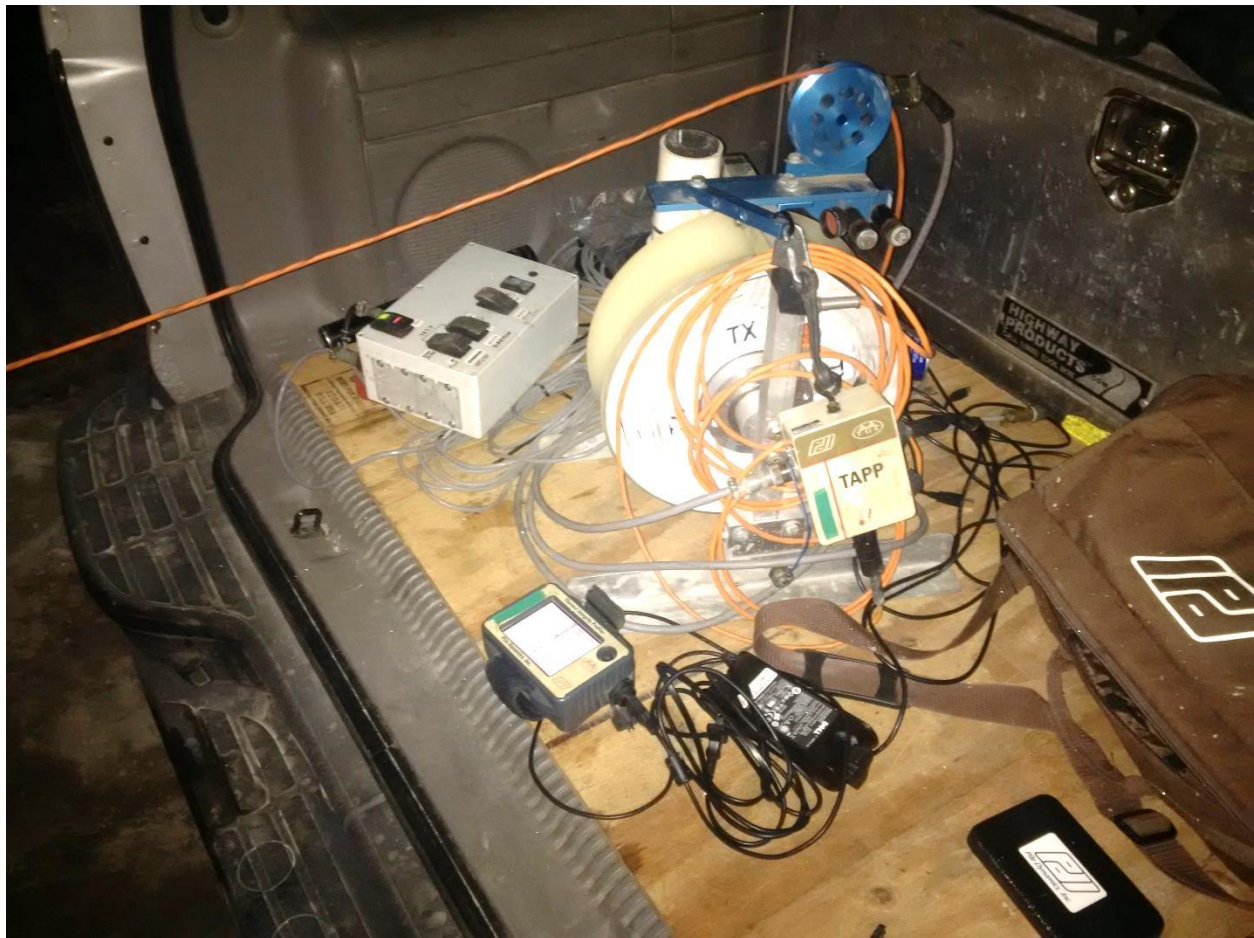
**Figure 2.9** Automated reel and data collection system used for probe testing.

Probe testing is usually only performed once, at a time that is near the peak temperature (ASTM 2014). At that time, the quality of the data is immediately evaluated by the testing engineer (or technician). If all profiles are clear and the data meaningful, then no more testing is required. However, for this study probe testing was performed on 6-hr intervals starting 6 hours after the piles were cast and continued up to 24 hours after casting. Each tube was profiled twice during each 6-hr interval/visit. Figures 2.9 - 2.11 show probe testing being performed at various stages of the curing/hydration process. For these tests an automated, reel-type system was used which frees the testing engineer to perform multiple field functions at once.

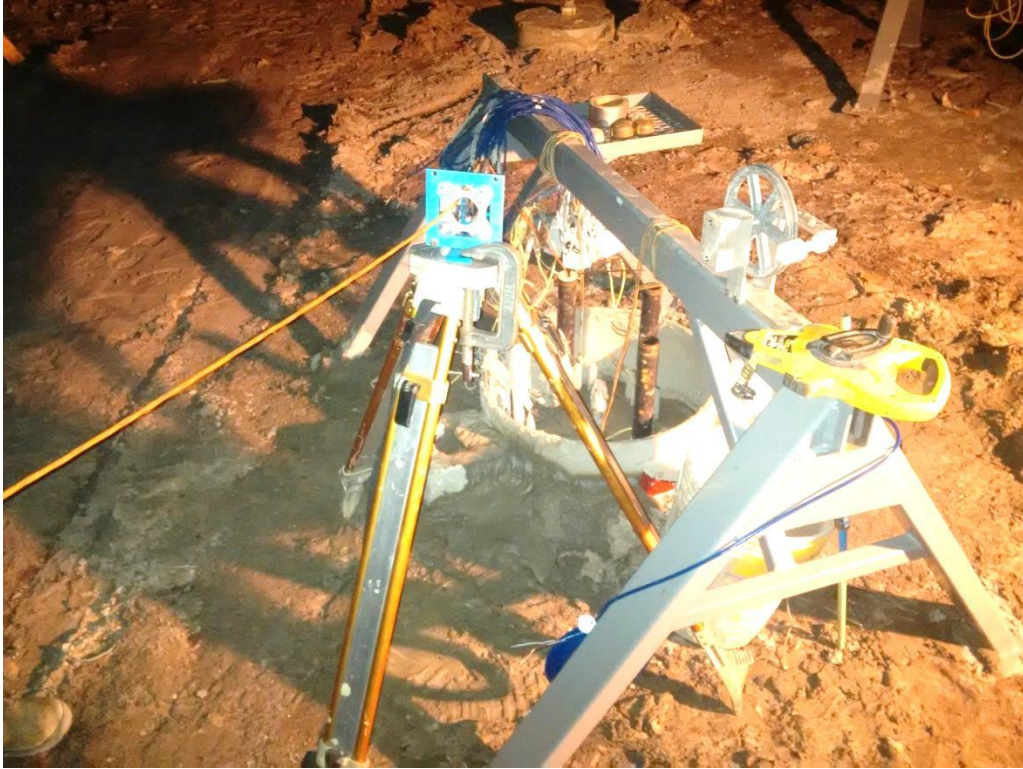
**Figure 2.10** Overnight probe testing.

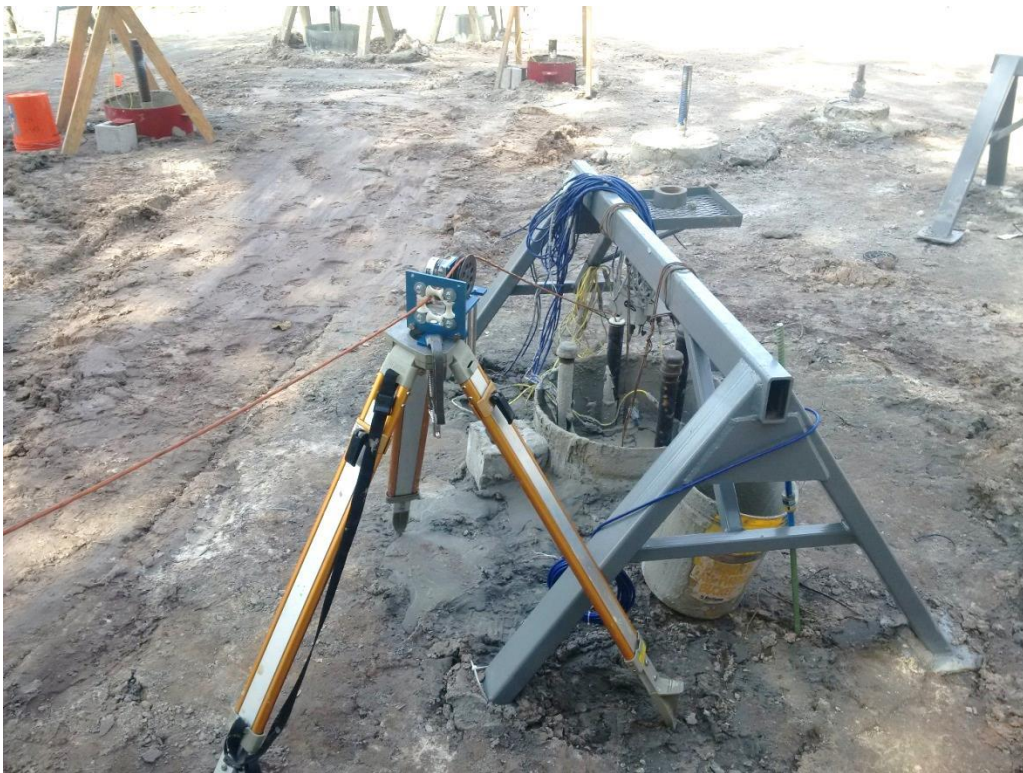
**Figure 2.11** Probe testing pile C2 at approximately 24 hours after pile installation.

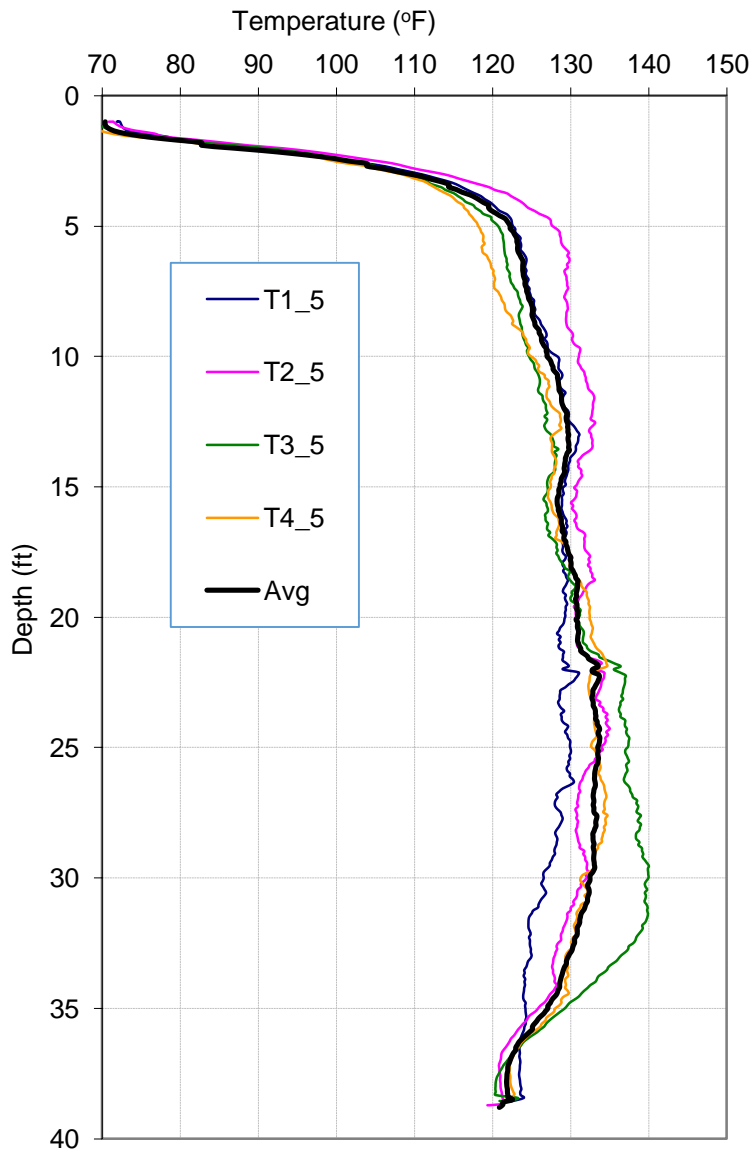
Figure 2.12 Temperature profile for pile C2 at peak temperature taken via probe system.

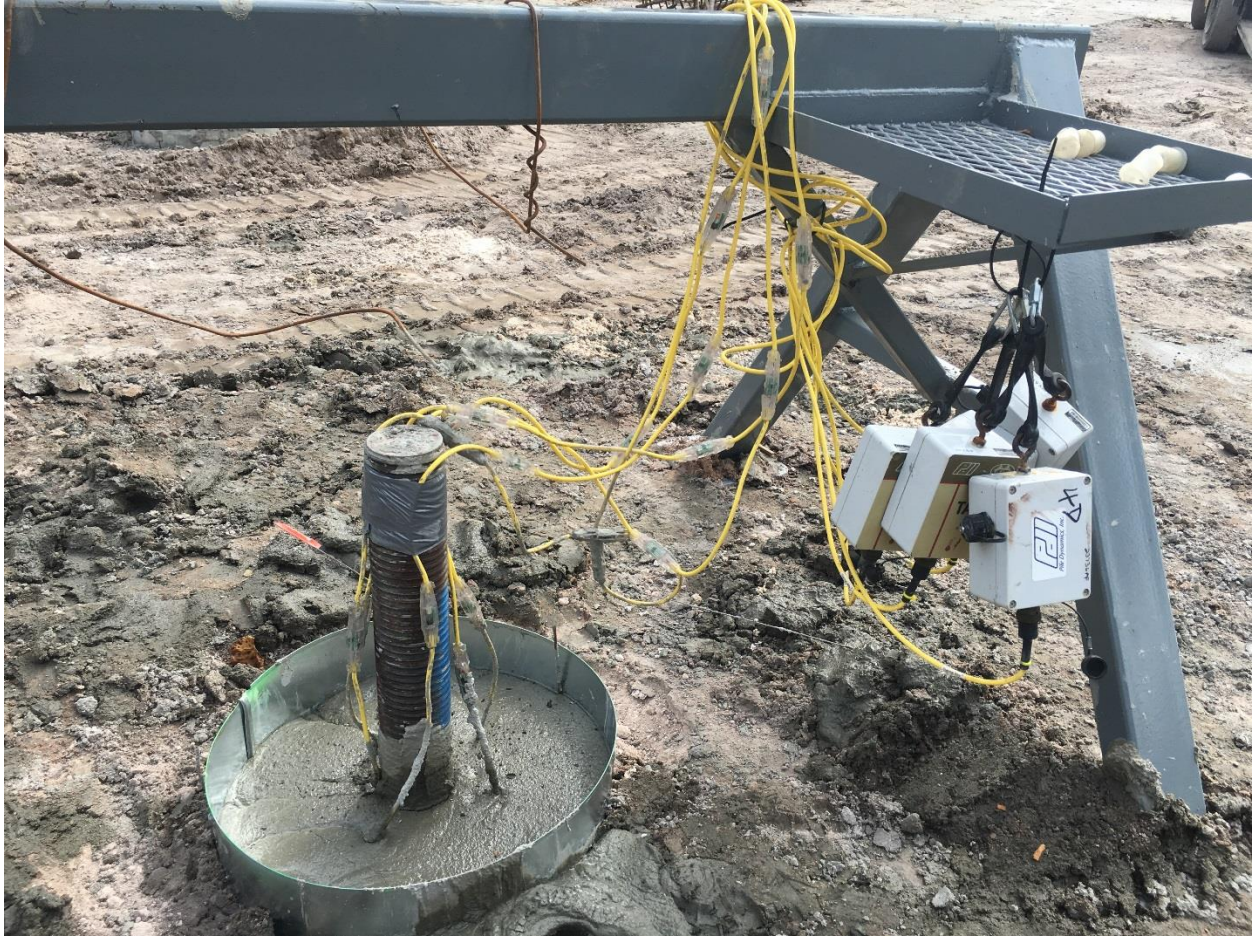
**Figure 2.15** Pile E1 with thermal wires and attached TAP units.

Thermal wire testing has the inherent advantage to the field technician in that no planning is necessary to ensure thermal testing aligns with the anticipated peak temperature timeframe. Rather, data collectors (TAP units / **T**hermal **A**ccess **P**orts) are attached to the wires immediately after casting or as soon as access is granted and data is continuously taken up to and beyond the peak temperature occurrence. The disadvantage is that the quality of the data is not known until after retrieval of the TAP units and the data is downloaded. Figures 2.15 – 2.21 show the TAP units attached to each of the test piles.

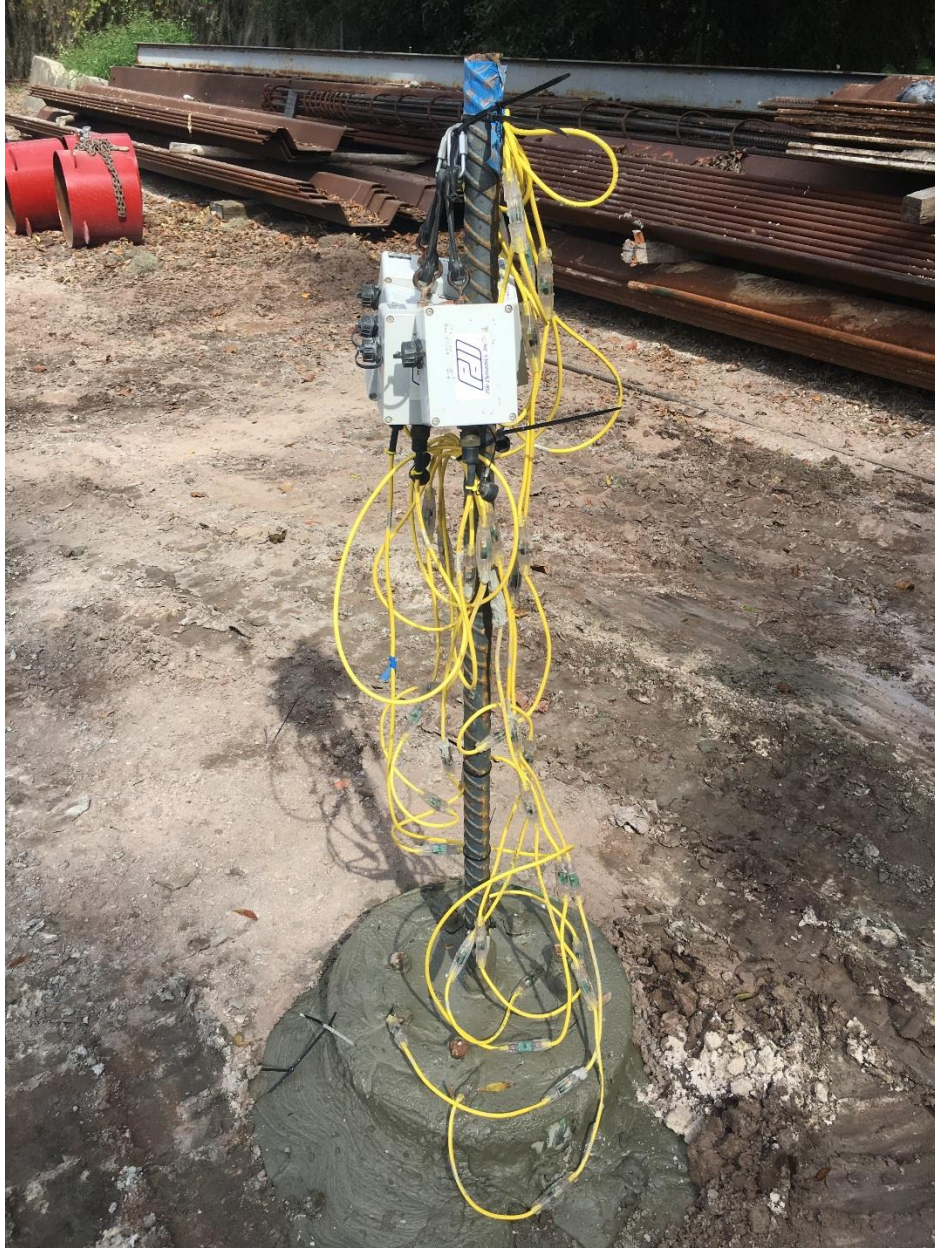
**Figure 2.16** Pile L1 with thermal wires and attached TAP units.

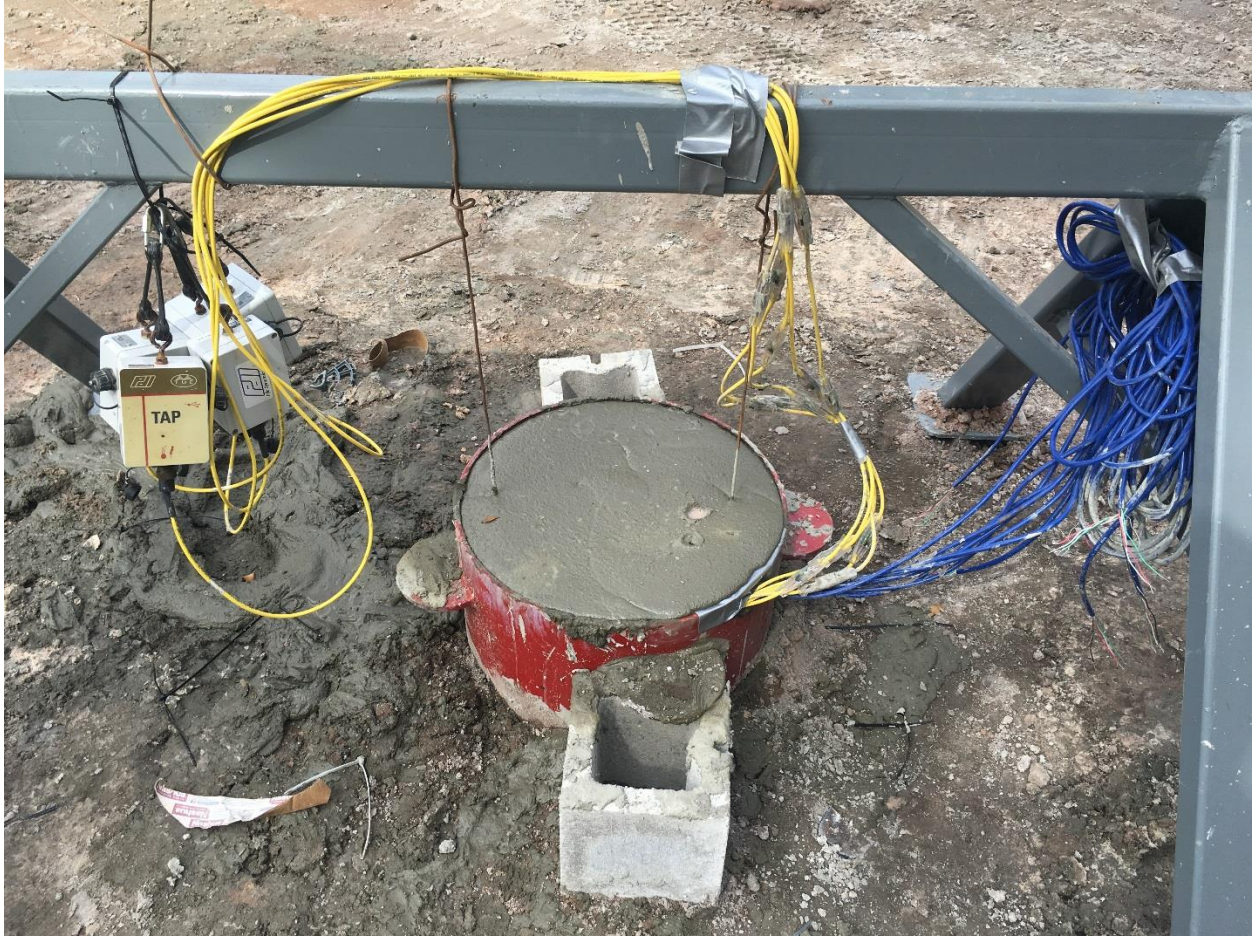
**Figure 2.17** Pile C1 with thermal wires and attached TAP units.

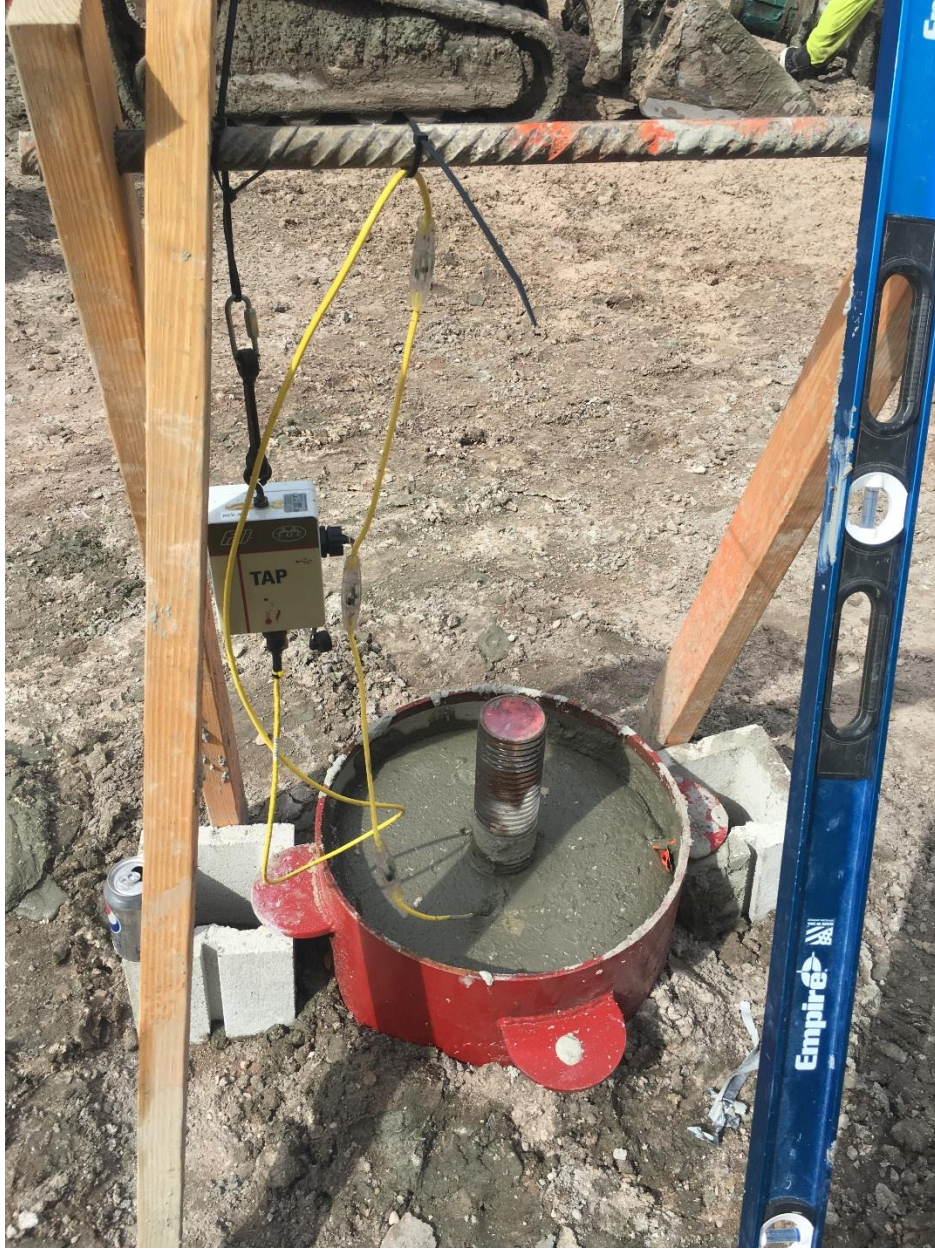
**Figure 2.18** Pile T1 with thermal wires and attached TAP unit.

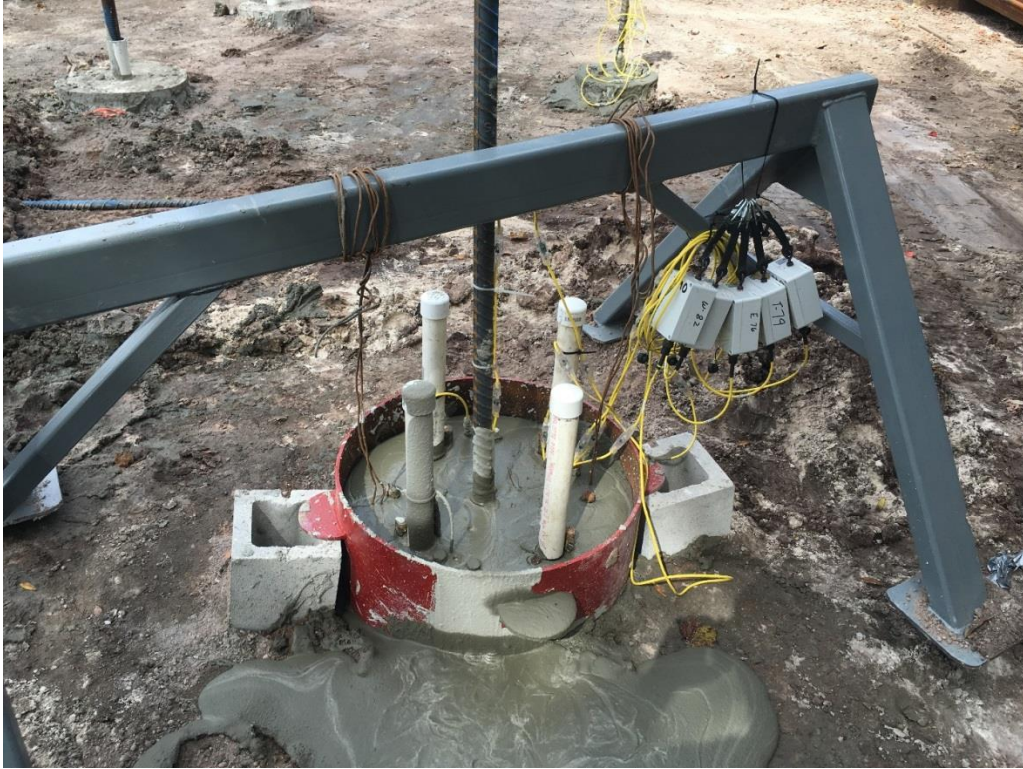
**Figure 2.19** Pile L2 with thermal wires and attached TAP units.

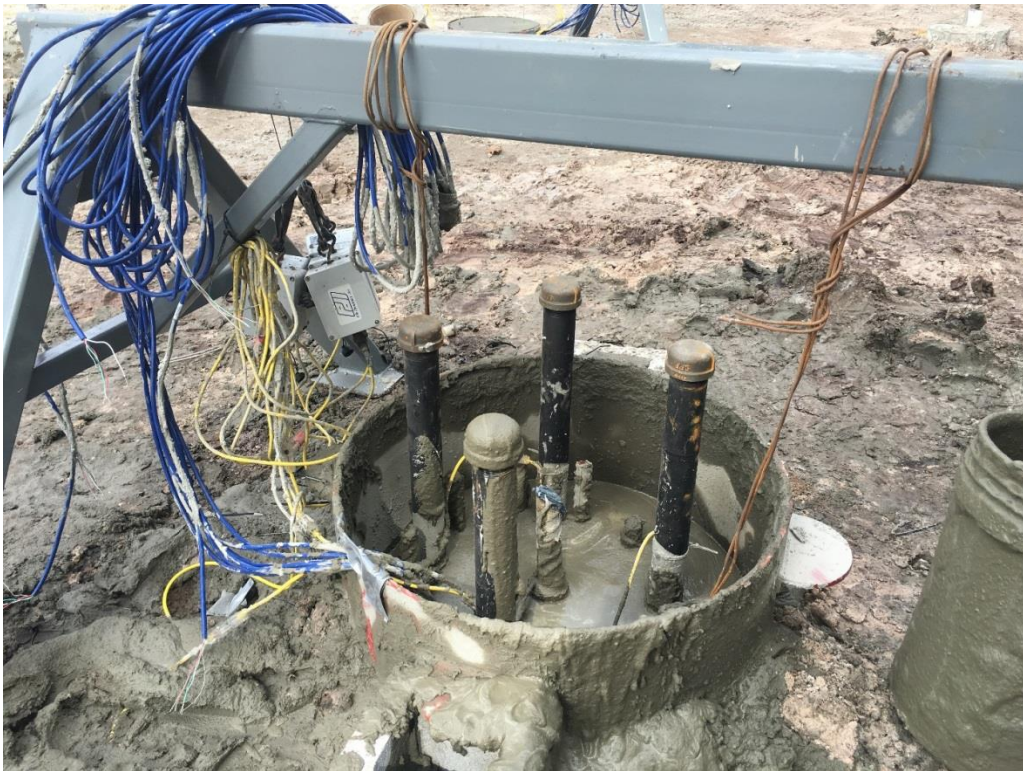
**Figure 2.20** Pile C2 with thermal wires and attached TAP units.

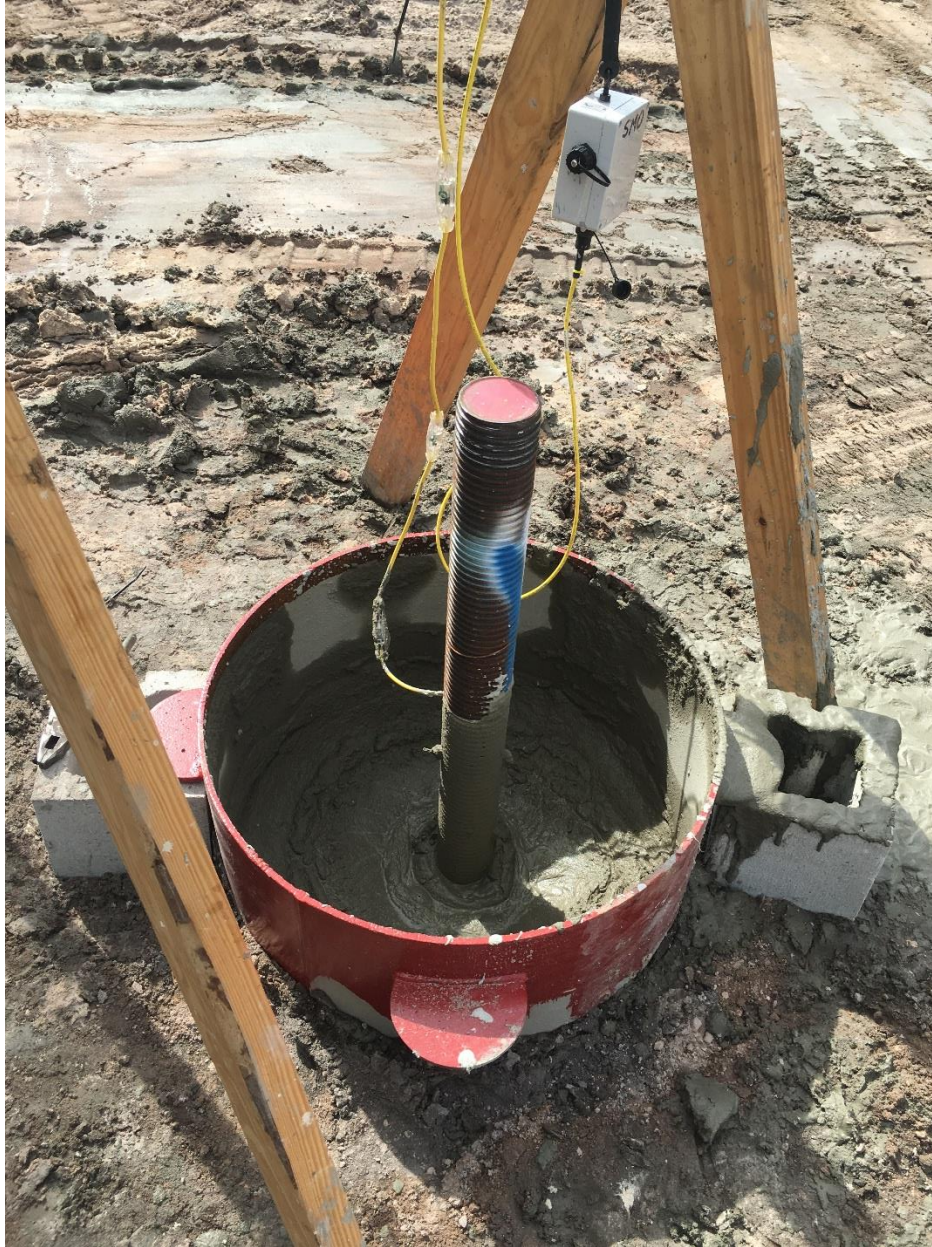
**Figure 2.21** Pile T2 with thermal wires and attached TAP unit.

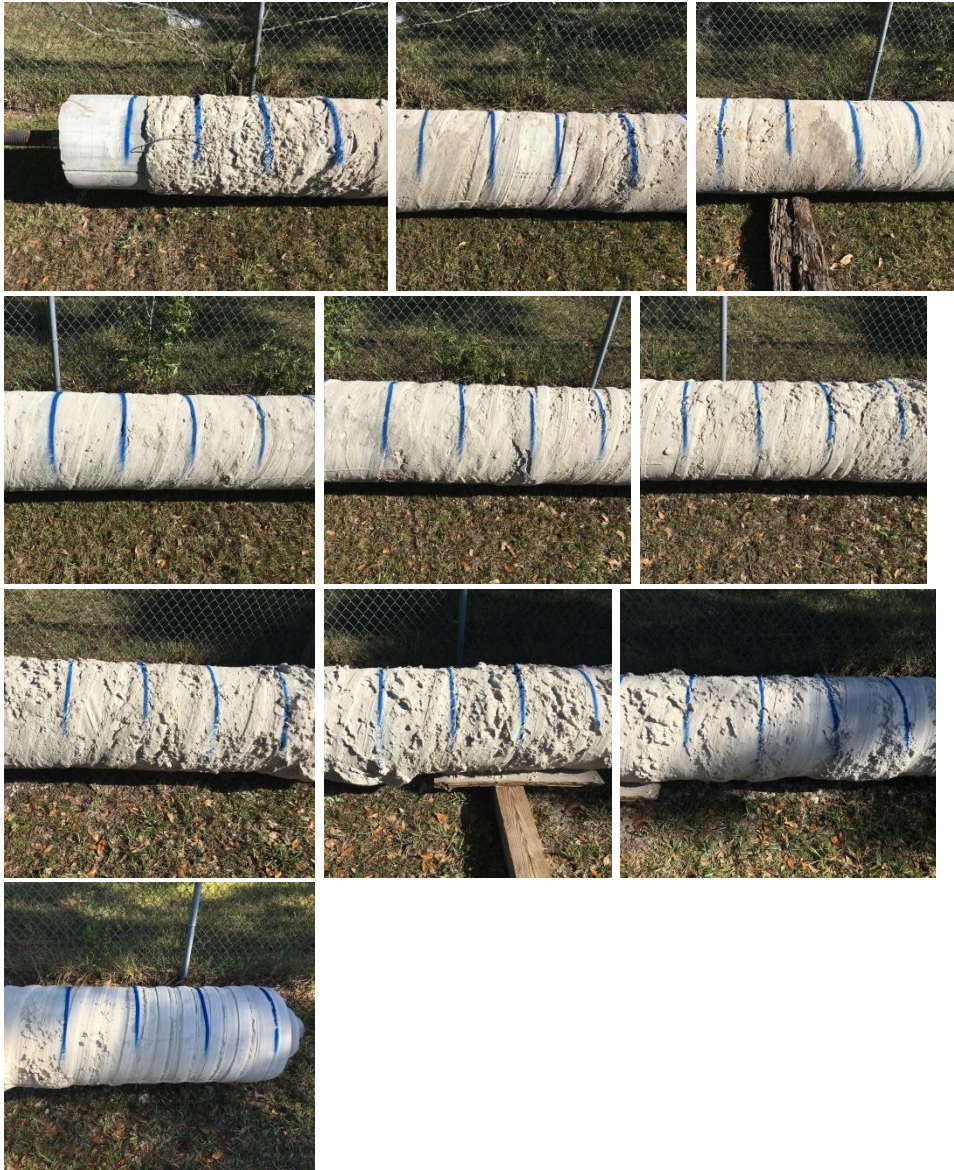
**Figure 2.24** Extracted pile shape from top to bottom (left to right and down).

Only one of the test piles was extracted for evaluation of as-built dimensions. Four relief holes were drilled around pile E1 to reduce side shear, and the pile was removed using the central threaded bar. The pile was cleaned and measured via manual measurements. Two different teams measured the circumference on 1-ft intervals down the pile. These measurements were then converted to the equivalent diameter, which assumed the pile was circular in section and that there were no significant voids or bulges. Using a large-scale caliper, direct measurements of diameter were taken at 90 degree locations down the length of the pile (i.e., two measurements per depth location). The results of the actual diameter were then used to assess the true as-placed volume of the pile and then compared to the predicted volume per pump strokes from the automated installation recorder. These data are presented and discussed in Chapter 3. Figure 2.24 shows the extracted pile marked on 1-ft intervals from top to bottom.

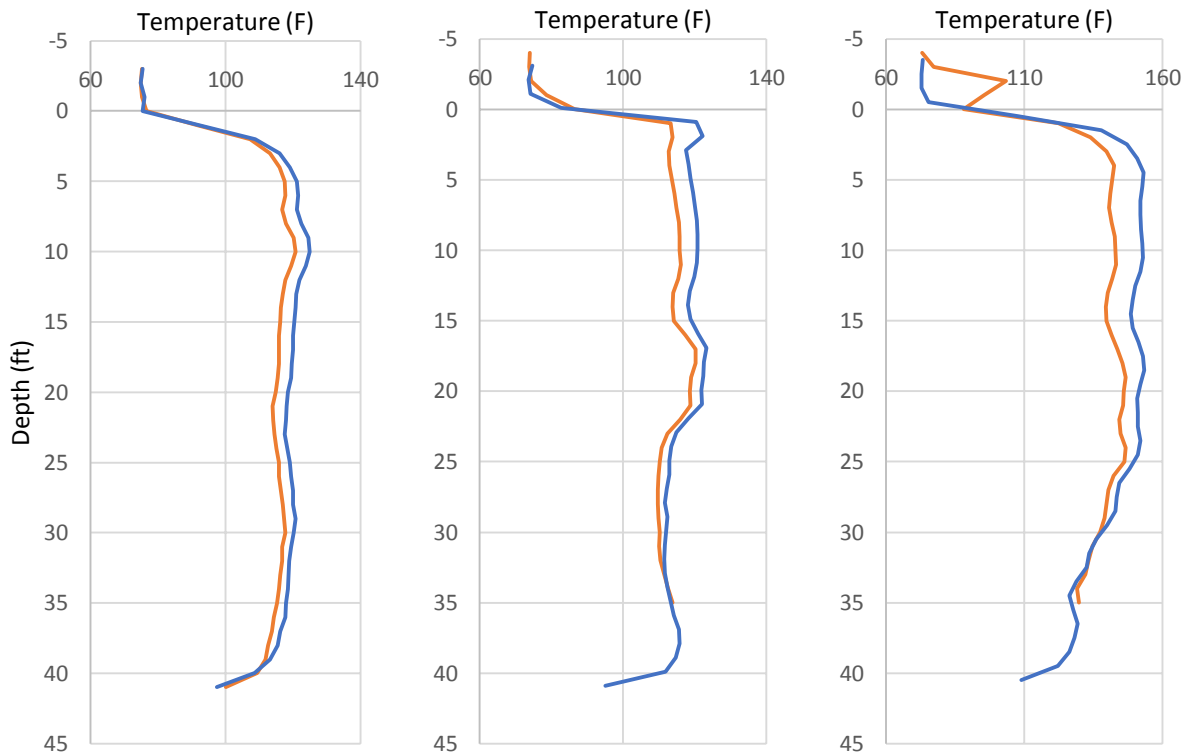
**Figure 3.4** Pile E1 (left), L1 (center), and L2 (right) – average cage wire data (orange) compared with center bar wire data (blue).

Five of the seven test piles were instrumented with both center bar and cage position temperature systems (two of which also included access tubes on the cage as noted above). Based on normal temperature distributions within a cylindrical hydrating foundation element, it is well understood that the centermost positions will be warmer than more peripheral positions closer to the surrounding cooler soil. This is especially true for smaller diameter ACIP piles, and for Pile E2 this phenomenon was clearly demonstrated where the center bar temperatures were consistently and uniformly warmer than the cage temperatures (Figure 3.4). However, for several other piles the average of cage-located measurements was consistently cooler near the surface (normal), but came to the same temperature as the center bar at depth. This showed that the center bar was not centered.

Piles C1 and C2 could not be used to produce reliable average profiles due to missing data from malfunctioning wire sensors; those comparative graphs were not prepared. However, the same basic trends can be seen in Figures A.3 and A.4 where the center bar was generally warmer than cage position measurements (Appendix A).

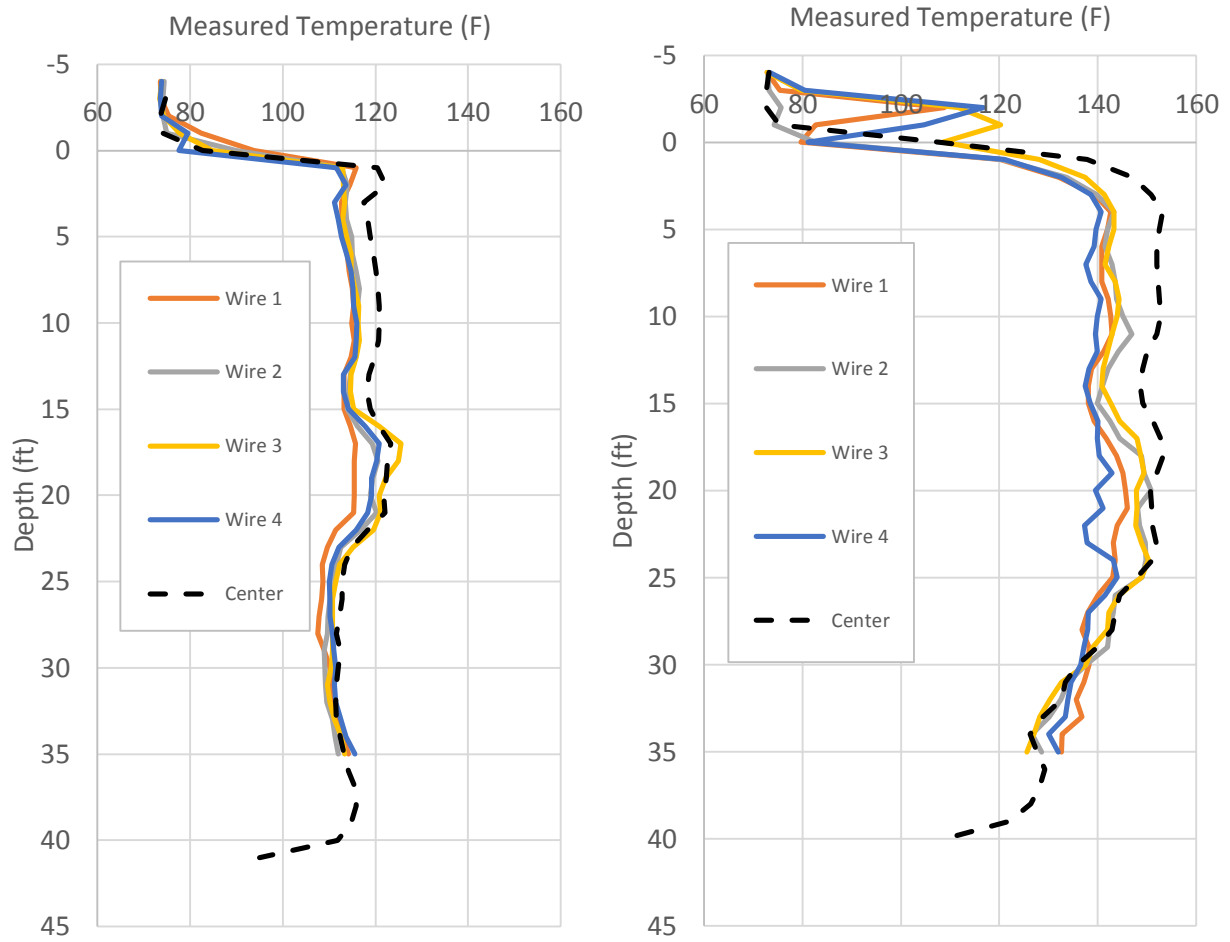
**Figure 3.5** Pile L1 (left) center bar temperature aligns with cage from 15ft downward; Pile L2 (right) from 20ft downward.

Overall, the 18-in piles can be quickly identified relative to the 24-in piles due to the normal cage temperature (115°F for 18-in or 140°F for 24-in) and center bar temperatures (120°F and 150°F, respectively) which were 25 to 30°F cooler.

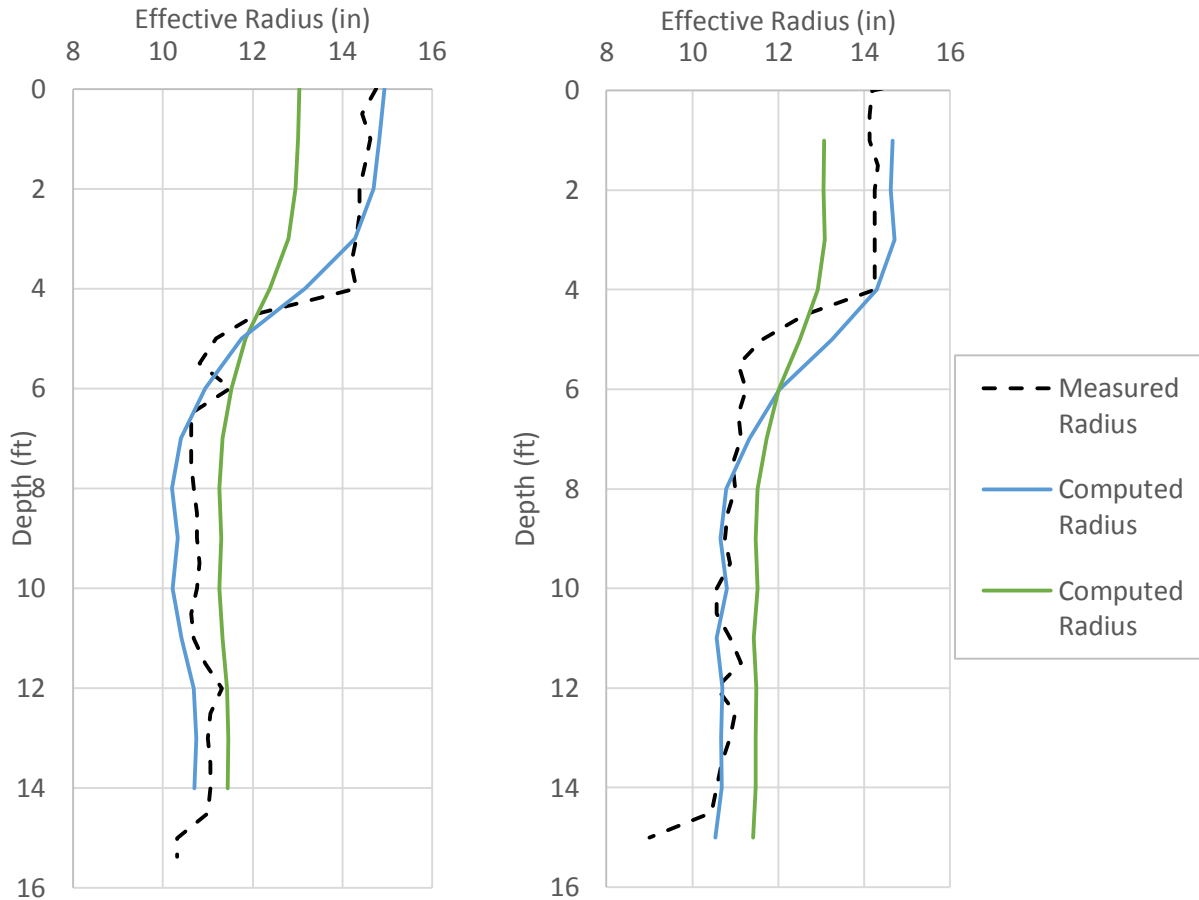
**Figure 3.13** 22-in diameter drilled shafts with center bar measurements analyzed using  $T_{zero}$  (green) and  $T_{soil}$  (blue) methods shown with post-extraction as-built dimensions.

The measured step in each shaft (black dotted lines) was caused by an oversized surface casing and resulted in the shaft diameter transitioning quickly to the smaller auger diameter. Similar to end of pile transitions to air or soil, sudden steps in the shaft appear in the temperature profiles as inverse hyperbolic tangent transitions from warmer to cooler (or vice versa). For top and toe profiles these transitions are adjusted to reflect the proximity to the known end of pile effects. For mid shaft steps no adjustments are presently employed. Review of this data reveals the possible need for this type of algorithm although the use would need to be selectively used. *Note: similar mid shaft profile transitions can occur from drastic changes in the surrounding environment (i.e. cased shaft extending from soil through water to air). In those cases the effects of the surroundings are removed; in this case the effect of transition would be emphasized.*

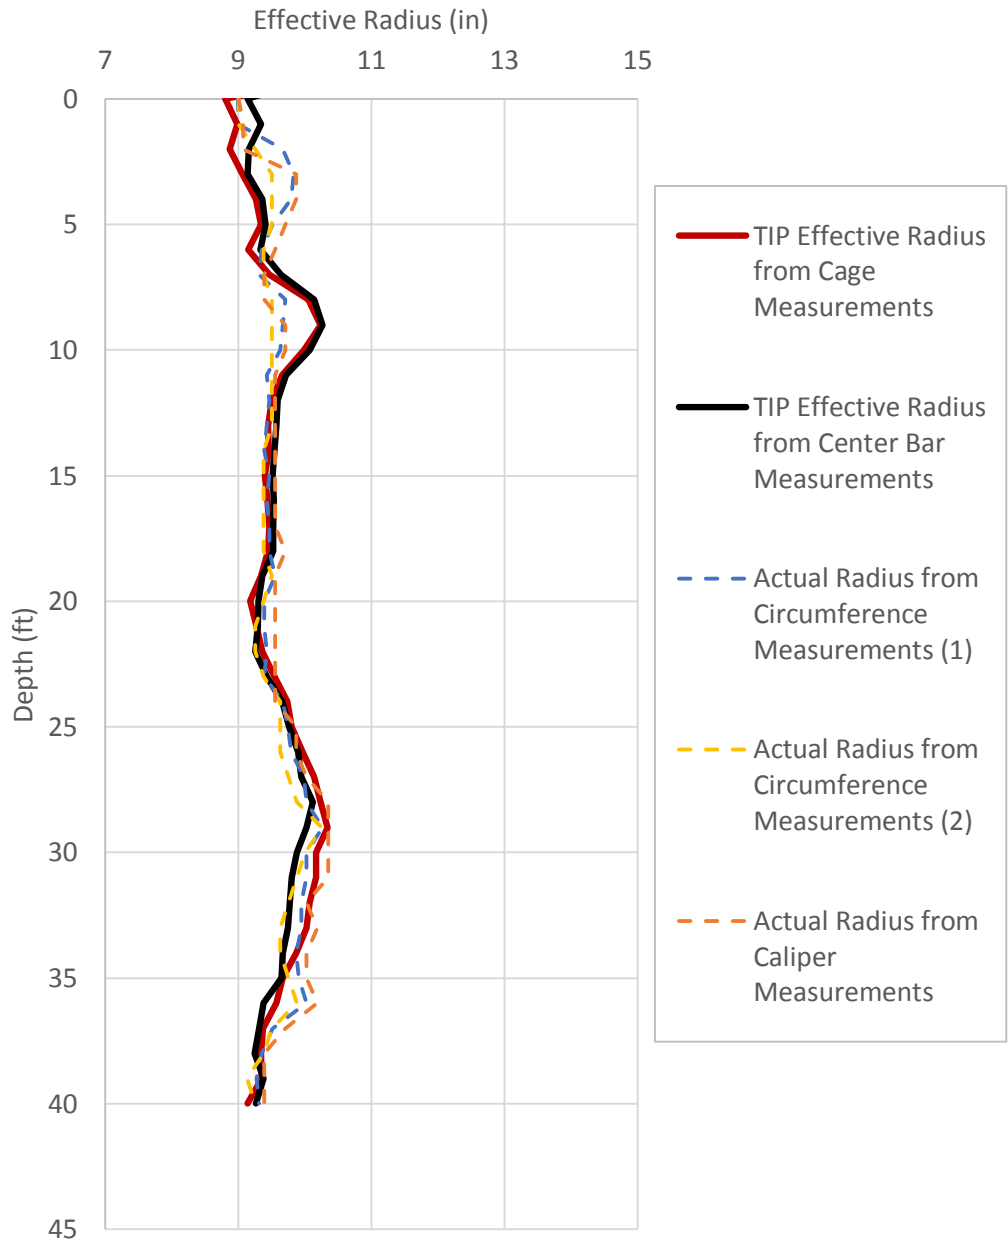
**Figure 3.16** Pile E1 effective radius determined from cage measurements and center bar measurements compared to actual radius measured after extraction.

Using only the true volume (as determined from post-extraction measurements), the effective radius profiles were estimated for both thermal measurement locations from Pile E1, which showed close agreement with the post-extraction as-built pile measurements (Figure 3.16). The magnitude of variation between the two estimated shapes is on the same order as that observed by different physical measurements conducted by two different teams (DFI contractor and USF researchers) or by using two different measurement methods (diameter from taped circumference vs localized diameter from calipers).
