**THERMAL INTEGRITY PROFILING FOR  
AUGERED CAST-IN-PLACE PILES -  
(IMPLEMENTATION PLAN)**

**BDV25-977-34**

**FINAL REPORT**

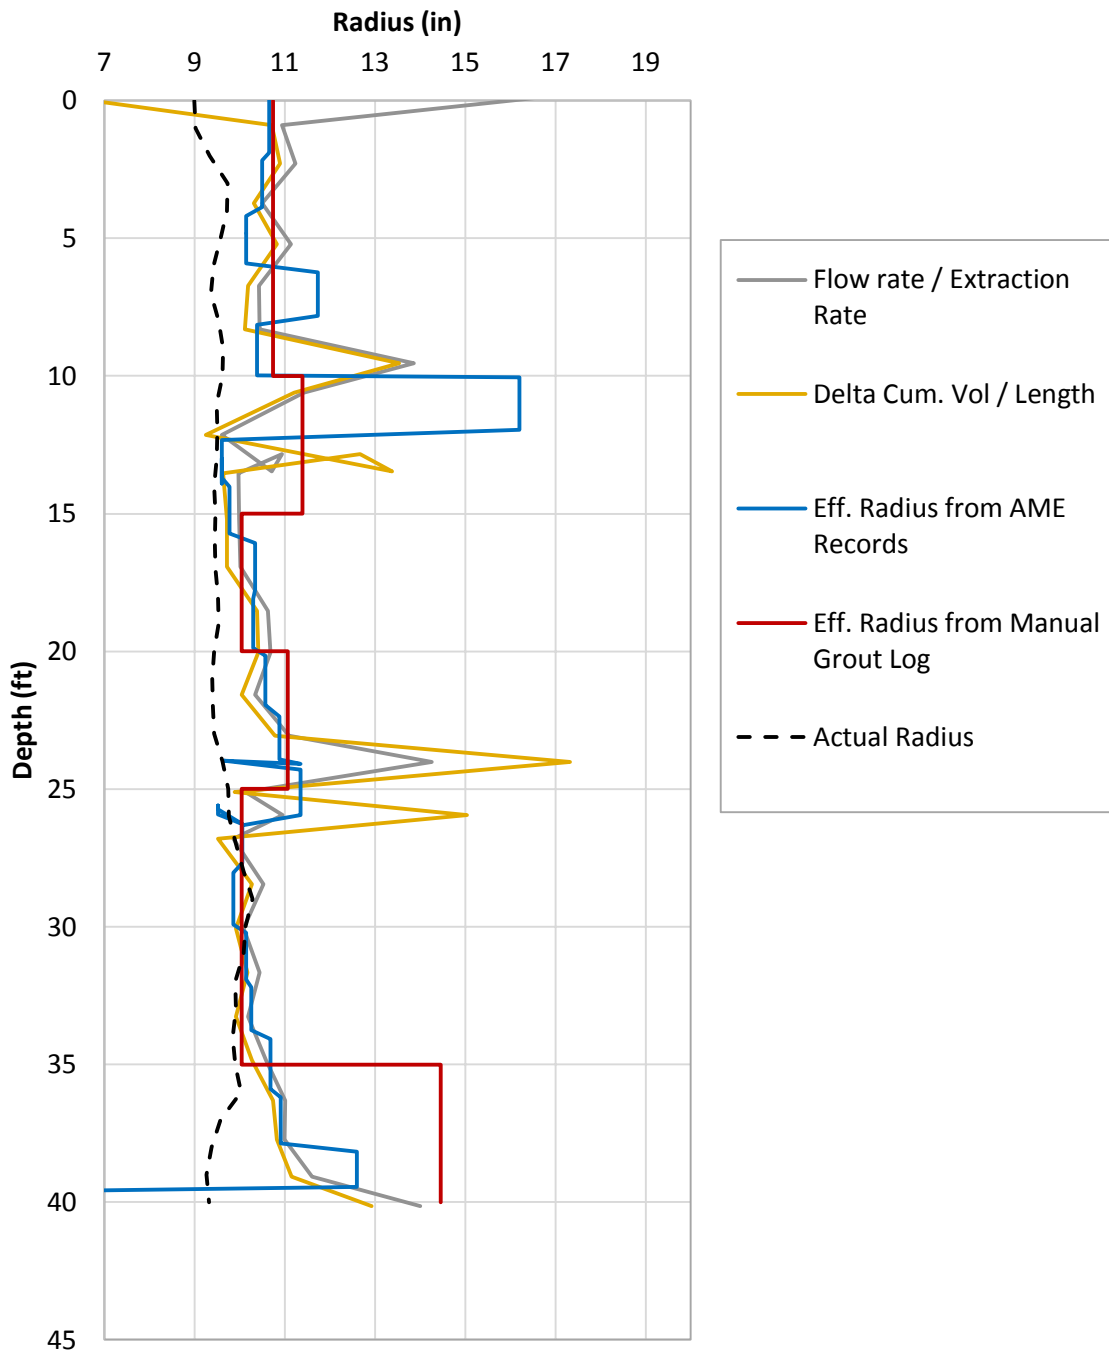
**Figure 4.1** Radius predictions from grout volume measurements.

The total grout volume is directly proportional to the square of radius. The various methods of determining radius place excess volume at different locations along the length of the pile making a simple rule for the determination of the true waste volume difficult (e.g. initial pump strokes or some portion of the volume after return is observed). For example with Pile E1 the true volume of the pile was determined from manual measurements to be approximately  $80 \text{ ft}^3$  and the overall pumped grout was  $109 \text{ ft}^3$ . By subtracting the volume from initial pump strokes ( $10 \text{ ft}^3$ ) and the entire volume after grout return was observed ( $34 \text{ ft}^3$ ), the pile volume would drop to  $65 \text{ ft}^3$ . Adding back the theoretical volume of the auger in the ground at the time return was noted ( $22 \text{ ft}^3$ ), the volume increases to  $87 \text{ ft}^3$  which is  $7 \text{ ft}^3$  too high (8.8%). This would increase the actual average pile radius (9.6 in) to a prediction of 10.4 in.

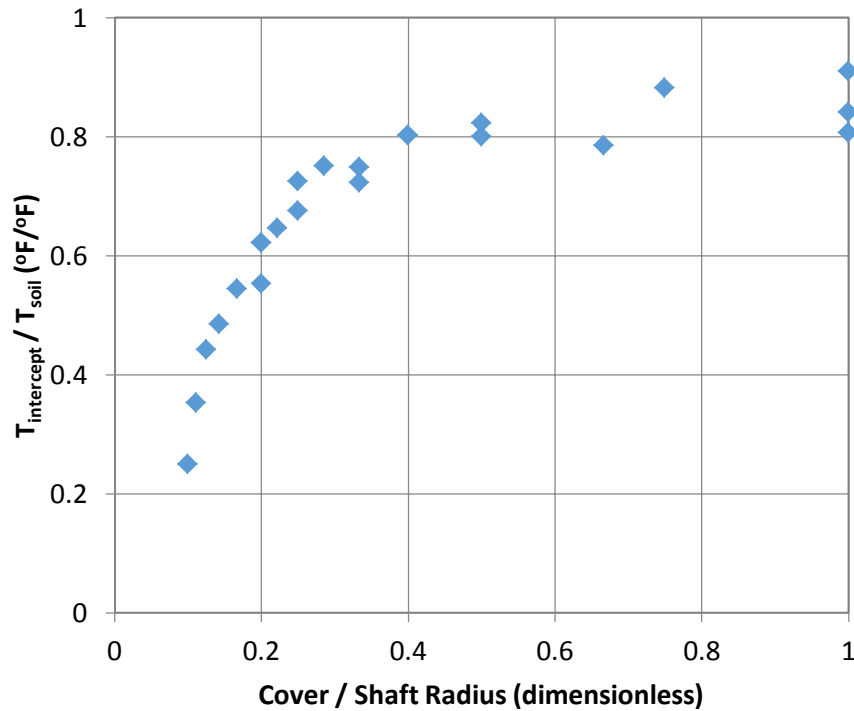
Figure 4.2 Intercept temperature as a function of measurement position.

The  $T_{zero}$  linearization of the hyperbolic T-R relationship was confirmed to be conservative for all diameters of foundation elements regardless of the measurement location. The  $T_{soil}$  method was shown to be a reasonable approximation for smaller elements for both center bar and cage position measurements. However, a slight over-prediction of radial variations results from its use. Figure 4.2 includes the model predicted best fit T-intercepts for cage based measurements in shafts greater than 2-ft diameter with no more than 6 in of cover, and for both center bar and cage measurements in piles 2-ft diameter or smaller. For ACIP piles, the simplistic  $T_{soil}$  method could be refined based on these model results to use  $0.9T_{soil}$  as the intercept value. In general any intercept selected that is less than that shown results in conservative radius variation predictions.

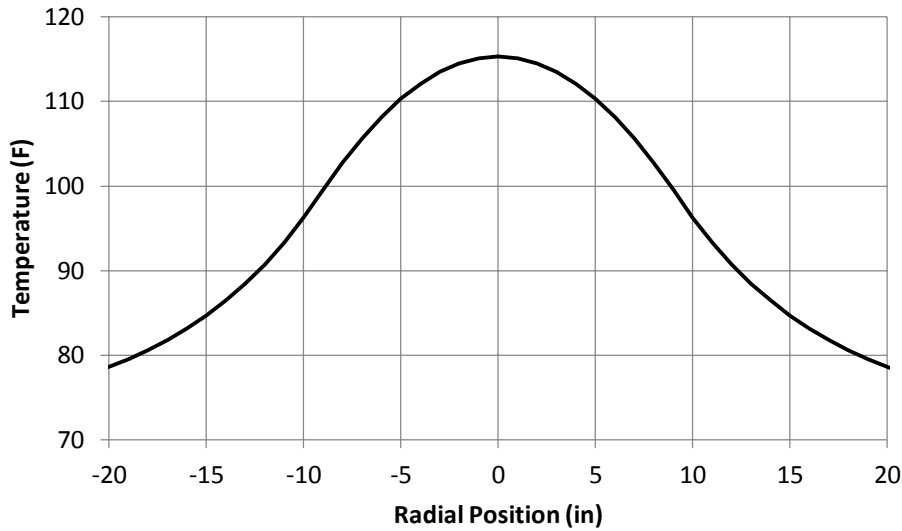
**Figure 4.3** Radial temperature distribution in 18-in ACIP pile (12 hrs).

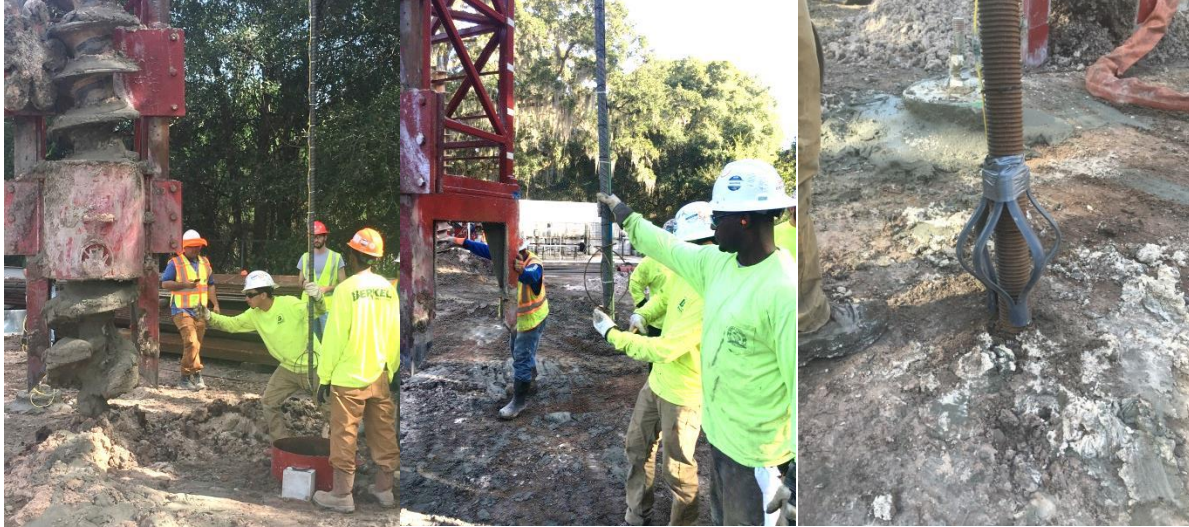
**Figure 4.4** Number 8 bar with small and widely spaced centralizers  $\approx 10$  ft (left).

However, piles tested in this study were confirmed to have moved up to 5.5 in for 18-in and 7.5 in for 24-in diameters. This translated into potential radius prediction errors of 1 to 2 in based on the observed R/T slope of  $0.25 \text{ in}/^\circ\text{F}$ . These errors create both under and over predictions as the integrated temperature vs depth curve is equated to the placed volume; where one region of the pile under-predicts radius from low temperature, higher temperature regions must over-predict to balance the overall volume. These types of errors are preventable via use of more centralizers to ensure the center bar reinforcement remains centered. In this case, centralizers were spaced approximately every 10 feet (Figure 4.4).

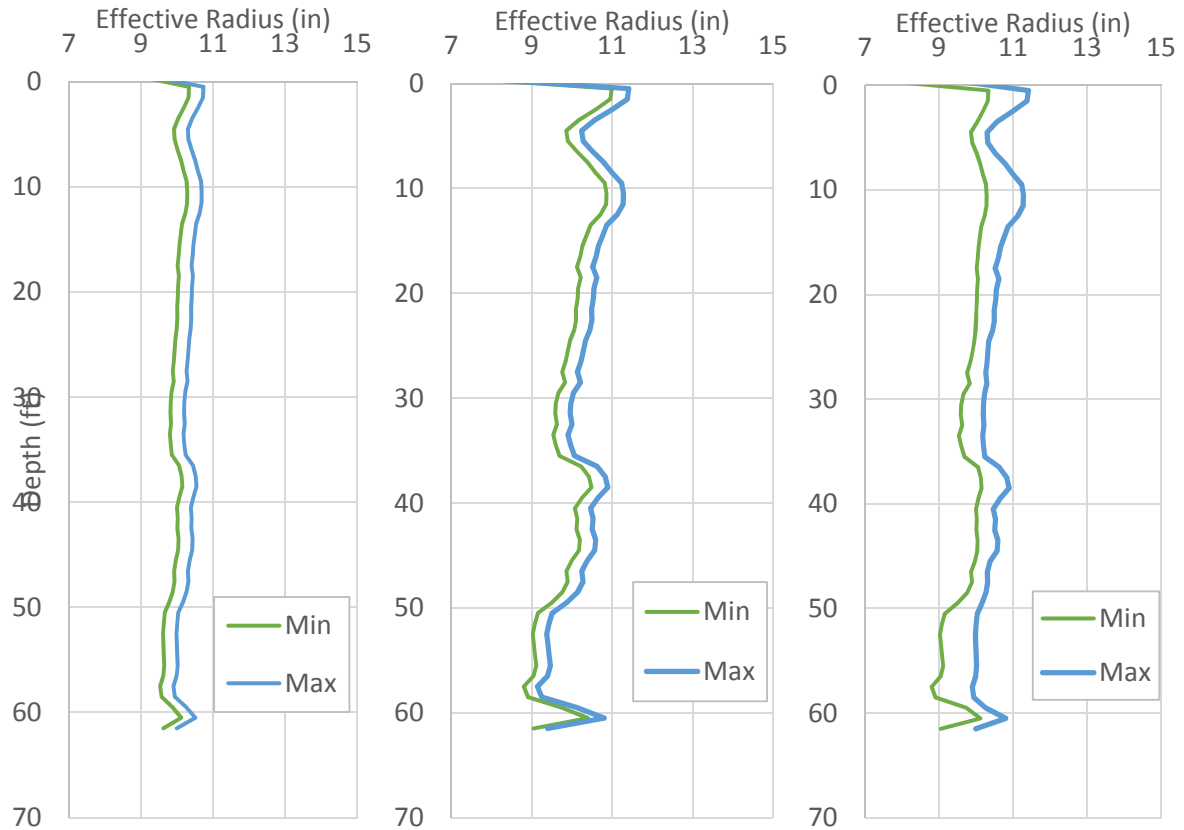
**Figure B.2** Pile C1 effective radius from center bar wire data using actual reported grout volume (max) and reported volume grout less initial pump count (min) – T0 method (left), Tsoil method (center), min/max from all combinations (right).

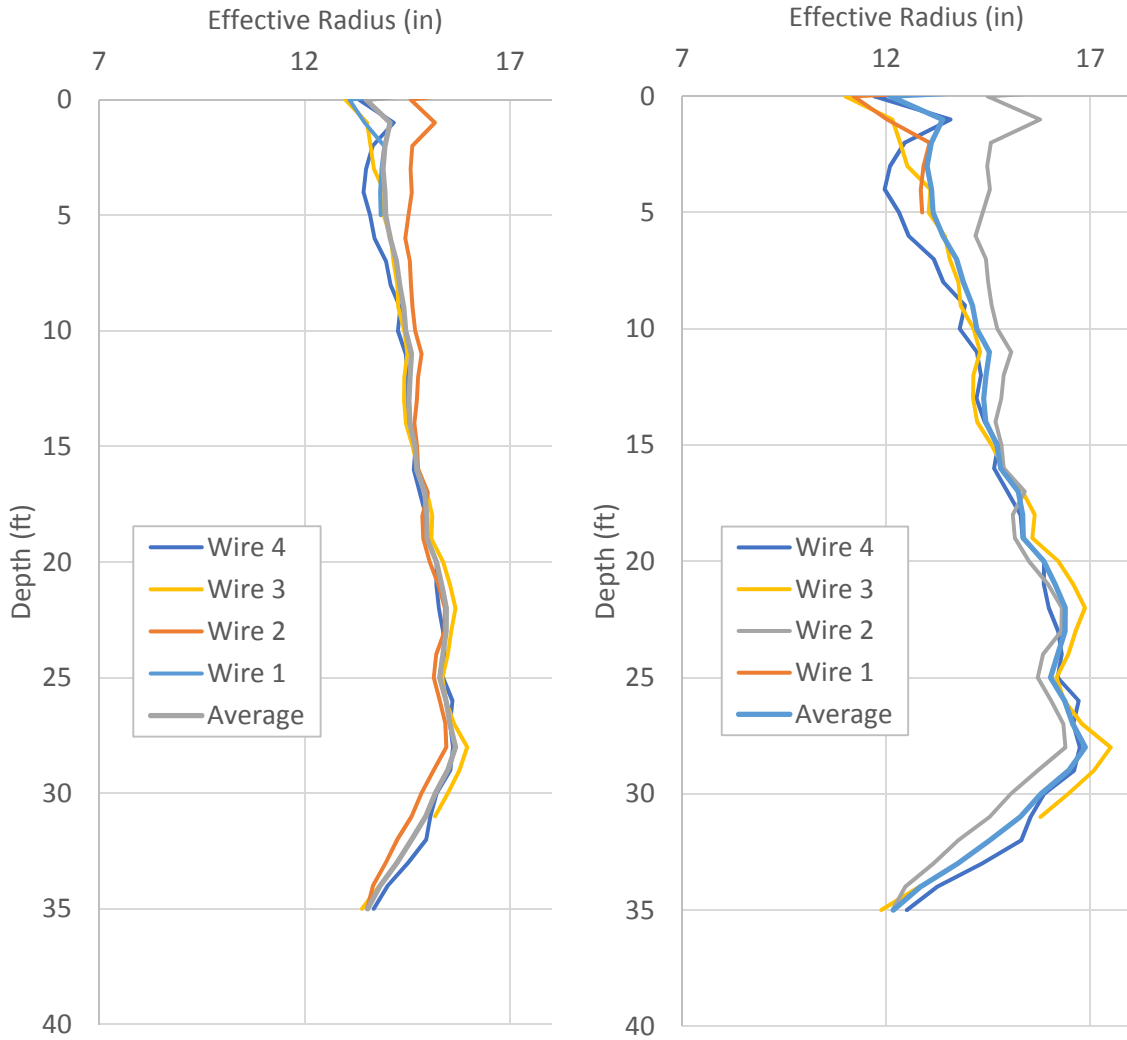
**Figure B.3** Pile C2 effective radius from cage wire data using reported grout volume over given partial length, T0 method (left), Tsoil method (right).

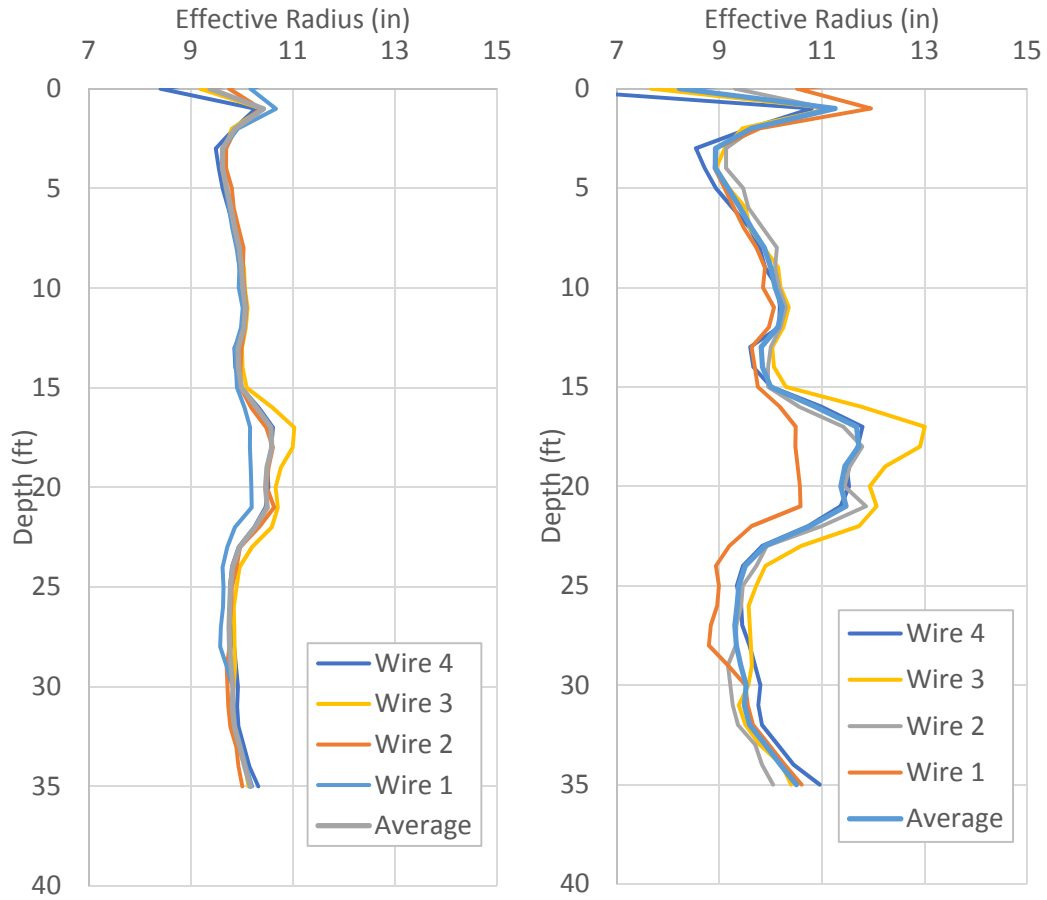
**Figure B.7** Pile L1 effective radius from cage wire data using reported grout volume over given partial length, T0 method (left), Tsoil method (right).

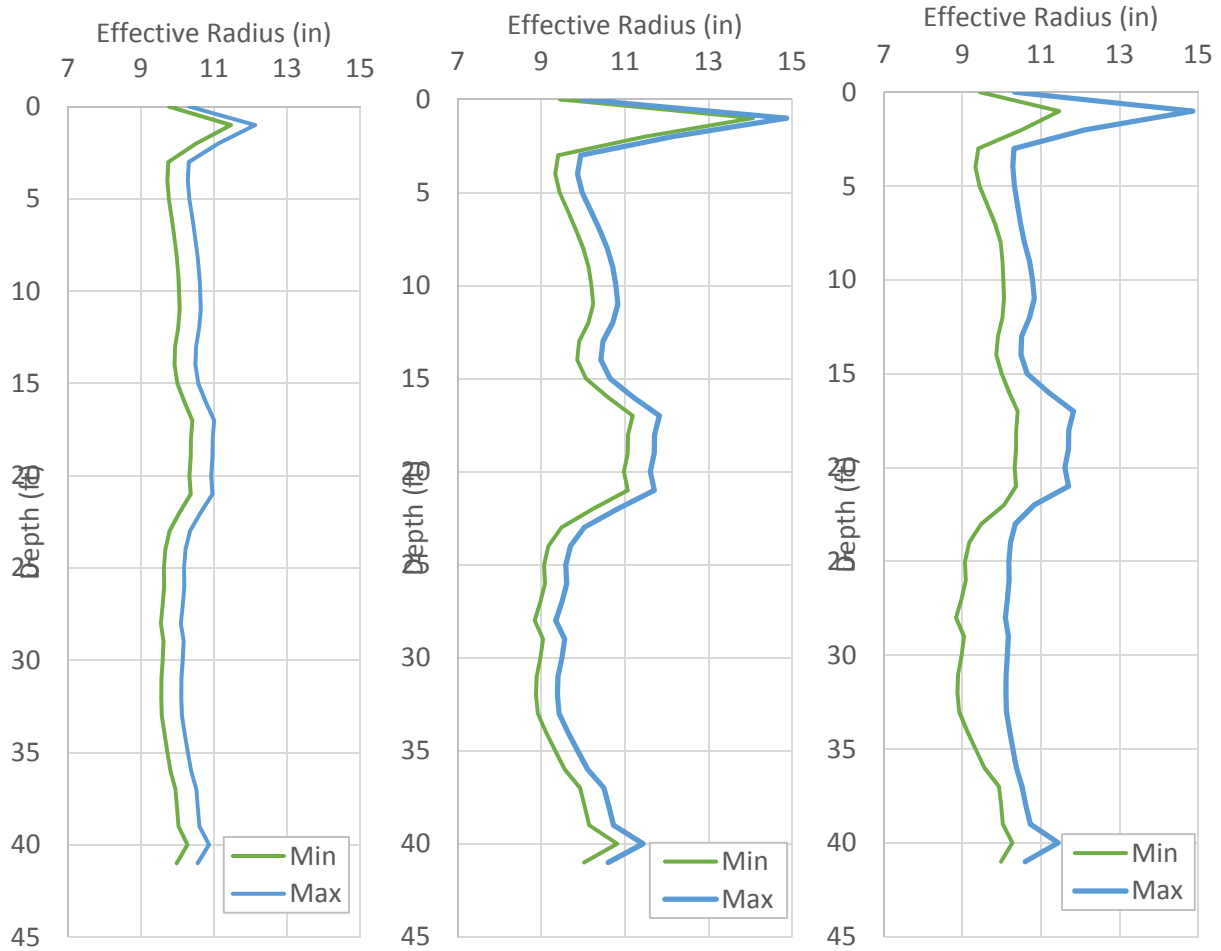
**Figure B.8** Pile L1 effective radius from center bar wire data using actual reported grout volume (max) and reported volume grout less initial pump count (min) – T0 method (left), Tsoil method (center), min/max from all combinations (right).

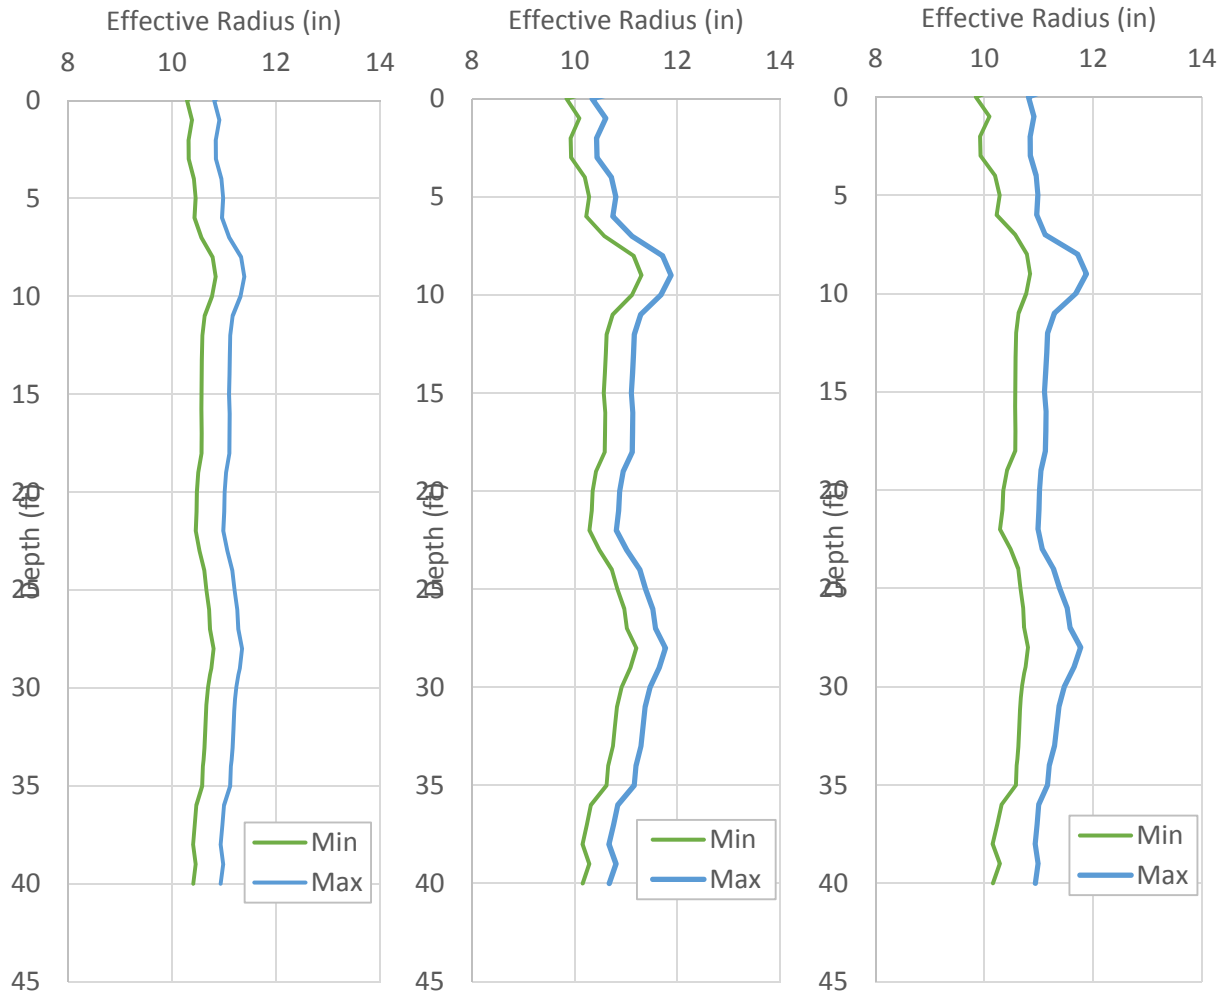
**Figure B.11** Pile E1 effective radius from center bar wire data using actual reported grout volume (max) and reported volume grout less initial pump count (min) – T0 method (left), Tsoil method (center), min/max from all combinations (right).

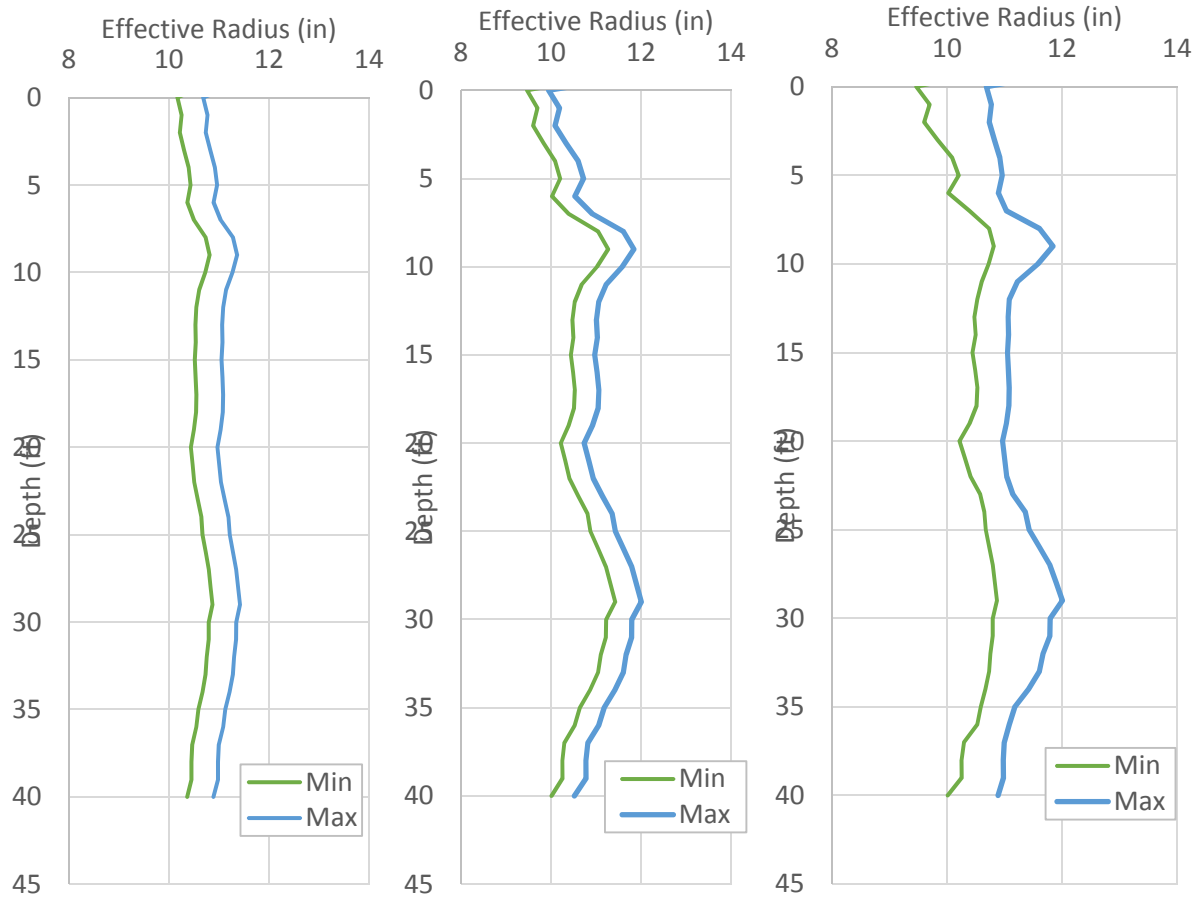
**Figure B.12** Pile E1 effective radius from cage wire data using actual reported grout volume (max) and reported volume grout less initial pump count (min) – T0 method (left), Tsoil method (center), min/max from all combinations (right).

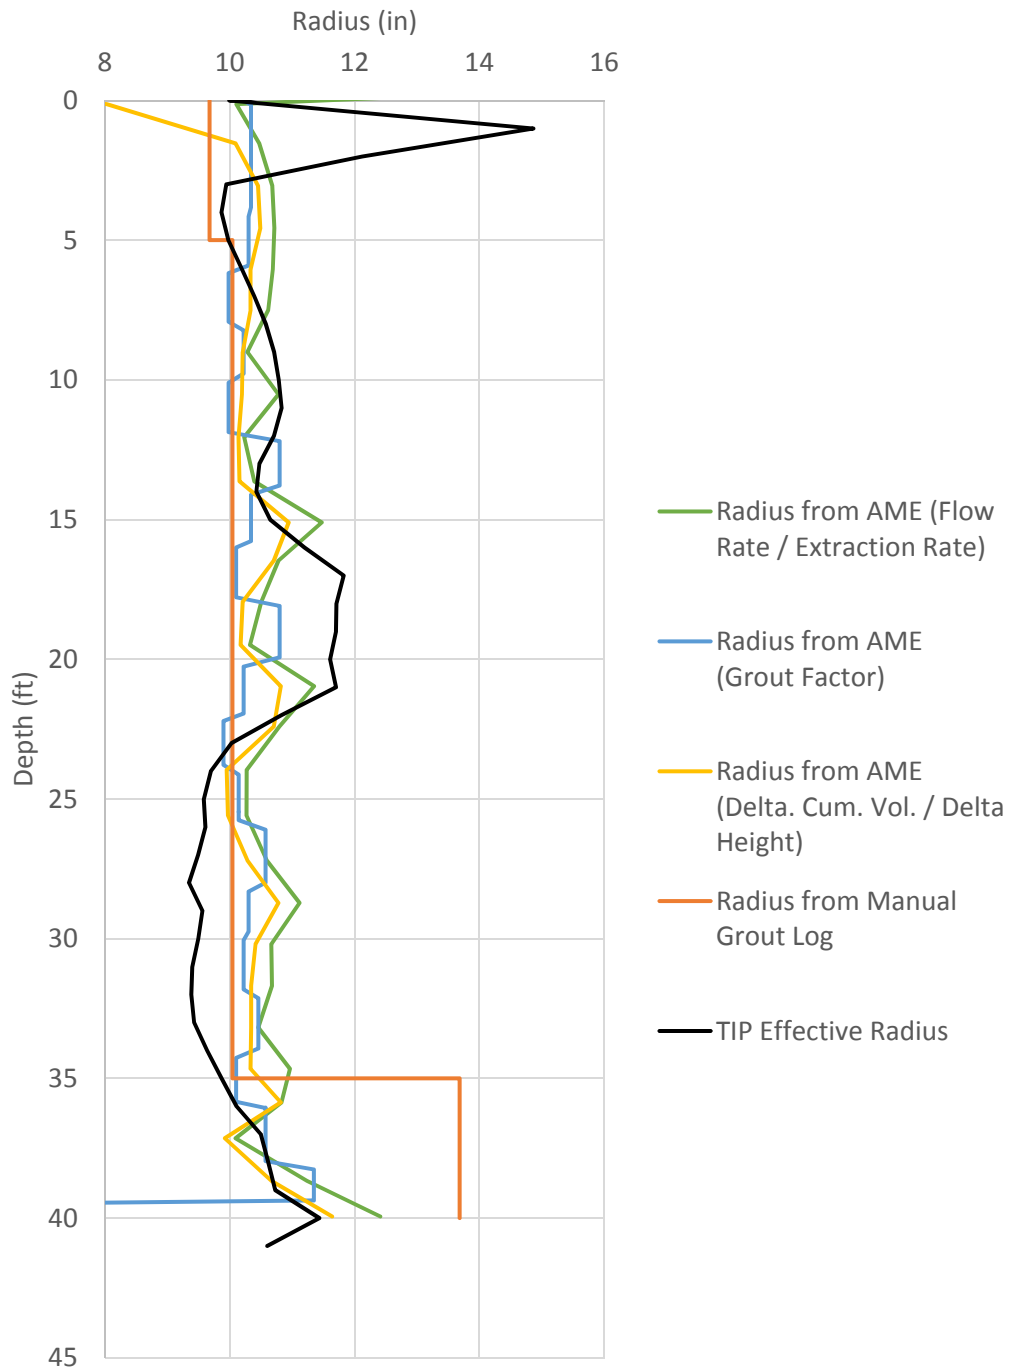
**Figure F.3** Pile L1 Computed Radius from AME Data, Manual Grout Log, and TIP Data.
