**LOAD AND RESISTANCE FACTOR DESIGN (LRFD) RESISTANCE
FACTORS FOR TIP GROUTED DRILLED SHAFTS**

BDV25-977-37

FINAL REPORT

September 2019

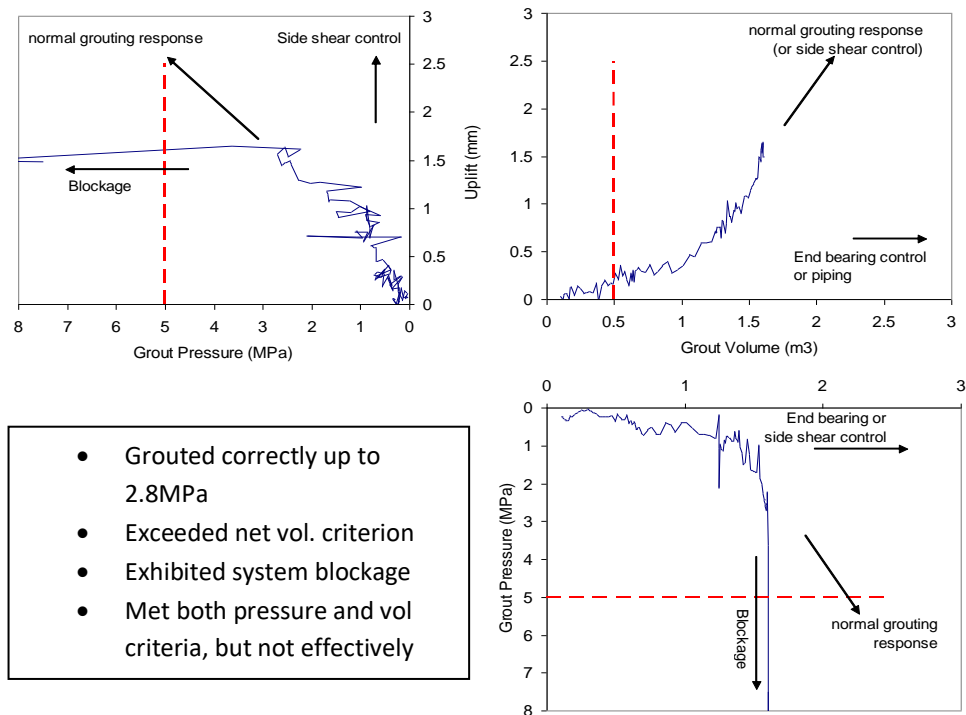
Figure 2.7 Grout distribution system blockage caused design pressure criterion to be artificially achieved; true grout pressure was half the design pressure; effectiveness plots detected the problem.

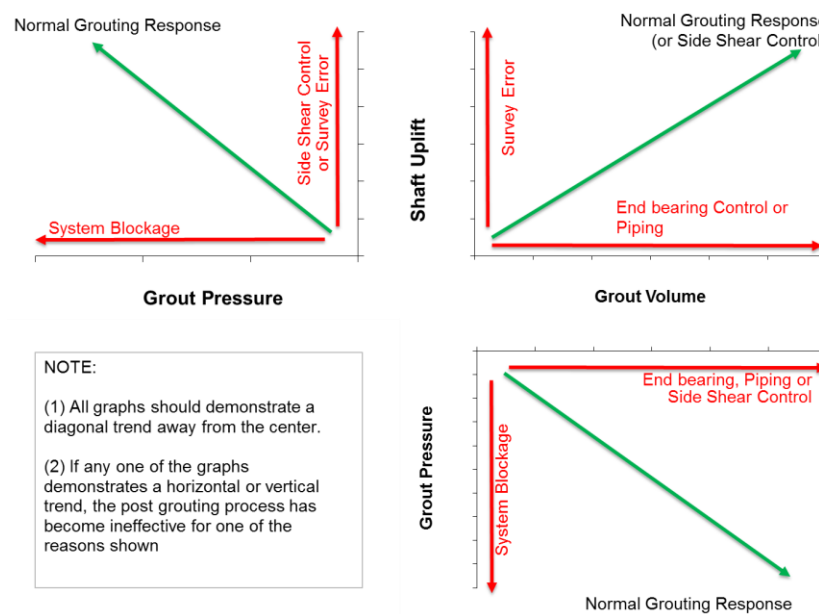
Figure 4.1 Concept tri-axis grouting effectiveness plots.

Tri-axis plots represent the three quality control or quality assurance (QA/QC) thresholds used for grouted shafts. In order to validate the grouting process, all field grouting data was analyzed and graphs correlating pressure vs displacement, pressure vs volume and volume vs displacements were plotted. These were used to determine the true effective grout pressure and the peak field recorded pressure which is often caused by blockage and different from the effective pressure. Data from each site was scrutinized for possible errors or conditions by which grouting became ineffective as indicated by the red arrows in Figure 4.1 (replotted for convenience from Chapter 2).

As noted in Figure 4.1, horizontal data lines in volume vs. pressure graph indicate an end bearing failure or grout loss to a surrounding void or cavern. This should be supported with a similar horizontal line in the volume vs. displacement graph. In this case, the horizontal lines occur at near zero pressure making the volume data suspicious although after the grouting event. Similarly unusual, is the increase in displacement as pressure decreases noted in the pressure vs. displacement graph. No explanations for the anomalous end of grouting conditions are presented, but this would be usually attributed to survey or reference beam disturbance. The max effective pressure was taken at 400 psi; peak measured pressure was 700 psi. Design pressure was 787 psi.
