Understanding Interactions between Drivers and Pedestrian Features at Signalized Intersections – Phase 3

FDOT BDV25-977-43

Final Report

Florida Department of Transportation

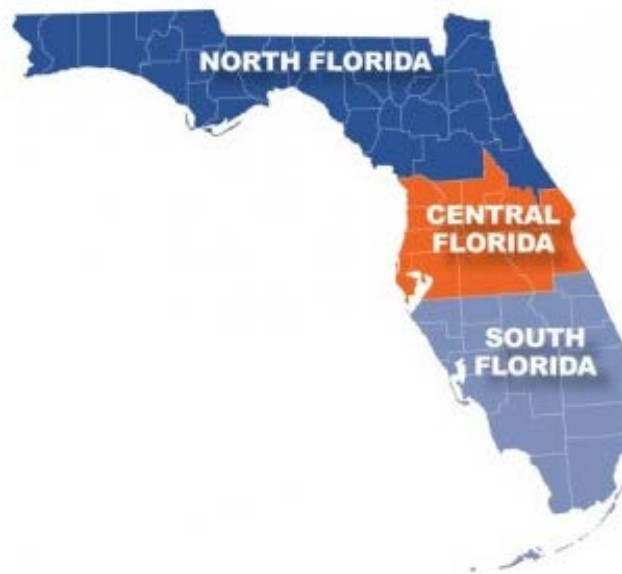
Figure 1. Regions for pilot implementations of selected countermeasures

Task 2 included two major subtasks. The first was to select the recommended countermeasures from the Phase 2 project for finalization for pilot implementations, and the second was to select candidate sites with pedestrian safety problems, pedestrian crashes, and/or conflicts between crossing pedestrians and right-turning traffic for consideration and finalization. Seven pilot study sites with one site in each of FDOT's seven Districts were selected for the pilot implementation. They covered the north (Districts 2 and 3), central (Districts 5 and 7), and south (Districts 1, 4 and 6) regions of Florida, as shown in Figure 1.

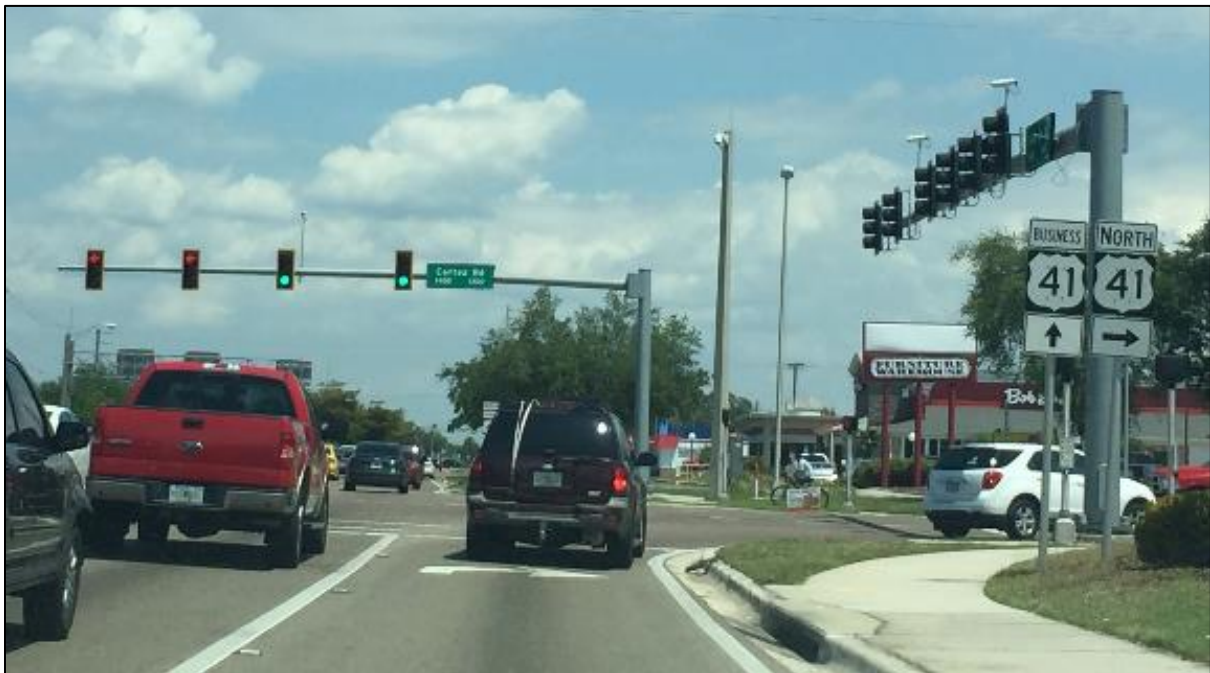
Figure 5. D1 site before implementation

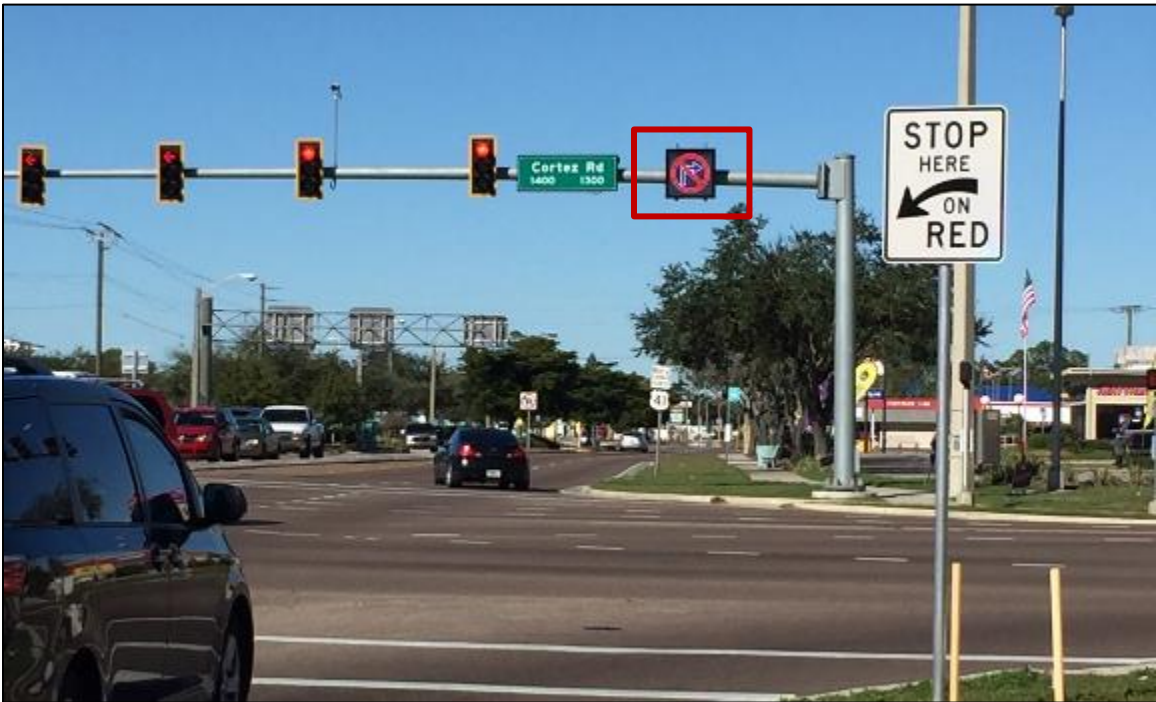
Figure 7. D1 site after implementation of “No Turn on Red” blank-out sign

1. When NB direction was under red phase, the sign was blank (Figure 6).
2. When NB direction was under red phase AND a pedestrian call was served on the SB leg (east-west direction) of the intersection, the sign displayed “No Turn on Red” (Figure 7).
3. When NB direction was under green and yellow phases, the sign displayed “Turning Vehicles Yield to Pedestrians” (Figure 8).

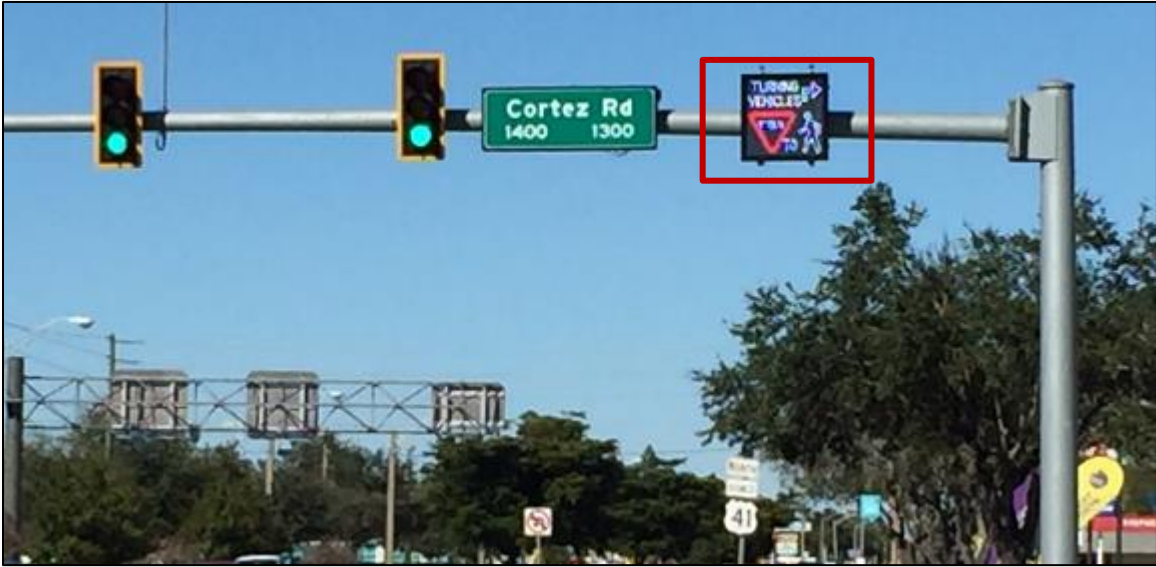
Figure 8. D1 site after implementation of “Turning Vehicles Yield to Pedestrians” blank-out sign

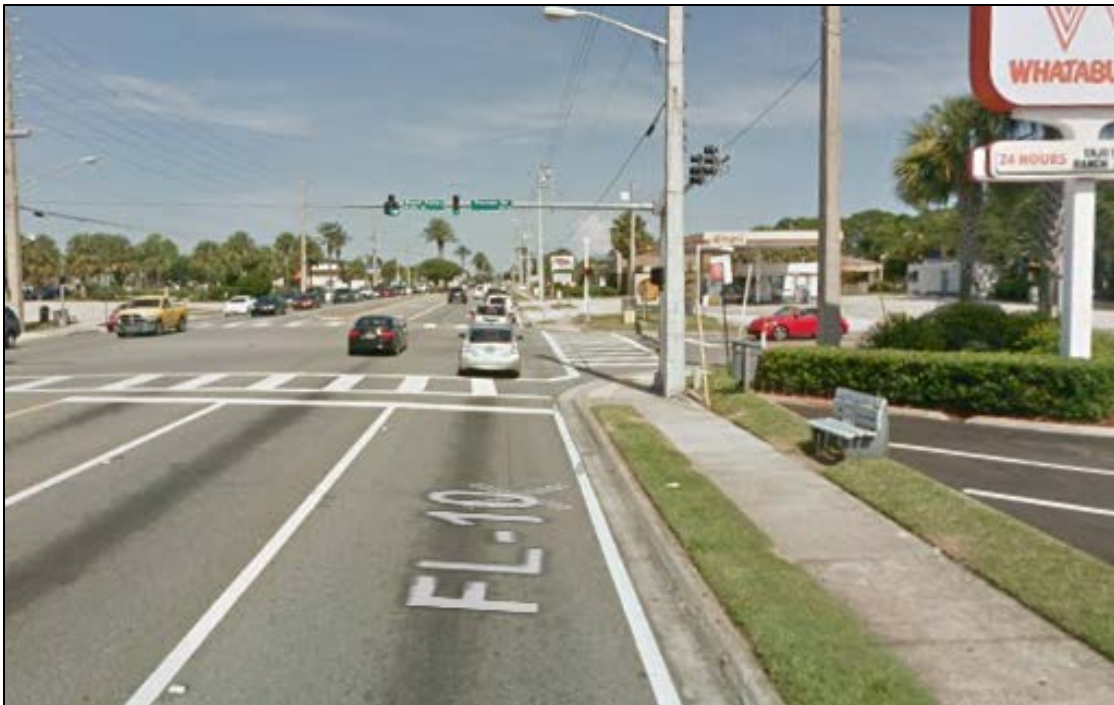
Figure 9. D2 site before implementation

For District 2, a “Right Turn on Red after Stop” sign was installed to remind drivers to stop before making a right-on-red maneuver. Figure 9 shows the site before implementation, and Figure 10 shows the site after implementation.

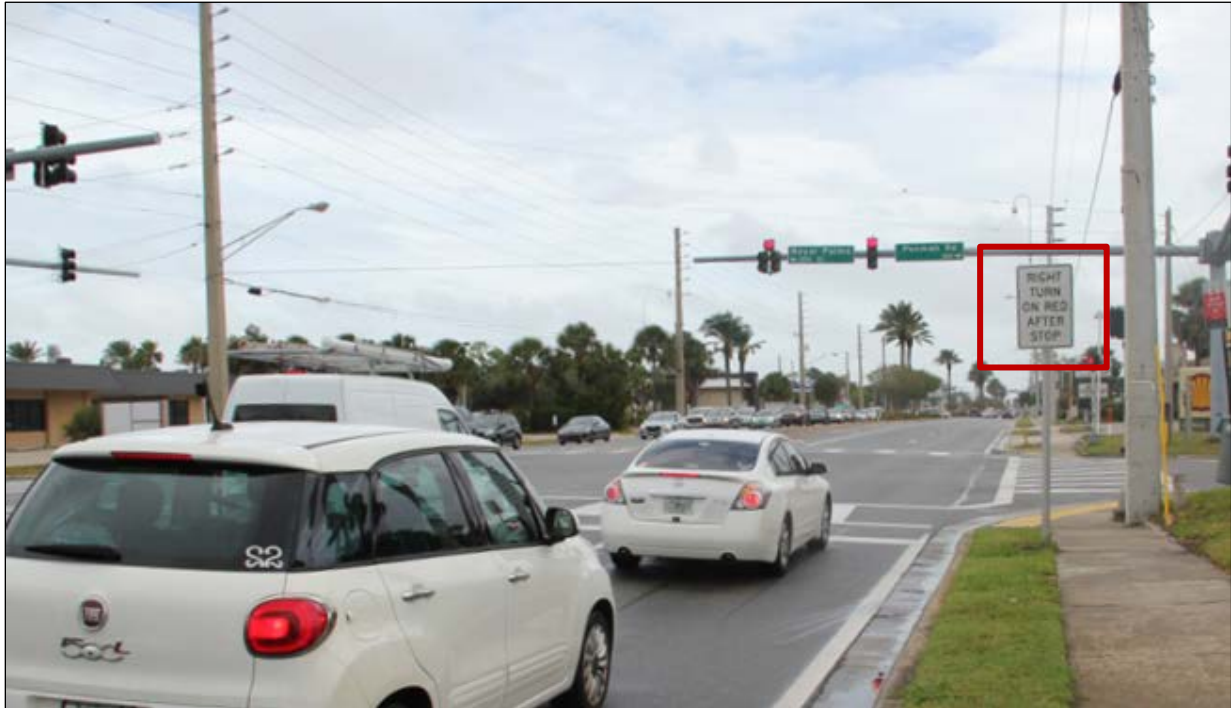
Figure 10. D2 site after implementation of “Right Turn on Red After Stop” sign

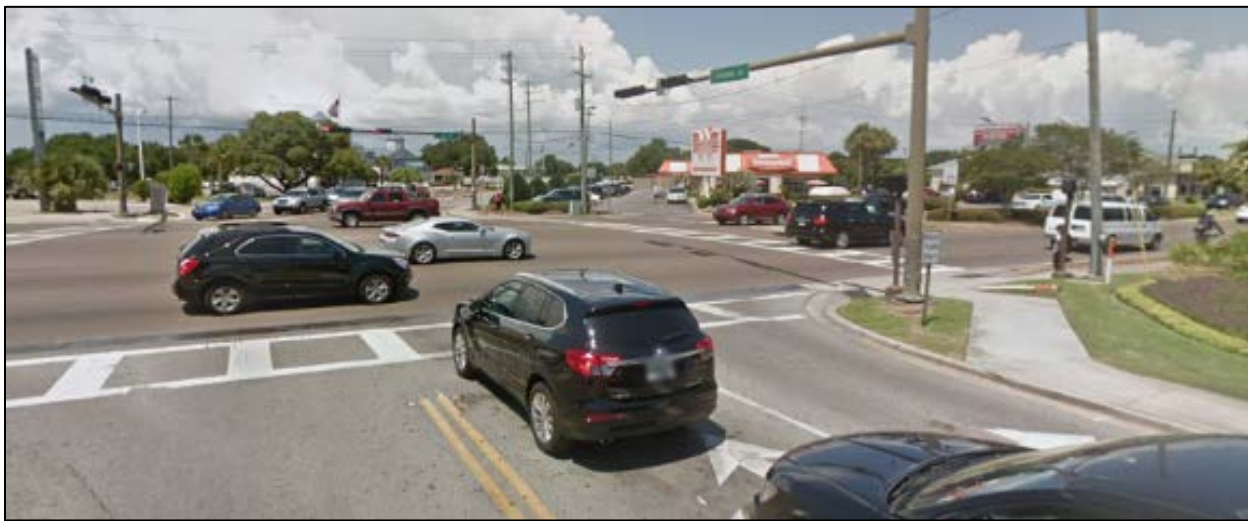
Figure 11. D3 site before implementation (NB)

For the District 3 site, two approaches were used to implement the same signs—“Right Turn on Red After Stop” and “Turning Vehicles Yield to Pedestrians.” Figure 11 shows the NB direction before implementation, and Figure 12 shows the NB direction after implementation. Figure 13 shows the EB direction before implementation, and Figure 14 shows the EB direction after implementation.

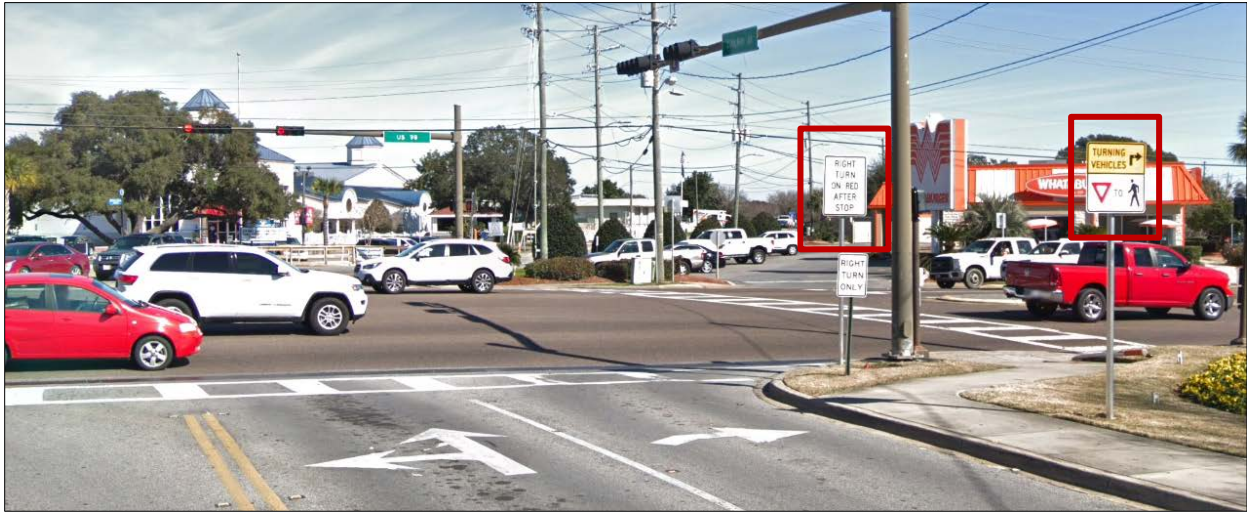
Figure 12. D3 site after implementation (NB) of both “Right on Red After Stop” and “Turning Vehicles Yield to Pedestrians” signs

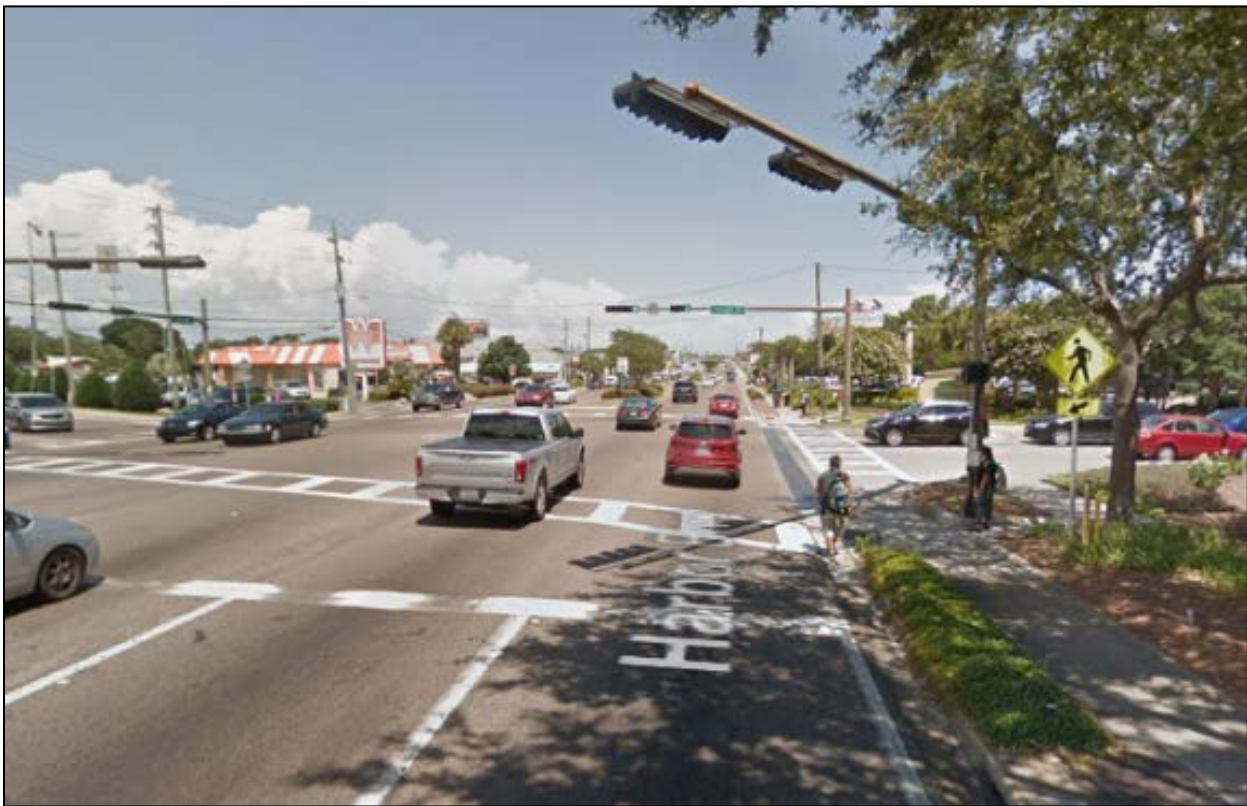
Figure 13. D3 site before implementation (EB)

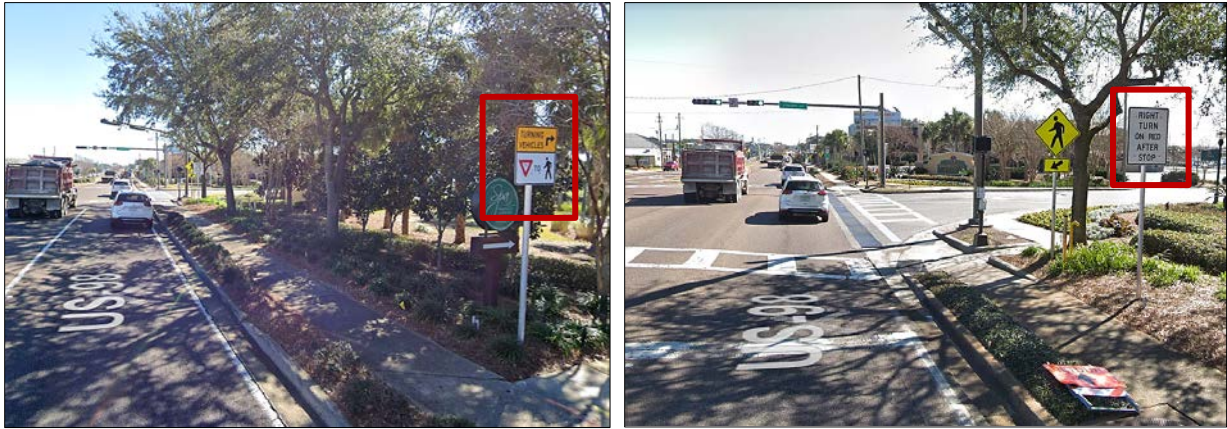
Figure 14. D3 site after implementation (EB) of both “Right Turn on Red After Stop” and “Turning Vehicles Yield to Pedestrians” signs

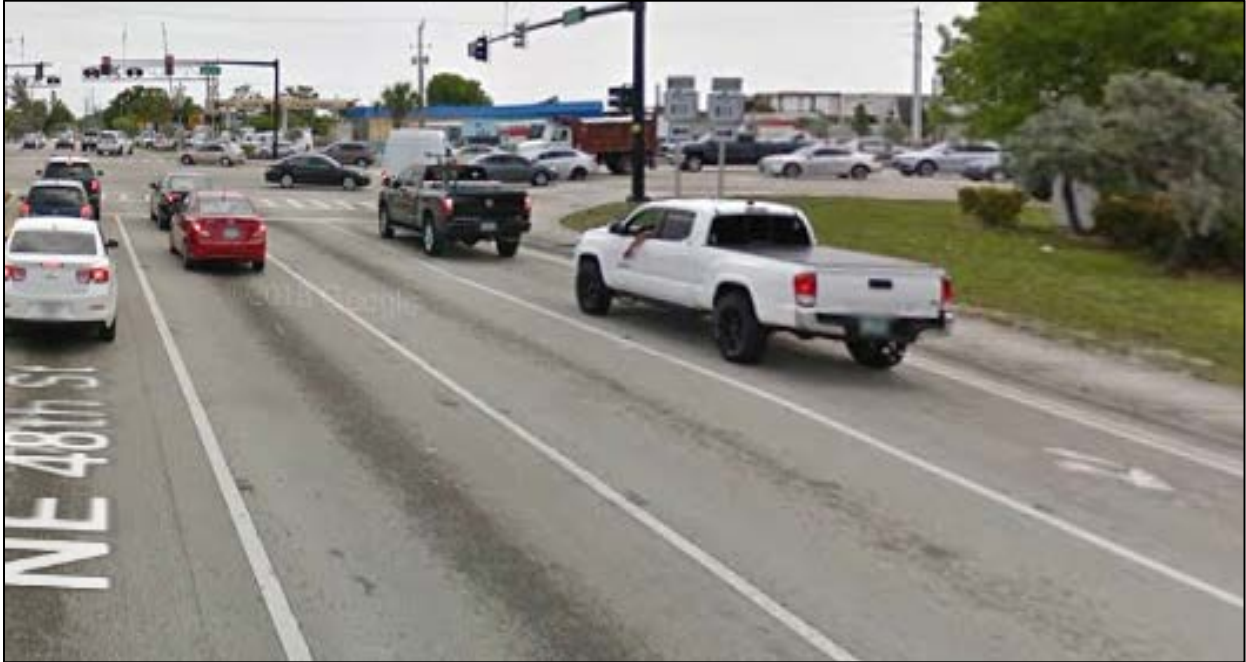
Figure 15. D4 site before implementation

The before and after implementation of the “Right Turn on Red After Stop” sign for District 4 are shown in Figure 15 and Figure 16, respectively.

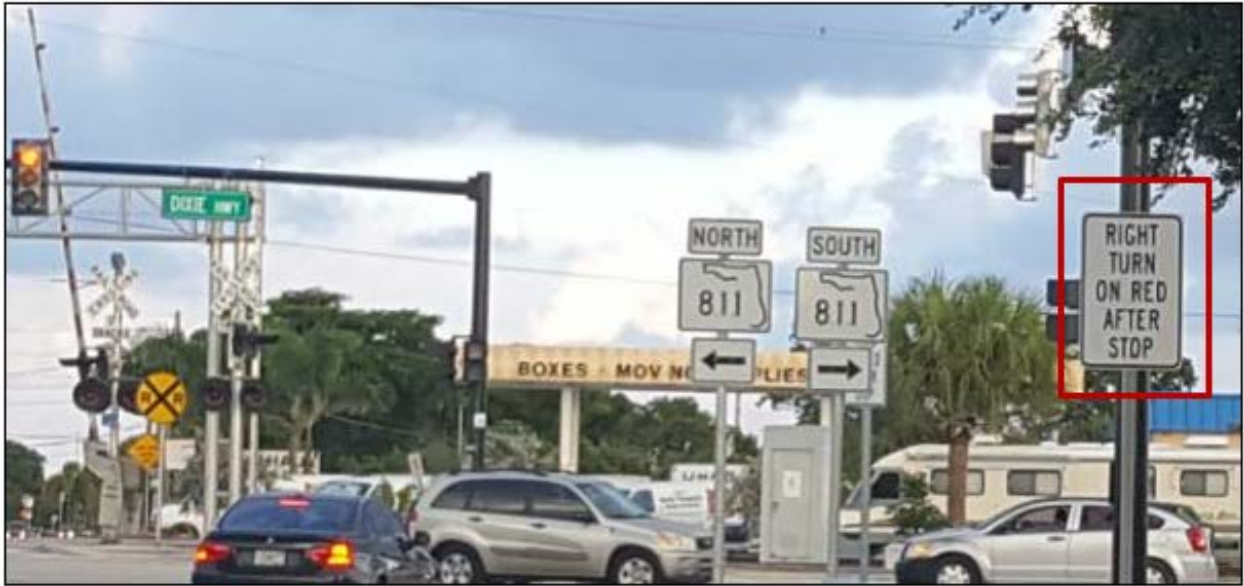
Figure 16. D4 site after implementation of “Right Turn on Red After Stop” sign

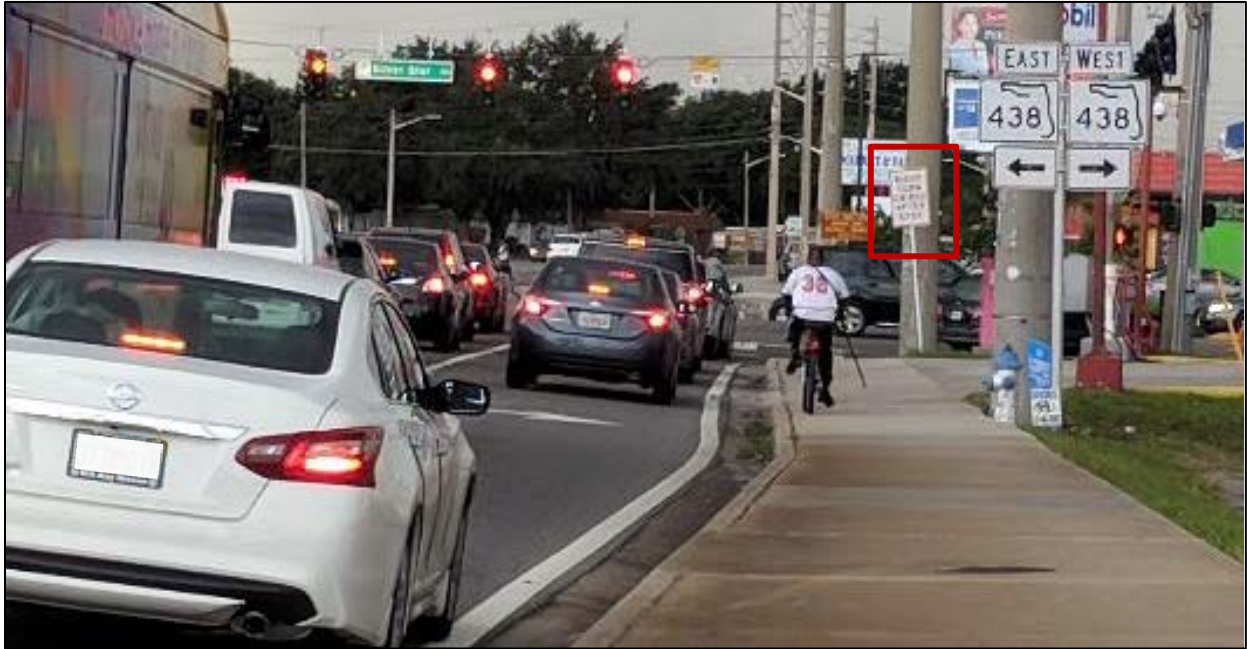
Figure 18. D5 site after implementation of “Right Turn on Red” After Stop sign

Before and after implementation photos for the District 5 site are shown in Figure 17 and Figure 18. The “Right Turn on Red After Stop” sign is shown in Figure 18.

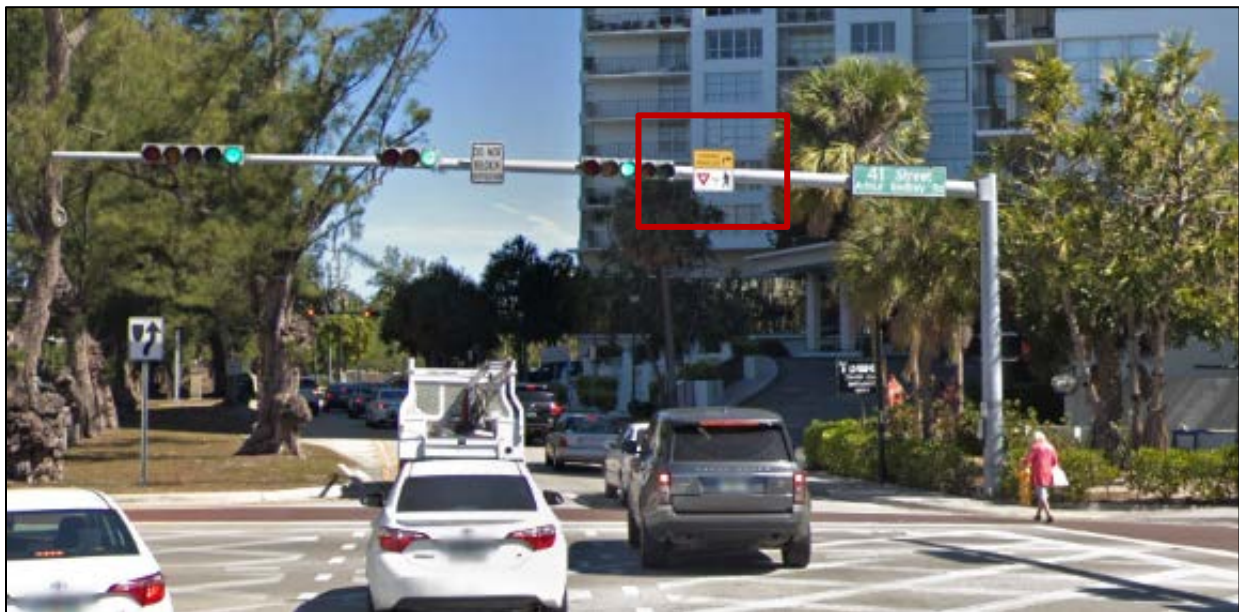
Figure 19. D6 site of using existing “Turning Vehicles Yield to Pedestrians” sign

For District 6, the selected location has an existing “Turning Vehicles Yield to Pedestrians” sign. This site was selected to conduct additional education for the sign. Figure 19 shows the sign installed overhead on the mast arm.

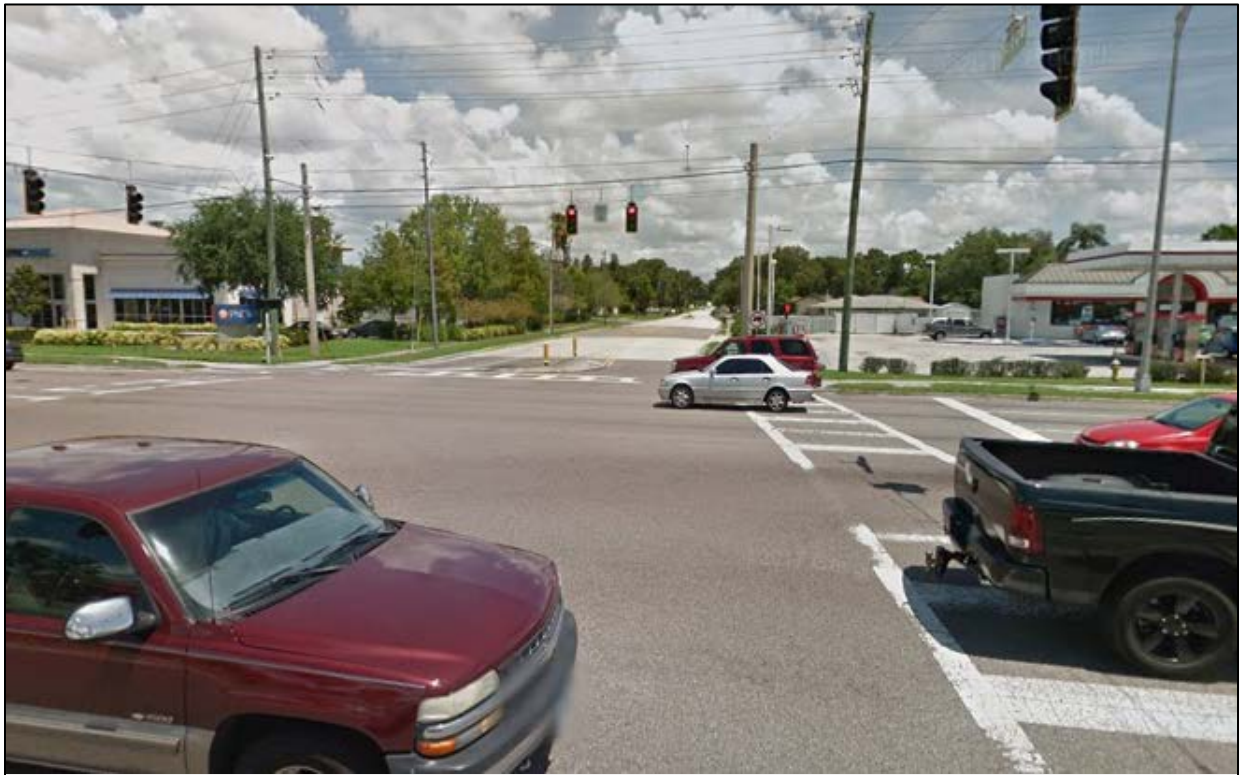
Figure 20. D7 site before implementation

Similar to the District 1 site, the District 7 site (Figure 20) received a blank-out sign with dual modes and a roadside sign. The timing of the displays of the blank-out sign was as follows:

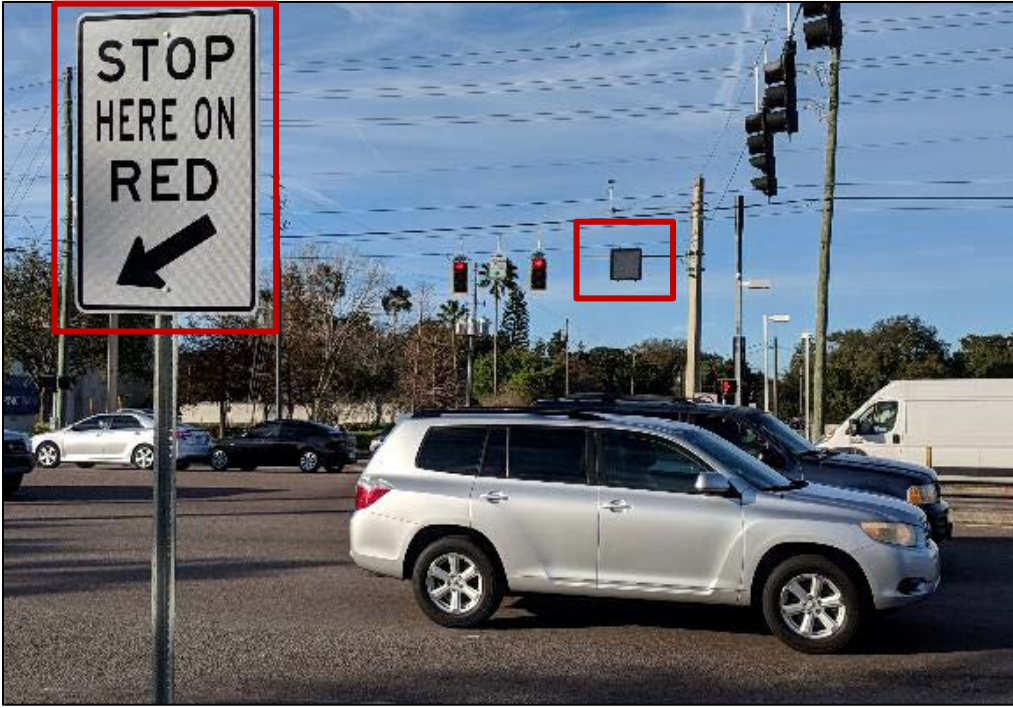
Figure 21. D7 site after implementation of blank-out sign and “Stop Here on Red” sign

1. When NB direction was under Red phase, the sign was blank (Figure 21).
2. When NB direction was under Red phase and a pedestrian call was served on the SB leg of the intersection, the sign displayed “No Turn on Red” (Figure 22).
3. When NB direction was under Green or Yellow phases, the sign displayed “Turning Vehicles Yield to Pedestrians” (Figure 23).

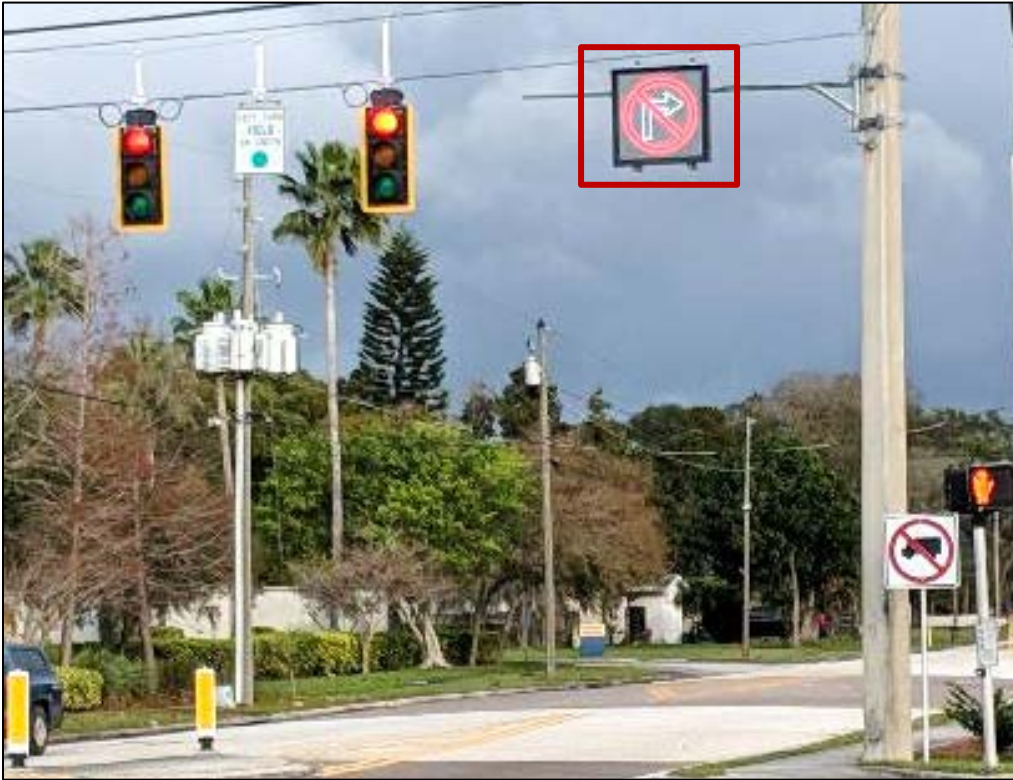
Figure 22. D7 site after implementation of “No Turn on Red” blank-out sign

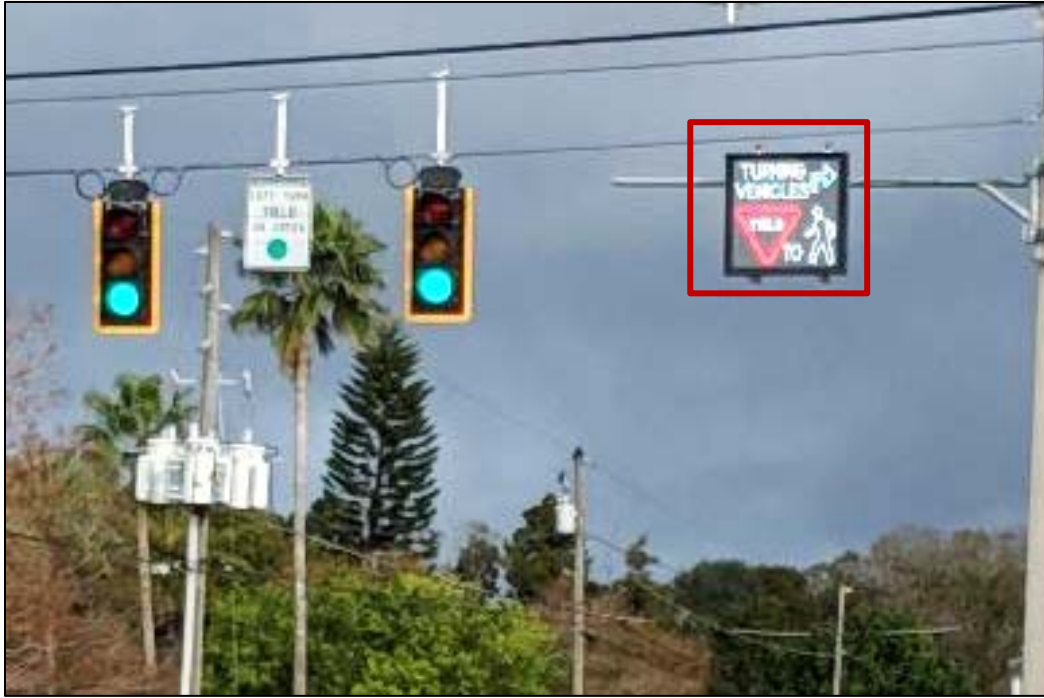
Figure 23. D7 site after implementation of “Turning Vehicles Yield to Pedestrians” sign

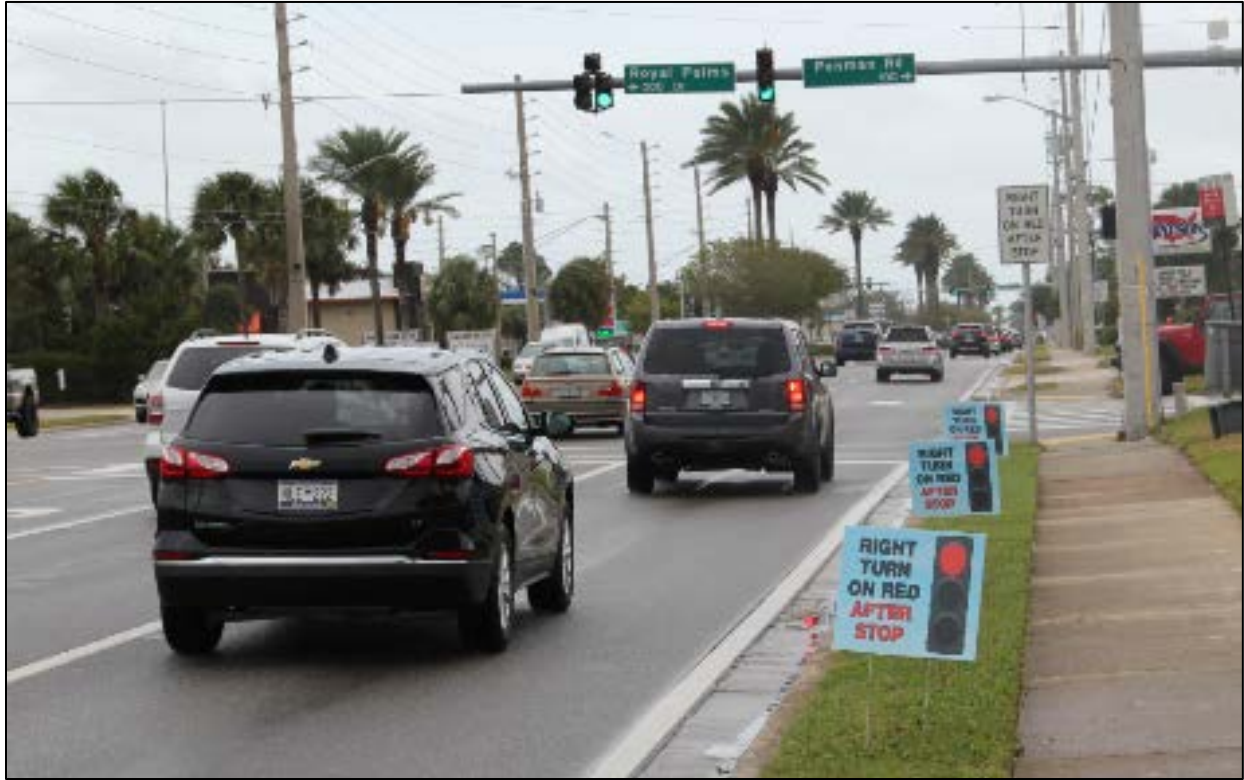
Figure 24. Placement of education yard signs at D2 study site

The CUTR team first informed the FDOT Districts and local agencies about the purpose and location for yard sign placement. CUTR designed and produced the yard signs and placed them at selected study sites after deployment of the engineering countermeasures. Photos for yard sign placements in FDOT Districts 2, 3, 4, and 5 are shown in Figure 24 through Figure 27, respectively.

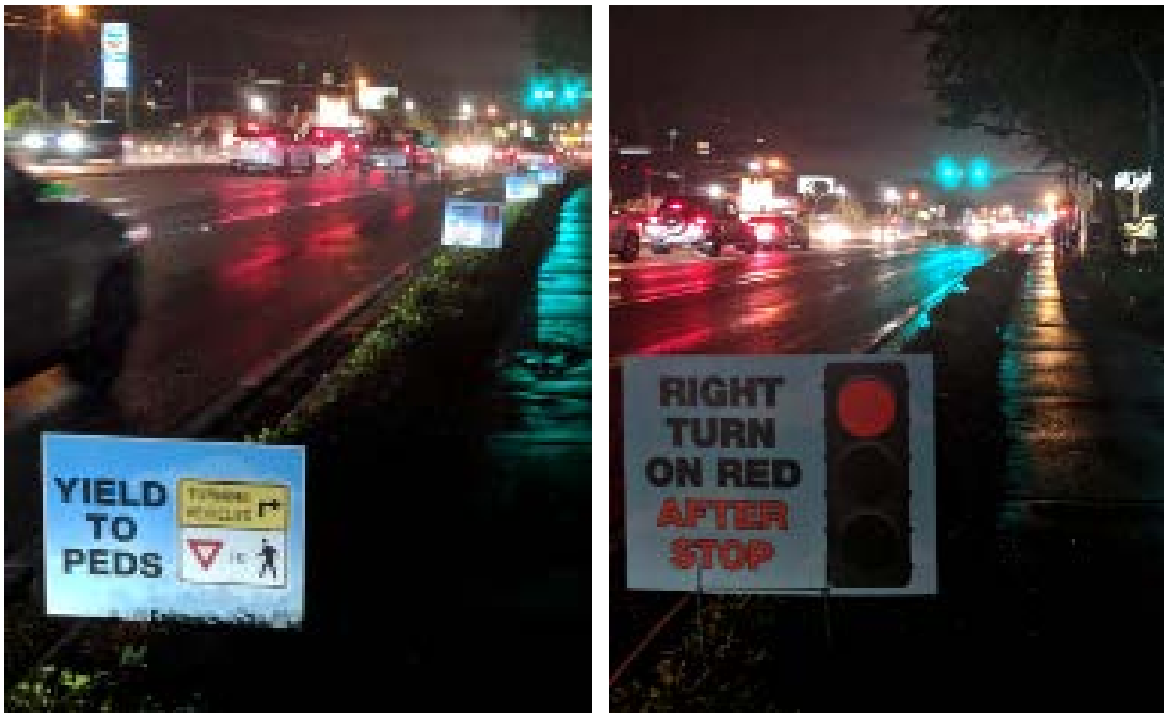
Figure 25. Placement of education yard signs at D3 study site

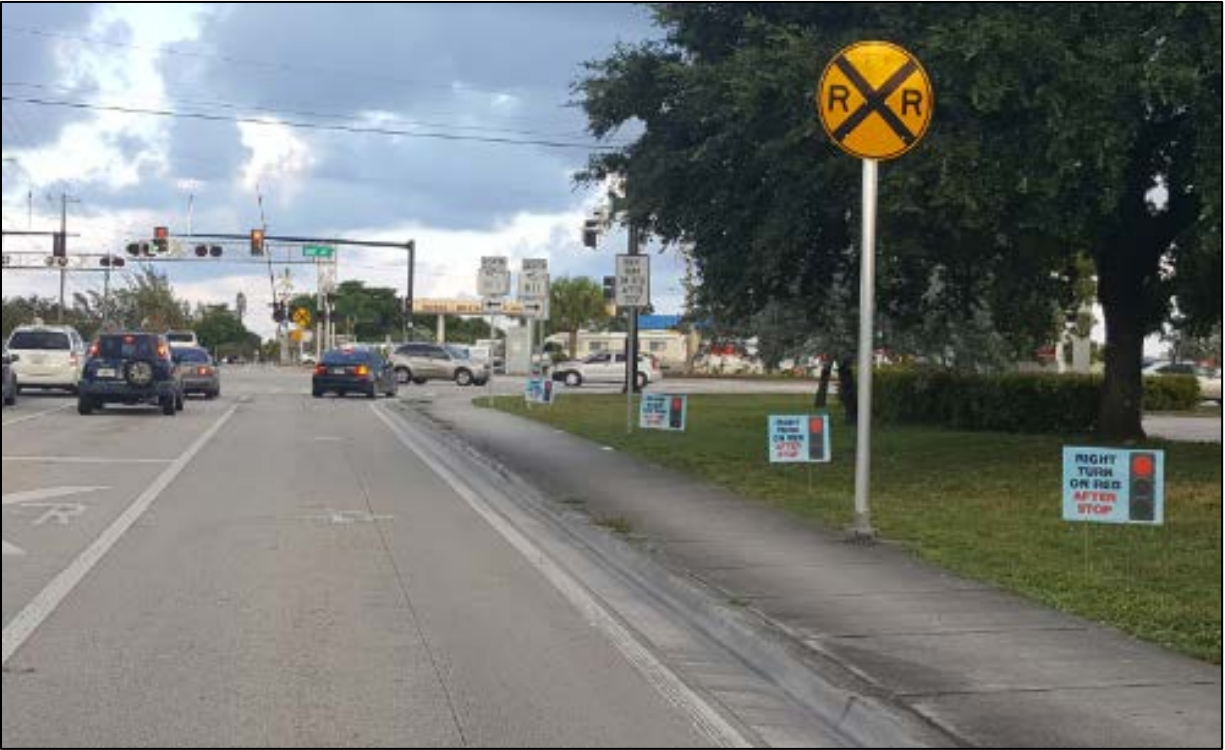
Figure 26. Placement of education yard signs at D4 study site

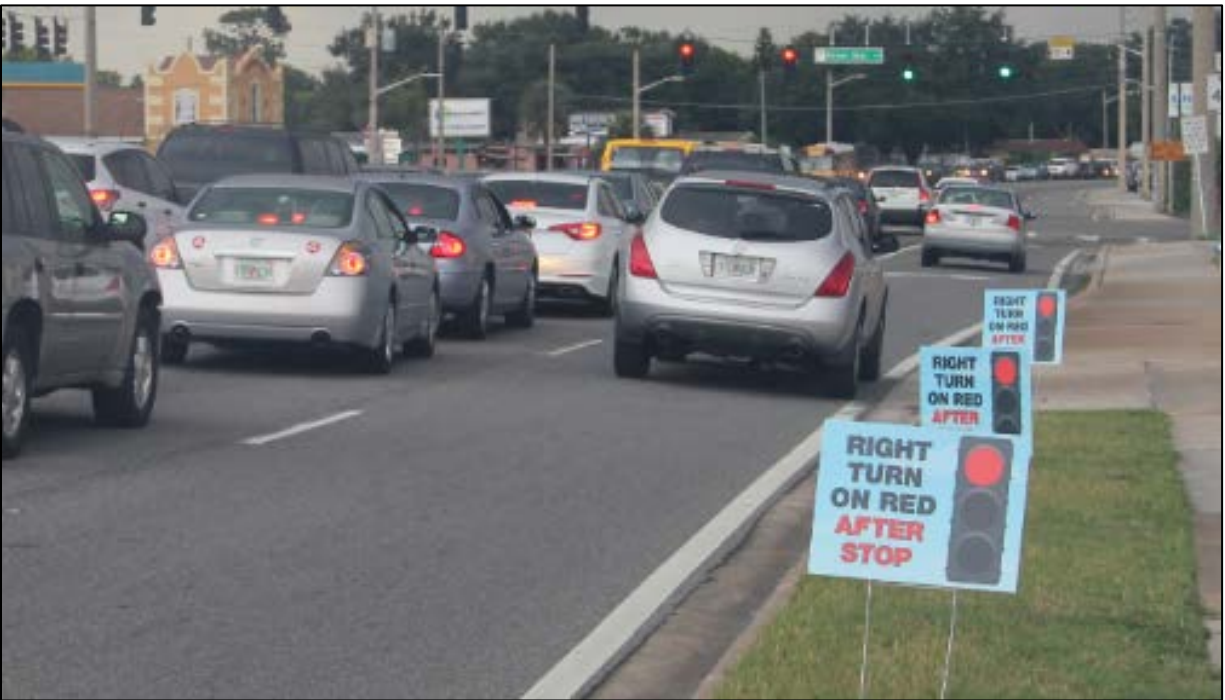
Figure 27. Placement of education yard signs at D5 study site

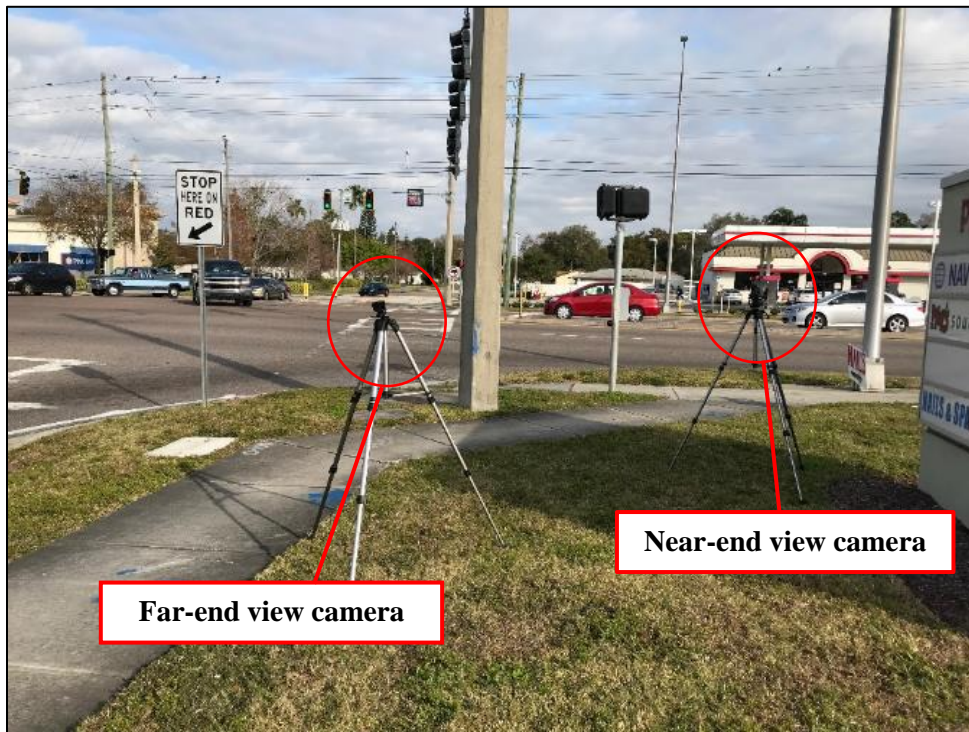
Figure 29. Installation of data collection devices

At some sites, if one camera was capable of collecting all necessary information, only one was used to reduce the workload for scene-matching in video reviewing. A one-day data collection period covered various traffic conditions, such as peak hours, non-peak hours, and lighting conditions (daytime and nighttime).

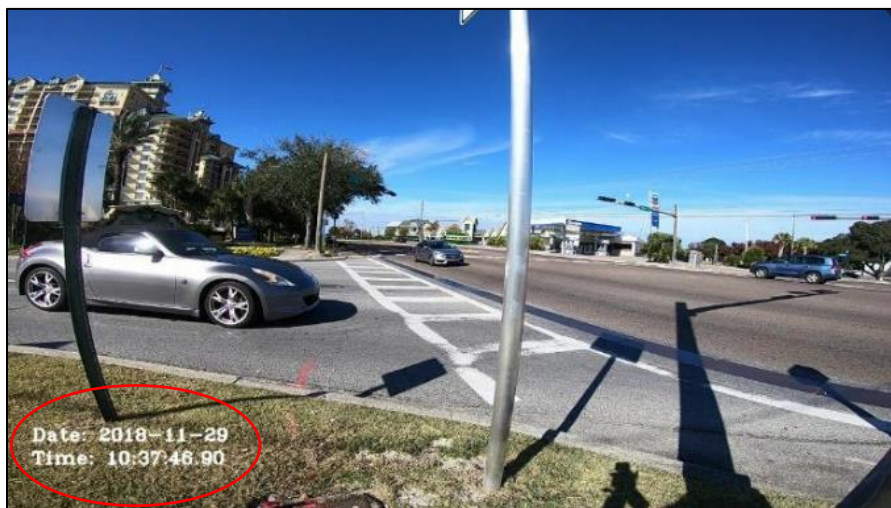
Figure 31. Example of timestamp on video scene

After the data were collected in the field, the research team reviewed the recorded “before” and “after” videos to validate and organize data for analysis. First, a Python application was developed to add time stamps at 100 milliseconds superimposed on the videos. The time stamp was used to (1) record event time, (2) synchronize the event data between the two views, and (3) locate event scenes for validation. A Linux-powered Dell workstation with an 8-core CPU (E5-2680 at 2.7GHz) was used to conduct the timestamp process. The execution interface is shown in Figure 30, and an example of video scenes with timestamp is shown in Figure 31.

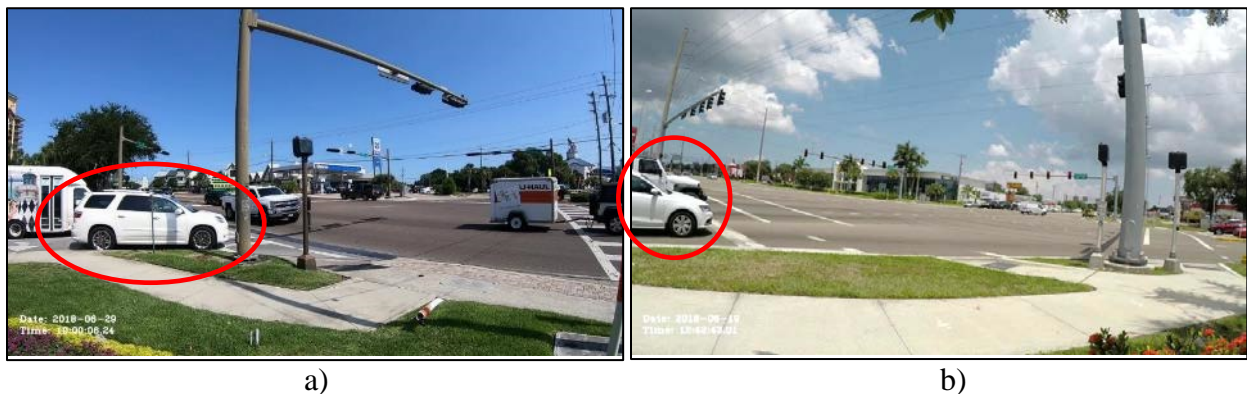
- a) Right-turning SUV stopping after stop bar on red in conflicting traffic
- b) Right-turning car stopping before stop bar on red
- c) Right-turning car not yielding to pedestrian at green signal
- d) Observed driver distraction while turning (drinking)
- e) Observed driver characteristics (adult male)
- f) Observed yielding to pedestrian behavior in rainy conditions

Figure 32. Events identified during video review

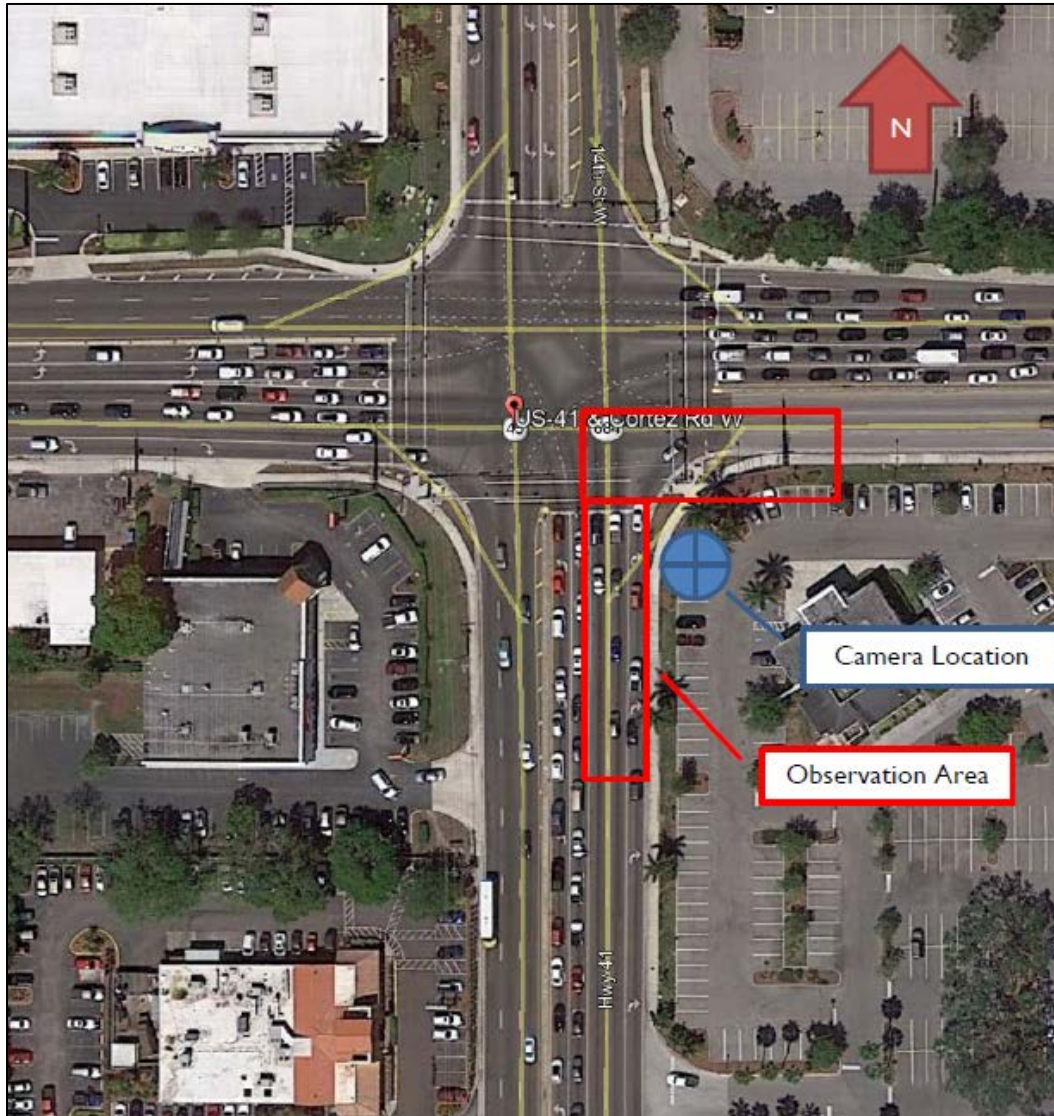
Figure 33. Layout of US-41 @ Cortez Rd, Bradenton, FL, NB

The D1 site is shown in Figure 33, and data collection information is summarized in Table 6.

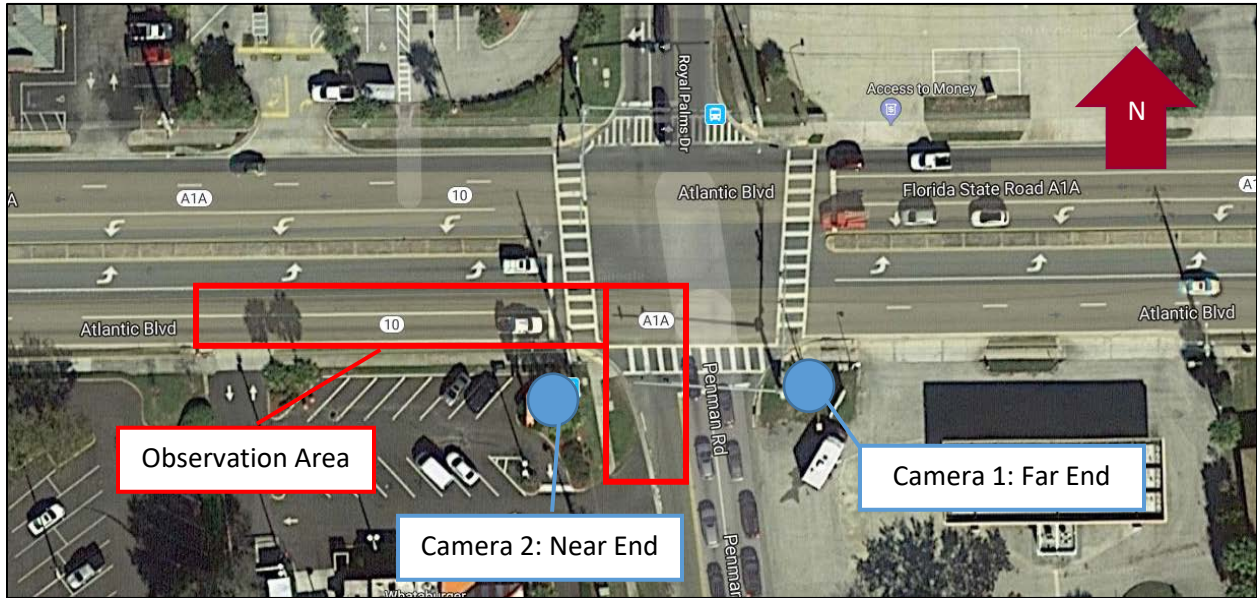
Figure 35. Layout at Atlantic Blvd @ Penman Rd, Jacksonville, FL, EB

The D2 site is shown in Figure 35, and data collection information is summarized in Table 7.
