Understanding Interactions between Drivers and Pedestrian Features at Signalized Intersections – Phase 3

FDOT BDV25-977-43

Final Report

Florida Department of Transportation

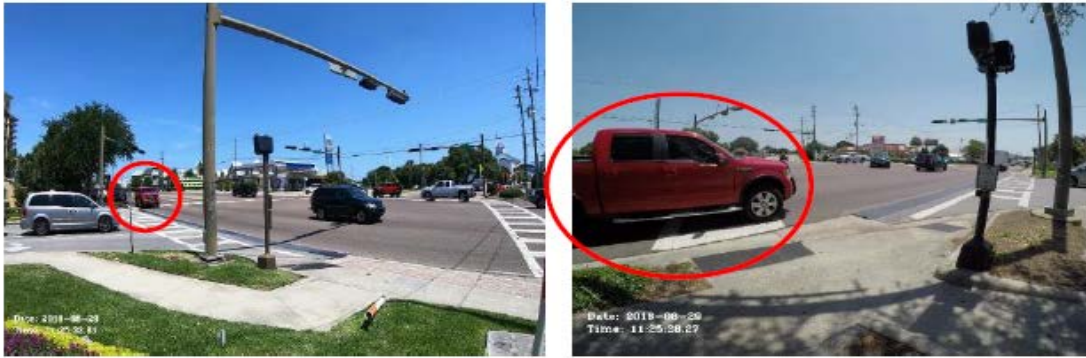
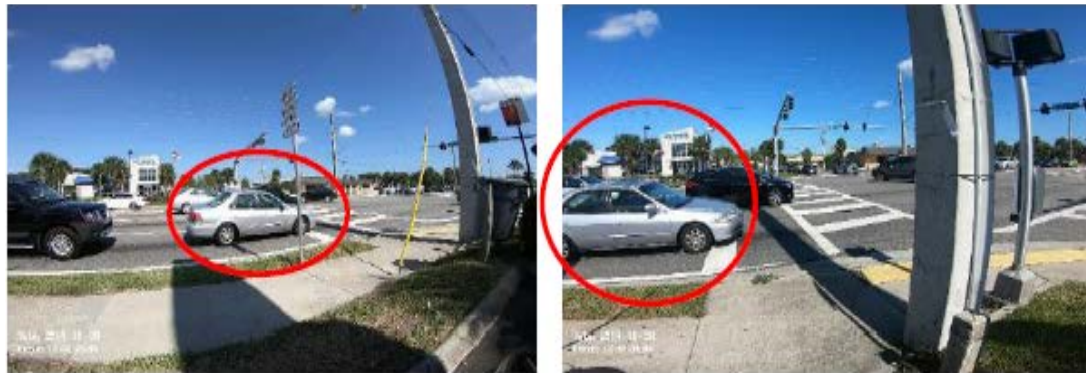
a) “Before” data collection (far-end view) b) “Before” data collection (near-end view)

c) “After” data collection (far-end view) d) “After” data collection (near-end view)

Figure 36. Video review scenes from District 2 study site

The “before” data collection was conducted on two days—6/29/2018 (morning) and 6/30/2018 (afternoon/night). The “after” data collection was conducted on 10/20/2019. Two cameras were used to capture far-end information (traffic, signal, pedestrian, conflicting vehicles) and near-end information (driver characteristics and behaviors). The reviewing scenes for before and after data collection are shown in Figure 36.

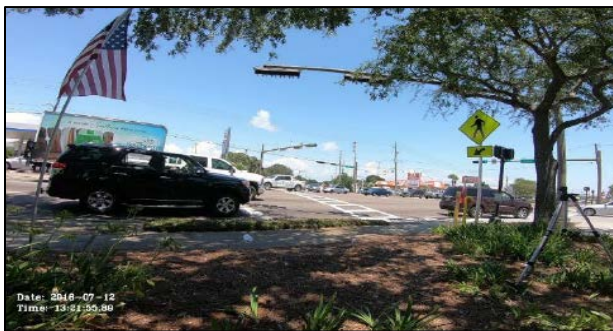
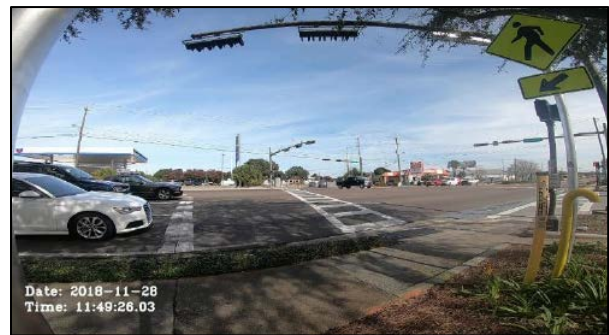
a) “Before” data collection EB (one camera) b) “After” data collection EB (one camera)

Figure 38. Video review scenes from District 3 study site (EB)

For the District 3 site, two approaches were used to implement the same signs, “Right Turn on Red after Stop” and “Turning Vehicles Yield to Pedestrians.” The layout of data collection in District 3 is shown in Figure 37, and a summary of data collection is presented in Table 8. The reviewing scenes for before and after data collection are shown in Figure 38 and Figure 39.

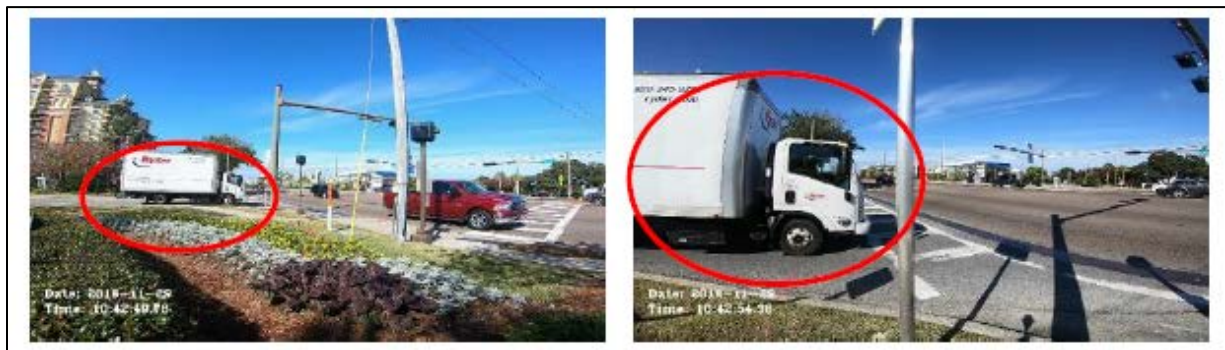
b) “After” data collection (far-end view) c) “After” data collection (near-end view)

Figure 39. Video review scenes from District 3 study site (NB)

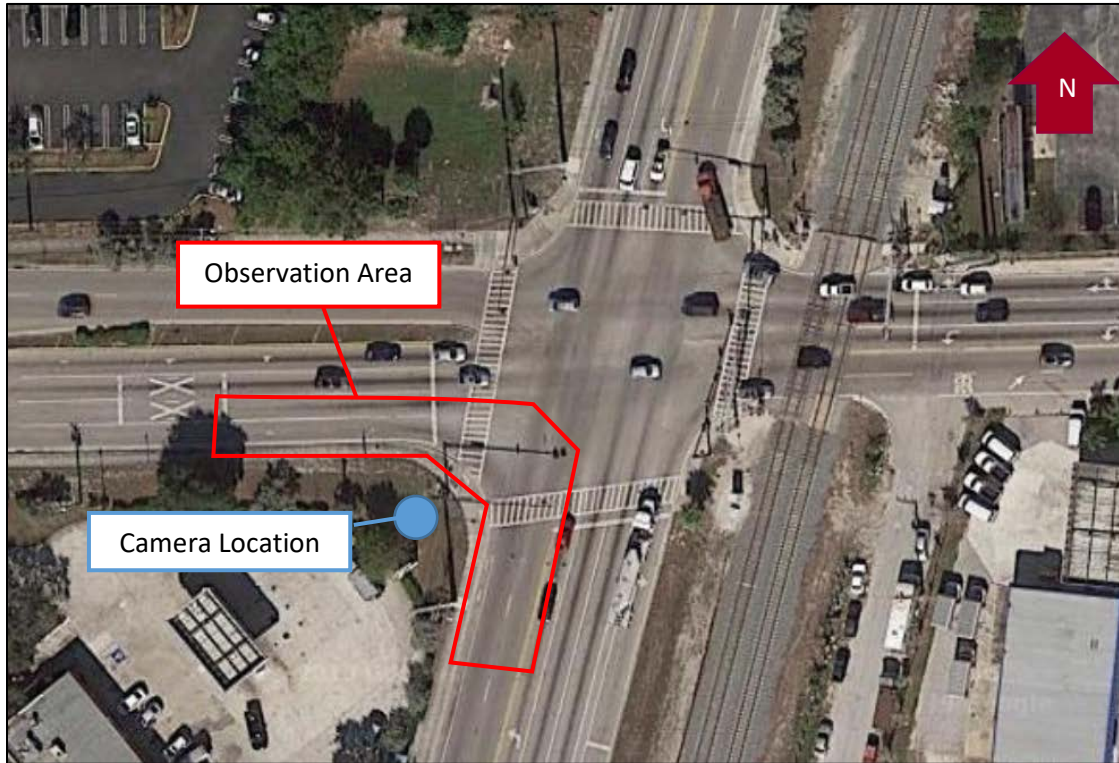
Figure 40. Layout at N Dixie Hwy @ NE 48th St, Pompano Beach, FL, EB

The layout of data collection in District 4 is shown in Figure 40, and a summary of data collection is presented in Table 9. The reviewing scenes for before and after data collection are shown in Figure 41.

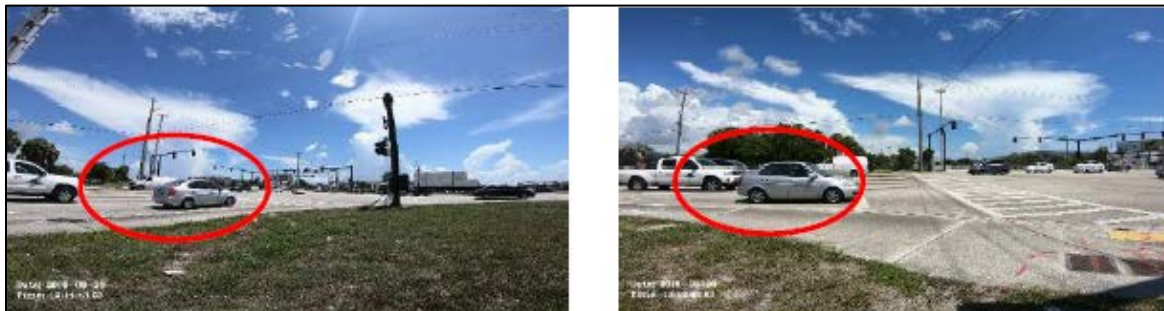
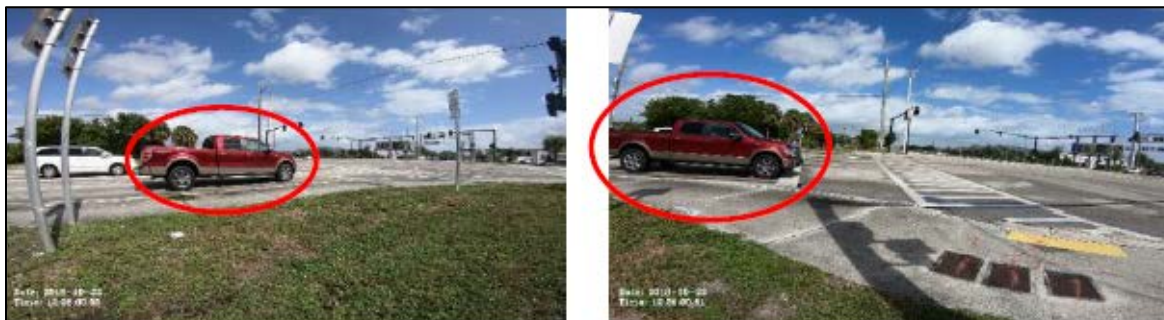
a) “Before” data collection (far-end view) b) “Before” data collection (near-end view)

c) “After” data collection (far-end view) d) “After” data collection (near-end view)

Figure 41. Video review scenes from District 4 study site

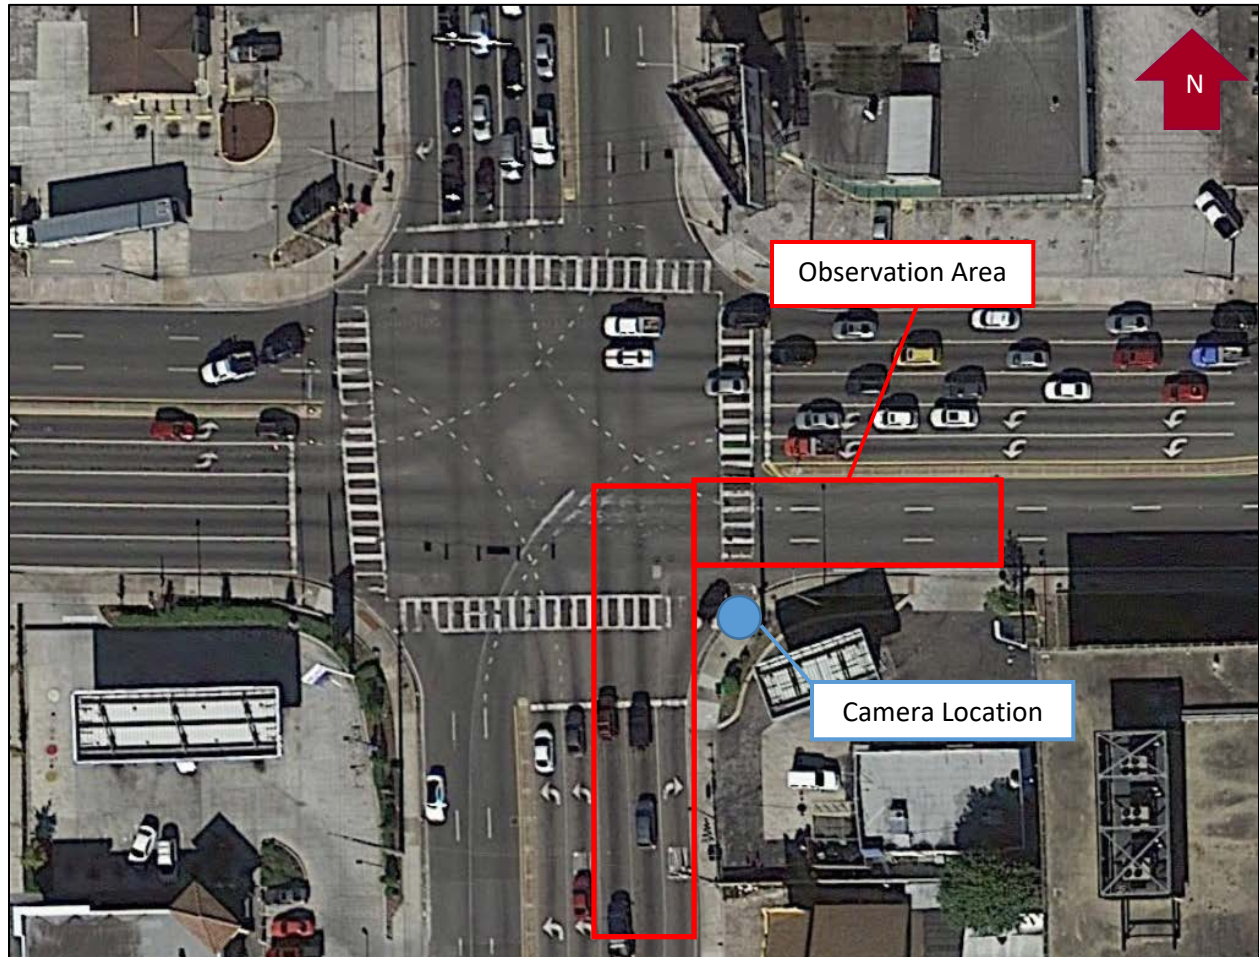
Figure 42. Layout at Silver Star Rd @ N Pine Hills Rd, Pine Hills, FL, NB

The layout of data collection in District 5 is shown in Figure 42, and a summary of data collection is presented in Table 10. The reviewing scenes for before and after data collection are shown in Figure 43.

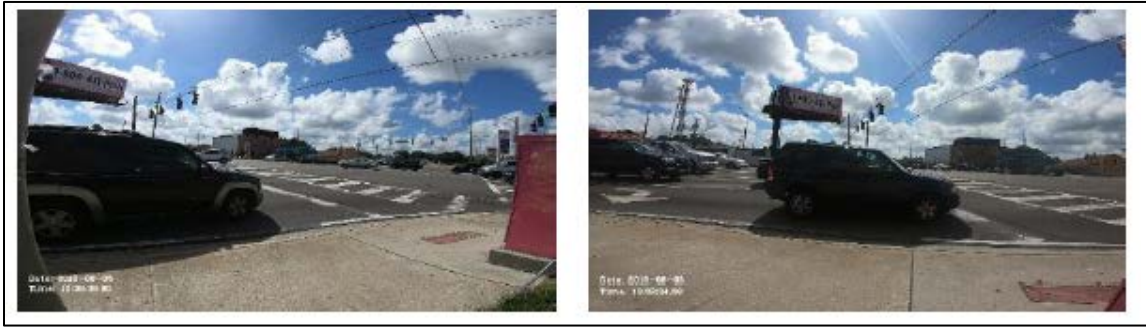
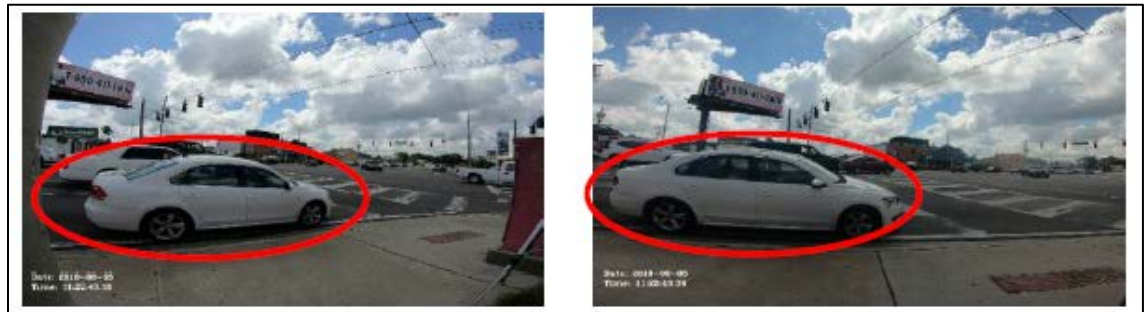
a) “Before” data collection (far-end view) b) “Before” data collection (near-end view)

c) “After” data collection (far-end view) d) “After” data collection (near-end view)

Figure 43. Video review scenes from District 5 study site

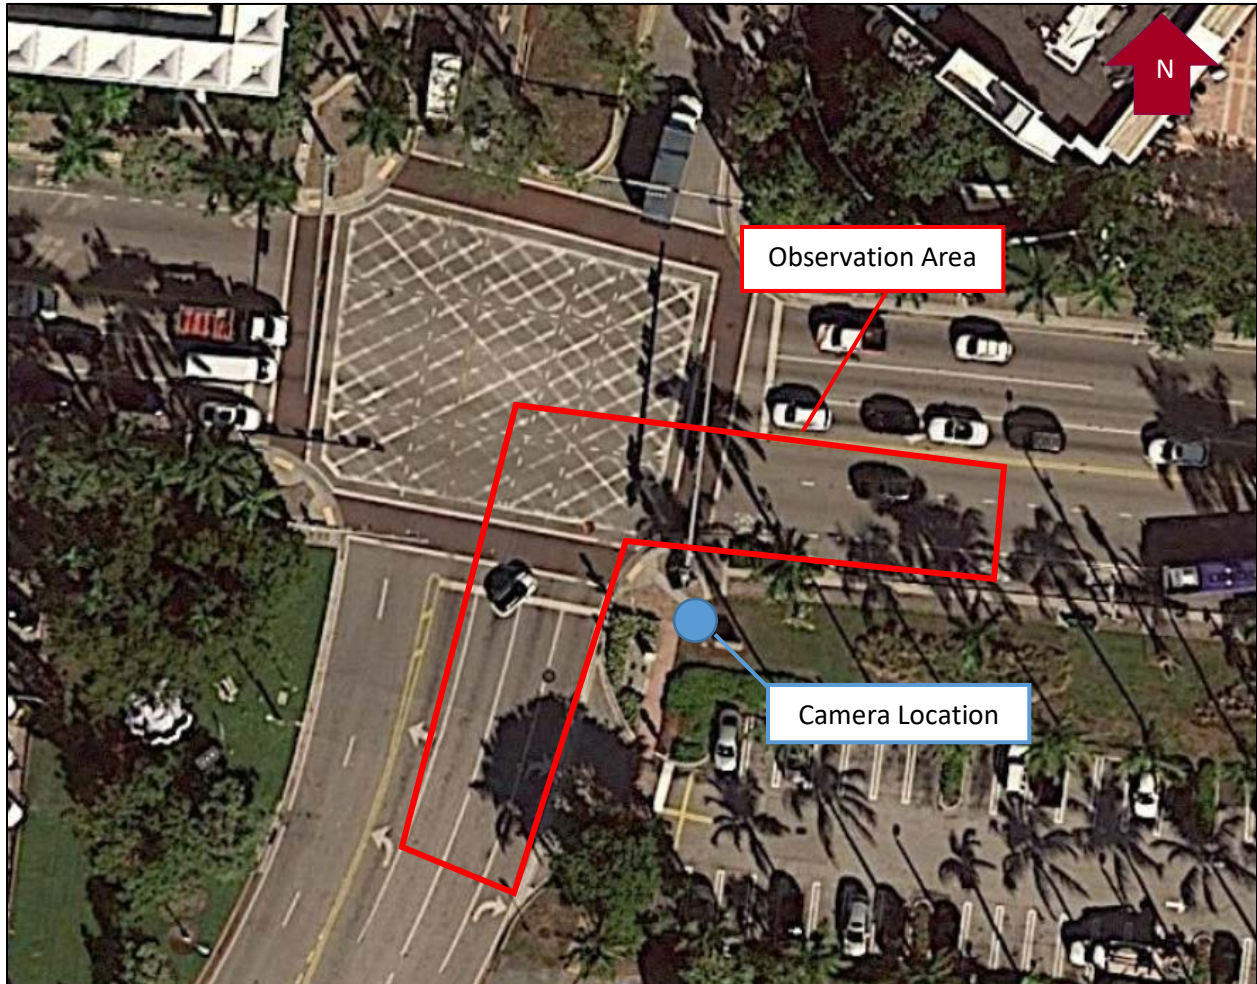
Figure 44. Layout at W 41st St @Pine Tree Dr, Miami Beach, FL, NB

For District 6, the selected location has an existing “Turning Vehicles Yield to Pedestrians” sign. This site was selected to conduct additional education for the sign. Figure 44 shows the layout of data collection in District 6, and Table 11 presents a summary of data collection. The reviewing scenes for before and after data collection are shown in Figure 45.

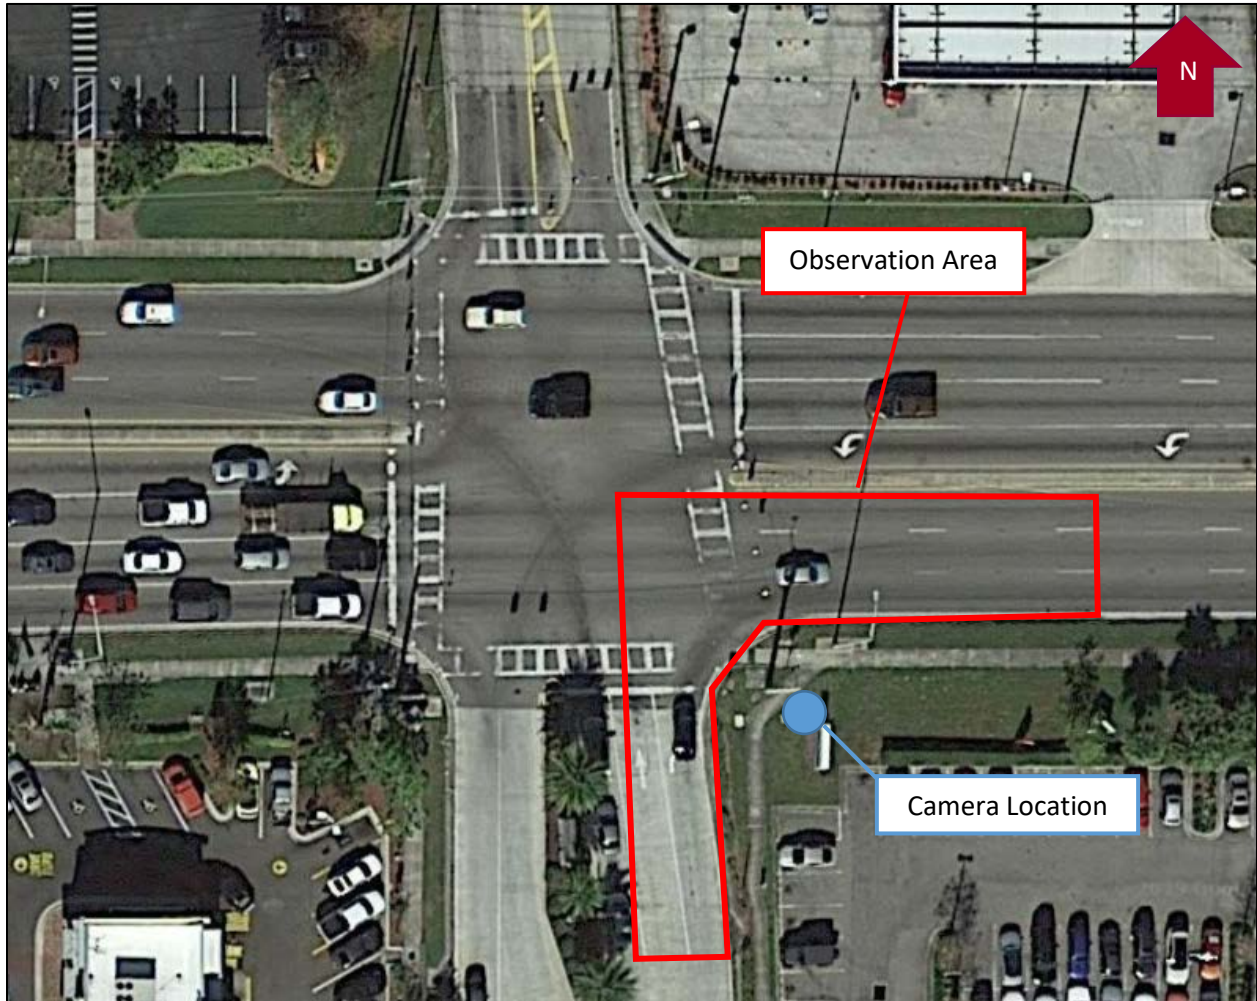
Figure 46. Layout at Roosevelt Blvd @ Dodge St, Largo, FL, NB

Similar to the District 1 site, the District 7 site received a blank-out sign with dual modes and a roadside sign. This site was selected to conduct additional education for the sign. Figure 46 shows the layout of data collection in District 7, and Table 12 presents a summary of data collection. The reviewing scenes for before and after data collection are shown in Figure 47.

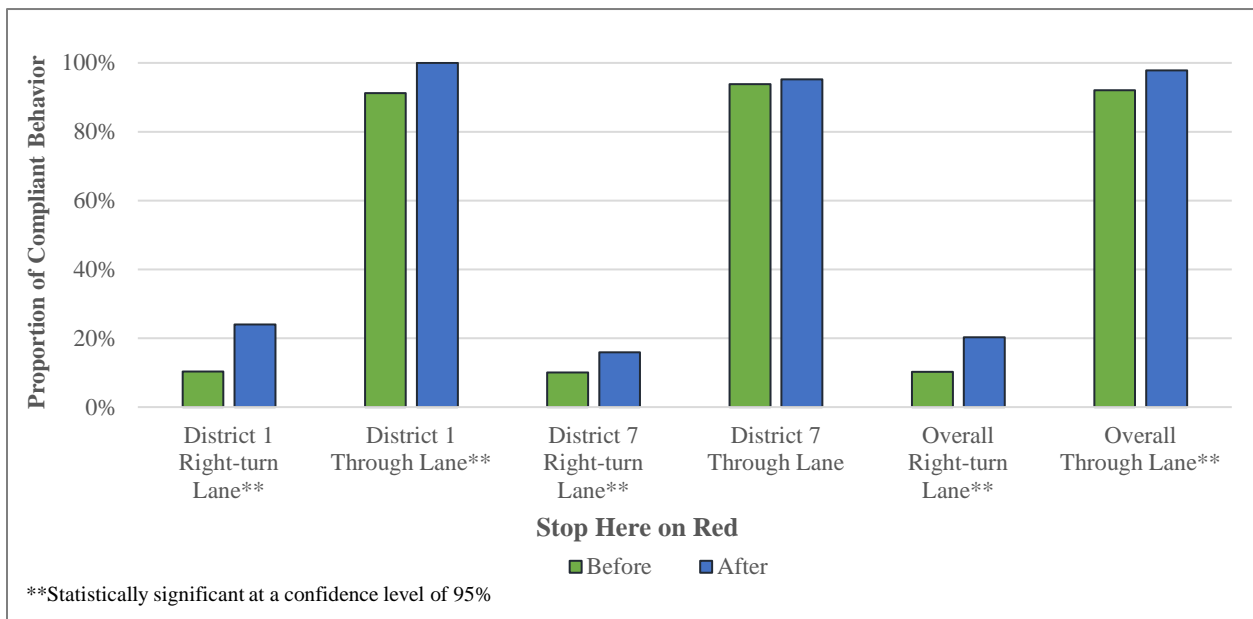
Figure 48. Comparison of compliance for “Stop Here on Red” sign, Districts 1 and 7

Figure 48 and Table 15 show the comparison results of driver compliance for the “Stop Here on Red” sign before and after the sign was implemented for the sites in Districts 1 and 7.

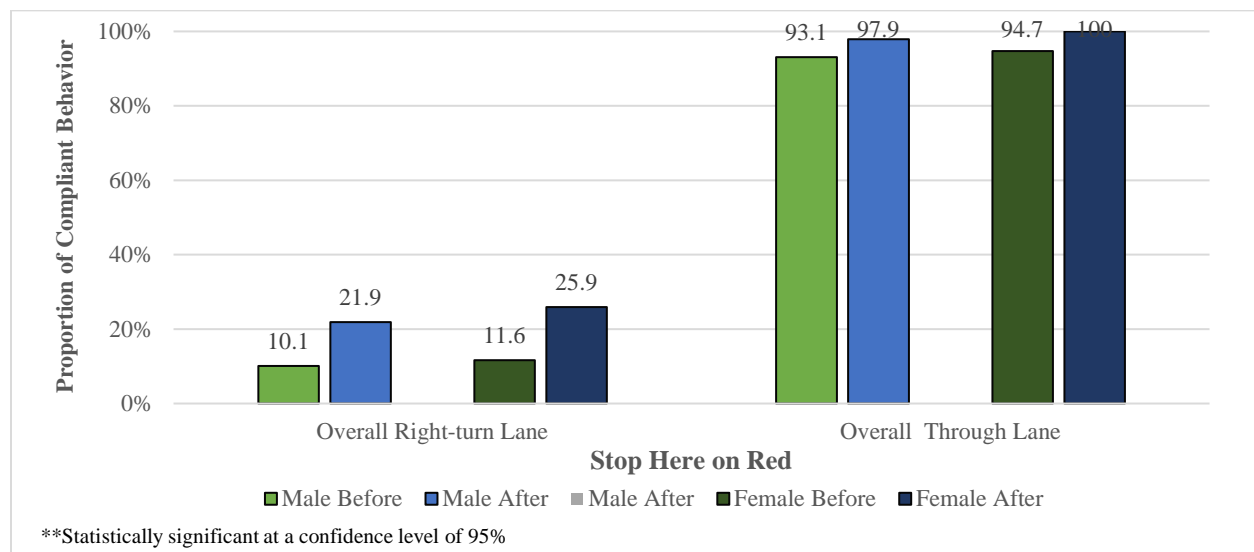
Figure 49. Comparison of compliance for “Stop Here on Red” sign by gender, Districts 1 and 7

Figure 49 and Table 16 show the comparison results of driver compliance by gender for the “Stop Here on Red” sign between a right-turn lane and a through lane before and after the sign was implemented.

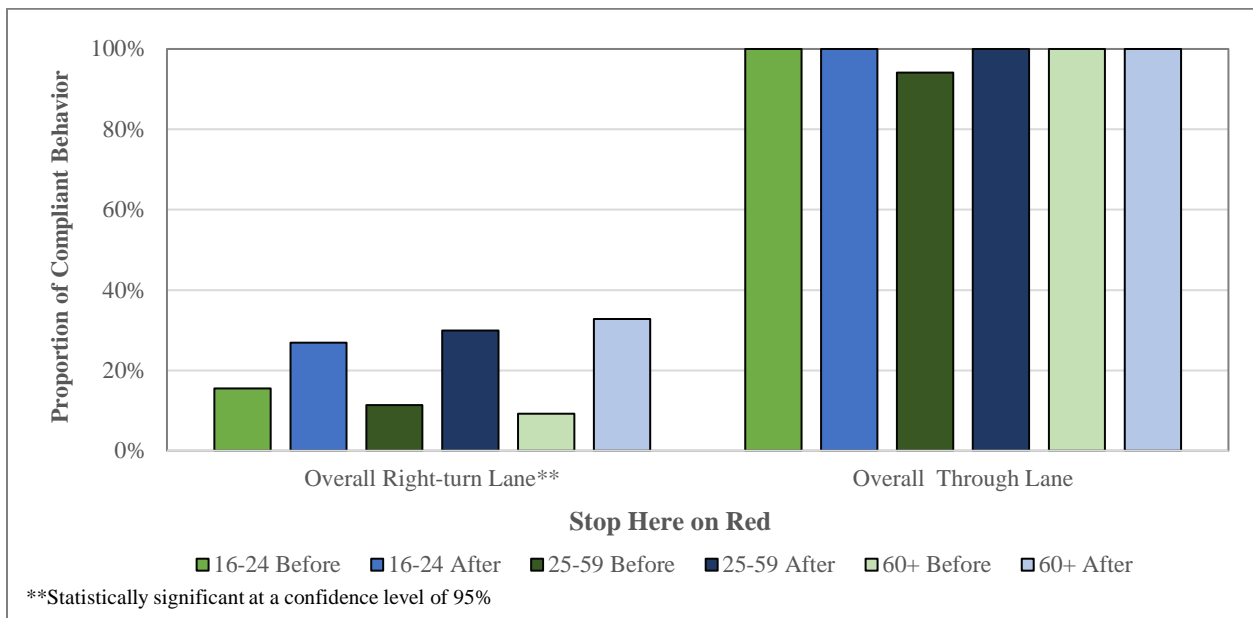
Figure 50. Comparison of compliance for “Stop Here on Red” sign by age, Districts 1 and 7

Figure 50 and Table 17 show the comparison results of driver compliance by age at a “Stop Here on Red” sign between a right-turn lane and a through lane before and after the sign was implemented based on overall data.

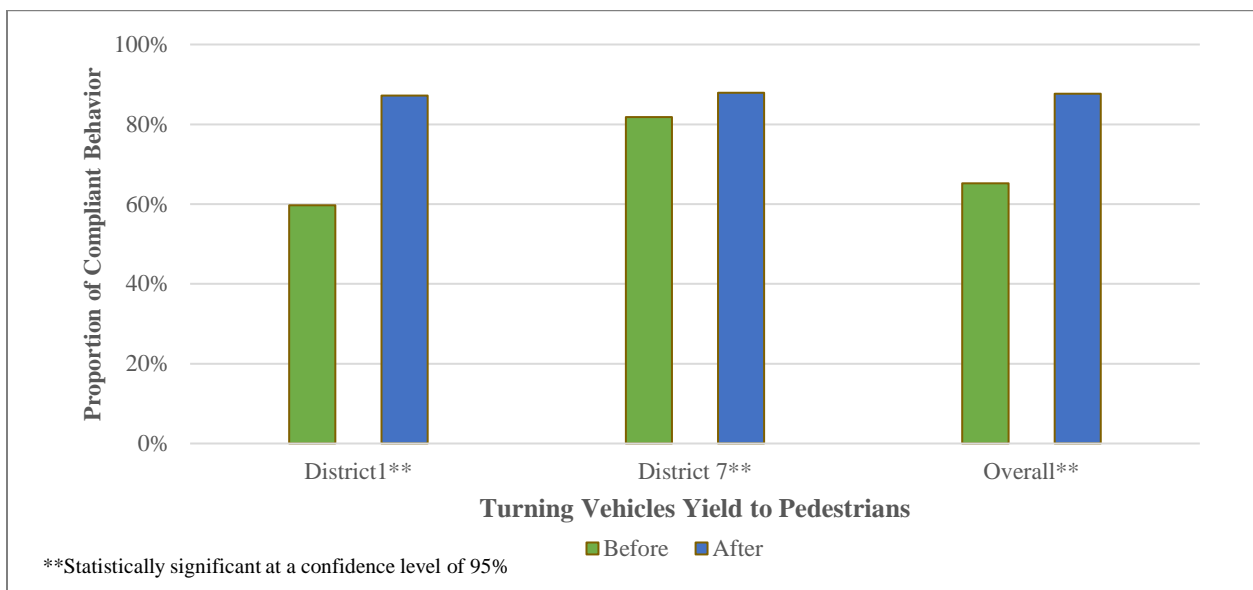
Figure 51. Comparison of compliance for “Turning Vehicles Yield to Pedestrians” sign, Districts 1 and 7

Figure 51 and Table 18 show the comparison results of driver compliance for a “Turning Vehicles Yield to Pedestrians” blank-out sign before and after the sign was implemented for the sites in Districts 1 and 7.

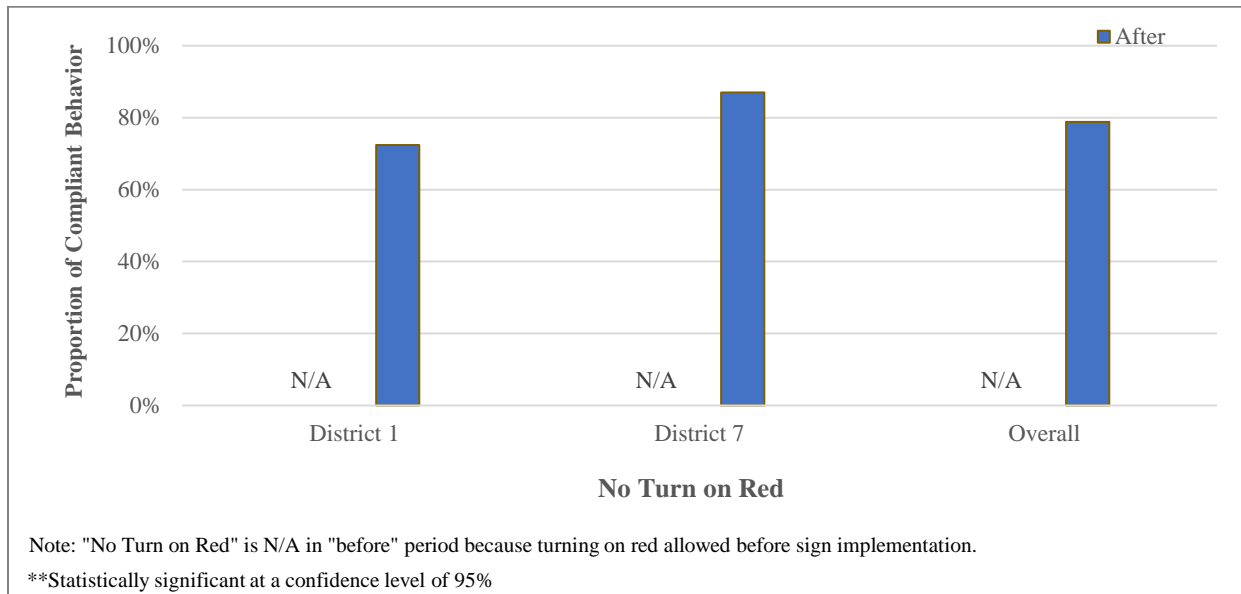
Figure 53. Comparison of compliance for “No Turn on Red” sign, Districts 1 and 7

Figure 53 and Table 20 show the comparison results of driver compliance for the “No Turn on Red” sign before and after the sign was implemented for the sites in Districts 1 and 7.

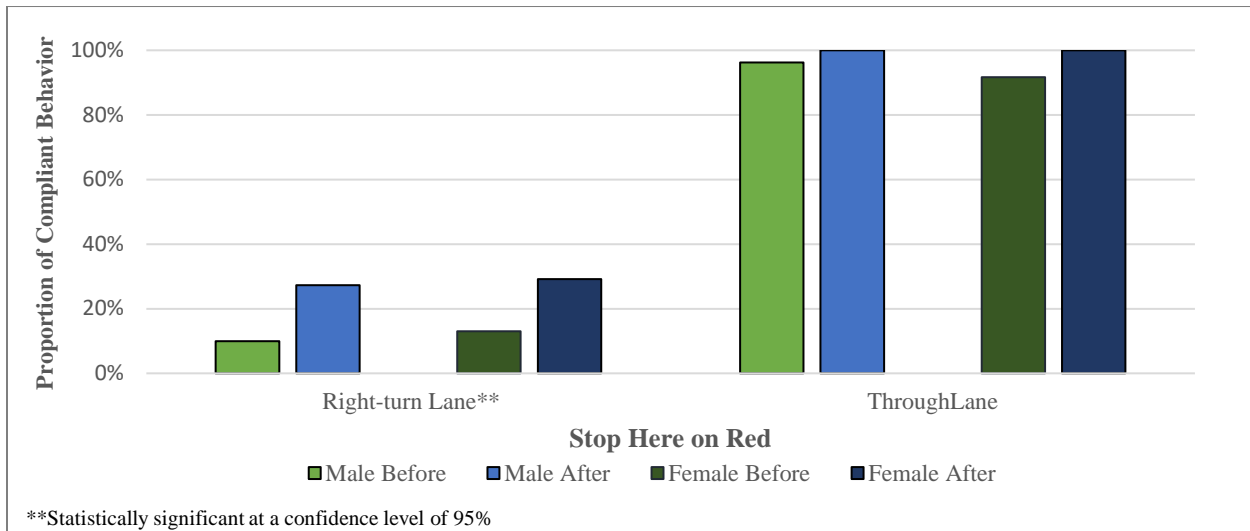
Figure 60. Comparison of compliance for “Stop Here on Red” sign by gender, District 1

Figure 60 and Table 27 show the comparison results of driver compliance by gender for a “Stop Here on Red” sign for a right-turn lane and a through lane before and after implementation of sign with education efforts at the site in District 1.

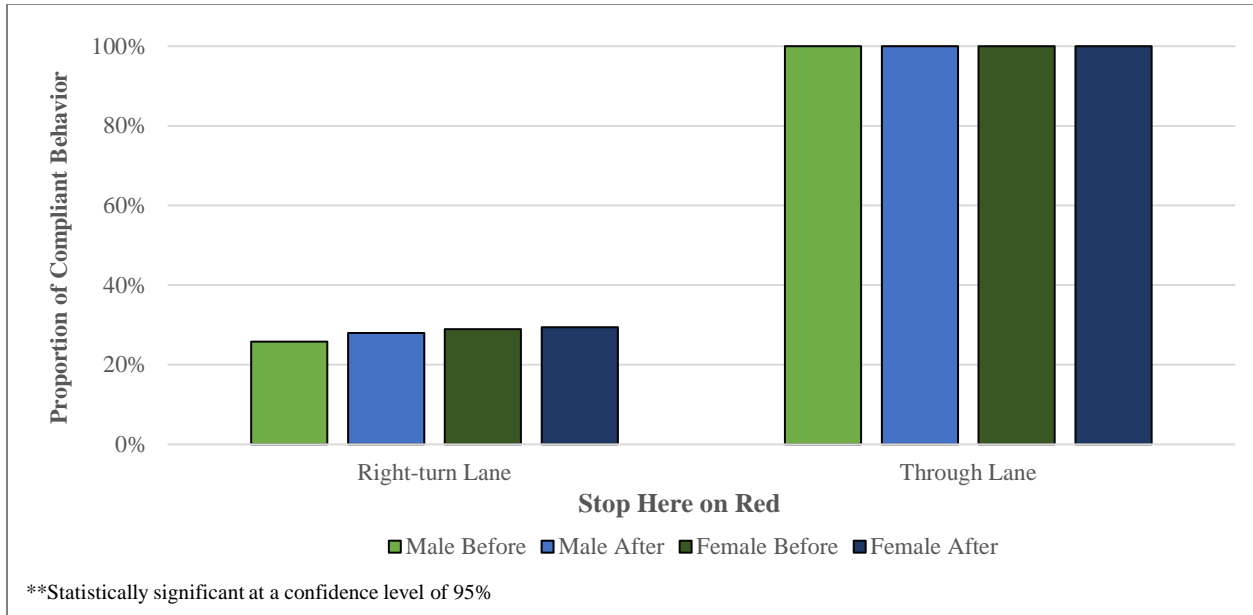
Figure 70. Comparison of compliance for “Stop Here on Red” sign by gender, District 1

- Before implementation of the “Stop Here on Red” sign, the proportion of compliance for a right-turn lane was 10.3%; after sign implementation, it increased to 24.0%. The compliance rate increased further, from 24.0% to 30.8%, after education. The difference in driver compliance behavior at right-turn lane is significant at a 95% confidence level.
- Drivers in through lanes completely complied with the feature before and after education.

Figure 70 and Table 37 show the comparison results of driver compliance by gender before and after education efforts for the “Stop Here on Red” sign between right-turn lanes and through lanes at the site in District 1.

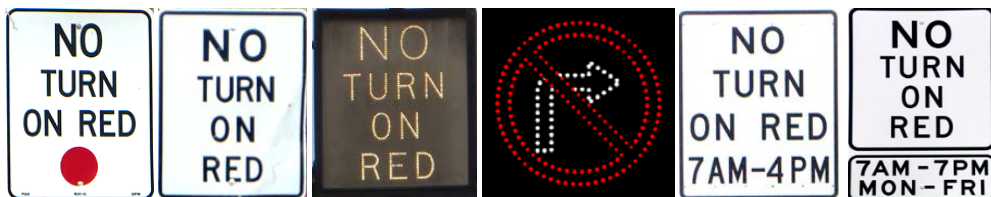
R10-11 R10-11a

Figure 83. Examples of “No Turn on Red” static and blank-out signs

- a) Per MUTCD, this type of signs may be used to regulate road users. Based on guidance from MUTCD, when used, the sign should be located adjacent to the signal face to which they apply. These signs include those “No Turn on Red” as shown in Figure 83.
- b) Per MUTCD, “No Turn on Red” (R10-11, R10-11a) signs (Figure 83) should be considered when an engineering study finds that one or more of the following conditions exists:
 - Inadequate sight distance to vehicles approaching from the left (or right, if applicable);

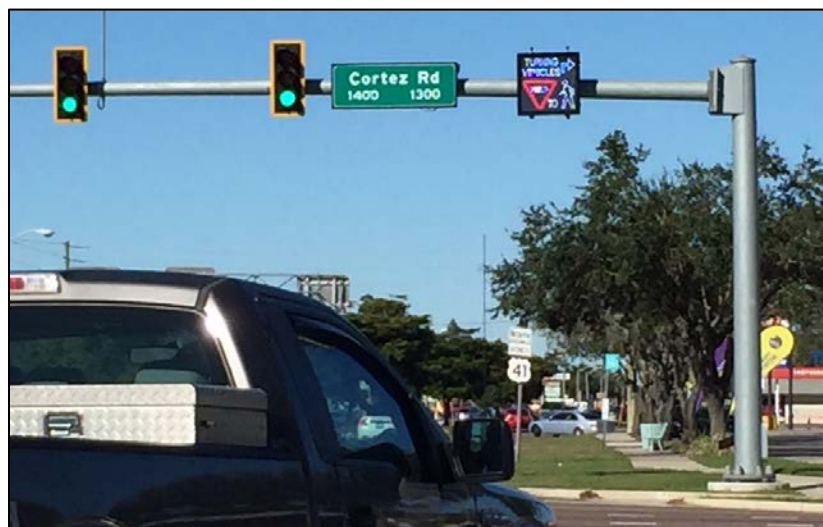
Figure 85. Example of “Turning Vehicles Yield to Pedestrians” blank-out signs

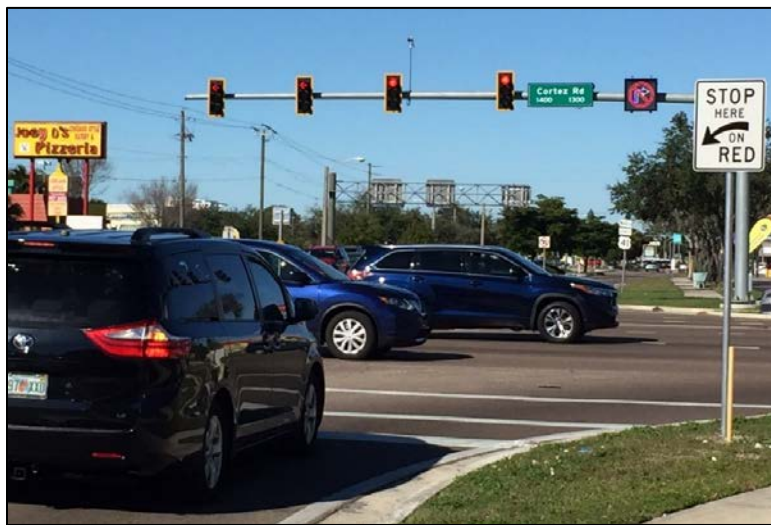
Figure 86. Example of “Stop Here on Red” sign.

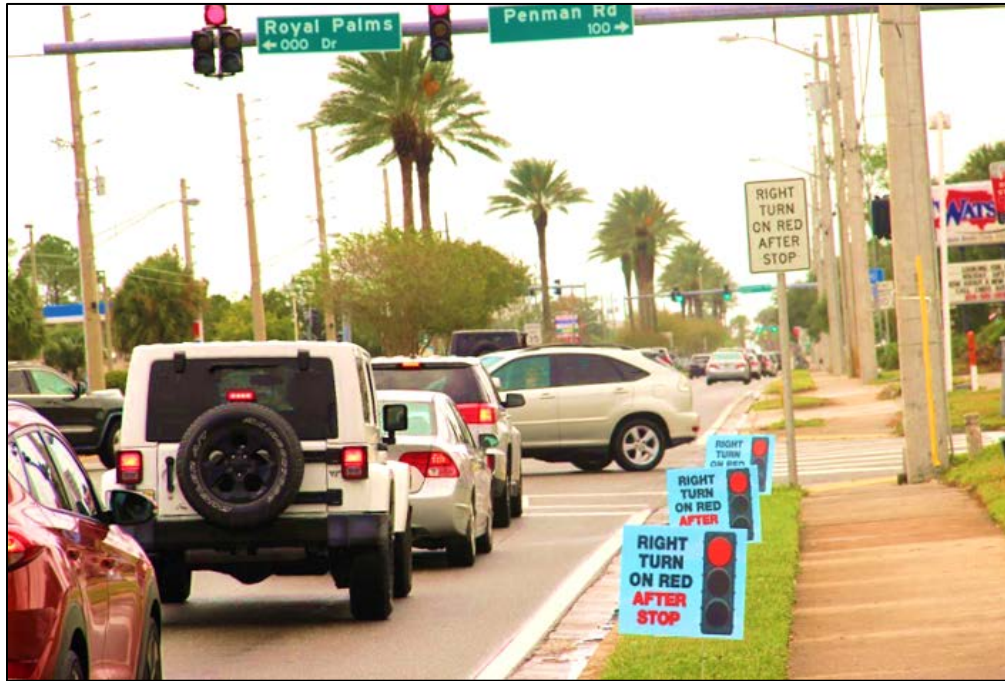
Figure 87. Example of yard sign education for “Right Turn on Red after Stop” sign

Figure 87 are examples of yard-sign education for the selected pedestrian features signs. Designs of these yard signs are shown in Appendix D.

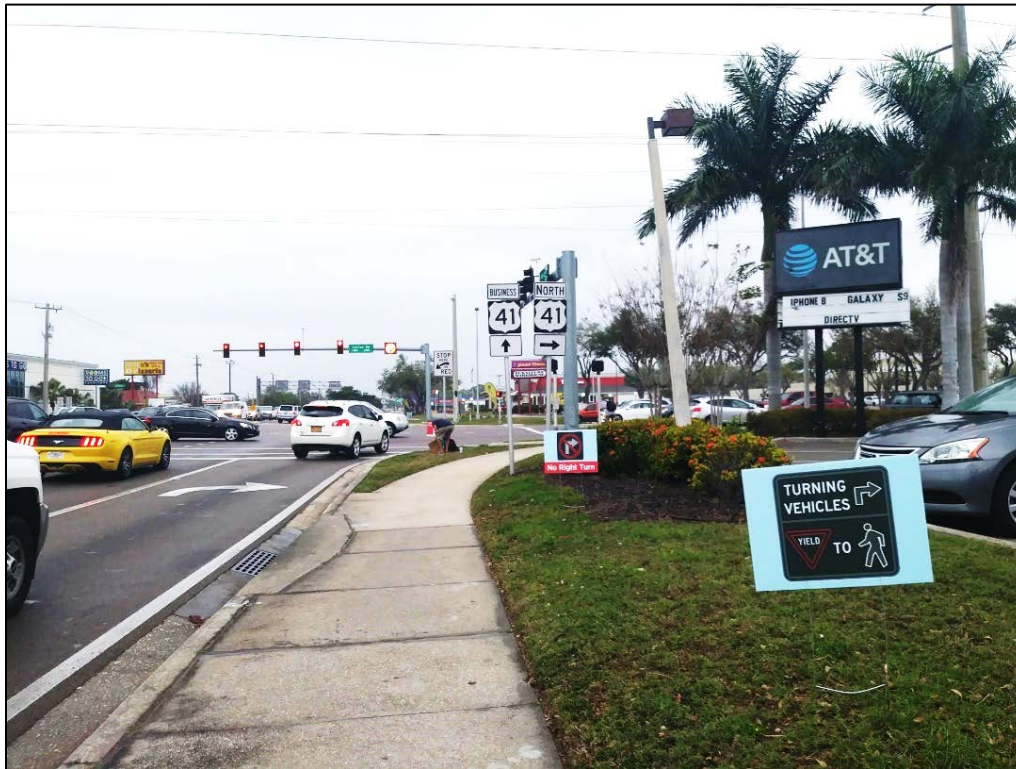
Figure 89. Example of yard sign education for “Turning Vehicles Yield to Pedestrians” and “No Turn on Red” blank-out signs
