FIELD DEMONSTRATION OF TENDON IMAGING METHODS

Contract No. BDV25-977-52

Final Report to Florida Department of Transportation

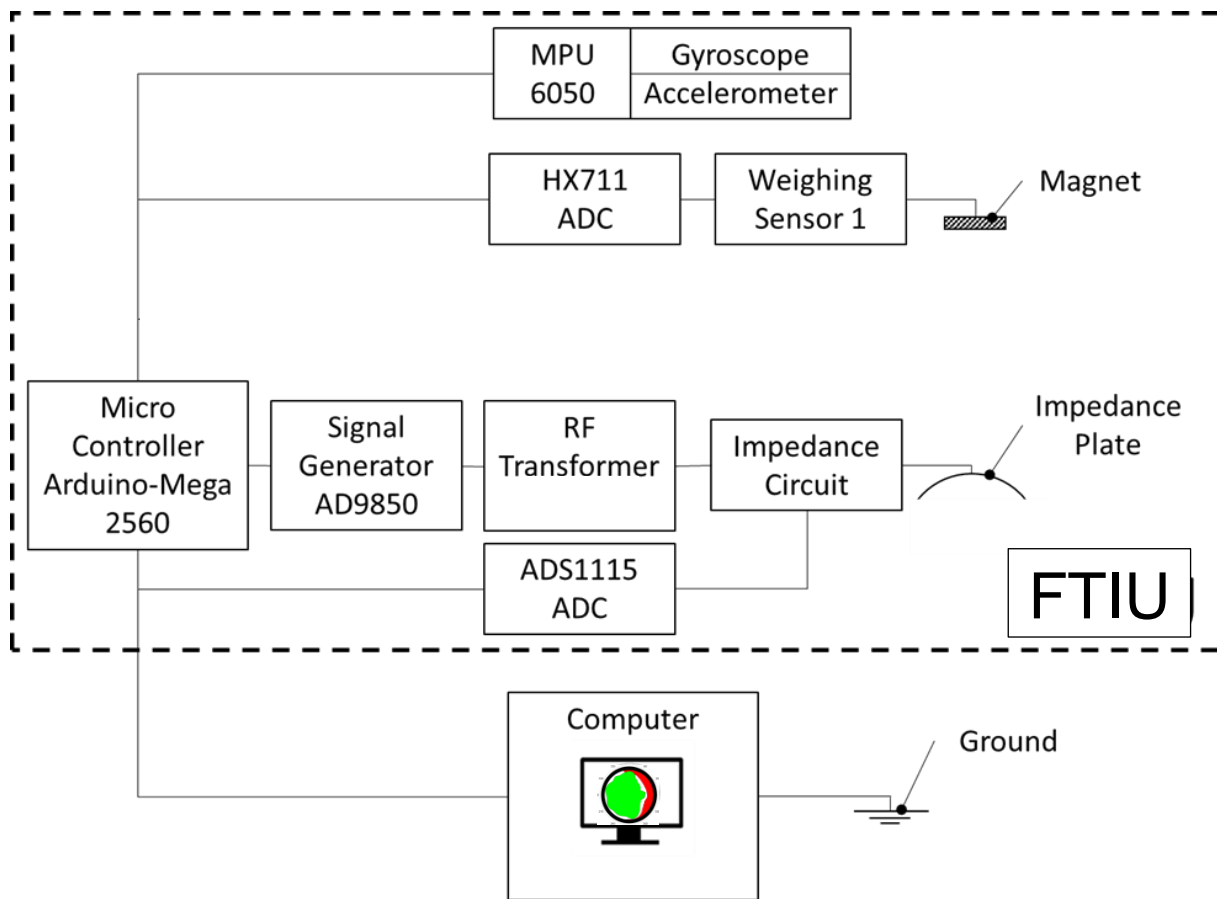
Figure 5 FTIU instrumentation block diagram. Patent Pending.

For operation, detailed in Appendix 1, the unit is first calibrated and then the clamshell is closed on the tendon place to be imaged. The unit is then manually rotated one full turn, producing a beep signal when the turn is completed. During rotation the unit produces, angular rotation, magnetic force, and impedance data that are sent together with inclination data to the laptop computer via a USB cable. Immediately afterwards the data are processed, and an image of the cross-section is displayed on the computer screen. The instrumentation used for data generation and processing is schematically described in Figure 5

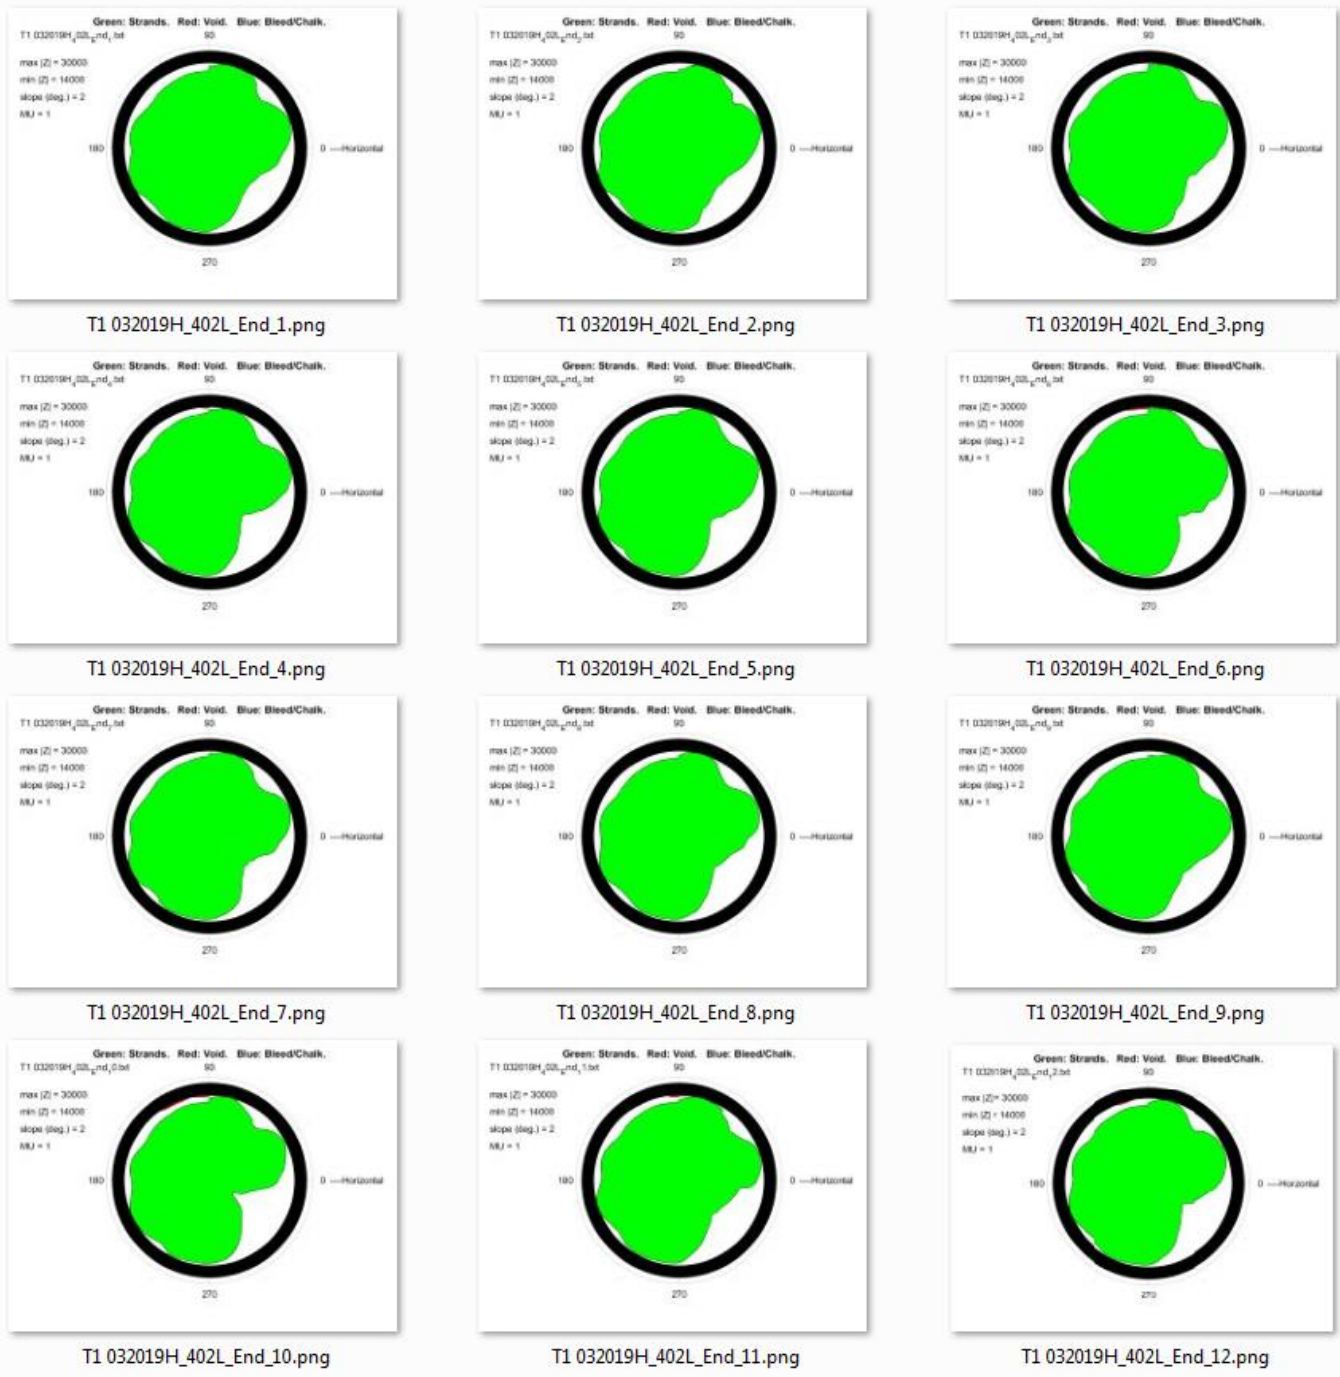
Figure 10 Images generated at Test 1 place on tendon 402L. Each row is for a group numbered as identified in the text, illustrating robustness of results to wiring and grounding variations, as well as illustrating repeatability within each condition. The strand bundle is colored green, while sound grout is white. No grout deficiencies were strongly apparent at this test place.

Figure 10 shows the 12 images generated at Test 1 place on tendon 402L. The results illustrated the stability of the response under grounding and wiring variations, as well as repeatability within each row. All images were successfully acquired with tendon rotations completed within a 10-second period. All images consistently identified the main pattern of strand locations (green) with a lopsided strand clustering to one side and top and a matching grout space opposite. The part of the clustering toward the top is consistent with the proximity and orientation of the bend of the nearby deviation block. No significant grout voids (which would have been colored red over a sizable portion of the image) were apparent, with the exception of vestigial indications as in Figure 11 that may be ascribed to marginal calibration and ground choices. It is noted that the duct was not breached to verify that interpretation.

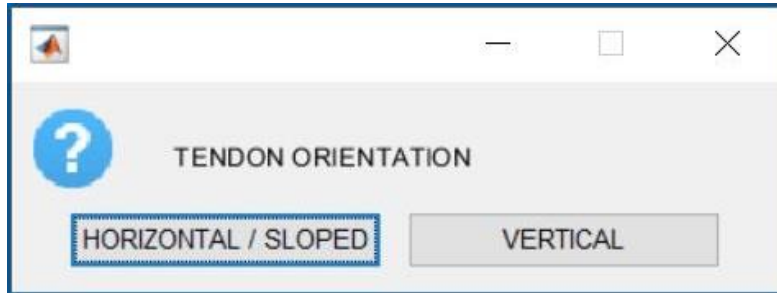
Figure 3.

5. Next query window (**Figure 3**) asks for tendon orientation.
- For horizontal or sloped tendons **click HORIZONTAL/SLOPED or Press Space Bar** and FTIU will determine slope of tendon automatically.
 - For vertical tendons **click VERTICAL** and keep blue line on FTIU always starting facing the same direction. This line is start position for vertical tendon images.

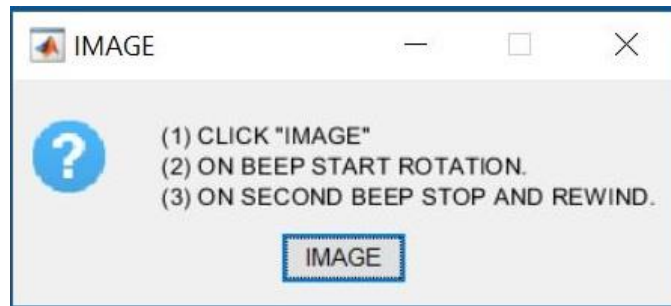
Figure 7.

8. After Hookup and Placement are complete the query window in **Figure 7** appears:

Click OK or Press Space Bar. A Beep will sound. After beep, start rotating FTIU in the arrow direction. It will beep again when it senses a full turn. Stop and wind-back to start. Cross-section image will show on screen right away (**Figure 9**).

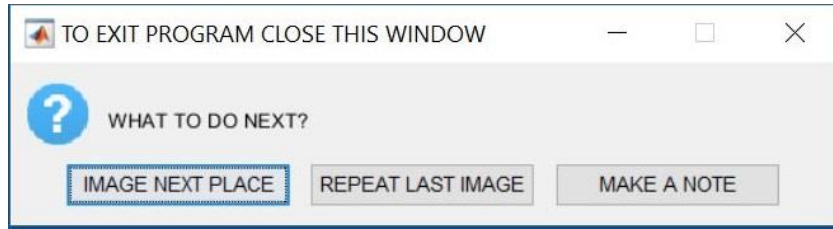
Figure 10.

9. A new query window will appear next (**Figure 10**).

- If image is acceptable **click IMAGE NEXT PLACE or Press Space Bar**. Slide FTIU to next place. Go back to Step 8.
- If a repeat is desired **click REPEAT LAST IMAGE**. Stay in the same place. Go back to Step 8. Repeat image will have "R1" added to file name. Multiple repeats are allowable and will be tagged R2, R3 etc.
- To add a comment, **click MAKE A NOTE**. That will launch a query window that accepts text and appends text to end of data file for the image just generated. This text will not affect image. Multiple notes can be appended to same data file if needed. After making the note the Figure 10 box appears again.

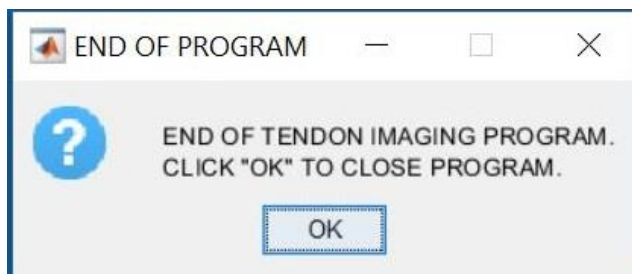
Figure 11.

10. The final window (**Figure 11**) appears when user is done and closes window in step 9. Final window acknowledges that program is ending and will close any remaining open windows or figures. **Click OK or close this window.**

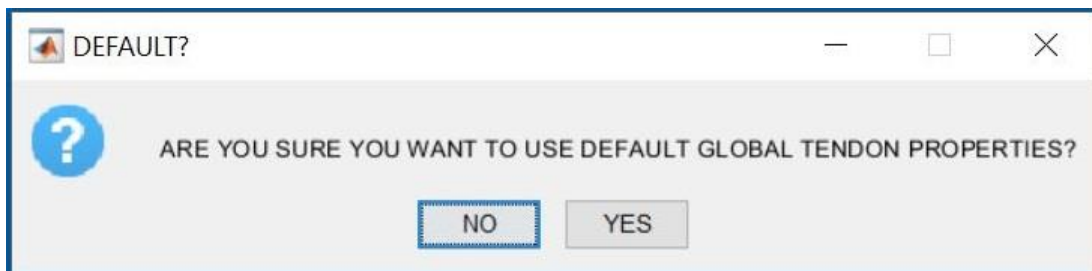
Figure 14.

- If the default values are desired instead (those happen to be the numeric values listed in Figure 13), **clicking USE DEFAULT** prompts a query window (**Figure 14**) asking to confirm that user wants the default properties. To accept default properties **click YES**.
