**FINAL REPORT (Project BDV25-977-56)**

**QUANTIFYING THE DURATION OF THE CORROSION PROPAGATION STAGE IN  
STAINLESS STEEL REINFORCEMENT**

**Final Report to Florida Department of Transportation**

**UNIVERSITY OF  
SOUTH FLORIDA**

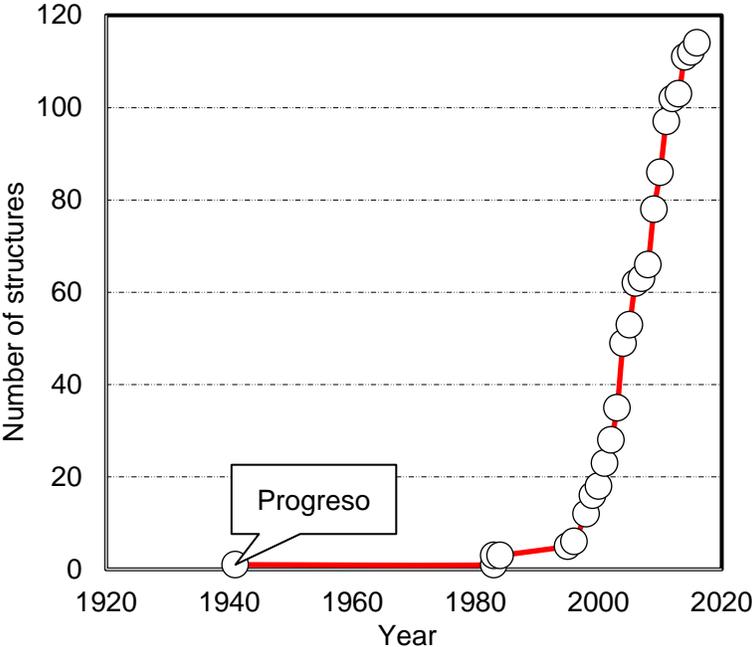
Figure 2.1: Cumulative worldwide tally of bridges with SS rebar.

Appendix A classified SS-reinforced structures by country of origin. As shown in the Figure 2.2, the U.S. leads with Europe and Canada filling much of the rest. Per Appendix A, the oldest major structure with SS reinforcing is located in Mexico (Progreso pier), having been the subject of several notable investigations. That work is detailed next, followed with a sampling of experience from other structures. It is noted that while there is abundant literature on the use of SS rebar in new structures, there are relatively few reports on actual performance evaluation after the structures were in service for an appreciably long period. The selection of cases discussed, accordingly limited, is presented in the following subsections. A summary of the main literature review findings is presented next. For a detailed account of the literature please refer to Appendix C.

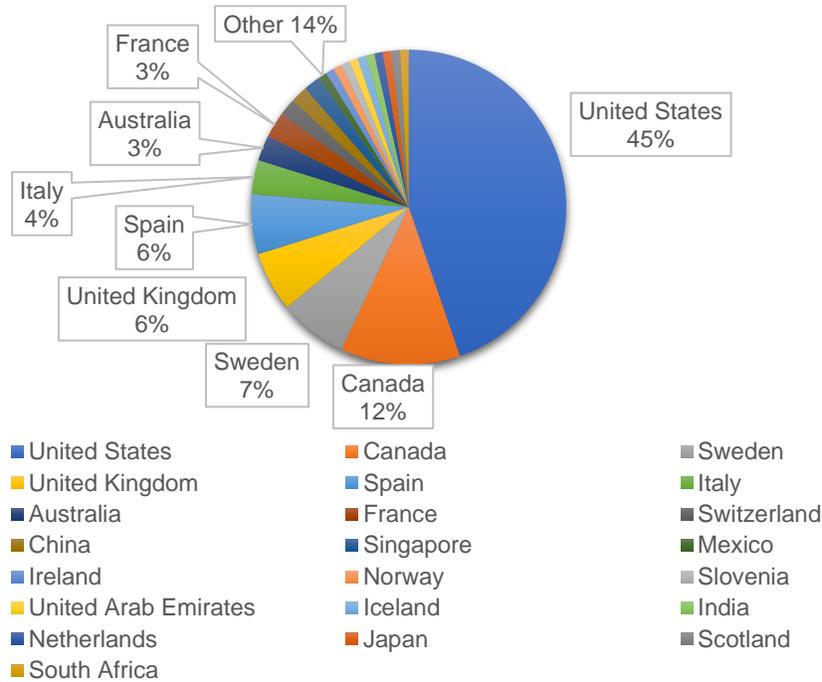
Figure 2.2: The use of SS reinforcement in bridges categorized by country.

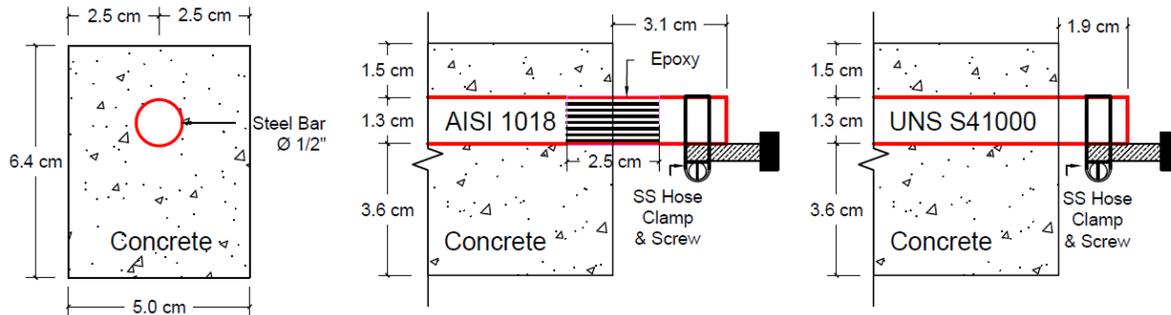
Figure 3.1: SS and CS reinforced concrete cross-sections.  
Specimens were casted upside down and flipped for use afterwards.

Six reinforced concrete specimens were prepared at the corrosion laboratory at the University of South Florida following the concrete mix procedure given by ASTM C192. UNS S41000 SS and AISI1018 CS specimens were investigated. The dimensions of the beams were 2 inches (~5 cm) wide, 2.5 inches (~6.4 cm) high and 70 inches (~180 cm) long as shown in Figure 3.1.

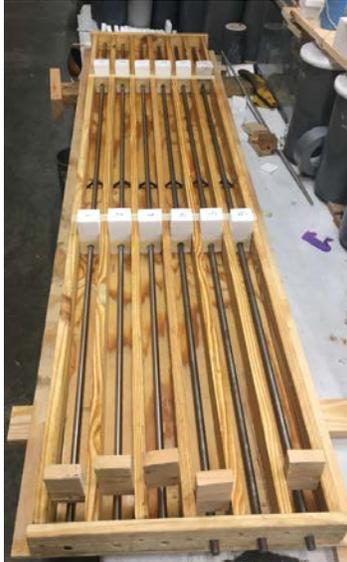
Figure 3.2: Wood mold coated with a mold release agent. Temporary polystyrene foam and 3D printed spacers were in place to implement the casting sequence to keep the concrete cover uniform.

Specimens were cast upside down and flipped for use afterward. Initially, the reinforcement was located closer to the bottom surface of the specimen with a concrete rebar cover of 0.6 inches (~1.5 cm). Mold release agent was applied to the wood form before concrete placement. The six specimens were cast in the wood mold displayed in Figure 3.2.

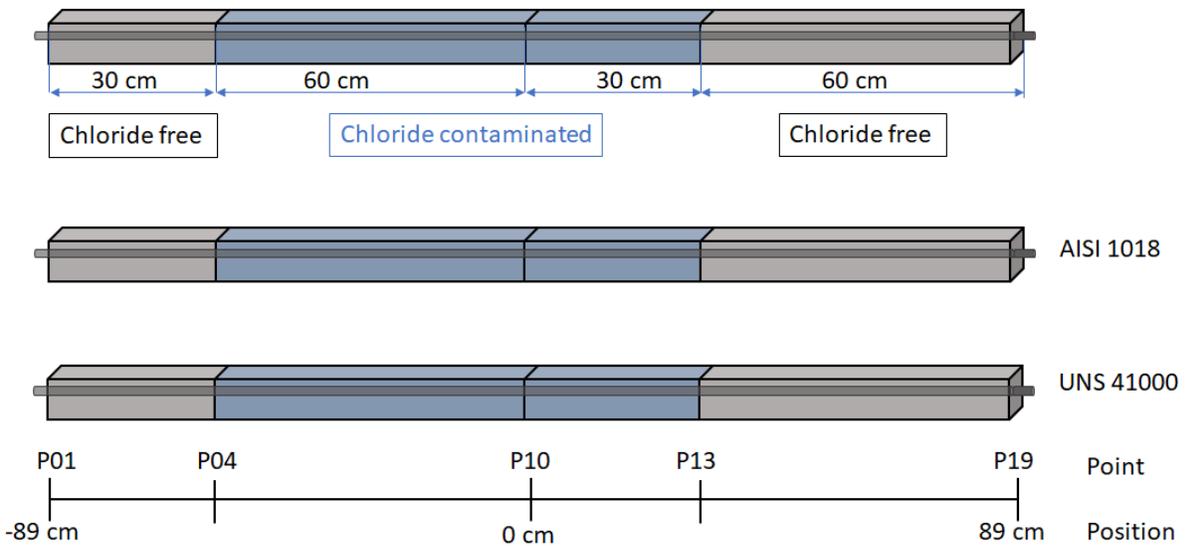
Figure 3.3: Longitudinal profile for UNS41000SS/ AISI1018CS specimens in concrete. “0 cm” represents the central point of the specimens, representing the longitudinal midpoint position. Spatial distribution of two types of concrete is shown as well.

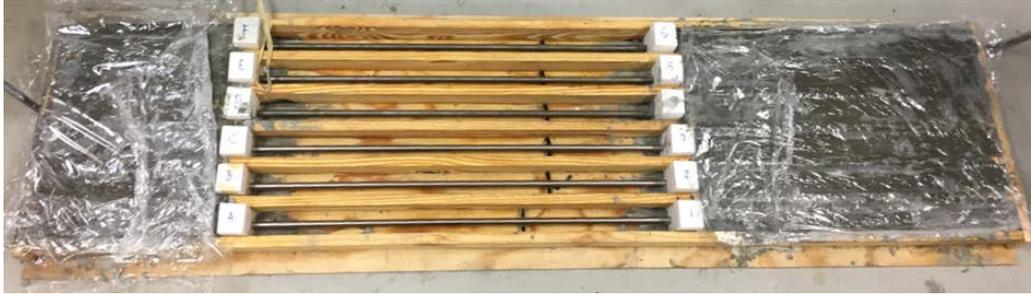
Figure 3.4: Chloride-free concrete batch covered with a plastic film. Polystyrene foam and 3d printed spacers were in place for the chloride-free concrete batch, removed before chloride-contaminated concrete placement.

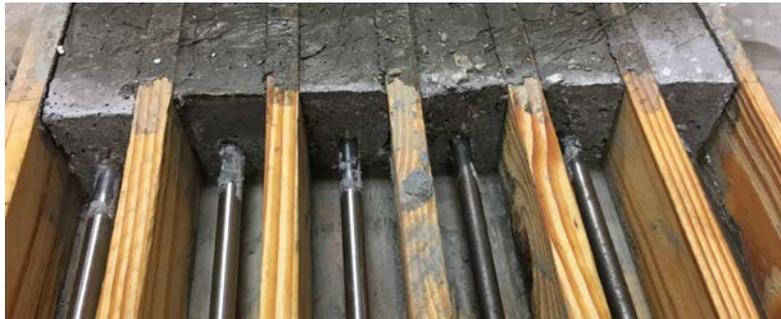
Figure 3.5: First concrete batch – left end of all specimens.

Chloride-free and chloride-contaminated concrete were cast in two batches. The first batch cast was the chloride-free concrete and the second was the chloride-contaminated concrete as displayed in Figure 3.3. The chloride-free concrete batch was cast (at day zero) at the ends of all specimens as shown Figure 3.4 following the preparation procedure given by ASTM C192<sup>38</sup>. Before the second batch was cast, the polystyrene foam and 3D spacers were removed from the wood mold, as shown in Figure 3.5.

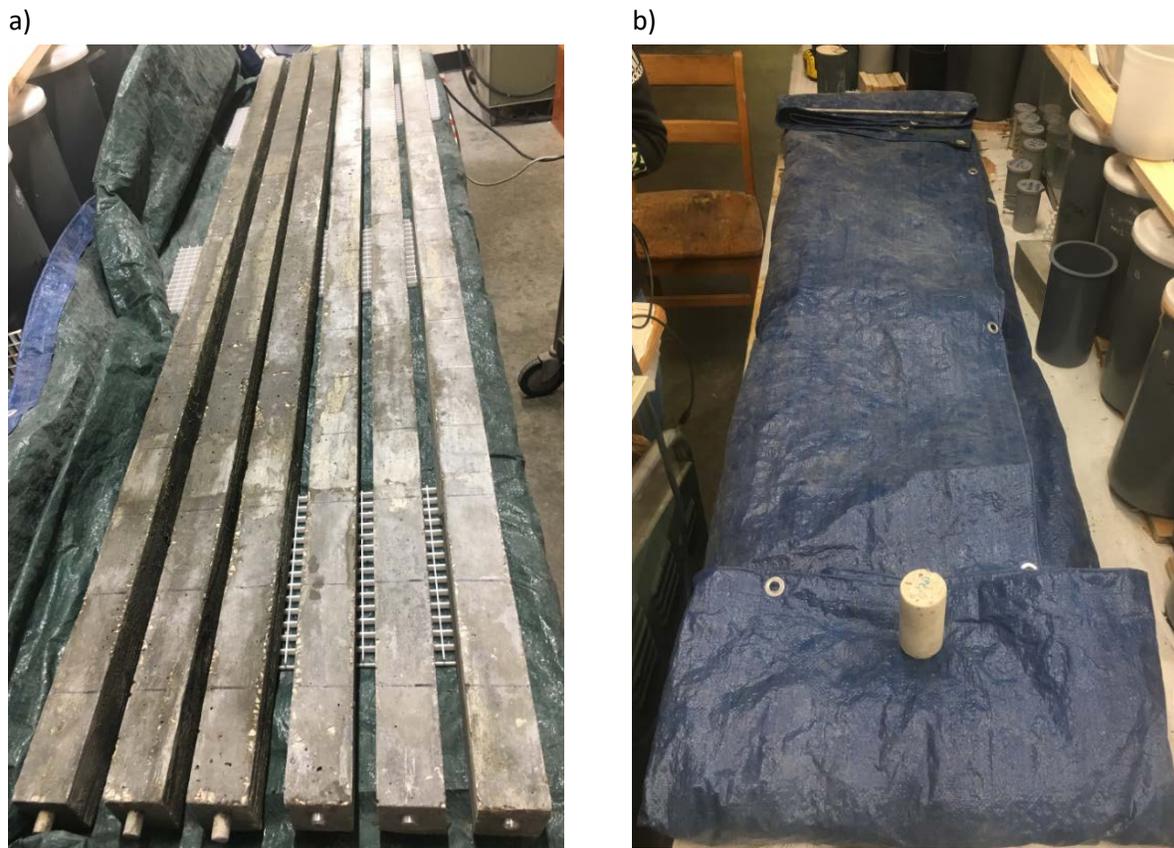
Figure 3.6: Concrete specimens with and without a tarp. Tarp usually covering the specimens was normally in place to avoid moisture evaporation and removed temporarily to take measurements.

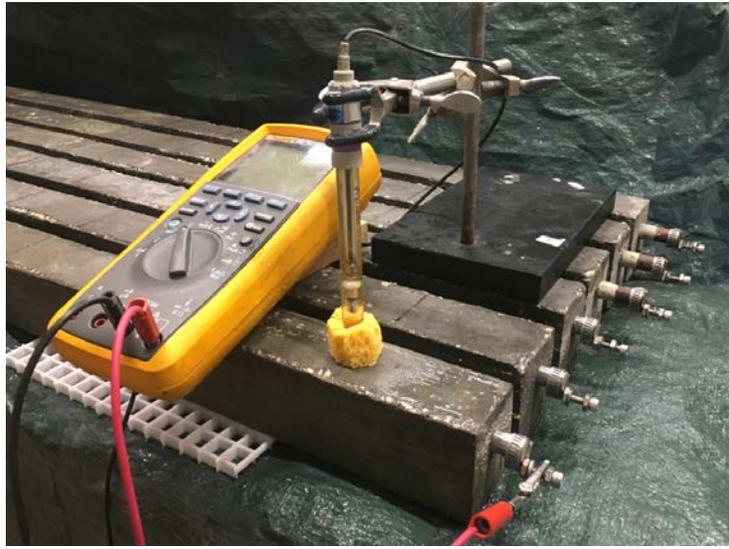
Figure 3.7: Half-cell potential measurement on specimen SS01. Reference electrode (SCE), electrical junction device (yellow sponge).

Prior to performing potential maps, all specimens were marked from the center of the specimen to the sides indicating the points of measurement. The spacing was 10 cm and the distance from the last mark at both ends to the ends of the beam was ~8.9 cm resulting in 19 total measuring points per specimen including the positions of the very ends of the beams. Potentials were measured with a multimeter (Fluke 289) with an input resistance of 10 M $\Omega$  and a reference SCE fitted with a sponge at the tip as shown in Figure 3.7.

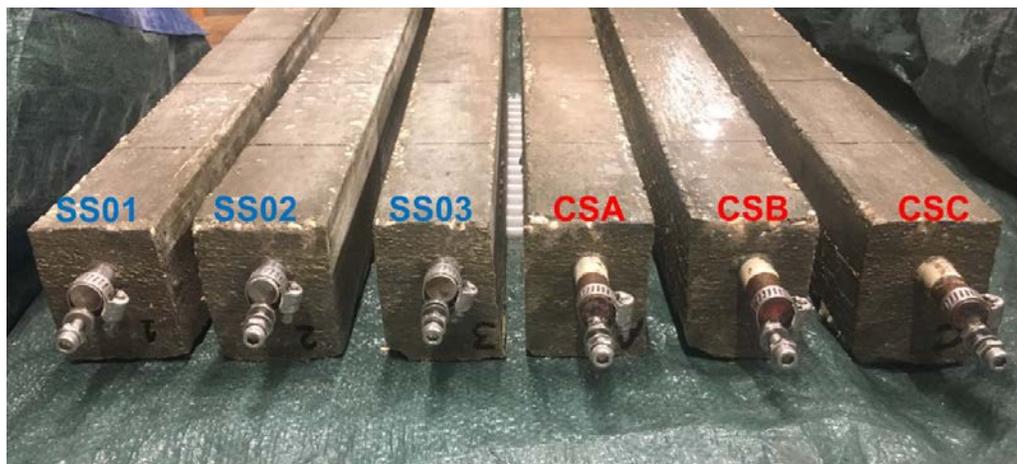
Figure 3.8: Electrical connections at the right end of all specimens. The left end of AISI 1018 CS specimens was epoxy-coated and UNS S41000 SS specimens were not.

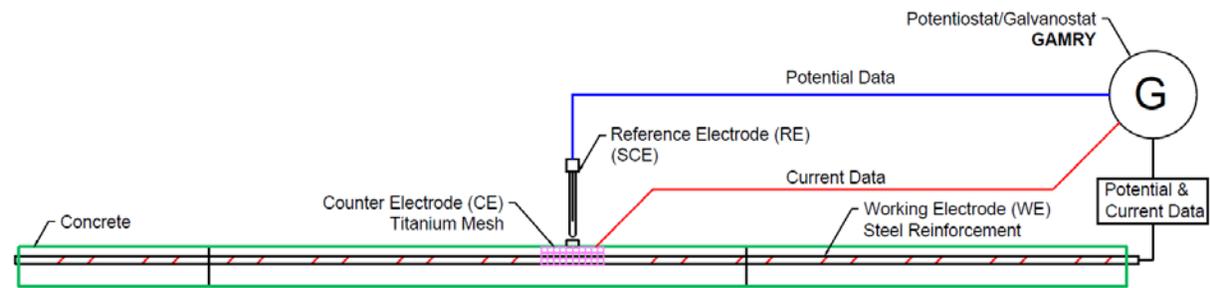
Figure 3.9: Schematic illustration of EIS measurement experimental setup.

EIS measurements are used to obtain the corrosion rates of a system through the estimation of the value of the polarization resistance.<sup>40</sup> This technique consists in the application of a sinusoidal disturbance of the electrical potential produced by a given alternating current to a circuit. Meanwhile, the potential response of the system (amplitude and phase angle) is measured and the impedance is computed at each frequency of the established range (typically 1 mHz to 1Khz).<sup>41</sup> The impedance "Z" is established by the ratio of the frequency-dependent potential and the frequency-dependent current. A schematic diagram for the EIS measurements performed in this investigation is shown Figure 3.9.

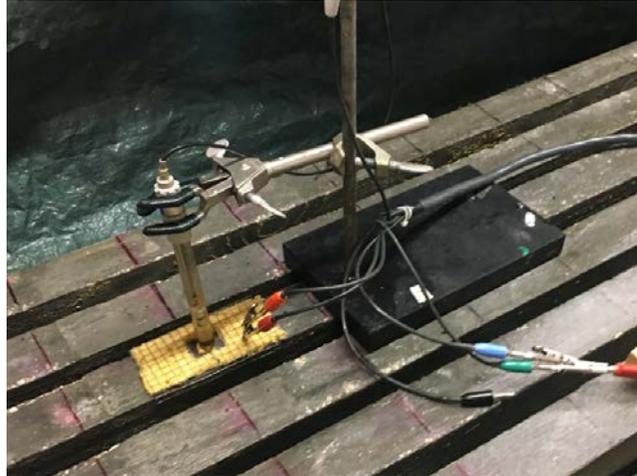
Figure 3.10: EIS measurement on specimen CS01. Counter-electrode (titanium mesh), reference electrode (SCE), and electrical junction device (yellow sponge).

The EIS measurements were obtained using a Gamry Reference 600+ potentiostat/galvanostat with a potential perturbation of 10 mV. A three-electrode array, shown in Figure 3.9, in which the steel reinforcement served as the working electrode, a ~10 cm long hollow rectangular titanium mesh on top of a moist sponge was used as the counter-electrode, and a SCE electrode with a small moist sponge on its tip placed in the middle served as the reference electrode. An initial range of frequencies between 10 mHz to 100 kHz with 10 points per decade was selected. The lower bound was later adjusted to 1 mHz at the end locations of the SS specimens to determine behavior in the low frequency portion of the impedance response. EIS measurements were conducted regularly to estimate the values of corrosion rates as a function of position.

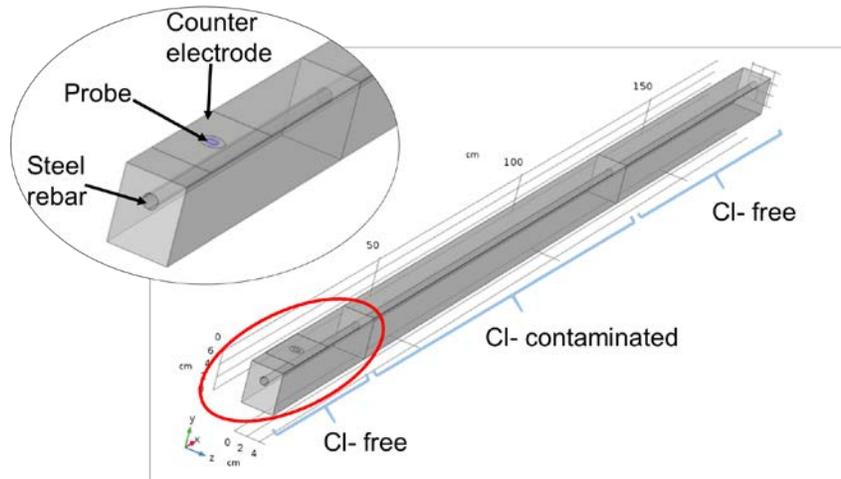
Figure 3.11: 3D model of specimens including chloride-contaminated and chloride-free regions; simulation of EIS test.

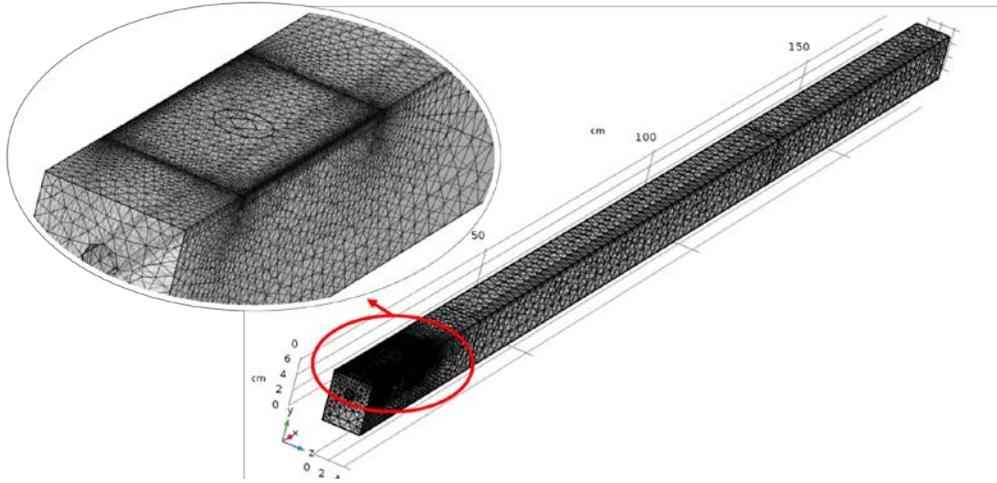
Figure 3.12: Finite-element mesh of the 3D model. Close-ups show the variation on the size in zone of high potential variation.

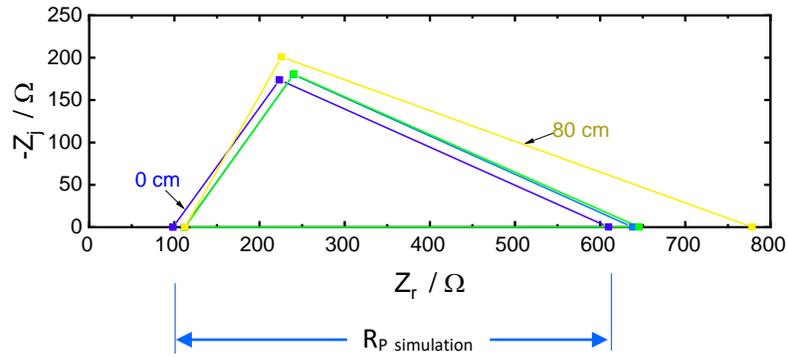
Figure 3.13: Nyquist plot from finite element model.

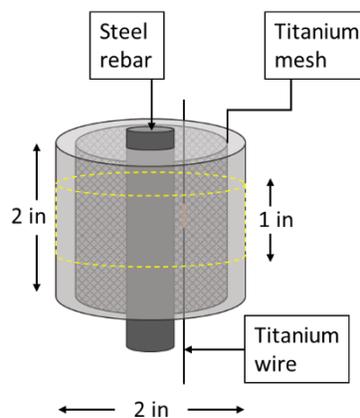
Figure 3.14: Schematic of cylindrical specimen showing the electrode configuration and a region shaded in yellow representing an opening where air flow was allowed (bounded by dashed yellow lines).

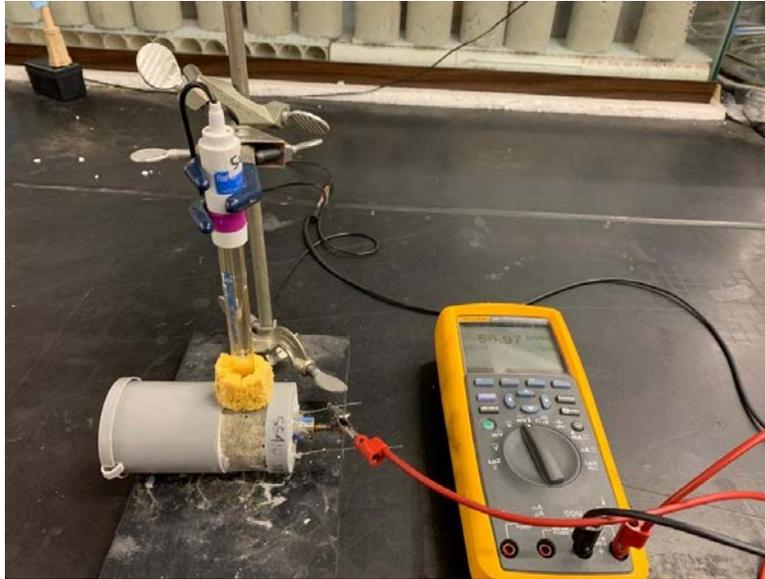
Figure 3.15: Half-cell potential titanium vs. SCE reference electrode measurement on specimen SS410-III. Multimeter, titanium electrode, reference electrode (SCE), and electrical junction device (yellow sponge).

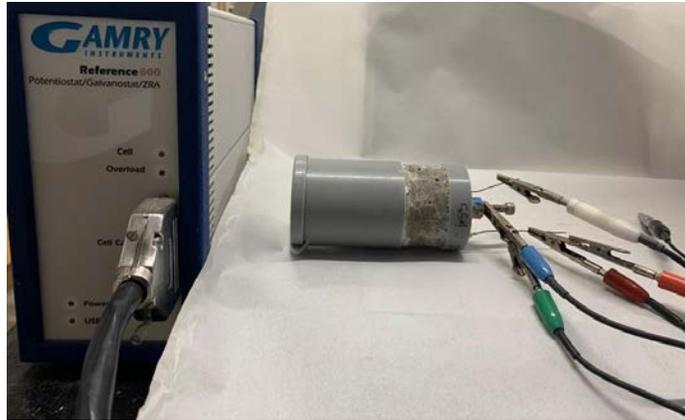
Figure 3.17: EIS measurement on UNS S41000 specimen labeled as B-I. Counter-electrode (embedded titanium mesh), reference electrode (embedded titanium wire), and working electrode (steel reinforcement bar).

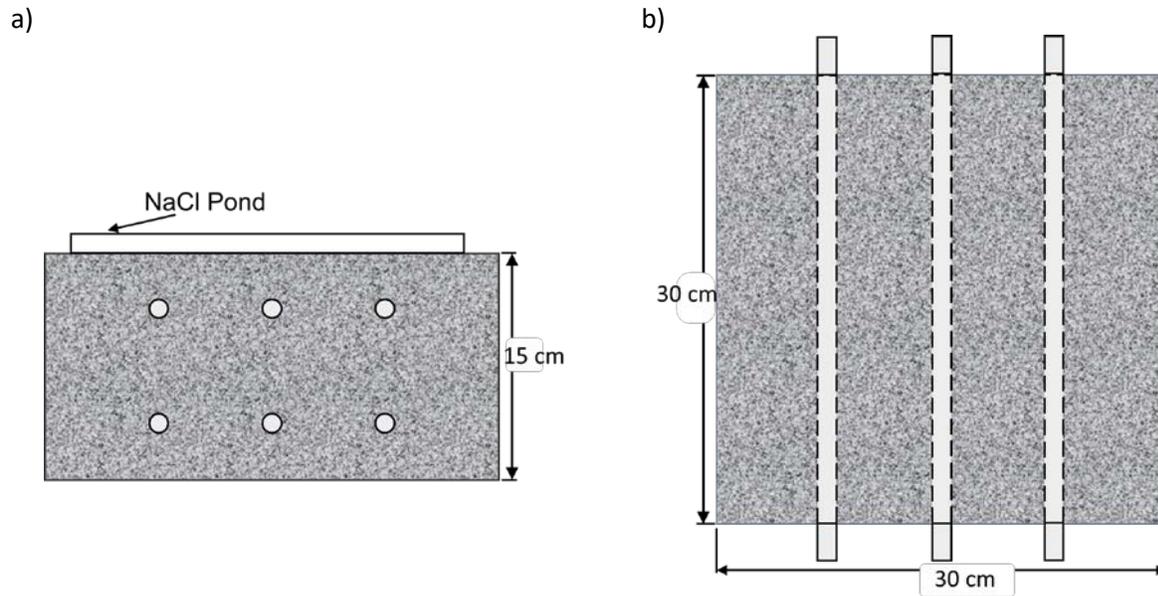
Figure 3.18: Schematic illustration of stainless steel-reinforced concrete specimen obtained from FAU: a) side view, b) top view.

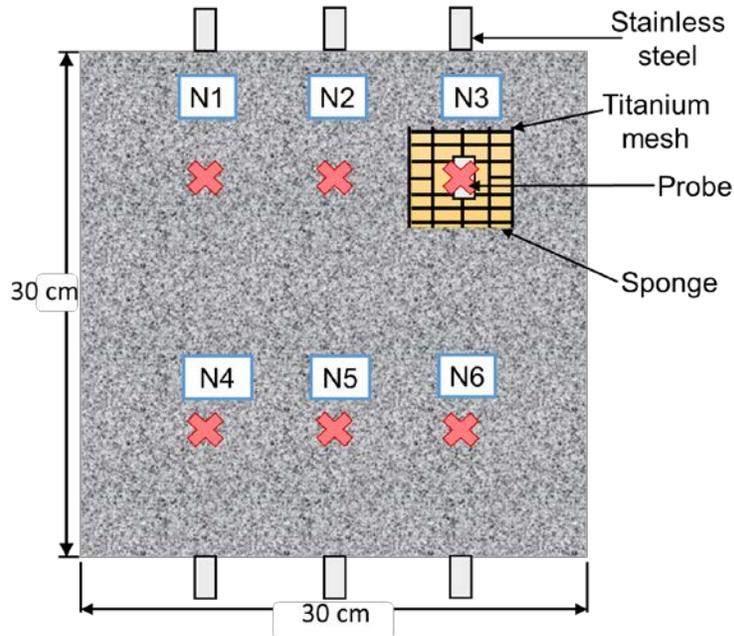
Figure 3.19: Schematic illustration of EIS experimental set-up of legacy specimen.

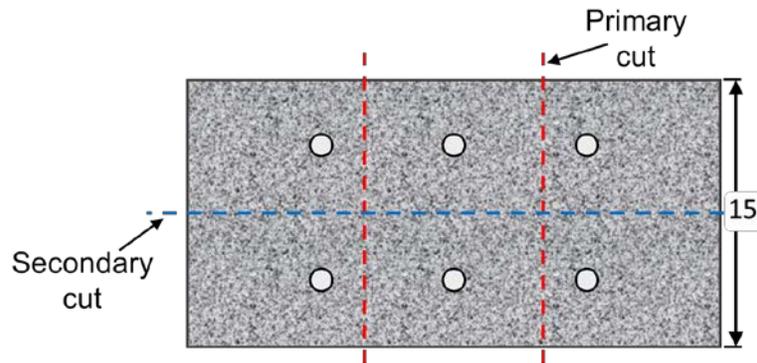
Figure 3.20: Schematic illustration of saw cuts performed in step 2 (red) and step 3 (blue).

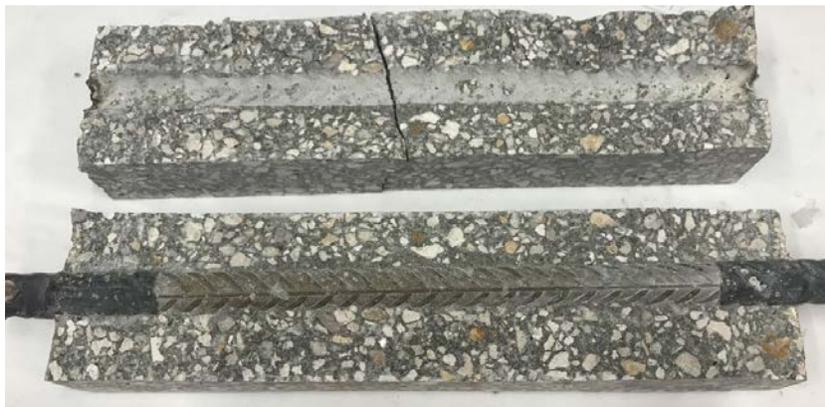
Figure 3.21: Resultant legacy specimen sections.

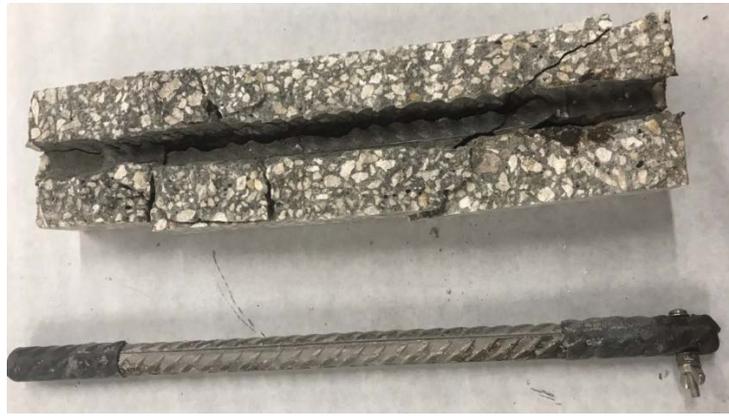
Figure 3.22: Steel reinforcement and concrete section after extraction.

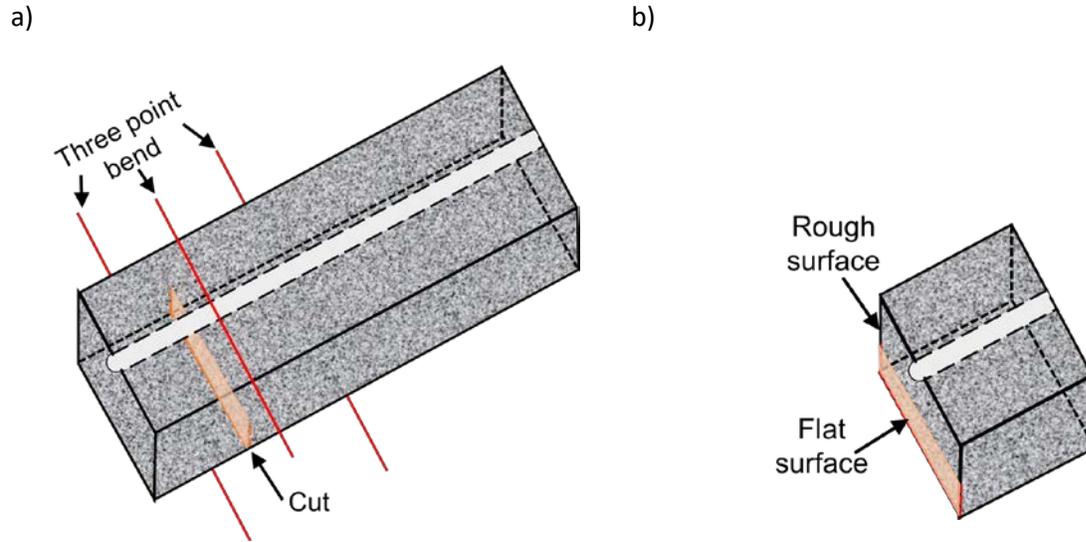
Figure 3.23: Schematic illustration of a) cross-sectional cut and b) three point bend-cross section.

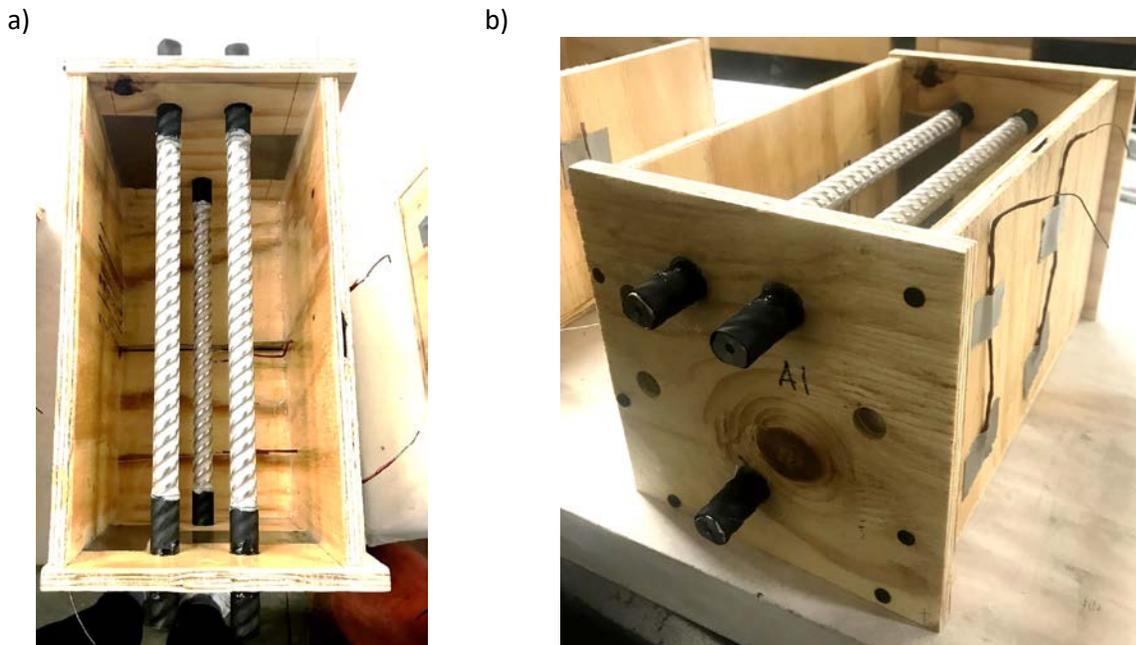
Figure 3.24: Final setup of specimens before casting. Wood mold was coated with a mold release agent, titanium reference electrodes and steel rebars were in place. (a) Top view, and (b) side view.

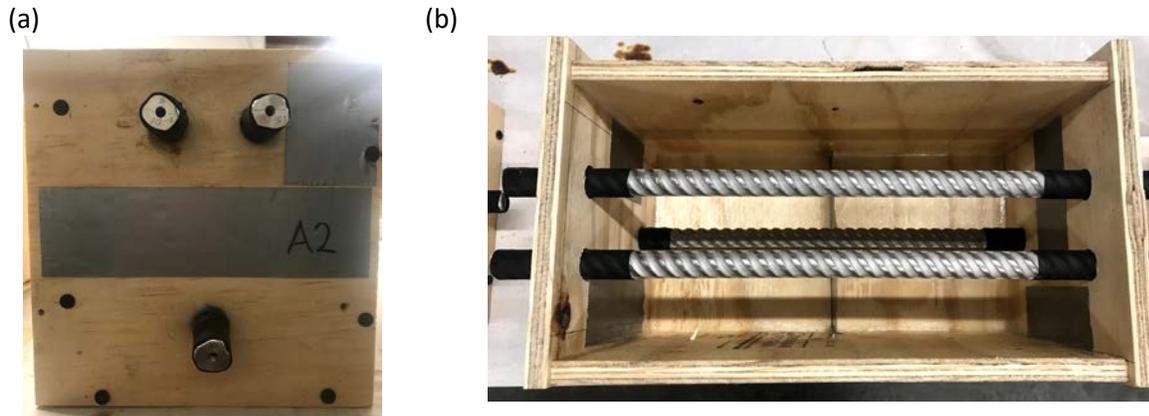
Figure 3.25: Steel placement in wood form prior to casting (a) front view of mold. Stainless steel reinforcement was tapped and drilled, and (b) top view of mold. Stainless-steel shim was placed parallel to the rebar.

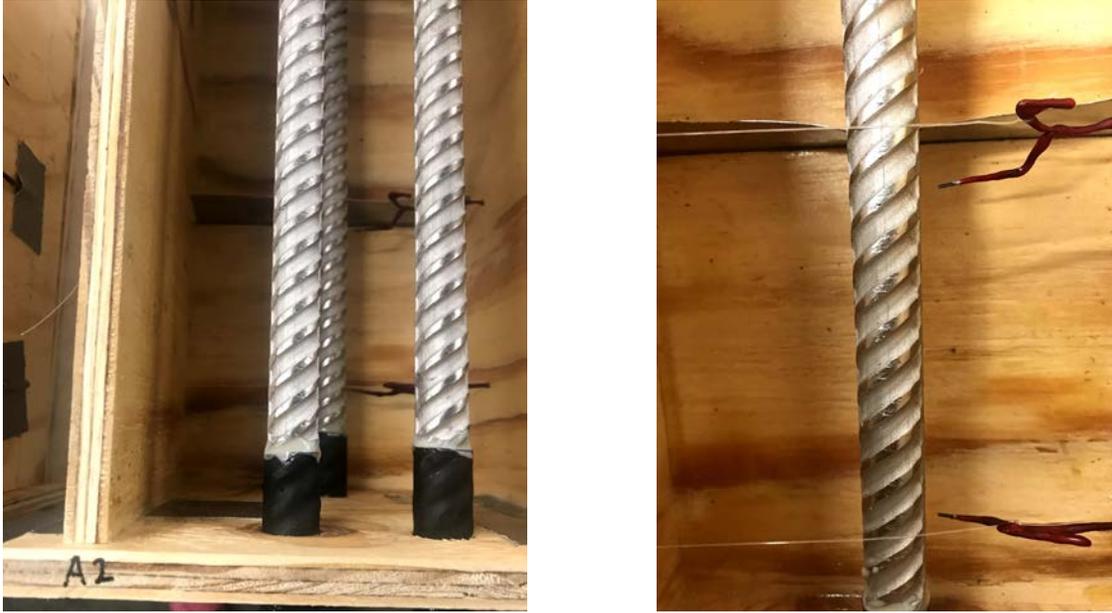
Figure 3.26: Experimental setup of reference electrodes.

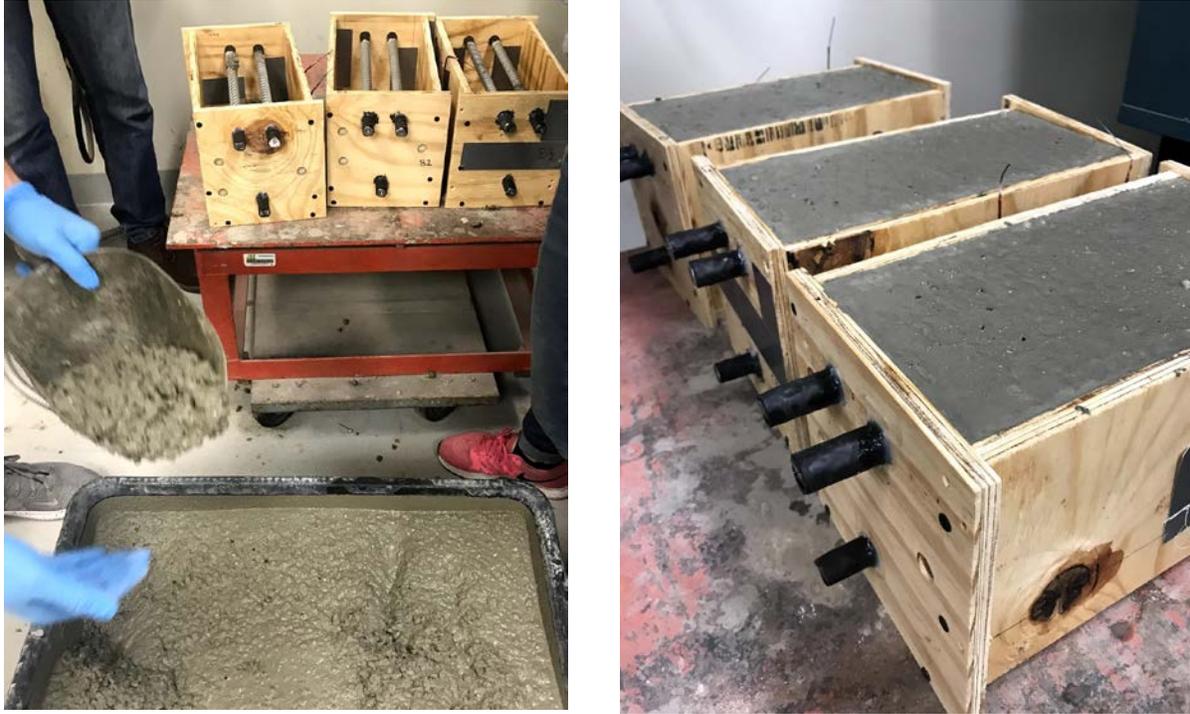
Figure 3.27: Concrete mixing and casting of samples.

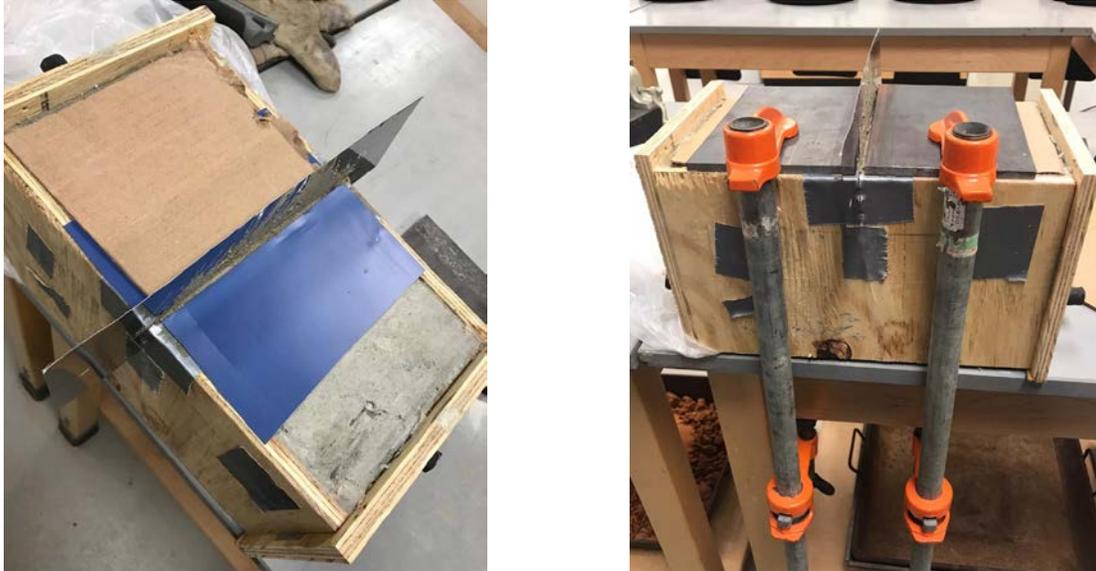
Figure 3.28: Shim removal process to generate local deficiency in concrete specimens.

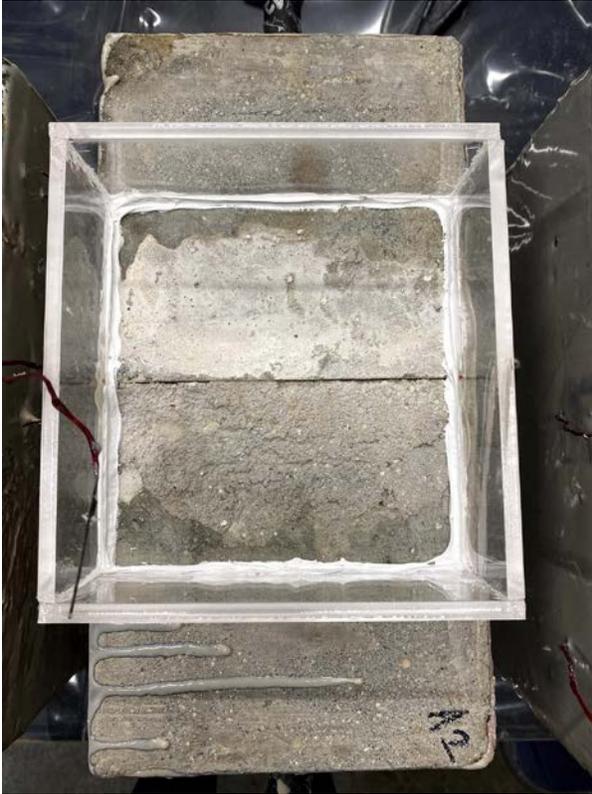
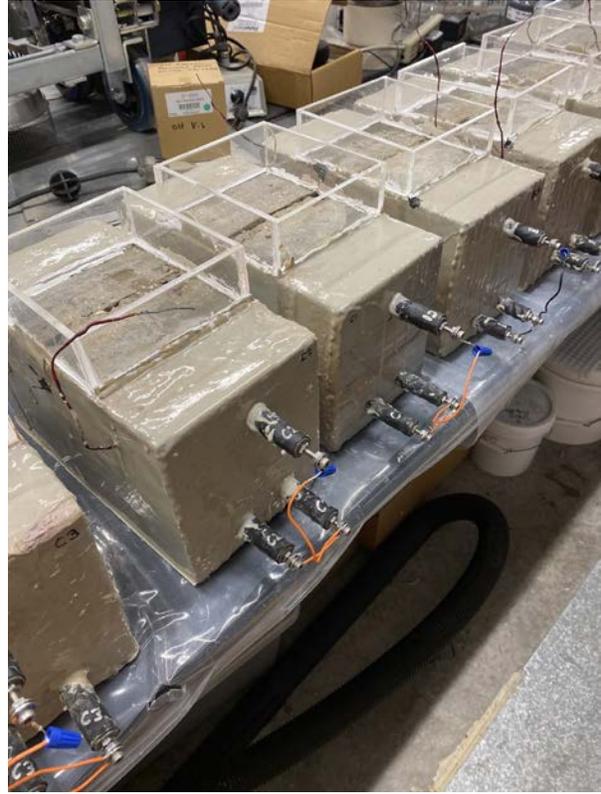
Figure 3.29: Specimens with concrete deficiencies. (a) Top view after acrylic reservoirs were installed; (b) preparation procedure prior to testing finished, two layers of epoxy were used to coat specimens and electrical connections. Circuit with 10-ohm resistor between anode and cathodes.

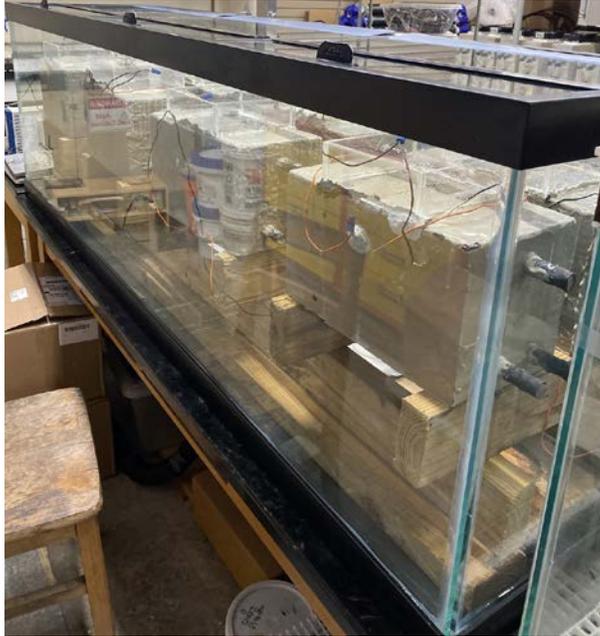
Figure 3.30: Specimens with concrete deficiencies in enclosed glass container.

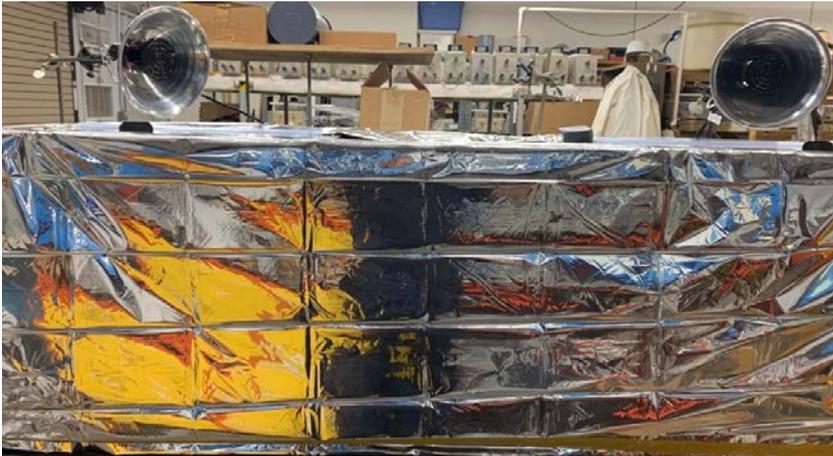
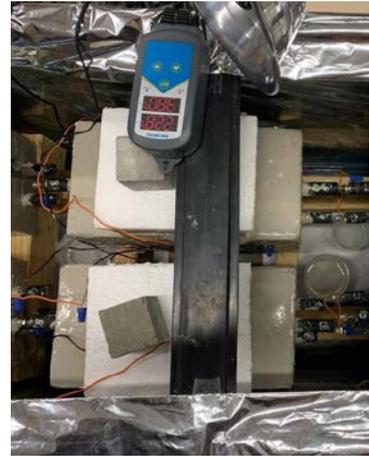
Figure 3.31: Experimental set-up of locally-deficient specimens in enclosed glass container covered in reflective wrap and heat lamps on top, (a) front view and (b) top view.

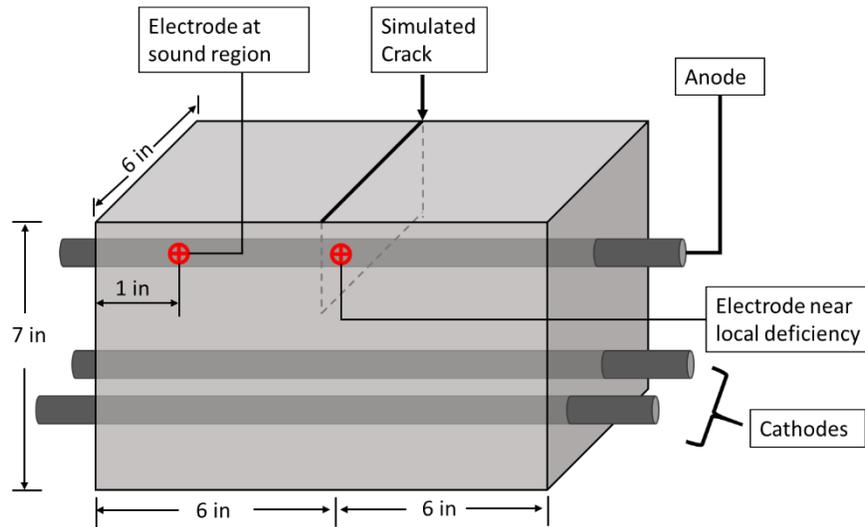
Figure 3.32: Experimental set-up of potential drop between reference electrodes placed near the local deficiency and the sound concrete region of the anode.

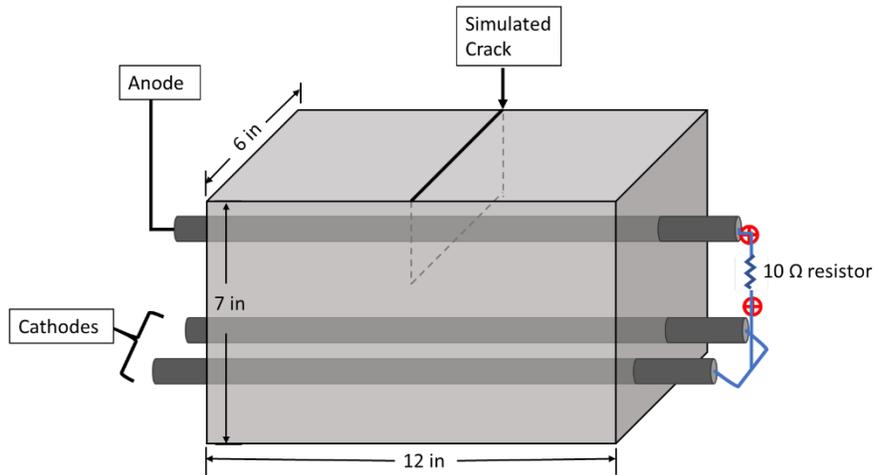
Figure 3.33: Experimental set-up of macrocell current density measurement. Measured across 10-ohm resistor.

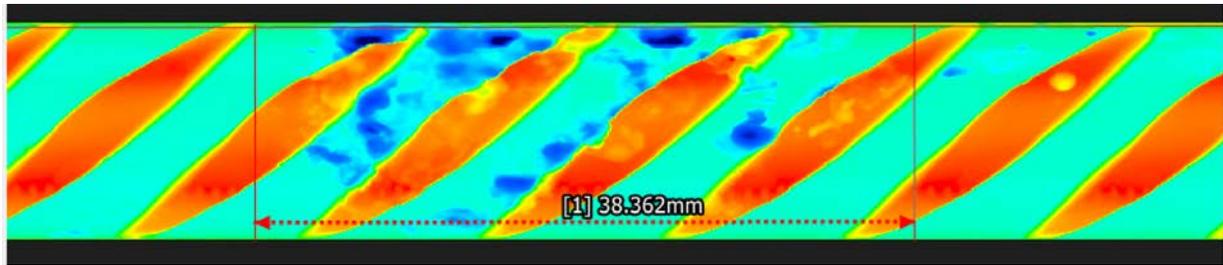
Figure 4.1: Height image of plane measurement of the length of the anode in steel reinforcement.

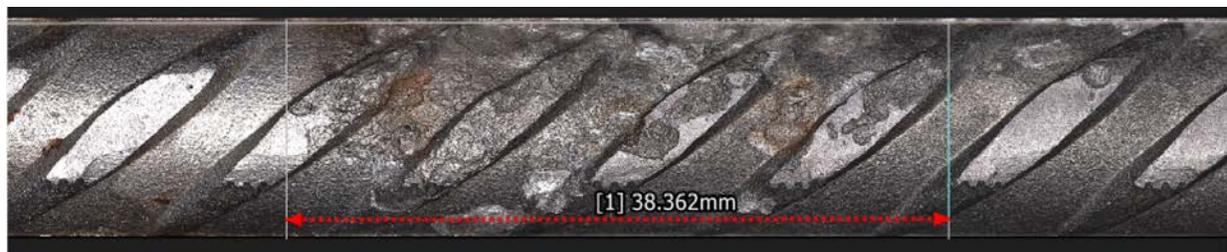
Figure 4.2: Optical image of plane measurement of the length of the anode in steel reinforcement.

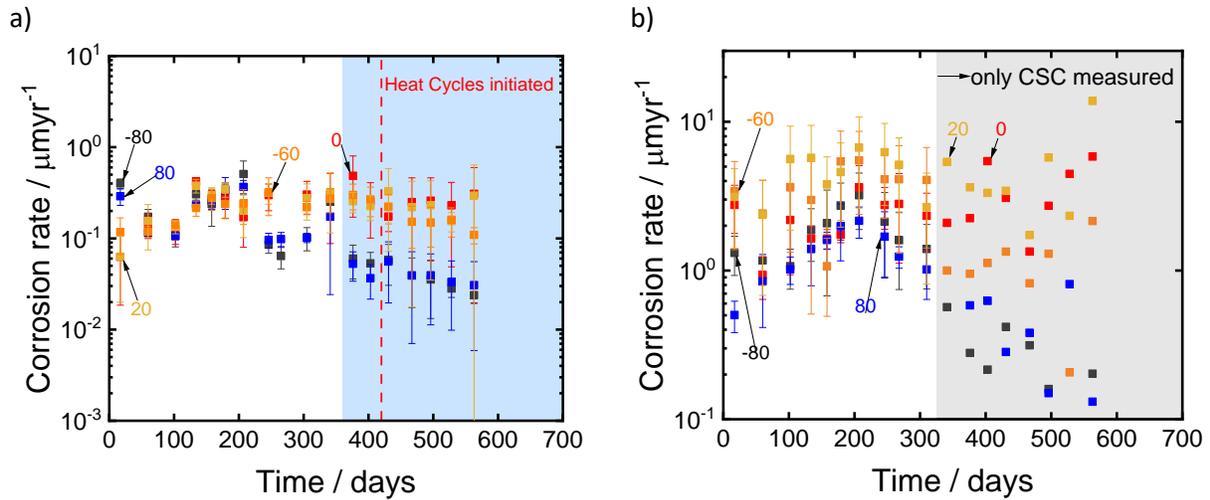
Figure 4.3: Behavior of the corrosion rate over time in (a) stainless steel (SS01, SS02, and SS03), and (b) carbon steel (CSA, CSB and CSC) specimens. Each data point represents the average value for the three specimens and the error bars the standard deviation. Black, orange, red, yellow and blue represented data points at locations -80 cm, -60 cm, 0 cm, 20 cm and 80 cm, respectively. Dashed line indicates initiation of elevated temperature exposure. Blue-shaded region designates the point at which low frequency limit of the impedance was extended to 1 mHz for points -80 cm and 80 cm. The number pointing to each series represents the position along the beam as described by number line shown in Figure 3.3.

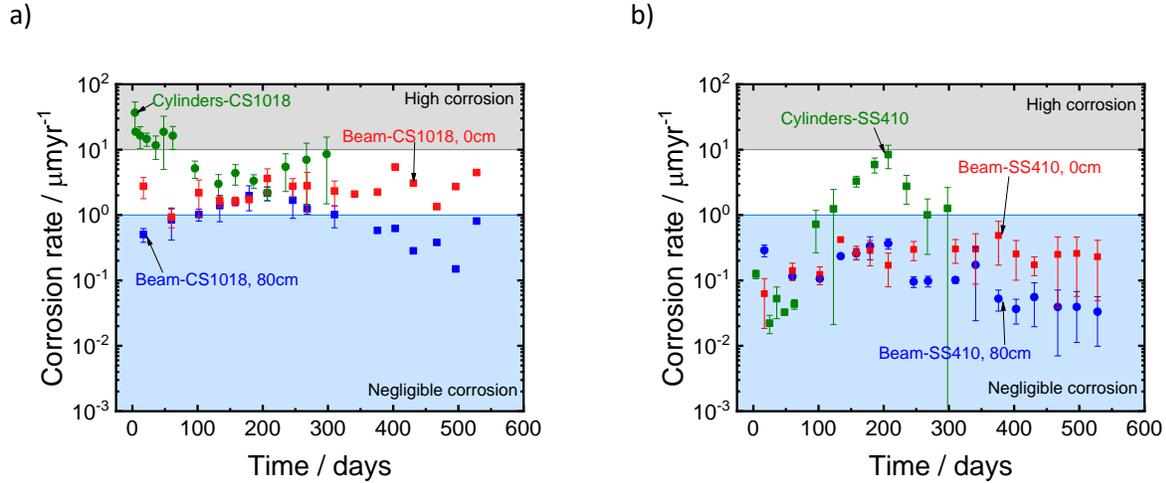
Figure 4.4: Corrosion rate as a function of time at different locations (i.e. end and center) of beams compared to cylindrical specimens reinforced with (a) SS and (b) CS.

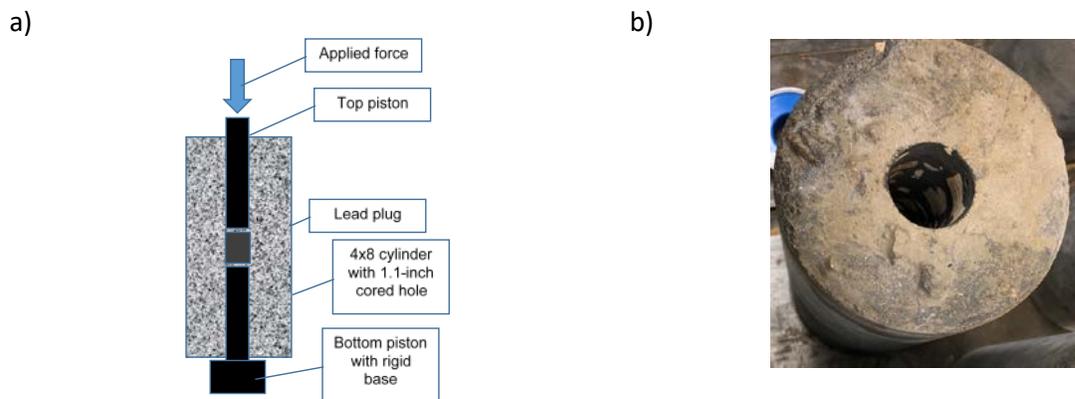
Figure 4.5: 4 x 8-inch concrete cylinder with 1.1-inch core hole.

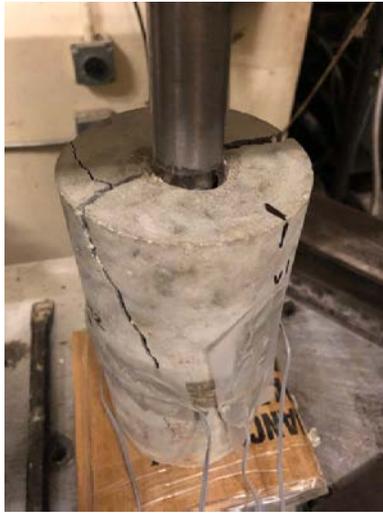
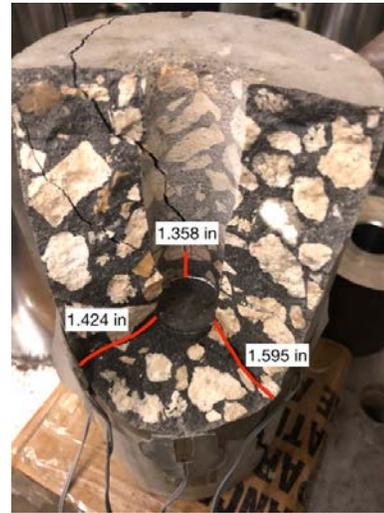
Figure 4.6: Extreme localized corrosion experimental results showing (a) concrete cracks, and (b) failure locations at the concrete cover. The red lines around the lead plug represent the concrete cover thickness at different locations ranging between 1.358 in and 1.595 in.

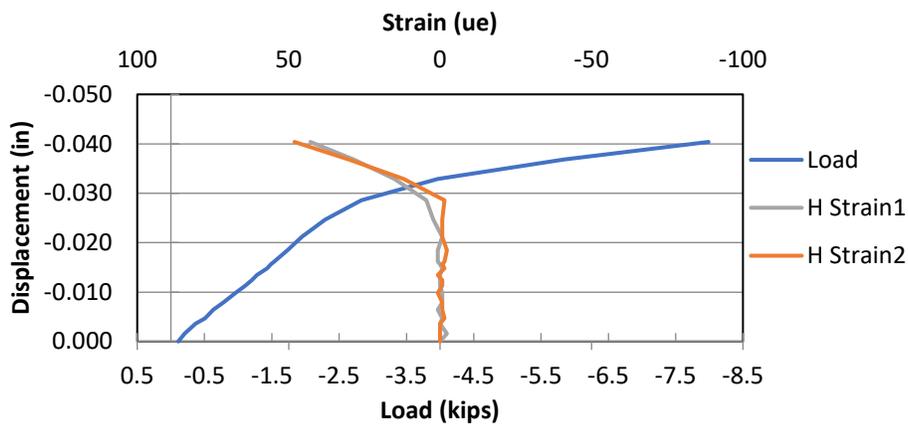
Figure 4.7: Horizontal strain.

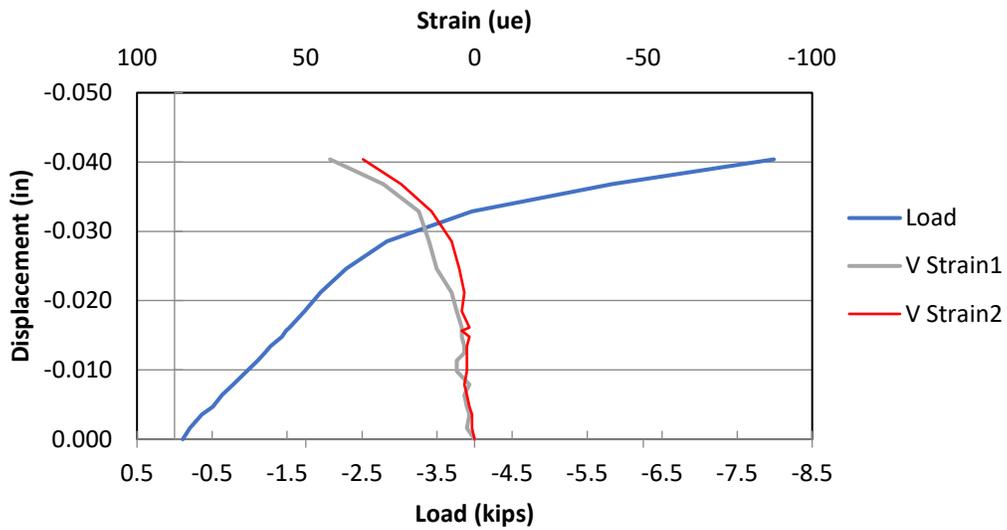
Figure 4.8: Vertical strain.
