**FINAL REPORT (Project BDV25-977-56)**

**QUANTIFYING THE DURATION OF THE CORROSION PROPAGATION STAGE IN  
STAINLESS STEEL REINFORCEMENT**

**Final Report to Florida Department of Transportation**

**UNIVERSITY OF  
SOUTH FLORIDA**

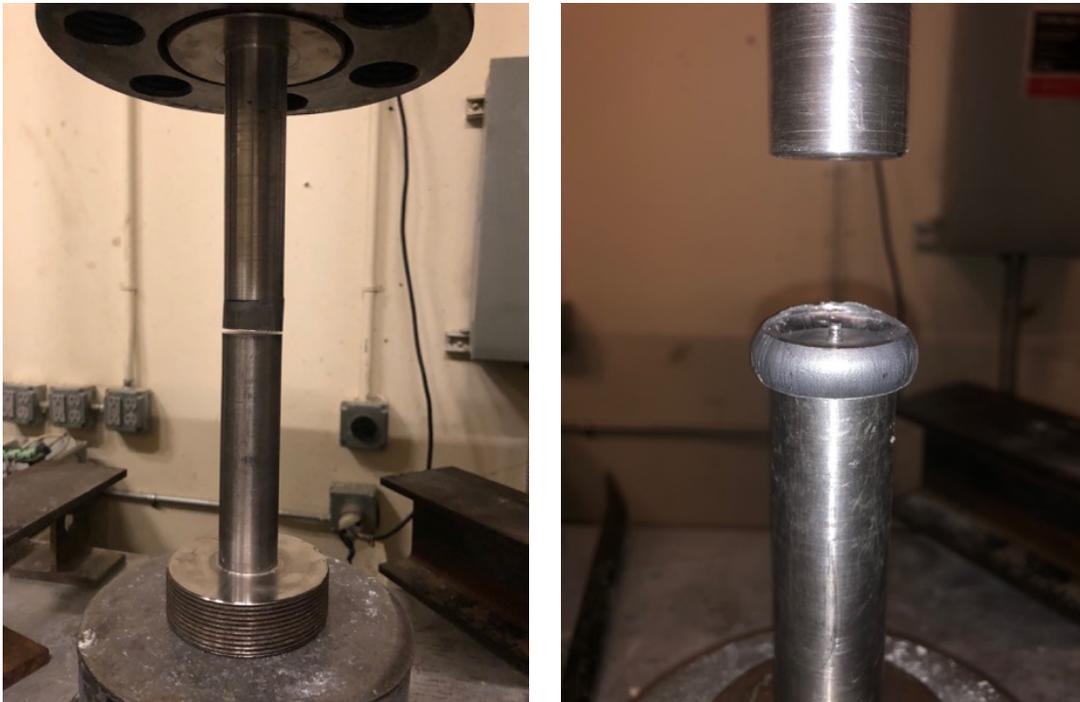
Figure 4.9: (a) Initial lead sample and (b) deflected shape of lead calibration.

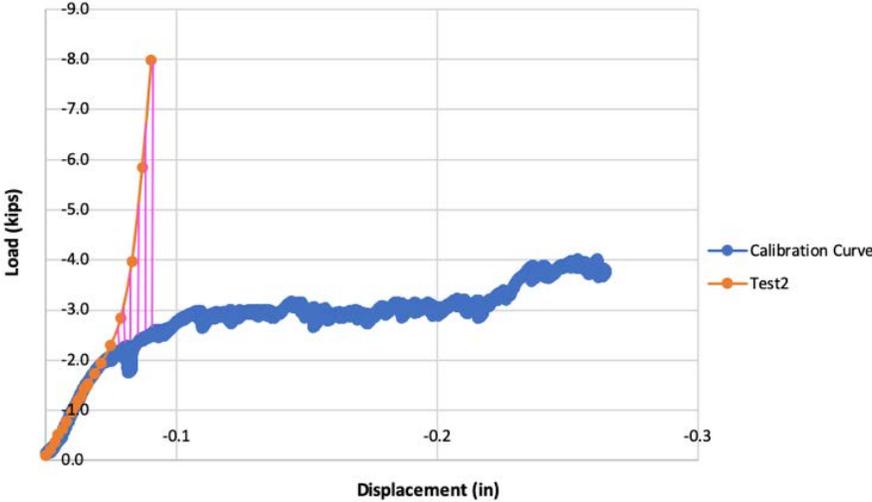
Figure 4.10: Load calibration.

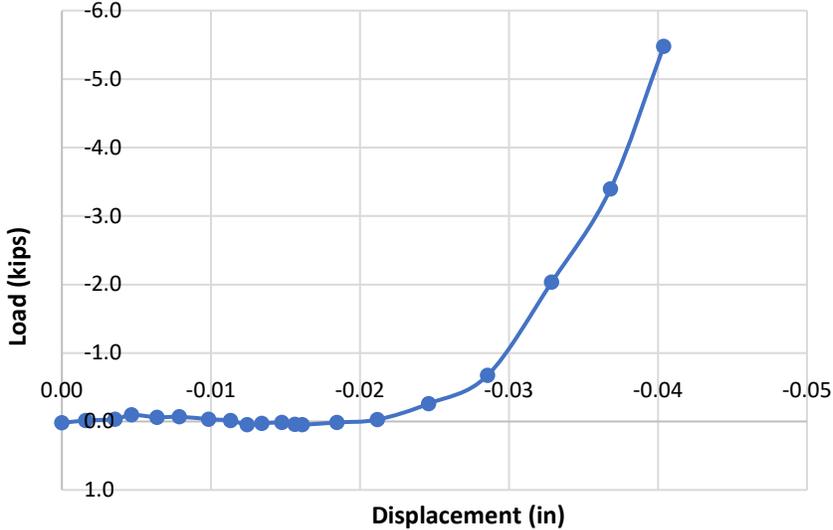
Figure 4.11: Concrete load vs. displacement.

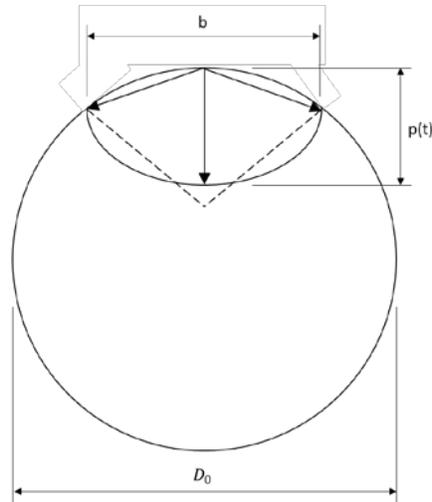
Figure 4.12: Schematic illustration of cross-sectional loss of rebar subjected to pitting corrosion.<sup>66</sup>

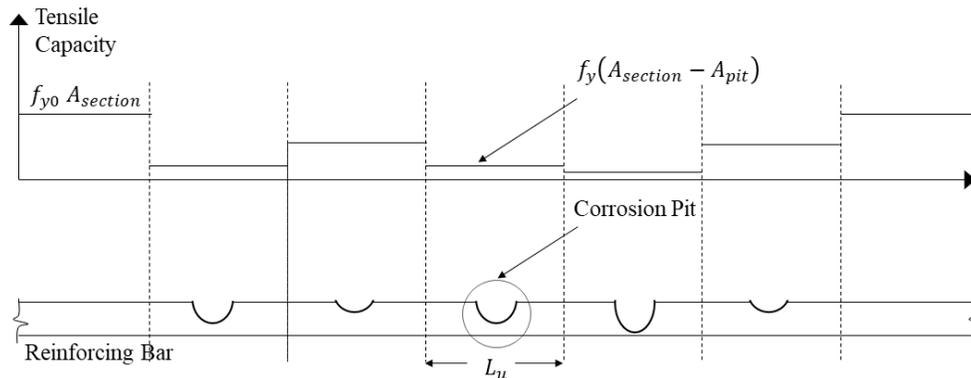
Figure 4.13: Spatial tensile capacity of non-uniformly corroding reinforcement bar.

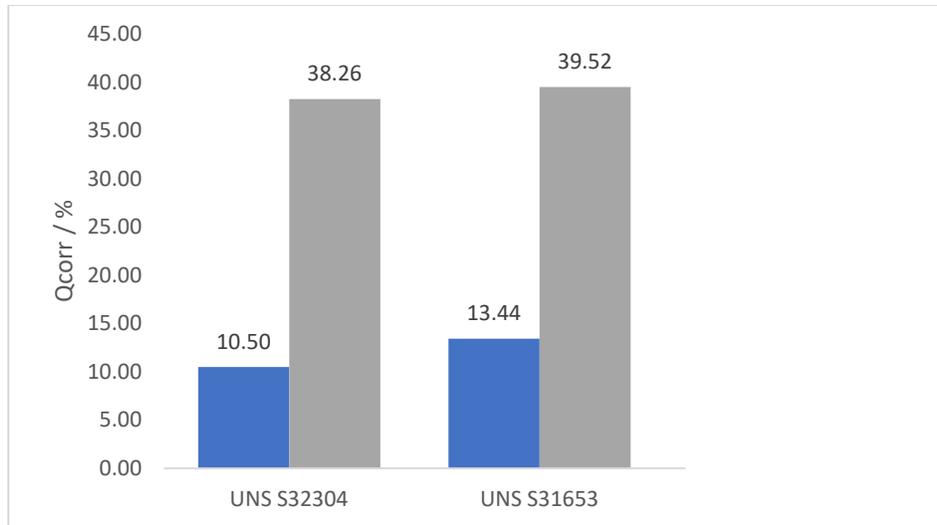
Figure 4.14: Comparison of corrosion degree to reach the IS limit state for the indicated percentage strength loss criteria. Each color illustrates a case of insufficient strength, in which blue represents ~21% strength loss and gray represents ~66% strength loss.

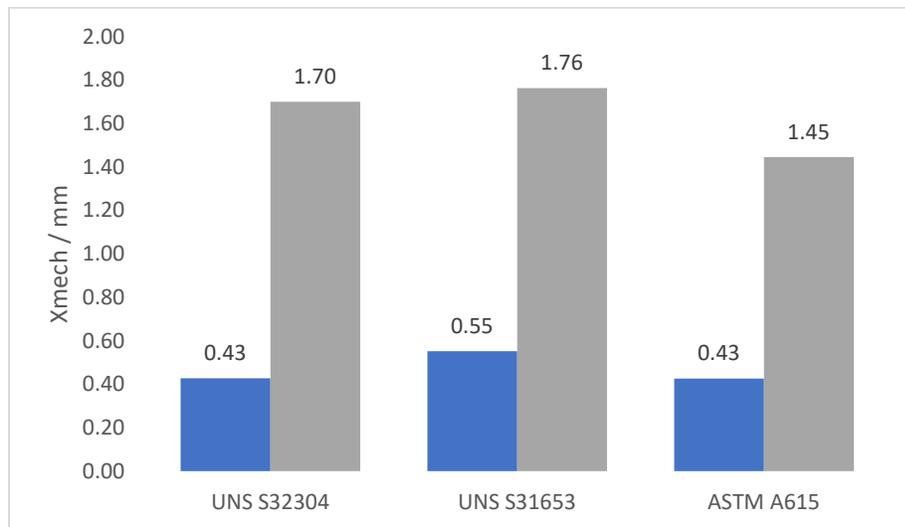
Figure 4.15: Comparison of corrosion penetration  $X_{mech_{IS}}$  required to reach the IS limit state for the indicated percentage strength loss criteria. In the onset of brittleness case, a threshold corrosion degree value 8.6%<sup>81</sup> was selected given that it was the most critical and the only experimental value obtained for stainless steel. In this scenario,  $X_{mech_{OB}}$  was estimated to be 350  $\mu\text{m}$ . The  $X_{mech_{IS}}$  and  $X_{mech_{OB}}$  values are summarized in Table 4.10.

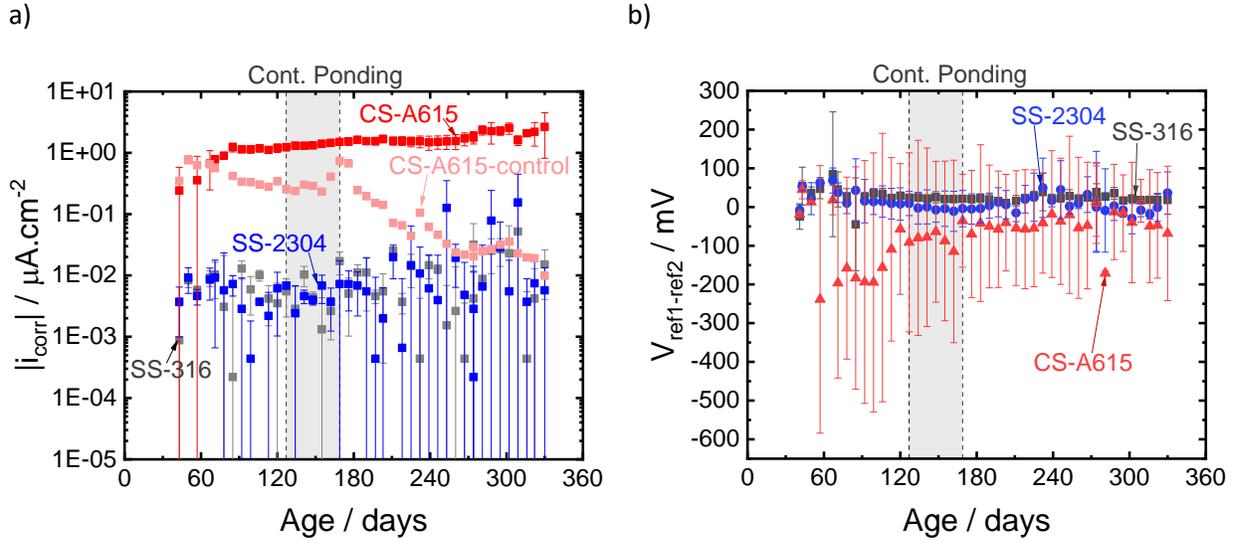
Figure 4.16: Preliminary results of specimens with concrete deficiencies (a) macrocell current density and (b) potential difference between defective and sound concrete region.

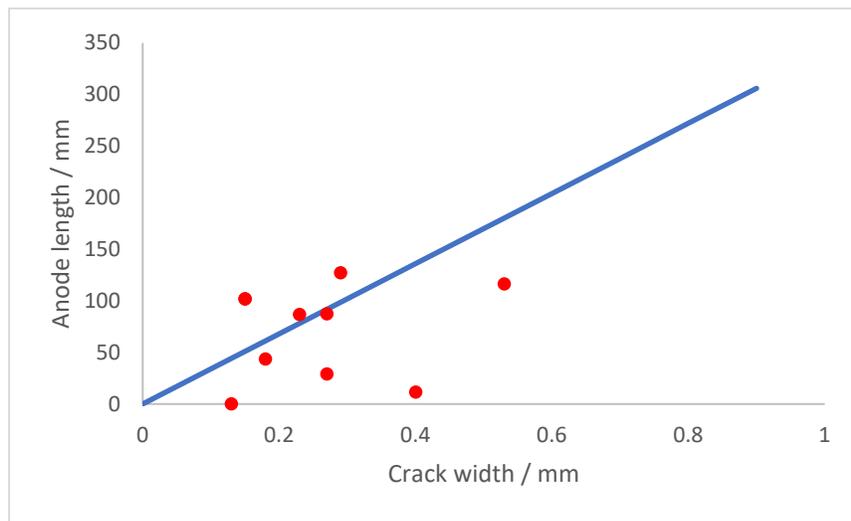
Figure 4.17: Anode length as a function of crack width. The line represents the empirical Equation (28) developed for CS. The points represent experimental results of SS taken from Niejenhuis.<sup>35</sup>

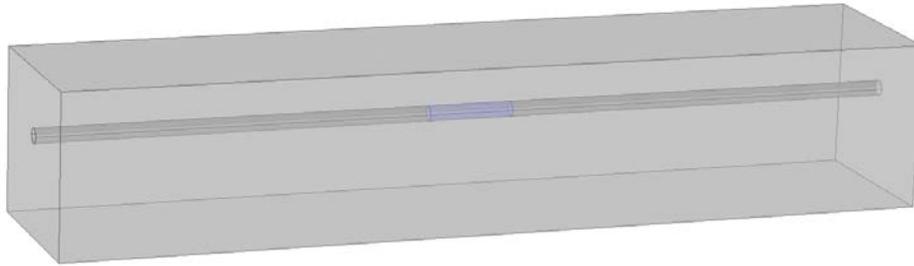
Figure 4.18: Finite element model geometry showing locally corroding anode of length 688 mm corresponding to a crack width of 0.2 mm.

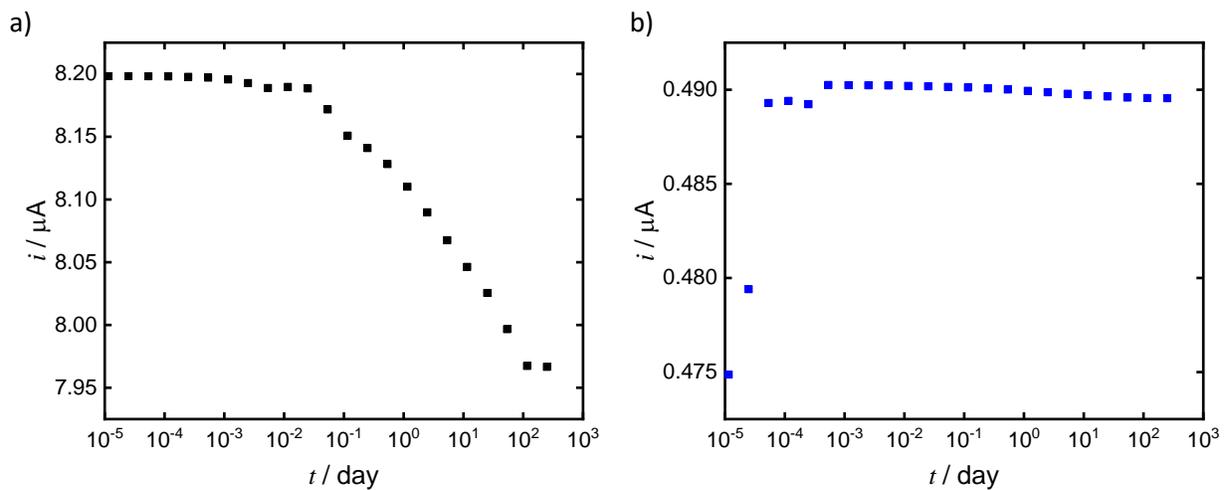
Figure 4.19. Macrocell corrosion rates as a function of time in cracked concrete: (a) CS and (b) SS.

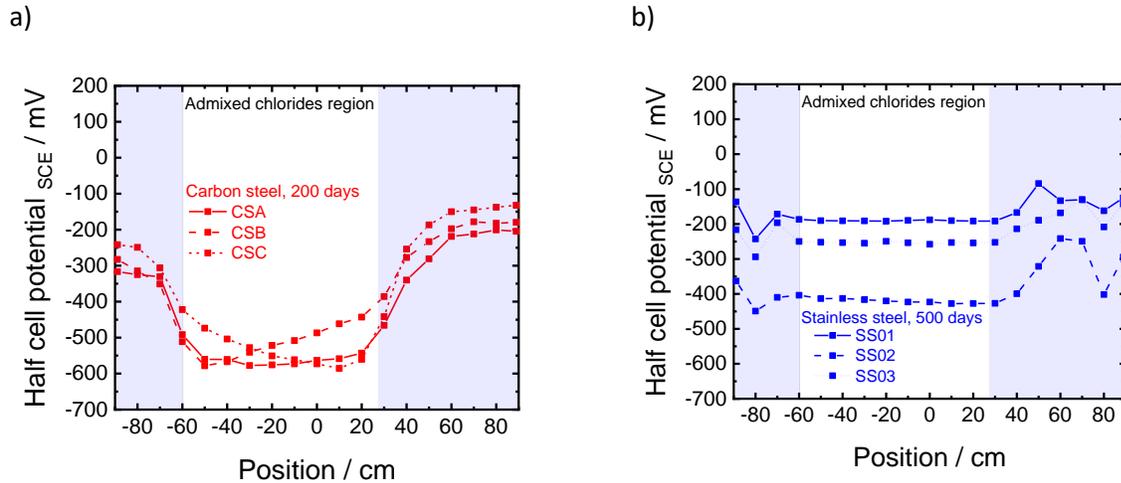
Figure 5.1: HCP results of specimens as a function of location in simulated beam specimens reinforced with (a) carbon steel at 200 days, and (b) stainless steel at 500 days (after ~250 days of aggressive ponding and ~120 days of heating).

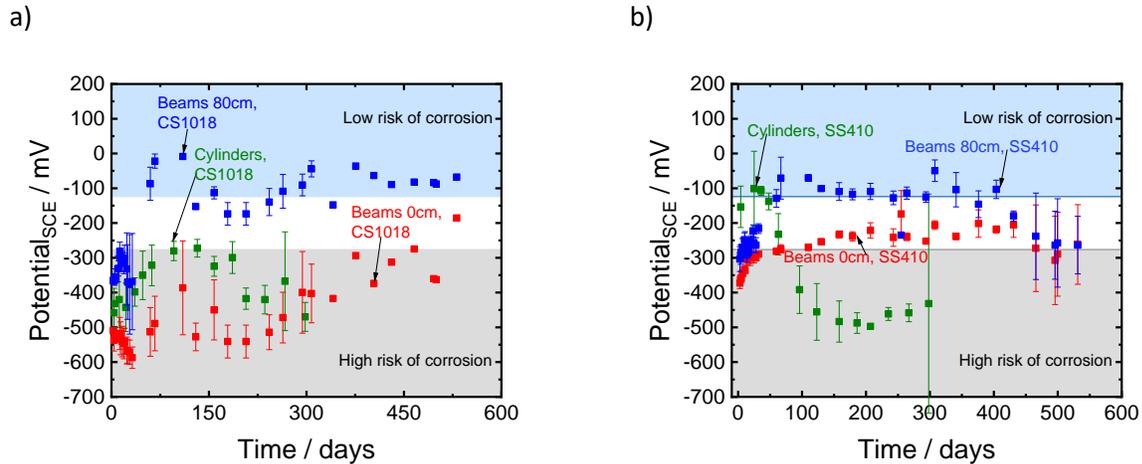
Figure 5.2: HCP results of specimens as a function of time considering different locations (i.e. end and center) in simulated beams compared to those of the cylindrical specimens reinforced with (a) carbon steel and (b) stainless steel.

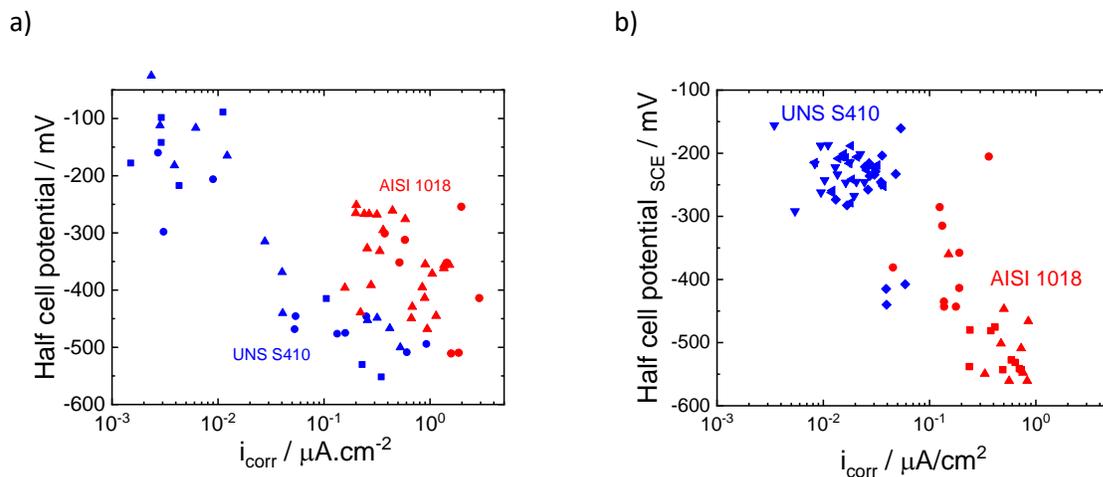
Figure 5.3: Potential as a function of corrosion current density for (a) cylindrical specimens and (b) midpoint of simulated beam with the highest potential drop.

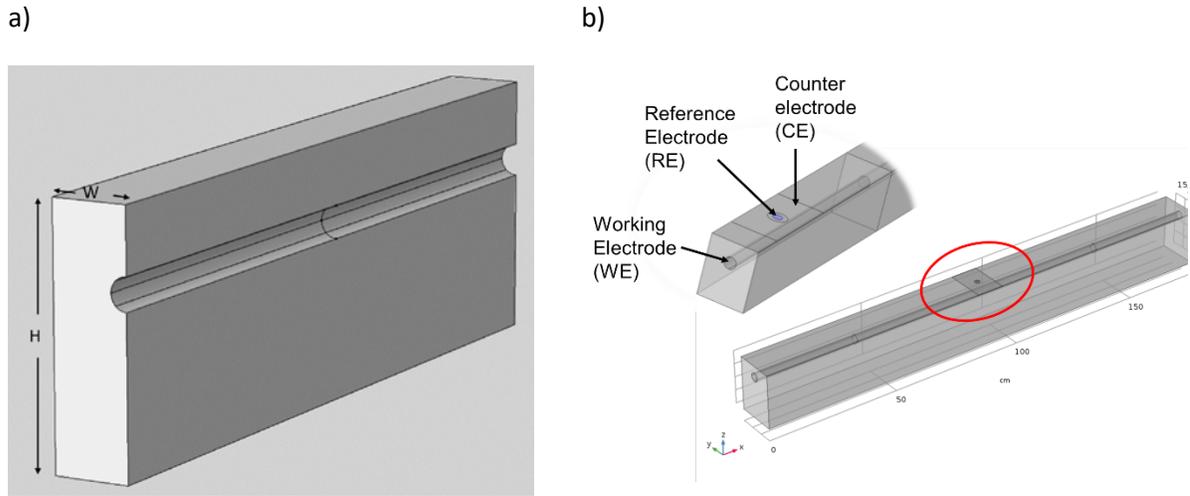
Figure 5.4: Schematic illustration of (a) HCP and (b) EIS Finite Element Model simulations.

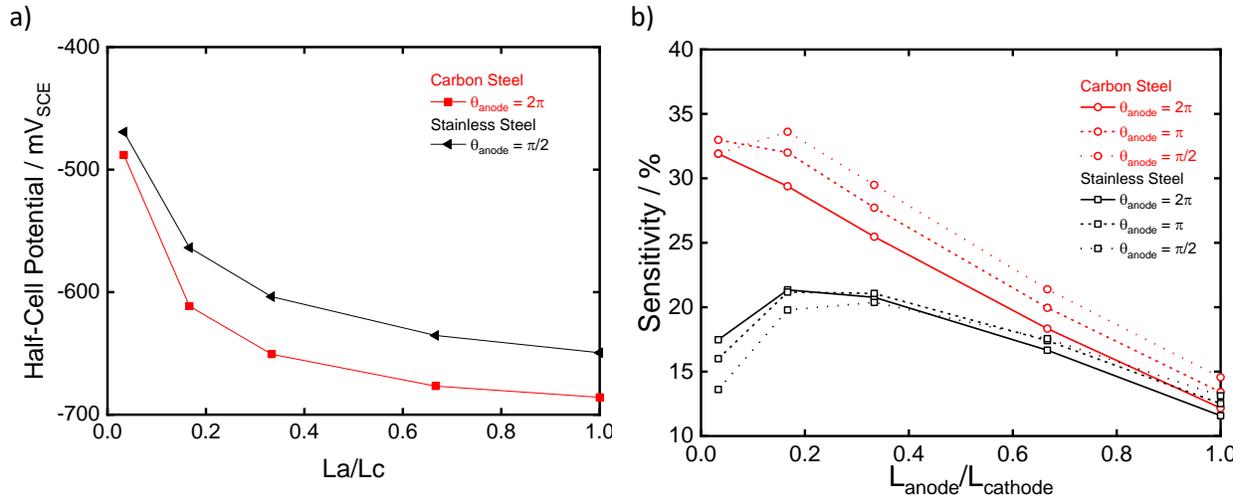
Figure 5.5: Finite Element Model results for SS and CS with varying corrosion morphologies showing (a) sensitivity and (b) HCP as a function of the anode to cathode ratio.

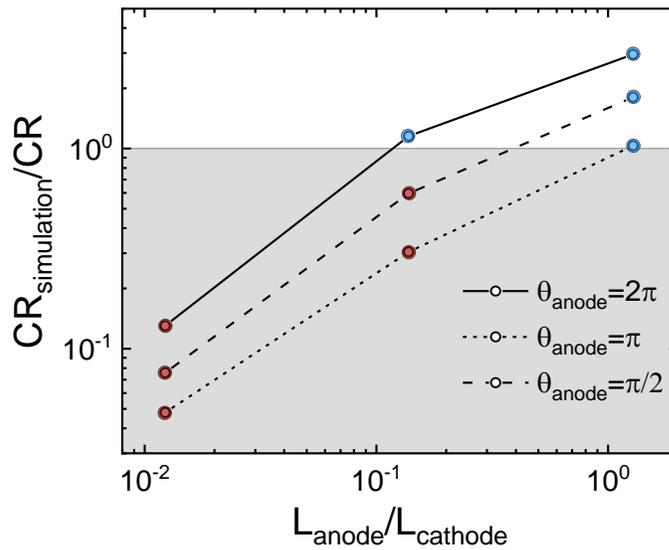
Figure 5.6: The ratio of the corrosion rate obtained from analysis of the simulated impedance and the input corrosion rate as a function of anode to cathode length ratio with anode circumference as a parameter.

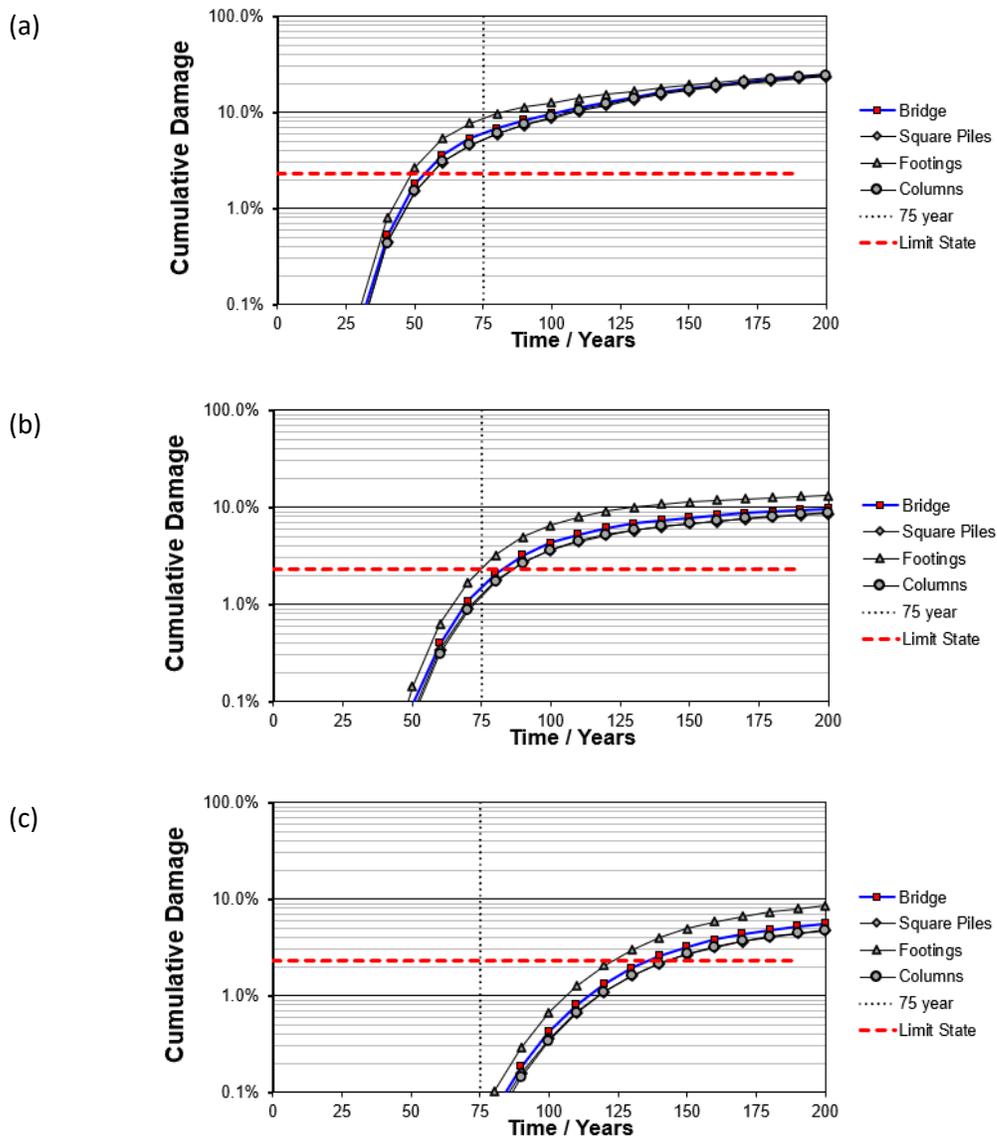
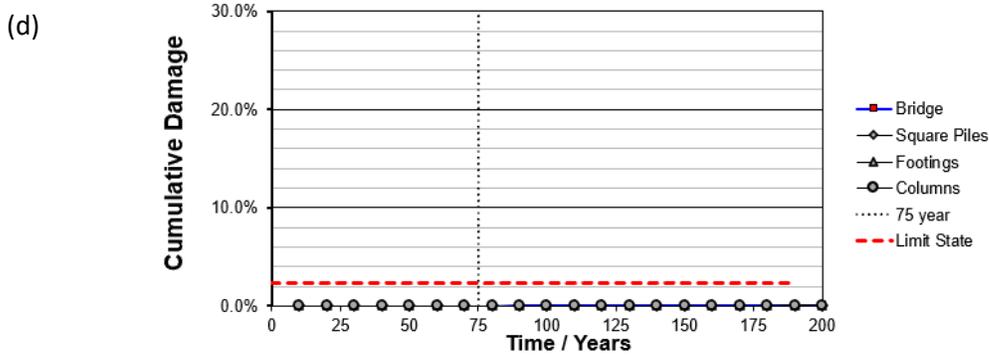
Figure 6.1: First scenario (moderately aggressive): life cycle analysis under moderately aggressive conditions for (a) Plain steel, (b) Ferritic SS, (c) E. Duplex SS and (d) Austenitic SS.

Figure 6.1 (continued): First scenario (moderately aggressive): life cycle analysis under moderately aggressive conditions for (a) Plain steel, (b) Ferritic SS, (c) E. Duplex SS and (d) Austenitic SS.

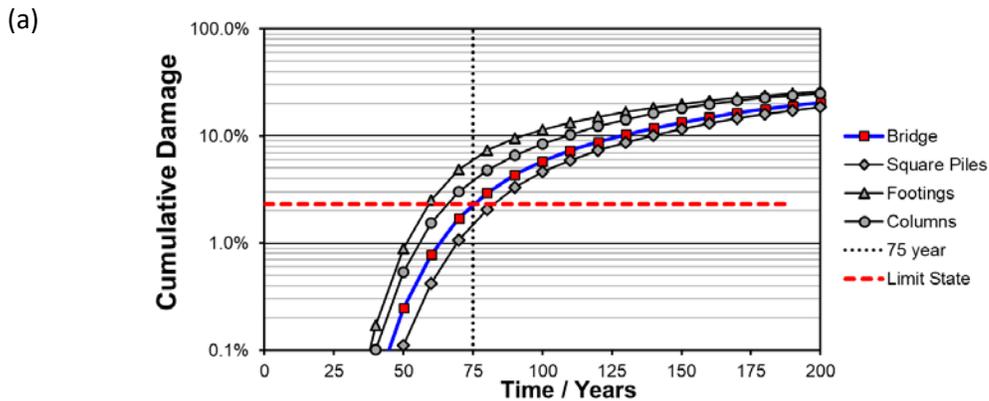
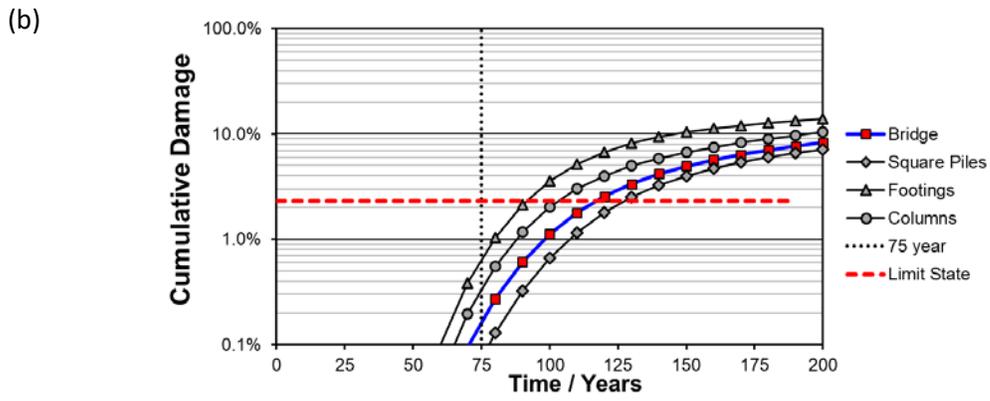
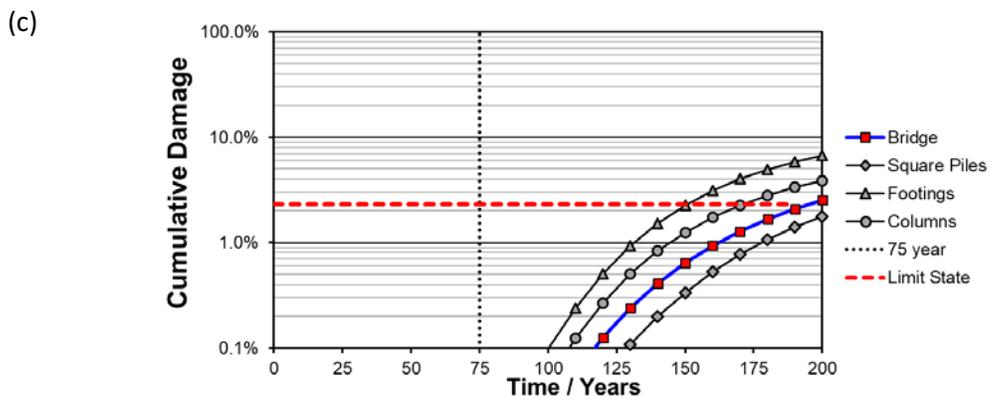
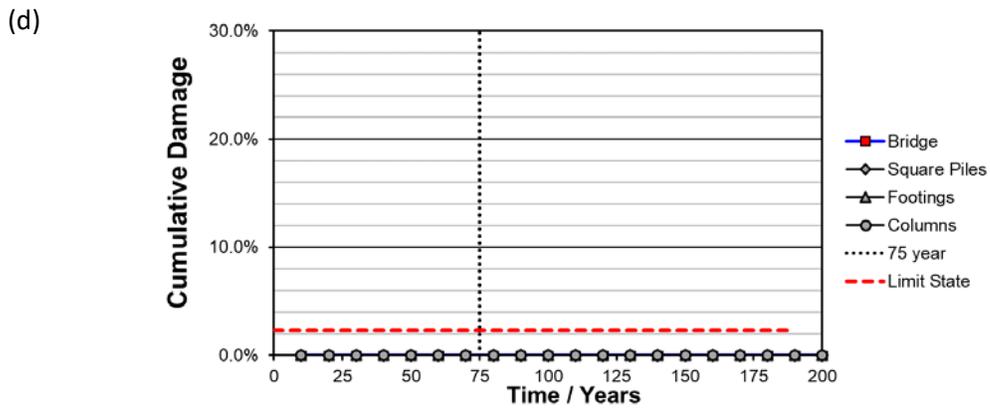
Figure 6.2: Second scenario (extremely aggressive): life cycle analysis under extremely aggressive conditions for (a) Plain steel, (b) Ferritic SS, (c) E. Duplex SS and (d) Austenitic SS.

Figure 6.2 (continued): Second scenario (extremely aggressive): life cycle analysis under moderately aggressive conditions for (a) Plain steel, (b) Ferritic SS, (c) E. Duplex SS and (d) Austenitic SS.

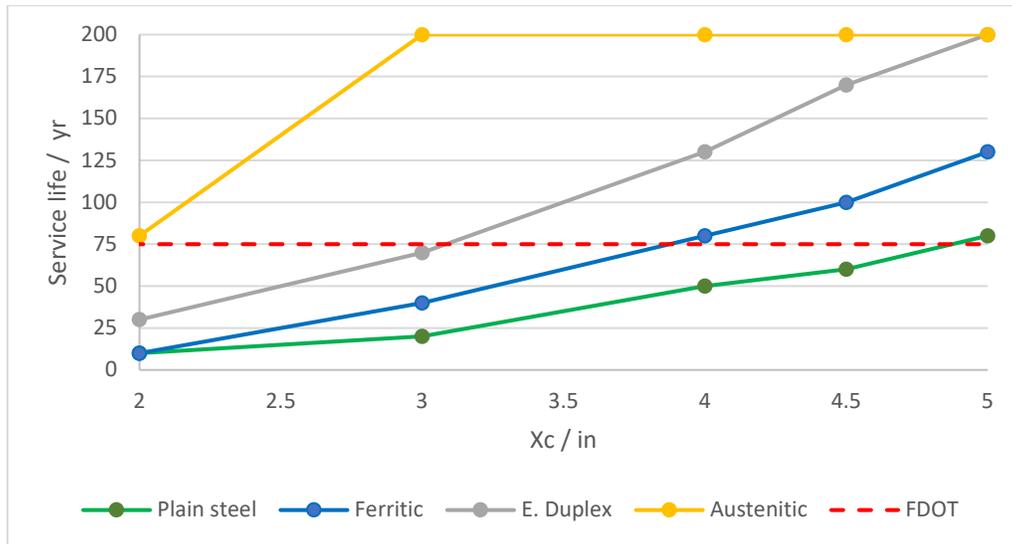
Figure 6.3: First scenario: life cycle analysis under moderately aggressive conditions as a function of concrete cover for each type of steel.

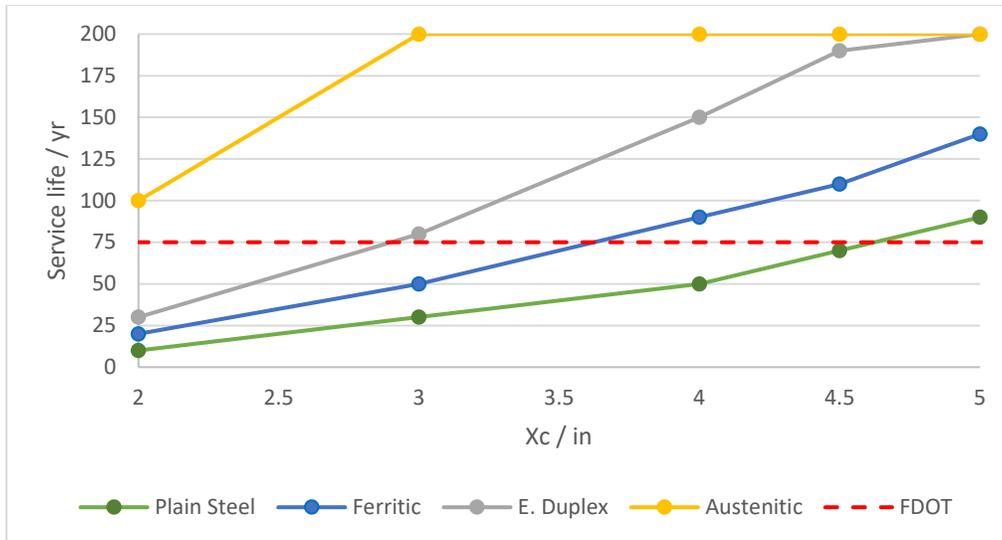
Figure 6.4: Second scenario: life cycle analysis under extremely aggressive conditions as a function of concrete cover for each type of steel.

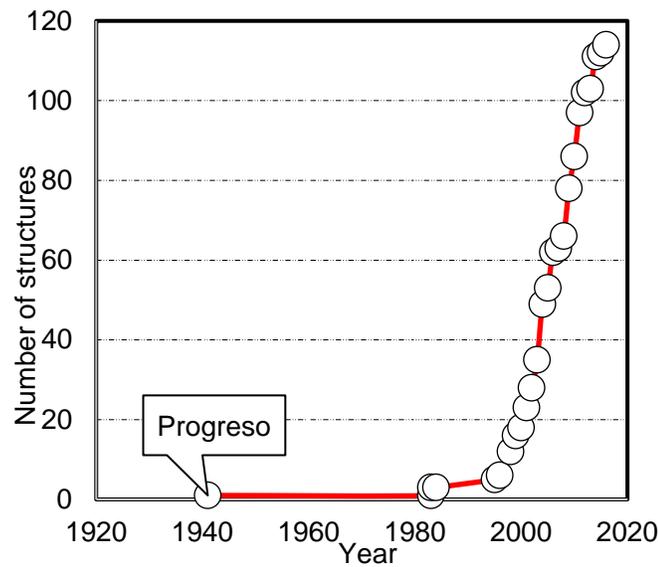
Figure 1: Cumulative worldwide tally of bridges with SS rebar.

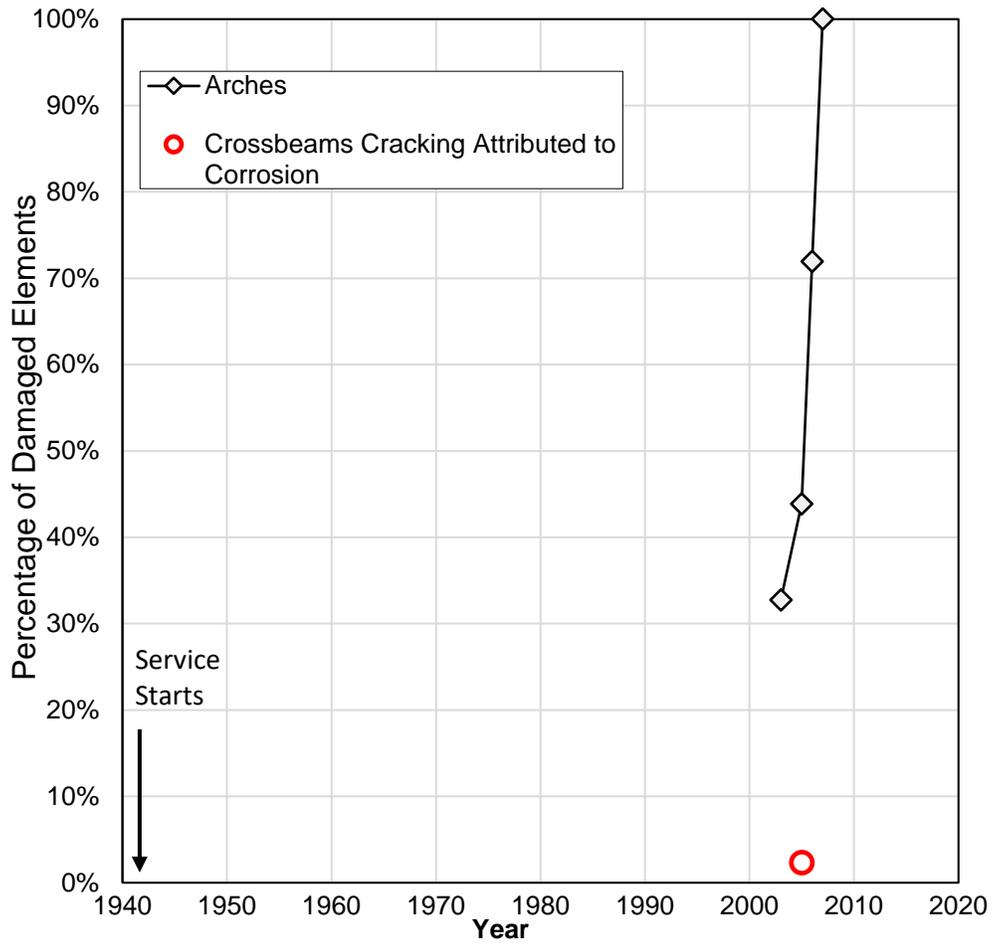
Figure 2: Notional damage function showing the time evolution of ratio of Progreso Pier arches showing distress from all sources (  $\diamond$  ), and of crossbeams with cracking attributed to corrosion damage (  $\circ$  ).
