**Final Report**

**Environmental Suitability of Weathering Steel Structures  
Florida - Material Selection, Phase 2**

BDV27-977-04

August 2017

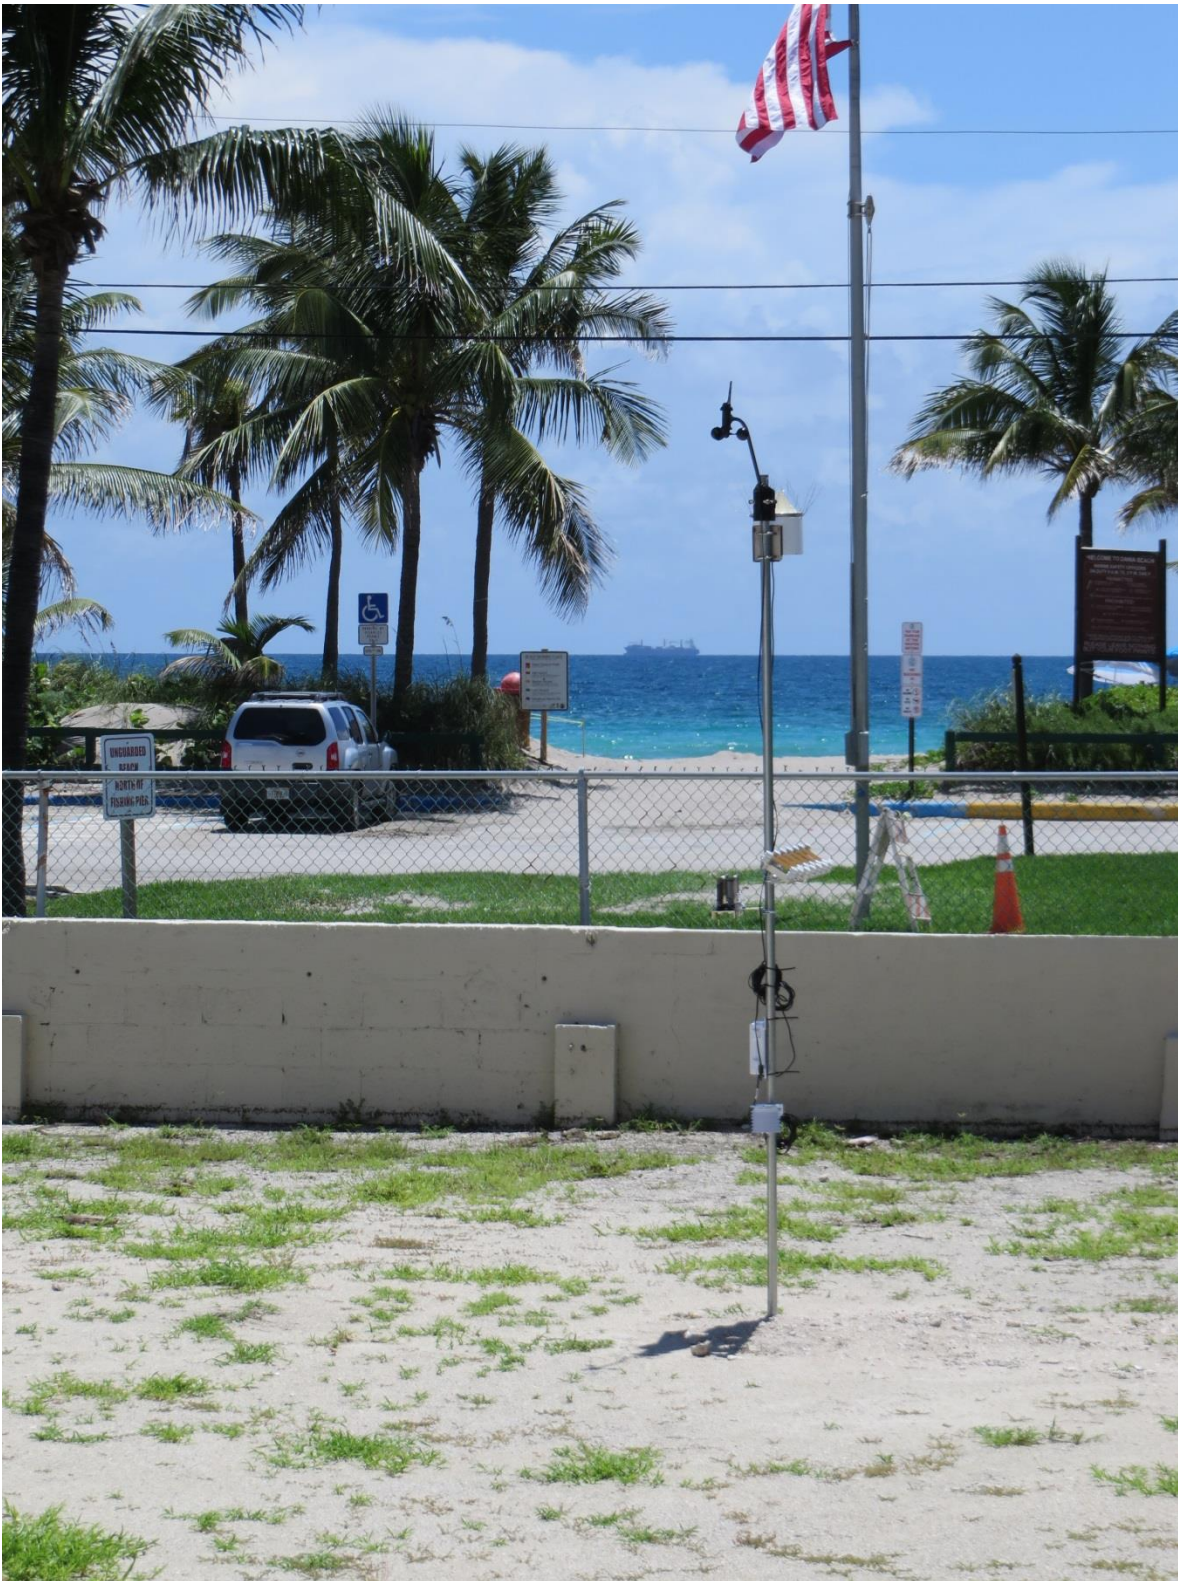
Figure 5: SeaTech east, site 01.

Stations were set up following ASTM requirements [9] [13] and weather station recommendations [34]. Note, especially, that plate specimens are required to face south. Details of the additional components shown are given in the subsequent sections.

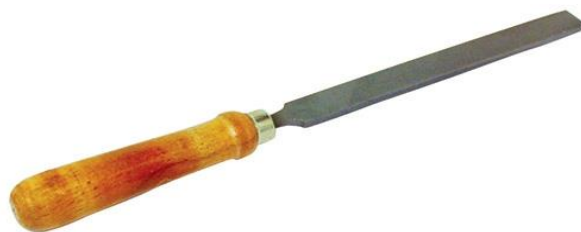
The WS specimens were exposed at the monitoring sites. The specimens were plate (G 50) and coil (G 116) shapes. To remove bulky corrosion product on panel specimens, a mechanical procedure was applied. Using a hand file as shown in Figure 7, the rust was scraped from each specimen surface. This step was carefully performed to ensure that the sample was not excessively scraped. In other words, only corrosion product was removed, not the base metal. Note that the rust from the front and the back of each specimen was collected and stored in separate bottles and labeled. For the first set of plate specimens, 25 mm x 25 mm square pieces were carefully cut from the plate using a heavy-duty hand shear. The cuts were made partially through the length and width of the specimen so that only the square piece was removed from the plate. The square piece was retained without cleaning for XRD measurements. The larger, remaining “L” shaped piece was cleaned and the area determined by image analysis using MatLab on a photocopied image of the “L” piece. The ratio of square piece to “L” piece was used to adjust the initial weight of the specimen for the weight loss determination.

Figure 7: Hand file used to remove corrosion products from plates.

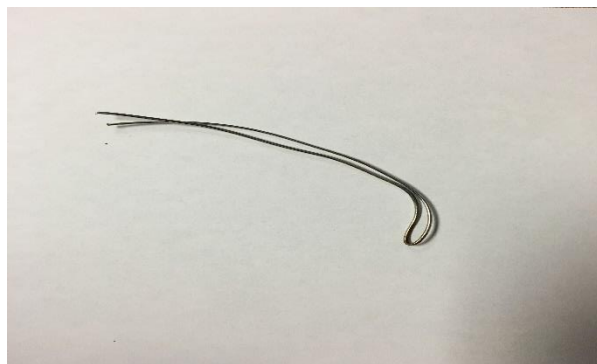
With the coil specimens, the coil must be removed from the bolt before performing the electrolytic cleaning procedure. The coils were impacted in the corrosion products that filled the bolt threads and were very difficult to remove either because corrosion continued beyond the recommended exposure times or in the corrosion was severe. To facilitate removal of the coil from its bolt, a stainless steel wire loop (Figure 8) was used. One free end of the coil was placed through the stainless steel loop, and then the loop was pulled around the bolt, lifting the coil out of the bolt threads until the other end of the coil was reached. The coil was loosened which allowed the coil to be twisted in the counterclockwise direction to separate it from its base bolt. In this manner, the loose coil was unscrewed from the bolt. In some instances while removing the coil, some corrosion products fell off of the specimens. These corrosion products were saved in a glass bottle with designated label for later X-ray diffraction procedure.

Figure 8: Stainless steel wire loop tool for loosening coil specimen from bolt.

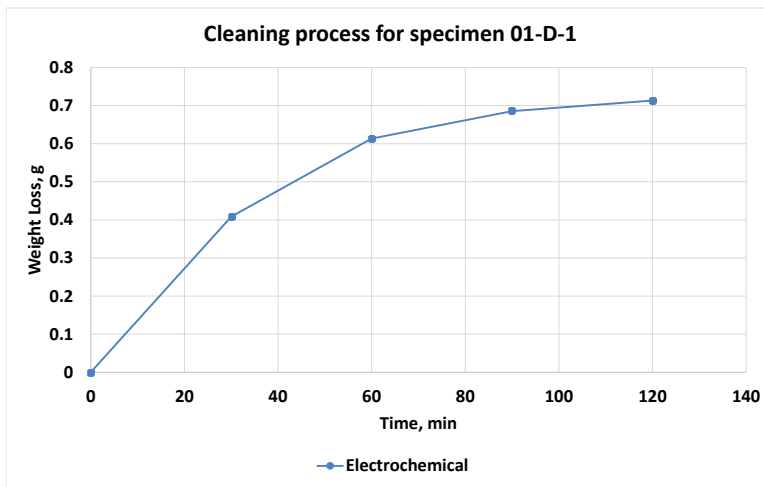
After the mechanical procedure, specimens were cleaned cathodically by an electrochemical method (ASTM Standard G 1, A2, Table A2.1, E.1.1) consisting of NaOH, Na<sub>2</sub>SO<sub>4</sub>, and Na<sub>2</sub>CO<sub>3</sub> at 25°C and 200 A/m<sup>2</sup> to remove the remaining corrosion product. Each specimen was basically cleaned in three cleaning cycles. In the first cleaning cycle, the specimen was placed in electrochemical cleaning cell for one hour. To simultaneously clean multiple specimens, the cleaning system was set up in series with constant currents of 2.3 A (L-shape specimens), 3.1 A (rectangle shape specimens) and 0.56 A for coils. The currents were calculated from their surface areas and the required 200 A/m<sup>2</sup>. After electrochemical treatment, the specimen was rinsed with distilled water and then placed in the ultrasonic cleaner for 5 minutes to remove the loose corrosion product. Next, the specimen was sprayed with alcohol before exposing it to a warm, dry air flow to prevent condensation until dried. Alcohol helped the specimen to dry faster. After drying and before weighing, the specimen was tapped a few times on the hard table surface to ensure all loose corrosion products (smut) fell off of the specimen. Finally, the specimen was weighed to obtain the weight loss to complete one cleaning cycle. In the subsequent cleaning cycles, the specimen was cathodically electrolyzed for half hour increments. The specimen weights obtained were plotted versus cleaning time until consistent results were obtained as per the ASTM Standard G 1. An example plot is shown in Figure 9. After examining the data obtained using this method, it was determined that the specimens were not completely clean. Additional cleaning steps were performed using hydrochloric acid with corrosion inhibitor, hexamethylene tetramine (ASTM Standard G 1, A2, Table A1.1, C.3.5), with rinsing, drying and weighing as described above for electrolytic cleaning. Instead of a dull, dark gray surface with electrolytic cleaning, a bright, clean surface was obtained. These data were more consistent. A plot of the combined weight losses is shown in Figure 10. The aluminum wire specimens were cleaned with nitric acid (ASTM Standard G 1, A2, Table A1.1, C.1.1), with rinsing, drying and weighing as described above.

Figure 9: Weight loss versus electrolytic cleaning cycle.

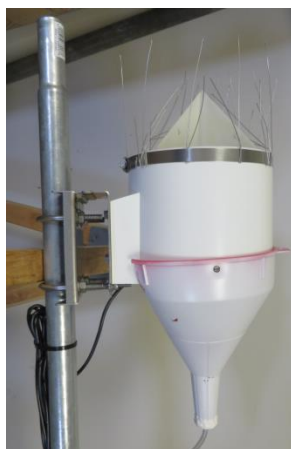
Weather station modifications consisted of bird deterrence and rainwater analysis. The bird deterrence was incorporated using stainless steel wire and hose clamp as shown in Figure 11. This arrangement was simple and was adopted from commercial products designed for straight edges of a wall or pipe. The perimeter and center of the round rain gauge was easily protected in this manner. Another detail (Figure 12) inserted into the rain gauge top was the crossed baffle designed to help collect passing airborne salt particles into the gauge opening. Continuing from the bottom of the rain gauge, a plastic funnel was attached to collect rainwater passing through the gauge (Figure 13) and to route the rainwater to the ion exchange filter shown in Figure 14. To prevent the conductivity detector and ion exchange filter from drying out, the water exits the conductivity gauge upward in a loop shown in Figure 14 that prevents complete drainage when the rainfall stops.

Figure 11: Rain gauge – bird deterrence and particle baffle.

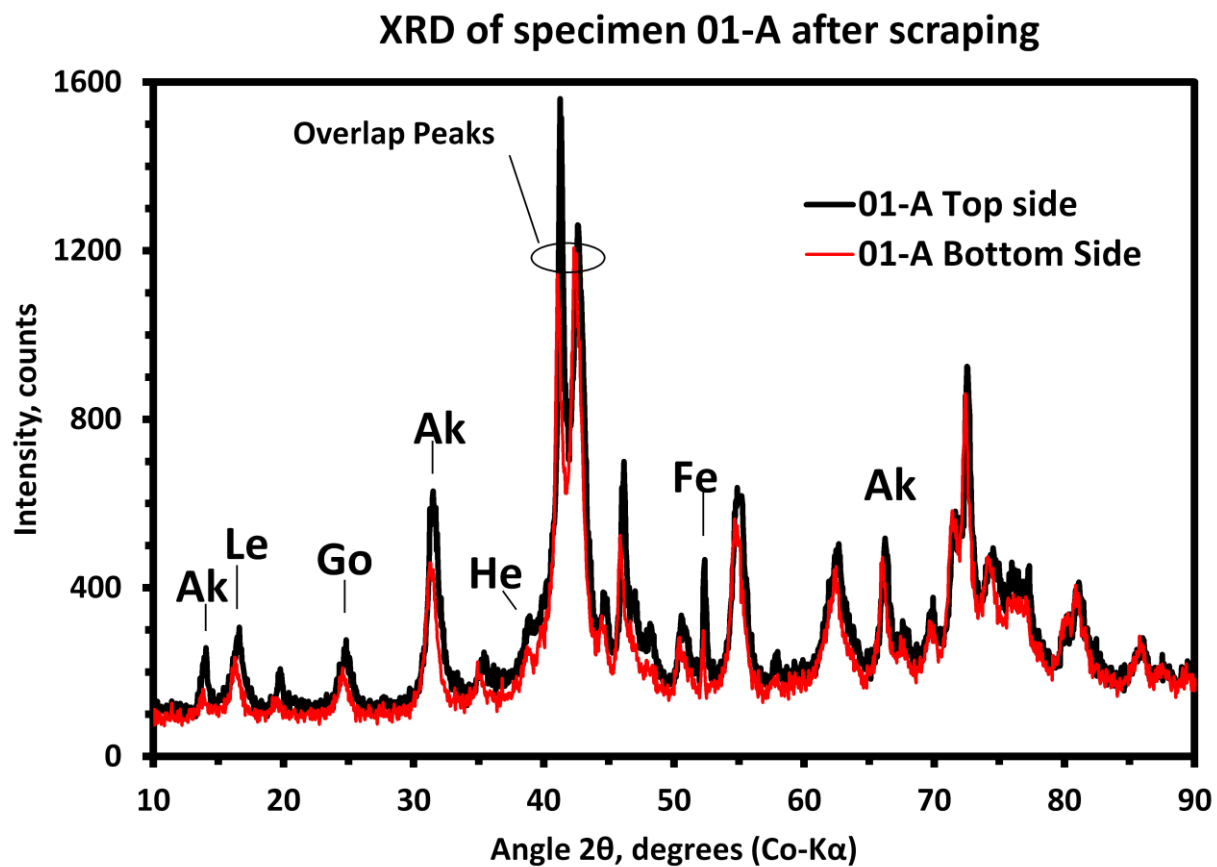
Figure 15: Corrosion products associated with peaks: Ak (akaganeite), Le (lepidocrocite), Go (goethite), He (hematite) and Fe (iron substrate). XRD pattern for top side of specimen (Black) and (Red) for the bottom side. The bottom side showed slightly lower intensities than the top side.

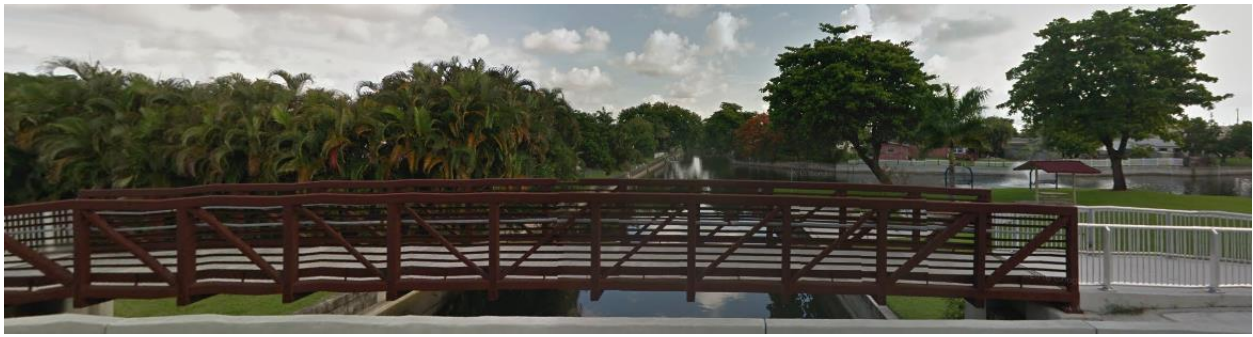
Figure 17: Weathering steel bridge in Margate, FL.

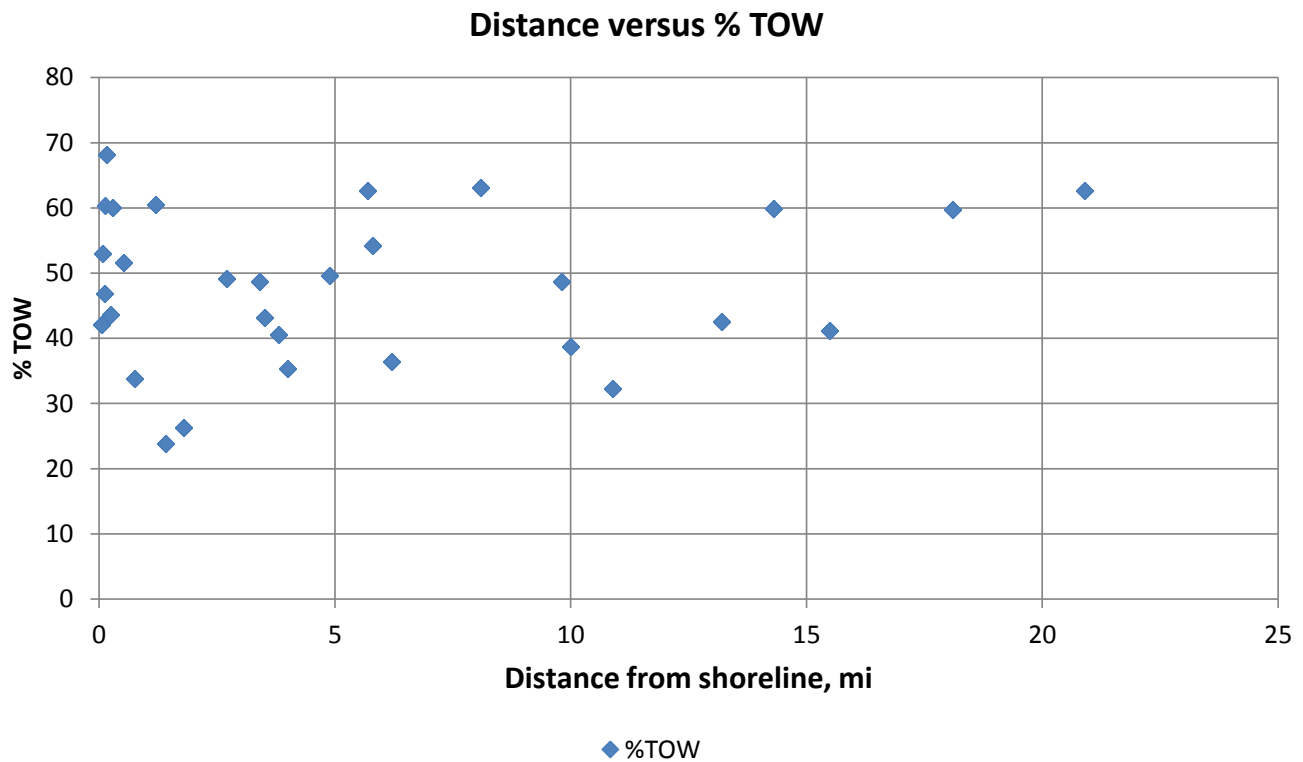
The monitoring sites were visited for corrosion specimen collections and data logger downloads. The corrosion specimens were cleaned and weight losses determined. Several data loggers suffered malfunctions that disabled them. For those data loggers, the most critical information desired was %TOW that was accommodated by accessing proximal weather station archived data. Table 6 provides the site, distance from shore, %TOW, specimen exposure times and weight loss data. Two plates were retrieved at the second collection, one for weight loss and the other for XRD analysis. Figure 18 shows that several sites exhibited TOW above the 60% level and TOW is weakly associated with an increase with distance from the shoreline. Figure 19 indicates that TOW above 60% does not yield the highest corrosion loss. It is likely that another parameter is responsible for high corrosion rates for these sites. The two highest corrosion losses occur at sites 01 and 02.

Figure 18: Time of wetness of all sites versus distance from shoreline.

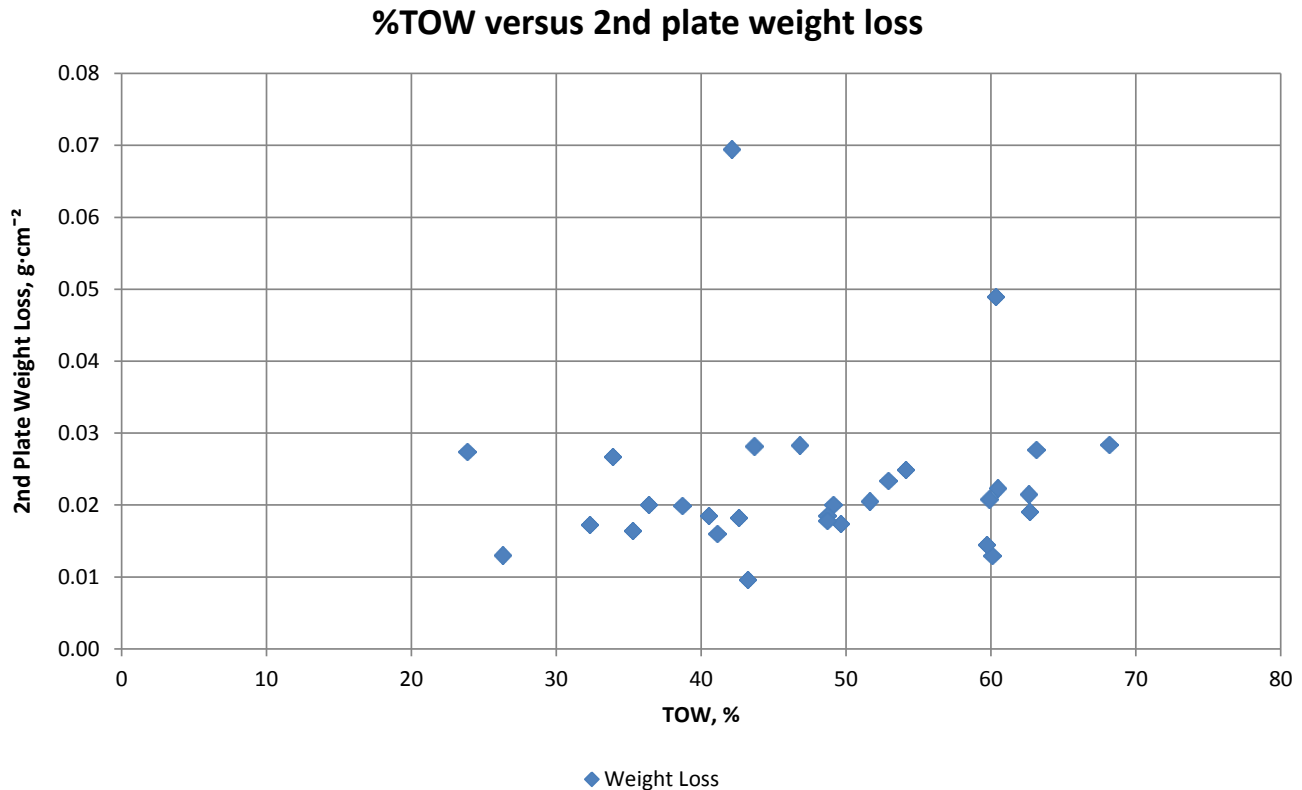
Figure 19: TOW versus weight losses for 2nd plate set.

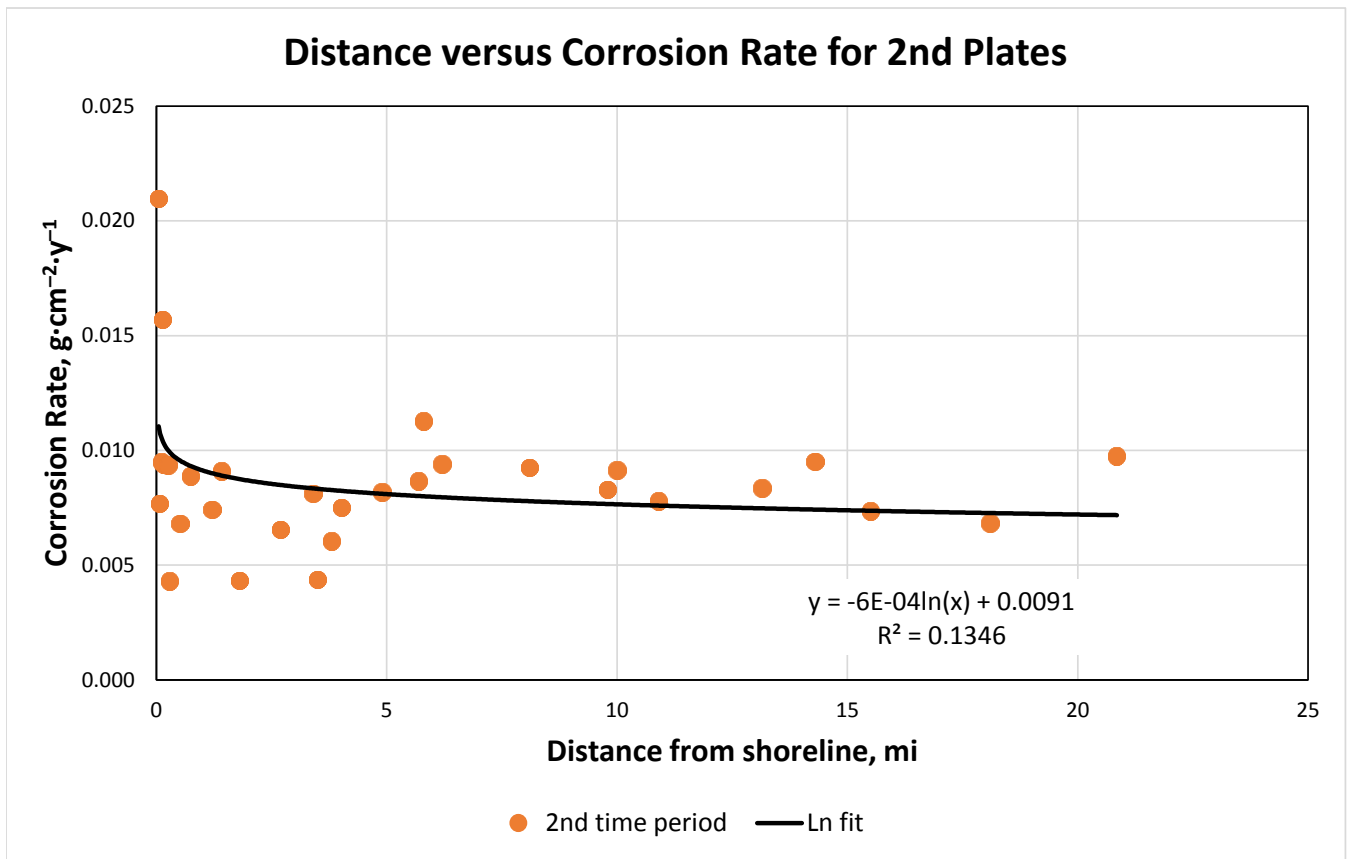
Figure 21: Distance from shoreline versus corrosion rate for 2nd plates.

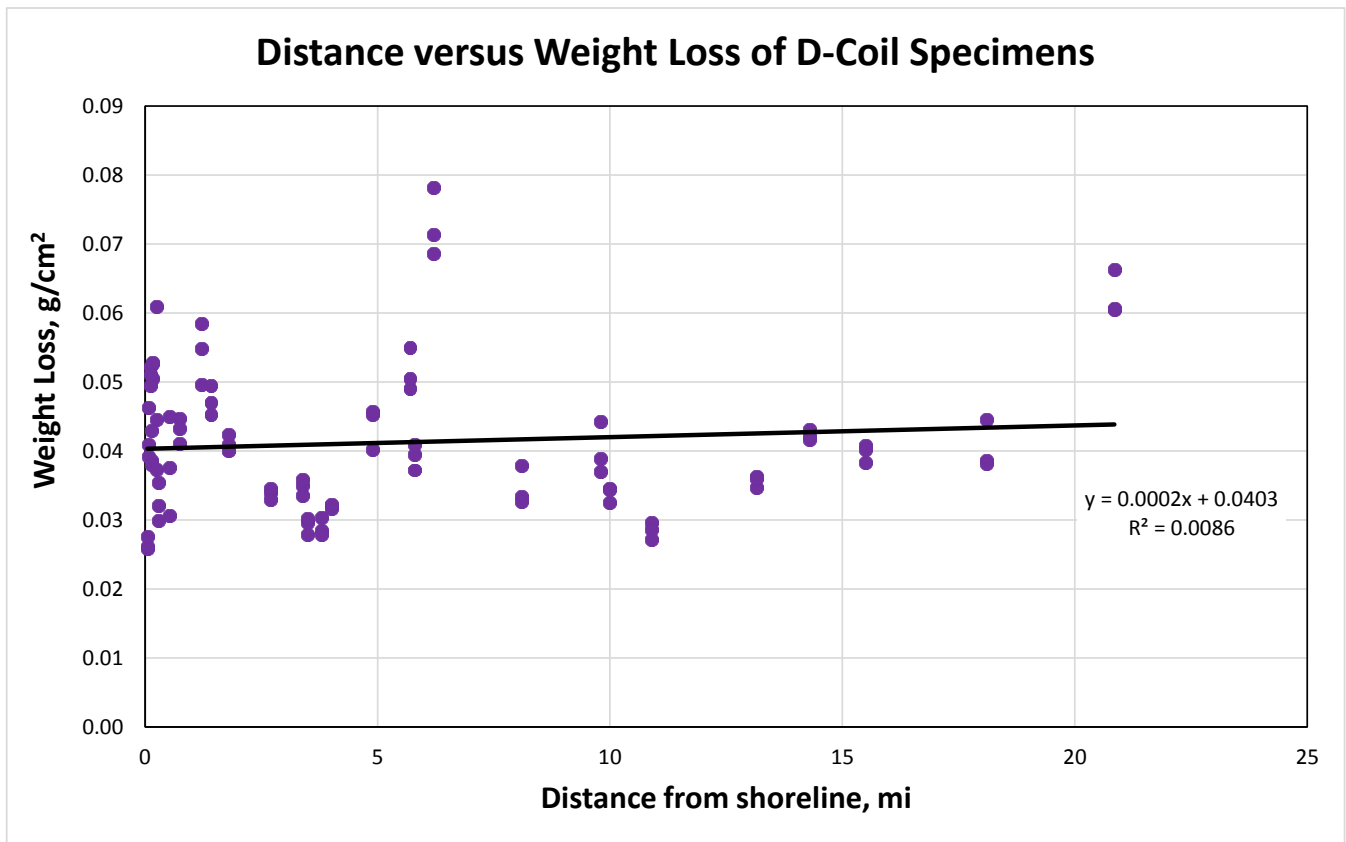
Figure 22: Distance from shoreline versus corrosion rate of CS coils on nylon bolts.

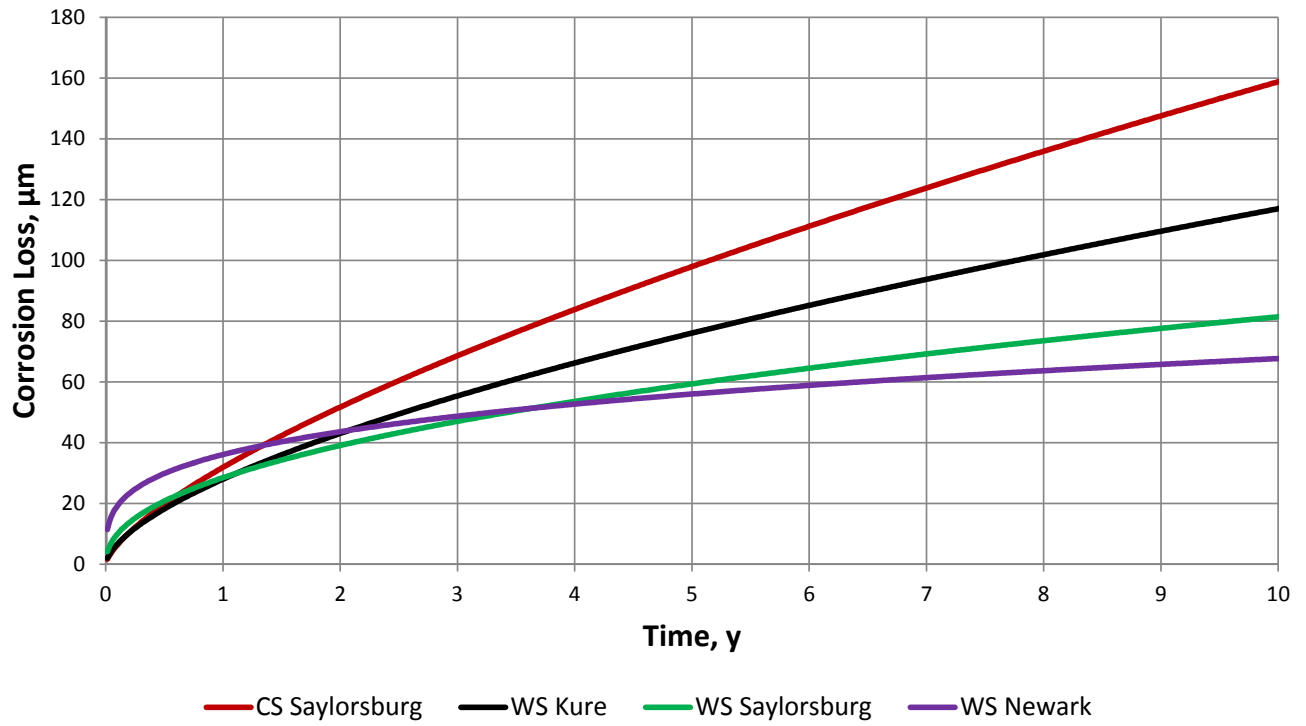
Figure 23: Replot of Townsend data (ASTM STP 767).

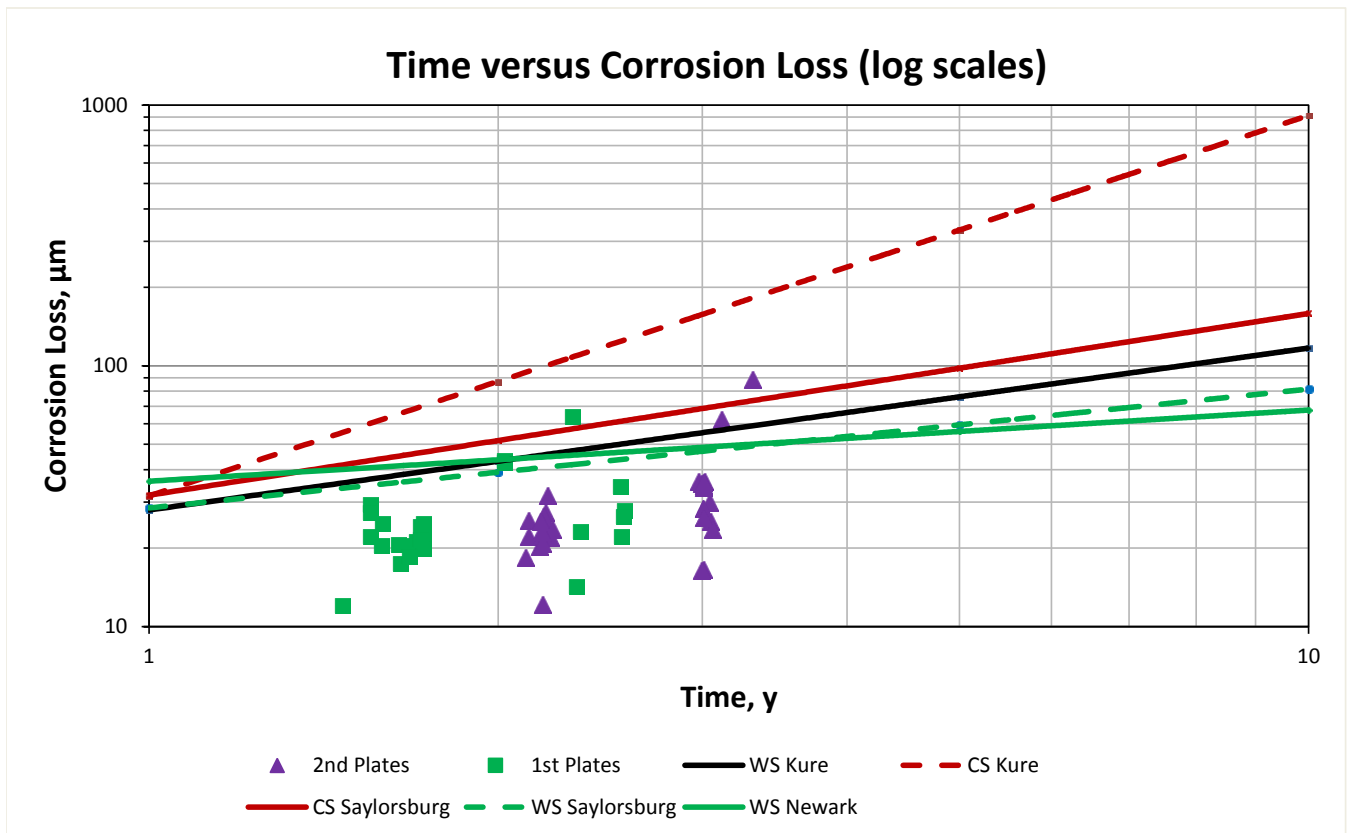
Figure 24: Townsend data with 30-site plate corrosion loss data.

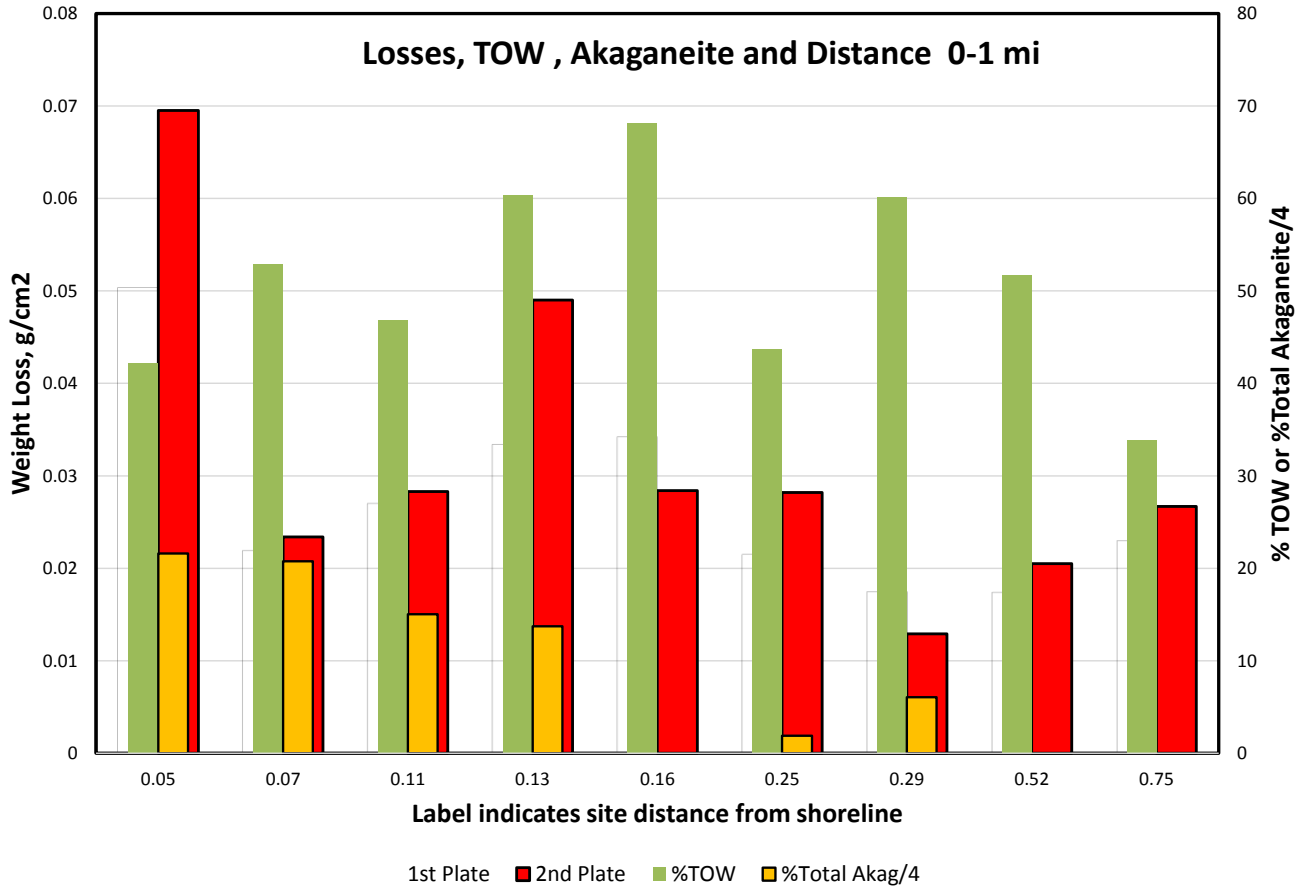
Figure 27: Graphic of corrosion loss, TOW and akaganeite for shoreline distances of 0-1 mi.

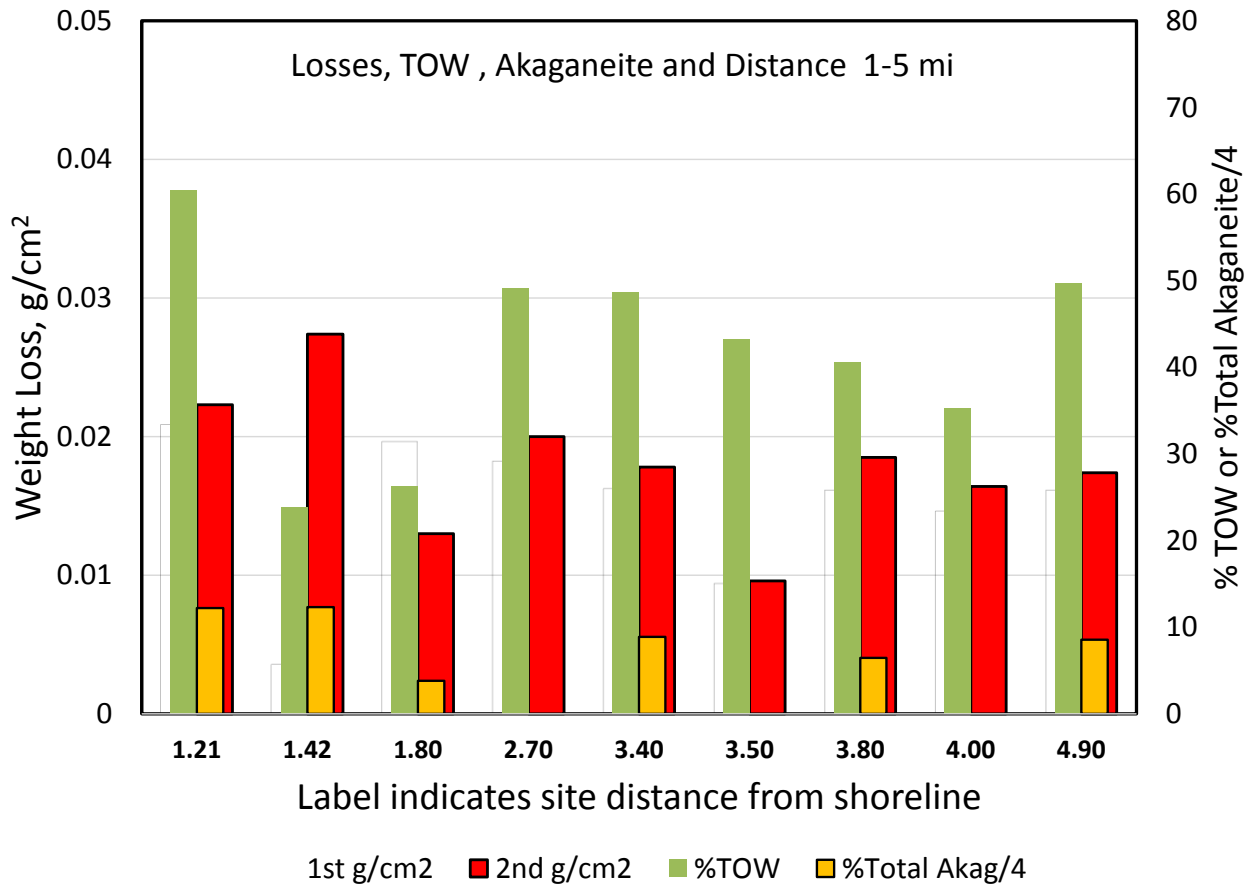
Figure 28: Graphic of corrosion loss, TOW and akaganeite for shoreline distances of 1-5 mi.

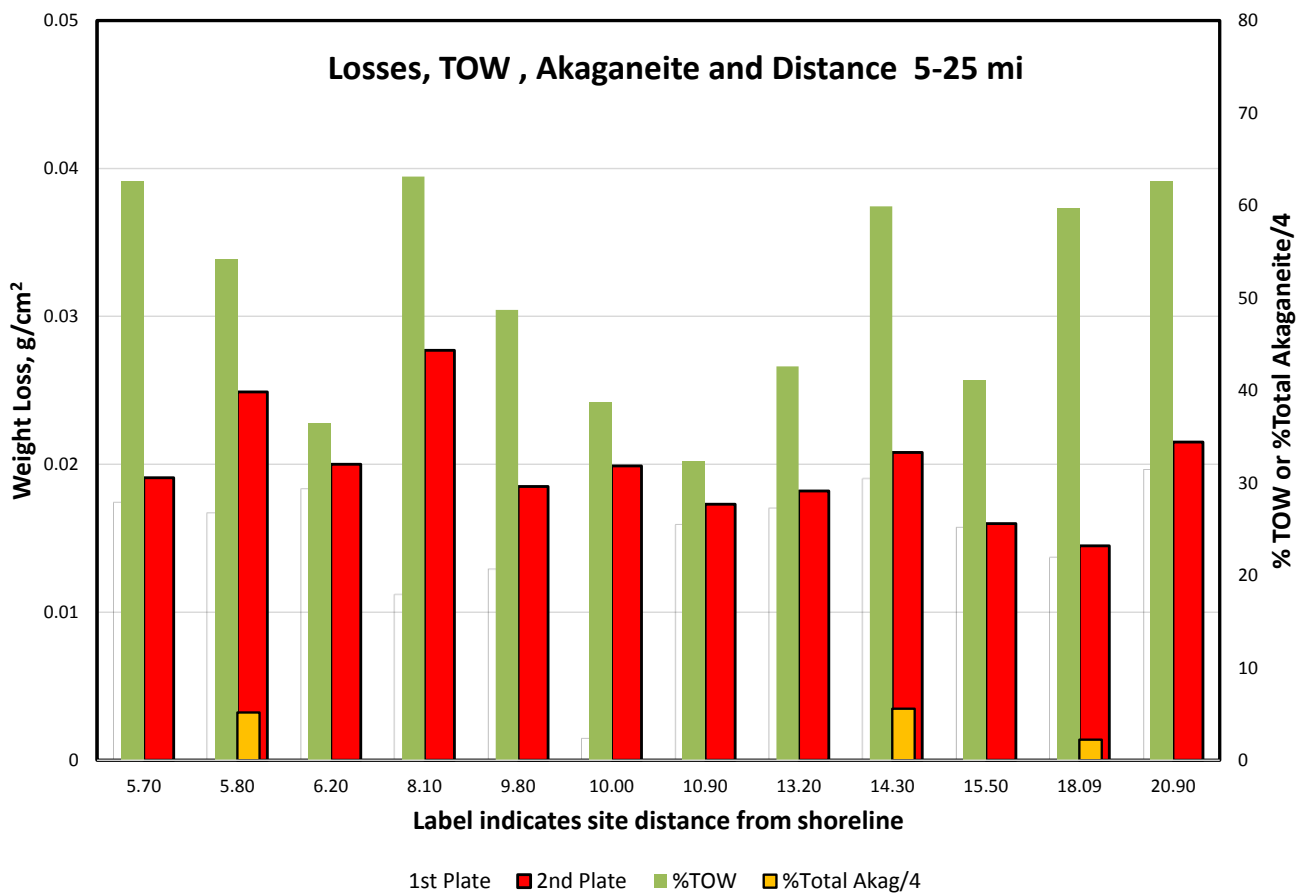
Figure 29: Graphic of corrosion loss, TOW and akaganeite for shoreline distances of 5-25 mi.

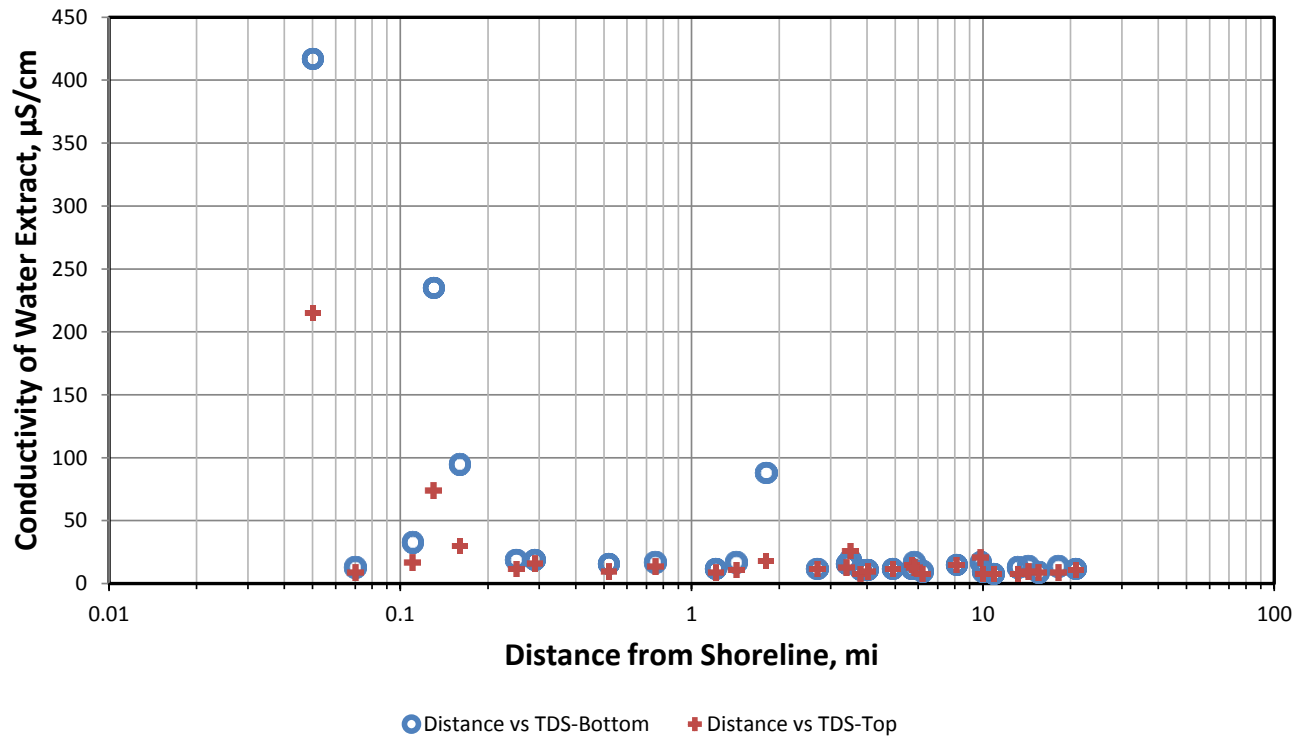
Figure 30: Distance from shoreline versus conductivity from top and bottom sides corrosion products.

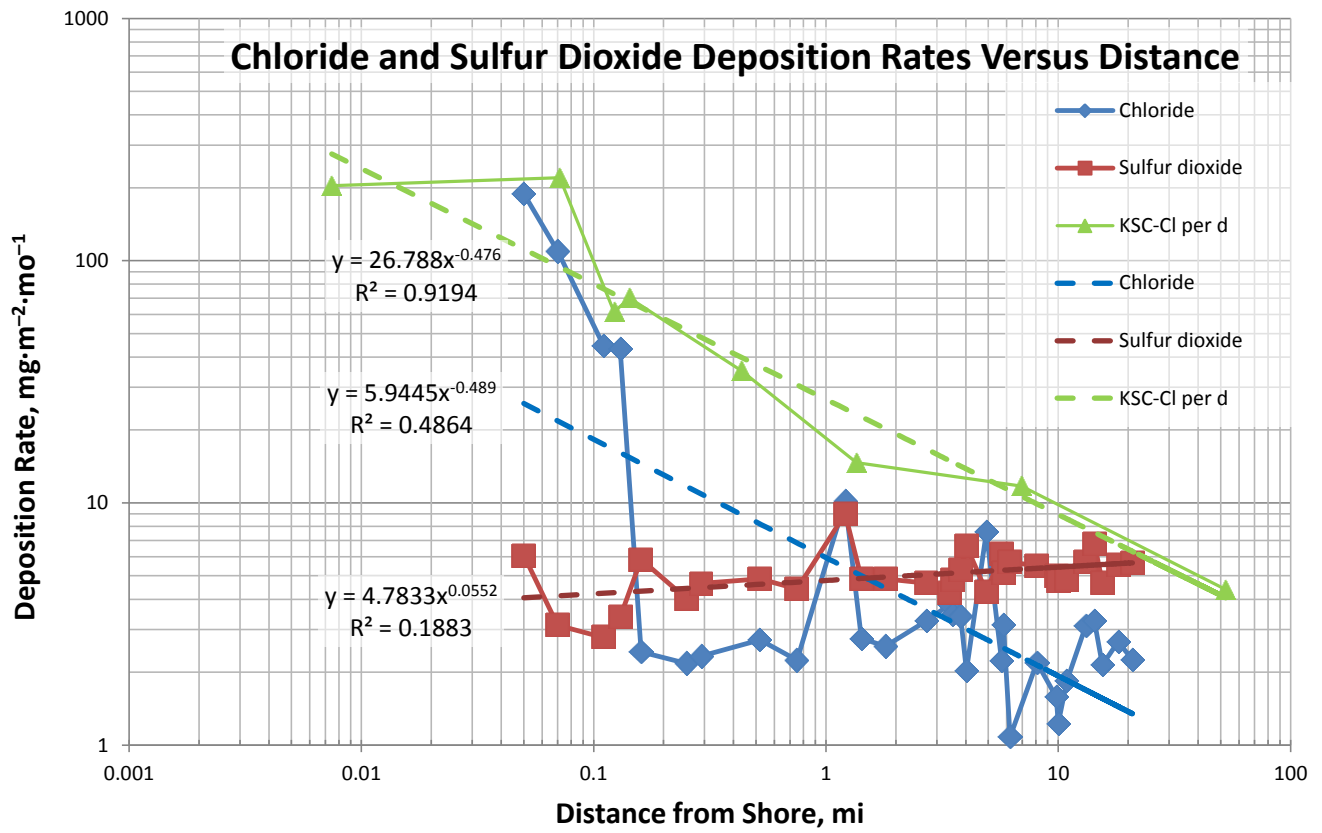
Figure 32: Deposition profiles of chloride and sulfate extracts and wet candle study.

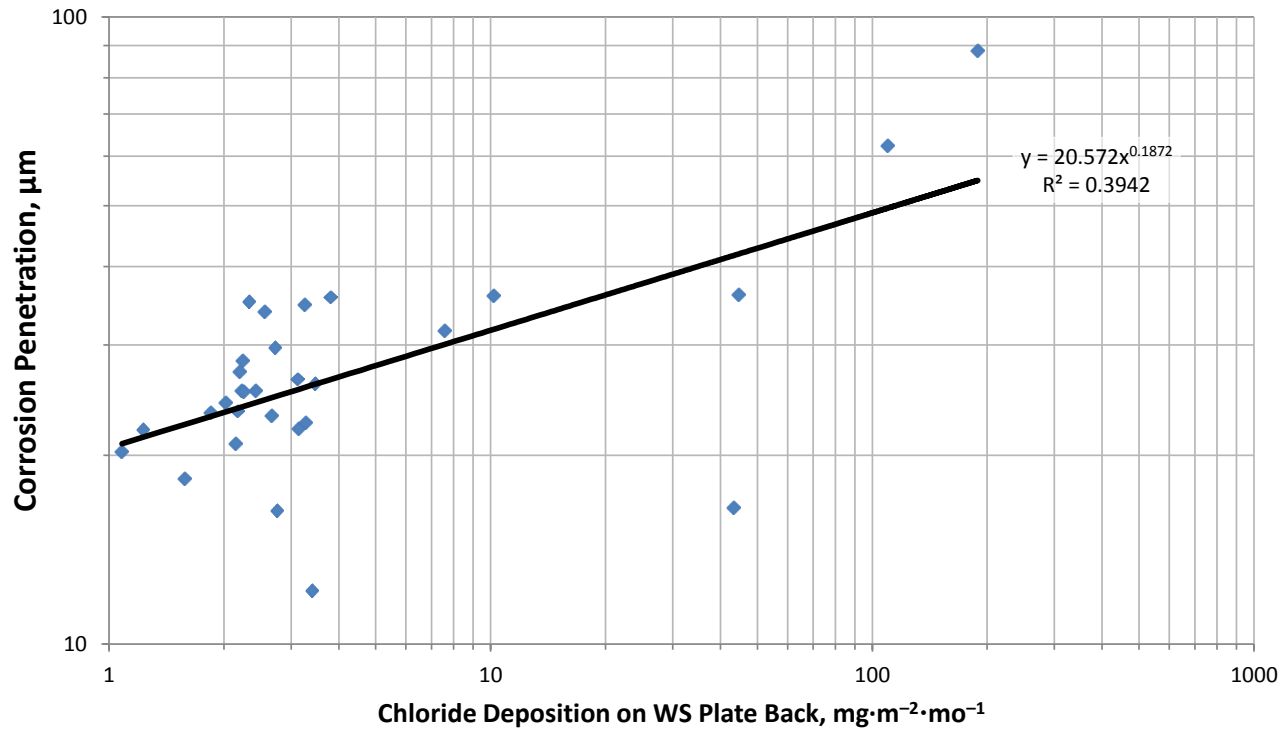
Figure 33: Chloride in corrosion product deposition versus penetration.

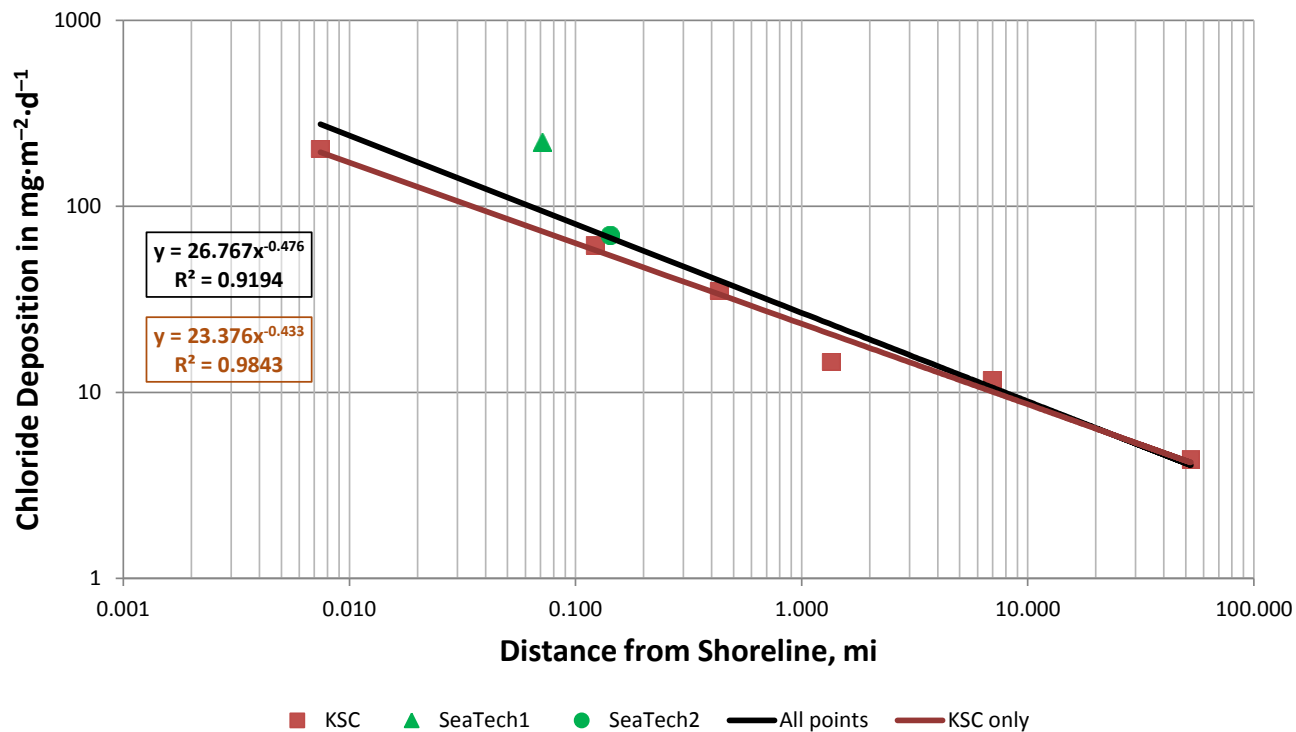
Figure 34: Chloride deposition versus distance from shore line.

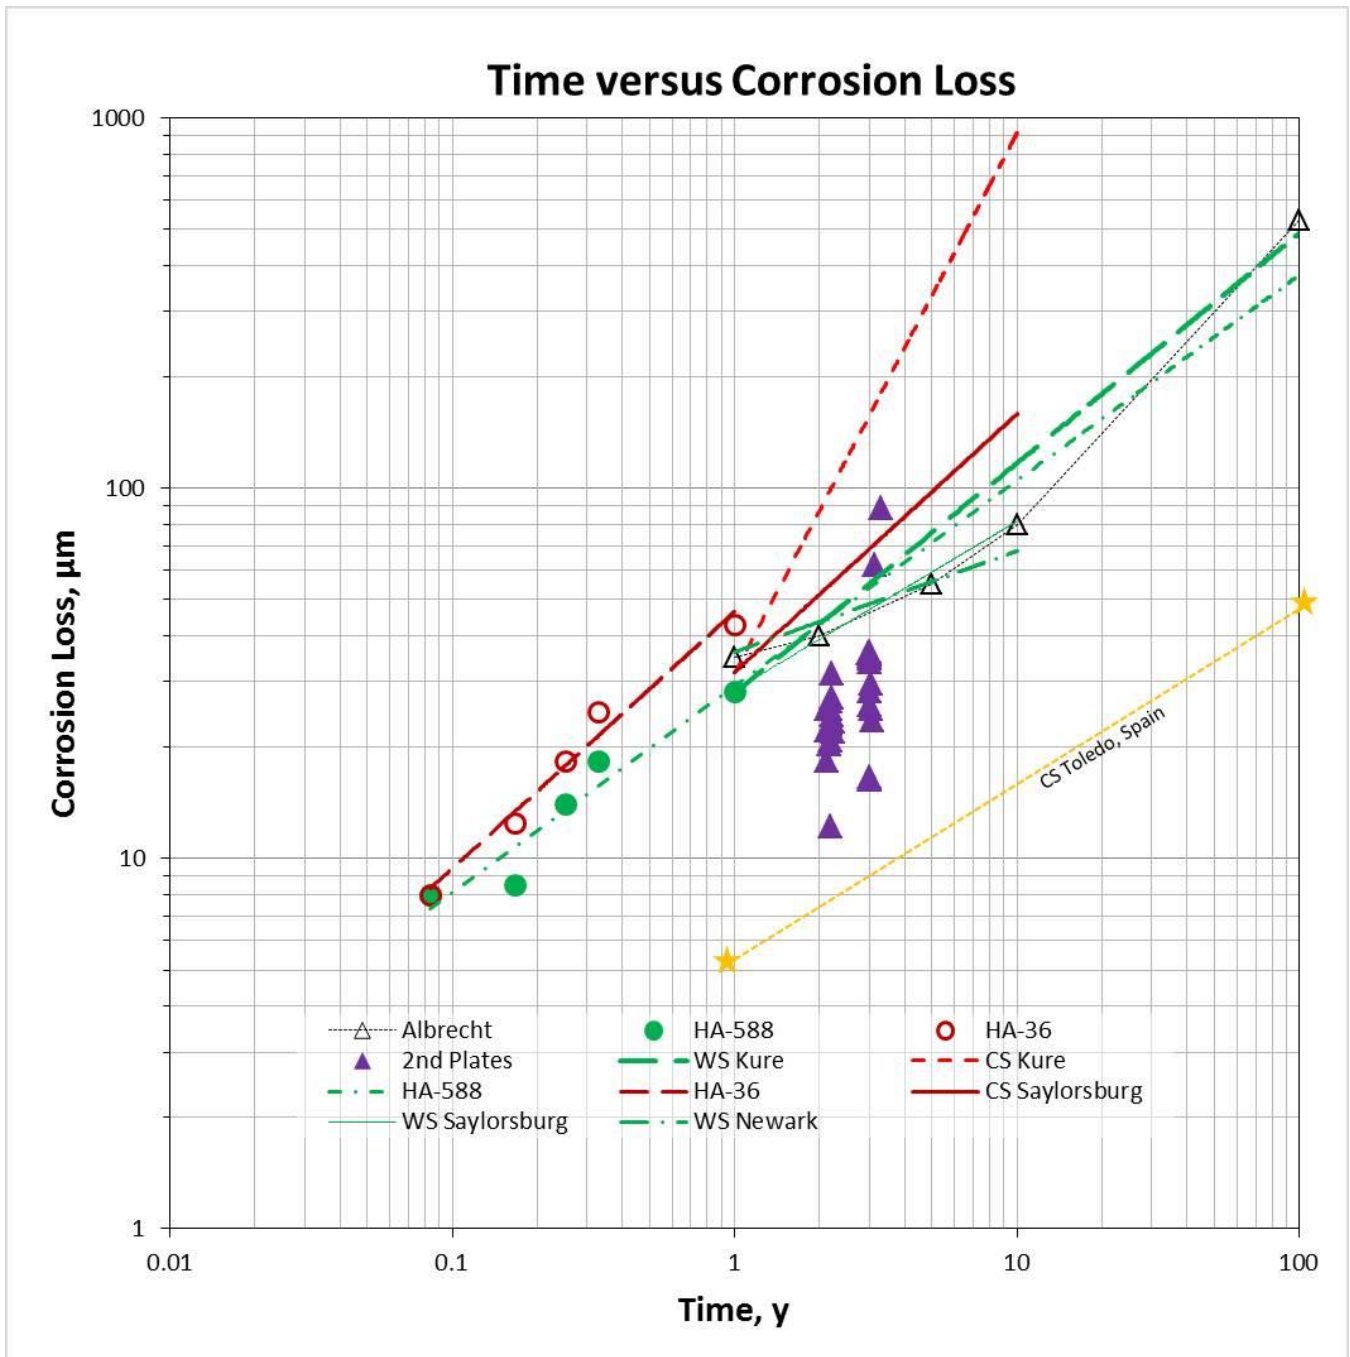
Figure 36: Plot of A36 and A588 steel plate corrosion losses in HA study with Townsend data. For comparison, low corrosion loss has been documented for Toledo, Spain.
