Final Report

Corrosion Propagation of Carbon Steel Rebars in High Performance
Concrete
BDV27–977–08

Submitted to
Florida Department of Transportation Research Center
605 Suwannee Street
Tallahassee, Florida 32399

November 2018

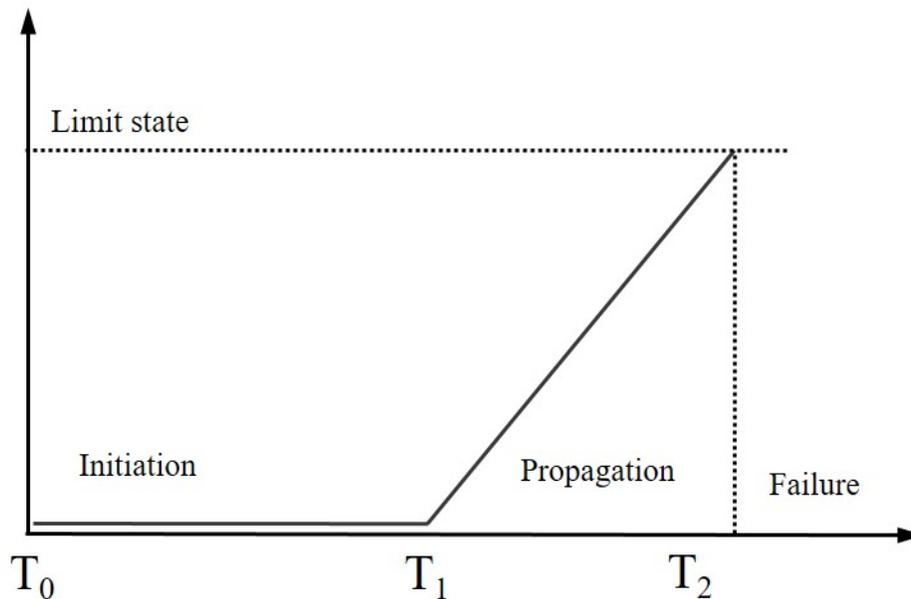
Figure 1. Schematic illustration of corrosion-induced structural deterioration(Tuutti 1982)

Compared with stage I, stage II is much more complicated. It is typically assumed that stage II only last a few years (e.g., five to ten years). The use of high-performance admixtures such as fly ash, silica fume, blast-furnace slag not only delay the corrosion initiation time (T_1) in stage I, but it is believed to reduce the corrosion rate in stage II, which then could result in an extended

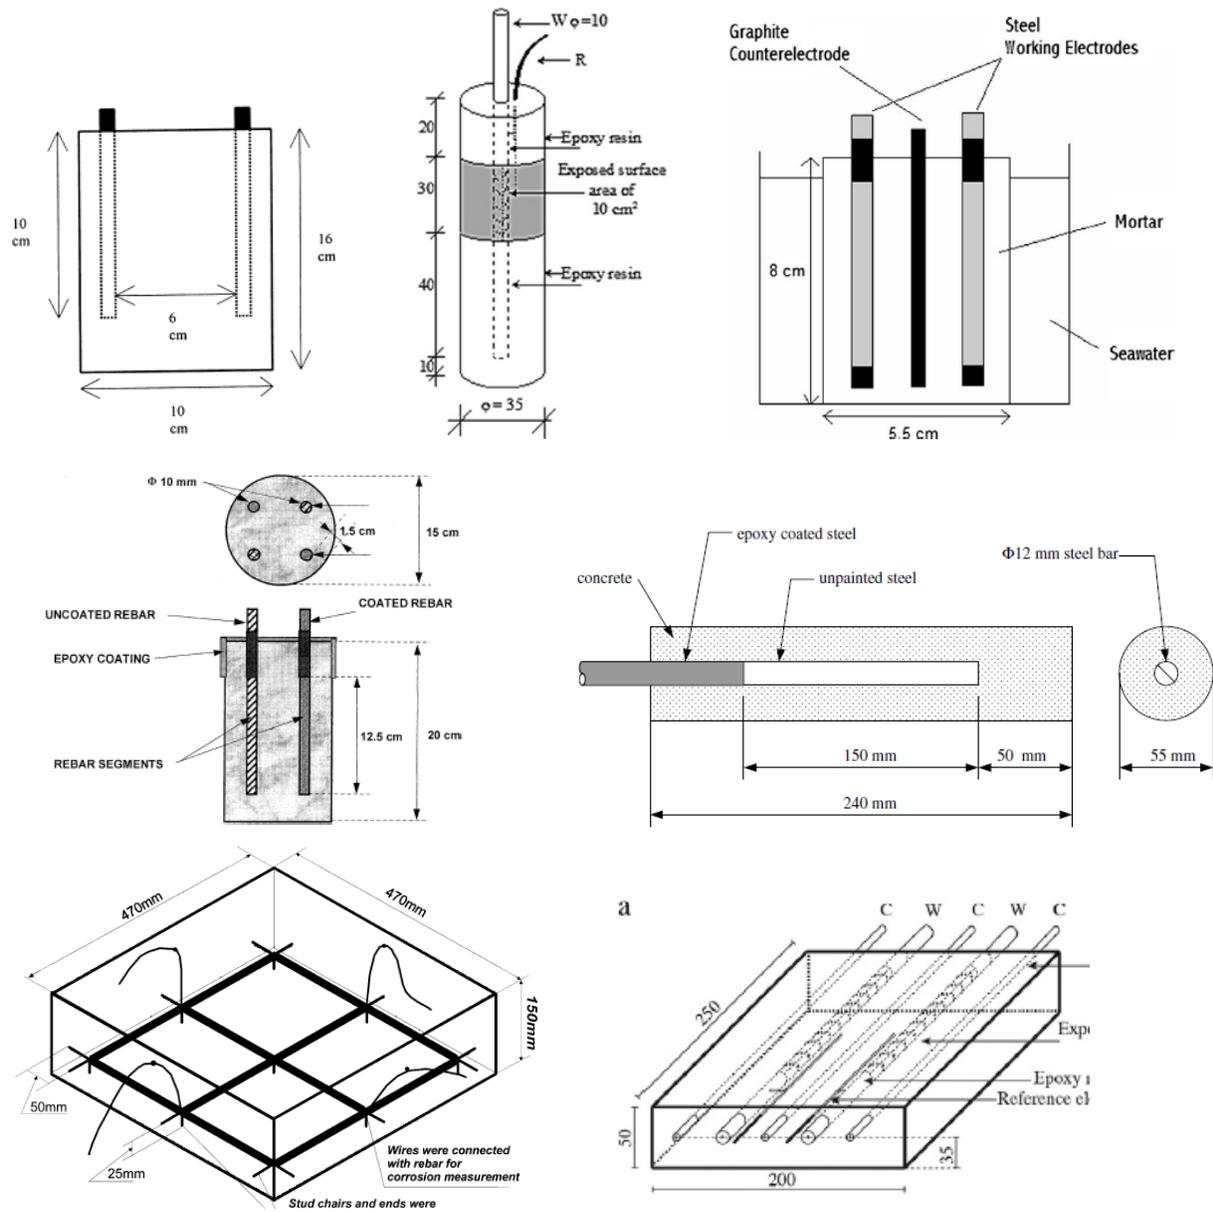
Figure 2. Different sample geometries found in the literature search.

Various concrete specimen geometries were prepared and tested in the literature (Elsener 2005; González, Miranda, and Feliu 2004; Ahmad and Ahmad 2014; Montemor, Simões, and Salta 2000; Garcés et al. 2010; Saraswathy and Song 2006; Choi, Kim, and Lee 2006; Monticelli et al. 2016b, 2016a; Criado et al. 2016; Miranda et al. 2005; Ip, n.d.; Yeau and Kim 2005; Huang, Chang, and Wu 1996; Kayali and Zhu 2005; Morris et al. 2002), including slab, prism, cube, and cylinder. Two of the most used specimens geometry to perform corrosion measurements are prisms and cylinders. Figure 2 shows some specimen geometries tested by other researchers to investigate the corrosion of the steel bar in concrete. For each specimen, different numbers of steel bars were embedded depending on the shape and size of the specimen. For cylinder specimen, one bar centered in the middle is the most used type. For prism specimen, multiple steel bars are usually embedded for corrosion observation.

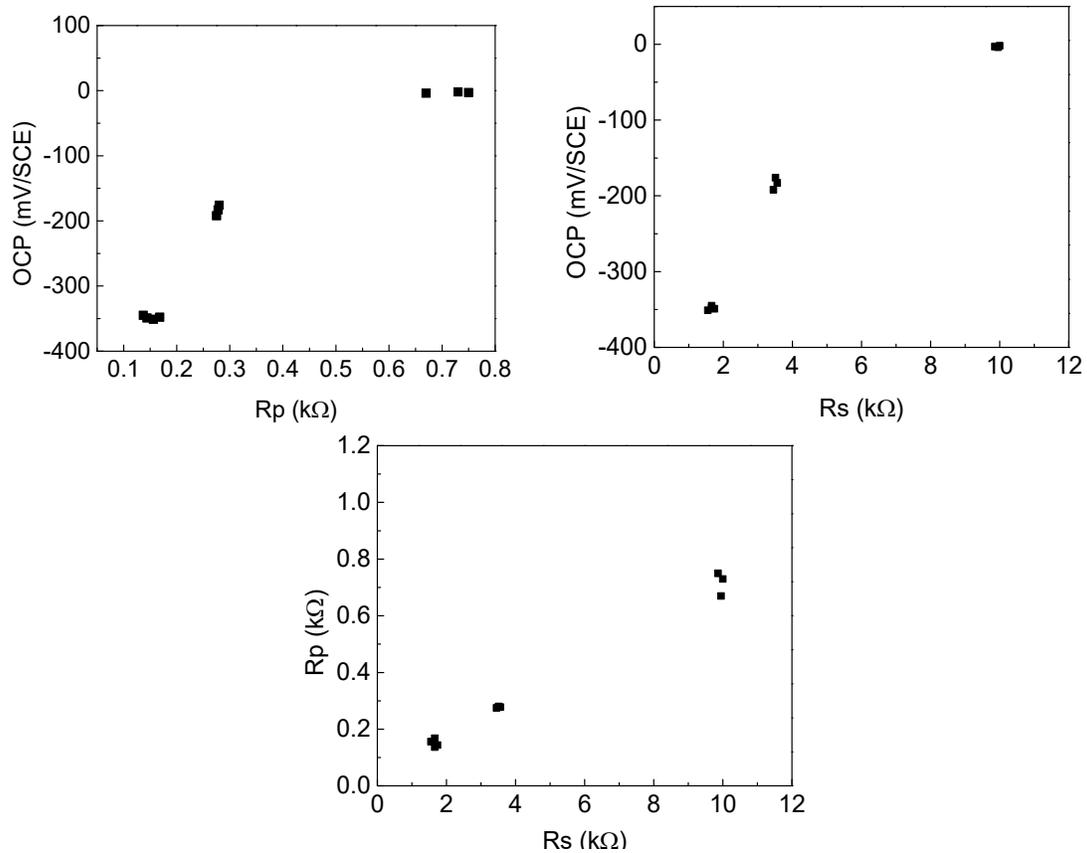
Figure 5 shows the results and correlation of OCP, polarization resistance and solution (ohmic) resistance. It is obvious that a negative OCP corresponds to a low polarization resistance and a low solution resistance.

Figure 5. Correlations between OCP, polarization resistance, and solution resistance (area polarized $\approx 150 \text{ cm}^2$).

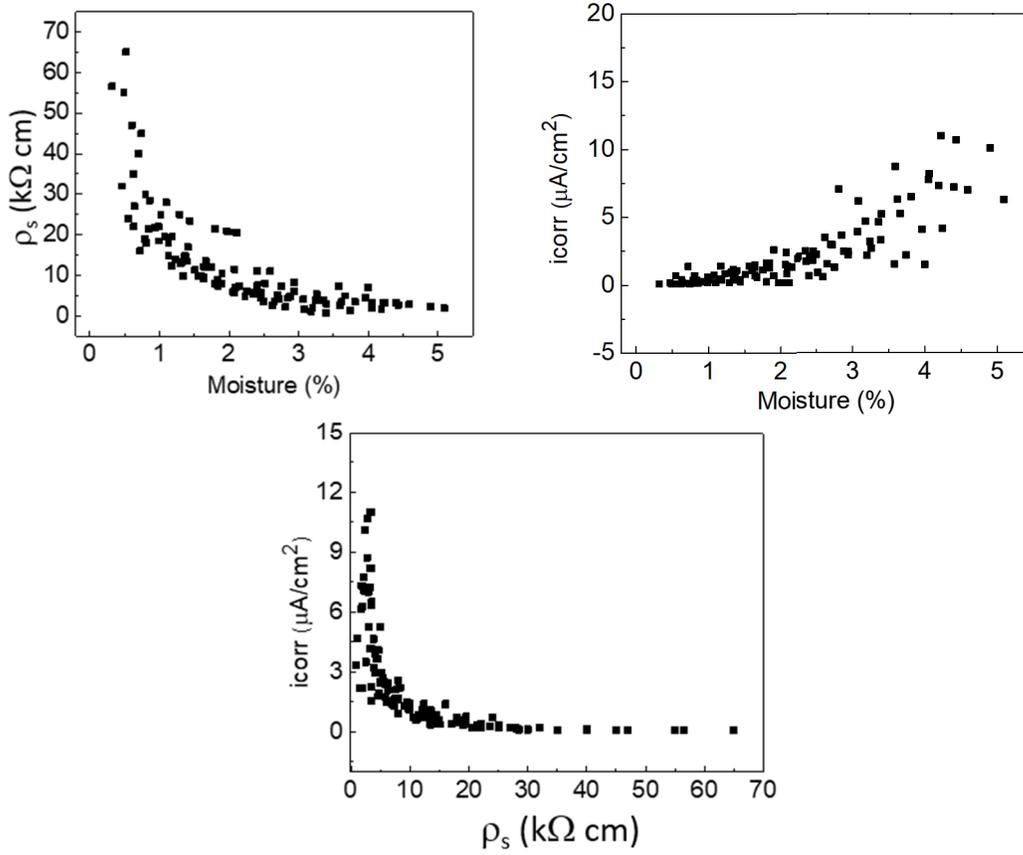
Figure 7 shows the result of concrete resistivity and corrosion rate as a function of concrete moisture. With an increase in the concrete moisture, the concrete resistivity decreased exponentially as shown in Figure 7a. The corrosion rate increased with an increase of the concrete moisture. The relationship between the concrete resistivity and the corrosion rate is evident; with an increase in the concrete resistivity, the corrosion rate of steel bar decreased.

Figure 7. Correlations between corrosion rate, concrete resistivity, and moisture.

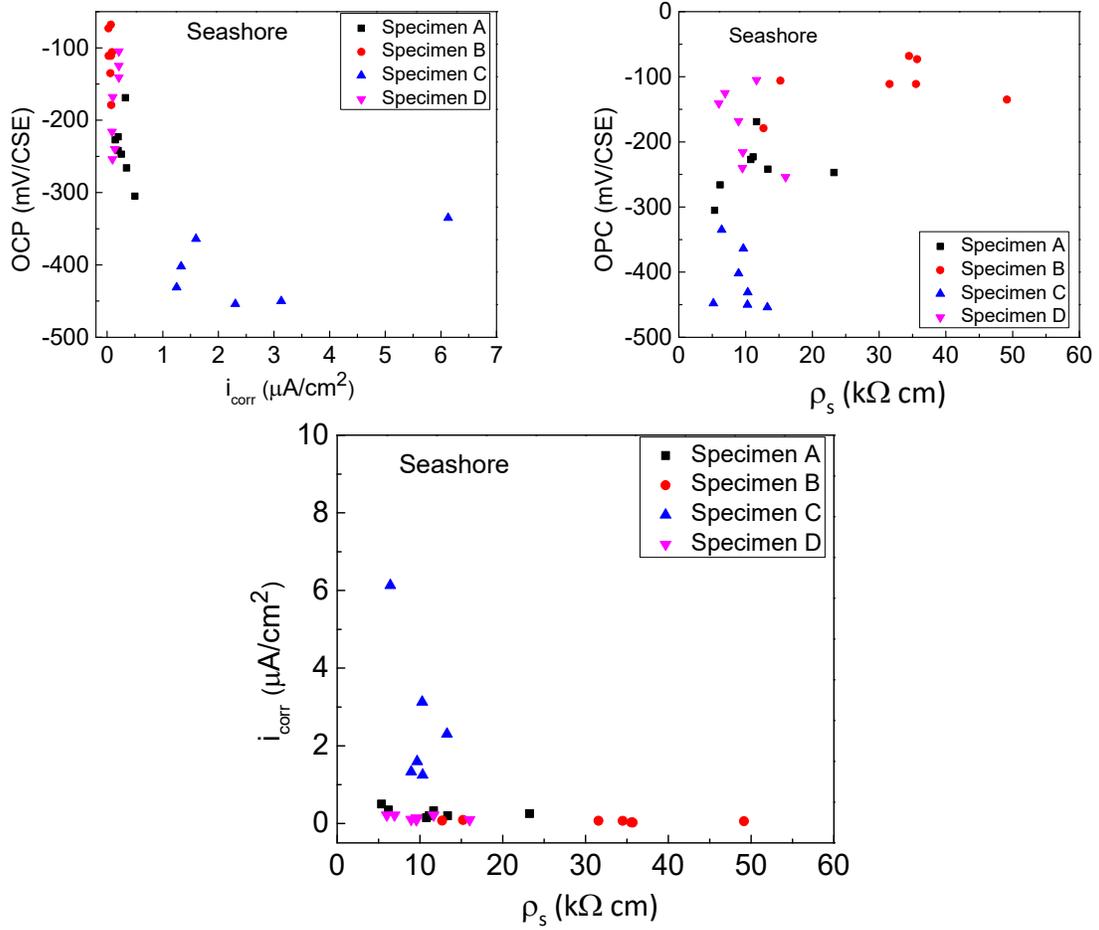
Figure 9 shows the correlations between OCP, corrosion rate, and concrete resistivity for specimens at the seashore. Figure 10 shows their correlations for specimens immersed in salt water. The corrosion rate measured reached 10 $\mu\text{A}/\text{cm}^2$ for steel immersed in a salt solution. It can also be observed that a negative OPC correspond to a high corrosion rate and a low concrete resistivity for all specimens.

Figure 9. Correlations between OCP, corrosion rate, and concrete resistivity for specimens located at the seashore.

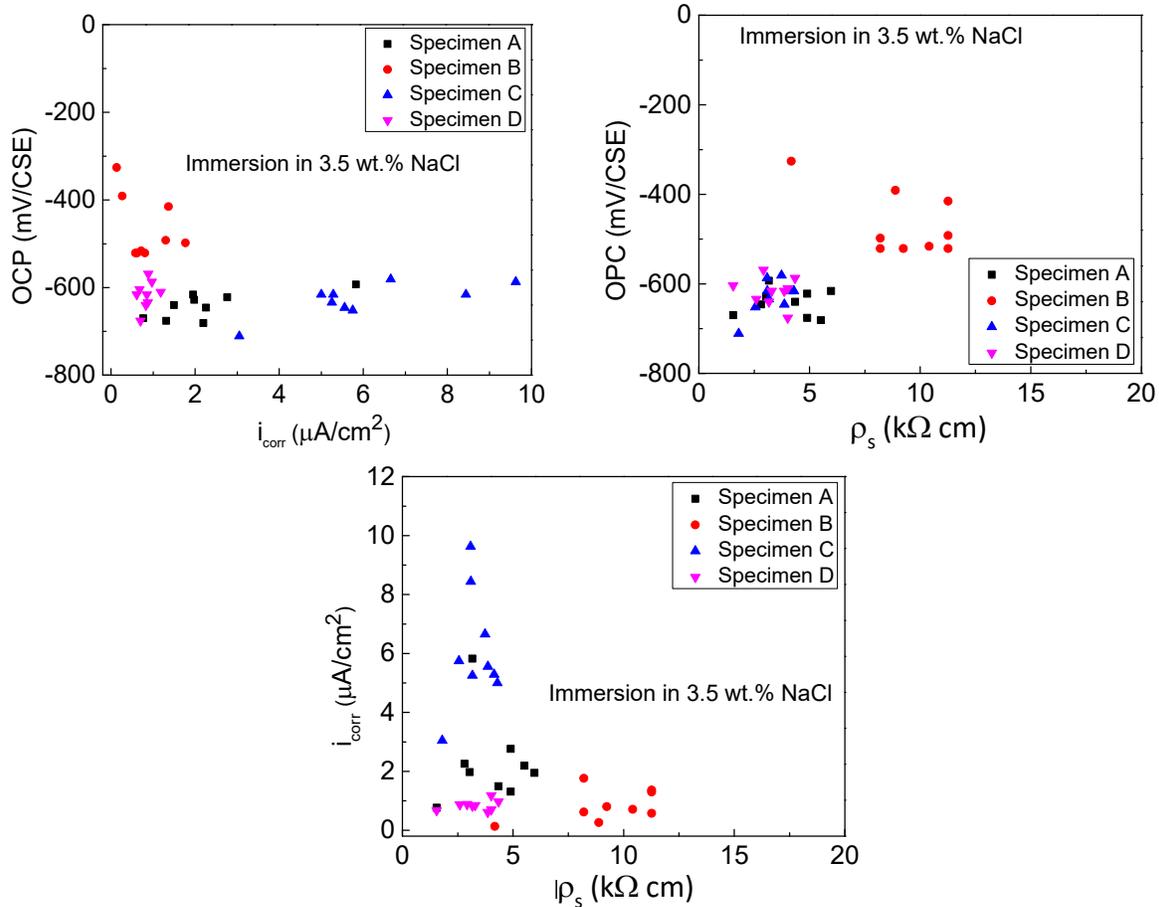
Figure 10. Correlations between OCP, corrosion rate, and concrete resistivity for specimens in 3.5% NaCl solution.

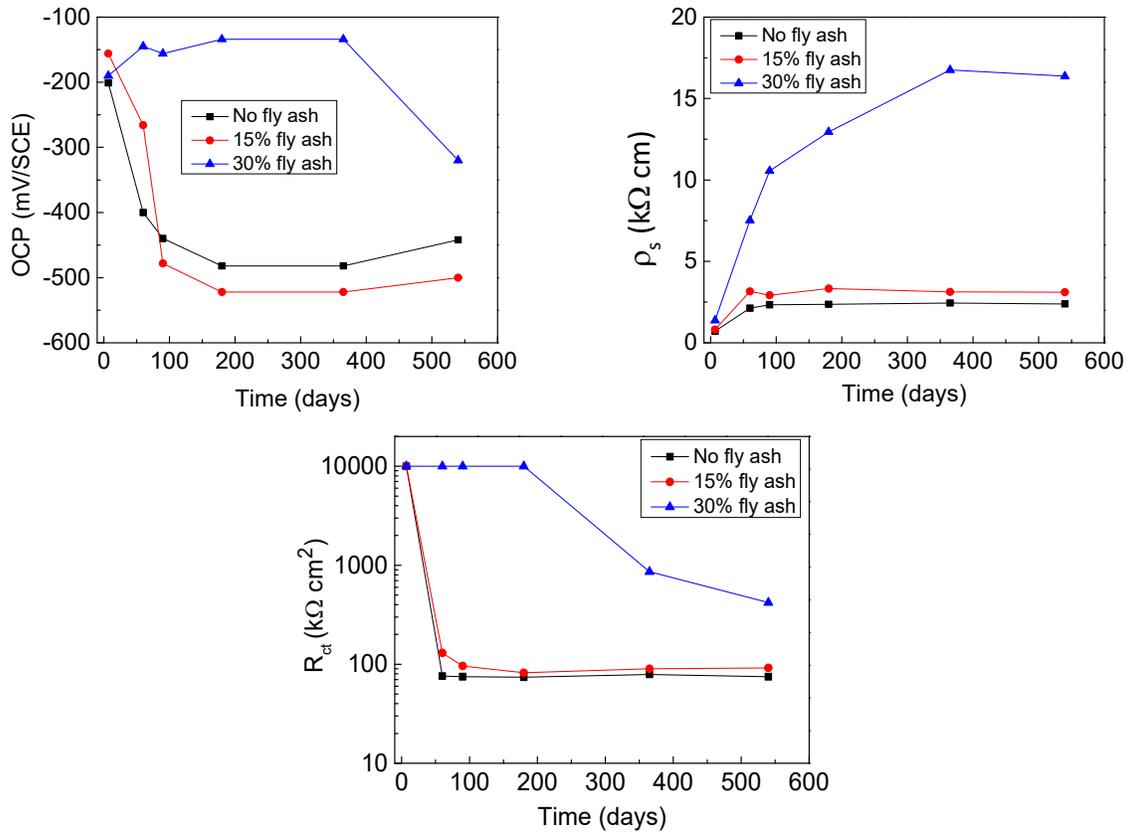
Figure 12 shows the evolution of OCP, concrete resistivity and charge transfer resistance with immersion time. It can be observed that with an increase in the immersion time, both the OCP and the charge transfer resistance decreased. Particularly after 60 days of immersion, a sudden drop of OCP and charge transfer resistance occurred. This is believed to be due to the initiation of corrosion. It also noted that the addition of fly ash increased the corrosion resistance of the steel bar, especially for concrete with 30% fly ash addition.

Figure 12. Corrosion parameters evolution with time.

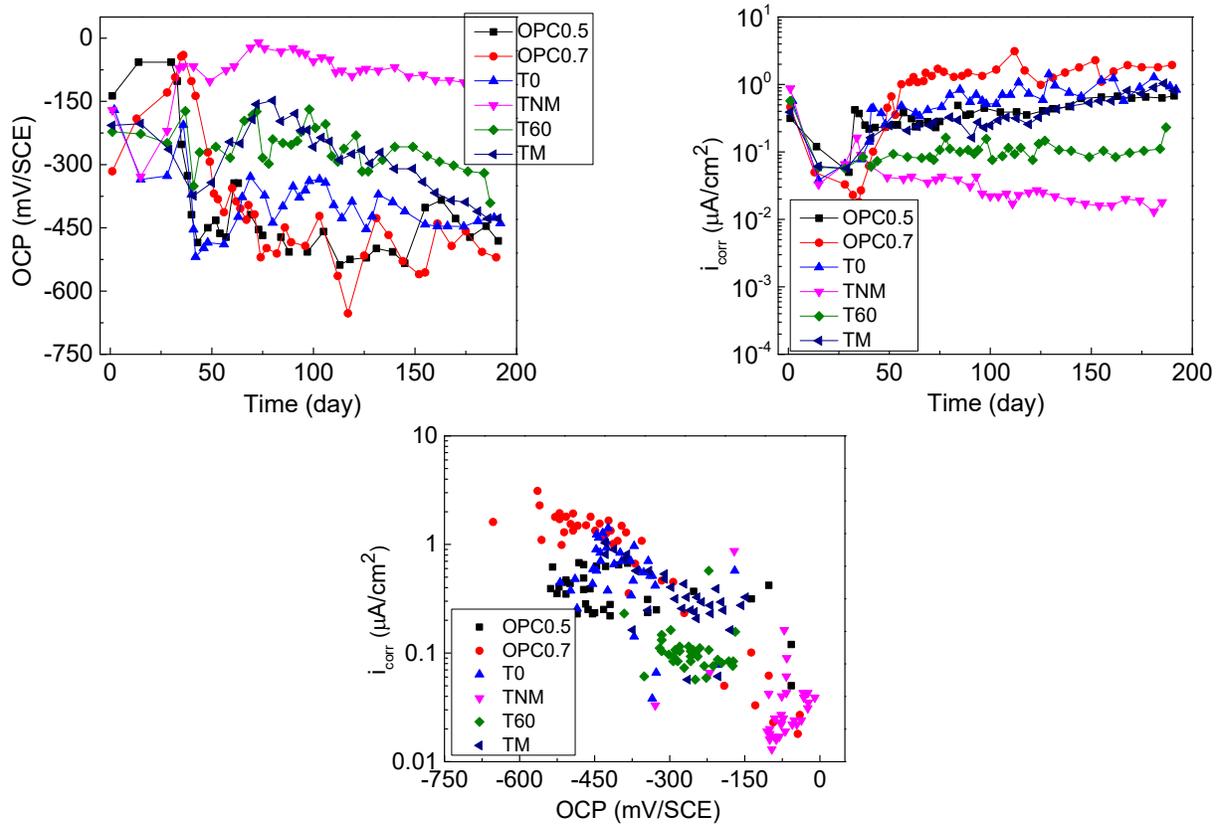
Figure 15 shows the change of OCP and corrosion rate over time and the correlations between OCP and corrosion rate. With an increase of time, the OCP decreased and the corrosion rate increased slowly. With a high corrosion rate, a more negative OCP was obtained.

Figure 15. Corrosion potential and rate evolution with time and correlation between them.

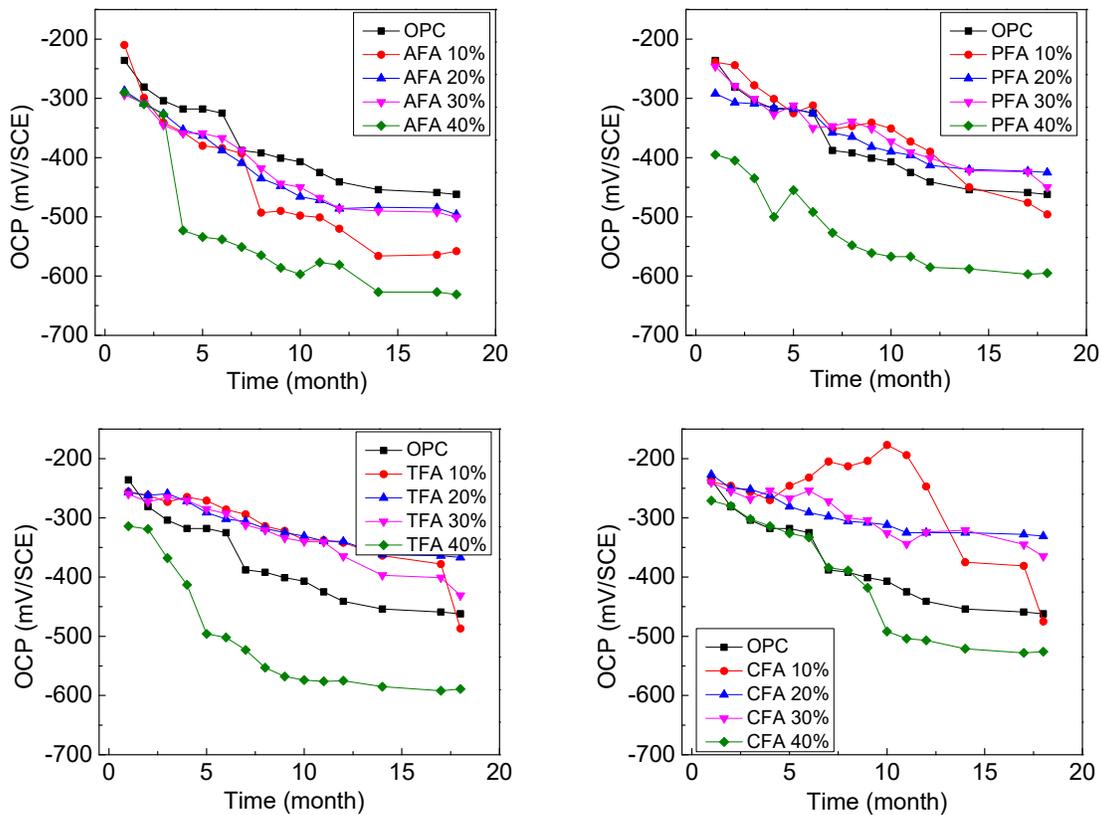
Figure 16 shows the OCP evolution with time. It can be observed all OCP decreased slowly as a function of test duration.

Figure 16. Corrosion potential evolution with time.

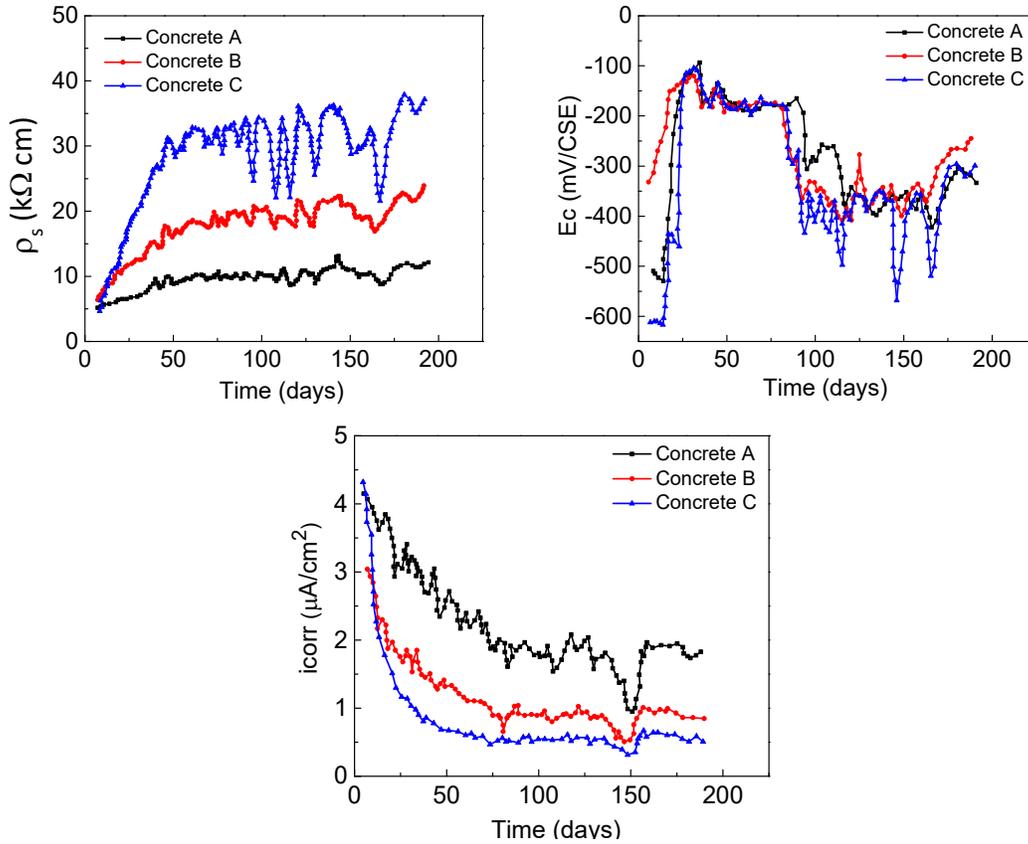
Figure 18 shows the evolution of concrete resistivity, corrosion potential and corrosion rates for all three concrete specimens. It can be observed that as time passed the concrete resistivity increased. Particularly in the first 60 days, the resistivity increased rapidly. Concrete with slag show a high resistivity, and with an increase of the slag percentage, the concrete resistivity also increased. As for the corrosion, the corrosion potential suddenly decreased around 80 days, indicating active corrosion. However, the corrosion rate decreased all the time from the start. This is probably because of the increase in concrete resistivity.

Figure 18. Evolution of concrete resistivity, corrosion potential, and corrosion rate over time.

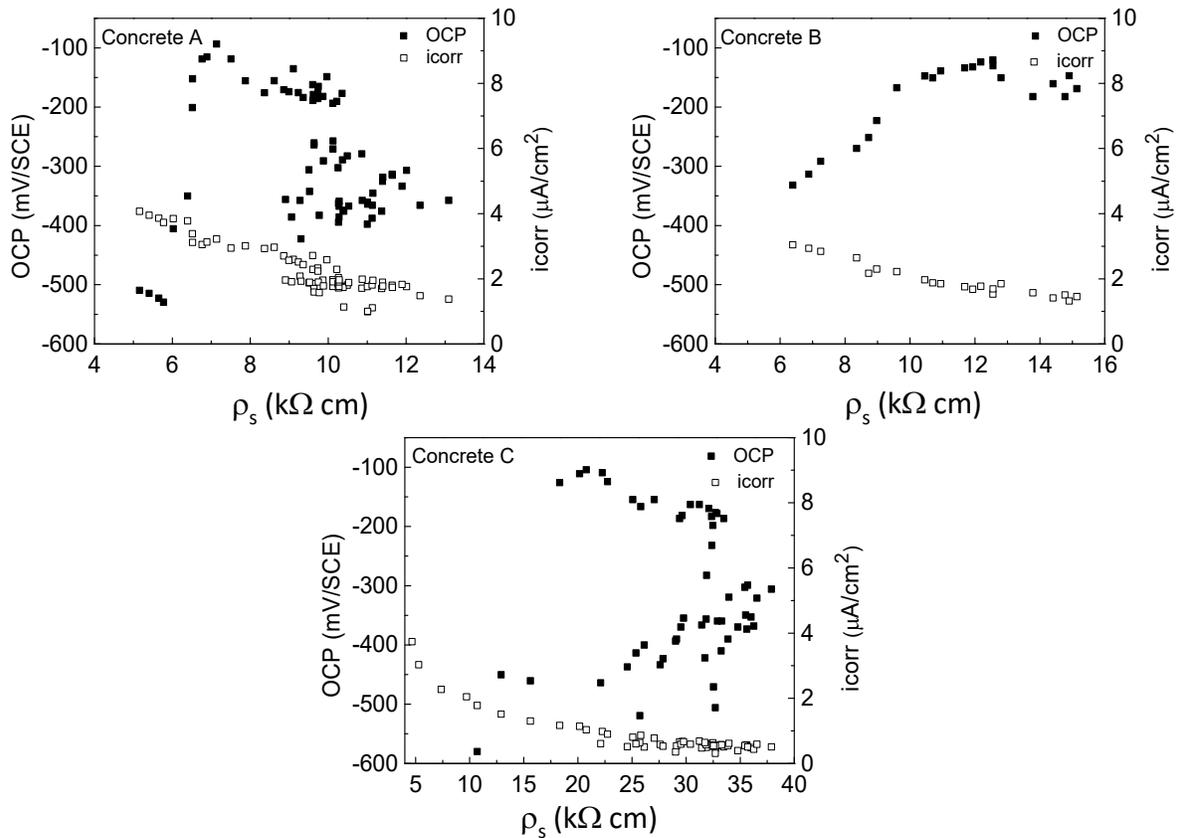
Figure 19 shows the correlation between concrete resistivity and corrosion potential, corrosion rate before 270 days. It can be observed with an increase of concrete resistivity, the corrosion rate decreased almost in a linear trend for all three specimens. However, no correlation was observed between the concrete resistivity and the corrosion potential for specimens A and C. For specimen B, a trend can be observed, and the corrosion potential increased with an increase in the concrete resistivity. This is in agreement with observations from other researchers.

Figure 19. Correlations between corrosion potential, corrosion rate, and concrete resistivity from the beginning to 270 days.

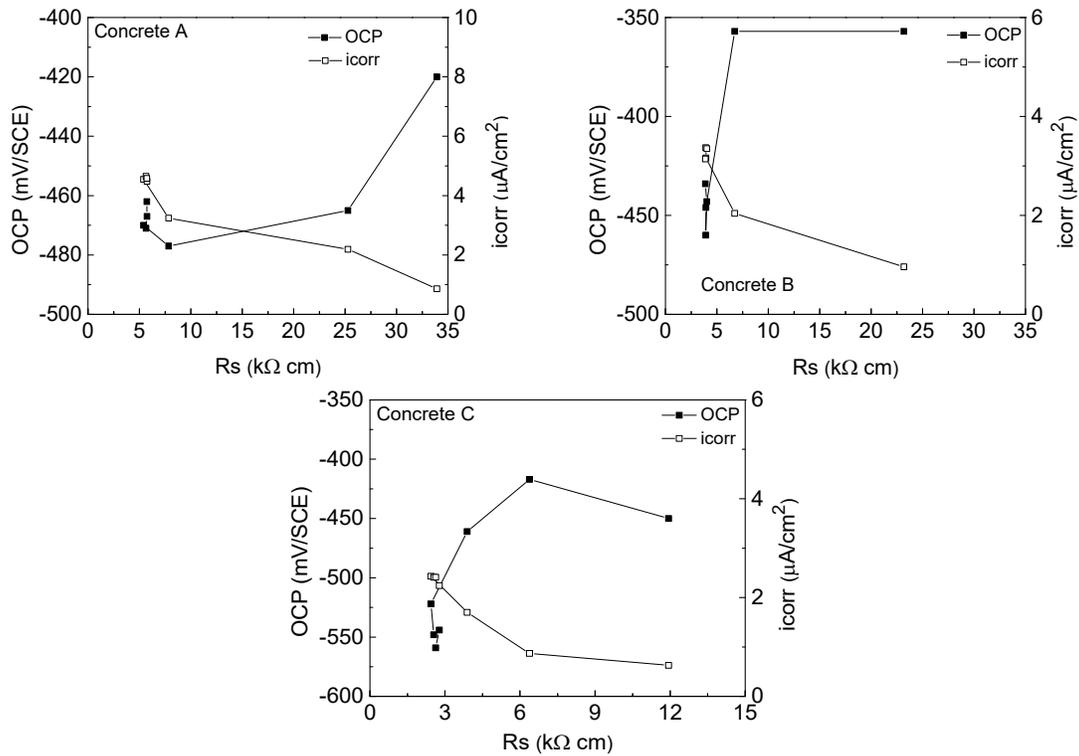
Figure 21 shows the correlation between concrete resistivity, corrosion potential and corrosion rate when the specimens were corroding after 270 days. It can be observed that in the active corrosion stage, the corrosion rate decrease with an increase in the concrete resistivity. Correspondingly, the corrosion potential increased with an increase in the concrete resistivity.

Figure 21. Correlations between corrosion potential, corrosion rate, and concrete resistivity after 270 days (active corrosion).

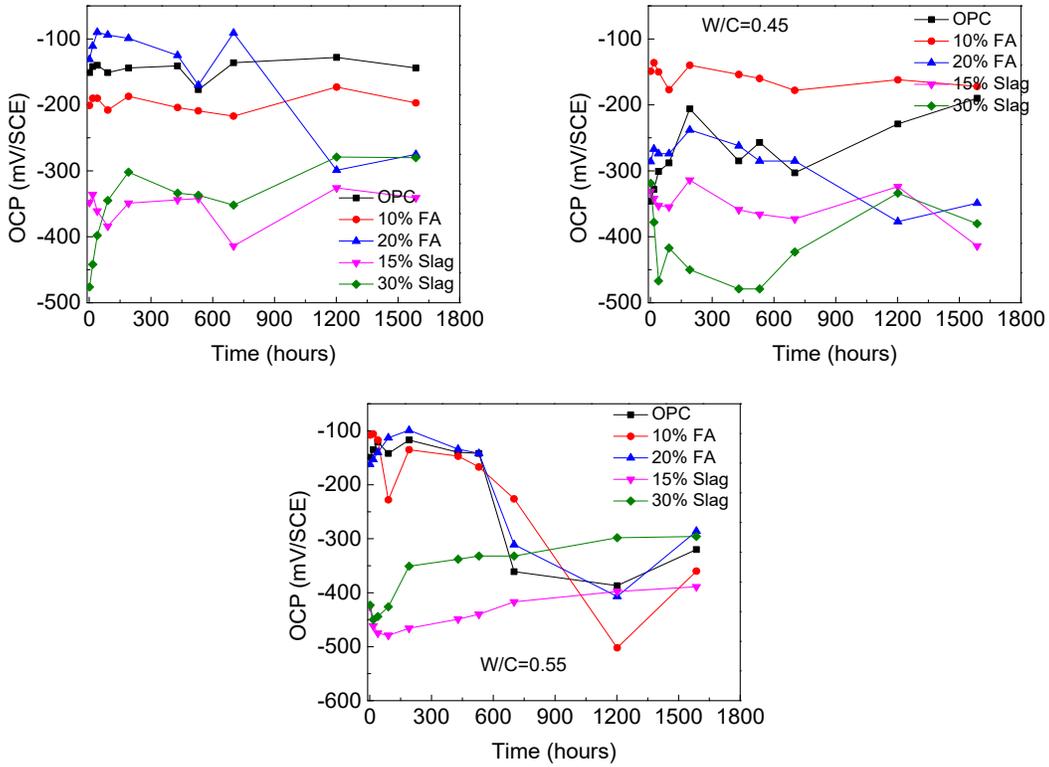
Figure 22 shows the evolution of OCP with time for different specimens. Specimens with slag addition had a lower corrosion potential than specimens with fly ash regardless of the water to cement ratio. For specimens with w/c equals to 0.35 and 0.45, no general trend was observed over time for open circuit potential, and most of the specimens fluctuated around certain values. However, for specimens with w/c=0.55, a decrease in the OCP happened after 600 hours, which is attributed to corrosion initiation.

Figure 22. Evolution of OCP over time for different specimens (w/cm=0.35, 0.45, 0.55).

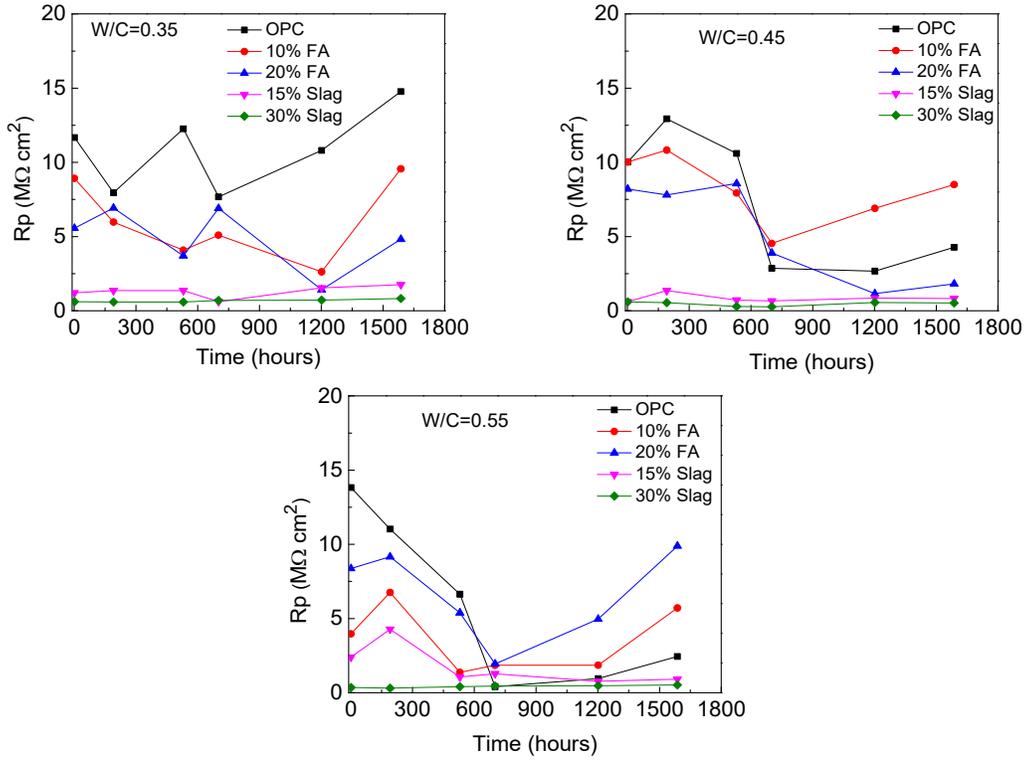
Figure 23 shows the evolution of polarization resistance with time. The polarization resistances of OPC specimens are higher than specimens mixed with fly ash or silica fume, particularly at the beginning of the test period. For specimens with w/c=0.55, the polarization resistances of specimens mixed with fly ash are higher than OPC specimens after 700 hours. But, the polarization resistance of the specimen mixed with silica fume is still lower than OPC specimens.

Figure 23. Evolution of polarization resistance over time for different specimens.

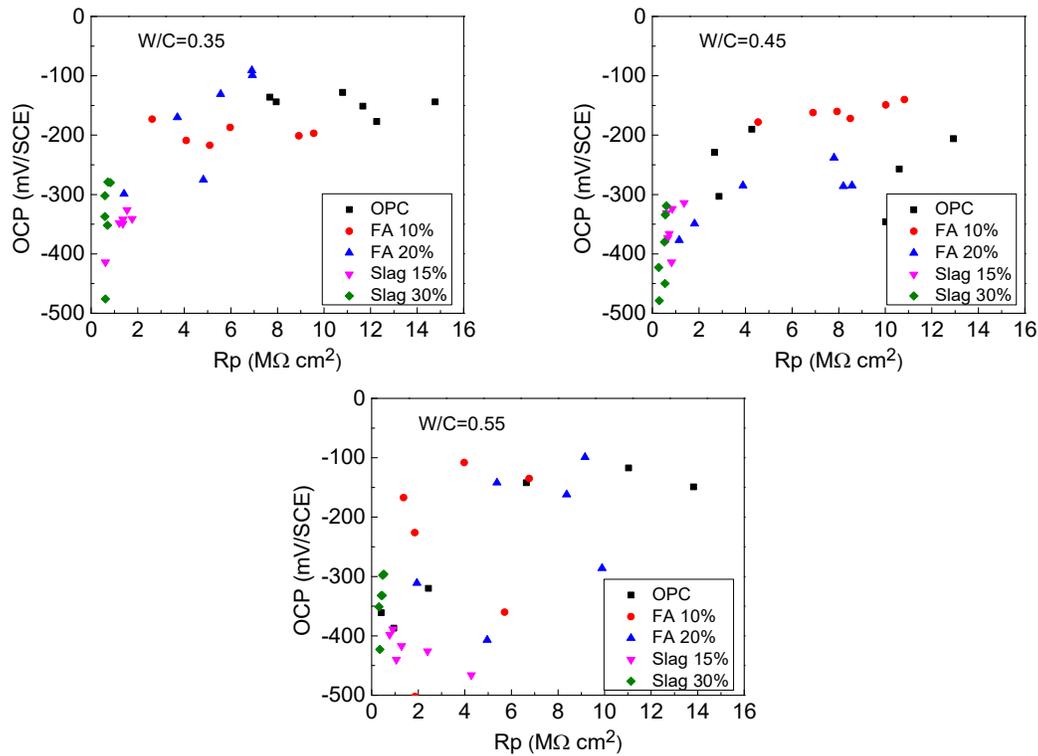
Figure 24 shows the correlation between OCP and polarization resistance for all specimens. It can be observed, a high polarization resistance corresponds to a more positive corrosion potential. This is more obvious for specimens with $w/c=0.35$ and 0.45 .

Figure 24. Correlation between OCP and polarization resistance.

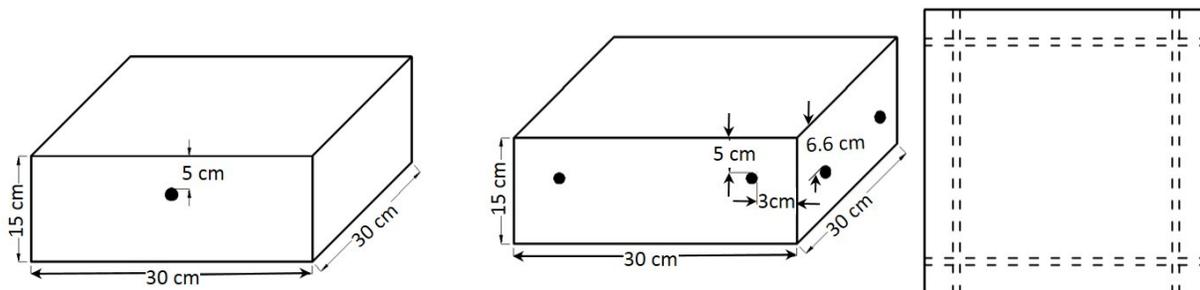
Figure 25. Diagrams showing the reinforced concrete blocks: one-rebar specimen (left); four-rebar specimen (center and right).

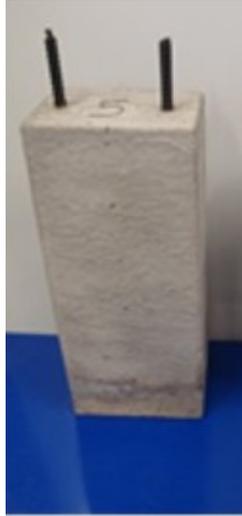
Figure 26. Two-rebar specimens

Two rebar specimens were prepared with the concrete mix containing 20% FA as described above. This geometry is named modified Tombstone specimen. The dimensions for the two rebar specimens are 61 × 25.4 × 17.8 cm (24 × 10 × 7 in). Five specimens were prepared with two #5 (1.6 cm diameter) rebar segment bars parallel and embedded along the long axis with a spacing of seven inches in between and displaced from the center to obtain four different concrete covers. The four concrete covers were: 8.9 cm, 7.6 cm, 4.4 cm, and 2.5 cm. Two of these five specimens were selected for this project. Figure 26 shows a picture of one of the two rebar specimens.

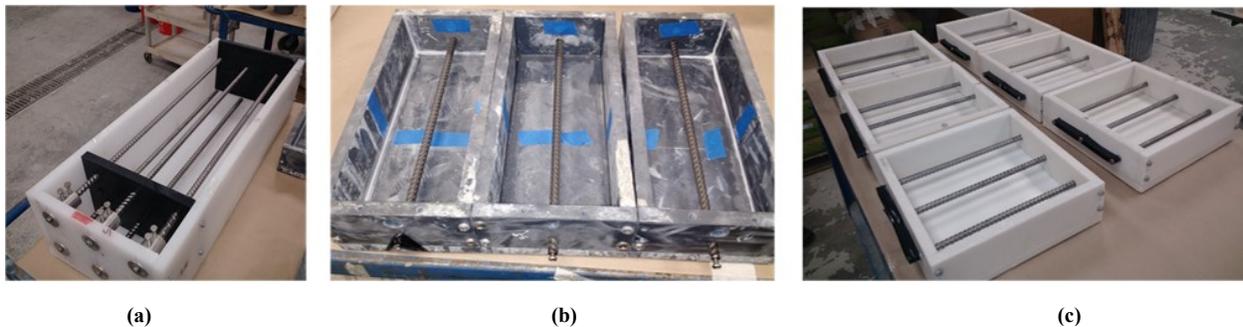
For single-rebar samples, each rebar was drilled and tapped on one end and a stainless steel screw installed before casting the concrete. This step was done to provide an electrical contact. The three-rebar samples were drilled (but not all tapped) and fitted with stainless steel screws, nuts, and washers, but this step was done after the samples arrived at the FAU marine materials lab, for sample and environment preparations.

Figure 28. Molds with reinforcement prior to casting: (a) modified tombstone specimen (6 rebars); (b) single rebar-samples; (c) three-rebar samples

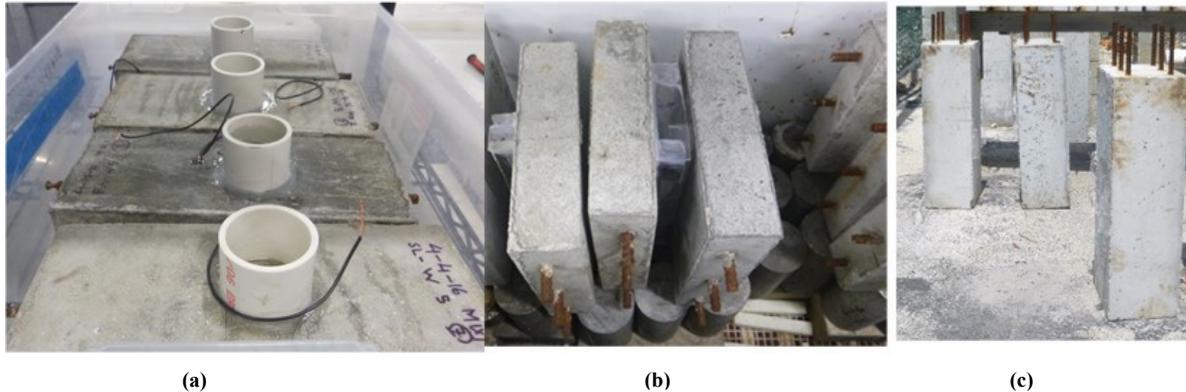
Figure 29 (a) shows a picture of four of the single rebar samples and Figure 29 (b) shows three of the 3 rebar samples after placing the solution reservoirs, but prior to filling it with the solution. The samples were stored in high humidity 3 to 7 days prior to the next step. Figure 29 (c) shows three out of four modified tombstone specimens with six rebars, prior to installing the solution reservoir. The solution reservoir was installed on each of these four samples.

Figure 29. Specimens with reservoirs installed (a) single-rebar specimens; (b) three-rebar specimens; (c) Modified tombstone specimens at SeaTech before testing.

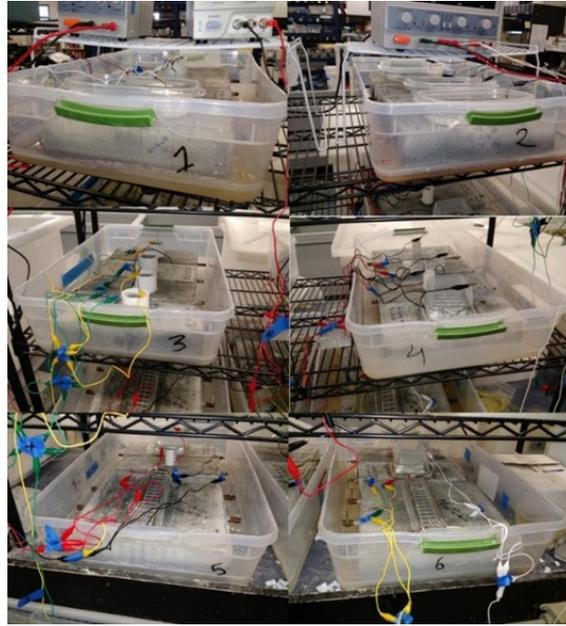
Figure 30. Selected samples during chloride migration process.

A power supply was used to set a potential hold between the top and bottom mesh. An electric field then drives the chlorides in the solution above each rebar via electromigration into the concrete and towards the embedded rebar(s). The electrode placed in the NaCl solution was connected to the negative terminal of the power supply. The embedded mesh in each specimen was connected to the positive terminal of the power supply. In some cases, an external TiMMO mesh was placed underneath the sample. An acrylic mesh was also placed in the solution reservoir to avoid direct contact between the titanium wire mesh and the concrete surface. Figure 30 shows selected specimens while being subjected to electromigration.

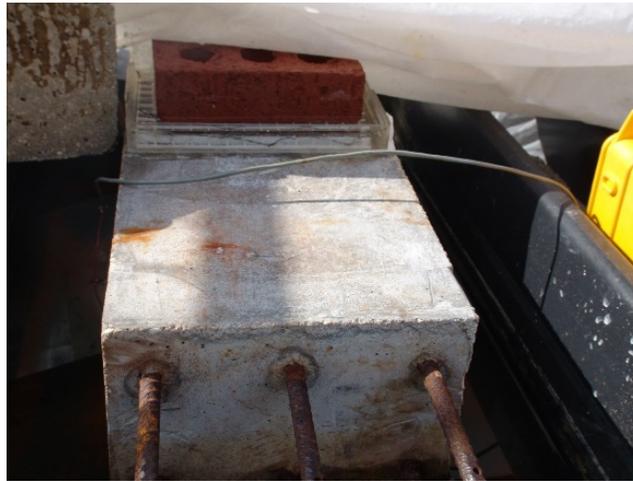
Figure 31. Electromigration being applied to a specimen with six rebars.

During the April 2016 concrete casting, two modified tombstone specimens were cast on each day (four total modified-tombstone specimens). Each specimen has six #4 rebars. Two specimens contain SL mix and two were prepared with FA mix. The samples are 24 in \times 10 in \times 7 in. The concrete cover along the wide side (10 inches) on the rebars is 1 inch. The samples were placed outdoors while awaiting set-up preparation for electromigration. A solution reservoir was installed on each specimen. For these specimens, a similar arrangement than that just described for electromigration approach (for single and three rebar specimens) was implemented during the summer/2016. The major difference is that rather than using a power supply, 9V batteries were used to provide the applied potential. The batteries were replaced periodically (typically once a week) once the battery potential was less than 2 V. A mesh was placed in the solution reservoir (connected to the negative terminal) and the embedded electrode on the bottom side of each specimen was connected to the positive terminal. The batteries were placed inside a pelican box that minimized moisture ingress.

A solution reservoir was installed on one of the wide sides of the selected six rebar specimens, the reservoir was filled with 10% NaCl. This specimen face became the top side, but it was the mold bottom during casting. Figure 31 shows one of these specimens. A TiMMO mesh was placed on the reservoir and a stainless steel mesh (or TiMMO mesh) was placed below the specimen (the mesh had similar dimensions than the mesh in the solution reservoir). The electromigration began mid-Summer 2016 (8/6/2016) and was suspended during Summer 2017 (7/25/2017).

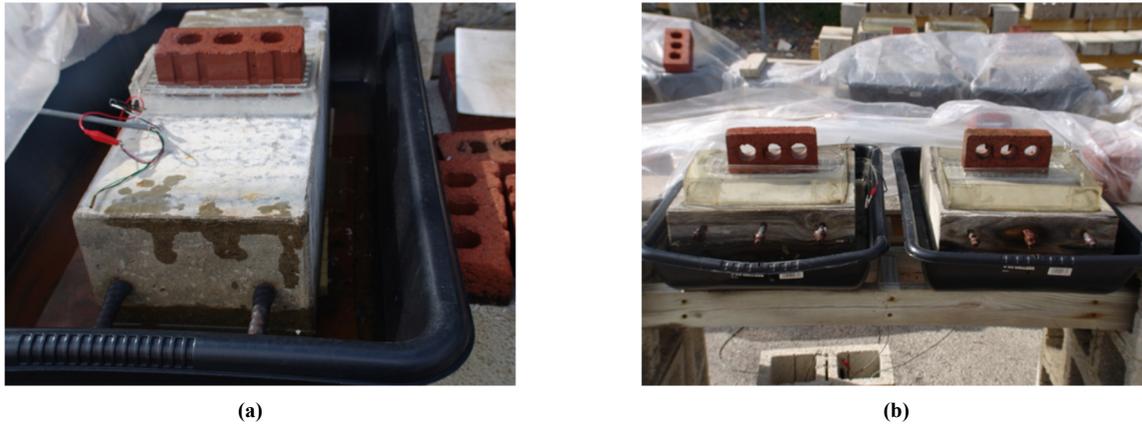
Figure 34. Electromigration applied to a specimen with (a) two rebars and (b) five rebars

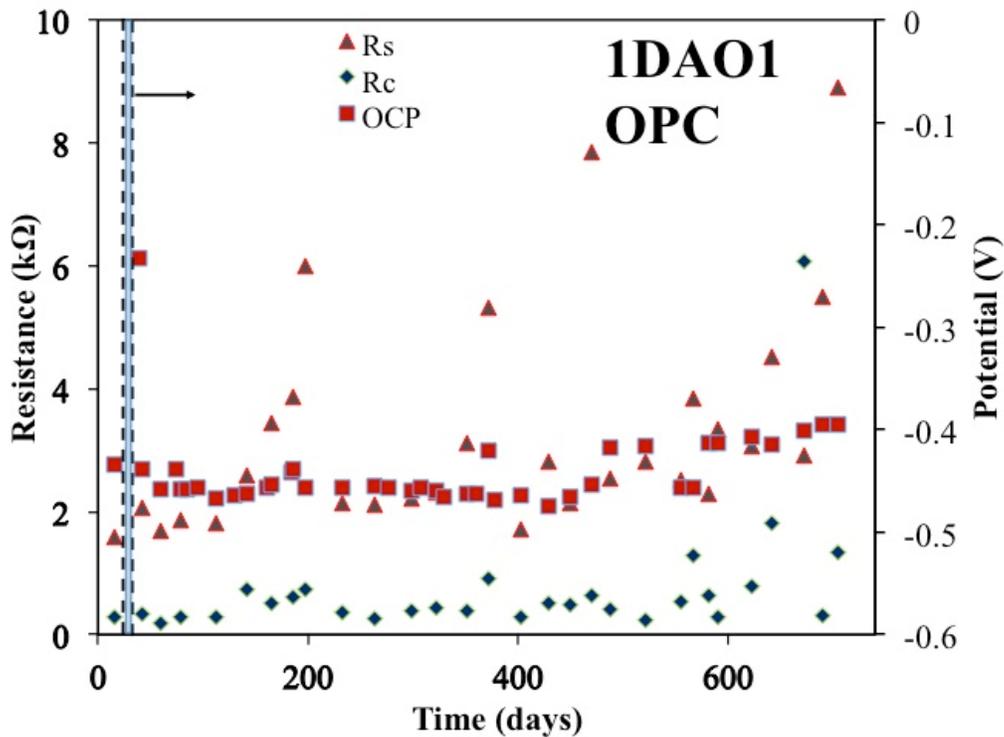
Figure 39 and Figure 40 show the evolution of the rebar potential and the measured R_s and R_c values on rebars 1DAO1 and 1DBO1. These are the rebars under a 2.5 cm diameter solution reservoir. The rebar identified as 1DAO1 showed an initial potential value that was more negative than -0.4 Vsce, whereas initially, the rebar potential for 1DBO1 was around -0.02 Vsce. The potential of 1DBO1 remained close to this value during the electromigration period and the 100 days that followed. The 1DBO1 rebar potential then shifted to more negative values ranging between -0.25 and -0.3 Vsce. The R_c values measured on 1DAO1 rebar were smaller than 0.3 k Ω s. The R_c calculated from the measurements after subtracting R_s were significantly smaller on 1DAO1 rebar compared to the R_c calculated on 1DBO1 rebar. After the potential drop was observed on 1DBO1 rebar, the R_c value decreased in magnitude but later oscillated to values similar to those measured during the electromigration period.

Figure 39. Rebar potentials, R_s , and R_c values measured on rebar 1DAO1

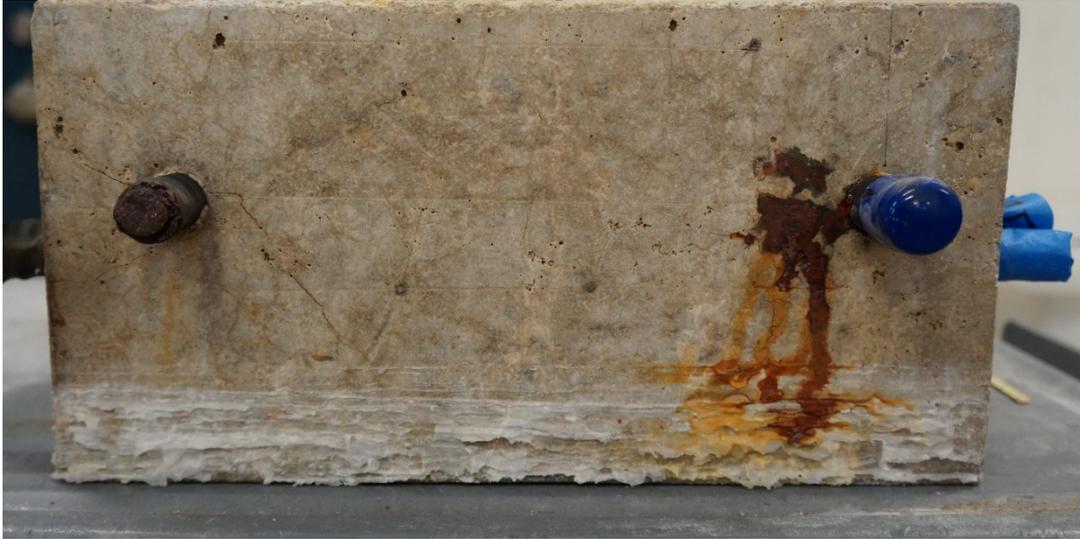
Figure 79. Specimen 1DA showing the crack that extended to the surface (left side) which depicts the crack extended to the concrete surface on the side.

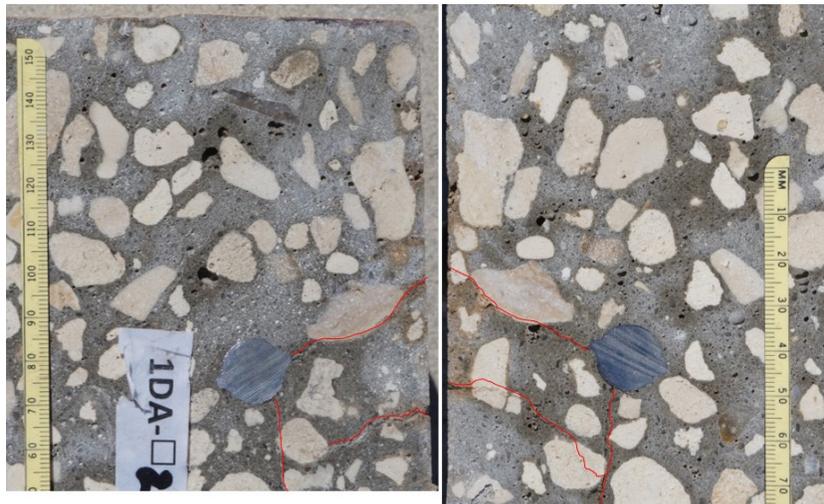
Figure 80. View of crack inside the concrete upon cutting the specimen for 1DASQ2. The red lines highlight an offset to the crack location.

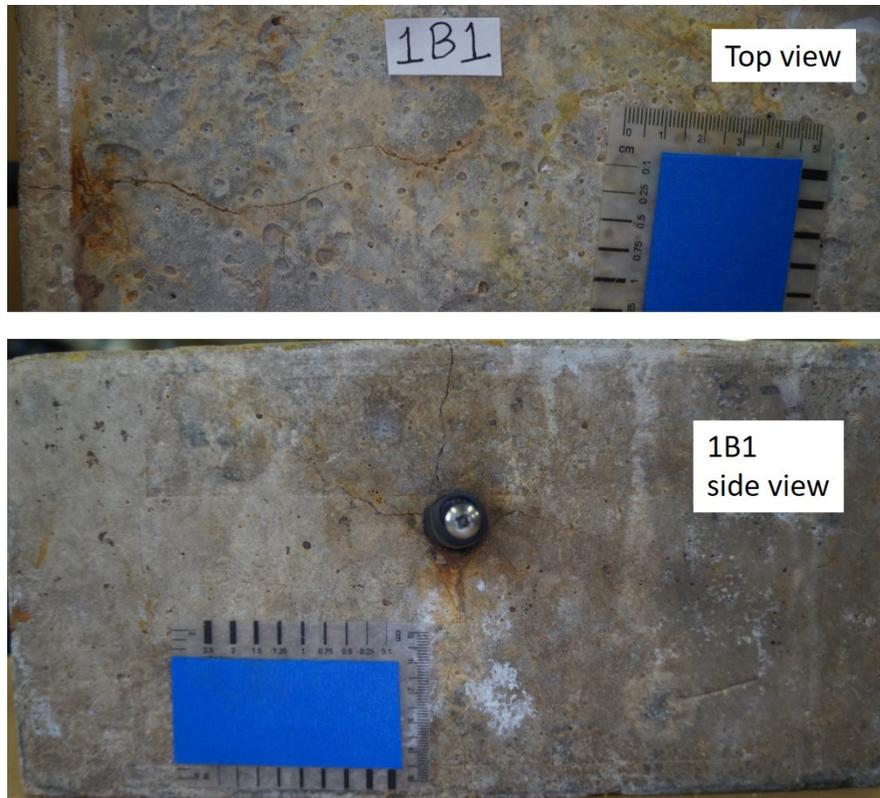
Figure 81. Top view and side view for specimen 1B1 (sides that show the crack)
