Final Report

Corrosion Propagation of Carbon Steel Rebars in High Performance
Concrete
BDV27–977–08

Submitted to
Florida Department of Transportation Research Center
605 Suwannee Street
Tallahassee, Florida 32399

November 2018

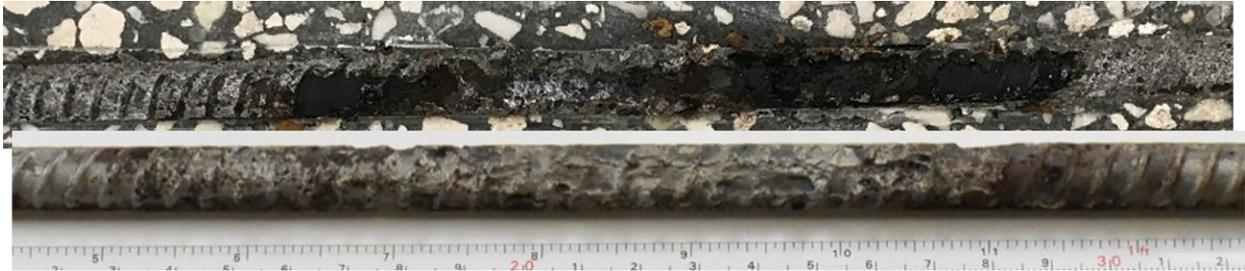
Figure 86. Before and after cleaning rebar AO7–A (close-up)

Figure 86 shows pictures of rebar AO7–A before and after cleaning it. It can be observed that after removing the corrosion products a good amount of cross-section loss had occurred on this rebar. Figure 87 shows pictures of rebar AO7–B before and after cleaning and on a third row two pictures showing close-ups of the regions that had the most corrosion. It can be observed that although there was cross-section loss on rebar AO7–B, the cross-section loss was not as significant as what was observed on rebar AO7–A.

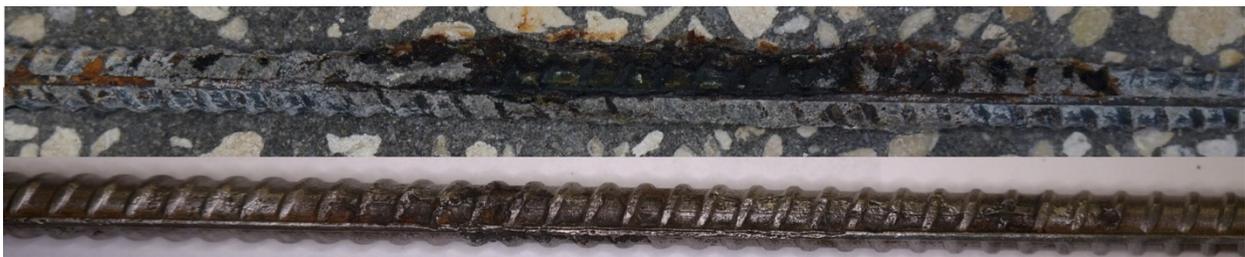
Figure 88. Before and after cleaning rebar AO4–C (close-up)

Figure 88 shows pictures of rebar AO4–C before and after cleaning. The rebar orientation shown on the top picture indicates that the rebar edge pointed up during exposure, the top side had the most corrosion, the picture after cleaning shows the rebar rotated a few degrees (compared to the rebar view before cleaning) so that the corroded area after cleaning can be better observed. This picture after cleaning suggests that there are two regions with major cross-section loss.

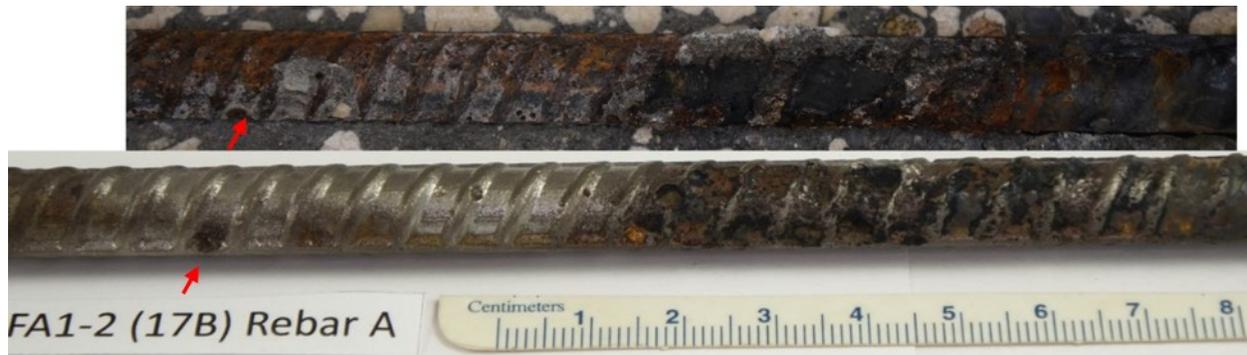
Figure 89. Before and after cleaning rebar FA1-2-A

Below are figures that compare the rebar surface condition upon opening and after cleaning the rebar for the four FA rebars that were terminated. For cases where the concrete had a crack above the rebar, a picture of the crack is included if available. Figure 89 shows pictures of rebar FA1-2-A before and after cleaning the rebar. A small corrosion spot is observed on the left and a large corrosion spot with significant cross-section loss observed on the right. Figure 90 shows a hair crack and a small spall that took place above the rebar along the corrosion site.

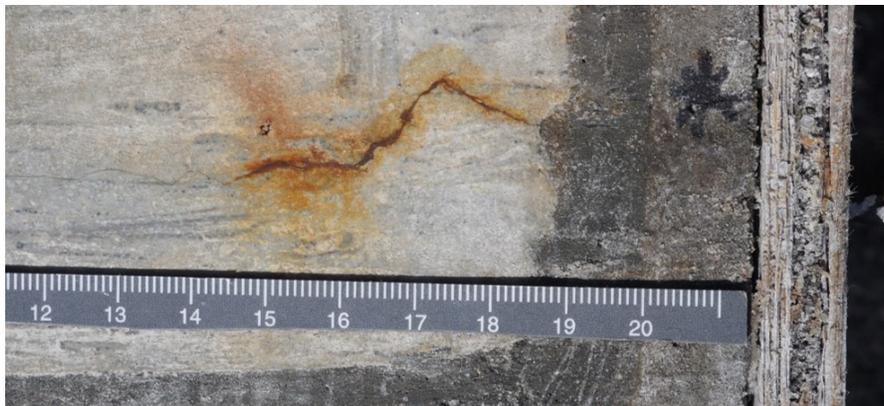
Figure 90. Crack observed on the concrete surface above rebar FA1-2-A

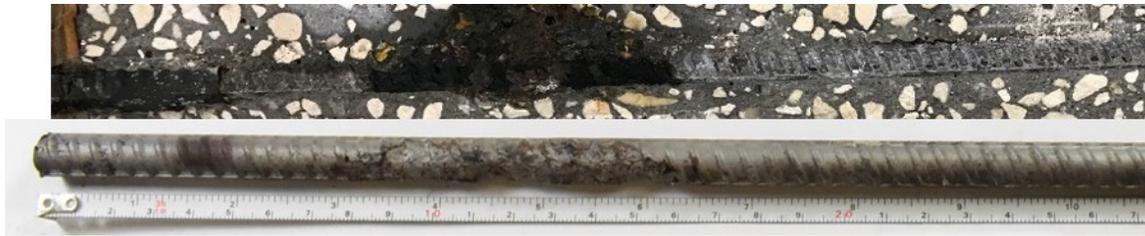
Figure 91. Before and after cleaning rebar FA2-4C

Figure 91 shows rebar C for a rebar embedded in specimen FA2-4. Figure 91 shows the rebar upon exposing it to the environment and the bottom picture shows the rebar condition after cleaning it. There is a large corrosion spot visible upon exposing the rebar, the picture after cleaning the rebar indicates that there was a significant amount of cross section. The surface of the concrete before opening showed a thin crack. See Figure 92 shows a hair crack that was visible on the concrete surface.

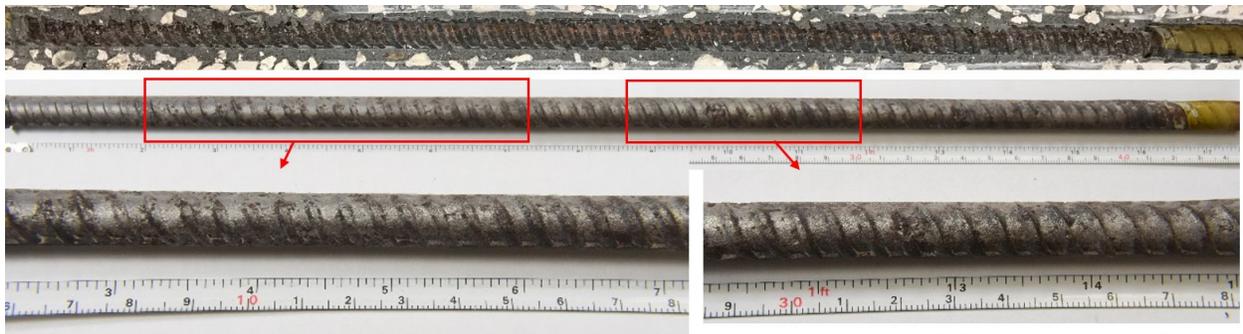
Figure 93. Before and after cleaning rebar FA4-3-B

Figure 93 shows rebar B embedded in specimen FA4-3-B. The top picture shows a number of reddish corrosion spots, suggesting that corrosion was not on-going at those locations. Although harder to see from the picture before cleaning (top row), there were several darker spots. The sites with red rust might be no corroding or now corroding at a low corrosion rate. The picture after cleaning suggests that in some regions there has been a modest reduction of the cross-section. Figure 93 shows in a third row a couple of close-up pictures for the regions with the most cross-section loss. Figure 94 shows rebar FA4-3C, the corrosion spot, which in this case, was almost 7 cm long, and the cross-section loss was not as significant as what was observed on rebar FA2-4-C, but more significant than that seen on rebar FA4-3-B.

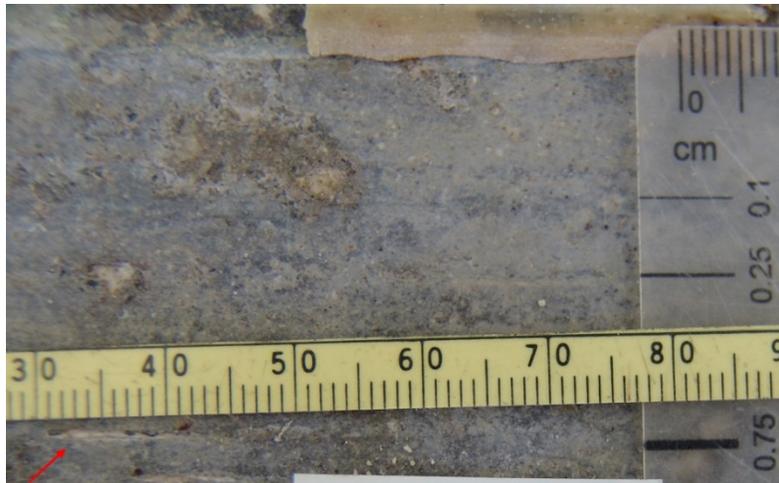
Figure 95. Crack observed on the concrete surface above rebar FA4-3-C

No crack was observed above rebar FA4-3-B, and a short thin crack was visible above FA4-3-C (See Figure 95).

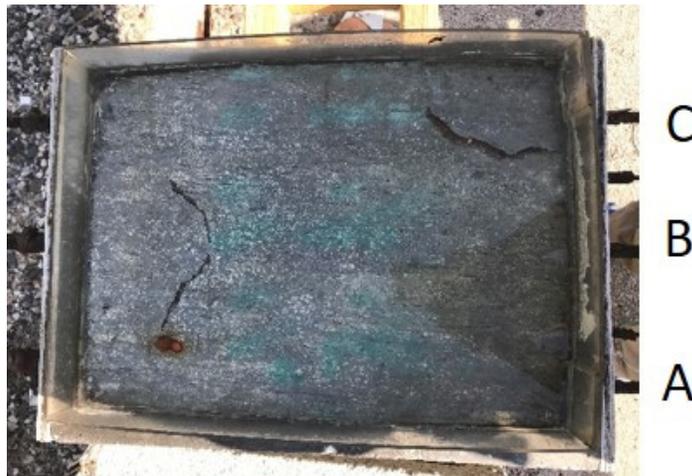
Figure 98. Cracks observed on the concrete surface on specimen SF2-3

The next three figures show the exposed rebars embedded in specimen SF2-3; the three rebars were removed. Two cracks were observed in these specimens (see Figure 98). It is not clear if the corrosion product from rebar SF2-3-A (Figure 99), or the corrosion products from rebar SF2-3-B (Figure 100) caused the transverse crack. The corrosion spots prior to cleaning are about the same length on all rebars in this specimen. Figure 101 shows that slightly more cross section loss was observed on SF2-3-C. The pictures shown in here and in the previous section are evidence that a significant amount of cross-section loss after corrosion that has been propagating (on-going) for several years can occur. The cross-section loss and consequent corrosion products can then cause cracks in the concrete samples cast with FA or SF.

Corrosion did initiate on specimens prepared with concrete containing supplementary cementitious materials. If the propagation stage is long it appears that the corrosion products that build up were able in a few cases to produce cracks. A few outdoor samples with FA and with SF displayed cracks. Only one sample with SF showed cracks that spalled the concrete (see Figure 98).

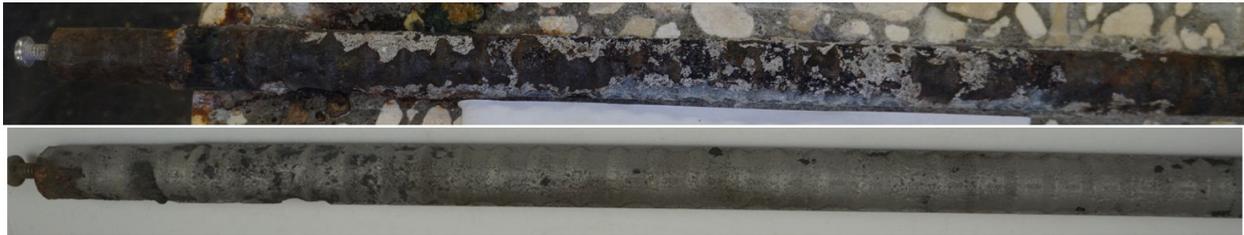
Figure 103. Before and after cleaning rebar 1B1, bottom view

The figures in this section describe the three specimens terminated that have a single rebar. A solution reservoir was installed centered and it was a 5 cm cylinder. The corrosion products in one of the rebars caused cracks that were visible on the top and side views. Figure 102 shows the top view indicating that corrosion occurred on one side, outside of the area of the rebar below the solution reservoir. Figure 103 shows that a significant amount of corrosion occurred on the bottom side of the rebar. This specimen was subjected to electromigration for about 400 days

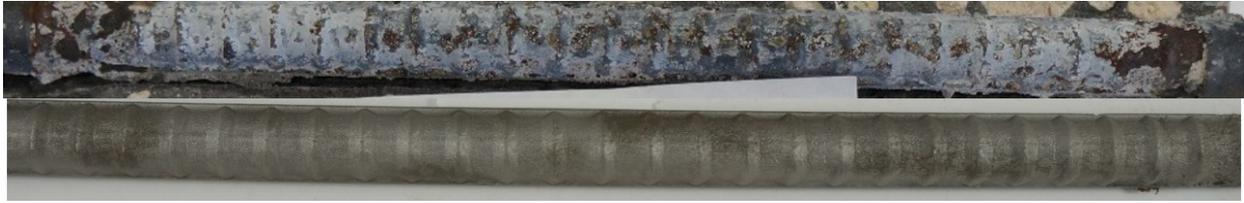
Figure 105. Before and after cleaning rebar 1F1, bottom side

Figure 104 and Figure 105 show the top view and bottom view respectively, of the rebar embedded in specimen 1F1. Figure 104 shows a dark region at the rebar center, and upon cleaning a few small corrosion spots were observed (pitting corrosion). On the left side of the picture, the rebar shows corrosion spots and suggests that crevice corrosion took place under the shrinkage wrap. The calculated (using R_c and Faraday law) mass loss was significantly larger than that amount of mass lost shown here.

The pictures in Figure 105 show several red rust spots on the bottom side of Rebar 1F1. However, upon cleaning the rebar, it appears that these were quite shallow corroding sites.

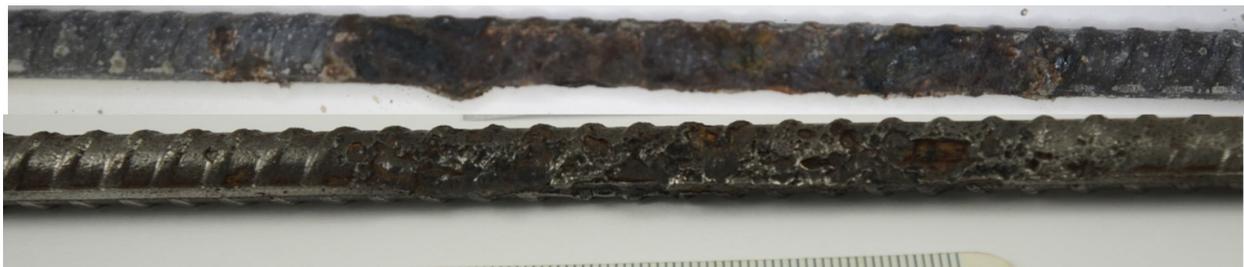
Figure 108. Before and after cleaning rebar in MD1-B

Figure 108 shows the corrosion spot shortly after removing the rebar and after cleaning from sample MD1-B. This rebar had 10 cm solution reservoir. The section shows that the corrosion spot was about 10 cm long. A significant cross section loss is visible after cleaning the rebar.

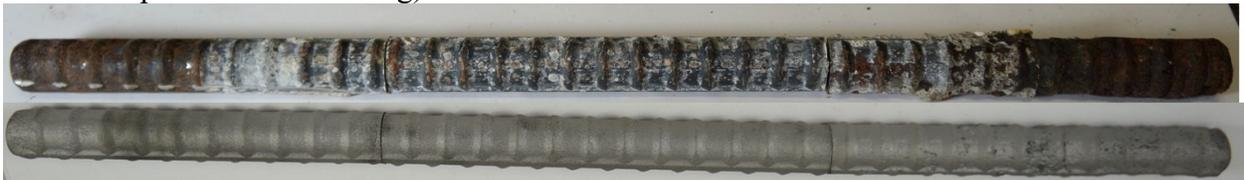
Figure 113. Before and after cleaning rebar 1DAO1, top side

Figure 113 and Figure 114 show the top and bottom respectively of rebar 1DAO1 before and after cleaning the rebar. No corrosion is observed in the center segments that were below the solution reservoir. Corrosion took place at the edge of the shrinkage wrap (see right side before cleaning). Figure 115 shows that corrosion did take place below the solution reservoir on rebar 1DAO2 (5 cm solution reservoir) and also some distance from the solution reservoir (see the spot on the left piece before cleaning). Moderate cross-section loss was observed at both locations.

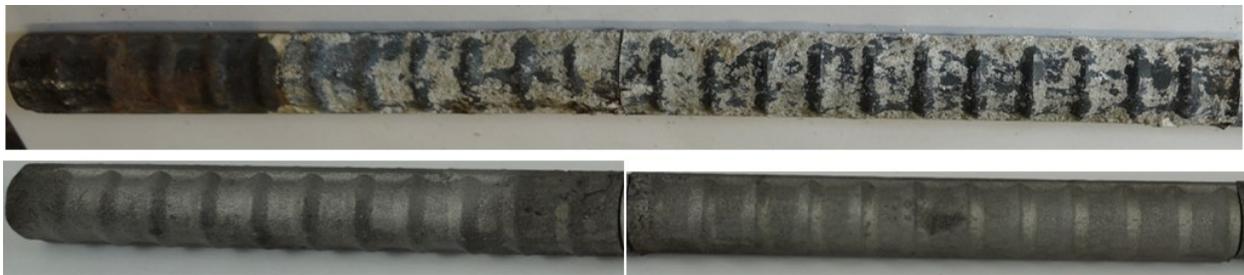
Figure 116. Before and after cleaning rebar 1DASQ1, top side

Figure 116 shows the top view of rebar 1DASQ1. A small corrosion spot was observed centered under the solution reservoir (in this case the solution reservoir was 10 cm) and another site on the left section also under the solution reservoir; the latter had a deeper cross section loss. The right side of the rebar is not shown and it did not show corrosion. Figure 117 shows the top view of rebar 1DASQ2, indicating that there was no significant corrosion under the reservoir. Figure 118 shows the bottom view of rebar 1DASQ2, a large spot is observed on the left side of the rebar, the cross-section loss was significant and it caused the crack that is shown in Figure 79 and Figure 80.

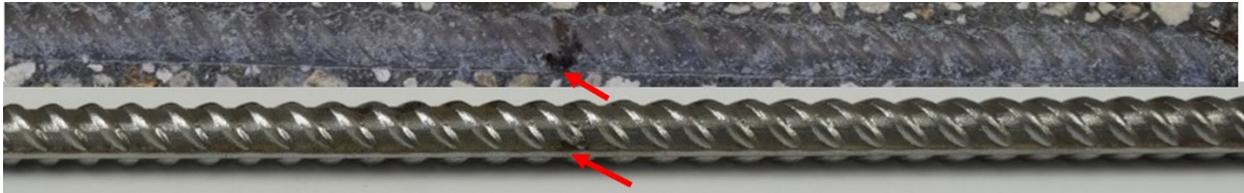
Figure 121. Before and after cleaning rebar in specimen FA8

Figure 121 and Figure 122 shows the rebar surface before and after cleaning on rebars embedded in specimens FA8 and FA9, respectively. Figure 121 shows a small corroding site before

cleaning on the rebar embedded on specimen FA8; the cross-section loss is visible but not significant. Figure 122 shows that three corrosion spots developed on the rebar embedded in sample FA9. The smallest spot is a little hard to see on the picture after cleaning due to the angle of the picture (an arrow indicates the location). The larger corroding spots show a modest but significant cross-section loss; the rebar in specimens FA9 was subjected to anodic current to accelerate corrosion for a short period of time. Both of these rebars had a solution reservoir of about 15 cm long, hence just a small fraction of the area corroded. The opposite side of both rebars showed no corrosion.

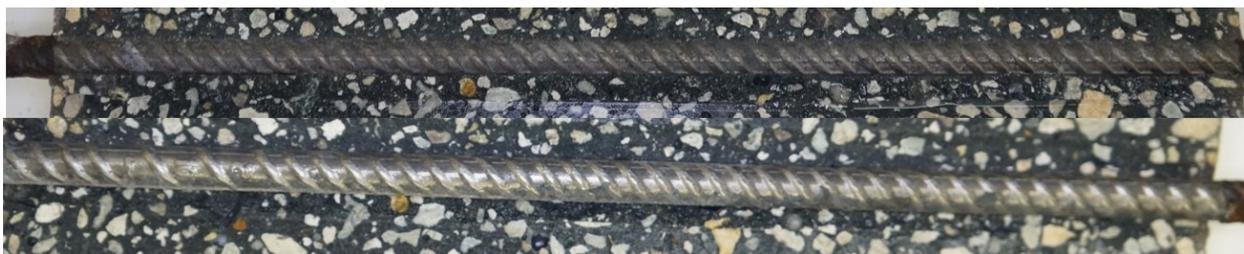
Figure 123. Rebar embedded in T1 specimen: top and bottom, no corrosion on either side.

Figure 123 shows the surface condition of the rebar before cleaning the top and the bottom sides of the rebar embedded in sample T1. In this case, the picture on the second row shows the bottom side of the rebar. No corrosion was observed within the region under the reservoir or the section within the concrete. However, surface corrosion took place on the rebar extending outside of the concrete. It is not clear why the potential and the R_c magnitude suggested some activity on the rebar. No corrosion was observed on the T2 terminated sample on the top side, a

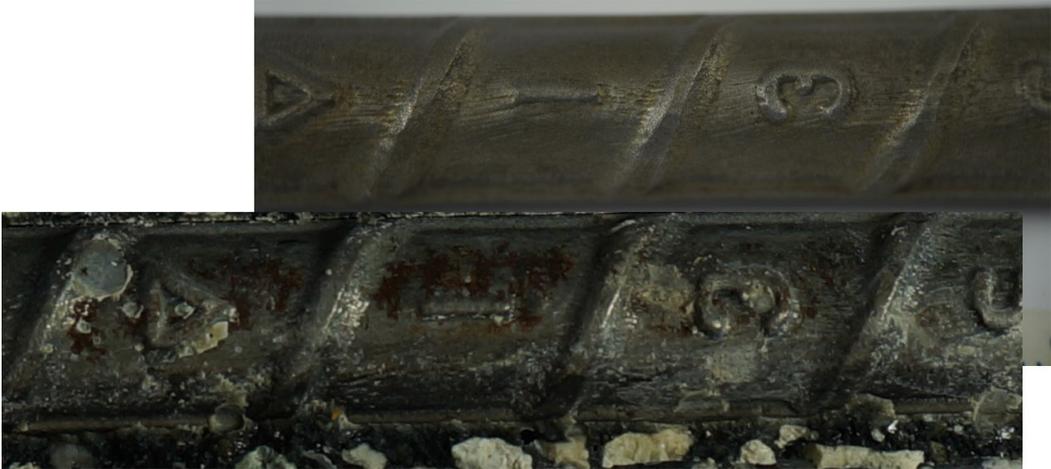
Figure 124. Before and after cleaning rebar 16X-A

small corrosion spot was observed close to the concrete edge outside of the region under the reservoir. Corrosion was observed on the rebar extending outside the concrete. The surface extending outside of all other T1 and T2 samples was wire brushed and then covered with shrinkage wrap. Sample 16X was terminated and it is not clear if corrosion was taking place before exposing the rebar. Figure 124 and Figure 125 show the surface before and after cleaning for rebars A and B embedded in specimens 16X. The red rust spots might have developed upon exposing the rebar to the laboratory environment. Upon cleaning both show that there was no cross-section loss.

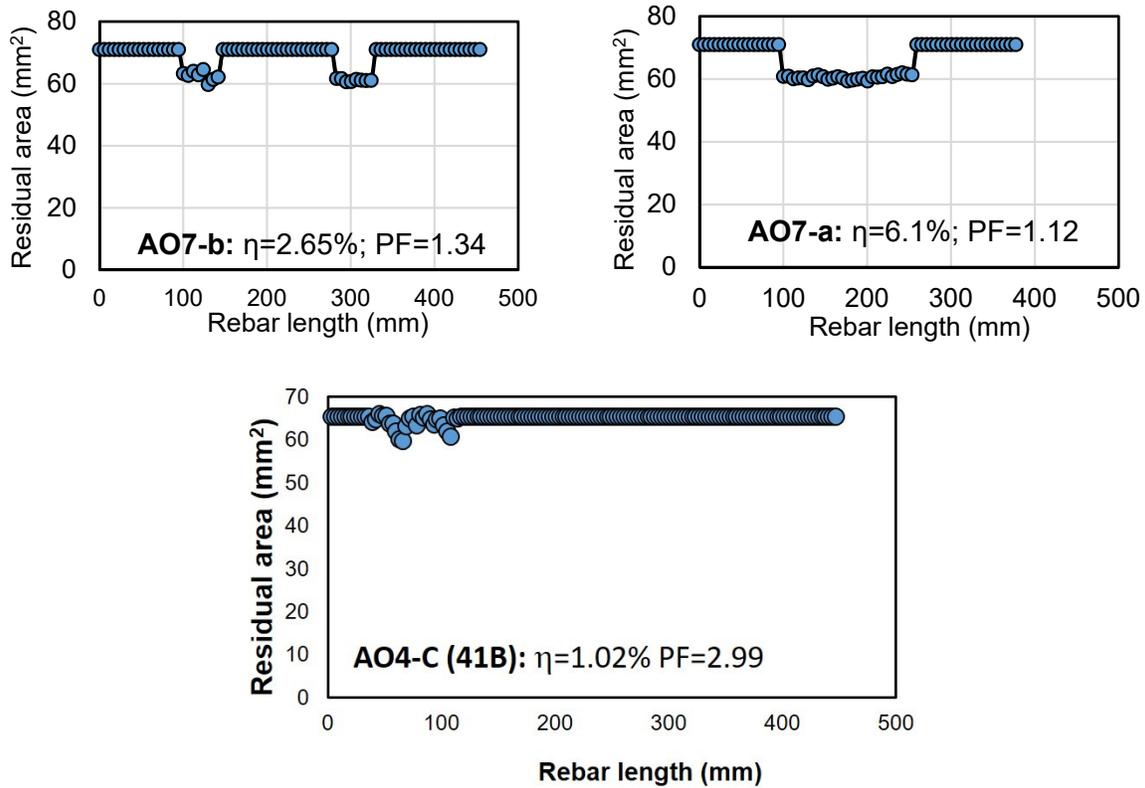
Figure 126. Distribution of residual cross-sectional area along the length for rebars in OPC specimens.

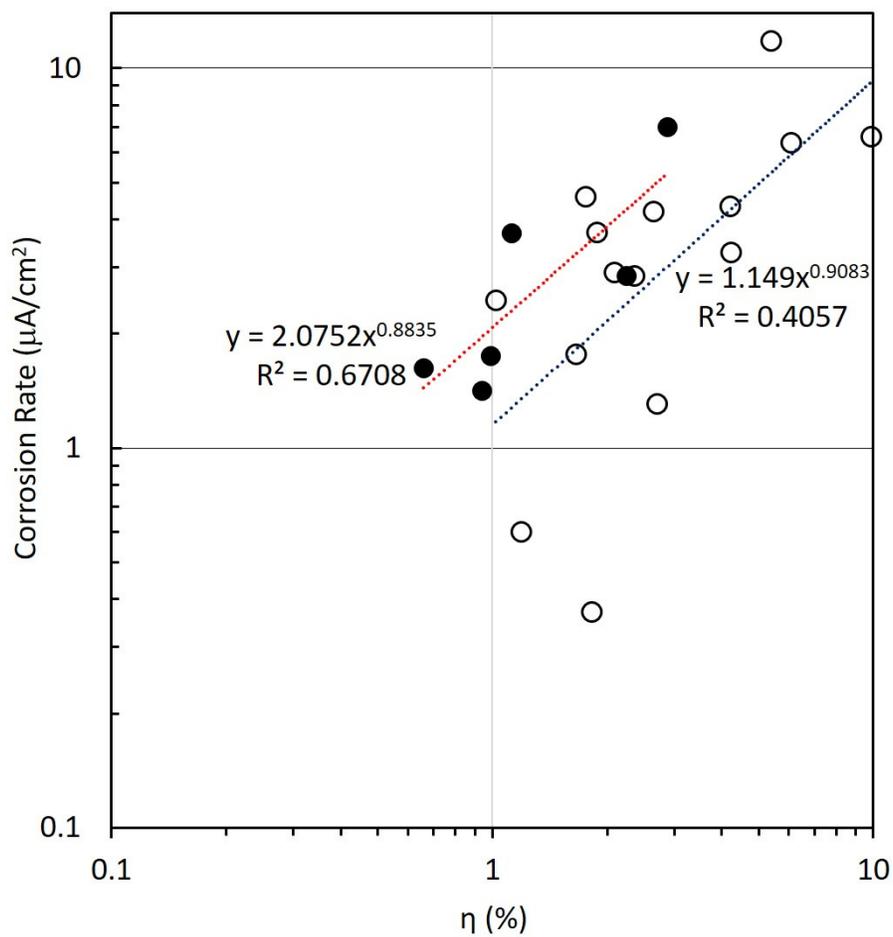
Figure 131. Corrosion rate vs. η

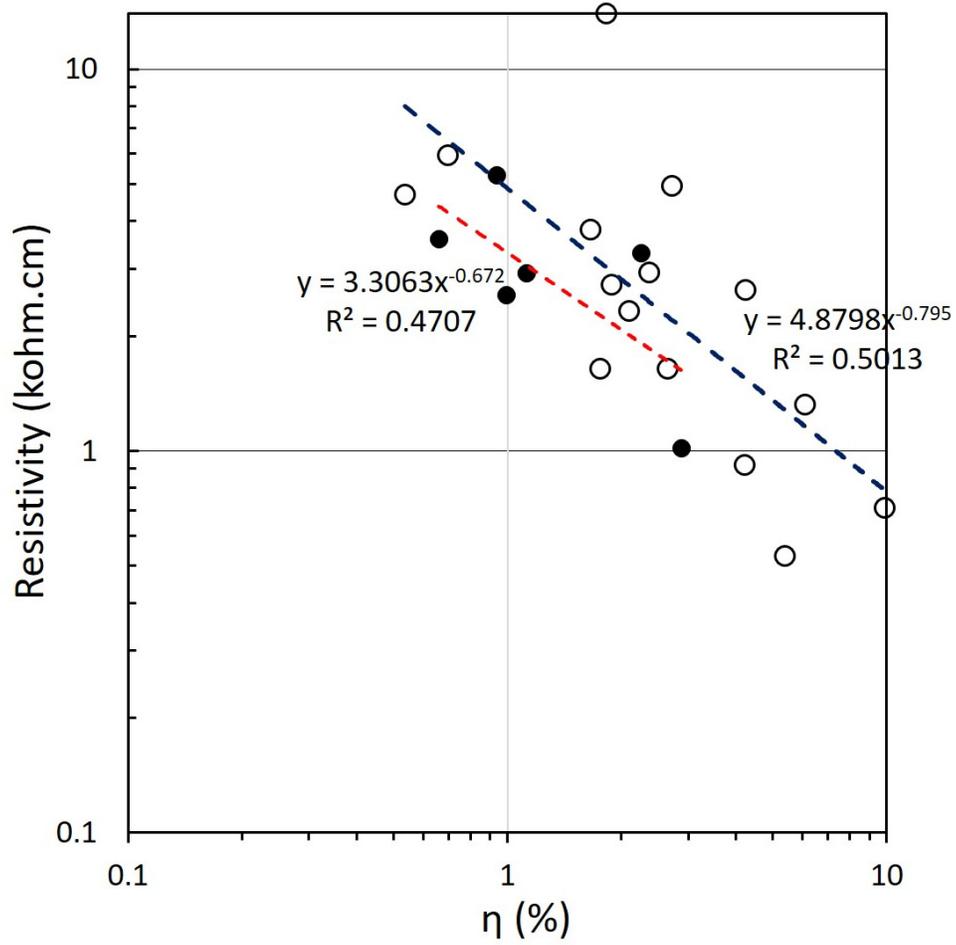
Figure 132. Resistivity vs. η
