BDV27-977-08

**Florida Department of Transportation Research****Corrosion Propagation of Carbon Steel Rebars in High Performance Concrete**

January 2019

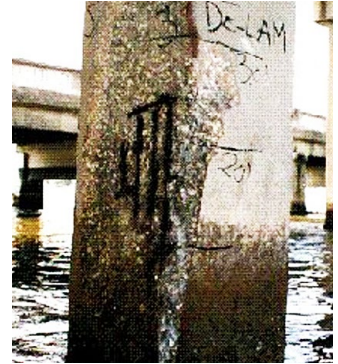
*As corrosion of steel reinforcing bars proceeds, it can cause cracking and loss of concrete.*
