Deliverable 10
Final Report

Durability of Fiber Reinforced Concrete Pipe Exposed to Florida Aggressive
Environments
BDV27-977-11

Submitted to
Florida Department of Transportation Research Center
605 Suwannee Street
Tallahassee, Florida 32399

June 2020

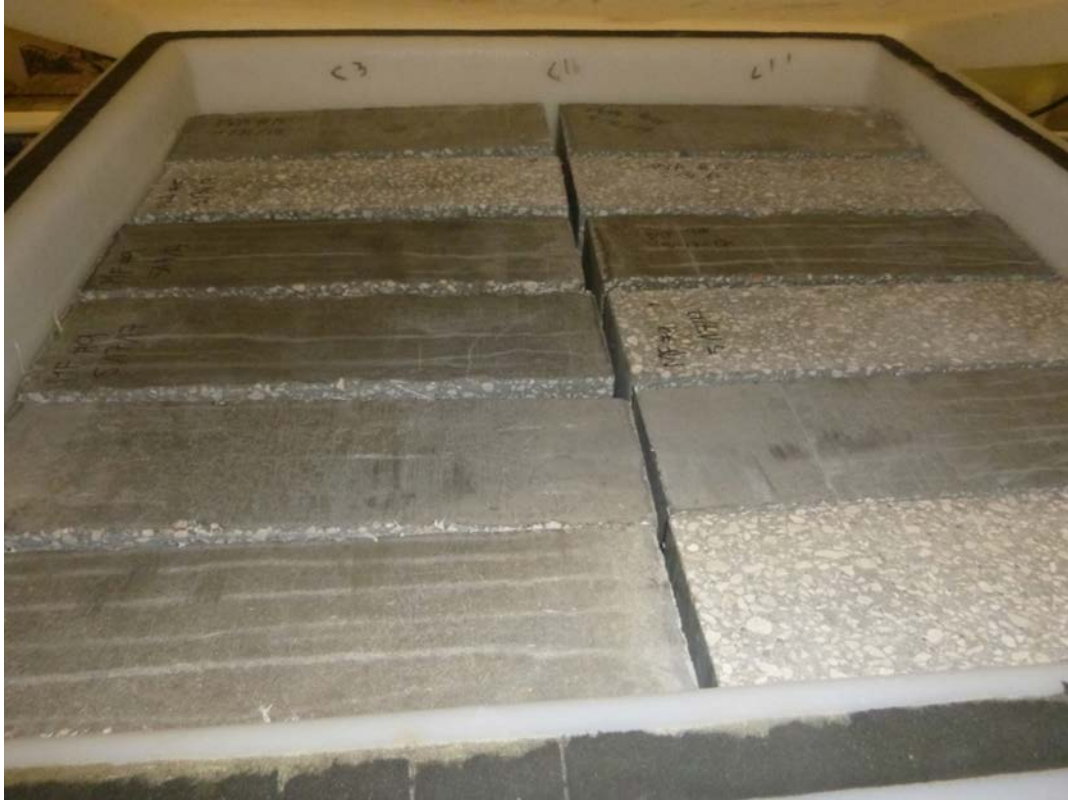
Figure 16. Beams from the different mixes stored in a high humidity environment.

Selected beams were stored in a 30" × 30" × 12" tall high-density polyethylene (HDPE) container. The cylindrical cores were stored in a 36" × 24" × 20" tall high-density polyethylene container. The drilled and cut cylinders and square MIDT specimens were stored in a non-working freezer that is used as a high moisture chamber (Figure 7). The two HDPE containers had water at the bottom (a plastic mesh lifted the beams/cores and prevented them from touching the solution). The water was there to assist in keeping the moisture high. Water was sprayed periodically on the wall of the container to assist in maintaining the high humidity. Figure 16 shows a view of the beams shortly after starting the exposure in the high moisture environment. Figure 17 and Figure 18 show two different views of the cores at the beginning of the exposure to the high moisture environment.

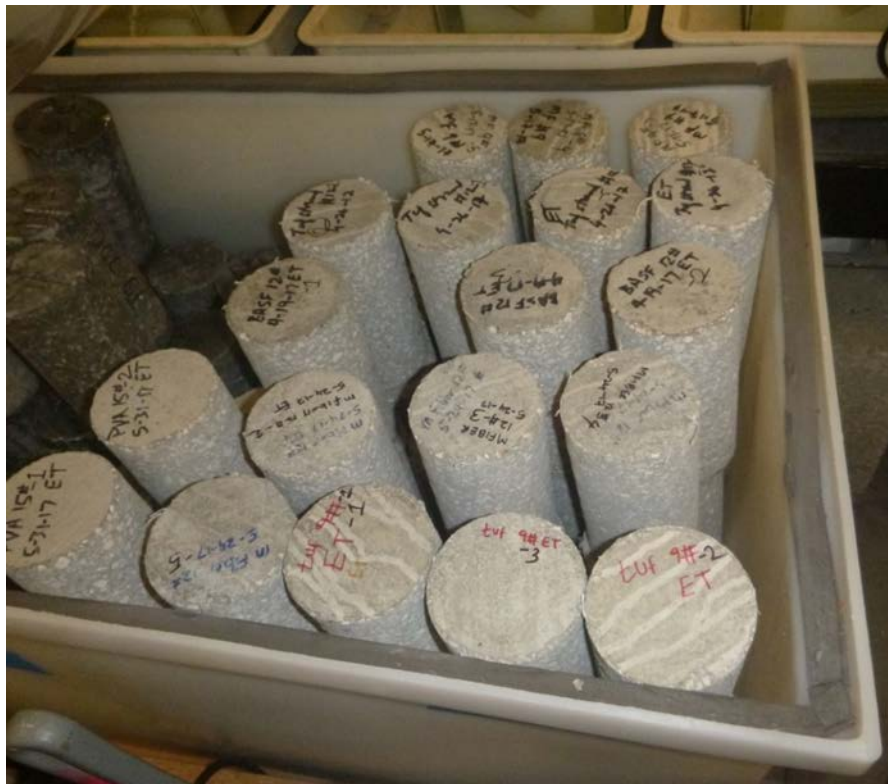
Figure 17. Cores while exposed in a high humidity environment.

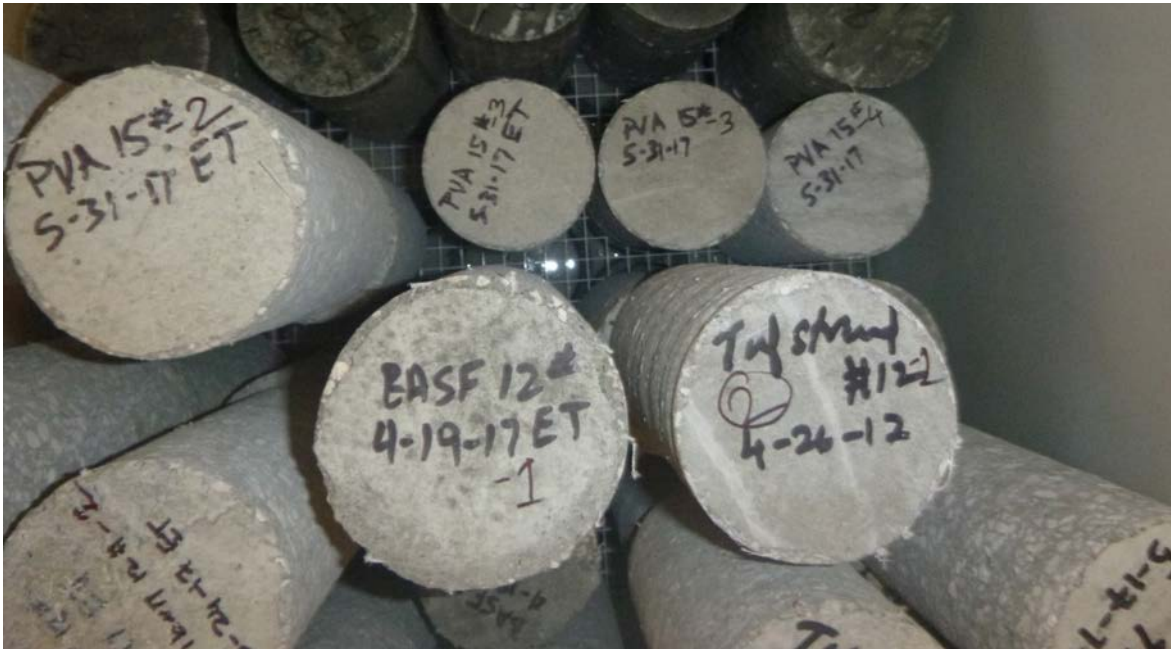
Figure 18. A closer view of the cores exposed in a high humidity environment.

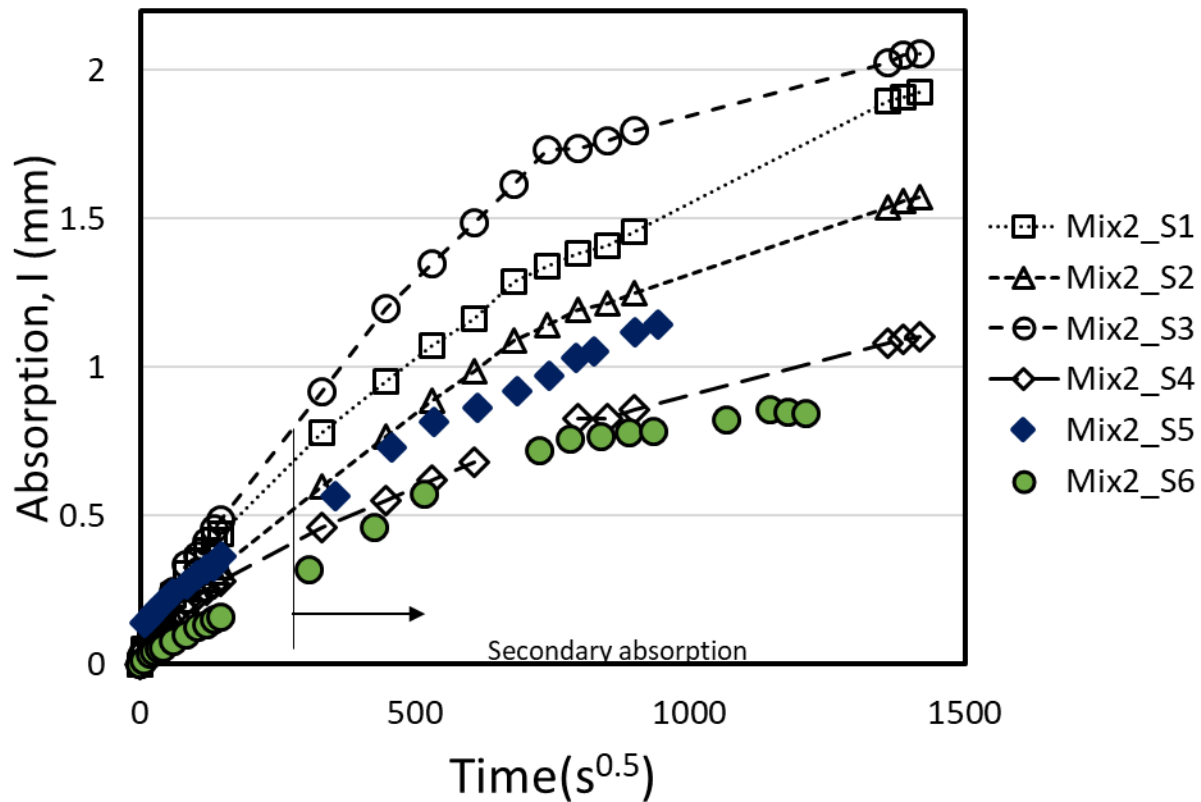
Figure 28 shows the water absorption results for mix 2 samples. The series in blue diamond symbols corresponds to the sample tested in December 2017, whereas the series with empty symbols corresponds to samples that were tested during August and September 2017. The green circles series corresponds to the test conducted during June 2018. The water absorption during the first 6 hours on the latter (also call primary rate) test was lower for the samples tested in June 2018, compared to the previous tests. The water penetrated up to 2 mm at $1500 \text{ s}^{1/2}$ on sample S3, compared to 8 (PVA) to 12 (PP) mm at $850 \text{ s}^{1/2}$ observed in Roque's study [9] for class V concrete. The water penetration observed on the other mixes reached similar maximum values, but most reached penetration depths of 1 mm or less.

Figure 28. Absorption measured on TS#12 specimens

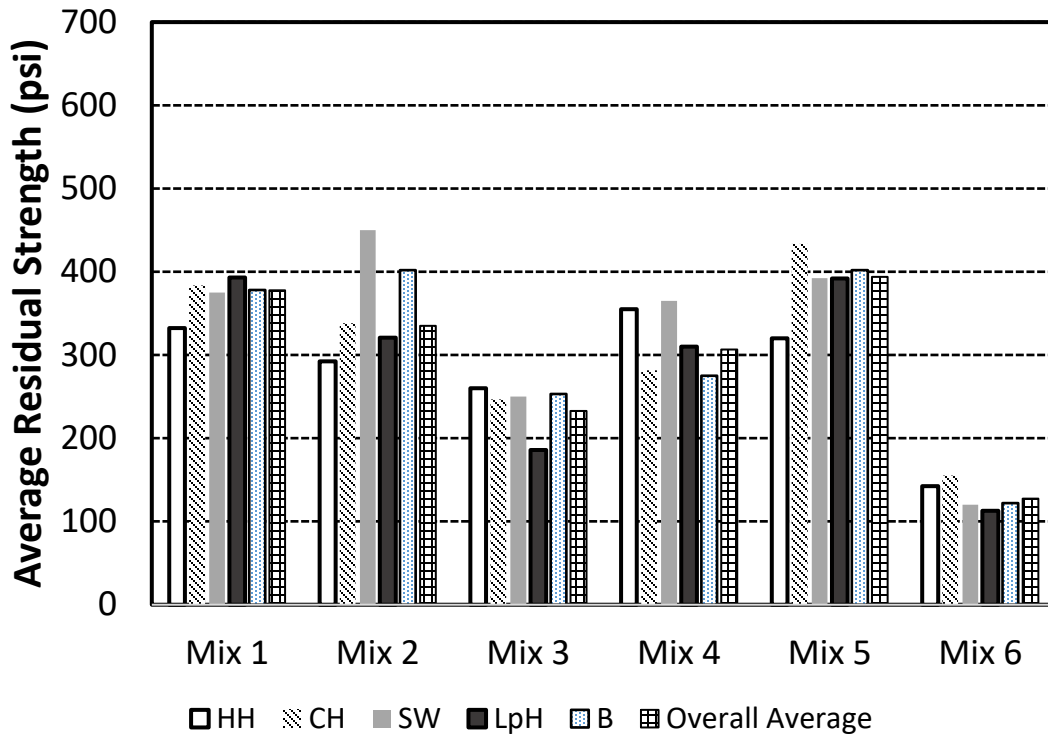
Figure 32. Average residual strength after 16.5 months of exposure

Slightly larger overall average residual strength was observed on samples of most mixes for those tested after 16.5 months of exposure, than those tested after 8 months of exposure. It is likely that the pozzolanic reaction of the fly ash might had continued on all samples sets. Moreover, for most groups this difference ranged between 4 and 22 percent (with larger values measured after 16.5 months), and for mix 5 the overall residual strength average measured after 16.5 months of exposure was smaller by 6 percent. For samples of mix 5 this latter observation, appears to be due to the significantly larger residual strength measured on samples exposed in seawater and tested after 8 months of exposure.

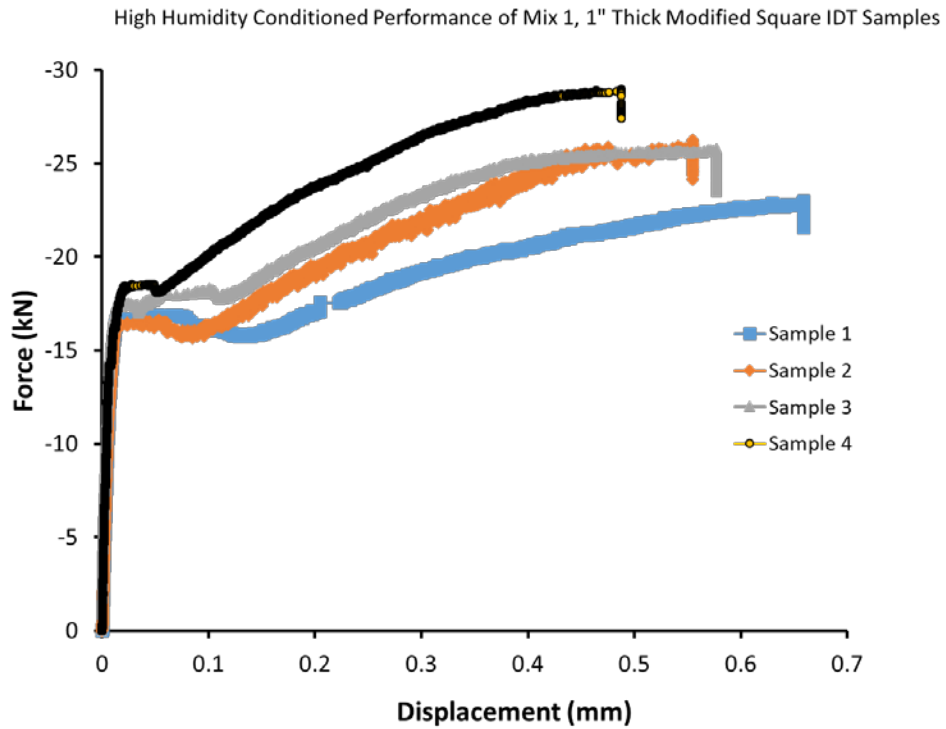
Figure 41. Square MIDT samples of mix 1 tested after 20 months of exposure to high humidity

Figure 41, Figure 42, and Figure 43 show the typical shape of load vs. displacement curves for samples exposed to high humidity, immersed in calcium hydroxide, and immersed in seawater (wet/dry), respectively. These figures correspond to tests on samples with 12 or 15 lb/yd³, tested after 20 to 23 months of exposure. Appendix C contains figures with the plots for the other tested samples (both square and round MIDT samples and various exposure durations). Note that in most curves on these figures, there is initially an elastic region, followed by a plastic region with a different slope (the change of slope is indicative that the load to first crack has occurred, as monitored on the load vs. time from the data logger). A modest drop load is then observed, indicative of additional cracks. In some cases, (e.g., sample 4 in Figure 41 and sample 2 in Figure 42) the load vs. displacement reverts to a monotonic increase in load vs. displacement. In other cases, the drop is followed by either a slower decrease in load vs. displacement or a short plateau in the load vs. displacement (e.g., sample 1 in Figure 43), this trend of decrease in load vs. displacement is also associated with strain softening. All curves then show a monotonic increase in load vs. displacement until additional vertical drop of the load (i.e., no additional increase in displacement) indicating the end of the test and additional cracking taking place at that point).

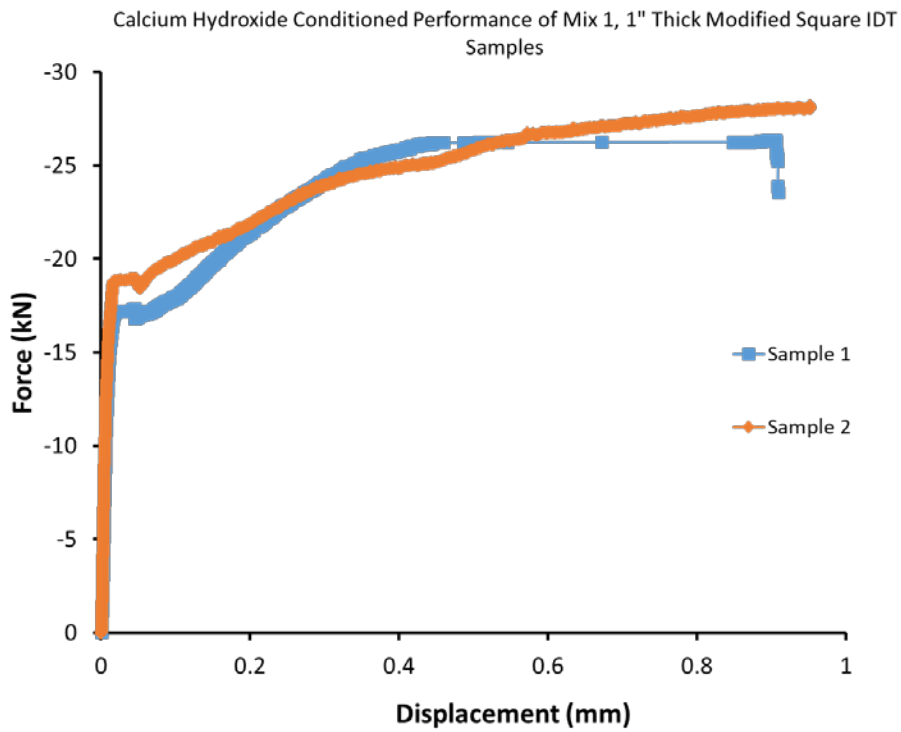
Figure 42. Square MIDT samples of mix 1 tested after 20 months of exposure immersed in calcium hydroxide solution

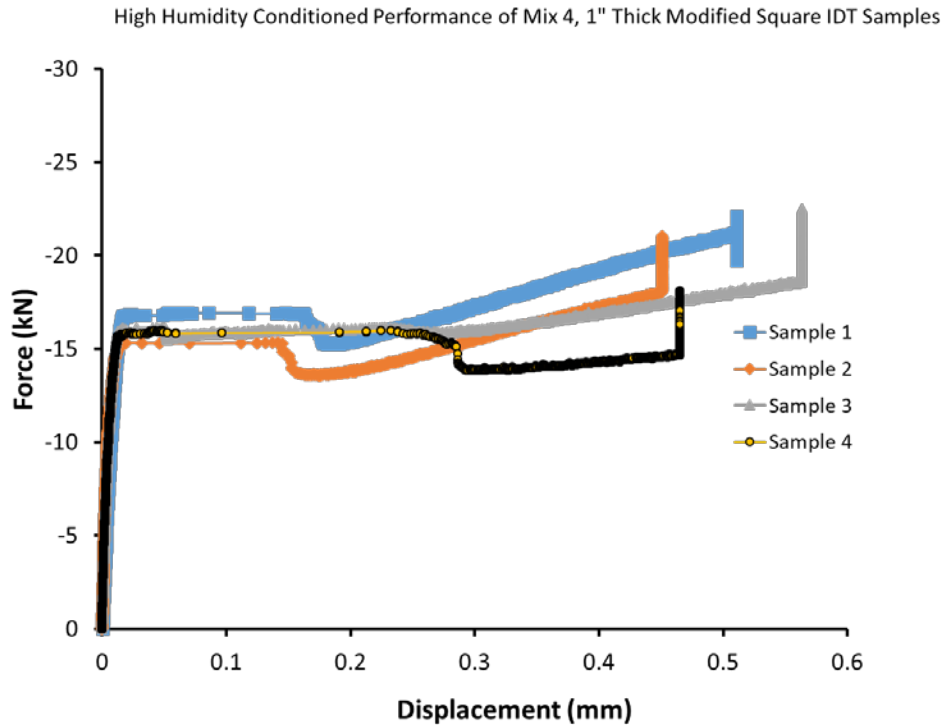
Figure 44 shows that sometimes the shape of the curves were somewhat flatter following the initial change in slope; this was observed on specimens with 9 lb/yd³ for samples exposed to high humidity (but also apply to samples immersed in calcium hydroxide and immersed in seawater) . The load decrease vs. displacement that followed was more gradual, and the slope of the monotonic increase in load vs. displacement was gentler and the maximum load did not reach as high values as those observed for samples with 12 lb/yd³ with the same fiber type.

Figure 44. Square MIDT samples of mix 4 tested after 20 months of exposure to high humidity

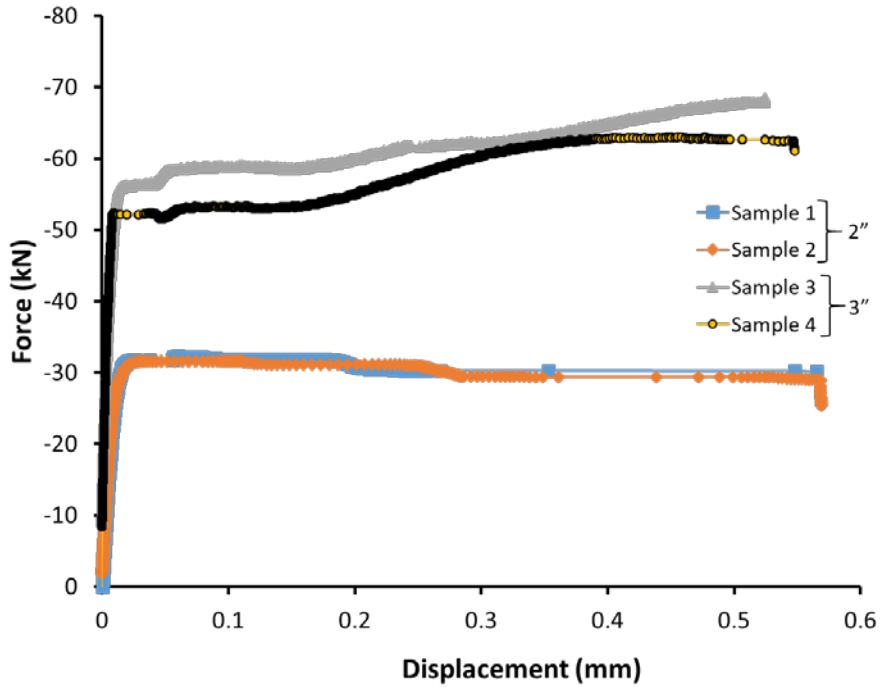
Barge Conditioned Performance of Mix 5, 2 and 3" Thick Modified Square IDT Samples

Barge Conditioned Performance of Mix 6, 2 and 3" Thick Modified Square IDT Samples

Figure 45. Square MIDT samples of mix 5 and mix 6, 2" or 3" thick, immersed in intercoastal waters for 16.5 months

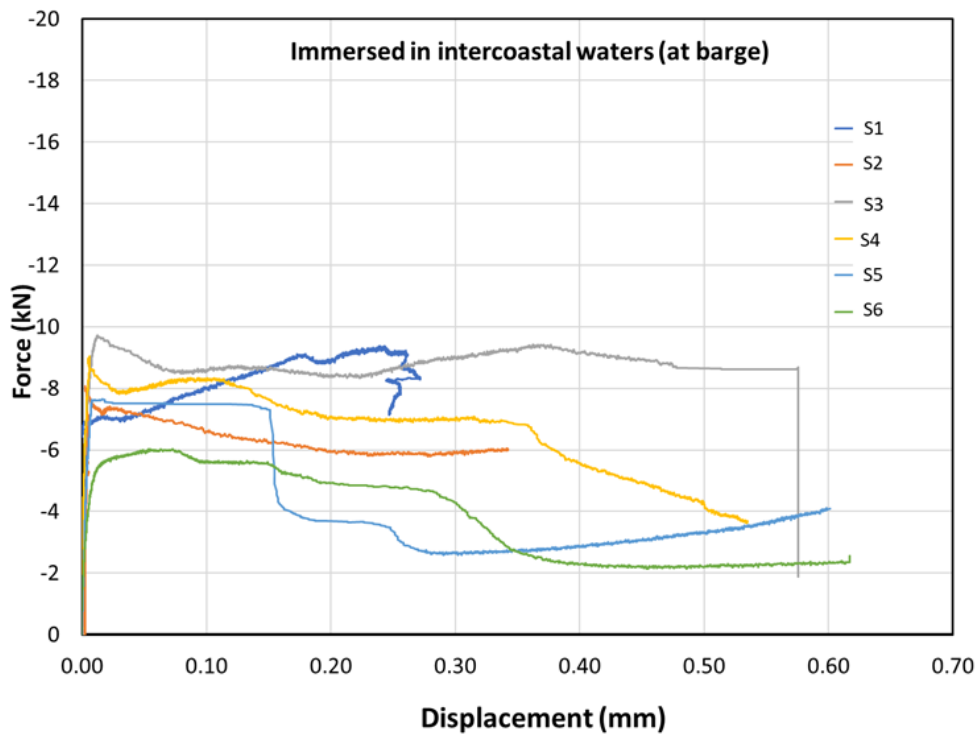
Figure 46. Square MIDT samples 1”-thick immersed in intercoastal waters for 12 months [72]

The next few pages show additional curves for samples in which either the fibers or the fiber concrete interface degraded after exposure immersed in intercoastal waters or immersed in seawater with the pH adjusted to pH of 4. Figure 46 and Figure 47 show plots for samples prepared with the same fiber types used in mix 2. The concrete contained similar fiber loading (12 lb/yd³) but slightly higher w/cm and it was also exposed at an earlier age (56 days). See Flaherty thesis [72] for additional details on sample preparation. Figure 46 shows that five out of six curves had a reduction in load vs. displacement following the elastic regime. Samples S4, S5, and S6 had more than one load drop, with sample S5 showing an abrupt drop in load at 0.15 mm displacement. These samples were immersed in the intercoastal waters during spring 2017. Figure 47 shows the curves for samples immersed in seawater with the pH adjusted to a value of 4. In this case, the curve for sample S4 had two drops in load one at 0.06 mm and another at 0.24 mm displacement. The other samples had a more modest reduction in the load vs. displacement past the elastic regime. Figure 48 shows the curves for 1” thick square MIDT samples of mix 6 after 23 months of exposure immersed in the intercoastal waters. Two of the curves (sample 1 and sample 3) showed either one drop in load (sample 3) or multiple drops (sample 1) followed by additional gradual decrease in load vs. displacement. Similar trend was observed on a sample of mix 4, but the drop in load took place at displacement of 0.4 mm (See Figure 49).

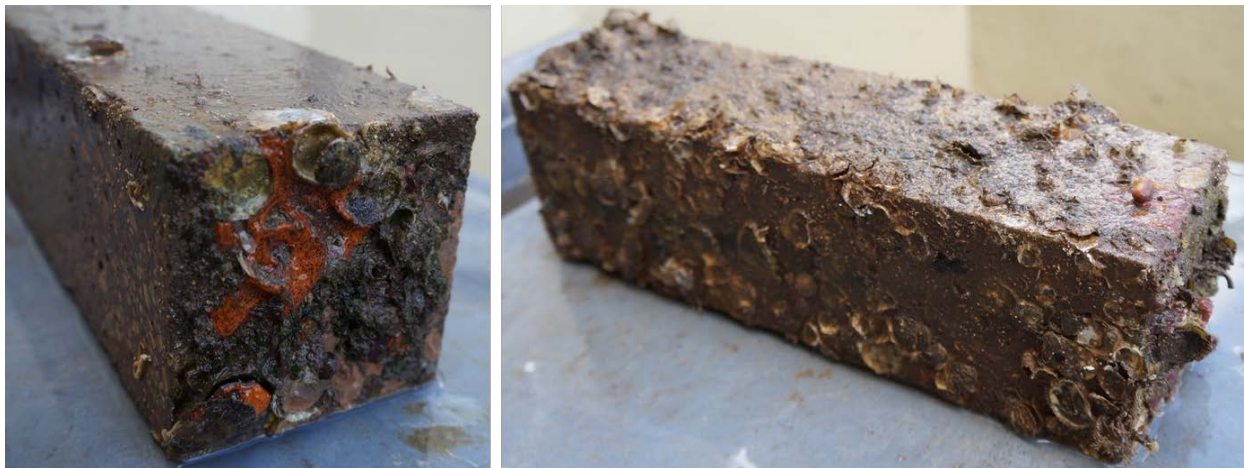
Figure 52 and Figure 53 show typical surface condition observed on the beam samples exposed immersed in intercoastal waters. The surface that was in contact with the bottom and touching another beam had significantly less marine growth. A variety of species appears to have attached to the specimens.

Figure 52. Beams with marine growth.

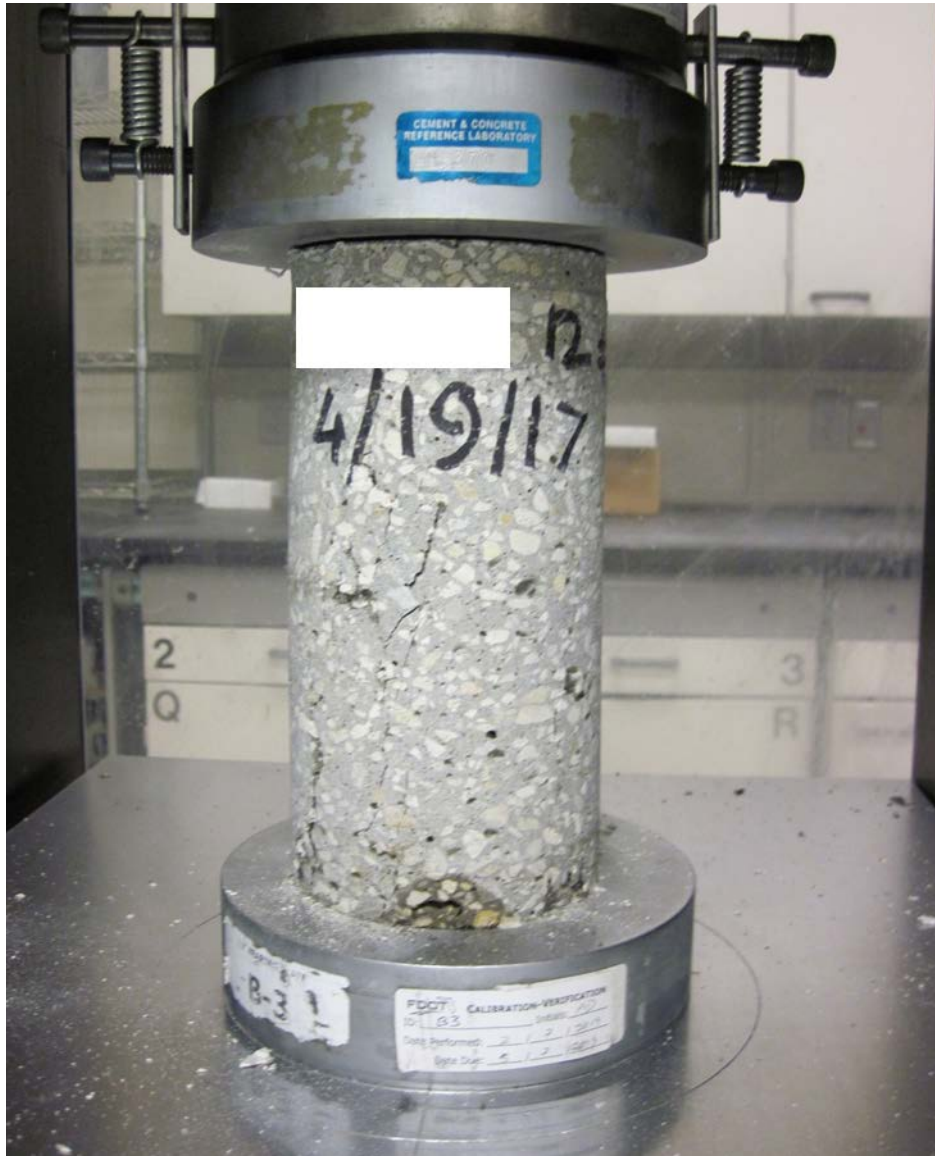
Figure 57. HH mix 1 sample tested in February 2019 after compression test.

Forensic analysis was performed on some of the samples tested in February 2019 and March 2019 after the compression testing took place. Two cores per mix were tested, one core was exposed immersed in calcium hydroxide solution and the other was exposed in a high humidity environment. Figure 57 shows an image with a core in the compression machine.

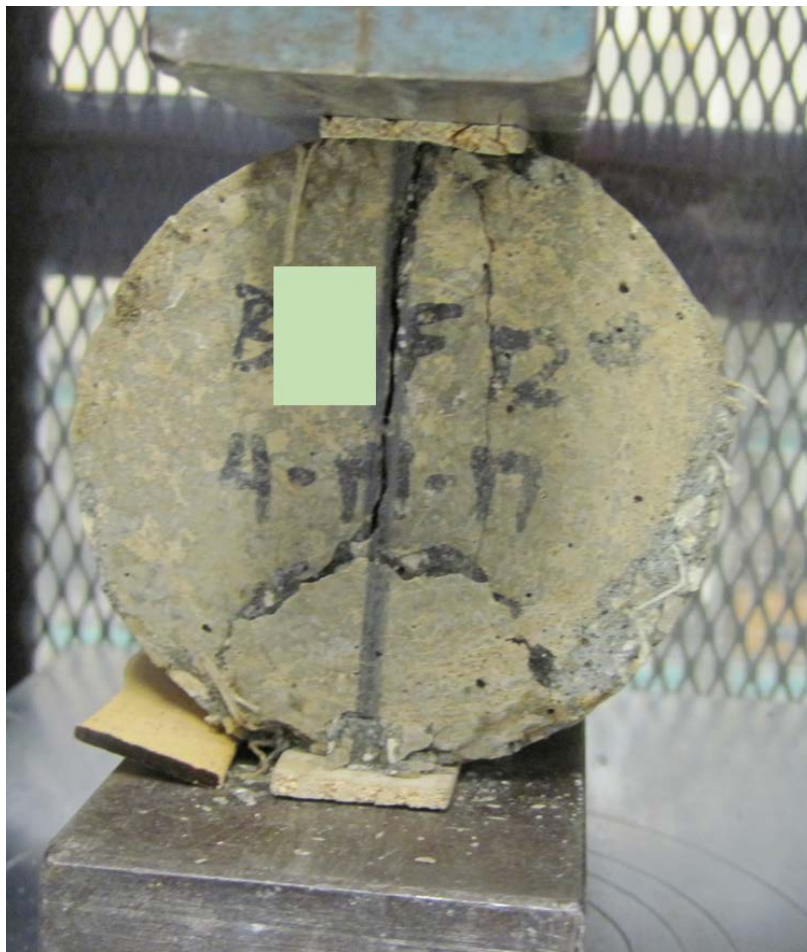
Figure 60. Mix 1 specimen exposed at the barge for 16.5 months after split tensile test.

Six samples per mix were tested during spring 2019 (2 samples exposed at the barge, 2 exposed to seawater adjusted to low pH, one exposed to high humidity (HH), and one core immersed in calcium hydroxide (CH) solution). Most pictures were taken after removing the sample from the testing machine. Selected samples were hammered to expose fibers and observe the fiber distribution. Figure 60 shows a mix 1 specimen (exposed at the barge for 16.5 months) still in the testing device. Note that several cracks are visible; in most instances only one crack was observed on each sample end. Figure 61 shows the same specimen after hammering to separate the concrete. In the picture on the left, one can observe some of the markings where the barnacles were attached. The image on the right shows the fiber distribution on the plane to which the load was applied. Appendix G contains additional images for other samples tested for the split tensile test.

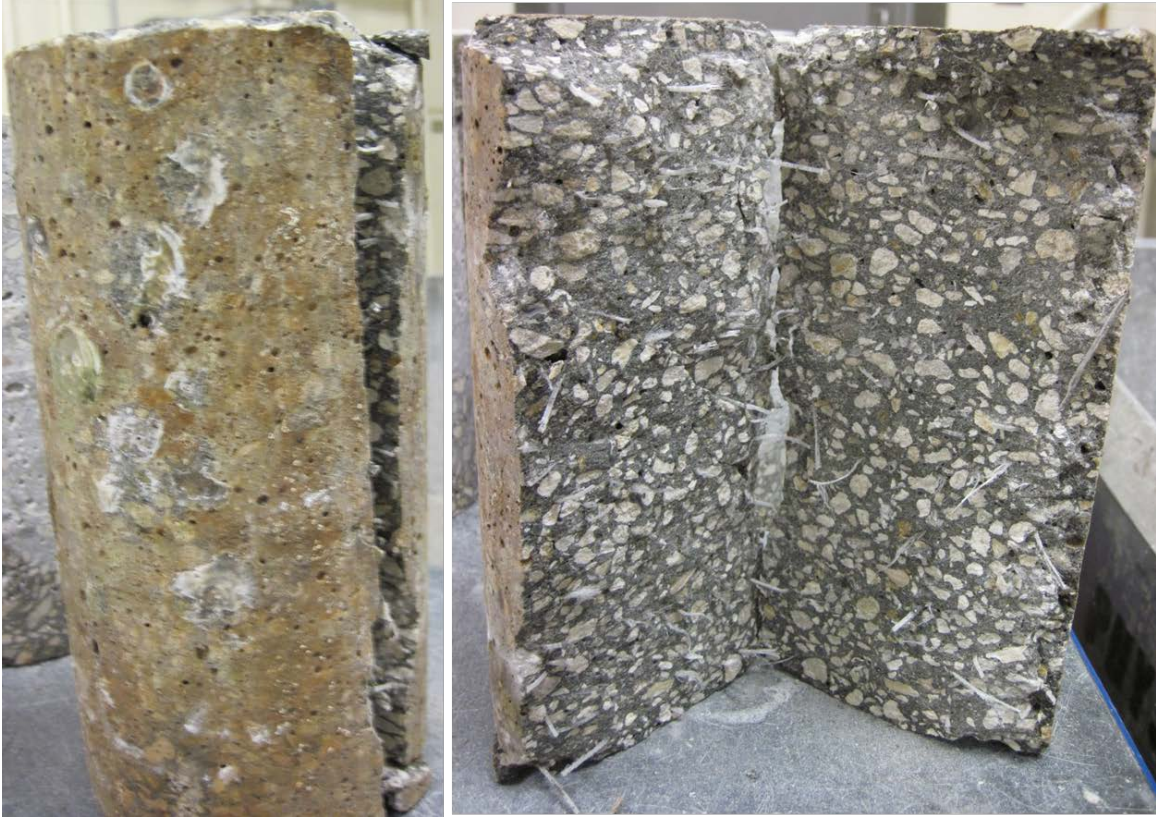
Figure 61. Mix 1 sample (exposed at the barge) after additional hammering.

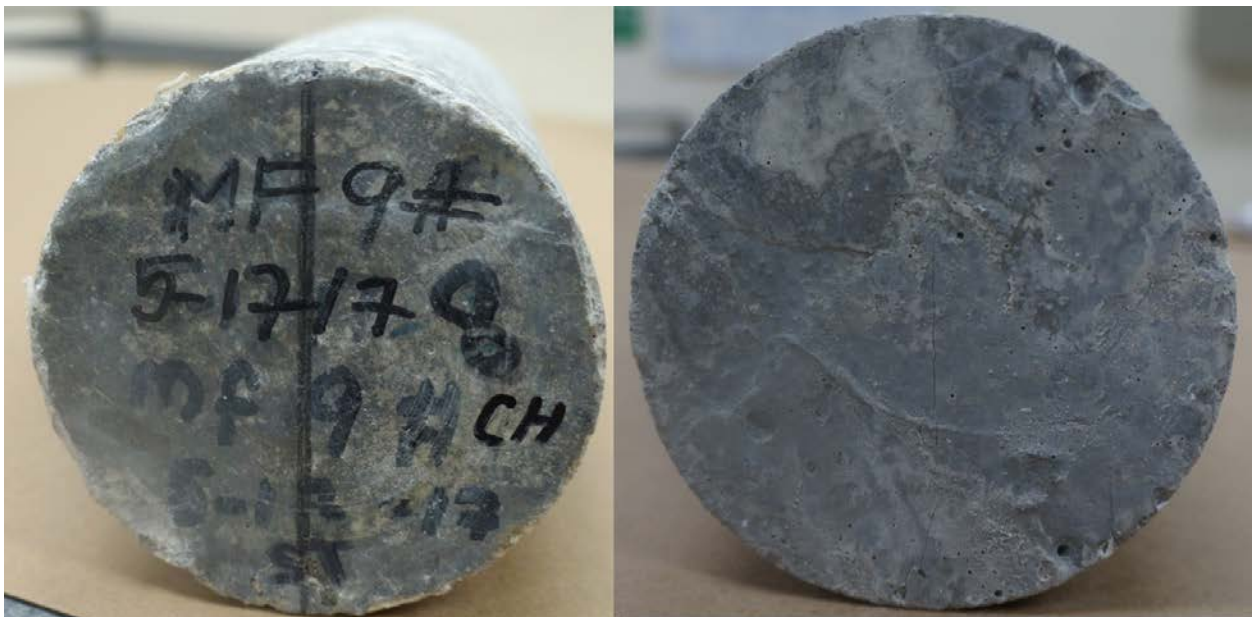
Figure 62 shows a CH mix 4 sample. Both images show that there was a crack (thin) on both ends of the cylinder. The split tensile test reached a max load of about 37420 lb, 2978 psi for this specimen.

Figure 62. CH mix 4 (5/17/17) samples after performing split test. Both core ends are shown.

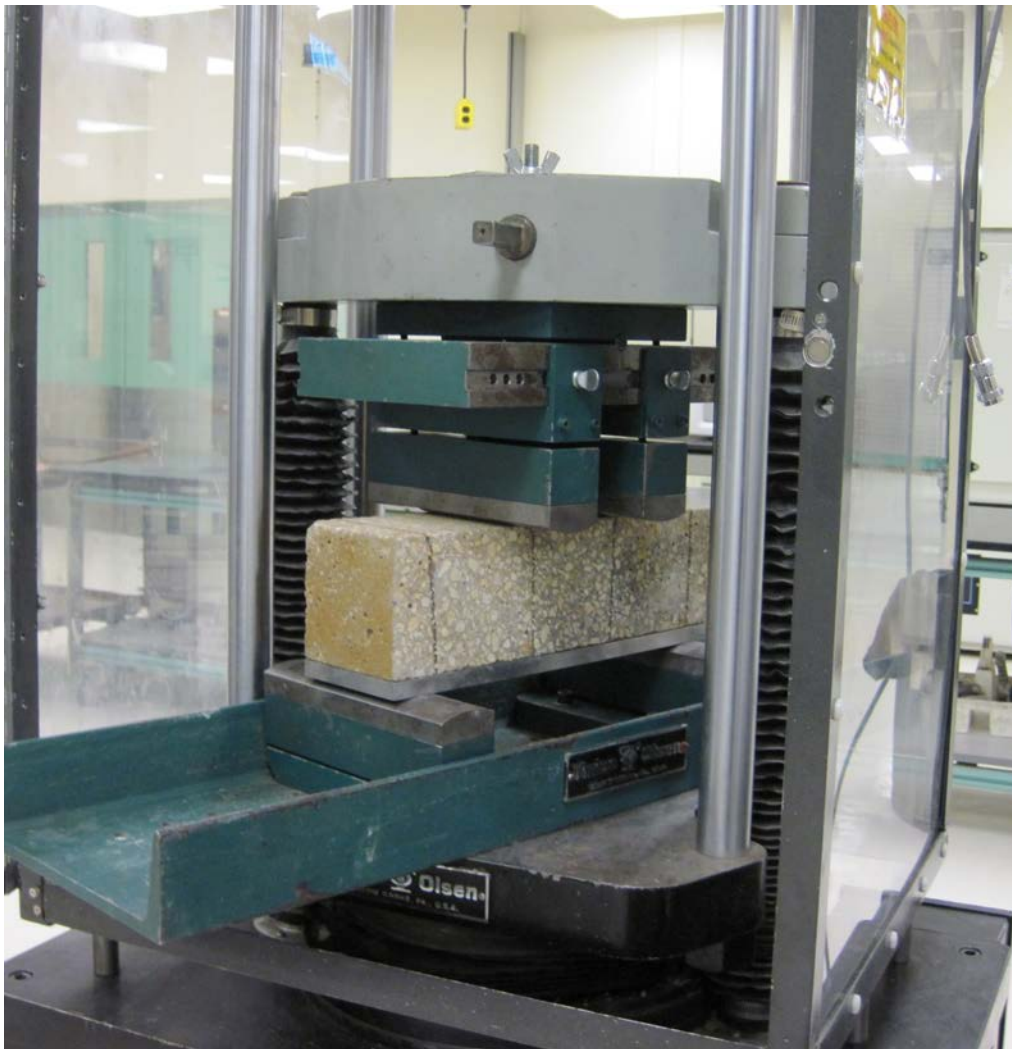
Figure 63. Sample in machine loaded to initial crack

The beams shown in this section were tested after 16.5 months of exposure. For each mix seventeen beams were tested: five beams exposed to seawater low pH (SW-LpH), five beams exposed immersed in intercoastal waters at the barge, two beams immersed in seawater, two beams exposed to high humidity, and three beams immersed in calcium hydroxide solution. Figure 63 shows an image of a beam specimen while loading to obtain the initial crack. All samples from a given group/mix were first marked. Then the samples were loaded to initial crack. Note the stainless steel plate below the sample in Figure 63. The samples were then tested for residual strength. Figure 64 shows a sample shortly after a residual strength test was completed. Note the wider crack and the LVDT's in place, and that the stainless steel plate is not used.

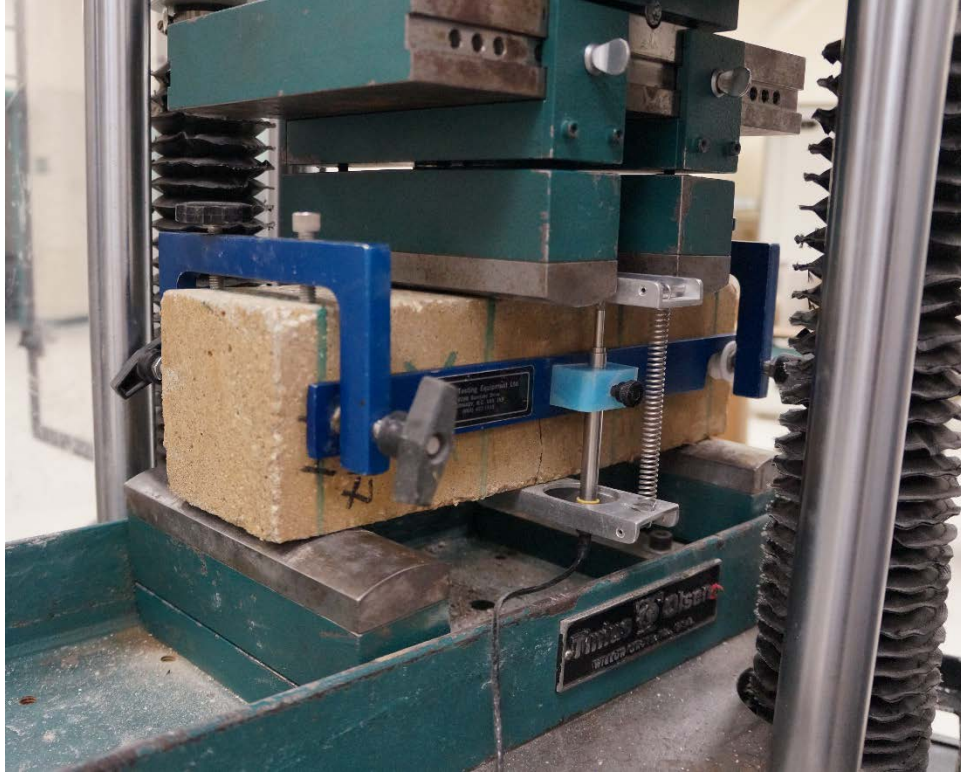
Figure 64. Beam sample being tested for residual strength with LVDTs

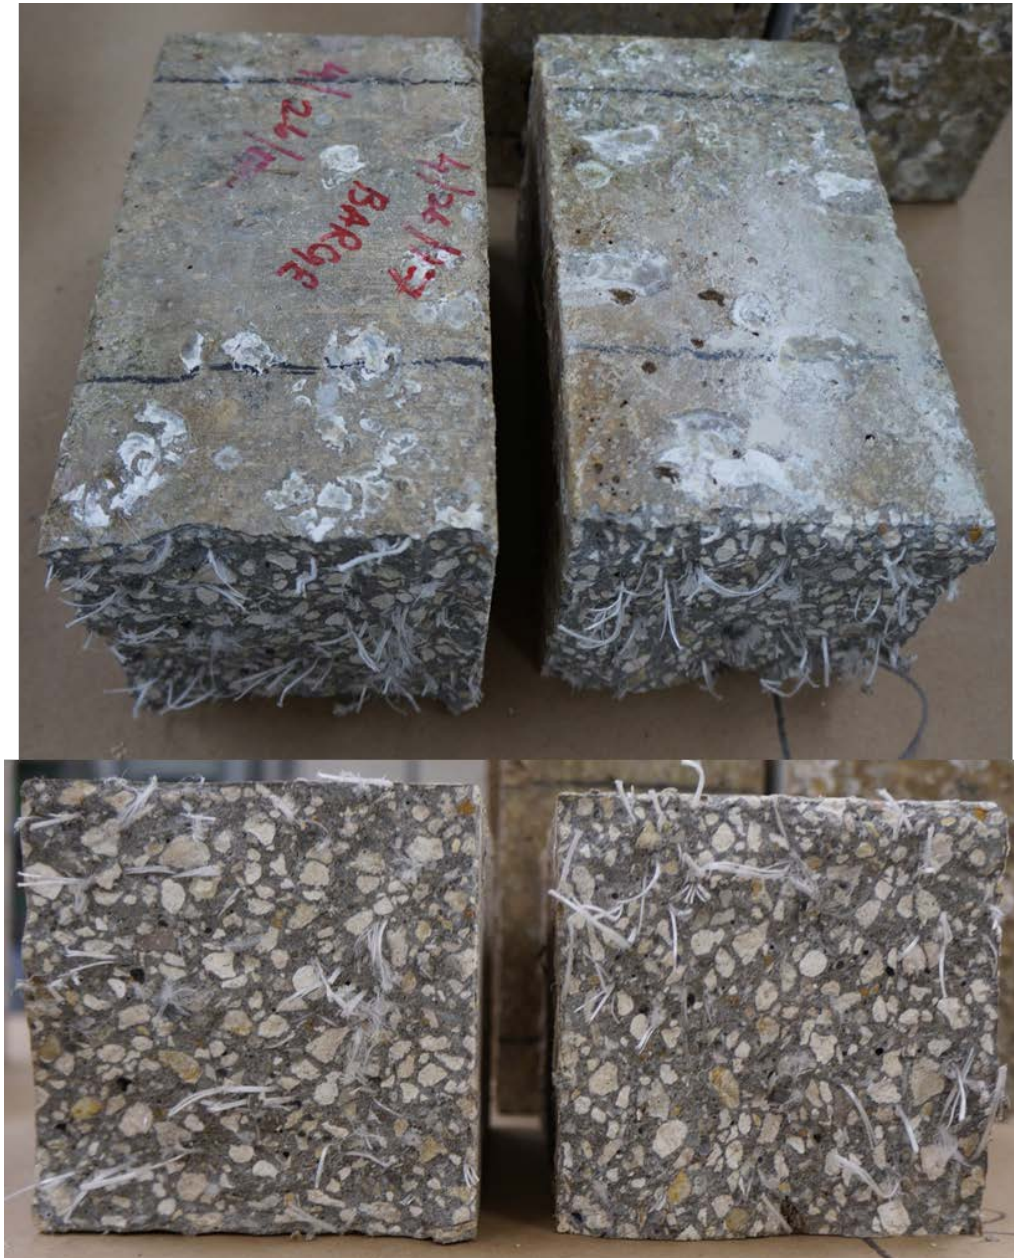
In some cases, the beams broke right on the middle; for example, see Figure 68. Most of the beams broke within the central section. Figure 68 shows a mix 2 beam that was exposed immersed in intercoastal waters (at the barge). The top image shows the top view and the bottom image shows the front view of both exposed surfaces and the fiber distribution.

Figure 68. Mix 2 beam after residual strength test (immersed in intercoastal waters).

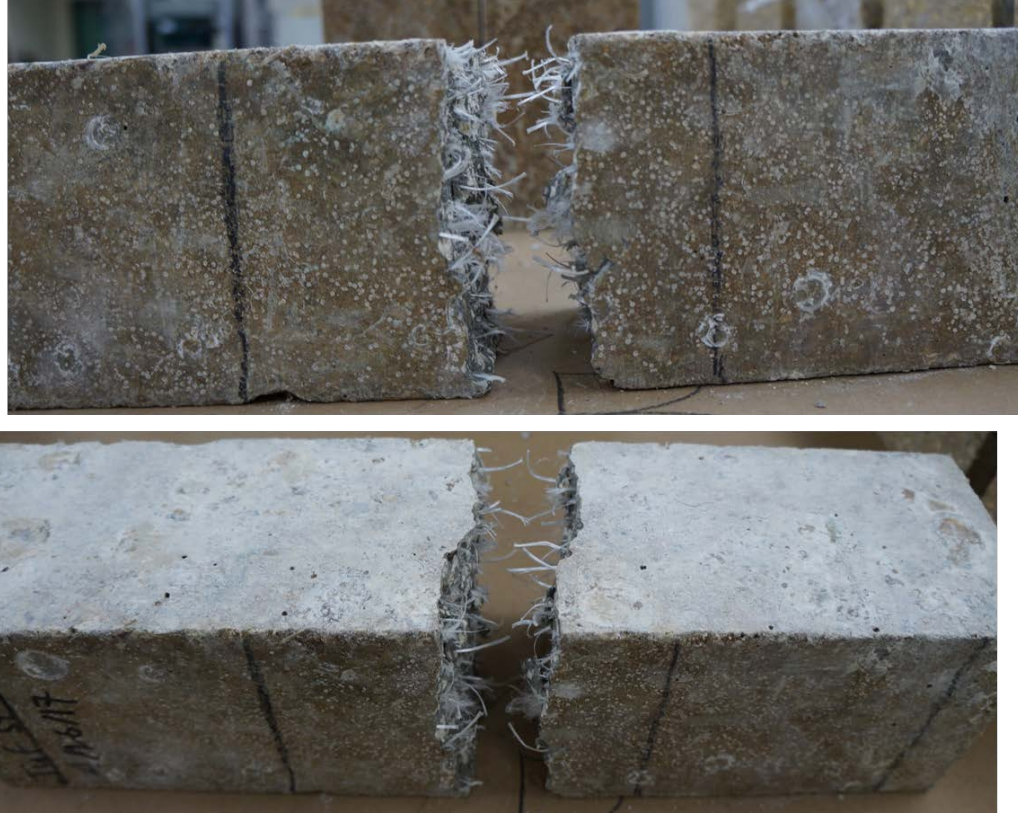
For some beams, pictures were taken in the longitudinal direction with the pieces separated. Figure 69 shows two other mix 2 beams in this orientation (exposed immersed in intercoastal waters). The beam on the top appears to have a larger concentration of fibers than the beam shown on the bottom image. The larger number of fibers in some of these samples might explain the larger residual strength observed on some samples within a given group.

Figure 69. Mix 2 beams after residual strength testing (exposed at the barge). Longitudinal direction.

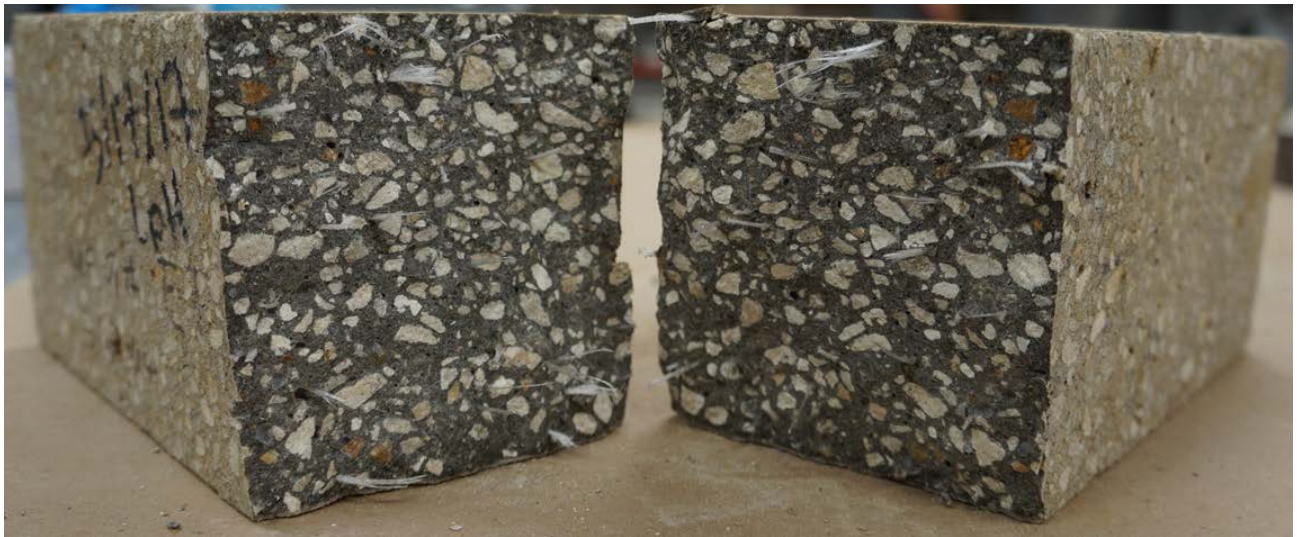
Figure 72. Mix 4 sample (SW-LpH) after residual strength test.

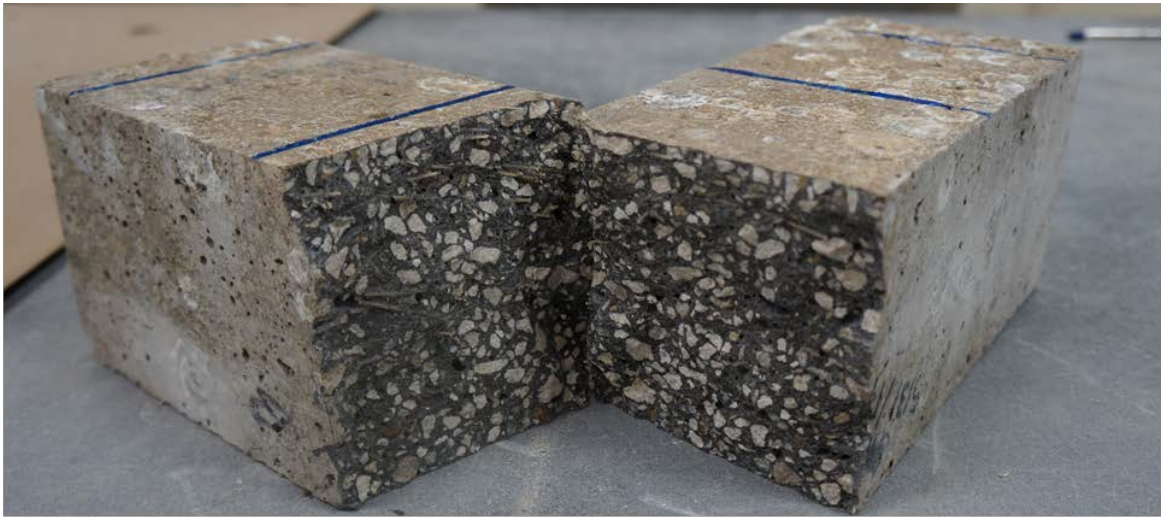
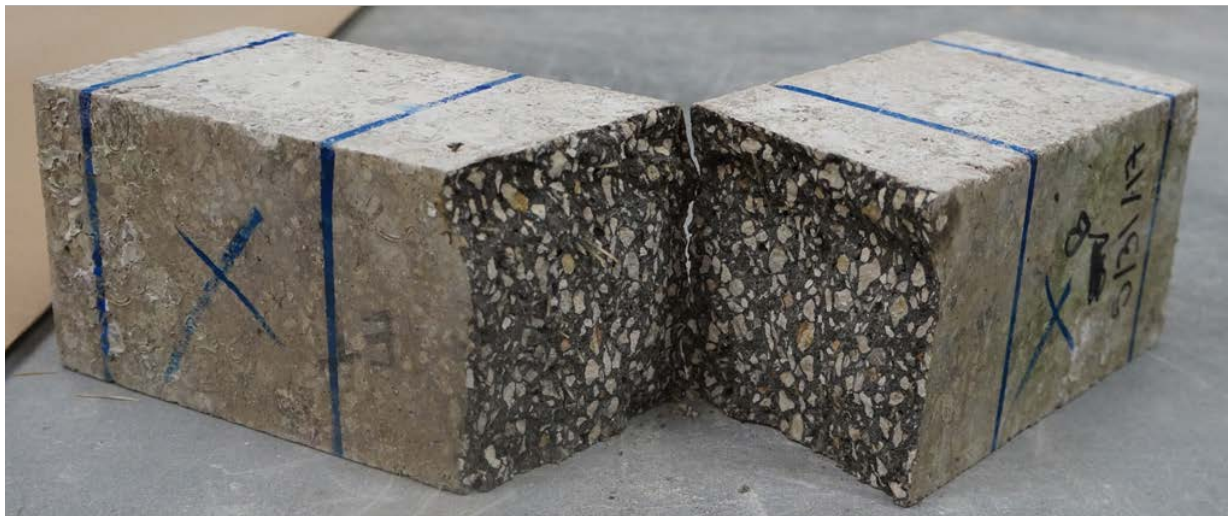
the concrete. Samples from mix 6 had a different failure mode than those presented above. Figure 75 shows images of two mix 6 beams that were exposed at the barge immersed in intercoastal waters. The fibers on these samples were shorter than that which was used for the other five mixes, but the concrete was prepared with 15 lb/yd³. These samples had on average the lower residual strength from all the sets tested. Figure 76 shows a front view for a sample exposed at the barge. (Same beam than top image on Figure 75). Figure 77 shows a front view of the exposed surfaces for a mix 6 beam after the residual testing (this beam was exposed immersed in seawater adjusted to low-pH). There appears to have been less pull-out/debonding and possibly more fiber breaks. It is also possible that the fibers were oriented somewhat different and because the fibers were shorter the length of the fiber that pulled-out/debonded was less.

Figure 75. Mix 6 samples after residual strength (exposed immersed in intercoastal waters)

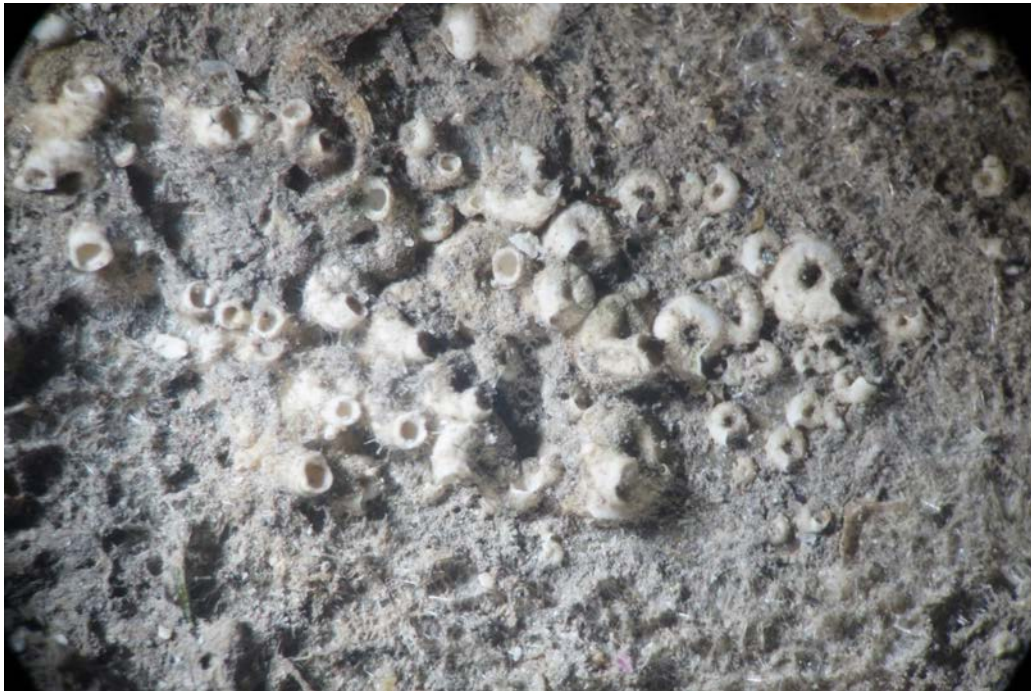
Figure 79. Marine growth observed on the surface of one of the samples.
