Deliverable 10
Final Report

Durability of Fiber Reinforced Concrete Pipe Exposed to Florida Aggressive
Environments
BDV27-977-11

Submitted to
Florida Department of Transportation Research Center
605 Suwannee Street
Tallahassee, Florida 32399

June 2020

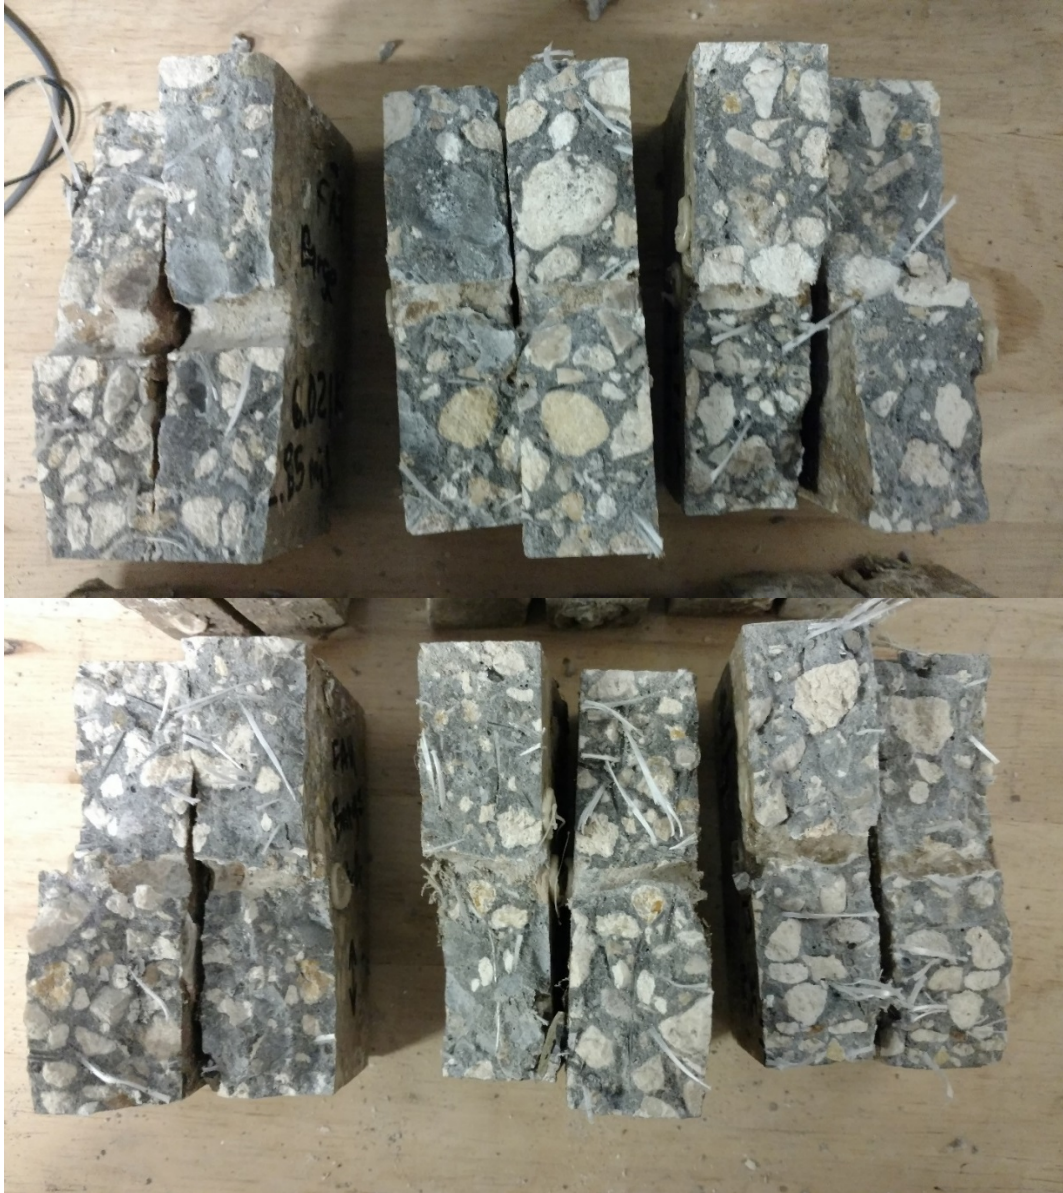
Figure 80. Barge specimens

Figure 86 shows mix 1 and mix 2 samples after modified IDT testing for samples exposed in high humidity for 8 months. Figure 87 shows mix 1 and mix 2 samples after modified IDT testing for samples that were exposed at the barge for 8 months immerse in intercoastal waters. In most cases the concrete cracks (fracture) took place at the expected locations (i.e., vertical and horizontal axis crossing the center of the drilled hole). Figure 88 shows mix 1 and mix 2 samples after modified IDT testing for samples that were exposed to seawater with the pH adjusted to a value of 4.5 (SW-LpH). Appendix I include the images for the other mixes. The images in Appendix I includes images after a mallot was used to separate the sample and a top view picture taken that shows the fiber distribution (similar to what is observed above on Figure 80 and Figure 84).

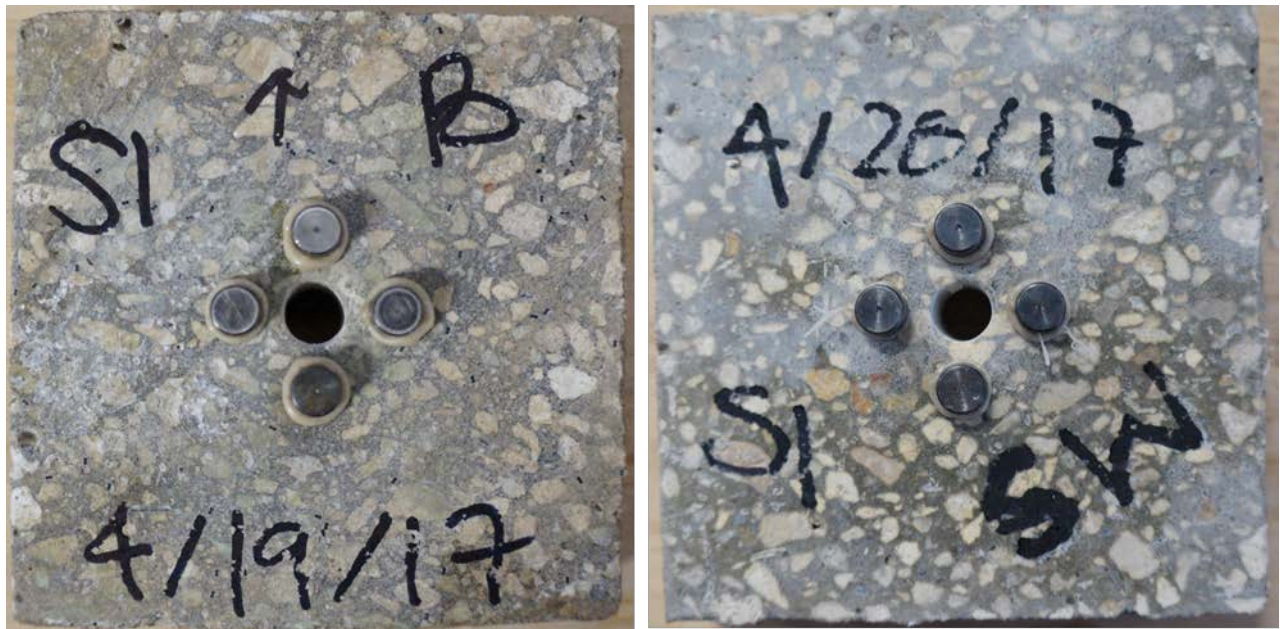
Figure 85 shows two samples prior to performing modified IDT testing. The image on the left corresponds to a mix 1 specimen exposed at the barge for 8 months and the picture on the right corresponds to a mix 2 specimen exposed immersed in seawater (wet/dry cycles) for 8 months.

Figure 85. IDT specimens with steel gauges glued prior to testing.

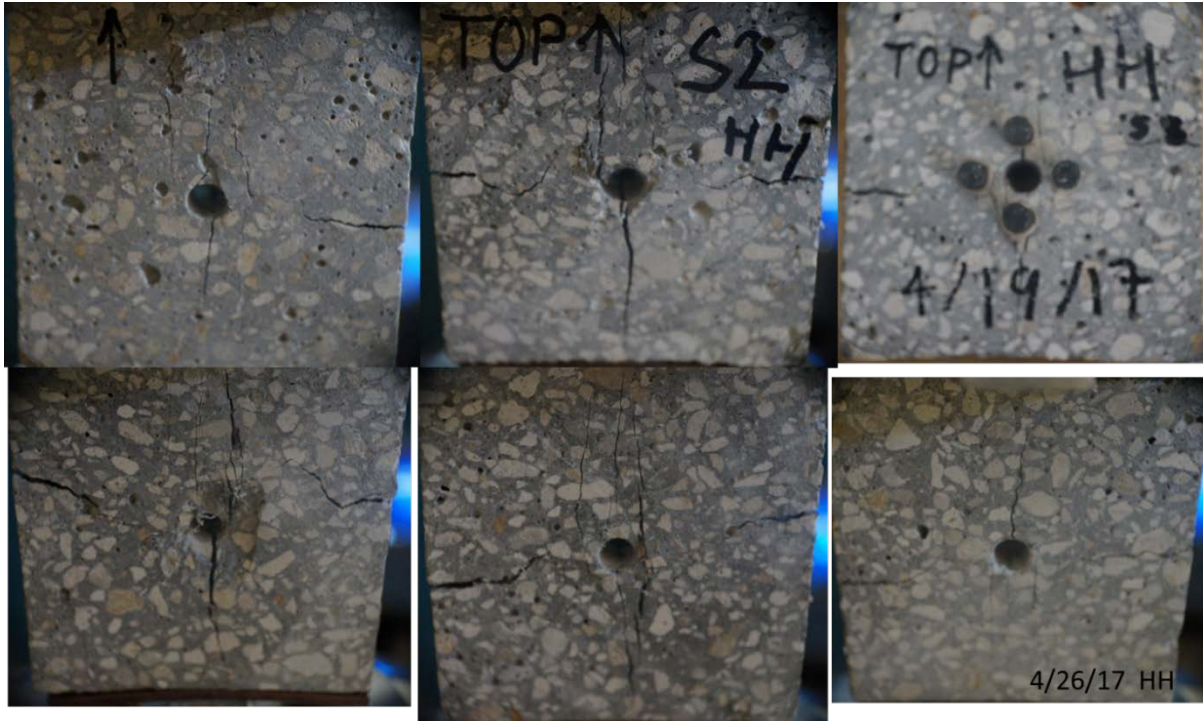
Figure 86. Mix 1 (top row) and mix 2 (bottom row) samples after modified IDT testing (high humidity)

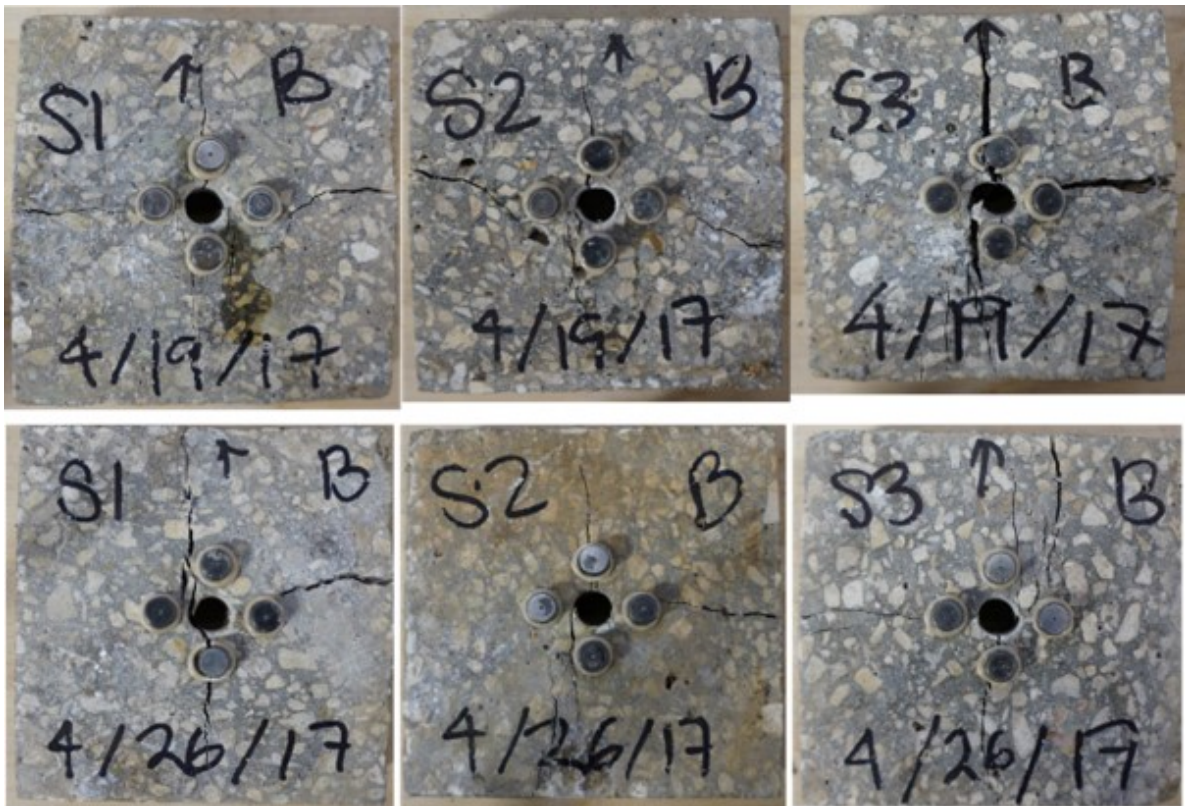
Figure 87. Mix 1 (top row) and mix 2 (bottom row) samples after modified IDT testing (immersed in intercoastal waters)

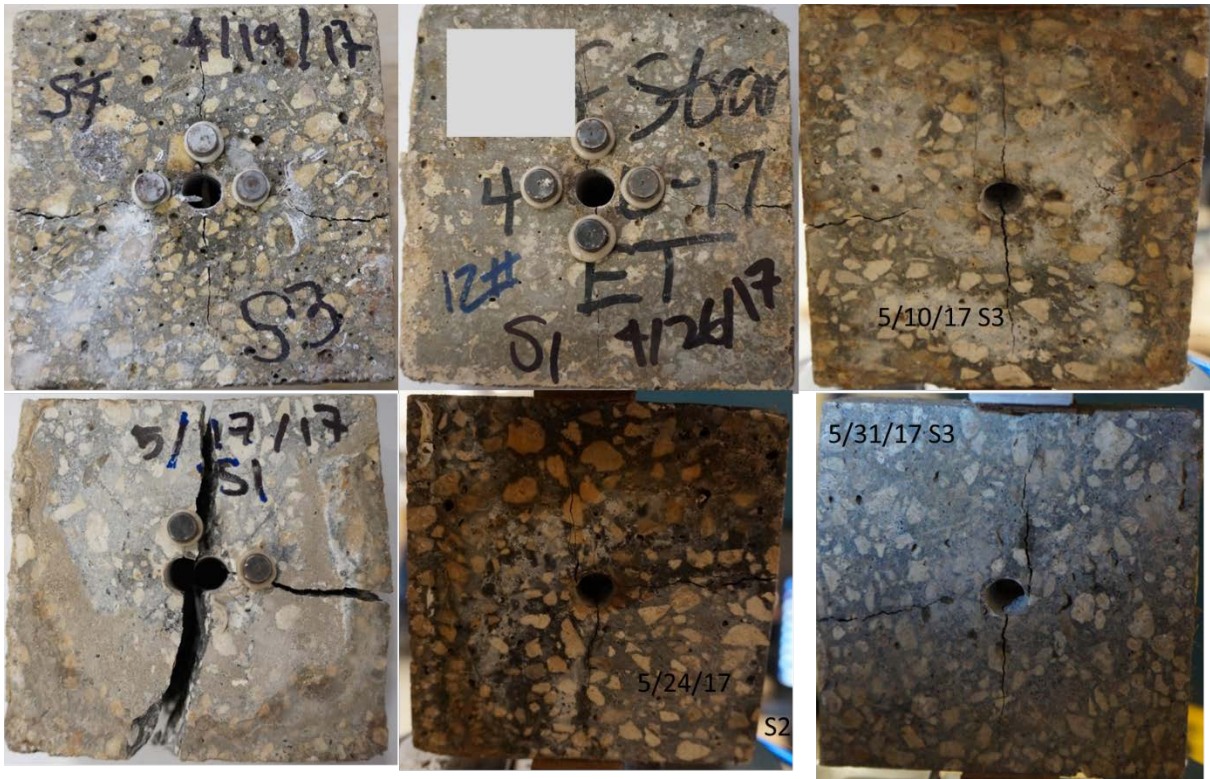
Figure 89. Two- and three-inch-thick samples after MIDT testing.

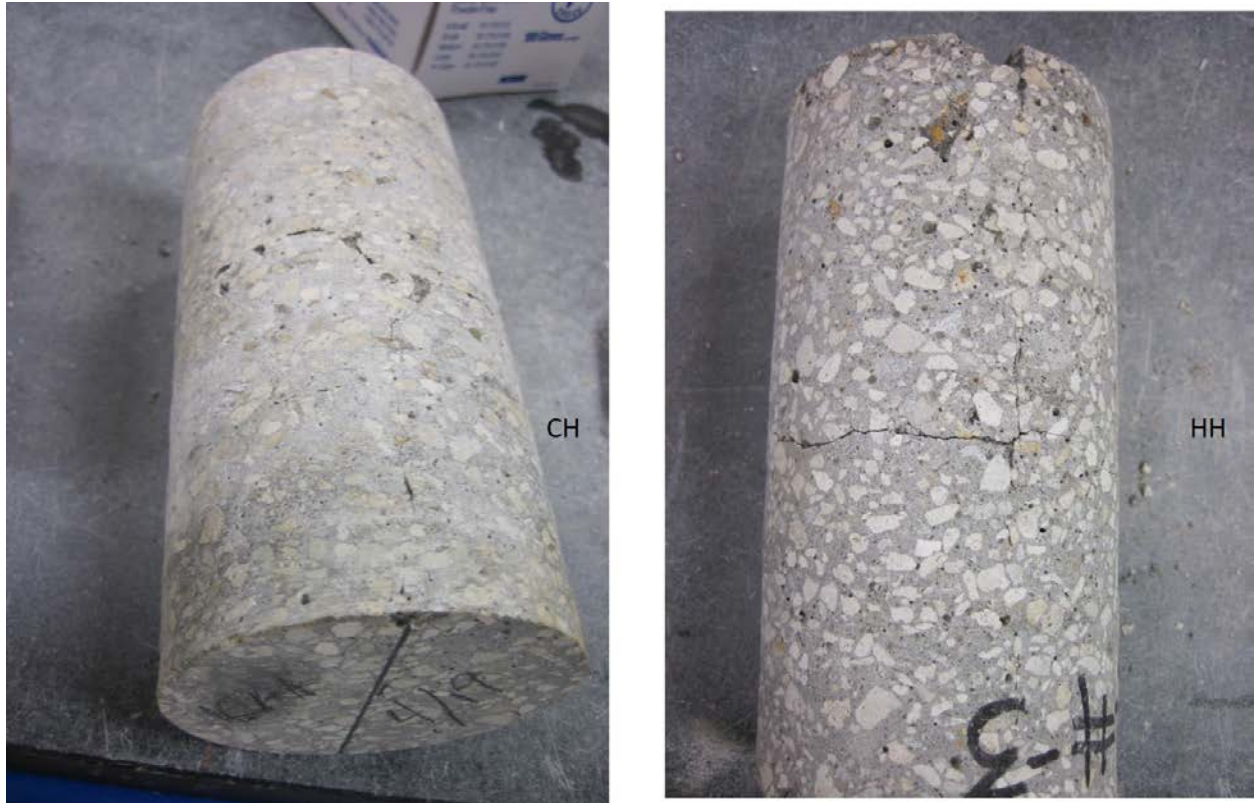
Figure 133. Visual inspection after split-tensile tests on cores of mix 1
