## **Final Report**

# **Develop Epoxy Grout Pourback Guidance and Test Methods to Eliminate Thermal/Shrinkage Cracking at Post-Tensioning Anchorages**

## **Phase II**

**January 2016**

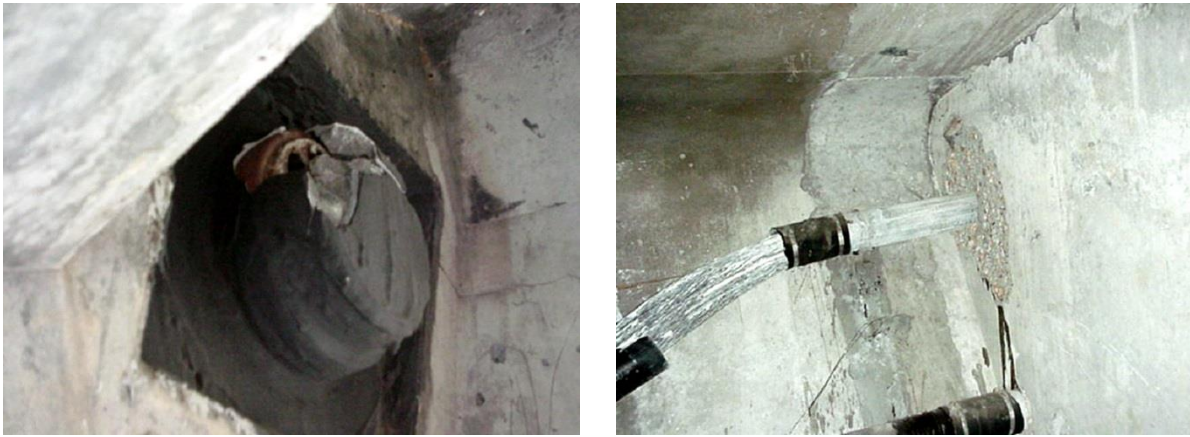
Pourbacks at end anchorages of post-tensioning tendons provide an essential level of corrosion protection. This is especially true when the anchorages are adjacent to expansion joints or other bridge deck discontinuities where water can flow freely to the tendon anchorage. Figure 1-1 shows an anchorage of a tendon in an expansion joint span of the Mid-Bay Bridge, where no pourback was provided. Water easily passed through the mastic coating and into the post-tensioning anchorage. Within seven years of installation, the tendon failed as a result of strand corrosion in the anchorage.

**Figure 1-1: Tendon failure on the Mid-Bay Bridge**

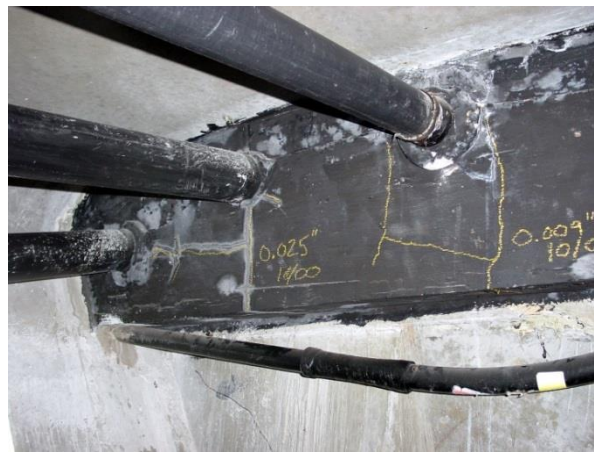
Early segmental bridges incorporated cementitious pourbacks to protect end anchorages. Figure 1-2 shows a single pourback that encases three anchorages of the span-by-span approaches on the Sunshine Skyway Bridge. Unfortunately, the details of the pourbacks, and the methods of placing the materials, led to significant cracking of the pourbacks.

**Figure 1-2: Pourback cracking on the Sunshine Skyway Bridge**

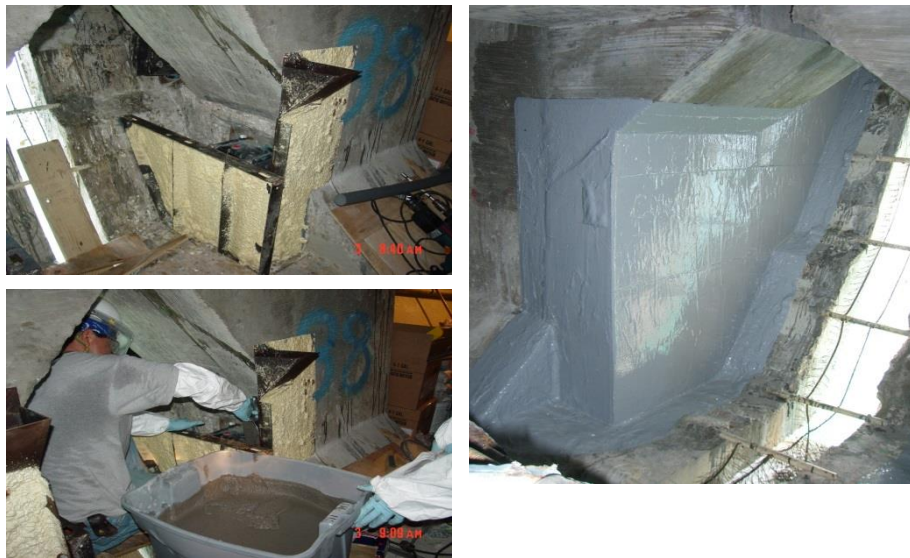
**Figure 2-3: Epoxy grout pourbacks in the Florida Keys Bridges**

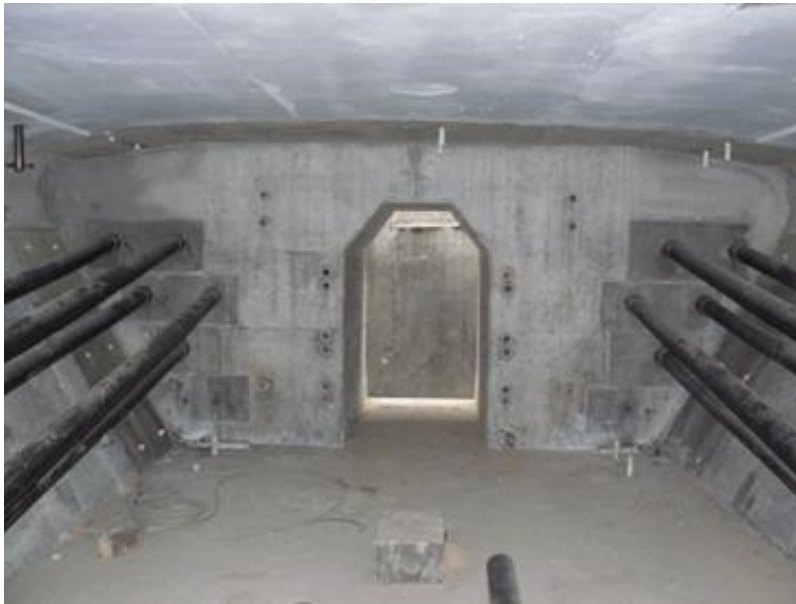
**Figure 3-1: Typical concrete dead-end segment. Notice the multiple anchorage points spread throughout the entire segment cross-section.**

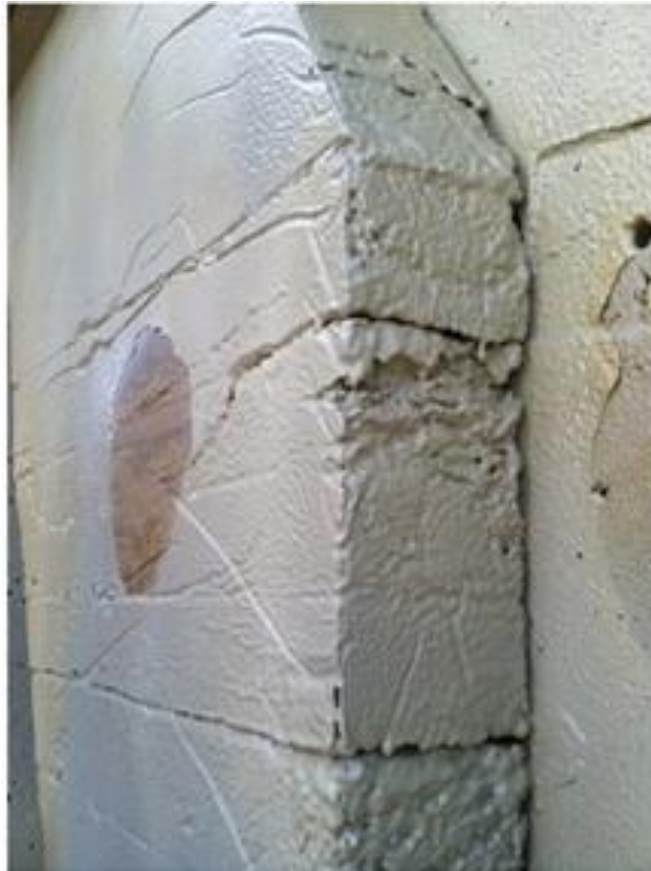
**Figure 3-4: Typical location of cracks**

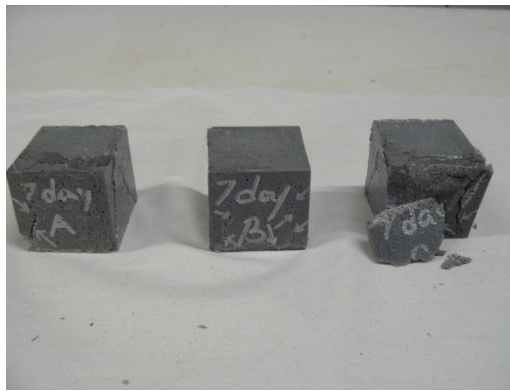
**Figure 4-1: Sample preparation and testing**

This task involves the evaluation of compressive strength of the epoxy grouts on the 420 epoxy grout (E-Bond) in accordance with ASTM C-579 using method B at 55°F, 75°F, and 110°F. At each temperature, three 2 in. cube specimens were tested at 8 hours, 16 hours, 24 hours, 3 days, 7 days, 14 days, and 28 days. Figure 4-1 illustrates the casting and testing of epoxy specimens.

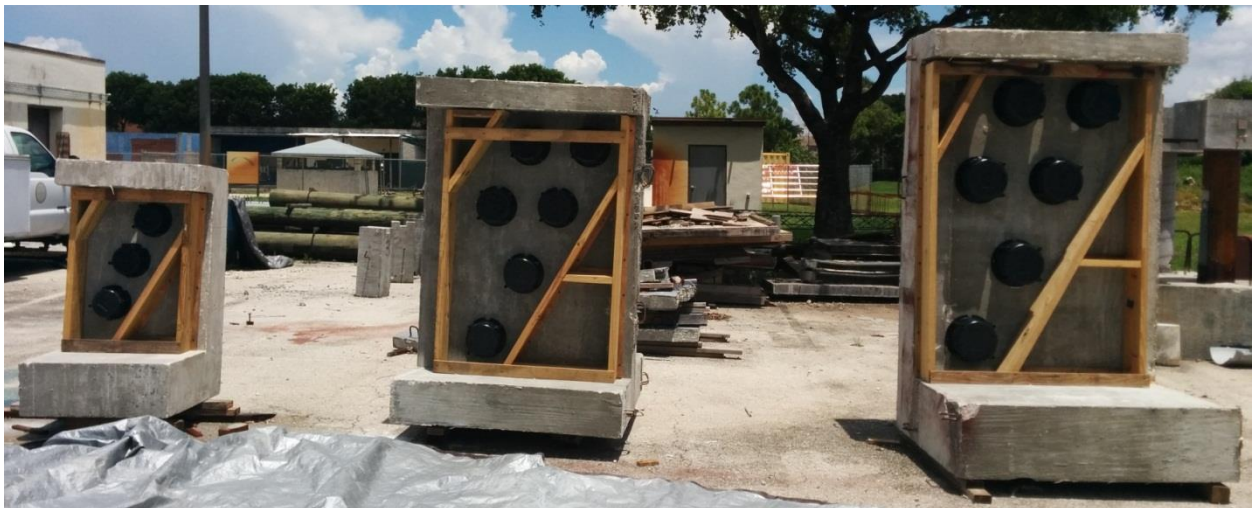
**Figure 4-3: Complex geometric shapes and properties (S-type)**

The full-scale epoxy grout testing consisted of two sets of epoxy pourbacks: 1) irregular shaped pourbacks (S-type) as illustrated in Figure 4-3; and 2) rectangular shaped pourbacks (R-type) as illustrated in Figures 4-4. For each set, three different volume-to-surface (V/S) ratios were

S2	S2.5	S3
Number of grout caps	3	6	6
Ambient temperature (F)	68	68	68
Volume/surface ratio	0.26	0.32	0.37
Construction method	Full Depth		
Reinforcement	Non		
Concrete temperature	Ambient: 68° F		
Initial temperature of epoxy	Ambient: 68° F (Store epoxy in laboratory for 48 hours at 68° F before casting)		
Concrete surface	Hydro blast

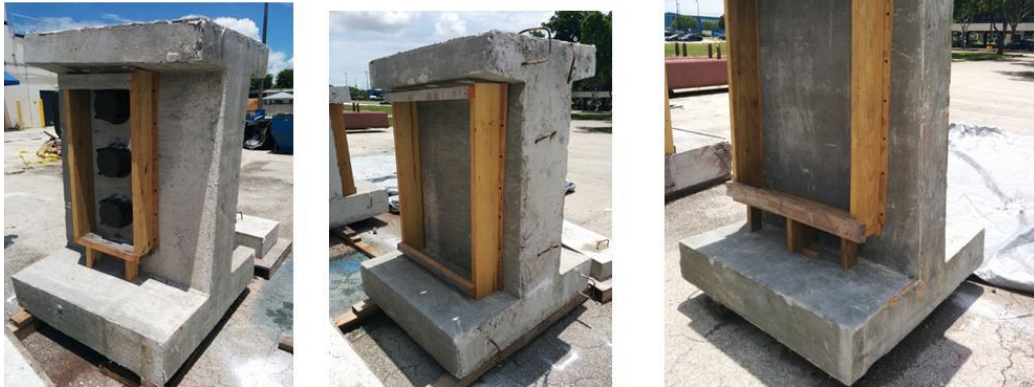
**Figure 4-4: Regular geometric shapes and properties (R-type)**

R2	R2.5	R3
<b>Number of grout caps</b>	3	6	6
<b>Ambient temperature (F)</b>	68	68	68
<b>Volume/surface ratio</b>	0.26	0.32	0.37
<b>Construction method</b>	Full Depth		
<b>Reinforcement</b>	Non		
<b>Concrete temperature</b>	Ambient: 68° F		
<b>Initial temperature of epoxy</b>	Ambient: 68° F (Store epoxy in laboratory for 48 hours at 68° F before casting)		
<b>Concrete surface</b>	Hydro blast

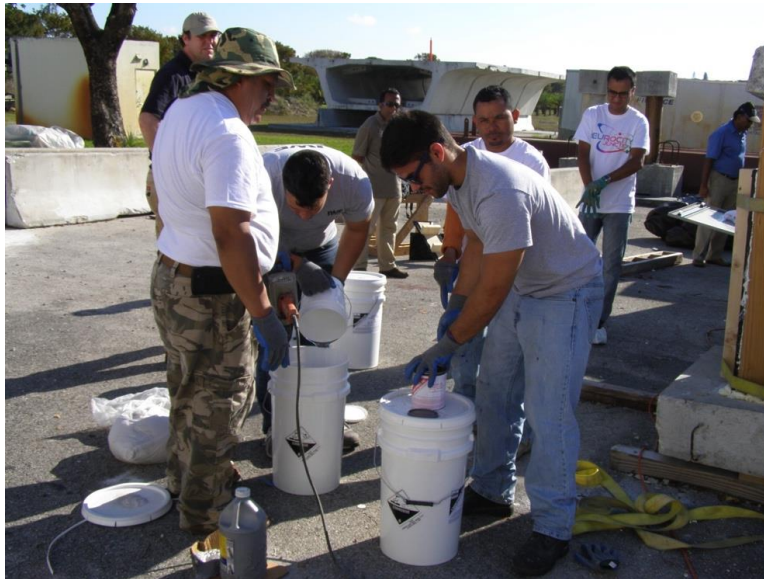
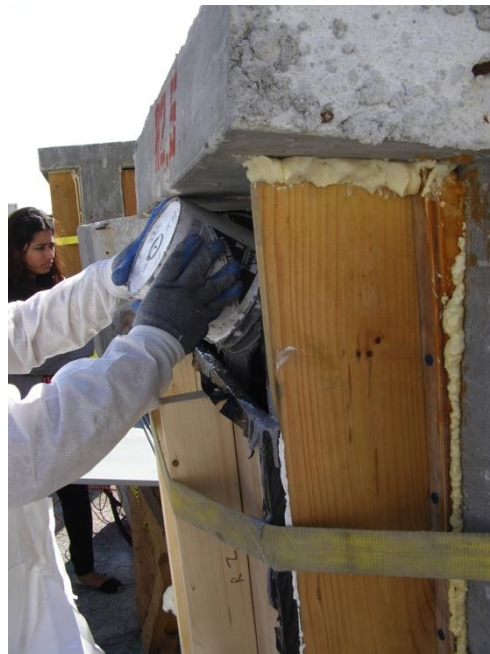
**Figure 4-6: Mixing and casting of epoxy pourback**

Wooded forms with plastic lining were used to mold the pourback. The forms were made such that a 12 in gap was left open to allow pouring of the epoxy grout. The grout was mixed in a 5 gallons bucket in accordance with the manufacturer specification using a hand mixer. After the epoxy grout was mixed, it was hand poured into the form. Once the epoxy grout reached the opening, the gap was sealed and the remaining portion was pour from a small opening from the top. Figure 4-6 illustrates the mixing and casting of the epoxy grout.

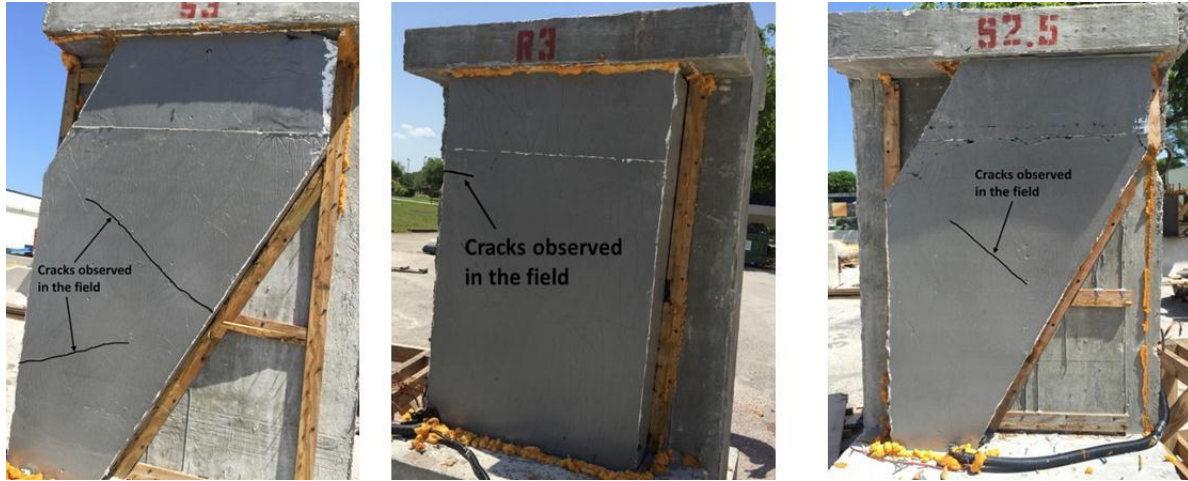
specimen (see Figure 5-4) while the rectangular shaped pourback had a horizontal crack forming towards the top.

**Figure 5-4: Cracks in pourback specimens**

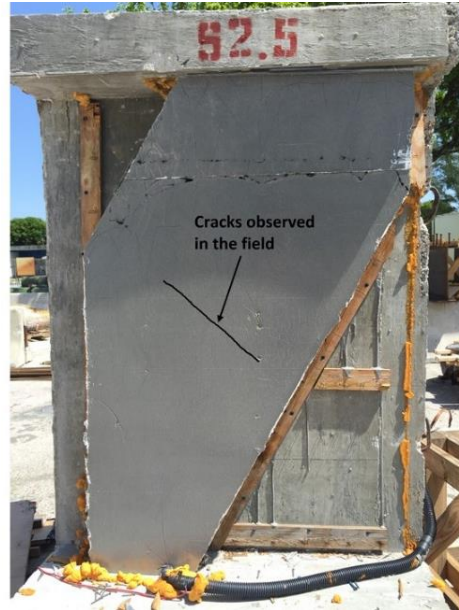
**Figure 5-11: Comparison of crack locations between FEM and experimental observations for S2.5 specimen**

Figure 5-9 shows the experimentally observed crack locations for the S3 specimen and the location of the tensile cracks determined by the maximum tensile stresses computed by FEM analysis utilizing the strength criteria provided in manufacturer's product data sheet (Figure 2-4). The maximum tensile strength of the E-Bond epoxy ranges between 24 to 28 MPa as reported in the product data sheet. Figure 5-9 indicates a remarkable agreement between the actual and predicted crack locations. This agreement is consistent with the crack locations observed in two other specimens, R3 and S2.5, shown in Figures 5-10 and 5-11, respectively.

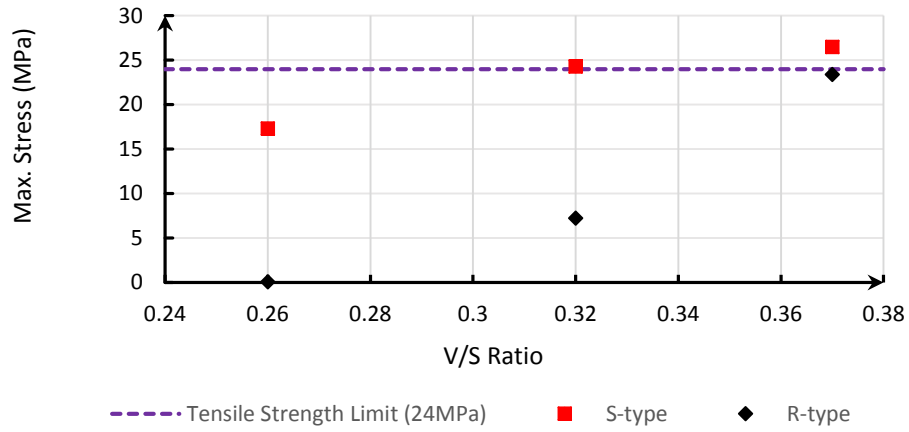
The dotted line in Figure 5-12 indicates the tensile strength (24 MPa) of the E-Bond epoxy reported in the manufacturer's product data sheet. A significant finding from this plot is that the S-type specimens reach cracking stress when V/S ratio exceeds 0.32 ft. For the R-type specimens, the cracking stress is reached at a higher V/S ratio of 0.37 ft.

**Figure 5-12: Variation in maximum tensile stress with V/S Ratio (FEM analysis)**

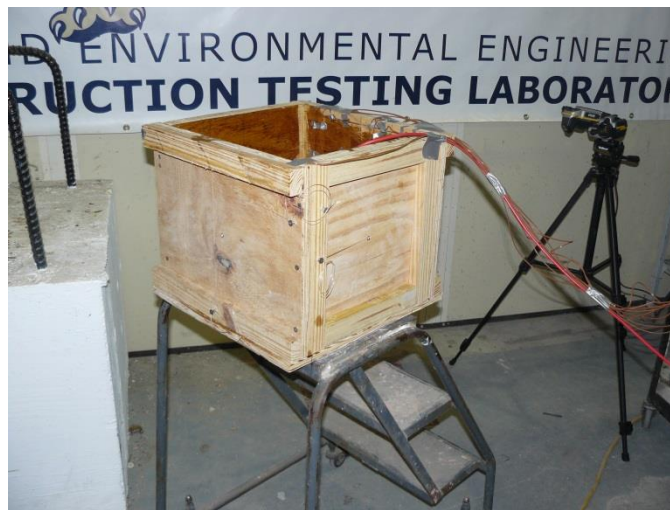
Figure A-1: Formwork for E3HP epoxy grout system

A cubic formwork with dimensions 1x1x1 ft was designed using 9/16 in. thick plywood built with five sides, four panels for walls and one panel for bottom surface. The form was placed on a metal stand (Figure A-1).

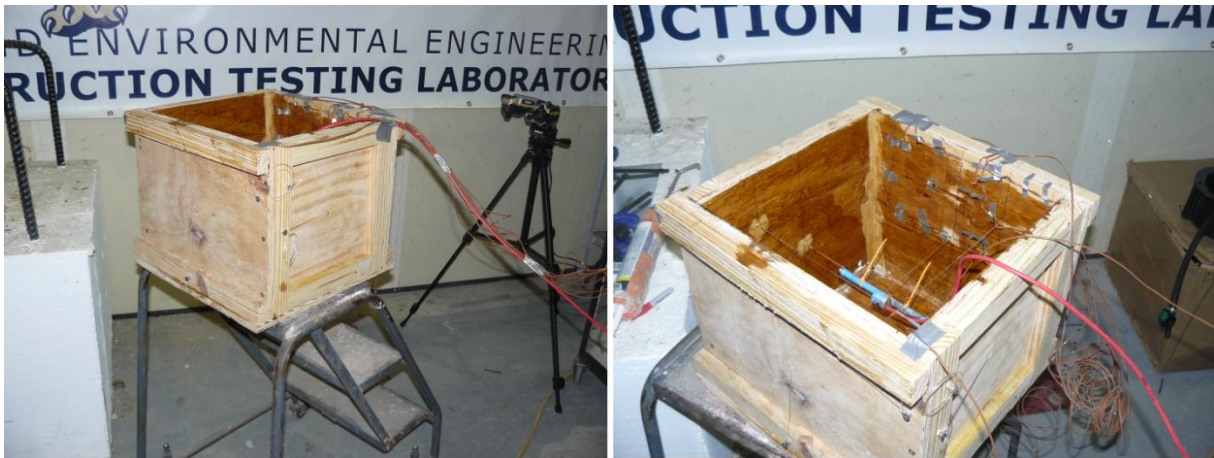
Figure A-3: Six thermocouple sensors were embedded in the neighborhood of the surface shot by the thermography Camera 1

Thermocouples were labeled as TC1 to TC8. Six thermocouple sensors, TC1 to TC6, were embedded in the neighborhood of the surface shot by the thermography Camera 1, Figure A-3.

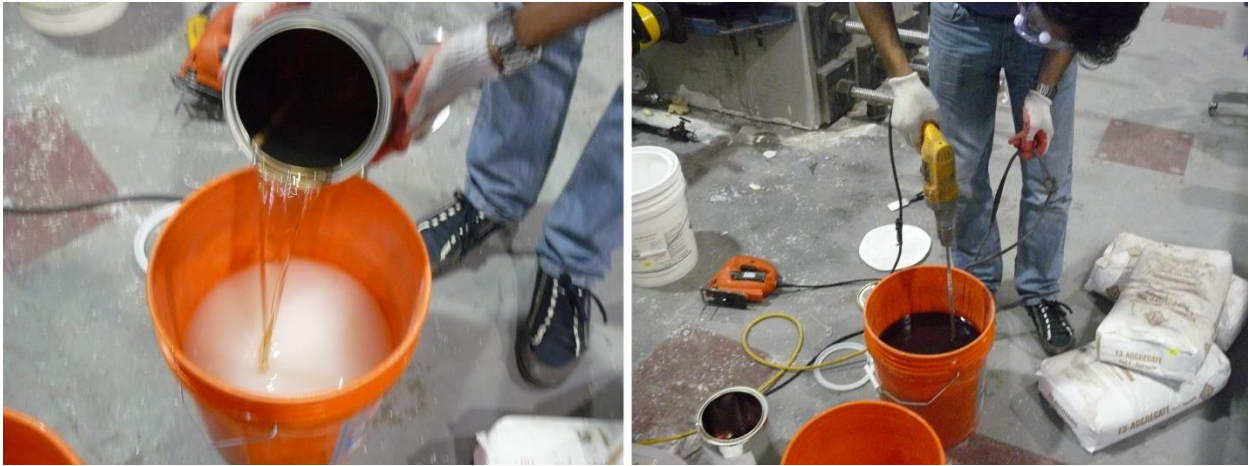
Figure A-7: Parts A & B (resin & hardener) mixed for 2 minutes using a drill and mixing prop

Before mixing, all E3HP materials, the three parts, were stored at the laboratory for 3 days, in order to bring the materials temperature close to ambient temperature. Parts A & B (resin & hardener) were mixed for 2 minutes using a drill and mixing prop (Figure A-7). For ease of mixing, the part B was added to the part A. The epoxy must be well mixed to ensure proper

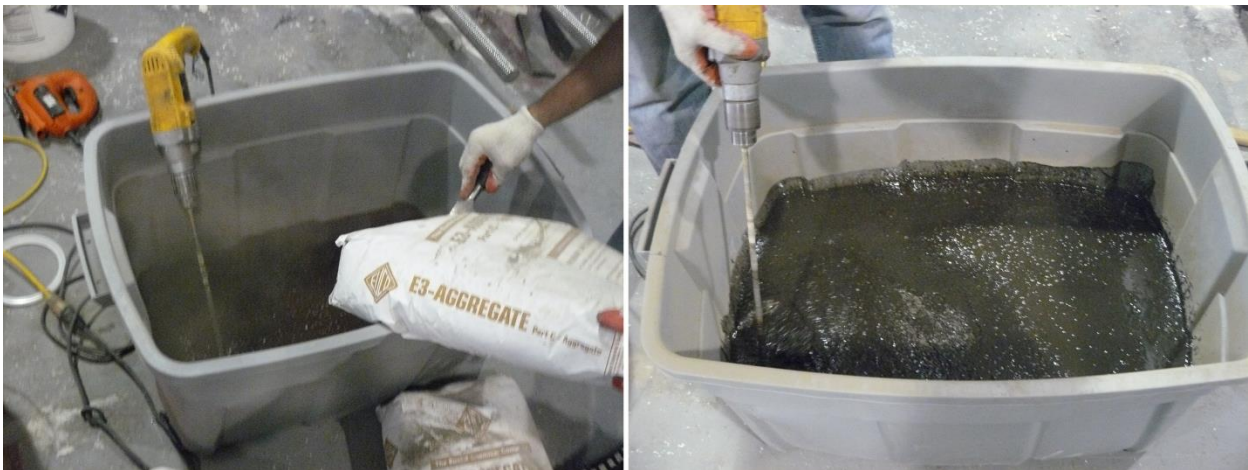
Figure A-8: The part C (aggregate) added and mixed for 5 minutes until the aggregate was completely wetted out

chemical reaction. After the epoxy has been mixed, the part C (aggregate) was added and mixed for 5 minutes until the aggregate was completely wetted out (Figure A-8).

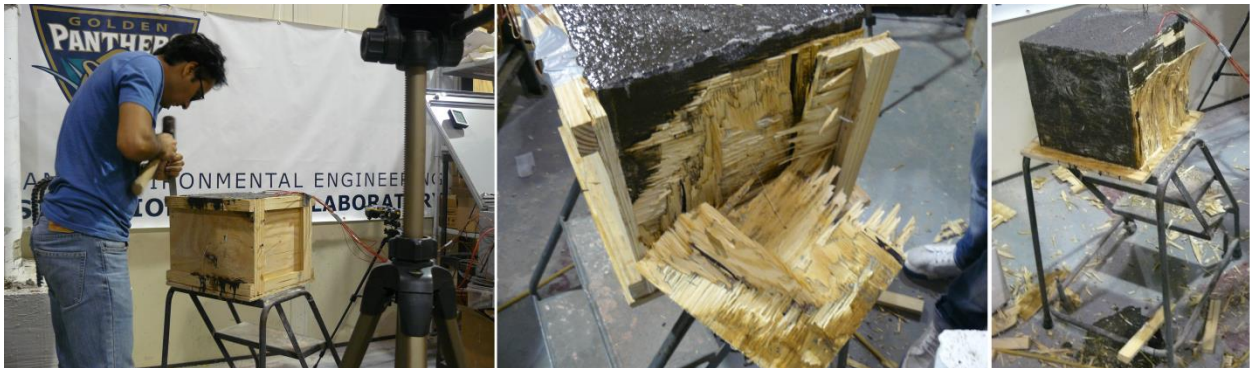
Figure A-10: Formwork removal

Formwork removal was started at the time of 130 min with surface 2 and finished at 165 min with surface 4. Although inside the wooden form was fully coated with oil, at the time of formwork removal, it was bonded to the specimen (Figure A-10). Thus it took about 35 minutes to remove the 4 lateral formwork panels, resulting in five surfaces in contact with the ambient environment. (Figure A-11).

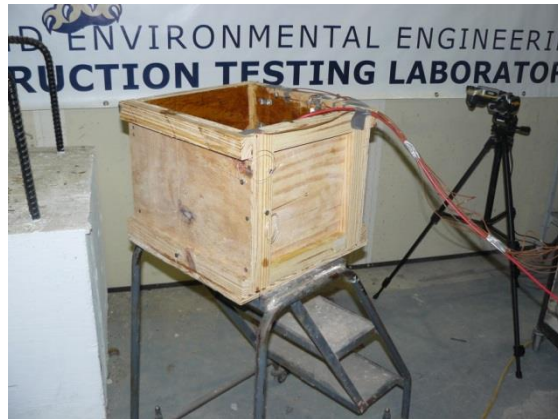
Figure A-13: Position of Camera 1 and specimen

The first camera (Camera 1) was placed in front of side 4, where the thermocouples was inserted, at the level of mid-height of the specimen, in a direction which was perpendicular to the specimen surface (see Figure A-13). This camera was able to monitor all the thermocouples on 6 surfaces.

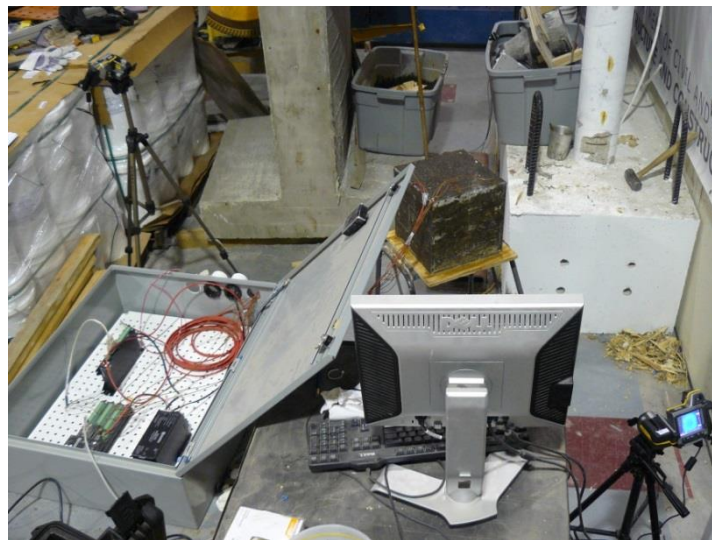
Figure A-14: The second camera (Camera 2)

The second camera (Camera 2) was placed at a distance of 43 in. from the specimen, and 12 in. above its top surface (Figure A-14), in order to allow the simultaneous visibility of three surface of the cube (Figure A-15). The observation angles were  $\alpha = 22.7$  deg. for the top surface and  $\alpha = 50$  deg. for the vertical surfaces. The reason for using the second camera was to monitor the top surface temperature, and also the center of two other surfaces, in order to compare the results obtained with camera 1 for detecting any error associated with the observation angle. The differences are described later.

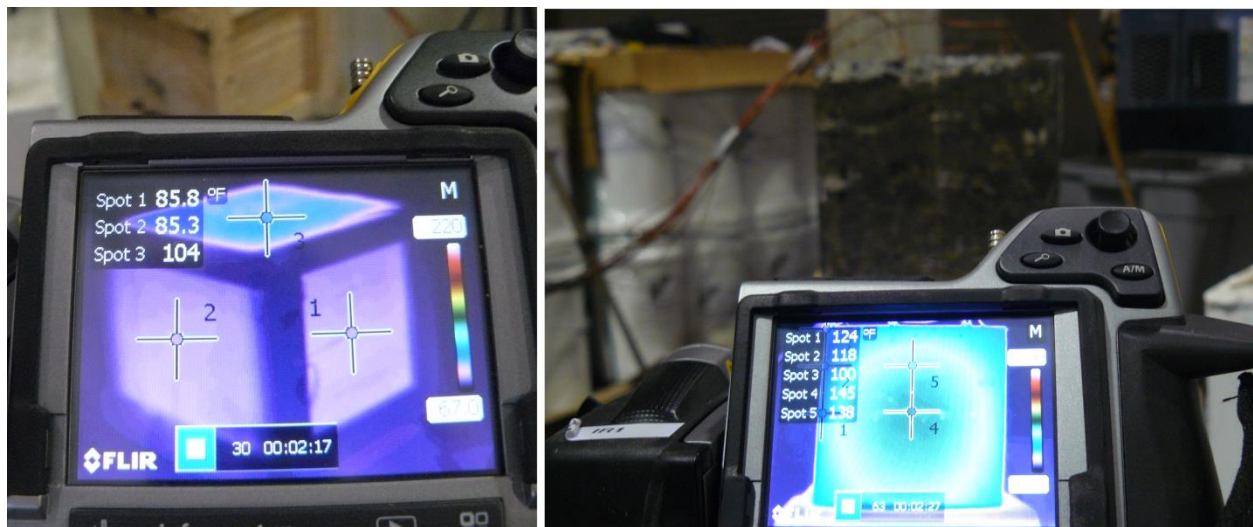
The epoxy grout emissivity value was obtained through the calibration of the thermography image to match the corresponding temperature resulting from temperature sensors. This value was assumed constant throughout the entire experiment, with the value of 0.90, which lies within the usual range considered for concrete. The cameras were set to monitor the temperature from 67 F, almost ambient temperature, to 220 F, somewhat higher than expected surface temperature. The camera has the capability to set up to 5 spotmeters (Figure A-16).

Figure A-16: Three spot-meters set for Camera 2 (left), and five spot-meters for Camera 1 (right)

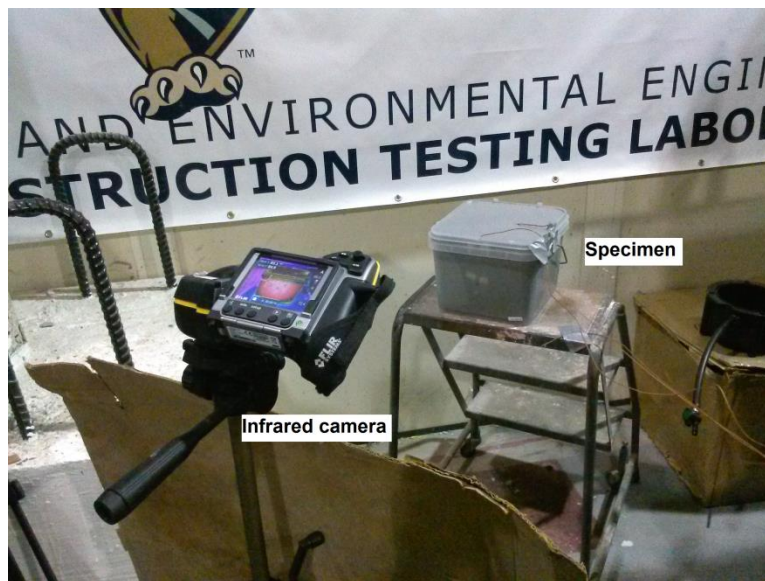
Figure A-29: Location of camera and specimen

In this test, a thin plastic form was used, with dimensions 8.5 in x 8.5 in x 6.75 in. Two thermocouples type K were embedded, one at the center of the specimen, and one at the center of the lateral surface. Camera locations and specimen are shown in Figure A-30.
