SUSCEPTIBILITY OF BRIDGE STEEL AND CONCRETE COMPONENTS TO
MICROBIOLOGICAL INFLUENCED CORROSION (MIC) AND MICROBIOLOGICAL
INFLUENCED DETERIORATION (MID) IN FLORIDA

FINAL REPORT
Project BDV29-977-26
(800006816)

May 2019

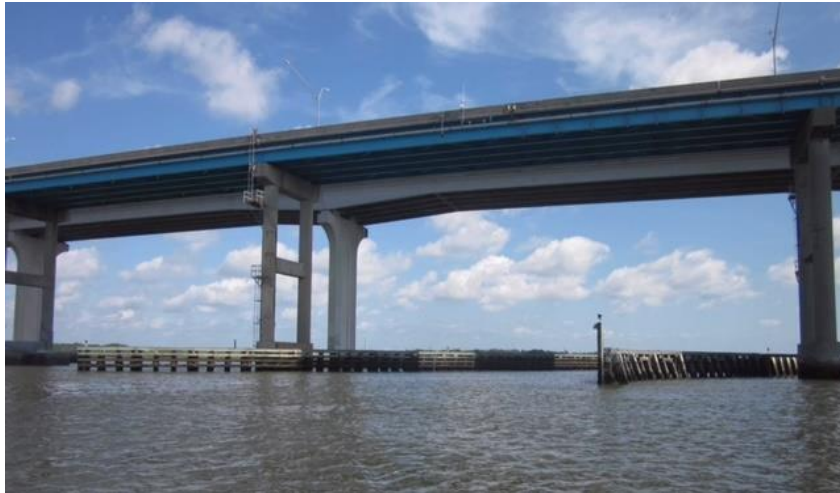
Figure 1.1. Picture of a Florida bridge over Matanzas River with Corrosion of Steel Piles.

Recent findings at a Florida bridge (Figure 1.1) showed that submerged steel piles had severe corrosion. Localized corrosion cells/pits were of up to 3" in diameter and penetrated through the steel thickness (Figure 1.2). Sampling and testing of water associated with the anomalous corrosion observations indicated strong presence of microbial growth that can be associated with microbiologically influenced corrosion (MIC). In particular, anaerobic sulfate reducing bacteria (SRB), acid producing bacteria (APB), and slime producing bacteria (SPB) were recovered in cultures produced from the steel and water samples. The water samples also showed high sulfate and chloride levels.

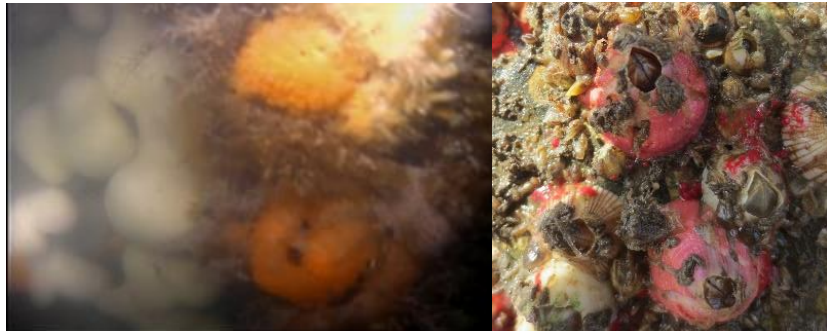
Figure 1.3. Picture of Heavy Marine Biofouling.

In addition to the microorganisms that can cause corrosion, the affected site also had heavy marine growth (Figure 1.3). Although the role of the macrofoulers on the corrosion of the steel piles was not clear, the macrofoulers may have been associated with the corrosion development. It was thought that the effect of localized crevice environments created by the presence of the macrofoulers may support MIC.

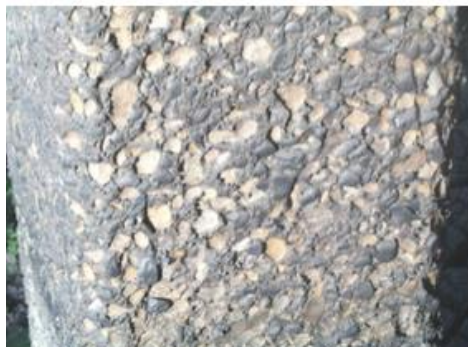
Figure 2.2. Microbial-induced Bio-deterioration of Concrete. (Trejo et al., 2008).

In 2014, the US Army Corps of Engineer reported that deterioration of the cement pastes and coarse aggregate in a south Florida reinforced concrete navigation structure was not due to sulfate attack, acid attack, or Cl^- induced corrosion of reinforcing steel (Moser et al., 2014). The concrete distress was thought to be caused by dissolution of soluble phases and bio-deterioration which can result in localized acidification at the surface and direct or chemical consumption of mineral phases present in concrete. Negligible concentrations of SO_4^{2-} and Cl^- was identified in the water and the pH was near neutral. XRF and petrographic analysis of extracted concrete cores showed minor carbonation and leaching of soluble phases from the surface of the concrete but no evidence of deterioration resulting from sulfate attack. SEM shows significant loss of limestone, while the siliceous, fine aggregates were unaffected.

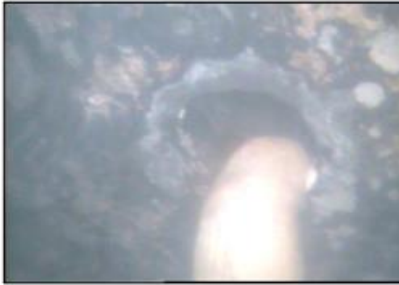
Figure 3.2. Underwater Image of a Hole on a Steel Pile due to Corrosion. Photo courtesy of FDOT.

The locations with suspected MIC often had heavy marine growth. An example of a corrosion hole in a steel pile suspected to be due to MIC is shown in Figure 3.2. Figure 3.3 shows the cumulative fraction of reported H-pile corrosion deficiencies for the bridge. The depths of corrosion pitting, or holes ranged from ~1 to 30 ft below the pile cap. The median value of the depths where corrosion deficiencies were observed was 2.5 ft indicating that a large fraction of the deficiencies occurred close to the water surface. Most of the corrosion pits were 1/8 inch in diameter but pits up to 1/2 inch were recorded and corrosion holes were as large as 3 inch in diameter.

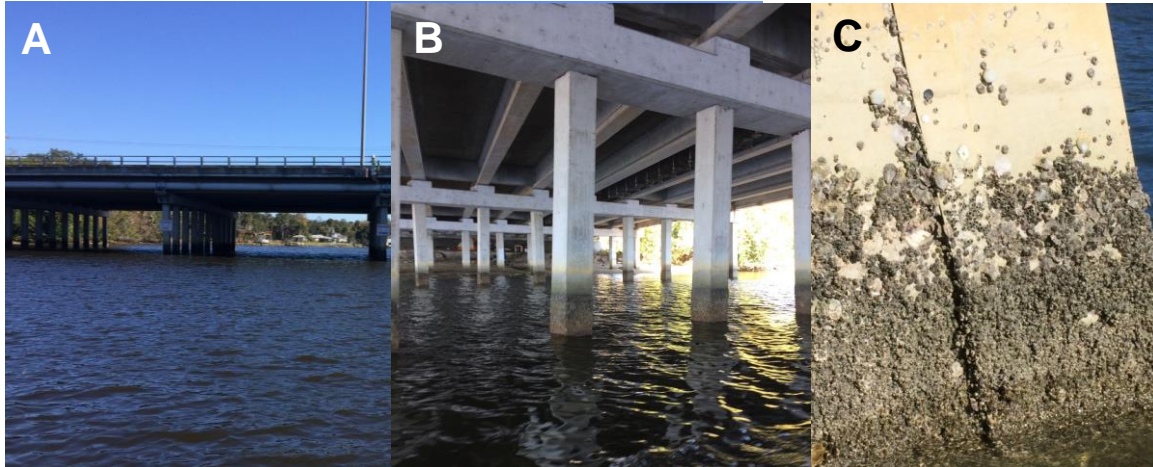
Figure 3.19. Images of US-301 Bridge over Alafia River (Site 4).

US-301 Bridge over Alafia River was surveyed on January 9th, 2017. The test site location was approximately 8 miles upstream from the US-41 Bridge. It has concrete piles, as depicted in Figure 3.19.

A. Bridge view. B. View of the concrete piles. C. Concrete piles with attached macrofoulers.

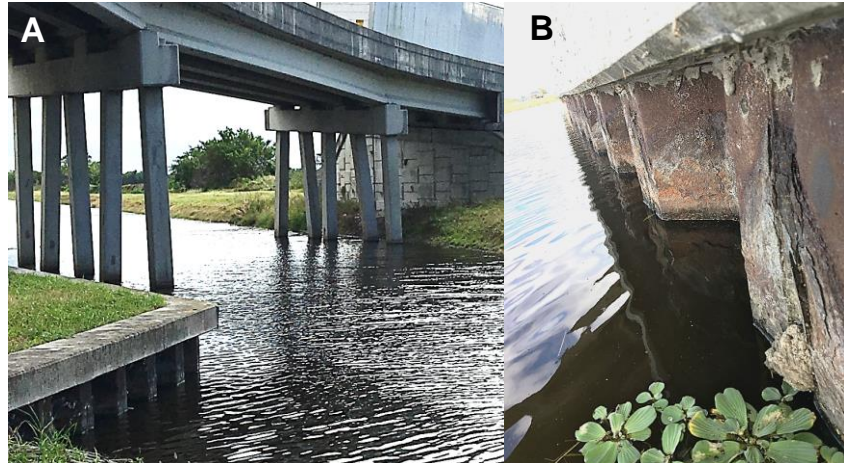
Figure 3.25. Images of Turnpike/Boynton Beach Site (west side) (Site 5).
A. View of the site. B. View of corroded steel piles.

Visual analysis of the steel piles show corrosion deterioration with loss of material, as can be seen in Figure 3.25B. It is depicted the absence of marine growth attached to the steel surface.

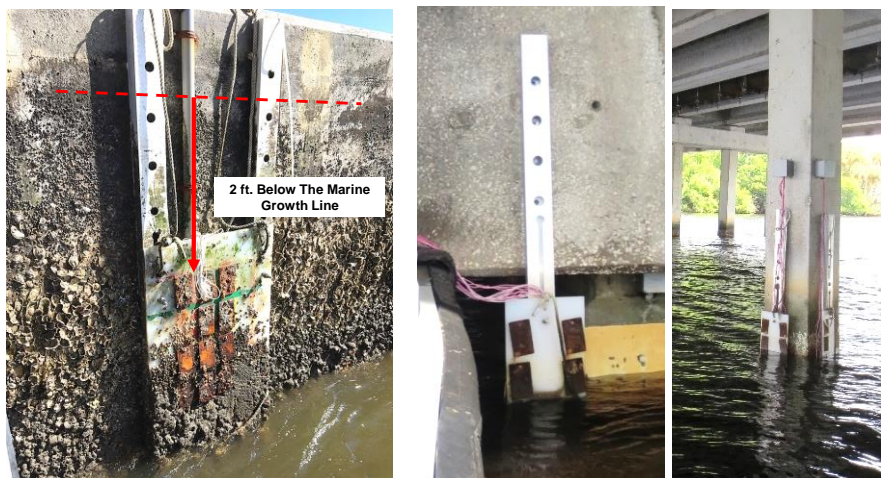
Figure 4.1. Typical Outdoor Exposure Test Rack at Three Sites.

Figure 4.1 shows an example test rack with marine growth. Sample placement was measured relative to the marine growth line, identified as distance below the marine growth line (BMG). The position of the test racks of each test site relative to the water surface varied due to the variation in the geometry of the test site bridge substructure where the test racks were installed as well as due to variation in tidal levels.

Generally, the test sites had some samples exposed in atmospheric conditions but were subjected to spray and tidal action as well as samples permanently submerged in water. Table 4.2 shows the depth locations of test sample and test condition at each test site. At site I, barnacles were predominant in the tidal region. Hydroids and marine flora amassed below low tide levels. At the site II and III, barnacles were the predominant macrofouler down to the depth of the test frame. The barnacles were more prolific at the Site II.

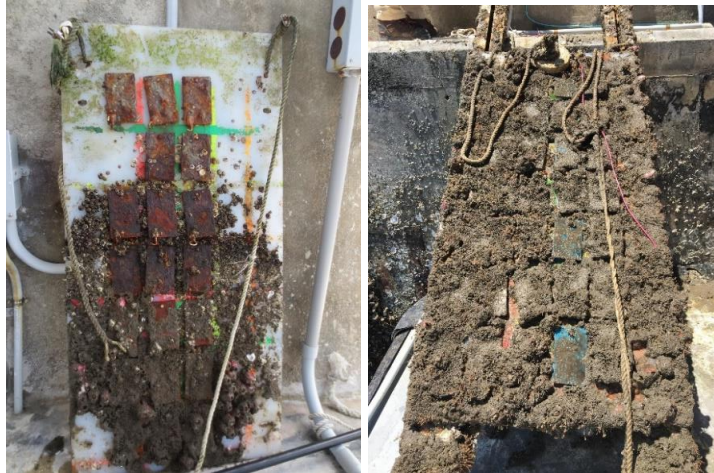
Figure 4.2. Example of Marine Fouling on Outdoor Test Racks.

Heavy fouling occurred during the 281 days of exposure (Figure 4.2). The general fouling organism of SR-312 (Matanzas River) were hydroids, bryozoans, barnacles, and oysters. During the period of exposure, fouling organisms consisted mostly of clustered acorn barnacles at 3-4 ft below marine growth (BMG) and soft marine masses (hydroids) at 4-8ft BMG along with isolated acorn barnacles at deeper depths. The species of the acorn barnacle at the intertidal zone can be recognized as *Amphibalanus Amphitrite* (diameters less <10 mm) and *Megabalanus coccopoma* in the immersion zone (diameters > 10 mm diameter) at immersion zone. Both species are common coastal and estuarine organisms. Settlement of fouling organisms on steel substrates typically included initial bacteria biofilm formation, preferential settlement of diatoms, colonization of bryozoans, and growth of barnacles and oysters. Figure 4.5 shows exposed samples before and after cleaning with three surface conditions at various depth (2-8ft BMG).

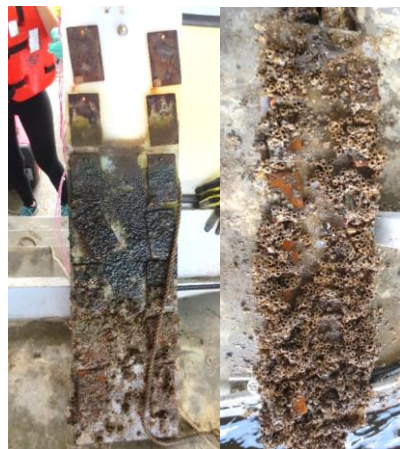
Figure 4.3. Example of Marine Fouling on Outdoor Test Racks.

Steel coupons were exposed for 248 days at US-41 which resulted in a very dense coverage of macrofouling organism (Figure 4.3), primarily bay barnacles, *Amphibalanus improvisus*, occurring in the brackish water environment at the mouth of the Alafia River emptying into the Gulf of Mexico. Barnacle diameters ranged from 5 to 16 mm. Clustered and interlayered populations of barnacles were observed from 2-5.5 ft. BMG. One sample in each surface condition was placed at 0.5 ft above the marine growth line (and as expected no marine fouling occurred there). Samples at 0.5 to 1 ft BMG developed a thick iron oxide layer even after hand cleaning. Fouling and oxide layers could be easily hand cleaned on samples from 2 to 5.5 ft BMG and revealed non-uniform sinuous texture. It was observed that the attachment of macrofouler on samples with 60 and 400 grit surface roughness were not as strong as samples in the as-received condition. Figure 4.6 shows exposed samples before and after cleaning with three surface conditions at various depth (-0.5-5.5ft BMG).

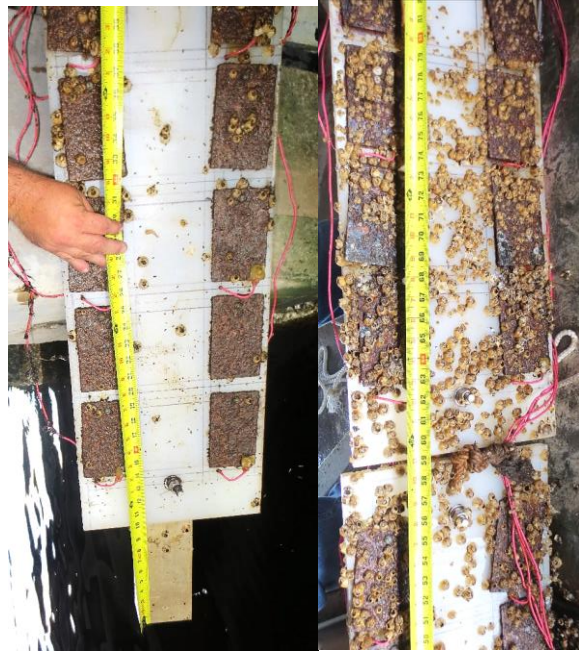
Figure 4.4. Example of Marine Fouling on Outdoor Test Racks.

Steel coupons were exposed in Alafia River at US-301 for 168 days (Figure 4.4). Similar fouling organisms as the US-41 site were observed but the barnacle population was significantly lower due to the lower salinity and nutrient levels upstream. The barnacles were clustered at 2-4.5 ft BMG but in less dense communities as compared to the US-41 site. Barnacle diameters were from 5 to 15 mm. Samples at 0.5 to 2ft BMG (intertidal zone) had thick outer oxide film with rough surface after cleaning. Figure 4.7 shows exposed samples before and after cleaning with three surface conditions at various depth (0.5-6ft BMG).

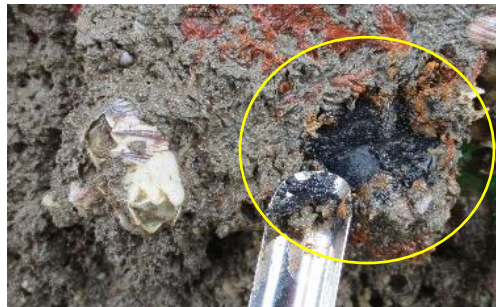
Figure 4.8. Example of Under Fouling Surface Condition.

Anaerobic environments can be created beneath the fouling organisms (such as barnacles) which can host sulfate reducing bacteria. MIC due to SRB typically develop surface biofilm and black deposits of iron corrosion products such as iron sulfide (Figure 4.8). In addition to SRB, three other types of corrosion related bacteria (IRB, APB and SFB) was measured under fouling surfaces for selected samples. Marine growth was removed, and ~1 in² of steel samples was swabbed. That swabbed material (often surface films) was suspended in deionized water in a sterile container. That solution was then tested with a BART test kit. This test was done during the interim testing and the final day for each site exposure. All results showed some level of bacteria development. The results of the final test (and maximum values from interim testing) are reported here (Table 4.3 and 4.4). All three site had high population of IRB, APB and SFB indicating aggressive condition. SR-312 and US-41 had highest population of SRB comparing to US-310 which has much less SRB presence. SR-312 and US-41 also had dense coverage of macrofoulers such as barnacle and soft marine massed.

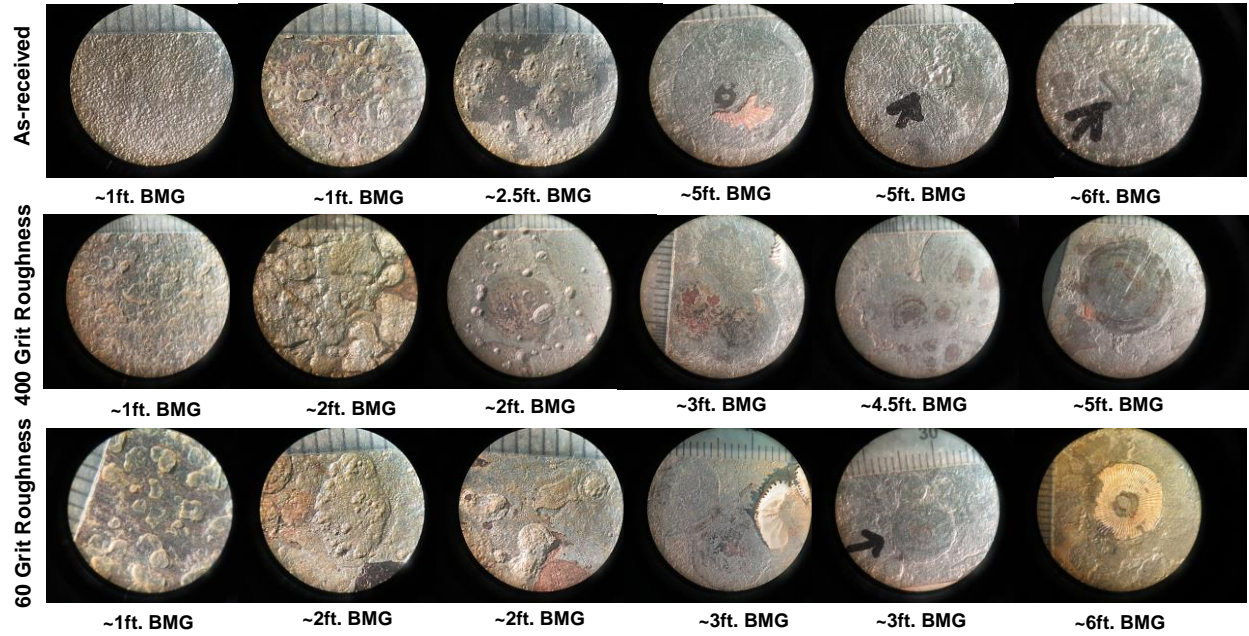
Figure 4.12. Magnified View of Surfaces of Samples from US-301 Site. Arrows highlight notable features such as pitting, surface corrosion, remnant barnacle location. Rule at 1 mm intervals.

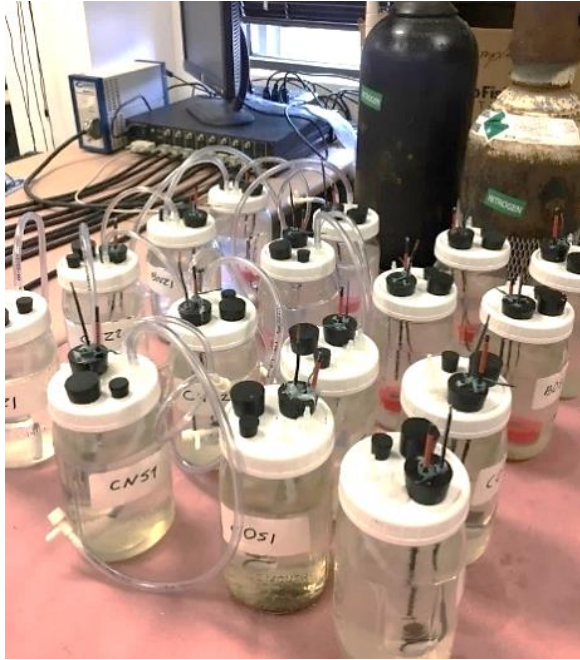
Figure 5.2. Test Setup A Test Cells.

Test cells as shown in figure 5.2 were filled with 600 mL of deionized water and 10 mL of modified postage B medium solution (Postgate, 1984). The growth media was chosen based on NACE standard TM0194-2014. The composition of the medium is presented in Table 5.1. In order to investigate the effect of nutrient concentration, sodium sulfate was added to the solution

as part of one test condition according to the maximum level of sulfate ion concentration in the Matanzas river (2,000 ppm). Test conditions are summarized in Table 5.2.

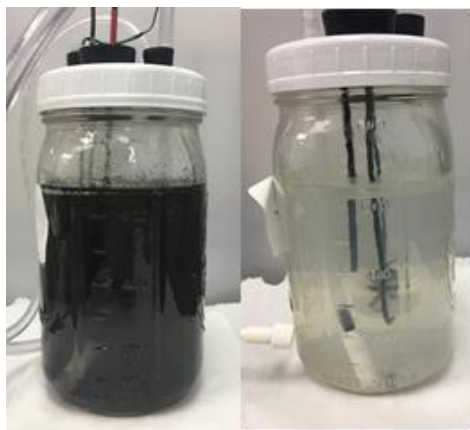
Sulfide levels were measured on select days after SRB inoculation for CTRL and SULF1/SULF2 samples as shown in Table 5.4. As an example, shown in Figure 5.5, SRB proliferation in the inoculated test solution was evident by precipitation of black iron sulfide in the test solution. Measured sulfide levels are shown in Table 5.4. As expected, some level of iron sulfide precipitation was seen in all inoculated de-aerated CTRL solutions including in crevice conditions (as evident by the higher measured sulfide content consistent with the opaqueness of the test solution). In the comparative naturally aerated open (non-crevice solution), sulfide levels were generally lower. Also, in contrast to the de-aerated condition, sulfide production levels appeared to drop after inoculation events possibly indicating less favorable environments for continued SRB activity despite the new introduction of additional bacteria and nutrients. Similarly, the crevice environments in the naturally aerated conditions did not appear to support prolonged SRB activity after inoculation events.

Figure 5.5. Visual Indication of Iron Sulfide Precipitation in Test Solution.
Left- Inoculation with SRB. Right- control case

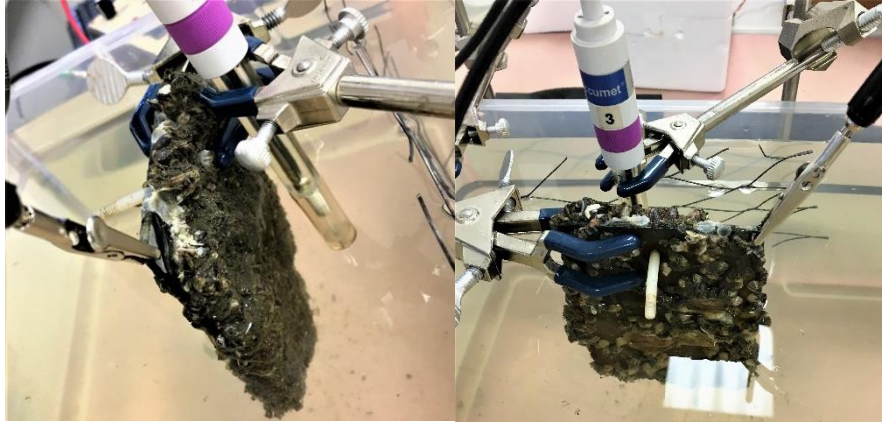
Figure 6.2. Example of Laboratory Electrochemical Test Setup.

. Figure 6.2 presents pictures of the test setup used in the laboratory. Corrosion evaluation consisted of measurements of the open circuit potential (OCP), linear polarization resistance (LPR), and electrochemical impedance spectroscopy (EIS). A saturated calomel electrode (SCE) was used as the reference electrode for all tests. An activated titanium mesh was used as the counter electrode. The scanned potentials for the LPR testing were made from the open-circuit potential and cathodically polarized 25 mV at a scan rate of 0.05 mV/s. The corrosion current was calculated from the polarization resistance, R_p , following the equation $i_{corr} = B/(R_p)$ where B was assumed to be 26 mV and A was the nominal surface area of steel coupon immersed in the solution. EIS testing was conducted at the OCP condition with 10 mV AC perturbation voltage from frequencies $1\text{MHz} > f > 1\text{Hz}$.

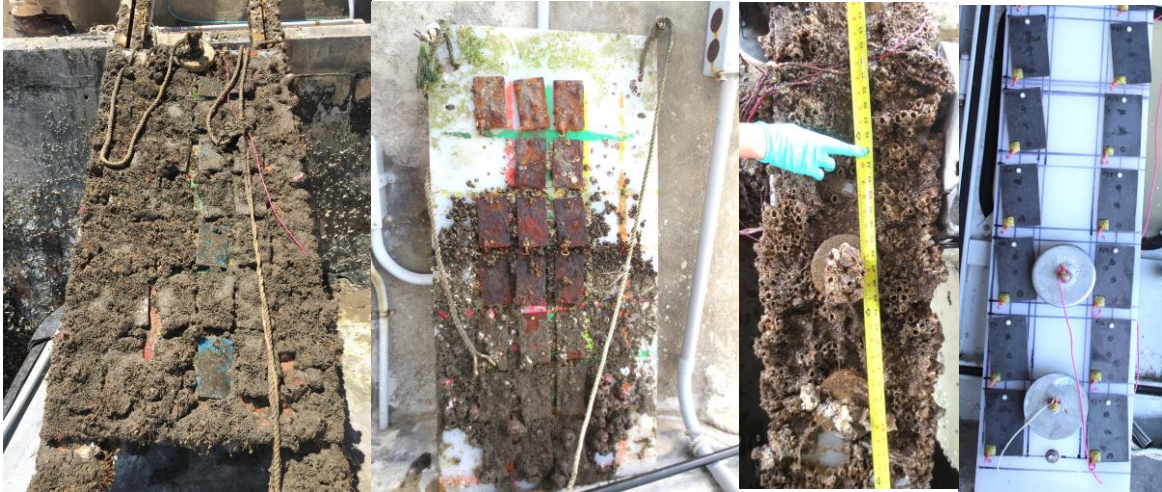
Figure 7.1. Typical Outdoor Exposure Test Rack.

At Site I (Matanzas River), hydroids and marine flora amassed with sporadic growth of barnacles at test depths. At Site II (Alafia River), barnacles were the predominant macrofoulers at test depths. Figure 7.1 shows representative marine growth. All test samples were fully immersed, and Table 7.2 lists the exposure depth for each test sample.

At both test sites, a set of steel coupons (Group A) were electrically coupled to a commercial bulk zinc anode (composition of 0.1-0.5% Al, 0.02-0.07% Cd, 0.005% Fe, 0.006% Pb, 0.005% Cu, and balance Zn) with 18-gauge marine-grade shielded copper wires for ~200-250 days. A second zinc anode was installed to monitor the free zinc anode potential. The electrical connections were encapsulated with epoxy to prevent moisture intrusion. The copper wires were terminated at a control box with an electrical switch to accommodate current measurements between the steel samples and the zinc anode. For Site I, the steel coupons were corroded at the open-circuit potential (OCP) condition prior to coupling of the steel samples to the zinc anode. There, the zinc anode was installed and coupled to the steel coupons 88 days after initial sample installation. In Site II, the zinc anode was installed together with the steel coupons but due to a possible bad electrical contact to the initial zinc anode, reconnection to an auxiliary zinc anode was made at day 80. A complementary set of steel coupons (Group B) were maintained at OCP throughout the exposure test period.

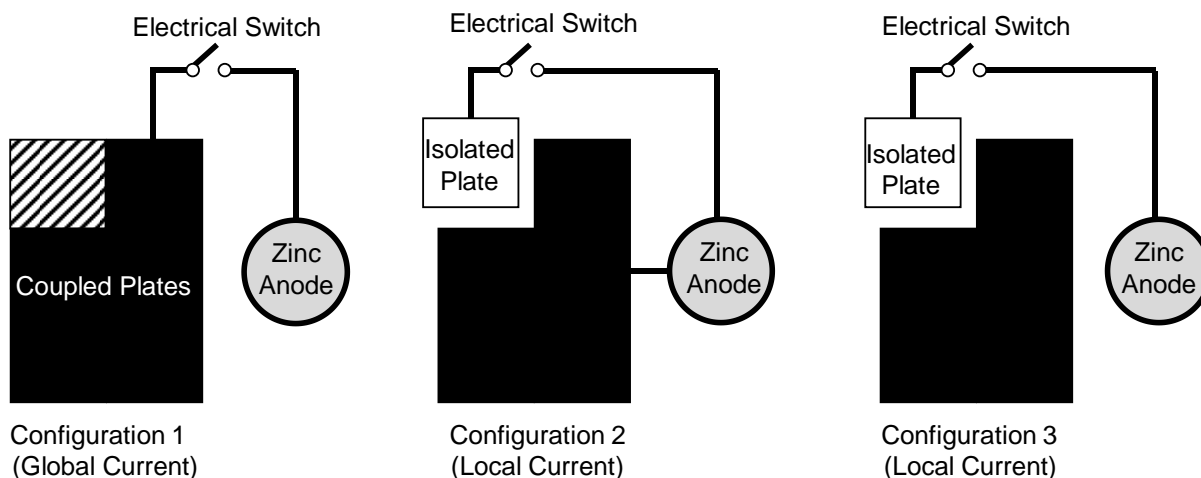
Figure 7.2. Different Test Configurations of Coupled Steel Coupons and Zinc Anodes.

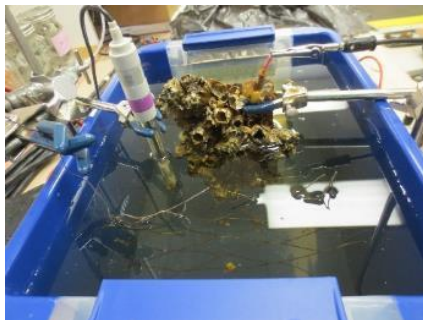
Figure 7.3. Example of Laboratory Electrochemical Test Setup.

The test samples were removed from the test rack and stored in sealed containers containing river water for transport back to the laboratory. In the laboratory, individual coupons were immersed in collected river water only immersing 3.5 inch of the coupon in solution. The immersed surface area was ~52 in². Additional electrochemical tests were made in the laboratory (Figure 7.3). Corrosion testing consisted of measurements of the open circuit potential (OCP), linear polarization resistance (LPR), and electrochemical impedance spectroscopy (EIS). A saturated calomel electrode (SCE) was used as a reference electrode for all tests. An activated titanium mesh was used as the counter electrode. The scanned potentials for the LPR testing was made from the open-circuit potential and cathodically polarized 25 mV at a scan rate of 0.1 mV/s. The corrosion current density was calculated from the polarization

resistance, R_p , following the equation $i_{corr} = B / (R_p \times A)$ where B was assumed to be 26 mV and A was the nominal surface area of steel coupon immersed in the solution.

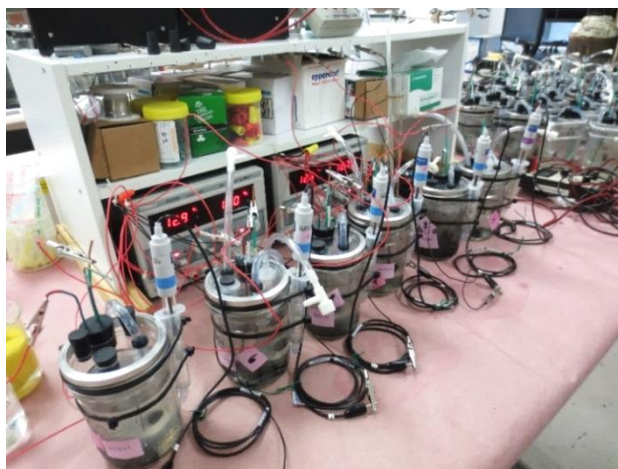
Figure 7.5. Test Setup B Test Cells.

Cathodic potentiostatic polarization tests (at -850 and -950 mV_{SCE}) were for up to 7 days. Supplemental testing at -500 mV_{SCE} was also made as comparative testing with anodic polarization. Experimental parameters for the test setup are shown in Table 7.3. For the working electrode, a copper electrical wire was soldered to an auxiliary steel screw attached to the steel sample. The exposed electrode surface was wet-ground to uniform P2000 grit (10 μ) finish. Crevice environments were also introduced. Testing included both representations of physical hard and porous crevice conditions characteristic of hard-shell barnacles and soft marine flora and fauna. Hard crevices with a controlled height (3 mils), radial depth (7/32 inch) and opening (1/16-inch diameter) was made by using plastic film of known thickness. The plastic shims were affixed on the surface of the mounted samples as shown in Figure 7.4. Soft crevice conditions were replicated by placing a porous sponge on the working electrode surface. Activated titanium mesh and saturated calomel (SCE) electrodes were used as reference electrodes. Another activated titanium mesh was used as counter electrodes. All test cells and equipment were cleaned with ethanol. Test cells were filled with 300 mL deionized water and 20mL of modified Postgate B medium solution (Postgate,1984). A picture of test cells for test setup is shown in Figure 7.5.
