Final Report

Contract No. BDV29-977-33

Effectiveness of Stationary Police Vehicles with Blue Lights in Freeway Work Zones

March 2018

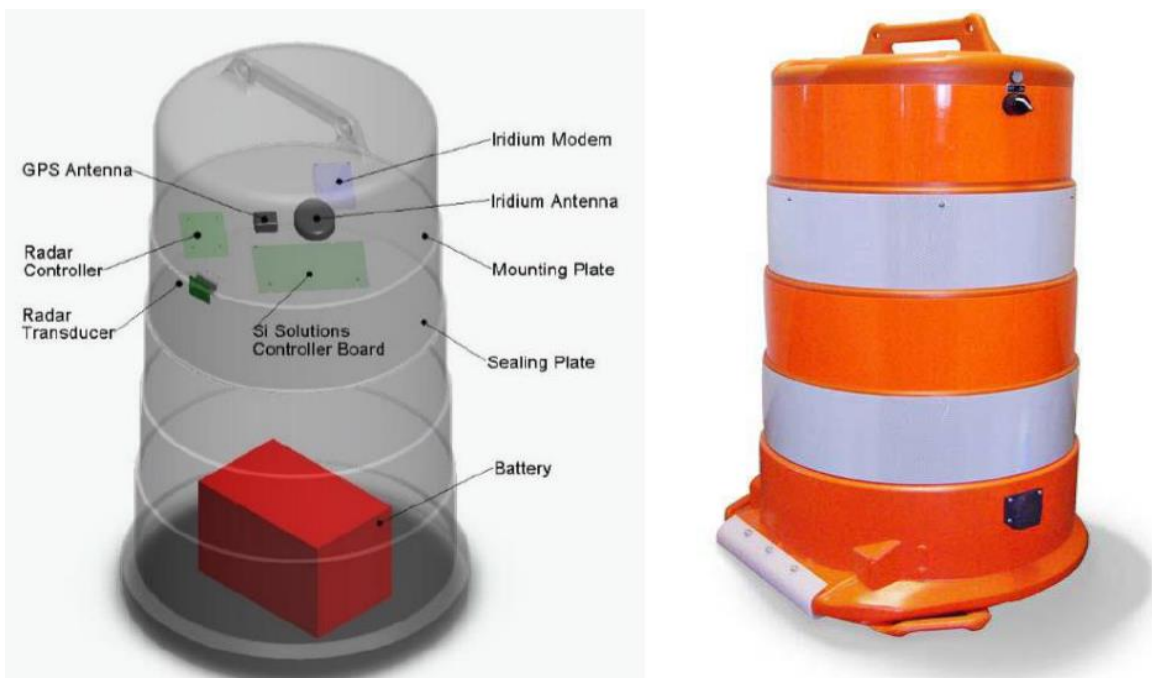
Figure 2-1. iCone Components

As the use of iCones was new to the research team, the team members spent extra time to fully investigate and become familiar with the system, including both the physical iCone units and the iCone online monitoring website. The research team continued to work with the iCone technical support to determine the desired iCone system settings for this project and to test the units to verify if the units produced and delivered the accurate and desired data.

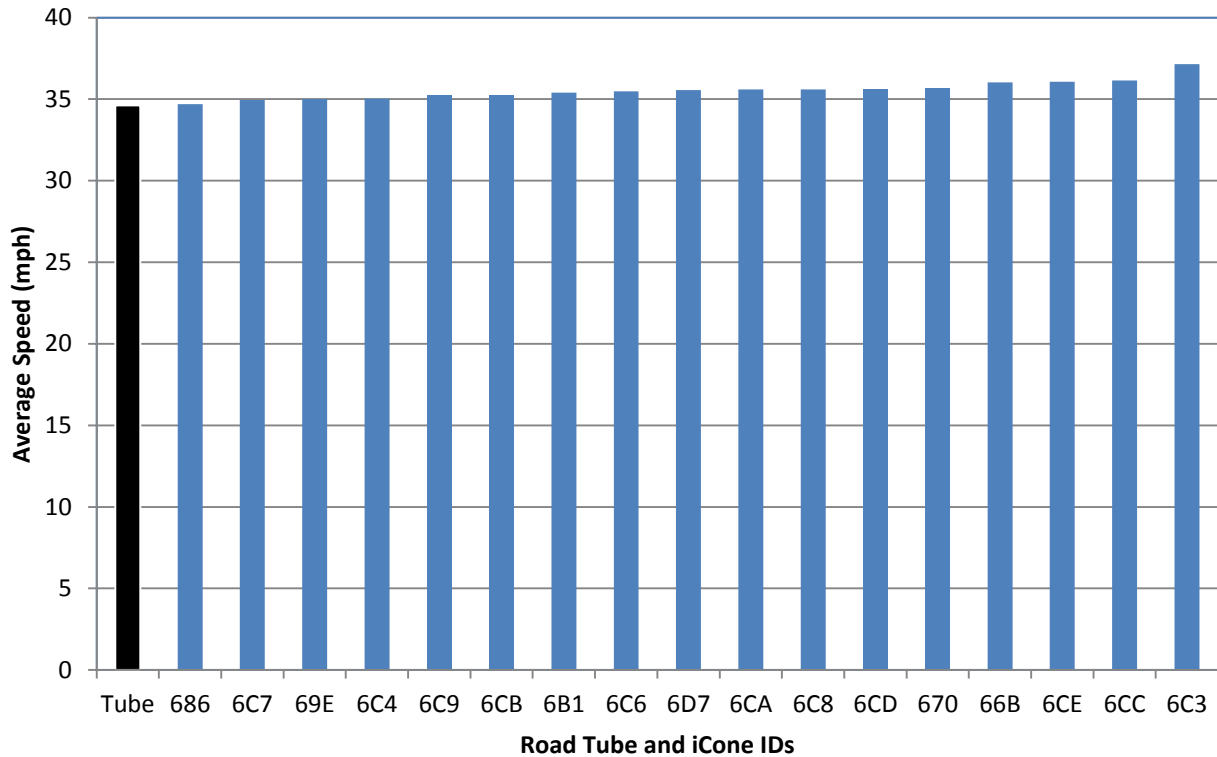
Figure 2-4. Overall Average Speeds from Road Tubes and iCones

It can be seen from Table 2-1 that the iCones detected only a fraction of the 4,050 vehicles detected by the road tubes. As a radar-based detector, iCone is designed to take a radar sweep every x number of seconds. The iCones in this test were set to a sweep rate of 2.5 seconds, with no delay between sweeps. According to the iCone manufacturer, iCones tend to pick up the vehicle with a higher speed when there are multiple vehicles. This may explain the consistently higher average speeds from the iCones vs. the road tubes.

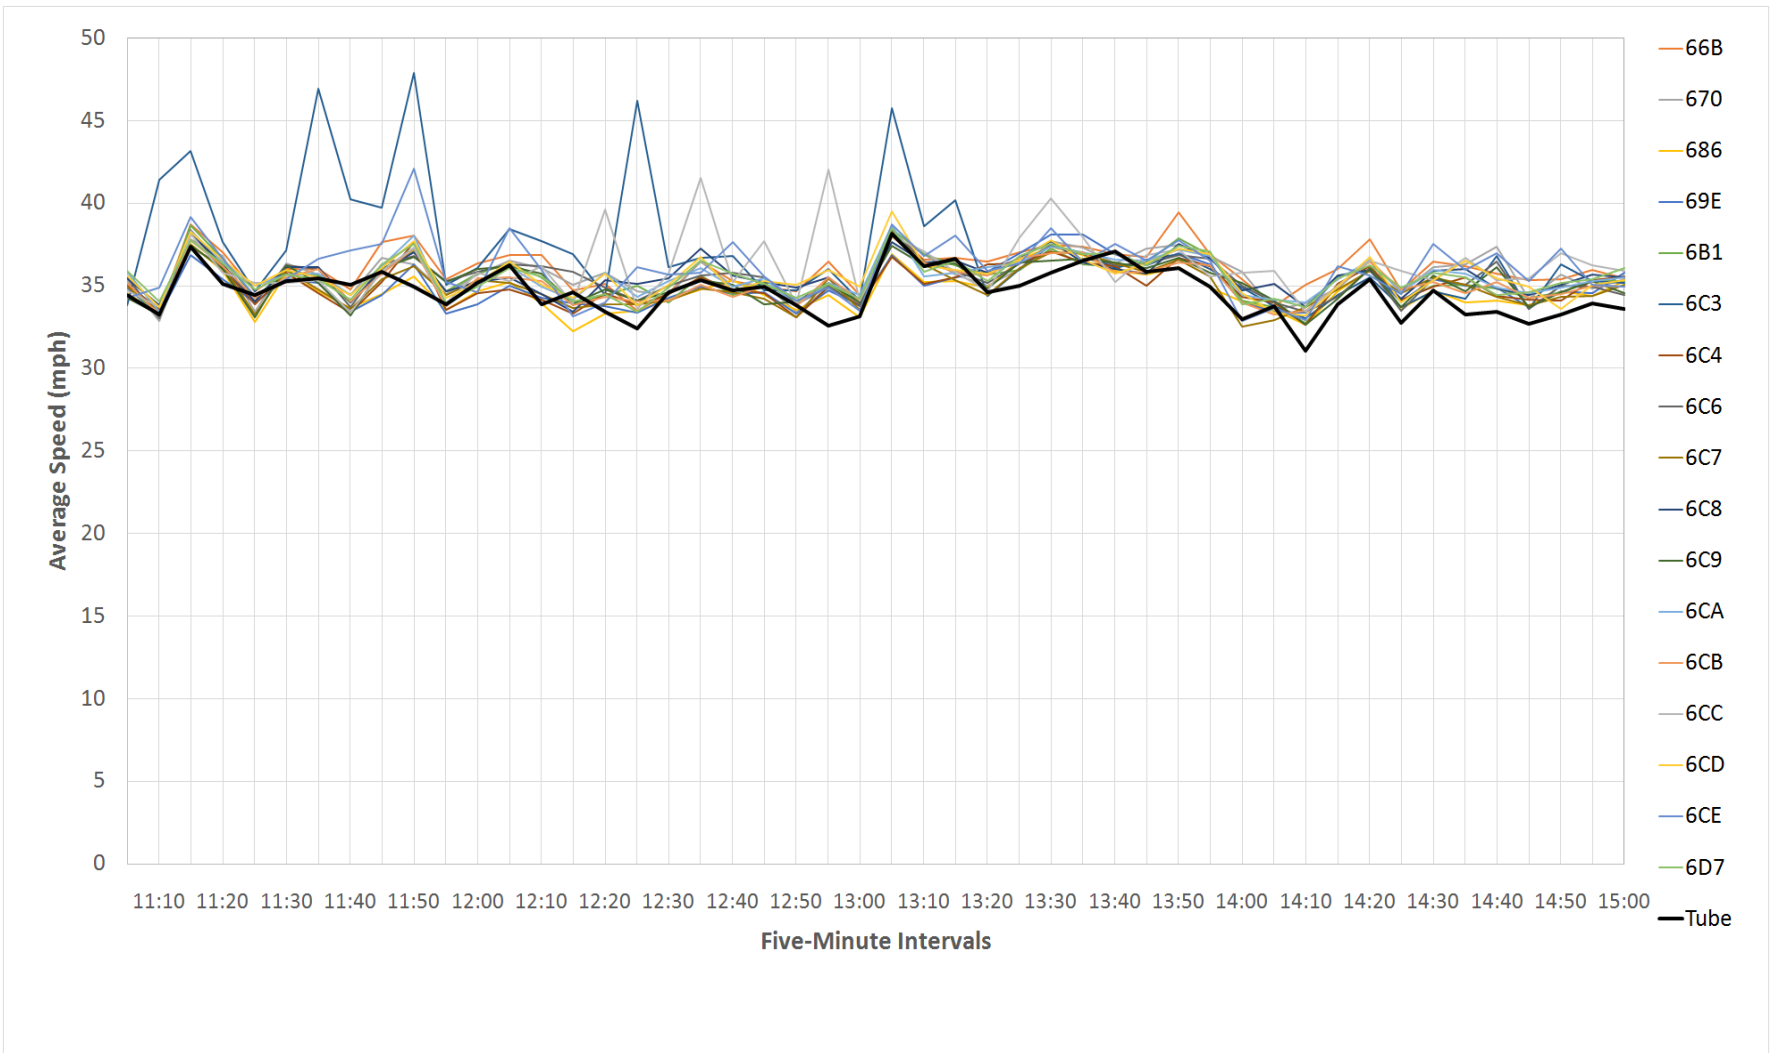
Figure 2-5 shows the five-minute average speed trends for the iCones. Overall, the average speed trends for the iCones follow that of the road tubes. The data for this figure are given in Table 2-2.

Figure 2-5. Five-Minute Average Speeds from iCones and Road Tubes

Overall, the test results show that the average speeds estimated by iCones are comparable to those of pneumatic road tubes, and are sufficiently accurate and consistent (among iCones) for the application in this project, i.e., to estimate the speed differentials along a work zone.

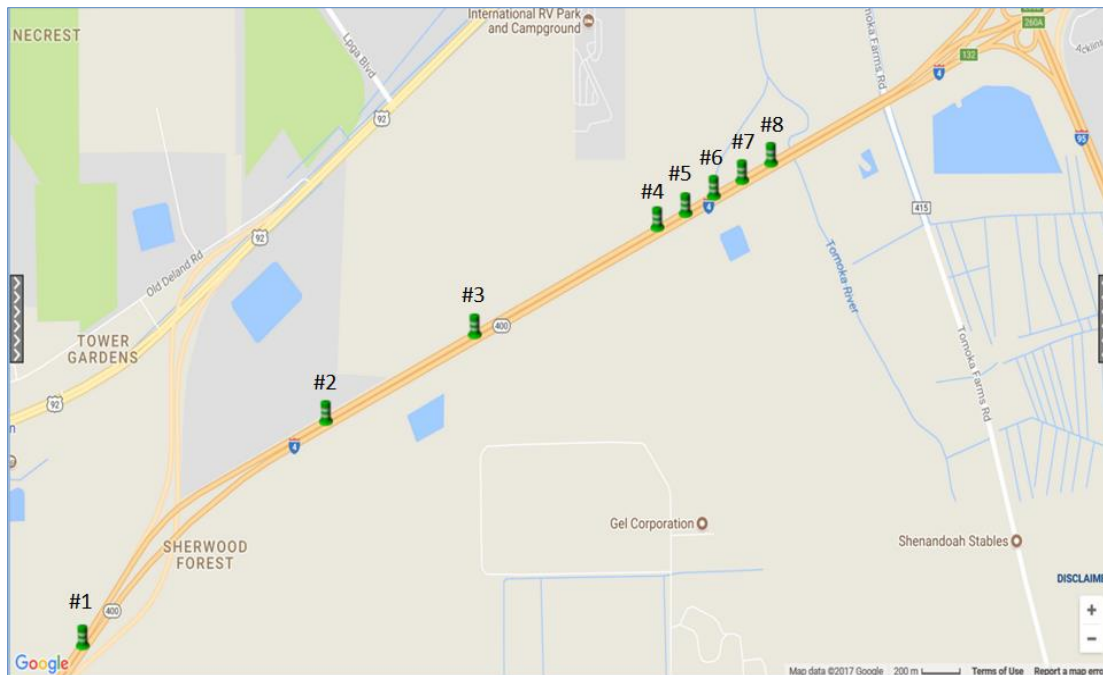
The setup for data collection involved mainly the placement of data collection equipment, which included: (1) eight iCones that were used to collect spot speeds at multiple locations along the study corridor, and (2) two video cameras that were used to record videos at two locations within the work zone. The videos were to be used for manual counting of the vehicles using each of the two open lanes in order to assess the impact of police vehicle with blue lights on vehicle lane use. Figure 3-5 shows the locations of the eight iCones that were used to collect speeds across the study area.

Figure 3-5. iCone Locations for Speed Data Collection

Among the eight iCones used, iCones #1 to #3 were located upstream of the work zone and iCones #4 to #8 were located within the work zone. More specifically:

- iCone #4 was located within the taper transition zone, which measured about 1,100 feet.
- iCone #5 was located at the beginning of the full lane closure.
- iCones #6 to #8 were additional iCones along the work zone.
- iCones #4 to #8 were spaced 500 feet from each other, for a total distance of about 0.5 miles. A larger spacing was not used as vehicles were observed to slow down as they got closer to the I-95 interchange area.

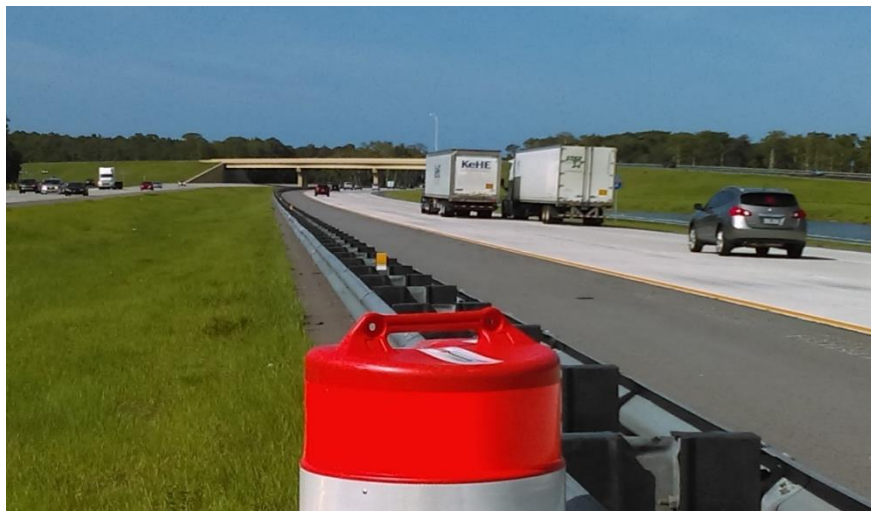
- iCone #1 was located before a horizontal curve (see Figure 3-6). At this location, drivers were not able to see the police vehicle with blue lights, ensuring that their speeds would not be affected by the police vehicle. As the horizontal curve was relatively straight, its impact on the vehicle speeds was expected to be negligible.

Figure 3-6. iCone #1 Located Ahead of the Curve (and Upstream of Work Zone)

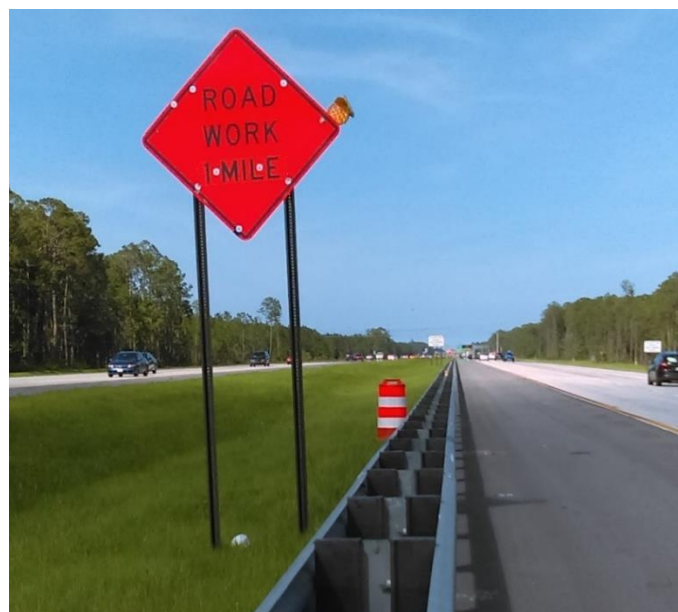
- iCone #2 was located at the “ROAD WORK 1 MILE” warning sign. At this location, drivers were able to see the police vehicle with blue lights relatively clearly (see Figure 3-7).

Figure 3-7. iCone #2 at “ROAD WORK 1 MILE” Sign

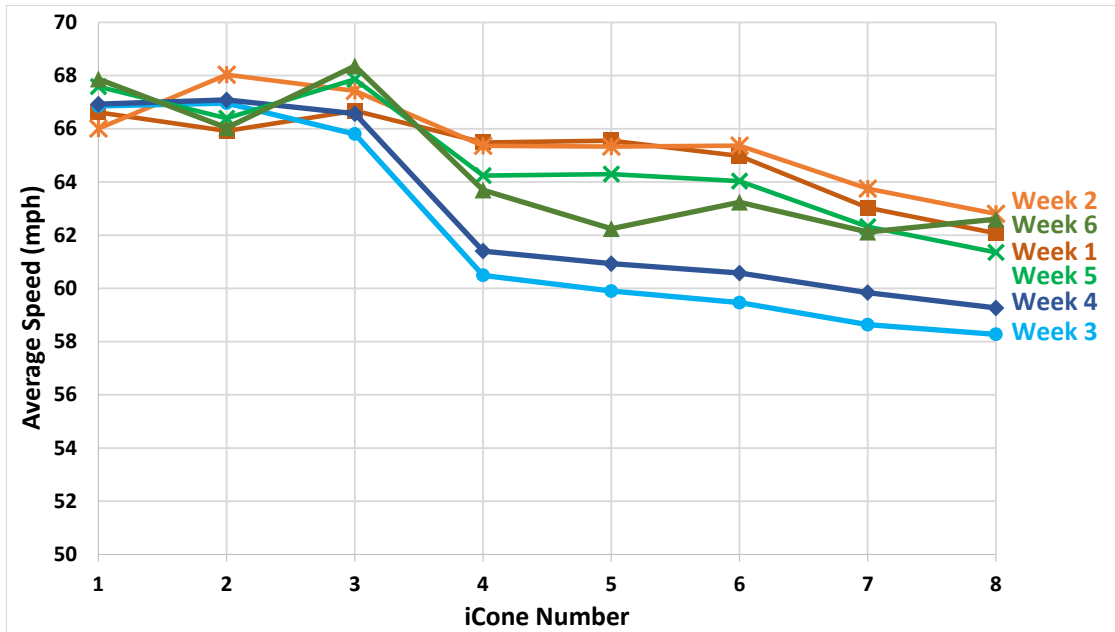
Figure 3-9. Average Speeds at iCone Locations by Week

It is observed that the overall average speeds are relatively low for the given speed limits (i.e., 70 mph before the work zone (iCones #1 to #3) and 65 mph within the work zone (iCones #4 to #8). Several factors could contribute to the lower average speeds, including but are not limited to:

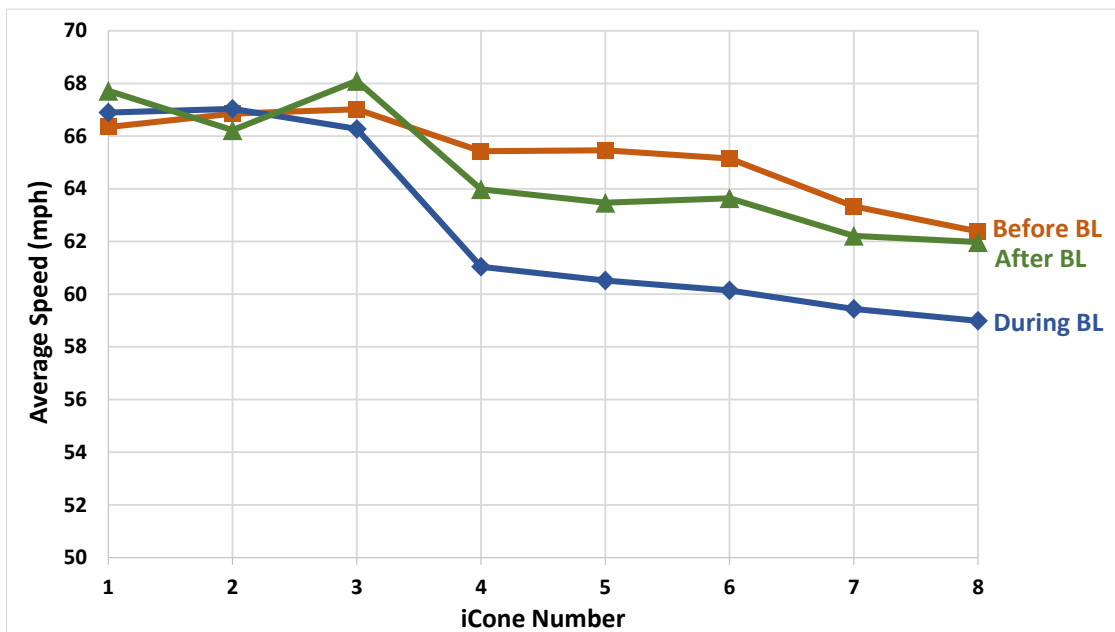
Figure 3-10. Average Speeds at iCone Locations by Evaluation Period

- Comparing the overall average speeds from the five iCones within the work zone before and during the FHP vehicle deployment, there was a net average speed reduction of **4.4 mph**, from 64.5 mph to 60.1 mph. Similarly, following the removal of the FHP vehicle with blue lights, there was a small net average speed reduction of **1.4 mph**, from 64.5 mph to 63.1 mph.

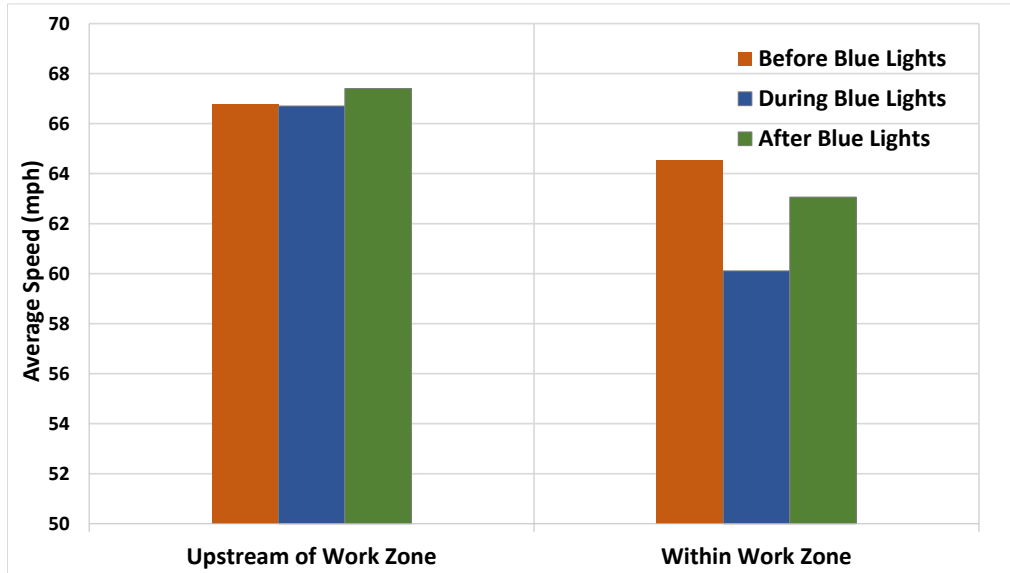
Figure 3-11 plots the overall average speeds for each evaluation period for iCones upstream of the work zone and iCones within the work zone.

Figure 3-11. Overall Average Speeds Upstream of and within Work Zone

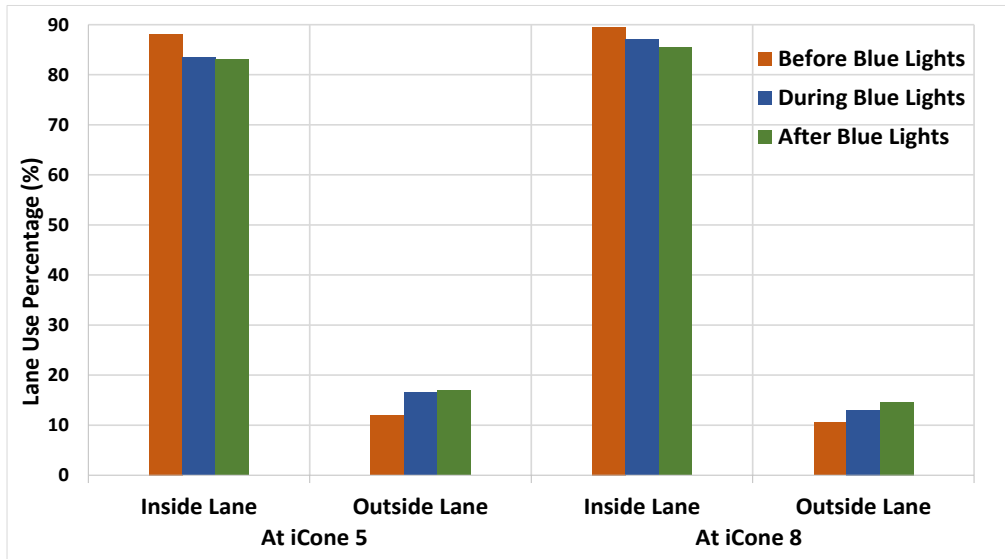
Figure 3-13. Lane Use Percentages before, during, and after Blue Light Deployment

As can be seen in Table 3-3, there was a small 4.5% shift in vehicles from the inside lane to the outside lane following the deployment of FHP vehicle. The shift percentage was reduced to 2.5% at iCone #8 (i.e., about 1,500 feet after passing the FHP vehicle), indicating that some vehicles shifted back to the inside lane after passing the FHP vehicle. Following the removal of the FHP vehicle, a slightly higher shift was observed at both iCone locations, which was somewhat unexpected. In any case, given the large number of pre-positioning vehicles, the study location is not ideal for assessing the impact of FHP vehicle with flashing lights on vehicle lane use.

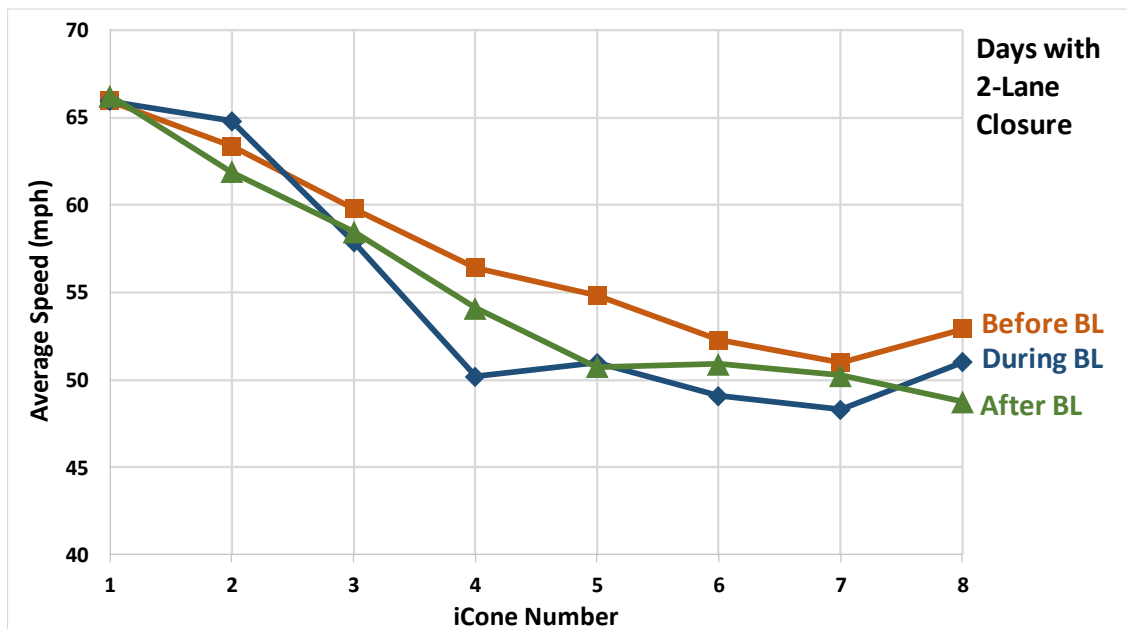
Figure 4-7. Average Speeds for Days with 2-Lane Closure

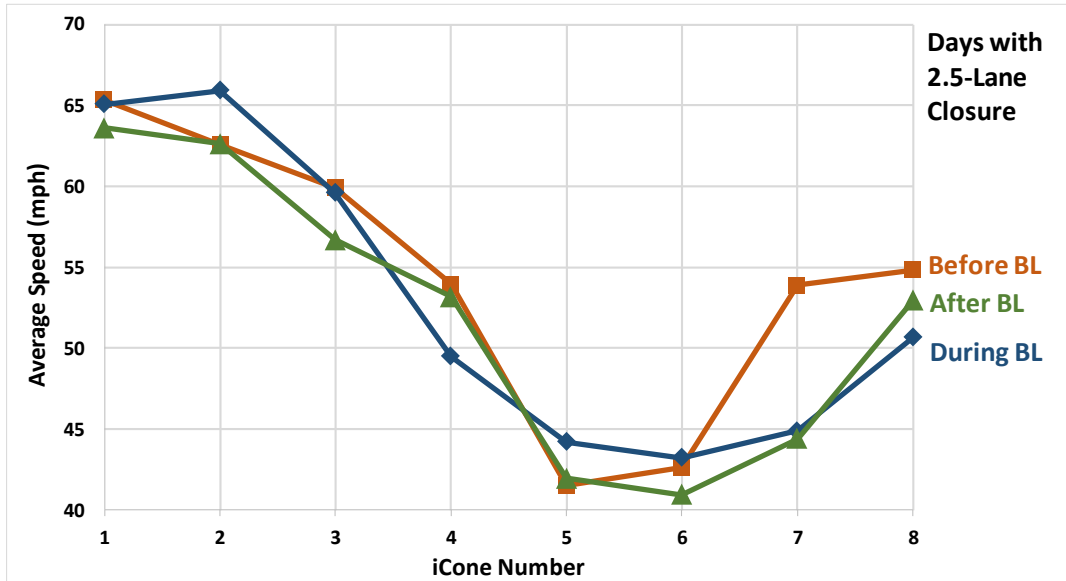
Figure 4-8 shows that, for the days with 2.5-lane closure, the average speeds dropped more drastically due to the extremely narrow travel space, with vehicles travelling partially on the right shoulder. However, the average speeds recovered as vehicles approached the end of work zone. It can also be seen that the presence of blue lights resulted in some speed reduction at iCone #4. It also contributed to more stable average speeds across the work zones.

Figure 4-8. Average Speeds for Days with 2.5-Lane Closure

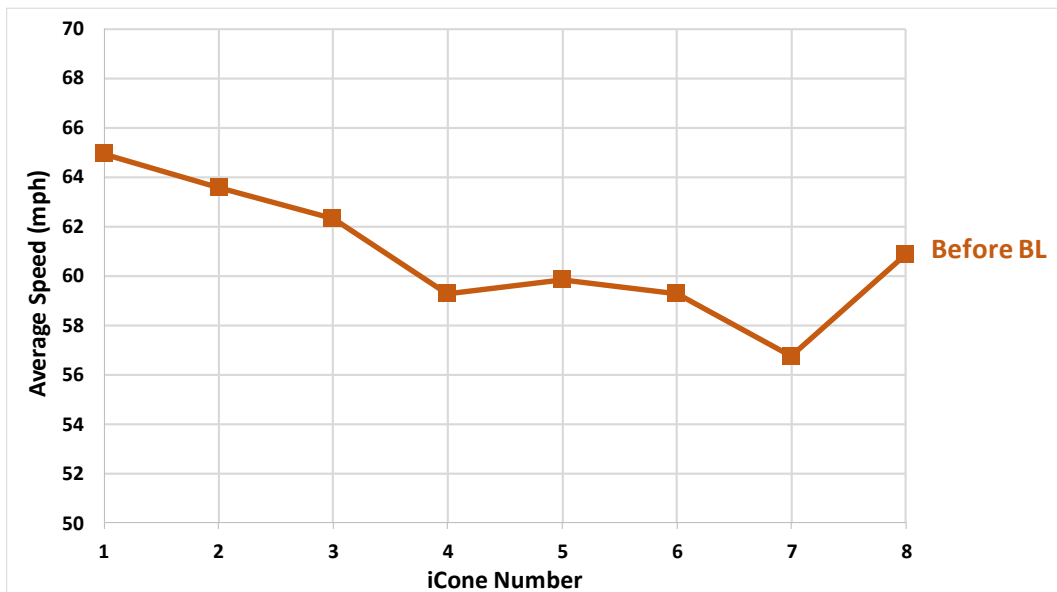
Figure 4-9 shows that the average speeds for the one day on October 4, 2017 when only one lane was closed and with no blue lights. It can be seen that the average speeds across the work zone with two lanes open were significantly higher than those with 2- or 2.5-lane closures, averaging at near 60 mph across the work zone, compared to near 50 mph when 2 or 2.5 lanes were closed.

Figure 4-9. Average Speeds for a Single Day with 1-Lane Closure

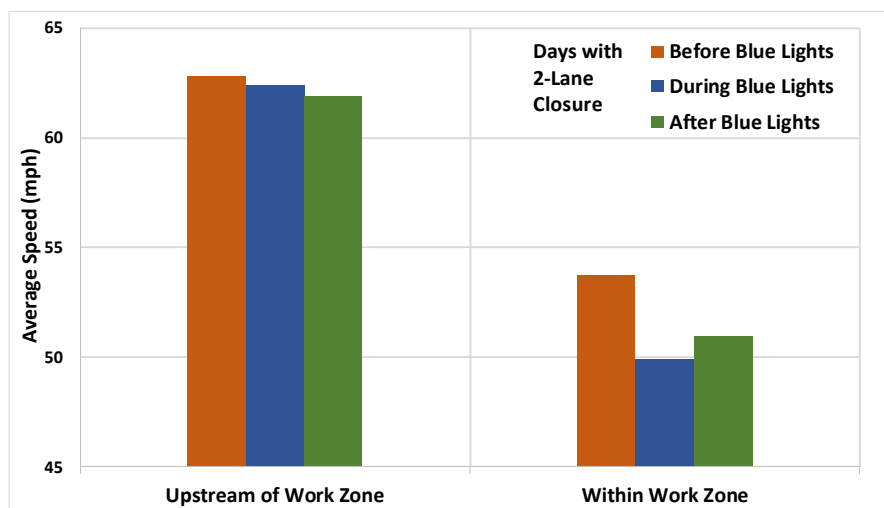
Figures 4-10 and 4-11 show the overall average speeds upstream of and within work zone for each of the three evaluation periods for 2-lane and 2.5 lane closures, respectively.

Figure 4-10. Overall Average Speeds Upstream of & within Work Zone for 2-Lane Closure

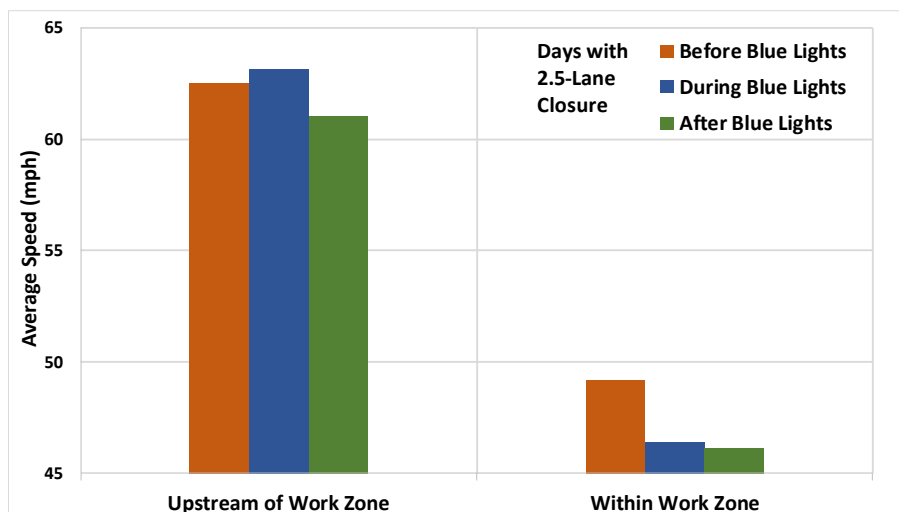
Figure 4-11. Overall Average Speeds Upstream of & within Work Zone for 2.5-Lane Closure

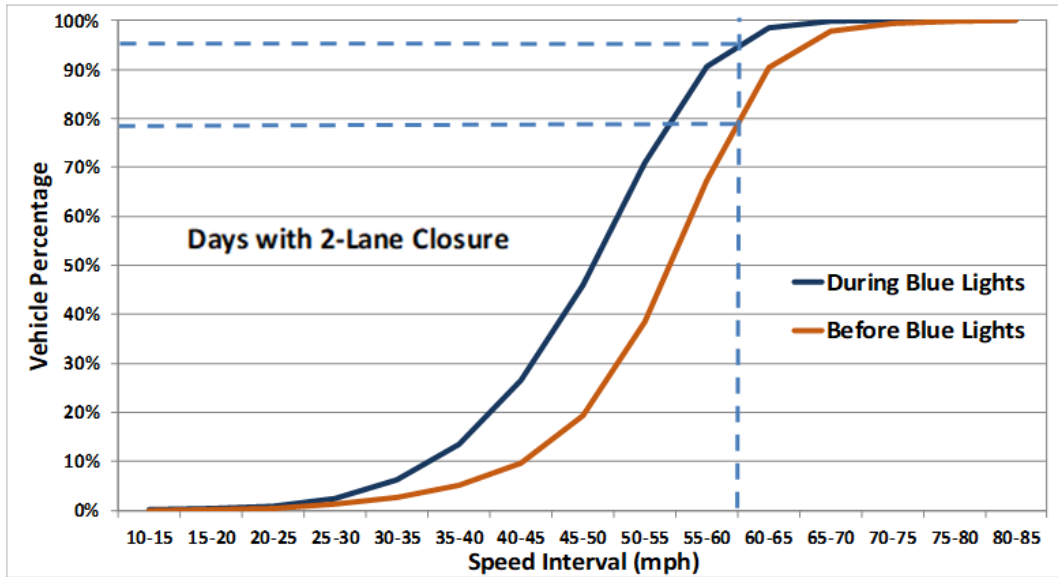
Figure 4-12 compares the cumulative speed distributions for the days with 2-lane closure before and during blue light deployment at iCone #4 where the vehicles with blue lights were stationed. It can be seen from the figure that the deployment of blue lights reduced vehicle speeding (i.e., >60 mph) from 21% to 5%, for a net reduction of 16%. Similarly, Figure 4-13 shows a smaller but significant reduction of about 10% in speeding (from 15% to 5%) in the case of 2.5-lane closure.

Figure 4-12. Cumulative Speed Distributions at iCone #4 before and during Blue Light Deployment for Days with 2-Lane Closure

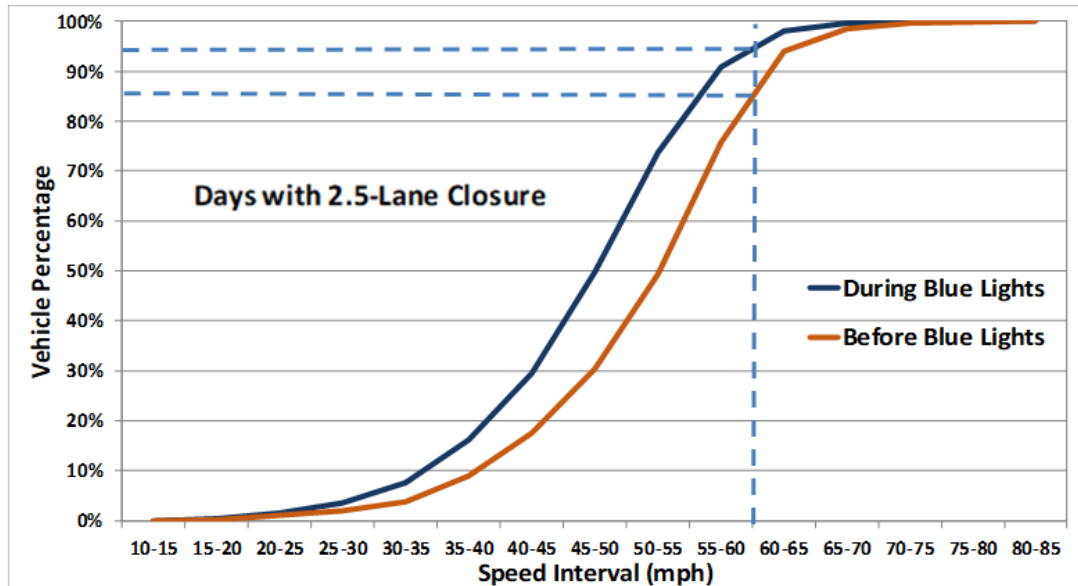
Figure 4-13. Cumulative Speed Distributions at iCone #4 before and during Blue Light Deployment for Days with 2.5-Lane Closure
