BDV29-977-34

*Florida International University***Florida Department of Transportation Research****Development of Quality Assurance and Quality Control System for Post-Tensioned Segmental Bridges in Florida: Case of Ringling Bridge – Phase II***March 2019***Current Situation**

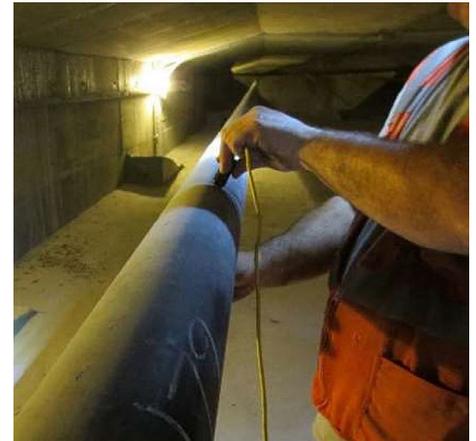
A worker begins testing on a post-tensioning tendon inside one of the box girders that make up the Ringling Bridge.

UST and MMFM were applied to the 44 tendons located in the open centers of the box girders. The inspected tendons have a combined length of over 12,000 linear feet. Some of these tendons were original to construction while some were installed as part of 2012 repairs. UST identified four potential anomaly locations to be opened for verification, and MMFM identified five more. A tenth, exploratory site was also chosen. Tendons were opened for direct inspection of grout and tendon condition.
