**ACCELERATED CORROSION TESTING OF GROUTS FOR PT STEEL STRAND**

FINAL REPORT

**Project BDV29-977-44  
(80002803)**

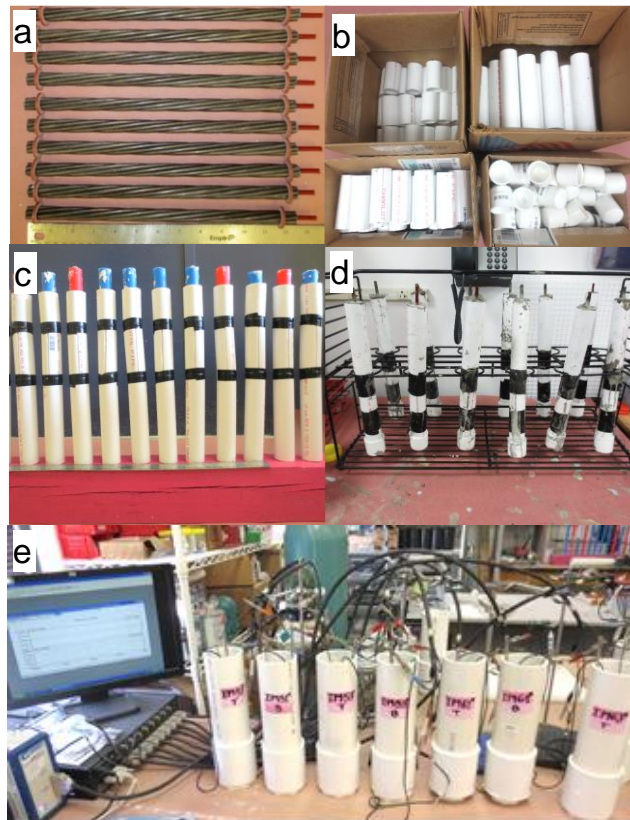
Figure 2.1. PTI Accelerated Corrosion Testing

One-inch diameter PVC pipe and caps were cut to size and prepared according the specification guide (Figure 2.1b). A Dremel circular saw with preset cut depth stops was found suitable to make the longitudinal slits for the center PVC section to be opened for exposure to the test solution. The PVC components were assembled connected by silicone and duct tape as shown in Figure 2.1c. Final assembly and grouting hand troweled in place within the mold was made as shown in Figure 1d. Specimens were demolded in two subsets: 28-day and 56-day curing within the mold and stored in 100% RH.

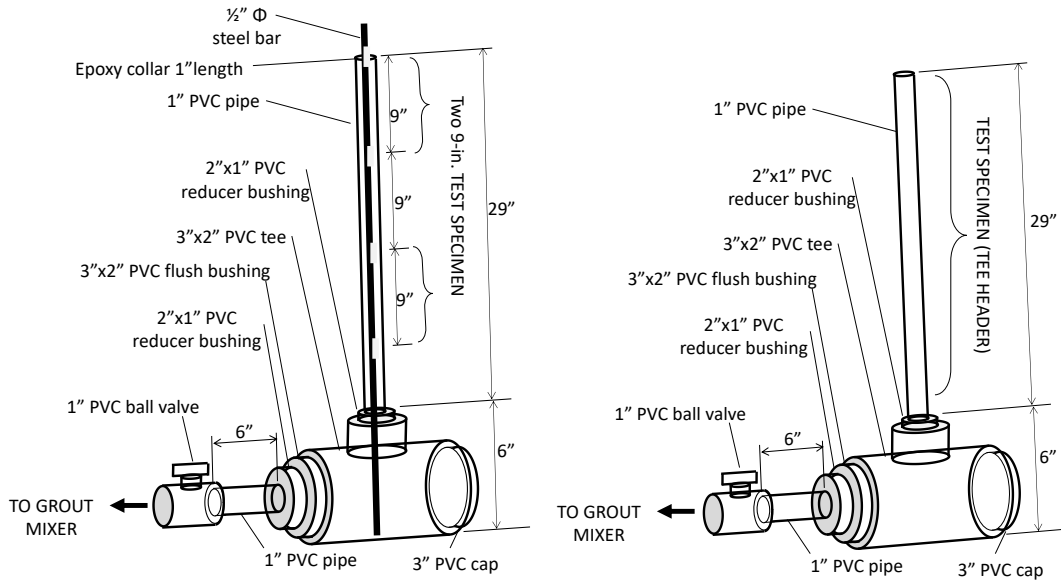
Figure 2.8. Schematic of typical inverted-tee specimen.  
 In some test cases, different tee header lengths and filters were used.  
 Left: Corrosion Testing. Right: Grout Testing.

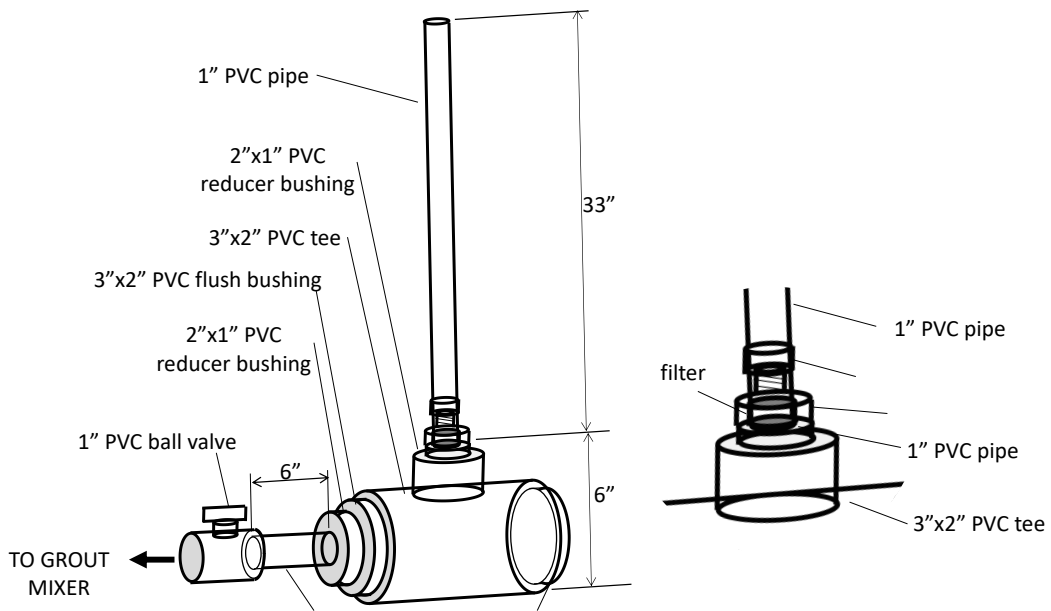
Figure 2.10. Schematic of INT with filter for flow constriction.

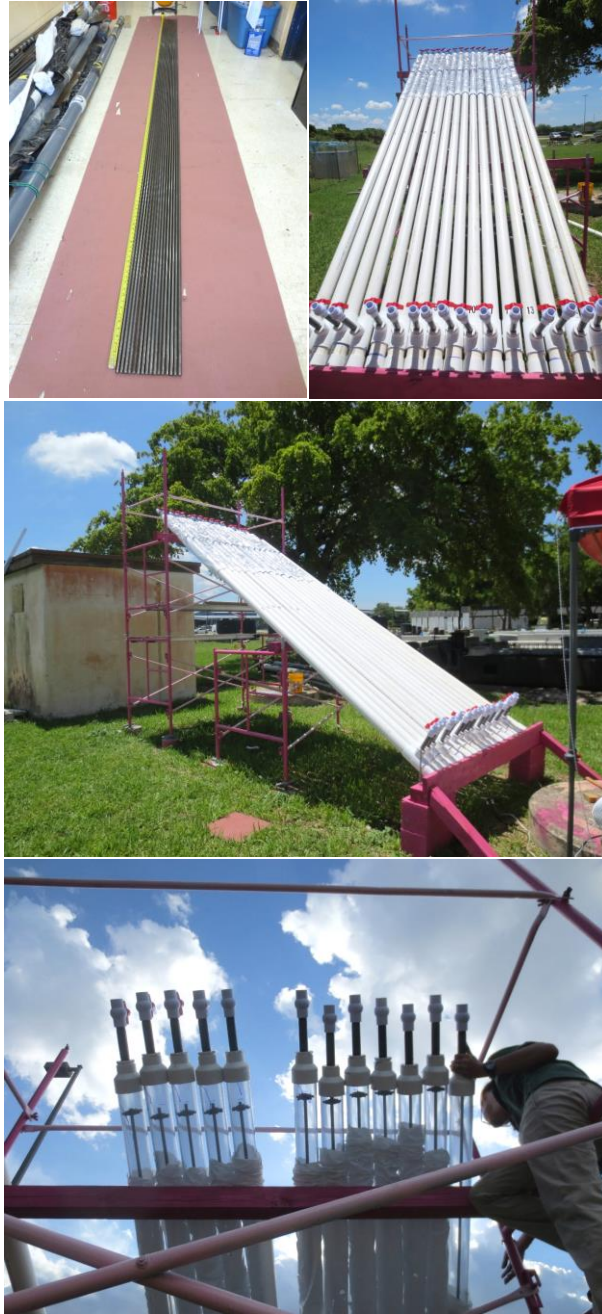
Figure 2.18. MIT assembly.

A. Steel bar. B. Front view of assembly. C. Side view of assembly. D. View of steel bar near MIT outlet.

A 15-foot 0.5-inch diameter steel bar was placed in the MIT for additional corrosion testing. The steel bar was cut to length and cleaned with acetone (Figure 2.18A). The PVC components were assembled according to Figure 2.17 and the steel bar was placed within the pipe, centered with rebar spacers. The specimens were placed on a steel frame with a 30 degree incline, as shown in Figure 2.18B-D.

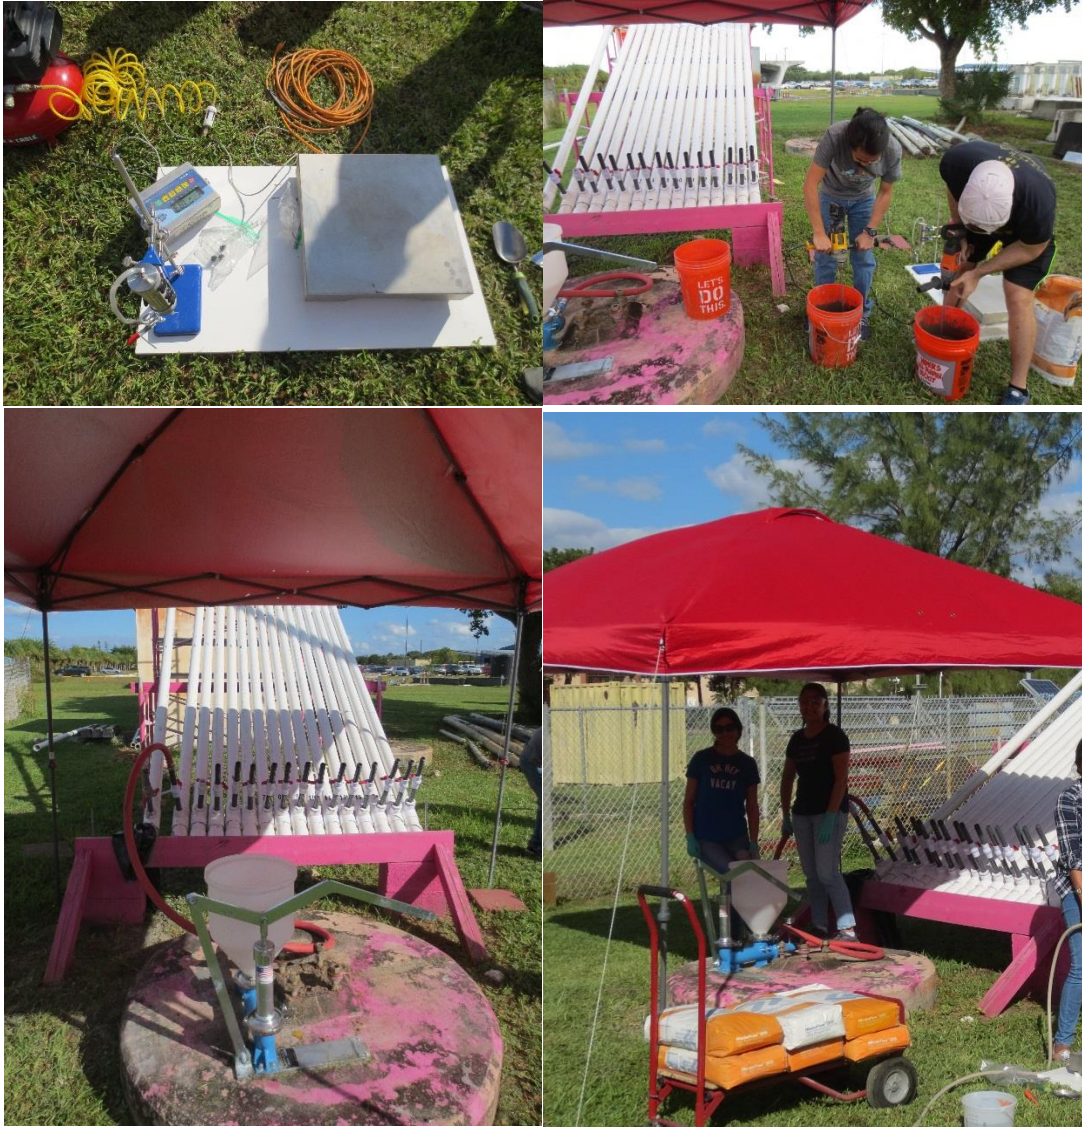
Figure 2.19. MIT Grout Mixing and Injection

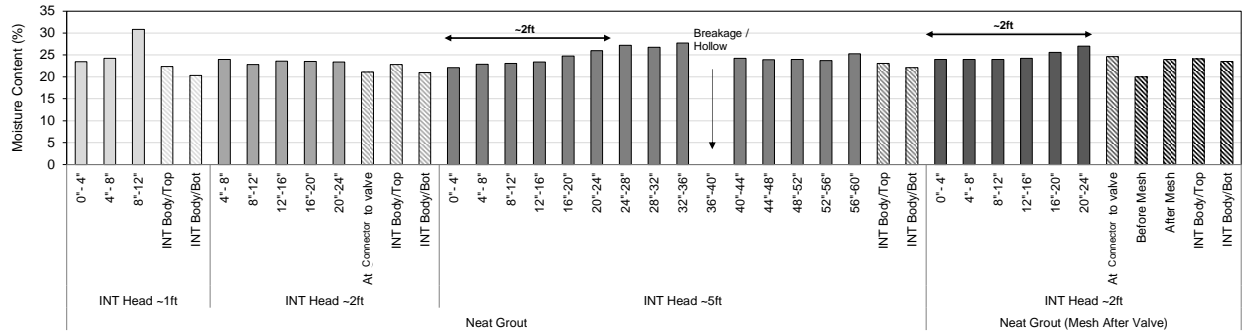
Figure 3.1. Moisture content of neat grout in INT setup with different vertical lengths.

the tee header made at 1 ft, 2 ft, and 5 ft. Subsequent INT tests were made with a vertical deviation of 3 ft.

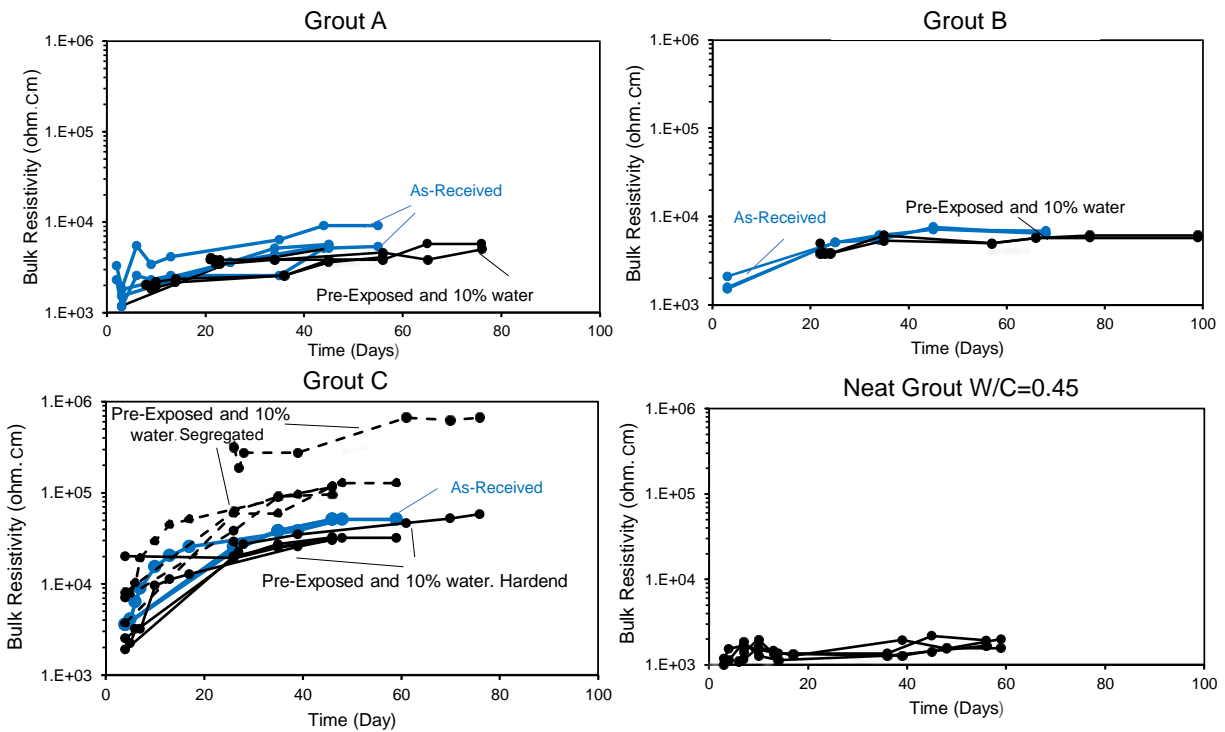
Figure 3.2. Bulk resistivity of grout cast in 3x6” cylinders.

The effect of excess 10% mix water was initially assessed for grout cast in 3x6” cylinders. As shown in Figure 3.2, the thixotropic grouts in the normal mix condition and with excess mix water were consistently higher than that for the 0.45 w/c neat grout, indicative of the good electrical characteristics of the thixotropic grouts. In the static pour for the cylinder specimens, the effect of the excess mix water on the bulk resistivity was not readily apparent. Indeed, any amount of grout segregation within the cylinder could not be easily differentiated.

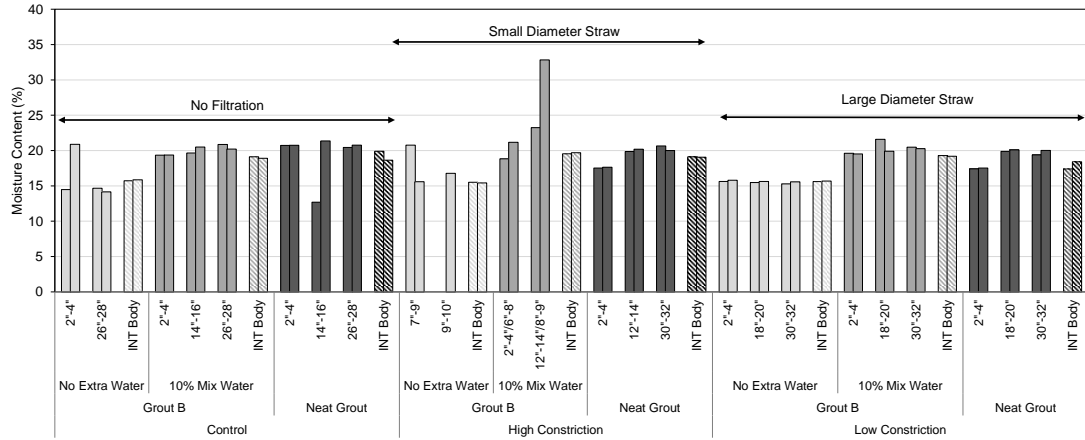
Figure 3.6. Moisture content of grout cast from INT with grout flow confinement.

Figures 3.6 and 3.7 show the moisture content and bulk resistivity of grout cast in INT setup with the presence of high and low grout flow constriction. Similar to the INT results without the flow constriction, the grout in the tee header had higher moisture content than the grout in the tee body. In all test cases, the excess mix water allowed for enhanced water displacement into the tee header. However, it was apparent that the presence of a high flow constriction amplified this effect. Much higher water contents (>30%) was measured in the grout from tee header.

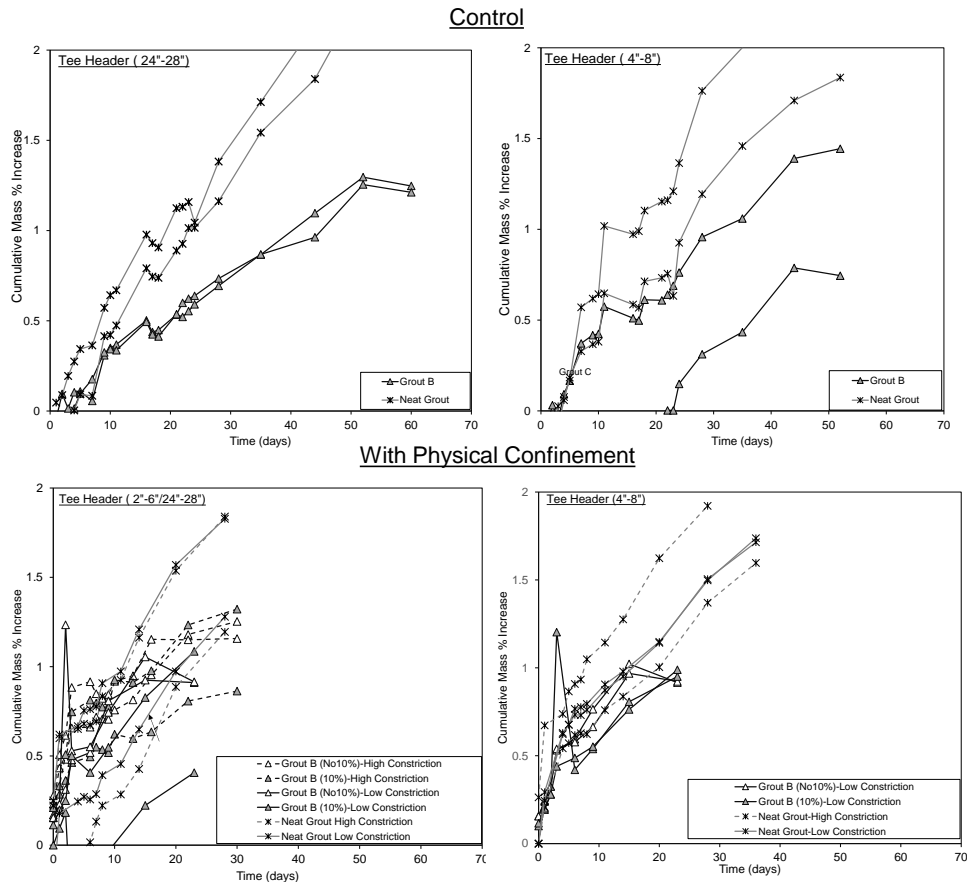
Figure 3.8. Moisture uptake of grout from INT setup cast with grout flow confinement.

After up to 40 days of conditioning in 100%RH, the grouts subjected to flow constriction continued to increase in mass due to water uptake, and the wet resistivity dropped accordingly. There is no clear differentiation in the results due to the flow confinement. Consistent with the observations from the other test cases, the thixotropic grouts showed improved characteristics over the neat grout.

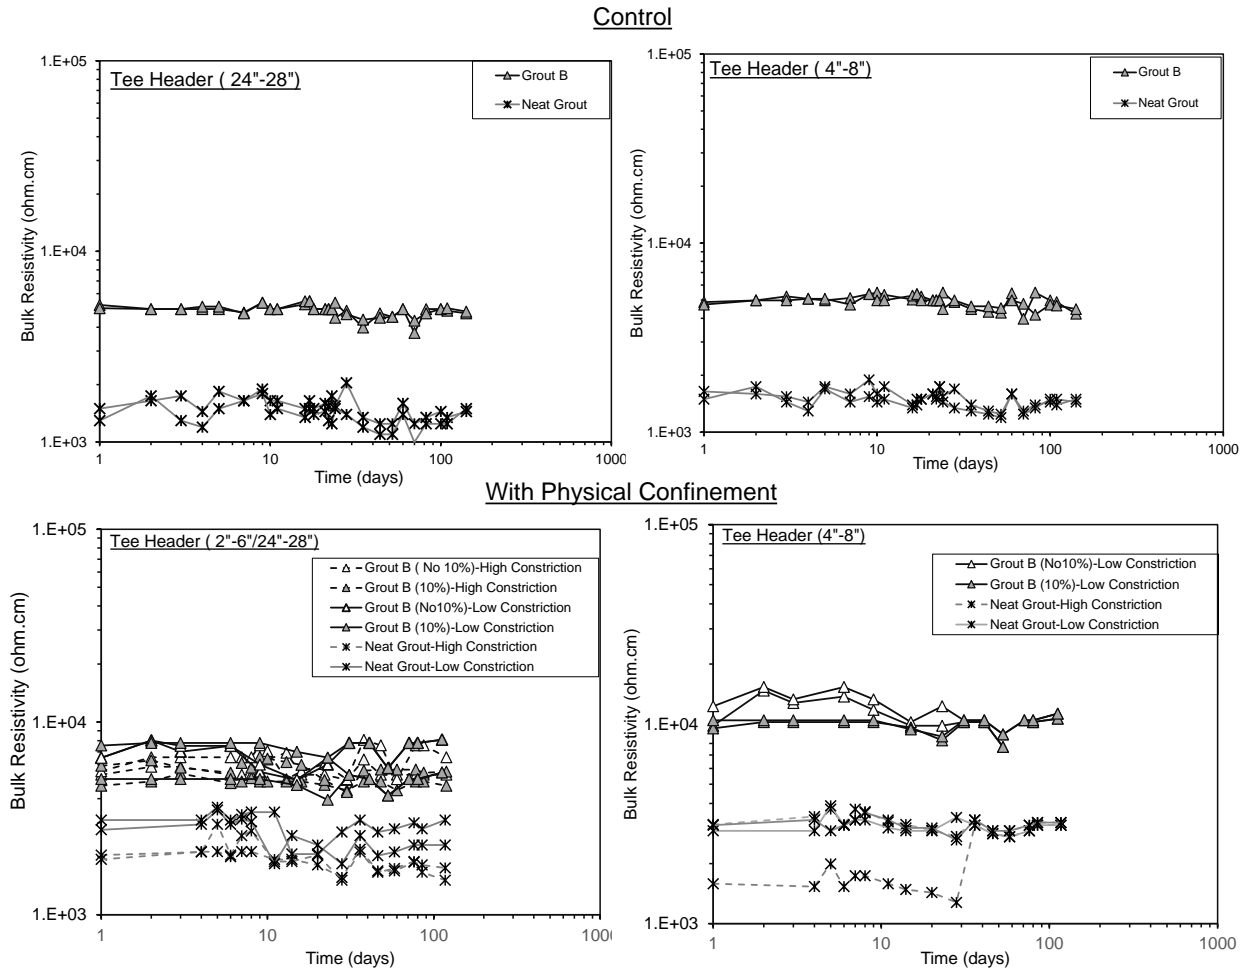
Figure 3.9. Wet resistivity of grout from INT setup cast with grout flow confinement.

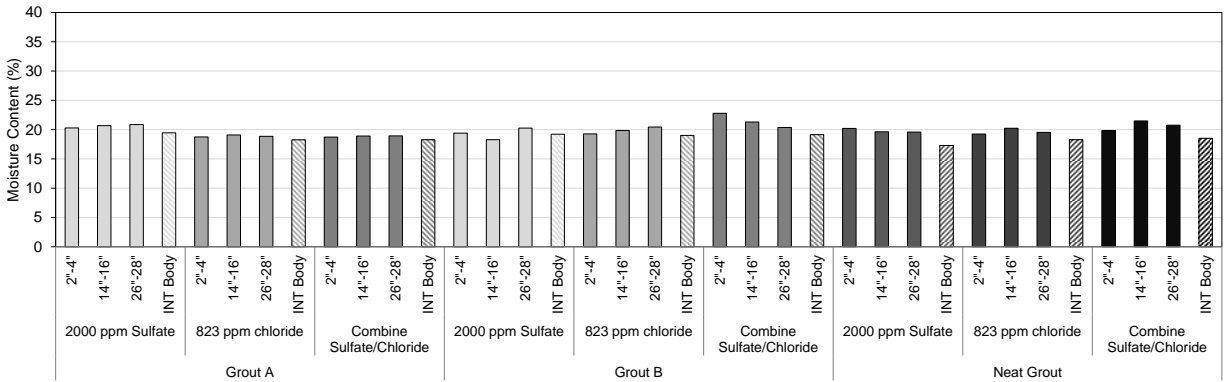
Figure 3.10. Moisture content of grout cast from INT with external ion contamination.

Figures 3.10 and 3.11 show the moisture content and bulk resistivity of the grout specimens cast with chloride and sulfate ion contamination. As expected, the moisture content was higher in the INT header than the INT body. The presence of the chloride and sulfate ions would enrich the ionic concentration of the grout pore water but it was evident that its presence would not be a dominant factor in the grout bulk resistivity. The differentiation in the moisture content of the grout in the tee header and tee body would imply that there was accumulation of moisture in the tee header. The transport of the water would likely allow for differentiation of the chloride and sulfate concentrations along the vertical height of the INT specimen.

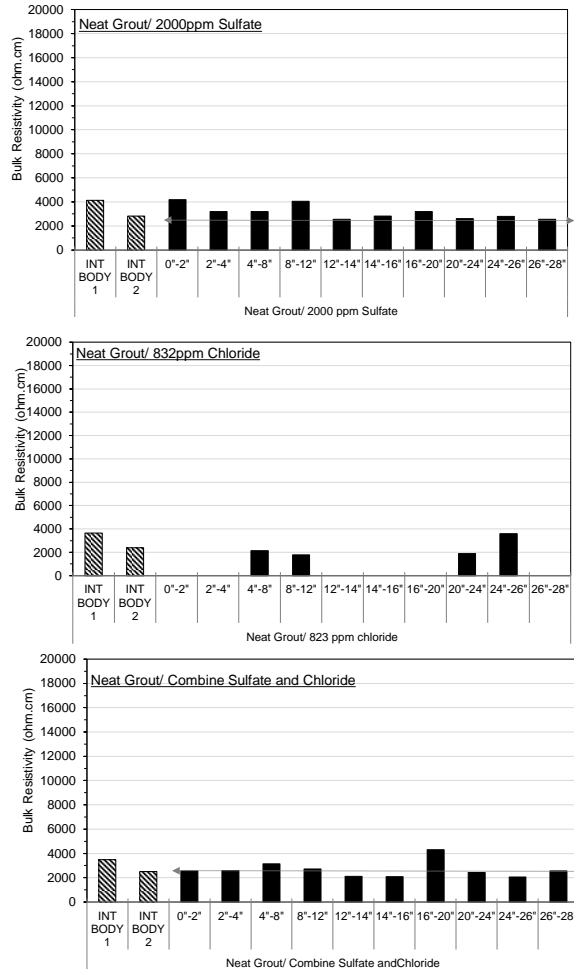
Figure 3.11. Bulk resistivity of grout cast from INT with external ion contamination.

Figure 3.11-continued. Bulk resistivity of grout cast from INT with external ion contamination.

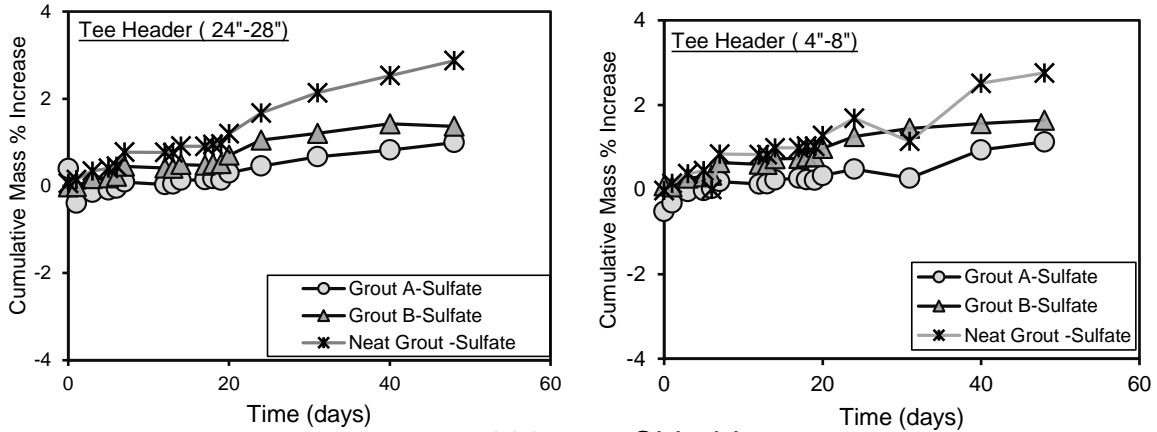
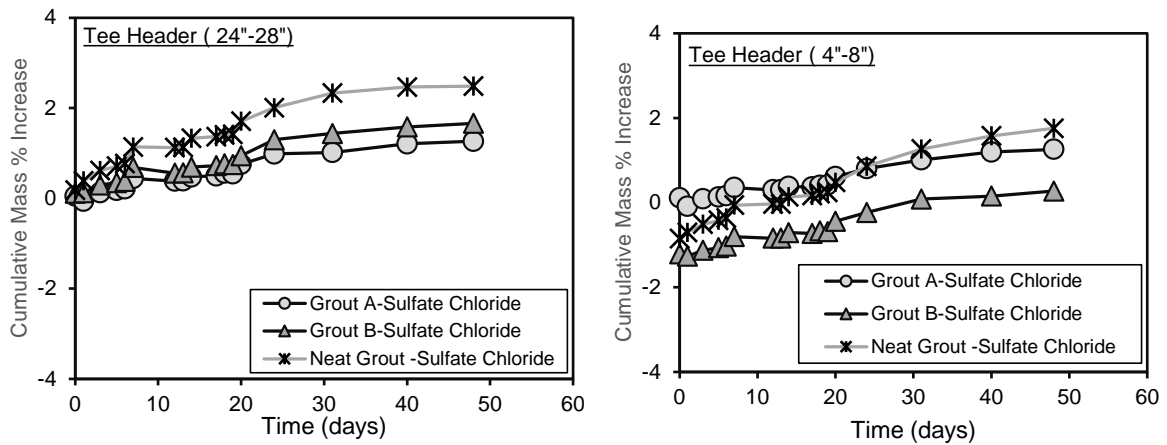
Figure 3.12. Moisture uptake of grout from INT setup cast with external ion contamination.

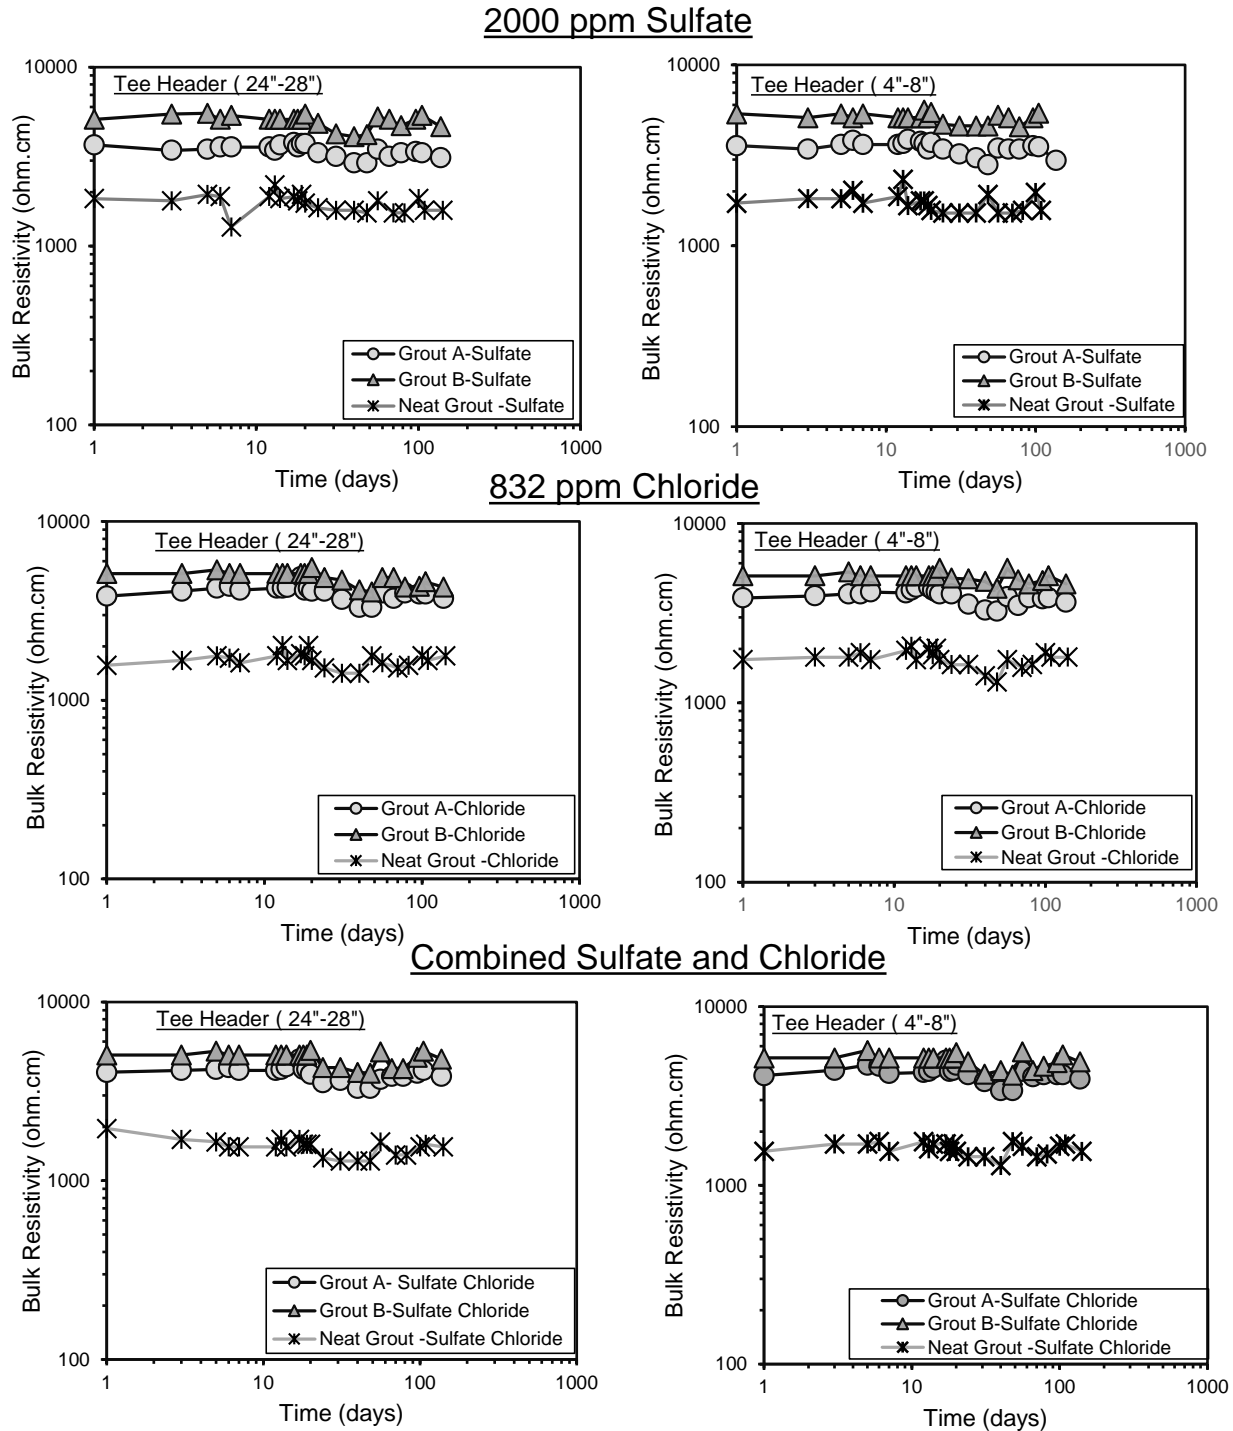
Figure 3.13. Wet resistivity of grout from INT setup cast with external ion contamination.

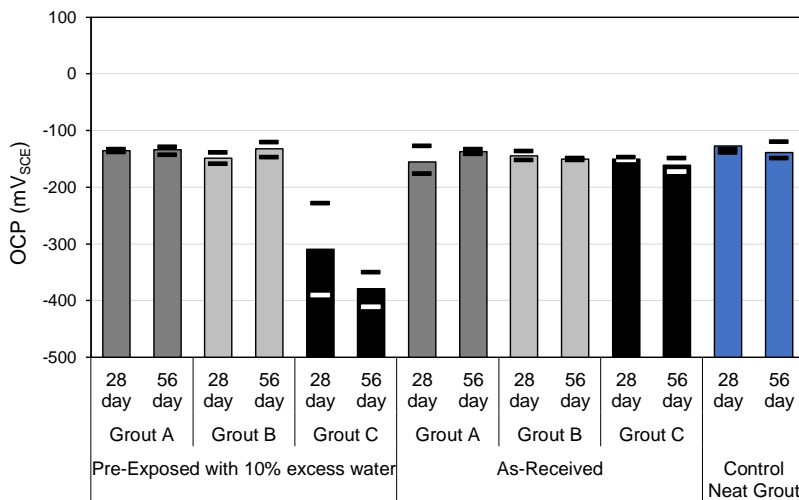
Figure 4.1. Corrosion potentials 28 and 56 days after casting.

The OCP of each test specimen was obtained prior to the LPR and anodic polarization tests prescribed by the ACT. As shown in Figure 4.1, the steel embedded in the neat grout as well as test specimens cast with grout in the control as-received condition all developed passive potentials in the range of  $-100 < \text{OCP} < -200 \text{ mV}_{\text{SCE}}$  after 28 and 56 days of curing, regardless of any grout imperfections. Specimens cast with pre-exposed Grout A and Grout B with 10% excess water also developed similar passive potentials. However, specimens cast with pre-exposed Grout C with 10% excess water developed more electronegative potentials at levels that may be interpreted as active corrosion (as negative as  $-400 \text{ mV}_{\text{SCE}}$ ). This observation was coincident with the physical grout deficiencies described earlier; however, since the specimens were immersed in saturated calcium hydroxide solution prior to testing and were tested in chloride-free saturated calcium hydroxide solution, corrosion activation was not expected.

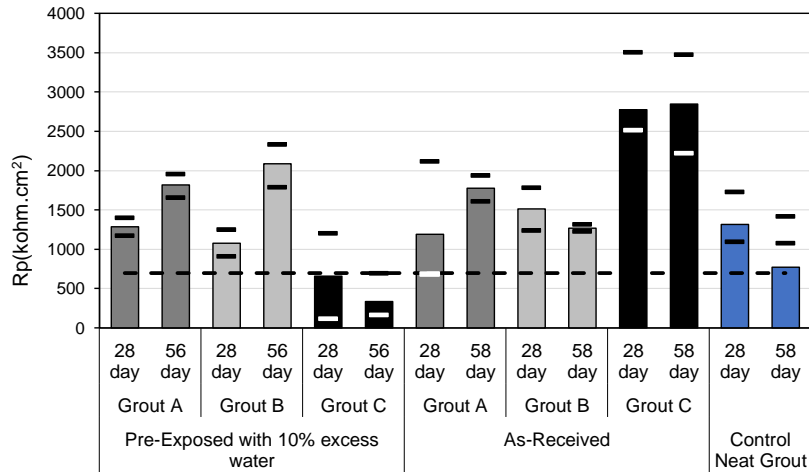
Figure 4.2. Measured polarization resistance 28 and 56 days after casting. Dashed line represents the limit described in PTI M55 Appendix B<sup>33</sup>, 700 kΩ·cm<sup>2</sup>.

The polarization resistance resolved from the LPR test, assuming a nominal steel area of  $96.6 \text{ cm}^2$  (surface area of the 7-wire strand within the grout section open to the test electrolyte), is shown in Figure 4.2. Consistent with the OCP measurements, all neat grout specimens and test grout specimens (in both control and adverse pre-exposure/mixing conditions) that developed passive-like potentials all exhibited  $R_p$  values that meet or exceed the  $700 \text{ k}\Omega\text{-cm}^2$  criteria established in the ACT. Likewise, the specimens cast with pre-exposed Grout C with excess mixed water had lower  $R_p$  values, corresponding to corrosion current densities as high as  $0.68 \mu\text{A}/\text{cm}^2$ , further suggesting that low to moderate active corrosion conditions<sup>43</sup> developed in those cases. Of note, specimens cast with Grout C following appropriate procedures (and with generally well hardened and consolidated grout) developed the highest  $R_p$  values corresponding corrosion rates as low  $0.015 \mu\text{A}/\text{cm}^2$ .

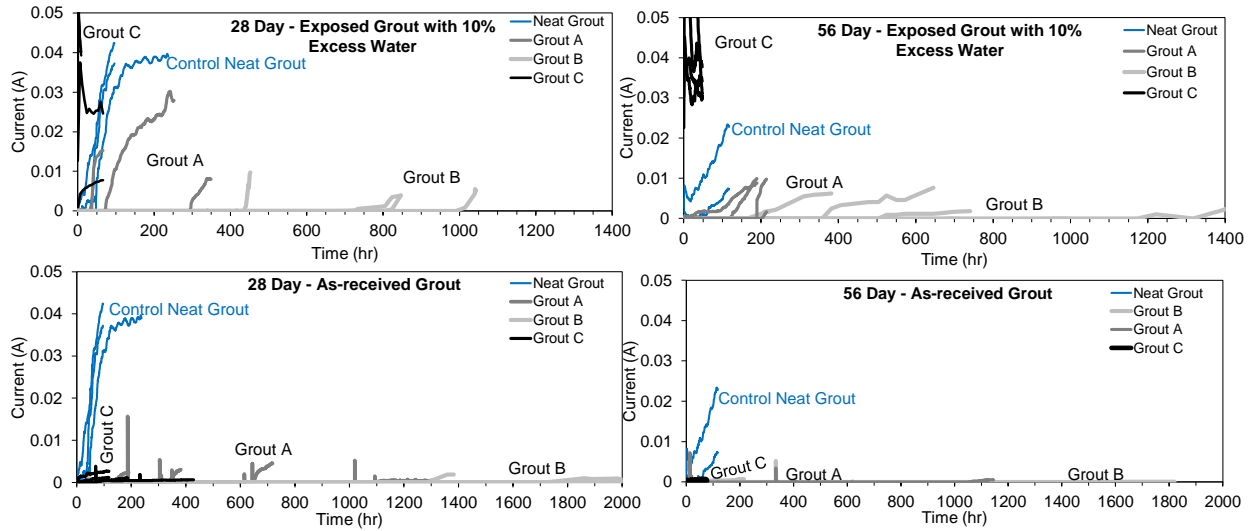
Figure 4.3. Anodic Currents for Steel in Anodic Potentiostatic Polarization Test

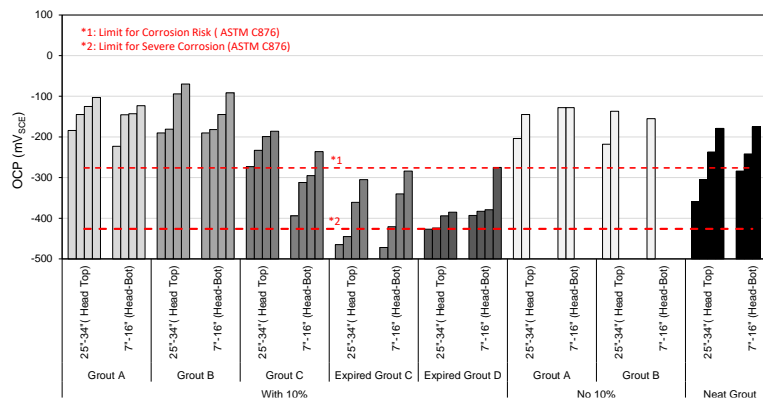
Figure 4.4. Corrosion potentials for INT testing.

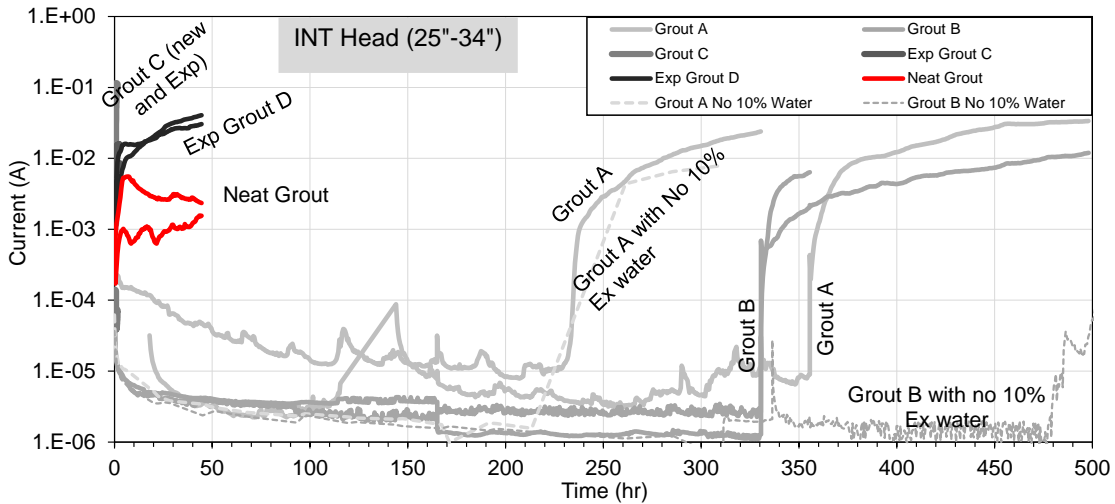
Figure 4.7. Anodic Currents for Steel in Anodic Potentiostatic Polarization Test for INT Header Top Section

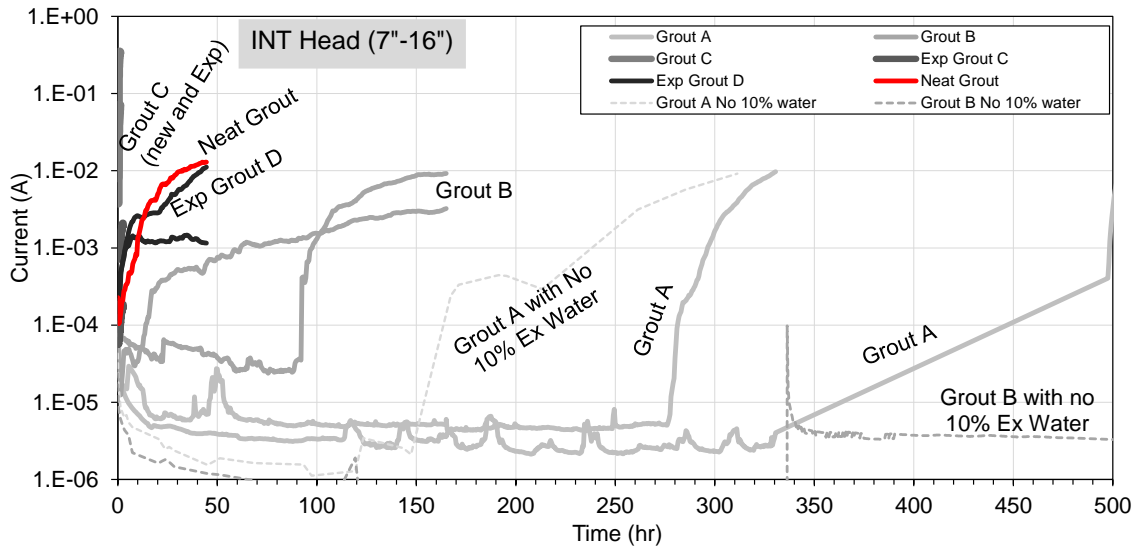
Figure 4.8. Anodic Currents for Steel in Anodic Potentiostatic Polarization Test for INT Header Bottom Section

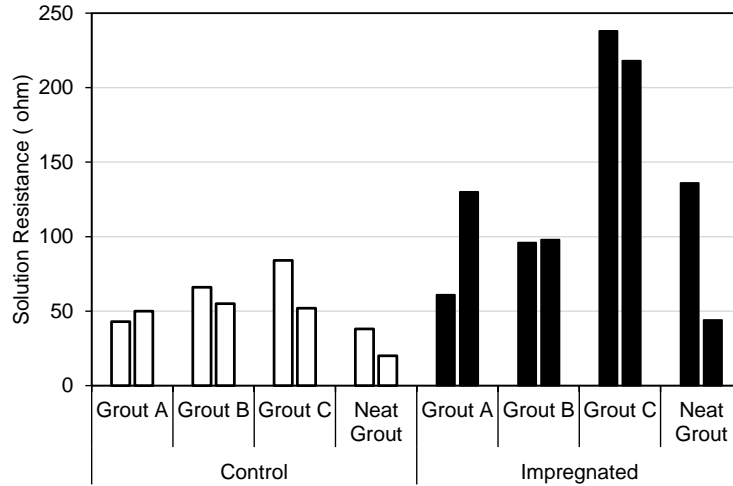
Figure 4.11 Resolved solution resistance

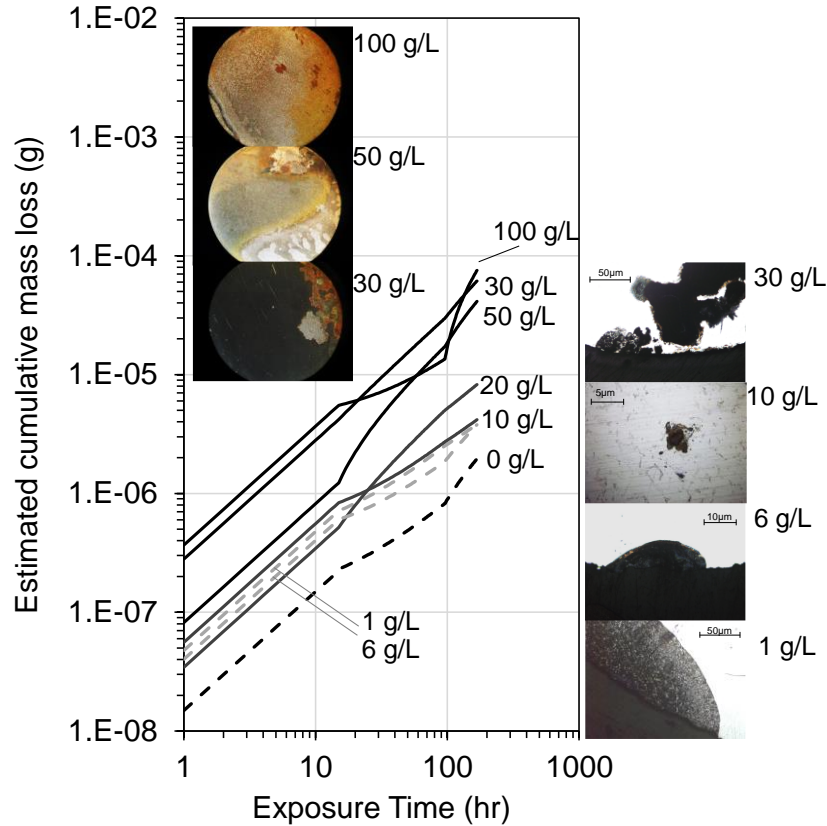
Figure 7.10. Estimated corrosion mass loss and pitting observations. Labels indicate g Na<sub>2</sub>SO<sub>4</sub> / L H<sub>2</sub>O.
