FLORIDA SLAB BEAM BRIDGE WITH ULTRA-HIGH-PERFORMANCE CONCRETE JOINT CONNECTIONS

(Project Nos.: BDV29-977-28 and BDV29-977-65)

Final Report

December 2021

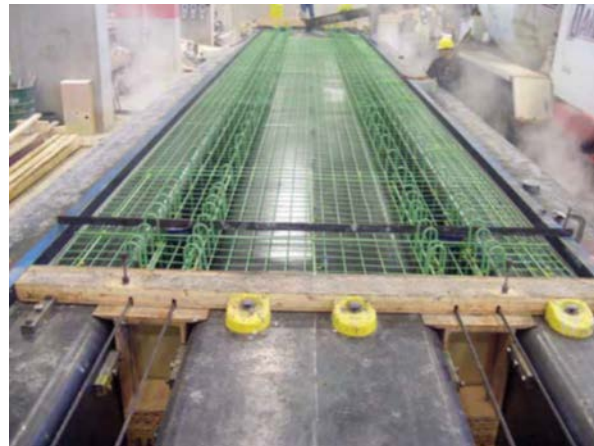
Figure 2.11: NEXT beam section at Dailey Precast plant, Shaftsbury, Vermont [7]

The first NEXT beam project was built in 2010 in Maine. As with many short-span bridge solutions, this one was used to completely replace the New Bridge on Route 103 in York, Maine. The Maine DOT had the additional challenges of maintaining the existing profile and navigational clearances, so the bridge section was designed accordingly. A photograph from casting of the NEXT F beams used in this project is shown in Figure 2.11.

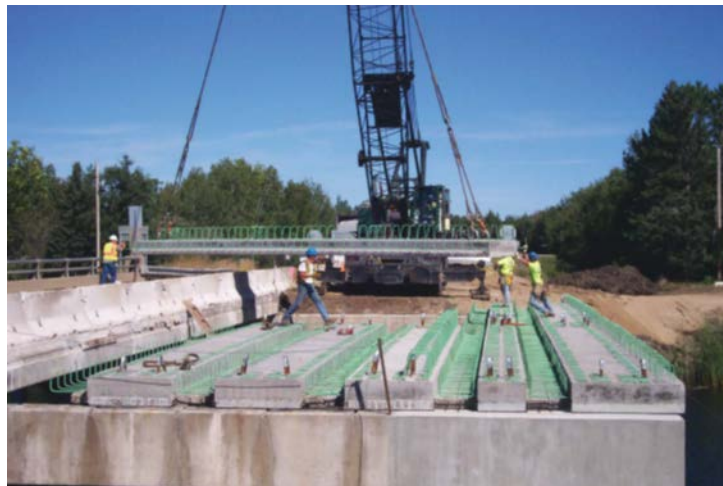
Figure 2.16: Erection of Bridge 04002 located on MN Highway 72 over the Tamarac River near the rural, northern Minnesota town of Waskish [11]

MnDOT first implemented the described section in two pilot bridge projects over two water crossings. The bridges served as calibration sites so that results of the field and adjustment data from laboratory tests could confirm the system’s durability and verify the first PCSS design assumptions. The bridges are Bridge No. 04002 located on MN Highway 72 over the Tamarac River and Bridge No. 13004 on U.S. Highway 8 over Center Lake Channel. The erection of the bridge is shown in Figure 2.16.

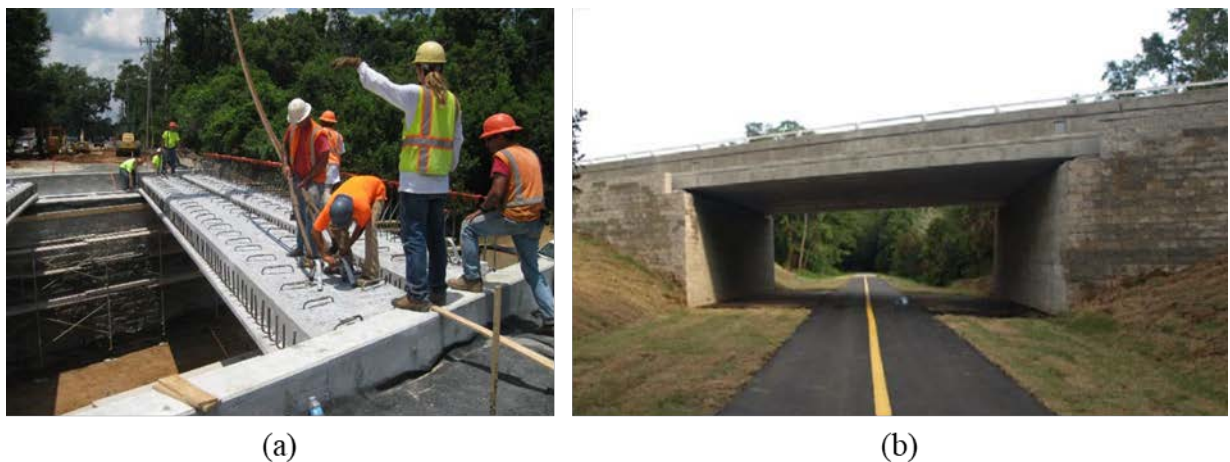
Figure 2.23: (a) Placement of FSBs adjacent to each other and (b) finished pilot project SR-373 [16]

The FSB system is intended to be used to replace prestressed slab units [19]. As mentioned before, the FSB superstructure system is currently recommended for off-system bridges with low ADT and ADTT. The pilot project for this system was SR 373 (Orange Avenue) over St. Marks Trail (District Three, Leon County; Tallahassee, Florida). The road closure was for seven weeks, from June 2nd to July 20th of 2014. The designers of this project were the FDOT State Structures Design Office (superstructure and GRS) and George & Associates (roadway, drainage, utilities, and permitting). The placement of the FSB members and the finished bridge are shown in Figure 2.23 (a) and (b), respectively.

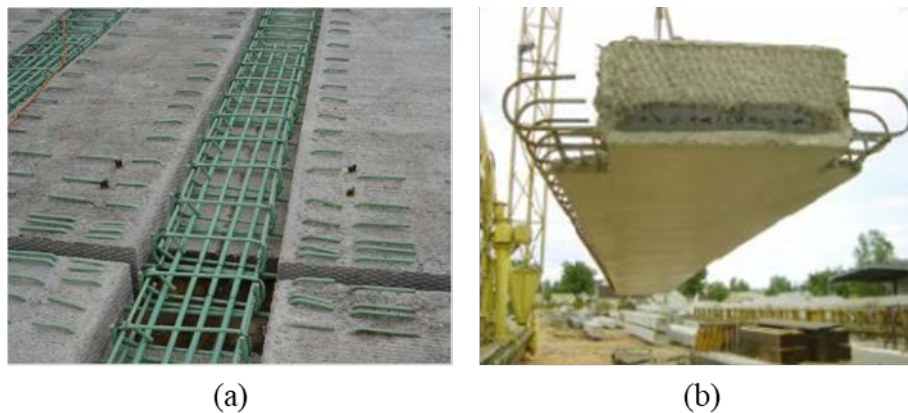
Figure 2.30: Additional reinforcement required in (a) transverse direction [25] and (b) extending from side of members [26]

Non-UHPC joints can offer satisfactory performance if they are designed and detailed properly. Most non-PT non-UHPC joint details require large amounts of reinforcement protruding from the precast members. This reinforcement is oftentimes challenging to place, which will result in higher labor costs. Additionally, many of the details described above require the placement of additional reinforcement in the joint, both transverse (to aid in development lengths) and longitudinal (to improve confinement), as shown in Figure 2.30 (a). In some details, reinforcement bars were required to be threaded through 180-degree hooks, as shown in Figure 2.30 (b). Simpler non-UHPC joint details (in terms of reinforcement) require PT, which is also labor intensive.

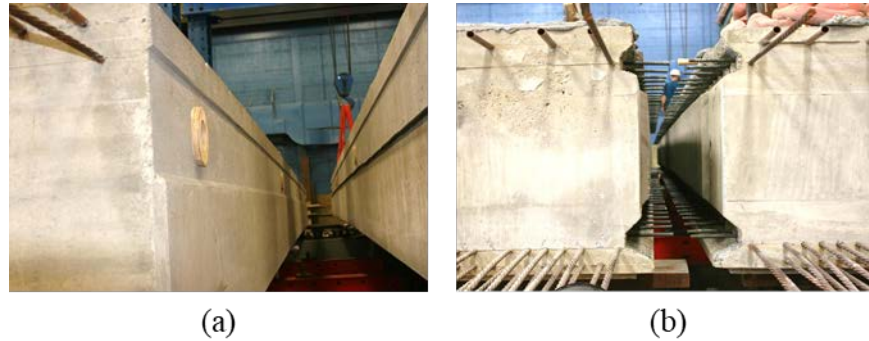
Figure 2.34: (a) Conventional shear key specimen and (b) UHPC shear key specimen [29]

These joint details were developed through an extensive experimental program involving both small-scale testing (focused on the joint development) and full-scale testing (focused on the performance of the joint detail in two adjacent girders). Two of the full-scale configurations used in the experimental program are shown in Figure 2.34. The current shear key configuration utilizing conventional grout materials and transverse post-tensioning tendons, shown in Figure 2.34 (a), was used to develop a baseline performance to start as a comparison point for testing. The developed UHPC connection detail, shown in Figure 2.34 (b), required the use of #4 reinforcement extended 5.5 inches into the joint, which provided a 4-inch splice length. The surface was prepared by using a retarding agent on the formwork and then sandblasting the

surface; this created an exposed aggregate finish in the joint and improved the bond performance.

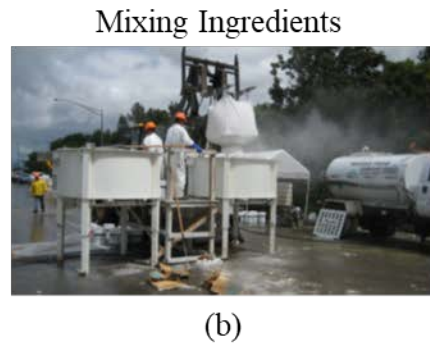
Figure 2.43: General procedure for mixing and casting UHPC [31]

Mixing of UHPC materials is done slightly different than conventional concrete materials. The full casting procedure is shown in Figure 2.43. One of the main differences regarding mixing is that UHPC requires a large amount of shear energy to mix properly. This means that either a high-shear mixer must be used, or a long mixing time is required. The mixing time and energy required for UHPC is one of the major limitations of the material. After the UHPC is properly mixed, it behaves similarly to a self-consolidating concrete. The UHPC can be placed in one location and allowed to flow down the member and joint. It should be noted that fiber reinforcement will align in the direction of the flow, so care should be taken to ensure that fibers are correctly oriented for the application. Steam curing will improve early age strength, but top forming or moist curing will result in satisfactory behavior for most applications. Finally, the UHPC can be used as the riding surface but requires grinding if it is to be used without an asphalt overlay.

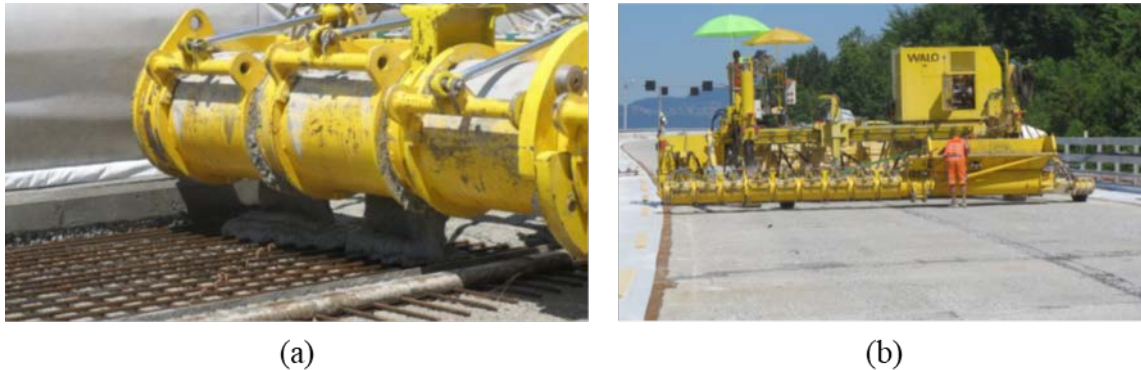
Figure 2.44: Cast-in-place UHPC overlay, immediately (a) before and (b) after placement [31]

Overlays made of UHPC are being used to rehabilitate decks of aging bridges. One example is the Chillon Viaduct near Lausanne (Switzerland), as shown in Figure 2.44. The deck was replaced with a CIP UHPC overlay in order to improve the durability of the riding surface and protect the existing structure underneath [33].

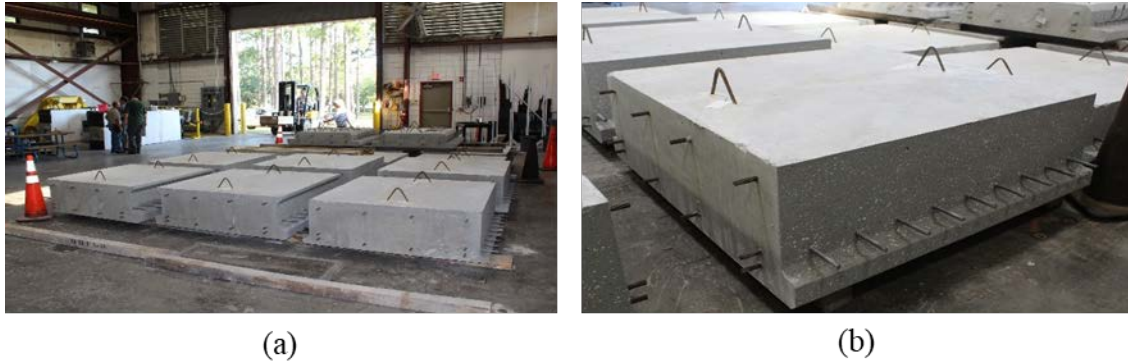
Figure 5.7: (a) Delivery of all slab-beam specimens, (b) beam showing strands, transverse reinforcement and lifting hooks (18-inch FDOT 1 shown)

After the beams were built at the precast plant, they were shipped to the FDOT M.H. Ansley Structures Research Center in Tallahassee, as shown in Figure 5.7.

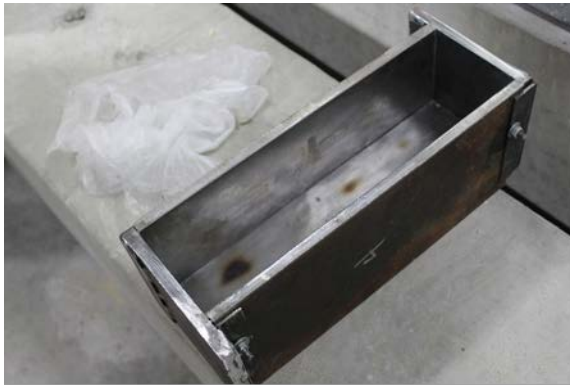
Figure 5.10: Beam samples for UHPC flexural performance: (a) 4x4x14 in. mold, and (b) broken UHPC beam samples

Per ASTM C1856 [63], the flexural strength of the UHPC was measured using small-scale beams subjected to third-point loading using ASTM C1609 [64]. Five 4-inch by 4-inch by 14-inch beam samples were cast at the same time the joints were built using metallic molds, shown in Figure 5.10 (a). These beams were tested on the day of joint testing to determine the tensile strength of the UHPC. Some of the fractured beams are shown in Figure 5.10 (b).

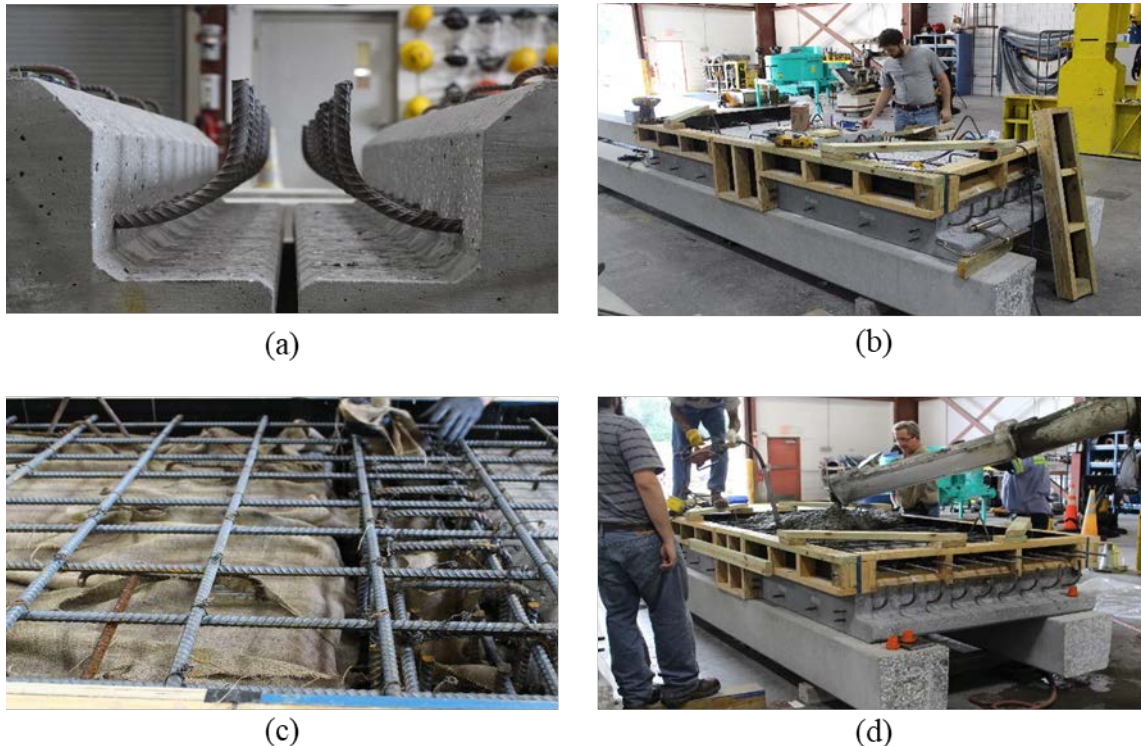
Figure 5.11: Construction of deck and joint in FSB: (a) adjacent FSBs with 3/4" spacing, (b) CIP deck form construction, (c) slab and joint reinforcement, and (d) CIP deck pour

The construction of the original FSB joint detail was done following the same construction procedure described in the FSB Developmental: FDOT Index D20450 Series Florida Slab Beams [57]. After the two beams were placed side-by-side with a 0.75-inch spacing, formwork was built around the top of the system, and the rebar mat and joint reinforcement cage were placed such that the CIP concrete could be poured. A closed cell polyethylene baker rod was used to seal the bottom gap between the two beams to avoid leakage of the concrete. The FSB joint construction is shown in Figure 5.11.

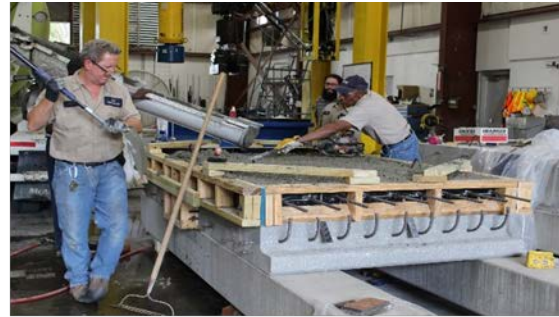
Figure 5.12: Deck cast for FSB specimens: (a) formwork layout for first testing stage, (b) deck casting operation for first testing stage after rebar placement, (c) alignment layout of broken pieces for second testing stage, and (d) second concrete cast operation

Each slab beam had the same joint geometry on both sides as they were designed to be interior beams in the superstructure. Having the same joint geometry on each side of the beam allowed for two strength tests to be performed per one set of beams, as described in detail in §5.6. Because the control FSB requires a CIP deck, the deck needed to be cast twice to fulfill the two-test requirement. For the first test, the FSB specimens were positioned adjacent to each other, the reinforcement and formwork placed, and the concrete cast, as shown in Figure 5.12 (a) and (b). The forms were placed, and deck reinforcement extended on the outside of the specimens to allow for the second test configuration shown in Figure 5.12 (c). After the beams were tested and rotated for the second phase, another reinforcement joint cage was placed and the top transverse bars in the deck were lapped. Finally, a second concrete cast was performed in the smaller joint-deck region for another testing round as shown in Figure 5.12 (d).

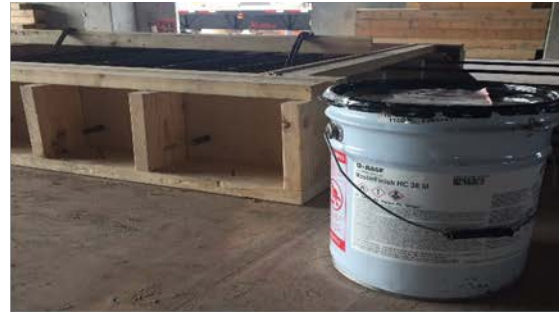
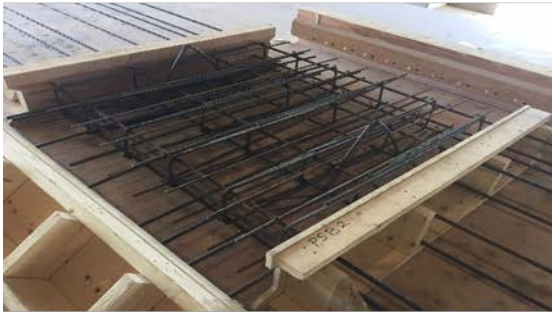
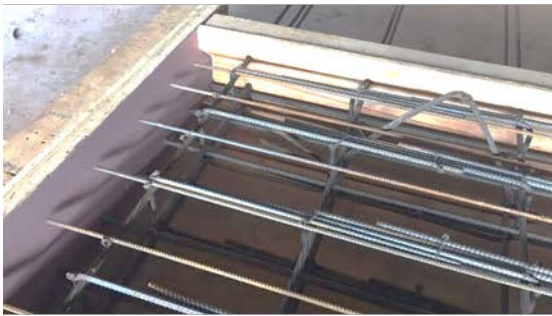
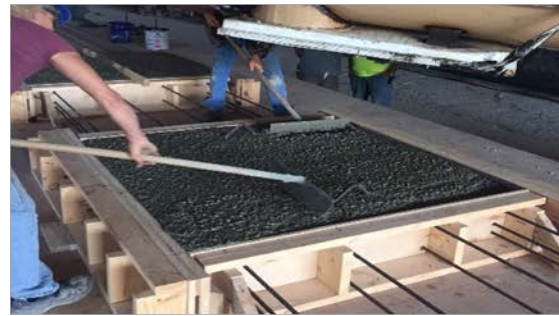
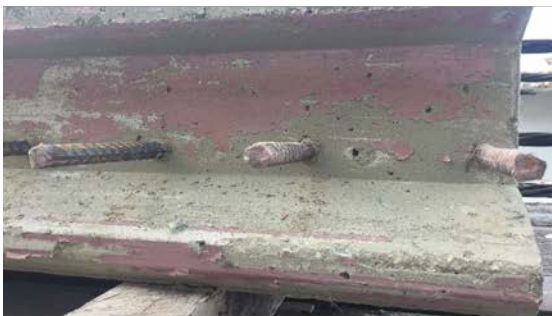
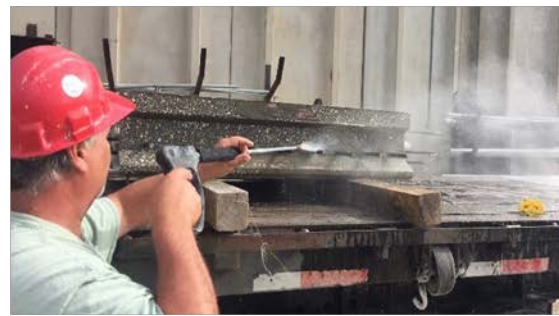
Figure 5.16: Process for exposed aggregate finish: (a) shear-key surface preparation detail, (b) in-form retarder agent, (c) removed shear-key region of the formwork, (d) retarder agent applied to the form wall, (e) block-outs with retarder agent fastened to the formwork, (f) concrete cast after product application, (g) retarded surface after block-outs removal, and (h) pressure washing operation

The final Alternate 2 joint surface preparation was achieved using the BASF: Master Finish® - Lilac agent by brushing one coat to the formwork of the keyway geometry approximately 6-8 hours prior to the concrete cast where the exposed aggregate finish was desired. The forms were removed one day after casting, and the surface was pressure washed using constant 3,500 psi water pressure at a controlled distance of application. The process for joint preparation and construction of the Alternate 2 specimens is shown in Figure 5.16.

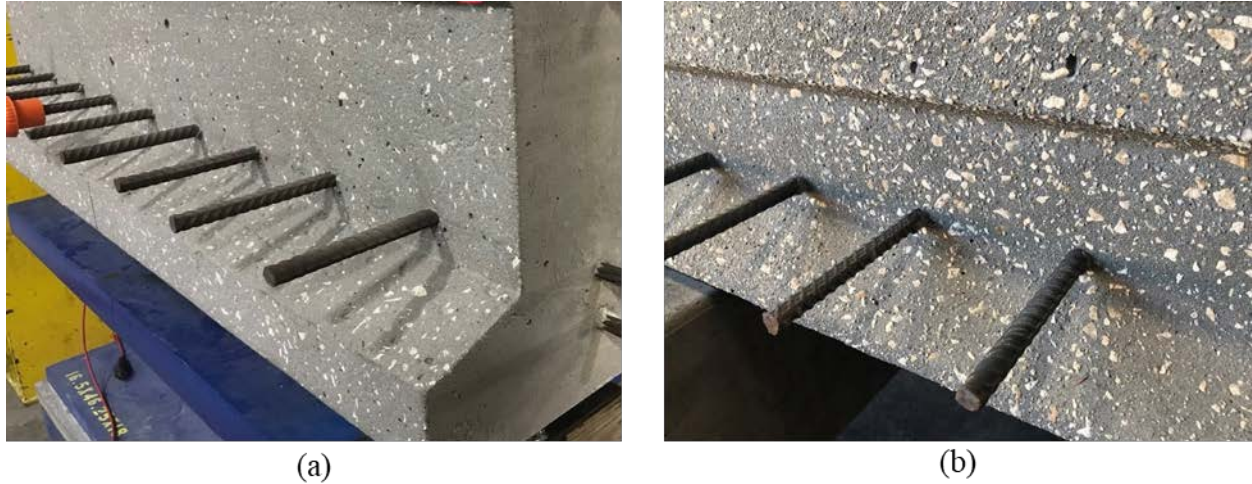
Figure 5.17: Comparison of joint finish: (a) sand-blasted finish and (b) exposed-aggregate finish

The completed joint finish for the Alternate 2 specimens compared to the finish achieved using sand blasting is shown in Figure 5.17. The procedure used to achieve the joint finish for the Alternate 2 specimens produced a much more roughened surface than the previous procedure, improving the precast concrete-to-UHPC bond.

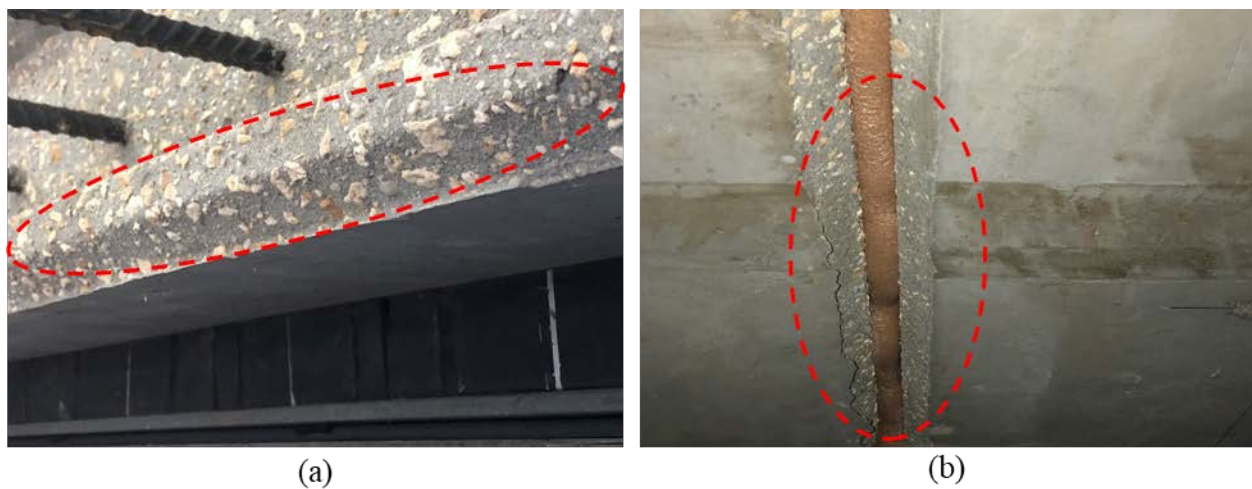
Figure 5.18: Unnecessary agent application zone (a) before and (b) after joint casting

Although the product worked as expected, it was still not enough to achieve a $\frac{1}{4}$ -inch amplitude as the resulted surface was only approximately $\frac{1}{8}$ -inch amplitude. The effect of the type of retarder agent used is directly dependent on the cement content, aggregate size, and environment relative humidity when the formwork brushing process is being performed. A maximum aggregate size of $\frac{3}{4}$ inch was used in the concrete mixture for these beams. Using a maximum coarse aggregate size of $1\frac{1}{4}$ inch is recommended for achieving a $\frac{1}{4}$ -inch amplitude. Additionally, the product application should be limited to the joint surfaces to be in contact with the UHPC. The product was applied to the side and bottom of the bottom flange in the Alternate 2, as shown in Figure 5.18.

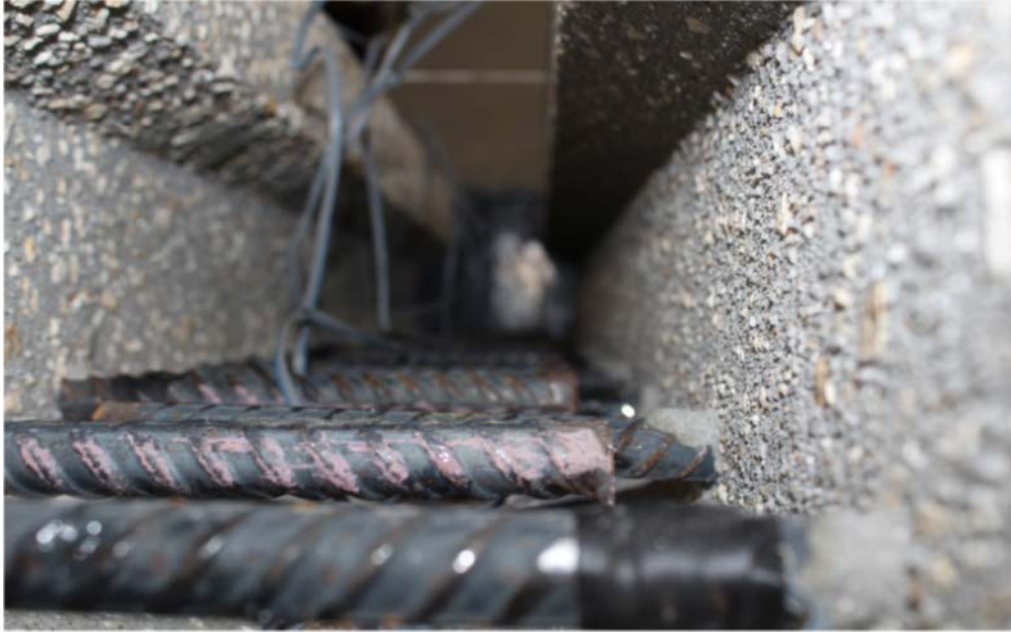
Figure 5.24: Transverse rebar misalignment observed in Alternate 2 joint specimen

Another concern during the construction of the members was a misalignment of the joint reinforcement. During the placement of the Alternate 2 beams before UHPC cast, it was noticed that one slab beam was roughly 3/16-inch thicker than the other. This difference in thickness meant that the joint reinforcement extending from the two adjacent beams was not in the plane, as shown in Figure 5.24.

The 3/16-inch misalignment was higher than the tolerance value specified in the FDOT Structures Design Manual (SDM), Section 25.3 [38], which states a maximum tolerance for dimensions of precast components of $\pm 1/8$ inch. The high tensile strength of the UHPC was thought to still be able to properly develop the reinforcement in the splice, so the decision was made to proceed with the testing. Because this superstructure system will not have a CIP deck to account for large construction misalignments, more restrictive construction tolerances and tolerances for beam camber variability may be required.

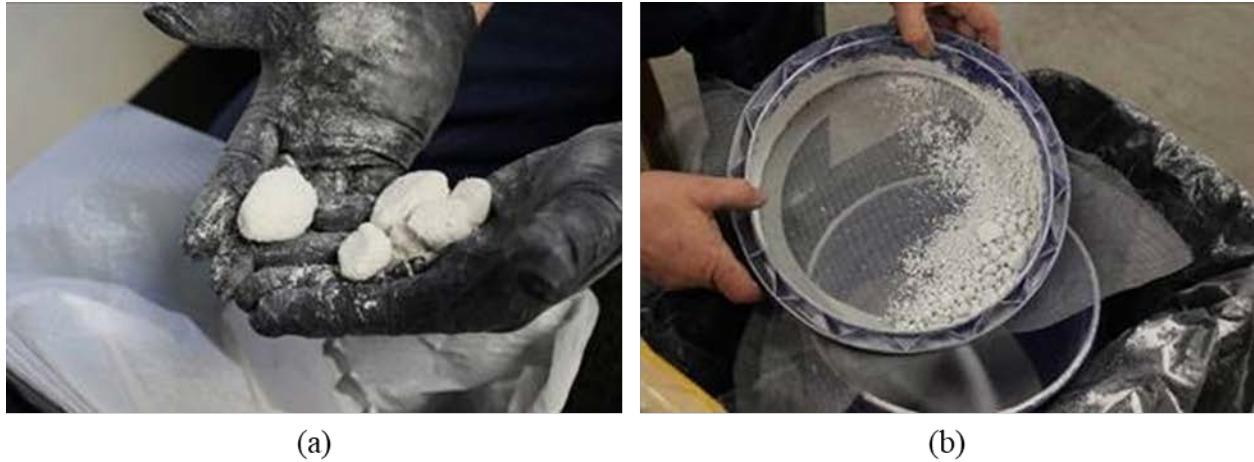
Figure 5.25: (a) Large and (b) small clumps collected from dry premix of UHPC

Several hardened clumps of UHPC dry premix were noticed during mixing for the first round of testing. One bag was sampled from the pallet of light grey premix by scooping out the material and sifting it over two layers of screen. Many clumps were found in each scoop of material from the top of the bag, as shown in Figure 5.25 (a). Even though the clumps could be broken up by hand, they were not completely broken up during 20 minutes of mixing with the Imer Mortarman mixer. It was determined that the clumps were in the premix because expired premix was accidentally shipped to the FDOT laboratory.

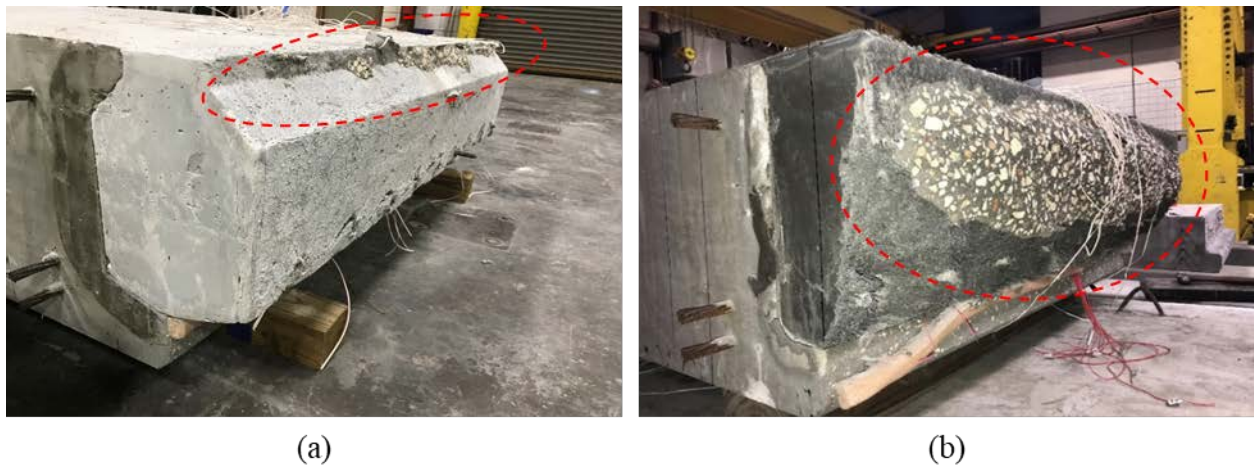
Figure 5.26: UHPC joint bond comparison: (a) poor bond observed with the faulty UHPC mixture and (b) enhanced bond observed with the adequate UHPC mixture

The first shipment of UHPC components received were a light grey dry premix and Chryσιο Premia[®] admixture. The light grey premix is used for Ductal[®] JS1212 accelerated mix, which requires a different set of admixtures. The Ductal[®] JS1000 is used with the Chryσιο Premia[®] admixture. The use of the wrong admixture with the wrong premix resulted in a faster setting time and stiffer mix. This likely contributed to the poor bond between precast beam and UHPC observed. The proper dark grey premix was then shipped to the laboratory and used for the second set of joint tests. Using this premix with the appropriate admixture improved flowability and extended the working time for the UHPC mixture. The comparison between the bond of the UHPC to the precast beam for sandblasted finish joints with the first and second UHPC mixtures is shown in Figure 5.26. There was an improved bond with the proper UHPC mixture.

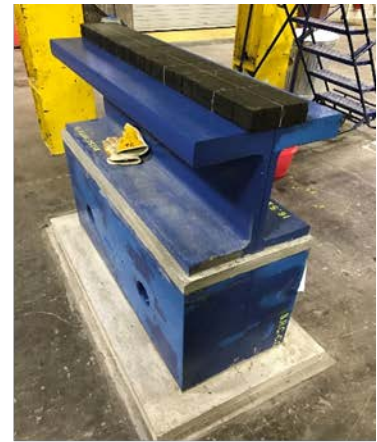
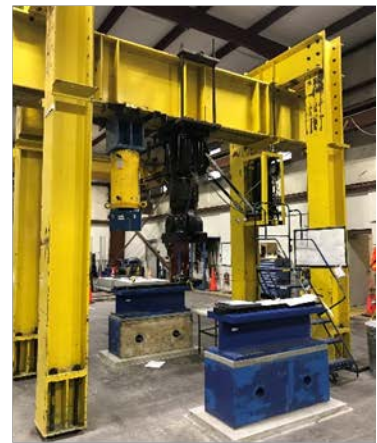
Figure 5.30: (a) Supports elevation layout, (b) display of support configuration, (c) supports plan layout, and (d) display of supports and testing frame

This test setup consisted of two main supports holding the samples in a simply supported configuration with a vertical clearance of 44 inches, as shown in Figure 5.30. The vertical clearance allowed for easy removal of the bottom instrumentation and ensured enough space for documenting crack patterns underneath the beams. The supports were grouted to the strong floor to ensure flatness and avoid undesired movement. The supports consisted of steel load blocks filled with concrete and steel I-beams to ensure enough vertical height.

Plain 2-inch-thick neoprene bearing pads measuring 48-inch long by 6-inch width were used for the initial test, as shown in Figure 5.30 (b). However, these bearing pads were found to partially restrain the horizontal degree of freedom, which caused undesired rotation and cracking in the grout pad under one of the supports, as shown in Figure 5.31 (a). A modified support was created to allow for horizontal displacement consisting of two sliding plates with a middle Teflon filling and guide rails, as shown in Figure 5.31 (b) and (c). These supports allowed for horizontal displacement and rotation, as shown in Figure 5.31 (c).

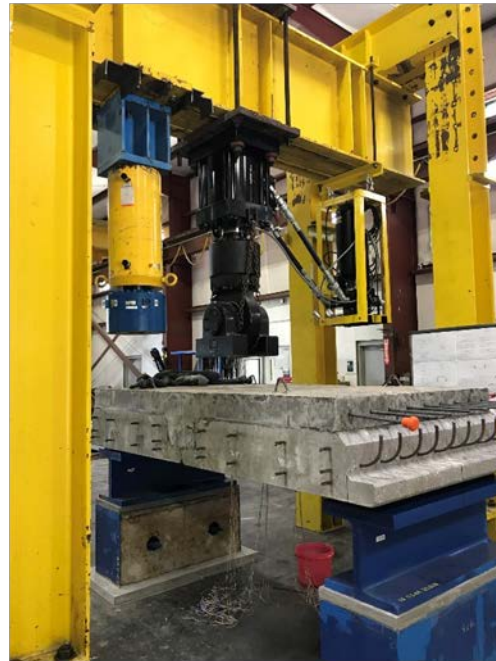
Figure 5.32: (a) Testing frame and specimen configuration layout (east view) and (b) display of specimen (control FSB) and testing frame

The test setup with one of the FSB specimens ready for testing is shown in Figure 5.32. The simply supported specimens were loaded by a Shore Western hydraulic jack with a 460-kip static and fatigue capacity and an available stroke length of 10 inches. The jack was mounted in a frame with four columns (W14) with a center-to-center dimension of 12 feet longitudinally and 6 feet transversely supporting a double W36x150 jacking beam. The load application point was a steel plate with a 20-inch by 10-inch surface area and 2-inch thickness with a bottom neoprene bearing pad of the same size. The load area is similar to the wheel path of an AASTHO HL-93 truck [72].

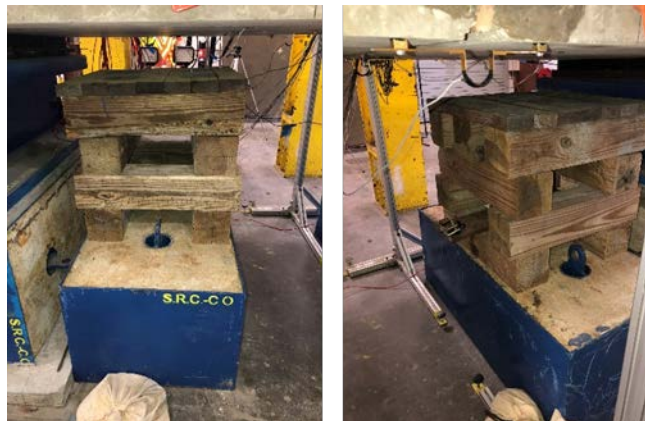
Figure 5.33: Bottom wooden frames

Due to possible excessive deflection or fracture that might occur during the test, two small lumber frames were placed underneath all the specimens as a safety measure, shown in Figure 5.33. Enough clearance was left between the lumber protection and the specimens to ensure adequate deflection until the ultimate capacity was achieved.

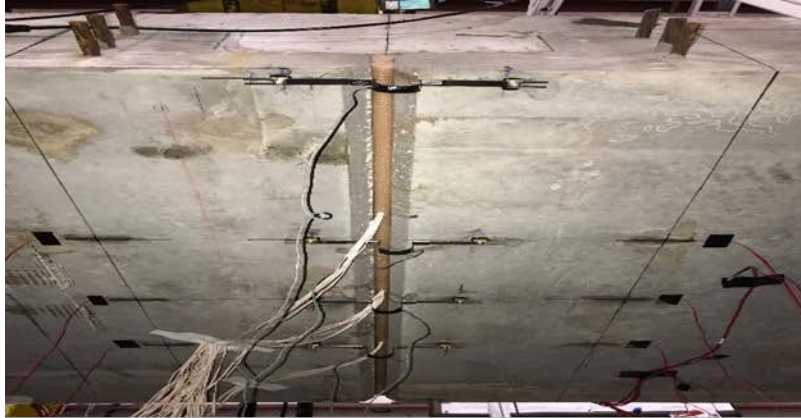
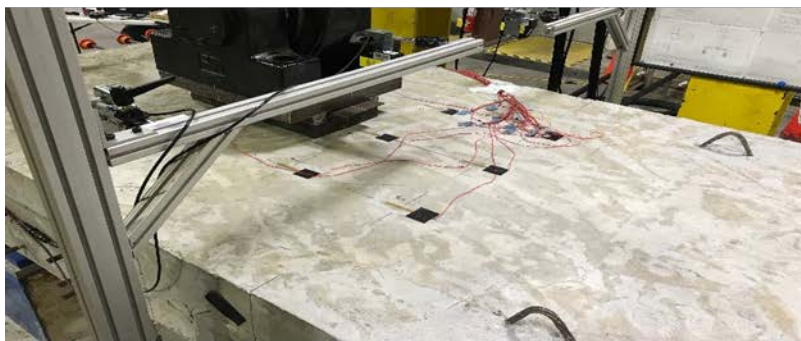
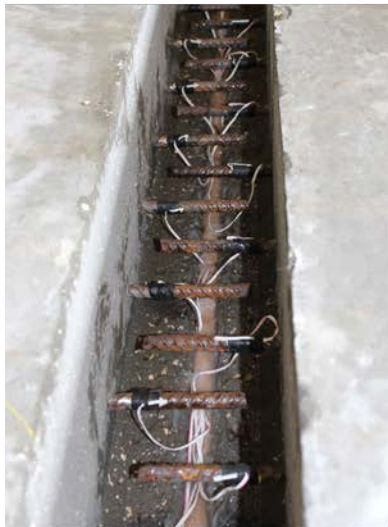
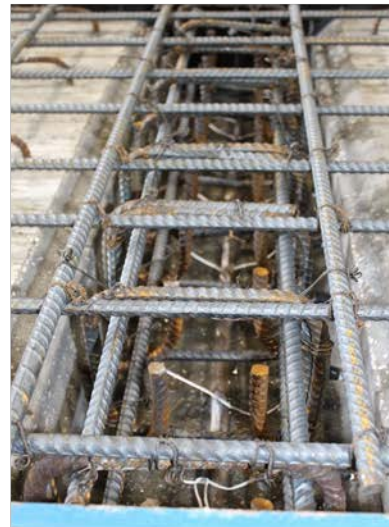
Figure 5.37: Actual installed sensors: (a) bottom view with CSGs and CDTs, (b) top view with CSGs, (c) RSG location in UHPC closure, and (d) RSG location in FSB closure

A photograph of the actual sensors installed on one of the specimens is shown in Figure 5.37.

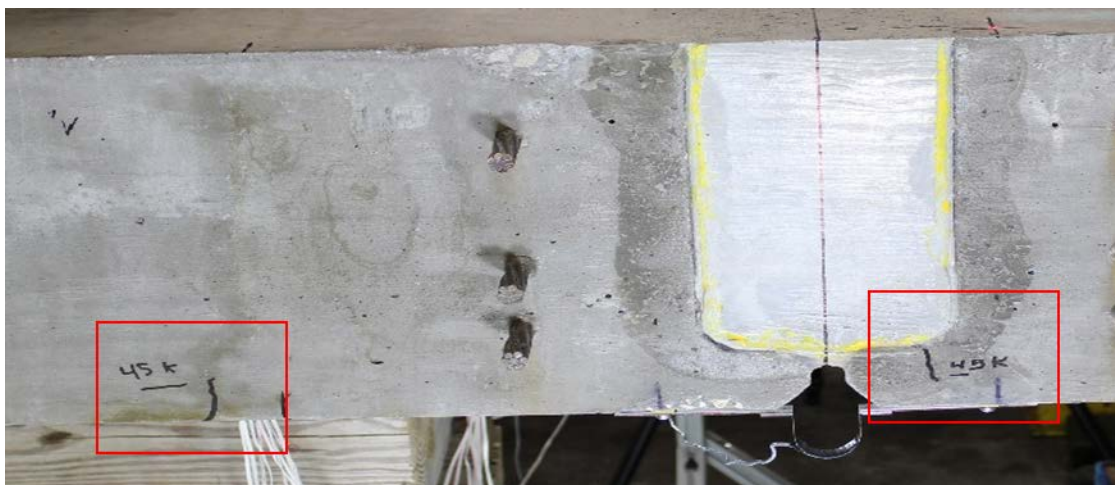
Figure 5.42: Actual cracks from visual inspection (12F2-1 shown)

- *Visual inspection:* An approximate cracking load was obtained through visual inspection during testing. The load at which first cracking appeared was documented and marked, as shown in Figure 5.42. First cracking either occurred in the precast section or at the joint boundary.

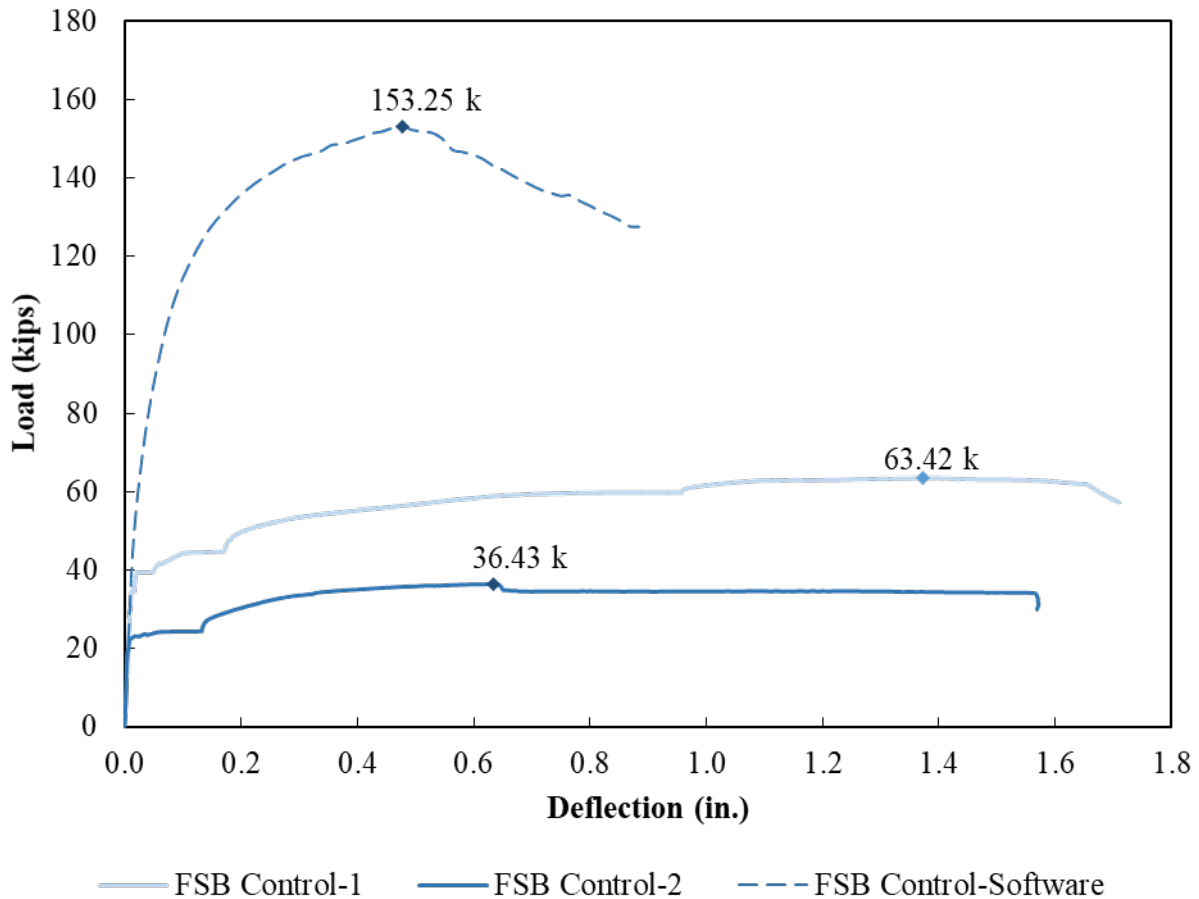
The measured load versus displacement response for the FSB control specimens (FSB-1 and FSB-2) compared to the predicted response from numerical modeling is shown in Figure 5.44. The measured initial stiffness was the same as predicted numerically. The experimentally tested specimens had much lower capacities.

Figure 5.44: FSB Control specimen load versus deflection responses with maximum values

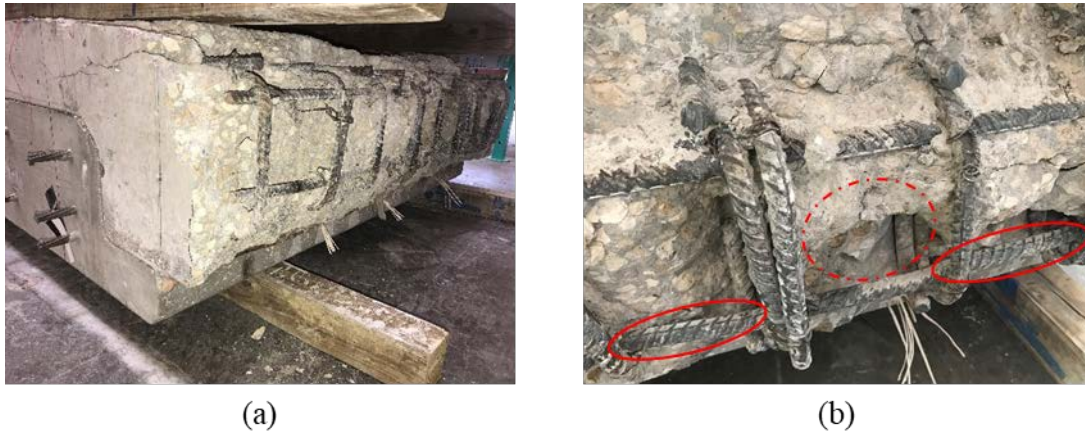
Figure 5.46: (a) Failed FSB Control-1 joint and (b) pull-out cavity in inner confined concrete (dashed line) and longitudinal rebar bend due to bending and pull-out forces (solid lines)

The failed FSB-1 specimen with the joint reinforcement is shown in Figure 5.46 (a). The hooked transverse reinforcement was pulled from the inner concrete confined by the rebar cage in the joint matrix, as shown in Figure 5.46 (b). The bottom longitudinal rebar of the joint cage reinforcement was bent due to the pull-out and bending forces.

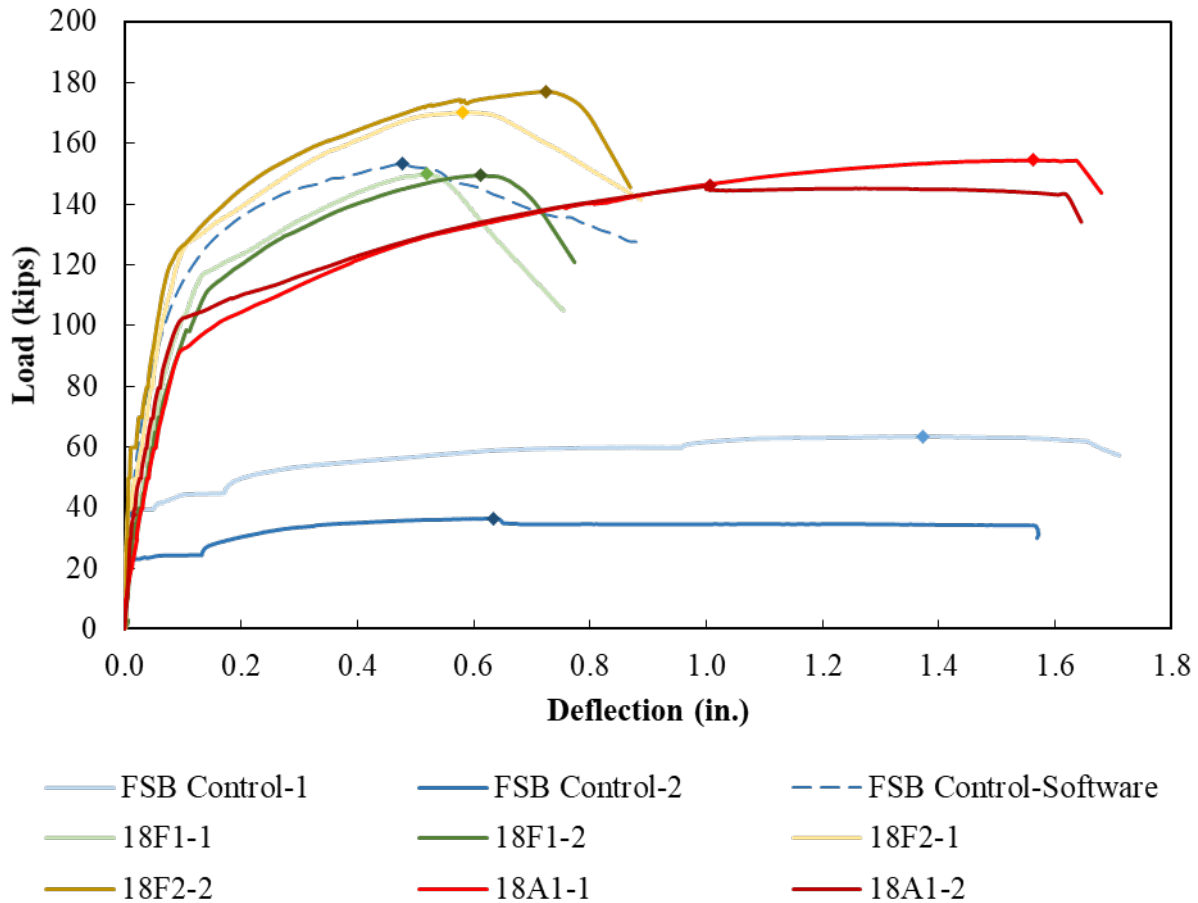
A comparison between all the 18-inch-deep specimens is presented in this section. The measured load versus displacement response for each of the 18-inch-deep specimens is shown in Figure 5.49. The maximum capacity achieved by each specimen is highlighted. The results from the measured and predicted response for the FSB control specimens are also plotted.

Figure 5.49: 18-inch specimens: load versus deflection experimental static tests with maximum values

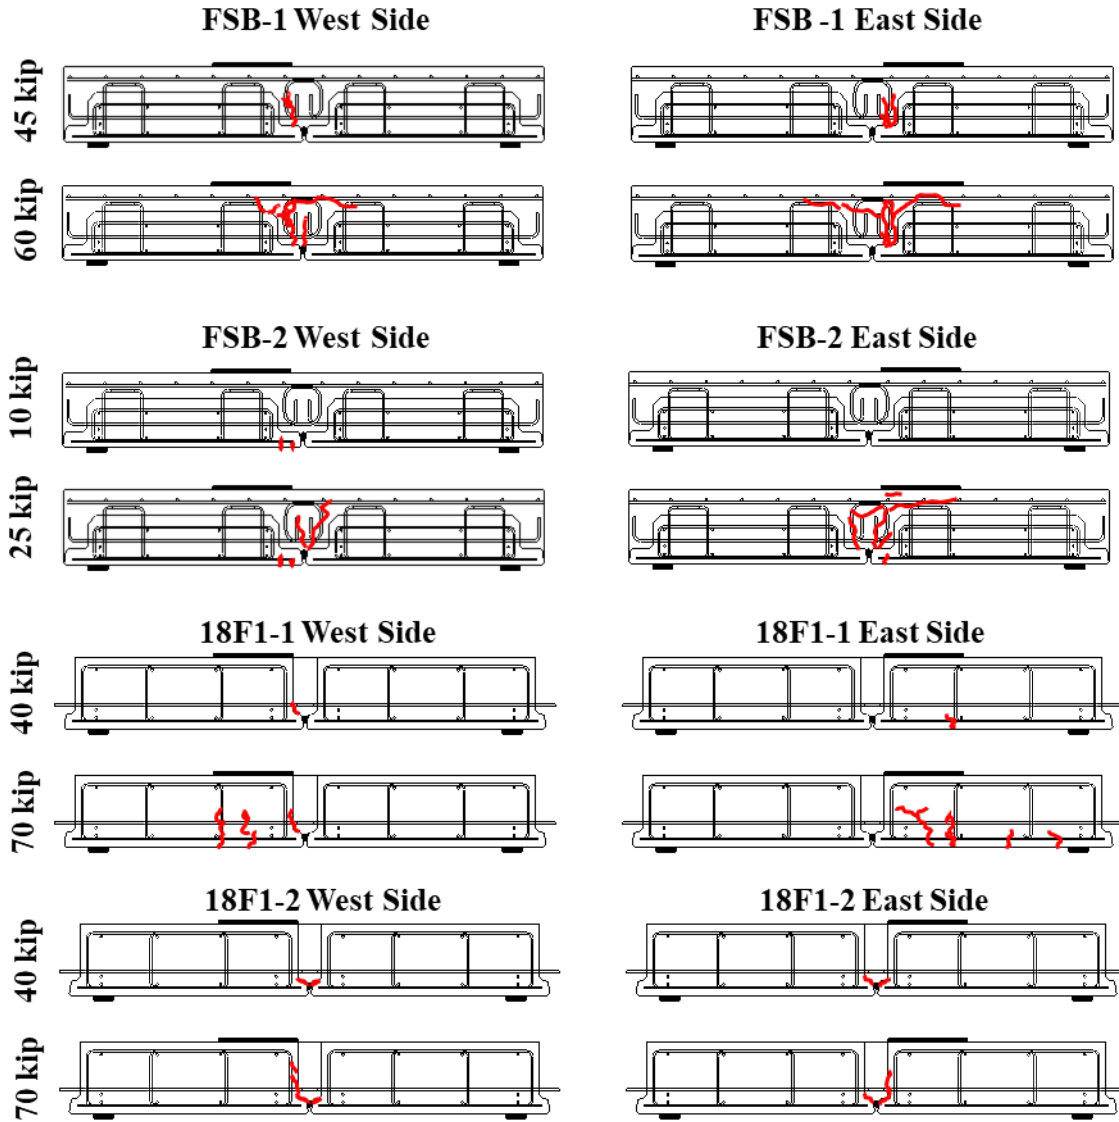
The progression of cracking was monitored during testing. The cracking on both sides of the beams when they were first observed and when the bottom CDTs were removed (at fourth loading step: 65% of failure in most cases) is shown in Figure 5.50 and Figure 5.51. Most of the cracking that occurred in the FSB control specimens was in the joint region, likely due to lower tensile concrete strength than the beams. Debonding between the precast beam and UHPC joint occurred in all the UHPC joint specimens, suggesting the bond strength was weaker than the tensile strength of the neighboring concrete.

Figure 5.50: Crack pattern of 18-inch specimens

| Figure 5.50: Crack pattern of 18-inch specimens | 125 |

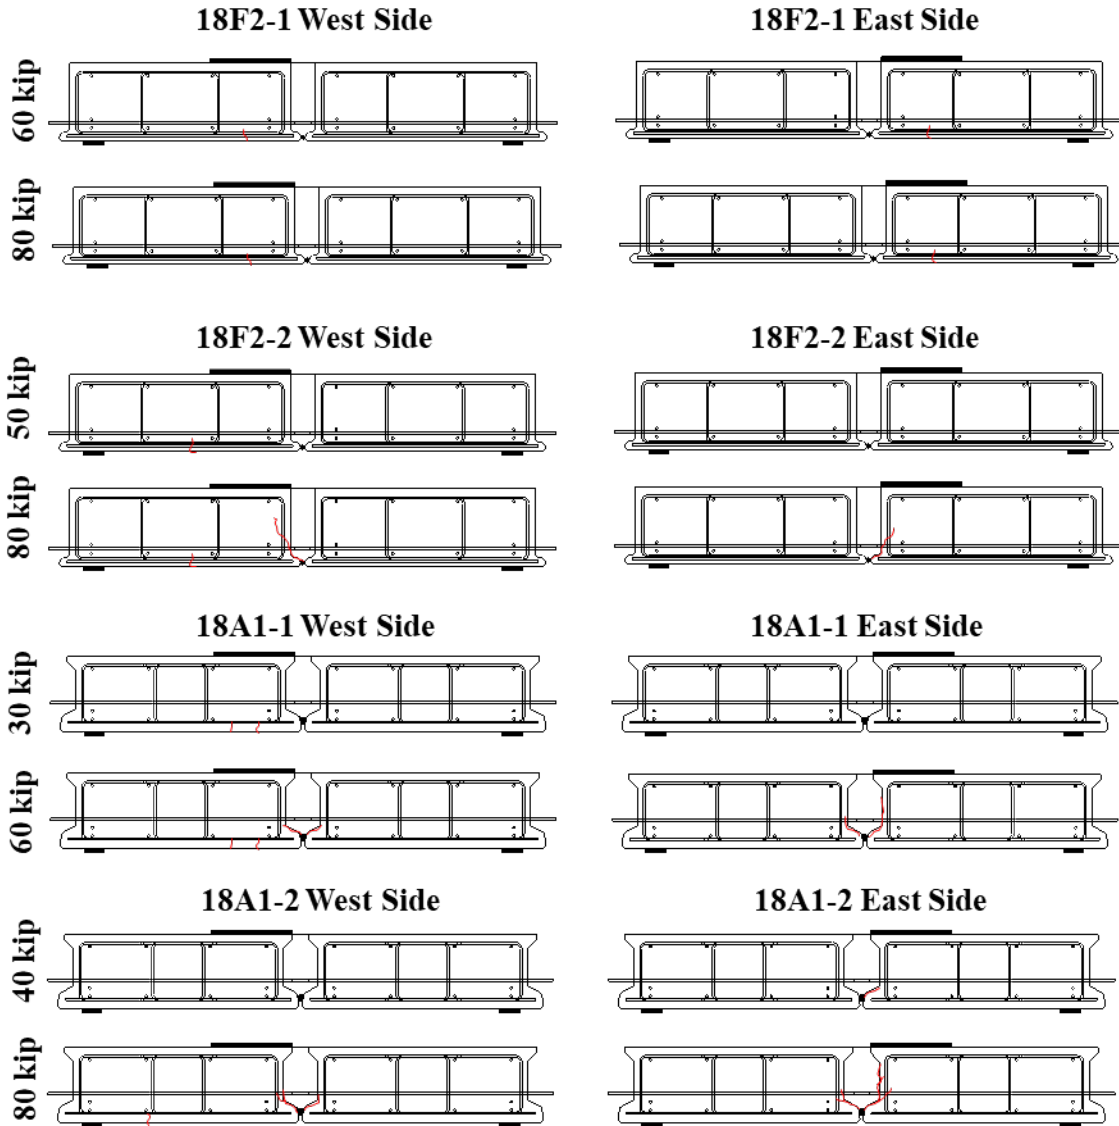
Only minor cracking was observed in the precast portions of specimens 18F2 and 18A1 during both testing stages. This was due to UHPC-to-precast bond loss that occurred before reaching the ultimate capacity of the connection.

Figure 5.51: Crack pattern of 18-inch specimens (cont.)

| Figure 5.51: Crack pattern of 18-inch specimens (cont.)..... | 126 |

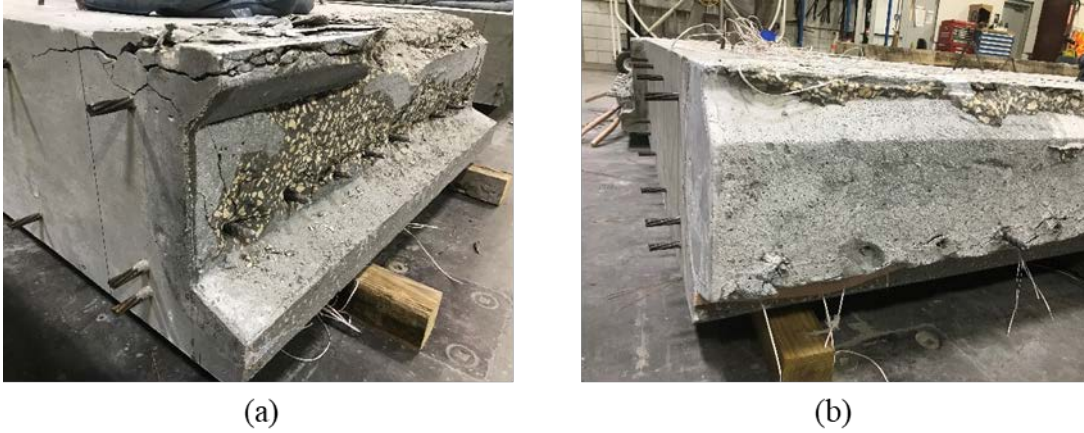
Figure 5.56: (a) Failed 18A1-1 specimen (loaded beam showed) and (b) UHPC matrix attached to unloaded beam

The failure plane of the 18A1-1 specimen is shown in Figure 5.56. This joint configuration was the only one in which all the joint reinforcement ruptured, which is likely due to a larger development length provided in the joint. Although its overall capacity was like 18F1 (a result of similar lever arms in the joint reinforcement), its ductility was larger (a product of failure being controlled by the rupture of reinforcement). All reinforcement on the loaded side ruptured at the interface between the precast section and UHPC joint, leaving a bottleneck shape at the tip of each bar as shown in Figure 5.56 (a). Additionally, there were no observed cones in the UHPC, as shown in Figure 5.56 (b).
