FLORIDA SLAB BEAM BRIDGE WITH ULTRA-HIGH-PERFORMANCE CONCRETE JOINT CONNECTIONS

(Project Nos.: BDV29-977-28 and BDV29-977-65)

Final Report

December 2021

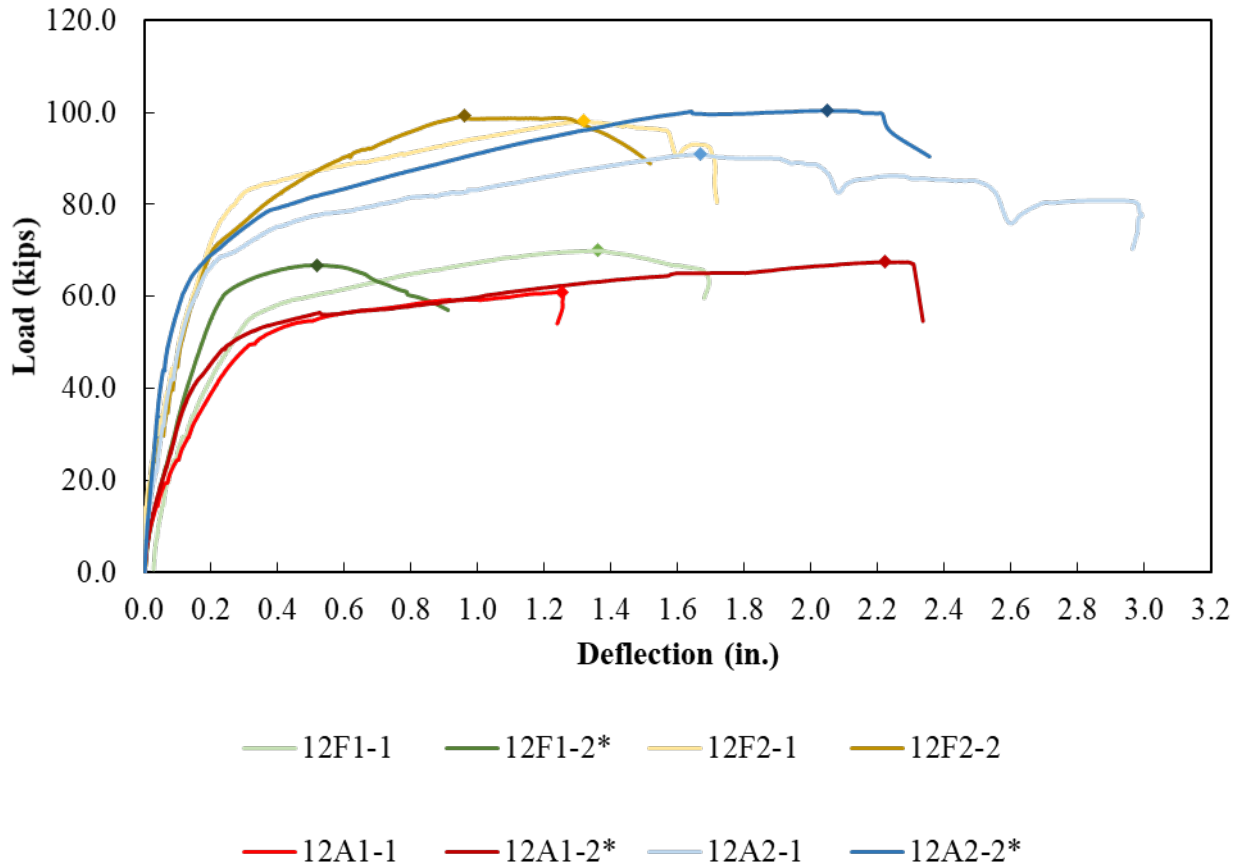
A comparison between all the 12-inch-deep specimens is presented in this section. The measured load versus displacement response for each of the 12-inch-deep specimens is shown in Figure 5.59. The maximum capacity achieved by each specimen is also highlighted. The results for three of the tests was following fatigue testing where over 2 million cyclic loads were applied. A further discussion of the results from the fatigue testing will be presented in subsequent sections.

Figure 5.59: 12-inch specimens: experimental static tests with maximum values

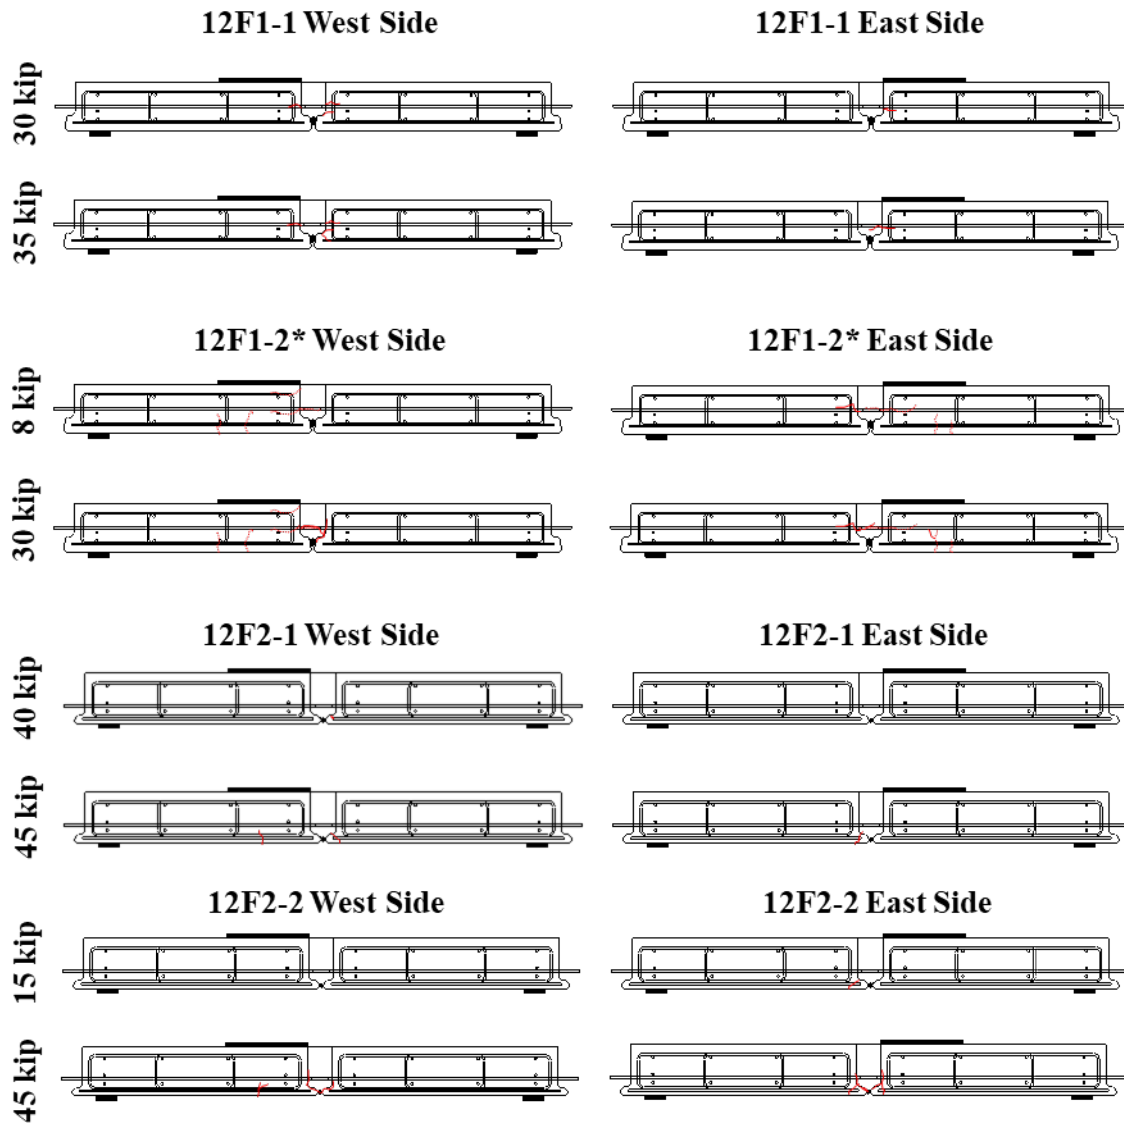
Figure 5.60: Crack pattern of 12-inch specimens (dashed lines indicate cracks formed in the cyclic stage); *strength test performed after fatigue testing

| Figure 5.60: Crack pattern of 12-inch specimens (dashed lines indicate cracks formed in the cyclic stage); *strength test performed after fatigue testing | 134 |

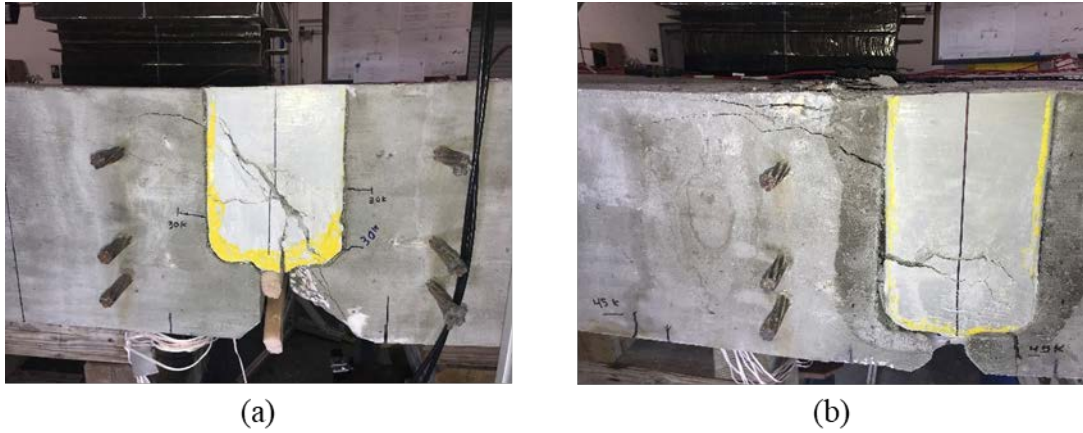
Figure 5.64: Cracking at failure for (a) 12F1-1 and (b) 12F2-1

The failed 12F1-1 and 12F2-1 specimens are shown in Figure 5.64 (a) and (b), respectively. Diagonal crack patterns were seen on both 12F1 specimens and horizontal splitting cracks on both 12F2 specimens. Hinging behavior was observed in 12F2-1 as the top concrete cover from the north beam ruptured and showed cover spalling.

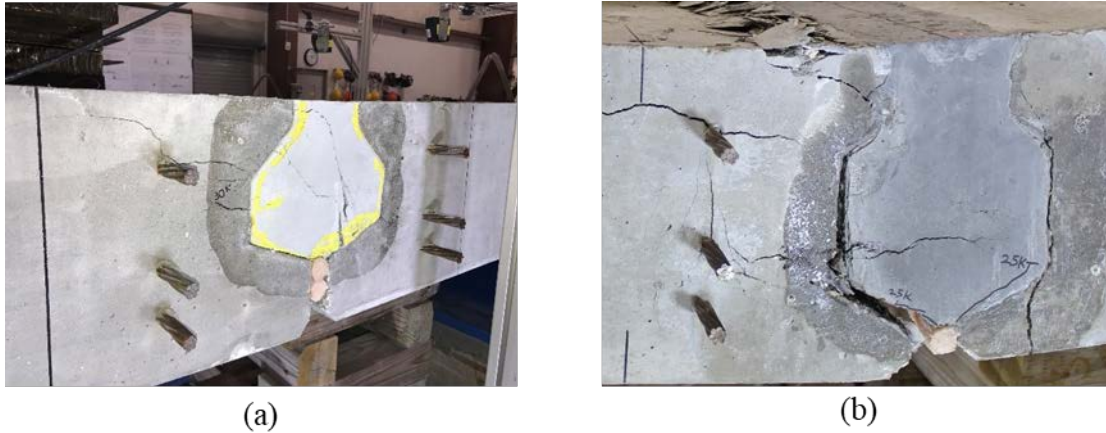
Figure 5.67: (a) Failed 12A1-1 specimen and (b) Failed 12A2-1 specimen

A more ductile behavior was observed in 12A1 and 12A2 specimens due to a larger embedment length of the joint reinforcement. Crushing of the concrete in the compression block under the load caused failure in these specimens, as shown in Figure 5.67 (a) for 12A1-1 and Figure 5.67 (b) for 12A2-1. There was cracking in the 12A1 specimens that extended from the inside corner of the joint to the center for the load point, showing a stress concentration at this point. There is no cracking extending from the inside corner of joint 12A2.

A horizontal crack developed at the level of the joint reinforcement in 12A2-1, shown in Figure 5.67 (b), but no pull-out of the reinforcement was observed. While cracking at the level of the reinforcement caused a splitting type pull-out failure in other specimens, shown in Figure 5.68 (a), the reinforcement level cracking in 12A2-1 extended into the precast section as well and is thought to be caused by bending stresses in the section, shown in Figure 5.68 (b).

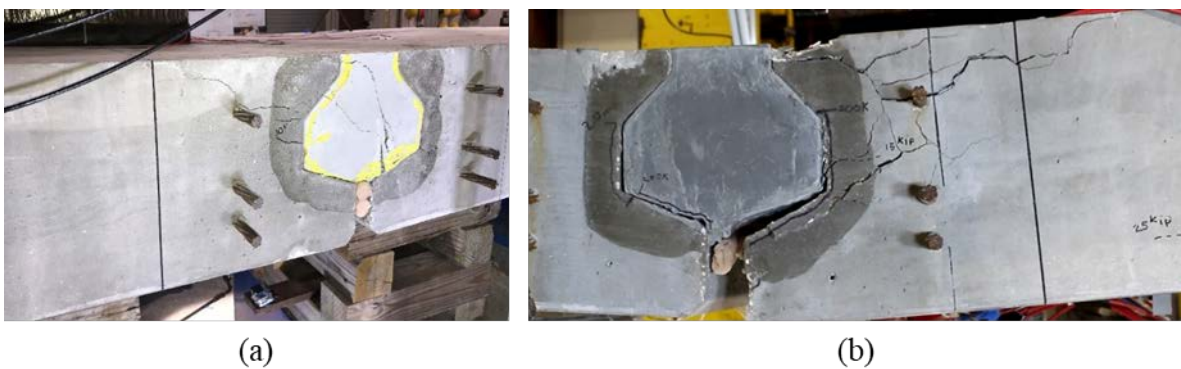
Figure 6.21: Failure crack for ultimate strength testing of 12A1 (a) without any fatigue load applied, 12A1-1 and (b) after fatigue loading, 12A1-2

The failure crack pattern for 12A1 without any fatigue load (12A1-1) and after fatigue loading (12A1-2) is shown in Figure 6.21 and Figure 6.22. Specimen 12A1-1 failed with a crack extending diagonally through the joint region; failure may have been at the splice between the reinforcement like 12F1-1. For the specimen tested after fatigue testing (12A1-2), cracking occurred along the boundary of the joint and then extended into the precast section; failure occurred when the concrete in the compression block crushed, and the joint reinforcement fractured.

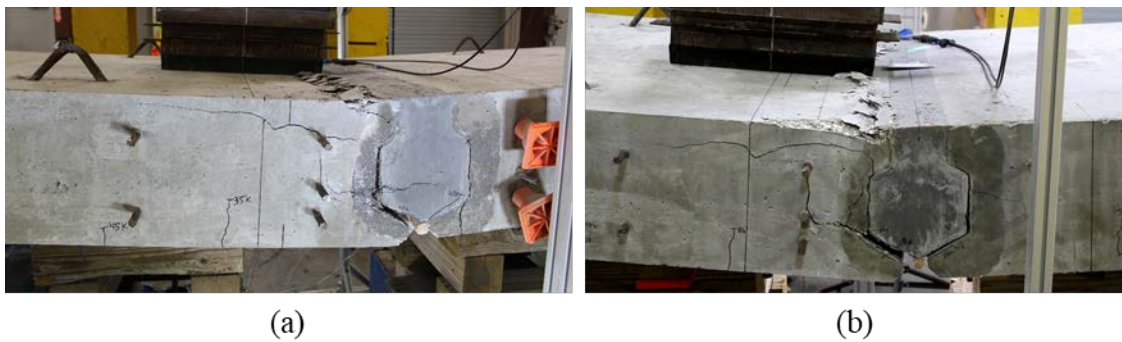
Figure 6.23: Failure crack for ultimate strength testing of 12A2 (a) without any fatigue load applied, 12A2-1 and (b) after fatigue loading, 12A2-2

The failure crack pattern for 12A2 without any fatigue load (12A2-1) and after fatigue loading (12A2-2) is shown in Figure 6.23 and Figure 6.24. Both specimens failed due to crushing of the concrete next to the load and the edge of the joint. Additionally, both specimens had large cracking along the joint interface and a moderately sized horizontal crack developing under the load. 12A2-1 developed a crack at the level of the joint reinforcement in the joint and the precast beam. 12A2-2 developed a crack extending from the edge of the bottom lip into the precast beam.

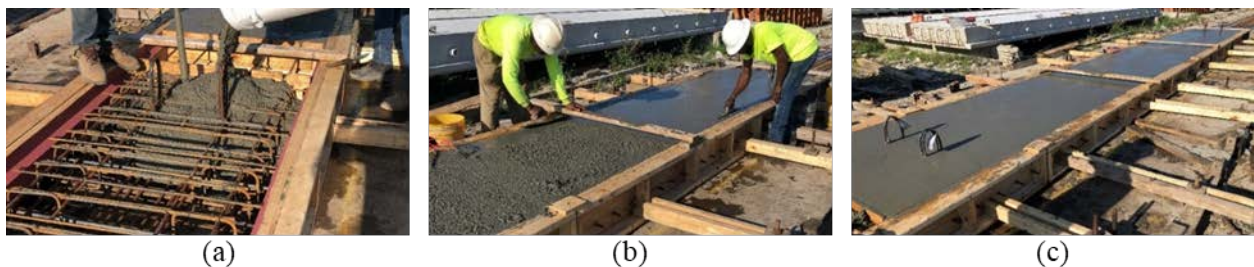
Figure 7.7: Casting of concrete for full-scale beams: (a) casting of concrete, (b) float finish on top of beams, and (c) finished beam after casting

The concrete was cast after the reinforcement cage and forms were assembled, as shown in Figure 7.7 (a). The top beam surfaces were prepared with a top smooth float finish, as shown in Figure 7.7 (b). Beams were moist cured for at least 24 hours after casting.

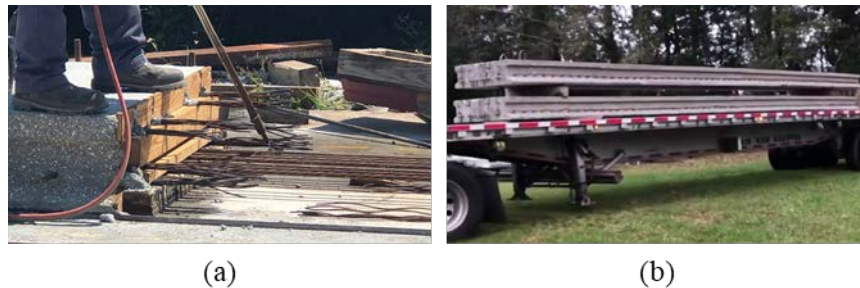
Figure 7.9: (a) Beam release stage and (b) delivery of slab-beam specimens

The strands were then released starting at the top row from exterior corner to interior strands; then the middle layers and bottommost layers were released using the same cut pattern, as shown in Figure 7.9 (a). After all the beams were built at the precast plant, they were shipped and delivered to the FDOT M.H. Ansley Structures Research Center in Tallahassee, as shown in Figure 7.9 (b).

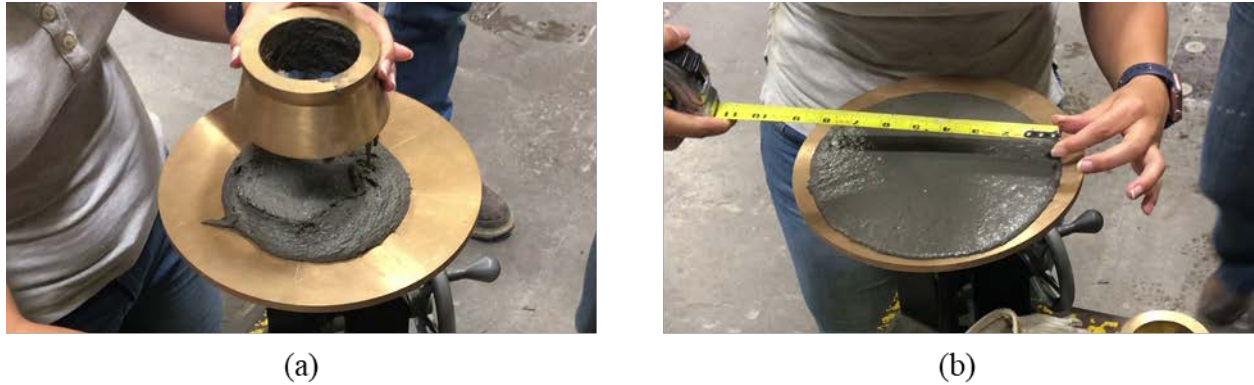
Figure 7.11: UHPC flow test: (a) mold removal and (b) spread measurement

The rheological properties were measured for each UHPC batch by performing static and dynamic flow tests. A slightly modified version of ASTM C1437 [76] was used per FHWA material tests recommendation [39], as shown in Figure 7.11 (a) and (b).

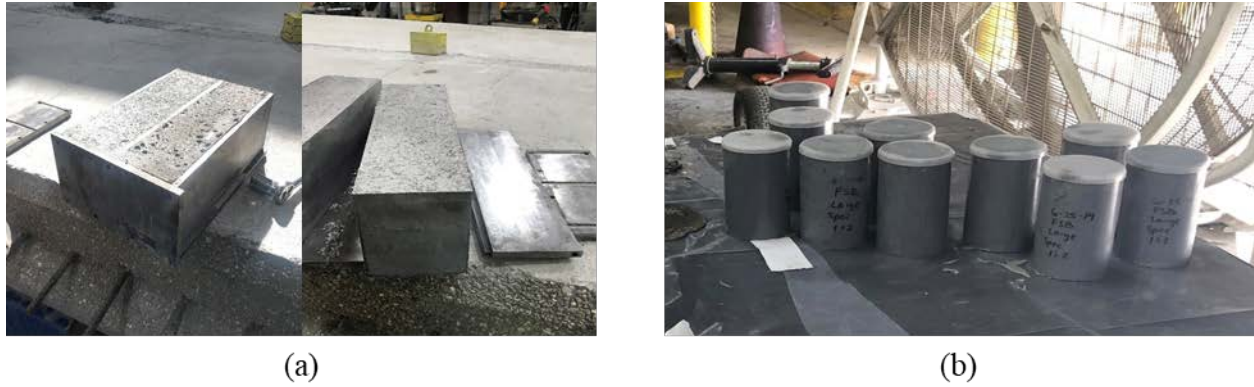
Figure 7.12: UHPC samples: (a) 4x4x14 in. beam in molds after grinding for dimensional consistency and (b) ten 4x8 in. cylinders for compressive strength

Per ASTM C1856 [63], the flexural strength of the UHPC was measured using small-scale beams subjected to four-point loading using ASTM C1609 [64]. Five 4-inch by 4-inch by 14-inch beam samples were cast at the same time the joints were built using metallic molds, and ground for dimensional consistency, as shown in Figure 7.12 (a). These beams were tested on the day of joint testing to determine the tensile strength of the UHPC. Some of the concrete cylinders for one batch are shown in Figure 7.12 (b).

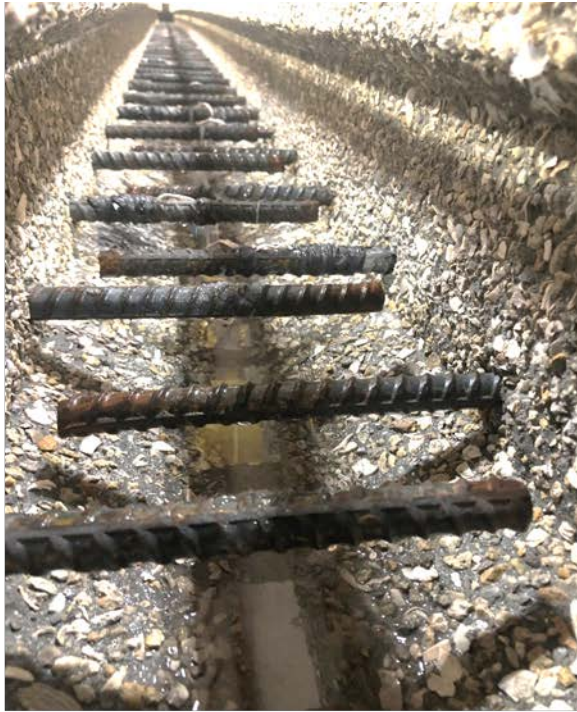
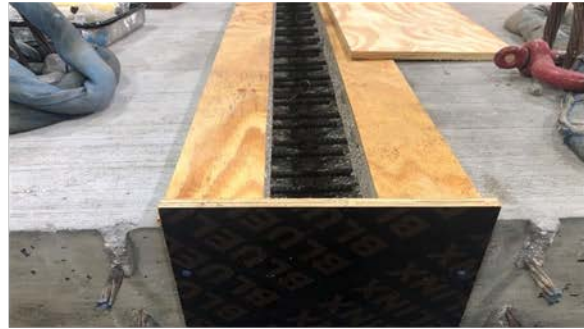
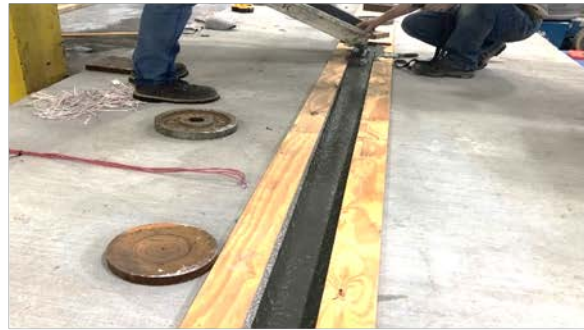
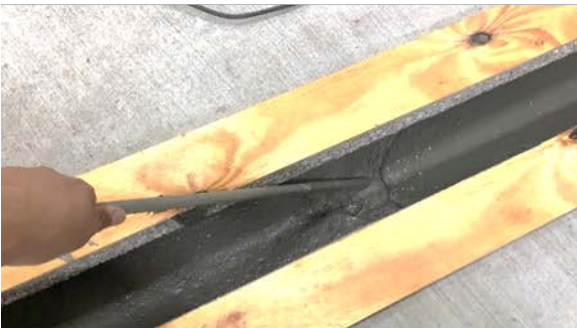
Figure 7.13: Casting procedure for UHPC joint: (a) beams alignment with $\frac{3}{4}$ -inch gap and backer rod, (b) connection detail with plywood block-out and top strips for over pour volume, (c) casting operation for the field-cast UHPC, (d) rodding procedure for two encountering pour heads, and (e) top formwork hold using weights

The construction of the large-scale UHPC joints followed the same guidelines described in the FHWA publication [39] and as shown in Figure 7.13. For each testing stage, the beams were placed side by side leaving a $\frac{3}{4}$ -inch clear gap and filled with a 1-inch backer rod, as shown in Figure 7.13 (a); a transparent silicone was used to fill the gaps between the bottom joint ledges and the backer rod. Plywood squares with painted waterproof sealer were then placed on each end to enclose the joint for UHPC cast, as shown in Figure 7.13 (b). This sealer avoided any water loss from the UHPC mix caused by the wood pores in direct contact. Wooden strips were also placed atop the precast beam ledges aligned with the joint boundary, providing at least a $\frac{1}{4}$ -inch depth for cast overpour purposes, as shown in Figure 7.13 (b). A day before casting the joint, a water seal test was performed by filling the joint volume up with water and leaving it for 24 hours; this also provided a saturated surface dry (SSD) condition for the joint.

The UHPC was mixed using the Mixer System Horizontal Shaft Mixer and cast in the joint starting from one end towards the center, as shown in Figure 7.13 (c). The procedure was then repeated from the other end until the two pour heads were encountered at the middle. A steel rod was gently used making sure the two pour heads mixed, and ensuring the steel fibers crossed the boundary, as shown in Figure 7.13 (d). Plywood formwork was used to cover the top of the joint when the UHPC almost reached the top of the joint, as shown in Figure 7.13 (e). The remaining UHPC was cast through a chimney at one end, increasing the pour height and pressure head to avoid air entrapped inside.

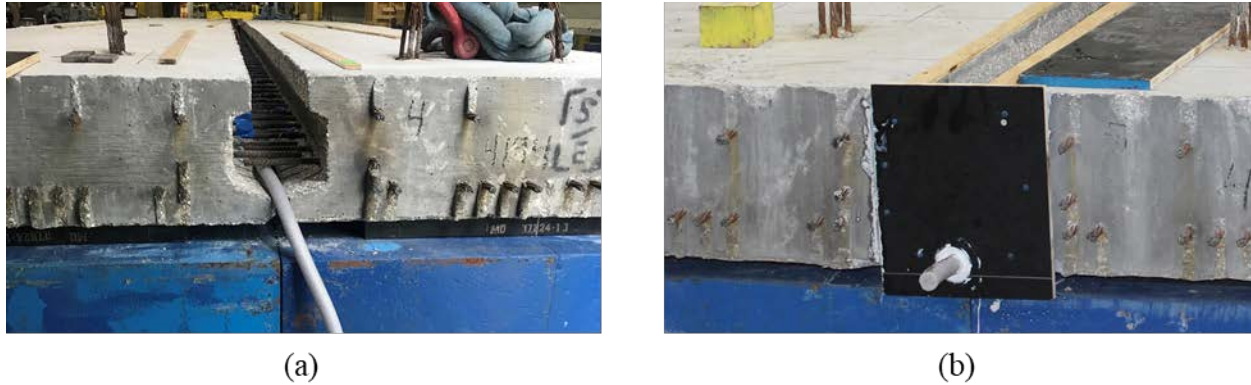
Figure 7.15: Backer rod detail: (a) 1-inch diameter rod and (b) rod extension through block-out form

Although the second set of beams (FIU-3 to FIU-8) was built using side form segments too as described in Figure 7.14 (a) and the same size backer rod (1 inch), the UHPC joint construction detail was improved by installing the backer rod from the top down, as shown in Figure 7.15 (a), and extending it outside the block-out joint end, as shown in Figure 7.15 (b). This construction technique helped to avoid any further UHPC leakage in the subsequent joint construction, increasing the joint tightness.

The use of a larger diameter backer rod (at least $\frac{1}{4}$ -inch larger than joint gap), installing the backer rod from the top down, and extending the backer rod through the joint end form created a water-tight seal while allowing for reasonable joint construction tolerances. The precaster used wood forms with holes cut for the joint reinforcement. The use of steel forms and mechanical threaded bars would help expedite construction process, improve joint quality, and avoid joint and reinforcement misalignments during bridge construction.

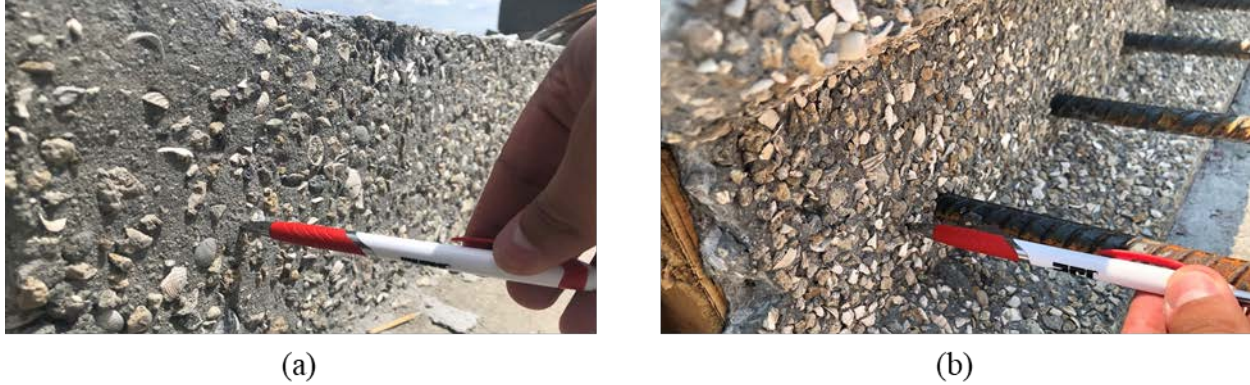
Figure 7.16: Master Finish HV retarder degrees of penetration: (a) light and (b) medium light

BASF – Master Finish HV Lilac (38) [67] was originally specified for the specimens constructed in this test program, which is used to create a light depth of etch for recommended aggregates ranging from $\frac{1}{4}$ -inch to $\frac{3}{8}$ -inch sizes. The precaster constructed several mockups and found that for their mixes the use of BASF Master Finish HV Lilac resulted in only a $\frac{1}{8}$ -inch amplitude surface roughness, as shown in Figure 7.16 (a). The precaster decided to use a deeper agent penetration (BASF – Master Finish HV Pink (48) [67]) to increase the exposure of the joint material; this product is specified for medium light depth of etch for aggregates ranging from $\frac{3}{8}$ -inch to $\frac{1}{2}$ -inch sizes. The use of this product resulted in the desired $\frac{1}{4}$ -inch roughness, as shown in Figure 7.16 (b).

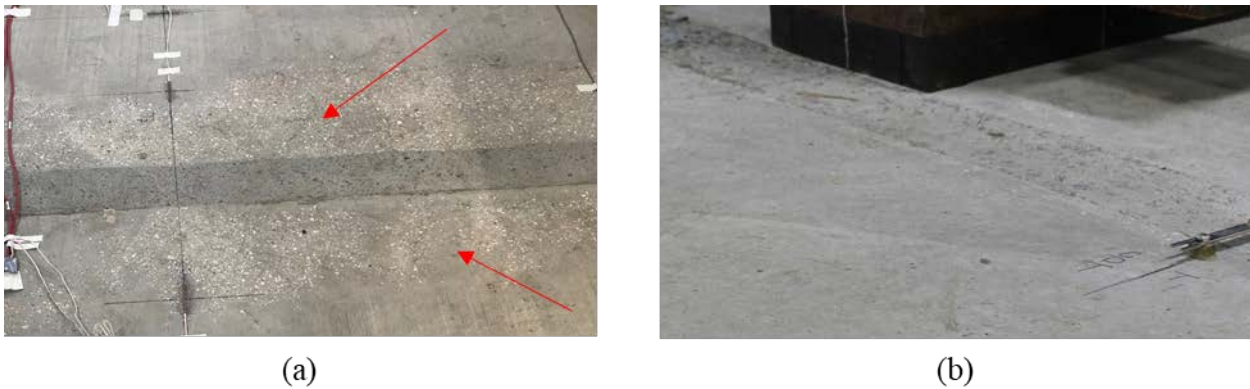
Figure 7.17: UHPC grinded surface: (a) surface finish after two days using gas grinder (showing precast abrasion), and (b) surface finish after one day using electric grinder

After casting the UHPC joint in the first set of beams (FIU-1 and FIU-2), the overpoured section was difficult to grind using an electric grinder two days after been cast. A gas grinder with a larger grinding area was required, hence it was unavoidable to grind down part of the precast sections, as shown in Figure 7.18 (a). As a result, it was recommended that the grinding to level the joint surface with the precast section should be done no later than one day after casting. After casting the UHPC joint in the second set of beams (FIU-4 and FIU-5), the overpoured section was easily ground down using an electric grinder 24 hours after cast, as shown in Figure 7.18 (b).

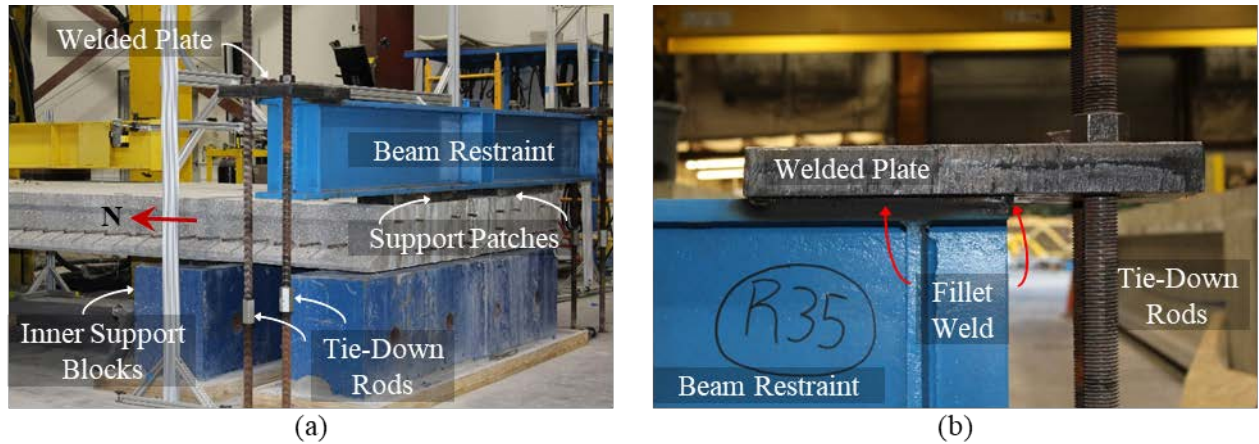
Figure 7.26: End moment restraint detail: (a) south-end view and (b) welded plate detail

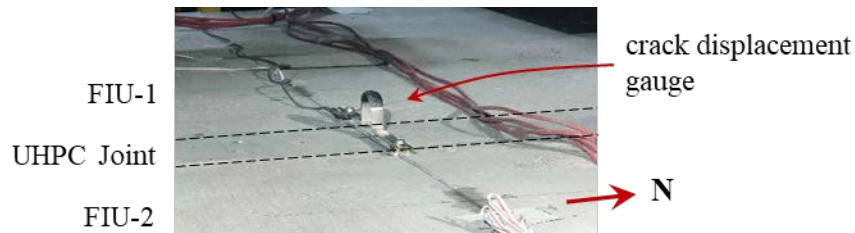
Figure 7.35: Crack displacement gauge used across joint

Crack displacement gauges (CDTs) were installed crossing the top and bottom of the joint between beams, as shown in Figure 7.36. The ends of the gauge were attached to the precast beam sections (not the joint) to measure any cracking in the joint or debonding of the joint interface.

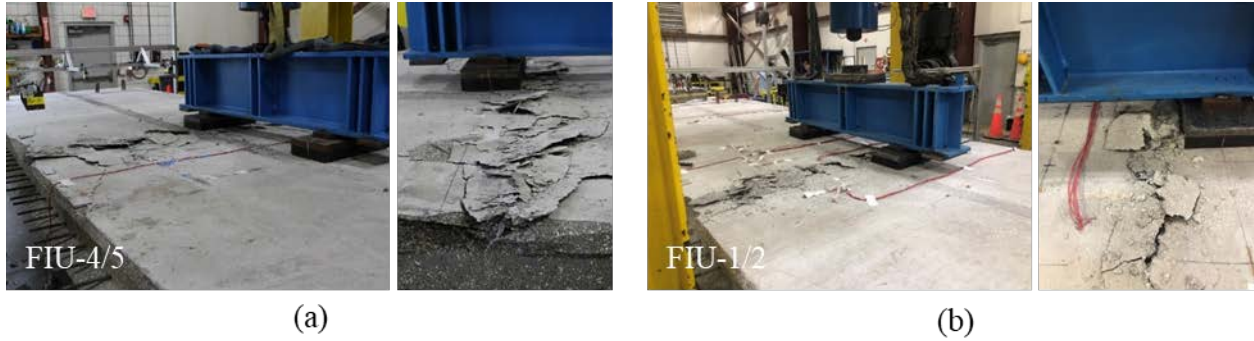
Figure 7.131: Crushing of FIU-5 and FIU-4 concrete at failure for Load Configuration 2-1: (a) overview and (b) crushing of UHPC in joint

Like FIU-1/2 ultimate strength test, no joint distress was observed in FIU-4/5 on the top or bottom of the joint along the length of the system. Failure of both FIU-1/2 and FIU-4/5 was triggered by crushing of the concrete just inside one of the load points, shown in Figure 7.132. The UHPC in the joint region also showed signs of crushing in both systems, which suggests a good bond between the precast beam and the joint.

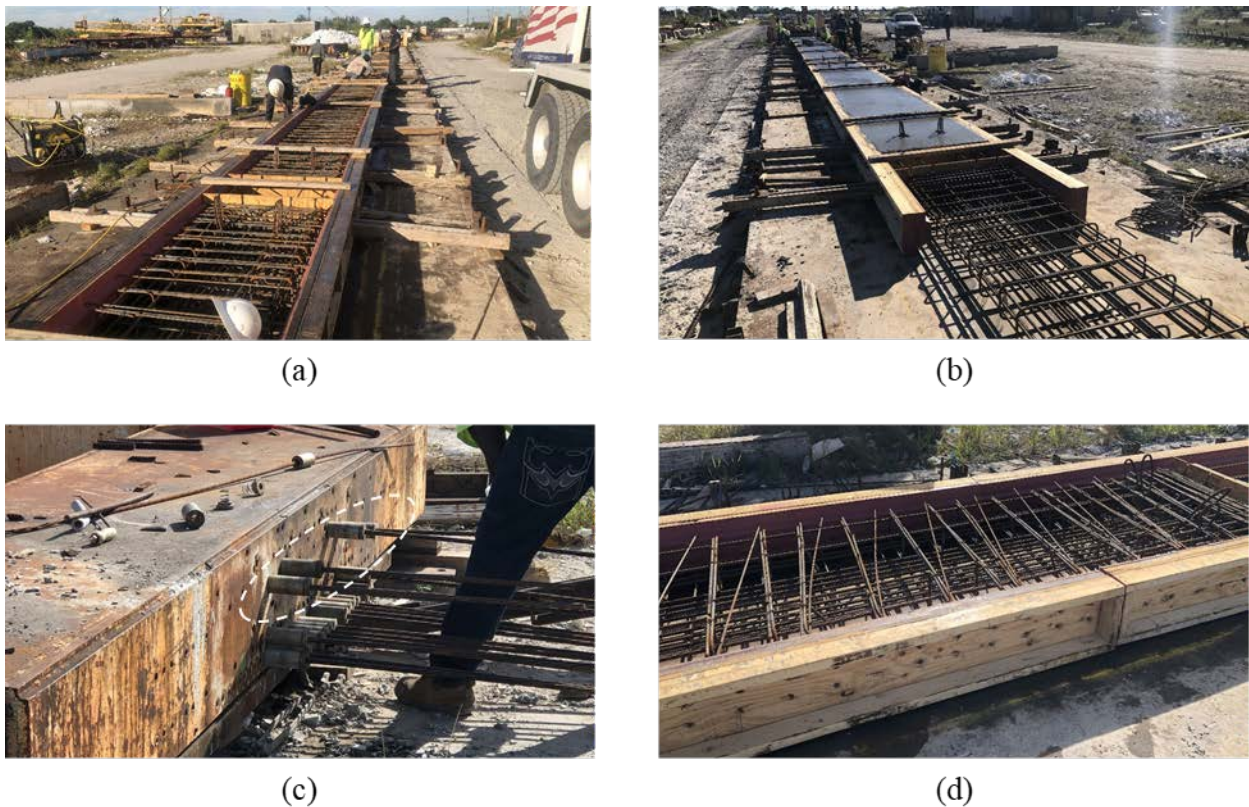
Figure 8.5: Construction of second set of beams: (a) FIU-8, FIU-7, and FIU-6 mild reinforcement and formwork construction, (b) concrete pour of first group of beams, (c) top strand layer de-tension, and (d) observed misalignment of mild reinforcement in second group of beams

Some photos of the casting process and shifting of the reinforcement after de-tensioning and re-tensioning the top strands are shown in Figure 8.5.

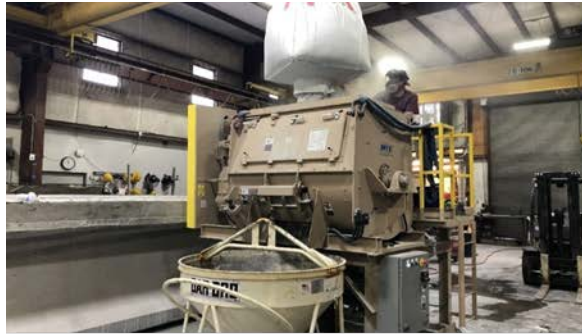
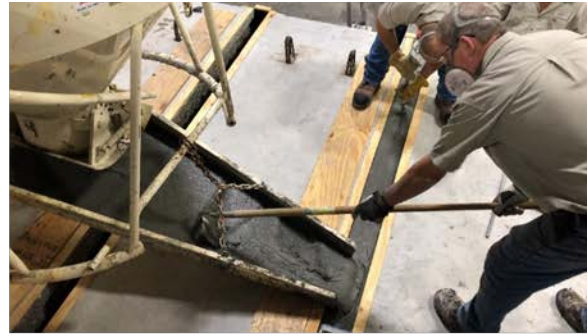
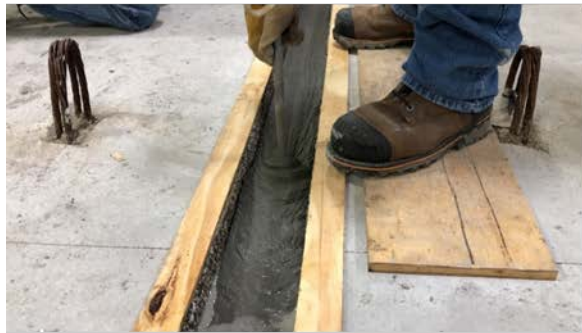
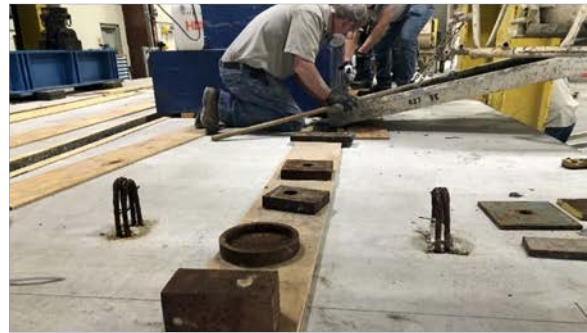
Figure 8.9: UHPC mixing and placement procedure: (a) premix added to mixer, (b) initial UHPC casting in uncovered joint, (c) rodding procedure for two encountering pour heads, and (d) joints covered with top formwork and weights to finish joint cast

The UHPC joints were cast using three different batches of UHPC. The UHPC mixture components were mixed in a Mixer System Horizontal Shaft Mixer, shown in Figure 8.9 (a). After finishing mixing all components for around 25 minutes, the UHPC was transported in a concrete hopper attached to an overhead crane and poured in the first joint as shown in Figure 8.9 (b).

The UHPC was placed at one end of the joint and allowed to flow up to the top of the joint at midspan of the beams. UHPC was cast in this position until it almost reached the top of the joint at midspan. At this point, casting was stopped, and top formwork and weights were placed on this half of the joint. The casting position was then moved to the other end of the joint and the process repeated. A steel rod was used to gently mix the region where two UHPC pour heads encountered each other, as shown in Figure 8.9 (c), which helped to ensure steel fibers crossed the boundary. The last UHPC in the joints was cast through a chimney at one end of the joint, which increased the pour height and pressure head to avoid entrapped air inside the joint. The complete joint length was fully covered when the UHPC was cast through the chimney. Joint 6-3 was cast first. This process was repeated for the second joint (Joint 3-8) and subsequently the third joint (Joint 8-7). Once the last joint (Joint 8-7) was cast and covered, the joints were allowed to harden for a period of 24 hours. All three joints were poured the same day with about 30 minutes between pours.

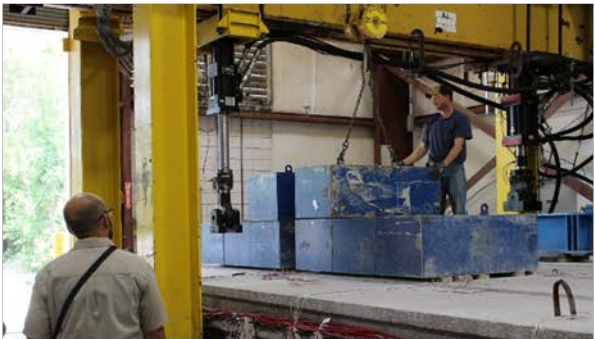
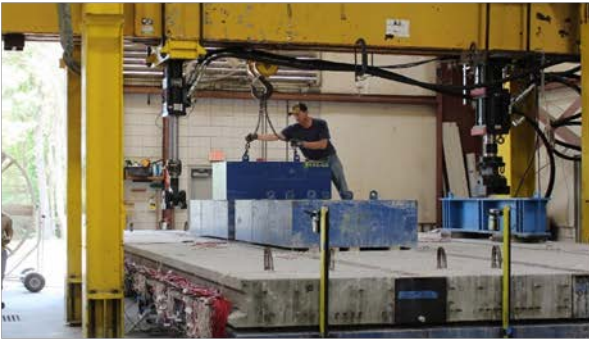
Figure 8.12: Load blocks removal from FIU-3: (a) load block weights in pounds and removal order (not to scale), (b) block 3 removal, and (c) block 4 removal

The surcharge load was removed from FIU-3 31 days after the casting of the UHPC joints. The load blocks used to apply the surcharge load were removed one at a time from alternating ends of the beam, as shown in Figure 8.12. All debris was cleared from the top of superstructure system after the removal of the load blocks and before the start of service testing.

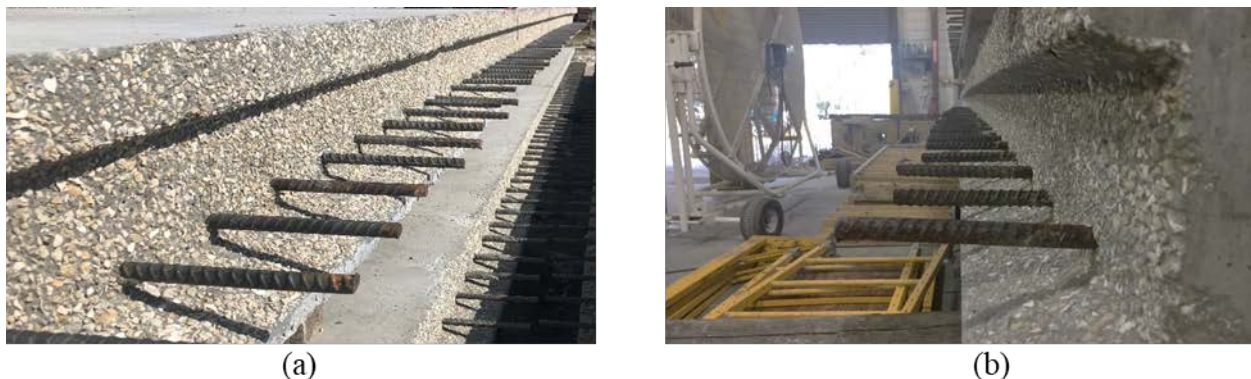
Figure 8.16: FIU-3 joint reinforcement length observations at (a) precast yard and (b) structures lab

A significant variation in the protruding length of the joint reinforcement was observed in FIU-3 after release when the specimens were being prepared for shipment to Tallahassee, as shown in Figure 8.16. The joint reinforcement crosses the entire width of the specimen, so a longer protruding length on one side of the beam coincided with a shorter protruding length on the other side of the beam.

It was decided to trim the extended bars to match the embedment length specifications before placing the beams for joint casting. Joint tolerances allowed for cutting some of the bars by 0.25 to 0.5 inches while still maintaining sufficient development and splice lengths. This construction issue was also observed in the other beams, but the length variations were not as significant as on FIU-3.

The variation in the FIU-3 joint reinforcement length was likely due to the construction procedure for these specimens. The reinforcement cage was completely tied, and side forms

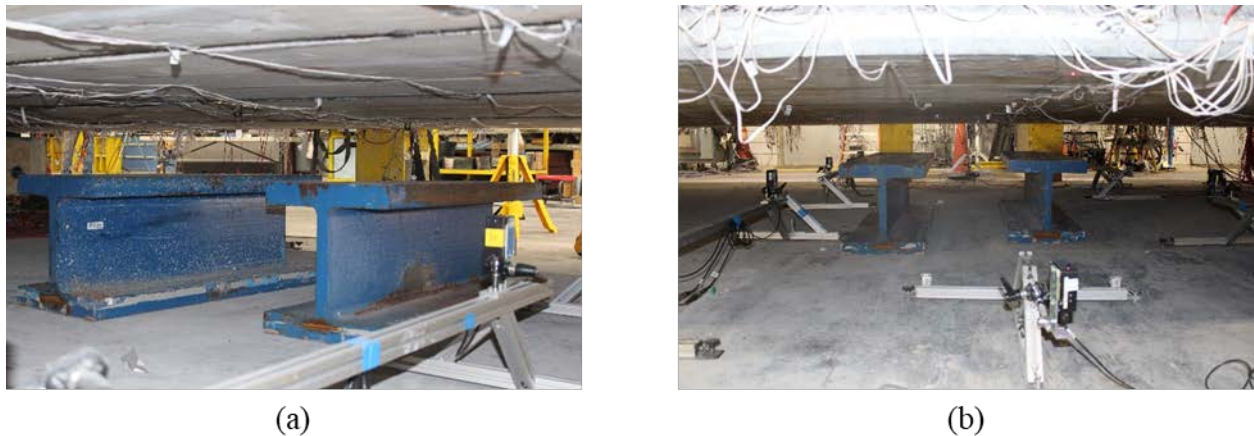
Figure 8.23: (a) Bottom steel I-beams, (b) clearance display between specimen and sensors

Two small steel I-beams were placed underneath the specimen at midspan as a safety measure in case of sudden failure of the superstructure system, as shown in Figure 8.23 (a). These I-beams helped to protect the sensors that were left underneath the specimen throughout the strength test, as shown in Figure 8.23 (b). Enough clearance was left between the I-beams and the specimens to ensure adequate deflection until system failure.

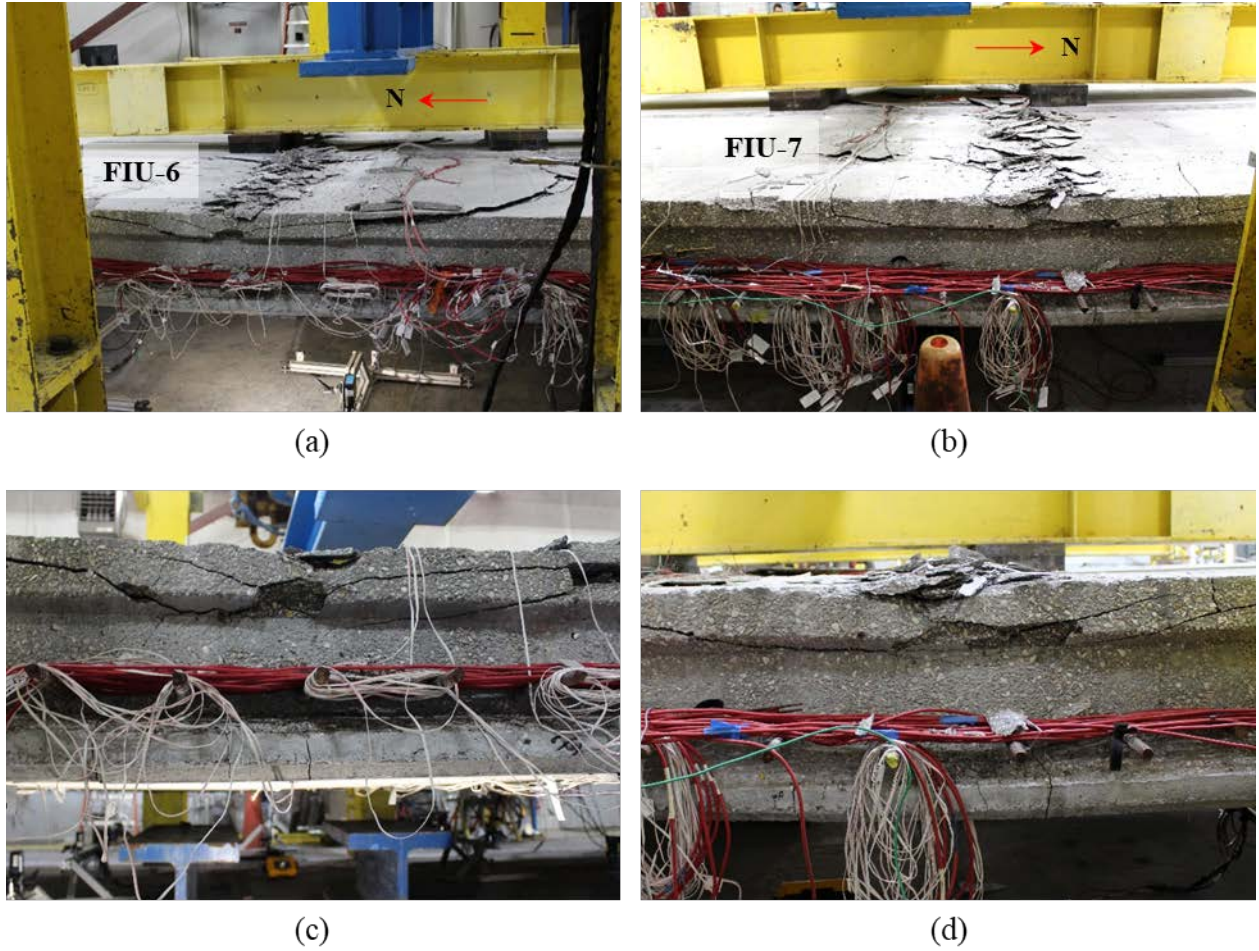
Figure 8.115: Crushing of FIU-6/3/8/7 concrete at failure for LC 4-5: (a) overview and (b) crushing of precast section and UHPC joint (FIU 6-3)

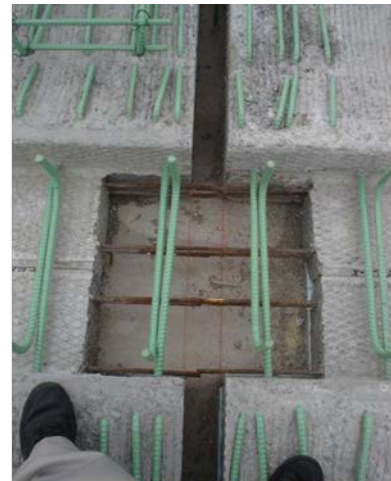
(b)

Figure 9.9: Example continuity connection at pier for precast inverted-tee beams with CIP deck from Bridge 13004, TH 8 over Center Lake Channel (MN) [104]

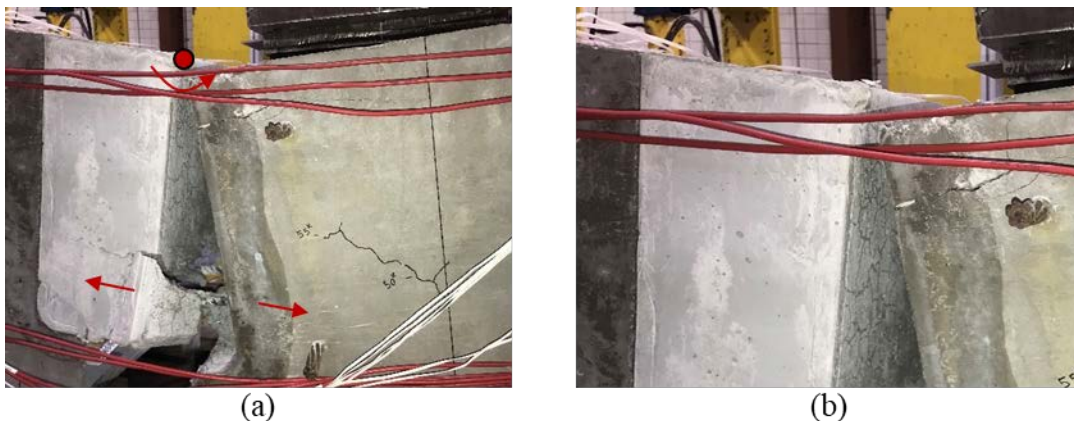
Figure D.9: 18F1-1: (a) failed specimen and (b) close-up of hinge developing in top corner of precast member next to UHPC joint

The cracking pattern at failure for 18F1-1 is shown in Figure D.9. A splitting failure in the UHPC at the level of the joint reinforcement appears to have occurred causing a pullout failure of the reinforcement. The poor bond between the UHPC and the precast concrete section resulted in the interface being the primary failure crack. This caused a similar hinge and failure mechanism to occur as illustrated in Figure D.2 above.

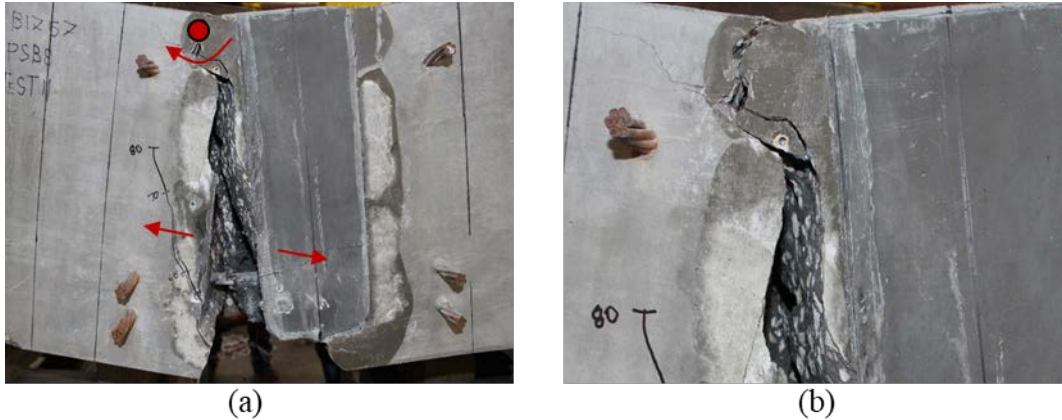
Figure D.21: 18F2-2: (a) possible tension and compression zones and (b) possible compressive stress concentration at the top in west side view

Cracking at failure for 18F2-2 is shown in Figure D.21. There was much better bond between the UHPC and precast concrete but hinging still appeared to occur at the corner of the precast section, highlighted in Figure D.21 (a).

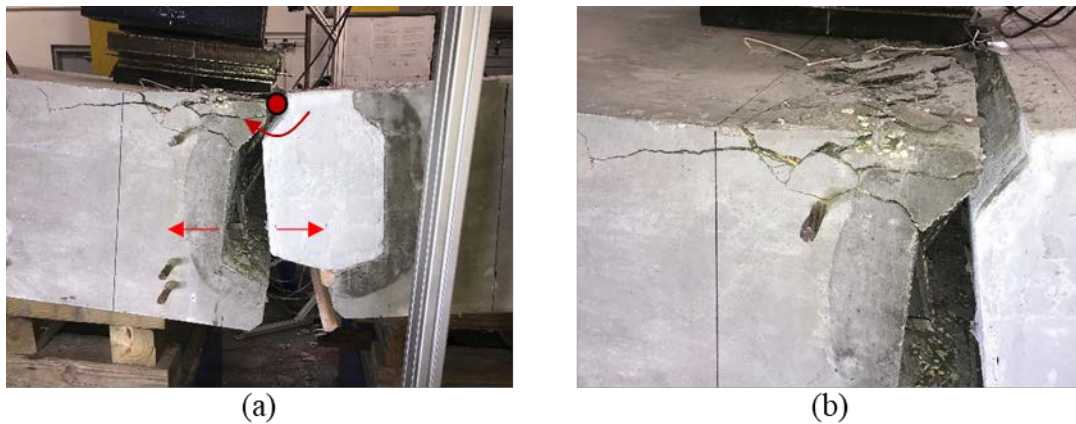
Figure D.25: 18A1-1: (a) failed specimen with complete UHPC matrix detachment, (b) Failure of top lip due to compressive stress concentration from west side

The 18A1-1 had the worst bond performance between the UHPC and precast concrete, as shown in Figure D.25 (a); the UHPC completely detached from the precast concrete. Failure in this joint was caused by crushing of the concrete along the length of the specimen under the load and then rupture of the joint reinforcement. The crushing of the concrete under the load is shown in Figure D.25 (b).

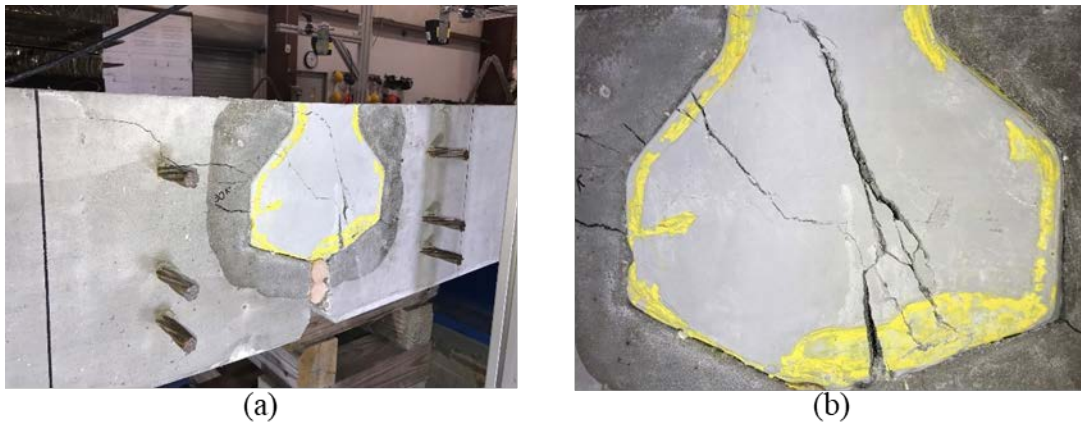
Figure D.46: 12A1-1: (a) failure cracks and (b) diagonal crack in UHPC matrix

The cracking pattern at failure for 12A1-1 is shown in Figure D.46. A diagonal crack developed in the UHPC joint from the load point to the bottom ledge of the unloaded precast beam, as shown in Figure D.46 (b). A crack also developed in the precast section on the loaded side extending from the top inside corner of the joint to under the middle of the load point, shown in Figure D.46 (a). There was no clear sign of a pullout failure or fractured reinforcement. There may have been a failure of the splicing of the joint reinforcement likely caused failure.

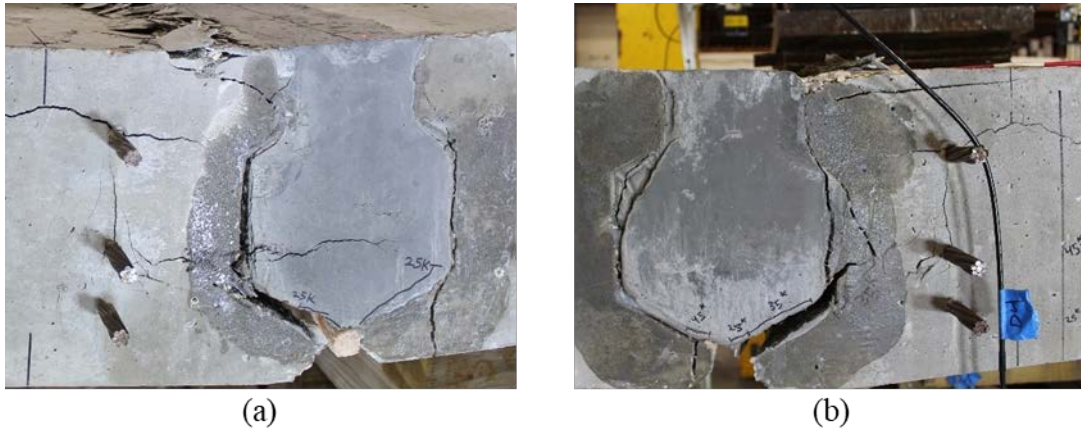
Figure D.52: 12A2-1: (a) failed specimen and (b) east side joint face showing similar rupture pattern with less amount of cracks

The failure of 12A2-1 is shown in Figure D.52. Cracking began at the interface between the UHPC and precast section and continued in the precast section. The interface crack continued to open followed by a horizontal crack in the UHPC and precast section at the level of the joint

reinforcement. Crushing of the concrete in the compression block triggered failure of the joint. The joint reinforcement did not rupture or experience a development or splice failure.

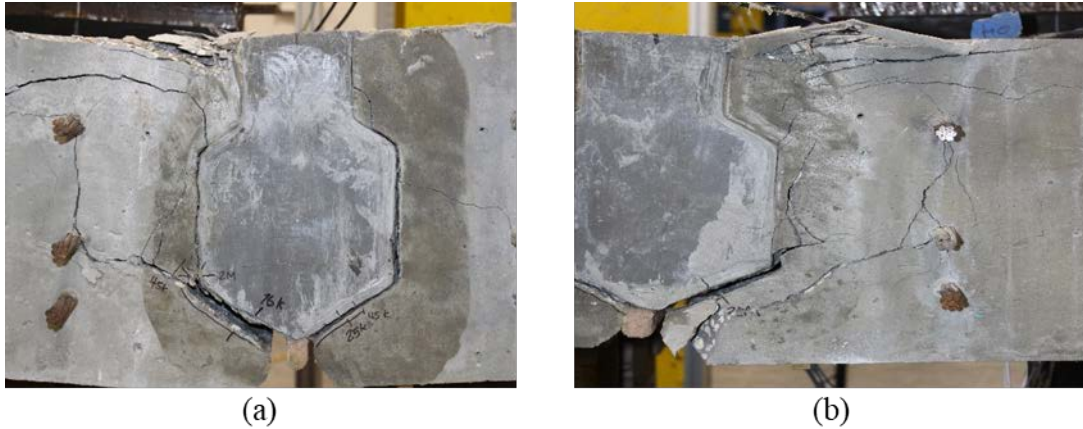
Figure D.55: 12A2-2: (a) west side failed specimen and (b) east side joint face showing similar rupture pattern with more amount of cracks

The failure of 12A2-2 is shown in Figure D.55. Similar to the Test 1, cracking began at the interface between the UHPC and precast section and continued in the precast section. The interface crack continued to open with a less predominant crack formed horizontally in the UHPC at the level of reinforcement. Test 2 followed a similar failure mechanism of concrete crushing in the compression block that triggered the failure of the joint. The joint reinforcement did not rupture or experience a development or splice failure.
