**Experimental Investigation of the Effect of Surface Markings on the Mechanical Integrity of
Weathering Bridge Steels**

Final Report

FDOT Contract Number: BDV31-977-02

University of Florida

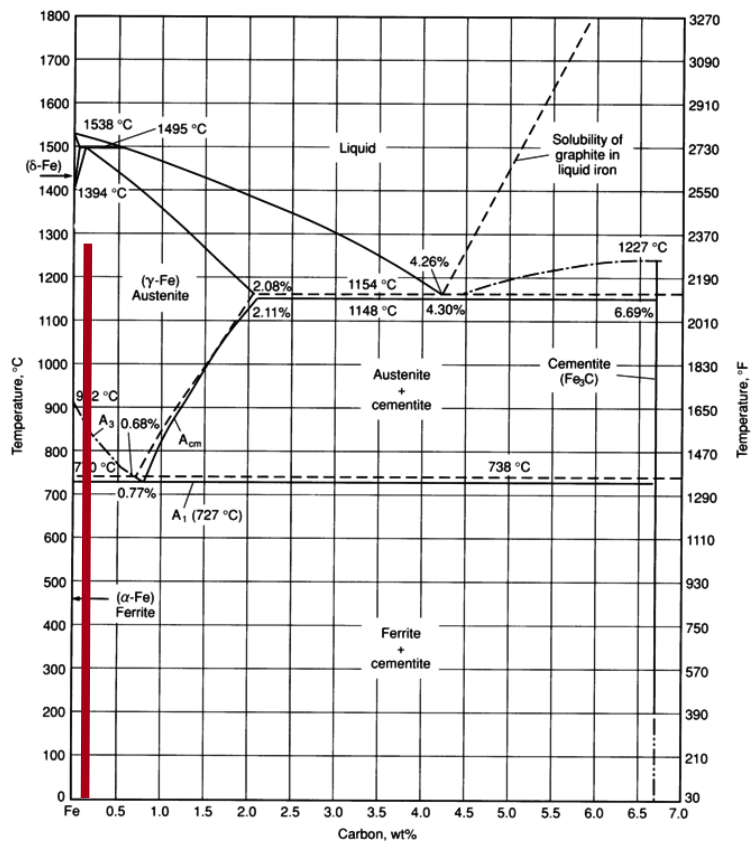
Figure 2-1: Iron (Fe) and carbon (C) phase diagram.[2] Highlighted in red is the allowable C range for ASTM A709/A709M.

In order to form a uniform, fine-grained microstructure, these α -Fe and Fe_3C must be precipitated from the parent phase, γ -austenite, at elevated temperatures (this can be seen in Figure 2-1) where grain growth can become excessive.[13-15] In conventional low carbon steels, this microstructure is processed through basic solution treatments by heating the cast material to the γ -austenite region and cooling to below the eutectoid temperature of approximately 730°C. The cooling rate, soak temperature and time below the eutectoid temperature determine the scale of the microstructure, as well as the pearlite lamellar spacing.[14, 15] There is a limit to refinement through conventional means in low carbon steels that constrains the upper strength levels of this material. Through the addition of alloying elements (V, Ti and Nb), greater strength has been accomplished in HSLA steels.[9, 16, 17] Along with solid-solution and precipitation strengthening, these elements aid in refining the microstructure. In addition to this

The goal of microalloying in HSLA steels is to achieve higher strength and improve corrosion resistance, while conserving or exceeding the toughness and ductility of conventional low carbon steels.[1] This can be seen in the phase diagram in Figure 2-1. To increase strength, the carbon content is increased to form a larger volume fraction of cementite (Fe_3C), though this limits weldability and reduces toughness. Additions of V (<0.10%) have been shown to improve strength through solid solution strengthening as being a strong carbide former.[1, 9, 17] In grades 70W and above, nitrogen (N) is introduced and reacts with V to form vanadium nitride (VN) and carbonitride (CN) precipitates. Small amounts of aluminum (Al) also form nitrides in HSLA steels. Both carbides and nitrides assist in impeding grain growth during hot rolling and annealing [9, 15, 16], refining the microstructure. The introduction of these CN formers allows for the C-content to remain low. Additions of Cr, Ni, Cu and P can impart solid solution strengthening and enhance corrosion resistance up to four-fold over that of conventional carbon steels.[1]

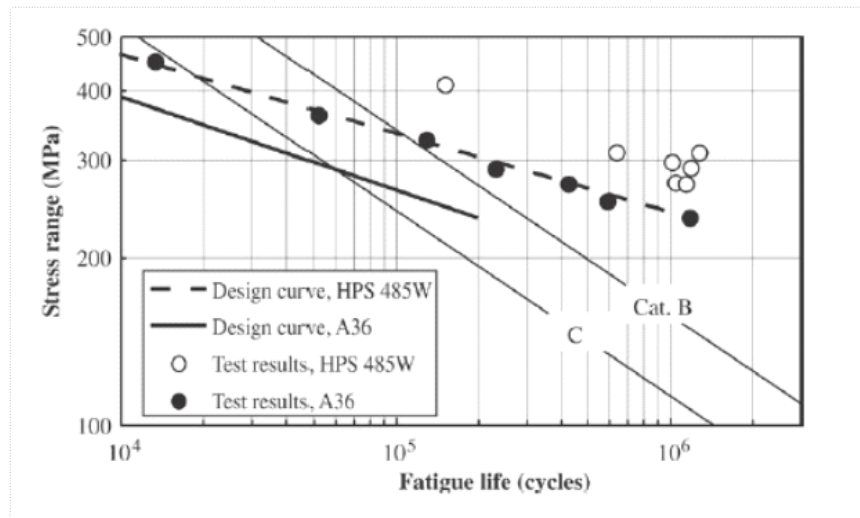
Figure 2-5. Fatigue life data from conventional (labeled A36) and HPS 70W (labeled HPS 485W) weathering steels with drilled holes represented as solid and open circles, respectively.[20]

Although literature on surface effects on fatigue performance is limited, some notch sensitivity can be inferred by studying the fatigue properties of bridge steels containing holes or rivets. Bridge connection details require welds and holes to be drilled or punched for rivets and bolts. Initially, HPS had an assumed rating for these members identical to conventional connection details due to the lack of experimental evidence allowing for a reformation of the design criteria.[6] Fatigue testing on HPS-70W and A36 (a conventional weathering steel), with circular drilled holes were evaluated for comparison.[20] Figure 2-5 shows the data gathered, along with S-N curves predicted via an inelastic finite element analysis and AASHTO Categories B and C. The slopes of the predicted curves agree well with the measured data, but vary significantly from the slope of the standard S-N curve for Categories B and C. Both steels performed better than the predicted values (labeled Design curve in Figure 2-5) and HPS-70W was well above Category B despite the lesser slope, while the conventional weathering steel fit different categories dependent on the stress range. HPS 70W with drilled holes was approximately one category greater than the conventional steel with the same sample geometry. Another study, evaluating the effects of punched, punched and reamed, and drilled holes revealed that HPS 70W adheres to the standard, Category B, for punched and reamed and drilled holes.[27] The samples with holes that were punched, but not reamed, resulted in lower fatigue life ranging between Categories C and D. Plate thickness plays a major role in the effect of punched holes.[27, 30] For thinner plates, the deleterious effect diminishes, so standards are set limiting punched holes to the thinner members.

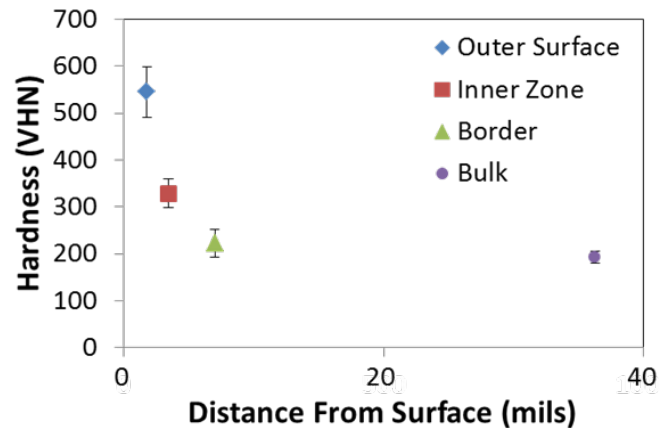
Figure 4-12. Vickers Hardness Number versus the sample depth from the plasma notch surface.

thinnest region, labeled inner, was on the order of 1.18 mils ($30\ \mu\text{m}$), so the lowest load level, 0.11 lbs (50 gf), was necessary to keep the dimensions of the indent within the region and this load level was used throughout this experiment for consistency in hardness values from region to region. Figure 4-12 is a plot of Vickers Hardness Number (VHN) versus the average distance from the notch surface. The hardness of the material increases 3-fold from 193 VHN, in the bulk microstructure, to 545 VHN on the plasma notch surface.

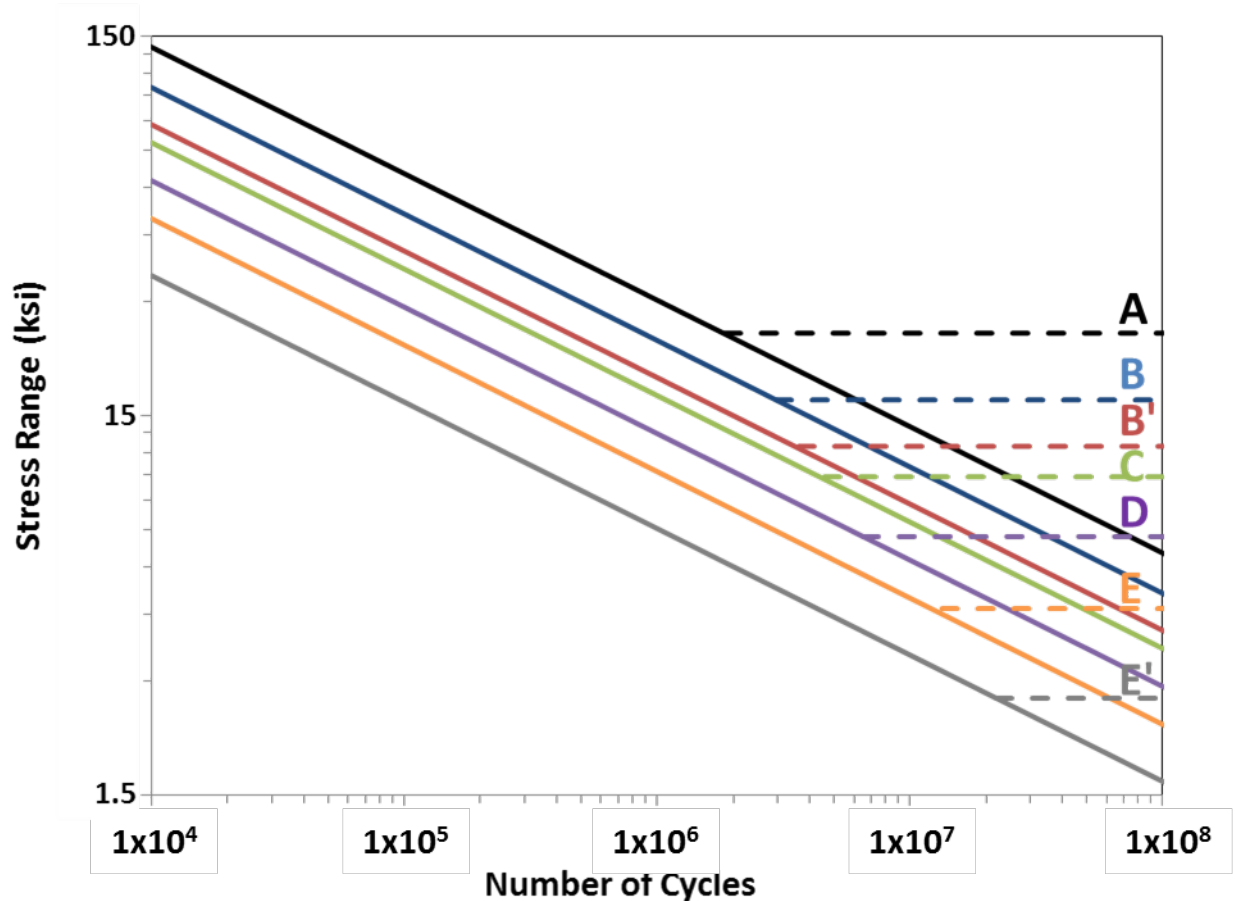
Figure 5-1. AASHTO Fatigue Requirements(Adapted from R.J. Dexter[47]).

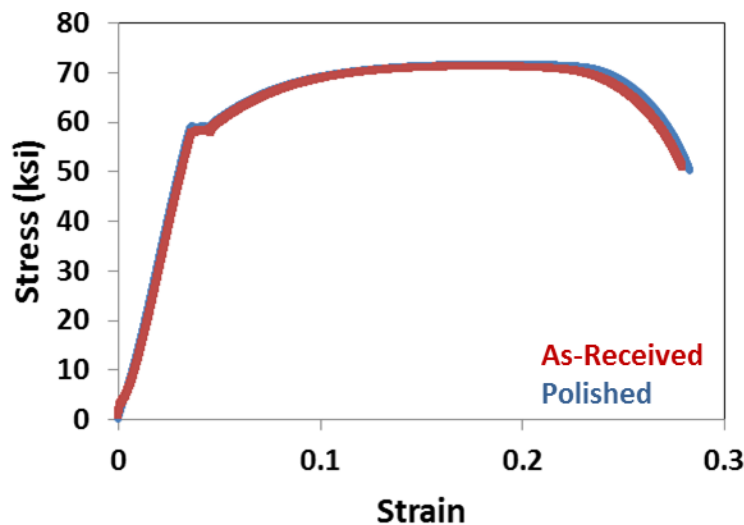
Figure 5-6. Representative stress-strain curves for as-received and polished 50W weathering steel.

Tensile testing results for a polished and an as-received sample are shown in Figure 5-6. These tests were undertaken to confirm that the material conformed to the required minimum properties outlined by ASTM standards and AASHTO guidelines.[3, 4, 6, 48] Additionally, testing conducted on the as-received samples (one representative sample is shown as the red curve in Figure 5-6) were compared to the tensile properties of the polished sample (blue curve in Figure 5-6) that had the weathering layer and areas potentially affected by the machining removed to determine if the surface roughness affected the mechanical properties, principally yield and ultimate tensile strengths of this 50W steel. The yield strength for the tests ranged from 58-60 ksi (400-415 MPa), which exceeds the 50 ksi (345 MPa) required by the standards. The polished sample did not result in a measureable difference when compared to the behavior of the as-received samples.

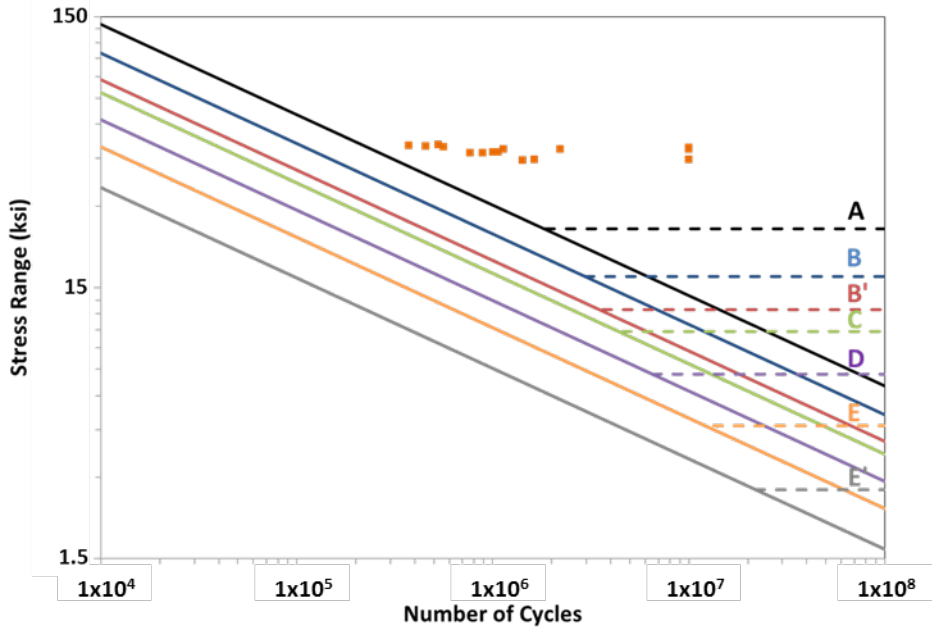
Figure 5-9. S-N curve for plasma-scribed 50W steel.

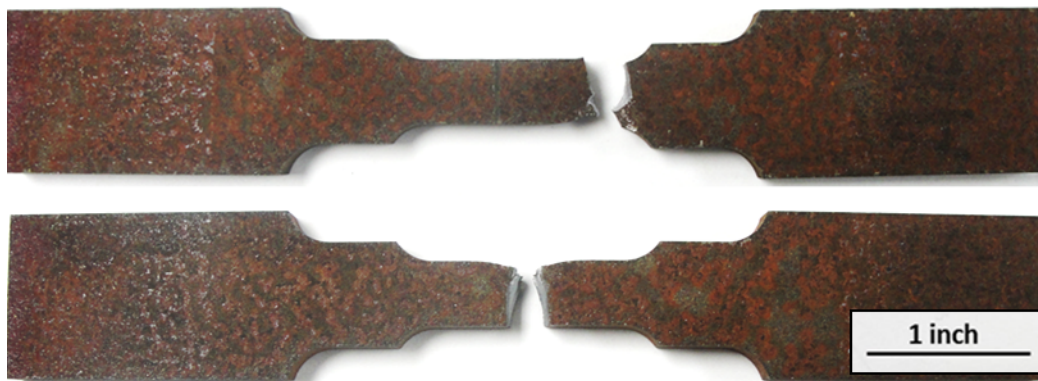
Figure 5-12. Fatigue specimen that fractured (top) near the shoulder and (bottom) at the plasma notch.

Despite the presence of plasma and laser scribed notches, fatigue cracks generally formed near the shoulder of the fatigue specimens (Figure 5-12 top). None of the laser scribed notches resulted in fracture initiation at the notch and only two, both tested at a stress range of 48.3 ksi, of the 16 tested plasma notched samples initiated at the notch (Figure 5-12 bottom). The samples shown in Figure 5-12 had fatigue lives of 5.31×10^5 cycles (top) and 5.64×10^5 cycles (bottom). Microscopic analysis conducted on
