BDV31-977-37

Florida Department of Transportation Research

# Evaluation of Asphalt Pavement Interface Conditions for Enhanced Bond Performance

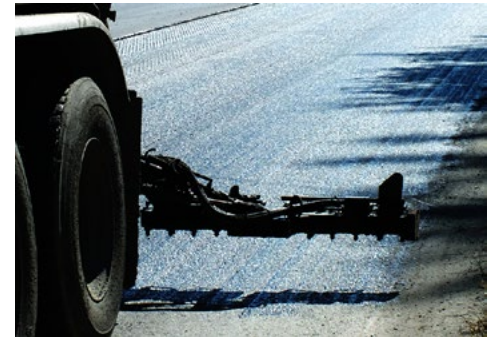
*An even layer of tack coat is essential for ensuring good bonding between layers of asphalt.*
