Evaluation of Techniques to Remove Defective Grout from Post-Tensioning Tendons

Final Report

February 2020

Florida Department of Transportation (FDOT)

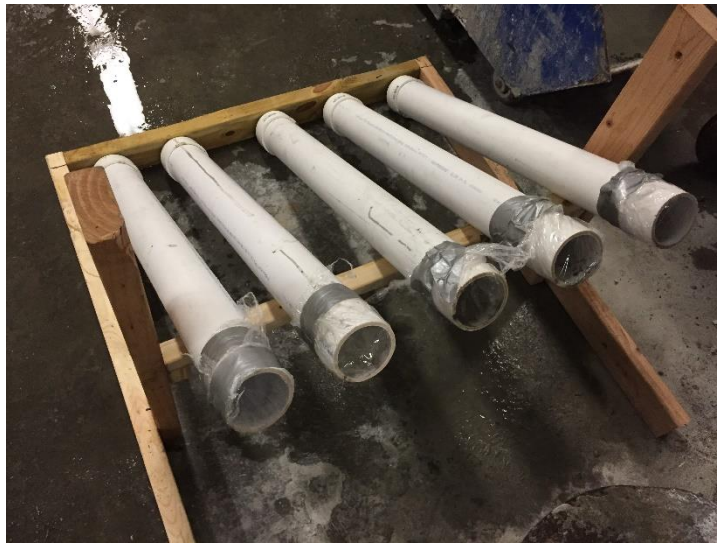
Figure 4-1. Mini-inclined testing

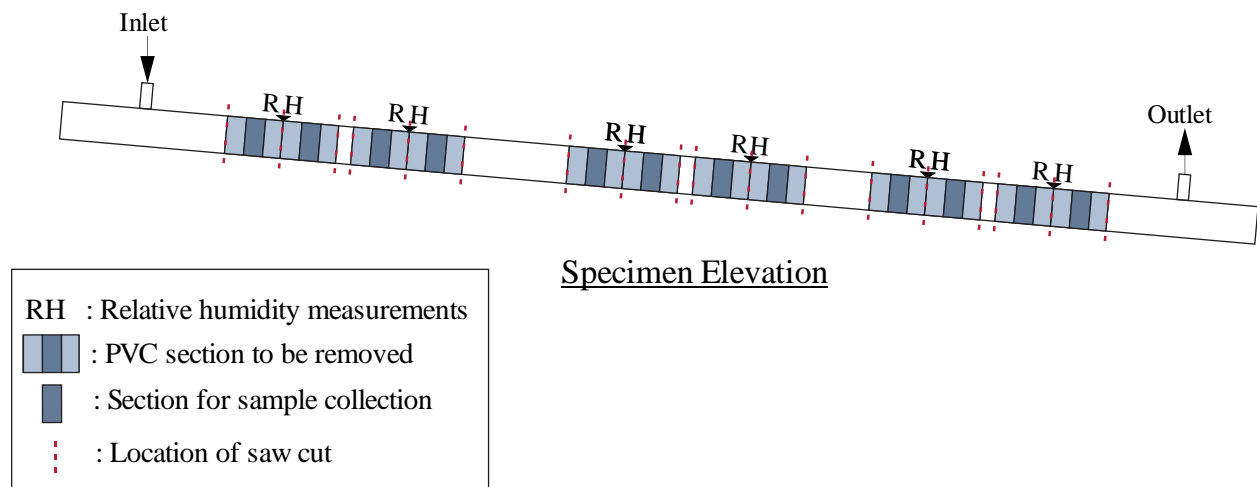
Figure 8-2. Dissection schematic

Figure 8-2 shows the sampling locations for grout in specimens ISG and TSG relative to the RH port where RH_g was measured. Grout samples were collected during dissection, and immediately weighed prior to placing them in the oven to determine their moisture content.

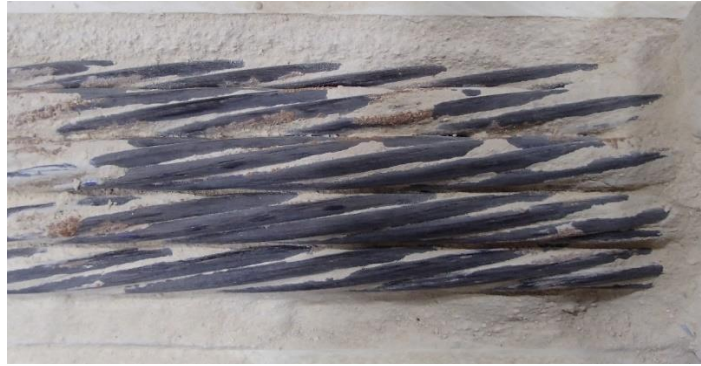
Figure 8-11. In situ corroded strands near port C dried TSG specimen

During dissection, sampling, and inspection of specimens, the prestressing strands were uncovered and systematically evaluated visually for the presence of corrosion. During visual evaluation, corroded strands were found predominantly in specimens subjected to drying (Figure 8-11). Corrosion was found in larger quantities on the peripheral strands of the tendon. The location of corrosion found on the tendon is shown in Figure 8-12.

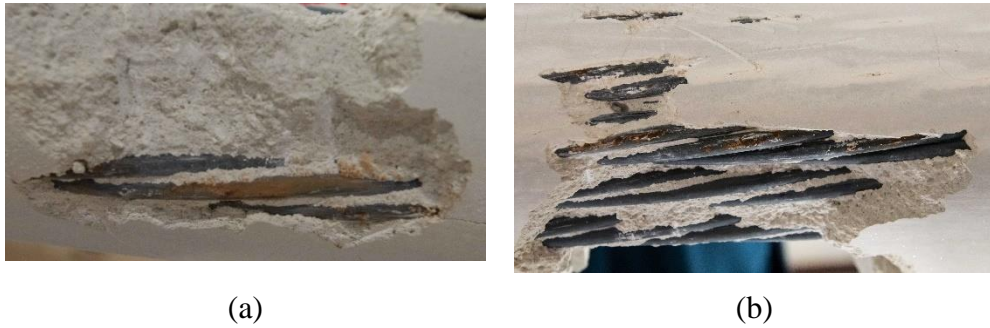
Figure 8-18. In situ corroded strands at: (a) port E; (b) port F dried ISG specimen

Corrosion was also present in the lower 15 PC layer in the dried specimen ISG which could have been due to dry air pushing moisture towards downstream end of specimen, meaning that moisture was available for longer time at this end. However, this corrosion was less severe than corrosion in 5 PC grout layer and was predominantly present in lower strands on the outer surface (Figure 8-18).

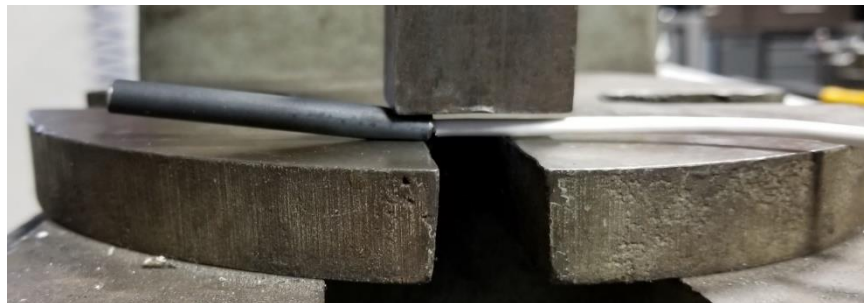
Figure 12-5. Crimping of RE

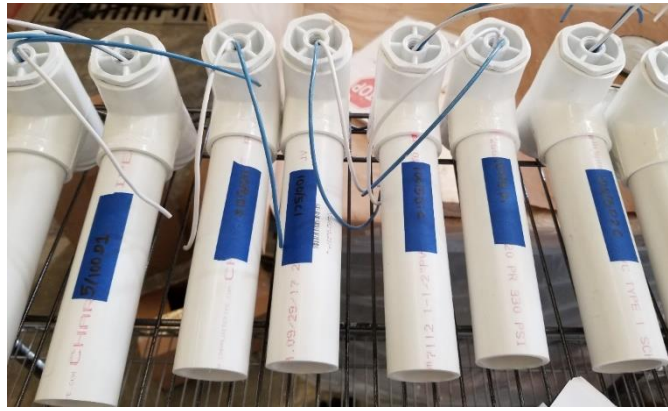
Figure 12-8. Specimens prepped for placement of first grout layer

After placing the first layer of grout, the second tee was glued onto the specimen. One bushing in this tee was left uninstalled to allow for the placement of the second lift of grout. After placement of the second lift, the remaining bushing and fittings were glued.

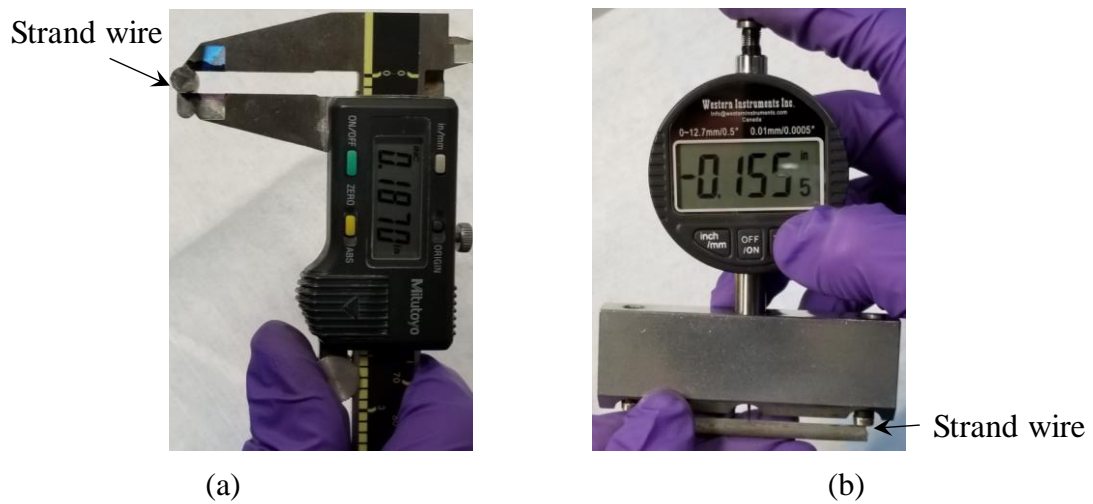
Figure 17-4. Corrosion evaluation of strands measurement (a) Loss in section (b) Pit depth

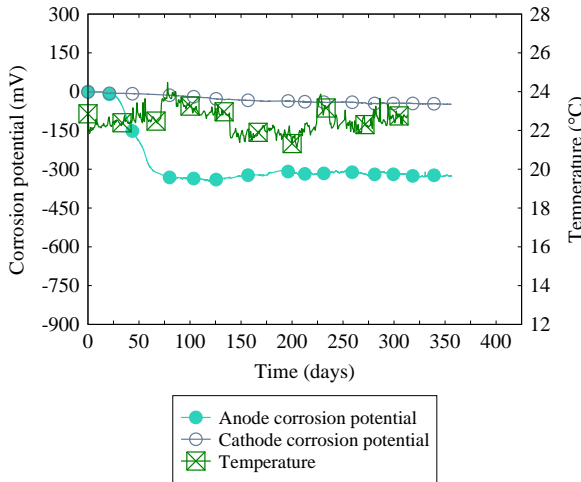
Figure 20-8. Post-drying corrosion measurements for 100/5D2C: (a) Corrosion potential; (b) Macrocell current

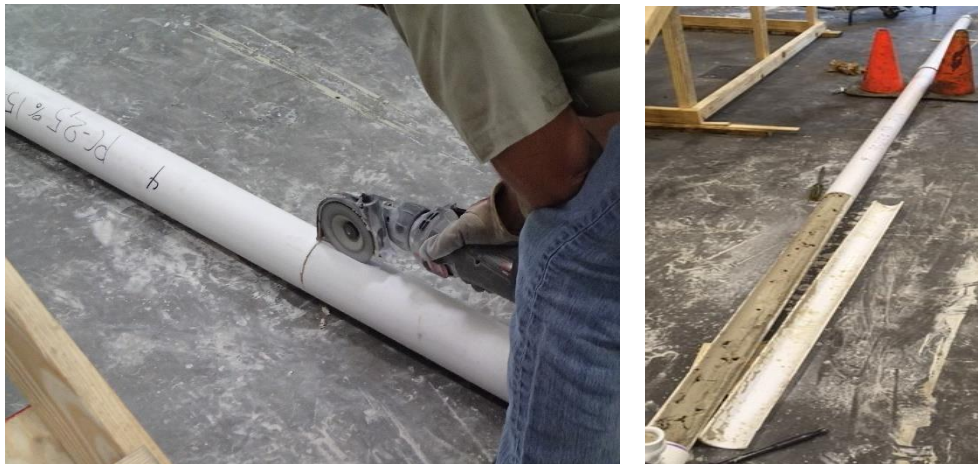
Figure A.3-8. Partial removal of PVC for inspection

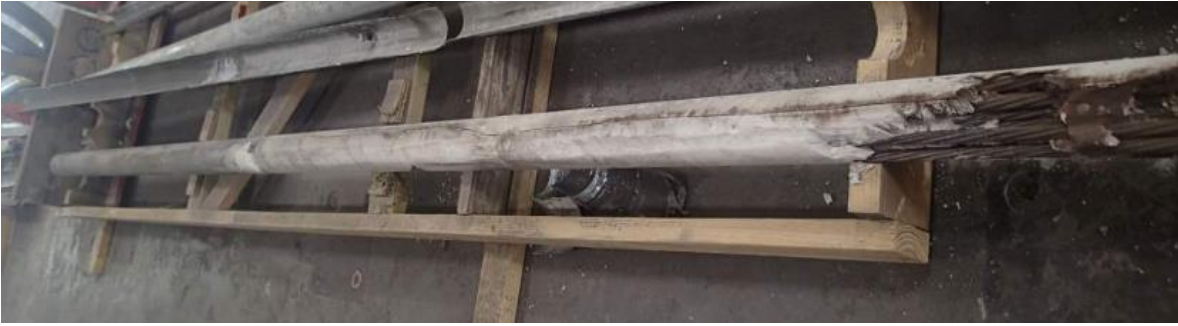
Figure A.3-16. EMT3 after hydrodemolition
