FLORIDA DEPARTMENT OF TRANSPORTATION
Experimental Investigation of the Effect of Surface Markings on the
Mechanical Integrity of Weathering Bridge Steels - Phase III
Final Report

FDOT BDV31-977-84
February 2018

University of Florida, Department of Materials Science and Engineering
Dr. Michele V. Manuel, Chair and Professor

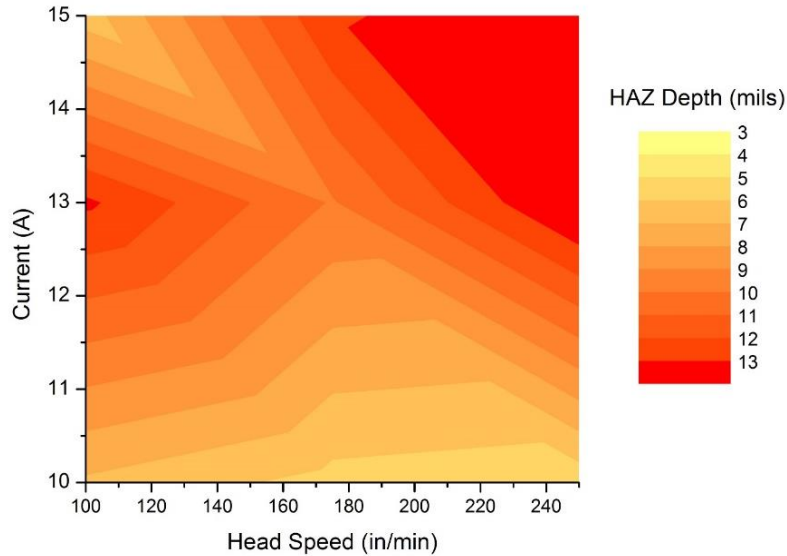
Figure 3-5. Contour plot indicating trends in absolute values of HAZ depth as a function of current and head speed (Plate A).

The contour plot shown in Figure 3-5 indicates trends in absolute values of notch and HAZ depths as a function of both current and head speed. A statistical analysis using ANOVA on the results of Plate A determined that the current influences notch and HAZ depths, but the head speed did not or did so minimally. However, the interaction between amperage/current and head speed was statistically significant. This interaction indicated that amperage/current work together in a synergistic manner with head speed to cause aggressive marking conditions and deeper notches and HAZ. For example, high head speed (250 in/min) and high amperage/current (15 A) caused damaging conditions similar to medium amperage (13 A) and low head speed (100 in/min). Figure 3-5 illustrates this interaction by the diagonal pattern across the diagram showing that the notch and HAZ depths did not increase or decrease linearly with linear changes in current and writing speed – highlighting the interaction effect. The interaction effect only resulted in a statistically significant change in notch and HAZ depths for a change in head speed, between the 13 and 15 A settings.

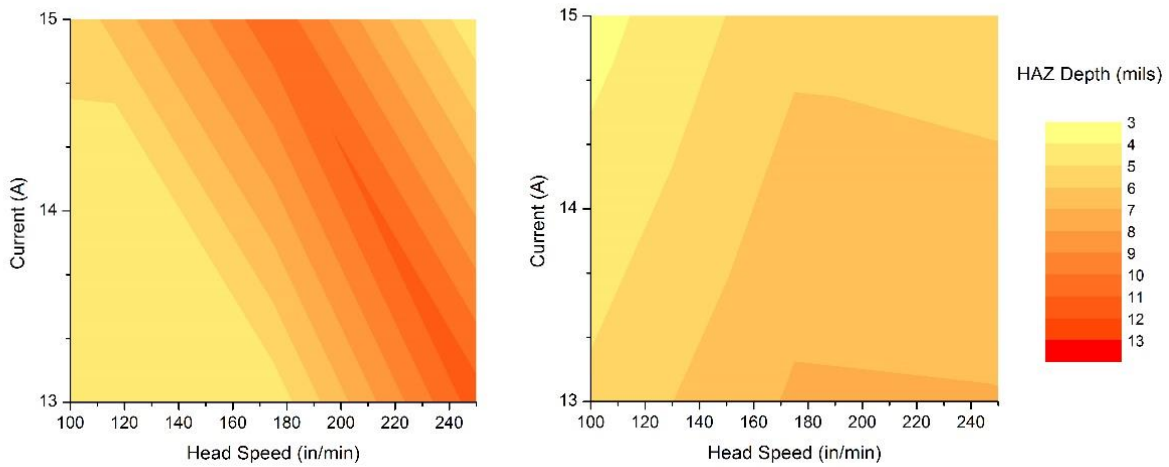
Figure 3-6. Contour plot indicating trends in absolute values of notch and HAZ depths as a function of current and head speeds of Plate B (left) and Plate C (right).

Through the above analysis, it was determined that certain write speeds can combine with certain marking currents to create an isolated zone of high HAZ depth. This trend is clearly seen in the contour plots of Figure 3-6 below, where the notch and HAZ depth is largest at different levels of head speed, depending on the level of amperage. This interaction effect is shown by the trend of notch and HAZ depths diagonally across Figure 3-6. An additional observation was made during these tests that indicated a possible plate-to-plate dependence of HAZ depth since the data in Figure 3-6 (left) has a different pattern than the data in Figure 3-6 (right).

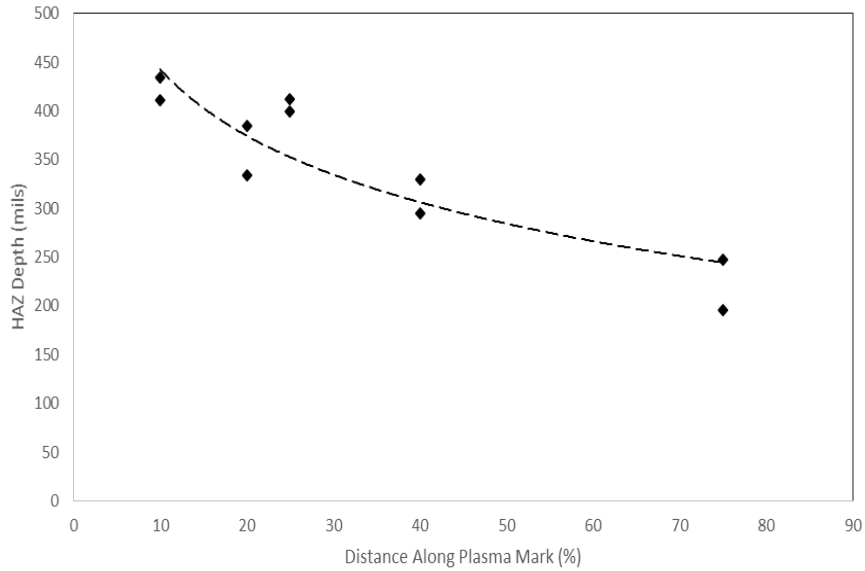
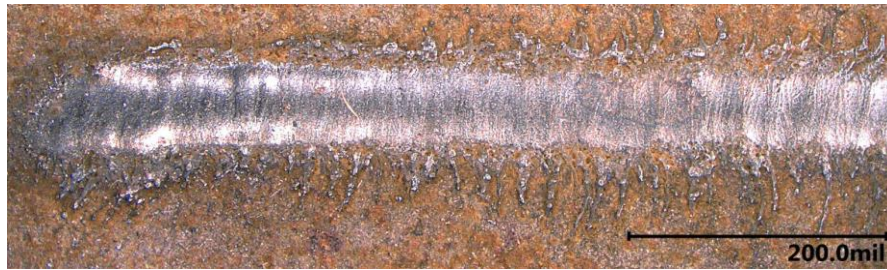
Figure 3-10. HAZ depth trails off as mark continues (above) and associated distances (below).
Marked at 15 A and 250 in/min

Figure 3-10 provides quantitative data indicating that the HAZ decreases as a function of marking length (i.e. distance along the mark from the beginning to the end). This effect was statistically significant as confirmed through a one-way ANOVA (p -value = 0.05). The beginning of the mark contains the largest HAZ depth and is statistically different than the HAZ depths further along the mark.

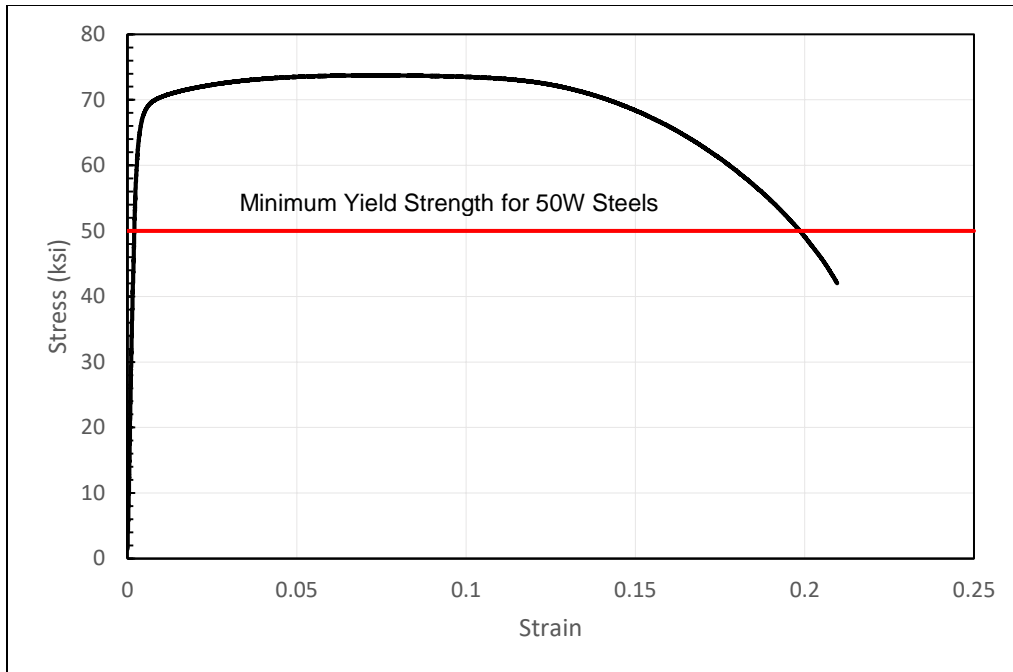
Figure 3-11. Representative stress versus strain curve illustrating the mechanical properties for bulk failure of tensile specimen.

A representative stress vs. strain curve is shown below in Figure 3-11 for one of the specimens from plate 3. This sample was marked at the 15 A and 75 in/min setting. The yield strength was higher than the 50 ksi minimum required for the steel grade, and consistent among all samples tested. Both the marked and unmarked samples experienced ductile failure, which is expected for an HSLA steel. All specimens failed in the gage section and away from the notch, effectively testing bulk properties.

This result indicates that there is a minimal effect of the marking on the tensile behavior of the material at the marking condition of 15 A. Since, none of the samples experienced failure at the notches, and given that the 15 A setting creates a much larger notch and HAZ depth and subsequently a higher stress intensity factor, it was determined that no tensile testing of the less aggressive 10 A setting was necessary.

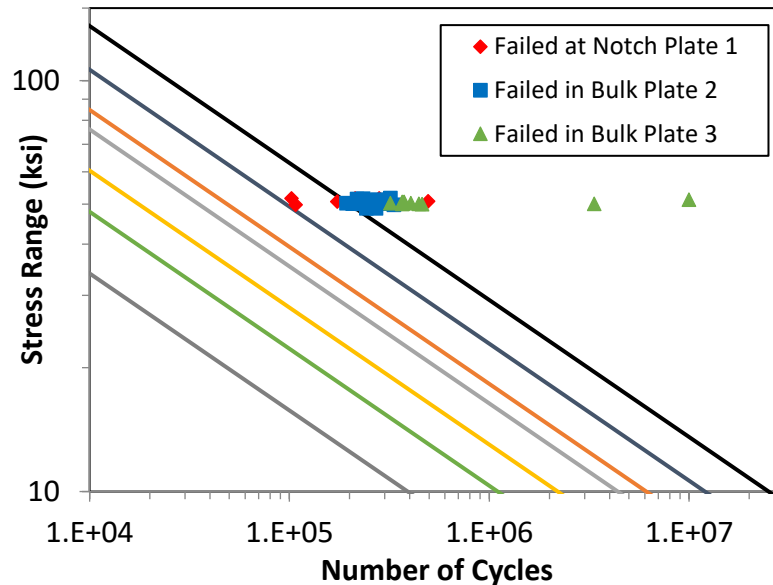
Figure 3-12. Stress range as function of number of cycles for the plate marked at 15 A, 75 in/min. Points in red represent samples that failed at the plasma mark. The fatigue data is overlaid on the AASHTO standard, where the black line represents Category A guidelines .

In order to study the effect of plasma marking on the service life of the specimens, fatigue testing on samples marked with a current of 15 A at 75 in/min (33 samples) and 10 A at 150 in/min (35 samples) was done. For the 15 A at 75 in/min marking condition, 6 samples out of 33 experienced failure at the plasma mark, and 3 of these 6 samples failed beneath the minimum fatigue (Figure 3-12). The minimum fatigue life obtained was 107,458 cycles which is considerably lower than the minimum fatigue lifetime required for 50W structural steel bars represented by the black diagonal line in Figure 3-12. For the 10 A at 150 in/min setting, the samples do not seem to be weakened by the

plasma mark (e.g., no samples failed below the AASHTO Category A limit). The plasma mark appears to have introduced a small flaw that caused the failure to occur at the location of the mark in 2 of the 34 specimens, but all 34 met the AASHTO A standard surpassing the minimum fatigue life requirement.

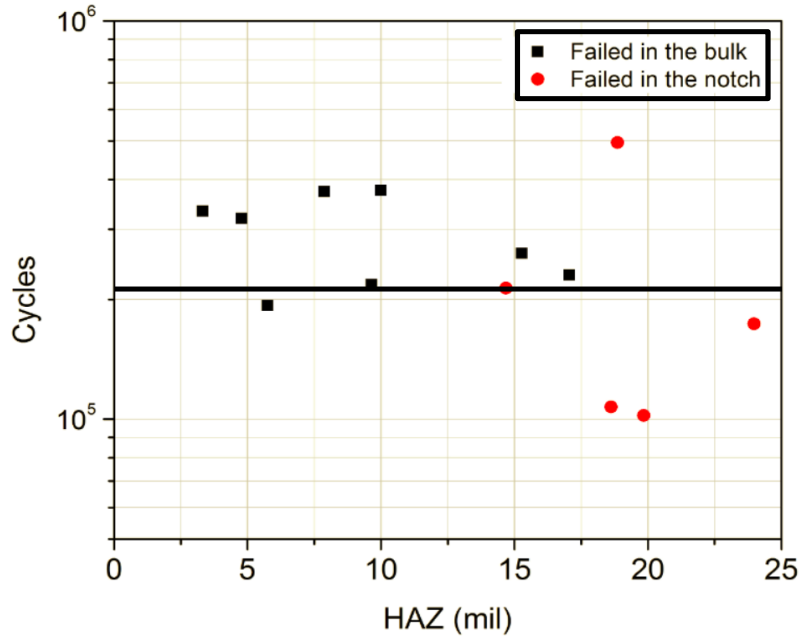
Figure 3-13. Scatter plot of cycles to failure vs. HAZ depth. Points in red indicate samples that failed at the HAZ. Light red zone indicates the range of HAZ depths that could cause premature to minimum fatigue life failure.

To highlight the relation between the cycles to failure, location of the failure and HAZ depth for both marking conditions, HAZ depths were plotted against the cycles to failure as shown in Figure 3-13. This plot reveals that all of the failures that occurred at the mark were due to the presence of a HAZ larger than 14 mils. This zone is highlighted in red. Although marks up to 17 mils were correlated with samples that did meet the minimum fatigue life, the 14 mils limit is used as a conservative measure. This scatter of the fatigue life values is largely a result of the stochastic nature of fatigue (Boardman 1990). As shown in the results from section 3.1 marking setting of 13 and 15 A are capable of creating HAZ larger than 14 mils. Thus, these results indicate that a limitation to the 10 A setting is recommended.

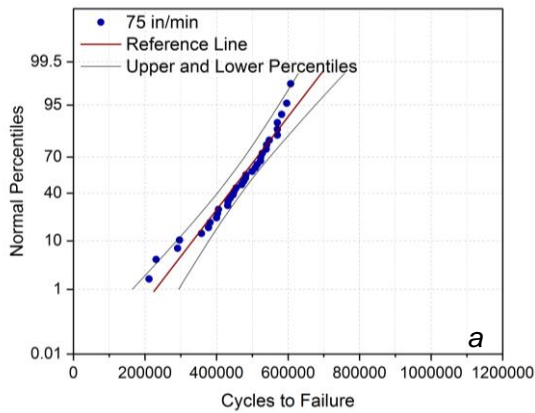
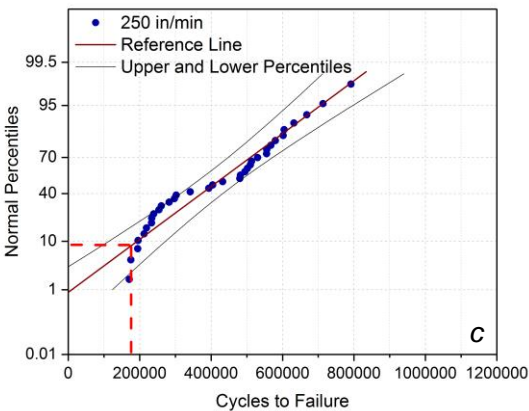
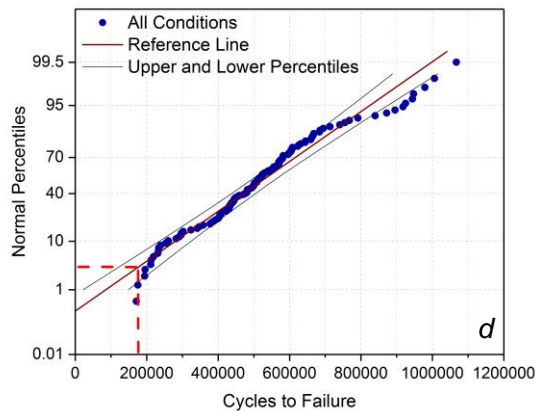
Figure 3-15. Normal distribution plot showing probability of failure below minimum fatigue life of 175,000 cycles for samples marked at 10 A and head speeds of (a) 75, (b) 150, (c) 250 in/min, and (d) all conditions. The minimum life according to the AASHTO guidelines is indicated by the red dotted line.

After determining that the data best fits a normal distribution by analyzing the Anderson – Darling statistic and p-value across many different possible distributions, a probability graph for each plasma head speed was plotted in Figure 3-15. This analysis allows for a comparison of the fit of the data to the normal distribution and the percentage of samples that are likely to fail below the minimum fatigue life of 175000 cycles at a stress range of 50 ksi (i.e., AASHTO category A) as shown in Figure 3-15 by the red dotted line.

As can be seen in Figure 3-15, with the number of failed samples below the fatigue limit, there is a low probability of the samples failing below the AASHTO minimum fatigue lifetime for 50W steel category A. With a 0.05 confidence level, none of the samples marked at 10 A and a head speed of 75 in/min are likely to fail below the minimum (Figure 3-15a). While, there is 0.9% and 8.4% probability that any sample marked at 150 and 250 in/min, respectively, will fail below the AASHTO minimum fatigue lifetime for 50W steel category A. As demonstrated in Section 3.1.1, plasma marks made at 10 A with different head speeds are not statistically significantly different. By plotting the cycles of all the samples marked at 10 A and different head speeds on a single plot, there is only a 3.2% probability of the sample failing below the AASHTO minimum fatigue lifetime for 50W steel, category A. The mean fatigue life is 518,351 cycles to failure with a standard deviation of 186,239 cycles to failure.
