Field Implementation of the Vertical In situ Permeameter (VIP)

Final Report

FDOT Contract No. BDV31-977-88

May 31, 2021

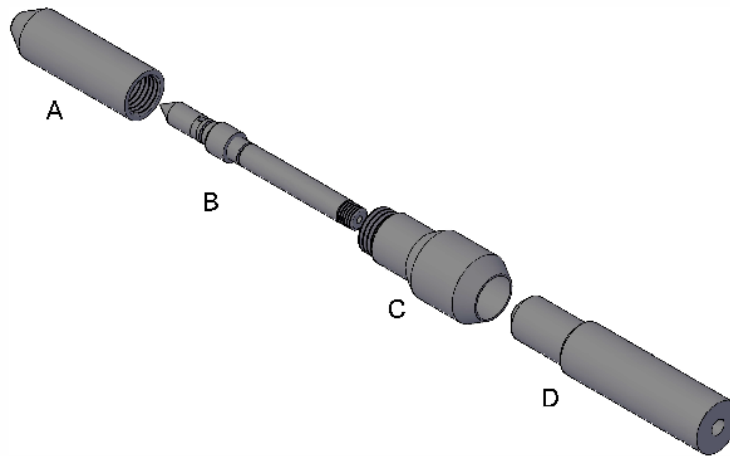
Figure 4-2. Step 1 of probe assembly.

2. Arrange probe parts A through D.

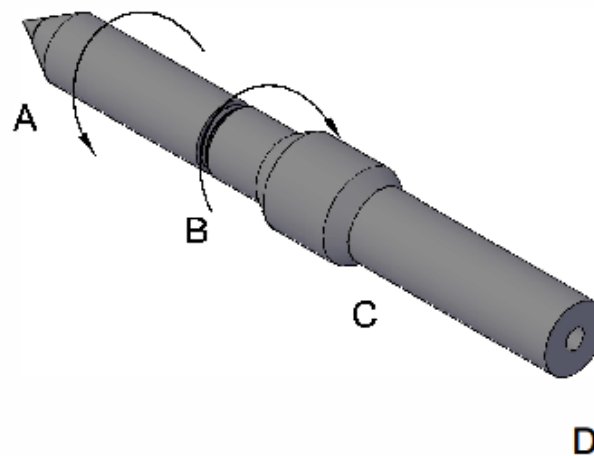
Figure 4-5. Step 4 of probe assembly.

Note: When threading part A onto part C, it is recommended to retract the inner rod as depicted in Figure 4 to reduce O-ring resistance during rotation.

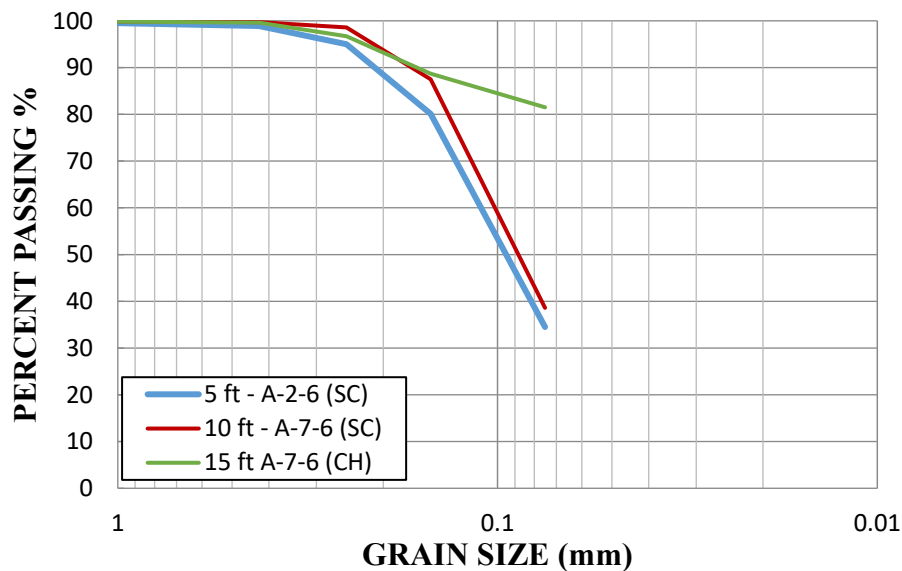
Figure 5-11. County Road 349 sieve analyses.

testing was completed due to the low permeability present. The VIP measurements at depths 10 and 15 feet were two of the lowest permeabilities measured throughout the research effort and provided the lowest permeability measured by any VIP probe at the time. This occurred at a depth of 15 feet where the soil recovered and tested in the laboratory was identified as an A-7-6 (CH) clay soil with high plasticity in a dense state as the SPT blow counts were $N = 25$. Images of the soil samples collected are provided in Figure 5-10, sieve analyses are provided in Figure 5-11, and the VIP results are provided in Figure 5-12.

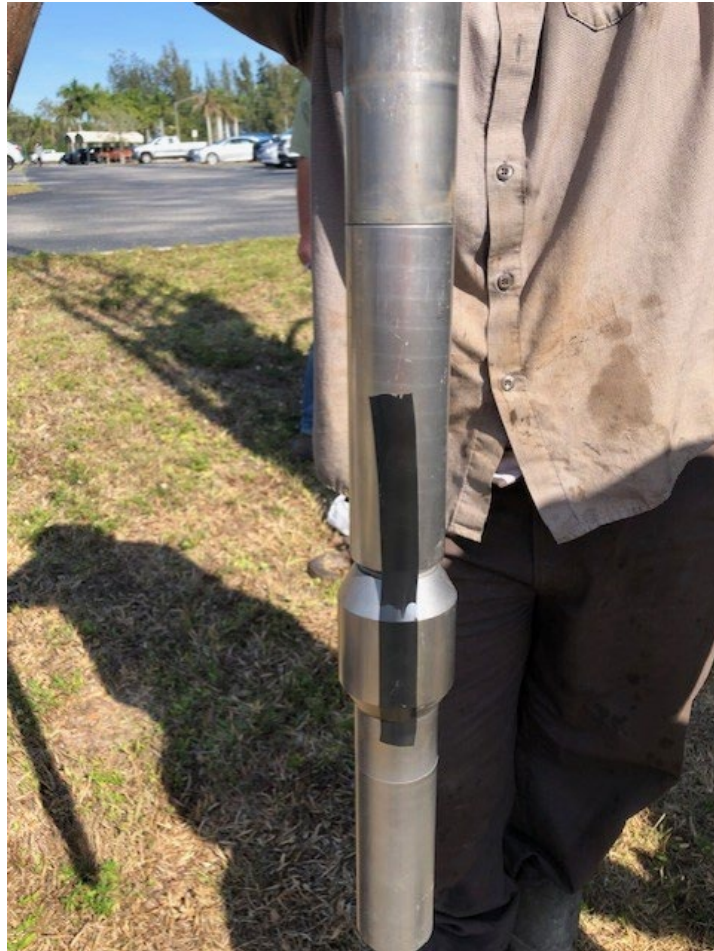
Figure 5-23. VIP probe with electric tape to ensure closed position for open-hole advancement.

subsequent test locations at the District 4 site and is recommended for future open-hole advancements. For example, if pre-drilling is required to advance the probe, predrill the hole to a minimum of one foot above the test depth, place electric tape on the VIP probe as indicated in Figure 5-23, advance the probe down the open hole, direct push the final one foot or more to the test depth, and then initiate the VIP test. Location 2 sieve analyses are provided in Figure 5-24, and the VIP results are provided in Figure 5-25.

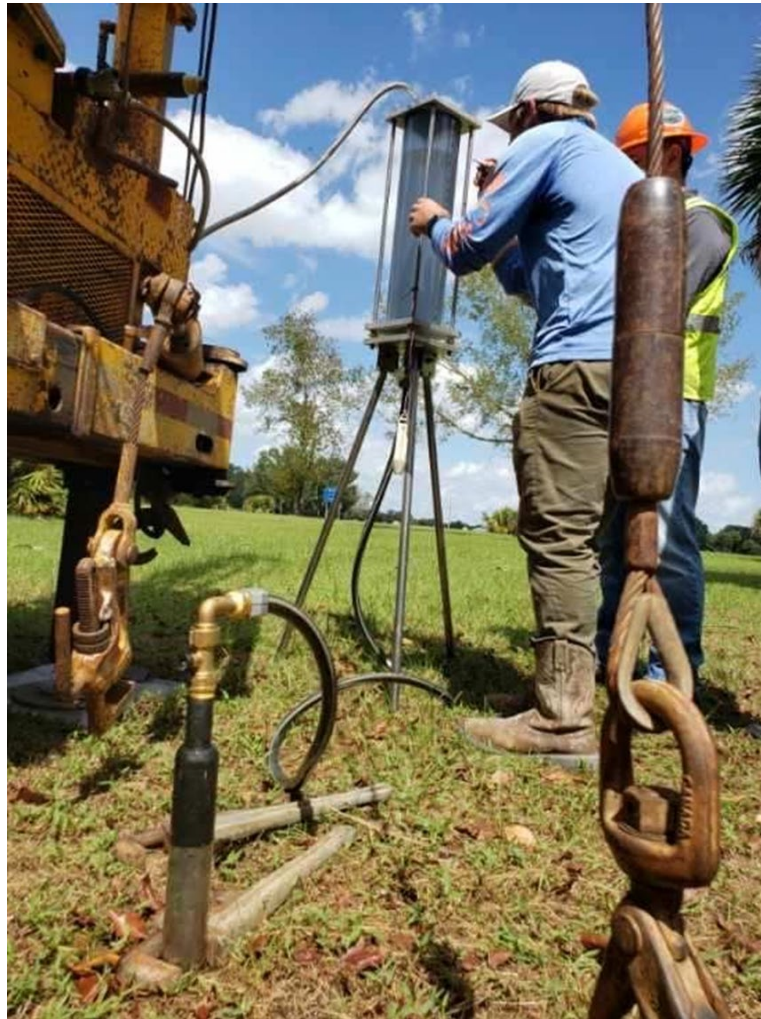
Figure 5-29. VIP being used for an infiltrometer tests.

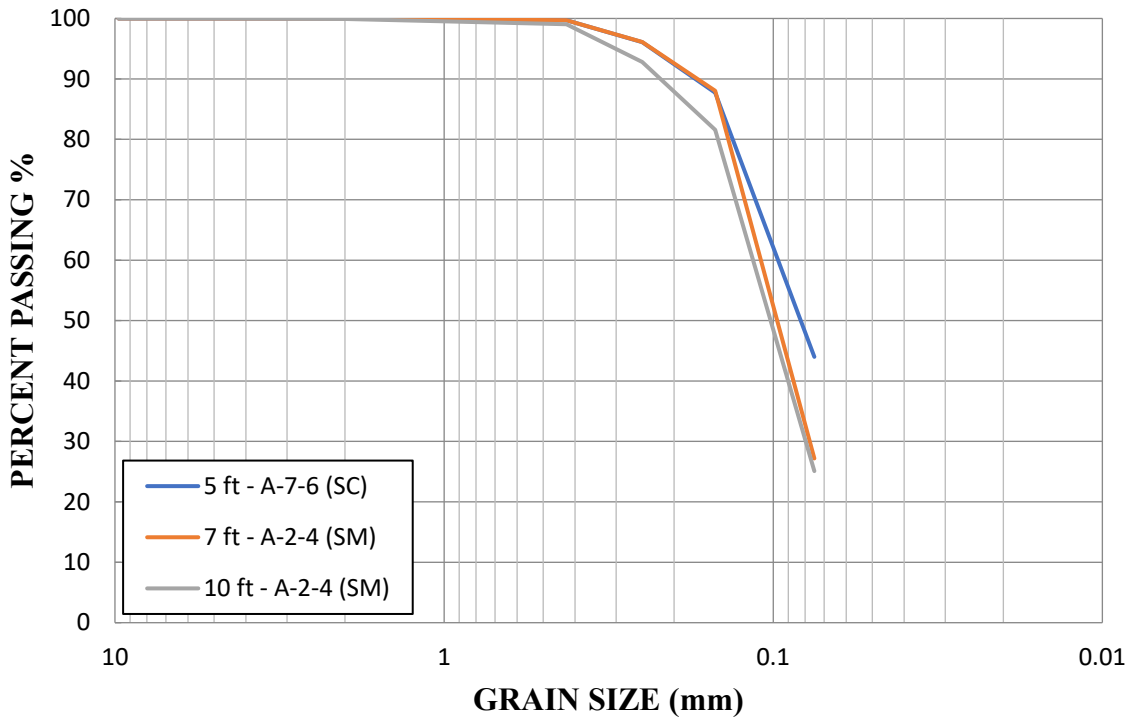
Figure 5-41. Brooksville Location P-3 sieve analyses.

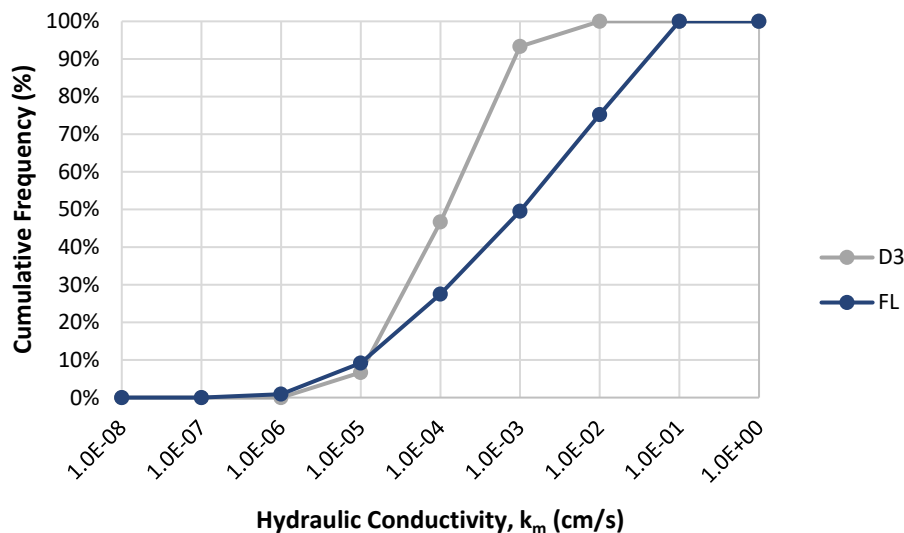
Figure 5-47. VIP cumulative frequency distributions for FDOT District 3 and Florida.

The analysis begins in the northern part of Florida, starting with District 3 located in the panhandle. Historically, clayey soils are commonly encountered and therefore a lower permeability is expected. This is the result that was found as the distribution indicates 93% of soils encountered had a $k_m < 1 \times 10^{-3}$ cm/s and the lowest range of permeabilities were encountered throughout the state as expected.
