Project Number
BE491

Florida Department of Transportation Research

Evaluation of Roadway Worms/Distortions

February 2022

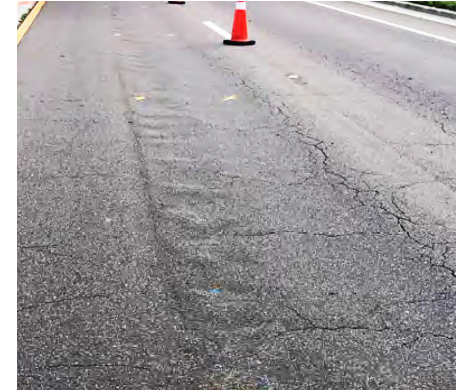
This pavement shows several kinds of distress: pavement blistering in the center; shoving and cracking right of center; and rutting far right.
