Final Report

# Inspection of Flexible Filler Tendons

Embry-Riddle Aeronautical University

Florida Department of Transportation

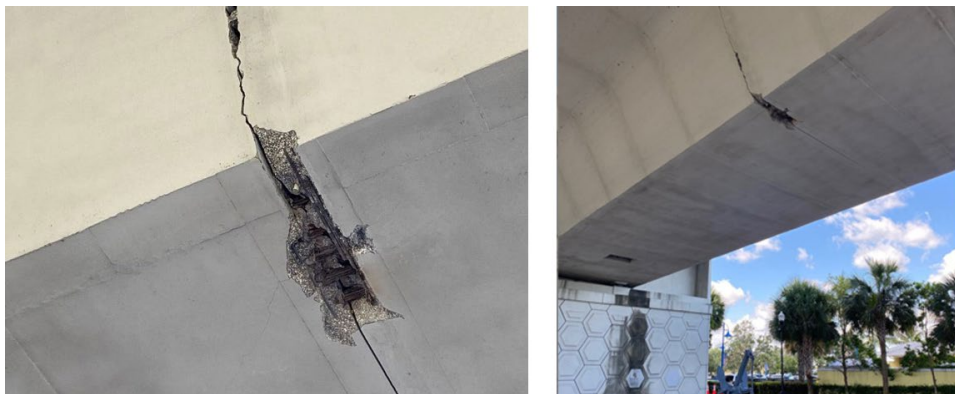
Figure 3. Localized corrosion damage for internal tendon on Roosevelt Bridge in Stuart, FL. (A) Concrete spalling and exposed tendons<sup>8</sup> and (B) location on bridge<sup>9</sup>

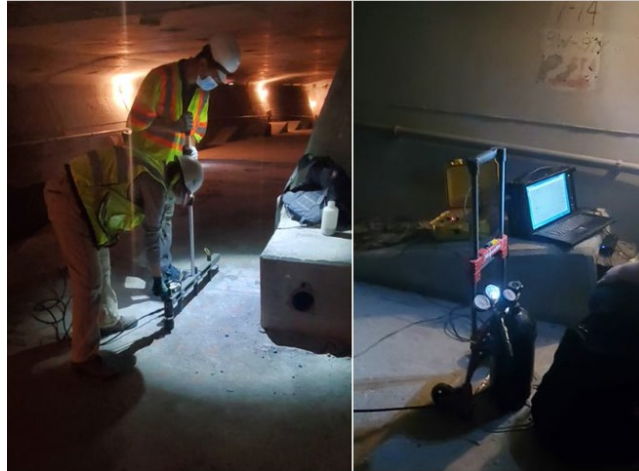
*Figure 7. Impact echo testing across closure pour. Seabreeze Bridge, Daytona Beach*

Several areas of concern were also identified during the annual inspection on the nearby Seabreeze Bridge. Mechanical sounding indicated potential problems in several anchorage blisters. Impact echo was used to evaluate the corresponding closure pours. The device used for the impact echo testing was a proprietary tool developed by the company performing the inspection (Vector Corrosion Services). A custom impactor was used to propel a stainless-steel BB into the concrete surface. An array of ultrasound transducers is positioned adjacent to the point of impact to record the ultrasonic waves as they travel through the structure. The data acquisition equipment is similar to the UPV, and the results also need to be interpreted by a highly skilled operator. The impactor device requires a pressurized nitrogen source to ensure that the impact energy remains consistent.

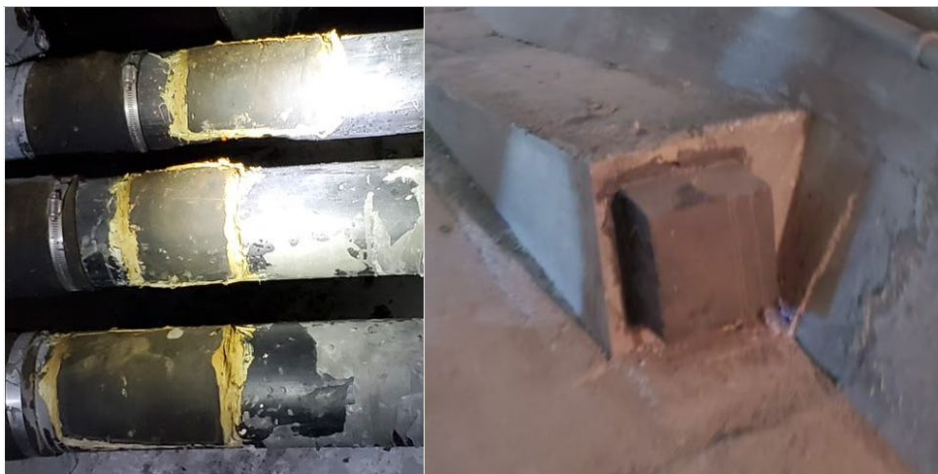
*Figure 8. External ducts that were previously targeted for invasive inspection (Broadway Bridge) and concrete pourback for anchorage protection (Seabreeze Bridge).*

Once the NDE work is completed, the company performing the inspections will make recommendations regarding the need for additional invasive inspections. For external tendons, this will involve removing a section of the duct to gain direct access to the grouted tendon. The research team for this project did not observe any invasive inspections in December 2020, but there was evidence of previous invasive inspections of external ducts (Figure 8). Once a portion of the duct has been removed, it is possible to identify grout defects or corrosion damage. A borescope can also be used to visually inspect and evaluate any voids that extend beyond the area of the duct that was removed.

Accessing anchorages requires additional invasive procedures. The concrete pourback can be broken off to expose the anchorage cap and vent port. The grout in the vent tube can be drilled out to provide access for a borescope inspection of the strands and grout on the back side of the anchorage plate. For internal tendons, a coring operation is required to access the duct in question. Once the duct is exposed, further invasive inspection can continue to provide access for a borescope or to conduct chemical analysis on the tendon grout.

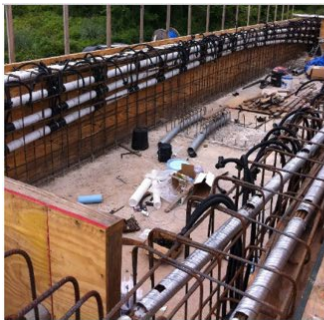
(c) Corrugated metal and plastic ducts being installed within the girder wall

Figure 16. Duct placement, concrete casting, and finished girder for NCHRP study by Hurlebaus et al. <sup>15</sup>

This NCHRP-funded project is by far the most comprehensive study identified by the research team. This work included the development of a mock-up bridge girder (Figure 15) with an array of internal and external tendons (Figure 16). The tendons were seeded with fabricated defects at multiple locations, and an array of NDE methods were deployed to inspect the tendons. An overall assessment of each method's functionality was provided.

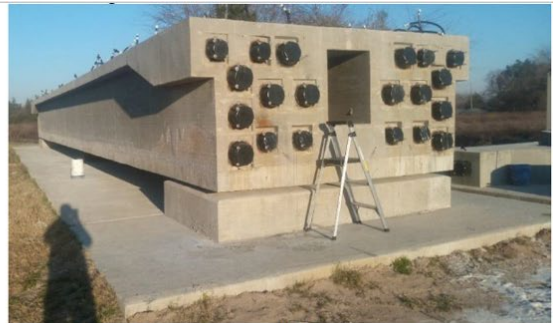
(e) Finished post-tensioned (U-beam) girder specimen

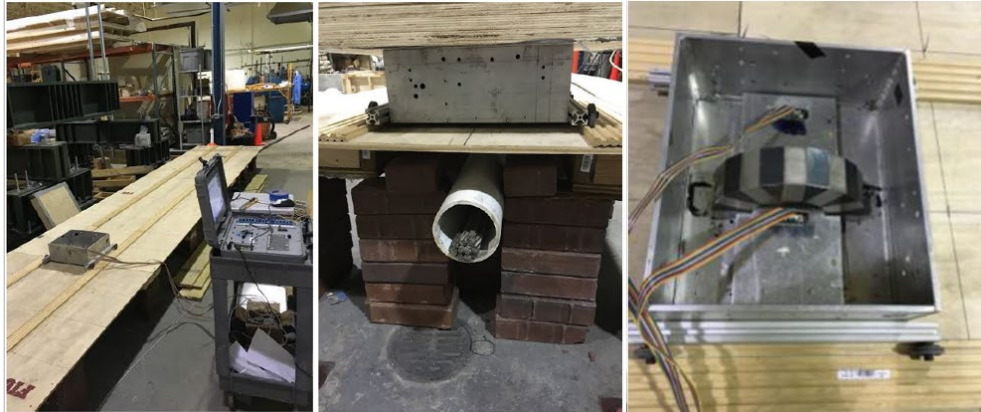
Figure 18. Experimental testbed and sensor for MFL inspections by Azizinamini<sup>21</sup>

Another interesting observation from this work relates to the MFL device that was developed for experimental testing in the lab (Figure 18). This setup was developed for internal tendons and the overall complexity was minimal compared to the device used for external tendons in the Hurlebaus study (Figure 17). The device developed by Azizinamini was based on finite element analysis of the magnetic fields involved. This suggests that there may be opportunities to develop an MFL sensor that is better suited for external PT duct applications that would be easier to mobilize and deploy for routine inspections (a significant shortcoming of the method reported by Hurlebaus). Additional research to refine the sensor to include electromagnetic capabilities was recommended as future work in Azizinamini’s latest study from 2017.<sup>21</sup>

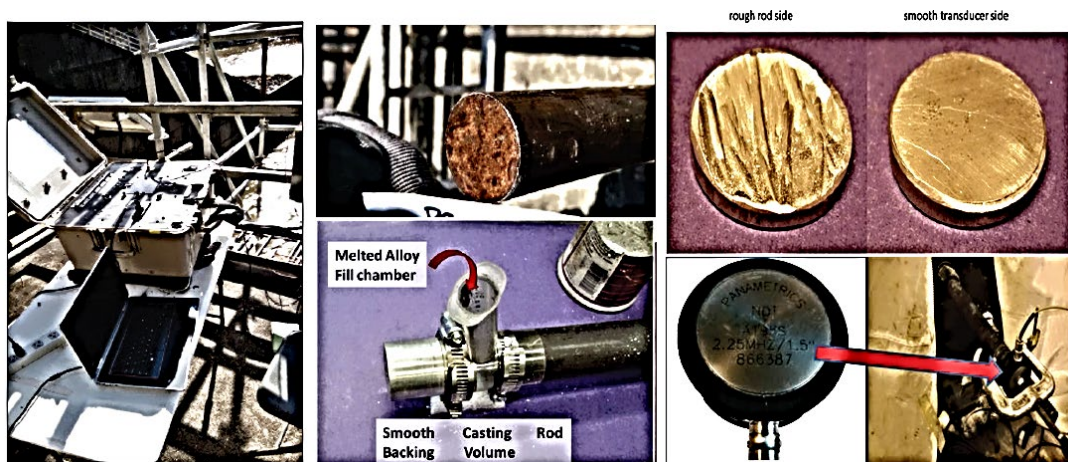
Figure 22. Data acquisition and transducer setup for GWUT of post-tensioned trunnion rods.<sup>13</sup>

After multiple iterations of laboratory and experimental testing, results reported in a 2019 technical note<sup>13</sup> on the solid-rod inspections appear to be the most promising. The system relies on guided wave ultrasonic testing (GWUT) and the basic apparatus is shown in Figure 22. Mounting the transducer to the end of the rod required an intermediate step of casting a small billet of metal alloy on the end of the rod. This resulted in a smooth end-surface at the transducer interface. Under normal circumstances, the required level of surface prep could be achieved with grinding and polishing, but the history of sudden catastrophic failures of the rods led to a prohibition on inducing vibrations into the rods.

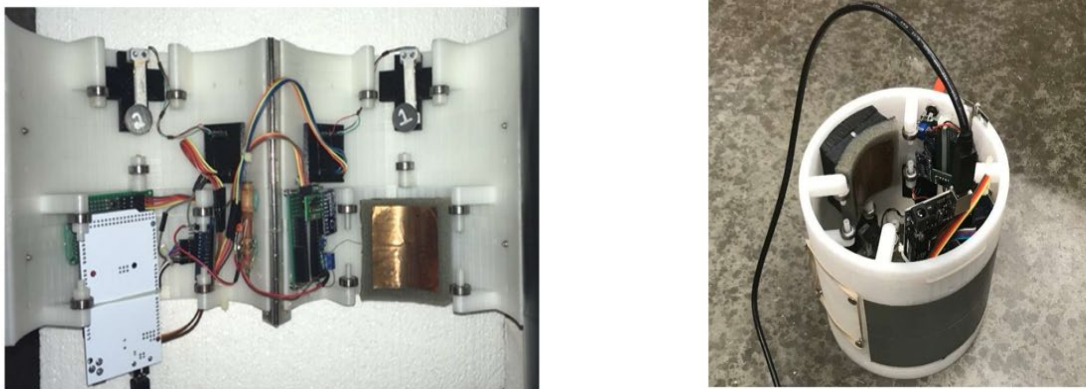
Figure 25. Layout of electronics for tendon imaging unit<sup>10</sup>

On a conceptual level, this device has numerous advantages. It is easy to operate for external ducts and it provides a clear image for the operator to interpret in near real time. Such a device, if properly calibrated and validated for external ducts with flexible fillers, would allow an FDOT inspection team to rapidly assess suspect areas and proceed immediately to an invasive inspection if the results indicate it is necessary. Additional information on results from this research and how the impedance measurements compare with radiography methods is provided in Section 2.3.15. One additional important note: the original device described in the FDOT report<sup>10</sup> indicates that an electrical connection with the tendon steel is required. The latest generation device that we observed during the

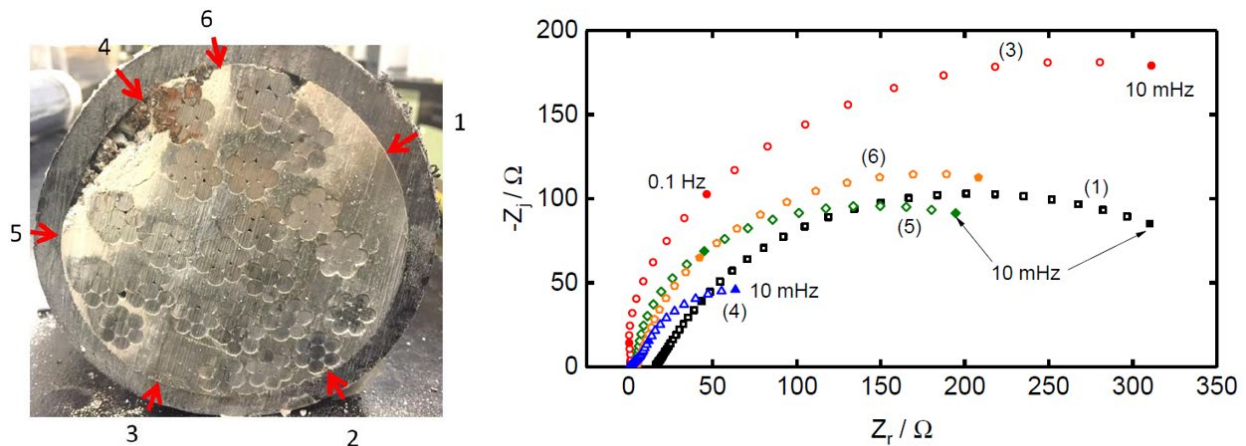
Figure 26. Electrochemical impedance spectroscopy results from corroded tendon.<sup>26</sup> Numbers in parentheses on chart correspond to circumferential locations on the tendon.

This study, led by Dr. Mark Orazem and Dr. David Bloomquist at the University of Florida,<sup>26</sup> relies on electrochemical impedance spectroscopy (EIS) to detect the presence of ferrous-oxide films on corroded prestressing strands. Experimental results obtained during a laboratory study on corroded tendons from the Ringling Causeway are highlighted in Figure 26. This method does require establishing direct electrical contact with the grout, so multiple holes must be drilled along the length of the duct for each desired inspection location around the circumference. Results from the experimental work indicated that corrosion could be detected only if it was occurring close to the surface of the duct and directly adjacent to the electrodes (see Location 4 in Figure 26). Additional discussion on the physics behind the method and deployment results for this device on the Texas A&M mock-up bridge girder is provided in Section 2.3.15.

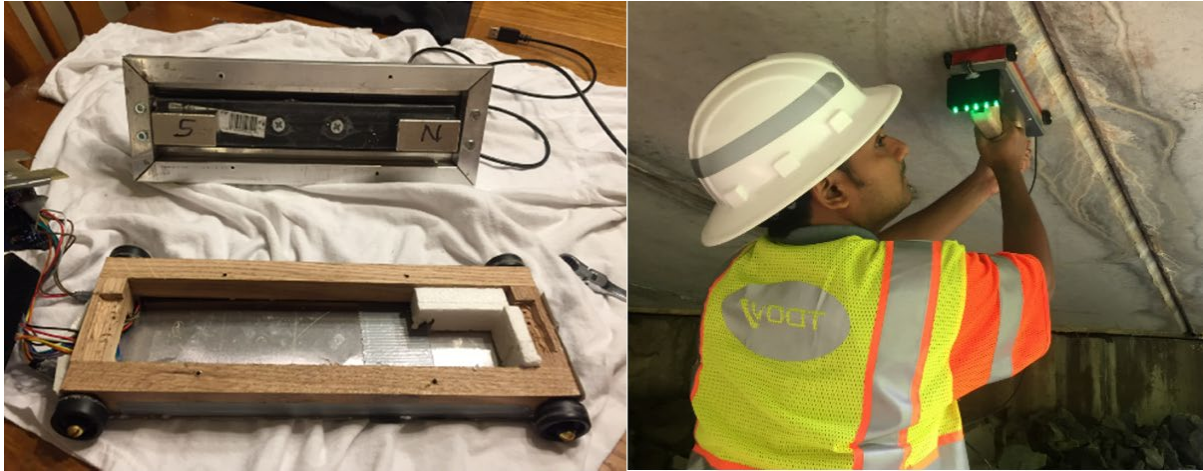
Figure 28. MFL device for corrosion detection in traditional prestressed (pre-tensioned) concrete box girders<sup>28</sup>

concrete Figure 28. The device operates using a color-coded LED system where green lights indicate sound prestressing strands and yellow lights indicate potential areas of concern.

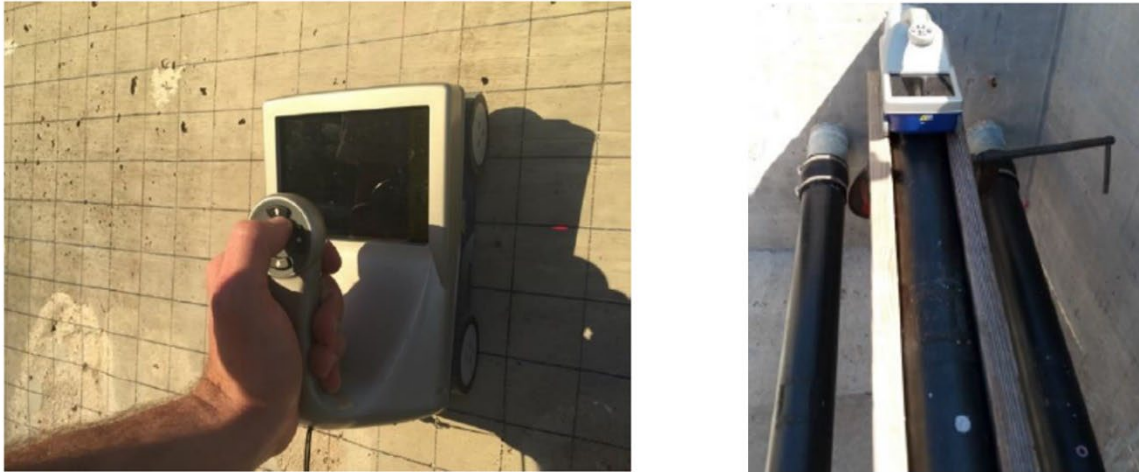
*Figure 29. StructureScan Mini HR GPR unit inspecting concrete and the external tendons (Hurlebaus et al. <sup>15</sup>)*

depth up to 16". This set up can be seen below (Figure 29). Due to the size of the PT girder specimen, it was divided up into several sections to allow for full coverage. To scan the external duct, wooden supports were added along the side to account for the circular shape to ensure the results were accurate (which can also be seen below).

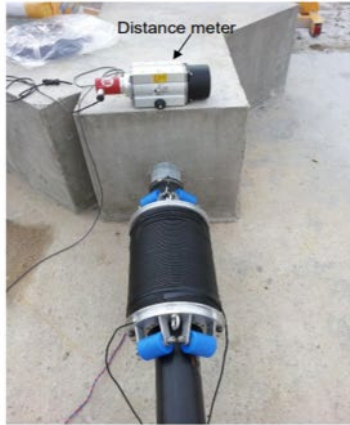
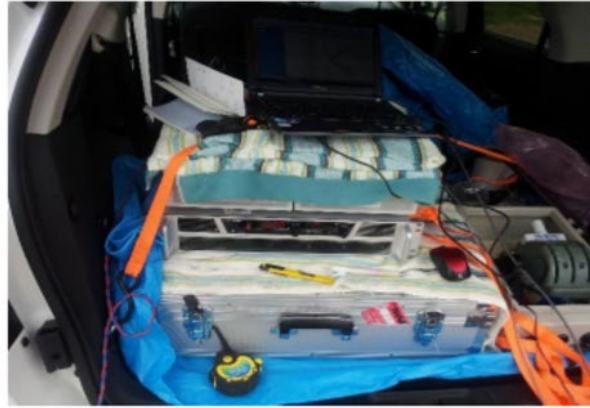
Coil System around the PT duct

Data Collection System

Figure 37. Solenoid type MFL Inspection System and the accompanying Data Collection System for the Analysis of PT Ducts (Hurlebaus et al. <sup>15</sup>)

This process utilizes a coil of wire set around the tendon in question, and then the tendon is magnetized by an external source to gather readings on the condition of the tendon. The coil of wire can be run along the length of the duct if there is no obstruction. This method can be used to find defects in the tendon such as corrosion or section loss. The main advantage of this method is the accuracy with which the coil device can locate the point of interest. The setup for this method developed, prototyped, and tested by Hurlebaus can be seen in Figure 37.

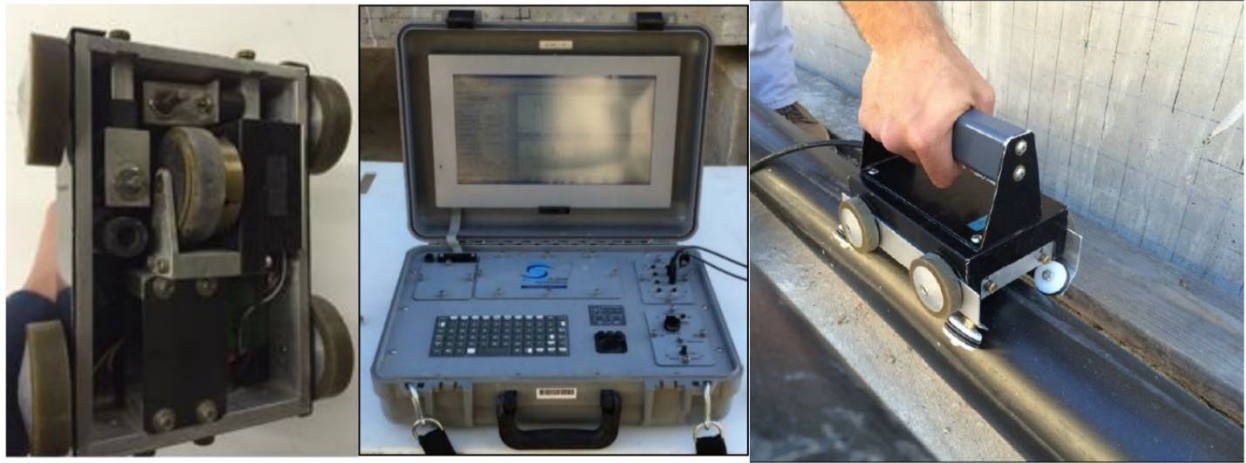
Figure 40. IE scanner test head, the PC data acquisition platform, and the IE device in use on an external duct (Hurlebaus et al. <sup>15</sup>)

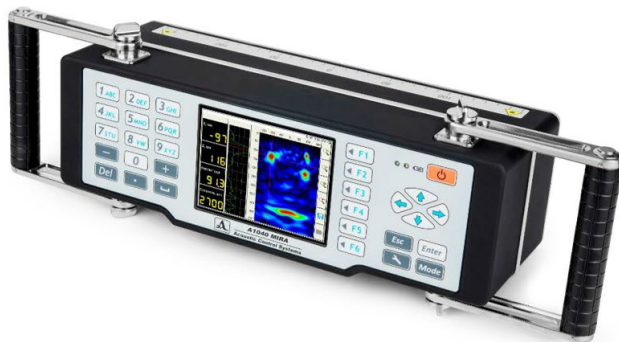
Figure 41. A1040 MIRA device and results from the deviator blocks (left is defect key, and right is the UST scan) (Hurlebaus et al. <sup>15</sup>)

Due to the size of the specimen, data was collected in sections and later combined to be analyzed. As a nonhomogeneous material, concrete requires sample velocities and then an averaging of the results for each section. This method was unable to identify grout defects in the internal ducts, with difficulties inspecting metal ducts. UST was able to identify the location of the internal ducts and proved to be more effective when used upon HDPE ducts. UST was also unable to locate defects in the anchorage zones of the PT system.

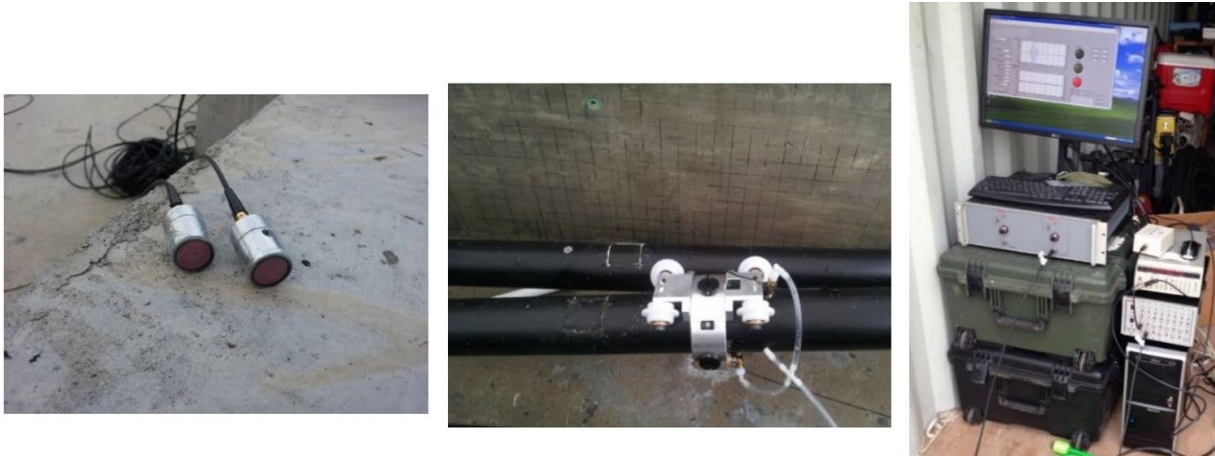
*Figure 44. Pulse transmitter and receiver, prototype scanning head with encoder and data acquisition system*

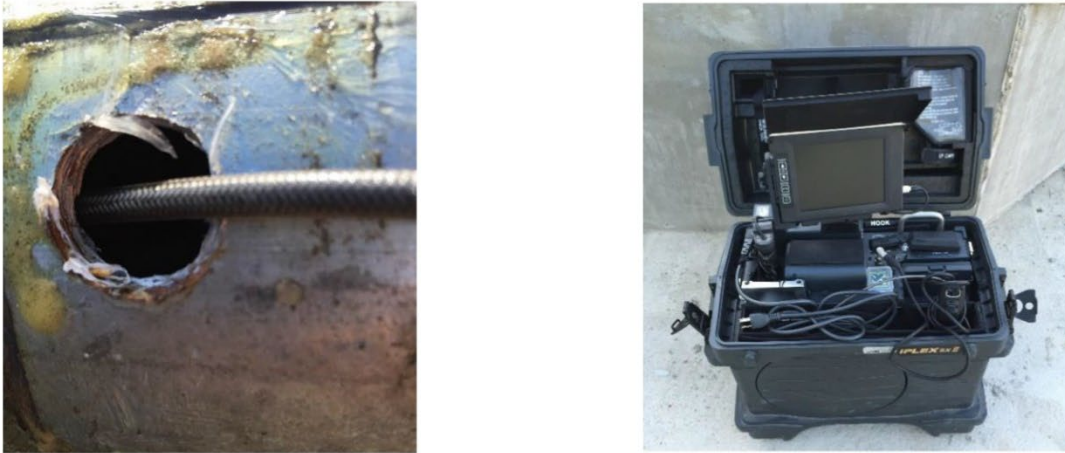
Figure 46. Borescope access port and equipment used (Hurlebaus et al.<sup>15</sup>)

This method allows the inspector to see the corrosion or voids within the duct by running the borescope inside the system.

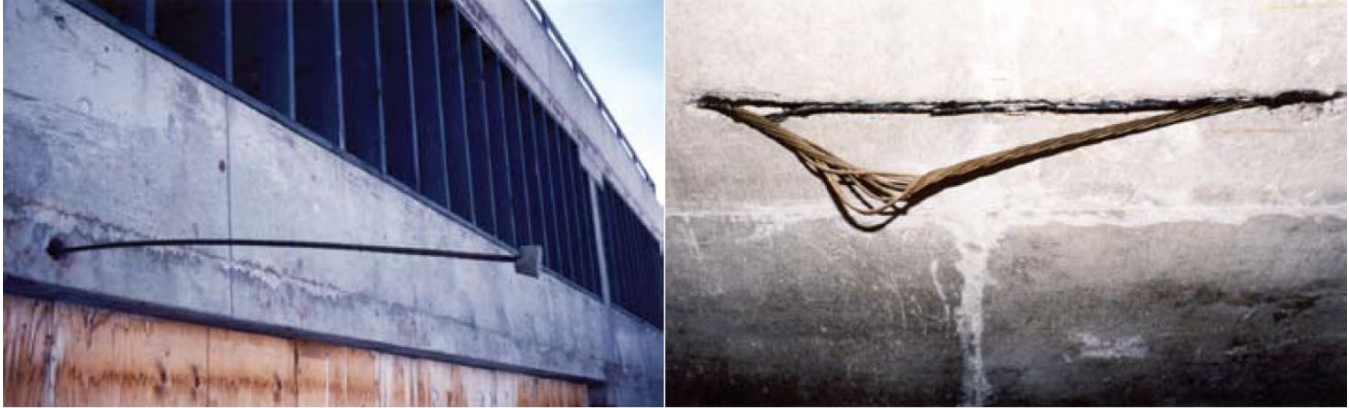
Figure 58. Erupted or ejected tendons from anchorage and slab soffit (Fallis et al. <sup>45</sup>)

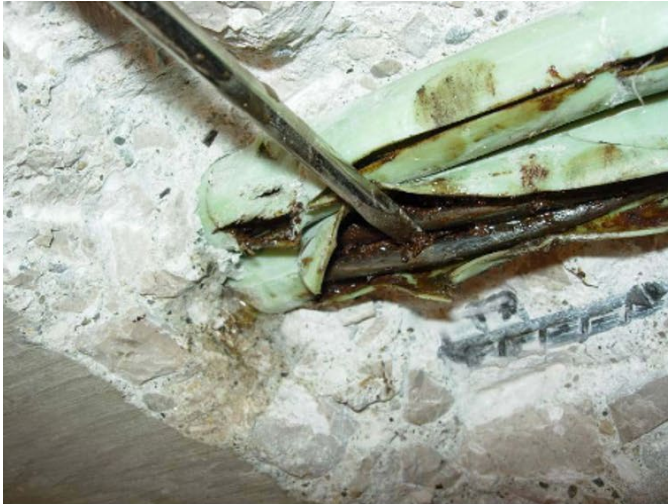
Water intrusion and subsequent corrosion damage in roof-slab post-tensioning system.

The most important question facing the building owner and the structural engineering firm hired to assess the problem was trying to understand the extent to which other tendons might be damaged. Concrete removal at six locations exposed 48 tendons with each tendon containing three strands. Of the 48 tendons exposed, 38 had a portion of the duct/sheathing removed to expose the steel strands. Forty percent of the exposed strands had water inside of the duct/sheathing. Twenty percent of the tendons with water were determined to be unstressed. Findings are summarized in Figure 59.

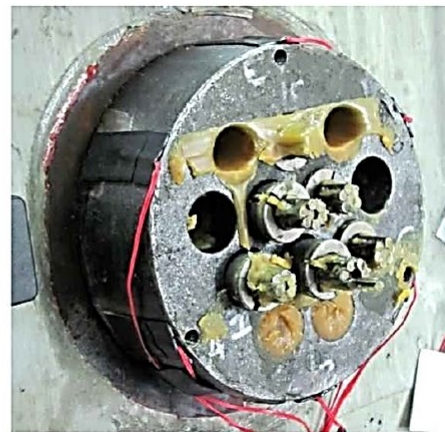
(b) after strand cuts

Figure 71. Possible inspection setup for x-ray imaging of PT anchorages with Type 5 protection systems. (Hamilton et al.<sup>4</sup>)

In the current study, we are trying to detect strand and wedge grip dislocations at PT anchorages. For Type 5 anchorage protection systems, the x-ray source only needs to be strong enough to produce a beam capable of penetrating the permanent nylon anchorage cap and the flexible filler contained within the anchorage. The strand tails will all protrude one inch from the wedge grips. Any wedge grip or strand dislocations will appear in the x-ray image if the x-ray generator and plate are oriented as shown in (Figure 71).

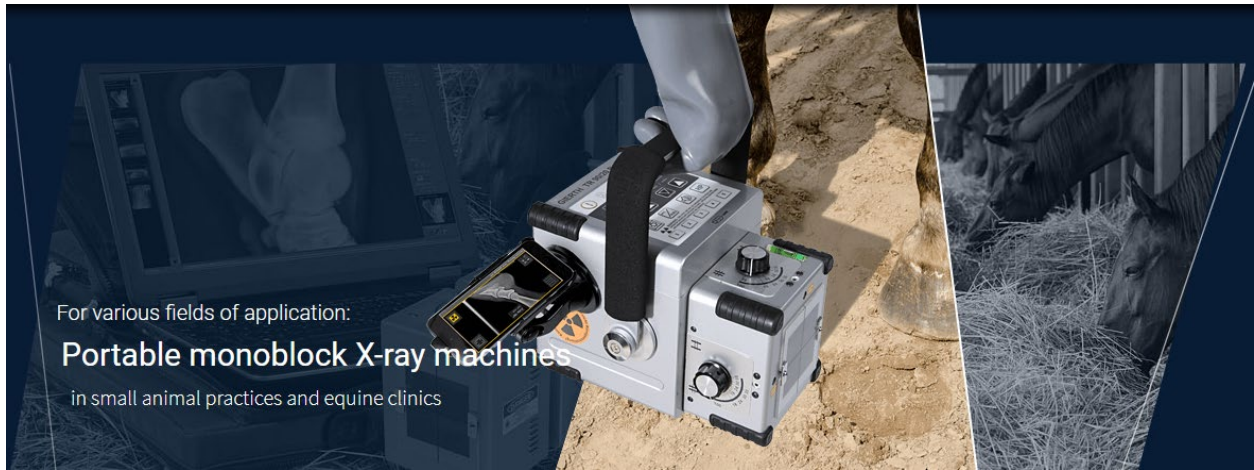
Figure 72. Portable X-ray generating unit for veterinary applications from OR Technology<sup>58</sup>

<b>X-Ranger</b>	
<b>MINXRAY TR90BH</b>	
X-RAY OUTPUT	20 - 10 mA @ 40 - 90 kVDC
EXTERNAL DIMENSIONS	8.6" x 7.4" x 12.6" (21.8 x 18.9 x 32.1 cm)
WEIGHT	16.3 lb. (7.4 kg)
POWER	60 VDC rechargeable lithium ion battery
<b>CSL WIRELESS DIGITAL IMAGING PANEL</b>	
SCINTILLATOR	CsI Direct Deposit
EXPOSURE CONTROL	F <sup>2</sup> AED™ Full-Field Automatic Exposure Detection
PIXEL PITCH	154 μm

Imaging for Type 1 anchorages that include an epoxy-grout pour back or internal PT ducts would require a significantly stronger radiation source, which reintroduces the limitations of excessive cost, difficulties with deployment, and operator safety. Imaging for Type 5 anchorages should be manageable with standard medical grade imagers. Recent advances in this technology have led to the development of multiple “off-the-shelf” portable x-ray imaging systems. Many devices are 100% battery powered and can generate 300 exposures on a single charge. These systems are commonly used in veterinary medicine applications (Figure 72) as well as forward military operations (Figure 73).

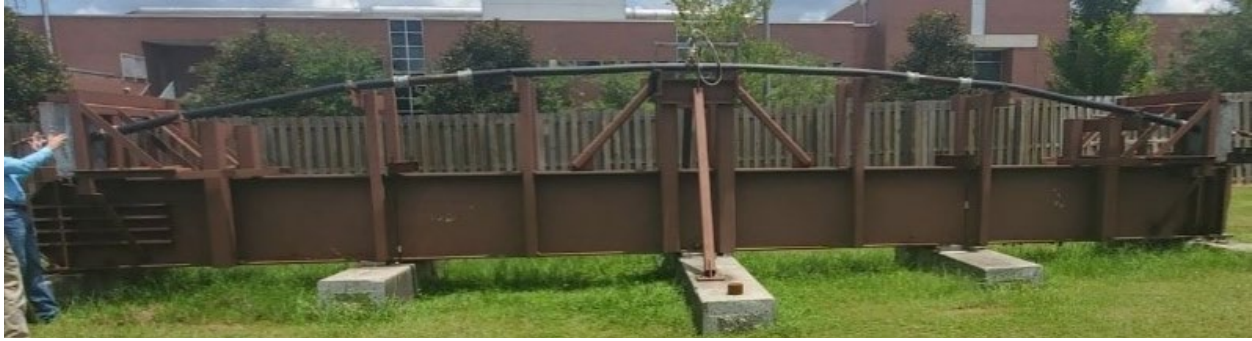
Figure 80. Filled external tendon mock-up

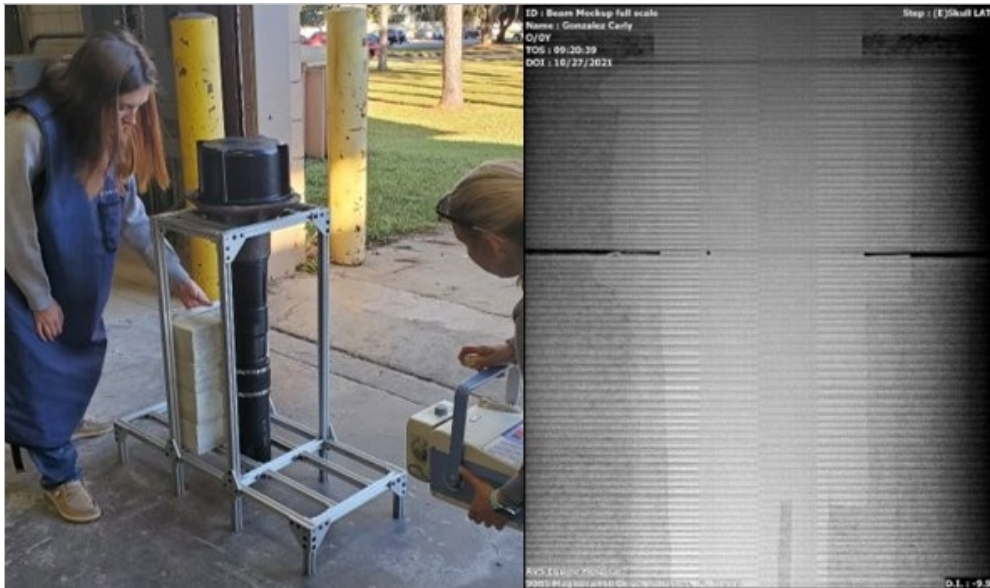
Figure 87. Anchorage mockup: duct results

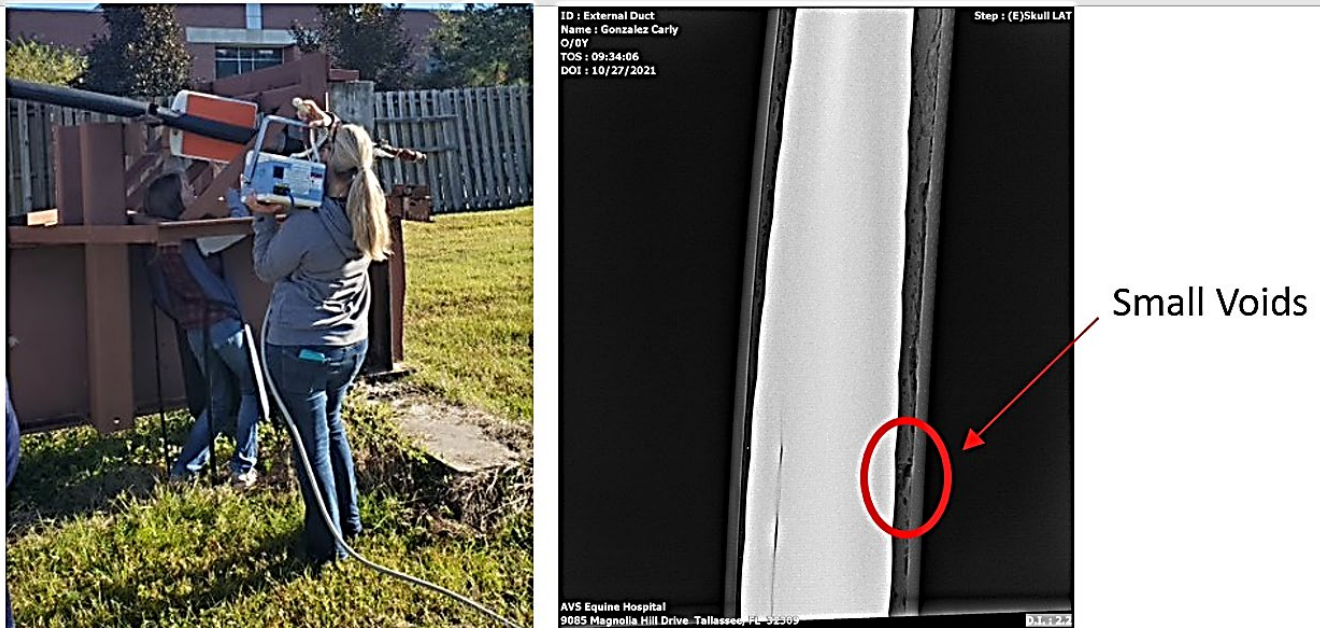
*Figure 88. Specimen 2: filled duct results*

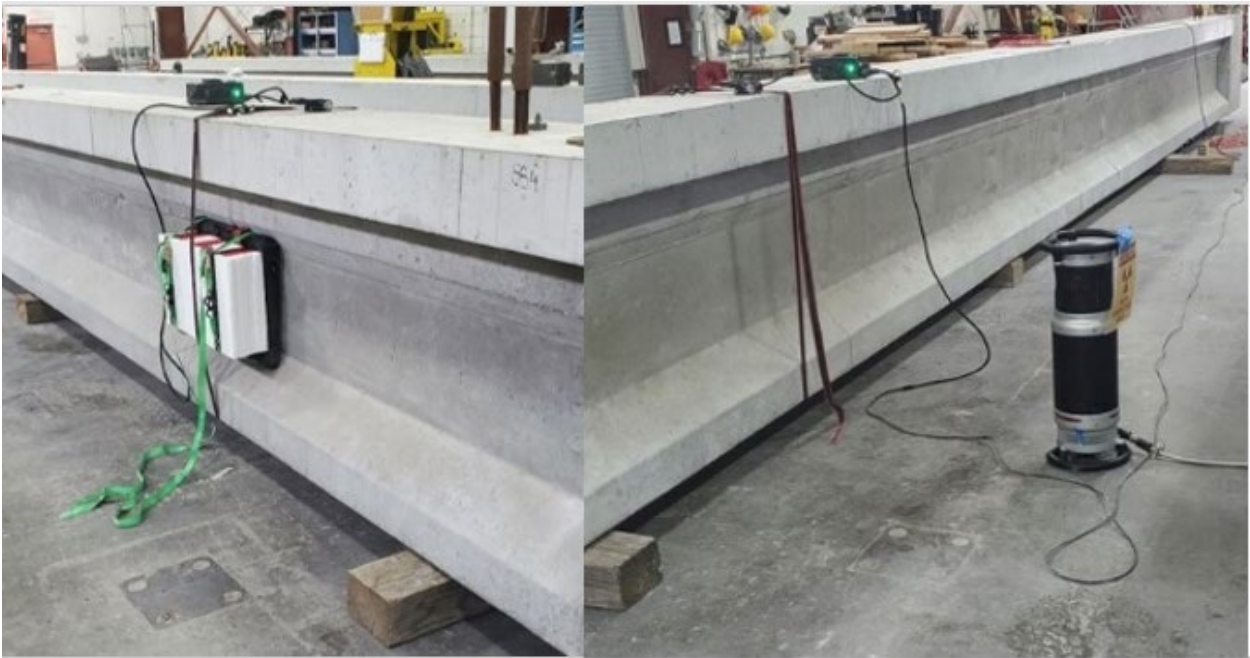
Figure 90. YXLON X-Ray machine on internal duct specimen

The setup of the YXLON machine for evaluating the internal-duct specimen is provided in Figure 90. The imaging plate is on the left and the radiation source is on the right.

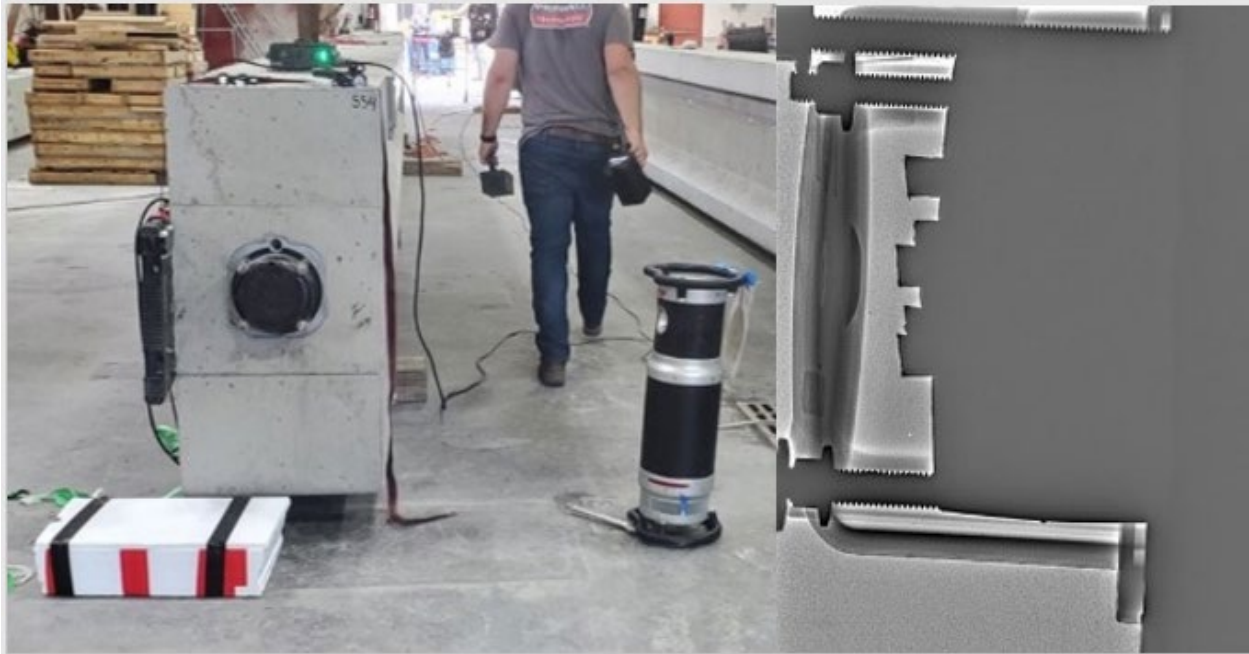
*Figure 91. YXLON machine on internal specimen anchorage cap*

Due to the considerable power of the YXLON X-Ray machine, the images captured through the cap exhibited a slight overexposure, leading to the "grayed" appearance of the cap (Figure 91). To mitigate this issue in future testing, it may be worthwhile to explore reducing the exposure time. Fortunately, despite the overexposure, it remains possible to discern the outline of strand and grip locations in

these images. For inspection purposes, this level of visibility would suffice in assessing the cap and alerting the inspector to any potential faults within it.

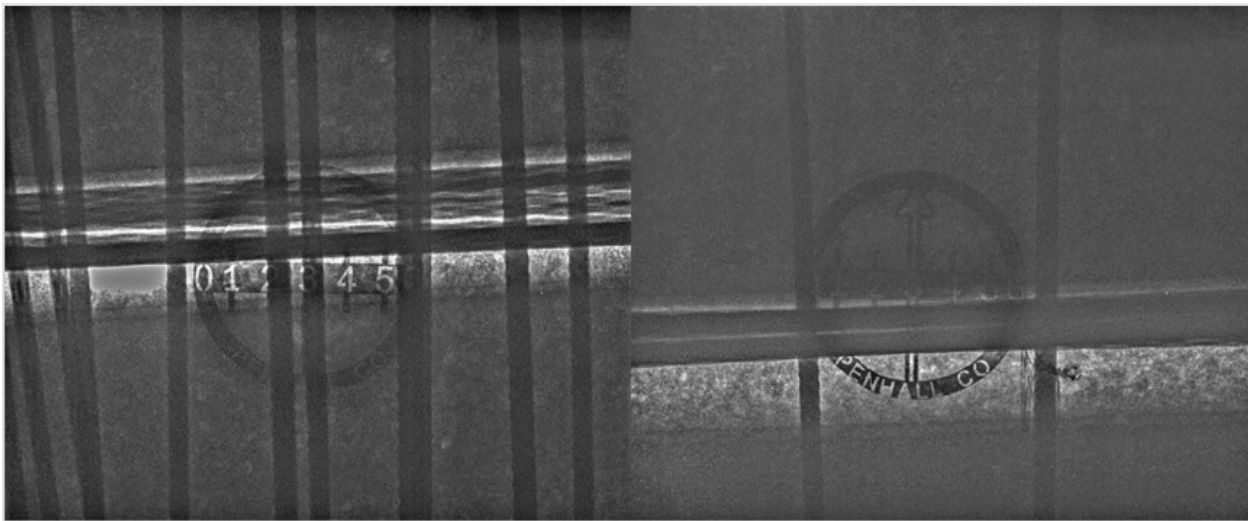
Figure 93. Internal Duct Specimen: duct with strands 1ft away from end block (Left) and 5ft away from end block (Right)

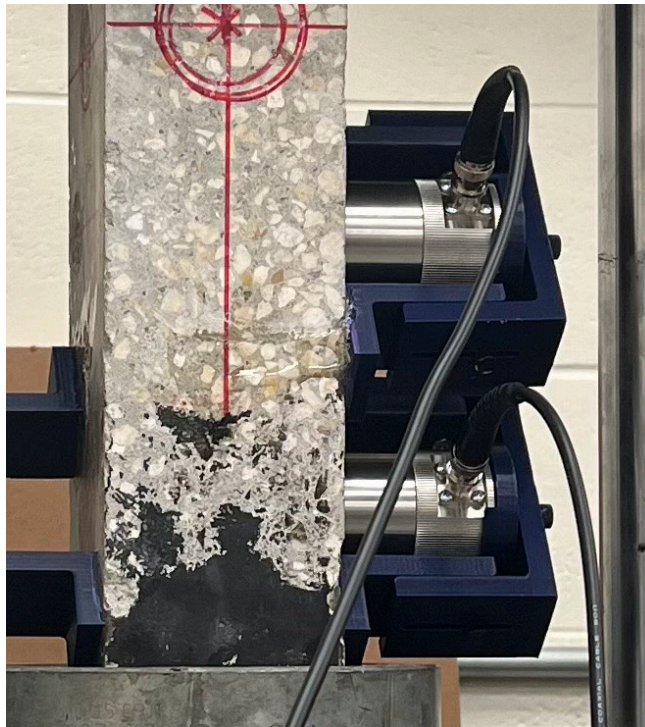
Figure 107. Test setup for compressive loading with fixture-assisted mounting for UT transducers.

It should be noted that the gel couplant performed very well immediately after it was applied. The couplant also provided excellent signal fidelity and did not require post-amplification. The signal quality did vary depending on how firmly the transducer was pressed into the surface of the specimen with external pressure from the fixture shown in Figure 107.

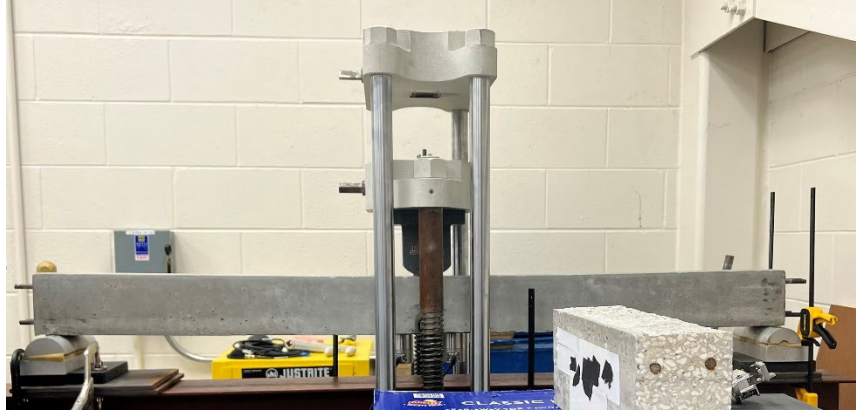
*Figure 112. 3-point load testing frame and the Tinius and Olsen universal testing machine.*

**3-Point Bending (Normally Reinforced Beam):** This test will be conducted on a 5-foot-long beam with a cross-section measuring 4.75x3.5 inches. The beam's reinforcement will consist of four #3 bars and shear reinforcement through 14 eight-inch stirrups spaced at 1.75-inch intervals on each side of the beam. The 50-kHz and 500-kHz transducers will be attached using epoxy bonding. The 50-kHz transducers will be centered on the beam with a 4-inch spacing, while the 500-kHz transducers will be arranged in a cross configuration at the beam's central point. The apparatus for this test will include a Tinius and Olsen universal testing machine and a 3-point load testing frame (Figure 112).

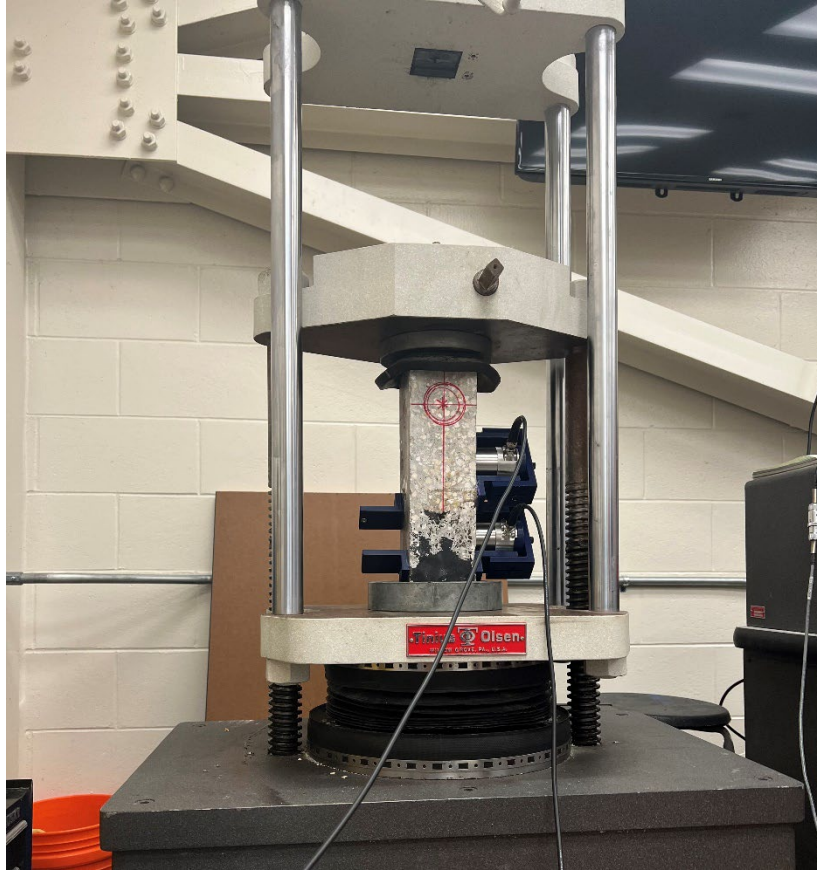
*Figure 113. Testing setup for small-scale block testing*

The load testing procedure involved two loading cycles of interest, one with the 50 kHz transducers and one test with the 500-kHz transducers. These direct compression tests, performed in the Tinius and Olsen machine, applied force to the specimen in 1,500-kHz-pound increments; at each increment, a transducer pulse was fired, and a set of data was collected until a peak loading of 15,000 pounds was reached. At this point, the sample was unloaded at increments of 3,000 pounds; again, a transducer pulse was fired, and data were collected at each increment until 0 pounds of force was applied to the sample. This exact procedure was followed for each of the two tests, one 50-kHz test followed by a 500-kHz transducer test. These tests are labeled as 1.1 and 1.2; the first number relates to the testing group, and the second is the test's time-correlated place in the group. The specific settings used with the equipment are provided in Table 12, and an image of the testing setup is provided in Figure 113.

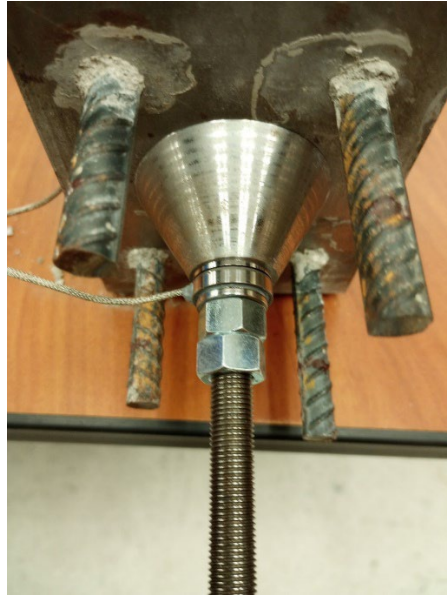
Figure 114. Load cell used for post-tensioning measurements on small-scale beam

The post-tensioning for this small-scale beam was accomplished by tightening a threaded rod placed through the center of the beam. The tensioning cycle was measured using a force cell placed on the threaded rod (Figure 42), which was connected to a multimeter for tension readings.

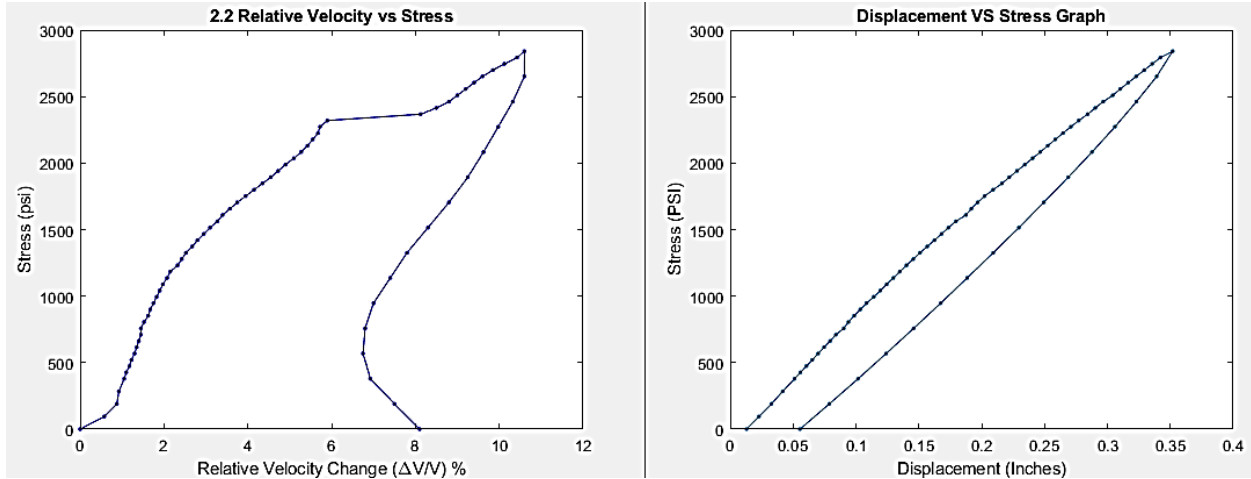
Figure 118. Small-scale normally reinforced beam, three-point load, Coda-wave interferometry Test 2.3- Graph of relative velocity change vs. Stress and displacement vs. stress

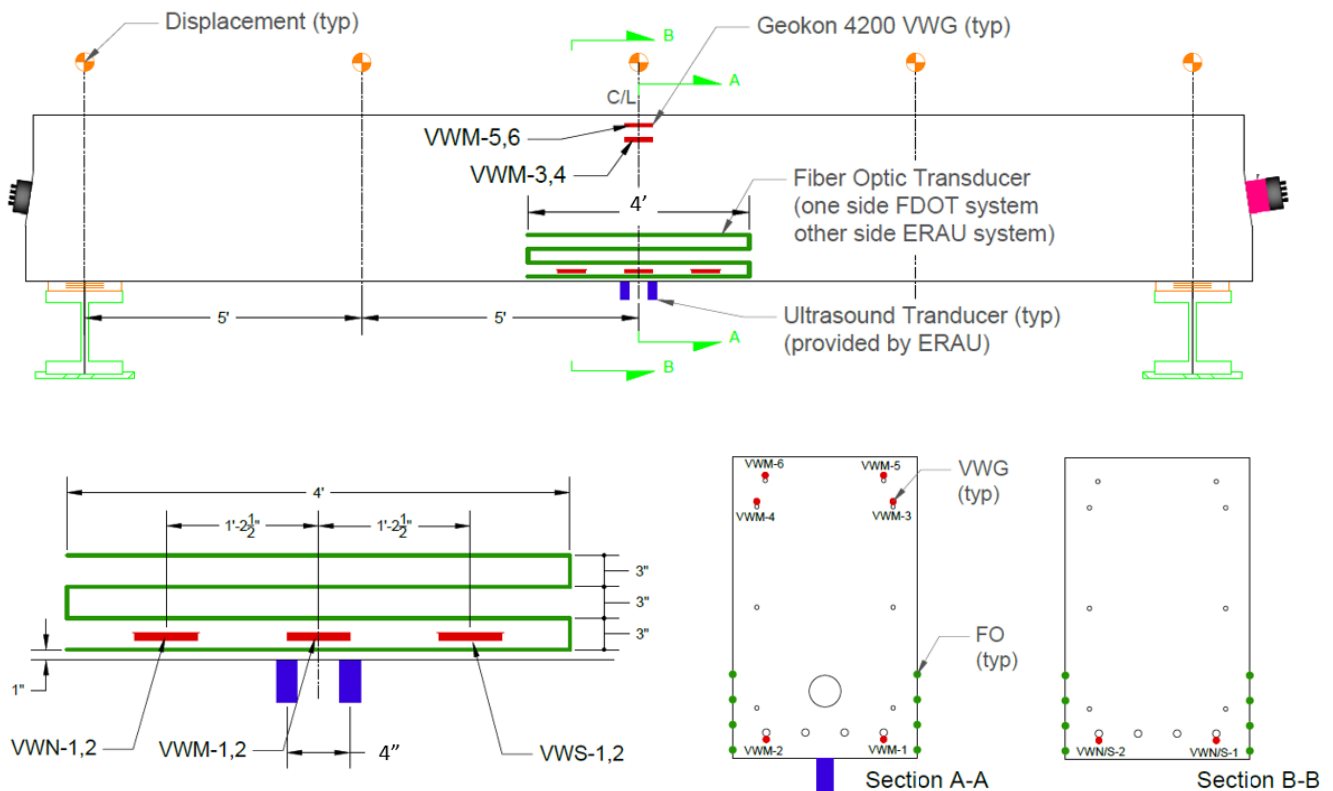
Figure 131. Instrumentation layout for Beam A

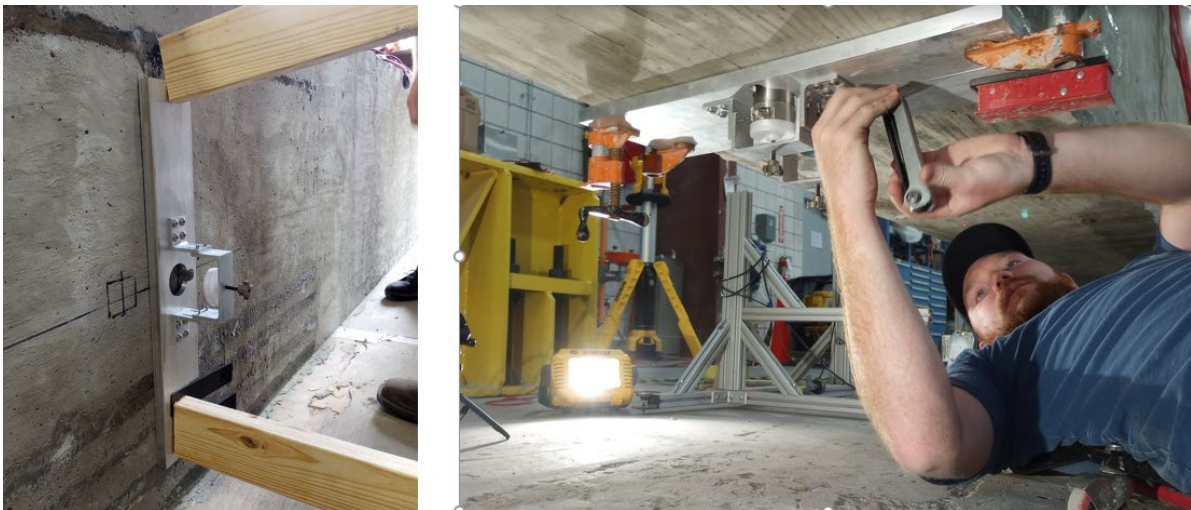
Figure 134. Fixture for mounting transducers using two-part epoxy

The research team also developed a fixture for mounting the transducers. The purpose of the fixture was to hold the transducers firmly in place while the two-part epoxy cured (typically less than five minutes). The fixture was effective for both vertical and horizontal (overhead) surfaces (Figure 134). In certain cases where the mounting fixture could not be secured to the beam, the research team was able to place the 7-gram slug of mixed putty on the center of the transducer and press it firmly against the beam until a visible bead of putty was extruded around the circumference. Simple hand pressure

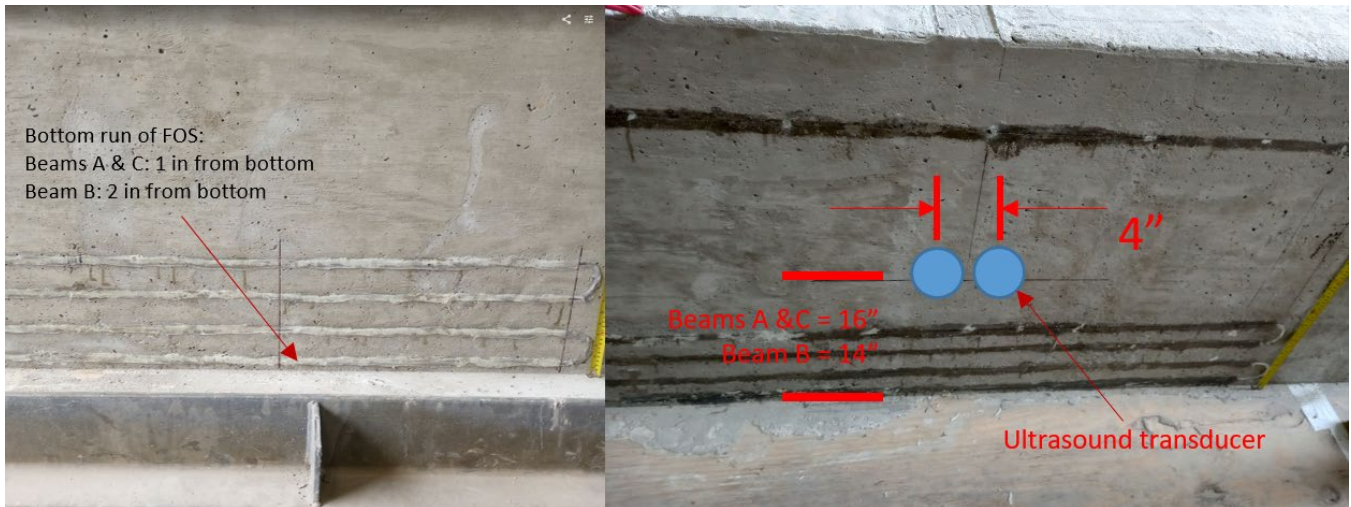
Figure 137. Fiber-optic sensor location and ultrasound transducer location for post-tensioning

Post-tensioning was performed with a 300-ton hydraulic actuator and pump system that was provided by Structural Technologies VSL. Post-tensioning was completed for Beam A, Beam B, and Beam C on June 23, June 30, and July 14, respectively. The hydraulic actuator was manually controlled during the stressing operation based on the pressure on the service side of the pump. Target pressures and the corresponding post-tension force are provided in Table 16. Imperfections in the concrete around the cold joint in Beam B required several minor alterations in the location of the ultrasound transducers and the fiber-optic sensors. For Beam A and Beam C, the ultrasound transducers were located 16 in from the bottom of the beam or two inches below the neutral axis. The two ultrasound transducers for Beam B were located 14 in from the bottom or four inches below the neutral axis. The bottom run of the fiber-optic sensor was located one inch from the bottom for Beam A and Beam C and two inches from the bottom for Beam B (Figure 137). This resulted in minor variations for the anticipated stress levels at the sensor locations.
