FDOT Contract Number: BEC97

# **A Review of Protocols Used for Evaluating Defective Asphalt Materials and Pavements**

Final Report-Deliverable 5

July 2024

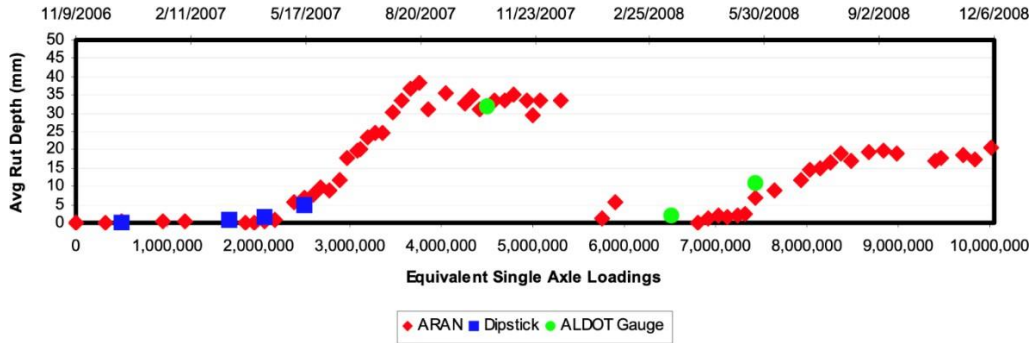
**Figure 1. Rutting in Section S8B for Original and Replacement Mixtures (Willis et al. 2009).**

The Test Track experiment included four 100-foot subsections. The first four mixtures placed in the fall of 2006 used virgin aggregates and an unmodified PG 64-22 binder. Three mixtures were produced with low QC voids by increasing the asphalt content, and one mixture was produced by increasing the asphalt content and adjusting the aggregate blend percentages. These sections failed with significant rutting when pavement temperatures increased in May of 2007 (after approximately 2.4 million ESALs). These mixtures were removed in February of 2008 (at approximately 5.6 million ESALs) and replaced with new mixtures at QC air void levels that were intended to better define the relationship between QC air voids and rutting performance. Rutting was again observed beginning in May 2008 (after approximately 2 million ESALs from the time of replacement). Figure 1 shows the rutting performance of both the original and replacement mixtures in one of the subsections. Similar results were also observed in the other subsections.

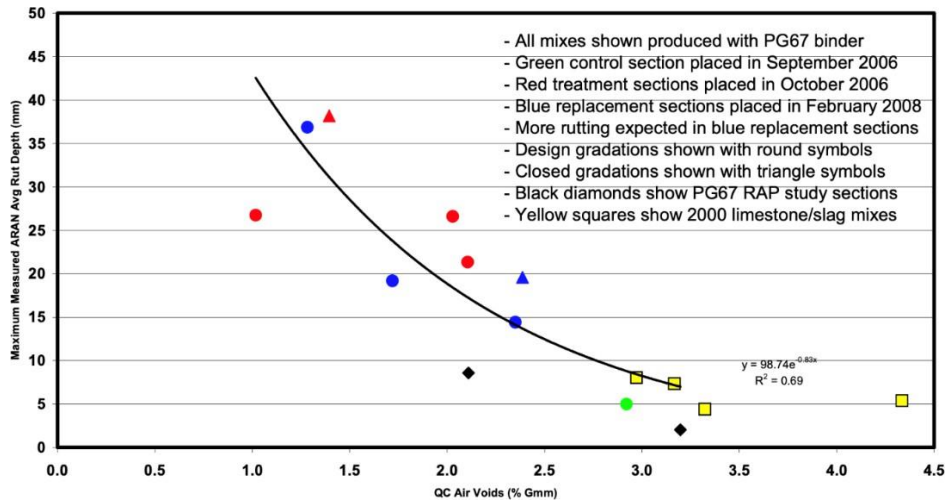
**Figure 2. Correlation between Field Rutting and QC Air Voids (Willis et al. 2009).**

Figure 2 shows the correlation between QC air voids and maximum measured field rut depths. The field rutting performance was satisfactory after 10 million ESALs for the mixtures with QC air voids above approximately 2.75 percent. However, the field rut depths increased significantly below this level, warranting removal and replacement. It is important to note that these limits may not apply to lower pavement structure layers.

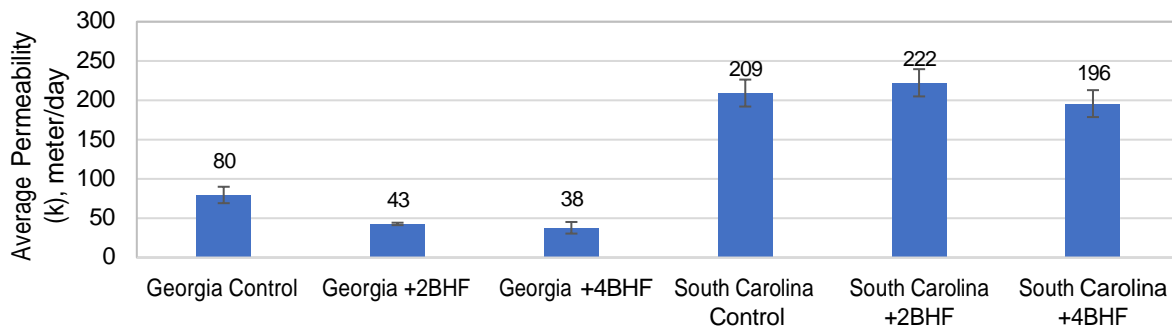
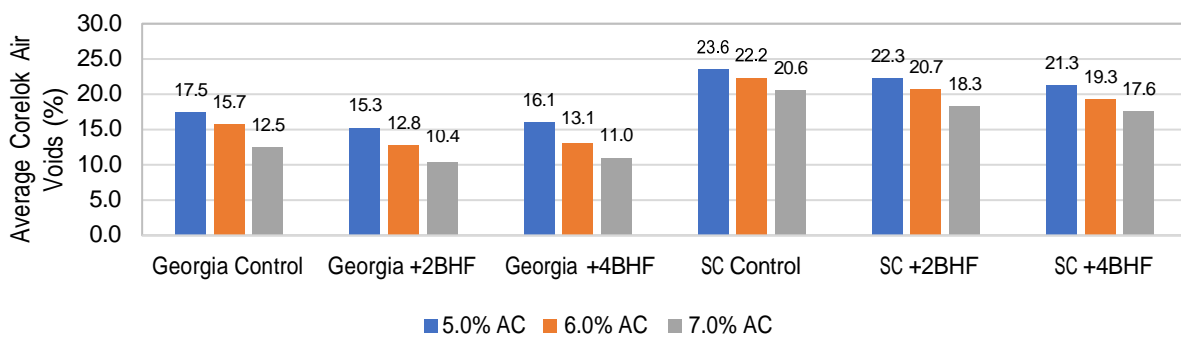
(a) Cantabro Loss

(b) Permeability at 6.0 Percent Binder Content

(c) Air Voids

**Figure 3. Effect of Binder Content and  $P_{200}$  on Durability and Permeability of OGFC Mixes (Watson et al., 2018).**

Figure 3(a) shows that the Cantabro loss of the control OGFC mixtures can be significantly affected by changes in binder content and  $P_{200}$  (i.e., adding 2 and 4 percent baghouse fines (BHF)). However, as shown in Figure 3(b), increasing  $P_{200}$  can significantly affect the permeability of the Georgia OGFC mixture, but it had a minimum effect on the permeability of the South Carolina OGFC mixture due to the difference in air void levels [Figure 3 (c)].

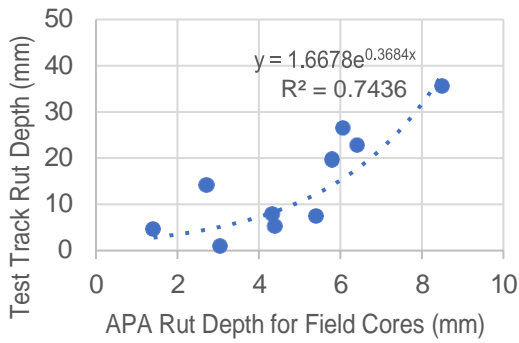
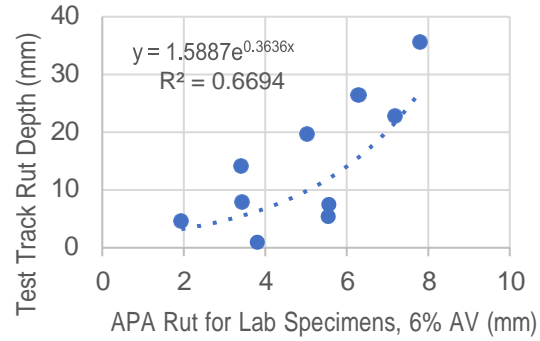
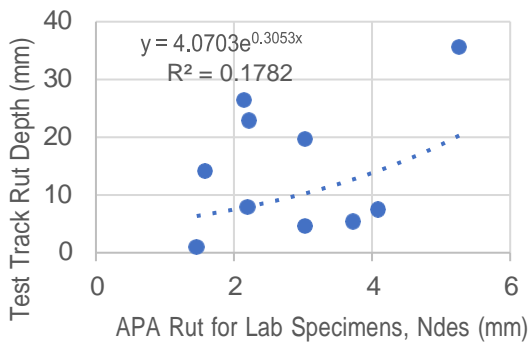
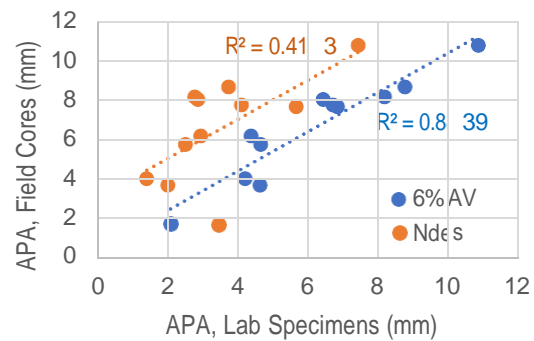
(a) APA for Field Cores vs TT Rutting

(b) APA for Specs @ 6-7% AV vs TT Rutting

(c) APA for Specimens @ N<sub>des</sub> vs TT Rutting

(d) APA for Lab Specimens vs Field Cores

**Figure 4. Correlations between APA Rut Depths and Field Rutting**

Figure 4 shows the correlations between the rut depths measured at the Test Track and the APA rut depths for the three specimen types based on an additional analysis conducted for this project. The APA rut depths measured on the field cores show the best correlation to the field rutting performance [ $R^2 = 0.74$ , Figure 4(a)], followed by those for laboratory specimens compacted to the target air voids of 6 to 7 percent [ $R^2 = 0.67$ , Figure 4(b)], and then those for laboratory specimens compacted to  $N_{\text{design}}$  [ $R^2 = 0.18$ , Figure 4(c)]. As shown in Figure 4(a), A maximum APA rut depth of 5.5 mm can be used to separate the mixes, with field-measured rut depths above 12.5 mm. In addition, as shown in Figure 3(d), compared to the lab specimens compacted to  $N_{\text{design}}$ , the lab specimens compacted to 6 to 7 percent air voids have a stronger APA rutting correlation to the field cores.

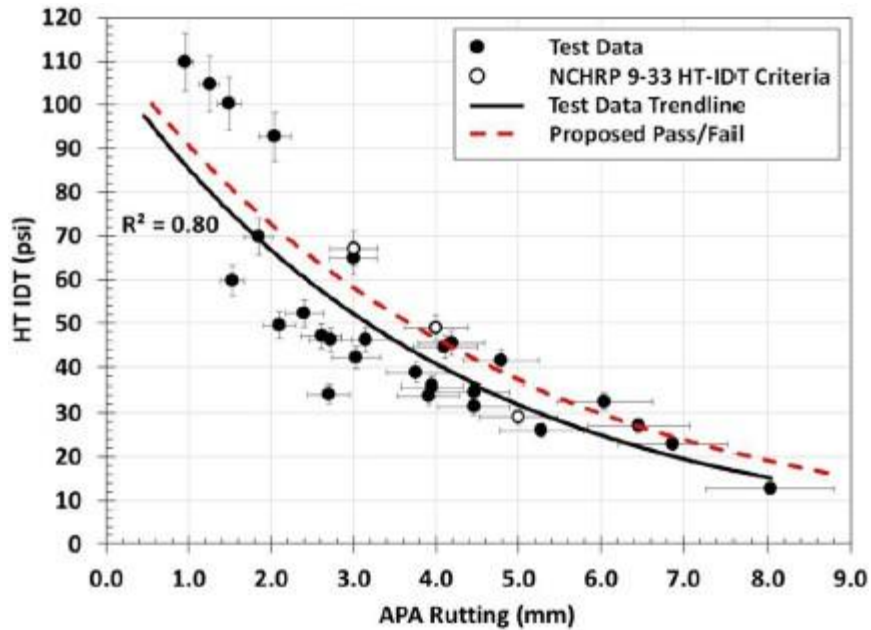
**Figure 5. HT-IDT vs. APA (Bennert et al. 2018)**

Figure 5 shows a comparison of APA vs. HT-IDT test results, indicating a strong relationship with an  $R^2$  of 0.8. The proposed pass/fail criteria shown in the figure incorporated the effects of variability based on the coefficient of variation (COV) as a conservative measure. The figure also superimposed the recommended criteria from the NCHRP 9-33 project which agreed with the data in this study.

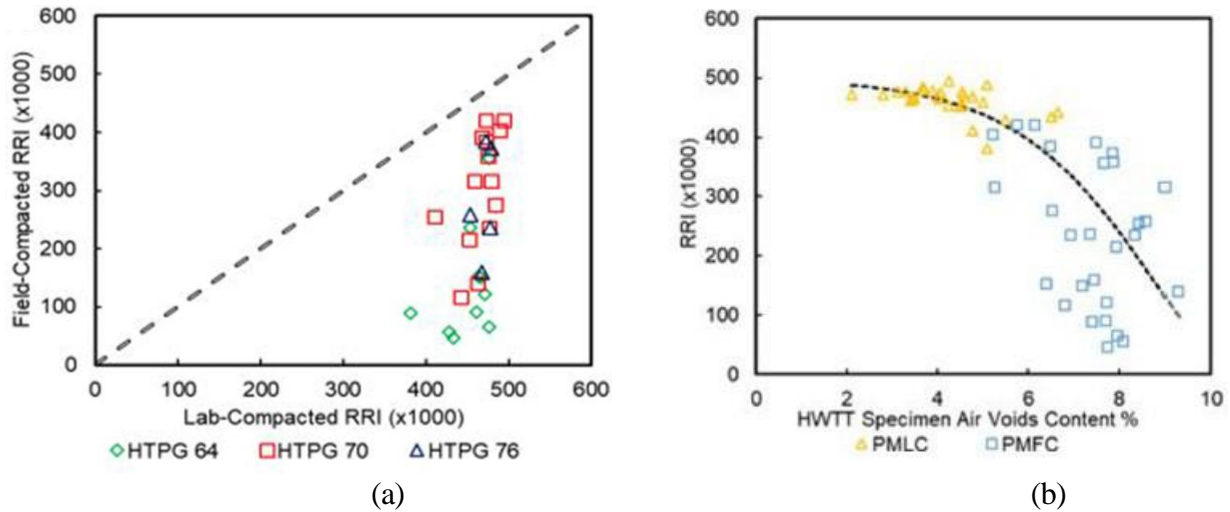
**Figure 6. RRI Values: (a) Laboratory-compacted vs. Field-compacted Samples; and (b) RRI vs. Air Voids Content**

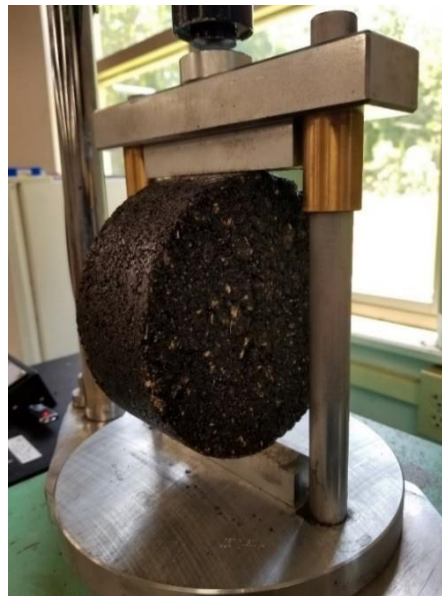
**Figure 13. High-Temperature Indirect Tensile Strength Test (HT-IDT)**

The HT-IDT test is being evaluated to quickly assess mixture rutting potential in a production setting where a rapid turnaround of results is necessary. The HT-IDT is performed using a standard Lottman breaking head (Figure 13) and any load press capable of loading the specimen at 50 mm/minute and measuring a peak load. A minimum of three specimens for this test were compacted in the SGC to 62 mm tall to the target density  $\pm 0.5$  percent for each testing condition. Specimens were conditioned in a water bath at 50°C for 1 hour before testing. The peak load and specimen dimensions are used to calculate each specimen's indirect tensile strength (ITS). A higher ITS is indicative of a more rutting resistant mixture. The ALDOT BMD Special Provision recommends a minimum ITS of 20 psi for mixtures with good rutting resistance (Yin and West, 2021).

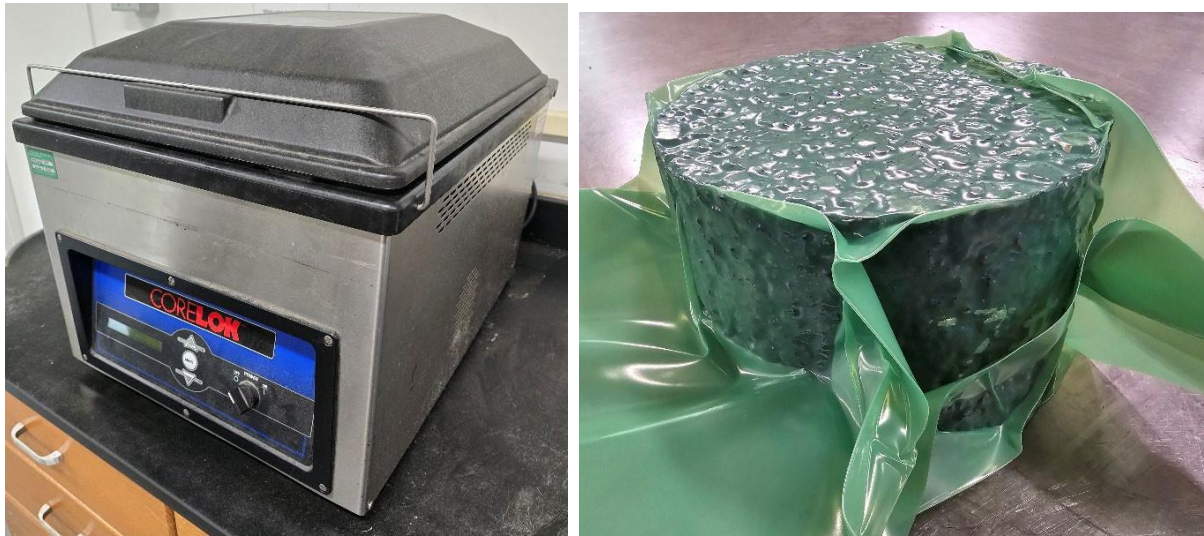
**Figure 14. Vacuum Sealing Apparatus (left) and Vacuum-Sealed FC-5 Specimen (right)**

The Cantabro test for FC-5 mixture durability was performed on the three FC-5 mix designs for this study by AASHTO T401-22. Three replicates compacted to  $N_{design}$  (50 gyrations) were tested for each gradation and AC combination for the three FC-5 mixtures. Before Cantabro testing, the air void content of each specimen was determined using the vacuum sealing method per AASHTO T331-23. The vacuum sealing apparatus used at NCAT, along with a photo of a specimen after vacuum sealing, are shown in Figure 14. NCHRP Report 877 *Performance-Based Mix Design of Porous Friction Courses* recommended an air void content of 15-20% for OGFC mixes determined with the vacuum sealing method (Watson et al., 2018).

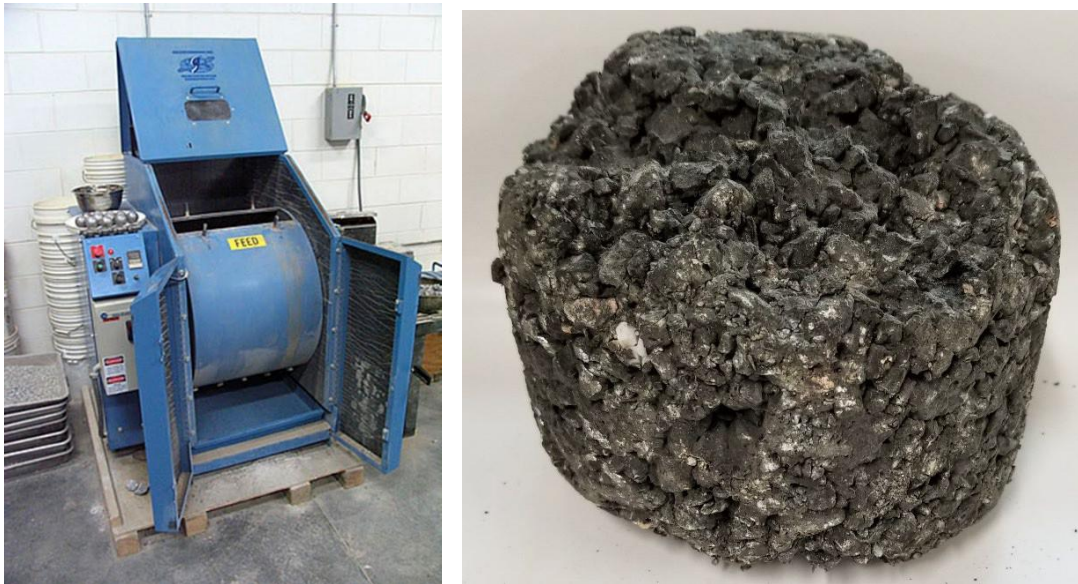
**Figure 15. Los Angeles Abrasion Machine Used for Cantabro Testing (left) and FC-5 Specimen after Cantabro Testing (right)**

The specimens were conditioned in an environmental chamber for at least four hours at 25°C before Cantabro testing. Subsequently, each specimen was placed inside the Los Angeles Abrasion drum without the charge of steel spheres and subjected to 300 revolutions at a speed of 30 to 33 revolutions per minute. After the test, the largest portion of the remaining specimen was removed from the machine, and the weight was determined (Figure 15). The mass loss is calculated by taking the original mass minus the mass after testing and dividing it by the original mass. A maximum Cantabro mass loss of 20 percent on short-term aged specimens is commonly used for the design of open-graded or porous friction course mixes and is cited in the ASTM D7084 standard for the design of open-graded friction course mixtures.

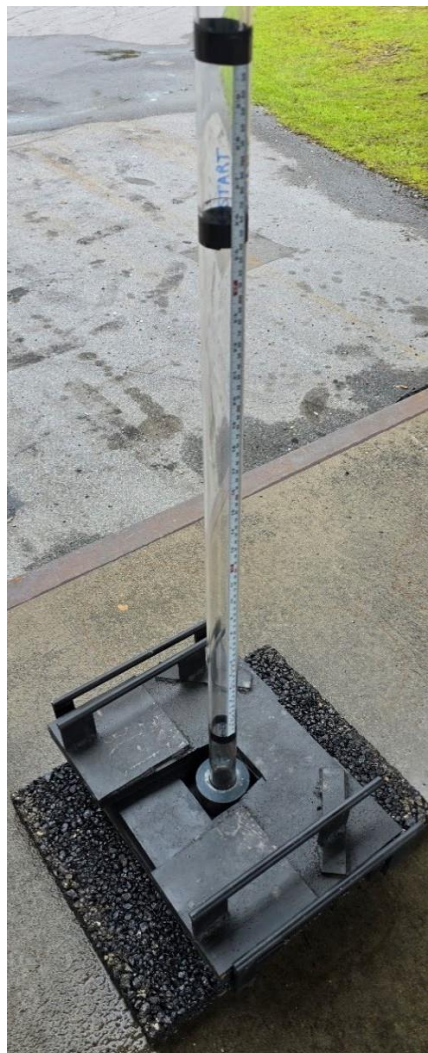
**Figure 16. FDOT Permeameter with FC-5 Slab**

permeability of each slab was determined using a spreadsheet provided by FDOT. The coefficient of permeability ( $k$ ) was calculated as a function of the slab thickness, the distance between the timing marks on the permeameter tube, and the time required for the water to travel between the tube markings.

It should be noted that all of the permeability readings taken using this method were extremely high. The field permeameter is typically used on continuous pavements with confined edges. When testing slabs sitting on top of a concrete pad, the edges of the slab were not confined. Hence, the water had very little distance to travel through the slab before being free to flow out of the slab. These issues were communicated with FDOT during testing, and the decision was made to proceed using this method for this study. However, it is recommended the permeability values in this report only be used as relative rankings within each mix rather than as definitive data regarding the permeability of a given mixture.

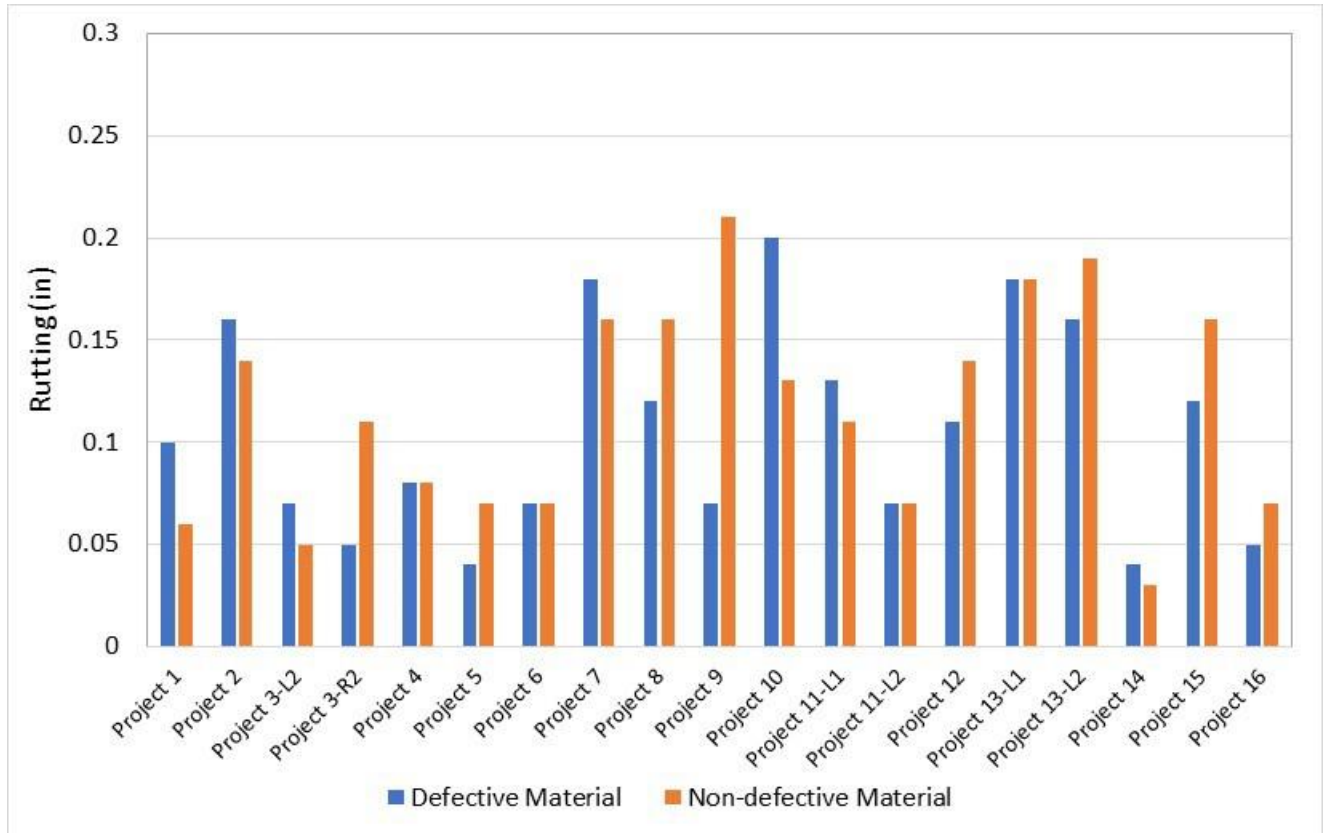
**Figure 17. Summary of Average Rutting of Defective and Non-Defective Materials by Project for Dense-Graded Mixtures with Low Air Voids**

indicates that for 15 comparisons, there is a difference in the mean rutting value, because of the overall low rutting results and their relatively high standard deviation, statistical comparisons using a t-test yielded no practical differences in the test results. Based on the results presented in Figure 17, it can be concluded that the decision to leave the defective materials in place for these projects was adequate.

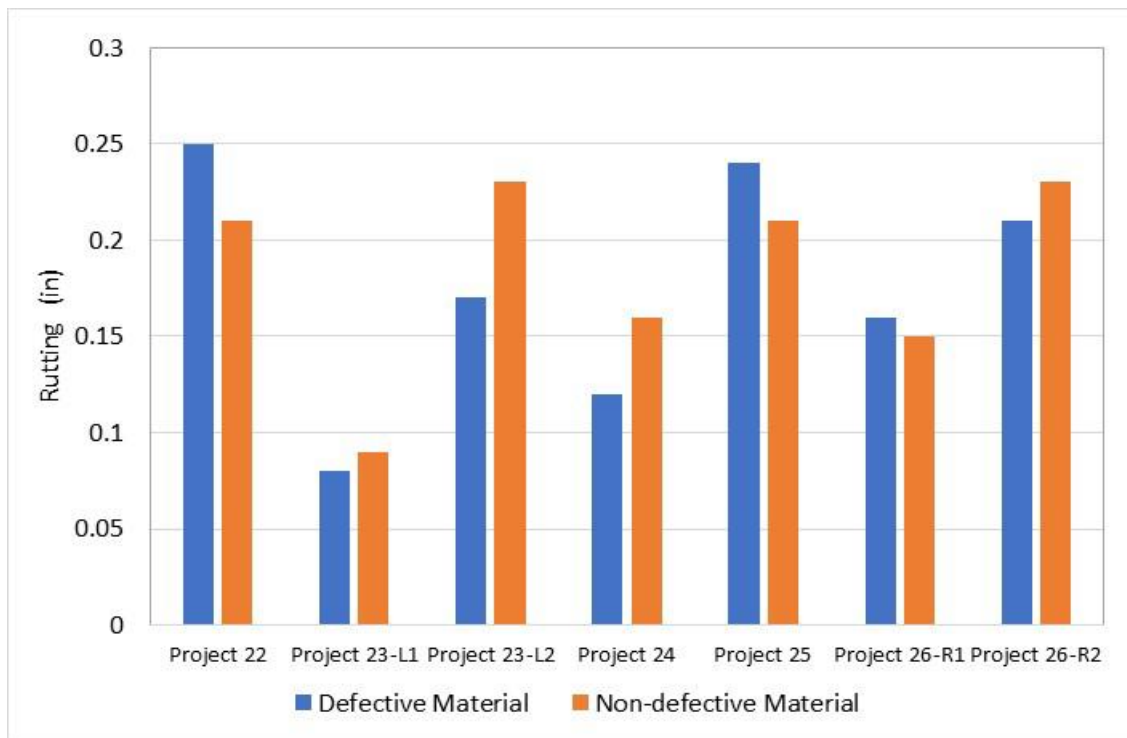
**Figure 18. Summary of Average Rutting of Defective and Non-Defective Materials by Project for FC-5 Mixtures with High Binder Content**

As indicated previously, only rutting data was included in this evaluation. Figure 17 summarizes the average rutting of defective and non-defective materials by project. In this figure, the performance of projects 23 and 26 was divided into two different data sets because 2 lanes within each project failed the QC binder content limit. This resulted in 2 additional data sets under evaluation. As presented in this figure, no project exceeded an average rutting of 0.25 in. For 3 out of 7 comparisons, the rutting of the defective material was higher than the non-defective material but still relatively low. Based on these results and considering that these projects have been in place for 9-12 years and that all used, at a minimum, a PG 76-22 binder, the rutting performance of these projects seems acceptable, and the decision to leave the defective material in place was adequate.

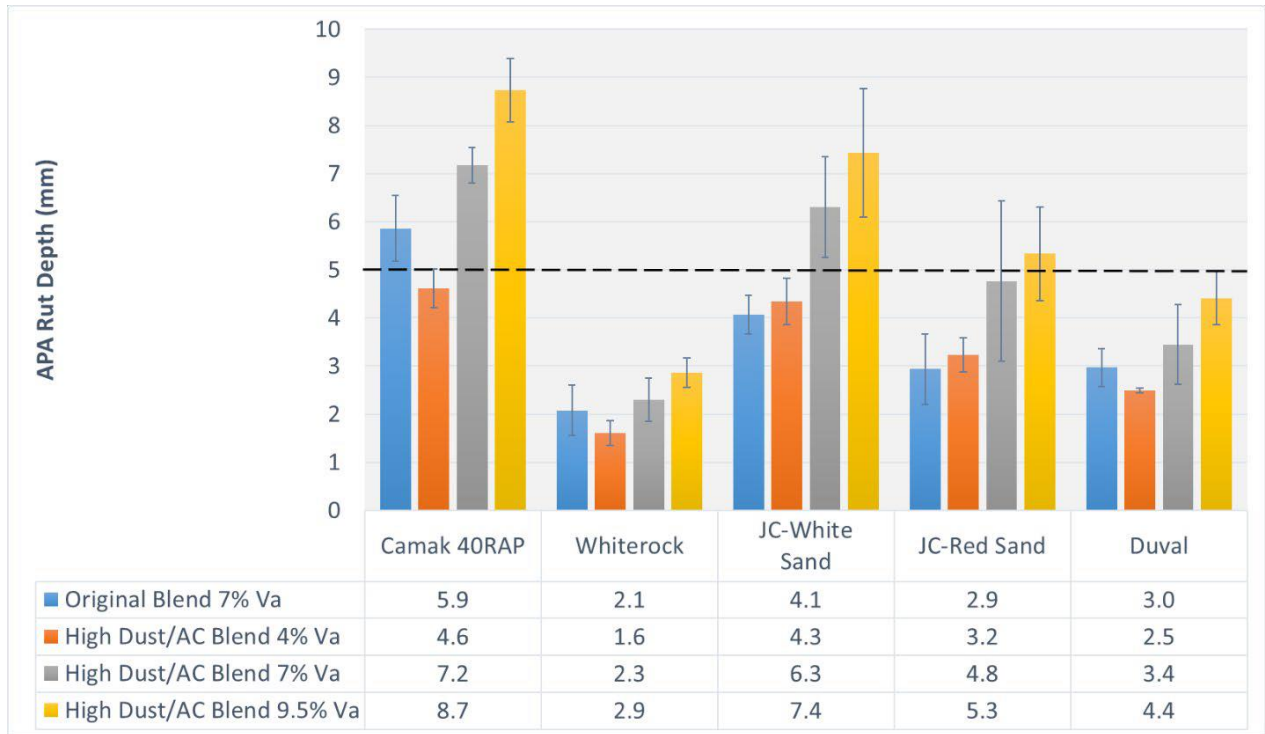
**Figure 19. Summary of APA Results – Laboratory Rutting Evaluation**

For each of the five mixes, the mix with unsatisfactory production (high-dust/high-AC) and poor in-place density (9 to 10% air voids) had the highest rutting and was in the lowest statistical grouping in terms of total APA rutting. This testing condition represented the worst-case scenario and was expected to give the highest laboratory rutting values. In most cases, the original blend with good production and good density (7% air voids) was in the top statistical grouping with the poor production (high-dust/high-AC) mix with high in-place density (4% air voids). It is to be expected that a higher density on a given blend will improve laboratory rutting resistance, given that there is a higher mass of material in the same specimen volume. It is also reasonable that the rutting resistance of a poorly produced mix can be improved with improved compaction in the field. The only exception was the Camak 40% RAP mix with the softer PG 52-28 binder, where the high-dust/high-AC mix with 4% air voids was in the top statistical grouping by itself. The mix with the softer base binder showed greater statistical separation in the APA results because of the higher rut depth magnitudes. When comparing the mixtures with the same density (7% air voids), the original blend always had numerically better (lower) rutting than the high-dust/high-AC blend. However, the only mix with a statistical improvement was the Camak 40% RAP mix. This is also reasonable in that if mixes have comparable density, the mix with higher AC and lower air voids should have higher rut depths. Overall, the relative rankings of the APA data fell in line with expected trends.

This data set was also compared against the FDOT defective material threshold of 5.0-mm used on roadway cores. For the Camak 40% RAP mix, the only mix to pass the 5.0-mm threshold was the high-dust/high-AC blend with high in-place density. Again, the higher rut depths for this set are owed to the use of the softer PG 52-28 binder. None of the sets had an APA rut depth above 5.0-mm for the Whiterock and Duval mixes, including the high-dust/high-AC mix with low in-place density. For the Junction City – White Sand mix, the high-dust/high-AC mix with normal and low in-place density failed the APA criteria. For the Junction City – Red Sand mix, only the high-dust/high-AC mix with low in-place density failed the APA criteria, though the high-dust/high-AC mix with normal density was close with a rut depth of 4.8-mm. In summary, these five mixes showed a wide range of outcomes relative to the 5.0-mm APA threshold.

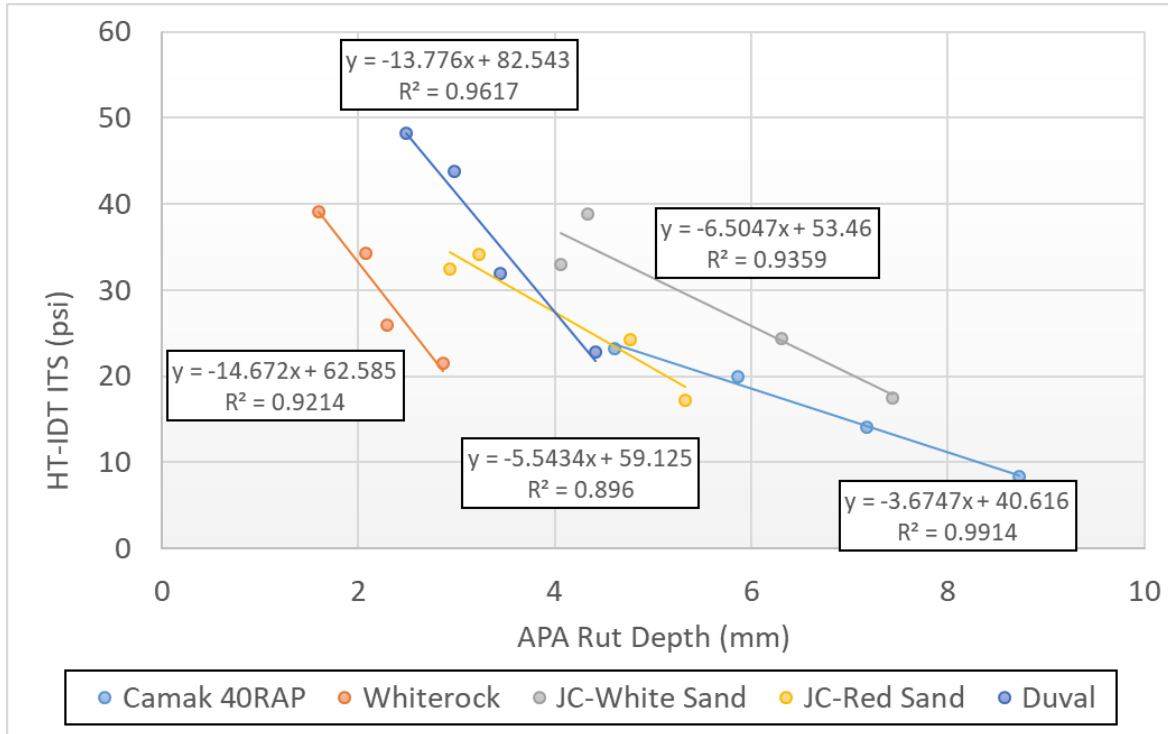
**Figure 21. APA Rut Depth vs. HT-IDT ITS – Individual Projects – Laboratory Rutting Evaluation**

regression  $R^2$  at or above 0.9 – albeit with only 4 data points per mix. Figure 22 shows all 20 HT-IDT and APA data points plotted against each other in the same relationship. The correlation was still reasonable, although with a bit more scattered (exponential  $R^2 = 0.69$ ). Hence, the HT-IDT and APA tests did show the same general trends in the data for this study.

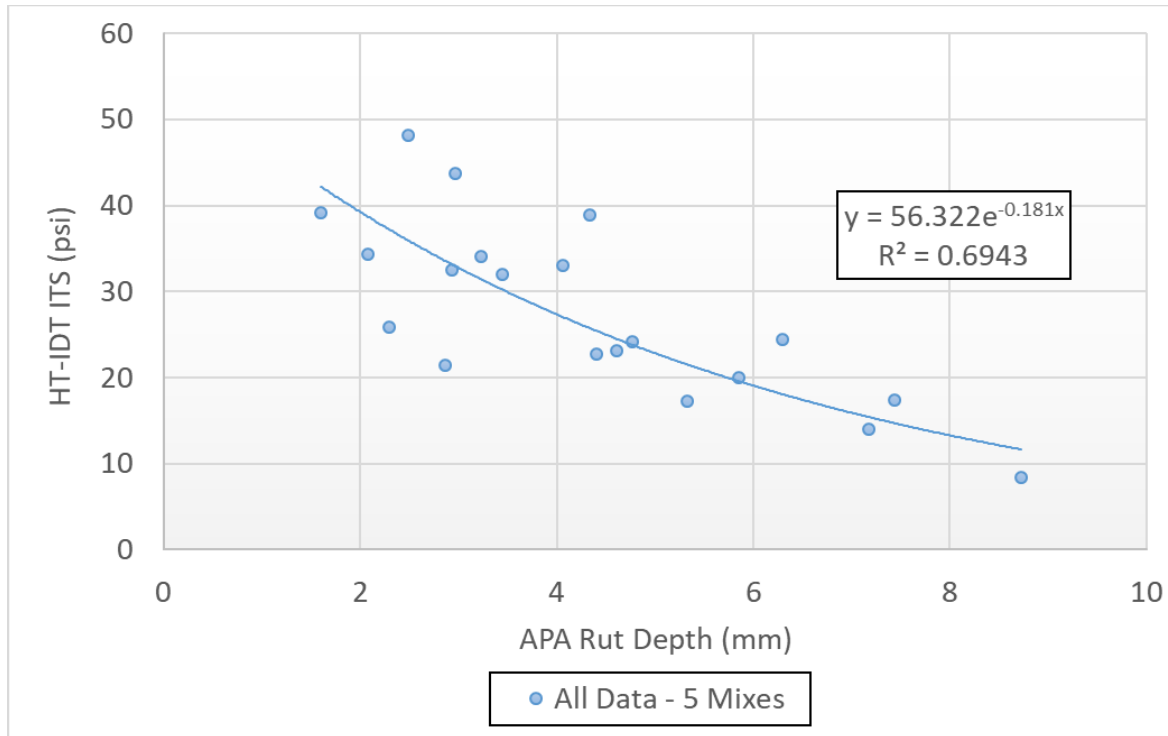
**Figure 22. APA Rut Depth vs. HT-IDT ITS – All Data – Laboratory Rutting Evaluation**

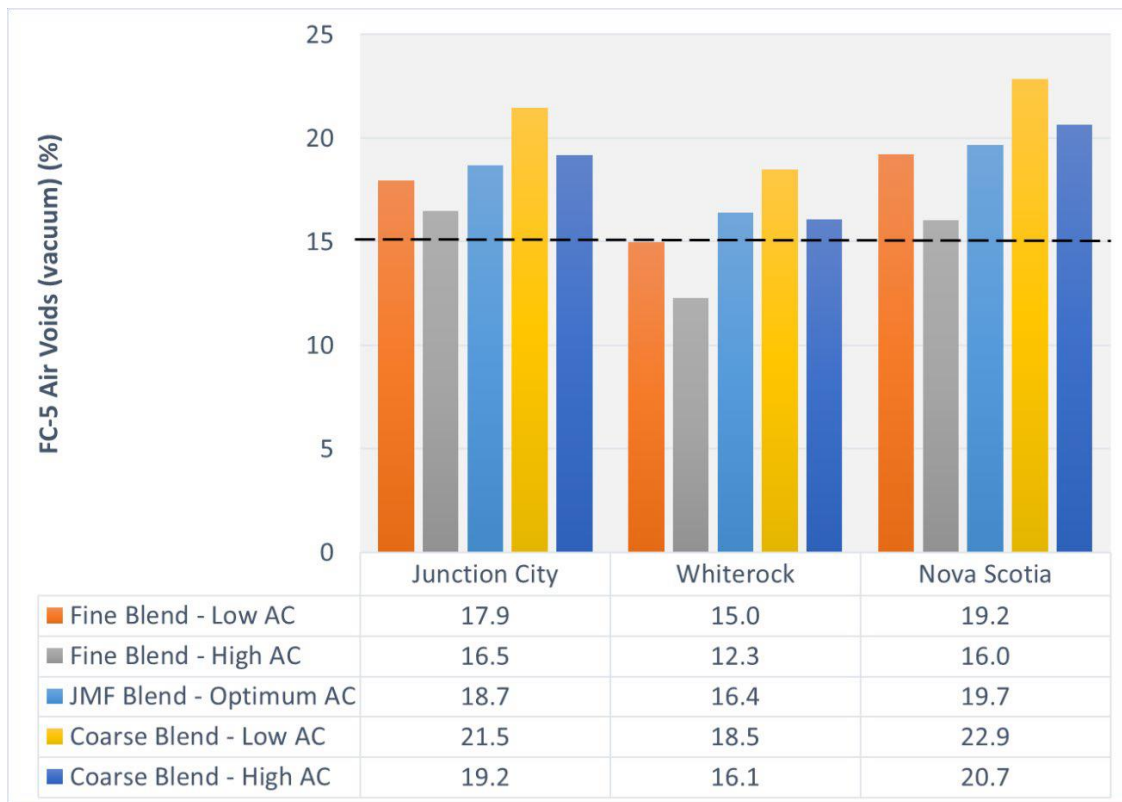
**Figure 23. Gyratory Air Voids Summary (vacuum method) – FC-5 Mixes**

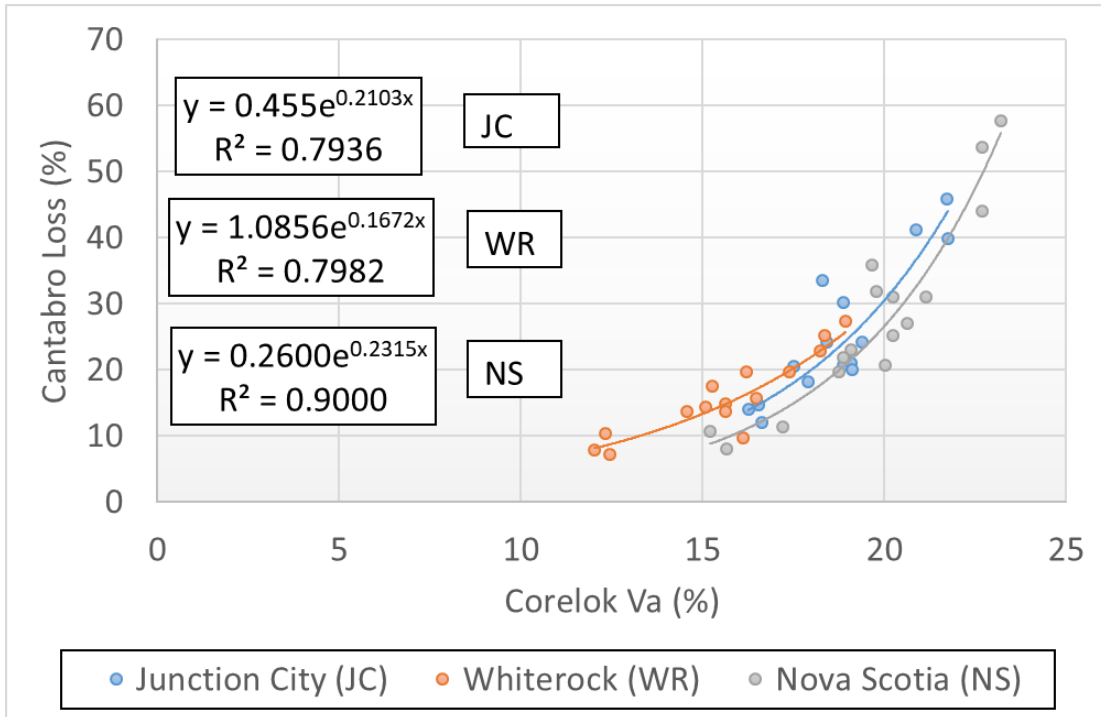
**Figure 25. Cantabro Mass Loss vs. Vacuum Sealer Air Voids – FC-5 Mixes – By Aggregate Type**

- A strong correlation between air voids and Cantabro loss was found for each of the three FC-5 mixes. For the combinations evaluated in this study, increasing the binder content decreased the air voids and improved Cantabro results. In addition, coarser gradation increased air voids but increased Cantabro mass loss.

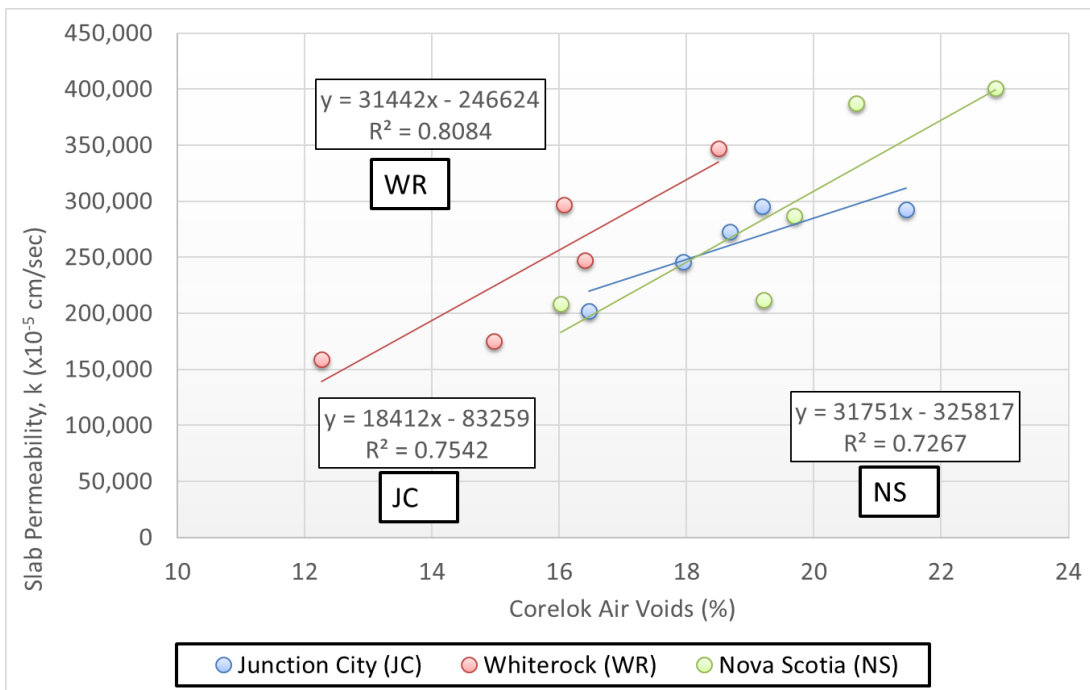
**Figure 26. Slab Permeability ( $k \times 10^{-5}$  cm/sec) vs. Vacuum Sealer Air Voids (%) – FC-5 Mixes**

- A strong correlation between air voids and permeability results was found for each of the three FC-5 mixes. In general, increasing binder content decreased permeability results. Moreover, coarser gradation increased permeability but increased Cantabro mass loss.
