STEEL BRIDGE COATING AND RECOATING WARRANTY REQUIREMENTS FINAL REPORT

July 30, 2024

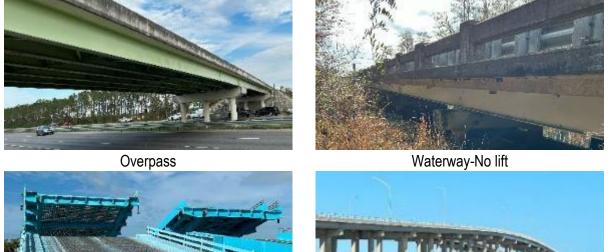
More than 50% of the inspected bridges were over waterways as these bridges were expected to have more coating condition issues. Table 4-1 describes the bridge population by type and Figure 4-2 shows examples of each bridge type.

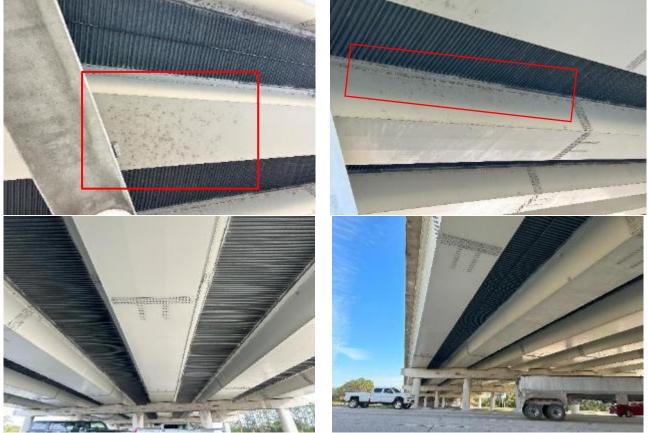
Inspected on 1/23/2023 & Painted 2016 OC

SSPC VIS 2 Area Rusted: 0.0-0.01% Delamination: None Notes: The spots seen in the pictures are mold and spiders

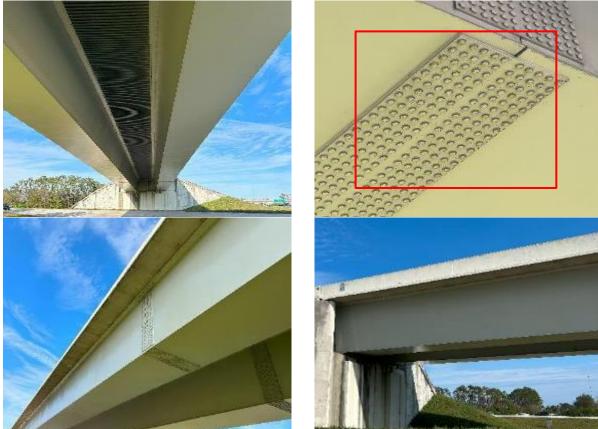
Inspected on 1/23/2023 & Painted 2016 OC

SSPC VIS 2 Area Rusted: 0.0-.01% Delamination: None Notes: Dirt near bolts appears

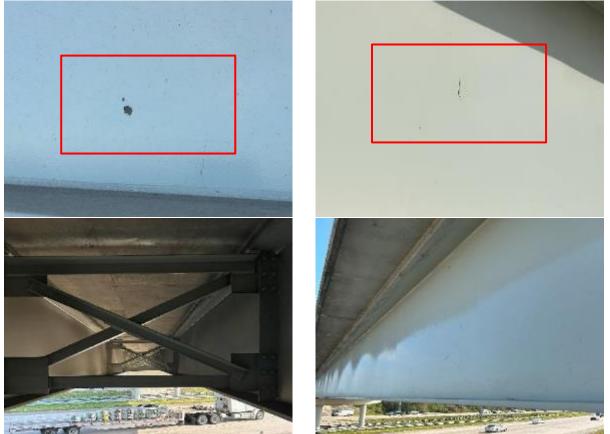
Inspected on 1/23/2023 & Painted 2016 OC

SSPC VIS 2 Area Rusted: 0.0-0.01%Delamination: 0.01-0.03% (Two small instance not to metal but prevoius coating)Notes: Clear Overcoat but edges could not be liftedDFT: \overline{X} = 14.96 Min= 9.1 Max= 17.2

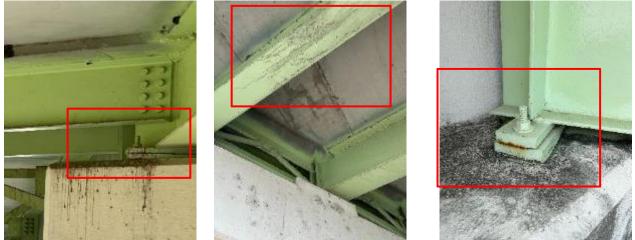
Inspected on 1/23/2023 & Painted 2016 OC

SSPC VIS 2 Area Rusted: 3.0-10.0% at crevies on brackets, 0.01-0.03% on edges of the some of the girders **Delamination:** None but clear coat has contaminates **Notes:** Lots of spider webs that appeared to be corrosion but are not **DFT:** \overline{X} = 13.08 Min= 11.6 Max= 15.3

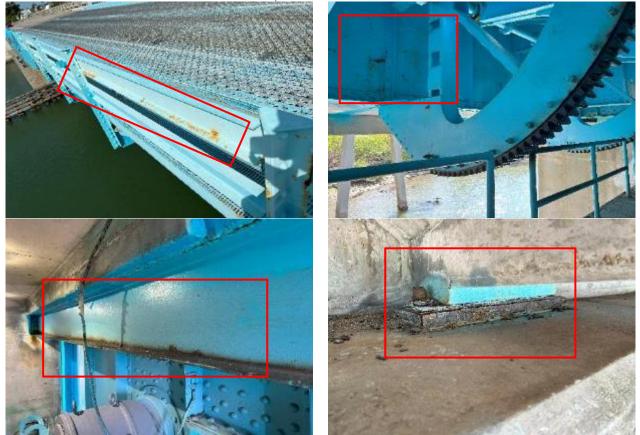
Inspected on 1/24/2023

SSPS VIS 2 Area Rusted: 0.03-0.1% on cross beams, 1.0-3.0% on Guardrails, 1.0-3.0% on Floor beams, 0.03-0.1% on Girders, 0.03-0.1% inside Mechanical Room Delamination: Cracking noticeable on the guardrails Notes: Big difference in the color between the guardrails

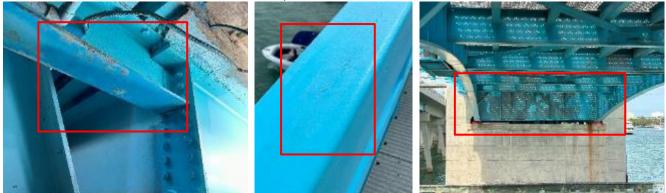
Inspected on 1/24/2023

SSPS VIS 2 Area Rusted: 0.01-0.03% on diagonal, 0.03-0.1% on Guardrail, 0.01-0.03% floor beam, 0.01-0.03% on Girders, 0.03-0.1% inside Mechanical Room

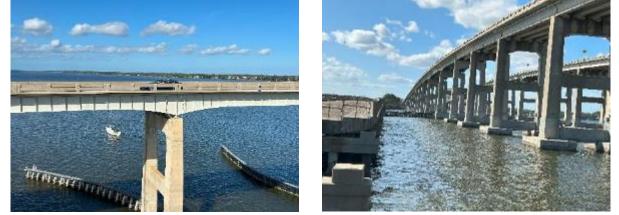
Inspected on 2/7/2023 & Painted 3/23/2017 (Metalize)

SSPS VIS 2 Area rusted: 0.0-0.01% Delamination: None Notes: Hard to really see any corrosion

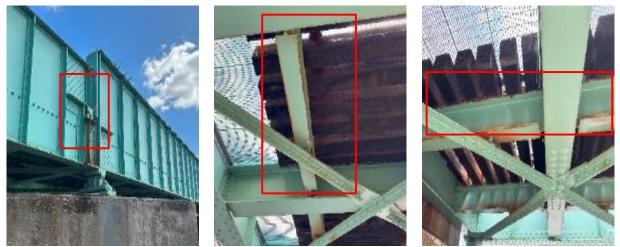
Inspected on 2/8/2023 & Painted on 8/15/2019 (Full RR only on girders interiors)

SSPS VIS 2 Area Rusted: 0.01-0.03% on interior of girders, appears to have crevice corrosion in some areas attached to interior girders Delamination: None

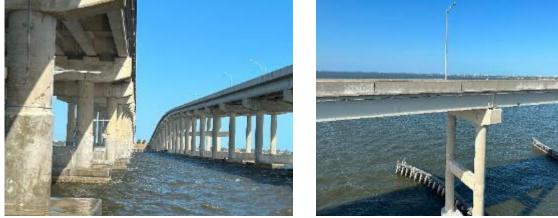
Inspected on 2/9/2023 & Painted 6/24/2014 (Portions Duplex coated)

SSPS VIS 2 Area rusted: 0.0-0.01% Delamination: None Notes: Limited available access (piers and parallel bridge)

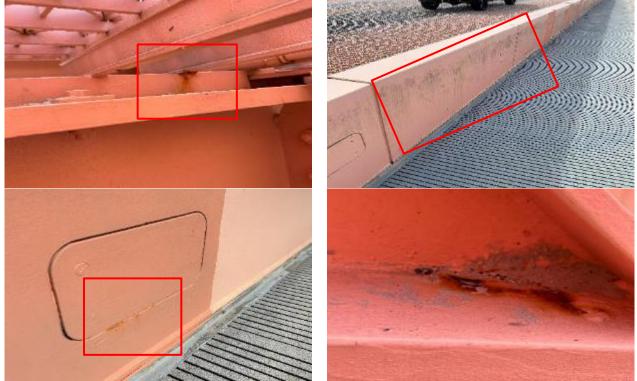
Inspected on 2/9/2023 & Painted 1/29/2019 (Full RR)

SSPS VIS 2 Area Rusted: 0.03-0.1% on cross beams, 0.01-0.03% on guardrails, 0.03-0.1% on floor beams, 0.01-0.03% on exterior girders, 0.0-0.01% inside the mechanical rooms

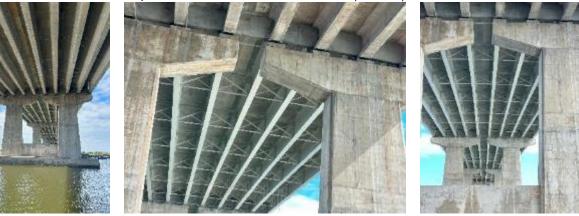
Inspected on 2/9/2023 & Painted 6/7/2019 (Metalize)

SSPS VIS 2 Area rusted: 0.03-0.1% seen from underneath on dock. Delamination: None Notes: Hard to see all areas from the dock

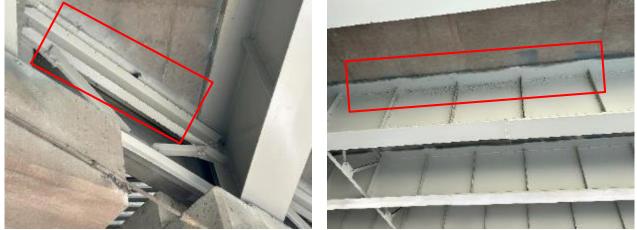
Inspected on 3/1/2023

SSPS VIS 2 Area Rusted: 0.01-0.03% on some diagonal edges. Delamination: None

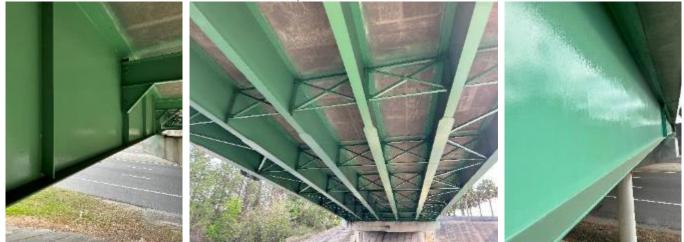
Inspected on 3/1/2023

SSPS VIS 2 Area Rusted: 0.0-0.01% Delamination: Small, quarter-sized spot Notes: Some pin holes in clear coat DFT: \overline{X} = 15.16 Min= 13.4 Max= 17.7

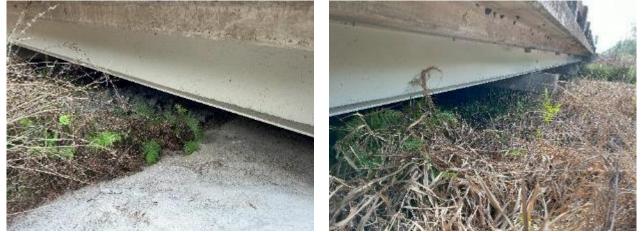
SSPS VIS 2 Area Rusted: 0.0-0.01% Delamination: None Notes: Dirt on exterior girder, and a lot of vegetation DFT: \overline{X} = 12.02 Min= 10.7 Max= 15.0

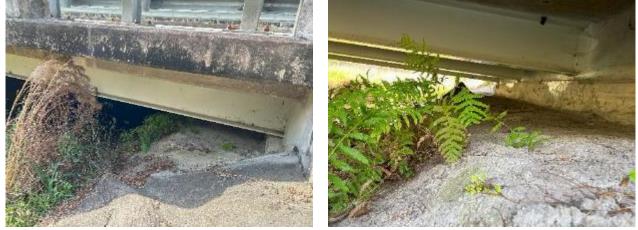
SSPS VIS 2 Area Rusted: 0.0-0.01%Delamination: None Notes: Dirt on exterior girders DFT: \overline{X} = 12.09 Min= 10.0 Max= 16.3

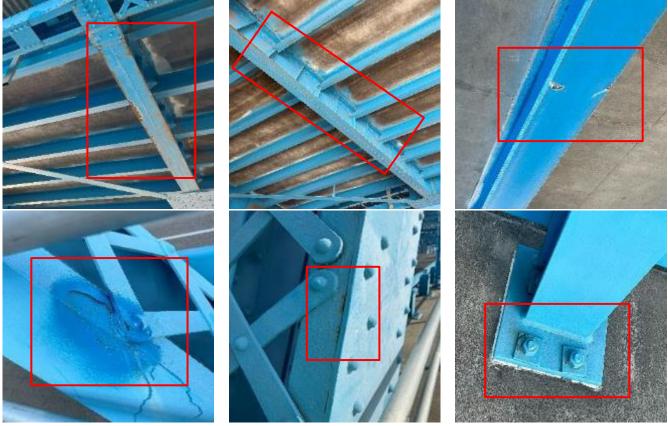
SSPS VIS 2 Area Rusted: 1.0-3.0% on the floor beams above the water, 0.3-1.0% on edges of girders, 0.3-1.0% on roadway bracing and some bolts

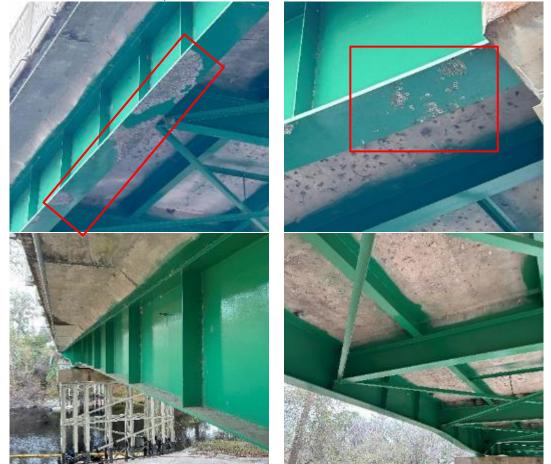
SSPS VIS 2 Area Rusted: 3.0-10% on lower flange of edge girder, 0.0-0.01% on all other areas **Delamination:** 3.0-10% on lower flange of the edge girder **Notes:** Appears to be significant delamination and corrosion of lower flange surfaces facing the water **DFT:** \bar{X} = 22.16 Min= 13.1 Max= 73.1
