**University of Florida  
Civil and Coastal Engineering**

**Structures Research  
Report 2026/  
P0260410-P0260749**

Deliverable 6: Final Report

## **Bond Performance of Post-tensioning Tendons with Corrosion Inhibitor**

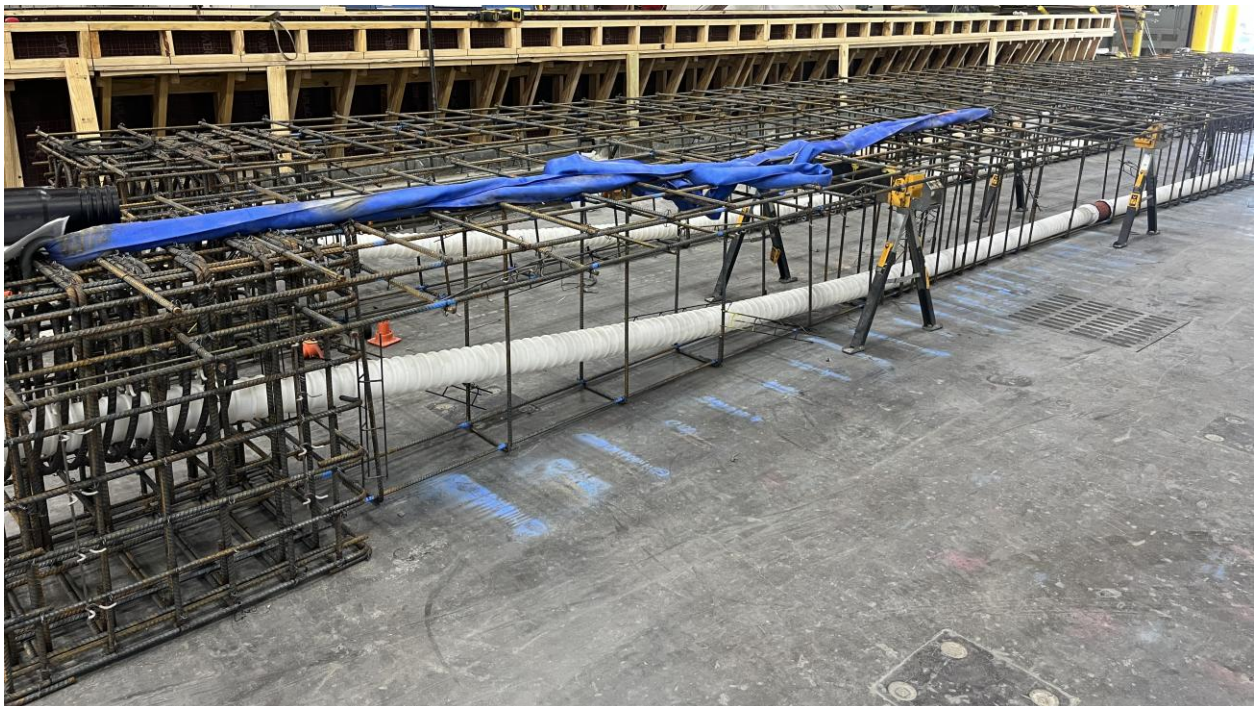
Figure 1.1. Assembly of reinforcement cages and ducts for the construction of a draped-tendon-profile post-tensioned girder.

A post-tensioned bridge girder system typically is comprised of concrete, mild reinforcement, and one or more tendons installed according to the specified tendon profile (Figure 1.1). Ducts vary in diameter, material (Figure 1.2), and surface texture depending on project requirements. Prestressing strands are threaded through the ducts and stressed. Tendon sizes defined by the number of strands may range from 4 to 31 for 0.6-in. diameter strands. Tendon profiles are designed with different eccentricities and prestressing forces to counteract service loads and provide adequate flexural resistance. Regardless of tendon size, eccentricity, or force, all post-tensioned girders must comply with AASHTO LRFD Bridge Design Specifications and the Florida Structures Design Guidelines.

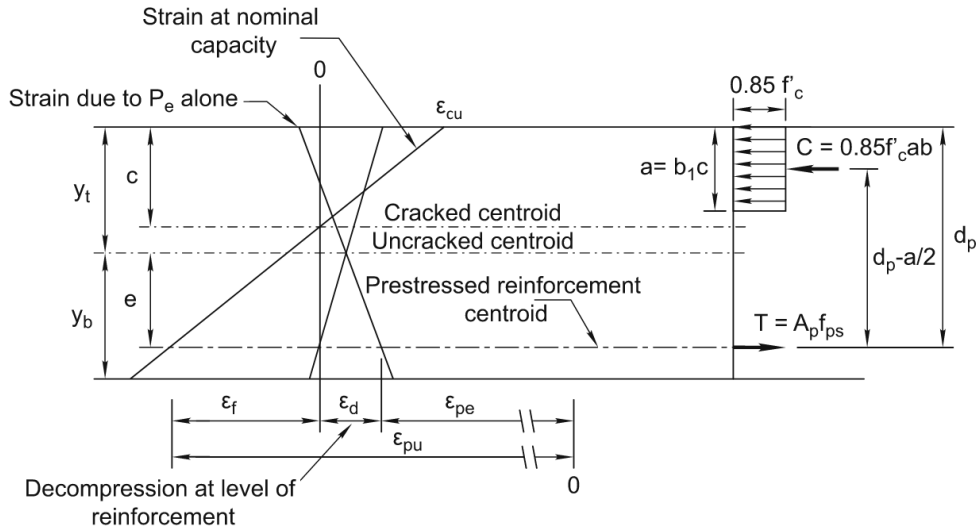
Figure 2.7. Strain profile of a prestressed concrete section and equivalent rectangular stress block at nominal flexure (Dolan and Hamilton 2019).

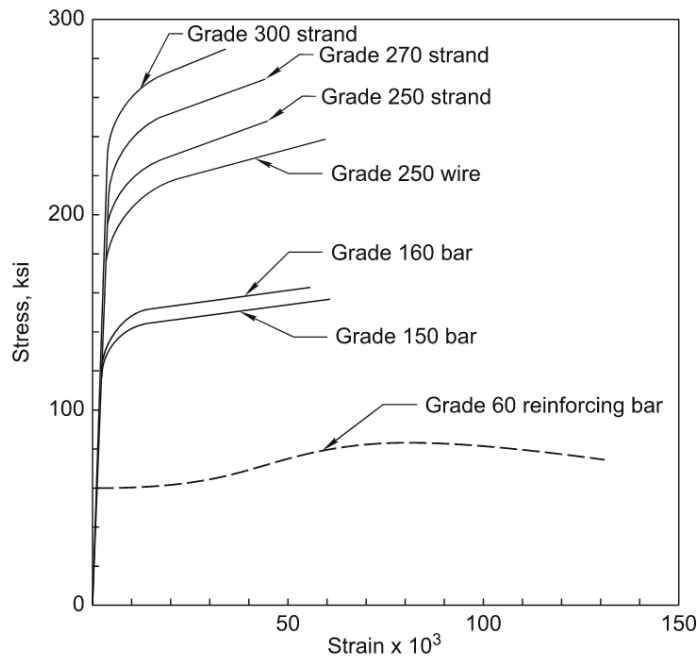
Figure 2.8. Stress-strain curves for different grades of prestressing steel (PCI 2010).

For a post-tensioned element, the stress in the prestressing strands up to rupture is obtained from the strand stress–strain curve (Figure 2.8).

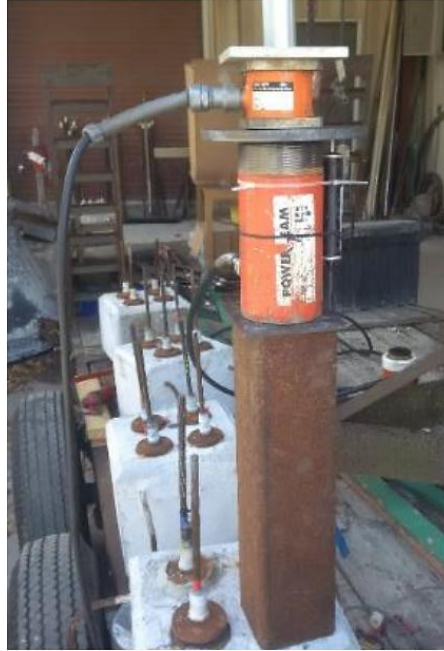
Figure 3.2. Pullout testing of grouted unstressed monostrand tendon (Silnutzer et al. 2020)

Silnutzer et al. (2020) carried out an experimental study focused on the influence of the Vector Post-Tech PTI impregnation material on the bond capacity of single-strand tendons as well as the long-term effectiveness of the corrosion protection provided to the strands. Pullout tests were conducted on concrete specimens 1-ft long with grouted seven-wire strands that had been treated with PTI material (Figure 3.2). Pullout test results revealed reductions of bond strength that ranged from 21% to 78%, with an average reduction of 47%. In contrast, tendons treated with other anti-corrosion materials such as PB Blaster and WD-40 showed no discernible reduction in bond strength relative to untreated control specimens. However, forecast models of future failure (Silnutzer et al. 2020), developed based on corrosion damage data, indicated that samples treated with the PTI material would extend the life of tendons up to three times longer than the untreated specimens or oil-treated specimens (PB Blaster and WD-40).

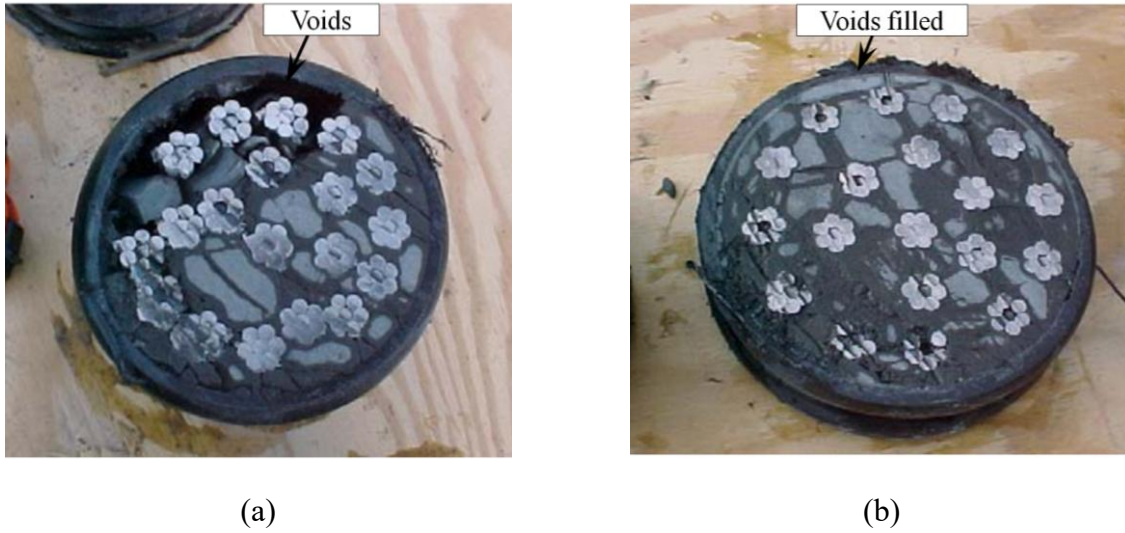
Figure 3.4. Dissected mock-up bonded tendon. Grout injected using: (a) pressure injection; and (b) vacuum injection (Corven 2001)

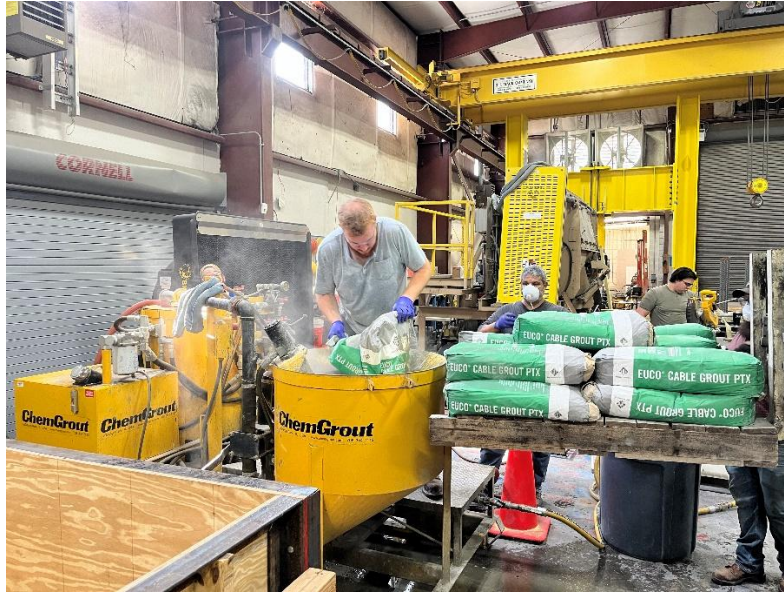
Figure 6.13. Pre-packaged grout being mixed in the colloidal grout plant.

A colloidal grout plant, equipped with a 13-cubic-foot capacity agitating holding tank and capable of delivering slurries at pressures up to approximately 260 psi was used for grouting the beams (Figure 6.13). However, for purposes of grouting the test beams, the grout injection pressure was consistently maintained between 15-30 psi for all beams.

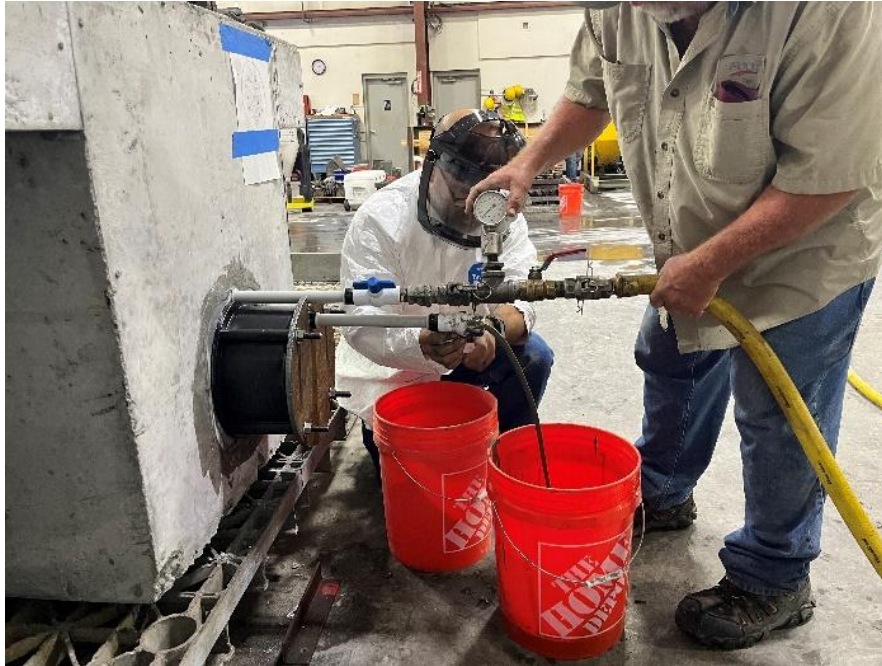
Figure 6.16. Grout injection at PT live end of beam S19-M-U

Similar to the grout injection process in the previous beams, the grout was injected at a constant pressure of approximately 15 psi, and the remaining three grout ports - one at the live end and two at the dead end were monitored visually with their valves open until grout discharge occurred. Grout injection was stopped once approximately 1 gallon of grout had been discharged from each grout port (except the injection port), after which all valves were closed.

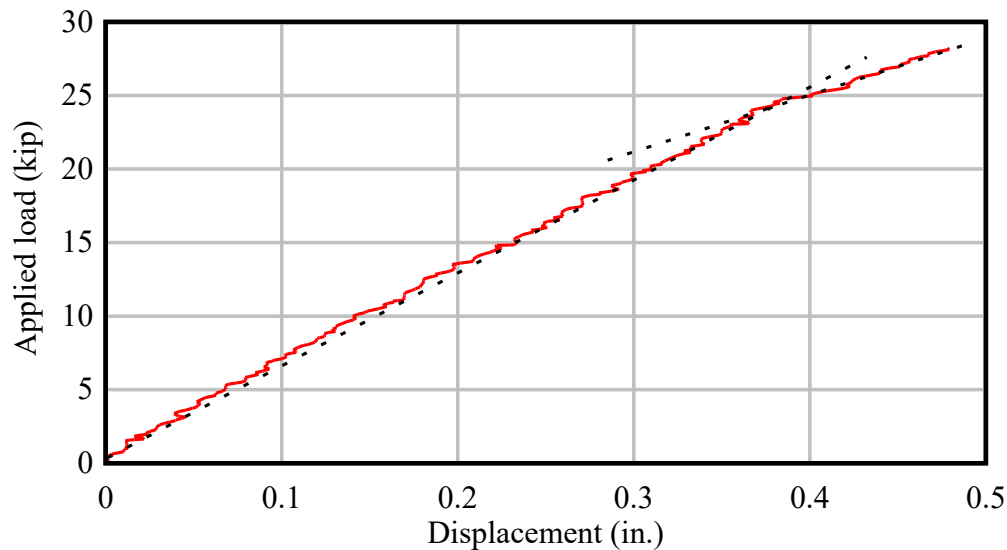
Figure 8.1. Load-deflection plot: S06-M-TC pre-impregnation cracking.

Beyond theoretical decompression of the bottom surface of the beam, load pauses were made more frequently to visually inspect for first crack formation. The first crack was visually observed at an applied load of 25.0 kips, corresponding to a tensile stress at the bottom surface of the beam of  $6.8\sqrt{f'_c}$ . This also corresponds to the point on the load-deflection plot where a change in slope was noted, as shown in Figure 8.1.

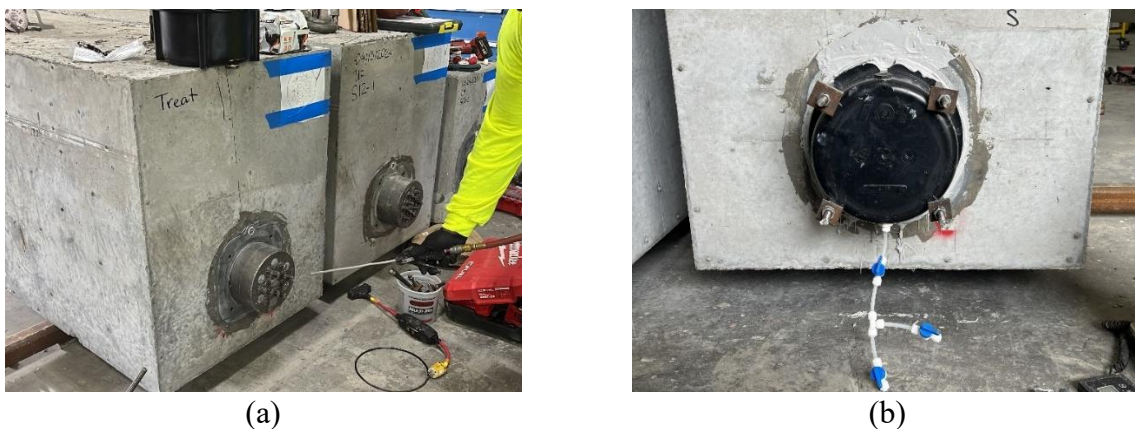
Figure 8.3. Preparing the PT live end of beam S12-P-T for impregnation of corrosion inhibitor: (a) Cleaning strands and anchorage end with compressed air; (b) Installation of customized end cap.

Once the strands at both ends of the beams were prepared, they were cleaned using compressed air (Figure 8.3a). Customized end caps (with sealed original grout ports and a new port added at the bottom for corrosion inhibitor) were then reinstalled at the live end of the beam (Figure 8.3b), where the corrosion inhibitor was to be introduced, while the dead-end anchor head remained exposed. Finally, all visible gaps between the bearing plates and surrounding concrete on both end faces of the beam were filled with epoxy to prevent corrosion inhibitor leakage.

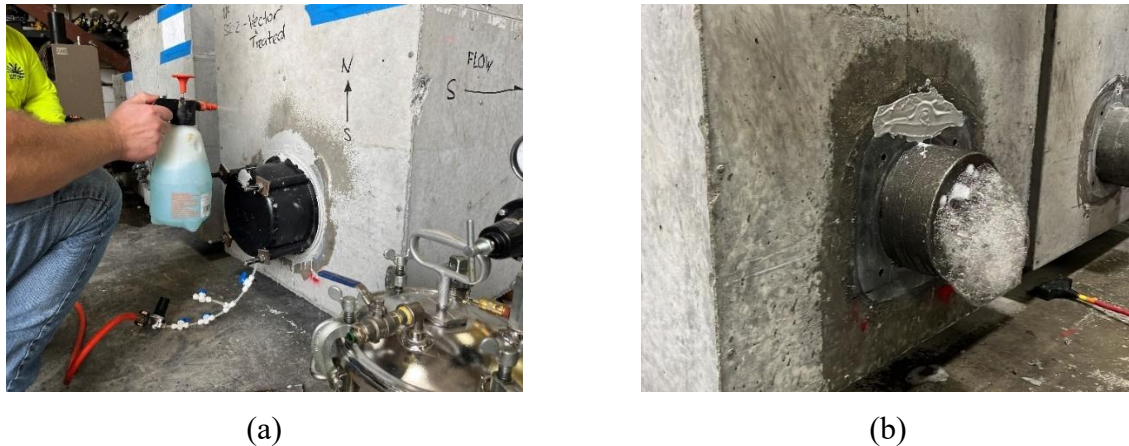
Figure 8.4. Air flow tests on S12-P-T beam: (a) Checking for leaks at the bearing plate-concrete joint at PT live end; (b) Bubbles confirming air flow at the PT dead end.

Air pressure tests were performed on each beam after anchorage end preparations were completed. Compressed air was injected through the customized port in the end cap at the live end, and the exposed strands at the dead end were visually inspected to confirm a free-flow path through every strand. This was accomplished by spraying a soapy film of water on the strands and observing the formation of bubbles from the interstitial spaces in each strand, as shown in Figure 8.4.

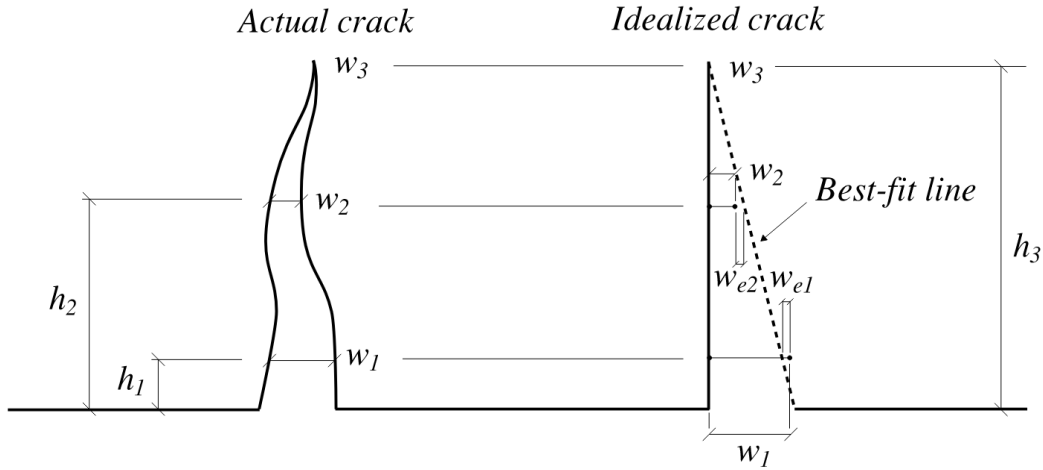
Figure 9.2. Idealization of crack and computation of crack area based on a best-fit line.

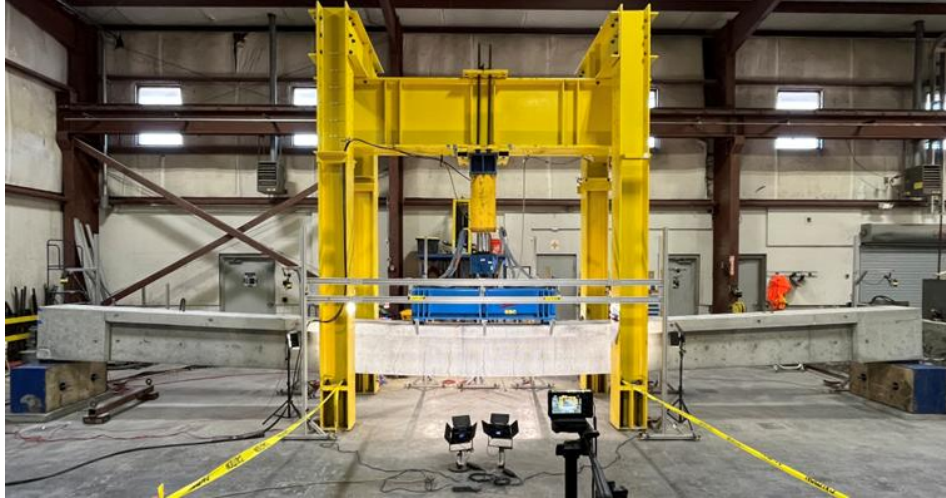
Figure 9.3 Flexural testing of S06-M-T beam

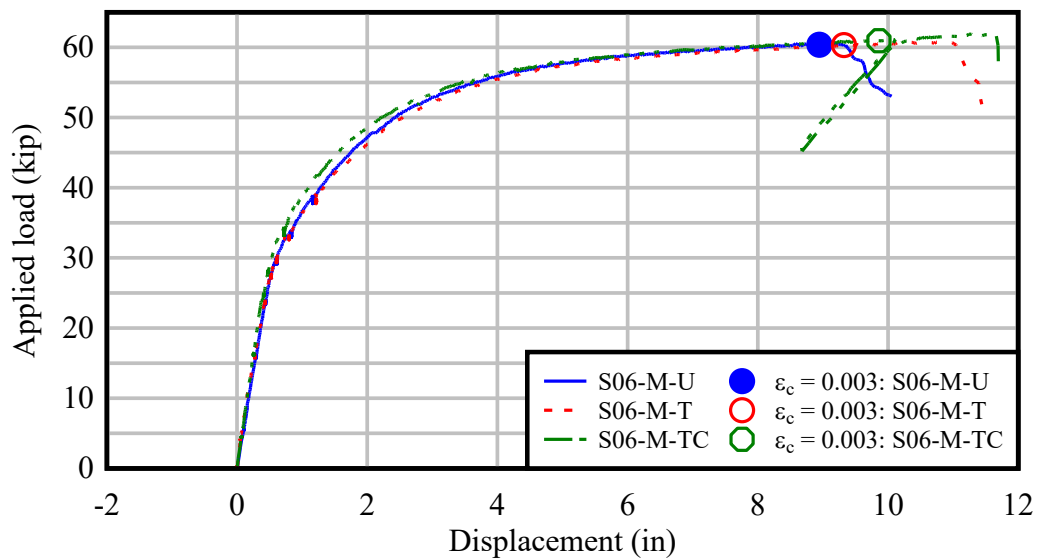
Figure 9.5. Load-deflection plot: S06 beams.

Based on the average concrete compressive strength of the three S06 beams on the day of flexural testing, the calculated nominal flexural resistance is 52 kip, and the corresponding displacement is 12.8 in.

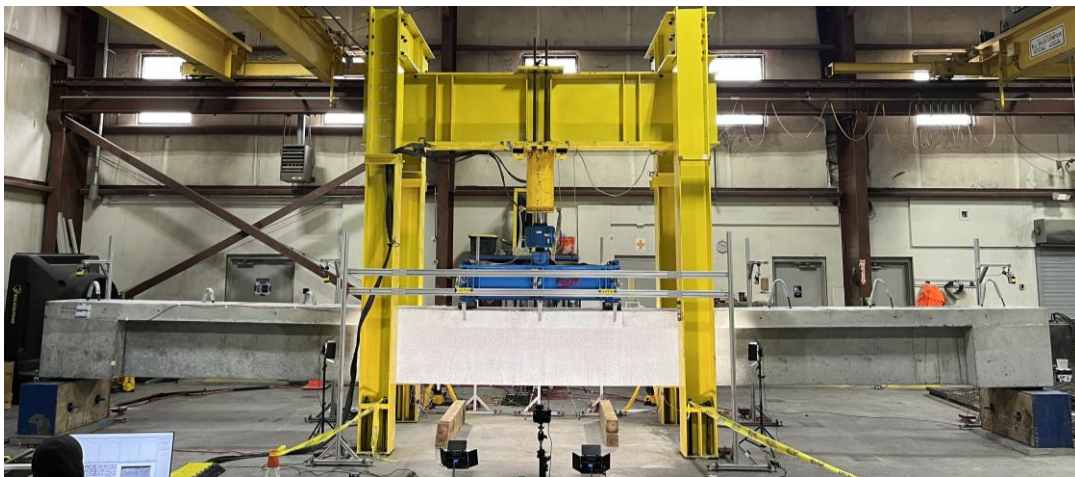
Figure 9.7. Flexural testing of S12-P-T beam

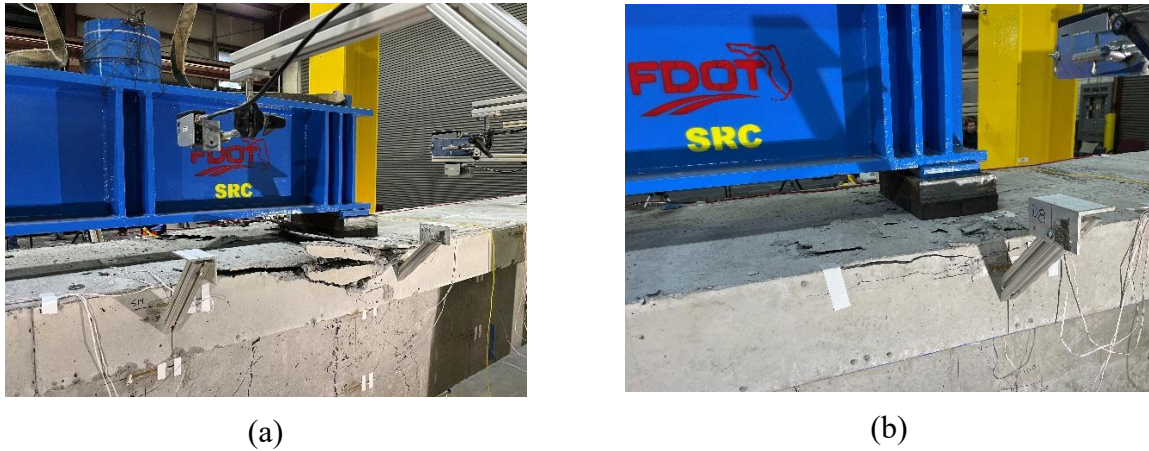
Figure 9.8. Crushing of concrete at the compression flange: (a) S12-P-U; (b) S12-P-T

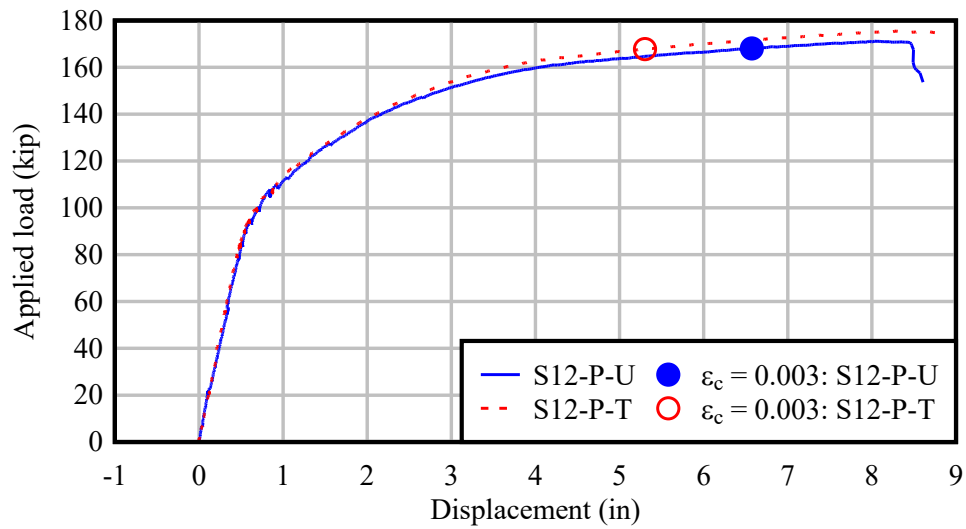
Figure 9.9. Load-deflection plot: S12 beams.

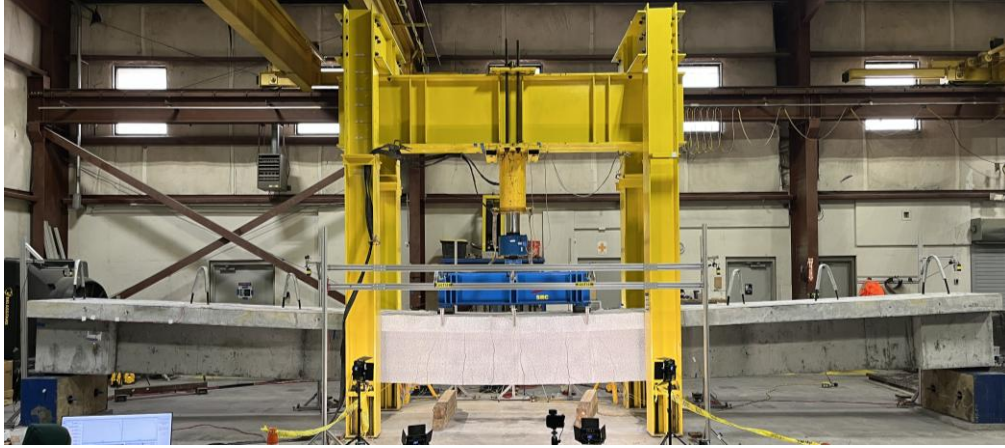
Figure 9.11. Flexural testing of S19-M-T test beam.

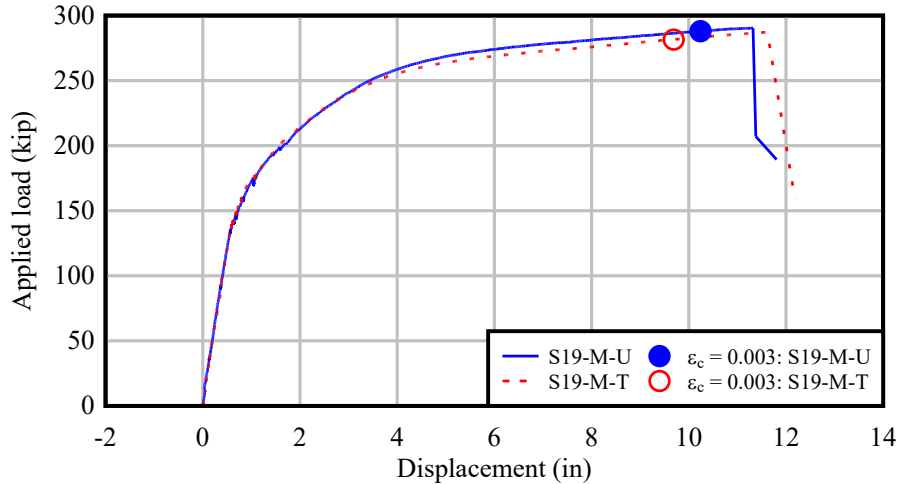
Figure 9.13. Load-deflection plot: S19 beams.

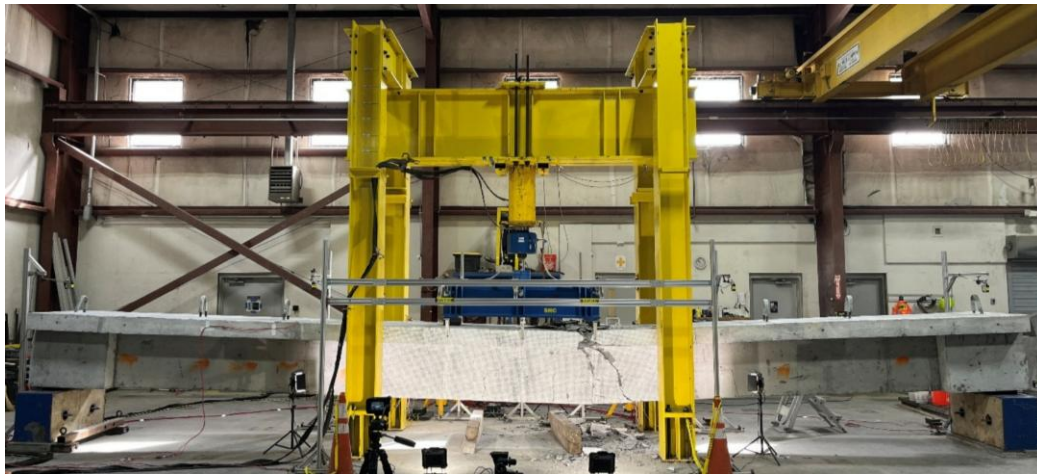
Figure 9.15. Failure of D19-M-U beam by crushing of top flange.

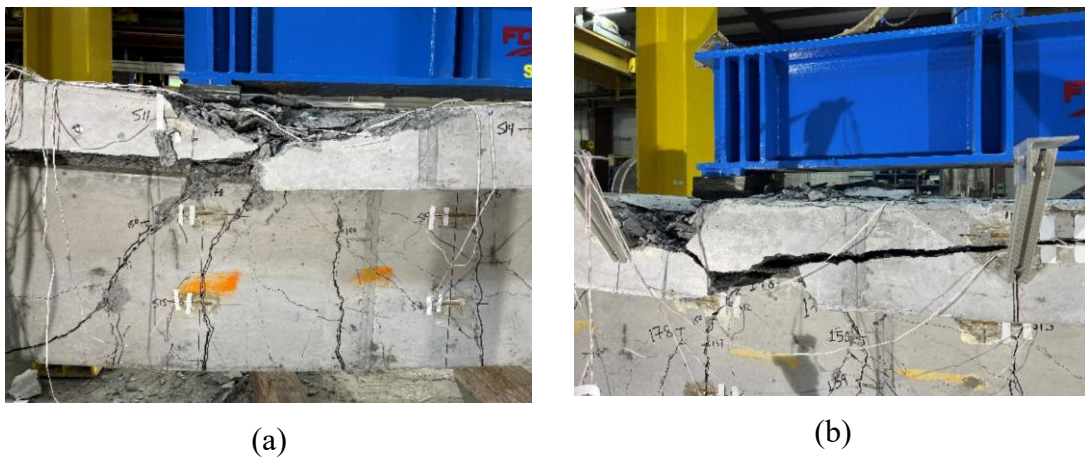
Figure 9.16. Crushing of concrete at the compression flange: (a) D19-M-U; (b) D19-M-T.

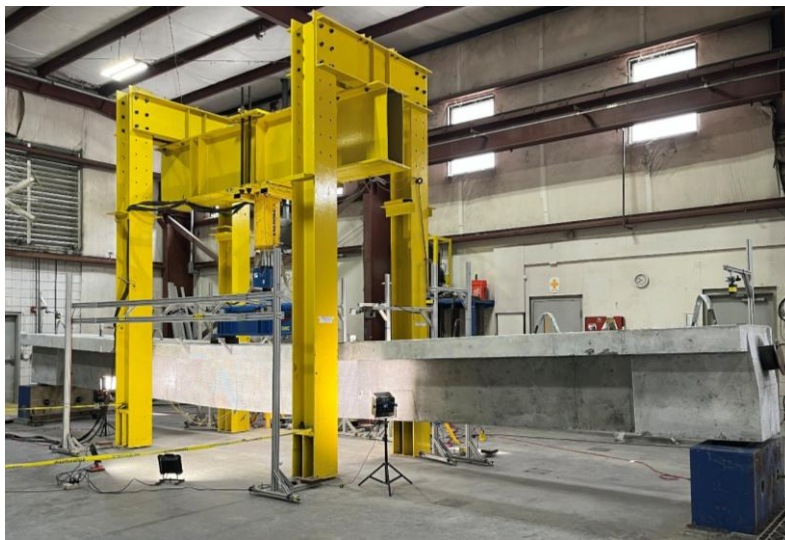
Figure 9.19. Flexural testing of the D19-P-T test beam.
