# Evaluation of Gainesville Pedestrian-Bicyclists Connected Vehicle Pilot

BED31-977-23

## **Final Report**

Submitted to James Landini, P.E.  
*Florida Department of Transportation*

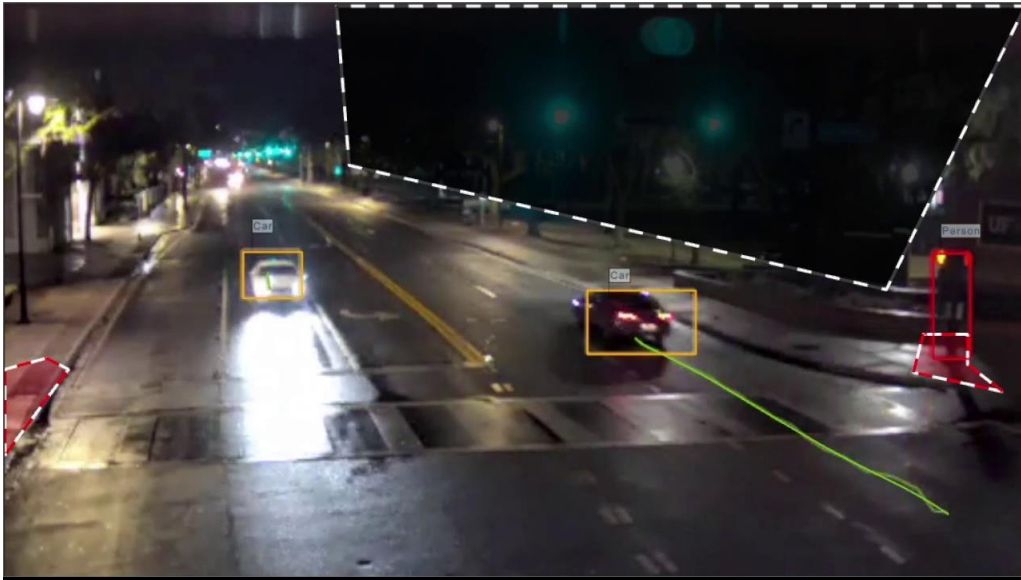
This type of error occurs when there is a problem with detecting objects. Figure 5-6 illustrates a detection error occurring at S2-W Univ. Ave. @ Gale Lemerand Dr., where the traffic signal pole shown on the right is mistakenly detected as a person, resulting in the activation of the

pedestrian detection zone. This type of error is classified as a false positive in the evaluation process.

Figure 5-6 – Detection error at S2-W Univ. Ave. @ Gale Lemerand Dr.

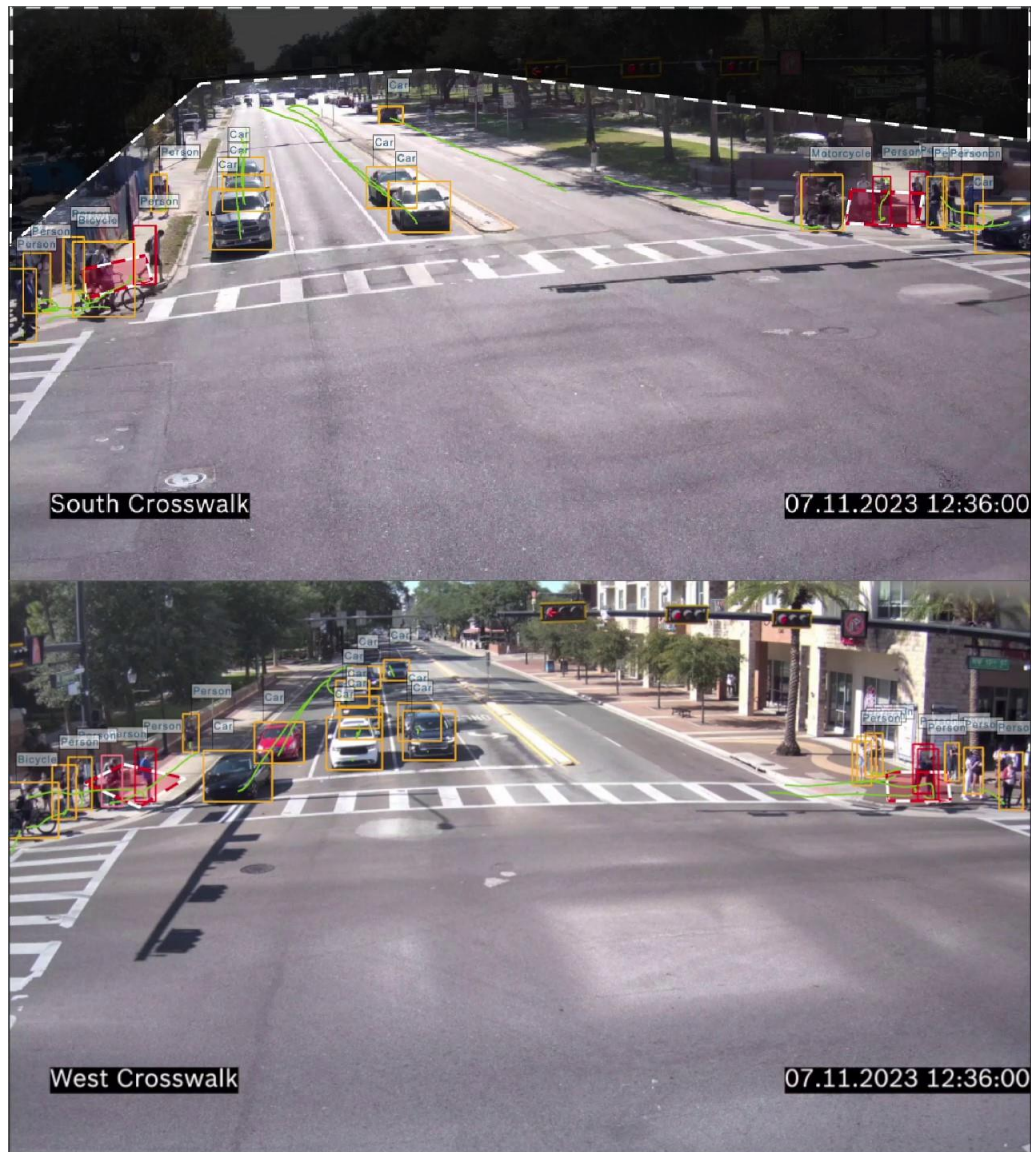
It was observed that the system detects only a few pedestrians when they are within a larger crowd in the detection areas. When pedestrian density is high, the pedestrians are underestimated by the camera's software. However, since there is no difference in the zone activation, whether there is one pedestrian or a group of pedestrians, for evaluation purposes we considered this as the correct activation of the system. Figure 5-9 illustrates a scenario where a crowd of pedestrians is crossing together.

Figure 5-9 – Error in detecting the number of pedestrians at S6-W Univ. Ave. @ 13th St.

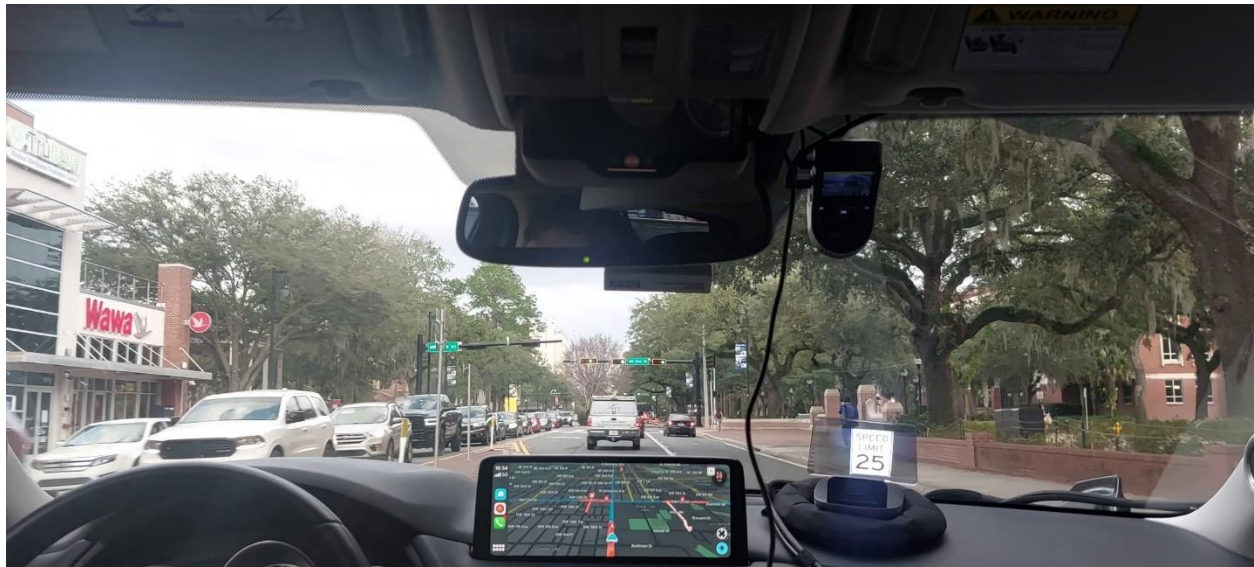
During the test runs, three types of messages were obtained. Figure 5-14 illustrates the speed limit message, which is displayed when the vehicle exceeds the posted speed limit. Figure 5-15 depicts the signal timing at intersections, showing a countdown during green and red light phases. Figure 5-16 indicates a pedestrian crossing warning message.

Figure 5-14 – Speed limit message received by OBU

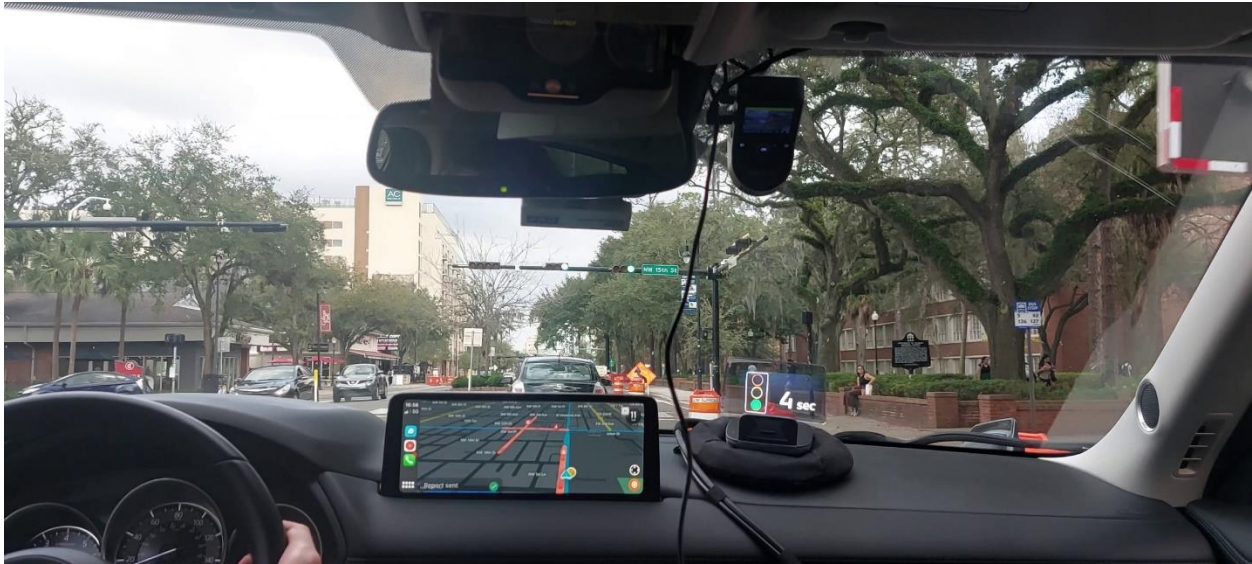
Figure 5-15 – Count down to the beginning of red on the OBU

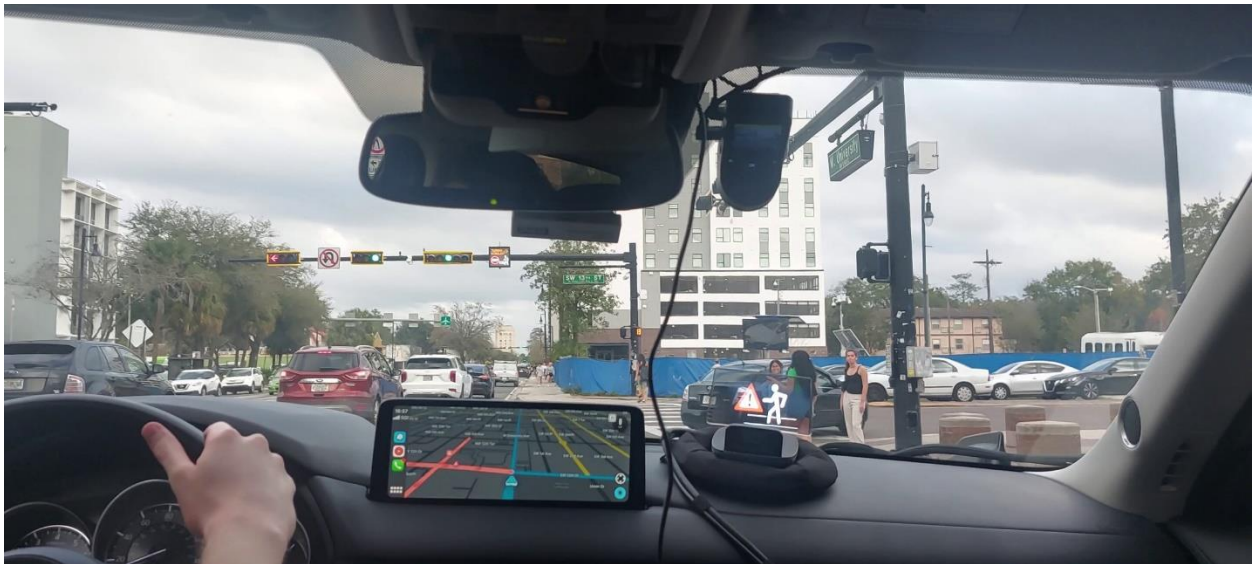
Figure 5-16 – Pedestrian crossing warning received by OBU.

Table 5–20 presents a summary of qualitative observations regarding the OBU messages received. According to our observations, pedestrian crossing warnings were received when pedestrians were detected at corners of intersections. Occasionally, messages were received even when no pedestrians were present, but the pedestrian phase was active at the intersection (i.e., false alerts). Pedestrian crossing warnings were sometimes observed after the pedestrian entering or immediately after the pedestrian passing the intersection.

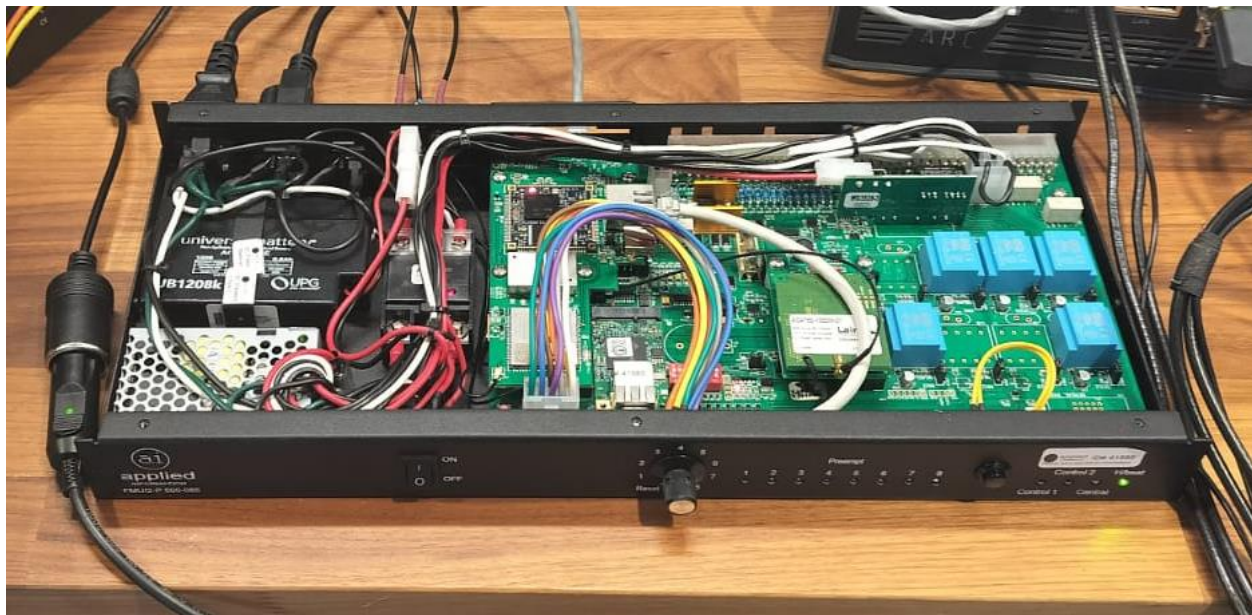
FMUs are installed at each location in the study area. FMUs directly connect and trigger pedestrian phases at intersections or activate the RRFBs at midblock crossings. FMUs receive the information regarding pedestrian or cyclist presence from the Glance Cloud. Figure 5-19 provides an image of an FMU used in the study area.

Figure 5-19 – A field-monitoring unit (FMU) used in the study area

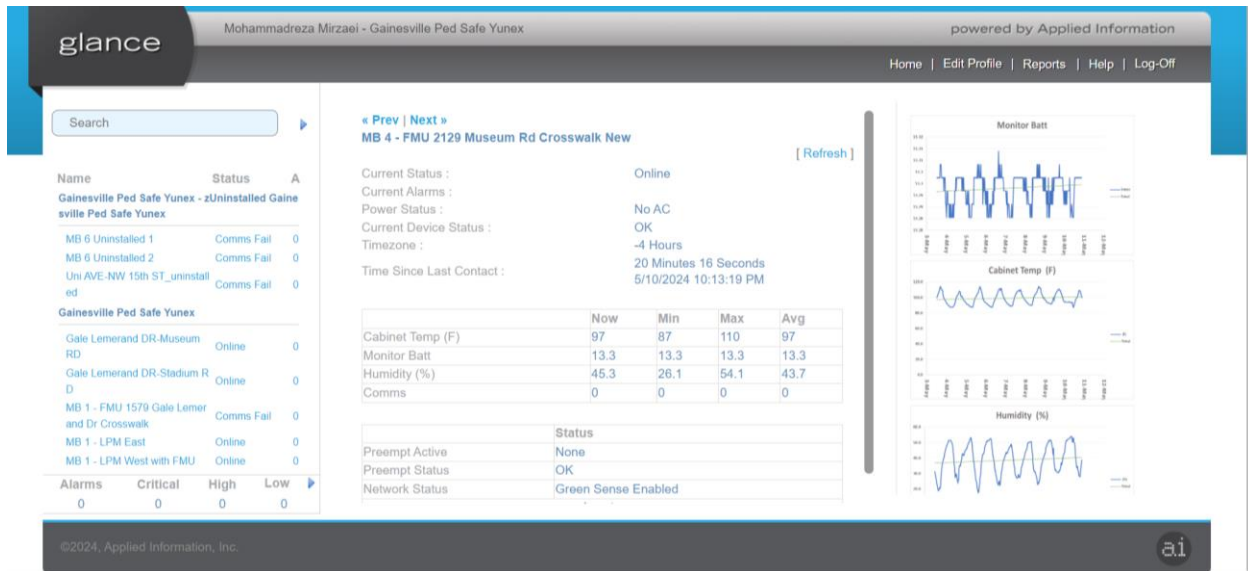
Figure 5-22 – FMU with online status

The research team evaluated the operational status of FMUs in the study area to ensure they function properly. The Glance portal, which is provided by Applied Information, was used to monitor the operational status of each FMU. Figure 5-20 presents the main page of the Glance portal with the list of intersections and midblock crossings shown on the left side of the screen, and a map of the deployed units on the right side. The portal provides information on the status, alarms, power status, time since last contact, cabinet temperature, battery, humidity, network status, etc., of each FMU. Figure 5-21 illustrates an example of an FMU with offline status and Figure 5-22 shows an example of an FMU with online status. Figure 5-23 provides a screenshot of the log page, which includes communication, diagnostic, and device logs.

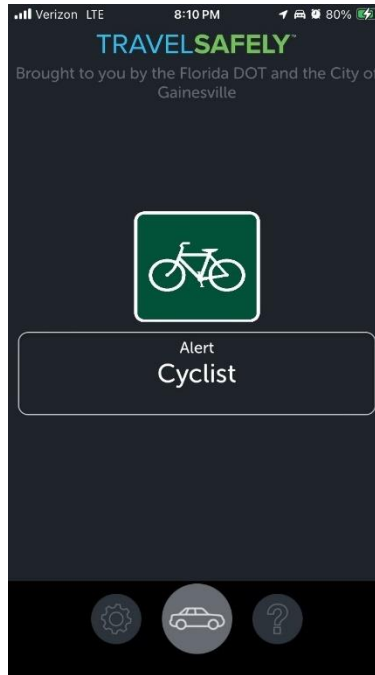
4. **Cyclist ahead:** For motorists, the app provides a warning if there is a cyclist on the road ahead. The bicyclist mode is mostly used to activate the bicycle phase in signalized intersections when a group of cyclists approach the intersection. A cyclist receives an alert if they ride along with the vehicle towards it, and a collision is projected (Figure 5-27).

Figure 5-27 – Cyclist alert in motorist mode

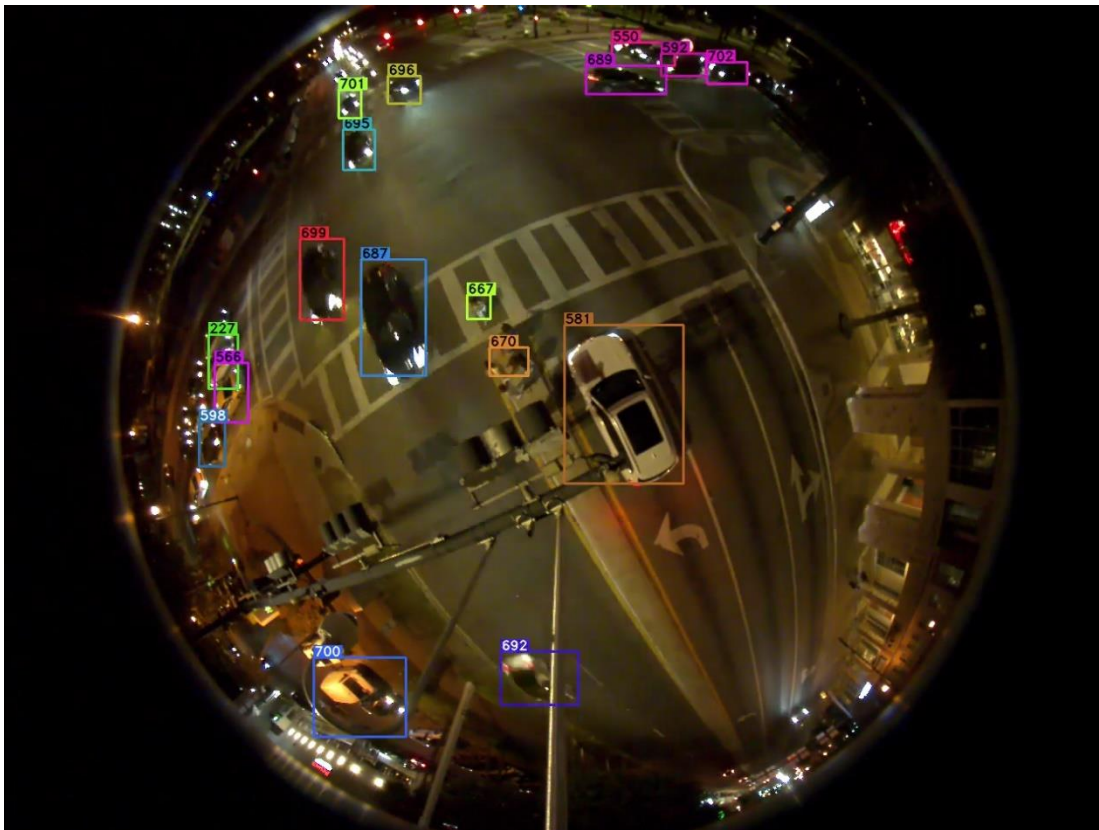
The near-miss data is the result of processing recorded videos from a fisheye camera located at the West University Avenue and 13<sup>th</sup> Street (S6) signalized intersection. Figure 8-11 shows a screenshot of the camera view at the intersection, capturing a near-miss situation involving pedestrians present at the crosswalk (ID 667) and median (ID 670) and approaching vehicles (ID 687).

Figure 8-11 – Camera view and a near-miss incident

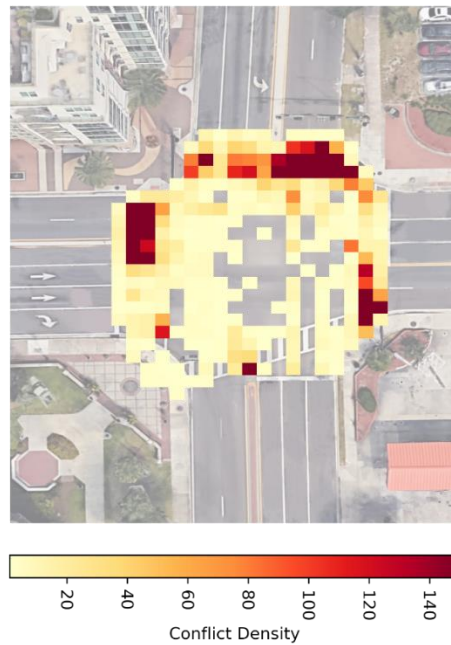
Figure 8-12 presents a heatmap visualization of near-miss incidents overlaid on a satellite view of the signalized intersection evaluated (S6). The heatmap utilizes a color gradient ranging from light yellow to dark red to indicate the intensity of near-miss activity. Light-colored areas represent low or no near-miss occurrences, while darker red zones show locations where near-misses have been more frequent or severe. This pattern shows that conflict points are concentrated around pedestrian crossing zones and turning vehicle paths. The diagram of vehicle movements shown in the heatmaps uses the labels shown in **Error! Reference source not found.**, and the diagram for pedestrian movements uses the labels shown in Table 8–9.

Figure 8-12 – Heatmap of near-miss incidents in October 2022

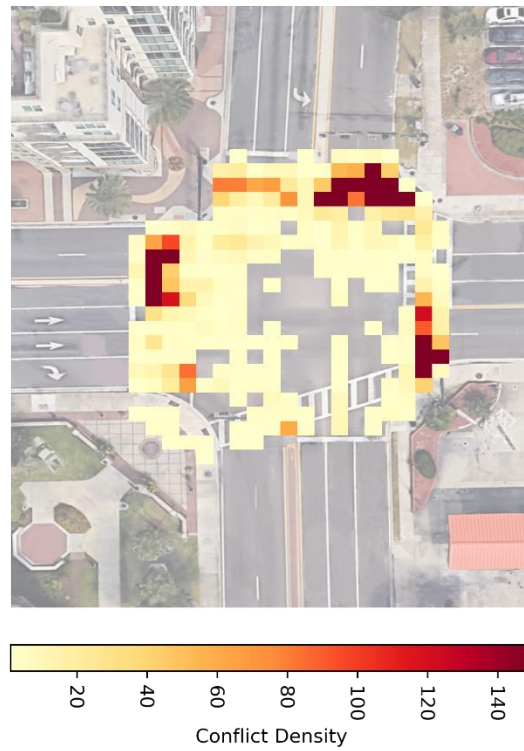
The near-miss data extracted from video footage for October 2024 were analyzed using the same methodology applied to the October 2022 dataset. Figure 8-17 shows a heatmap of the spatial distribution of near-miss incidents between pedestrians and vehicles. Figure 8-18 shows the number of near-miss incidents for each pedestrian and vehicular movement. These figures show that right turns from WB, NB, SB, and left turns from NB and EB are still the most critical movements.

Figure 8-17 – Heatmap of near-miss incidents in October 2024

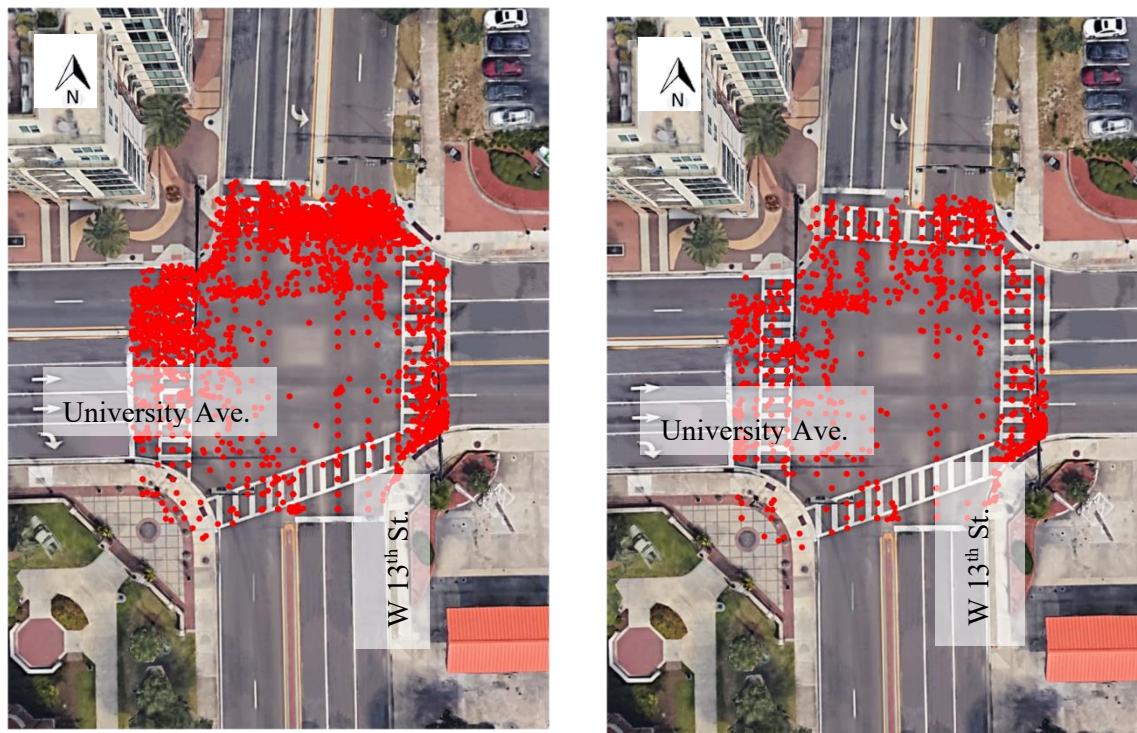
The 2024 image shows a reduction in the number and density of near-miss incidents, particularly in the crosswalks. While near-misses still occur, they appear more evenly distributed and less concentrated, suggesting an overall improvement in pedestrian safety. This change may be attributed to safety interventions implemented between 2022 and 2024, such as signal timing adjustments, infrastructure modifications, technology deployments, and enhanced pedestrian detection technologies.

Figure 8-21 – Comparison of near-miss incidents in October 2022 and October 2024

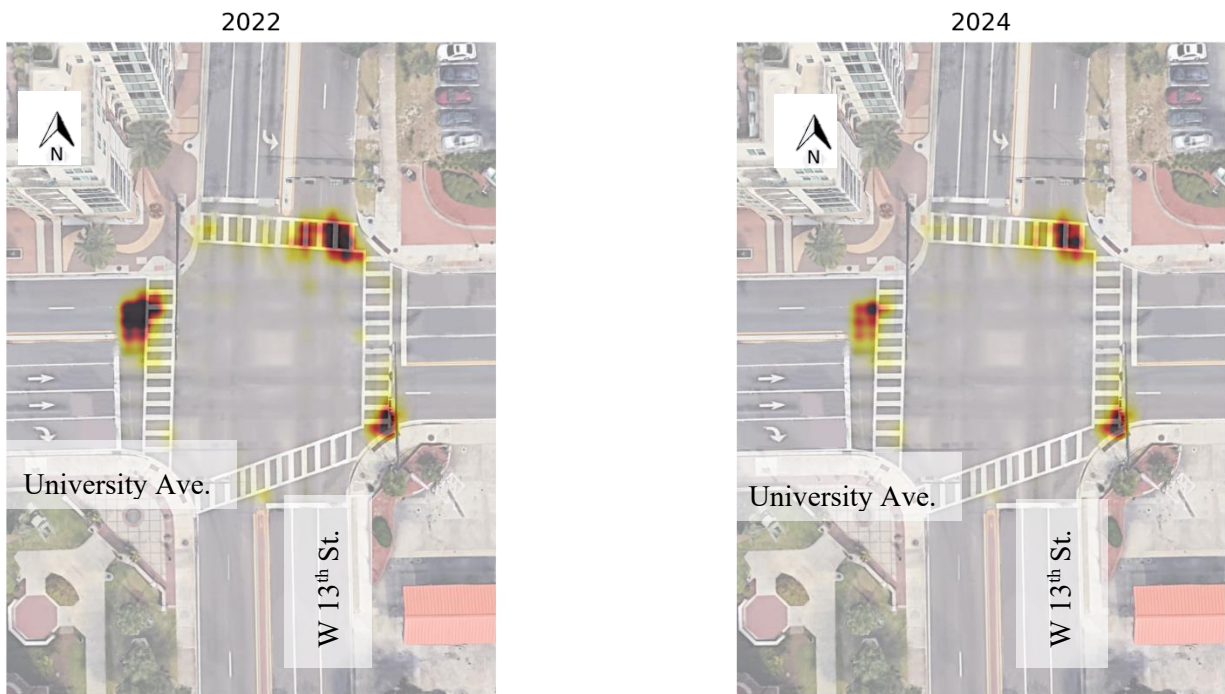
Figure 8-21 compares the spatial distribution of near-miss incidents at the signalized intersection (S6) for two time periods: October 2022 (left) and October 2024 (right). The background is a satellite image of the intersection, overlaid with red dots representing the location of each detected near-miss event. Figure 8-22 shows the heatmap of the distribution of near-misses.

Figure 8-22 – Heatmap comparison of near-miss incidents in October 2022 and October 2024

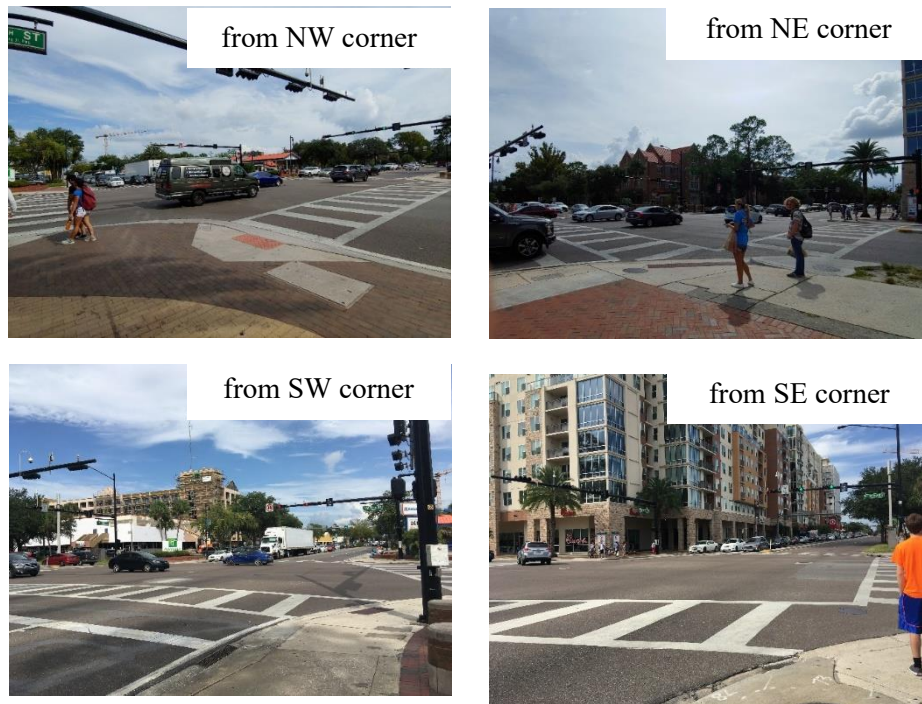
The overall reduction in the number of near-miss incidents is most likely due to changes in the roadway network between the before and after study periods. Figure 8-24 presents photos taken of the intersection at West University Avenue and 13th Street (S6) on September 13, 2019, during the previous project (BDV31-977-120), while Figure 8-25 shows photos captured on October 8, 2023, at the same location, where the near-miss analysis was conducted. Figure 8-26 provides an aerial view of the intersection (S6) during the before and after periods. The lane configuration and geometric design remain largely unchanged; however, one notable modification is the slight adjustment of the southern crosswalk's angle, which has been realigned to form a more rectangular shape consistent with the other crosswalks. Additionally, the reduction could be due to other changes in the network. For example, upstream on West University Ave., there are several new speed tables, new pedestrian crossings (between S2 and S14, and between S5 and S6), and signals (S14 and S15), which tend to slow down the vehicles before they approach the intersection (S6).

Figure 8-24 – Photos of the intersection at W Univ. Ave. & 13 St. (S6) in the previous project (September 13, 2019)

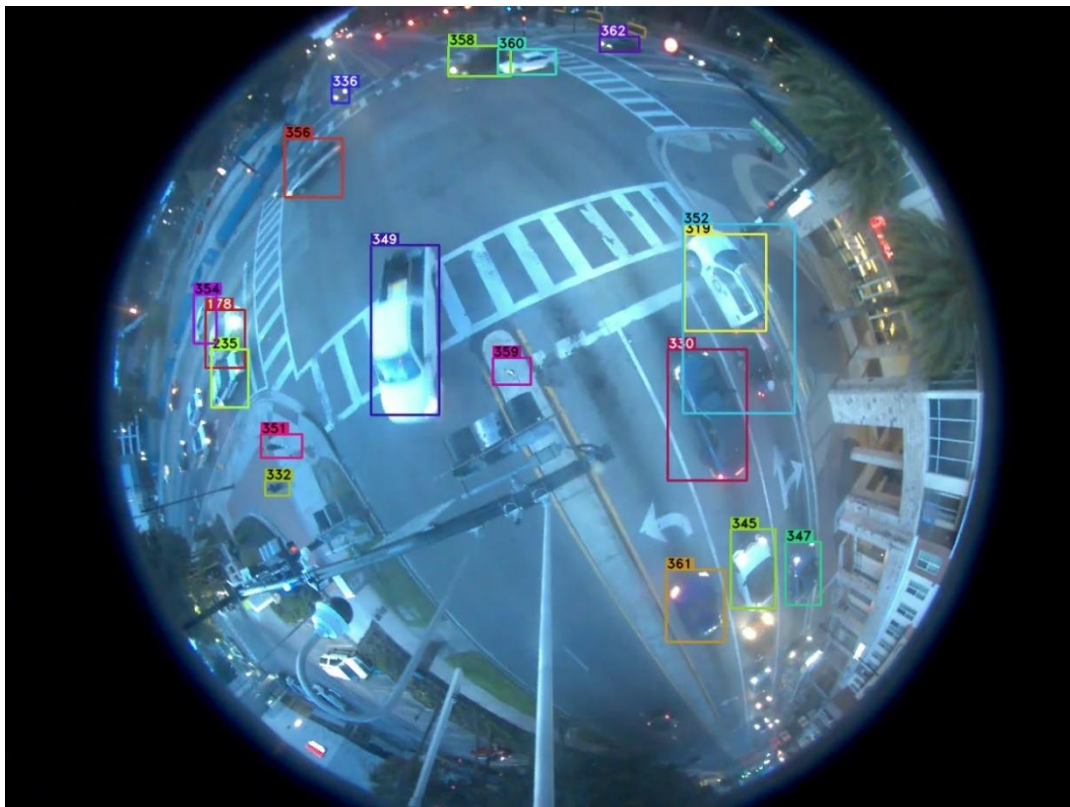
To address this issue, the research team retrained the model using data collected at different times of the day, under varying weather conditions, and with a larger set of pedestrian samples to improve accuracy. The final results presented in the previous sections are based on this updated model, which demonstrated improved performance and reliability.

Figure 8-28 – False detection of the fisheye camera (ID 359)

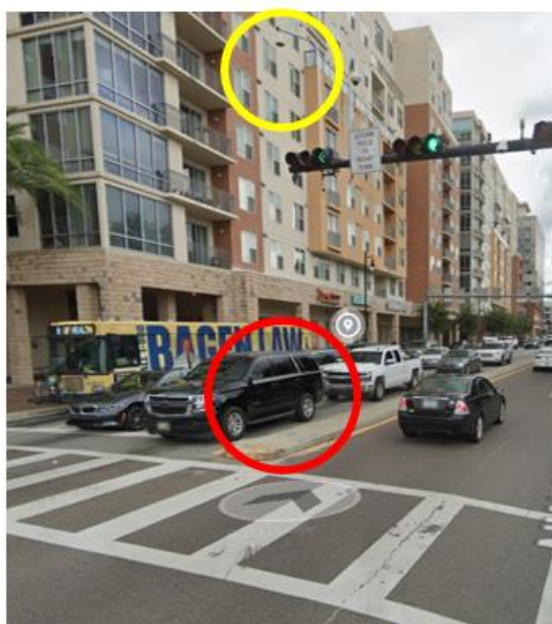
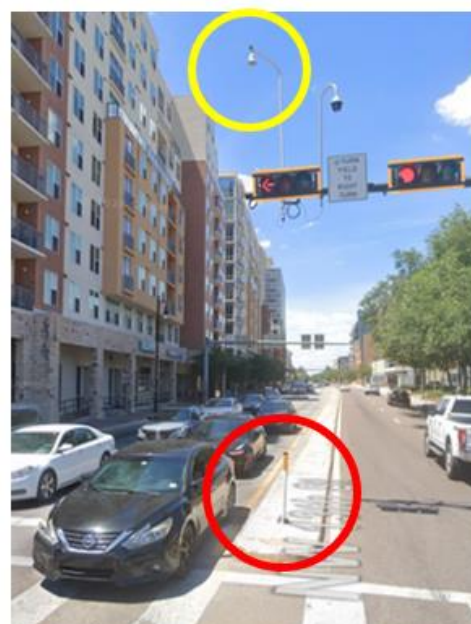
Figure 8-27 presents the initial heatmap generated from the data. Upon closer examination, including a review of the video footage, the team discovered that the near-miss detection algorithm was mistakenly identifying a sign located on the median as a pedestrian, which led to false detections at that spot (see Figure 8-28). This sign was not present at the same location in October 2022, as found from Google Street maps and indicated by the red circle in Figure 8-29. The position of the camera used for data collection is marked by the yellow circle in the same figure.

Figure 8-29 – Fisheye camera and the sign on the median in different periods

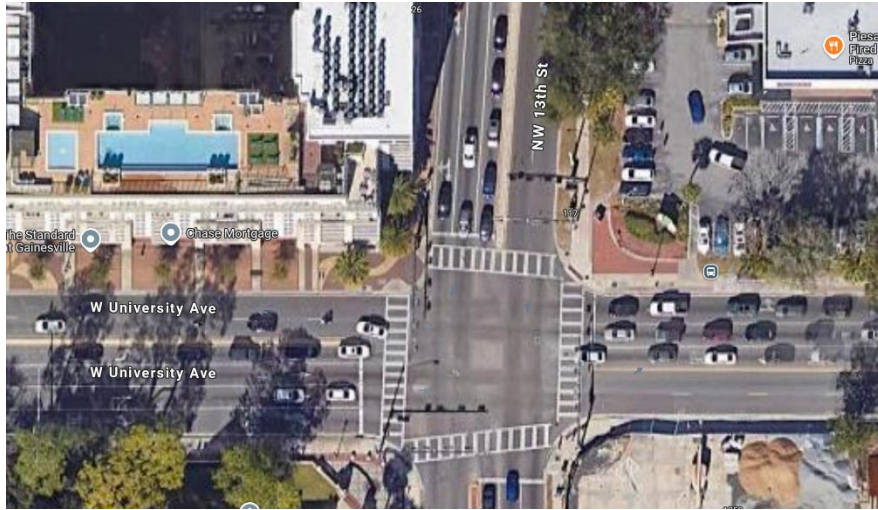
Geometric data were obtained using the aerial view from Google Maps. The intersection of W Univ. Ave. & 13<sup>th</sup> St. (S6) has four approaches, as shown in Figure 9-1. The northbound, southbound, and westbound approaches have three lanes and a left-turn bay of 310 ft., 470 ft. and 240 ft. respectively. All approaches have an exclusive through lane and a shared through and right turn lane. The eastbound approach has four lanes including a nearly 450-ft. left-turn bay, two exclusive through lanes, and a dedicated right-turn bay of approximately 240 ft. There is no on-street parking along any of the approaches. The approach grade is assumed to be 0% for all approaches. The geometric design information, such as number of lanes per approach, lane width, grade, turn bay length used as input for capacity analysis are provided in Appendix K. Compared with the “before” scenario, at the intersection W. Univ Ave & 17<sup>th</sup> St, the southbound traffic direction is restricted for vehicles, as shown in Figure 9-2. Another important change along the corridor is the placement of traffic calming devices and the reduction of the speed limit from 30 mph to 25 mph. Figure 9-1, Figure 9-2, and Figure 9-3 show the current intersection layout, used for the “after” analysis.

Figure 9-1 – Intersection of W Univ. Ave. & 13th St.

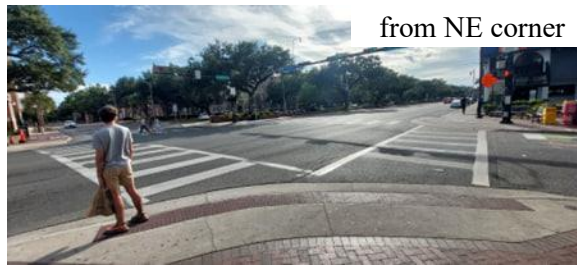
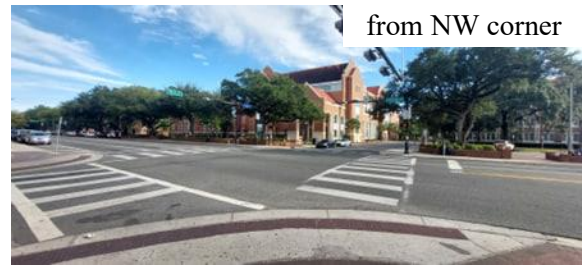
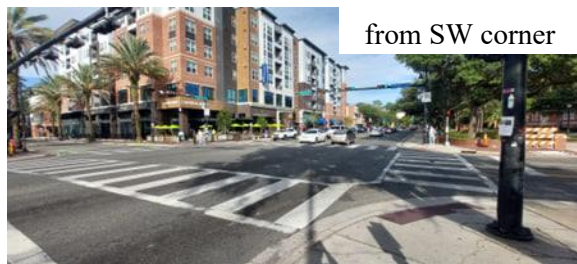
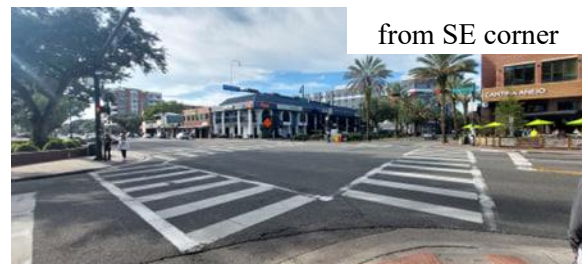
Figure I-2 - Intersection of W Univ. Ave. & 17<sup>th</sup> St

- The intersection has a bike signal.
- NW 17th St is one-way from West University Ave., and it includes bicycle lanes.

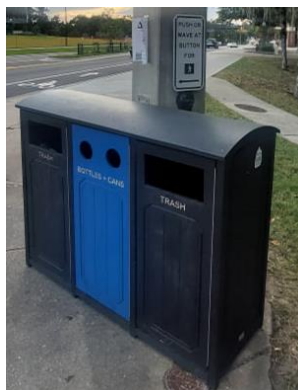
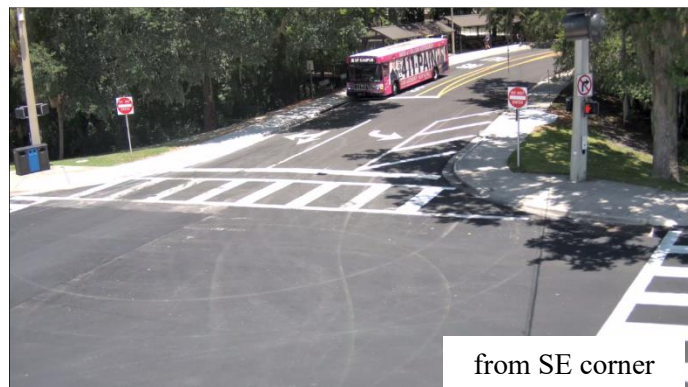
Figure I-3 – Intersection at Museum Rd. & Center Dr

- Some trash bins are located next to the push button, which can cause pedestrians not to push the buttons because of accessibility or bad smell.

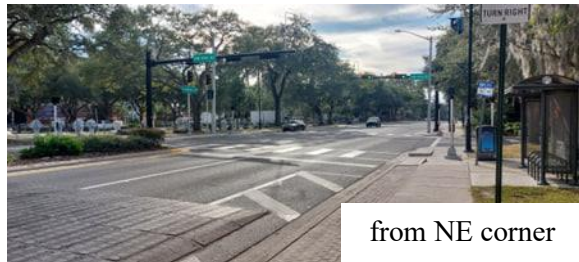
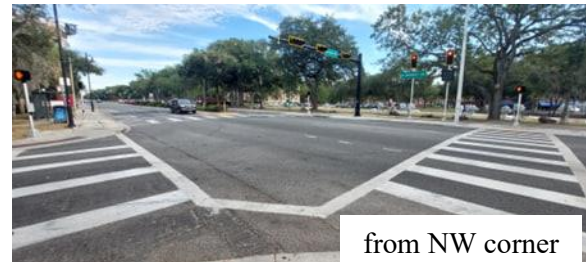
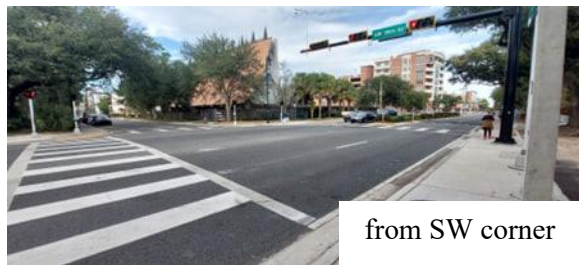
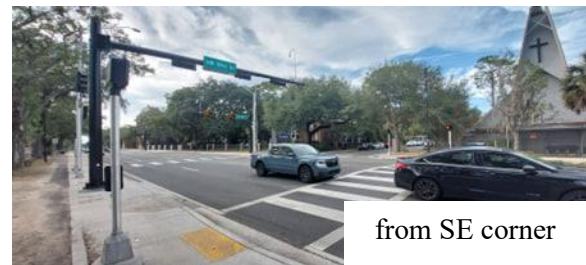
Figure I-4 – Intersection at NW 19th St & West University Ave

- This intersection was not reported in the previous project.
- It is a 3-legged intersection.
- There is a bus stop before the intersection heading WB.
- The EB has a speed bump after crossing the intersection, and the WB has a speed bump before the intersection.
- Traffic spillback was observed.

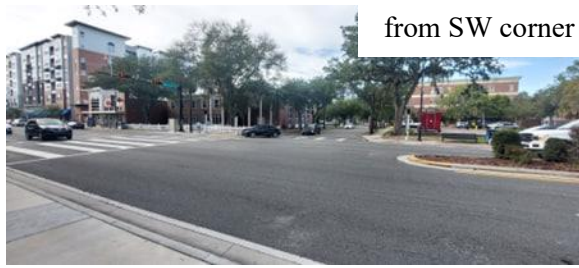
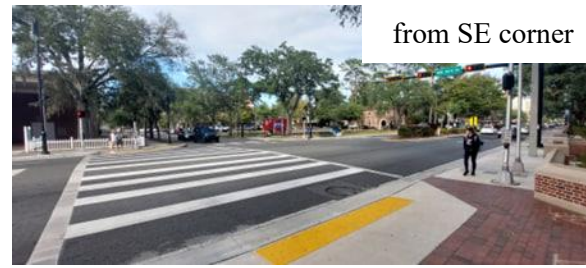
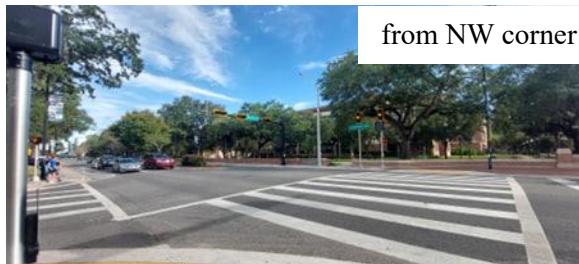
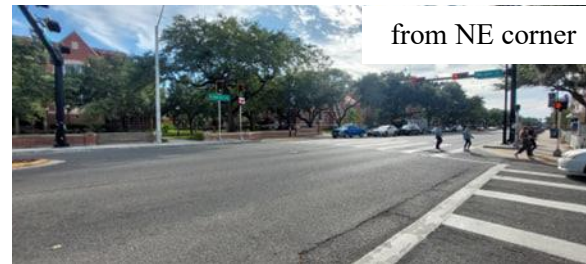
Figure I-5 – Intersection at NW 16th St & West University Ave.

- This intersection was not reported in the previous project.
- It is a 3-legged intersection.
- There is a bus stop before the intersection heading WB.
- The EB has a speed bump after crossing the intersection, and the WB has a speed bump before the intersection.
- The east side of the intersection does not have a pedestrian crossing, but the west side pedestrian crossing is wide.
- Push buttons are available and beeping, and they have a voice to say the available crossing street name.

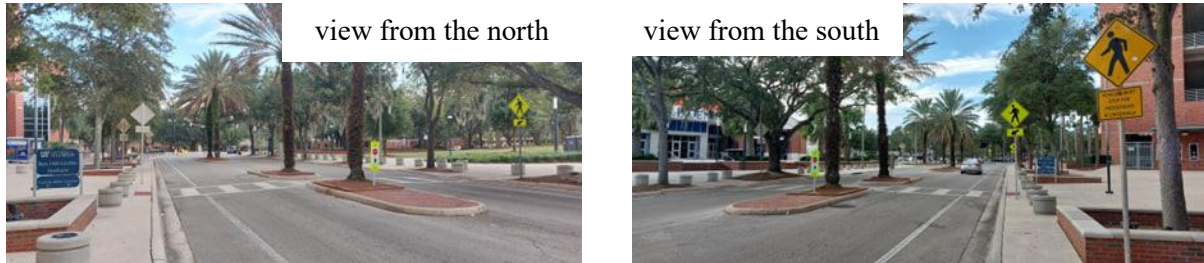
Figure J-1 – Intersection between signals at Gale Lemerand Dr

- Yellow and orange signs indicating that “vehicles must stop for pedestrians in crosswalk” are observed toward NB.
- Jaywalking has
- Rectangular “stop for pedestrian within a crosswalk” sign in traffic separator (pedestrian island).

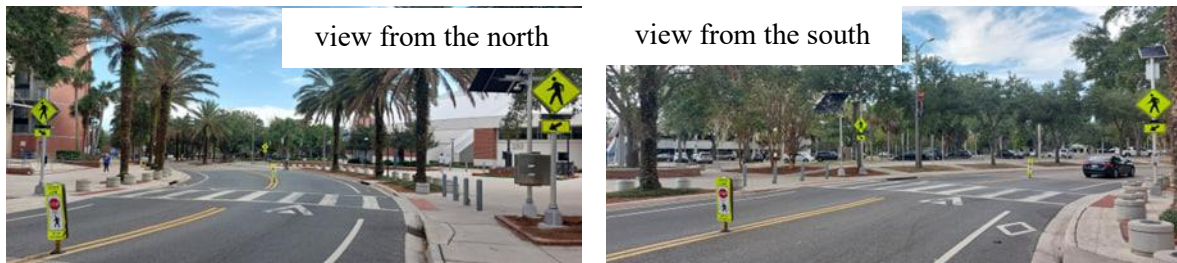
Figure J-2 – Intersection between signals at Gale Lemerand Dr

- Yellow “pedestrian ahead” sign before the crossing.
- Yellow pedestrian crossing warning signs and flashing beacons have been installed.

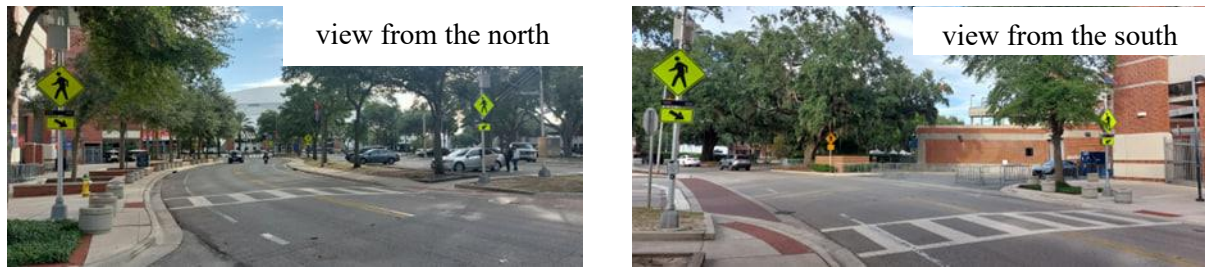
Figure J-3 – Intersection between signals at Gale Lemerand Dr

- Rectangular “stop for pedestrian within a crosswalk” sign between yellow lines.
- Yellow pedestrian crossing warning signs and flashing beacons have been installed.
- Pedestrian detection and flashing beacons work.

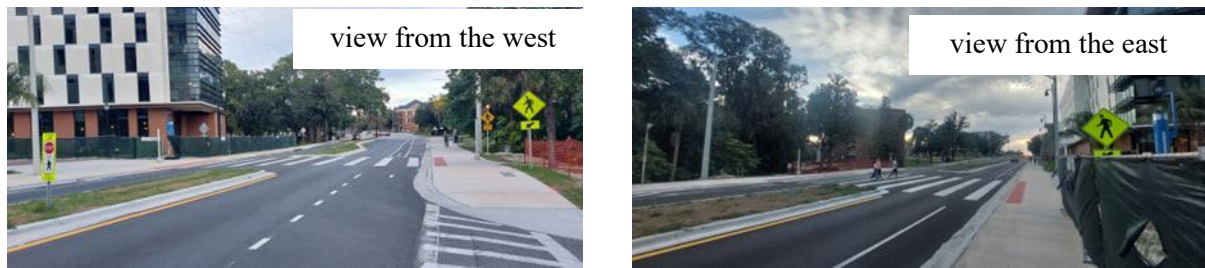
Figure J-5 – Intersection between signals at Museum Rd

- Yellow “pedestrian ahead” sign before the crossing.
- The orange sign “vehicles must stop for pedestrians in crosswalk” with a red beacon on top is observed toward EB.
- Rectangular “stop for pedestrian within a crosswalk” sign in traffic separator (pedestrian island).
- Yellow pedestrian crossing signs were observed, but one of them was inside the construction site.

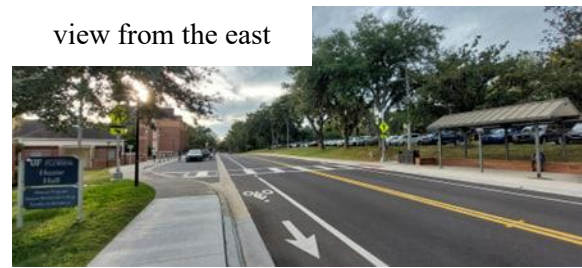
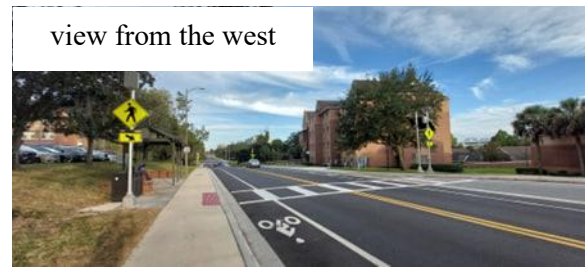
Figure J-7 – Intersection at between signals at Museum Rd

- Yellow signs with flashing beacons have been installed.

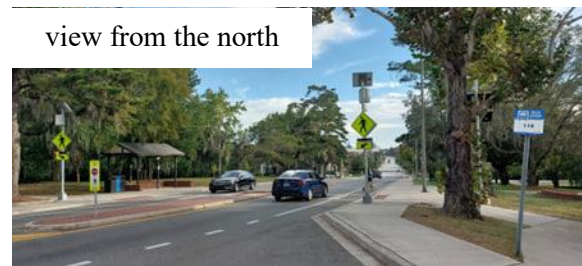
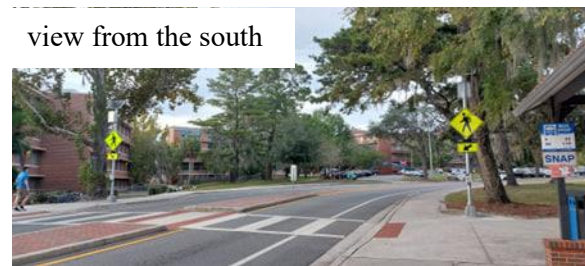
C9:

Figure J-8 – Intersection at between signals at Gale Lemerand Dr.

- Orange “pedestrian ahead” sign before the crossing toward SB.
- Rectangular “stop for pedestrian within a crosswalk” sign in traffic separator (pedestrian island).
- Bus stop locating before crossing in both directions.
- Pedestrian detection and flashing beacons work.
- Medium pedestrian traffic crossing observed.
