**Energy Conservation Study – Madison County:  
2010 Survey of Roadside Vegetation**

Contract No. PR4516611

*FINAL REPORT*  
February 2012

Dr. Jeffrey G. Norcini  
OecoHort, LLC  
726 Riggins Road  
Tallahassee, FL 32308

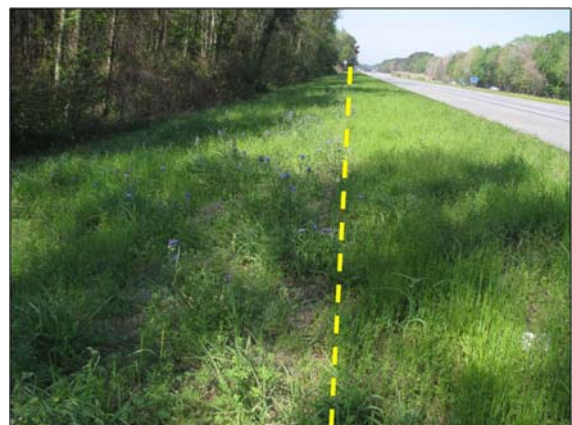
2. On both the north and south side ROWs, it is becoming apparent that the modified mowing regime has enhanced the density and extent of native wildflowers. Showy spring wildflowers are increasing in density beyond the 10-ft safety strip – mainly *Tradescantia ohiensis* (Figure 1), *Salvia lyrata*, and *Erigeron quercifolius*.

**Figure 1. The showy spring wildflower, *Tradescantia ohiensis*, in the clear zone just beyond the 10-ft safety strip on I-10 in Madison County, Florida (18 March 2011). The yellow dashed line delineates the safety strip from the remainder of the clear zone.**

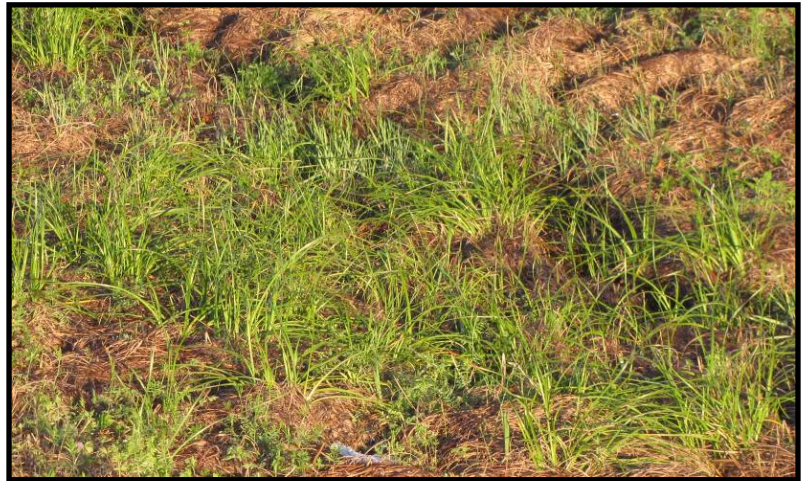
Extent        Widespread and locally abundant on north side; locally abundant on  
                 south side

**Figure 2. *Allium canadense*, I-10, Madison County, Florida; image recorded 19 March 2010.**

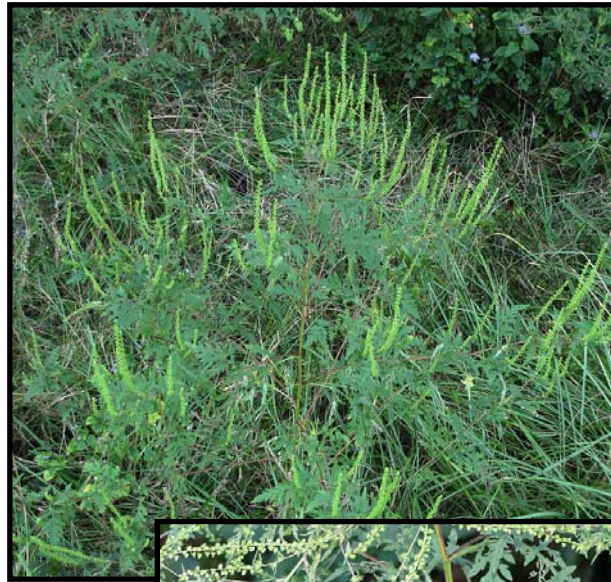
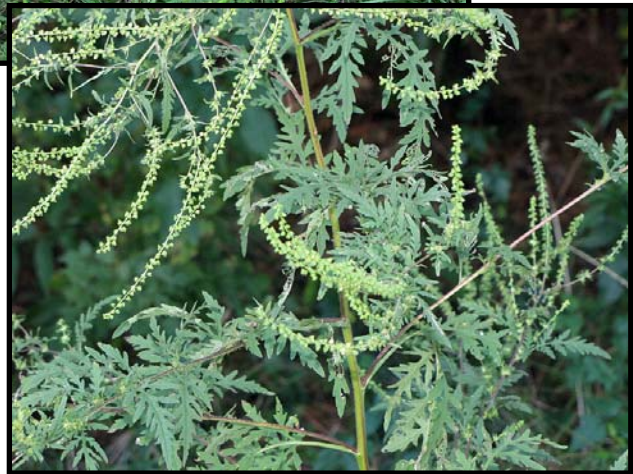
**Figure 3. *Ambrosia artemisiifolia*, I-10, Madison County, Florida; images recorded 19 October 2010.**

Extent            Frequent

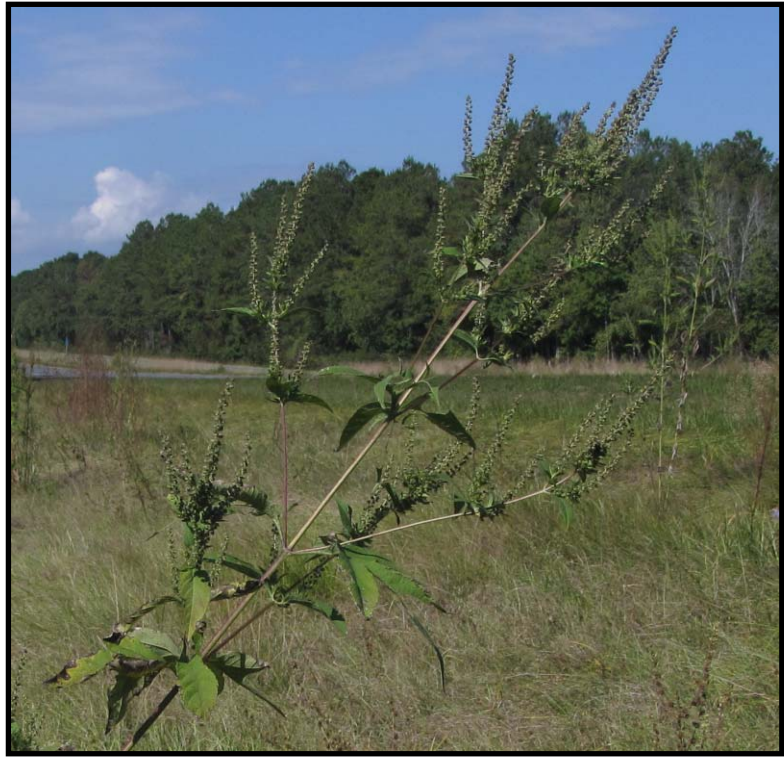
**Figure 4. *Ambrosia trifida*, I-10, Madison County, Florida; image recorded 19 October 2010.**

Extent            Fall 2011: north side – occasional; south side – locally abundant, and noticeably more prevalent in 2011 than in 2010

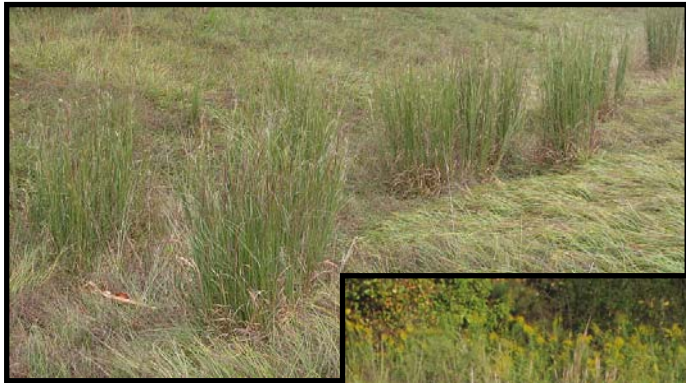
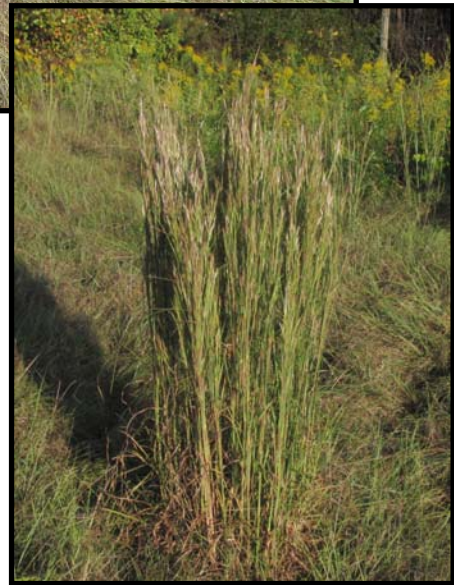
**Figure 5. *Andropogon glomeratus* var. *pumilus*, I-10, Madison County, Florida; images recorded 19 October 2010 (UL) and 13 October 2011 (LR).**

Extent Most abundant in non-mowed portion of clear zone in western part of pilot study area on north side. Very sporadic in the median.

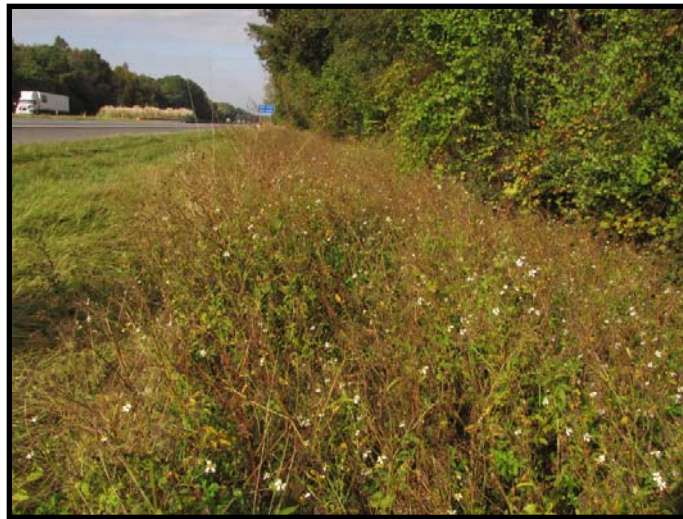
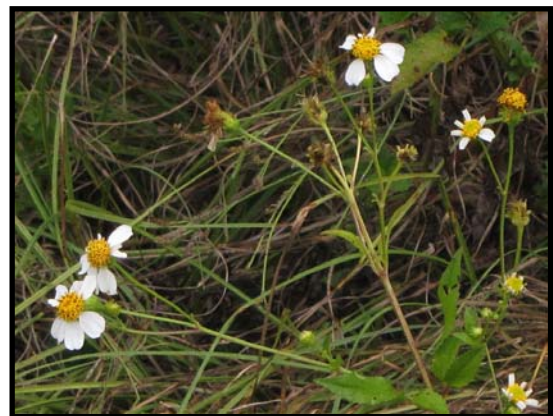
**Figure 6. *Bidens alba*, I-10, Madison County, Florida; images recorded 19 October 2010 (UL) and 13 October 2011 (LR).**

Extent            Widespread and locally abundant

A preferred native wildflower of the Monarch butterfly; showy in mass. The current management regime will facilitate its spread and aesthetic appeal beyond the 10-ft safety strip.  
Erosion concern. Very tolerant to mowing. *Bidens* chokes out the turf, and when *Bidens* dies after frost the bare soil is susceptible to erosion (Ferrell, 2010c).

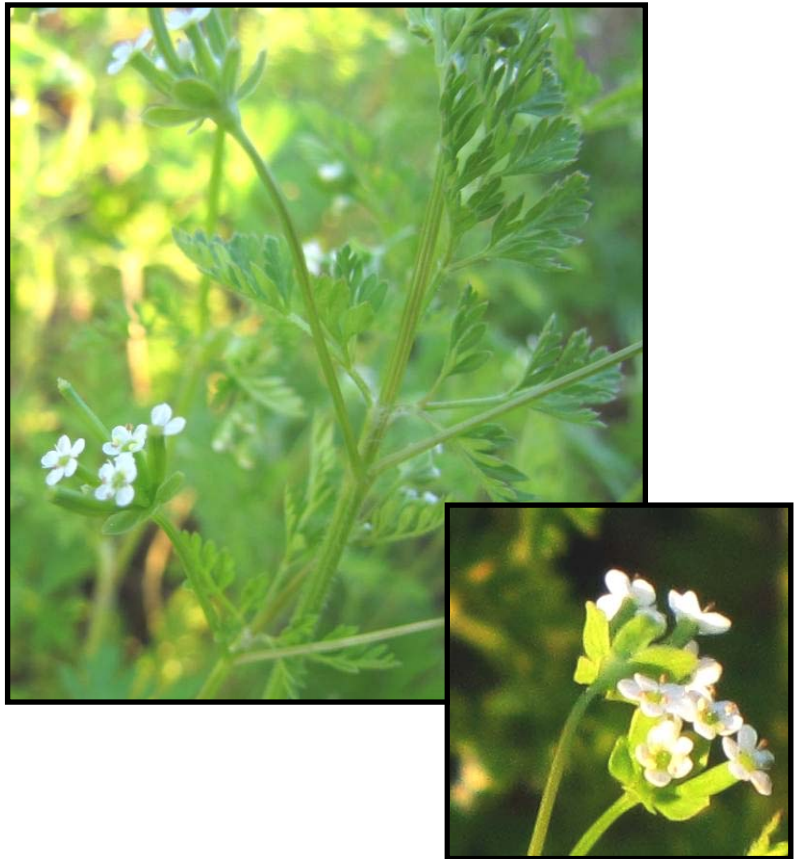
**Figure 7. *Chaerophyllum tainturieri*, I-10, Madison County, Florida; images recorded 19 March 2010.**

Extent        Widespread, and locally abundant.

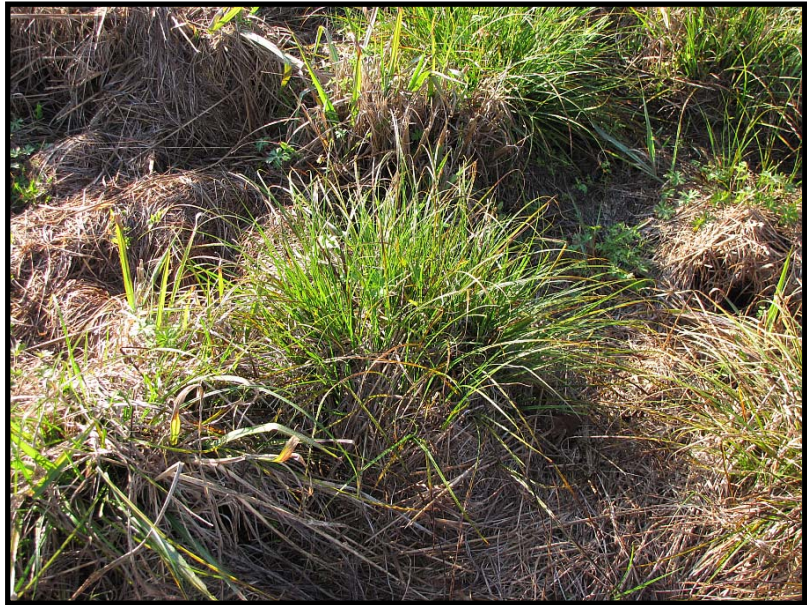
**Figure 8. *Cyperus* sp., I-10, Madison County, Florida; image recorded 19 March 2010.**

Extent           Widespread in moist areas in median

Likely to spread vegetatively regardless of mowing; in moist areas, where it is thriving, appears to have good soil stabilization properties so no need to control at this point; control will require herbicide program, but must identify in order to select appropriate herbicide(s)

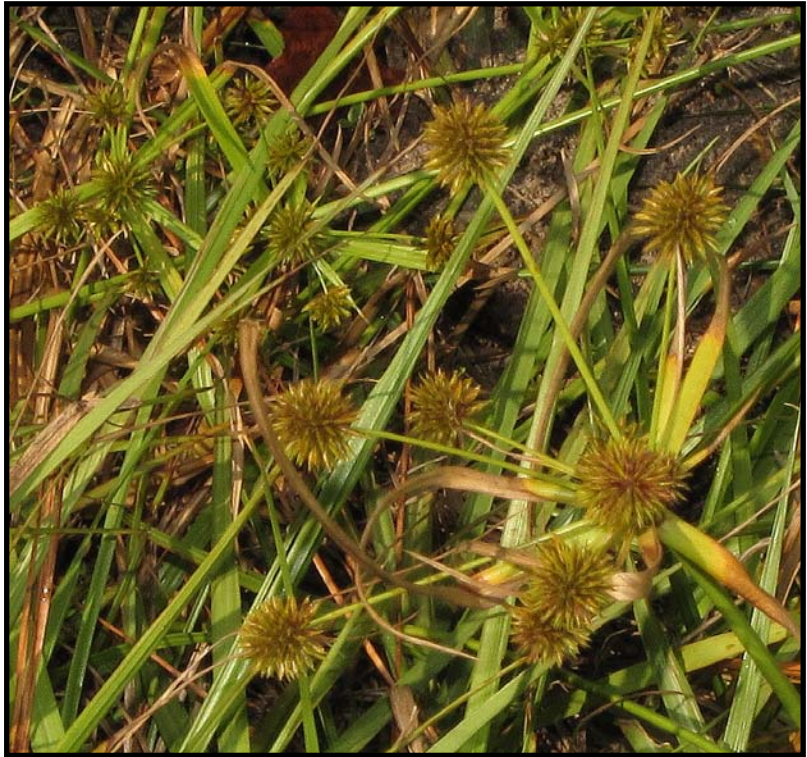
**Figure 9. *Cyperus croceus*, I-10, Madison County, Florida; image recorded 13 October 2011.**

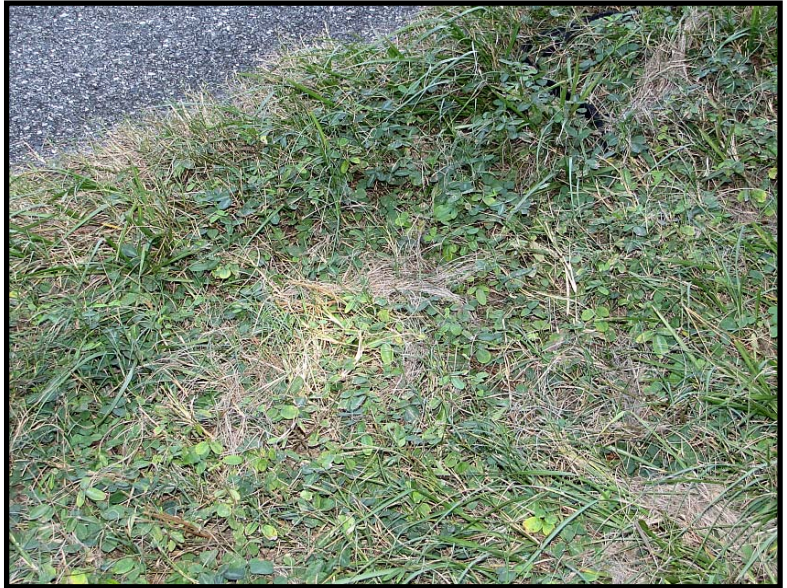
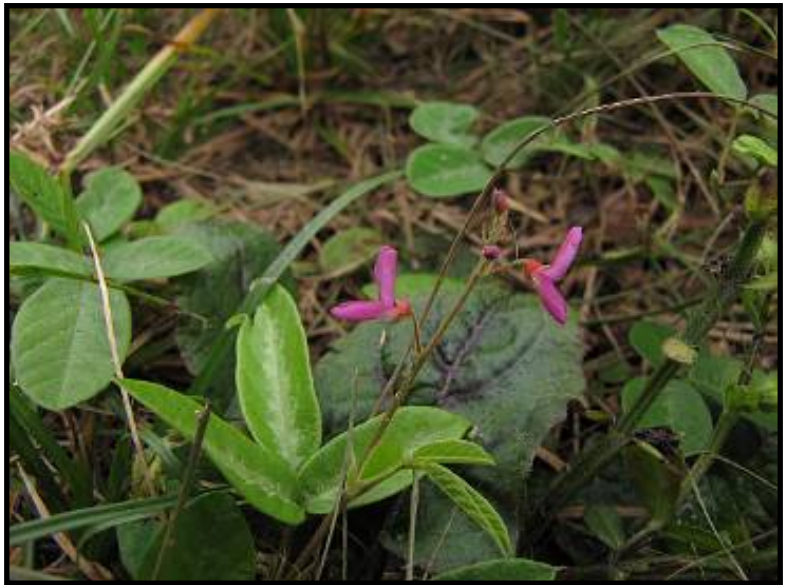
**Figure 10. *Desmodium incanum*, I-10, Madison County, Florida; images recorded 19 October 2010.**

Extent Locally abundant on south side in safety strip near pavement; infrequent on north side and median in safety strip near pavement.

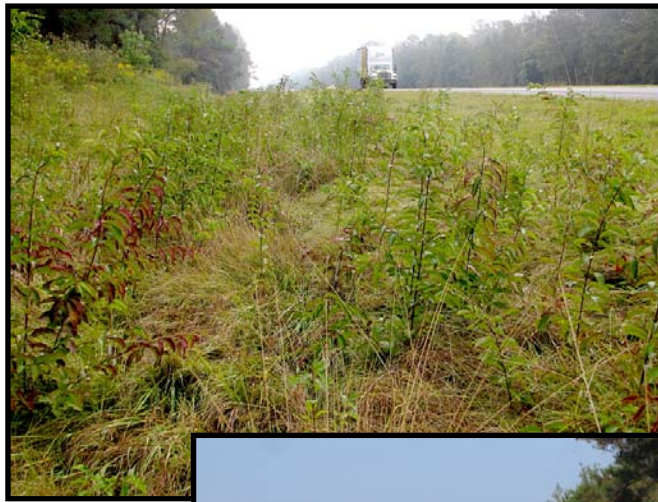
**Figure 11. *Diospyros virginiana*, I-10, Madison County, Florida; images recorded 19 October 2010 (UL) and 13 October 2011 (LR).**

Extent           Widespread beyond 10-ft safety strip on the north side in the eastern part of pilot study.

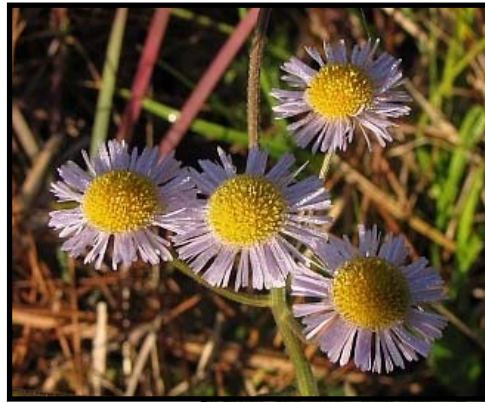
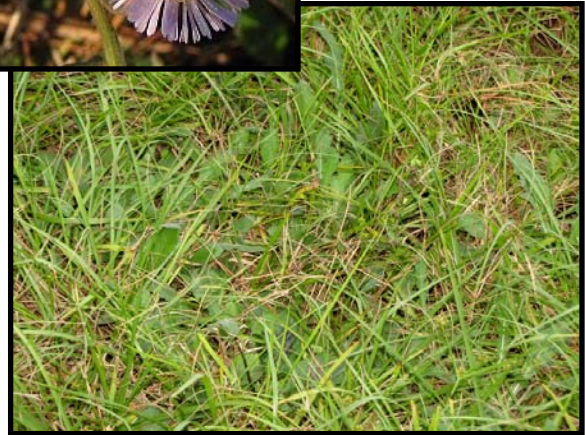
**Figure 12. *Erigeron quercifolius*, I-10, Madison County, Florida; images recorded 19 March 2010 (UL) and 13 October 2011 (LR).**

Extent Locally abundant in 2011, on north and south side ROW, starting about 10 ft from pavement and continuing into reduced mowing regime area; appeared to be more abundant on south side.

Appeared to be much more abundant in spring 2010 than in spring 2011. In fall 2011, many basal rosettes were noted in turf just beyond the 10-ft safety strip on south side ROW (Figure 12); one plant was in full bloom on north side.

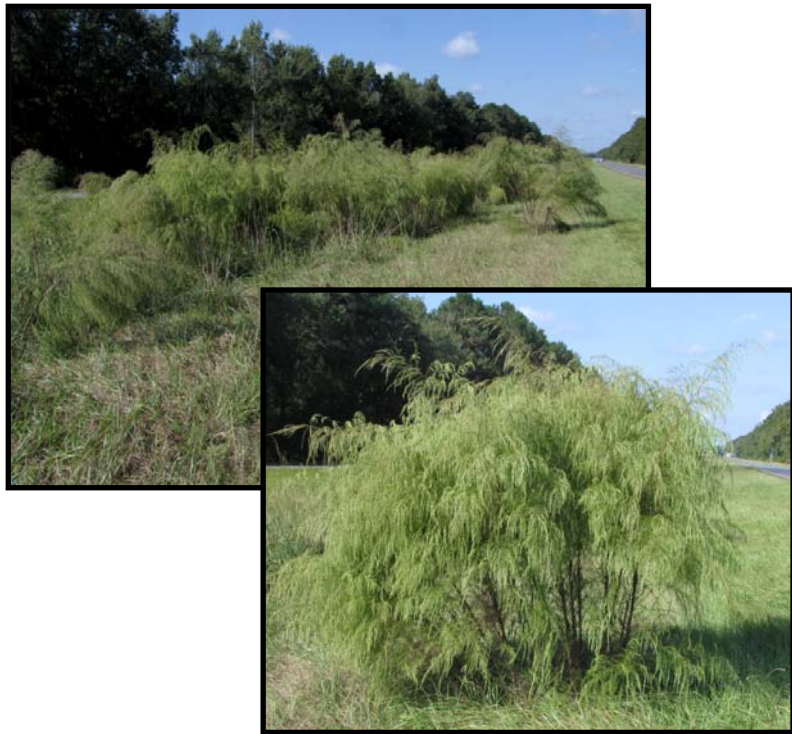
**Figure 13. *Eupatorium capillifolium*, I-10, Madison County, Florida; images recorded 13 October 2011.**

**Extent** In 2010, locally abundant, mainly in moister areas beyond the 10-ft safety strip on north and south side. In fall 2011, it was locally abundant mainly in the median and on the south side.

While listed by FDOT as being an undesirable species (Florida Department of Transportation, Office of Maintenance, 2011, p. 125), it does not occur in the 10-ft safety strip. In the median, it is limited to the central part of the median and has not caused any apparent detrimental effects.

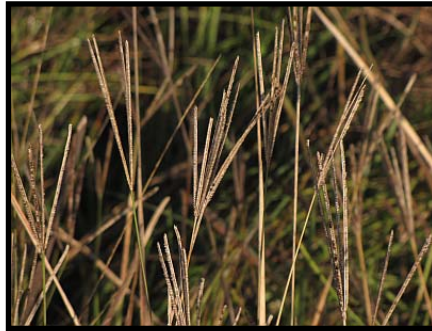
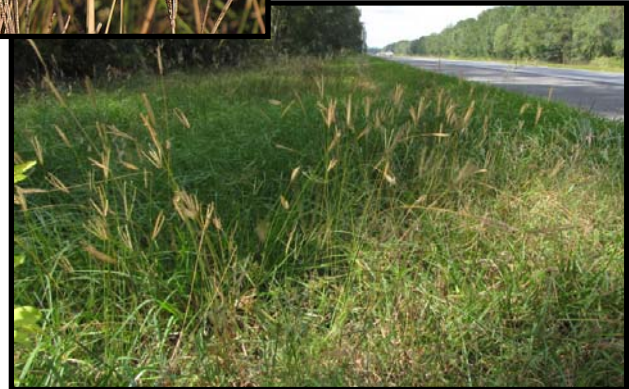
**Figure 14. *Eustachys petraea*, I-10, Madison County, Florida; images recorded 19 October 2010 (UL) and 13 October 2011 (LR).**

Extent Locally abundant, mainly in moister areas beyond the 10-ft safety strip on north and south side

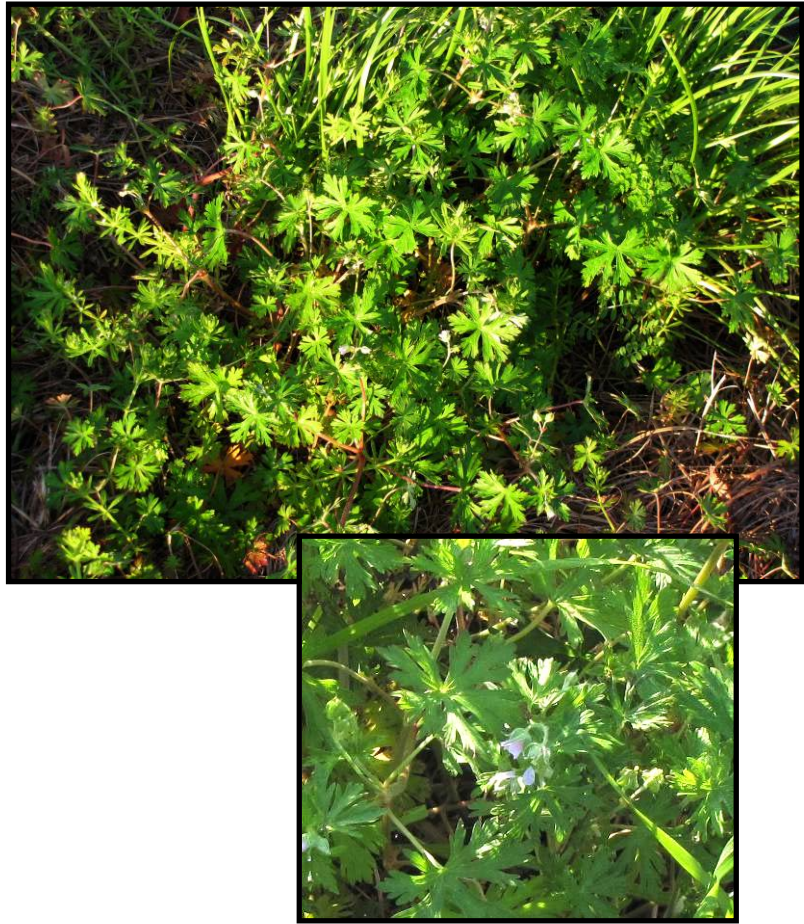
**Figure 15. *Geranium carolinianum*, I-10, Madison County, Florida; images recorded 19 March 2010.**

Extent        Widespread

Minimal aesthetic appeal, even in mass. Numerous small seedlings noted in 10-ft safety strip on south side ROW in October 2010.

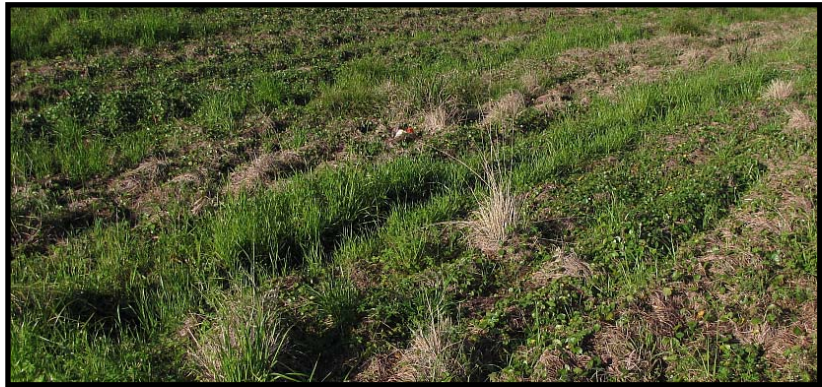
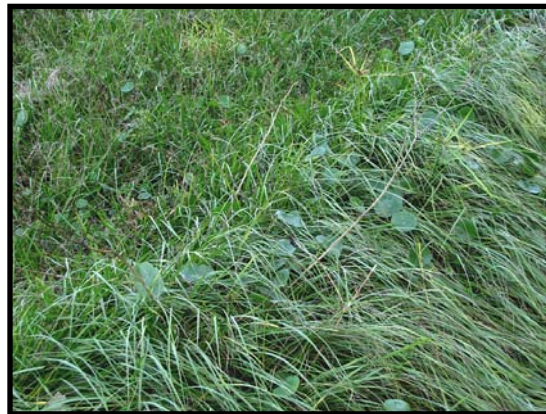
**Figure 16. *Hydrocotyle* sp., I-10, Madison County, Florida; images recorded 19 March 2010 (U) and 19 October 2010 (L).**

**Extent** Median (spring 2010): 1000-1500sq. ft, mainly in swale but also extending up slope, and much of it contiguous; median (fall 2010) – did not seem as extensive as in spring 2010; south side – occurred at a number of locations in fall 2010. Sporadic on north side in March 2011.

"... not a big issue unless it excludes the bahiagrass. ...some work with this weed a few years ago ... found it was most sensitive to clopyralid. But, I rarely recommend clopyralid and think that aminopyralid (Milestone VM\*) would probably be a better choice ". (Ferrell, 2009)

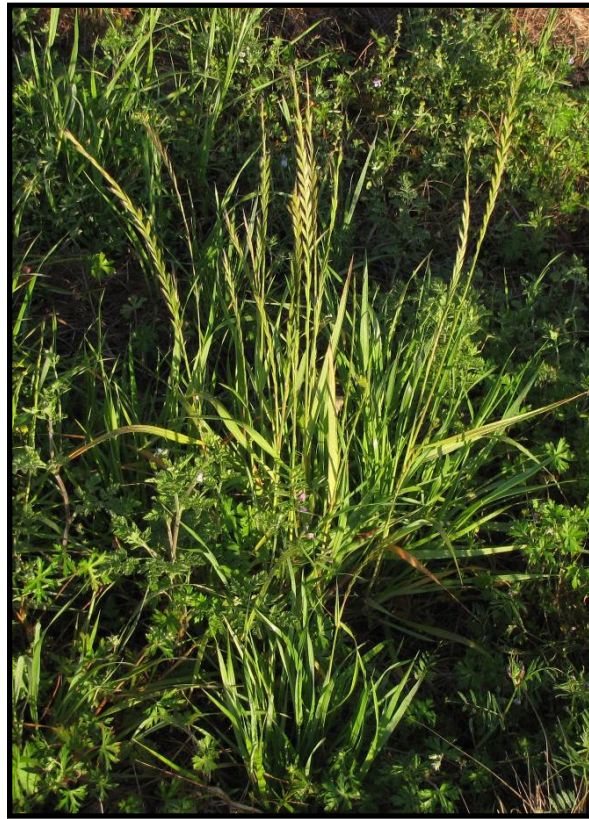
**Figure 17. *Lolium perenne*, I-10, Madison County, Florida; image recorded 19 March 2010.**

Extent            Widespread and locally abundant on north side and median.

“...can get really tall...and persist well into summer. This delays bahiagrass growth and will cause the bahia to thin.” (Ferrell, 2010a)  
Consider spring mowing to reduce competitiveness with bahiagrass.

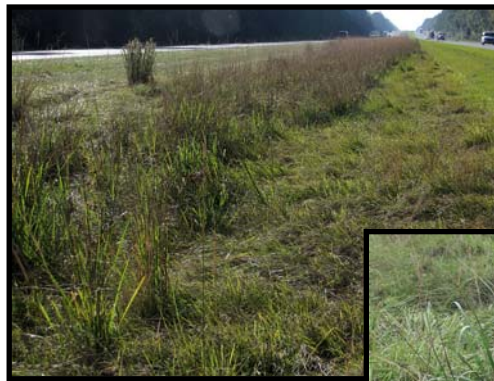
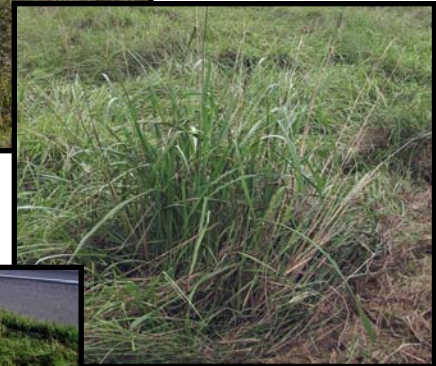
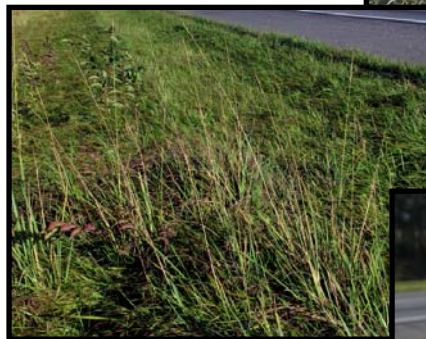
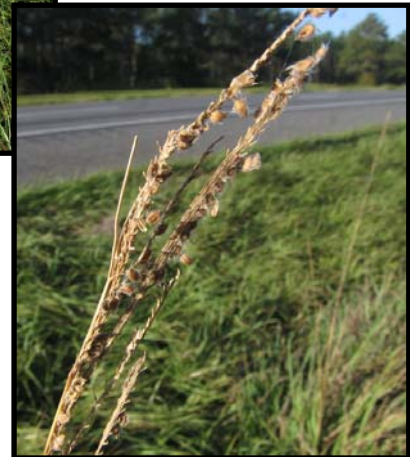
**Figure 18. *Paspalum urvillei*, I-10, Madison County, Florida; images recorded 8 October 2009 (UR), 19 October 2010 (UL), and 13 October 2011 (LL, LR).**

| Extent | Median: >1100 ft; mainly in swale; abundance gradually declines to none proceeding east, with increase in elevation and decrease in moisture. North side – in 2011, much more prevalent than previously thought. South side – locally abundant. |

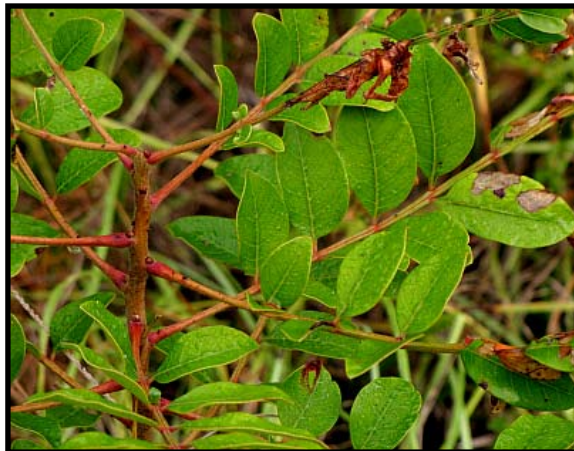
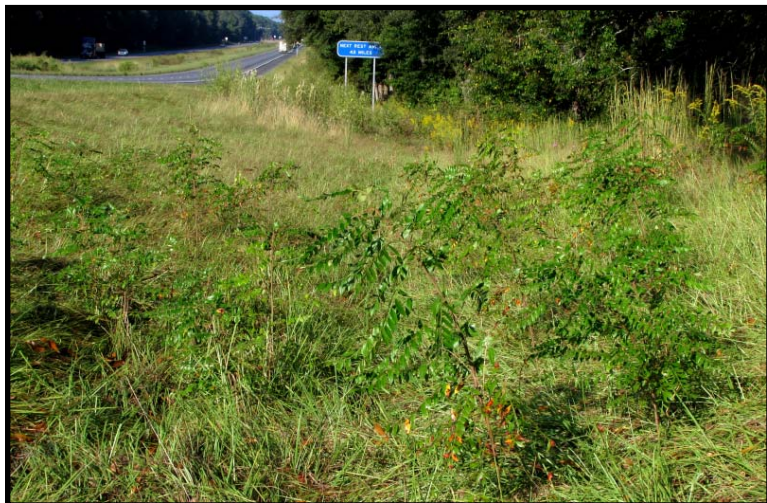
**Figure 19. *Rhus copallinum*, I-10, Madison County, Florida; images recorded 19 October 2010 (U) and 13 October 2011 (L).**

Extent Locally abundant on north side ROW beyond 10-ft safety strip, especially in eastern half of north side.

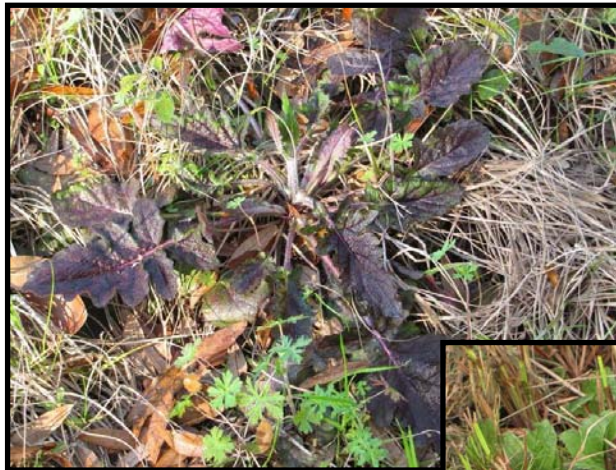
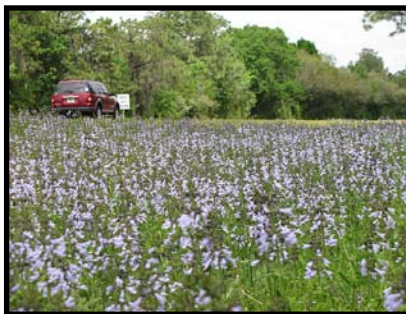
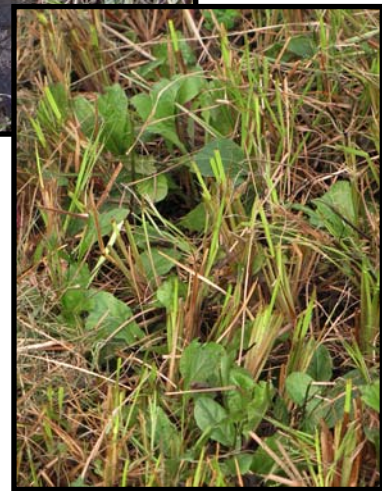
**Figure 20. *Salvia lyrata*, I-10, Madison County, Florida; images recorded 19 March 2010 (UL) and 8 October 2009 (LR). LL image recorded 13 April 2010, I-10, Suwannee County, Florida.**

Extent           Mainly occurred in two populations on south side ROW, and locally abundant on north side in western end. Overall abundance appears to have increased since March 2010.

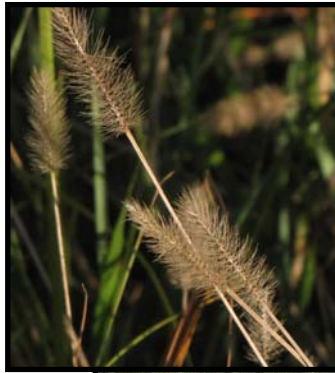
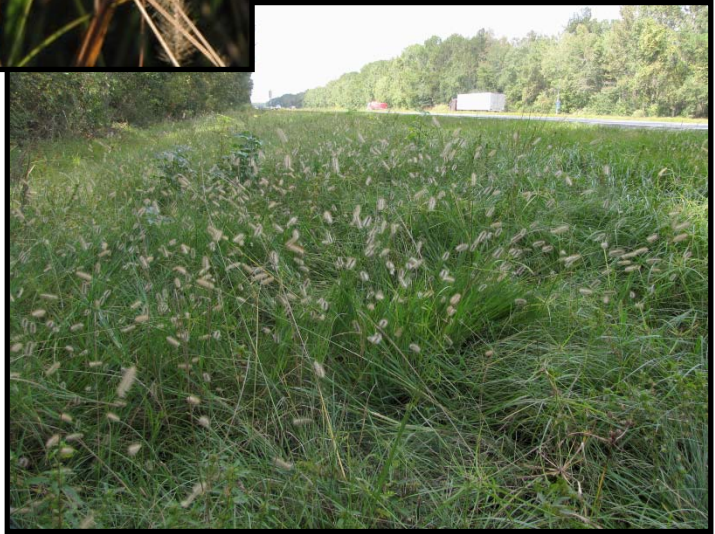
**Figure 21. *Setaria parviflora*, I-10, Madison County, Florida; images recorded 13 October 2011.**

Extent Locally abundant, mainly in moister areas.

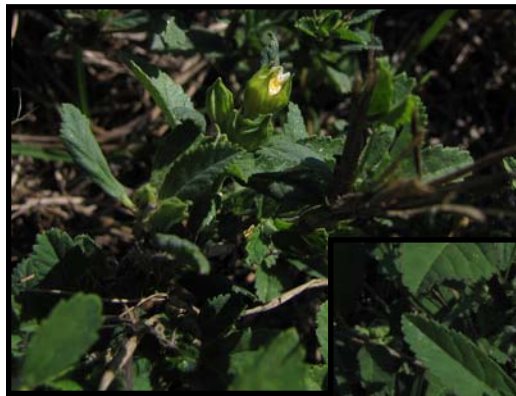
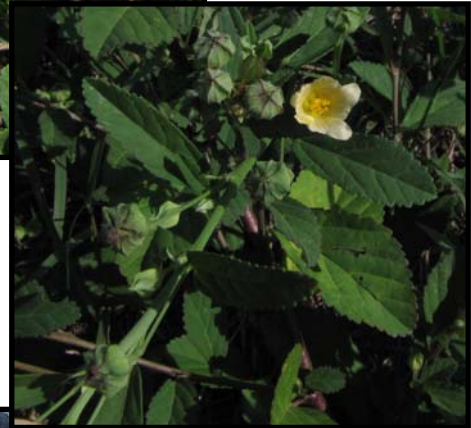
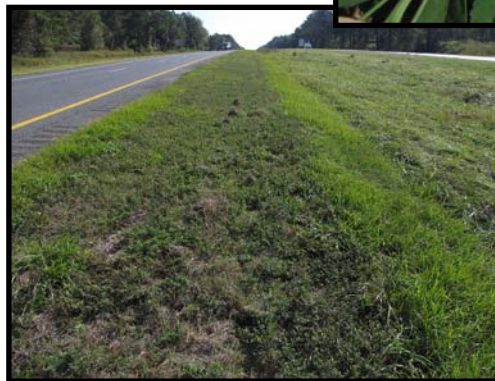
**Figure 22. *Sida* spp., I-10, Madison County, Florida; images recorded 19 October 2010 (UL, LL) and 13 October 2011 (MR).**

Extent            Mainly median, ~ 210 ft long x 7 wide; infrequent on north side ROW.

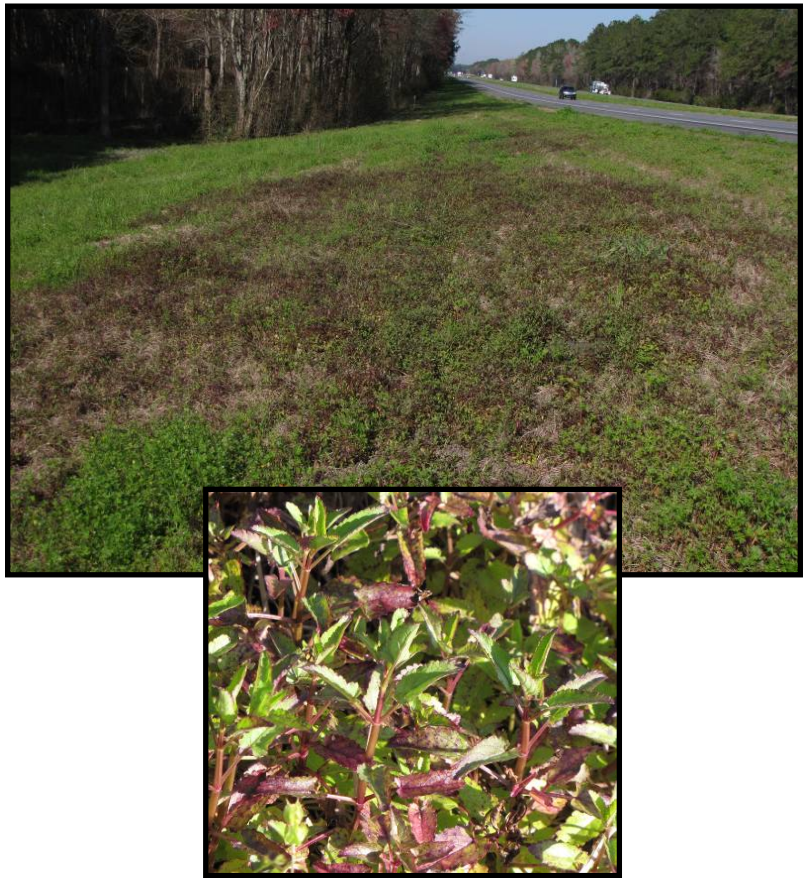
**Figure 23. *Stachys floridana*, I-10, Madison County, Florida; images recorded 19 March 2010.**

Extent      One south side population (500-600 ft<sup>2</sup>); locally abundant along woodland edge.

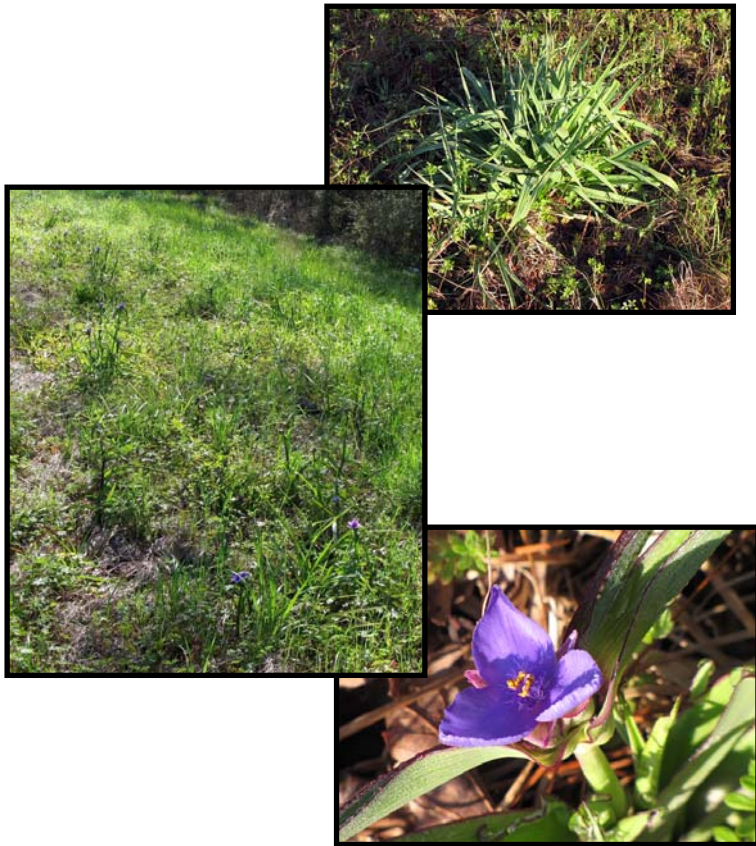
**Figure 24. *Tradescantia ohiensis*, I-10, Madison County, Florida; images recorded 19 March 2010.**

| Extent | Westbound; median – sporadic; eastbound – more widespread, with one small population; appears to be more individuals in March 2011 than March 2010. |

Avoiding mowing thru mid-May will enhance the aesthetic impact of *Tradescantia*; based on anecdotal evidence, such practices should be compatible with normal highway operations.

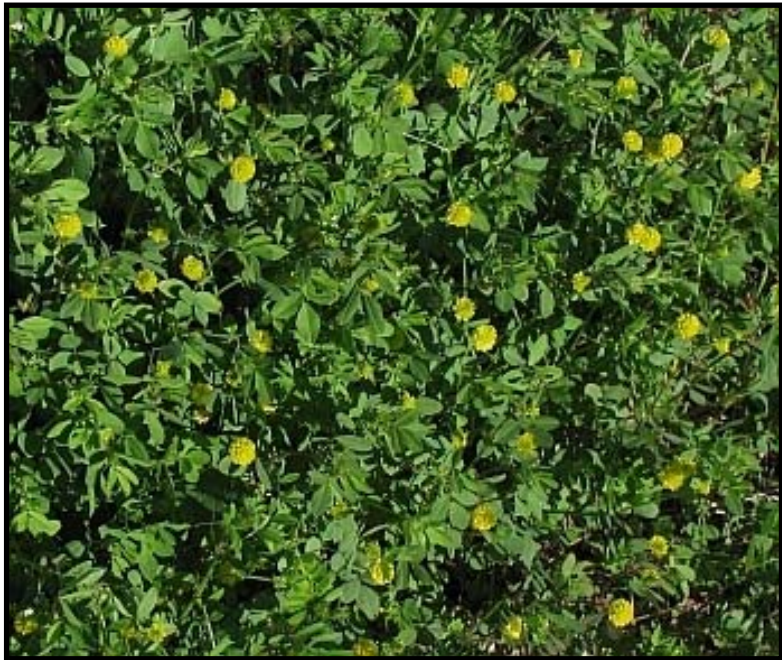
**Figure 26. *Trifolium campestre*, I-10, Madison County, Florida; image recorded 19 March 2010.**

Extent            Widespread and locally abundant in all areas in March 2011.

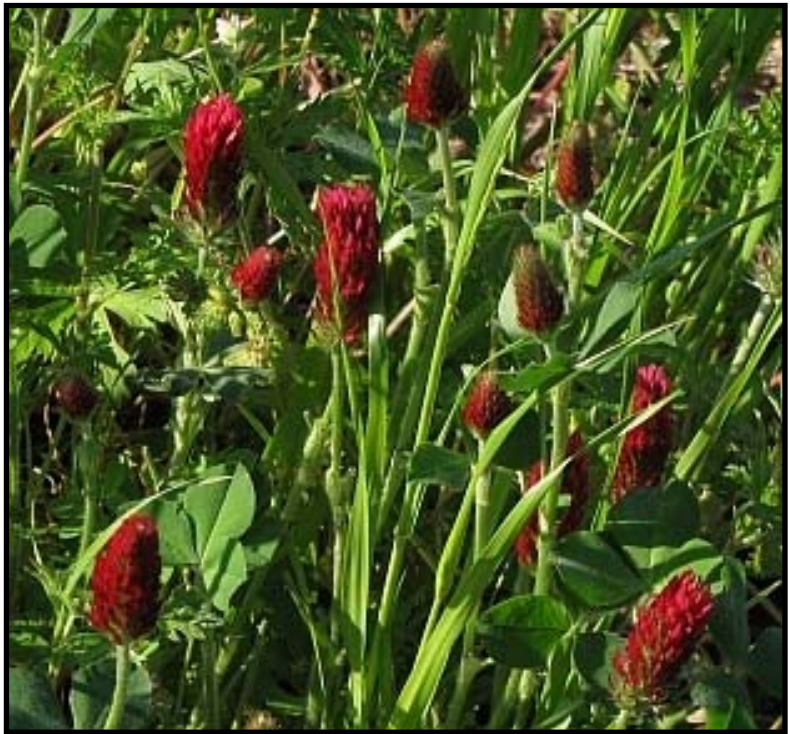
**Figure 27. *Trifolium incarnatum*, I-10, Madison County, Florida; image recorded 19 March 2010.**

Extent            March 2011 – Locally abundant on north side; occasional in median; sporadic on south side.

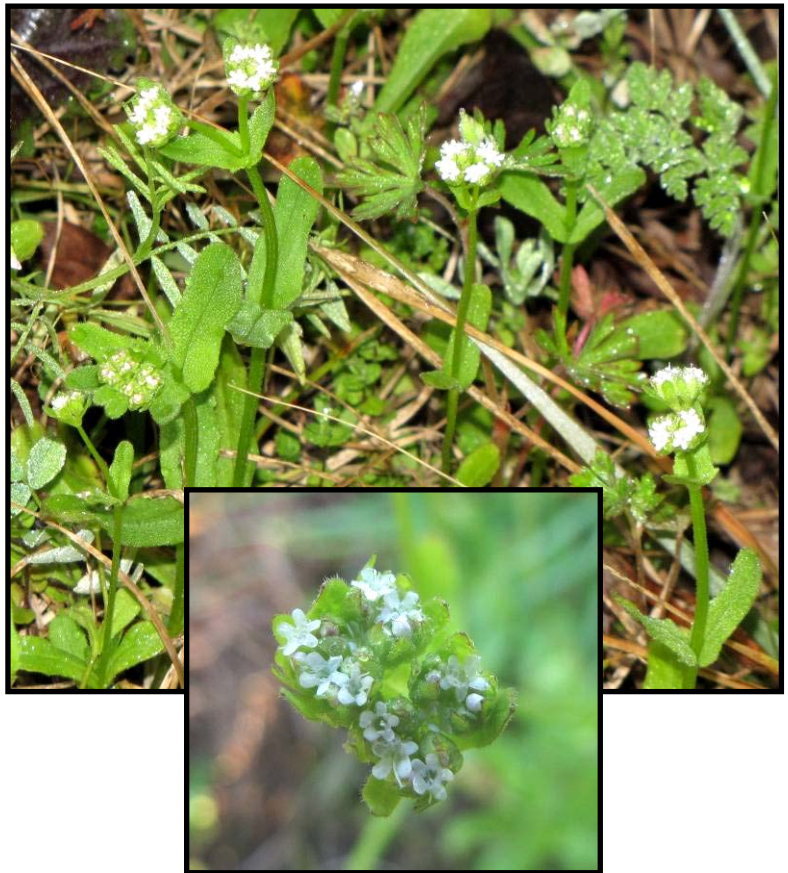
**Figure 28. *Valerianella radiata*, I-10, Madison County, Florida; images recorded 19 March 2010.**

Extent           Widespread and locally abundant but more so north and south side.

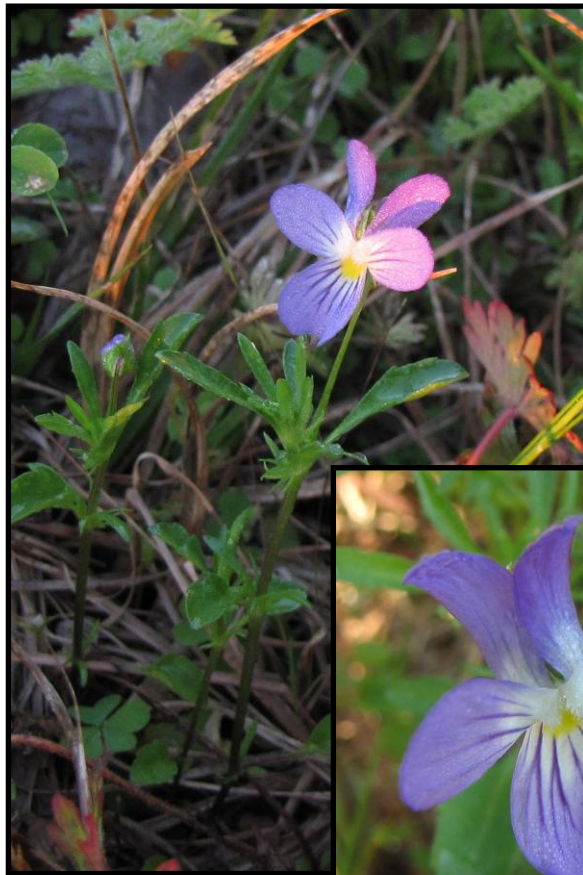
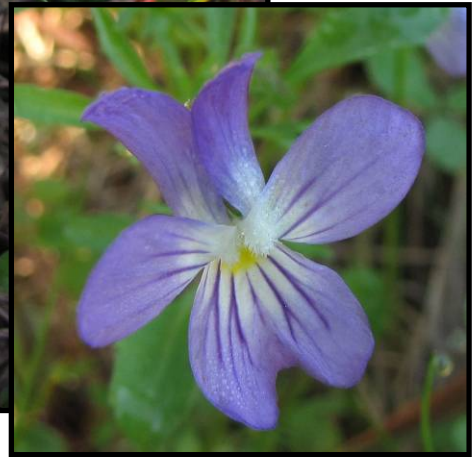
**Figure 29. *Viola bicolor*, I-10, Madison County, Florida; images recorded 19 March 2010.**

Extent           Locally abundant in a few locations.

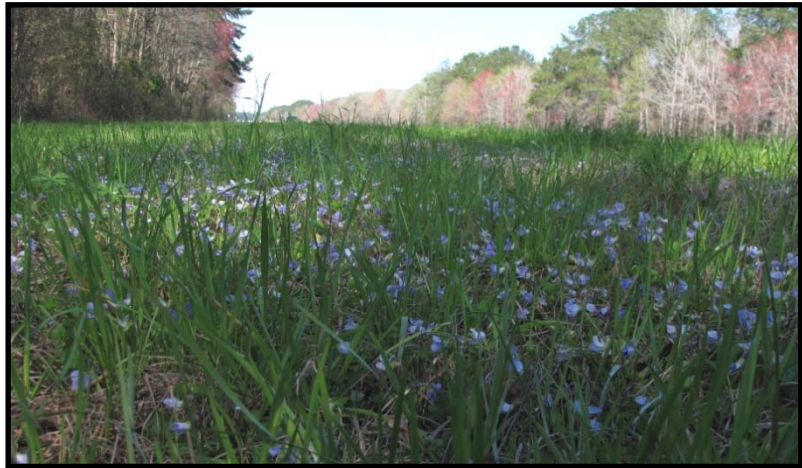
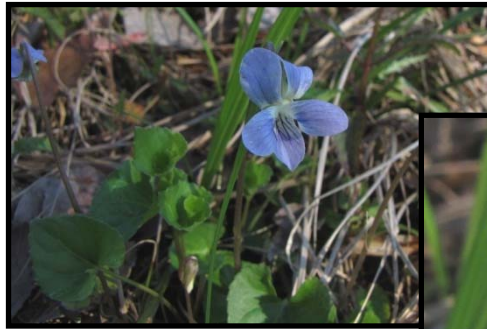
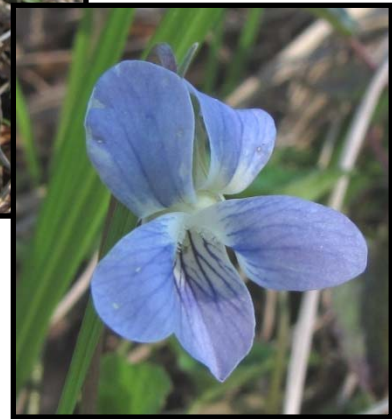
**Figure 30. *Viola sororia*, I-10, Madison County, Florida; images recorded 19 March 2010.**

Extent            Widespread and locally abundant, especially on south side.
