Progress Report 4

Time Dependent Load Response of Flexible Pipe Subjected to Sustained Loading

FDOT Contract No. BDK75 977-21

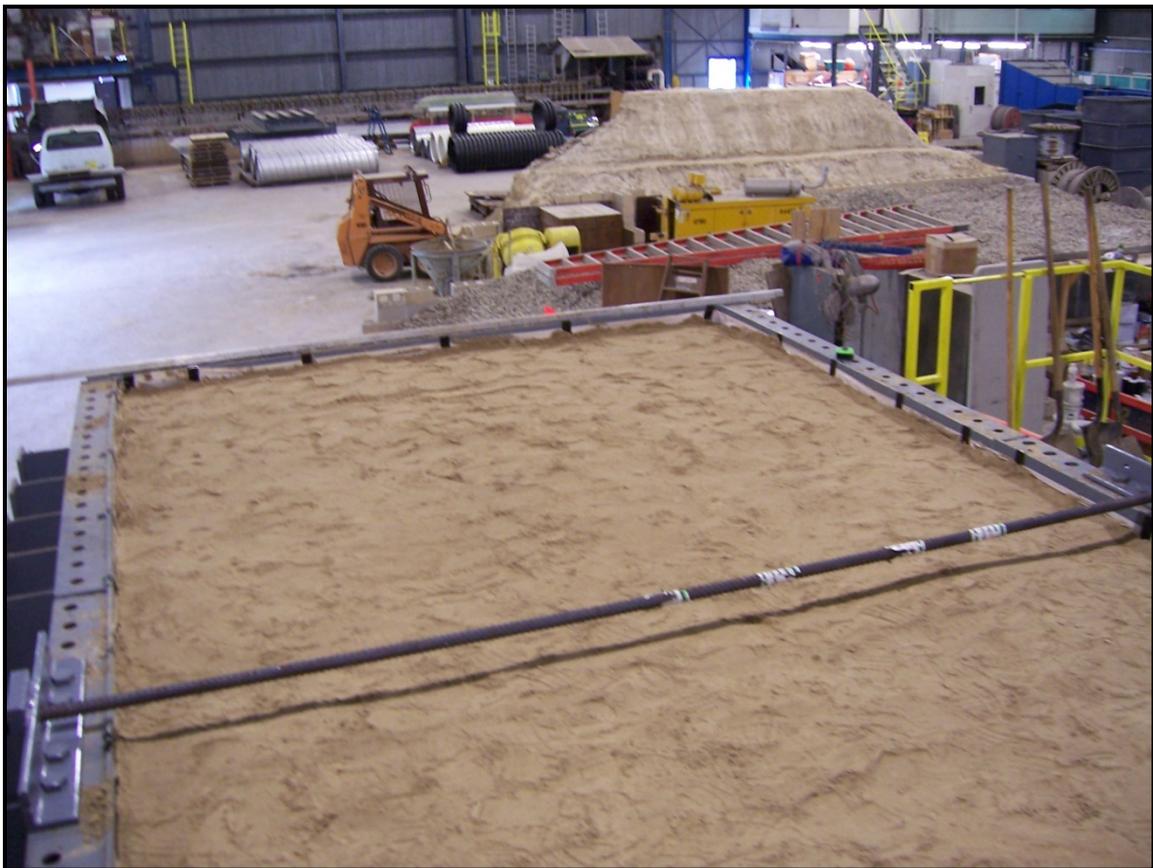
Figure 1: Final soil level in Soil Box.

This particular task followed a work sequence similar to that discussed in Progress Report 3 for preparation of the Soil Box. It was accomplished in a number of stages. First, four to six inches of soil were added to close the eventual gap between the bottom of the Soil Box top and the lift bags that would be placed on top of the load plates. The final soil level can be seen in Figure 1 below.

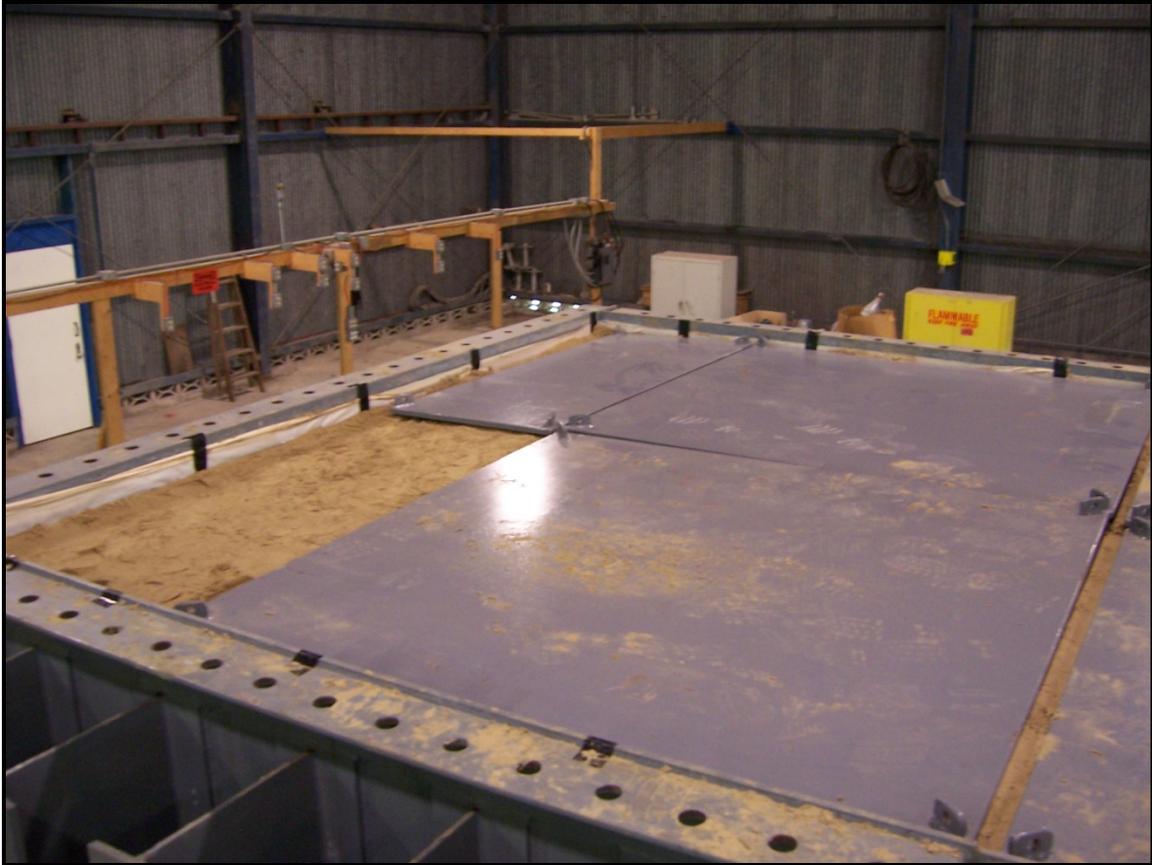
Figure 2: Load plates in the process of installation.

The next step was to install the load plates on top of the soil. The load plates were lifted individually and set in their appropriate locations. As per the AutoCAD drawings submitted with Progress Report 2, six five-foot by five-foot and four two-and-a-half-foot by five-foot load plates were installed. This step can be seen in Figure 2 below.

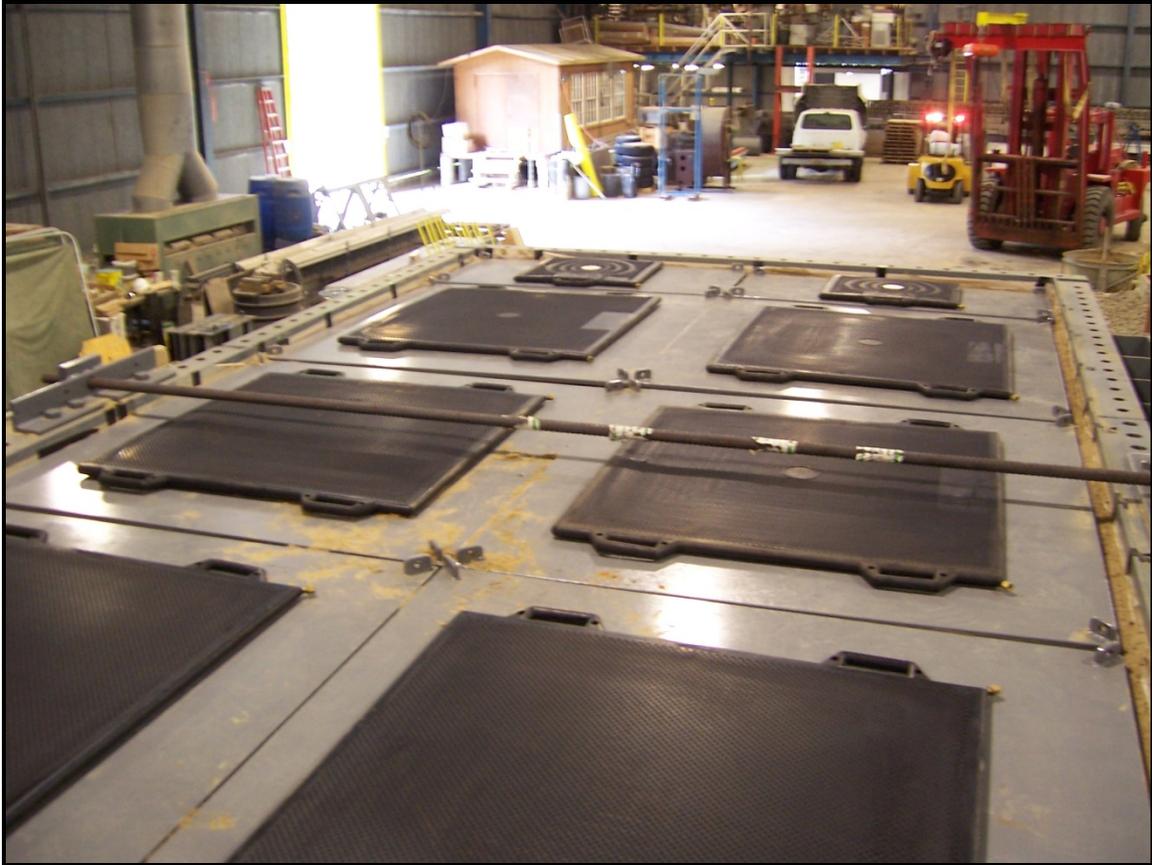
Figure 3: Lift bags after placement directly over center of the load plates.

After the load plates were successfully installed, the lift bags needed to be set in place. They were hoisted into place in the same manner as the load plates. See Figure 3 below. The smaller lift bags seen towards the end of the long dimension of the Soil Box are so sized to account for the smaller load plates. This is to avoid eccentric loading of the soil.

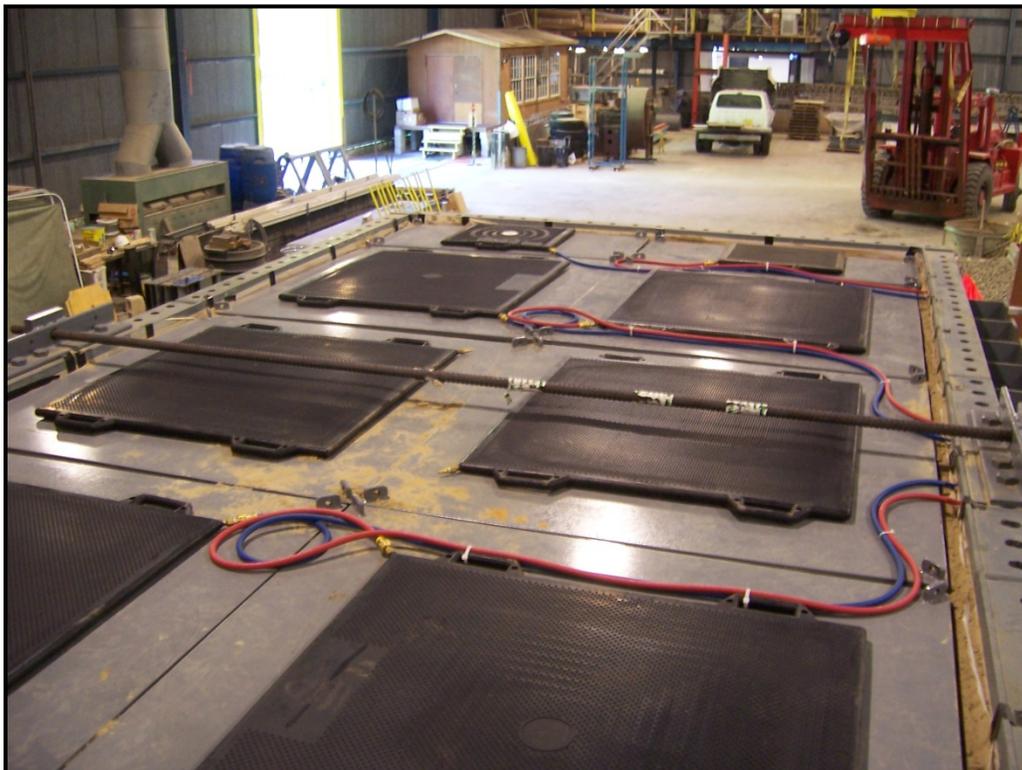
Figure 5: Air hoses connected to lift bags.

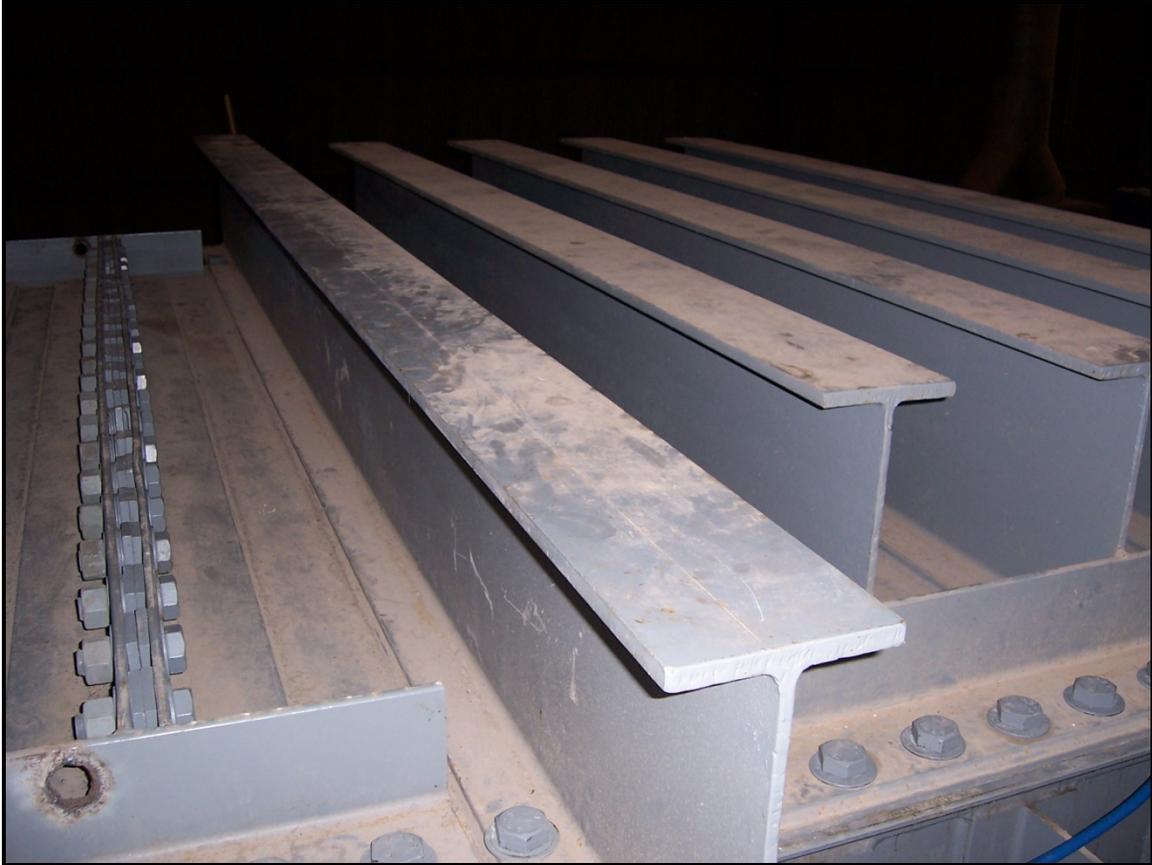
Figure 11: Completed installation of Soil Box top.

Once this was performed, the top could be properly put in place and fastened with all the necessary hardware, seen below in Figure 11. This was the last step in preparing the Soil Box itself for the first test.

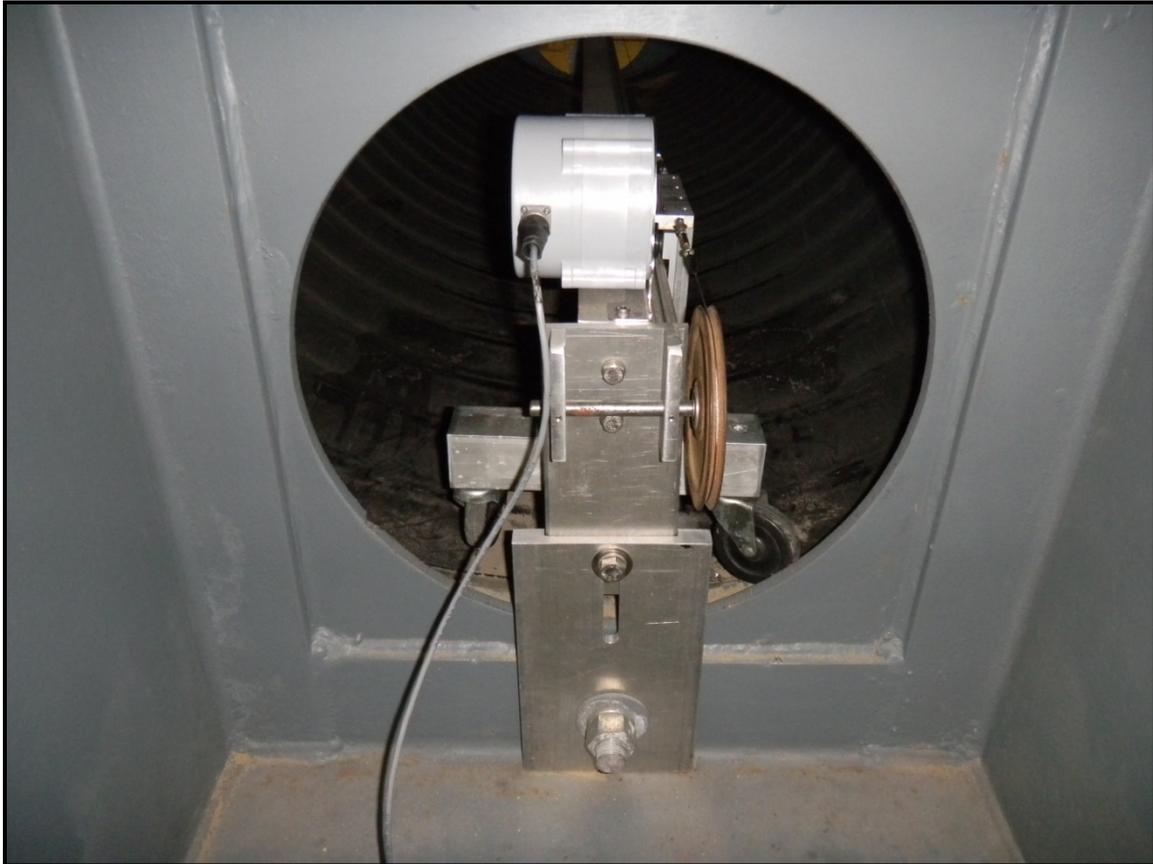
Figure 14: String potentiometer attached on the East end of the track.

Each pipe being tested has the setup shown in Figure 14 below. This makes the data acquisition process much quicker when compared to having to move the entire rig from one pipe to the other.

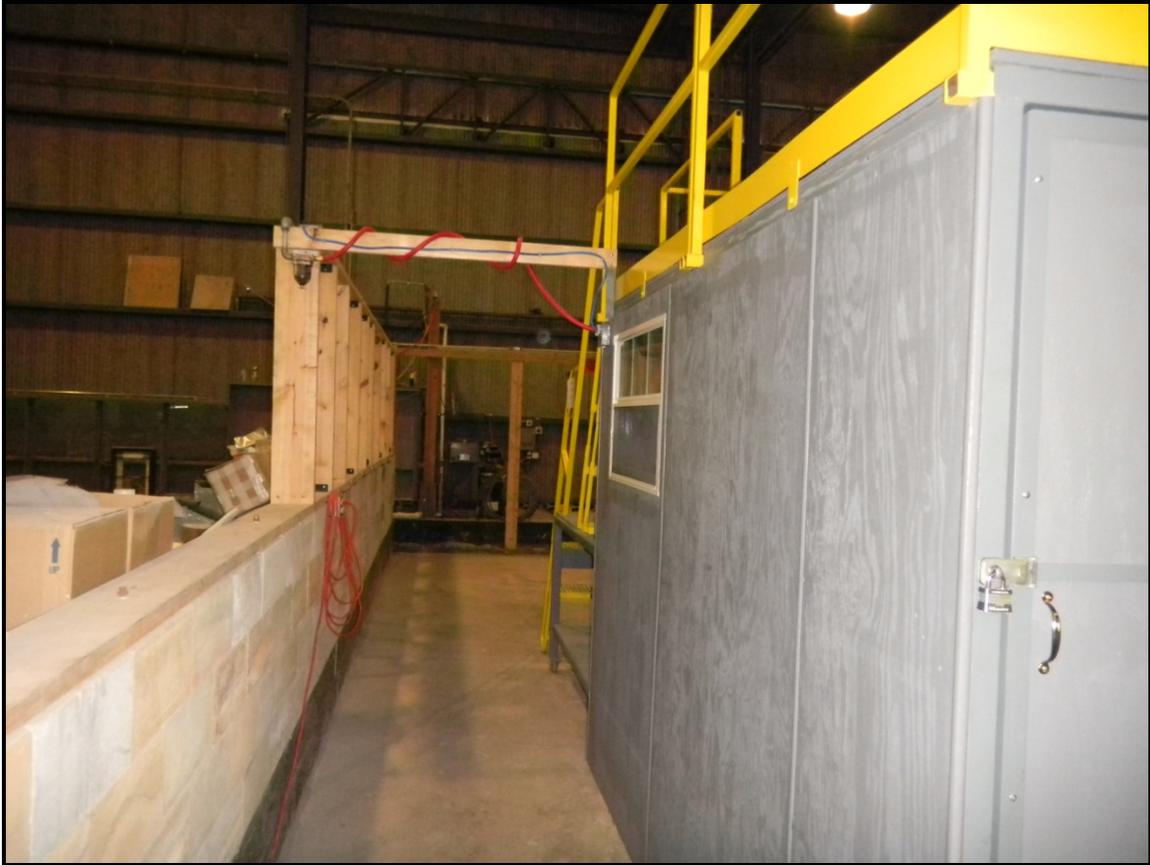
Figure 15: Completed exterior of instrumentation room.

The instrumentation room was required for protection of all data acquisition hardware and the various pieces of instrumentation. There is a window on the East face of the room to allow for air ventilation. It also provides ease of communication between the person operating the laser and the person sitting at the computer at which the data is collected. Exterior and interior views of the completed instrumentation room can be seen in Figures 15 and 16 below.

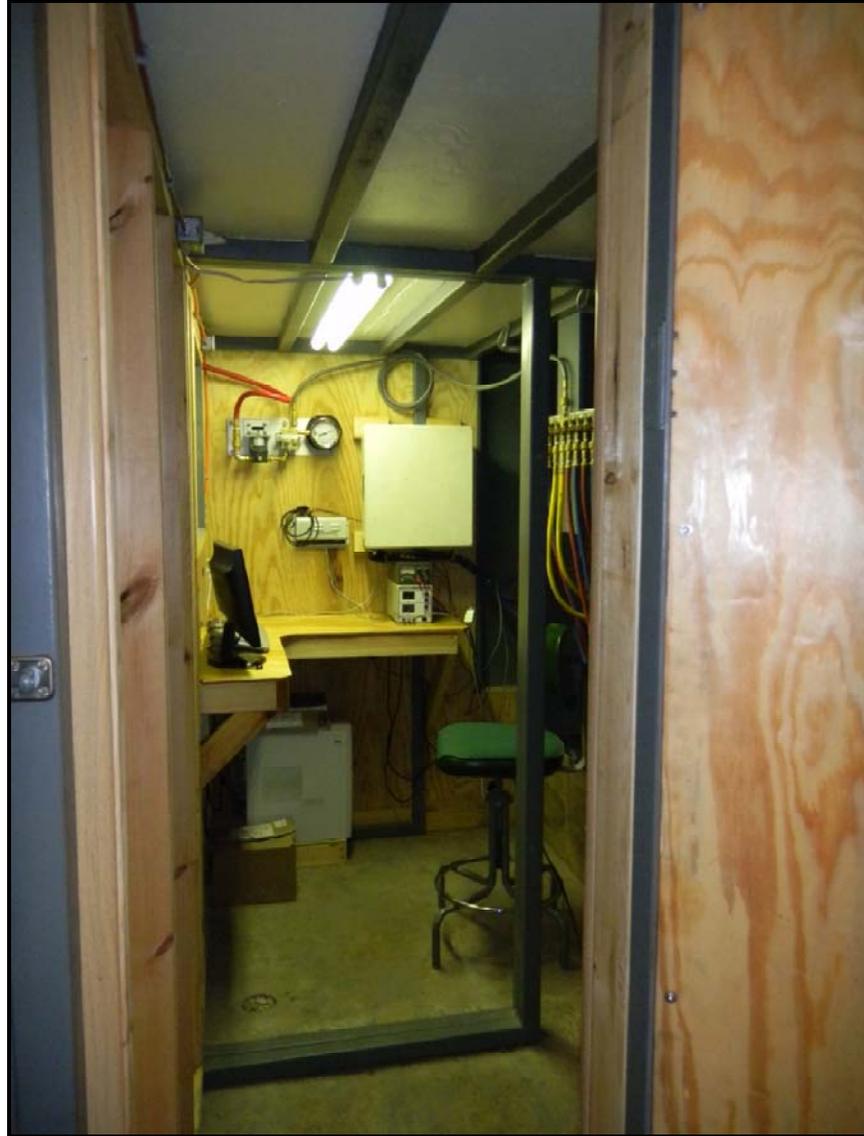
Figure 16: Completed interior of instrumentation room.

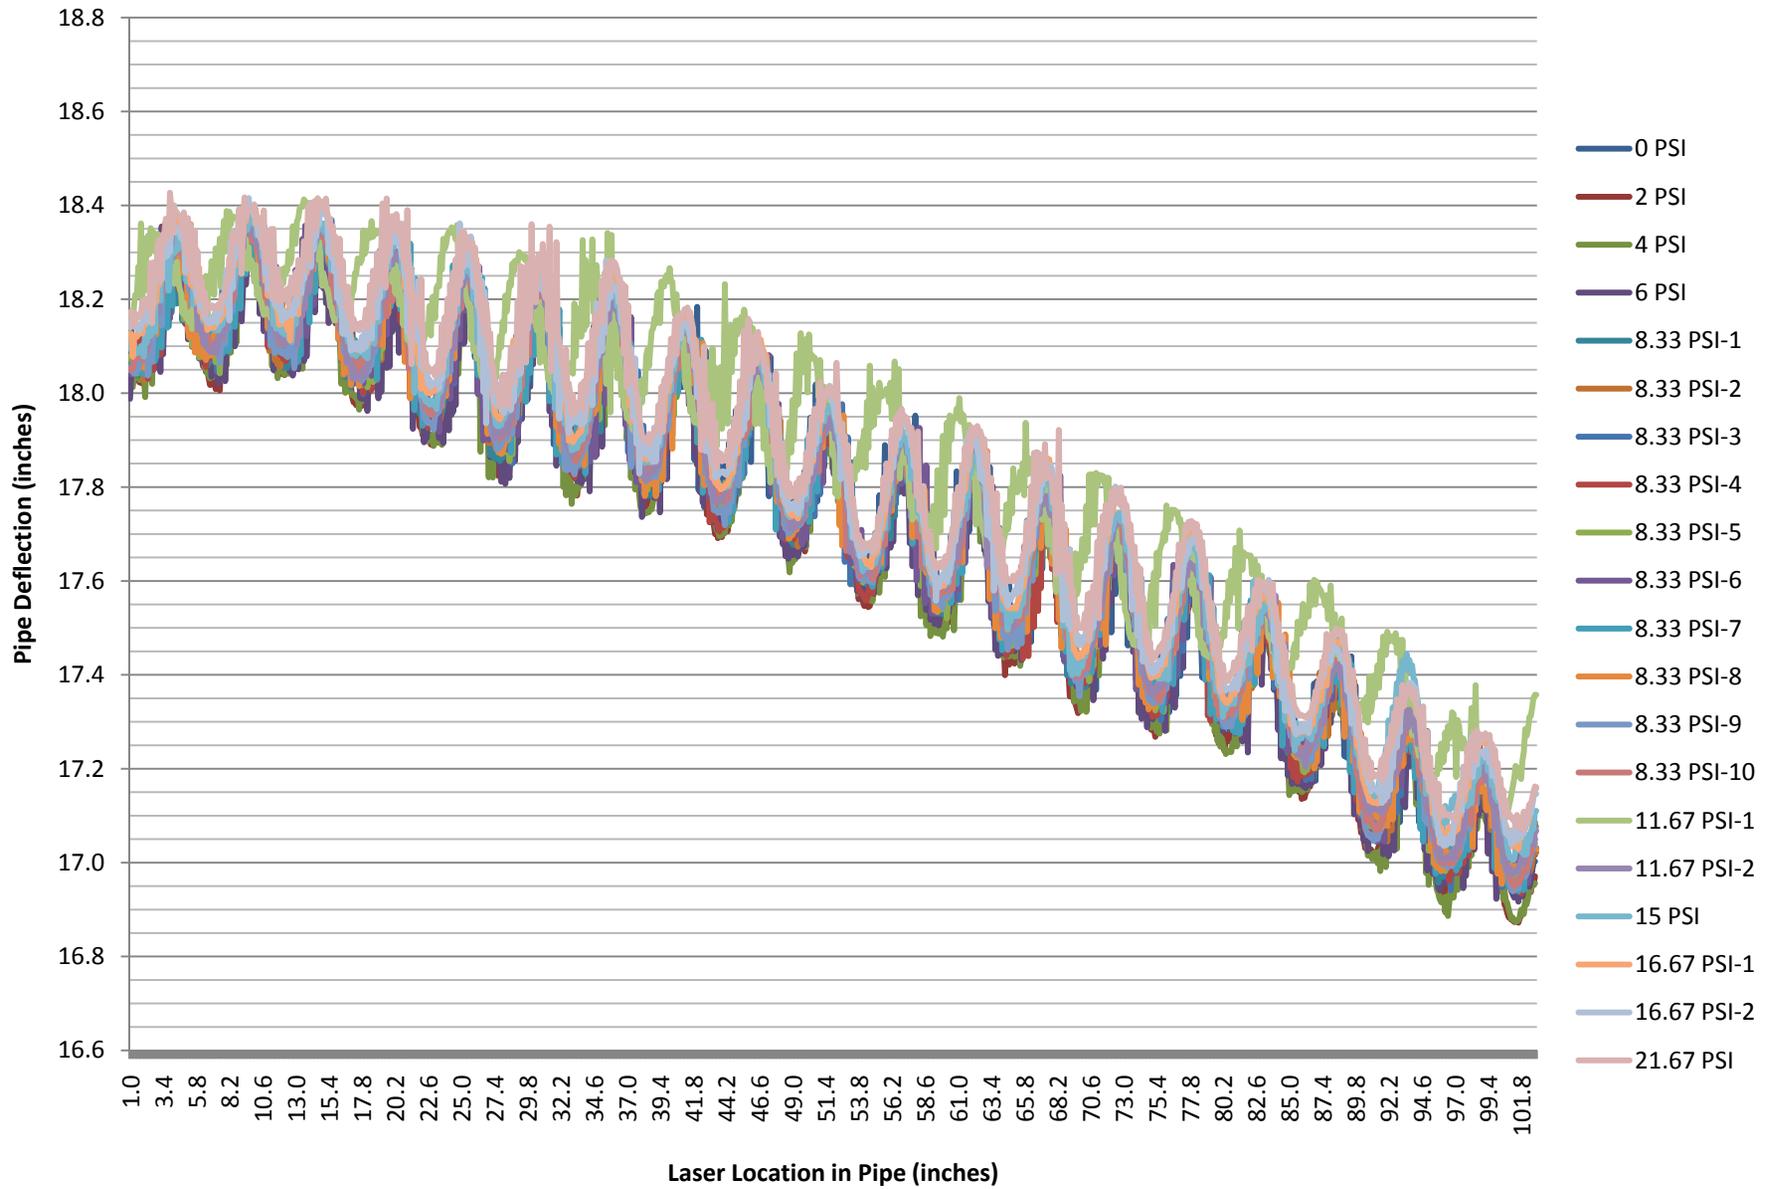
Figure P: HDPE 36" South End Quadrant 3 Profile

Of special note are Figures K through P in *Appendix D*. These figures show the deflection measurement of each pipe quadrant, except for the bottom, plotted against the length dimension of the pipes for the pressures being applied during this quarter. There are noticeable changes in the plots as the pressure is increased. However, the deflections from the zero readings are not actually that large. This fact is what first sparked doubts regarding the actual pressure being applied in the soil. The graphic in Figure 19 below shows the quadrant orientations when looking from the East end of the pipe to the West end. Therefore, Quadrant
