Final Report FDOT Project BD521-02

# Performance Assessment of Portland Cement Pervious Pavement

## Report 4 of 4: Performance Assessment of a Pervious Concrete Pavement Used as a Shoulder for an Interstate Rest Area Parking Lot

June 2007

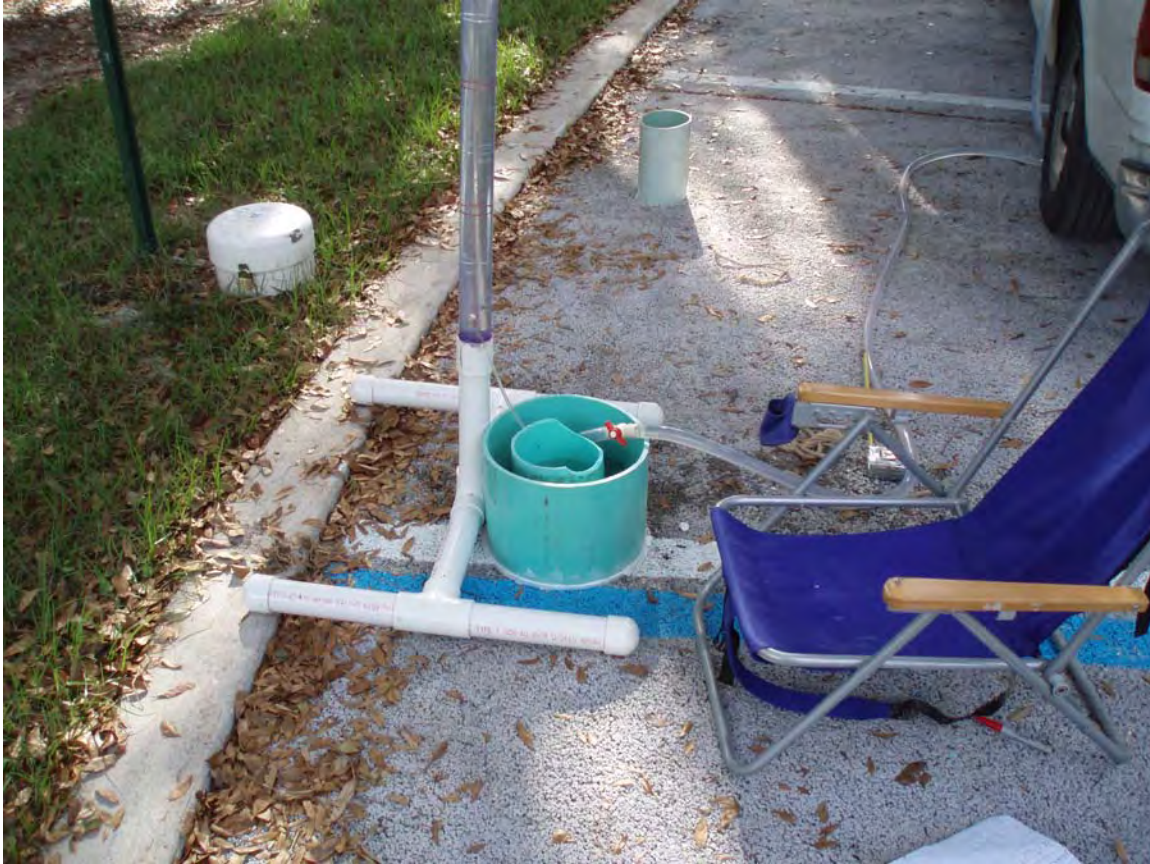
The ERIK consists of inner embedded 6 inch diameter pipe, an outer embedded 12 inch diameter pipe, a 2 inch ID graduated “reservoir” cylinder with red marks indicating every inch drop in water level within the embedded ring, and a timing device with a recording pad. The complete set up is shown in Figure 4. On the present model, there are two manually adjusting valves located near the bottom to control flow of water out of the reservoir cylinder. A 6 inch and 12 inch ID PVC pipe are included for the embedment and testing applications. (Note: The 9 inch drop in the reservoir pipe will equal a 1 inch drop in the 6 inch inner testing infiltrometer pipe)

**Figure 4 - Embedded Ring Infiltrometer Kit Showing On-Site Measurement**

1. Place the inner (six (6) inch pipe) and the outer (nine (9) inch pipe) on the top of the embedded pipes.
2. Apply bead of silicone caulking around bottom of 6 inch and 9 inch test pipes.
3. Allow time for drying or about 15 minutes with the silicone used.
4. Fill rings with water until saturation is reached and check for side leakage
5. Using tape measure, pour water until desired head is reached and mark inside wall of the inner pipe with permanent marker
6. Adjust valves on reservoir to keep a constant head desired in the inner pipe
7. Record time it takes for water level to drop to each marked interval

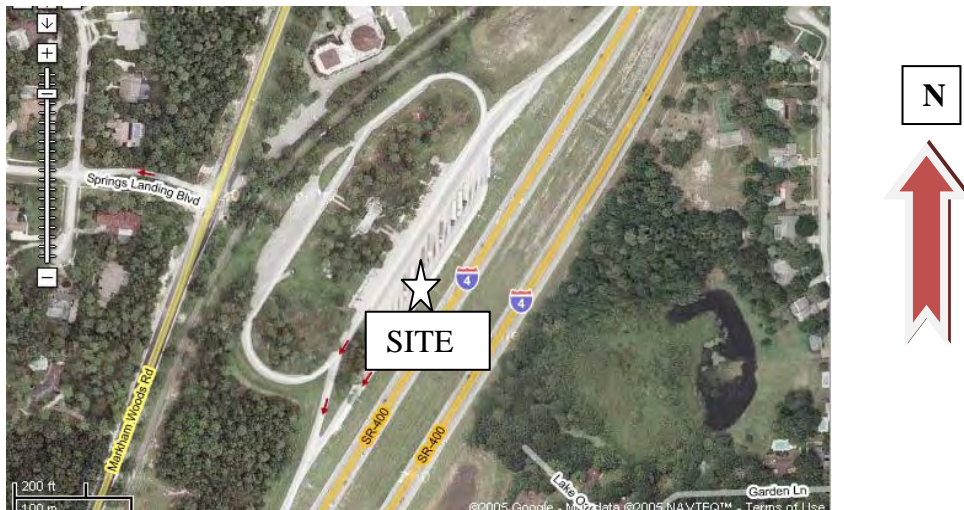
An interstate rest area was selected because the watershed had a length of flow equal to 100 feet and the slope (about 5%) was toward the shoulder area. The shoulder area was constructed at a standard width of 10 feet and was 90 feet long. The area is along Interstate 4 in central Florida (Figure 5). Also, there was on site evidence that the runoff water was eroding the loose shoulder materials and traffic was using the shoulder area for parking.

**Figure 5 - Site Map for Pervious Concrete Shoulder**

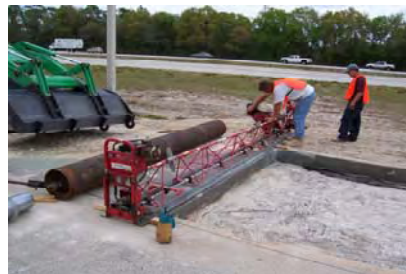
The placement and finishing techniques for pervious concrete are different from regular concrete. The equipment used for the shoulder pour is shown in Figure 6.

- A. BACK HOE (lifting)
- B. STEEL ROLLER (compaction)
- C. GROOVER (controlled expansion joints)
- D. VIBRATORY POWER SCREEDER (to "Strike-off" and remove excess concrete)
- E. LUBRICANT (keeps tools clean "a clean tool is a happy tool")

**Figure 6 - Pervious Concrete Equipment Used**

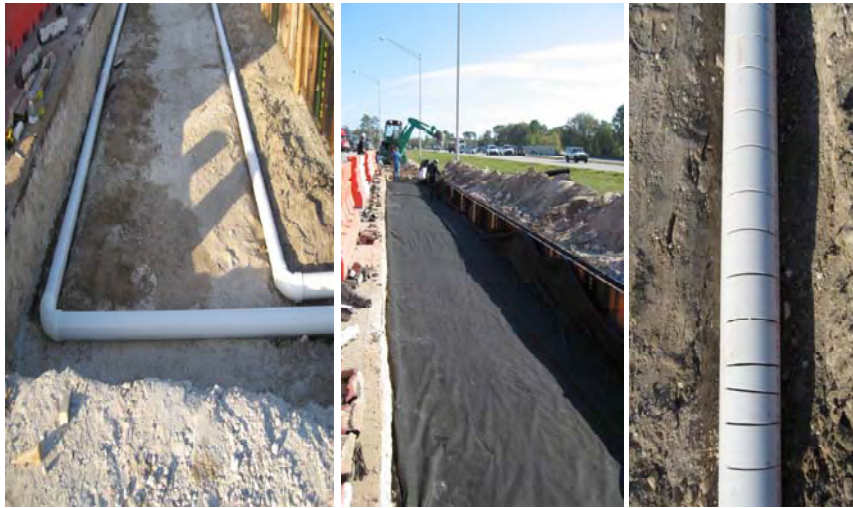
Since the rest area parking does contribute runoff volume to the shoulder area, two collection slotted pipes were placed at the bottom of the reservoir (22 inches below grade) to document the runoff volume and to provide storage for water quality analyses (see Figure 7). A section is shown in Figure 8. The first pipe was located at the edge of the parking area, and the second one seven feet from the parking area edge. The volume of water collected from the edge pipe was at least fifty times greater than that collected from the pipe seven feet from the edge. There was no visible water collected at the edge of the pervious concrete shoulder for the rainfall conditions experience over the one year of measurement (June 2006 – June 2007). The rainfall in this time period was approximately 44 inches. The normal rainfall for the same period is approximately 49 inches. It is estimated that the pervious concrete has infiltrated almost all of the water that was transported to it and all of the rainfall on it.

Adjacent to existing pave  
And 7 feet from edge of pave

Separation  
Fabric

Slotted pipe to collect  
Infiltrated water

**Figure 7 - Installation of Collection Pipes for Water Volume and Quality**

Water samples were collected from the two slotted sampling pipes at the bottom of the reservoir; one at the edge of pave and the other seven feet from the edge of pavement. Eighteen runoff events were monitored. Not all rainfall events produced runoff to the sampling pipes. A maximum of 53 samples were analyzed from the pipe adjacent to the existing pavement and a minimum of 30 samples from the pipe seven feet from the edge of pavement, because of a lack of water in the pipe seven feet from the edge of pavement. All the data are shown in Appendix A. Table 1 shows the statistical data for all events.
