2006 Interim Design Standard

TEMPORARY DETOUR BRIDGE DETAILS
TIMBER PILE FOUNDATIONS

Interim Date	Sheet No.
07/01/06	1 of 3
Index No.	
21610

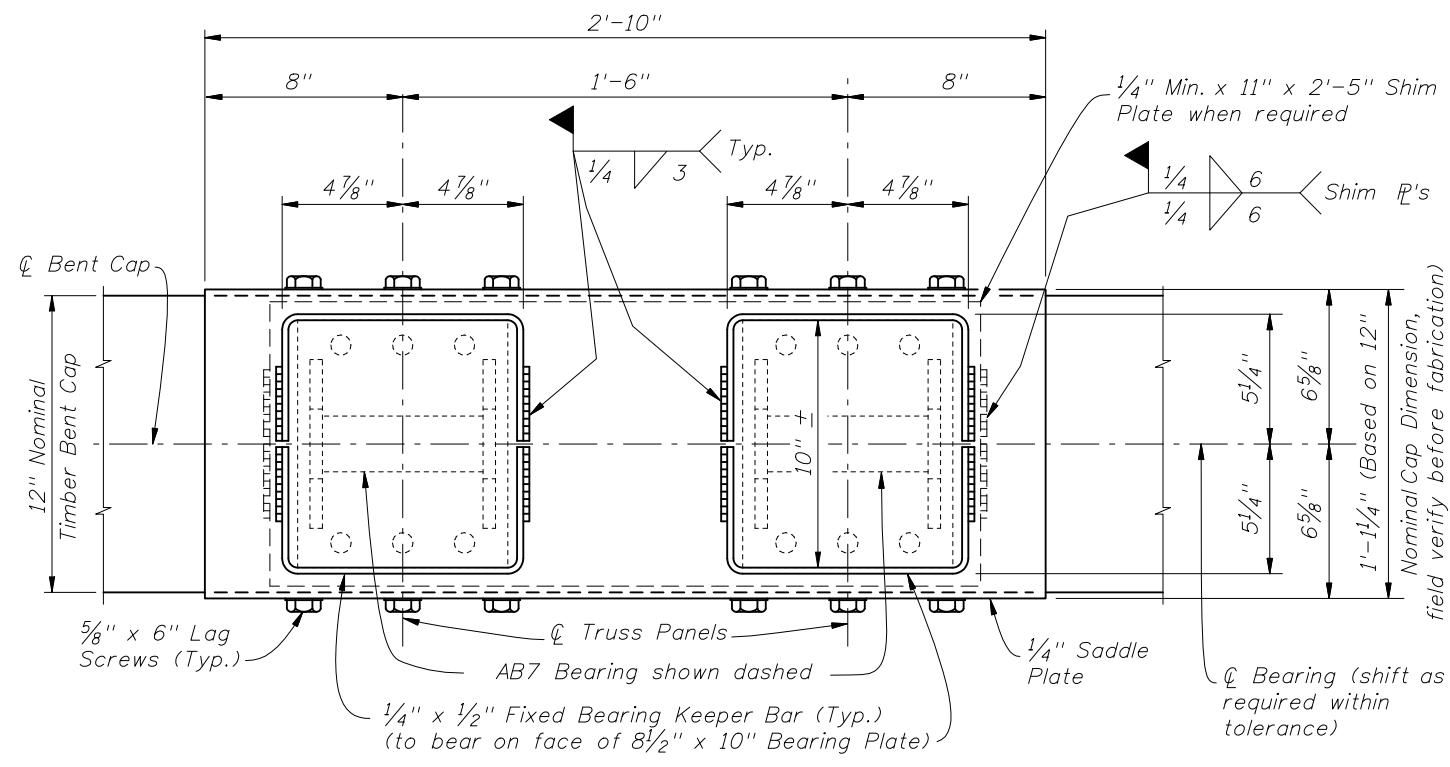
FIXED BEARING DETAILS

PLAN VIEW

ELEVATION VIEW OF SADDLE PLATE

END VIEW

FIXED BEARING KEEPER BAR DETAIL
