DRAFT
CONTAMINATION SCREENING EVALUATION REPORT

SR 5/ US 1 at Aviation Boulevard

Project Development & Environment (PD&E) Study

Contamination Screening Evaluation Report

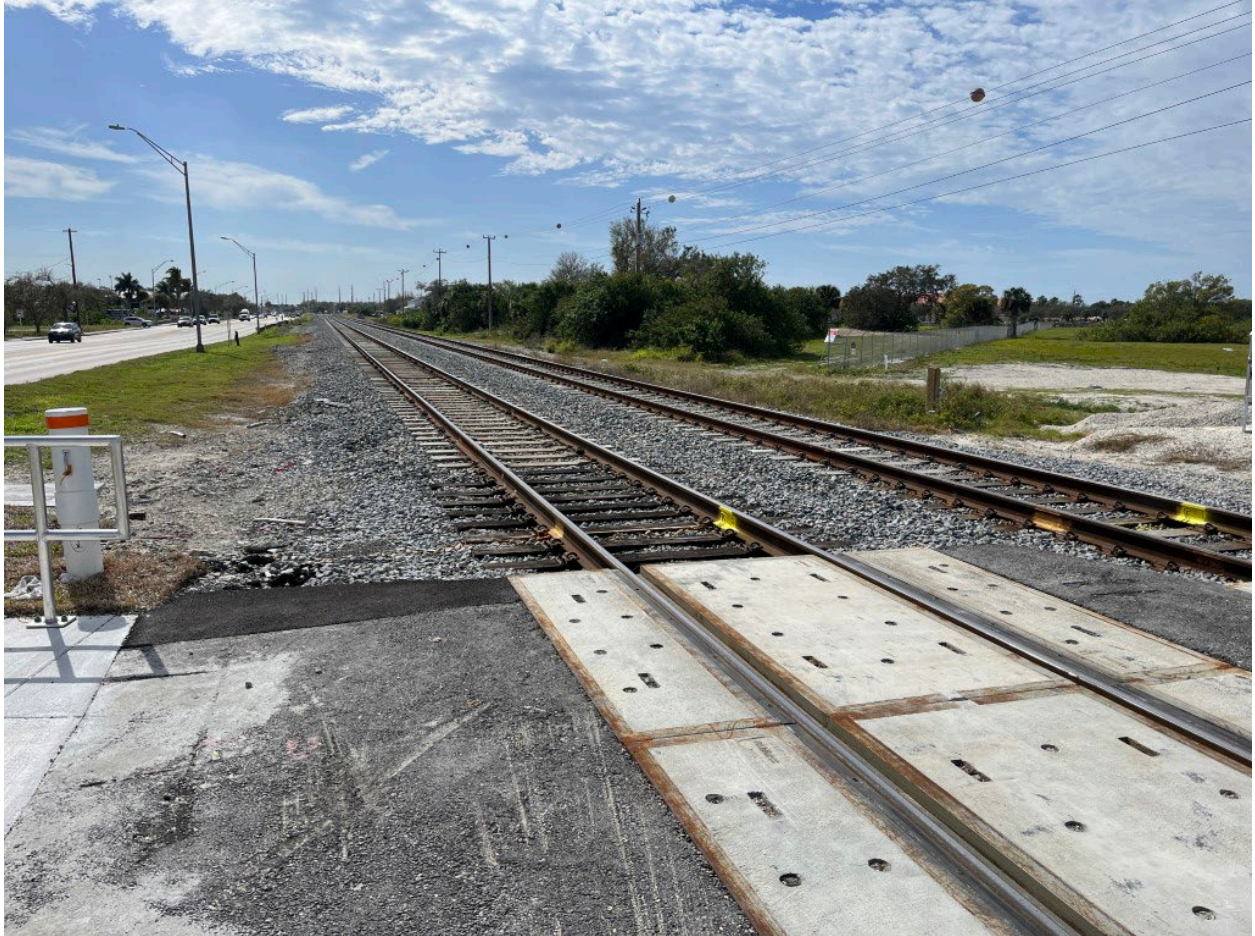
Photo 1. Map ID #1. FEC Railroad. Aviation Blvd crossing. Photo date 2/13/2024. View to south.

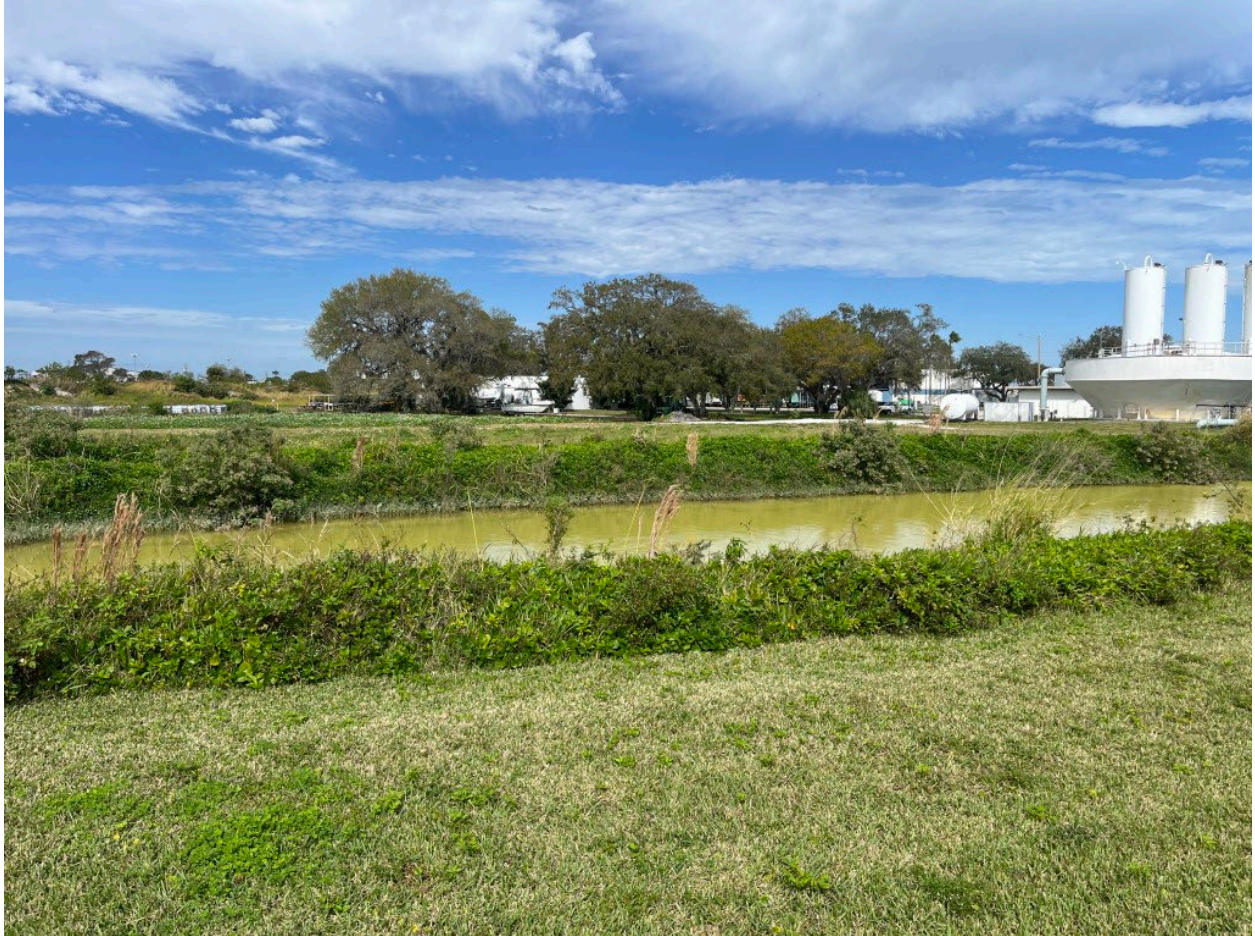
- Vero Beach Water Treatment Plant (Map ID #2)
 - There have been one or more ponds or ditches along Aviation Boulevard that have received effluent including spent lime sludge from the City's water treatment plant.

Photo 2. Map ID #2. Vero Beach Water Treatment Plant. Effluent pond receives spent lime sludge from the City's water treatment plant. Photo date 2/13/2024. View to north.

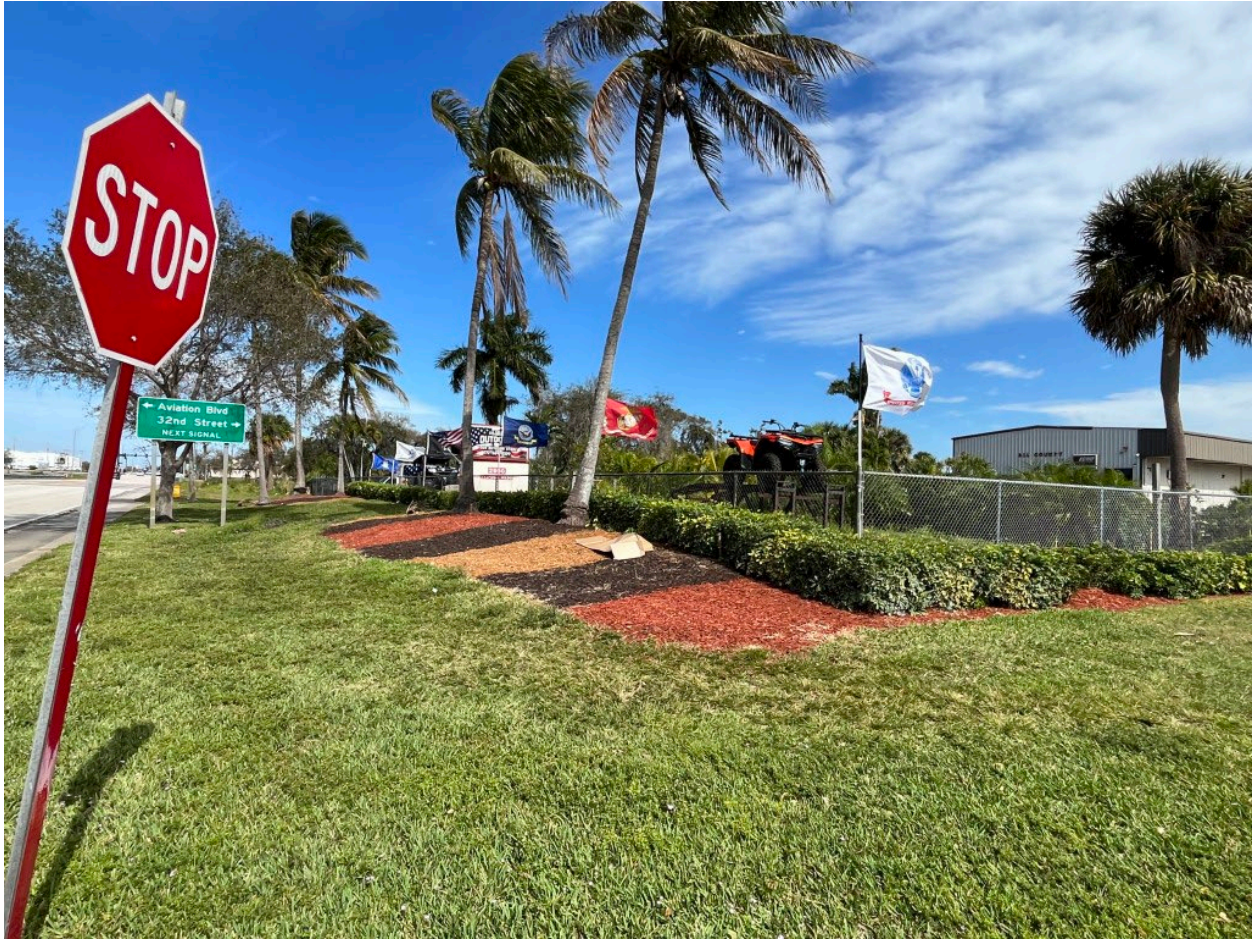
- Sullivan Property (Map ID #3)
 - Two underground storage tanks (USTs) were removed circa 1998 but no tank closure report with confirmatory soil or groundwater sampling was found.

Photo 3. Map ID #3. Sullivan Property. Location of former USTs; now a plant nursery. Photo date 2/13/2024. View to north.

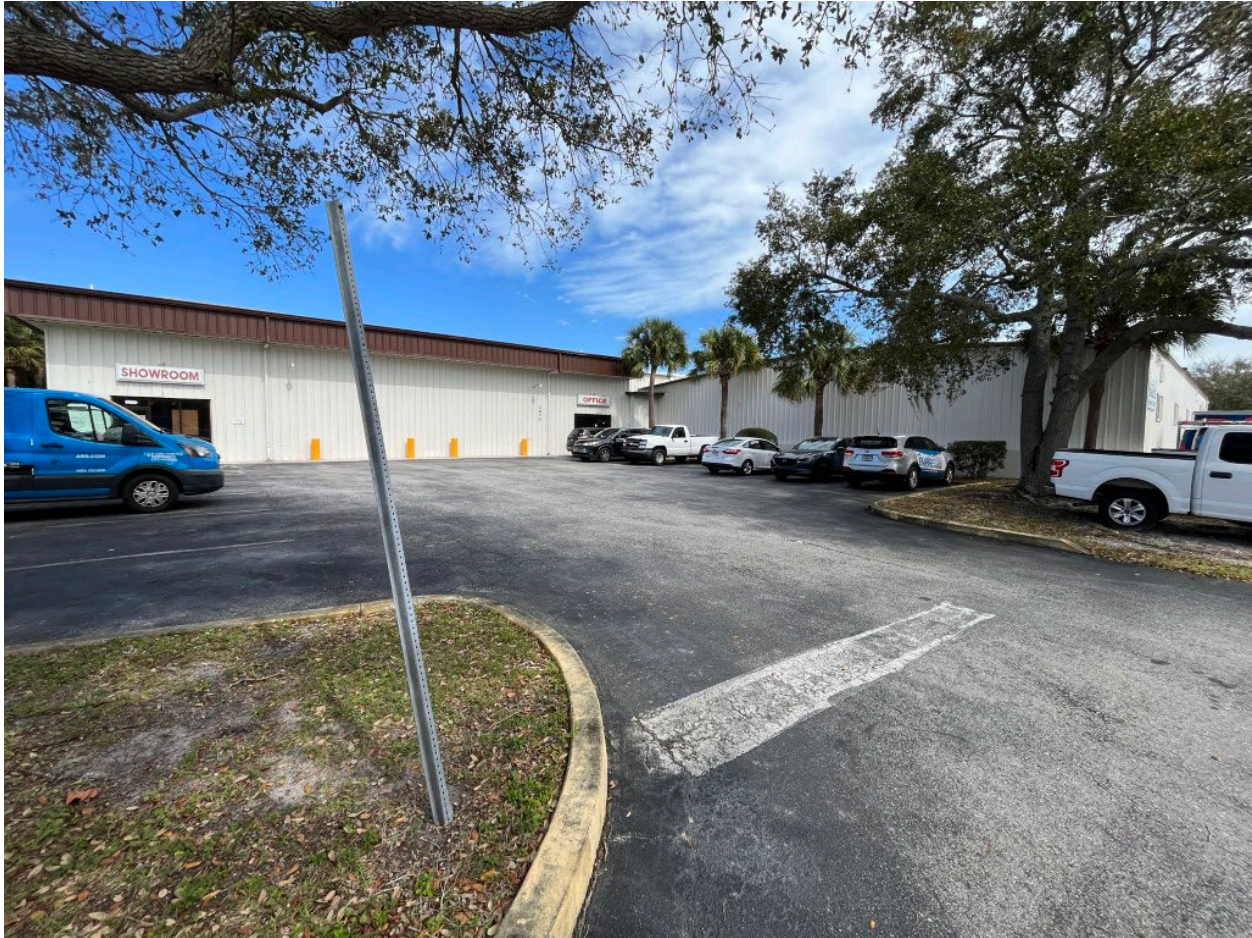
Photo 4. Map ID #4. Graves W C JR-Indian River Associates. Location of former USTs. Photo date 2/13/2024. View to north.

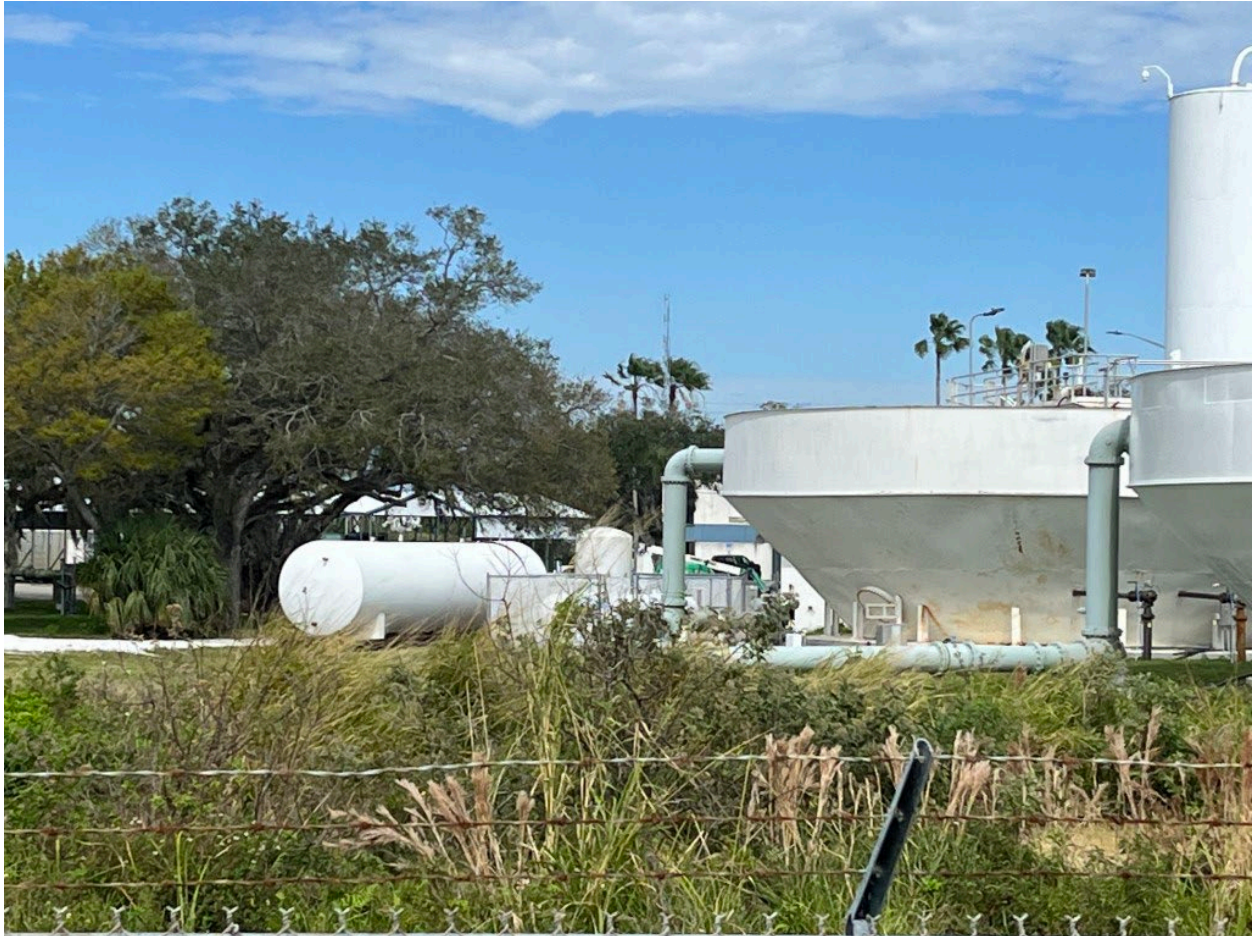
Photo 5. Map ID #5. Vero Beach City – WTP. The water treatment plant currently has at least three ASTs for fuel – the fuel ASTs are not visible in this photograph. Photo date 2/13/2024. View to north.

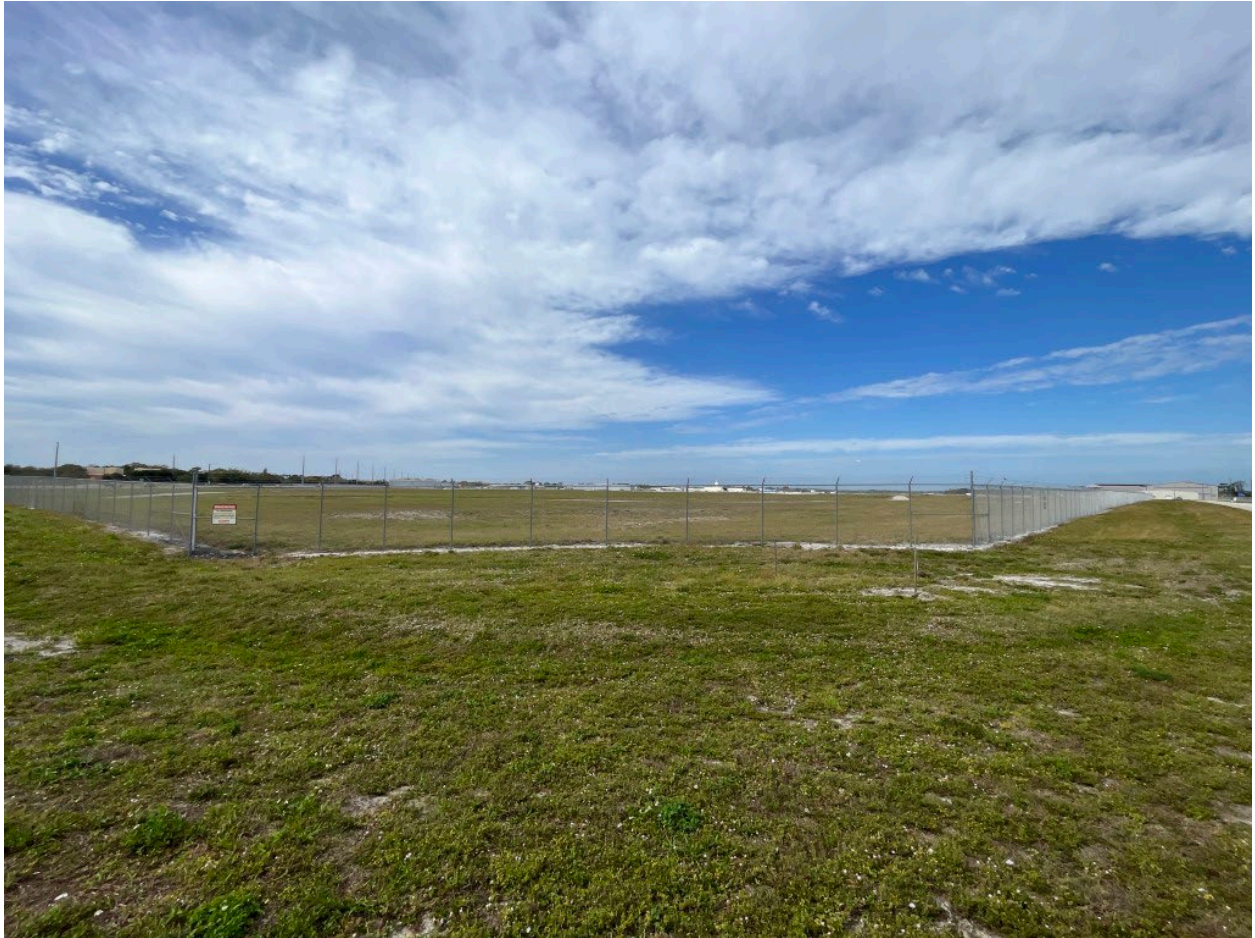
Photo 6. Map ID #6. Vero Beach Naval Air Station. This is a Formerly Used Defense Site (FUDS) that is now the Vero Beach Regional Airport. Photo date 2/13/2024. View to west.

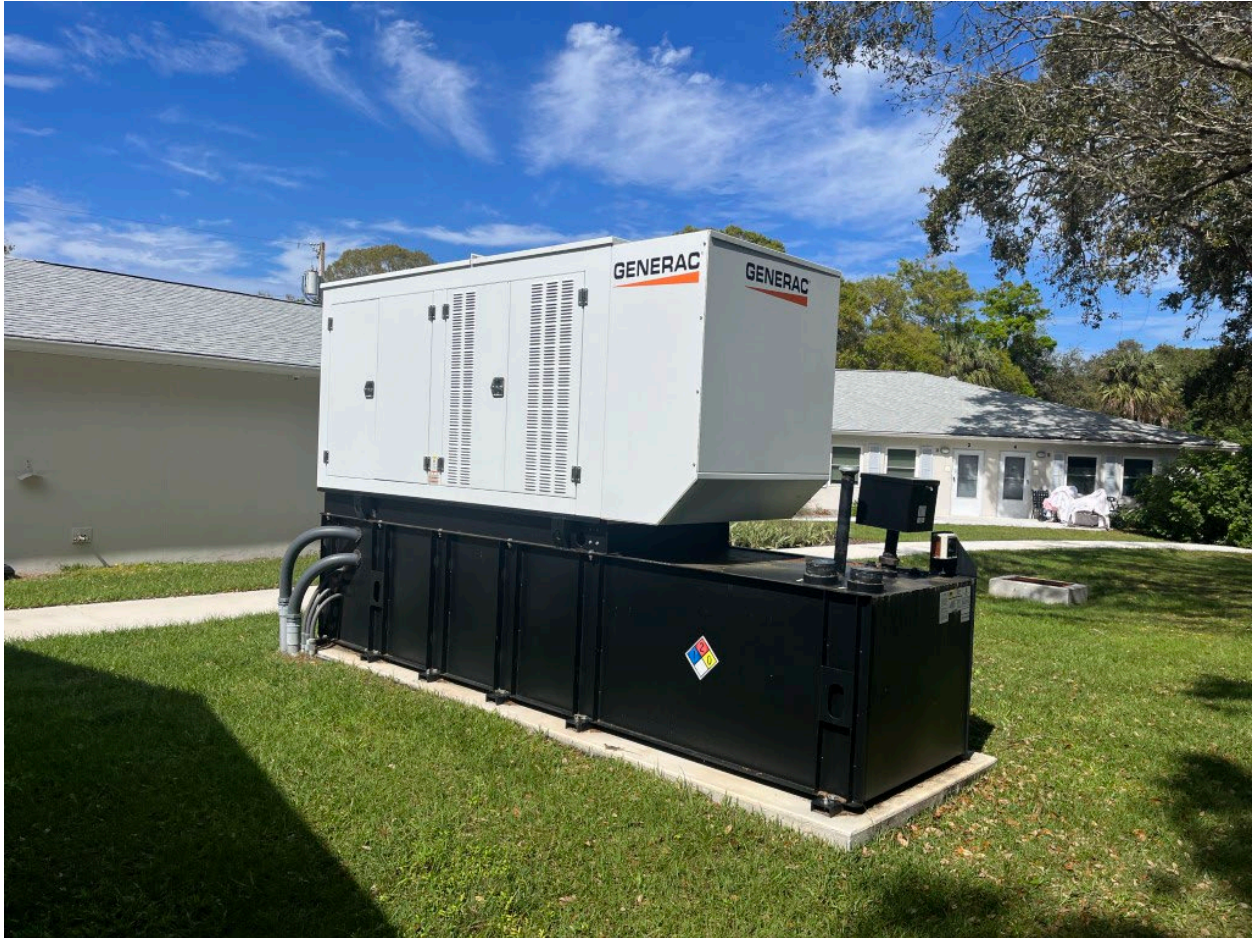
Photo 7. Map ID #7. Orange Blossom Village. This residential community has an emergency power generator with belly-mounted AST. Photo date 2/13/2024. View to north.

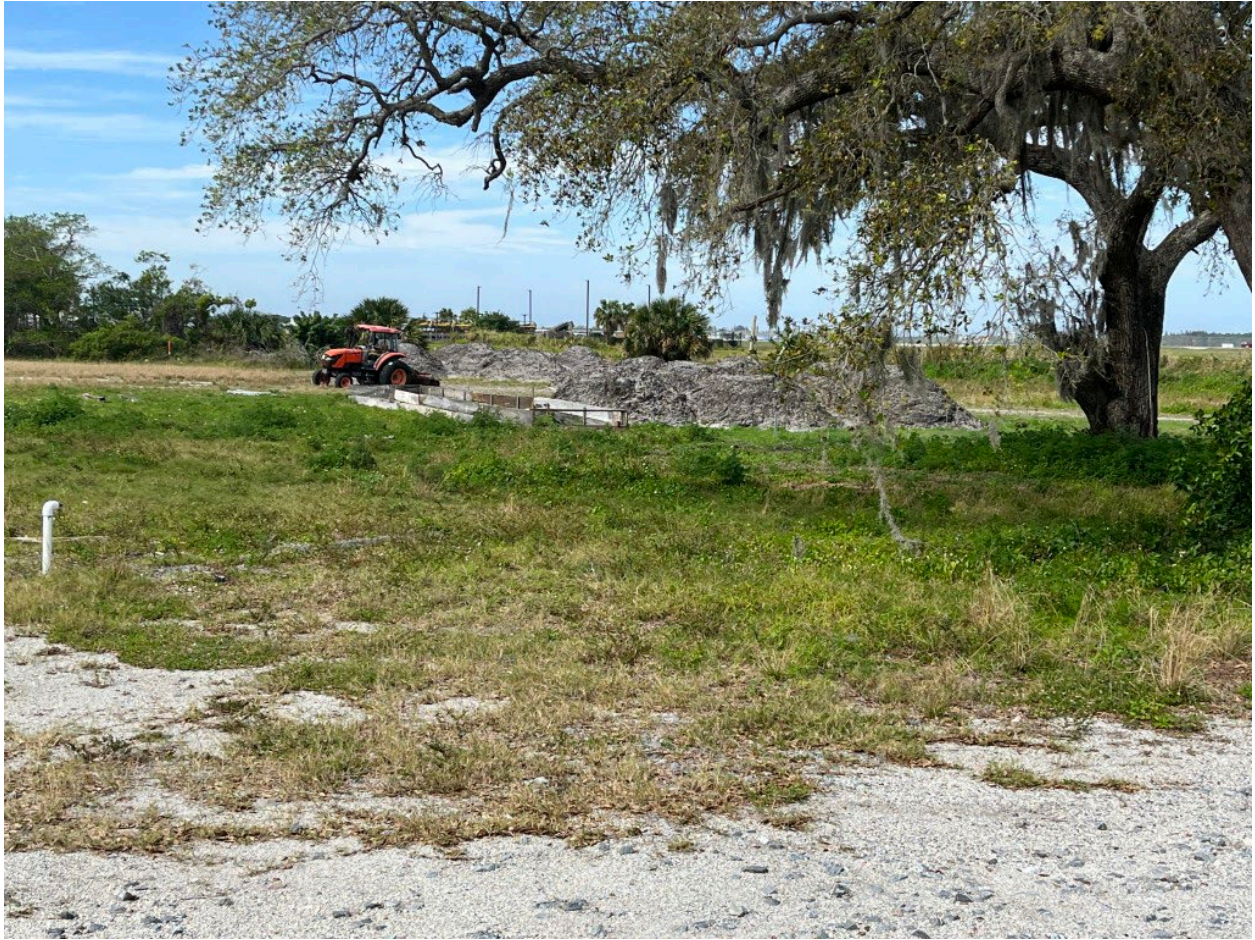
Photo 8. Map ID #8. Hogan & Sons Citrus Packers. Former percolation pond for a fruit washing and packing house. Photo date 2/13/2024. View to north.

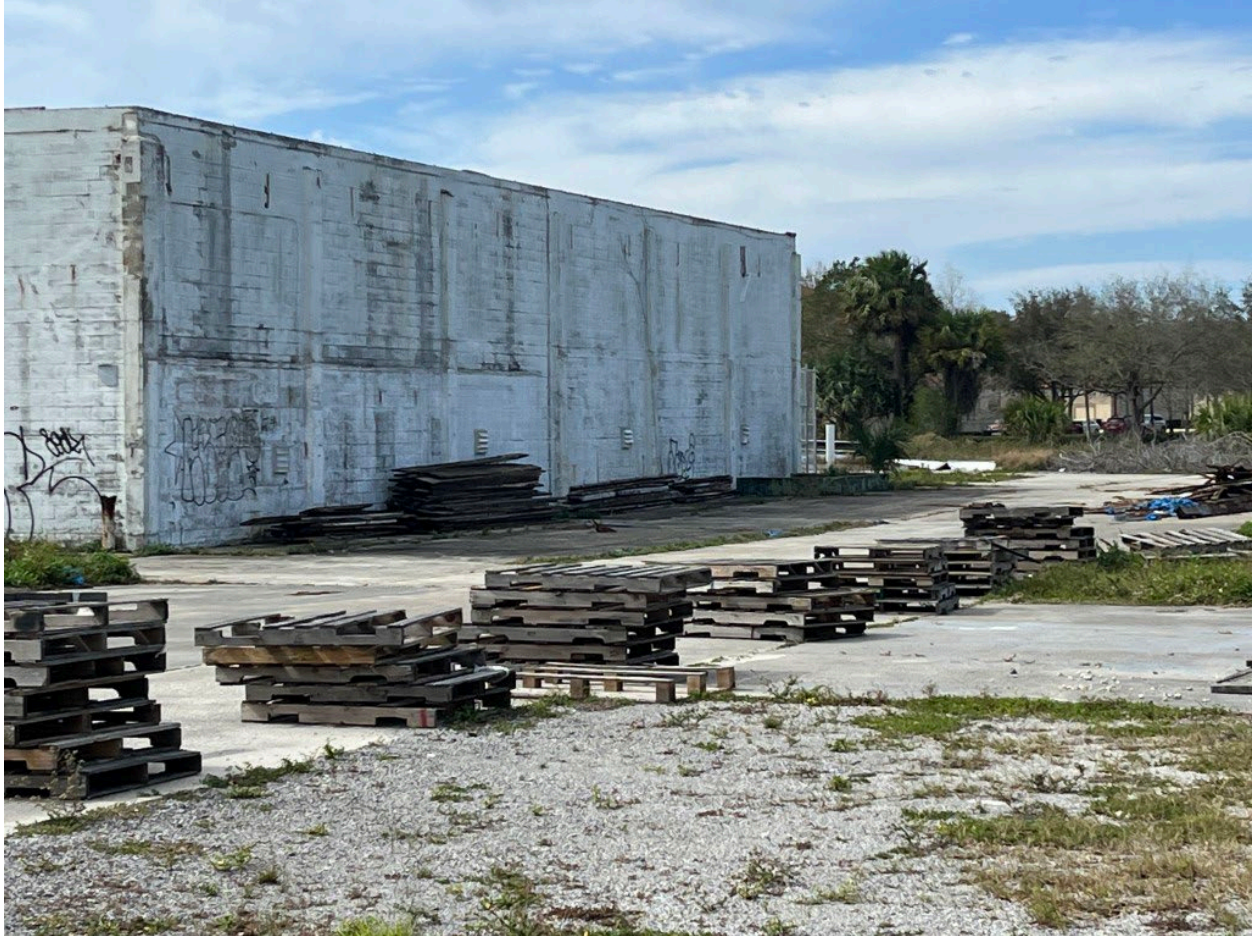
Photo 9. Map ID #9. Hogan & Sons, Inc. Location of former ASTs. Photo date 2/13/2024. View to southwest.

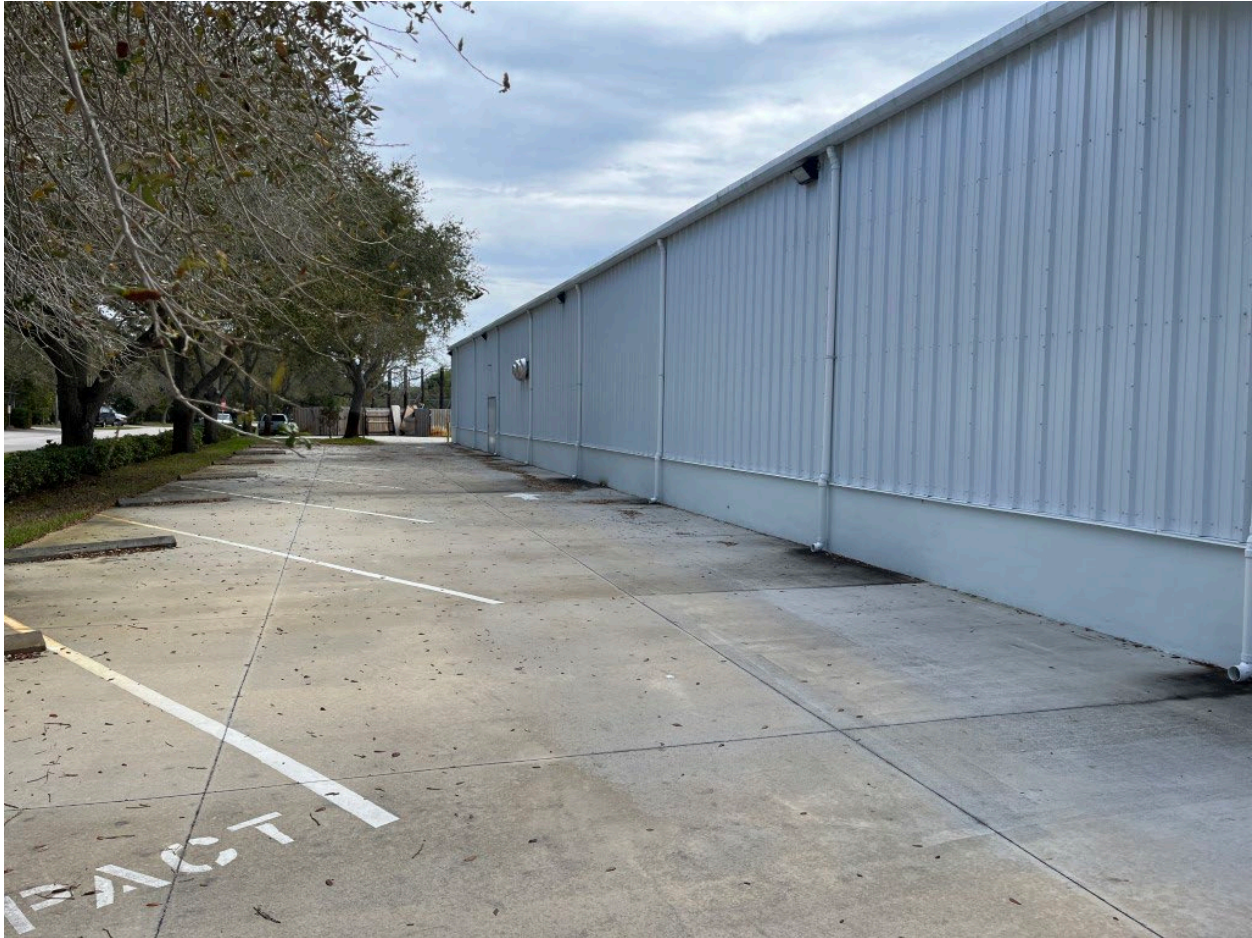
Photo 10. Map ID #10. Treasure Coast Oil Inc / Tire Kingdom. This facility formerly had USTs. Photo date 2/13/2024. View to east.

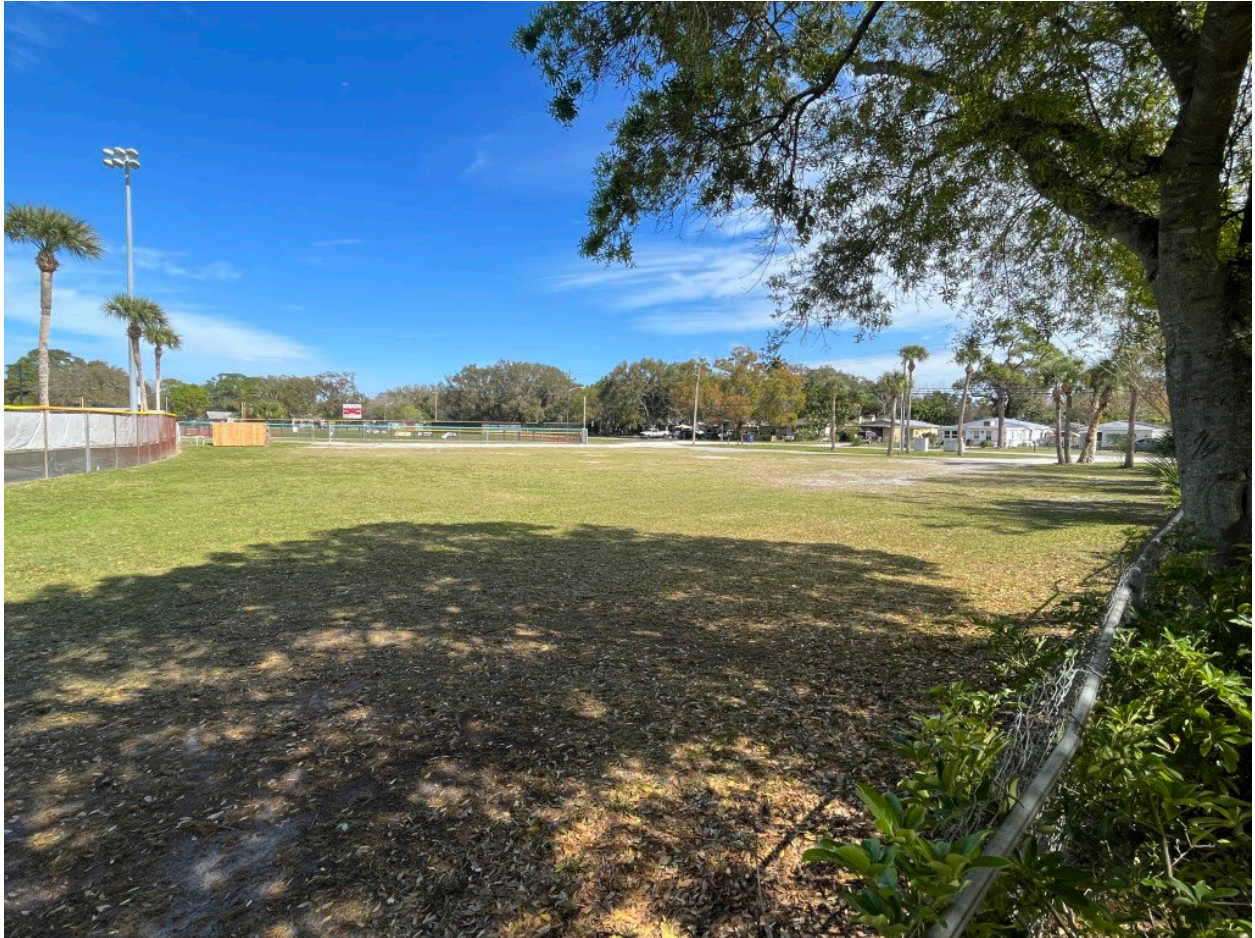
Photo 11. Map ID #11. Michael Field DDMS. A pre-approved debris management site. Photo date 2/13/2024. View to northeast.

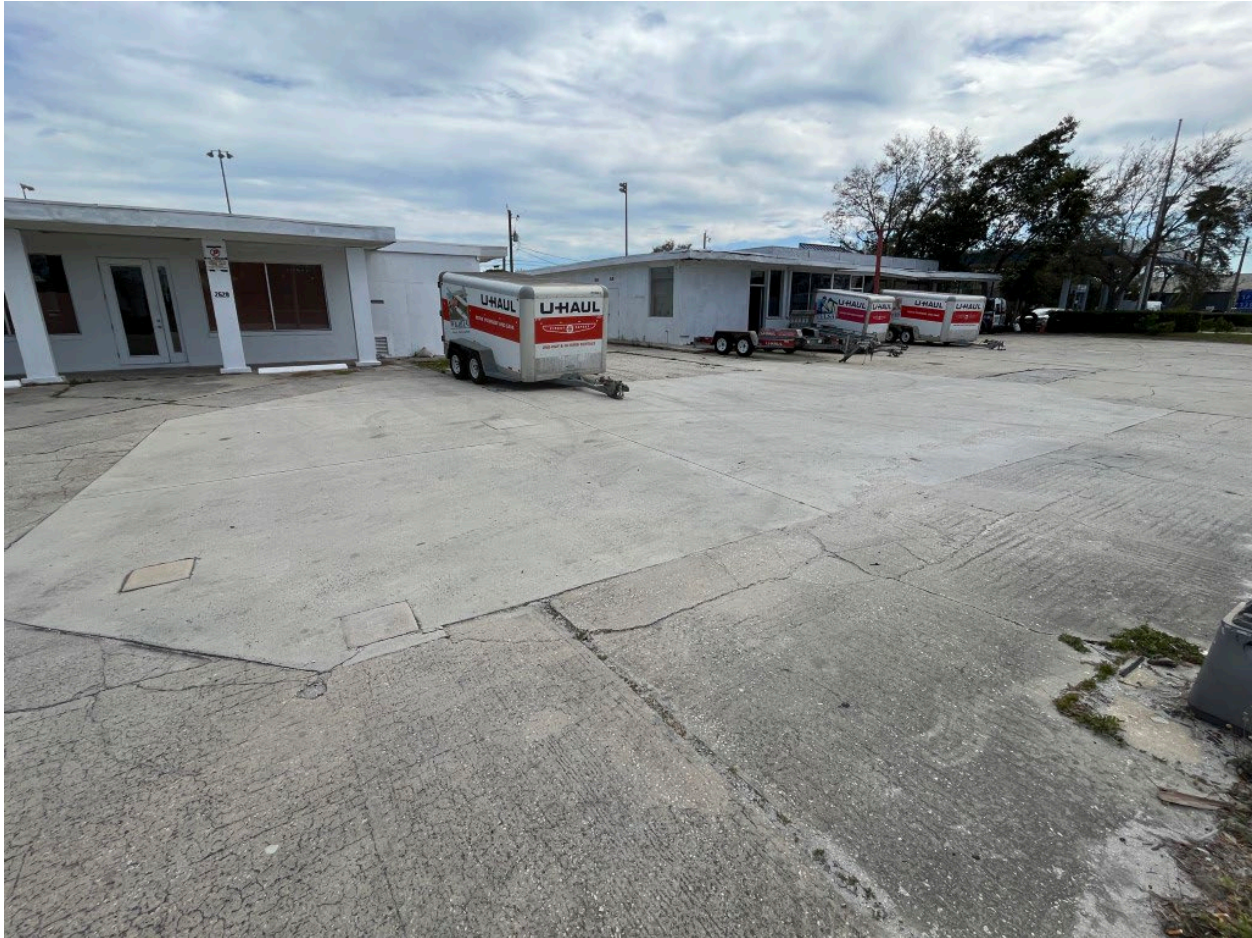
Photo 12. Map ID #12. Moran Service Station. Former gas station. Concrete patching for UST removal and abandoned monitoring wells are evident. Photo date 2/13/2024. View to southeast.

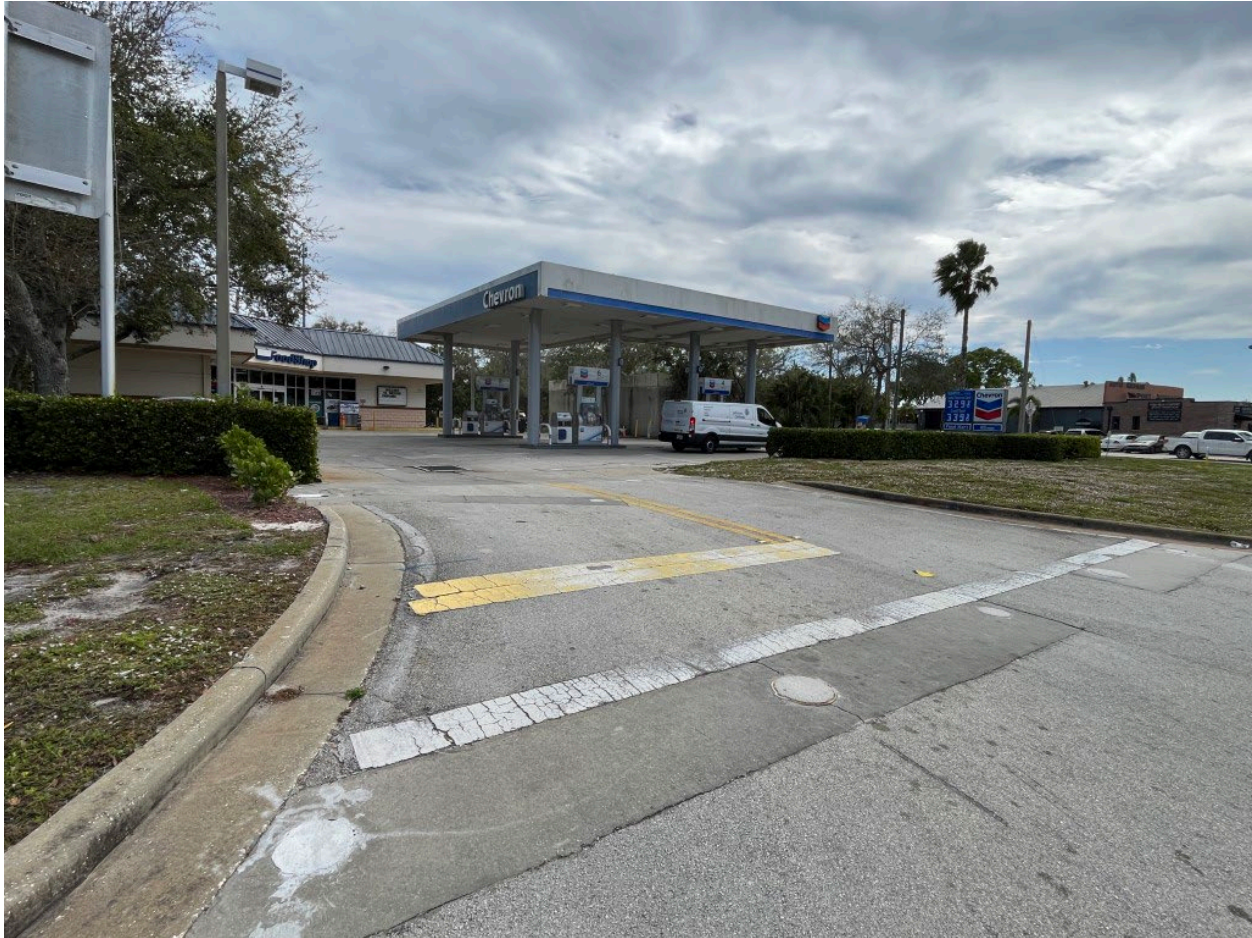
Photo 13. Map ID #13. Amoco #60304 / Country Corner 2602 Inc. Gas station currently operating as Chevron. NFA has been approved. Remediation wells and monitoring wells appear to have been recently abandoned – evident in foreground. Photo date 2/13/2024. View to southeast.

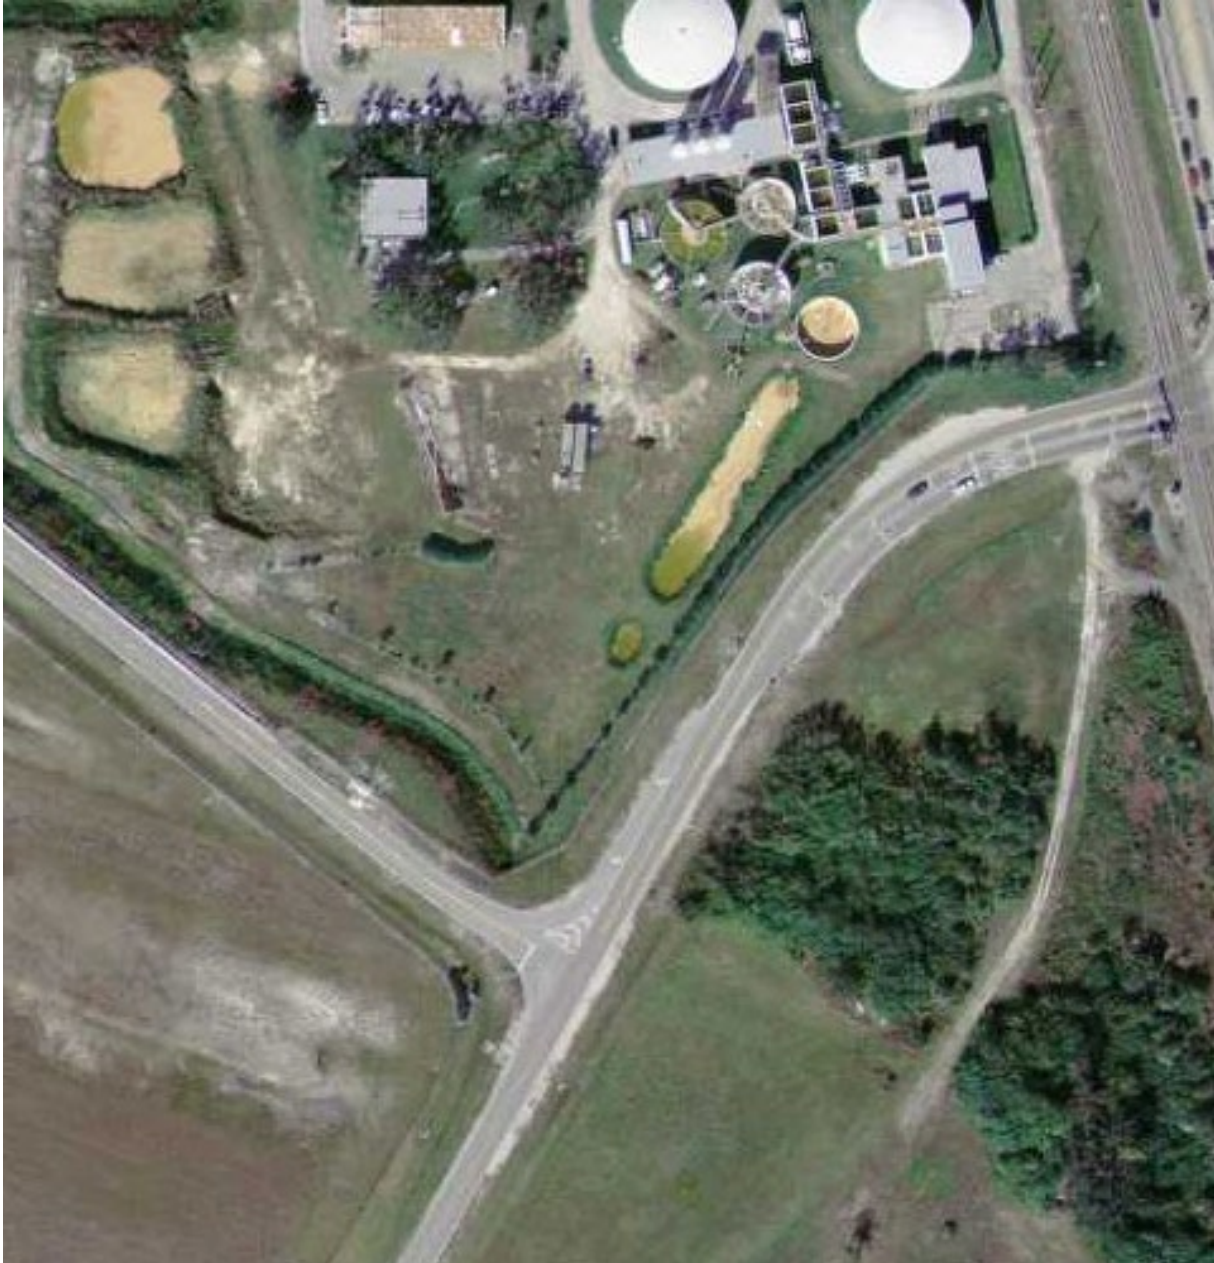
Vero Beach Water Treatment Plant (Map ID #2). 2005 aerial photograph showing effluent ponds and ditches, including linear pond along Aviation Blvd that receives waste lime sludge.

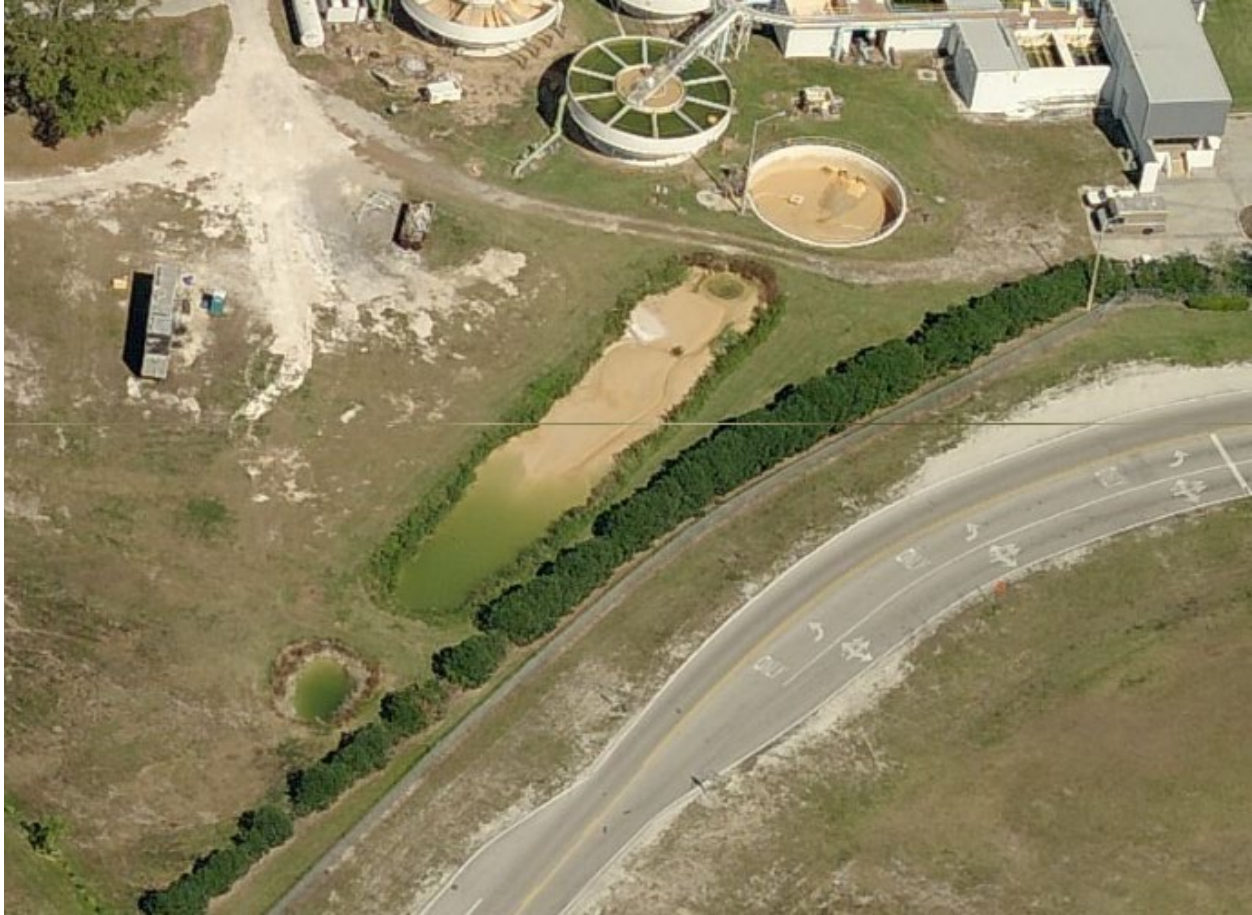
Vero Beach Water Treatment Plant (Map ID #2). 2007 oblique aerial photograph showing linear effluent pond that receives waste lime sludge. Oblique view to north. Aviation Blvd is in lower right.

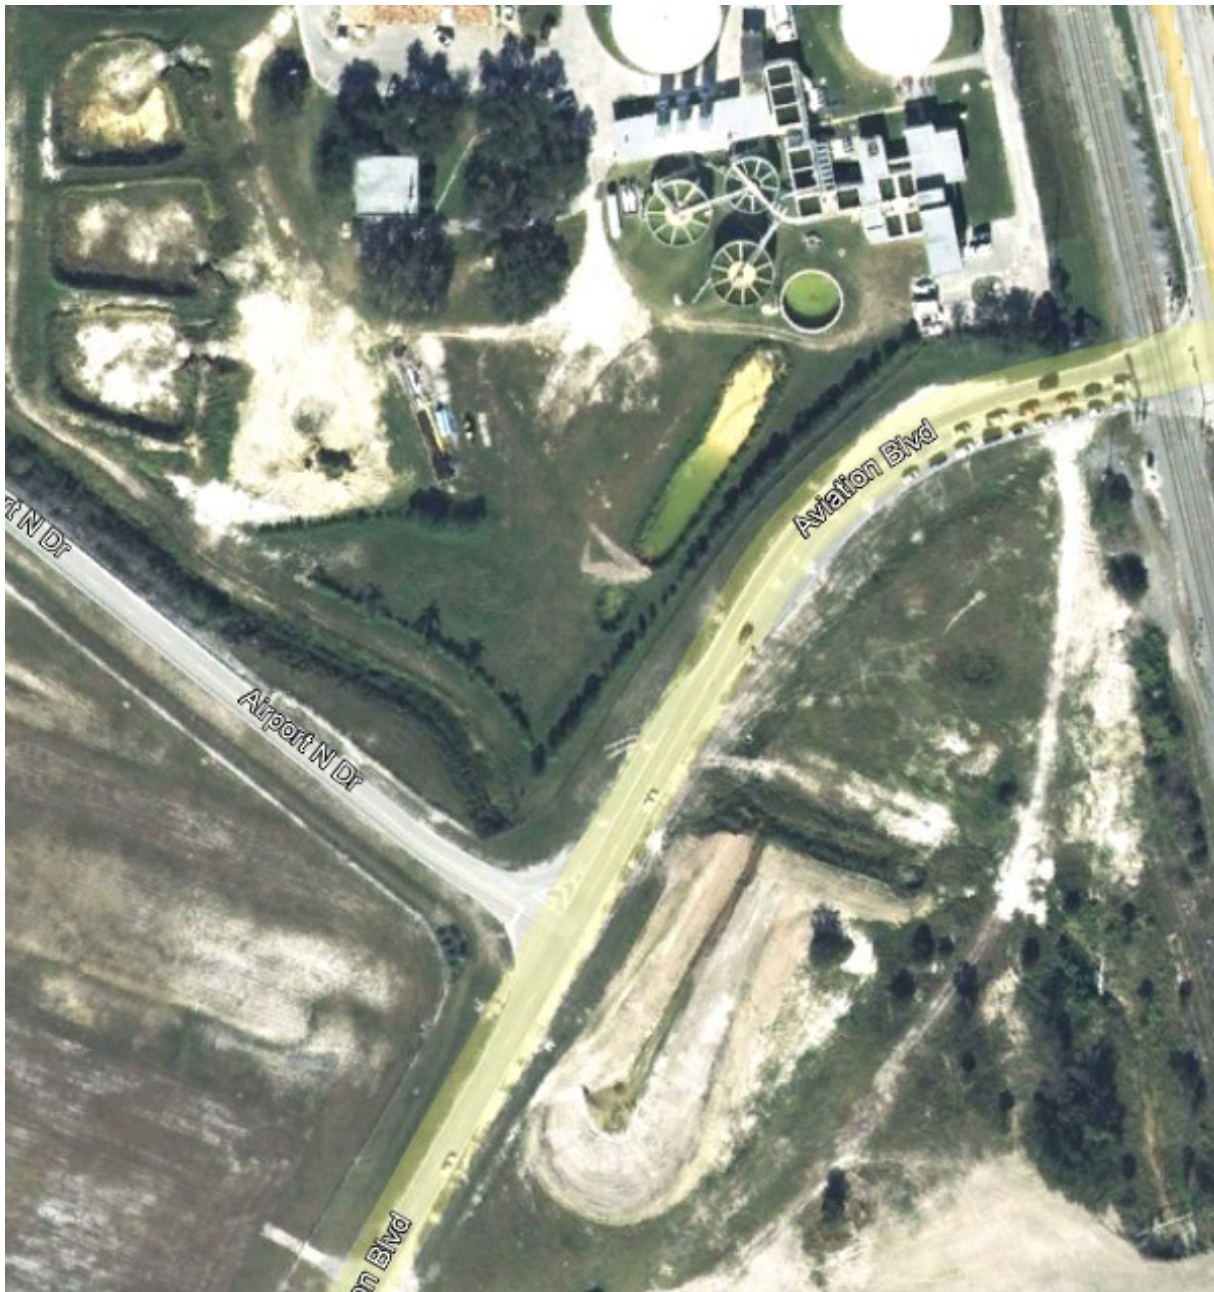
Vero Beach Water Treatment Plant (Map ID #2). 2008 aerial photograph showing effluent ponds and ditches, including linear pond along Aviation Blvd that receives waste lime sludge. Construction of drainage features on the southeast side of Aviation Blvd.

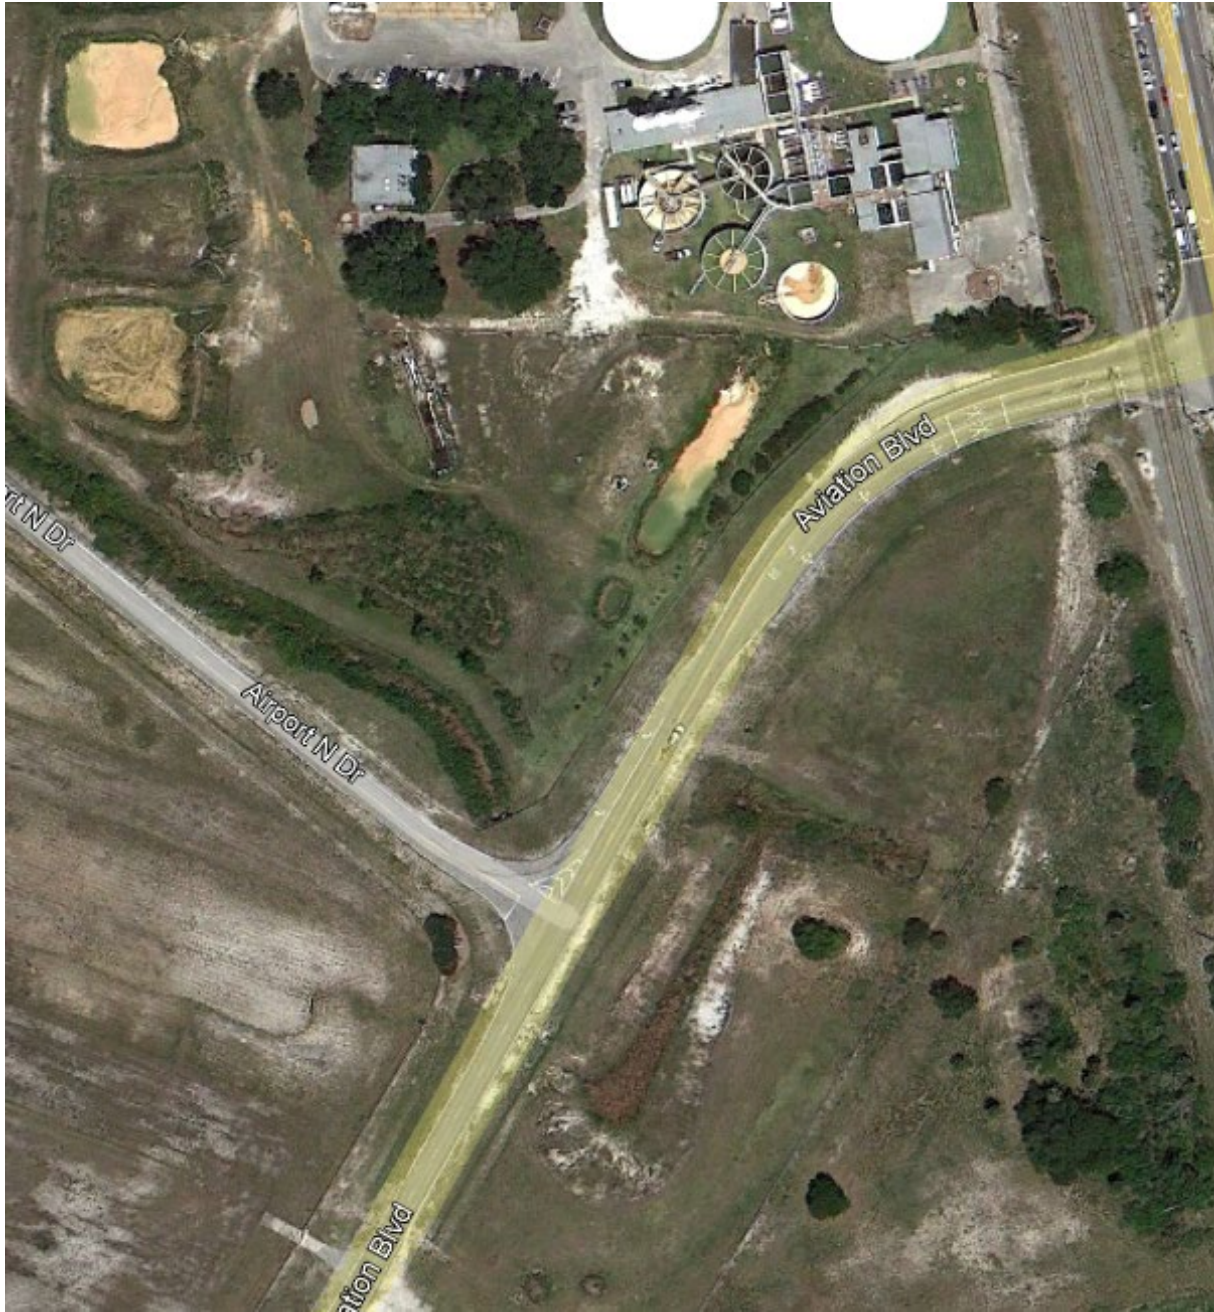
Vero Beach Water Treatment Plant (Map ID #2). 2012 aerial photograph showing effluent ponds and ditches, including linear pond along Aviation Blvd that receives waste lime sludge.

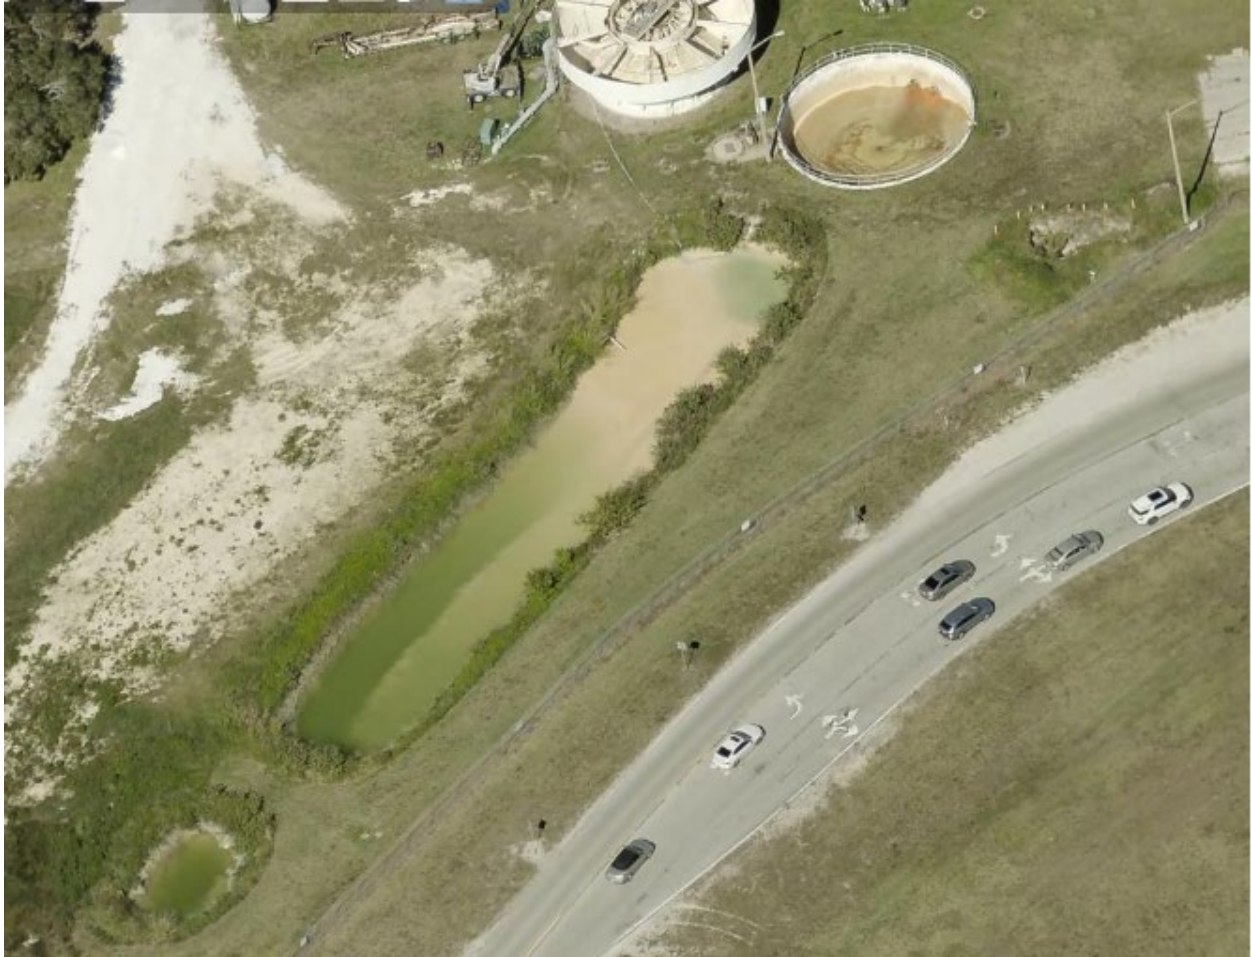
Vero Beach Water Treatment Plant (Map ID #2). 2023 oblique aerial photograph showing linear effluent pond that receives waste lime sludge. Oblique view to north. Aviation Blvd is in lower right
