DRAFT
CONTAMINATION SCREENING EVALUATION REPORT

SR 5/ US 1 at Aviation Boulevard

Project Development & Environment (PD&E) Study

Contamination Screening Evaluation Report

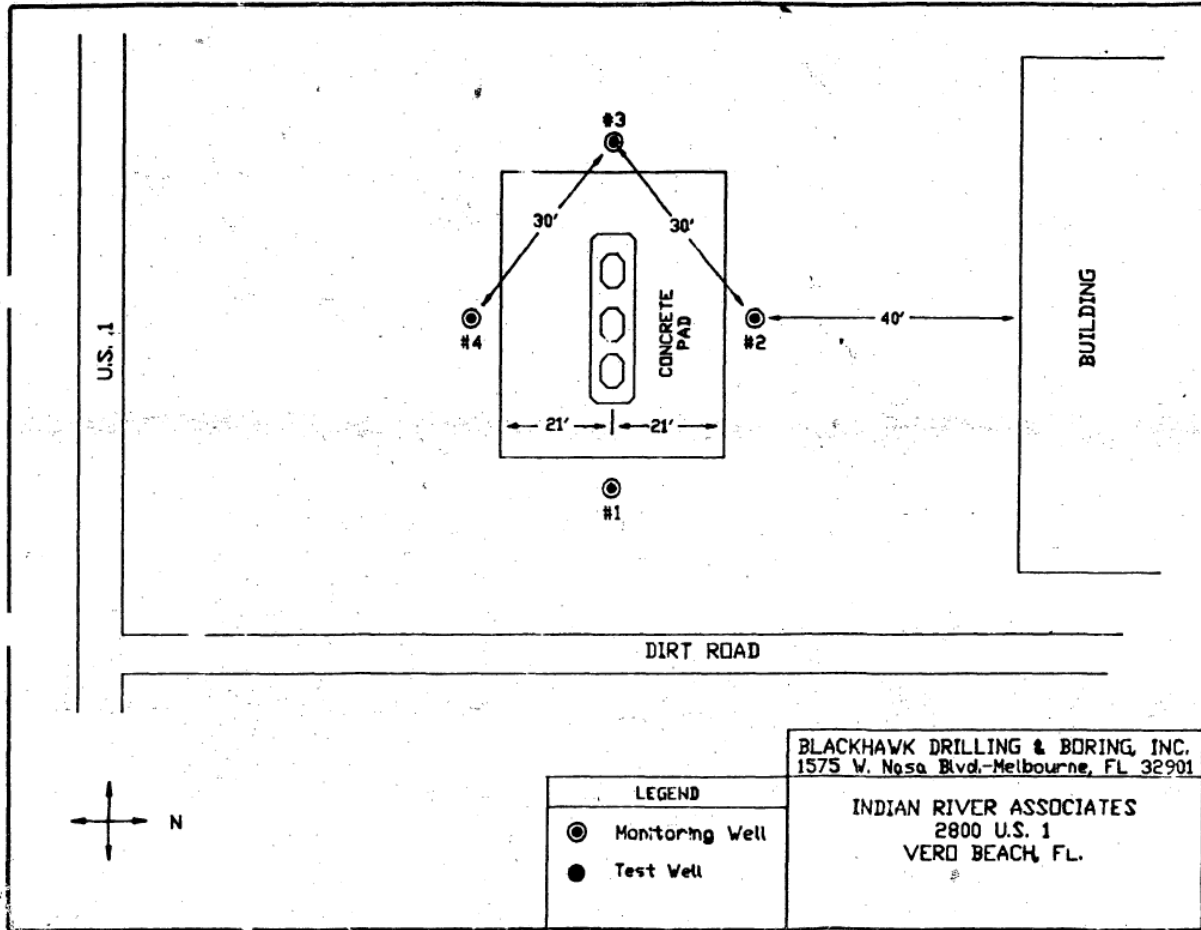
Graves W C JR-Indian River Associates (Map ID #4). Un-scaled sketch from 1987 indicates there were three pumps on a fuel island between a building and US 1 and there were four groundwater monitoring wells around the fuel island.

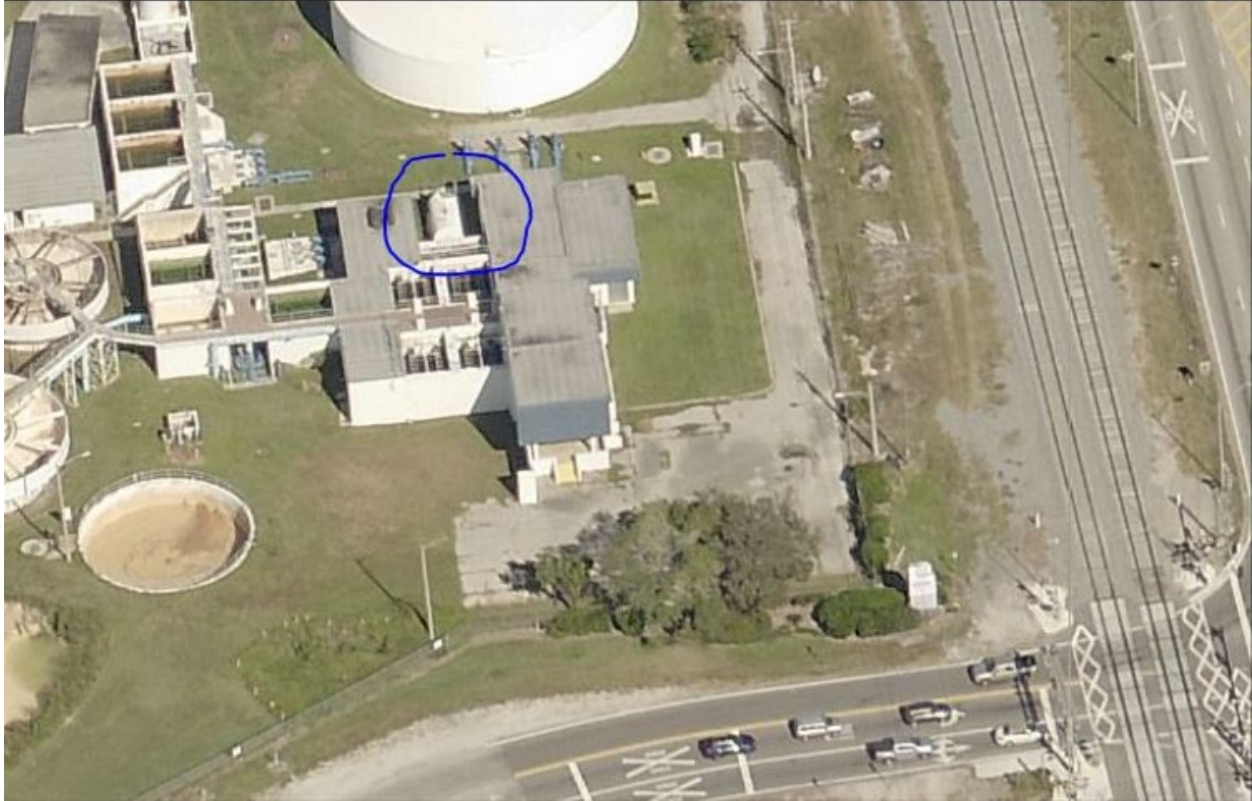
Vero Beach Water Treatment Plant (Map ID #5). 2023 oblique aerial photograph of the closest of the ASTs at the Vero Beach Water Treatment Plant to the project alternatives. Aviation Blvd in the foreground; FEC Railroad at right. View to north.

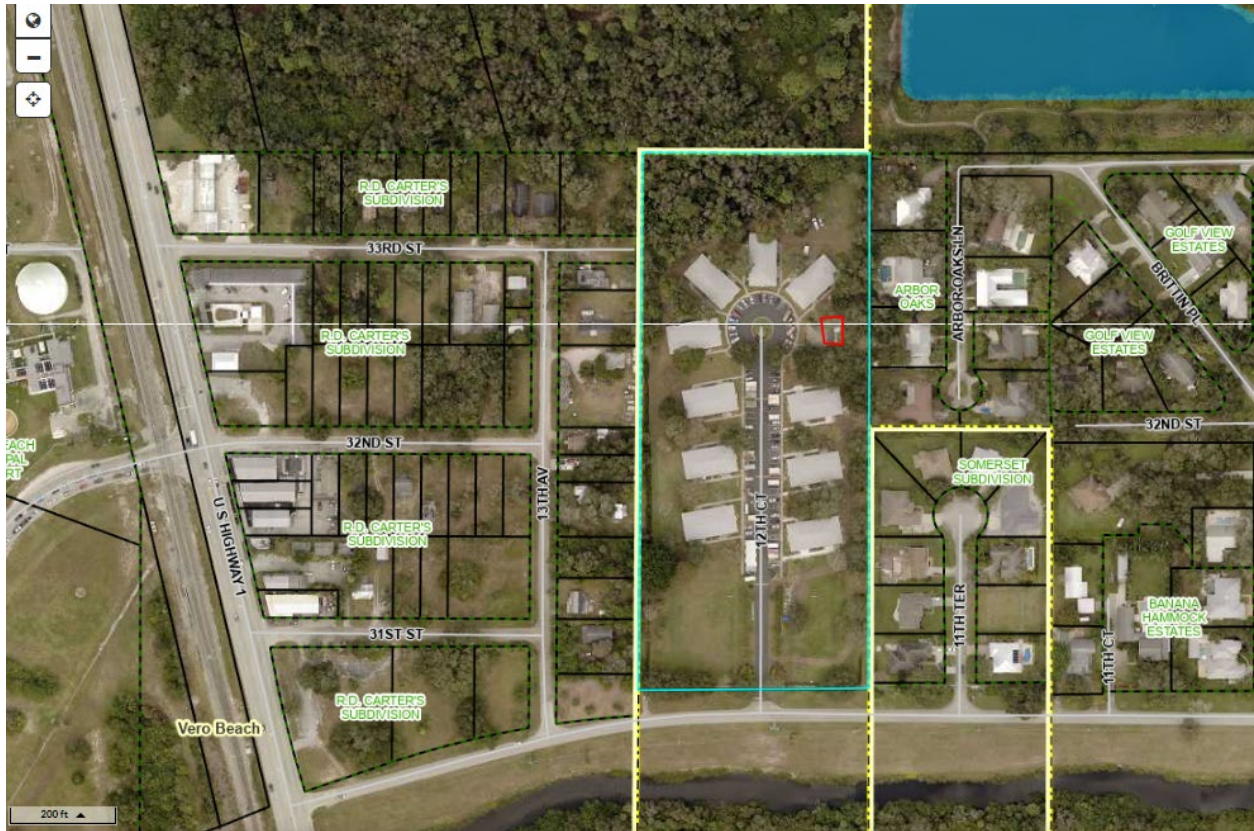
Orange Blossom Village (Map ID #7). Map, dated 2022. AST location marked in red.

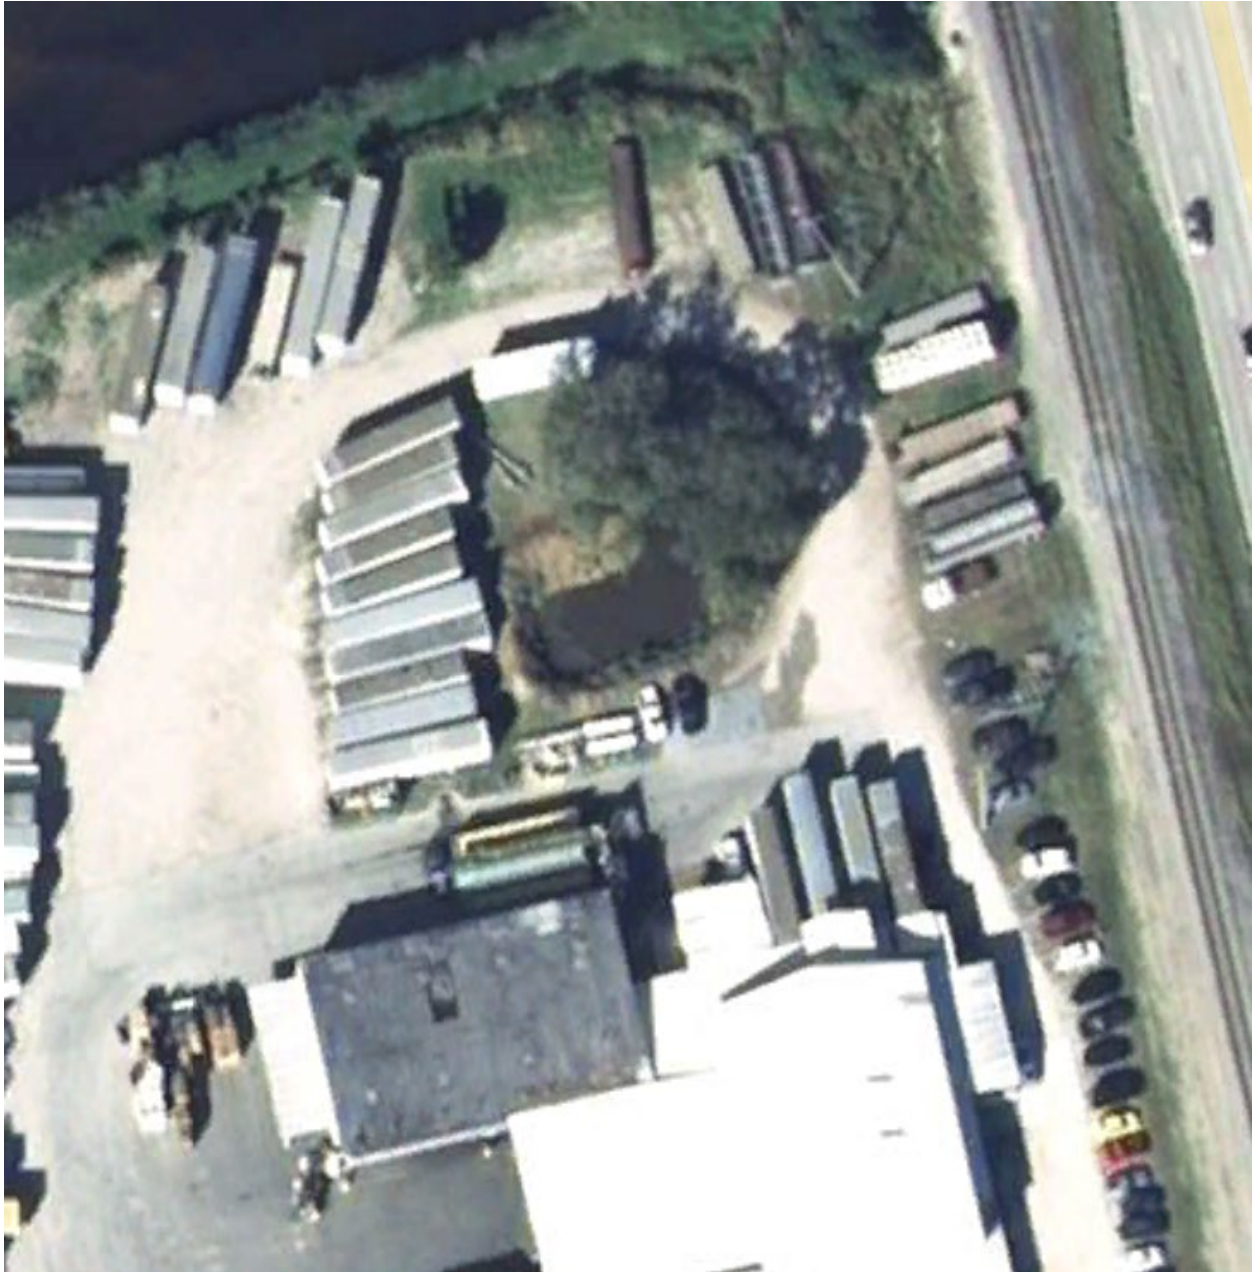
Hogan & Sons Citrus Packers (Map ID #8). 2008 aerial photograph, wastewater effluent pond is evident

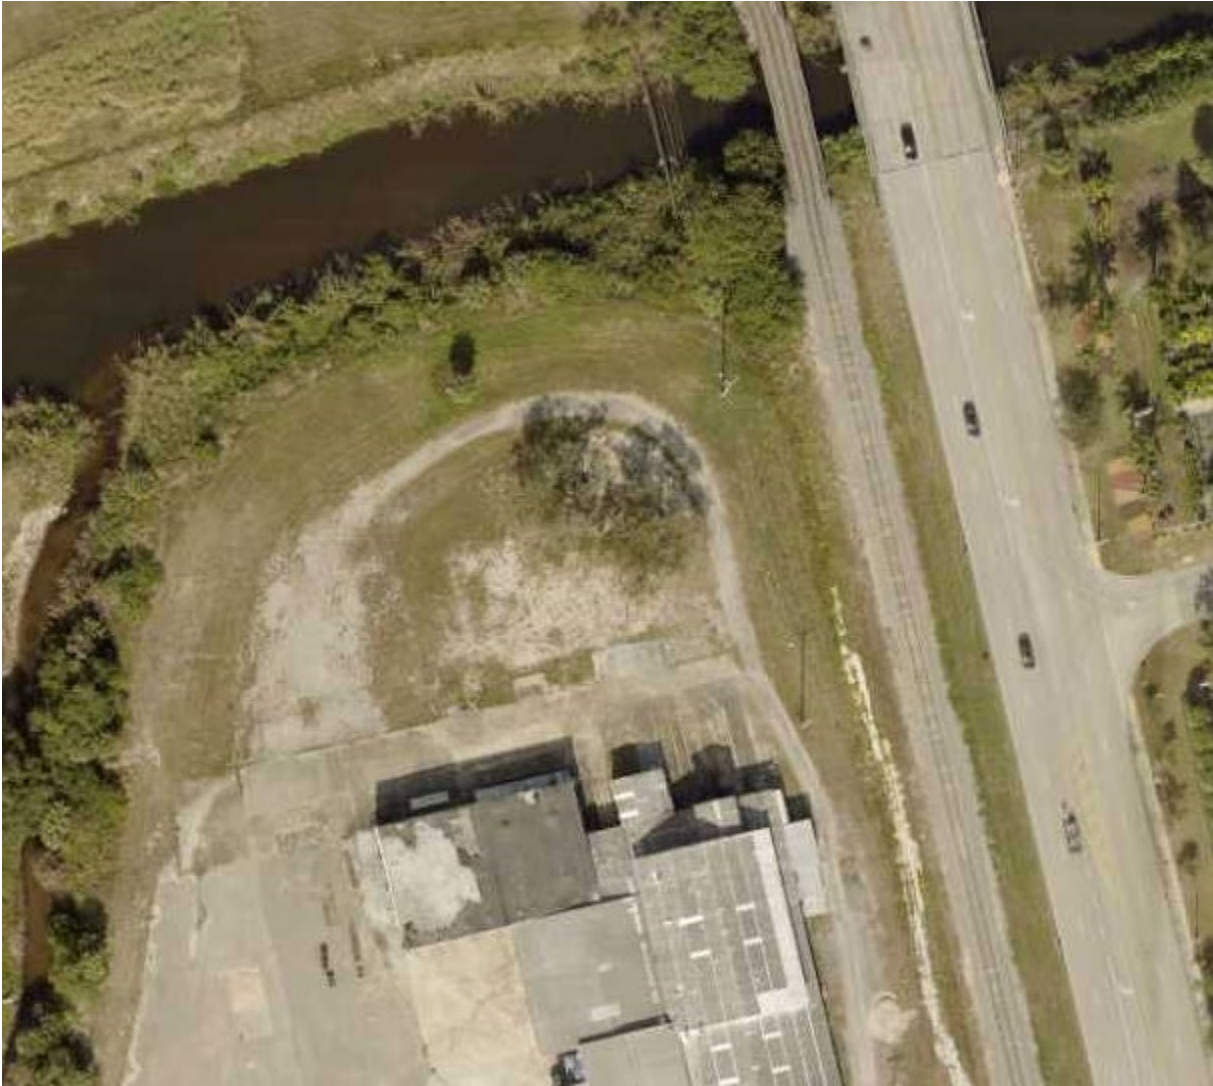
Hogan & Sons Citrus Packers (Map ID #8). 2021 aerial photograph, wastewater effluent pond filled
