Project Case Studies on GFRP Reinforcing Bars

1. Application of GFRP Bars to Ultra-High Performance Concrete
(Jun Wang and Yail J. Kim)
2. Quality Control of continuous processes
(Xavier Seynave)
3. Application of GFRP rods in bridge railway masonry arches
(Gabriele Balconi)
4. FDOT GFRP-RC Market Size Estimate for Cast-In-Place Concrete by 2020
(Steven Nolan)
5. The Correlation between Moisture Absorption and Mechanical Strength Properties of GFRP Rebars
(Raphael Kampmann and Jan Suhrheinrich)
6. GFRP Mesh Used for Column Repairs
(Borna Miragha)
7. Skyway South Rest Area Seawall Rehabilitation
(Lowry Denty, Steven Nolan, and Lisa Propps)

Application of GFRP Bars to Ultra-High Performance Concrete

By: Jun Wang and Yail J. Kim (University of Colorado Denver)

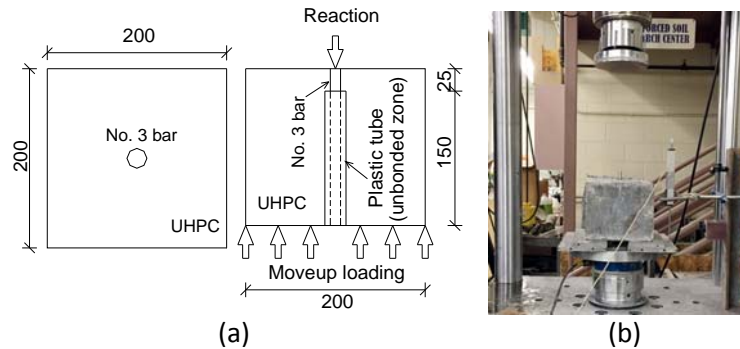
Interface test specimens were cast with UHPC and steel/GFRP bars, as illustrated in **FIGURE 1**. The bond length of the bar was 25 mm and a plastic tube was used to unbond the bar from UHPC. It should be noted that the bond length recommended in ACI 440.3R-12 [8] is not valid for UHPC owing to its high strength.

FIGURE 1. Interface specimen: (a) schematic; (b) test

The interface test was conducted at a loading rate of 1 mm/min. Instrumentation included a load cell and a linear potentiometer to monitor the applied load and the interfacial displacement, respectively.

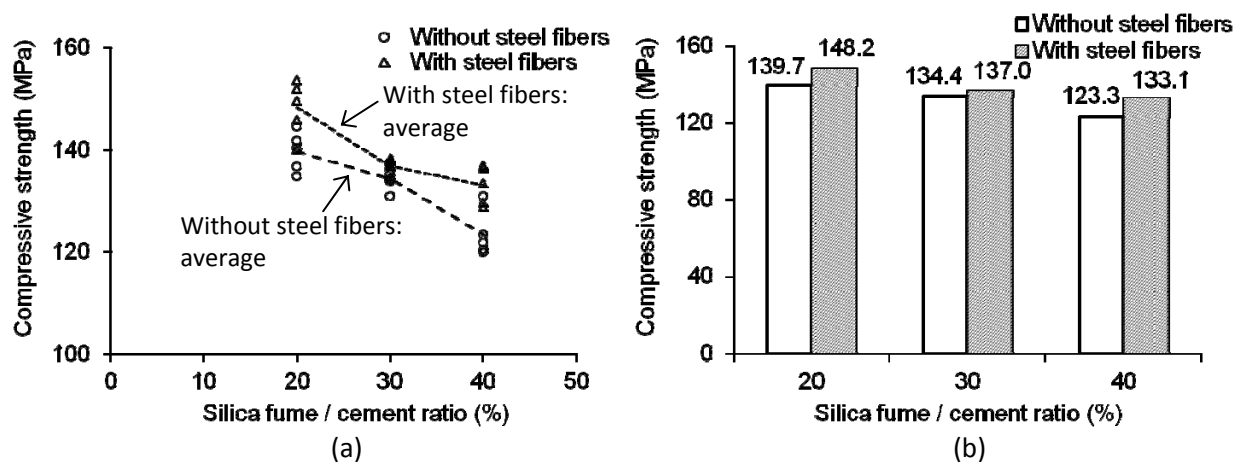
FIGURE 2(a) exhibits the variation of UHPC strength in compression. Regardless of silica fume/cement ratio, the strength of UHPC mixed with steel fibers was higher than that of UHPC without the fibers. This observation is ascribed to the fact that the steel fibers precluded the development of random cracks; accordingly, the cement binder better resisted local principle stresses. The implications of the silica fume/cement ratio were apparent on the compressive strength of UHPC, as shown in FIGURE 2(b). It was reported that the amount of silica fume can increase the presence of entrapped air bubbles in UHPC [9], leading to a decrease in compressive strength.

FIGURE 2. UHPC strength in compression: (a) individual; (b) average

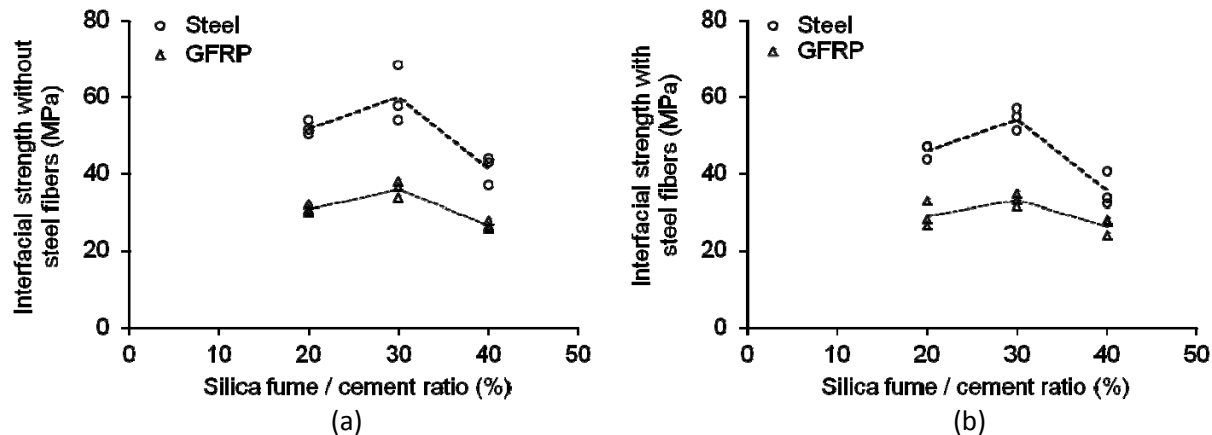
A comparative plot on the interfacial capacity of UHPC with the steel and GFRP bars is provided in **FIGURE 3**. The steel-UHPC interface showed higher capacities in all cases primarily due to the presence of a mechanical interlock, irrespective of silica fume/cement ratio. An interesting observation was made that the capacity was not directly proportional to the silica fume/cement ratio. This may be explained by the plastic viscosity of UHPC alongside the entrapped air [10].

FIGURE 3. Interfacial capacity: (a) without steel fibers; (b) with steel fibers

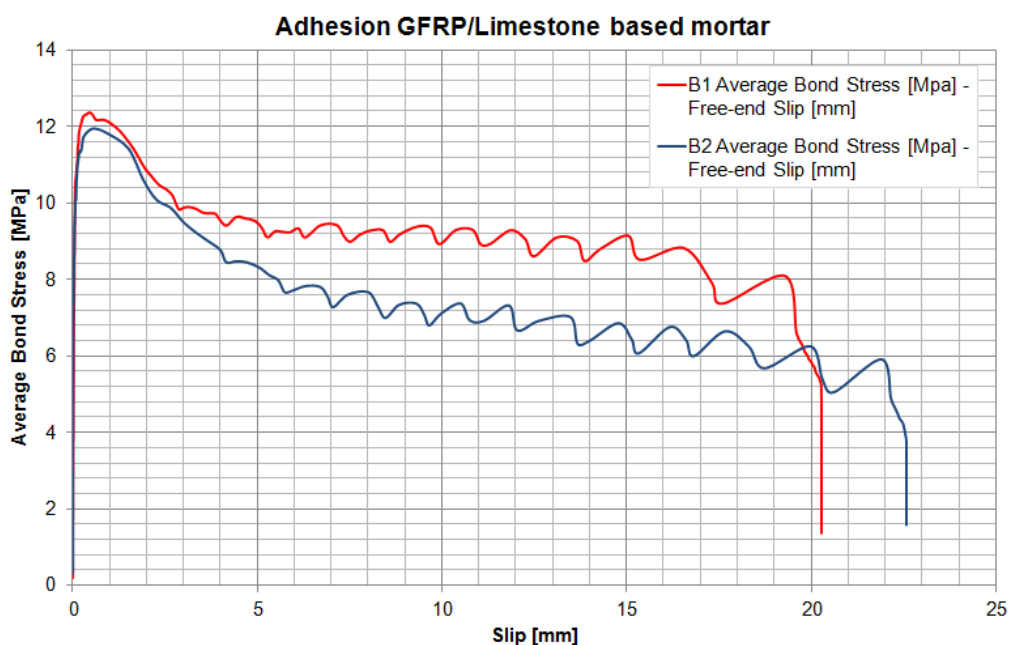
FIGURE 1: GFRP average bond stress/free-end slip chart (limestone)

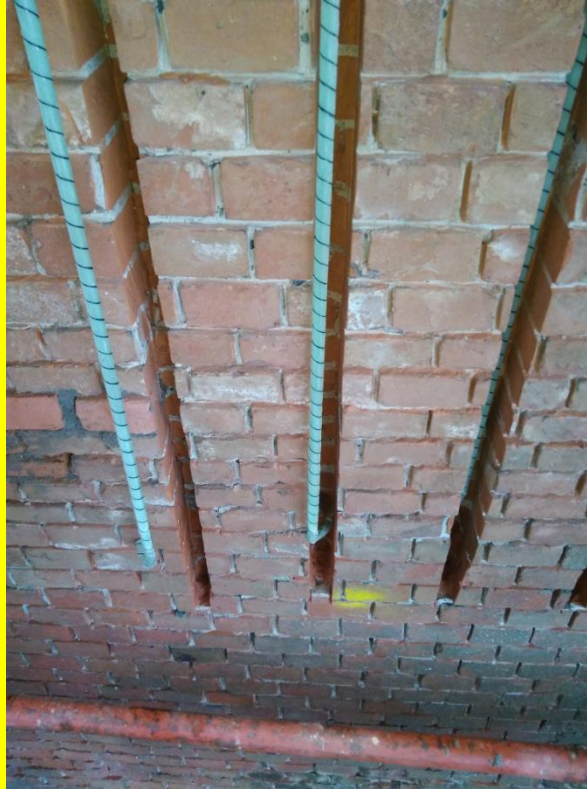
FIGURE 2: Sleeves ready for the reinforcement

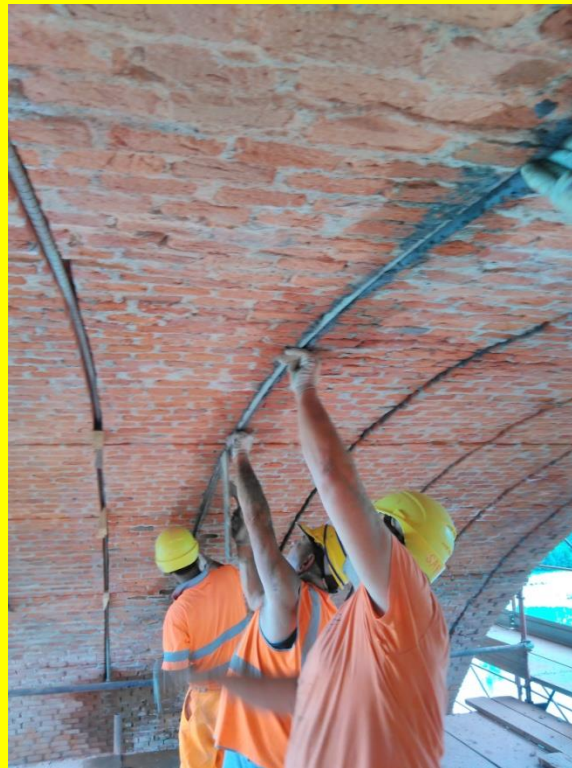
FIGURE 3: GFRP rods are inserted in the sleeves

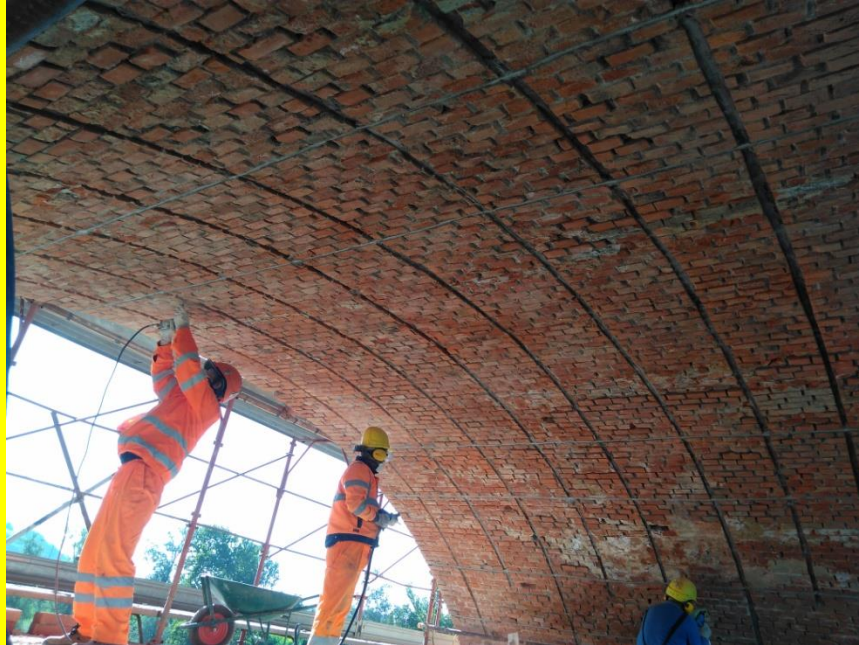
FIGURE 4: CFRP chords are applied in the transversal direction

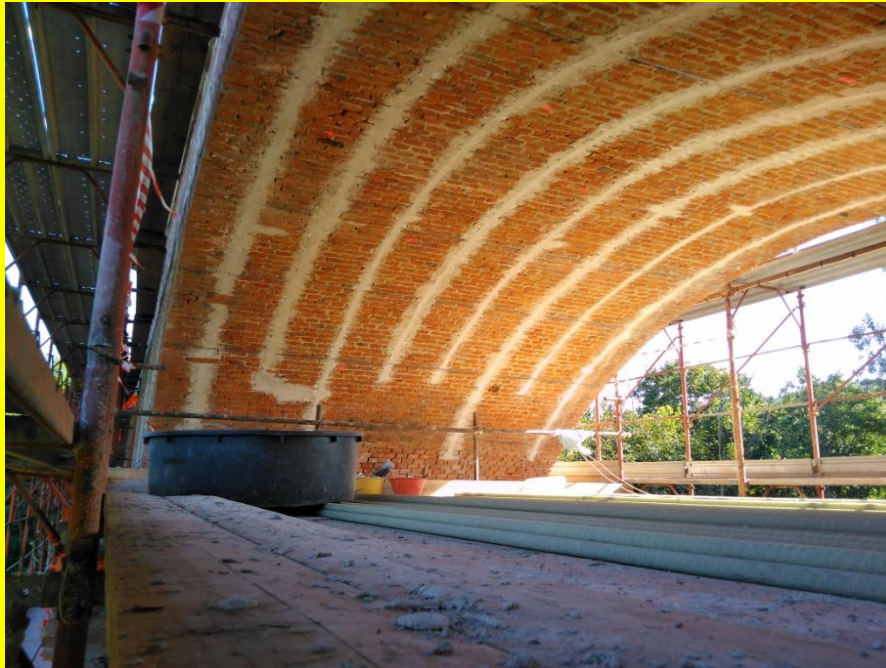
In this case the NSM technique has been extended to piers, see FIGURE 5, and CFRP chords were wrapped all around inside horizontal mortars joints to enhance shear performance.

FIGURE 5: The reinforcement operations are finished, sleeves are painted to hide the reinforcement

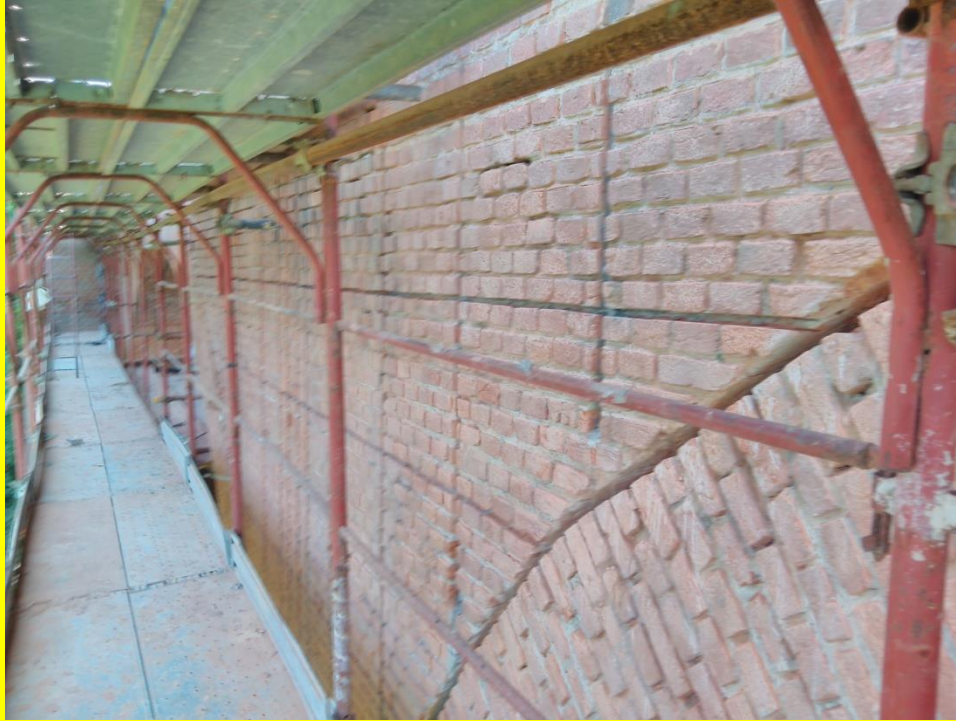
FIGURE 6: CFRP chords are travelling all around the piers

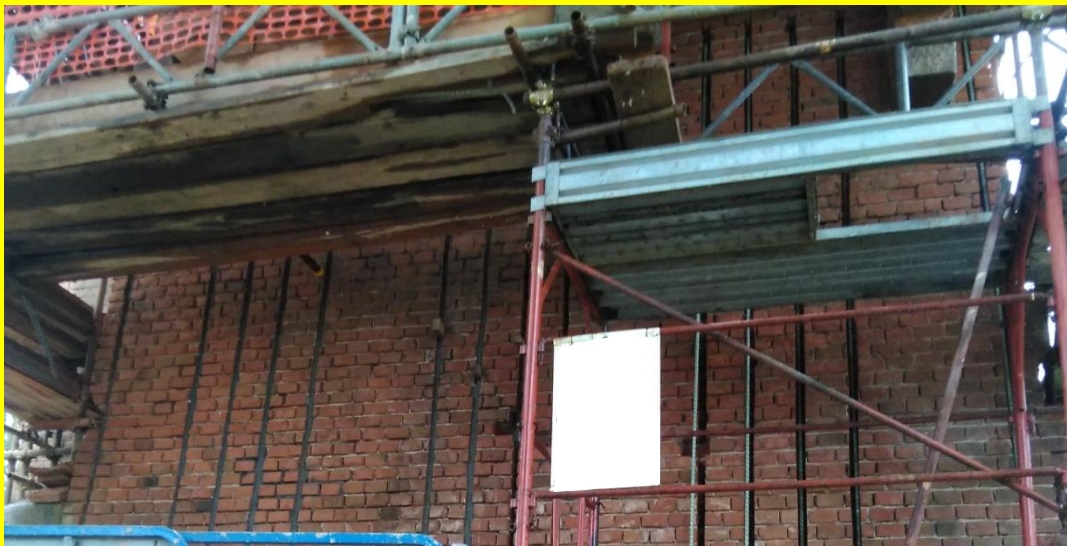
FIGURE 7: Piers were reinforced for bending using GFRP rods for out of plane and in plane bending

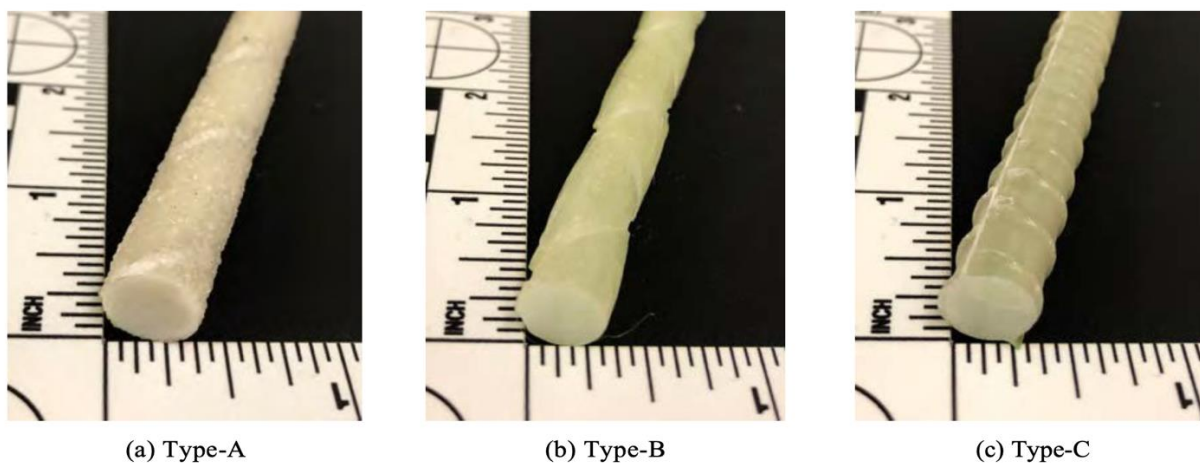
ester. Type-B rebars were also solid and round, but the surface was enhanced via helical wraps (without any sand coating). This composite rebar was also made from E-CR glass and vinyl-ester. Type-C rebars were produced with a solid cross-section that is oval or not perfectly round, it used helical ribs (comparable to traditional steel rebars) formed from pure resin. The following Figure 1 provides an

Figure 1: Cross-sectional features of tested GFRP rebar products

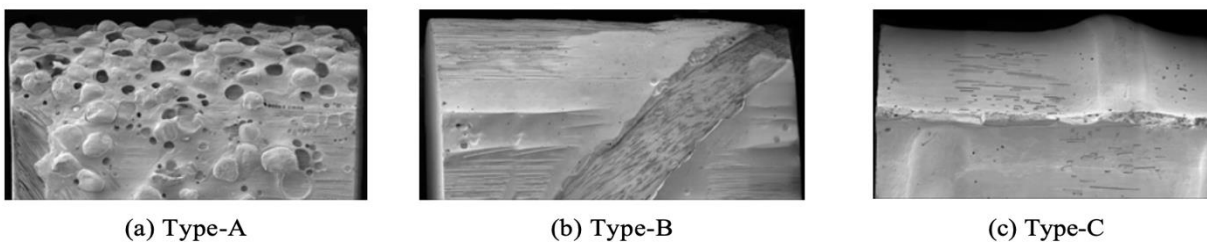
overview of the physical features of the three tested products. Figure 2 shows scanning electron microscope pictures that were taken parallel to the rebar axis to emphasize the difference in surface enhancements on the microscopic level and to evaluate the surface porosity of these rebars.

Figure 2: Surface enhancement details of tested GFRP rebar products

Presumably due to lost sand grains, Type-A rebars had the most and also the largest pores at the surface. Type-B rebars had small voids along the helical wrapping fibers and Type-C rebars had small holes between the impressed ribs, both of these rebar types had a relatively dense surface. The mechanical properties — as reported by the manufacturers — for the evaluated GFRP reinforcement bars are shown in Table 3. Although all bars were made from similar raw materials, like E-

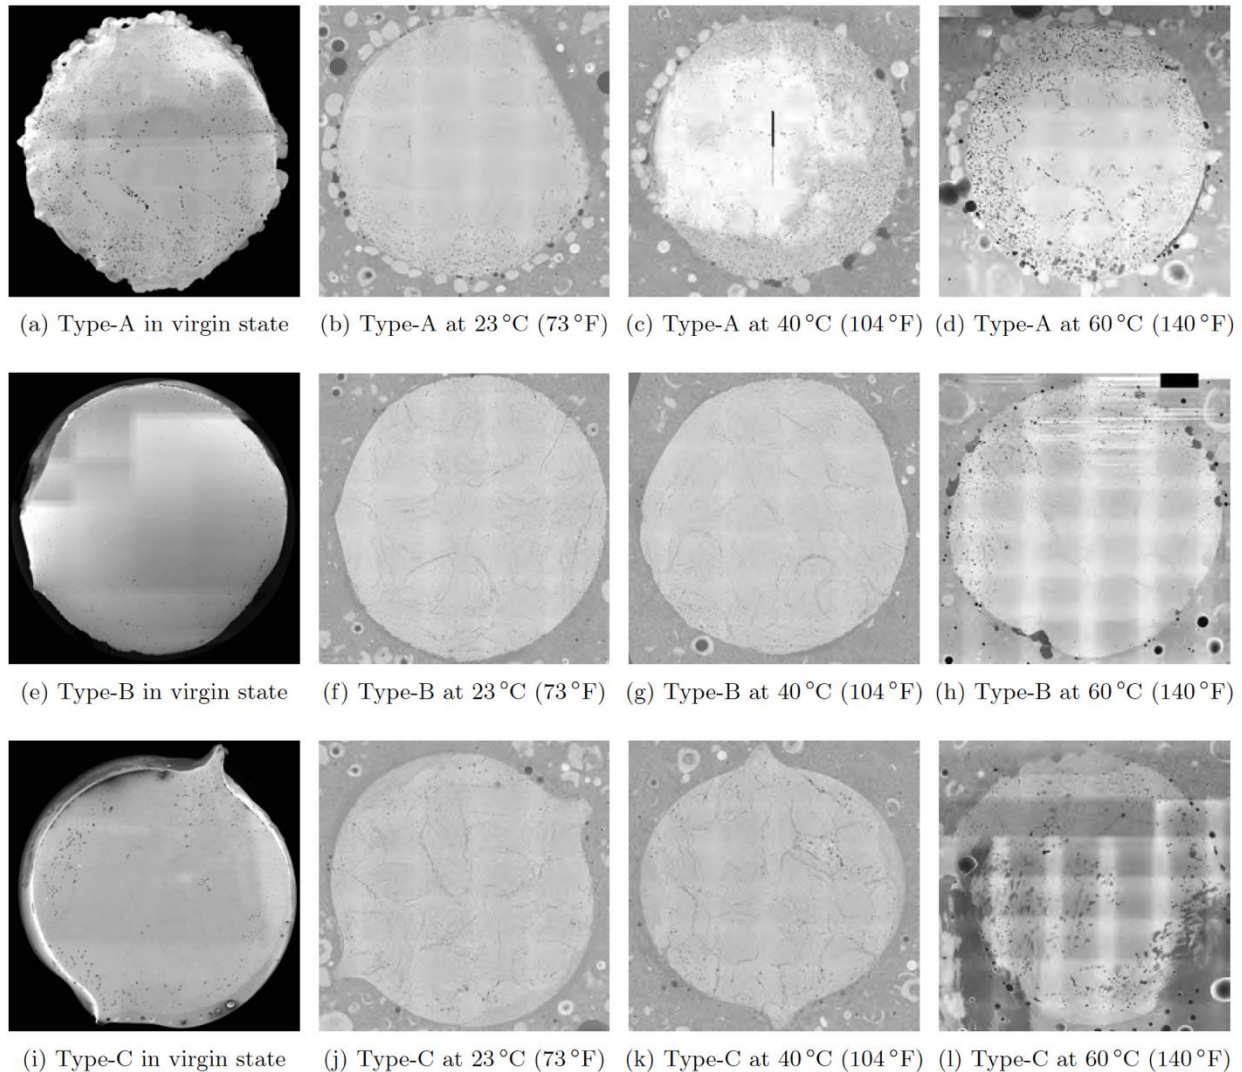
pictures were generated from numerous (at least 30) individual SEM pictures, to provide a full overview of the microstructure and porosity of the entire rebars. In Figure 4, each rebar type is presented in an

Figure 4: Combined SEM pictures for all rebar types in virgin state and after 365-day saltwater exposure

individual row. The pictures with the black background in the left column were captured in a pristine, un-aged, state, while the following consecutive columns show the representative cross section as it was scanned for successively increasing conditioning temperatures. Once again, it can be seen that Type-A rebars were the most porous rebars in this study. But more importantly, the images clearly show that higher temperatures lead to significantly more deterioration because the SEM pictures on the right-side show most damages for all three types. Moreover, the more porous Type-A rebars suffered the most (c.f. Figure 4d) damaging effects, and it can be seen that this happened mostly along the perimeter of the cross section because the density of the Type-A rebars was reduced due to the production method (open mold). Unfortunately, the image in Subfigure 4l appears unclear and partially blurry because the SEM detector was not properly aligned nor cleaned when some of the detail images (need to produce the full cross section) were captured. However, it is emphasized that only the black (and not the gray)

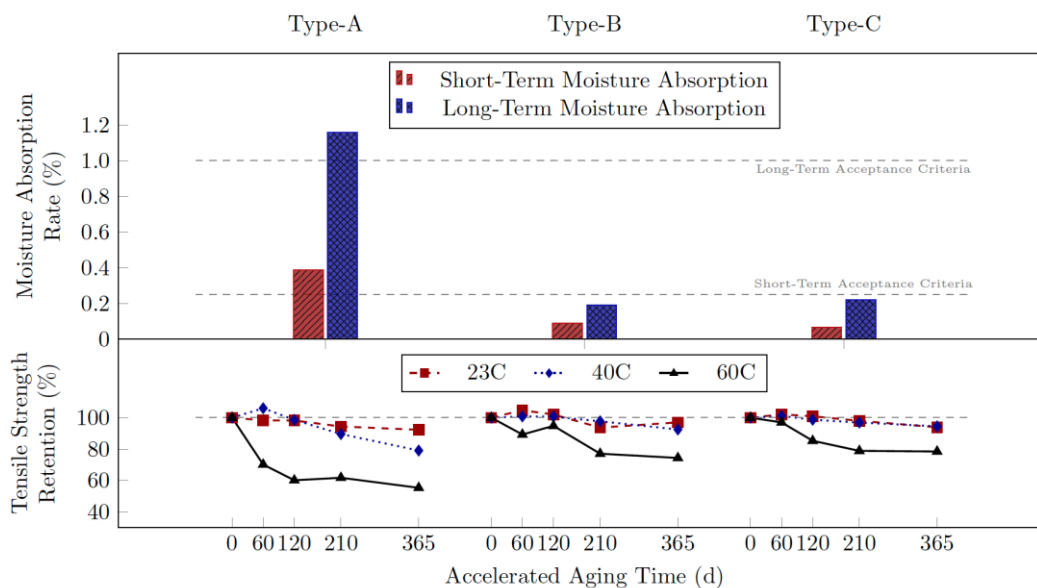
The short and long-term moisture absorption properties for each rebar type are plotted in the top graph of Figure 5, to compare it to the tensile strength retention, which is plotted in the bottom graph. As the

Figure 5: Moisture absorption to strength comparison

data for the bar graphs was taken from the previously shown Figure 3, it can be seen once again that Type-A rebars absorbed significantly more moisture. Moreover, the graph clarifies that Type-B and Type-C rebars were the only types that met the short and long-term moisture absorption criteria listed in ICCES AC454 (ICC Evaluation Service, 2016), whereas Type-A rebars exceeded both limitation criteria. The excessive moisture absorption characteristics lead to significant strength degradation, specifically for an exposure temperature of 60 °C (140 °F). While the minimum strength retention for Type-B and Type-C rebars remained above 90 % at low temperature exposure and at approximately 80 % for the high temperature exposure, Type-A rebars lost significantly more tensile strength with values below 60 % at high exposure temperatures.

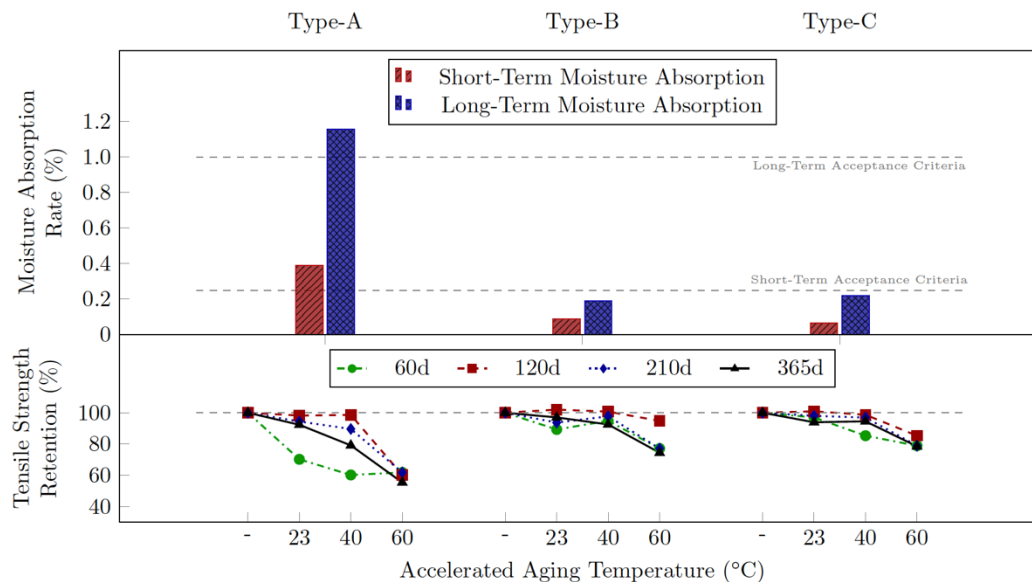
While Figure 5 graphs the exposure duration along the x-axis, the following Figure 6 lists the exposure temperature on the x-axis and plots the data sets by exposure duration. This graph was created because the SEM pictures of the microstructure revealed a significant difference due to elevated temperatures. Figure 6 confirms or emphasizes this finding as a significant change in tensile strength retention between 40 °C and 60 °C (104 °F and 140 °F) was noted for all data sets. Based on this graph, the exposure temperature appears to have a more significant impact on the rebar durability than the exposure duration.

Figure 6: Moisture absorption to strength comparison

From the graphed data and the observed microstructure, it can be inferred that the production porosity impacts the moisture absorption properties, which in turn has a significant impact on the durability or strength retention properties of the rebar. It is emphasized that the evaluated tensile strength is a fiber driven strength property and it has to be assumed that saltwater exposure (at high temperatures) degrades the fibers of porous GFRP rebars. Accordingly, a dense rebar structure and a low moisture absorption are imperative for a proper and long service life of concrete structures reinforced with FRP rebars. In addition, the exposure temperature appears to have a significant impact on the long-term performance of GFRP rebars and the effect should be considered for future acceptance testing of composite materials for the use in harsh environments. Likewise, a realistic accelerated conditioning temperature should be determined to realistically reflect the degradation of FRP rebars in concrete structures throughout their entire service life.

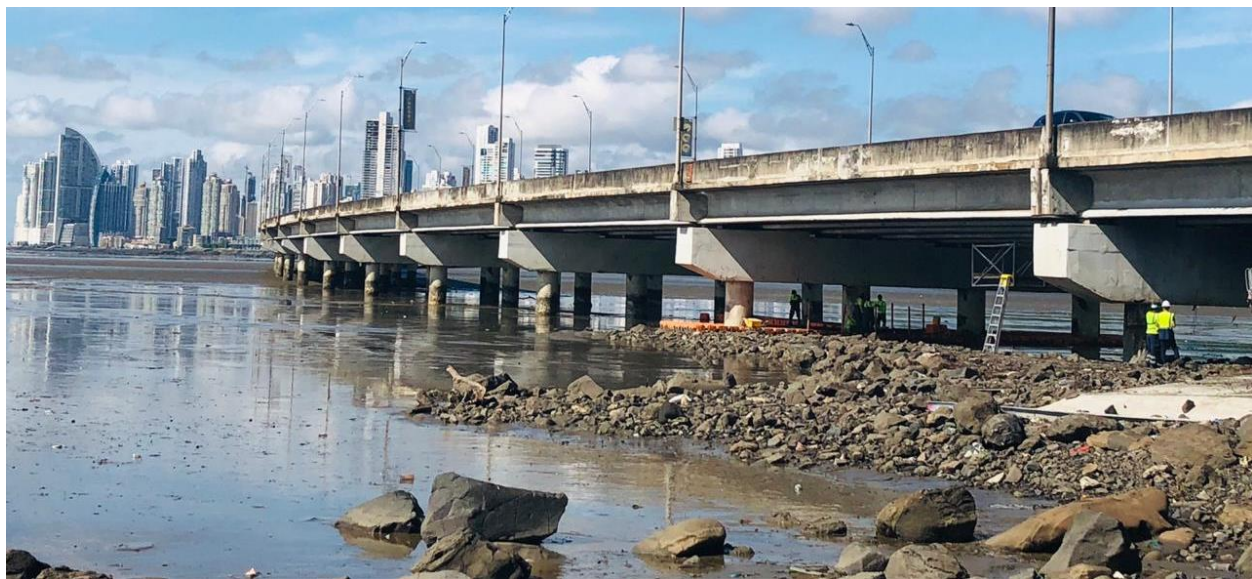
The structure, as shown in **FIGURE 1**, is made up of eight NU1350 precast prestressed girders spanning 98 feet through 80 spans in total. The bent caps are 5-feet deep and 5-feet wide. The highway includes 6 lanes across. Each bent cap is supported by four columns, 48 inches in diameter and exposed between 6 and 15 ft above the seabed.

FIGURE 1: South corridor as works begin

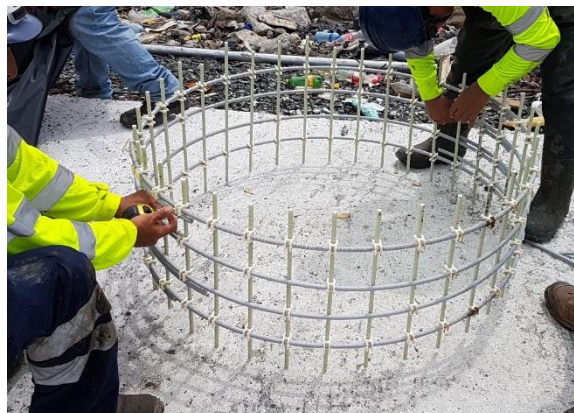
Pre-bent GFRP was incorporated into the rehabilitation scheme of the columns. Two half cylinder meshes were to be placed around the columns to reinforce the new cover material. This option was only to be used if the hydrodemolition did not reach the spirals. If cover was removed all the way to (and a small distance behind) the spirals, the designers considered that the new cover was embedded with the steel spiral which would control shrinkage as it usually does. Pre-bent GFRP was also chosen for reinforcing the initial base of the column rehabilitation as will be explained in the following section.

FIGURE 2: Pre-bent GFRP reinforcement for column bases

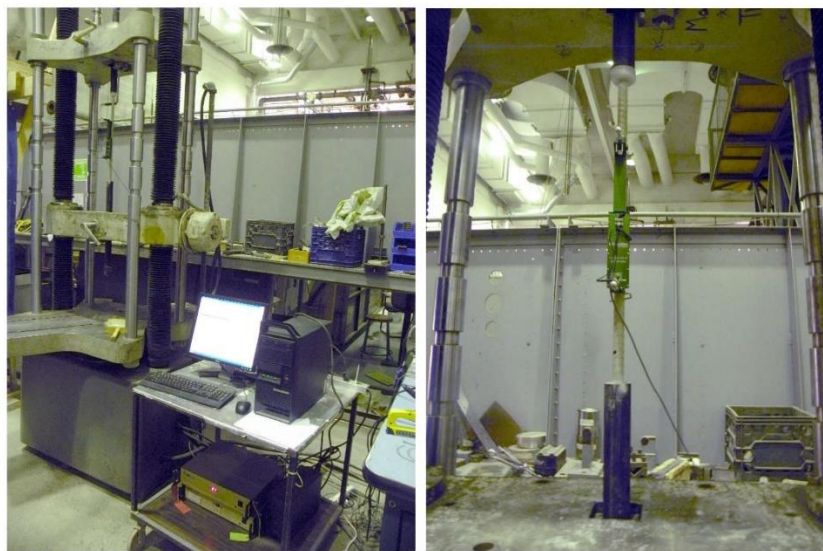
The test was performed using 120 kips (530 kN) Tinius-Olsen testing machine that was recently calibrated by the Tinius-Olsen representative (Fig. 1). A 200 mm gauge length Epsilon axial clip-on-type extensometer was used to measure the strain having +50 mm measuring range. Vishay 5000 data acquisition system was used with 5 readings per second recording rate. The samples were tested according to CSA-S806-12 (2012) Annex C “Test method for tensile properties of FRP reinforcements” and ASTM D7205/D7205M – 06 (2011) “Standard test method for tensile properties of fiber reinforced polymer matrix composite bars.”

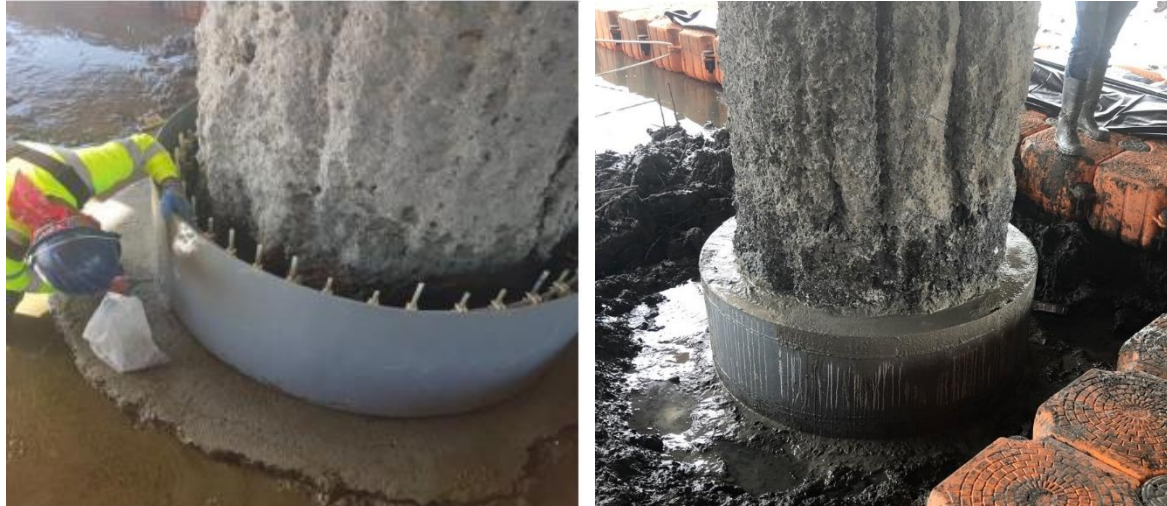
FIGURE 4: Left: reinforcement and jacket before concrete placement of column base, Right: finished column base

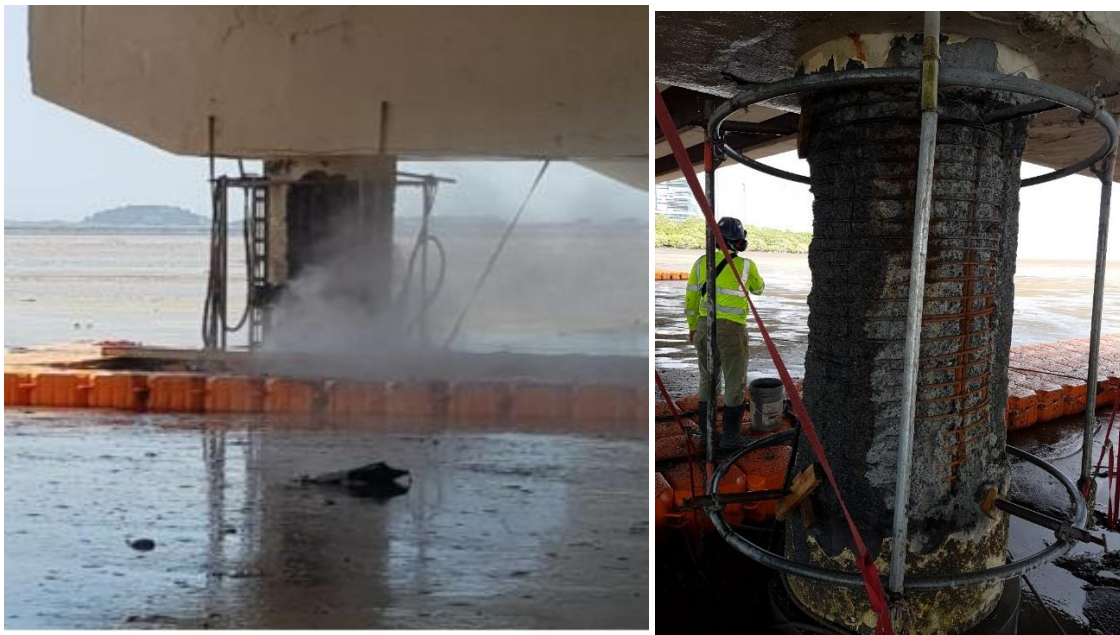
After the base was fabricated, hydrodemolition of the main exposed length of the column took place. A robotically guided nozzle was used instead of hand lances as can be seen in **FIGURE 5**.

FIGURE 5: Left: hydrodemolition operation, Right: hydrodemolition frame for robotic guided nozzle

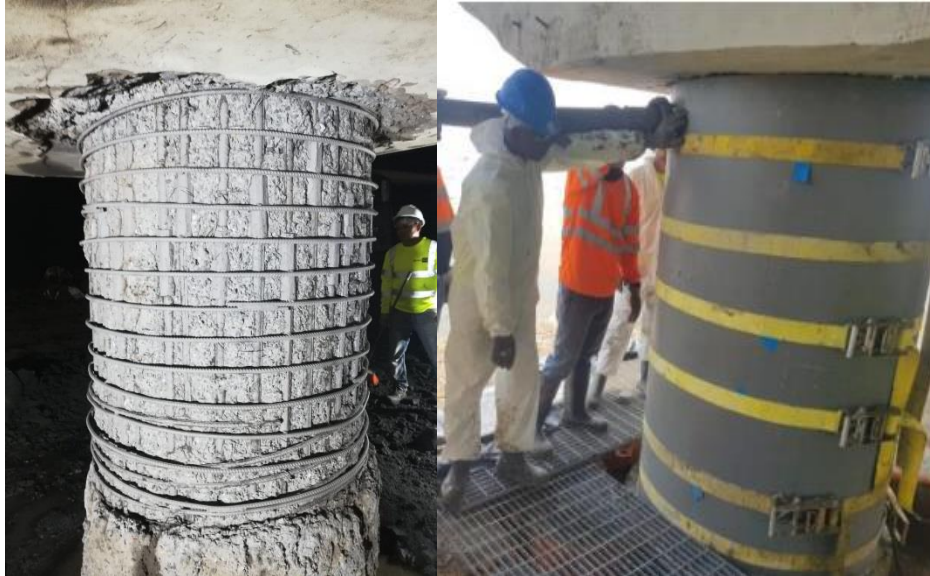
FIGURE 6: Left: column with replaced steel spiral reinforcement, Right: SCC placement operation, FRP stay-in-place jacket

A concrete pump was used to place the self-consolidating concrete into the main length of the column jacket.

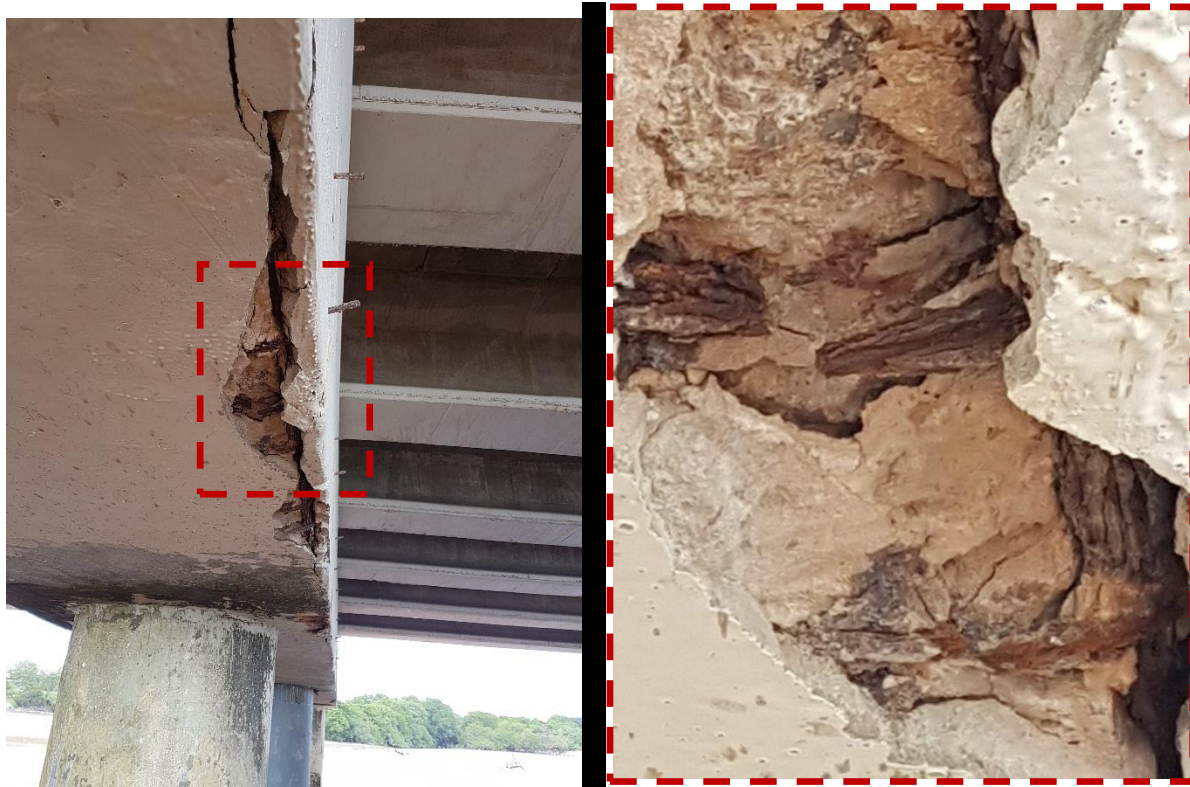
FIGURE 7: Left: damage at underside of bent caps, Right: close-up of broken corner of stirrup

As was done with the column, concrete cover was removed through hydrodemolition. Exposed rebar was treated with an epoxy-cement coating. Rebar with significant section loss due to corrosion was either supplemented with additional steel or replaced entirely. Broken stirrups were repaired.

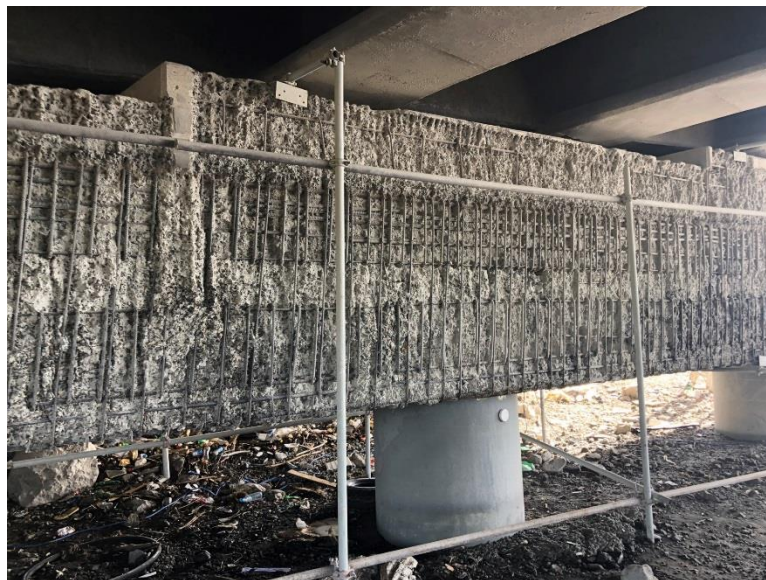
FIGURE 8: Bent cap after cover removal

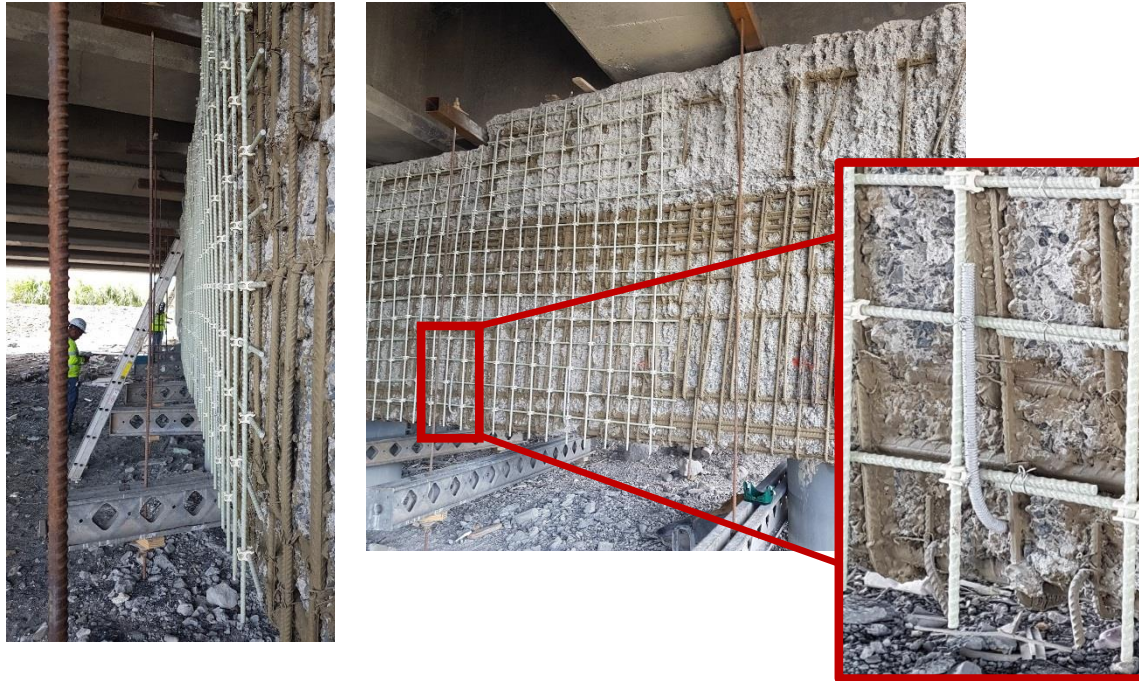
Next, skin reinforcement is placed. A GFRP mesh of #3 bars spaced at 6 inches was held in place with pre-bent L-shaped GFRP anchors as can be seen in **FIGURE 9**.

FIGURE 9: Left: Skin reinforcement of bent cap, Right: close-up of pre-bent GFRP anchor

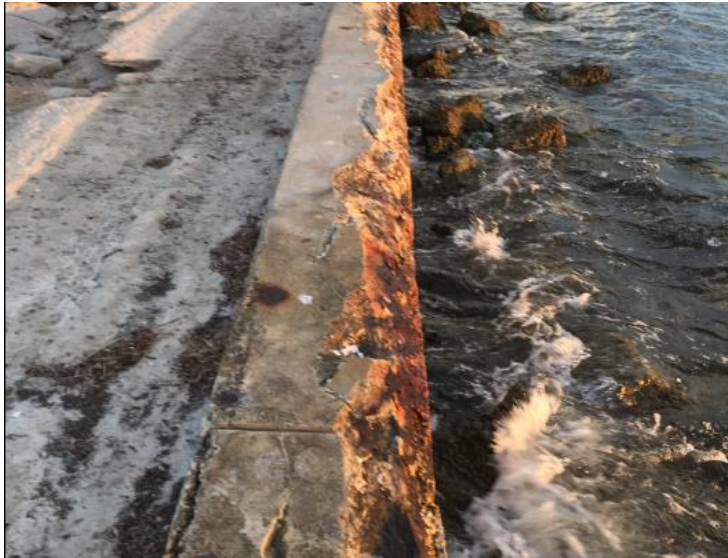
The existing seawall cap along fishing pier road was constructed at various times. The oldest portion was constructed in the 1950s and the newer portion was constructed in the 1980s. Different conditions exist for the different aged caps. The older cap has severe corrosion and spall conditions (see **FIGURE 1**) and the newer cap has minor cracks and spalls. An Alternative Technical Concept (ATC) was submitted and accepted to replace and/or repair based on the condition of the cap. Based on the assessment the 1950s portion of cap was to be completely replaced and the 1980s portion of cap to be repaired. The repairs consist of patching all spalled concrete, pressure injection of epoxy into the cracks 0.02-inches and greater, then applying a penetrant sealer to the entire cap.

FIGURE 1. (a) Existing 1950s concrete cap to be replaced.

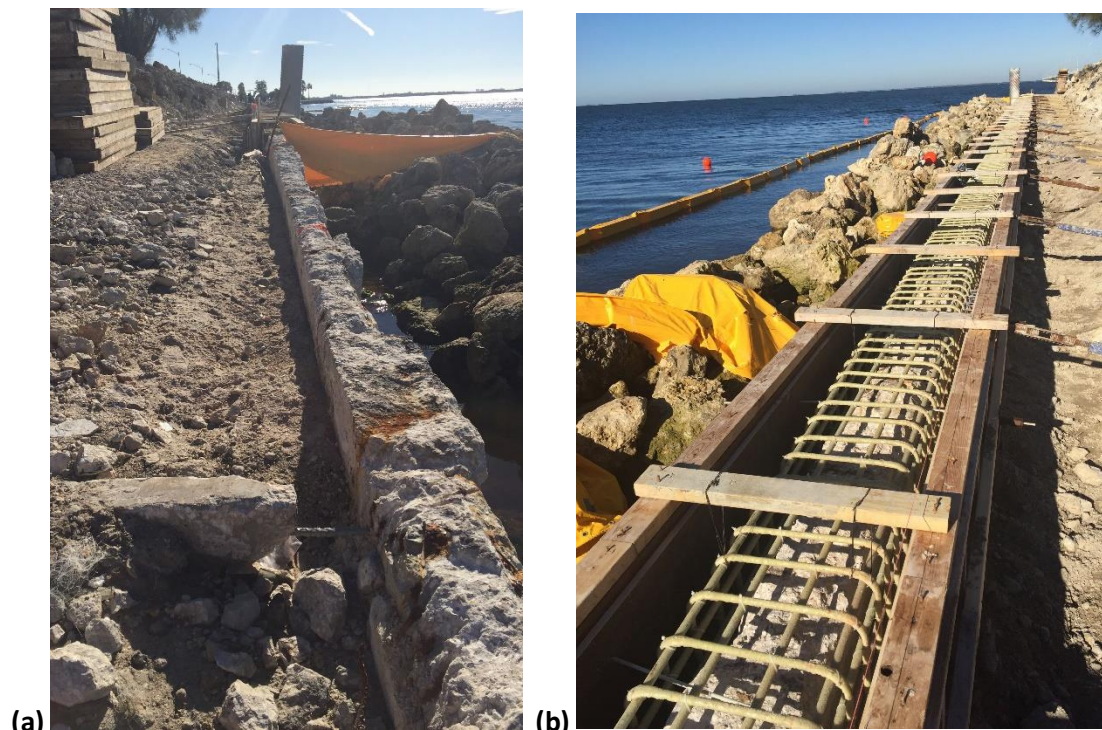
FIGURE 3. (a) Demolition of existing caps showing deep corrosion damage; (b) GFRP rebar replacement caps ready for concrete casting.

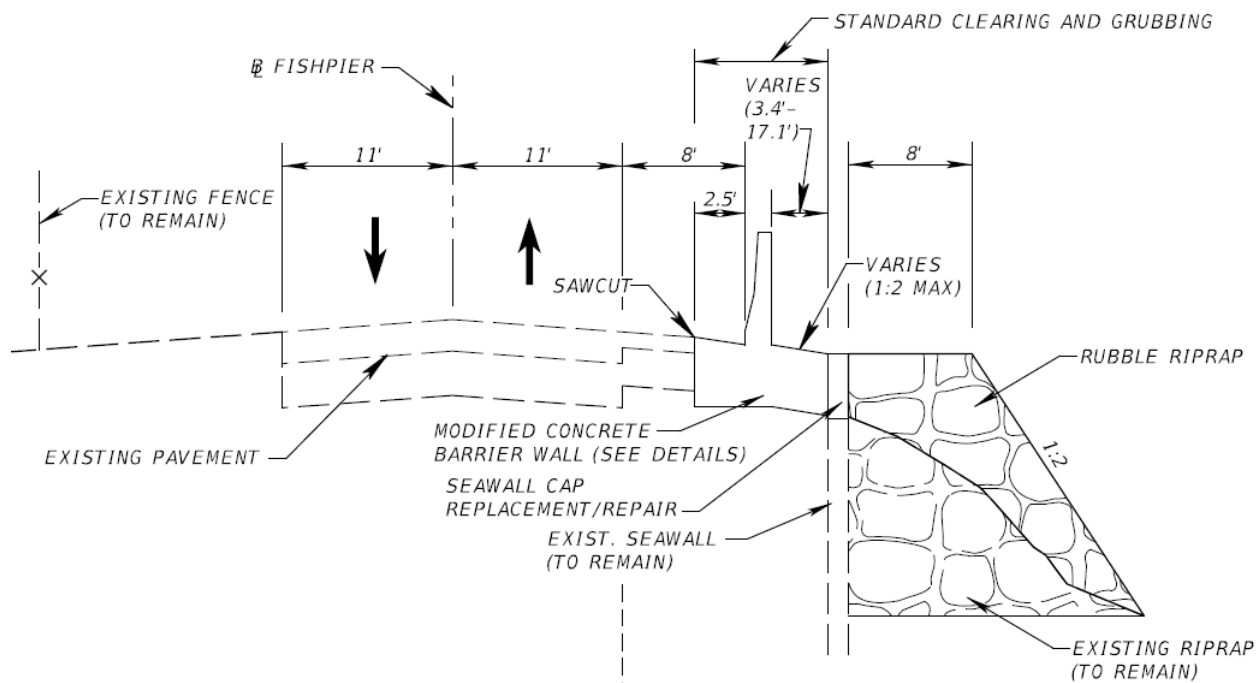
FIGURE 4. GFRP-RC traffic barrier to replace existing guardrail and provide additional wave splash protection to the Fishing Pier access road.

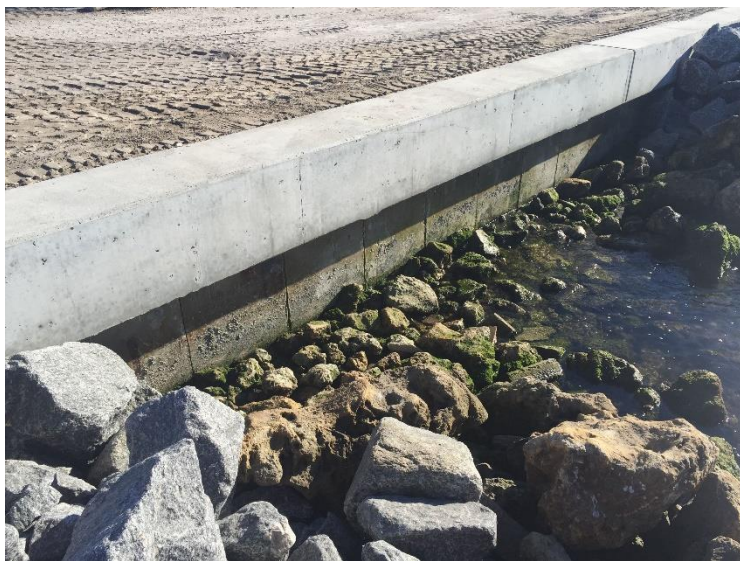
FIGURE 5. (a) Completed GFRP-RC cap on existing sheet piles
