Session 2: GFRP Bar Manufacturer's Installer's, & Supplier's Perspective

Repair of Damaged Bent Caps & Columns Using SCC & GFRP Rebar

“South Corridor” in Panama, Panama

Quality control of continuous processes

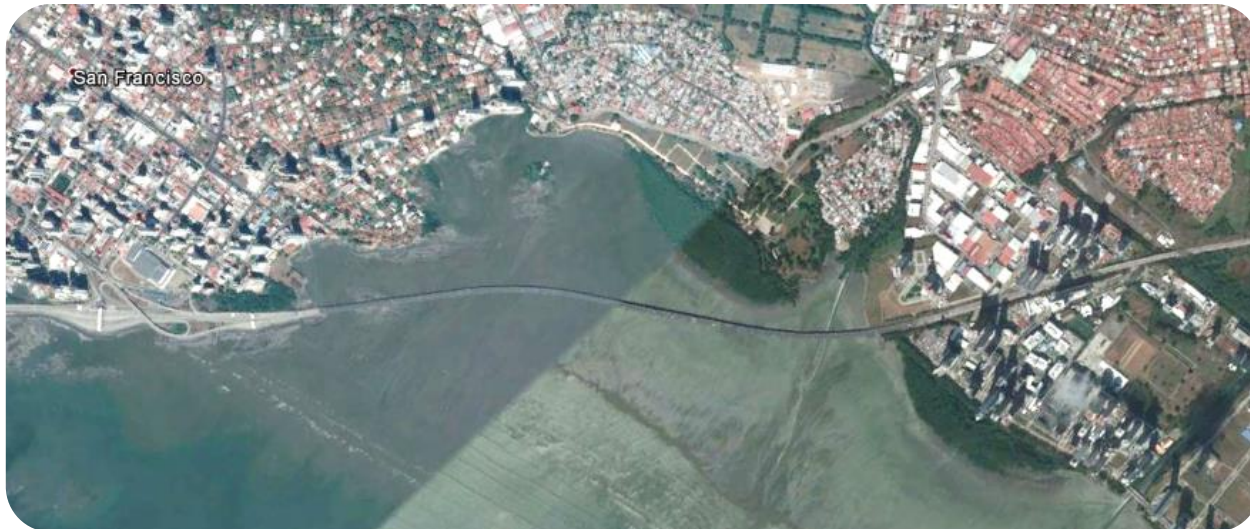
- Inaugurated in 2000
- 1.5 miles
- 6 lanes
- NU1350 girders, five foot deep pile cap, 4 x 48” Diameter columns
- Road Concession - Toll road. Bought back by government in 2015

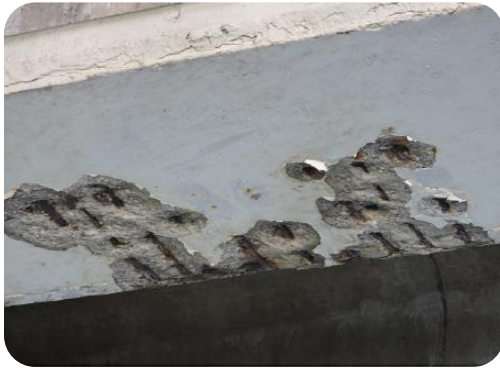
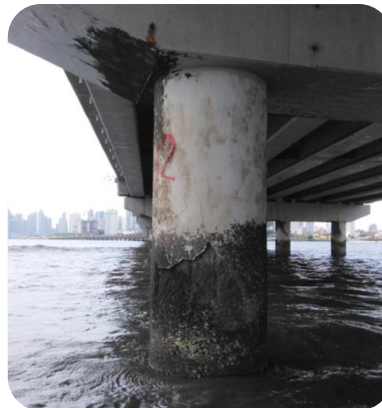
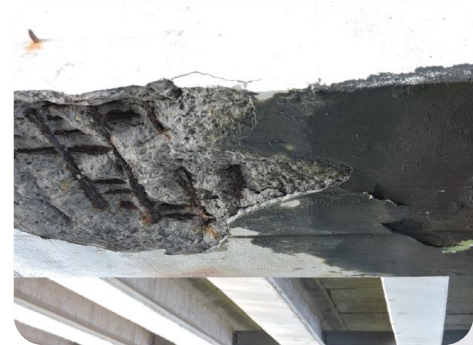
Initial Condition

- Highly Aggressive Environment
- Spalling in NU girders and in pile caps
- Columns have longitudinal cracks consistent with corrosion damage
- Concrete design strength
 - Columns 2500 psi
 - Pile Caps 4500 psi

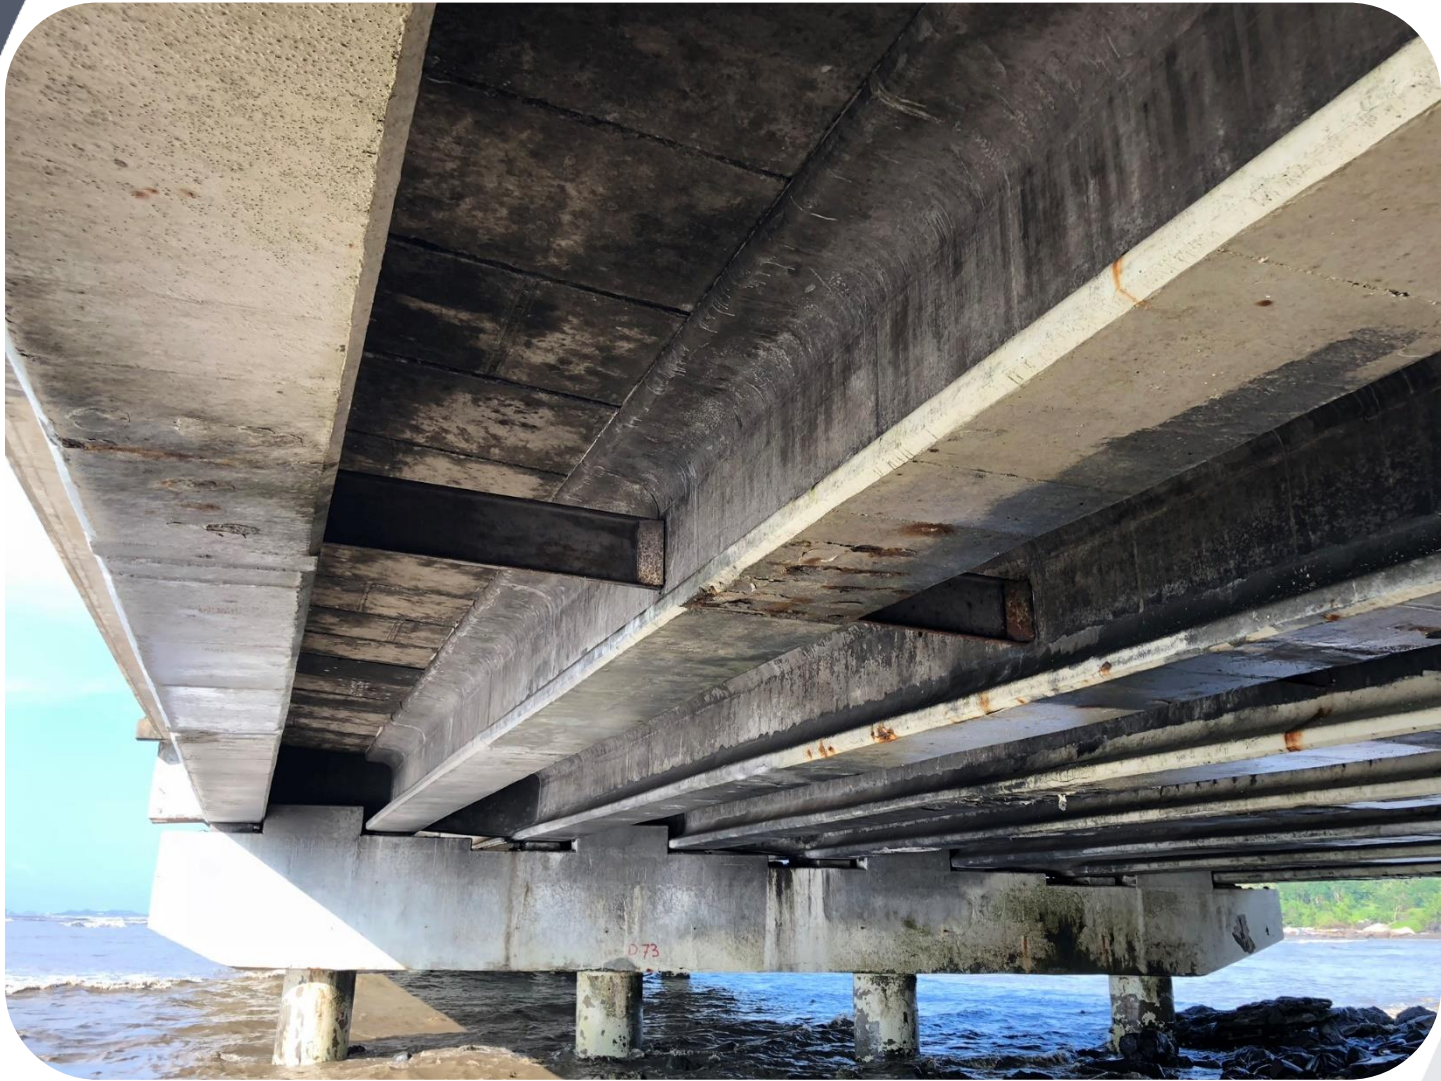
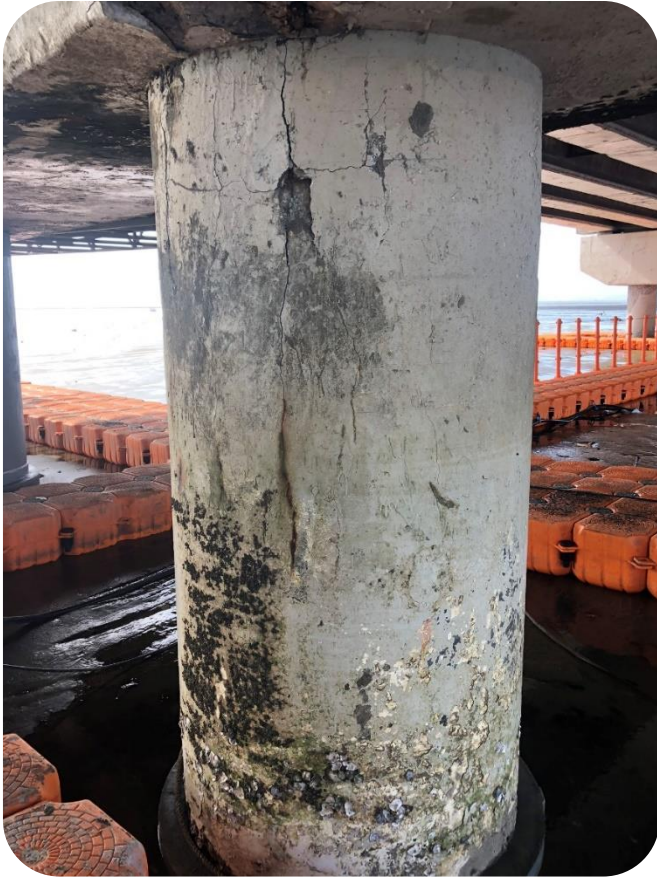
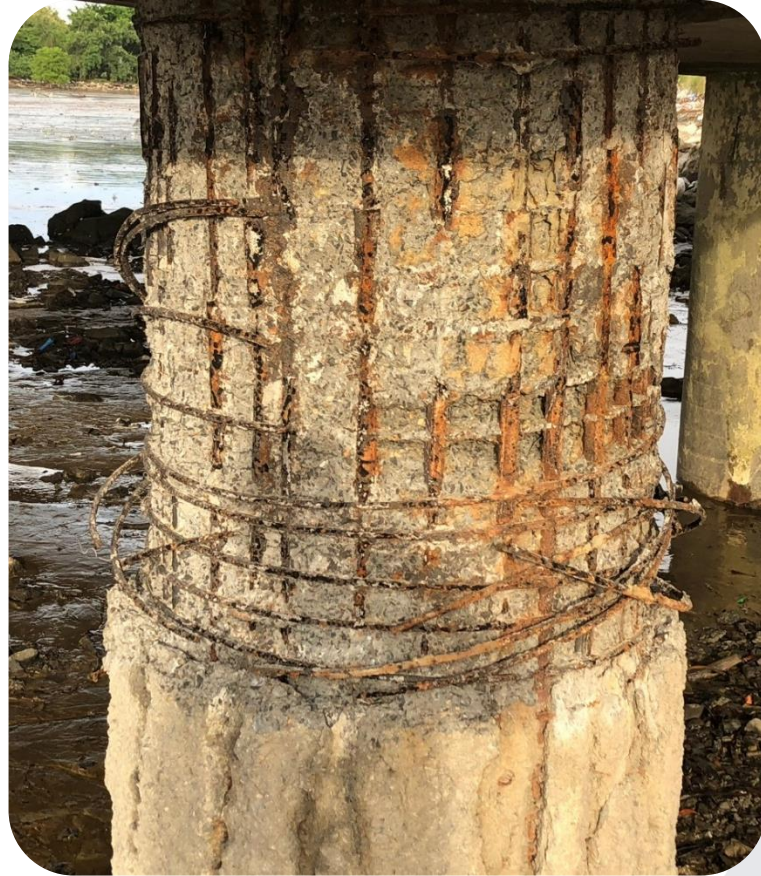
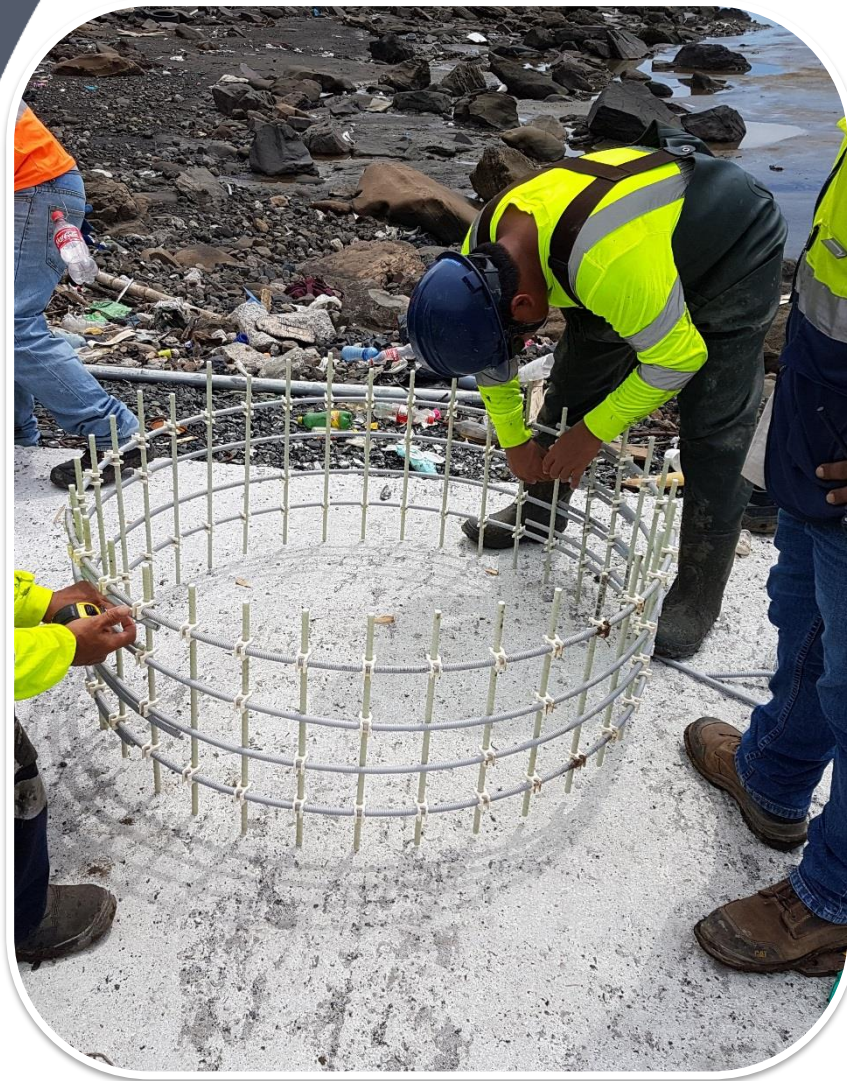
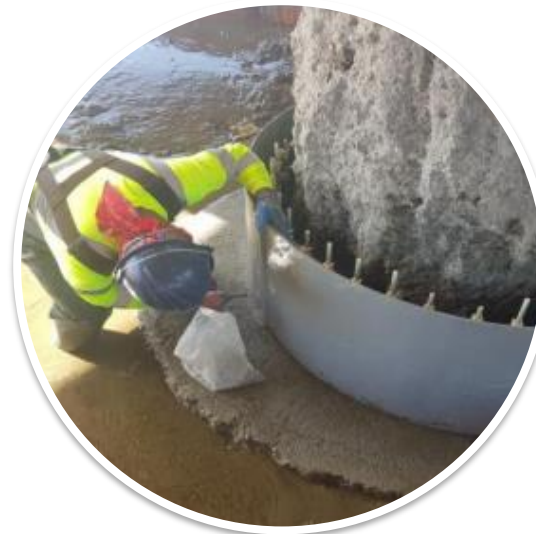
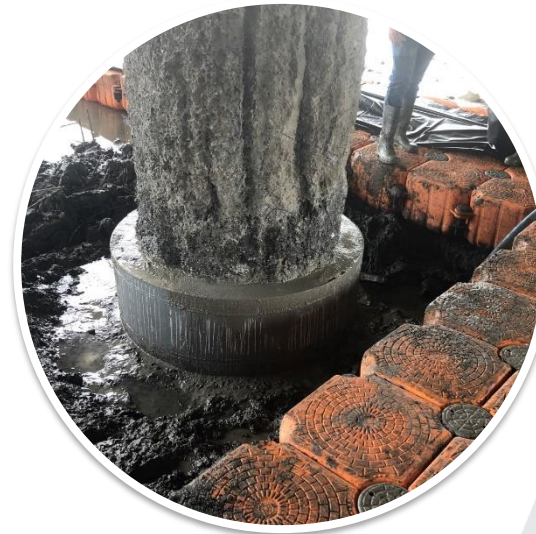
Column Rehabilitation

- Removal of contaminated concrete through hydro demolition
- Replace of highly damaged rebar
- Apply epoxy-cement passivator coat
- Apply Migrating corrosion inhibitor (longitudinal reinforcement is not exposed)
- Install GFRP cage for shrinkage control
- Install Permanent FRP jacket
- Cast new self-consolidating concrete (Type I cement, Corrosion inhibitor, ~12000 psi @ 28 days)

- Use pre-packed repair mortar
 - PRO: Very little shrinkage, very high early strength, low permeability
 - CON: \$\$\$\$\$\$\$\$\$\$
- Use self-compacting concrete with 3/8" aggregate
 - PRO: high early strength, low permeability, Surface resistivity is ~40 KOhm-cm, \$\$\$
 - CON: possible shrinkage problem
- **Shrinkage in SCC was addressed by the use of GFRP reinforcement. Approximately 1.2M USD in savings.**

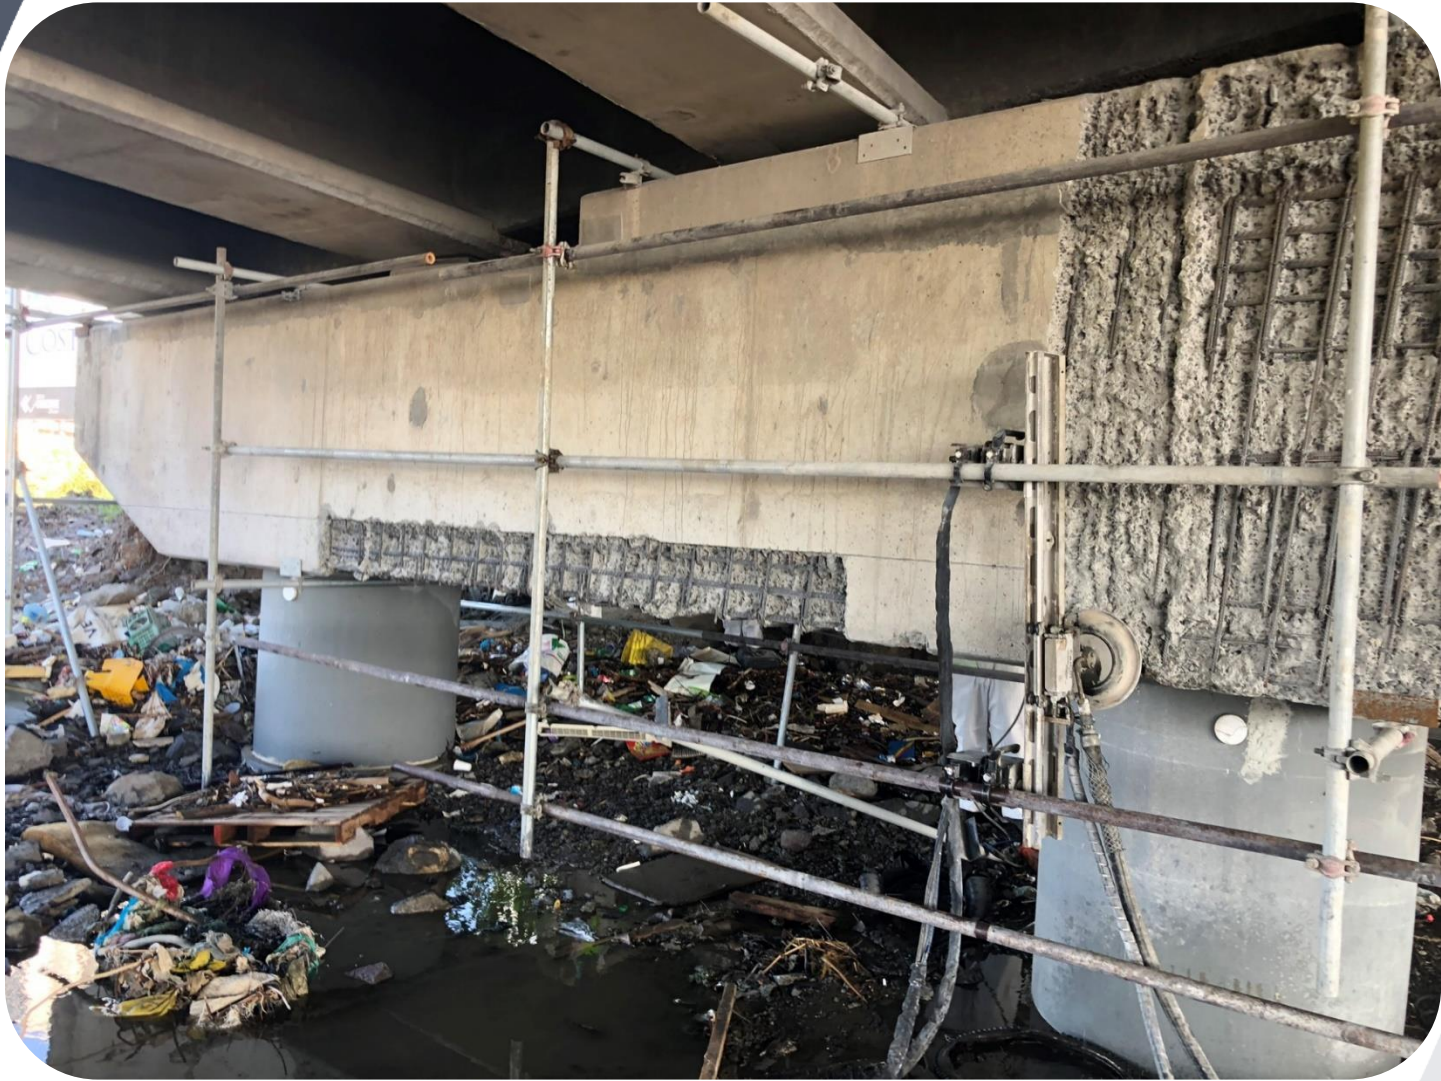
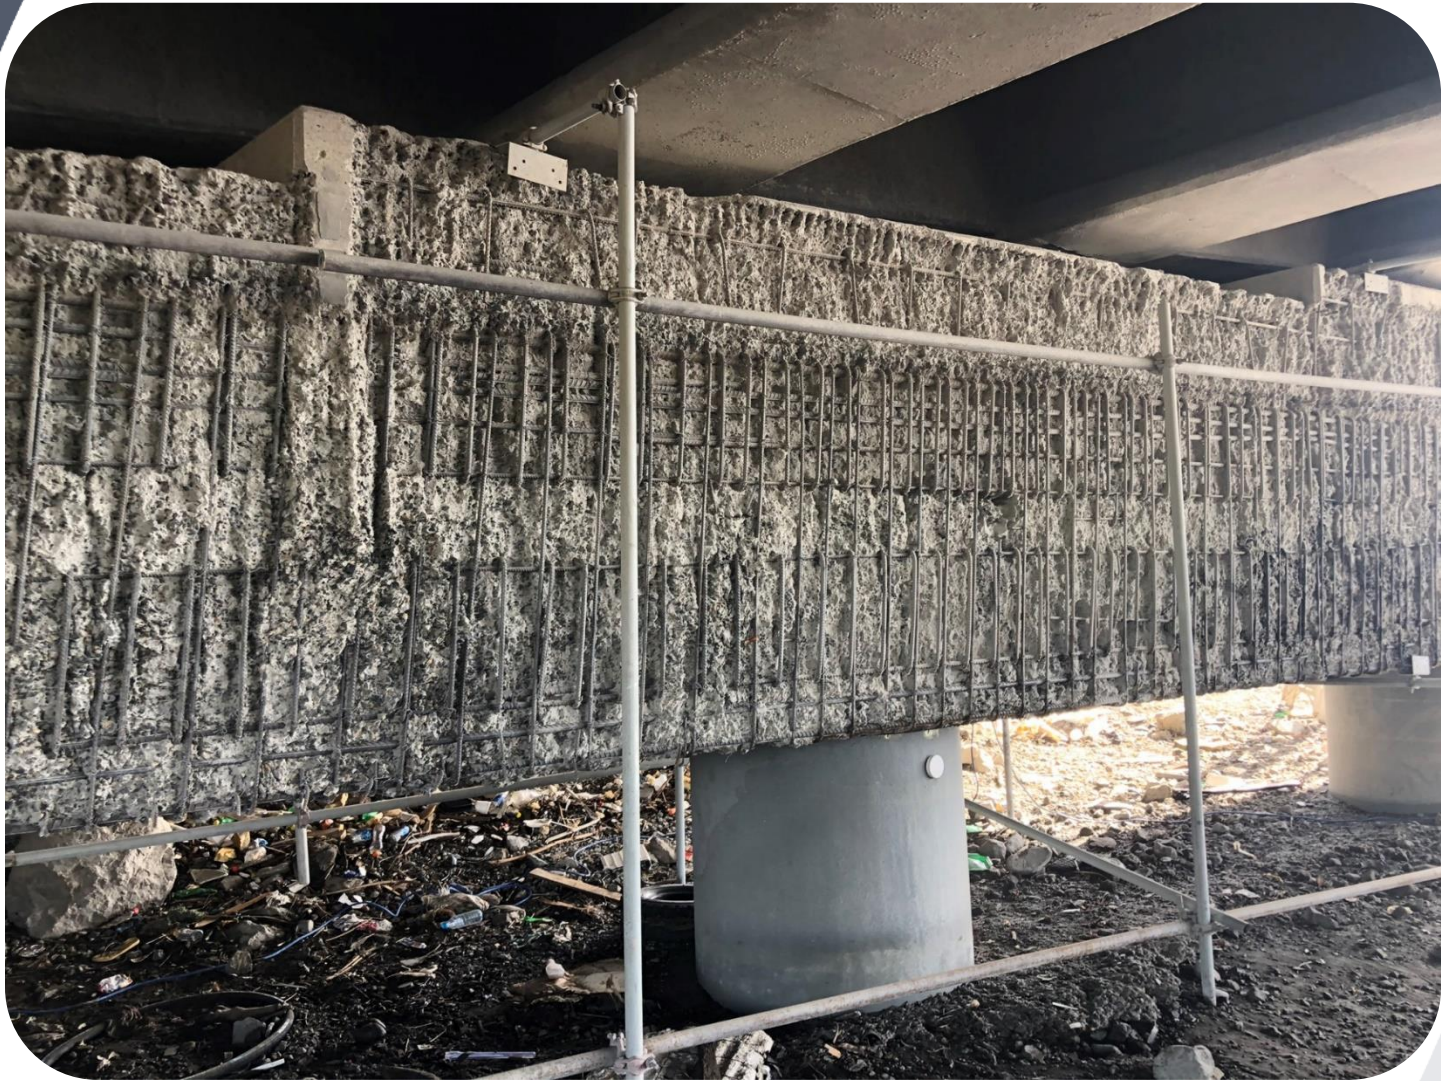
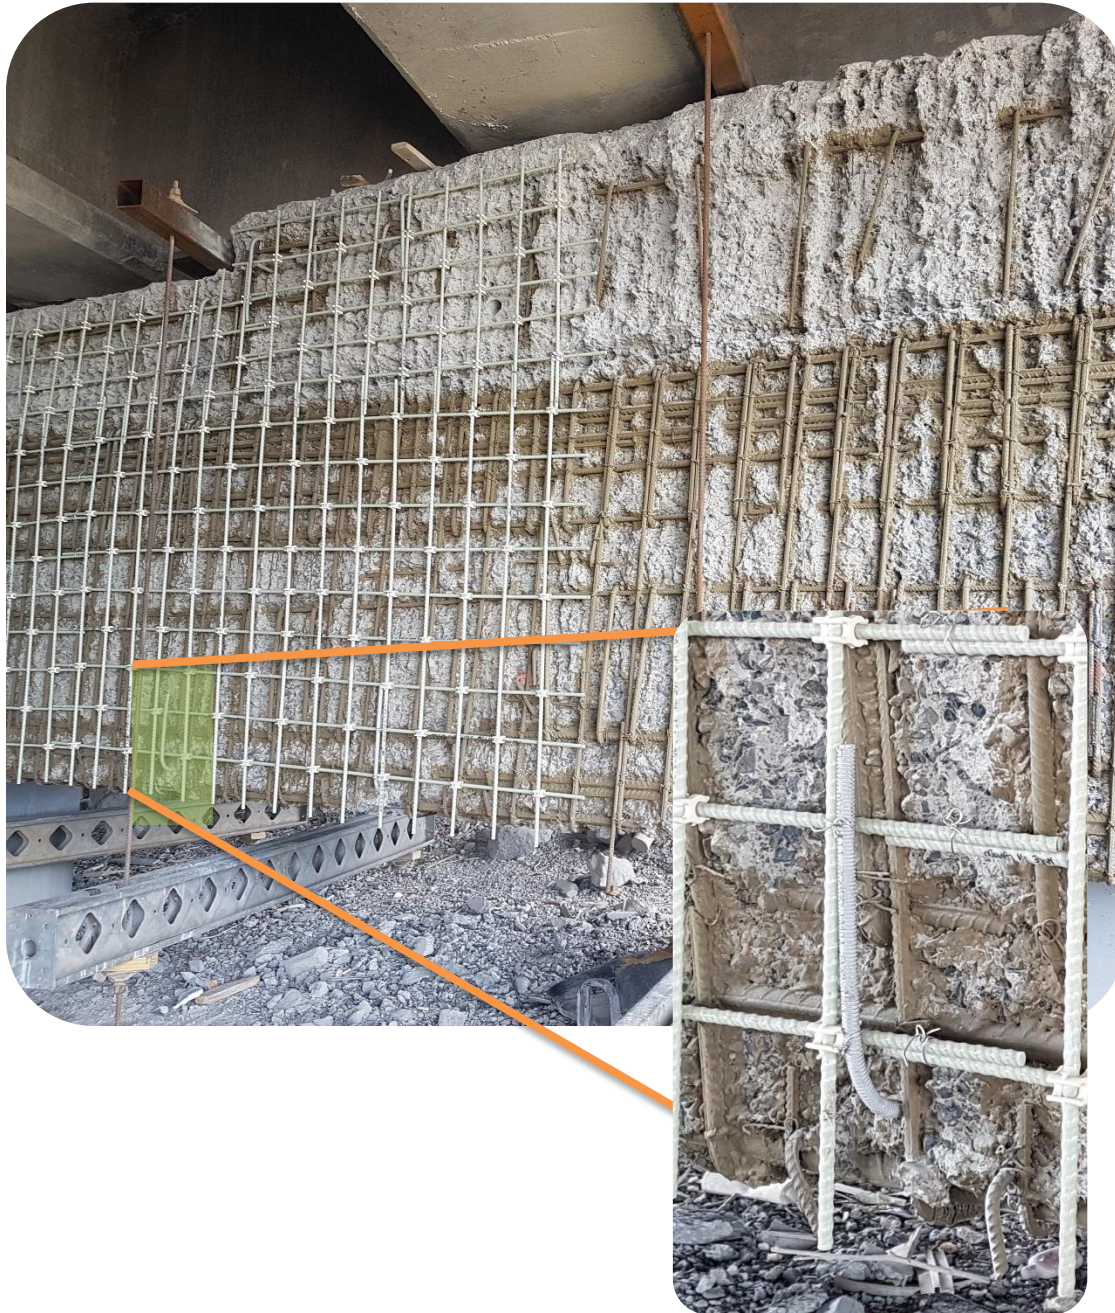
Bent Cap Rehabilitation

- Hydro demolition of cover
- Some rebar replacement, epoxy-cement coating over all rebar
- Apply migrating corrosion inhibitor
- GFRP reinforcement over bottom and sides
- Install formwork and place self-consolidating concrete
