1. Report No. FIU-EDPSE-04	2. Government Accession No.	3. Recipient's Catalog No.	
4. Title and Subtitle  <b>Epoxy Dowel Pile Splice Evaluation</b>		5. Report Date March 2021

# Epoxy Dowel Pile Splice Evaluation

**Project No. BDV29-977-52**

**Interim Report – Task 4 Deliverable**

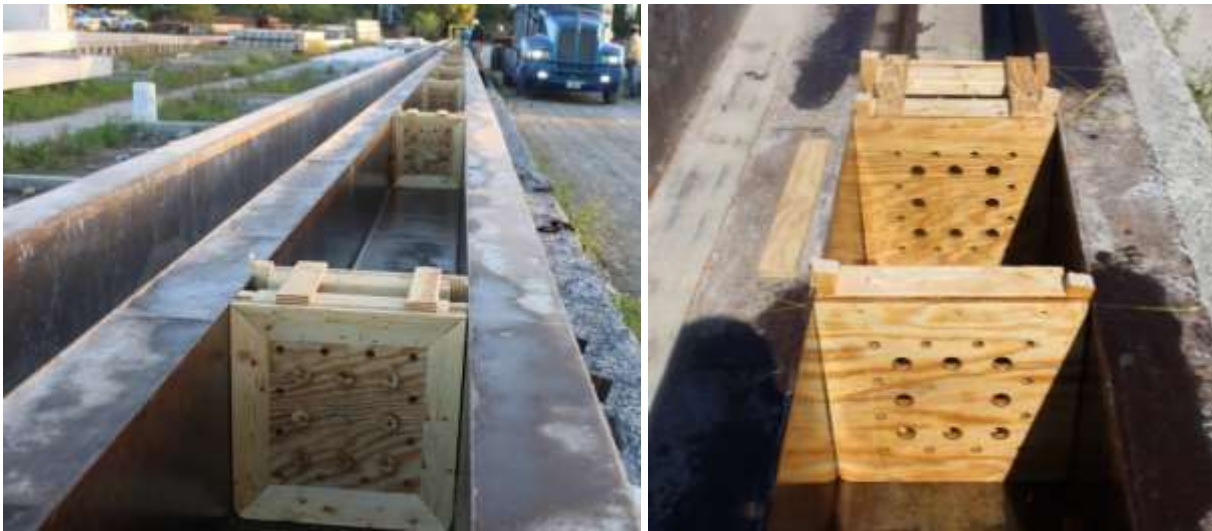
**Figure 1: Wooden headers arrangement in casting bed**

Figure 1 shows the precast bed used for fabrication of the specimens. Wooden headers were used, along with a casting bed to construct the test specimens. Twelve holes were drilled in the headers to accommodate the CFRP and steel strands. According to the dowel arrangements, eight or nine holes were also drilled in the headers to accommodate the steel, CFRP, and GFRP dowels. In addition, spacing between wooden headers were used to allow for the embedment length required for the dowels of the “male” pile specimens (Figure 1, right photo).

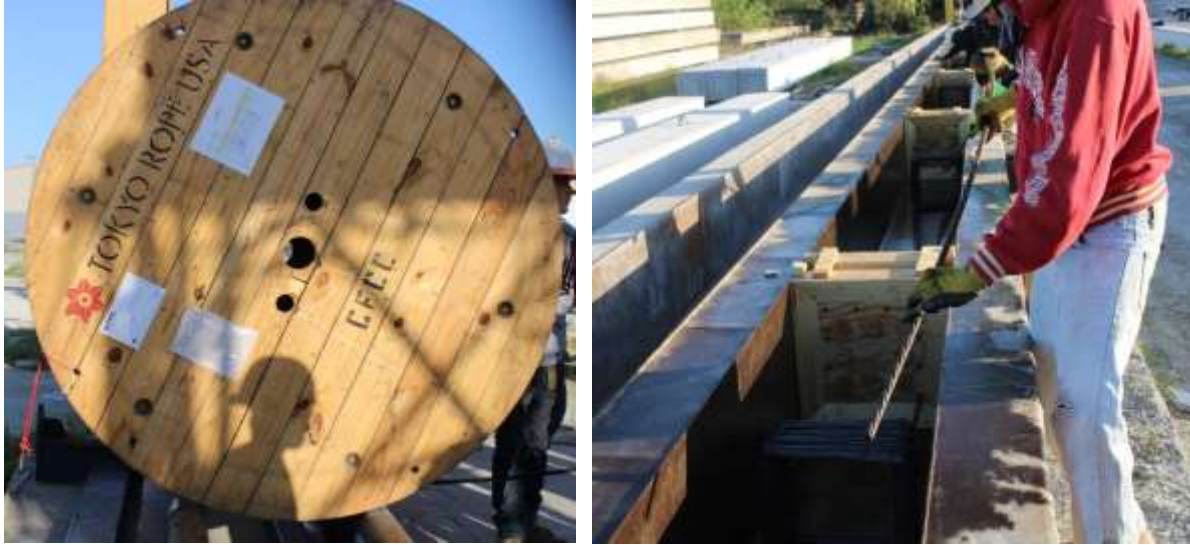
**Figure 2: Stand installation**

As shown in Figure 2, the strands were delivered in spools. The strands were pulled from the spool along with the casting bed, while being fed through the headers. #10 steel dowels and strands were used for pile splices in accordance with the FDOT Standard Drawings Index 455-002 and 455-018.

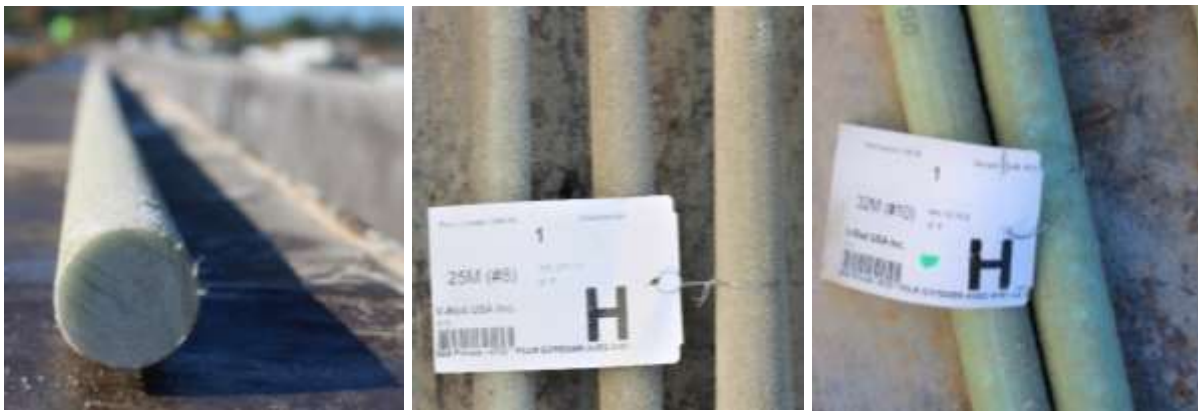
According to proposed Drawings in Task 3 of this research, GFRP #10 and #8 bars were used as dowel and auxiliary bars, respectively (Figure 3) in accordance with the original design presented in Task 3 of this project.

**Figure 3: The GFRP bars used for the construction**

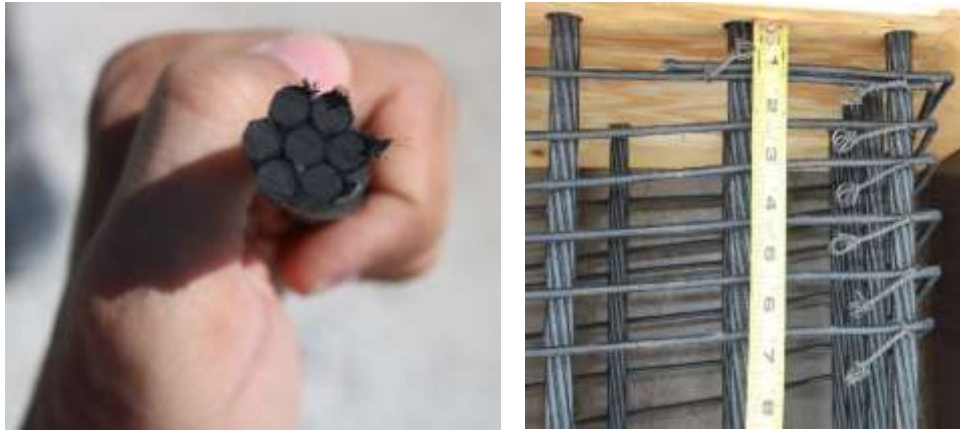
**Figure 4: The CFRP strands and spirals used for the construction**

used instead of #6 CFRP bar for dowels. The modulus of elasticity and guaranteed breaking load of the 7-strand 19.3mm  $\phi$  strand are 21,756 ksi and 106.9kips, respectively (see Appendix B)

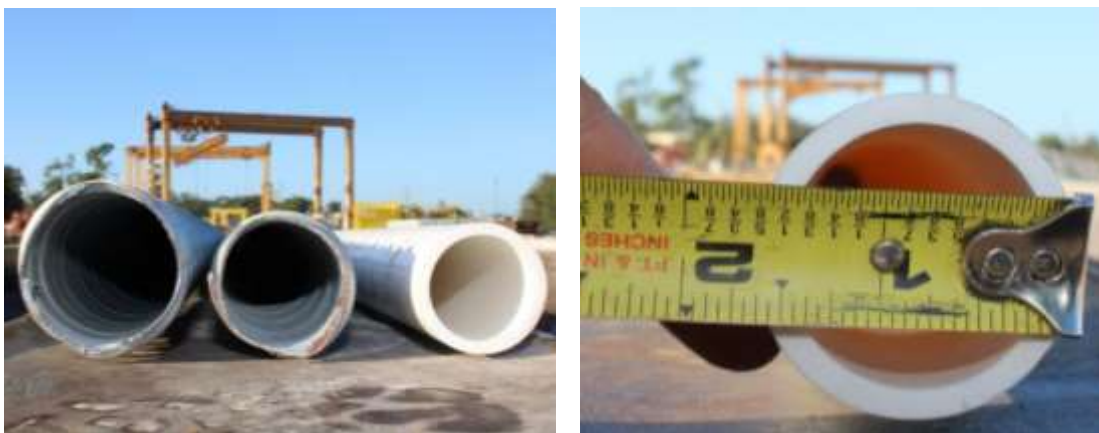
**Figure 5: The pipes used for the construction**

According to FDOT Standard Drawings Index 455, the holes for the “female” pile specimens were cast using 2-inch galvanized pipes for the preplanned Specimens 3-8, and 1 ½-inch galvanized pipes for Specimens 9 and 10 (Figure 5) meeting the requirements of ASTM A653, Coating Designation G90, 26 gauge. The holes for “Unforeseen Splice” specimens (Specimens 1 and 2) were to be drilled with 1 ¾ in. drill size. However, the contractor used 1 ¼-inch PVC pipes to first cast the holes, and then drilled 1 ¾-inch holes in the pipes to simulate field conditions.

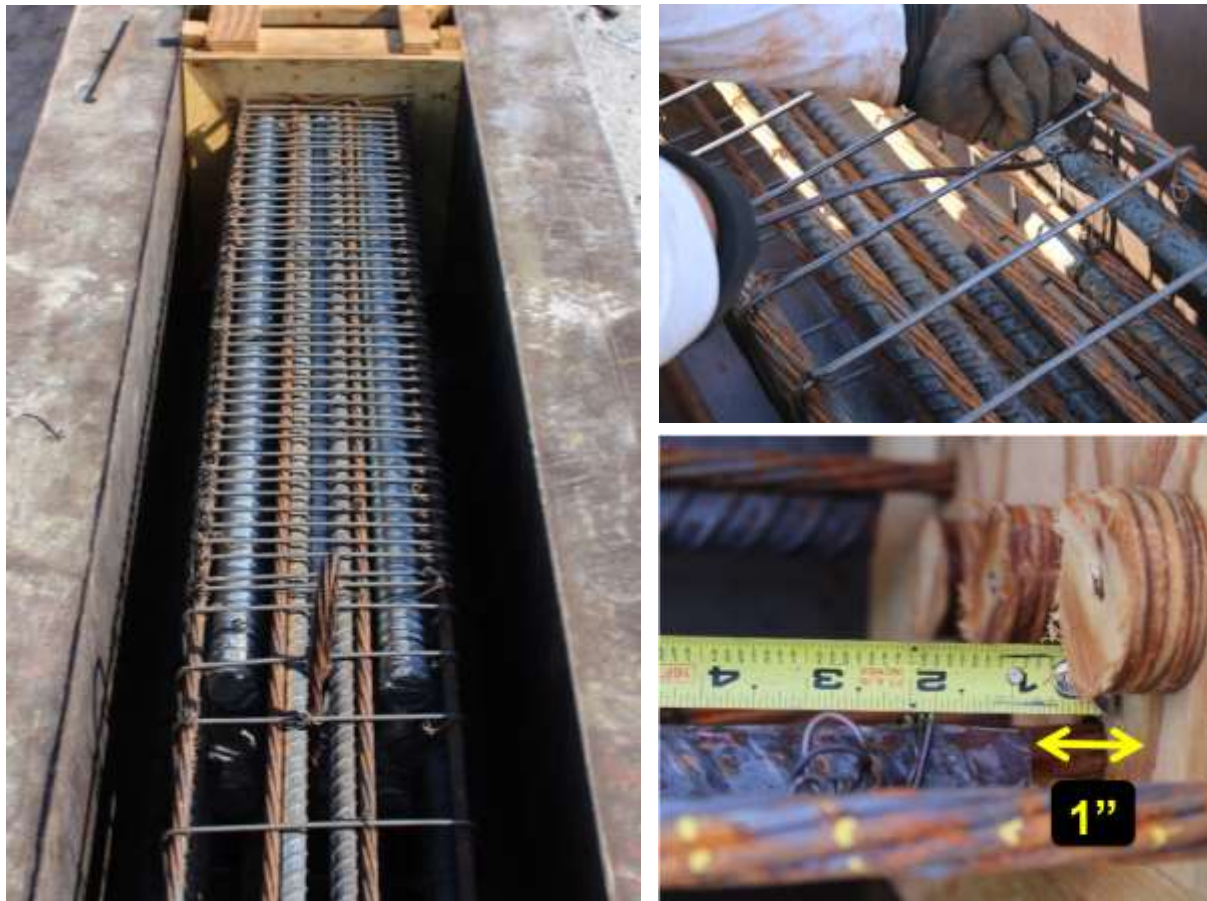
**Figure 6: The spirals, strands and bars configuration**

As shown in Figure 6 (left), in accordance with Index 455-102, Note 4. “1” spiral tie pitch was considered to be continued to 4 ft below the head of the pile where the dowel holes are utilized. One full turn spiral was used to splice the spiral ties. Each wrap of the spiral strand was tied to a minimum of two corner strands. All CFRP and steel spirals were tied in their final position to strands with steel ties (Figure 6, upper right photo). According to the proposed drawings in Task 3 of this research, all auxiliary bars were installed with a distance of 1-inch from the chamfer (Figure 6, lower right photo).

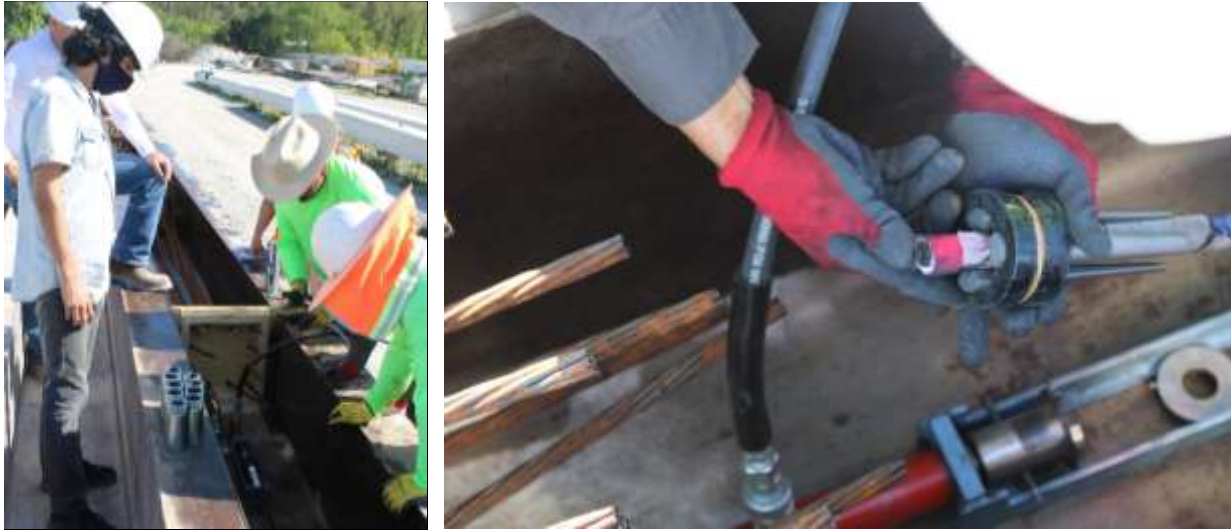
**Figure 7: Coupling arrangement and installation by TRUSA**

installation procedure prescribed by TRUSA (Figure 7). TRUSA engineer was present to train the precaster and inspect the procedure.

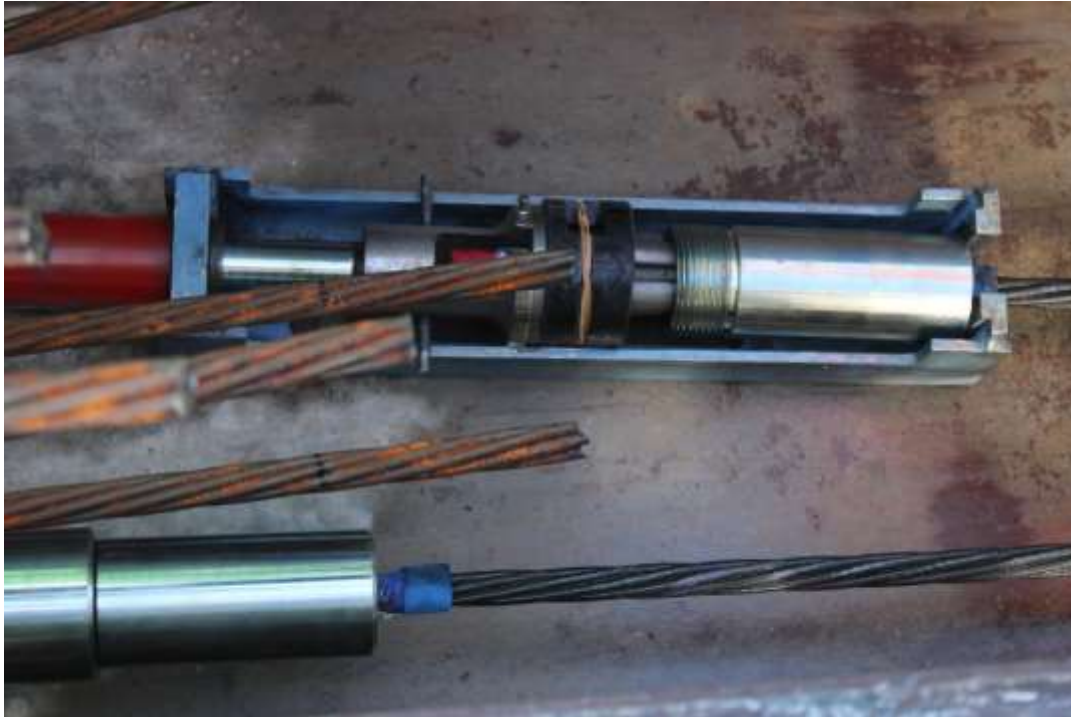
**Figure 8: The steel strands (left) coupled with the CFRP stands (right)**

Figure 8 shows one of these special couplers in which the CFRP strand end installed with wedges and buffer materials was coupled to the steel strand end by twisting together the threaded ends of the sleeve and the coupler.

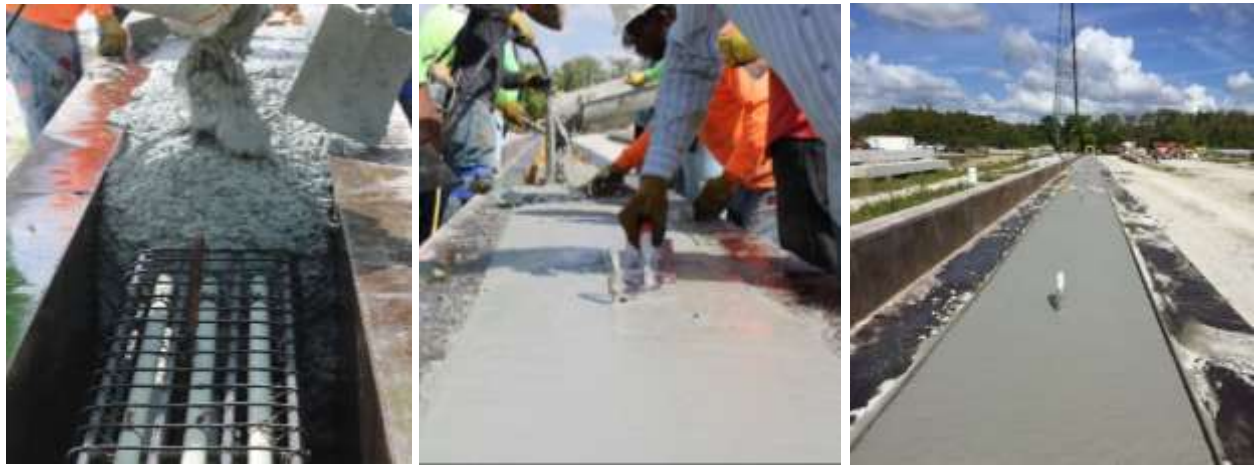
**Figure 10: Casting concrete**

construction for future testing to determine the compressive strength of the concrete used for fabrication of the test specimens. Concrete pour for all specimens was carried out between 12:30 and 2pm on Friday, November 6, 2020. Temperature at the time of casting was in the range of 82°F to 88°F.

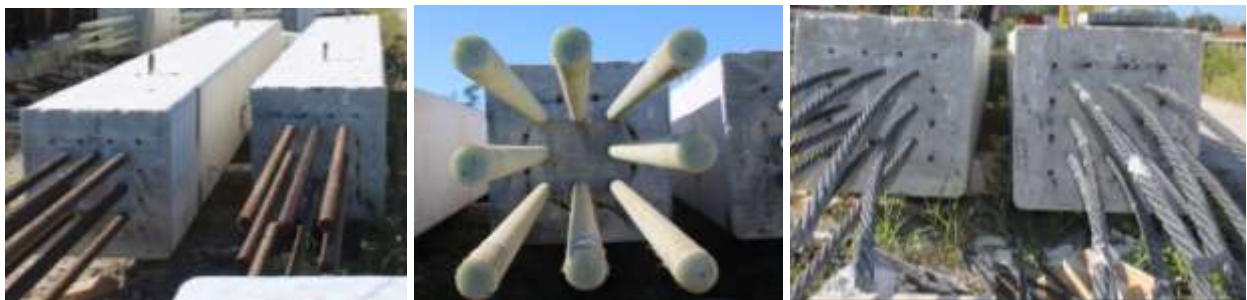
A total of 20- 14-ft-long prestressed precast pile segments with a 18x18 in. cross-section were built at the S&S Precast, Inc. yard to be spliced based on the test matrix shown in Table 1. Figure 12 shows some of the prestressed precast pile segments.

**Figure 12: Pile specimens using steel (left), GFRP (middle), and CFRP (right) dowels**

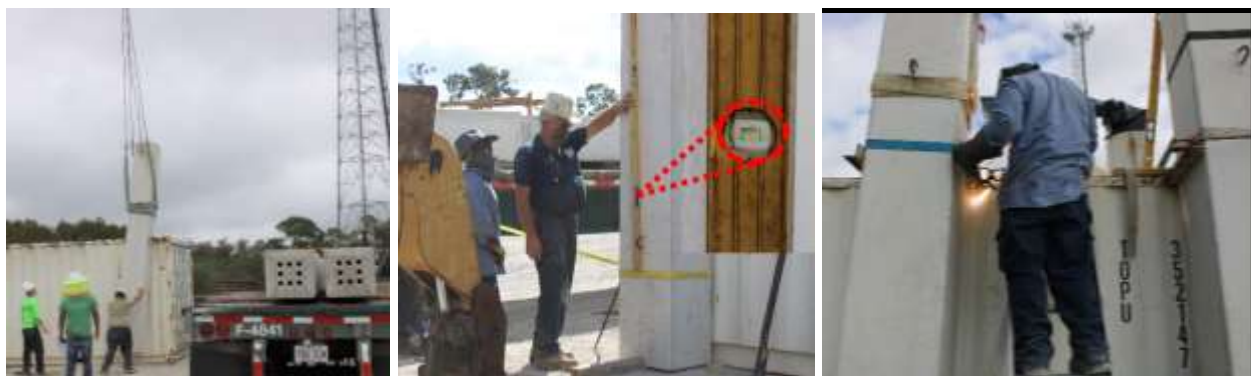
**Figure 14: Splice setup**

Before installation, concrete members receiving dowels were checked to be structurally sound and free of cracks in the vicinity of the holes. The interior surfaces of the holes were cleaned to be free of loose particles, oil, and other contaminants (Figure 14). For installation, all debris, oils, and any other deleterious material from dowels were first removed to avoid contamination of the adhesive bonding material. As shown in Figure 14, the pile segments were assembled in a vertical alignment to mimic the site condition. The precast contractor (S&S Precast, Inc.), established a setup to first keep the 10 female pile specimens in a vertical position. The male pile segments were then installed with the use of crane one by one. A proper lifting device and suitable locations were determined to keep the segments balanced at the splice location.

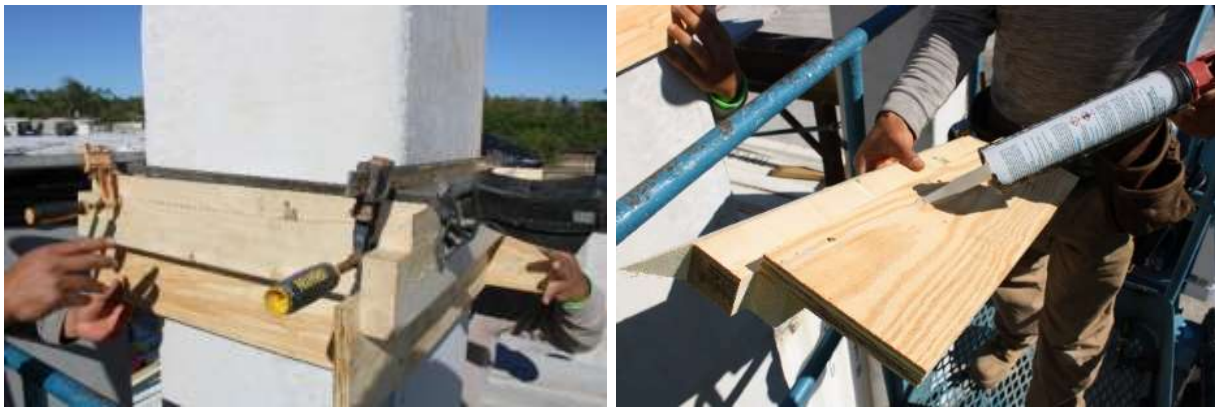
To adequately fill the holes and cover the dowels with epoxy, a wooden framework was installed at the pile splice location before splicing (Figure 15).

**Figure 15: Wooden framework used for splicing the pile specimens**

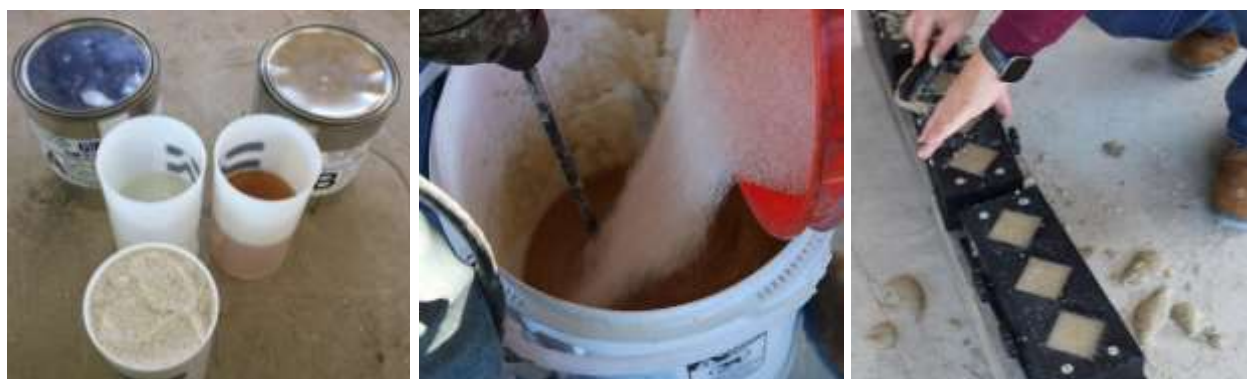
**Figure 16: Epoxy mixture and sampling**

In accordance with FDOT Standard Specification Sections 926 [2020], epoxy was used to fill the interface and sockets of the lower segment (female pile) so that the dowel bars of the upper segment (male pile) could be fully enveloped with the epoxy. Type AB Epoxy- Pilgrim EM 5-2 compound was used to fill the holes and form the joint between pile sections. The final mixture of this epoxy contained the A (epoxy) + B (curing agent) and C (aggregate). As shown in Figure 16, the kiln-dried 20-30 grade silica was used as the aggregate with the epoxy to increase its strength and reduce the potential shrinkage. In addition, some epoxy samples were collected for bond testing with concrete.

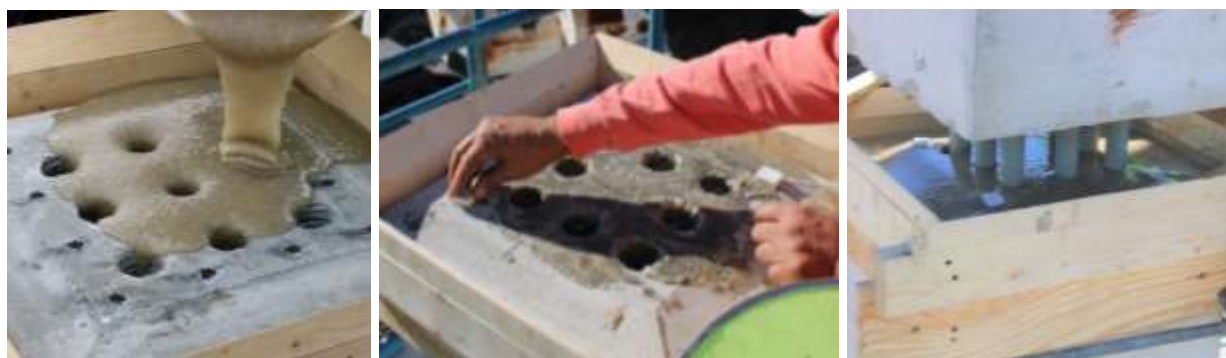
**Figure 17: Filling the holes by epoxy and assembling pile specimens**

Piles were spliced with particular attention to the requirements and limitations due to ambient temperature and curing. As shown in Figure 17, adequate quantities of the epoxy were used to fill the drilled hole and the joint between segments at the splice to ensure no air voids. Table 7 shows the details and conditions of the pile splicing for all specimens.

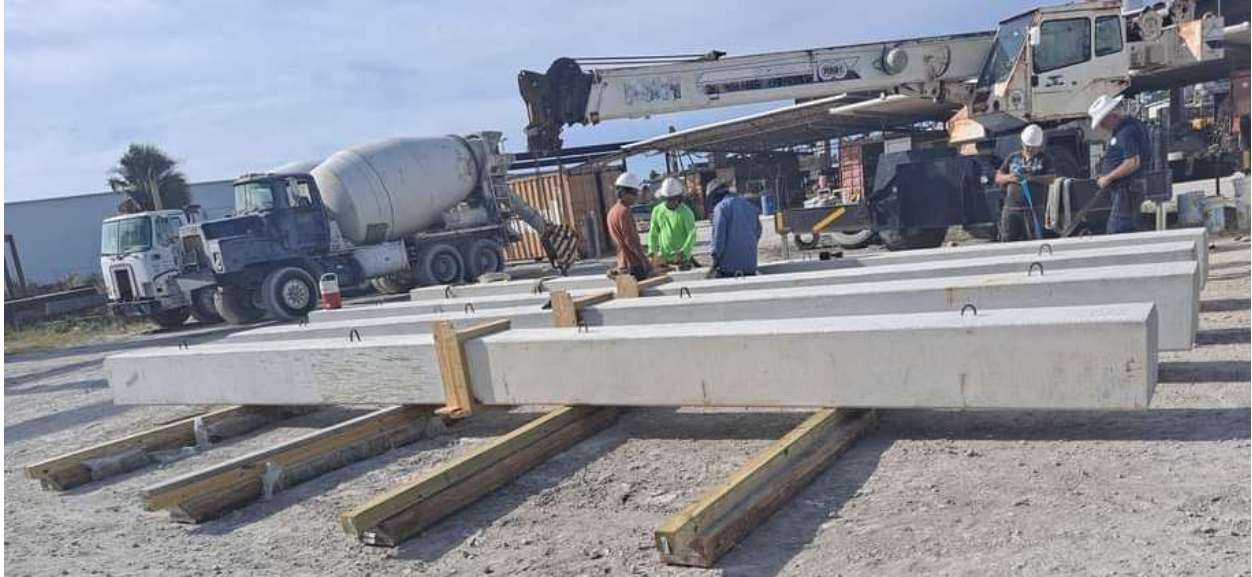
**Figure 18: The spliced specimens**

The piles, once spliced, were left standing for a minimum of seven days for the epoxy to be fully cured, and then all spliced piles were lowered and placed on multiple supports, with two near the ends and two straddling the splice section in close proximity (Figure 18). The contractor used bridles, slings and other required handling equipment for supporting the splices during storage and shipment.

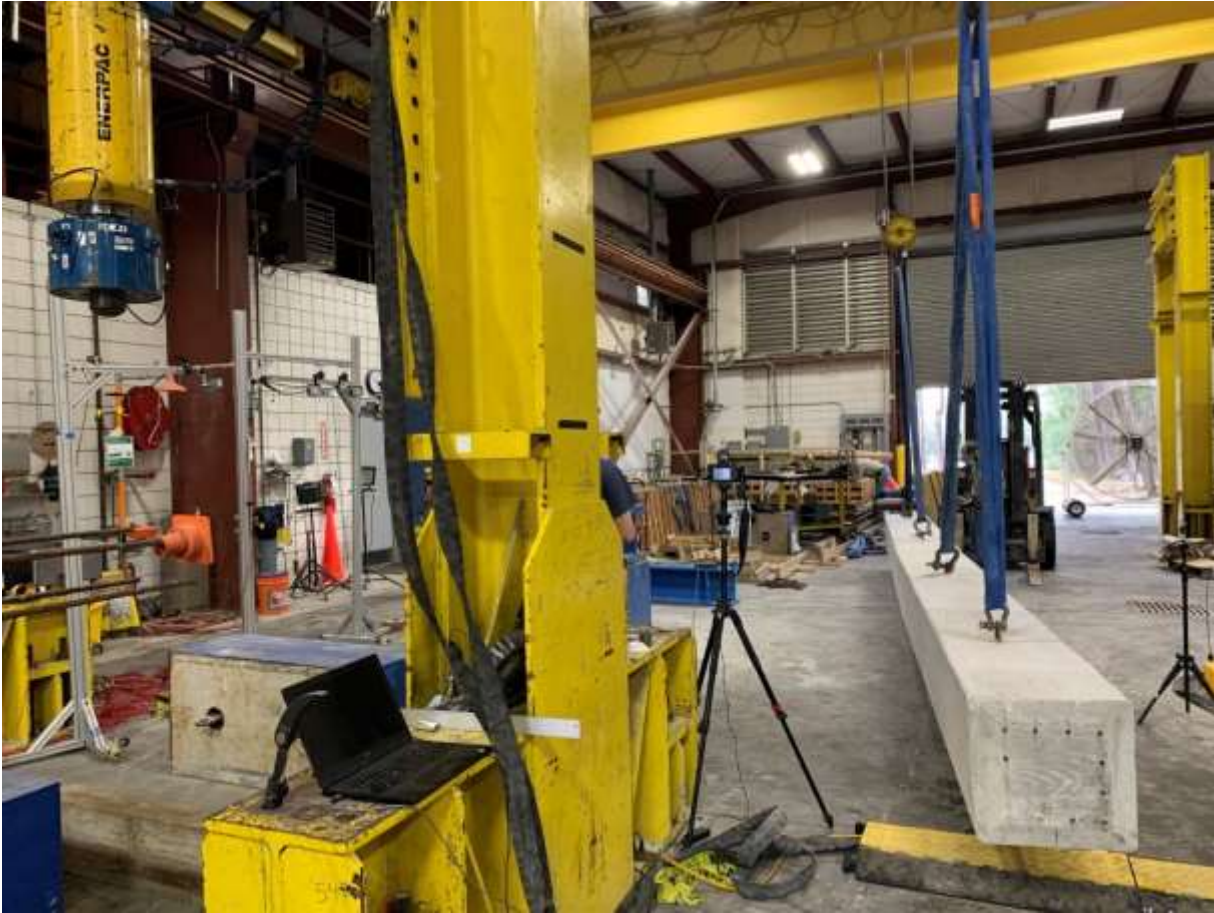
**Figure 19: Test specimen installation**

As shown in Figure 19, the assembled test specimens were installed in the test setup with extreme caution to avoid damage to the splice section. This testing program focused on the global behavior and flexural capacity of the epoxy dowel splices. The test specimens were instrumented to capture the flexural behavior of the splice.

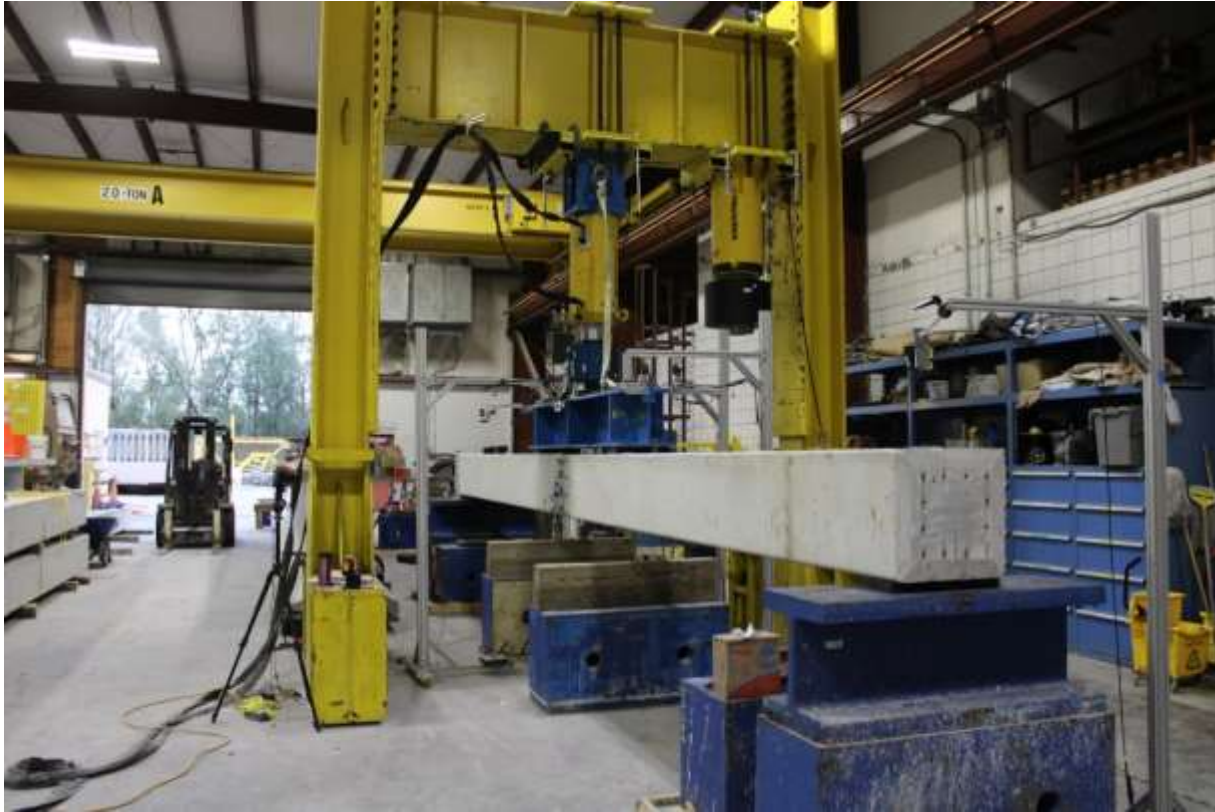
**Figure 24: The test setup**

This chapter reports the results that were obtained from the experimental test performed at the FDOT structures lab based on the proposed experimental program. The main purpose of this experimental program was to determine the flexural strength of different pile splices. Another purpose was to determine the development length of the proposed FRP dowels. Figure 24 shows the test setup with a spliced pile specimen.

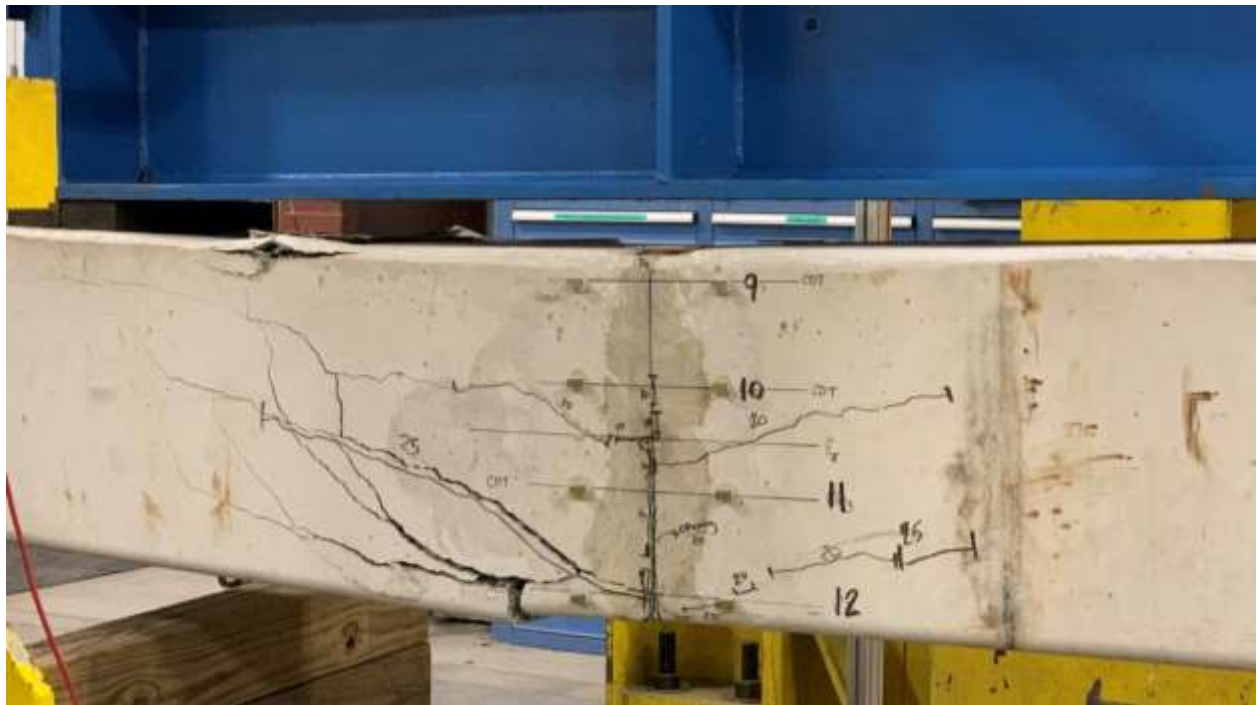
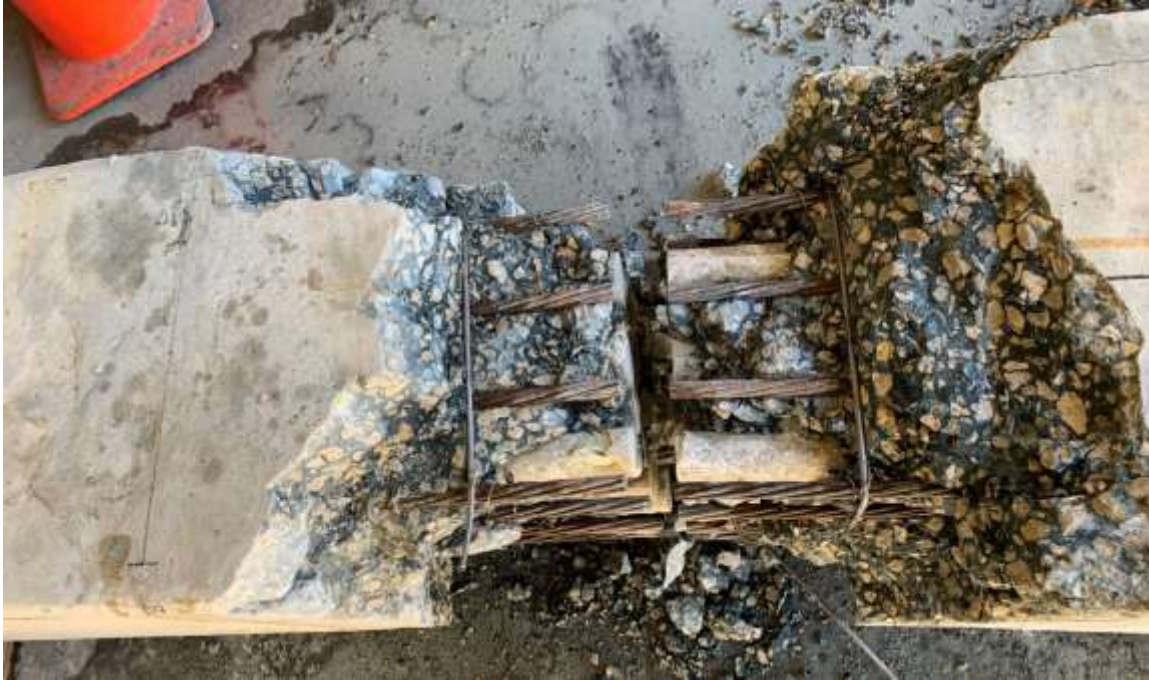
Figure 26: Crack propagation and failure mode of Specimen 1

In Specimen 1, a crack was observed in the splice section prior to the test setup. In this test, the first new flexural crack was observed at the splice section at Step 1, load  $\leq 5$  kips. Moreover, the first splitting crack (near-horizontal crack) was detected at Step 2 (load  $\leq 10$  kips) at the level of the lowest set of strands. As the load increased, more splitting cracks developed on both sides of the splice section at the level of the lowest strand and midsection. These cracks extended farther until the specimen reached its maximum load at 28.09 kips with concrete crushing at the top of the section in the female segment, 2 ft from the splice section. This is in the proximity of the end of the dowel's length (2ft, 6in.). Prior to the concrete crushing, horizontal and vertical cracks showed large openings consistent with splitting due to bond failure. Figure 26 shows the failure mode and crack pattern for this test specimen. The maximum moment capacity was calculated for this specimen to be 178.13 k-ft, taking into account the moment from the self-weight of the specimen and the spreader beam. Dissection after testing showed that there is no major misalignment with the holes drilled in the female segment and their corresponding dowels in the male segment (Figure 27).

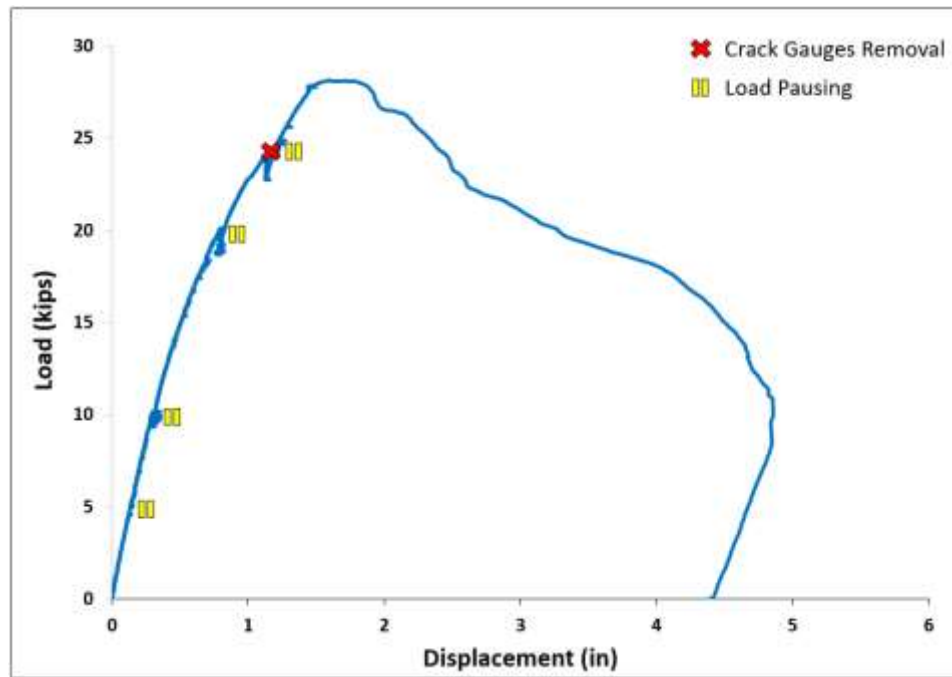
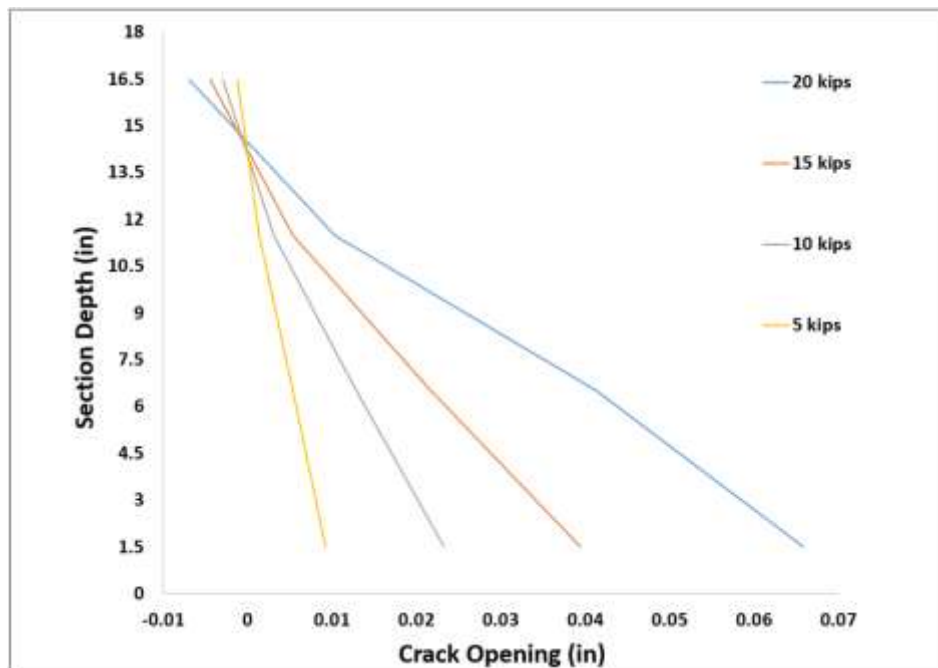
For Specimen 1, the load-displacement curve, load-deflection profile, crack-opening profile, and load-crack opening curve were plotted, as shown in Figures 28-31, respectively.

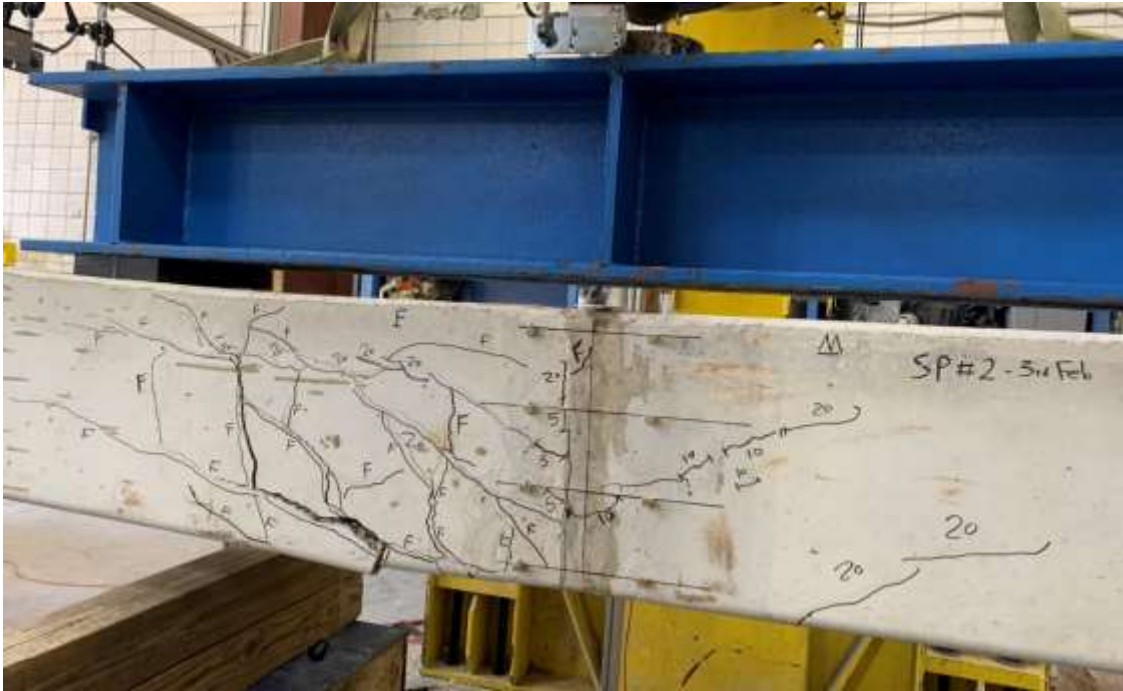
**Figure 32: Crack propagation and failure mode of Specimen 2**

In Specimen 2, a crack was observed in the splice section prior to the test setup. In this test, the first new flexural crack was observed in the splice section at Step 1, load  $\leq 5$  kips. Moreover, the first splitting crack was detected at Step 2 (load  $\leq 10$  kips) at the second level of strands from the top, the second level of strands from the bottom, and at the midsection level. As the load increased, additional splitting cracks developed on both sides of the splice section. These cracks extended farther until the specimen reached its maximum load at 20.53 kips with a large opening consistent with splitting due to bond failure at the bottom of the section in the female segment. Figure 32 shows the failure mode and crack pattern for this test specimen. The maximum moment capacity was calculated for this specimen to be 139.38 k-ft, taking into account the moment from the self-weight of the specimen and the spreader beam.

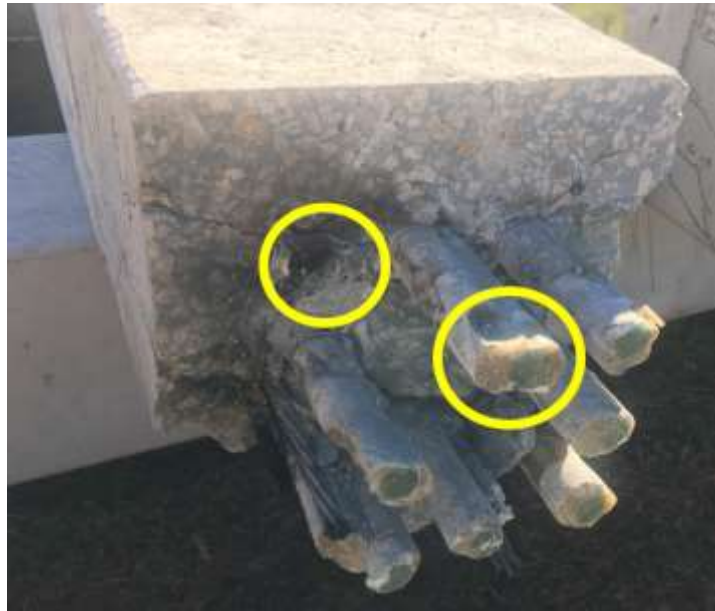
**Figure 33: The oversized slanted holes**

Dissection after testing revealed some issues with the holes drilled in the female segment to receive the dowels. Apparently, secondary drilling was performed to align with the dowels. Figure 33 shows the oversized slanted hole. It is also clear from this figure that the splitting cracks in concrete have bridged the oversized hole, likely resulting in lower over strength for the specimen.

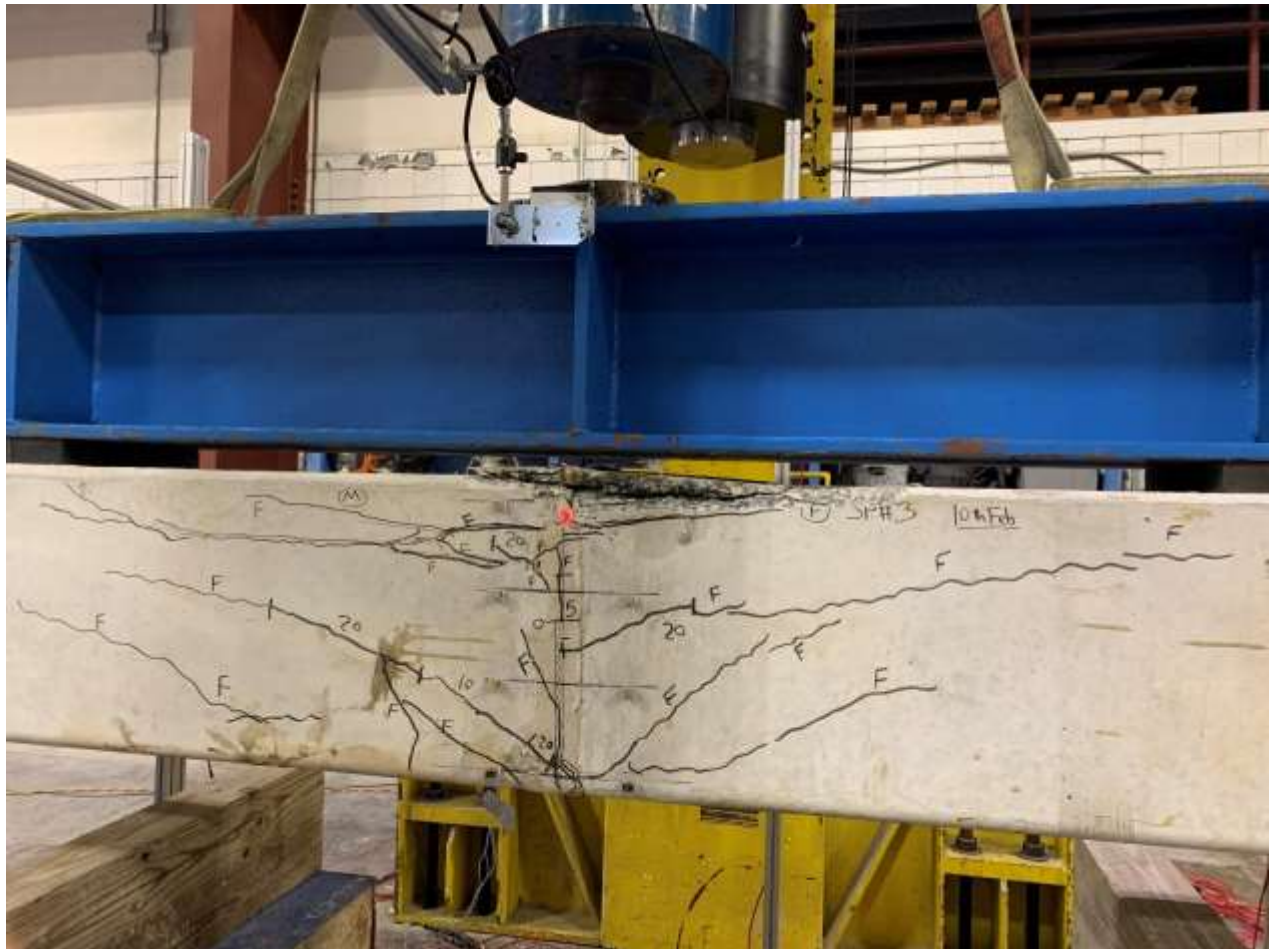
Figure 38: Crack propagation and failure mode of Specimen 3

In Specimen 3, a crack was observed in the splice section prior to the test setup. In this test, the first new flexural crack was observed in the splice section at Step 1, load  $\leq 5$  kips. Moreover, the first splitting crack was detected at Step 2 (load  $\leq 10$  kips) at the first and second levels of strands from the bottom of the section. As the load increased, additional splitting cracks developed on both sides of the splice section. These cracks extended farther until the specimen failed at 41.72 kips with concrete crushing at the top of the pile at the splice section. Figure 38 shows the failure mode and crack pattern for this test specimen. The maximum moment capacity was calculated for this specimen to be 247.98 k-ft, taking into account the moment from the self-weight of the specimen and the spreader beam.

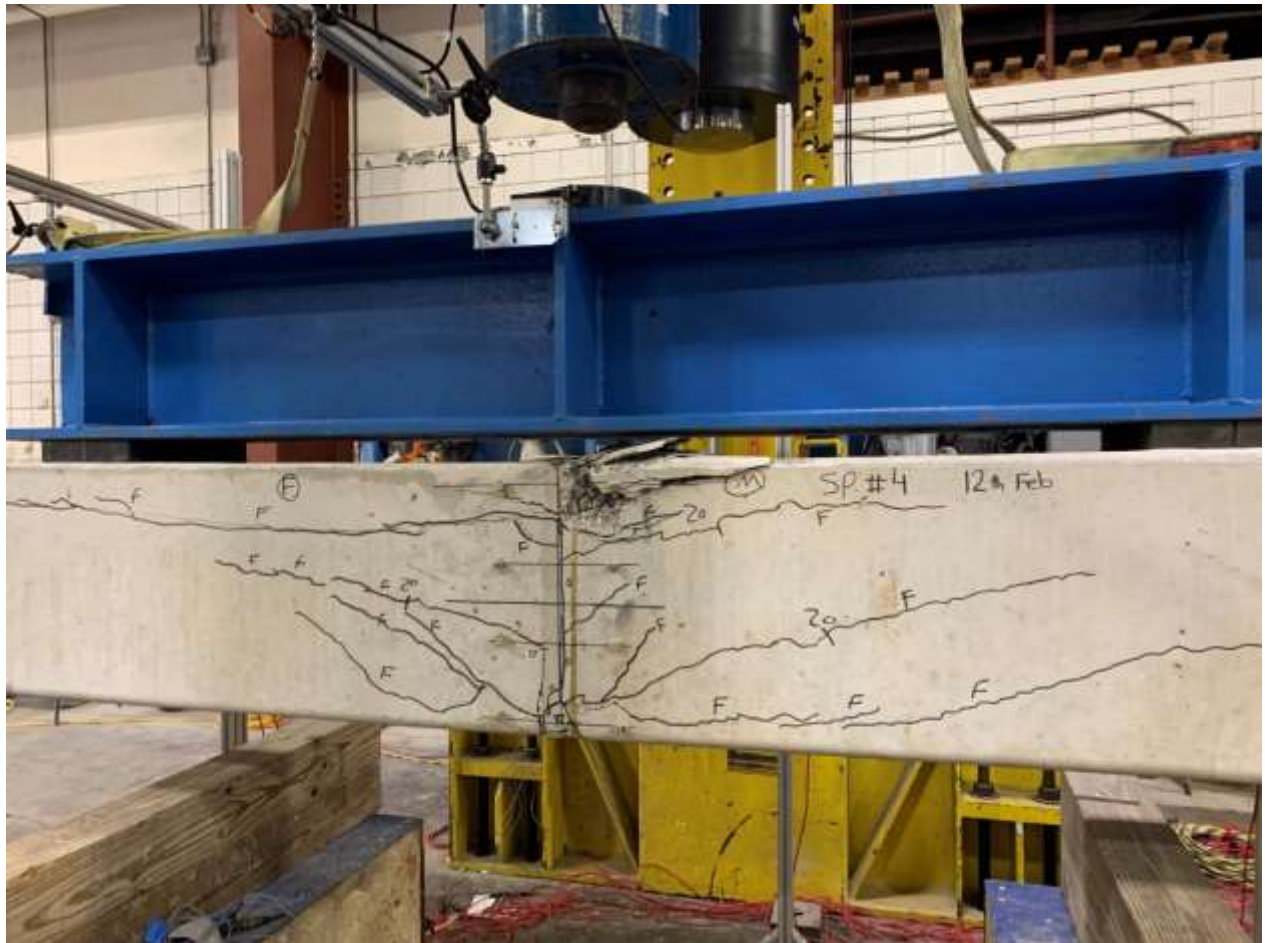
Figure 43: Crack propagation and failure mode of Specimen 4

In this specimen, a crack was observed in the splice section prior to the test setup. In this test, the first new flexural crack was observed in the splice section at Step 1, load  $\leq 5$  kips. Moreover, the first splitting crack was detected at Step 2 (load  $\leq 10$  kips) at the second level of strands from the bottom of the section. As the load increased, additional splitting cracks developed on both sides of the splice section. These cracks extended farther until the specimen failed at 41.26 kips with concrete crushing at the top of the pile at the splice section. Figure 43 shows the failure mode and crack pattern for this test specimen. The maximum moment capacity was calculated for this specimen to be 245.62 k-ft, taking into account the moment from the self-weight of the specimen and the spreader beam.

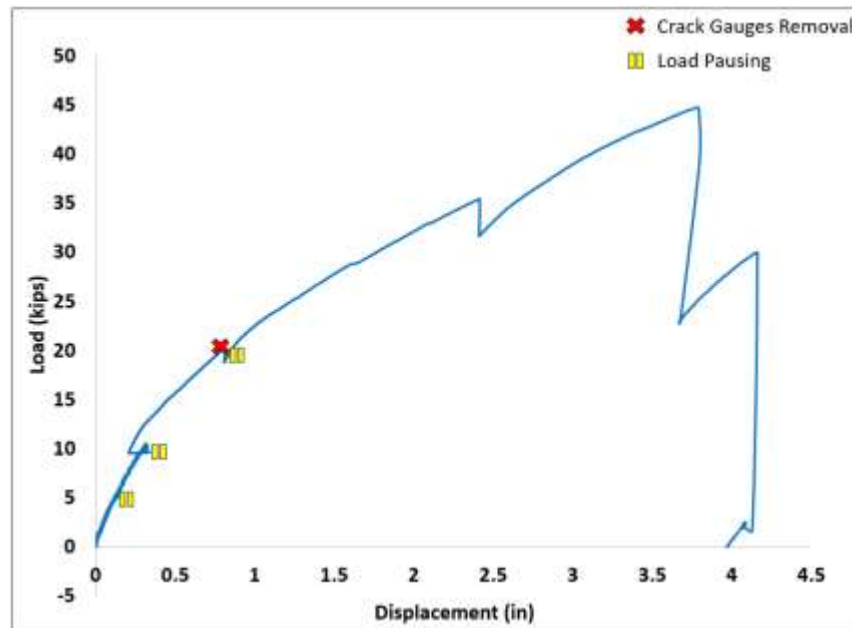
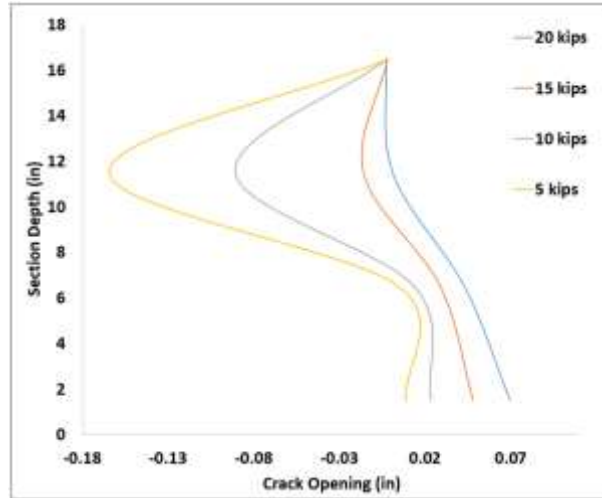
For Specimen 5, the load-displacement curve, load-deflection profile, crack-opening profile, and load-crack opening curve were plotted, as shown in Figures 49-52, respectively.
