1. Report No. FIU-EDPSE-04	2. Government Accession No.	3. Recipient's Catalog No.	
4. Title and Subtitle  <b>Epoxy Dowel Pile Splice Evaluation</b>		5. Report Date March 2021

# Epoxy Dowel Pile Splice Evaluation

**Project No. BDV29-977-52**

**Interim Report – Task 4 Deliverable**

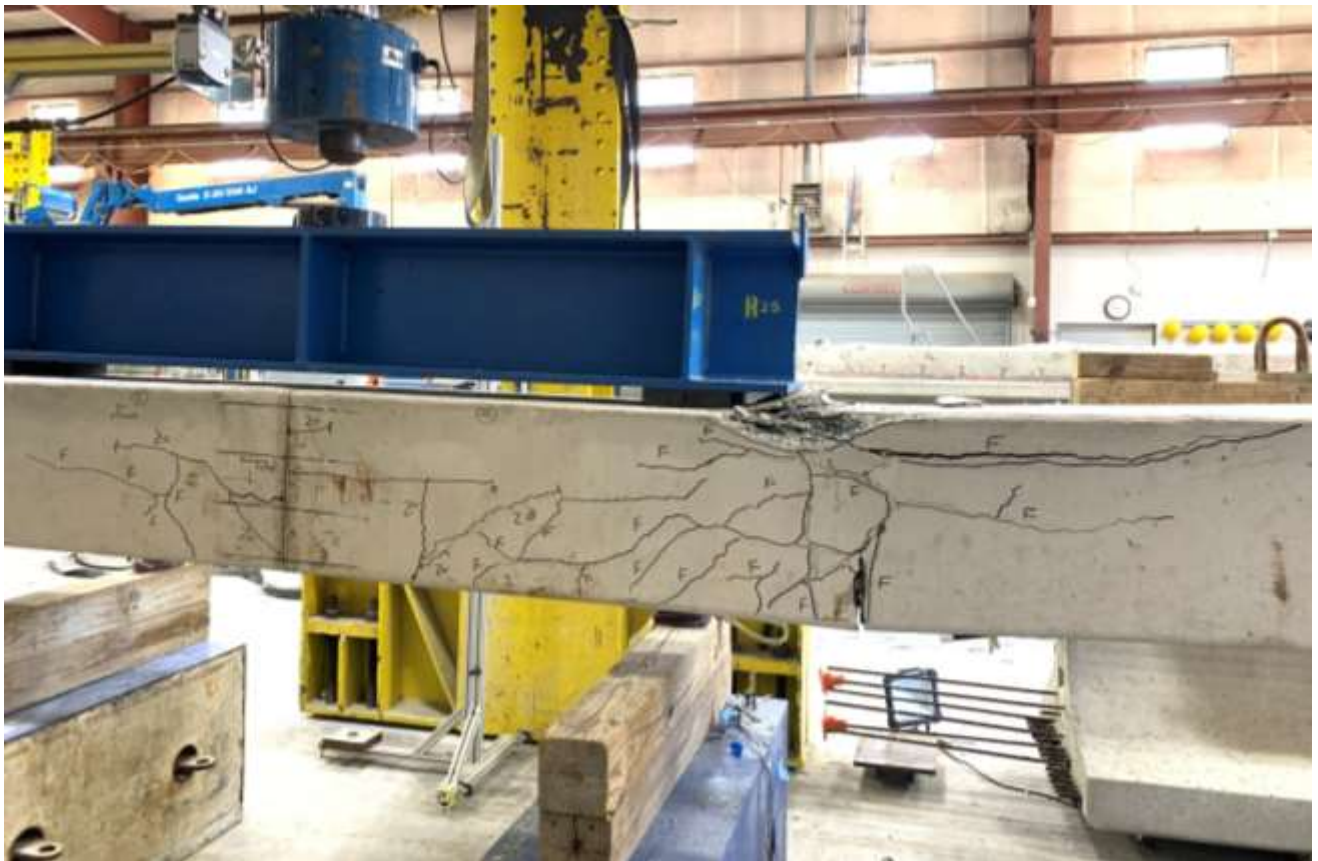
Figure 53: Crack propagation and failure mode of Specimen 6

In this specimen, a crack was observed in the splice section prior to the test setup. In this test, the first splitting crack was detected at Step 2 (load  $\leq 10$  kips) in the upper level of the dowel and the second level of strands from the top of the section. As the load increased, additional splitting cracks developed on both sides of the splice section. These cracks extended farther until the specimen failed at 43.59 kips with a large opening in the male segment at 4ft and 6in from the splice section, which is in the proximity of the end of the dowel's length. The test was continued until the concrete crushed at the top of the section in the male segment at 30.91 kips. Figure 53 shows the failure mode and crack pattern for this test specimen. The maximum moment capacity was calculated for this specimen to be 257.57 k-ft, taking into account the moment from the self-weight of the specimen and the spreader beam.

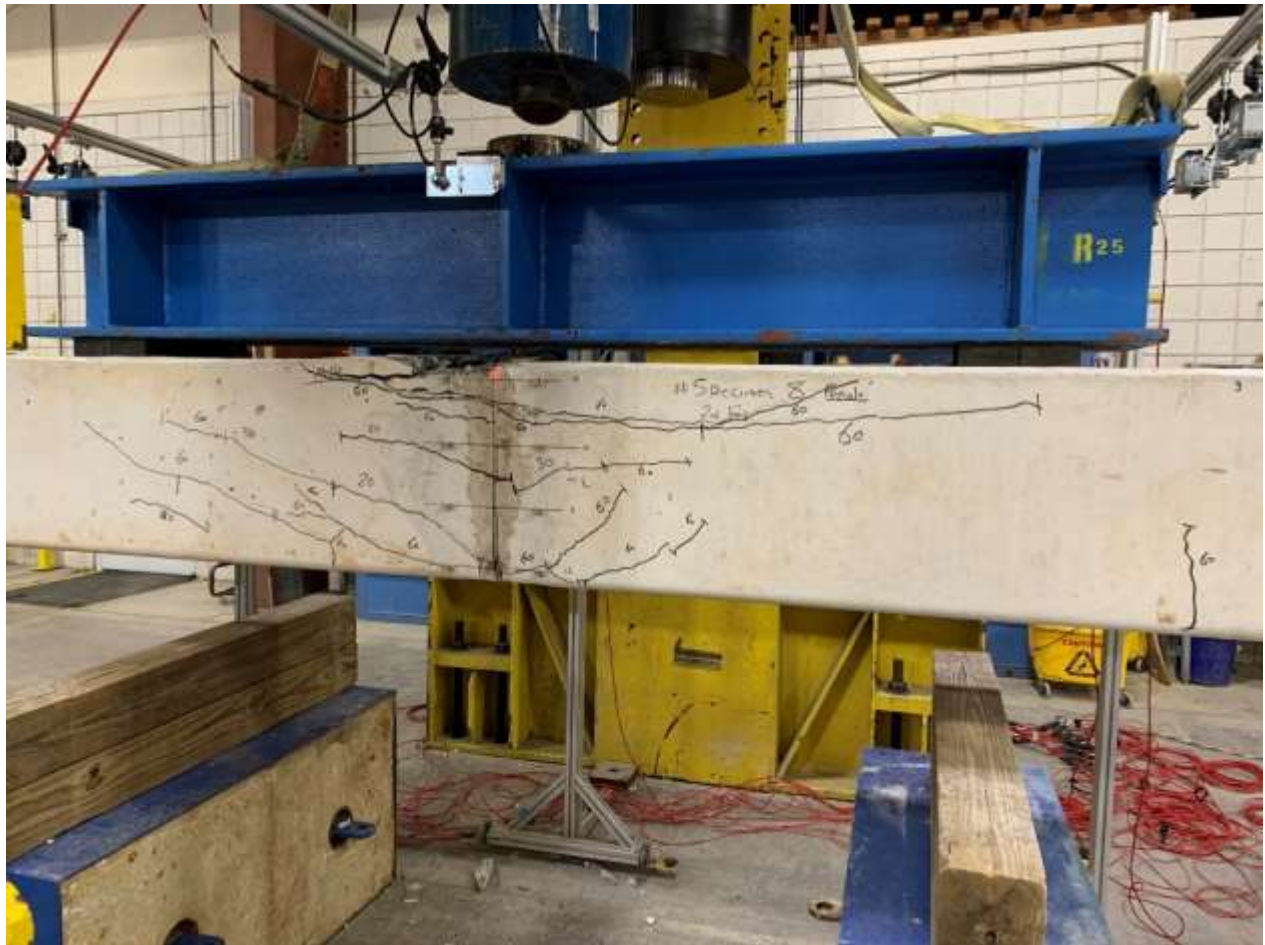
**Figure 63: Crack propagation and failure mode of Specimen 8**

In Specimen 8, a crack was observed in the splice section prior to the test setup. In this test, the first new flexural crack was observed at splice section at Step 1, load  $\leq 5$  kips. Furthermore, the first splitting crack was detected at Step 2 (load  $\leq 10$  kips) at the midsection level. As the load increased, additional splitting cracks developed on both sides of the splice section at the level of the lowest strands and midsection. These cracks extended farther until the specimen failed at 59.82 kips with the concrete crushing at the top of the pile near the splice section. Figure 63 shows the failure mode and crack pattern for this test specimen. The maximum moment capacity was calculated for this specimen to be 340.75 k-ft, taking into account the moment from the self-weight of the specimen and the spreader beam.

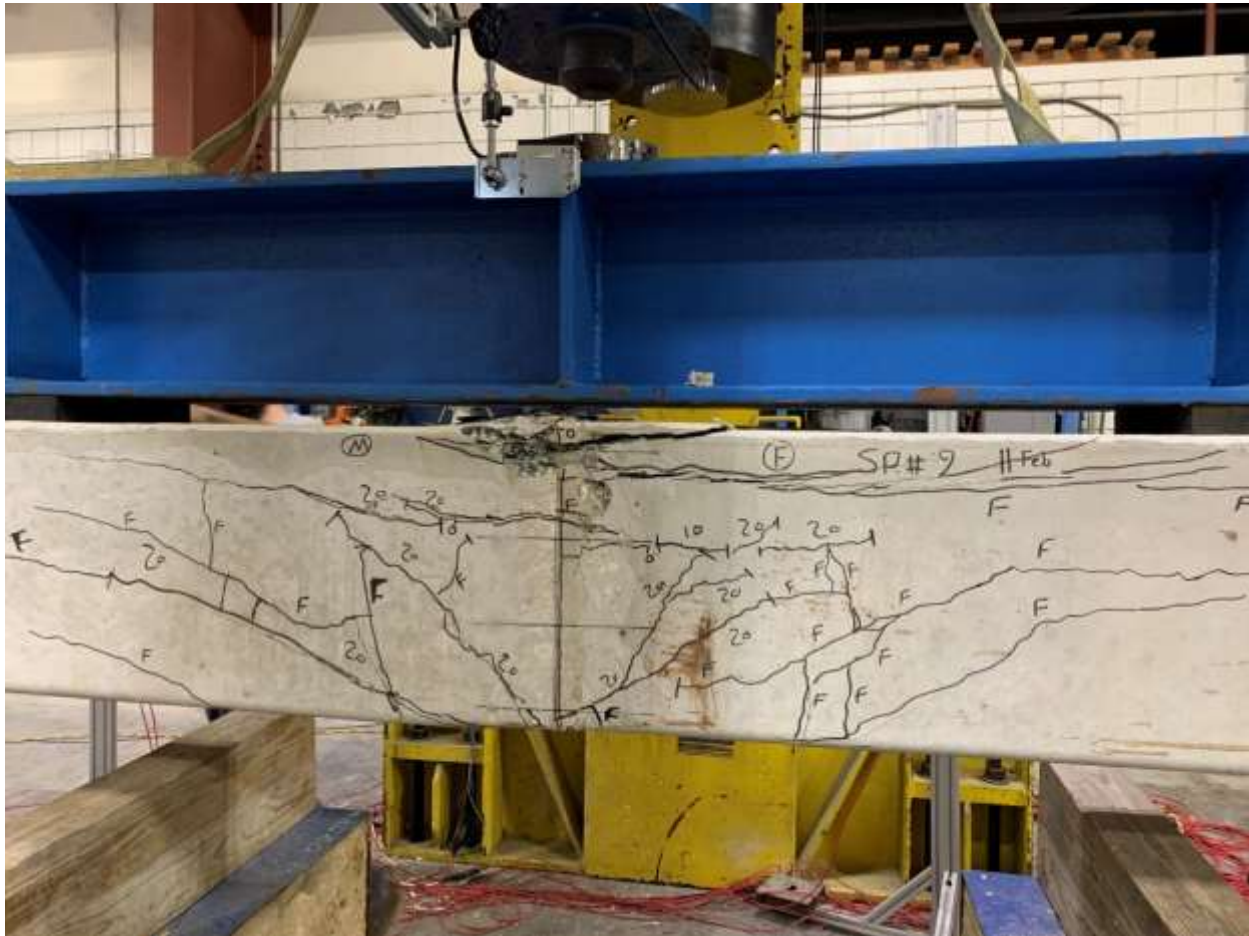
**Figure 68: Crack propagation and failure mode of Specimen 9**

In Specimen 9, a crack was observed in the splice section prior to the test setup. In this test, the first splitting crack was detected at Step 2 (load  $\leq 10$  kips) at the first and second levels of strands from the top of the section. As the load increased, additional splitting cracks developed on both sides of the splice section. These cracks extended farther until the specimen failed at 36.95 kips with the concrete crushing at the top of the pile at the splice section. Figure 68 shows the failure mode and crack pattern for this test specimen. The maximum moment capacity was calculated for this specimen to be 223.54 k-ft, taking into account the moment from the self-weight of the specimen and the spreader beam.

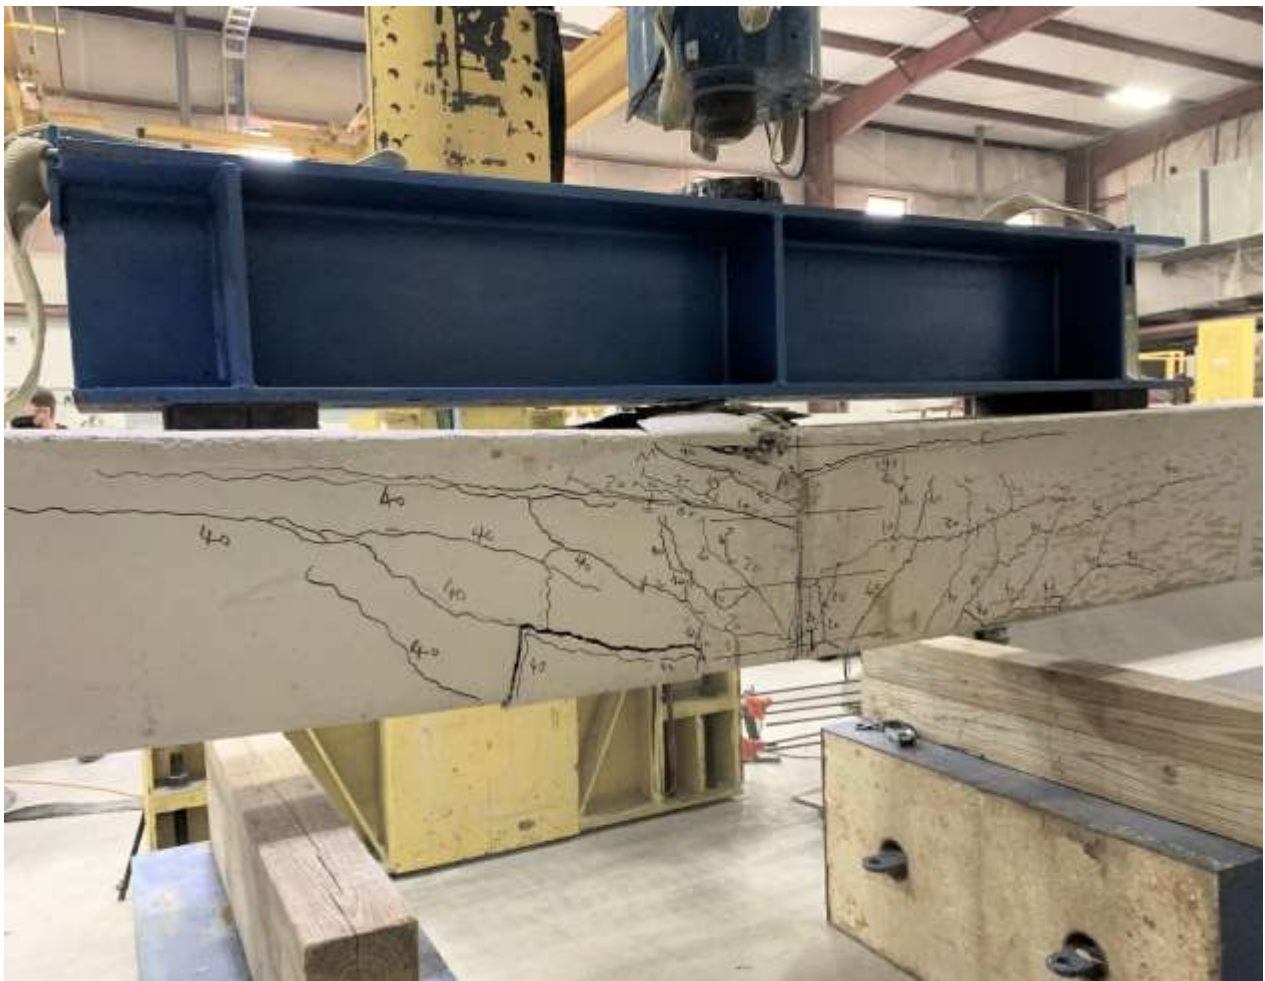
**Figure 73: Crack propagation and failure mode of Specimen 10**

In Specimen 10, a crack was observed in the splice section prior to the test setup. In this test, the first new flexural crack was observed in the splice section at Step 2 (load  $\leq 10$  kips). In addition, the first splitting crack was detected at Step 2 (load  $\leq 10$  kips) at the second level of strands from the top and midsection. As the load increased, additional splitting cracks developed on both sides of the splice section. These cracks extended farther until the specimen failed at 40.98 kips with the concrete crushing at the top of the pile at the splice section. Prior to the concrete crushing, horizontal and vertical cracks showed large openings consistent with splitting due to bond failure in the male segment. Figure 73 shows the failure mode and crack pattern this test specimen. The maximum moment capacity was calculated for this specimen to be 244.19 k-ft, taking into account the moment from the self-weight of the specimen and the spreader beam.
